## **RCRA Inspection Report**

Lockheed Martin Space Company (LMS)  
5100 Standby Road  
Stennis Space Center, Mississippi 39529

**COMPLIANCE EVALUATION Inspection**

**MSR000100834**

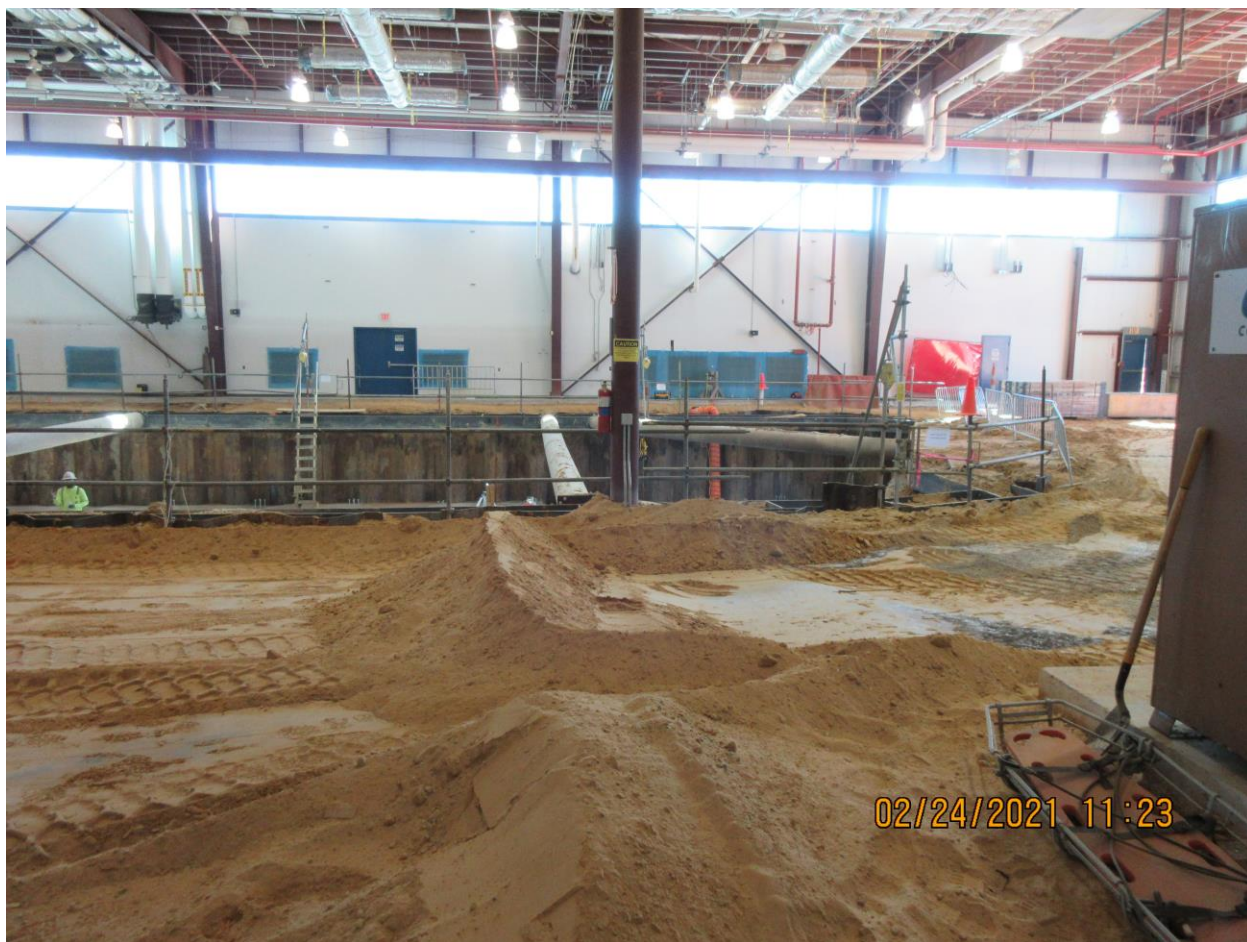
Photo 1 – New Electroplating Area

This area was also currently under new construction (Photos 1 & 2) and will be used in the future for electroplating and possible chemical conversion coating of various parts. No hazardous wastes were observed in this area at the time of the inspection. After the CEI, a phone meeting was conducted on March 4, 2021, between representatives of the EPA, MDEQ, LMS and the operator of the Stennis Space Center wastewater treatment plant.

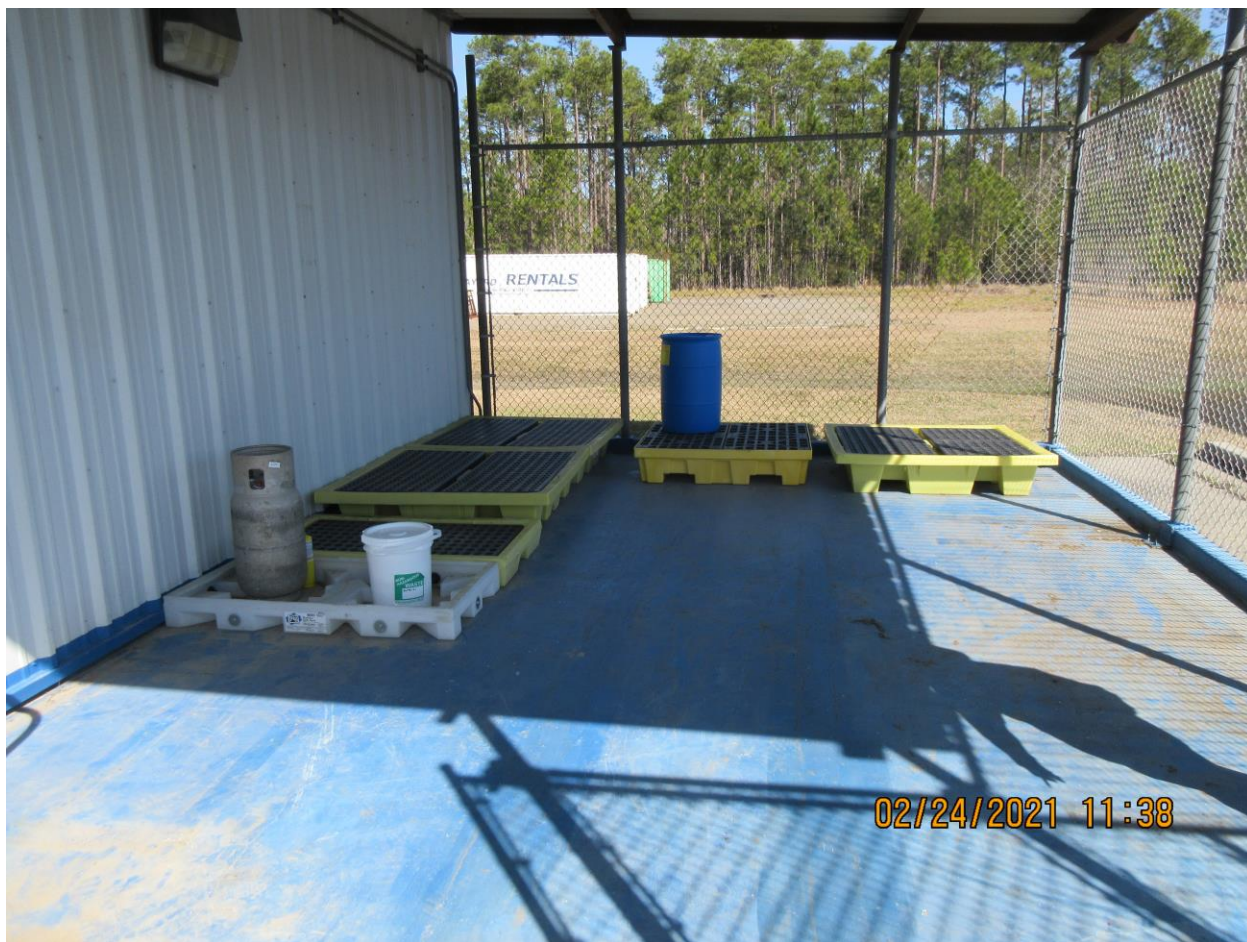
Photo 3 – Hazardous Waste Accumulation Area

This area consisted of a fenced cage on top of a bermed concrete pad beneath a metal roof (Photo 3).

One 30-gallon container of spent x-ray fixer (D002 corrosive hazardous waste) was observed in

this area at the time of the inspection. The container was closed, marked with the words “Hazardous Waste,” an accumulation start date (2/22/2021) and an indication of the hazard of the contents. One 5-gallon container of nonhazardous alkaline batteries was also observed in this area. The area was equipped with a fire extinguisher and spill equipment at the time of the inspection.

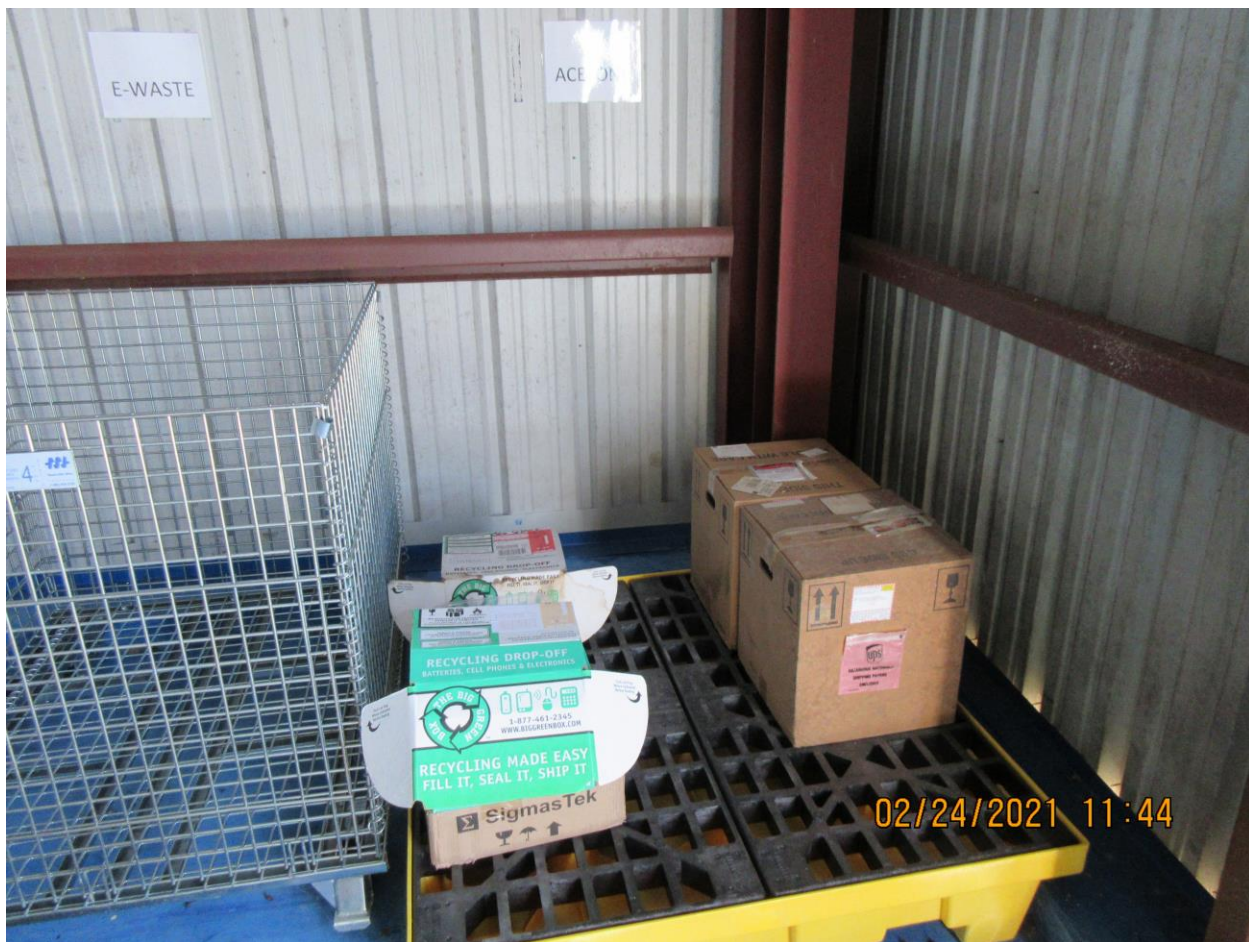
A cage located within a building located adjacent to the Hazardous Waste Accumulation Area for the management for electronic waste was empty at the time of the inspection (Photo 4).

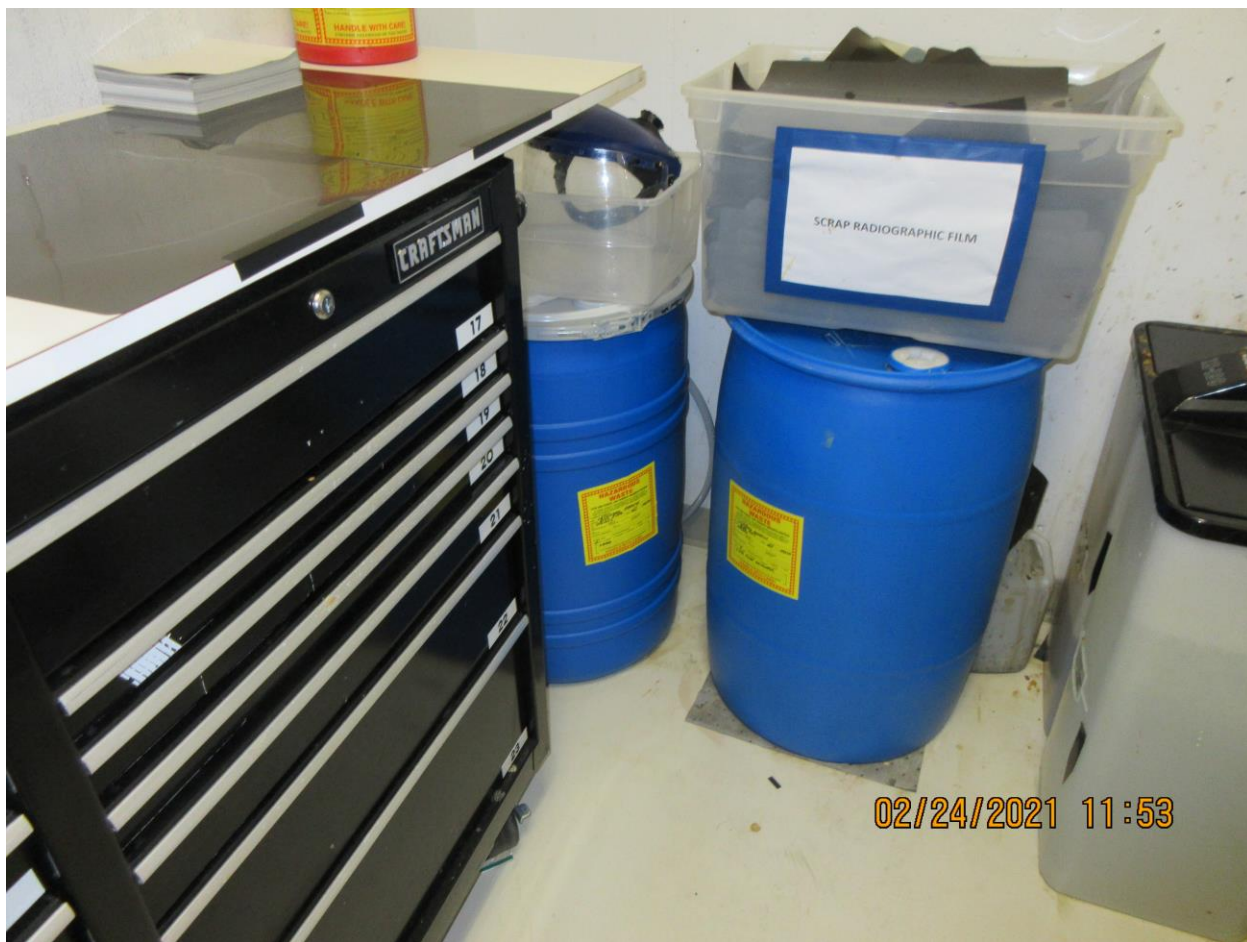
Photo 5 – X-ray Dark Room

This area is used for the X-ray of parts for quality control. Two 30-gallon containers (Photo 5) of hazardous waste were managed within SAAs in this area at the time of the inspection. One of the containers managed spent x-ray developer. The other container managed spent lead materials from the x-ray process. Each of the containers were closed, marked with the words “Hazardous Waste” and an indication of the hazard of the contents.
