## **RCRA Inspection Report**

NCSU Main Campus  
2620 Wolf Village Way  
Raleigh, NC 27695

EPA ID#: NCD000830737  
NAICS #: 61131 – Colleges, Universities, and  
Professional Schools

## Appendix 1- NCSU Main Campus RCRA CEI Photographs

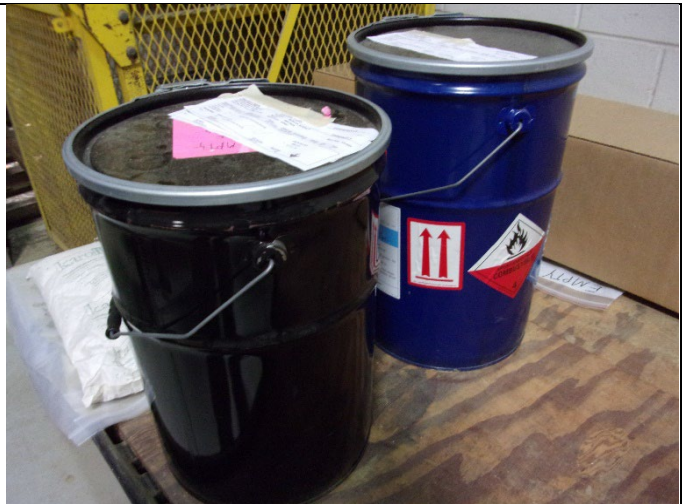
NCSU also manages reactive wastes generated by campus laboratories and a flammable cage with compressed gas cylinders in this area (Figure 3). Inspectors observed two 5-gallon containers which were closed, marked with an accumulation start date, labeled hazardous waste, and identified with an indication of the hazards of the contents (Figures 1 and 2).

Figure 2: July 11, 2023, 9:24 AM WMF: Room 214-R Reactives  
Two (2) 5-gallon containers with hazardous waste label, accumulation start date, and indication of the hazards of the contents.

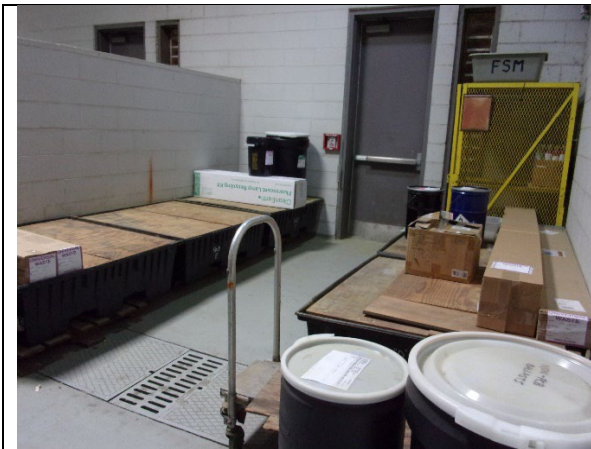
NCSU manages universal waste lamps in Cell 214-R. The inspectors observed three 4-foot, two (2) 12-foot, one 5-gallon, and one 1-foot by 1-foot box containers of universal waste lamps in this area during the inspection. Each container of lamps was closed, marked with an

accumulation start date, and were labeled universal waste lamps (Figure 3). The oldest date observed on any container of lamps was May 17, 2023.

Figure 3: July 11, 2023, 9:25 AM WMF: Room 214-R Reactives  
Overall perspective of Room 214-R Reactives with universal waste lamps and flammable cage.

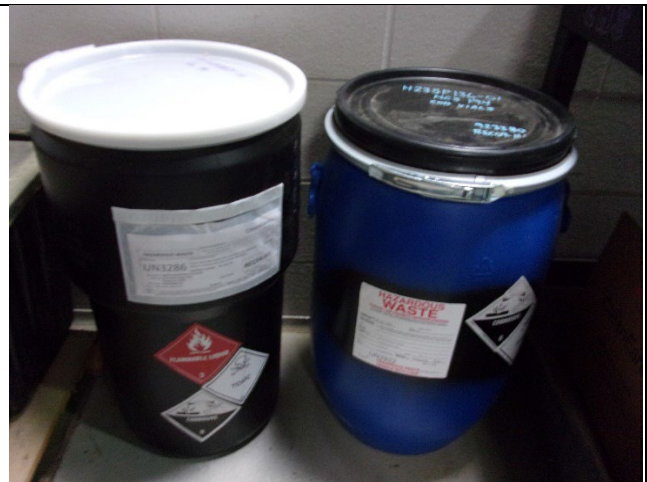
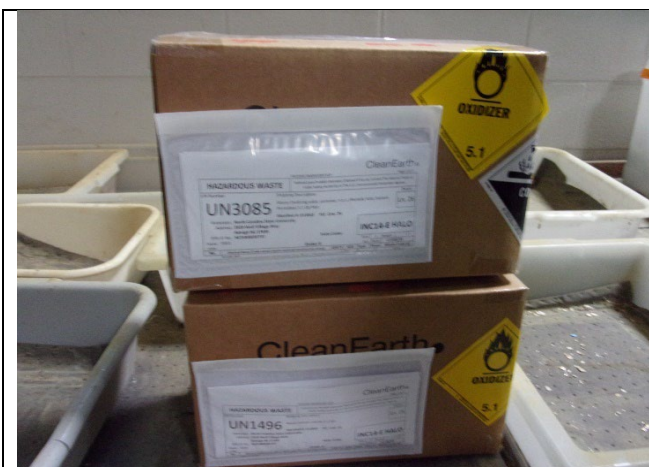
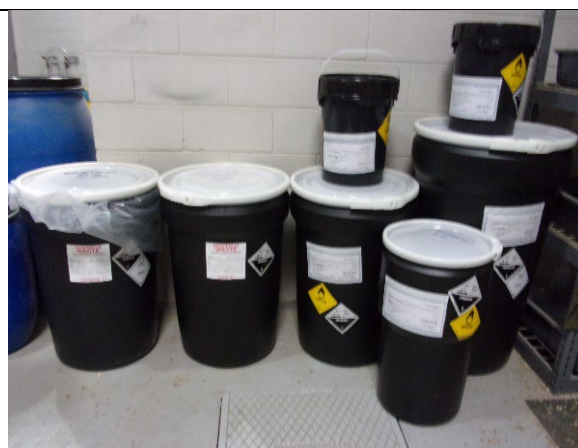
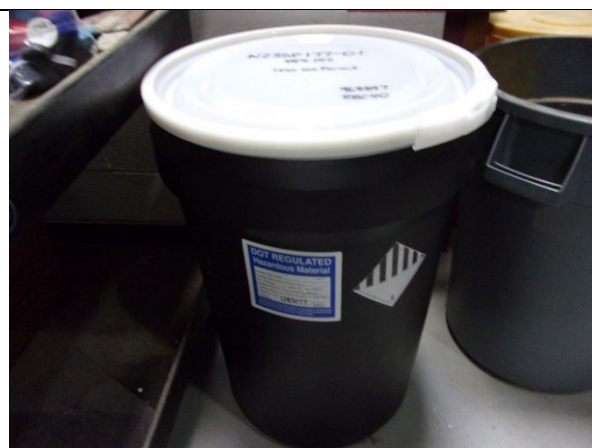
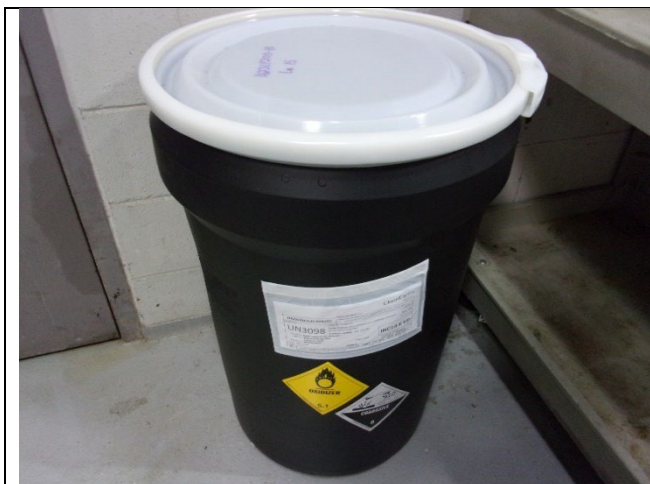
NCSU manages inorganic waste generated by campus laboratories in this section of the WMF. Inspectors observed all containers within Cell 214-I closed, marked with an accumulation start date, labeled hazardous waste, and identified with an indication of hazards of the contents (Figure 4 through 9).

Figure 4: July 11, 2023, 9:33 AM WMF: Room 214-I Inorganic  
Two (2) 15-gallon containers with hazardous waste label, accumulation start date, and indication of the hazards of the contents.

Figure 5: July 11, 2023, 9:34 AM WMF: Room 214-I Inorganic  
Two (2) 1-foot by 1-foot containers with hazardous waste label, accumulation start date, and indication of the hazards of the contents.

Figure 6: July 11, 2023, 9:41 AM WMF: Room 214-I Inorganic  
One 55-gallon, three 30-gallon, one 15-gallon, and two (2) 5-gallon lab packs with hazardous waste label, accumulation start date, and indication of the hazards of the contents.

Figure 7: July 11, 2023, 9:45 AM WMF: Room 214-I Inorganic  
One container of used batteries and one container of lithium-ion batteries with hazardous waste label, accumulation start date, and indication of the hazards of the contents.

Figure 8: July 11, 2023, 9:46 AM WMF: Room 214-I Inorganic  
One 30-gallon container of "Lead for Recycle" DOT regulated material.

Figure 9: July 11, 2023, 9:47 AM WMF: Room 214-I Inorganic  
One 30-gallon container with hazardous waste label, accumulation start date, and indication of the hazards of the contents.

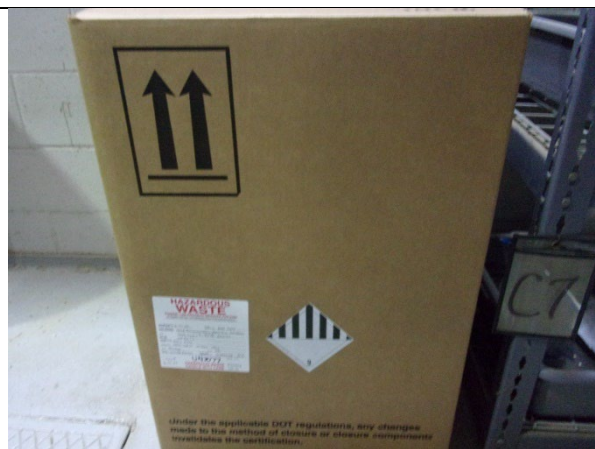
**Pursuant to 15A NCAC 13A .0107(a) [40 C.F.R. § 262.17(a)(5)(i)], which is a condition of the LQG Permit Exemption, a generator must mark or label its containers with the following: the words “Hazardous Waste”; an indication of the hazards of the contents; and the date upon which each period of accumulation begins clearly visible for inspection on each container.**

Figure 10: July 11, 2023, 9:50 AM WMF: Room 214-O Organic  
One 2.5-foot by 2-foot container with hazardous waste label, accumulation start date, and no proper indication of the hazards of the contents.

Figure 11: July 11, 2023, 9:50 AM WMF: Room 214-O Organic  
One 2.5-foot by 2-foot container with hazardous waste label, accumulation start date, and no proper indication of the hazards of the contents.

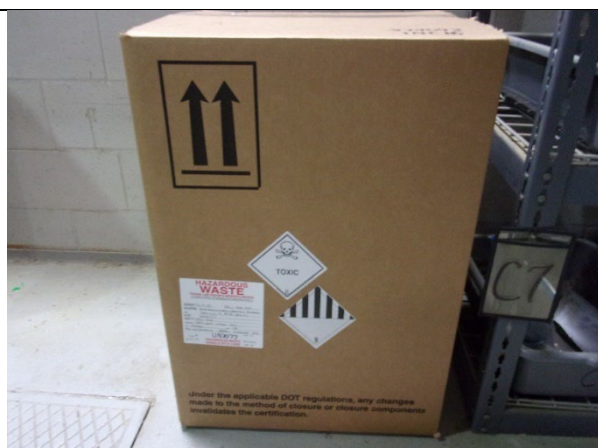
NCSU utilizes Cell 214-O for managing hazardous waste organics generated by laboratories within the campus. The inspectors observed one 55-gallon, one 15-gallon, one 5-gallon, and one 2.5-foot by 2-foot box of containers in this storage area. The 55-gallon, 15-gallon, and 5-gallon containers were closed, labeled hazardous waste, and identified with an indication of hazards of the contents. The inspectors observed the 2.5-foot by 2-foot box closed, labeled D008 and D022 hazardous waste solid, with no indication of hazards of the contents (Figures 10 and 11). Facility personnel corrected the indication of the hazards of the contents at the time of the inspection (Figure 12).

Figure 12: July 11, 2023, 9:51 AM WMF: Room 214-O Organic  
One 2.5-foot by 2-foot container with hazardous waste label, accumulation start date, and corrected indication of the hazards of the contents.

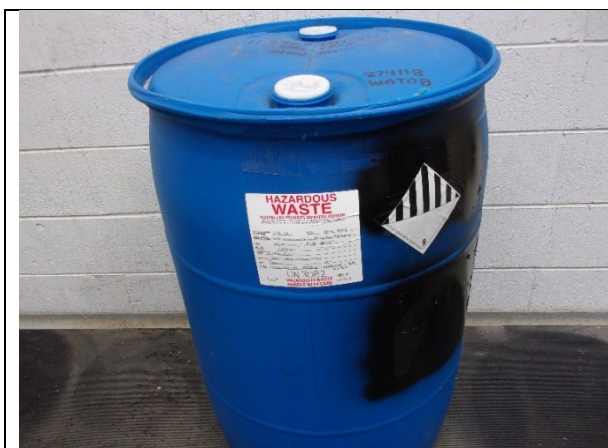
Inspectors also observed five 55-gallon, two 35-gallon, four 8-gallon, and one 5-gallon containers within this storage area. All containers were marked with an accumulation start date and labeled hazardous waste. All of the containers except for one 35-gallon container had an indication of hazards of the contents (Figure 13 and 14). Facility personnel corrected the indication of the hazards of the contents at the time of the inspection.

**Pursuant to 15A NCAC 13A .0107(a) [40 C.F.R. § 262.17(a)(5)(i)], which is a condition of the LQG Permit Exemption, a generator must mark or label its containers with the following: the words “Hazardous Waste”; an indication of the hazards of the contents; and the date upon which each period of accumulation begins clearly visible for inspection on each container.**

Figure 13: July 11, 2023, 10:06 AM WMF: Room 215  
One 35-gallon container with hazardous waste label, accumulation start date, and no proper indication of the hazards of the contents.

Figure 14: July 11, 2023, 10:06 AM WMF: Room 215  
One 35-gallon container with hazardous waste label, accumulation start date, and no proper indication of the hazards of the contents.

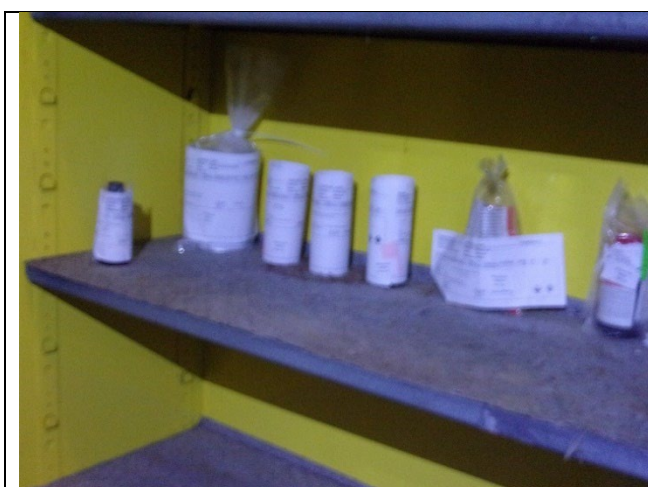
Inspectors observed discoloration from absorbent padding for reactive metals (e.g., lithium metal) within a flammable cabinet (Figure 15). Although, containers did not appear to be leaking, odors occurred after opening the flammable cabinet. Inspectors recommended Facility personnel to replace the padding in case the padding was creating the odor.

Figure 15: July 11, 2023, 10:26 AM WMF: Room 209  
Seven (7) containers under absorbent padding inside flammable cabinet.

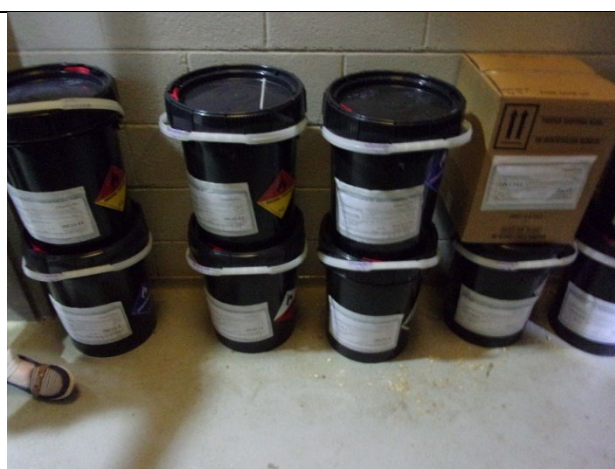
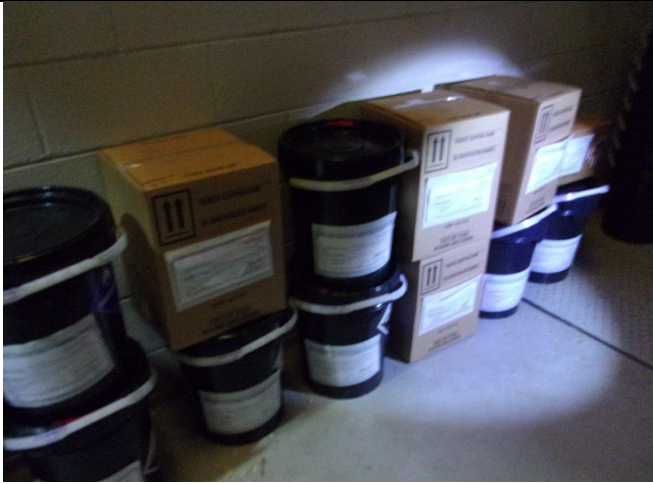
At the time of the inspection, inspectors observed 11 5-gal containers, five (5) one-foot square boxes, and 15 containers of various sizes ranging from 100-milliliter to 500-milliliter bottles (Figures 16 and 17). The containers consisted of various chemicals such as vanadium, phosphorus pentoxide, sodium hydrosulfide, and bromine. The Permit states that the maximum storage capacity for Room 209 is 45-gallons. The inspectors observed containers totaling more than 90-gallons.

**Pursuant to HW Permit NCD000830737-R2, Part III- Storage in Containers, the Permittee shall store no more than 45-gallons of hazardous waste in Room 209. Dabney Hall**

Figure 16: July 11, 2023, 10:30 AM WMF: Room 209  
11 5-gal containers, five (5) one-foot by one-foot boxes.

Figure 17: July 11, 2023, 10:30 AM WMF: Room 209  
11 5-gal containers, five one-foot by one-foot boxes.

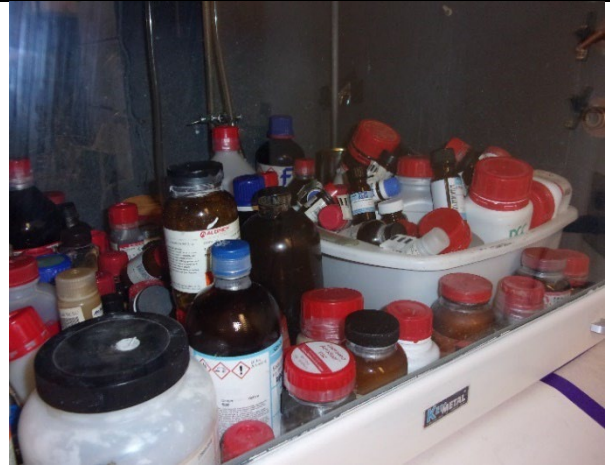
In the Laboratory Management Plan, it states "Laboratories should conduct routine reviews of inventories and chemical stocks to identify any obsolete chemicals or substances at least once per quarter." Inspectors observed in a fume hood multiple containers unorganized and placed in a secondary containment bin (Figure 18). Inspectors asked Facility personnel the reasoning for the arrangement. Facility personnel stated that Room 842 was currently undergoing an inventory check to determine whether any of the containers would be considered unwanted material. At the time of the inspection, it was unclear of when the inventory check was last conducted. Inspectors recommended Facility personnel organize the containers to prevent potential mishandling, damage, or use while making unwanted material determinations.

**Pursuant to 15A NCAC 13A .0107 (g) [40 C.F.R. § 262.206(a)(2)], the following information may be affixed or attached to the container, but must at a minimum be associated with the container: (i) the date that the unwanted material first began accumulating in the container, and (ii) information sufficient to allow a trained professional to properly identify whether an unwanted material is a solid and hazardous waste and to assign the proper hazardous waste code(s), pursuant to 40 C.F.R. § 262.11. Examples of information that would allow a trained professional to properly identify whether an unwanted material is a solid or hazardous waste include, but are not limited to: (A) The name and/or description of the chemical contents or composition of the unwanted material, or, if known, the product of the chemical reaction, (B) Whether the unwanted material has been used or is unused, and (C) A description of the manner in which the chemical was produced or processed, if applicable.**

Figure 18: July 12, 2023, 8:59 AM Dabney Hall: Room 842  
Fume hood with multiple containers unorganized and placed in a secondary containment bin.

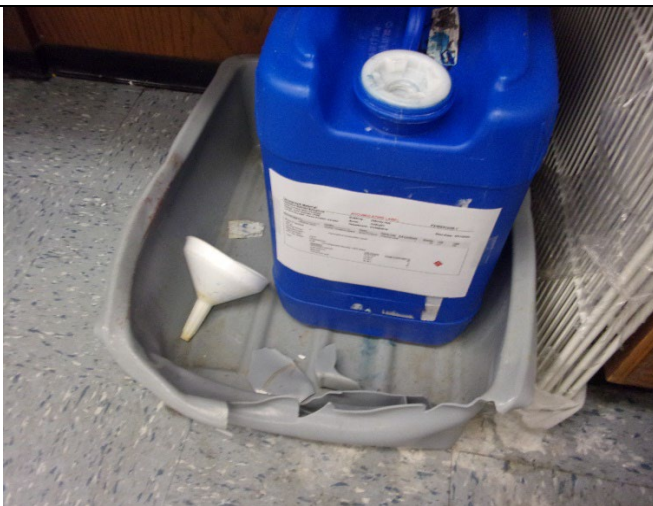
Inspectors observed a 3-gallon container with a damaged secondary containment bin (Figure 19). Inspectors recommended Facility personnel to replace the secondary containment bin and was replaced at the time of the inspection. Under the Laboratory Management Plan, it states "Areas where unwanted materials are accumulated must have secondary containment sufficient to collect incidental spills that might occur when adding waste to containers."

Figure 19: July 12, 2023, 9:14 AM Dabney Hall: Room 847  
Damaged secondary containment bin.

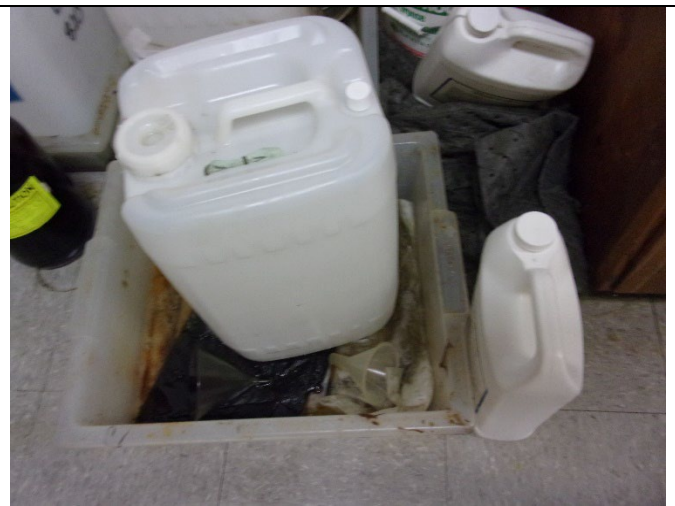
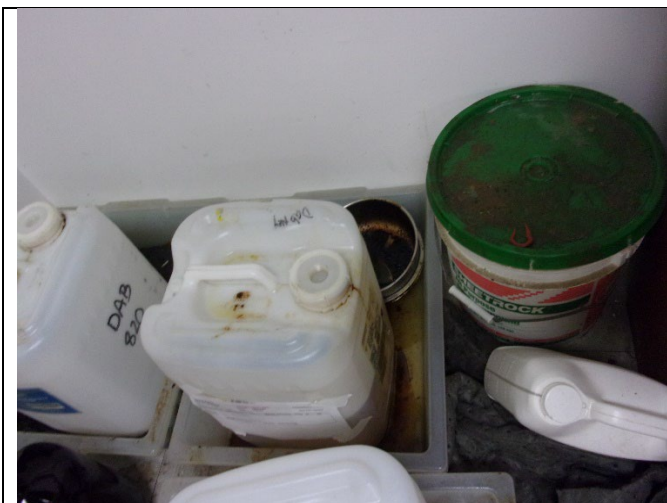
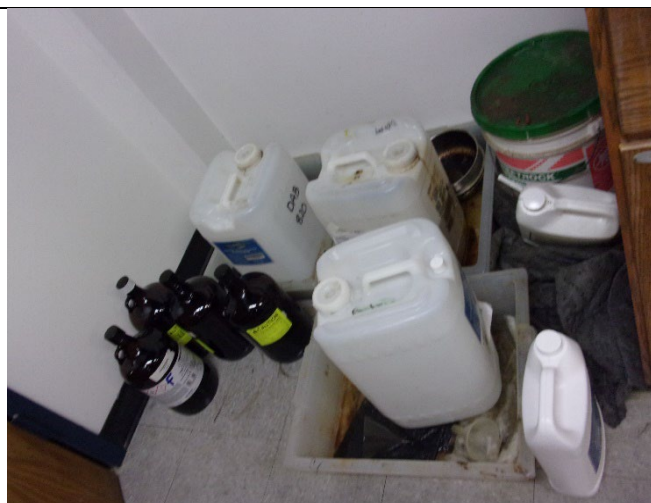
Inspectors observed a used oil spill within their secondary containment bin (Figures 20 through 22). Inspectors asked Facility personnel to clean up the spill. Facility personnel cleaned up the spill at the time of the inspection.

- At the time of the inspection, the inspectors observed the following:
    - used oil spill in Room 820.

Figure 20: July 12, 2023, 9:21 AM Dabney Hall: Room 820  
Used oil spill within their secondary containment bin.

Figure 21: July 12, 2023, 9:22 AM Dabney Hall: Room 820  
Used oil spill within their secondary containment bin.

Figure 22: July 12, 2023, 9:22 AM Dabney Hall: Room 820  
Used oil spill within their secondary containment bin.

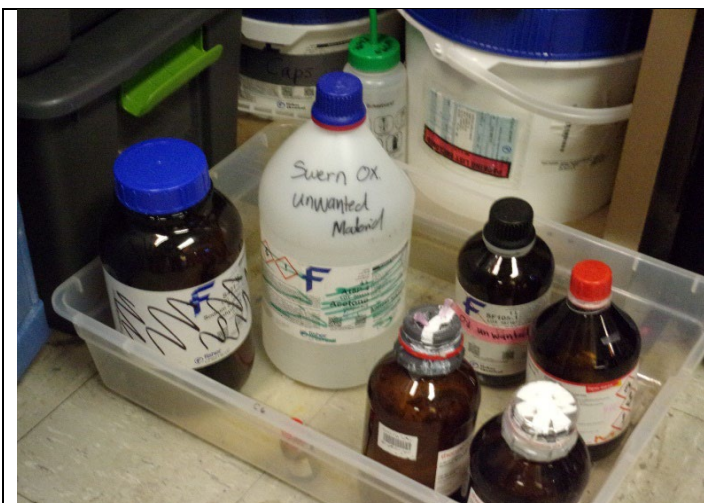
Inspectors asked Facility personnel about the container labeled “Swern Ox Unwanted Material” (Figure 23). Inspectors asked for a waste profile or waste/unwanted material determination since the label did not include an accumulation start date and any sufficient to allow a trained professional to properly identify whether an unwanted material is a solid and hazardous waste.

Figure 23: July 12, 2023, 9:28 AM Dabney Hall: Room 830  
Container labeled "Swern Ox Unwanted Material" in question.

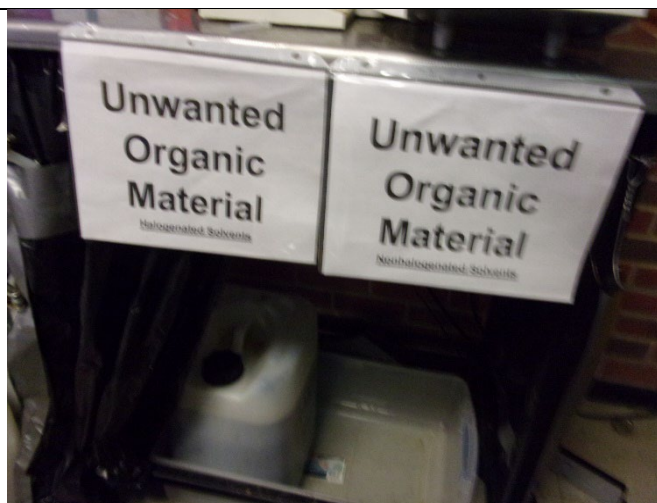
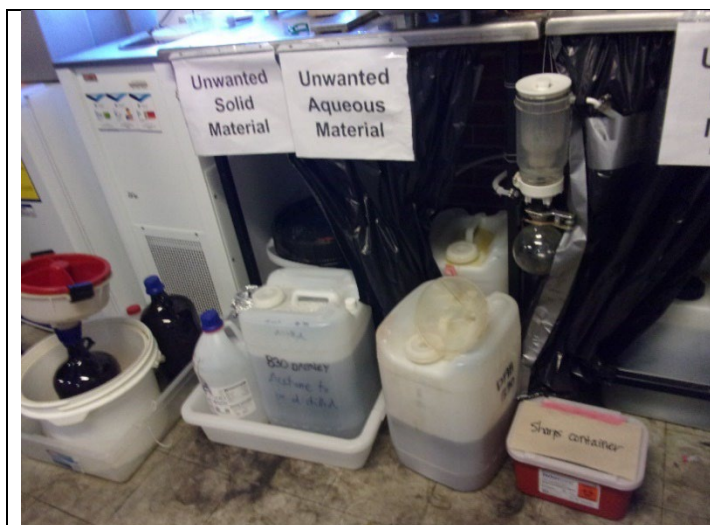
Inspectors observed four (4) 5-gallon containers of unidentified unwanted material. One of the 5-gallon containers was in a section labeled "Unwanted Organic Material" (Figure 24). The other three (3) 5-gallon containers were in a section labeled "Unwanted Aqueous Material" (Figure 25). The four (4) 5-gallon containers did not have an unwanted material label, accumulation start

date, and any sufficient to allow a trained professional to properly identify whether an unwanted material is a solid and hazardous waste.

**Pursuant to 15A NCAC 13A .0107 (g) [40 C.F.R. § 262.206(a)(2)], the following information may be affixed or attached to the container, but must at a minimum be associated with the container: (i) the date that the unwanted material first began accumulating in the container, and (ii) information sufficient to allow a trained professional to properly identify whether an unwanted material is a solid and hazardous waste and to assign the proper hazardous waste code(s), pursuant to 40 C.F.R. § 262.11. Examples of information that would allow a trained professional to properly identify whether an unwanted material is a solid or hazardous waste include, but are not limited to: (A) The name and/or description of the chemical contents or composition of the unwanted material, or, if known, the product of the chemical reaction, (B) Whether the unwanted material has been used or is unused, and (C) A description of the manner in which the chemical was produced or processed, if applicable.**

Figure 24: July 12, 2023, 9:32 AM Dabney Hall: Room 830  
Section labels for "Unwanted Organic Material."

Figure 25: July 12, 2023, 9:32 AM Dabney Hall: Room 830  
Section labels for “Unwanted Solid Material” and “Unwanted Aqueous Material.”

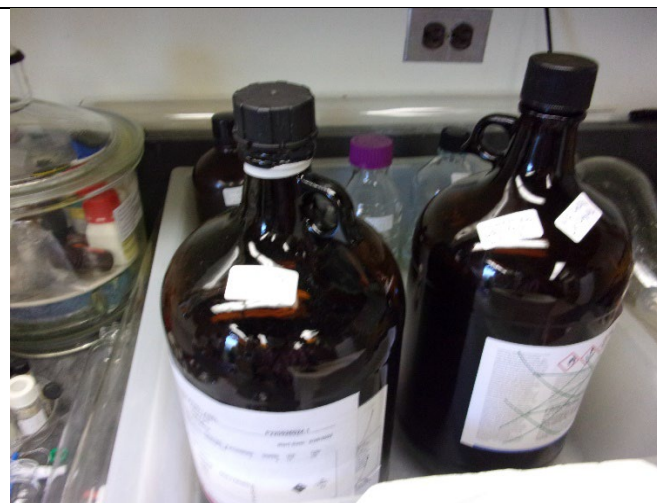
Inspectors observed three (3) 4-liter containers of unwanted material. One of the three (3) containers was labeled “Unwanted Organic Waste No  $\text{CHCl}_3$  or  $\text{CH}_2\text{Cl}_2$ ” (Figures 26 through 28). Note the terms “No  $\text{CHCl}_3$  or  $\text{CH}_2\text{Cl}_2$ ” means no halogens.

Figure 26: July 12, 2023, 9:41 AM Dabney Hall: Room 734  
Two (2) of three (3) 4-liter containers observed.

Figure 27: July 12, 2023, 9:41 AM Dabney Hall: Room 734  
One of the three (3) 4-liter containers were labeled “Unwanted Organic Waste No  $\text{CHCl}_3$  or  $\text{CH}_2\text{Cl}_2$ ” (no halogens).

Figure 28: July 12, 2023, 9:42 AM Dabney Hall: Room 734  
Label with accumulation start date, and indication of the hazards of the contents.

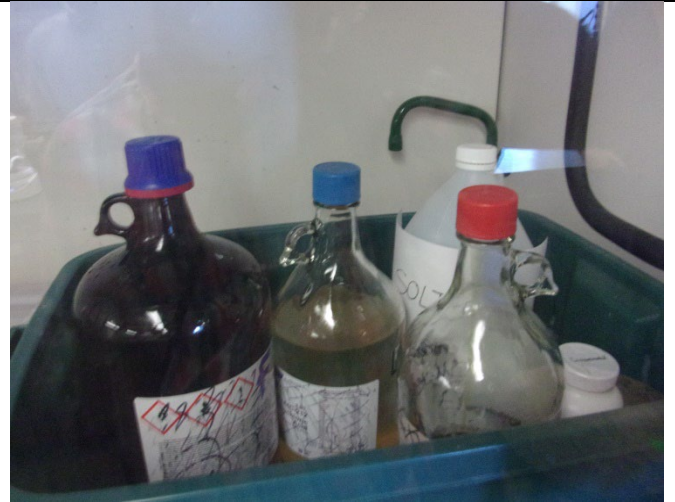
Inspectors observed a fume hood with an unwanted material area and various unidentified containers in a secondary containment bin (Figure 29). The containers observed were two (2) 2.5-liter containers, one 4-liter container, one container with barium sulfate, one container with solid unwanted material, and one container with unknown contents (Figure 30). Inspectors asked Facility personnel to properly identify each container within the secondary containment bin. On July 25, 2023, Facility personnel provided documentation in an email that disposal labels have been requested, obtained and placed on the containers.

**Pursuant to 15A NCAC 13A .0107 (g) [40 C.F.R. § 262.206(a)(2)], the following information may be affixed or attached to the container, but must at a minimum be associated with the container: (i) the date that the unwanted material first began accumulating in the container, and (ii) information sufficient to allow a trained professional to properly identify whether an unwanted material is a solid and hazardous waste and to assign the proper hazardous waste code(s), pursuant to 40 C.F.R. § 262.11. Examples of information that would allow a trained professional to properly identify whether an unwanted material is a**

**solid or hazardous waste include, but are not limited to: (A) The name and/or description of the chemical contents or composition of the unwanted material, or, if known, the product of the chemical reaction, (B) Whether the unwanted material has been used or is unused, and (C) A description of the manner in which the chemical was produced or processed, if applicable.**

Figure 29: July 12, 2023, 9:52 AM Dabney Hall: Room 708 Fume hood with designated unwanted materials area.

Figure 30: July 12, 2023, 9:53 AM Dabney Hall: Room 708 Various unidentified containers in a secondary containment bin.

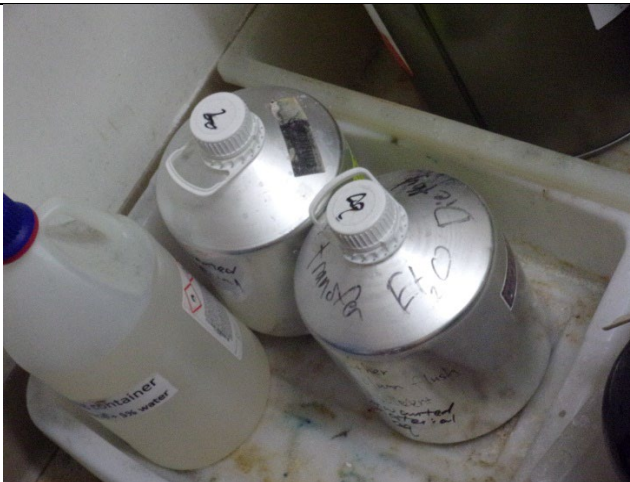
Inspectors observed two (2) 1-liter containers labeled “Diethyl Ether.” The two (2) containers did not have proper unwanted material labels, an accumulation start date, and sufficient to allow a trained professional to properly identify whether an unwanted material is a solid and hazardous waste (Figure 31).

**Pursuant to 15A NCAC 13A .0107 (g) [40 C.F.R. § 262.206(a)(2)], the following information may be affixed or attached to the container, but must at a minimum be associated with the container: (i) the date that the unwanted material first began accumulating in the container, and (ii) information sufficient to allow a trained professional to properly identify whether an unwanted material is a solid and hazardous waste and to assign the proper hazardous waste code(s), pursuant to 40 C.F.R. § 262.11. Examples of information that would allow a trained professional to properly identify whether an unwanted material is a solid or hazardous waste include, but are not limited to: (A) The name and/or description of the chemical contents or composition of the unwanted material, or, if known, the product of the chemical reaction, (B) Whether the unwanted material has been used or is unused, and (C) A description of the manner in which the chemical was produced or processed, if applicable.**

Figure 31: July 12, 2023, 10:04 AM Dabney Hall: Room 722  
Two (2) 1-liter diethyl ether containers not having proper unwanted material labels.

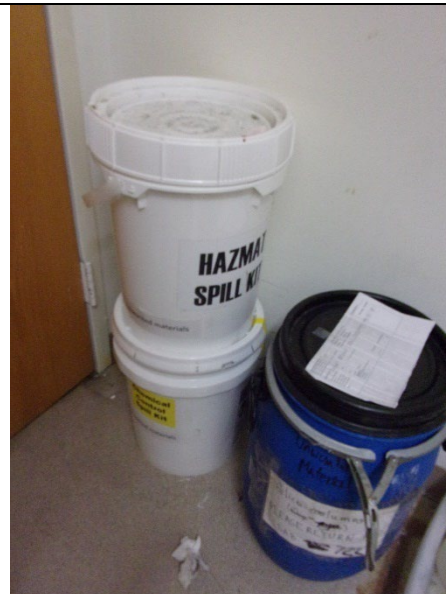
Inspectors observed unwanted material containers, and a hazardous spill kit potentially blocking the back entrance of the laboratory (Figure 32). Inspectors recommended Facility personnel to move the unwanted material in another location to not cause emergency exit issues. Facility personnel corrected it at the time of the inspection.

Figure 32: July 12, 2023, 10:05 AM Dabney Hall: Room 722  
Unwanted material containers, and a hazardous spill kit potentially blocking the back entrance of the laboratory.

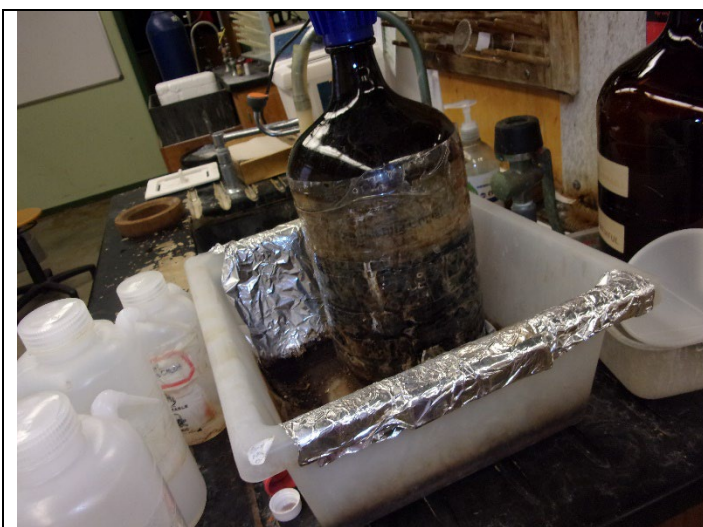
Inspectors observed working containers with stained secondary containment bins (Figures 33 and 34). Inspectors recommended Facility personnel replace the secondary containment bins and was replaced at the time of the inspection.

Figure 33: July 12, 2023, 10:24 AM Dabney Hall: Room 440  
Working container with stained secondary containment bin.

Figure 34: July 12, 2023, 10:25 AM Dabney Hall: Room 440  
Working container with stained secondary containment bin.
