**Region 6 - Enforcement & Compliance Assurance Division**  
**INSPECTION REPORT**

| Regulatory Program: | Water (CWA) Brine Program (Oil & Gas Inspection) | |
| Facility Name: | Kress City Warnock SWD #1 SWD | |

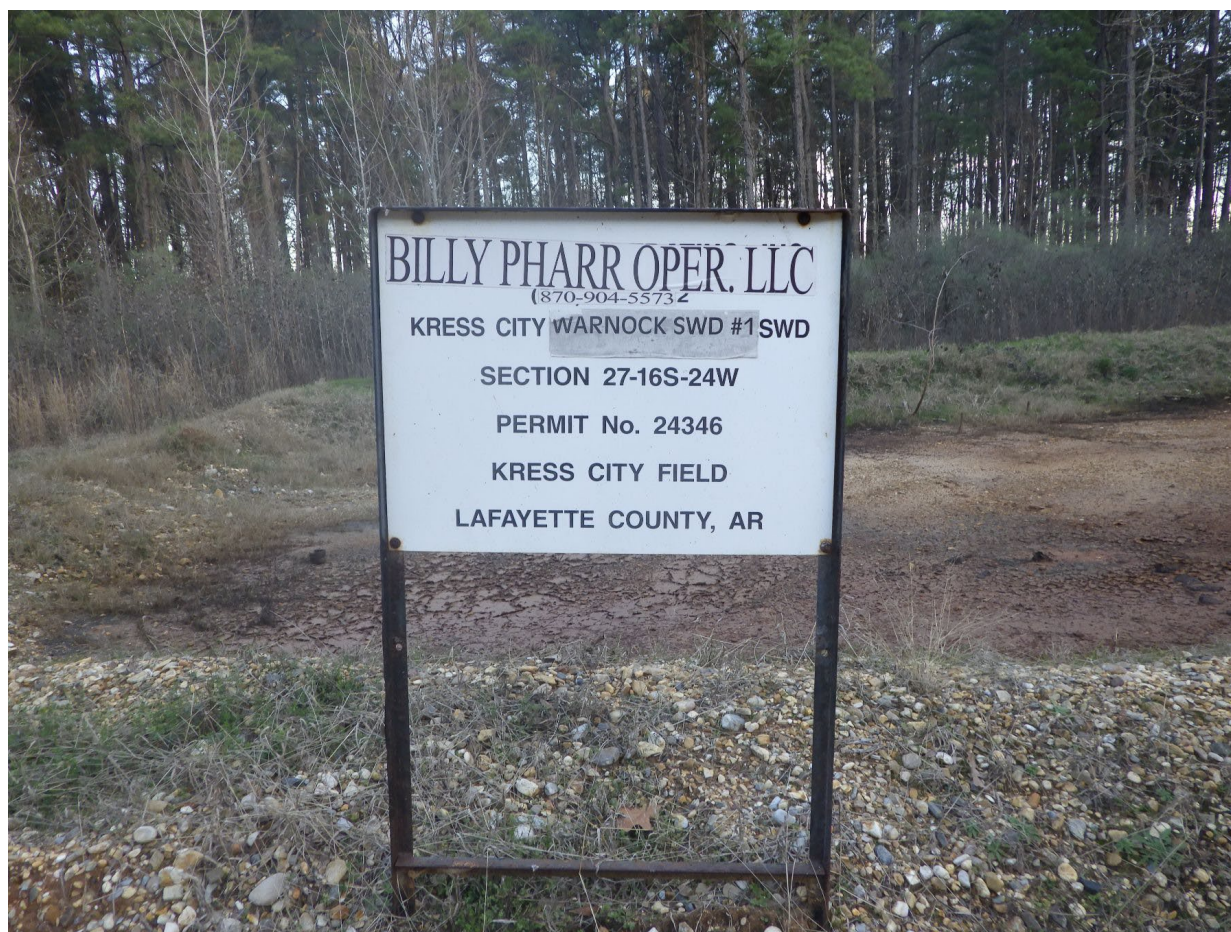
Photo No. 1

| Description: | This photo was taken facing northeast and shows the facility sign. | | |

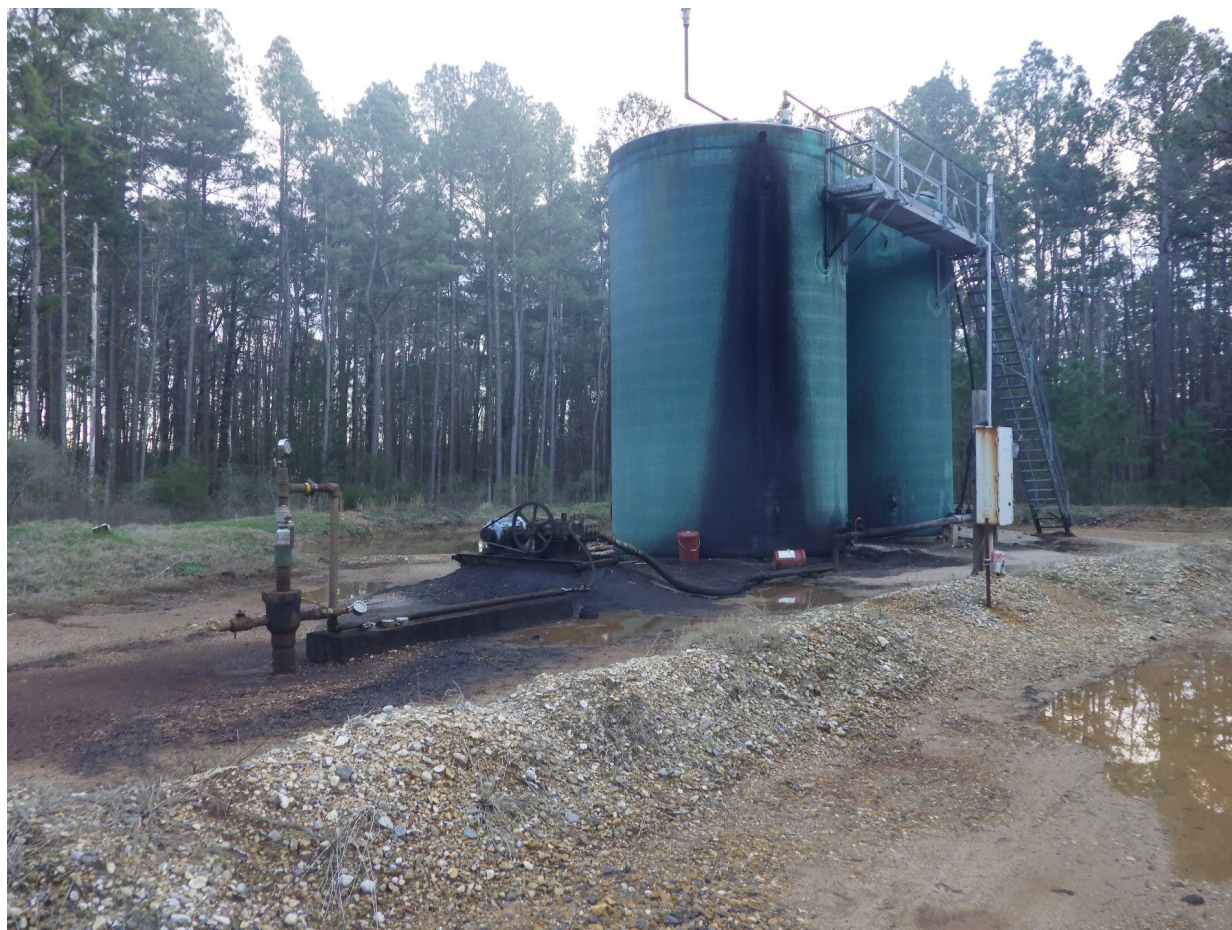
Photo No. 2

| Description: | This photo was taken facing southeast and shows the tank battery and injection well. | | |

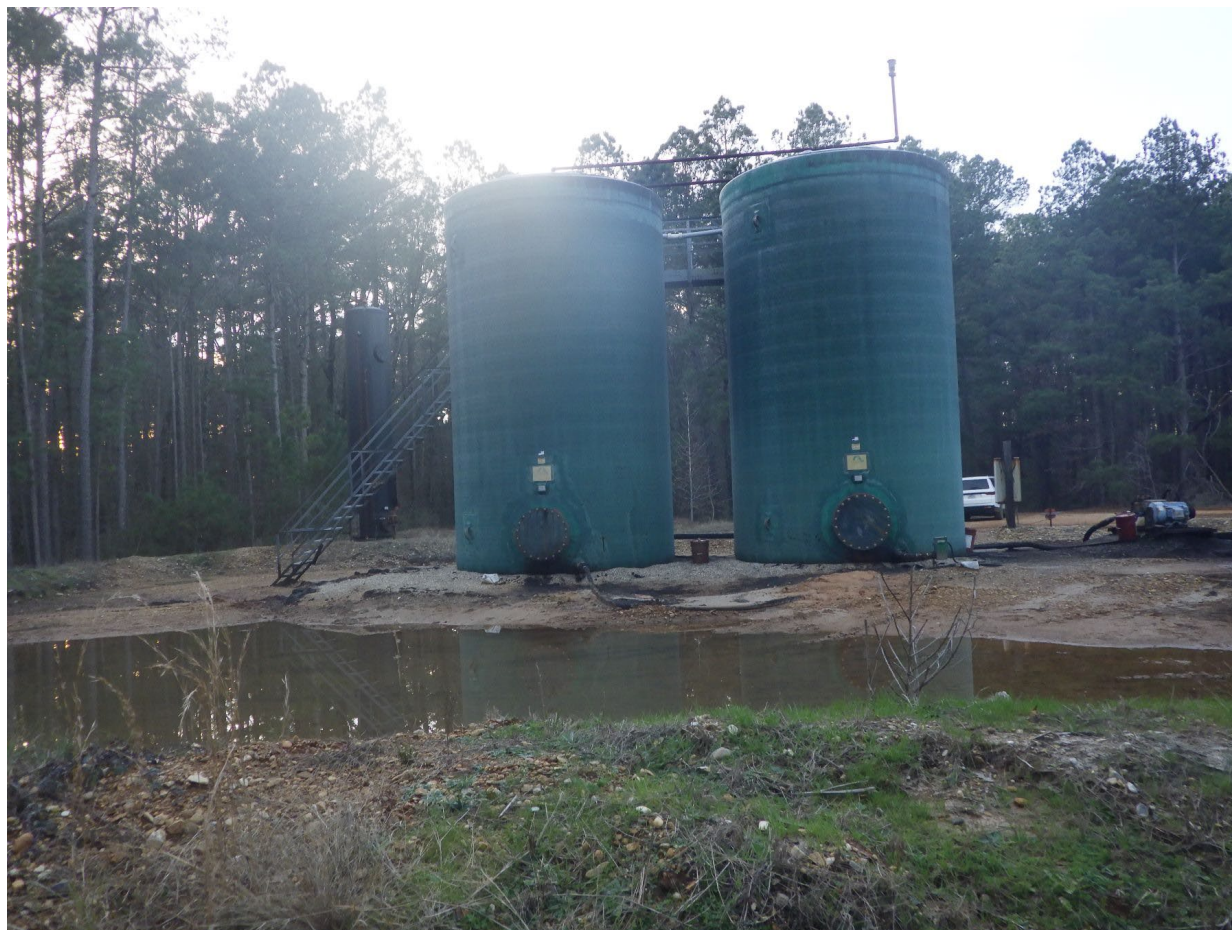
Photo No. 3

| Description: | This photo was taken facing west-northwest and shows another view of the tank battery and injection well. | | |

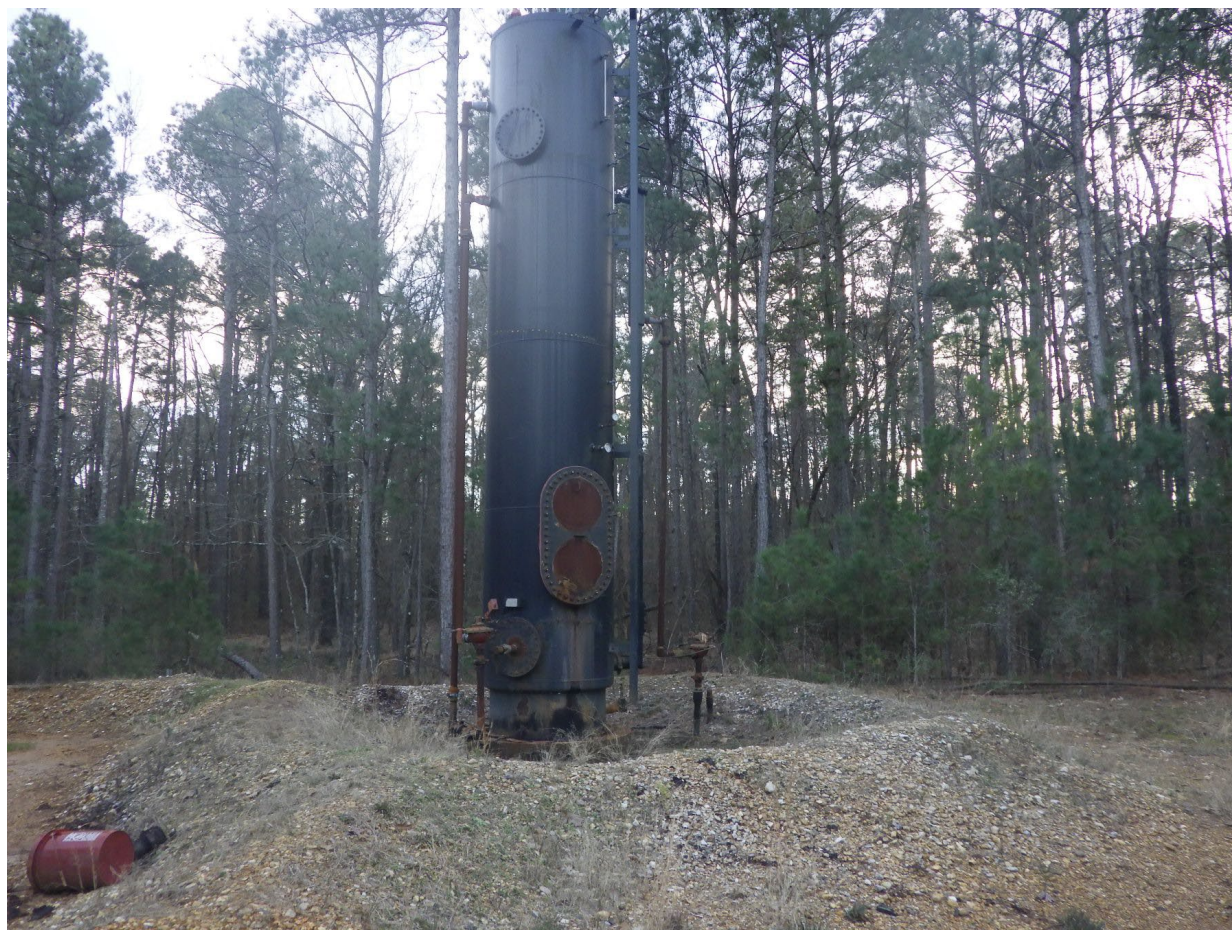
Photo No. 4

| Description: | This photo was taken facing south-southwest and shows a separator at the facility. | | |

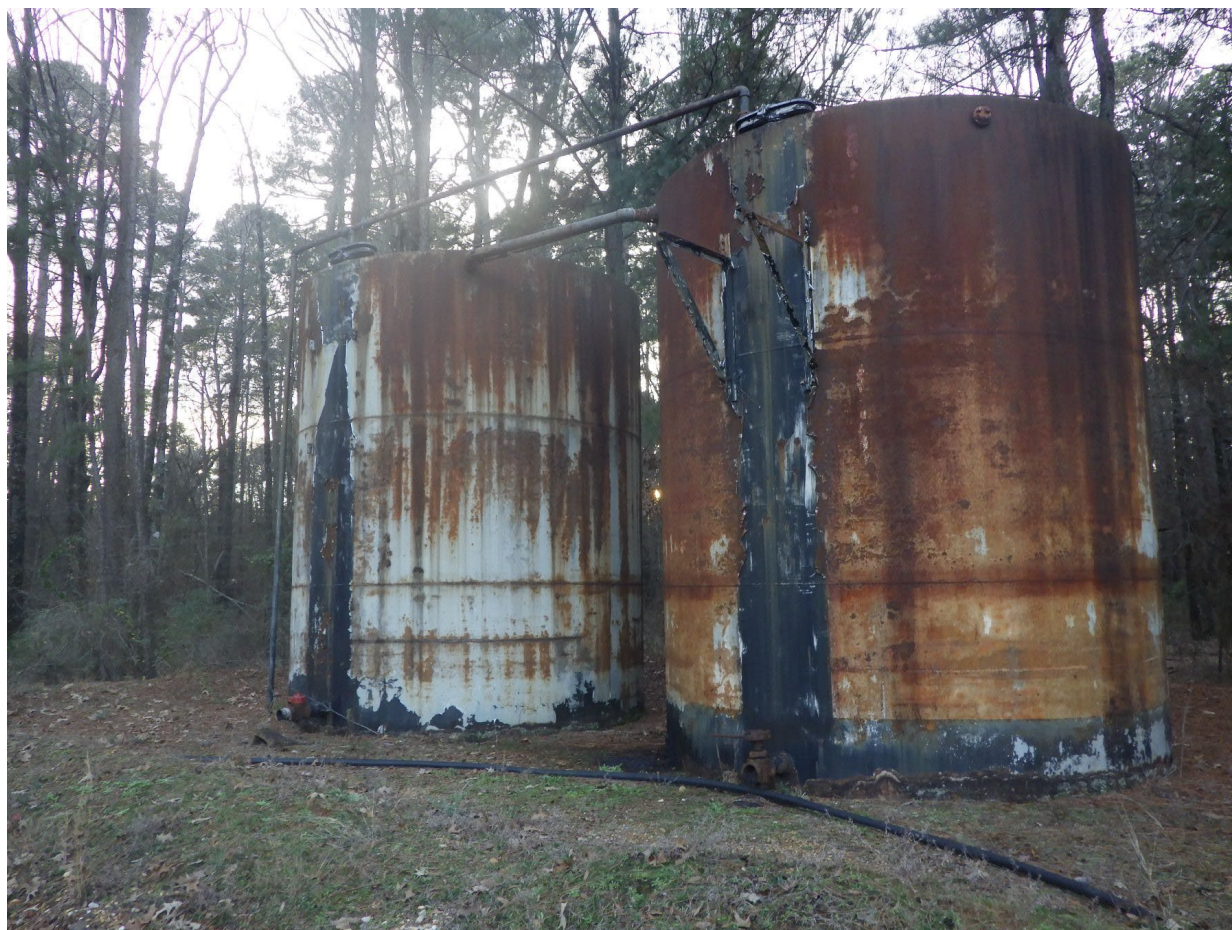
Photo No. 5

I observed two (2) storage tanks that appeared to be “out of service” or “not in use,” see Photo No. 5.

- Tanks that appeared “out of service” or “not in use.”
- The uncapped secondary containment discharge valve.

| Description: | This photo was taken facing west-southwest and shows tanks that appear to be "out of service" or "not in use." | | |

If the operator is attempting to permanently close the tanks, then 40 CFR §112.2 of the Spill Prevention Control and Countermeasure (SPCC) rule requires that:

- “(1) all liquid and sludge have been removed from each container and connecting line; and
- (2) all connecting lines and piping have been disconnected from the container and blanked off, all valves (except ventilation valves) have been closed and locked, and
- (3) conspicuous signs have been posted on each container stating that it is a permanently closed container and noting the date of closure.”

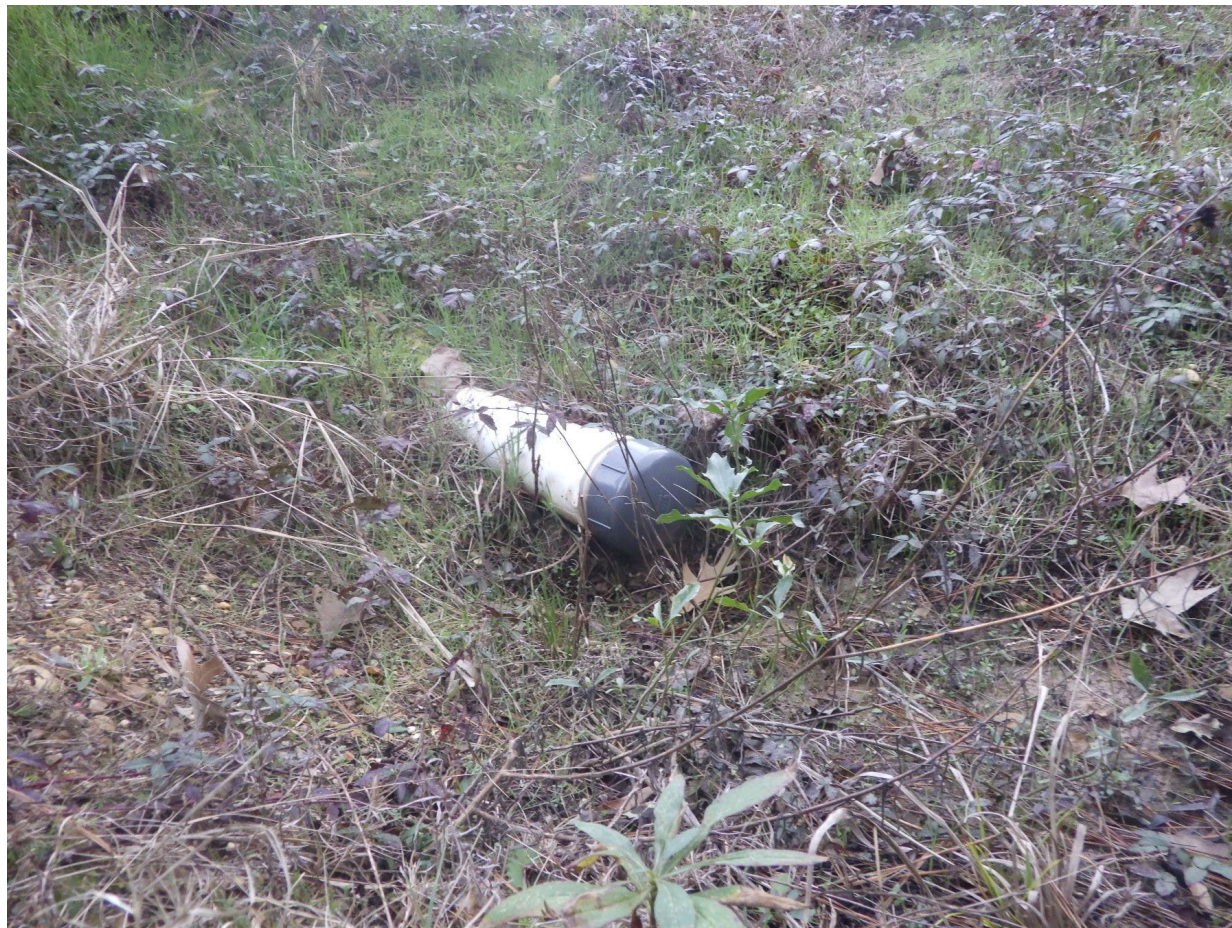
Photo No. 6

| Description: | This photo was taken facing northeast and shows a capped secondary containment discharge valve. | | |

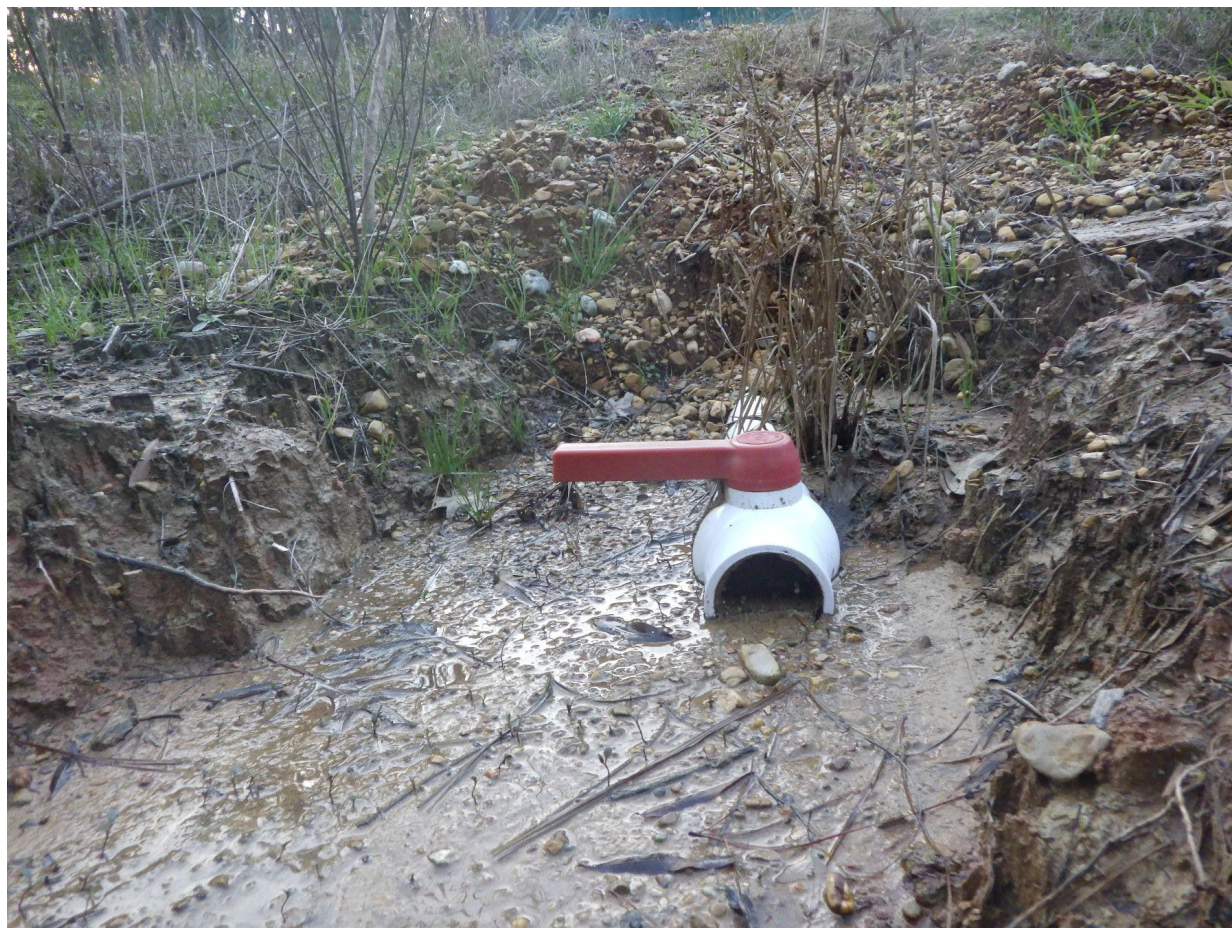
Photo No. 7

I observed a secondary containment discharge valve that was capped, see Photo No. 6. I observed another secondary containment discharge valve that was in the closed position but not capped, see Photo No. 7. I observed a flow path from the discharge valve that indicates that the operator discharges fluids from secondary containment, see Photo No. 8.

| Description: | This photo was taken facing west-northwest and shows a secondary containment drainage valve in the closed position but did not have a cap. | | |

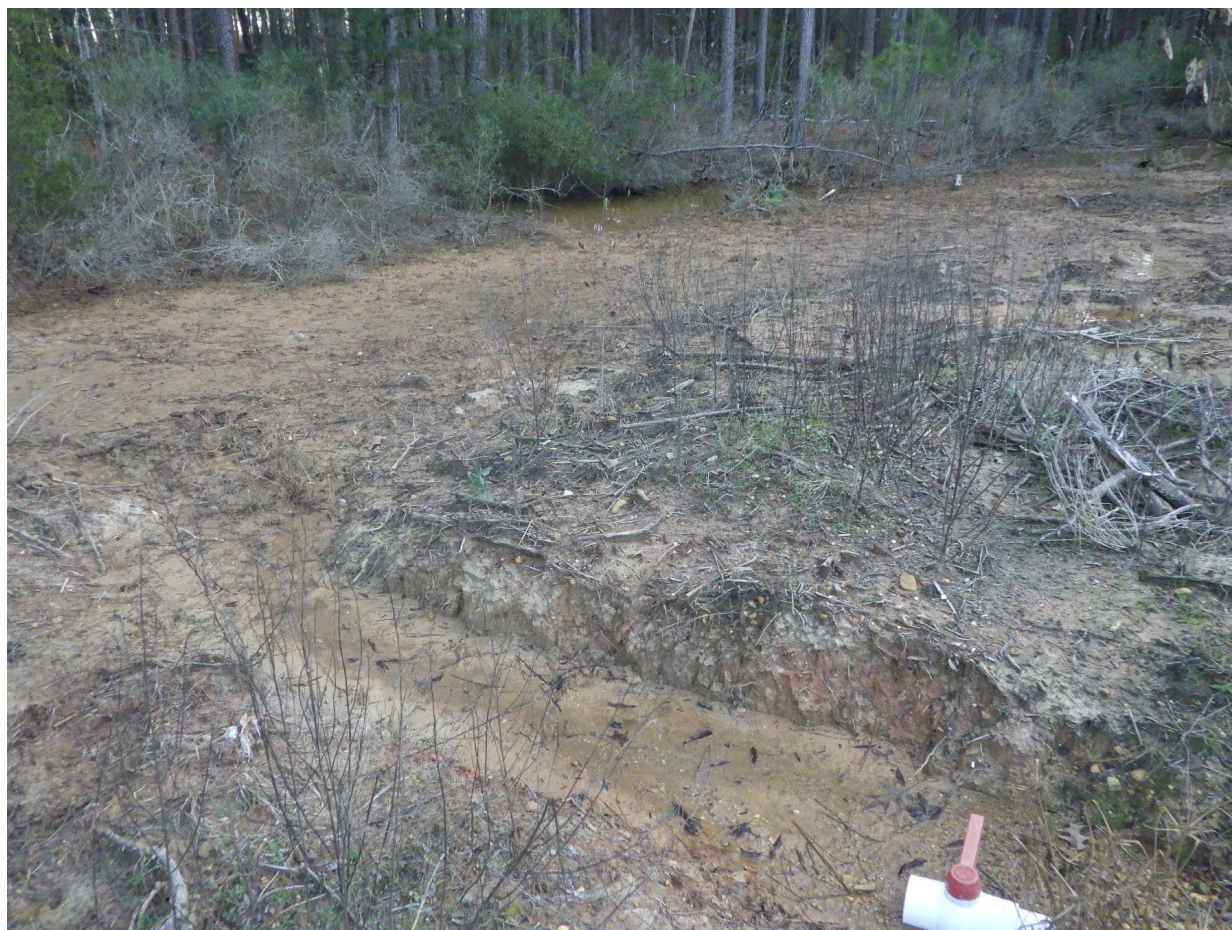
Photo No. 8

| Description: | This photo was taken facing northeast and shows a flow path from the secondary containment discharge valve that was closed but did not have a cap. | | |
