INSPECTION REPORT

| Type of Inspection | Focused Compliance Inspection (FCI) | | | |
| Facility or Site Name | Environmental Response Services, Inc. (ERS) | | | |

**Southwest Regional Office  
Hazardous Waste Inspection Report**

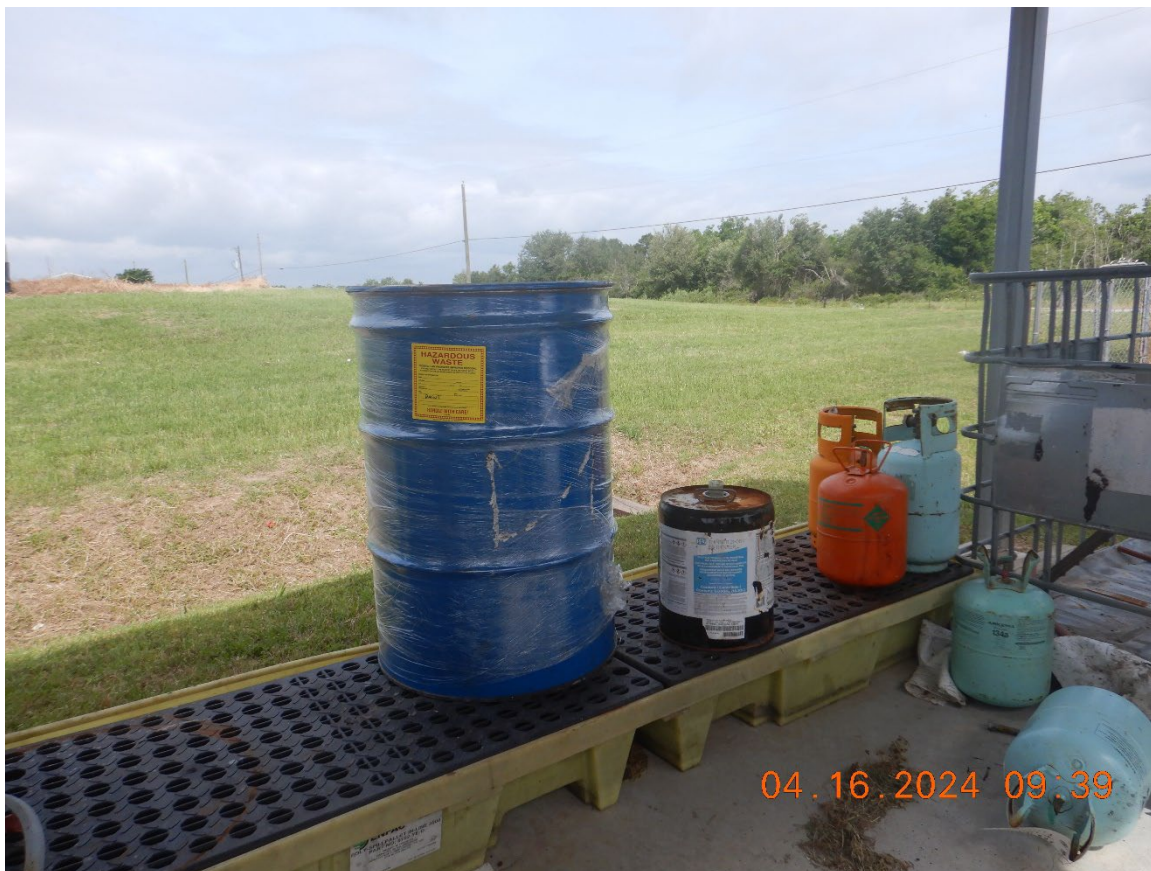
Description: View of 55-gallon waste paint drum in the ERS Hazardous Waste Pad area, which was unsecured, labeled "paint," and not dated.

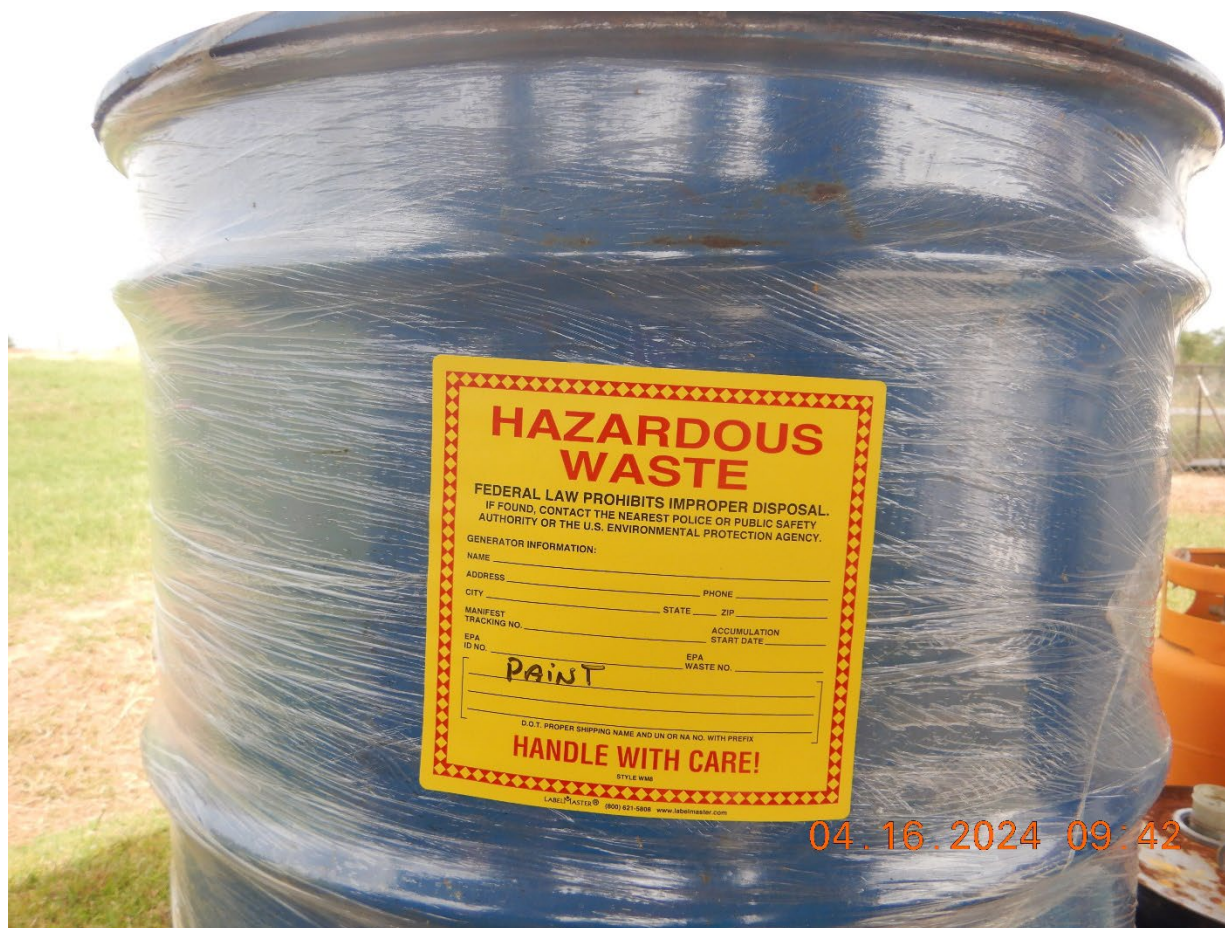
Photo No. 4

Description: View of label on 55-gallon waste paint drum in the ERS hazardous waste pad area, which was unsecured, labeled "paint," and not dated.

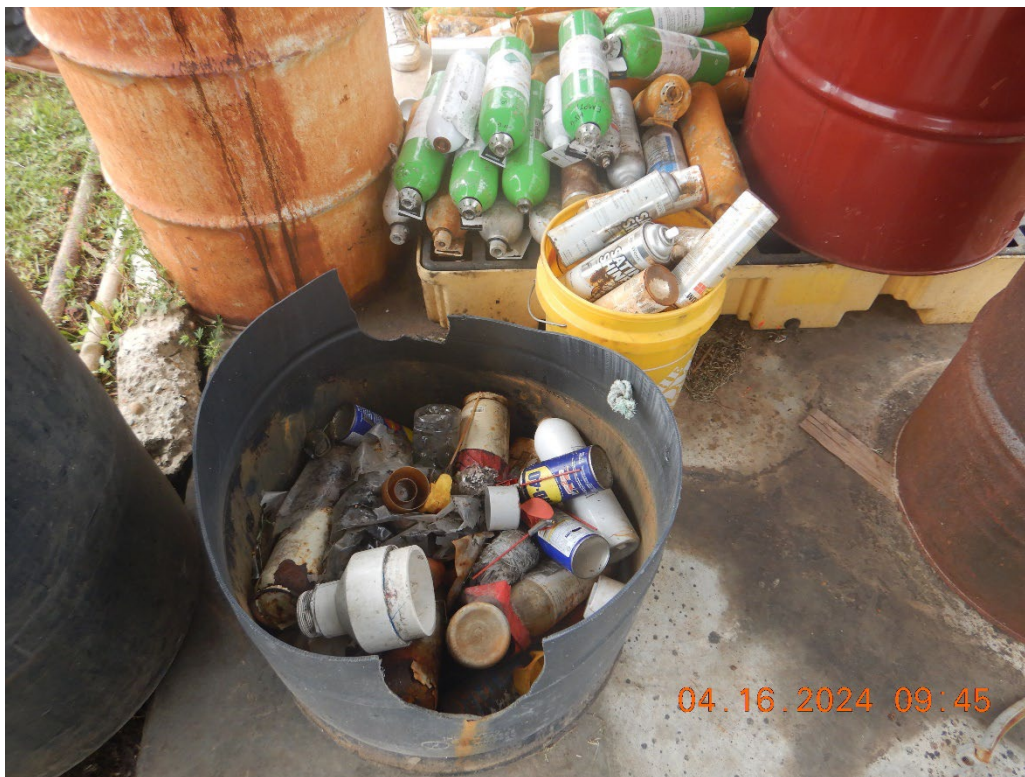
Description: Waste aerosol cans that were not RCRA-empty and not secured, labeled, or dated in the ERS Hazardous Waste Pad area.

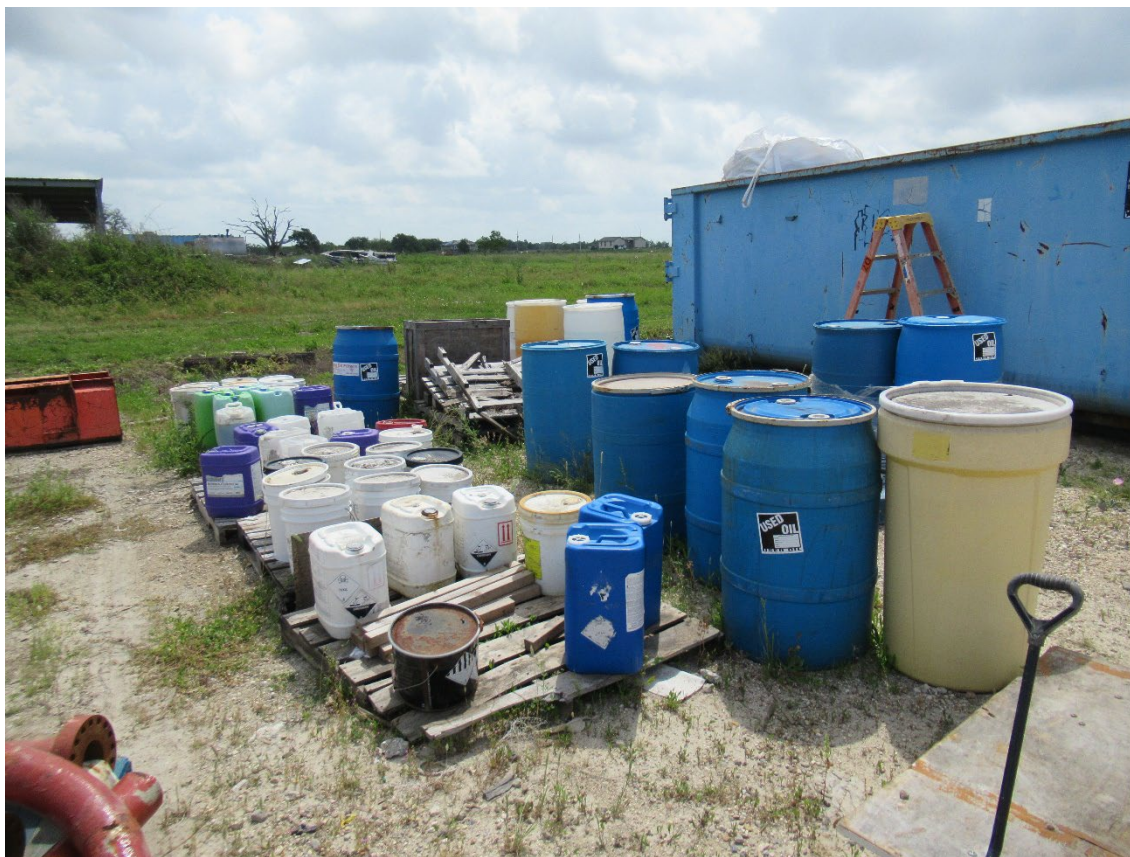
Photo No. 13

The inspection team observed 40 5-gallon buckets and 14 55-gallon drums of potentially hazardous waste that had been on site for over a year according to Mr. Clark (see Appendix 1 – Photo 13). Waste determinations were not conducted on the contents of these containers. **[AOC #4 – ERS did not make an accurate determination as to whether their waste is a hazardous waste in order to ensure wastes are properly managed according to applicable RCRA regulations. – 40 CFR 262.11]**. Similarly, three white drums containing "soaps" according to Mr. Clark, which had been on site for about six years, and three blue drums of unknown material without waste determinations were observed (see Appendix 1 – Photo 14). [see **AOC #4**]

Description: View of 40 buckets and 14 drums of potentially hazardous waste that had been on site for over a year according to Mr. Clark in ERS' general waste storage area.

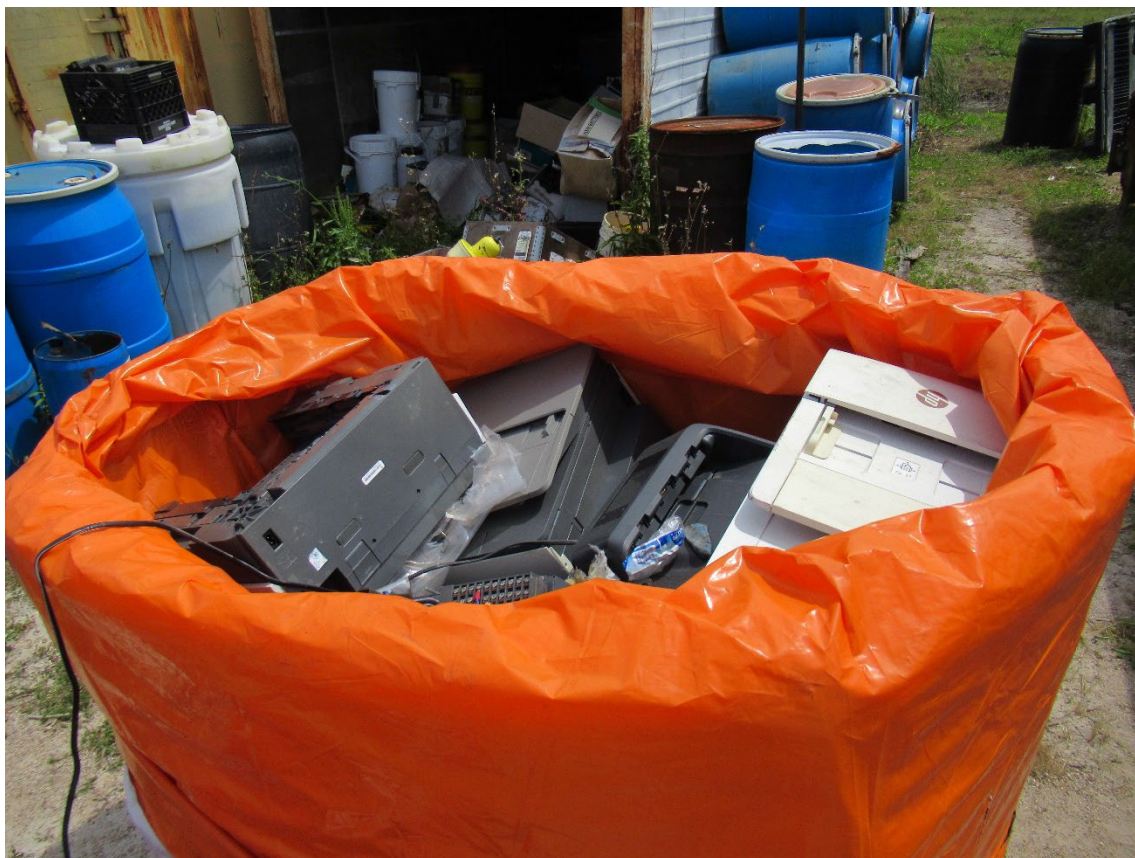
Description: View of a container of e-waste in the universal waste storage area, observed.

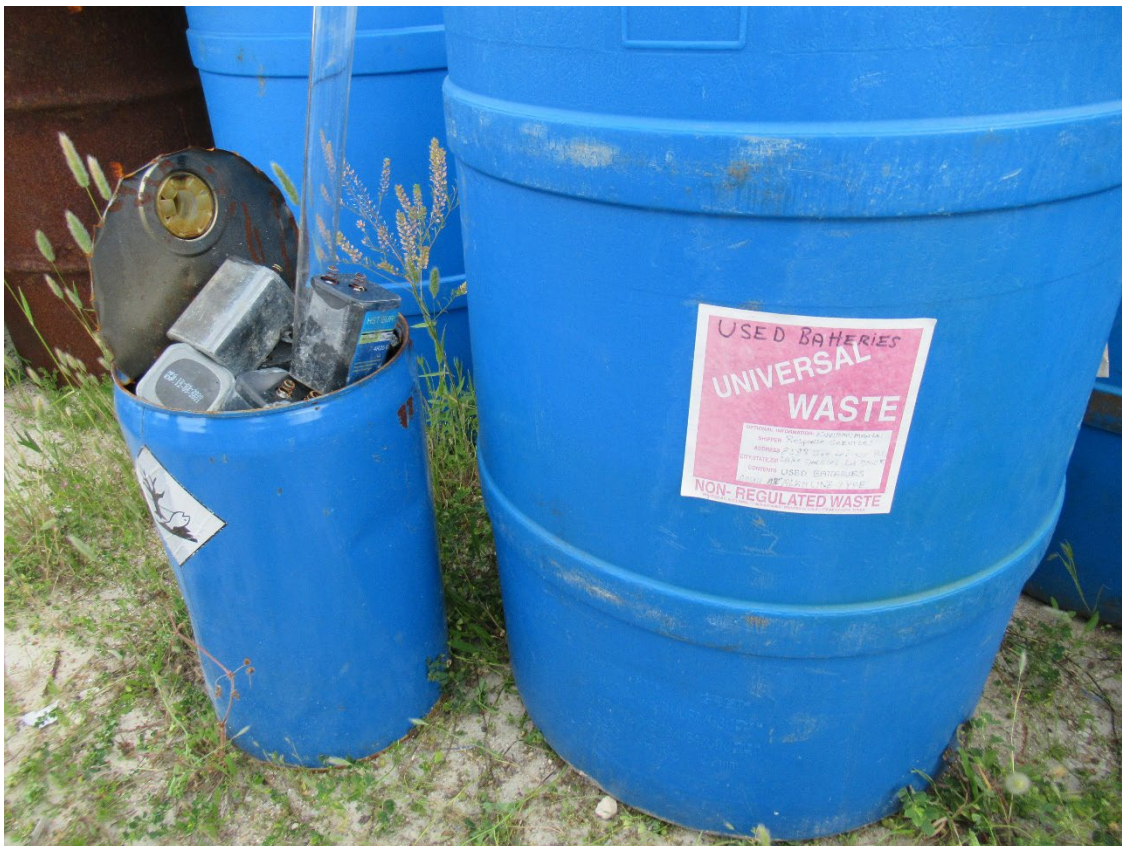
Description: Close-up view of used battery containers in the universal waste storage area with universal waste labels, observed.

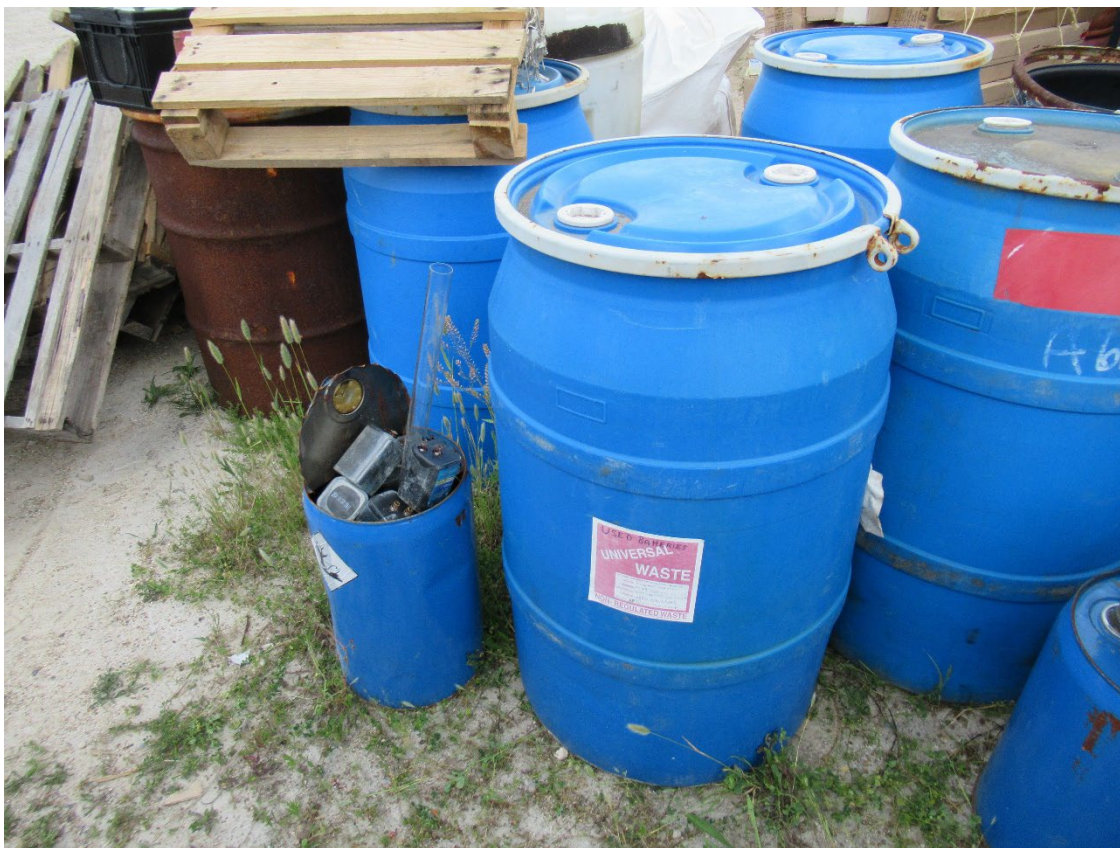
Description: Overview of used battery containers in the universal waste storage area with universal waste labels, observed.

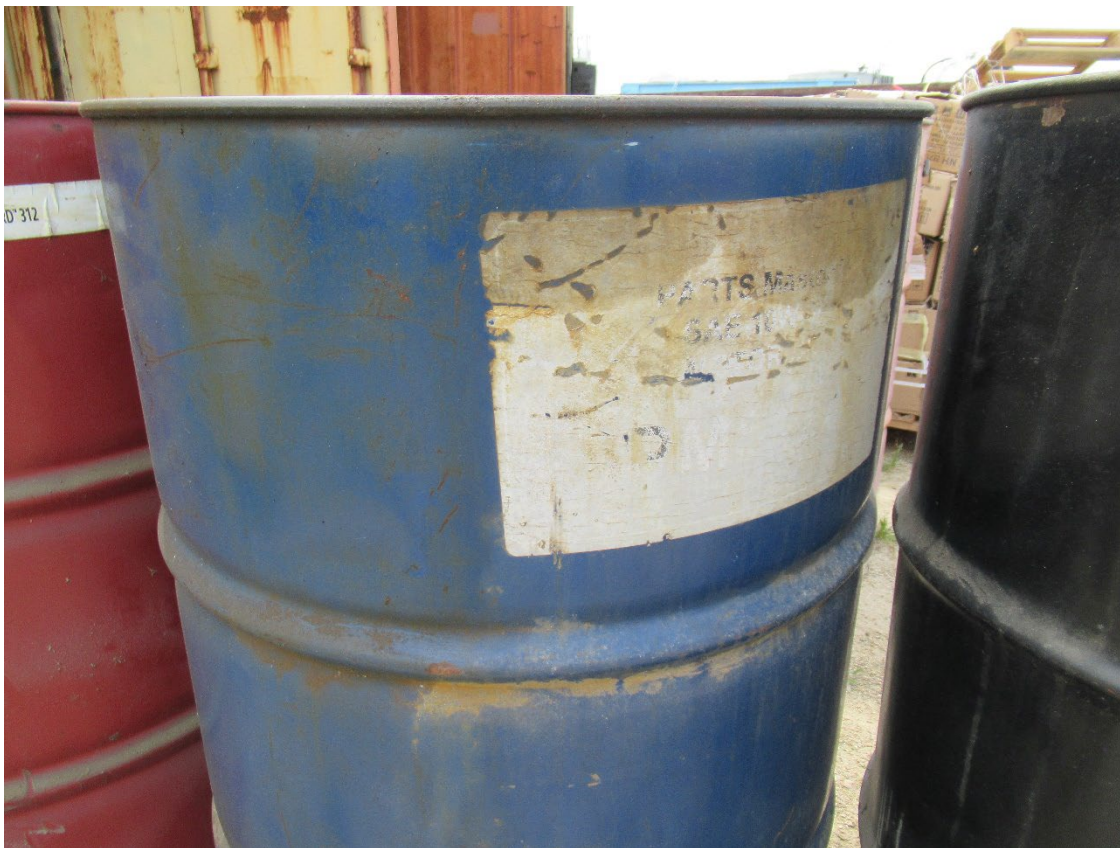
Description: Close-up of one of the used oil drums shown in Photo No. 38 with a faded label.

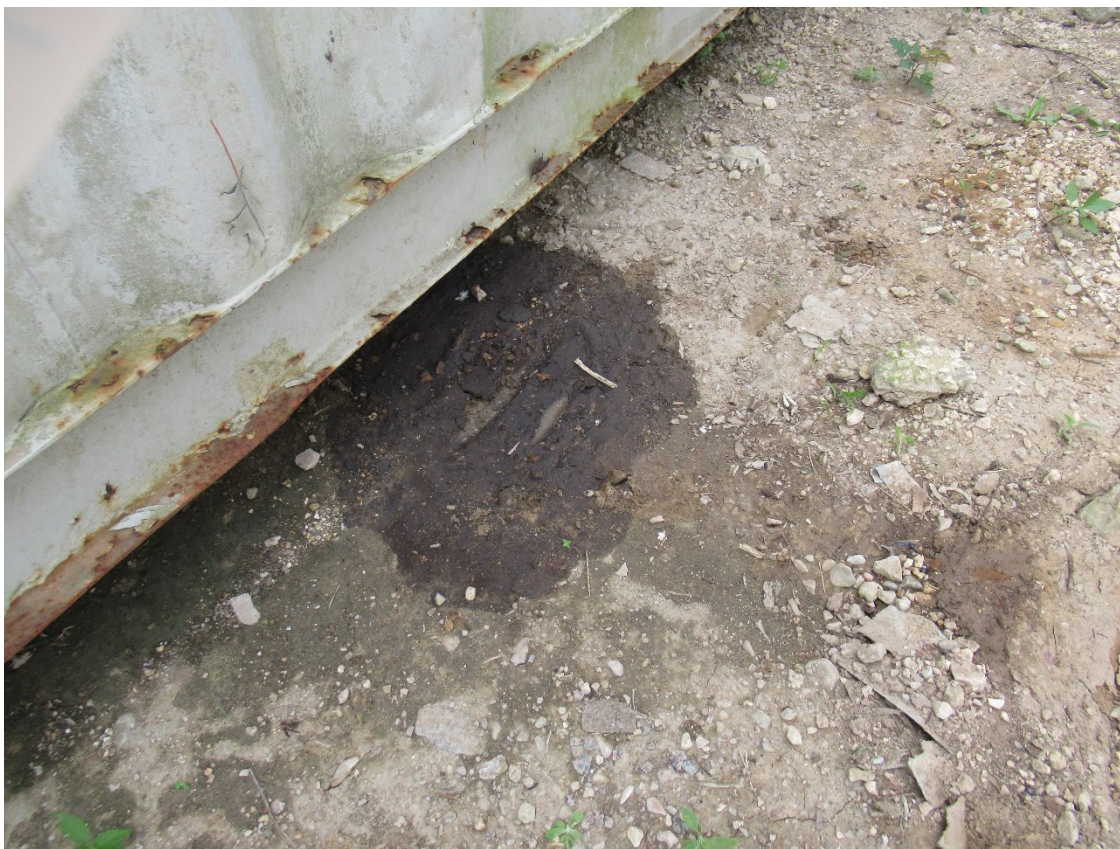
Description: View of contaminated soil from spill observed to be coming from a drum that Mr. Clark indicated contained grease in ERS' general yard area.

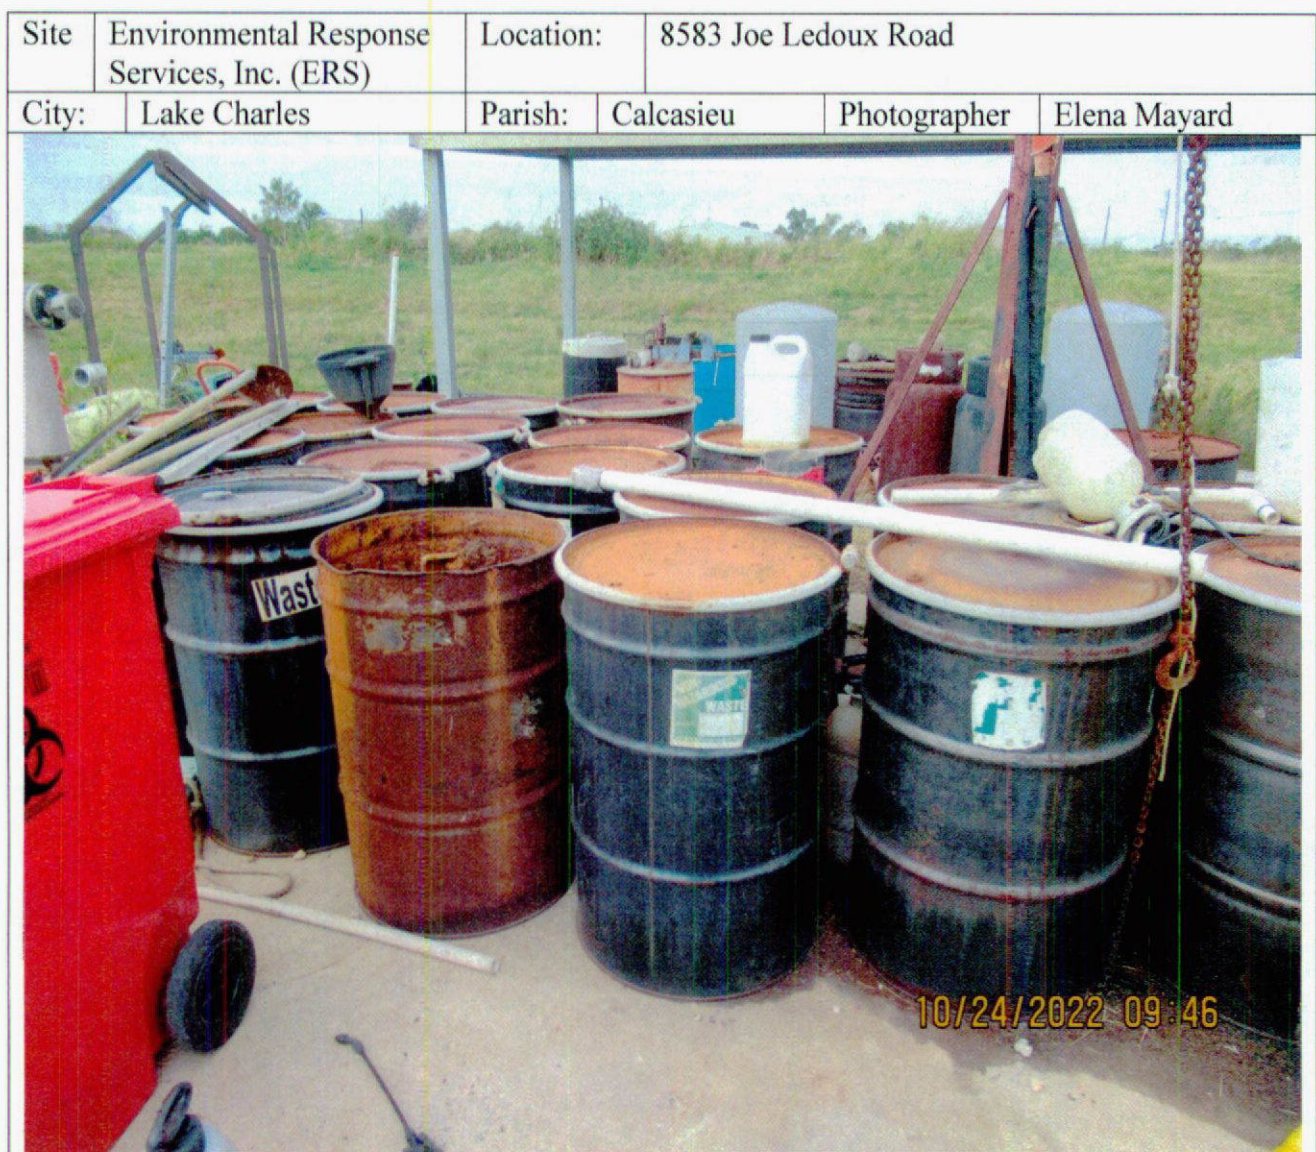
Photo #: 1 Of 81 Date: 10/24/2022 Time: 09:46 AM  
 Description: Southwest of the main office, I observed numerous drums of non-hazardous waste and some hazardous waste drums. The facility representative stated drums are pickup from businesses and brought to their facility.

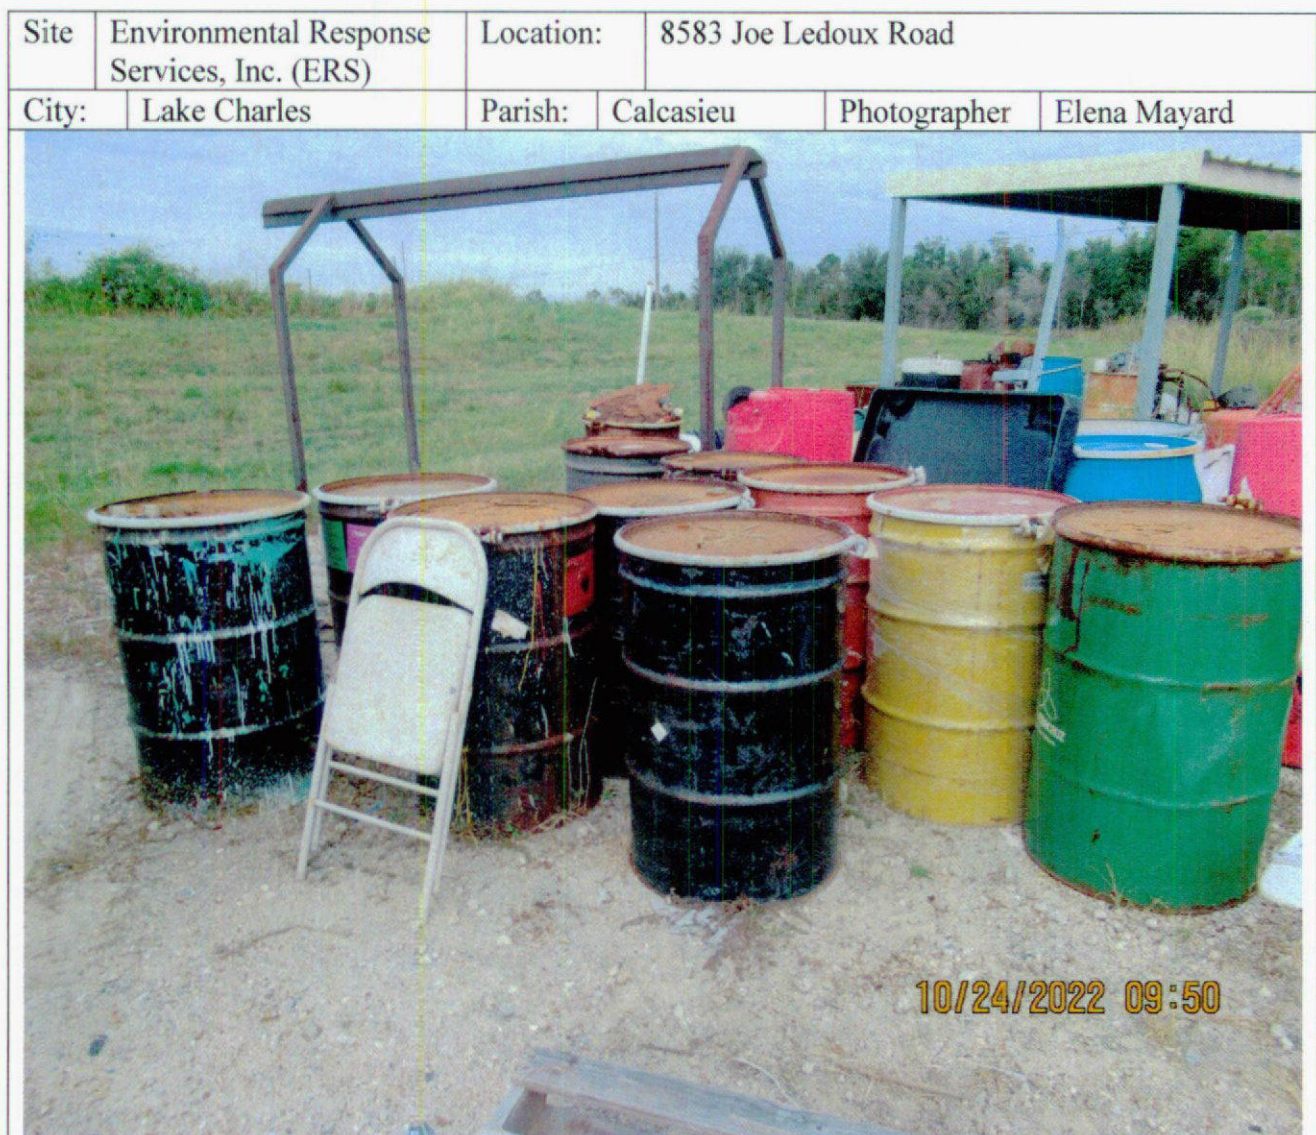
Photo #: 2 Of 81 Date: 10/24/2022 Time: 9:50 AM  
 Description: Drums of waste paint located southwest of the main office.

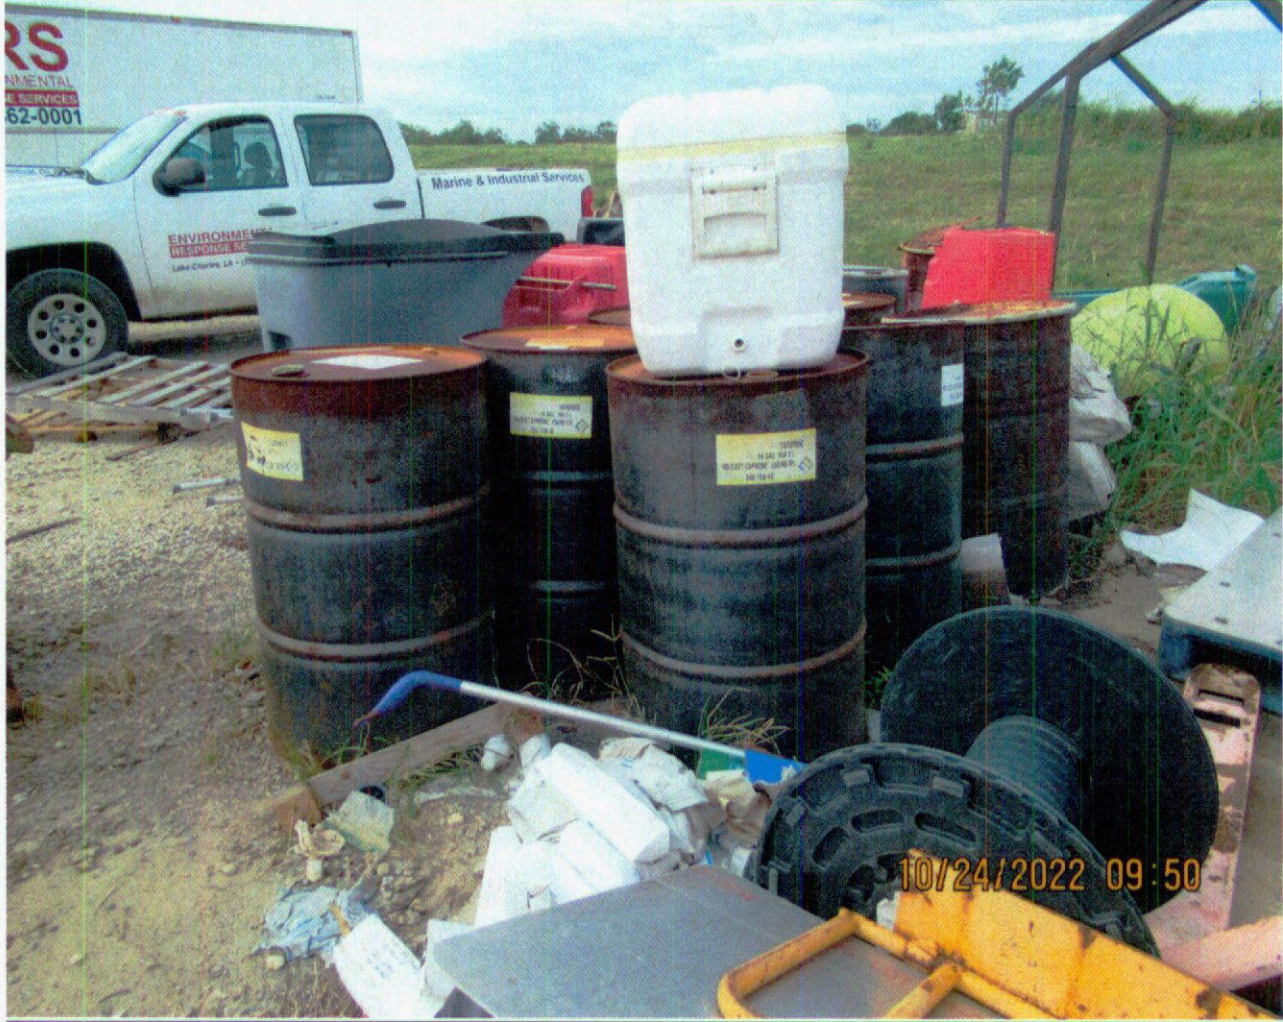
Photo #: 3 Of 81 Date: 10/24/2022 Time: 09:50 AM  
Description: Drums of engine oil product that were showing signs of deterioration and rusting.

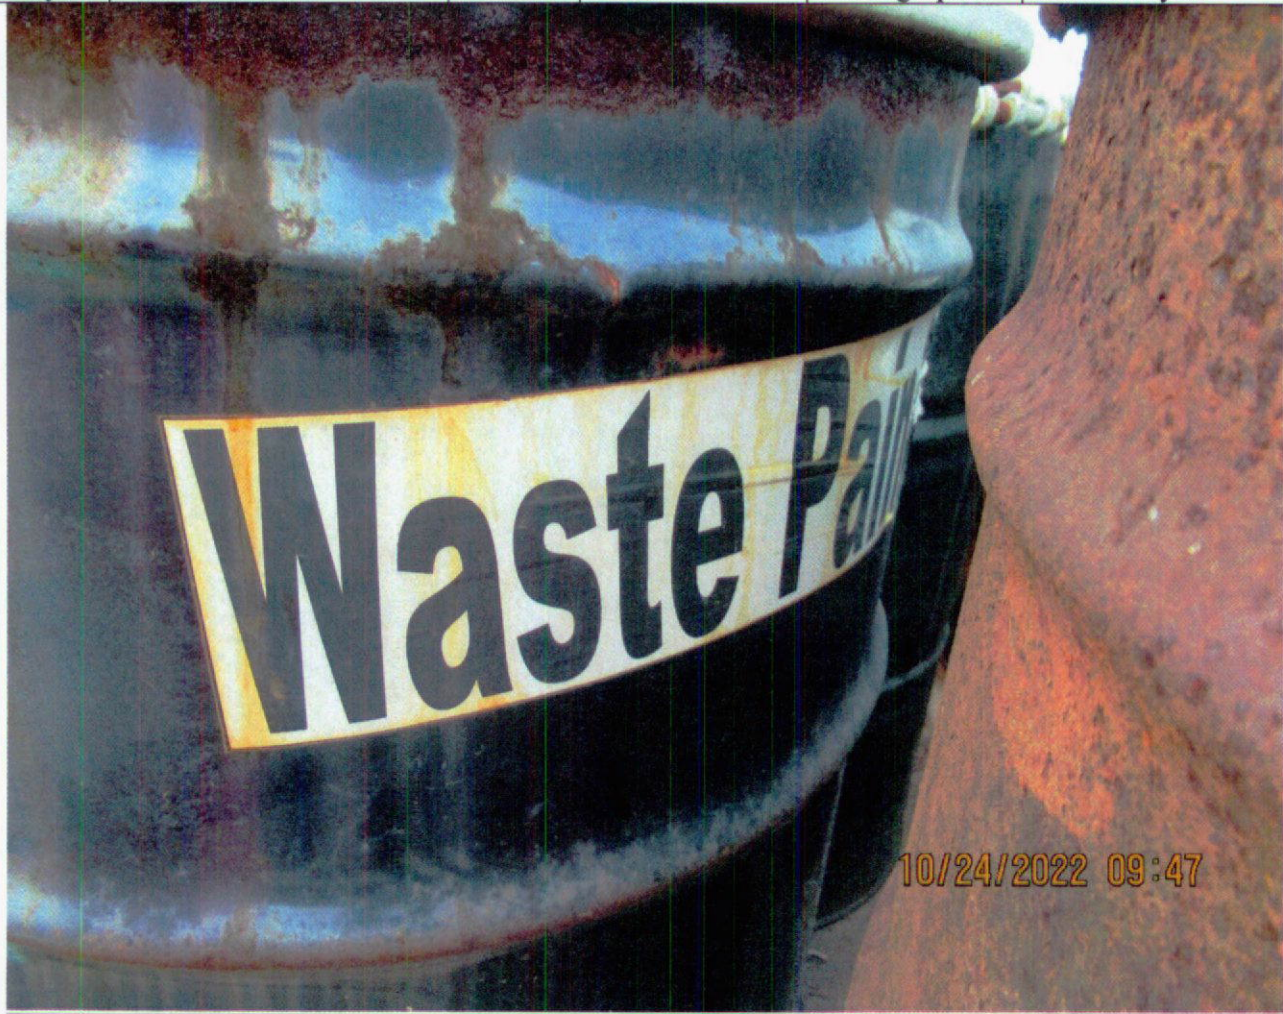
Photo #: 4 Of 81 Date: 10/24/2022 Time: 9:47 AM  
Description: A 55-gallon drum labeled "Waste Paint." This is a close-up photograph of a drum from Photograph 2.

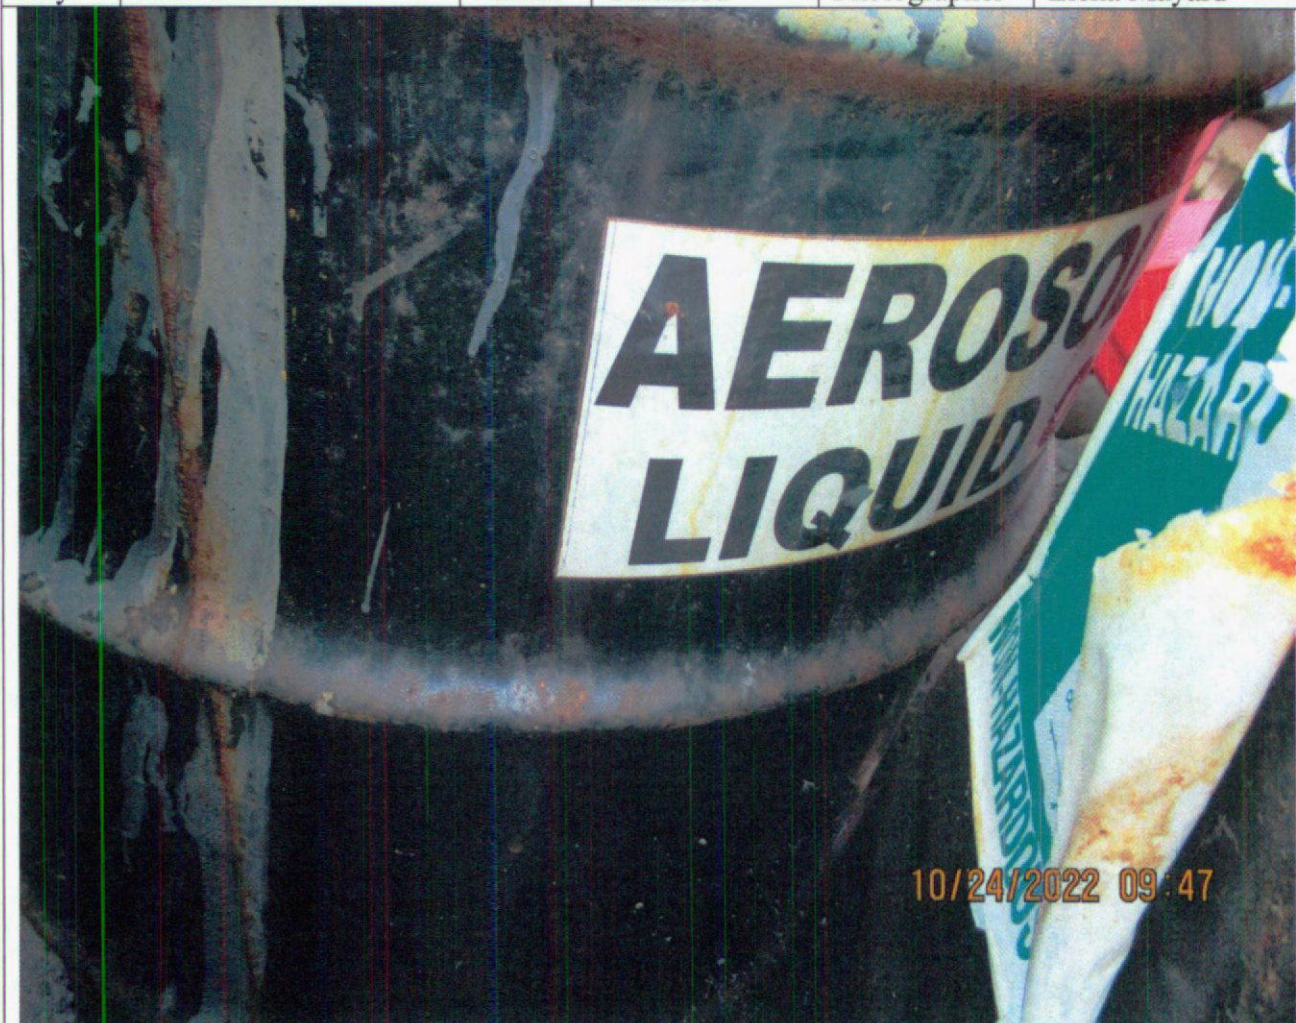
Photo #: 5 Of 81 Date: 10/24/2022 Time: 9:47 AM  
 Description: A 55-gallon drum labeled "Aerosol Liquids." This is a close-up photograph of a drum from Photograph 2.

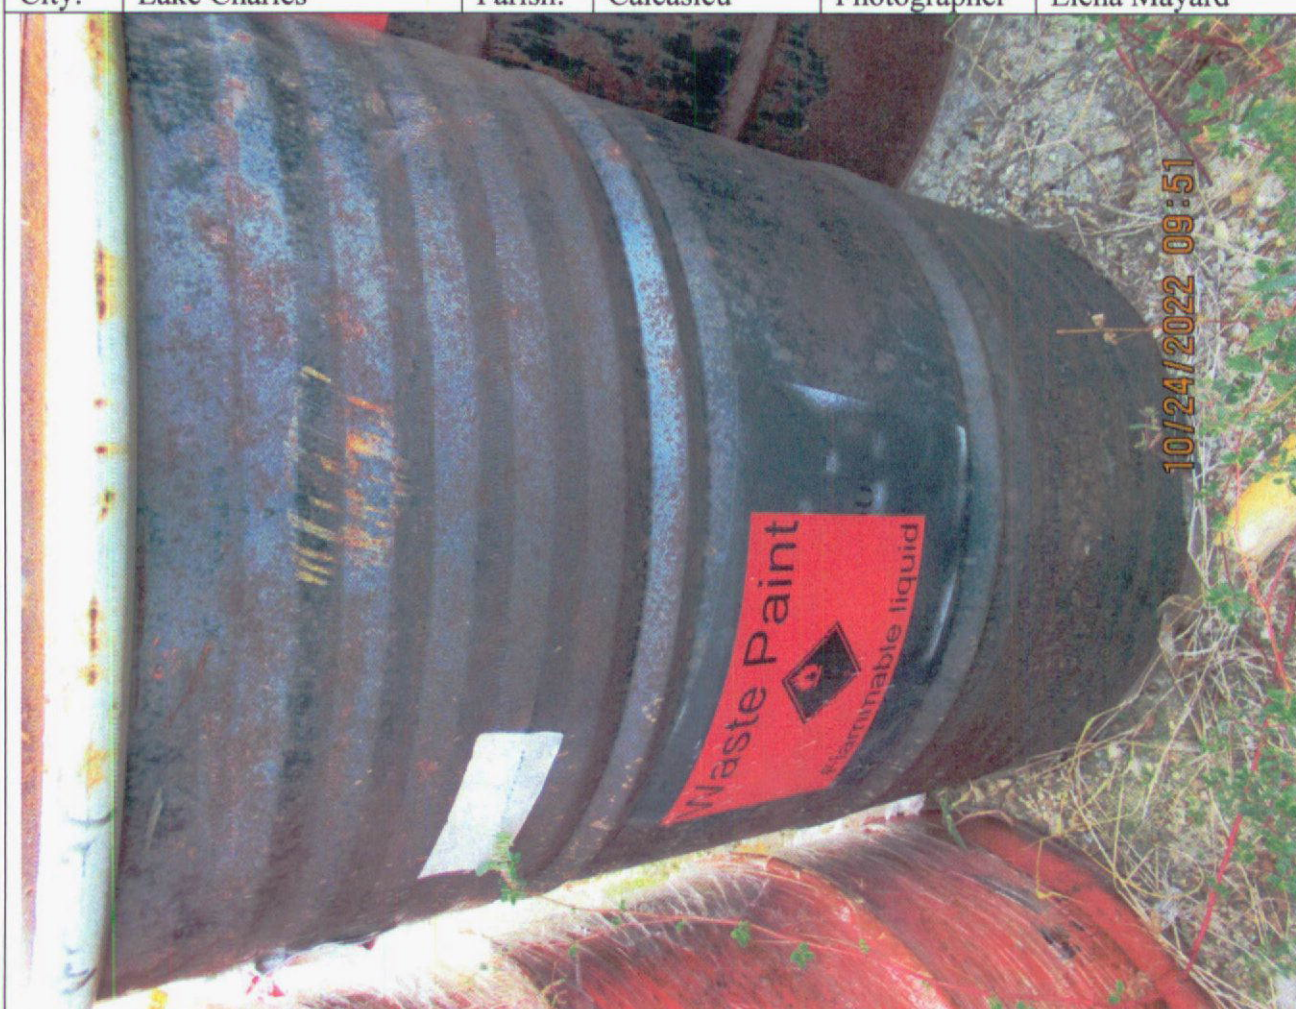
Photo #: 6 Of 81 Date: 10/24/2022 Time: 9:51 AM  
 Description: A 55-gallon drum labeled "Waste Paint | Flammable Liquid." This is a close-up photograph of a drum from Photograph 2.

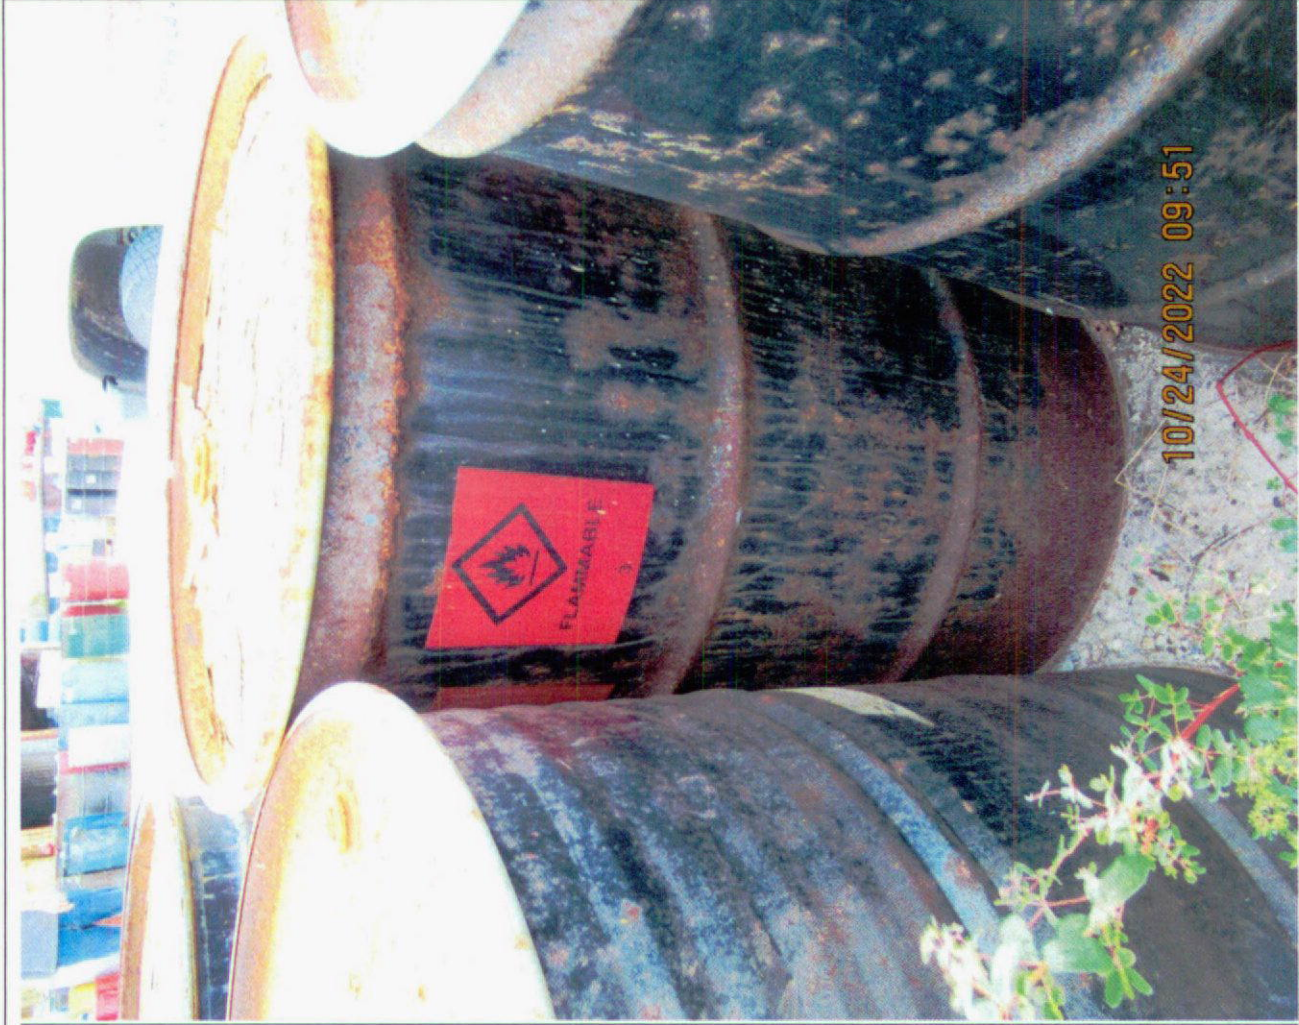
Photo #: 7 Of 81 Date: 10/24/2022 Time: 9:51 AM  
Description: A 55-gallon drum labeled "Flammable." This is a close-up photograph of a drum from Photograph 2.

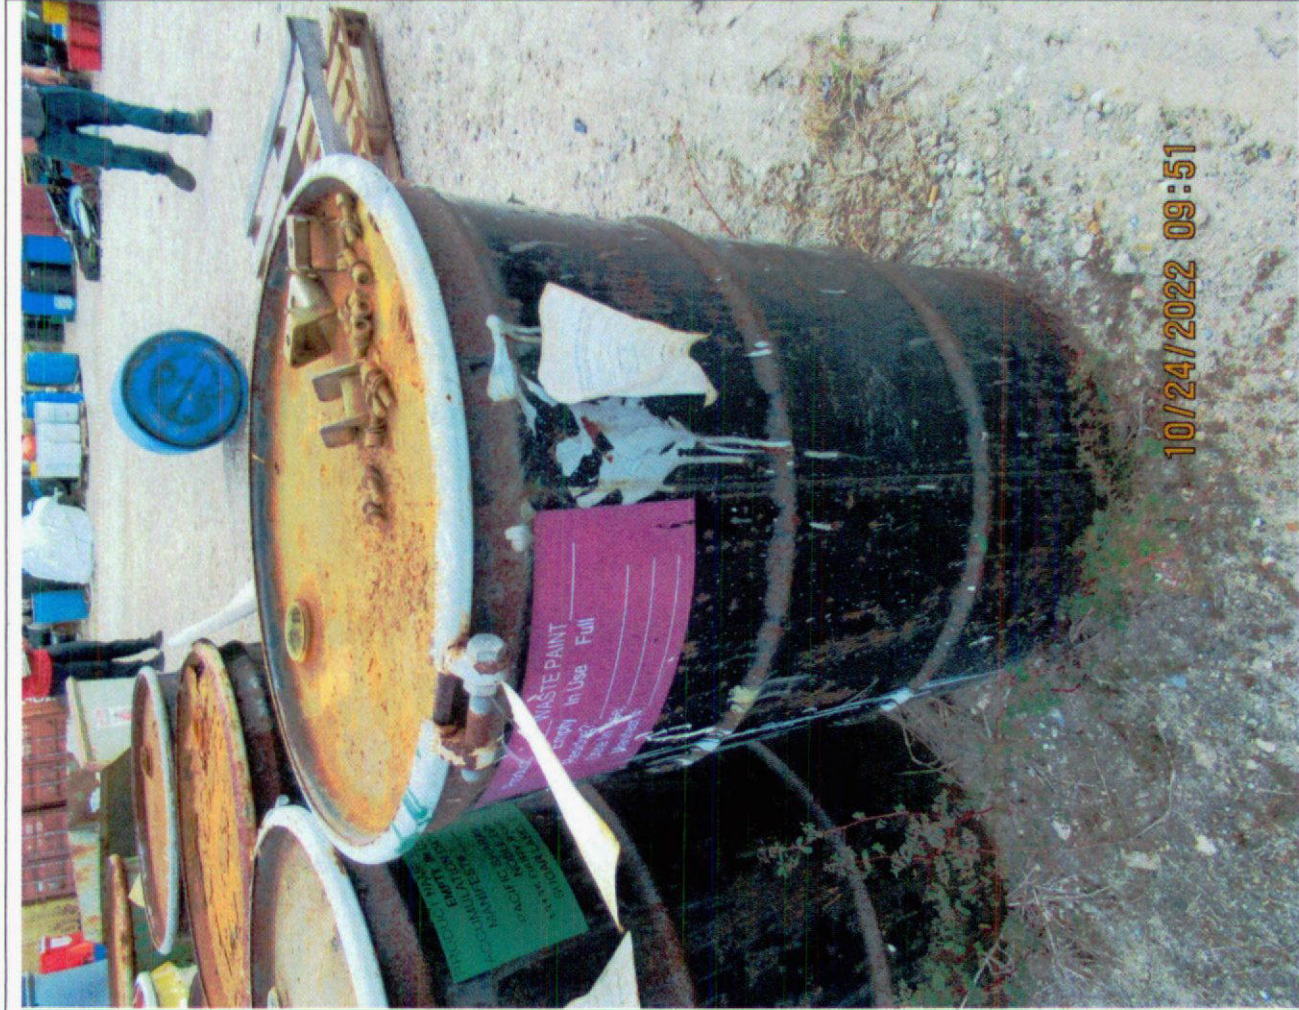
Photo #: 8 Of 81 Date: 10/24/2022 Time: 9:51 AM  
Description: I observed a 55-gallon drum with a hazardous waste label that indicated the waste was generated by Noble Services – Stanley in Port Fourchon. The drum was labeled with an additional tag that had "3/22." This hazardous waste drum has been onsite for greater than the allowed 10 days.

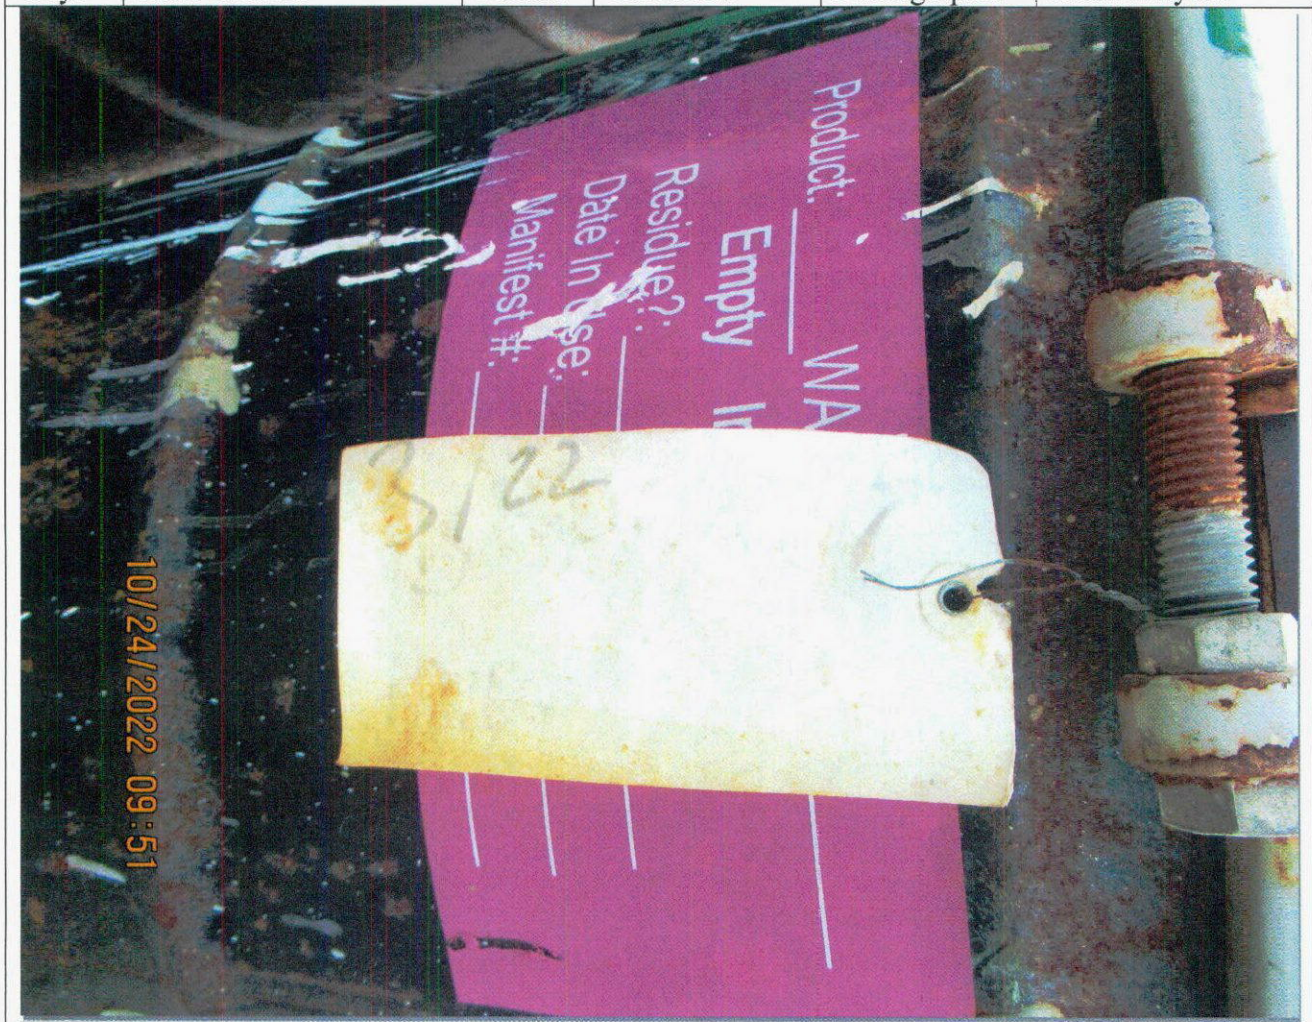
| Photo #: 10 Of 81 Date: 10/24/2022 Time: 9:51 AM | | | | | |

| Description: Close-up photograph of the dated tag from drum shown in Photograph 8. This hazardous waste drum has been onsite for greater than the allowed 10 days. | | | | | |
