INSPECTION REPORT

| Type of Inspection | Focused Compliance Inspection (FCI) | | | |
| Facility or Site Name | Environmental Response Services, Inc. (ERS) | | | |

**Southwest Regional Office  
Hazardous Waste Inspection Report**

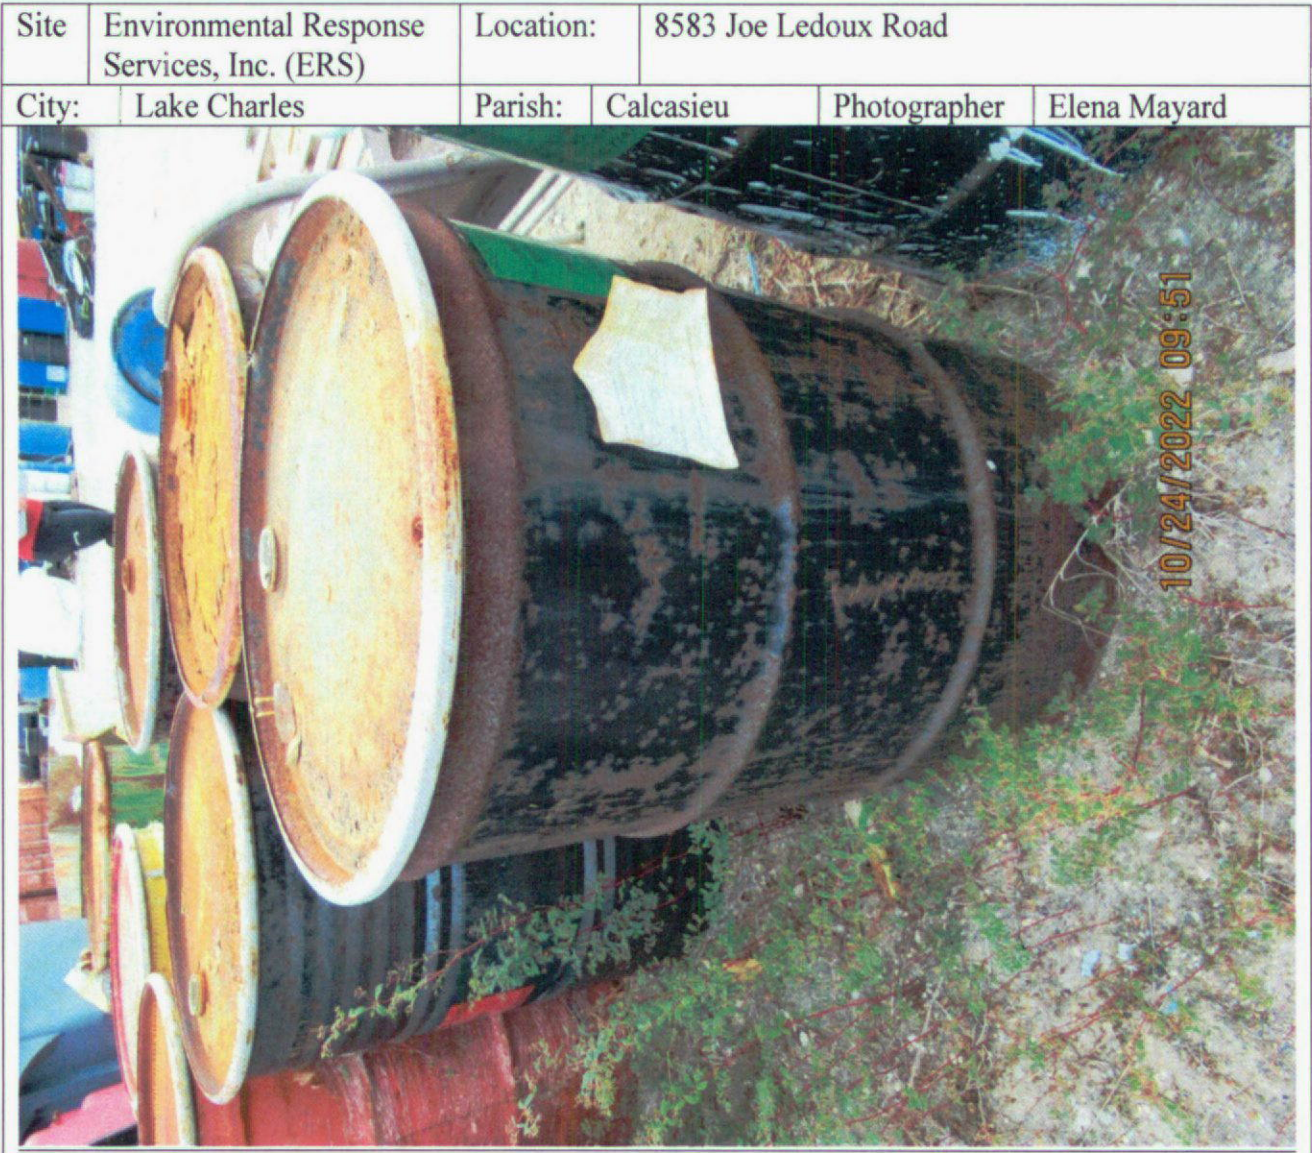
Photo #: 11 Of 81 Date: 10/24/2022 Time: 9:51 AM  
Description: Second 55-gallon drum with a hazardous waste label that indicated the waste was generated by Noble Services – Stanley in Port Fourchon. This hazardous waste drum has been onsite for greater than the allowed 10 days.

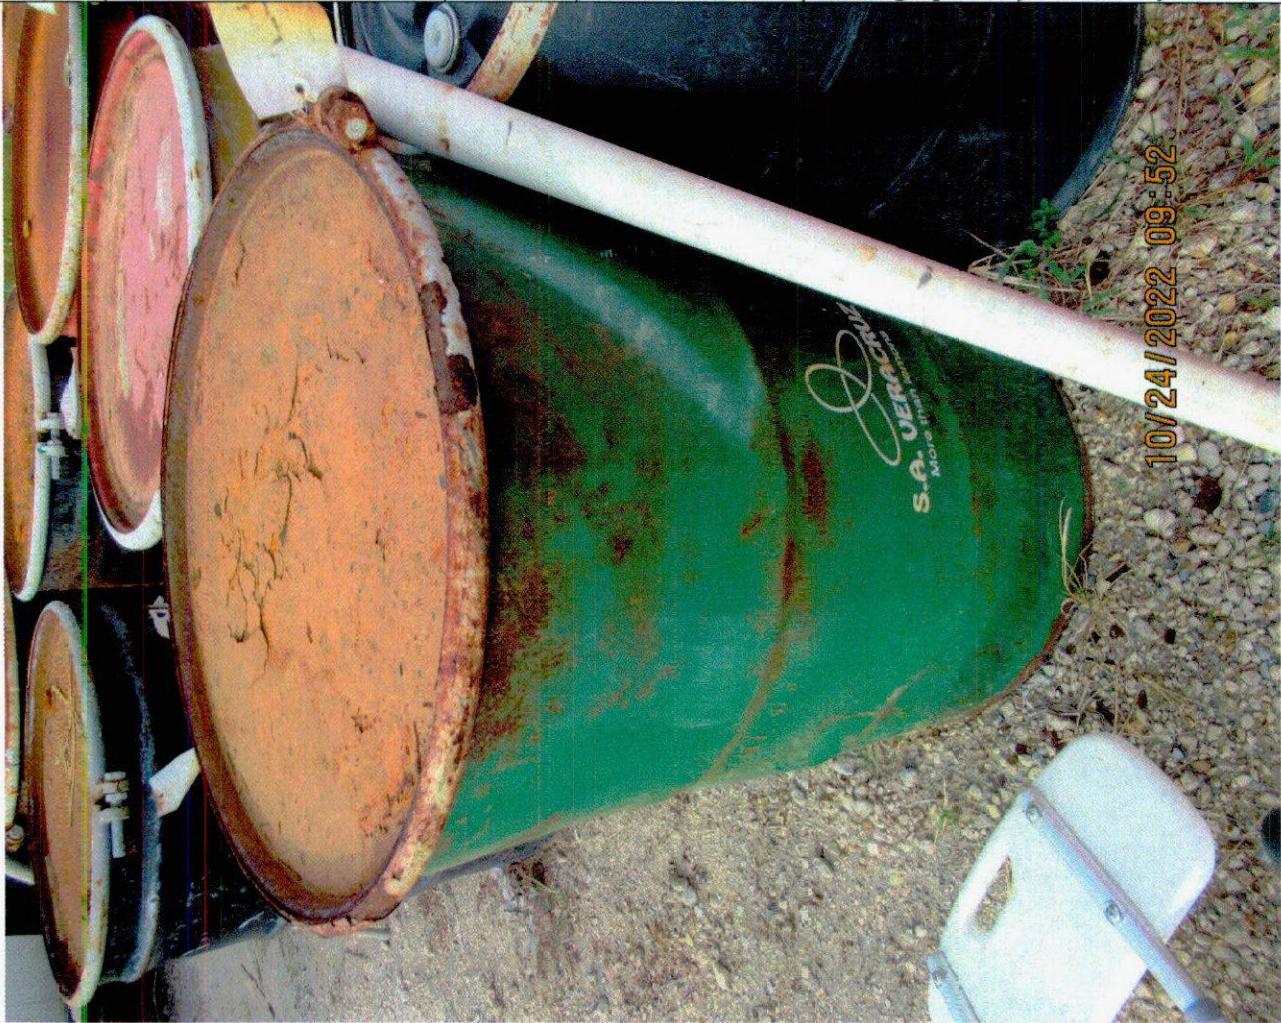
Photo #: 13 Of 81 Date: 10/24/2022 Time: 9:52 AM

Description: I observed a green 55-gallon drum that contained paint, according to the tags. A manifest (Photograph 76) indicated this was a hazardous waste. The drum was not labeled adequately.

Photo #: 76 Of 81 Date: 10/24/2022 Time: 10:44 AM  
Description: Hazardous waste manifest from waste that ERS picked up from Breaux Petroleum and transported back to their facility. The manifest corresponds to the drums pictured in Photographs 13-16. The hazardous has been onsite for greater than the allowable 10 days.

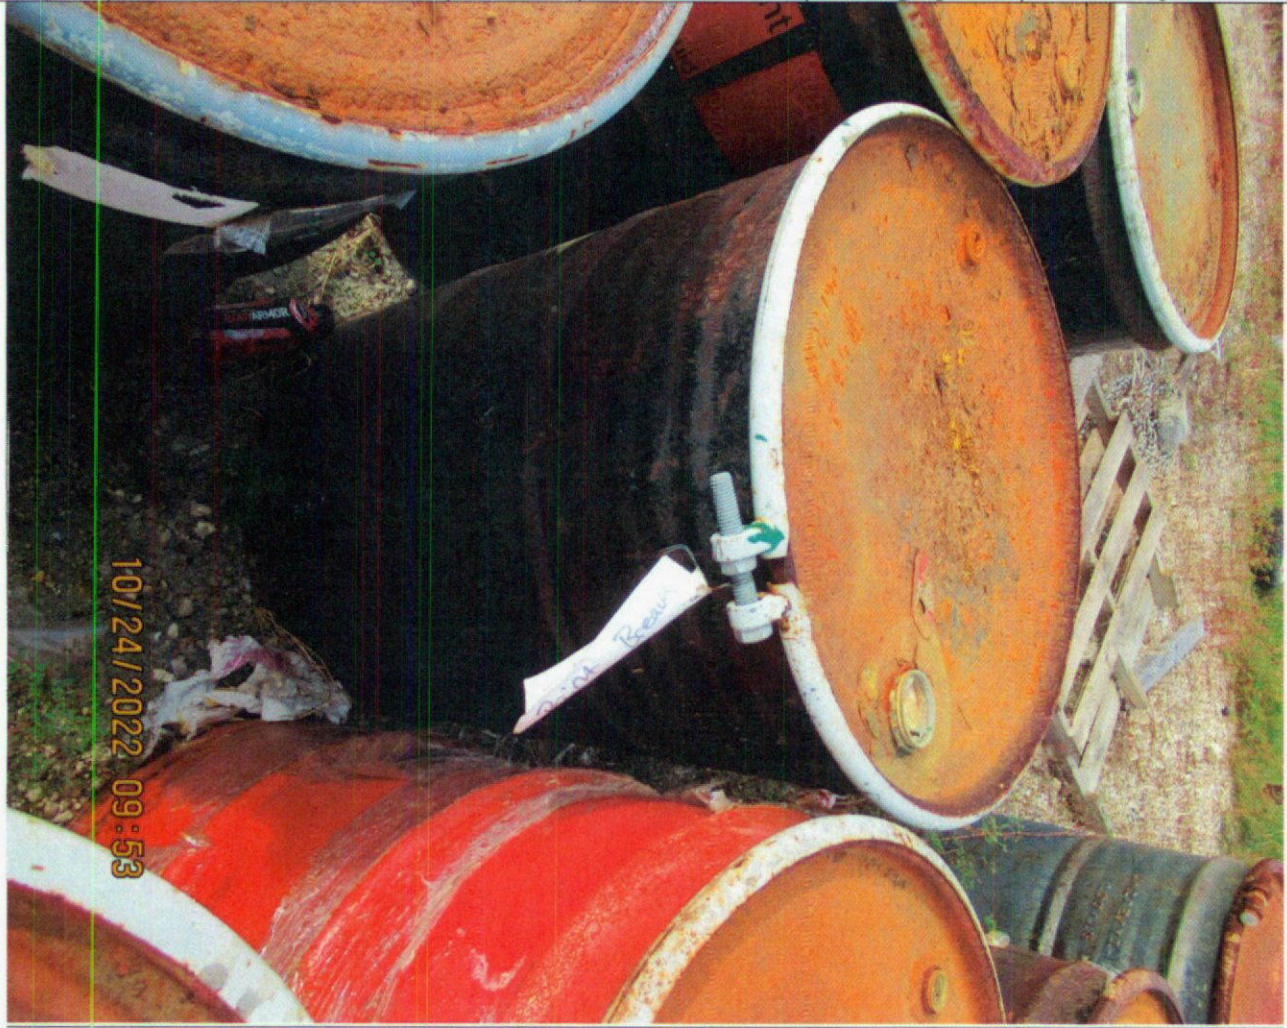
Photo #: 15 Of 81 Date: 10/24/2022 Time: 9:563 AM  
 Description: Another 55-gallon drum of hazardous waste paint generated by Breaux Petroleum and transported to the facility by ERS themselves.

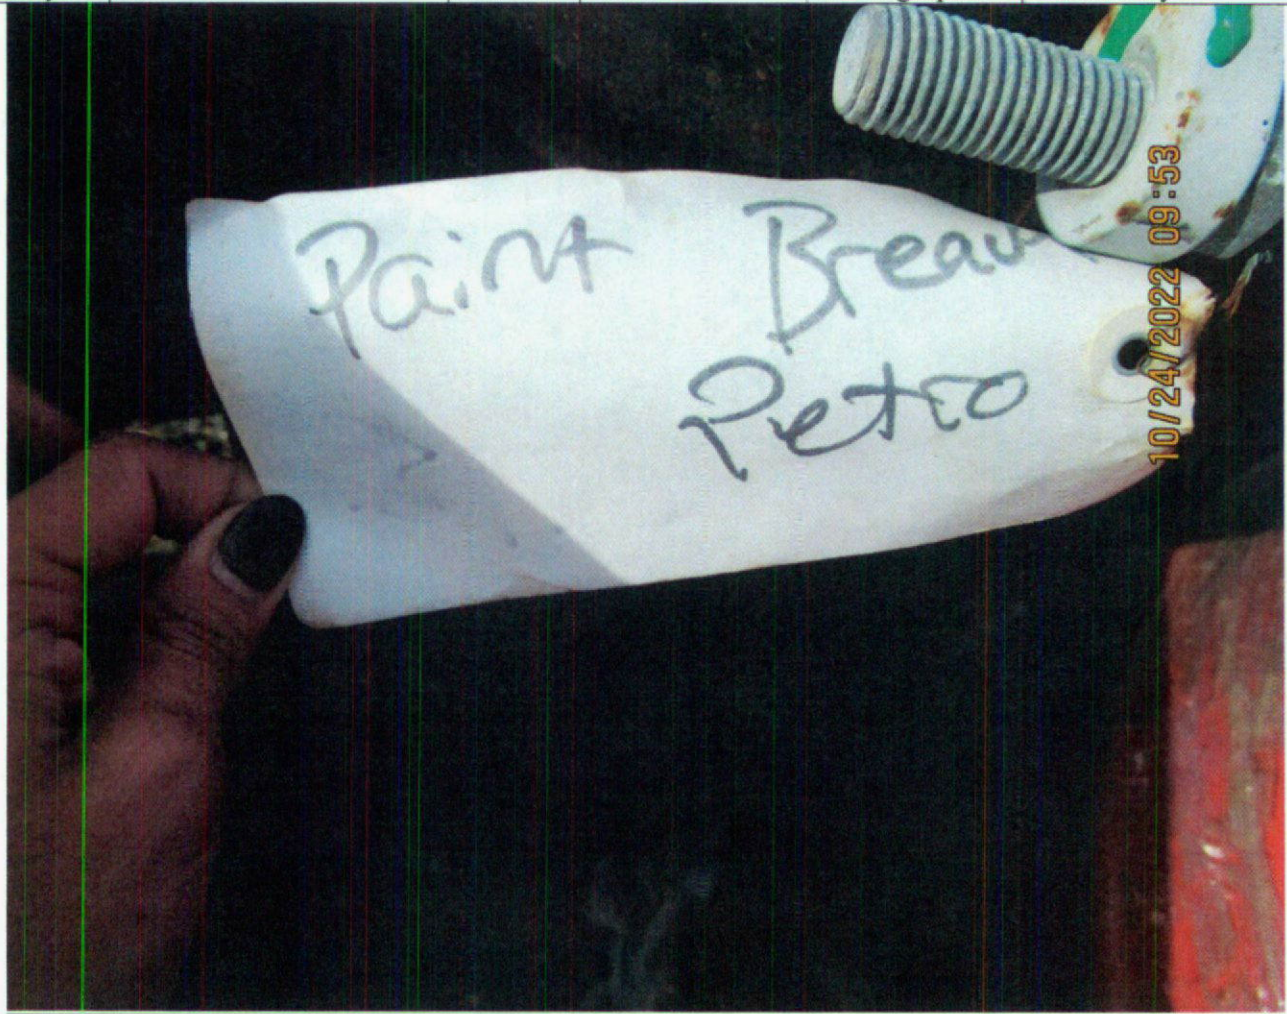
Photo #: 16 Of 81 Date: 10/24/2022 Time: 9:53 AM  
 Description: Close-up photograph of the tag from Photograph 15. Manifests indicate this was hazardous waste paint and has been onsite since March 2022.

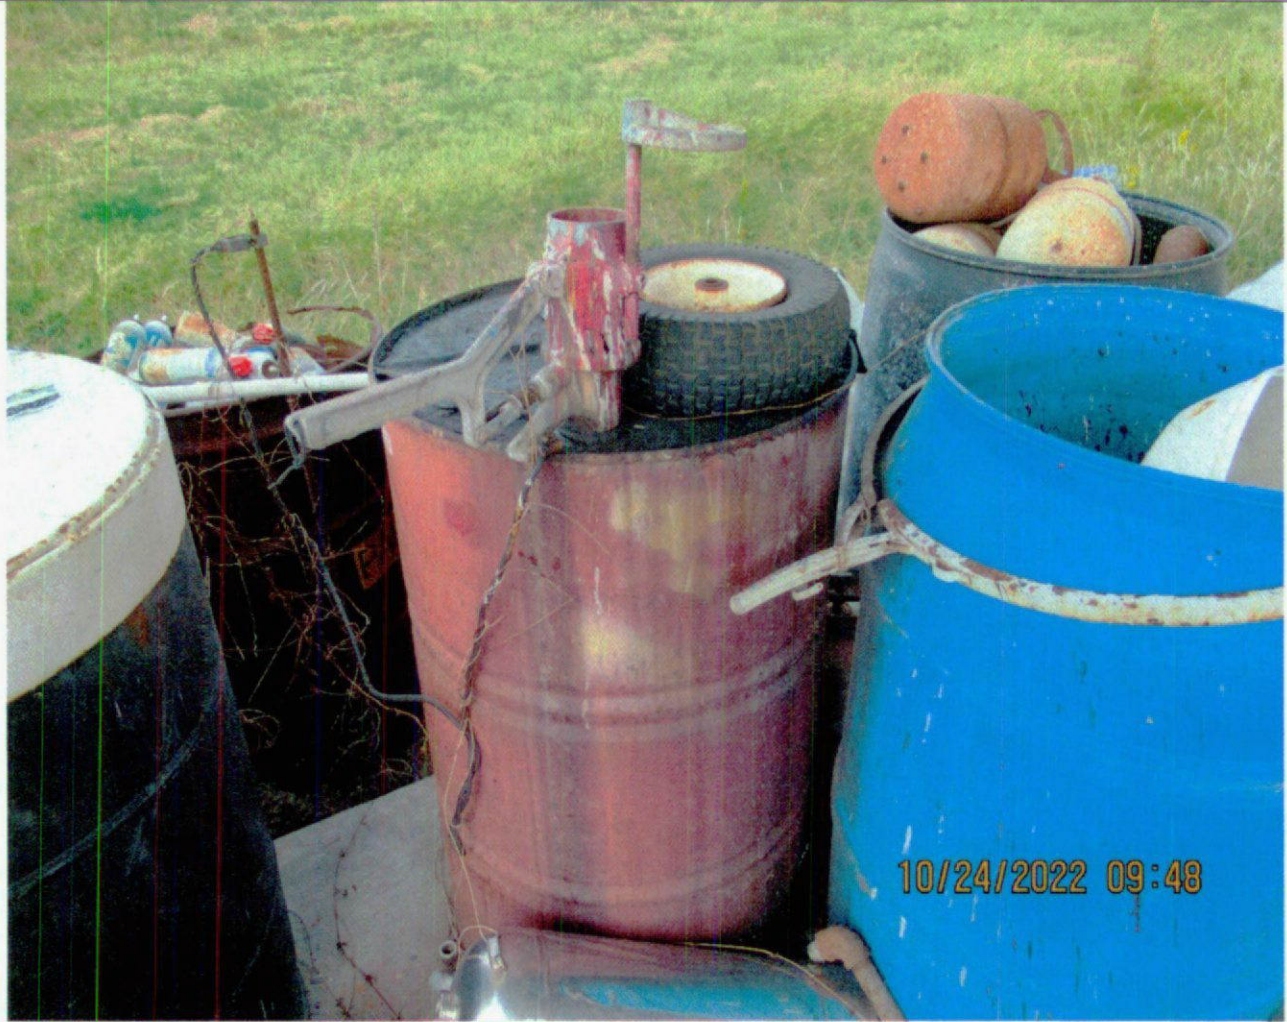
Photo #: 17 Of 81 Date: 10/24/2022 Time: 9:48 AM  
 Description: A 55-gallon drum with a puncture device storing aerosol liquids. The drum was full at the time. Mr. Harris stated this was hazardous waste generated at ERS. The drum was not adequately labeled.

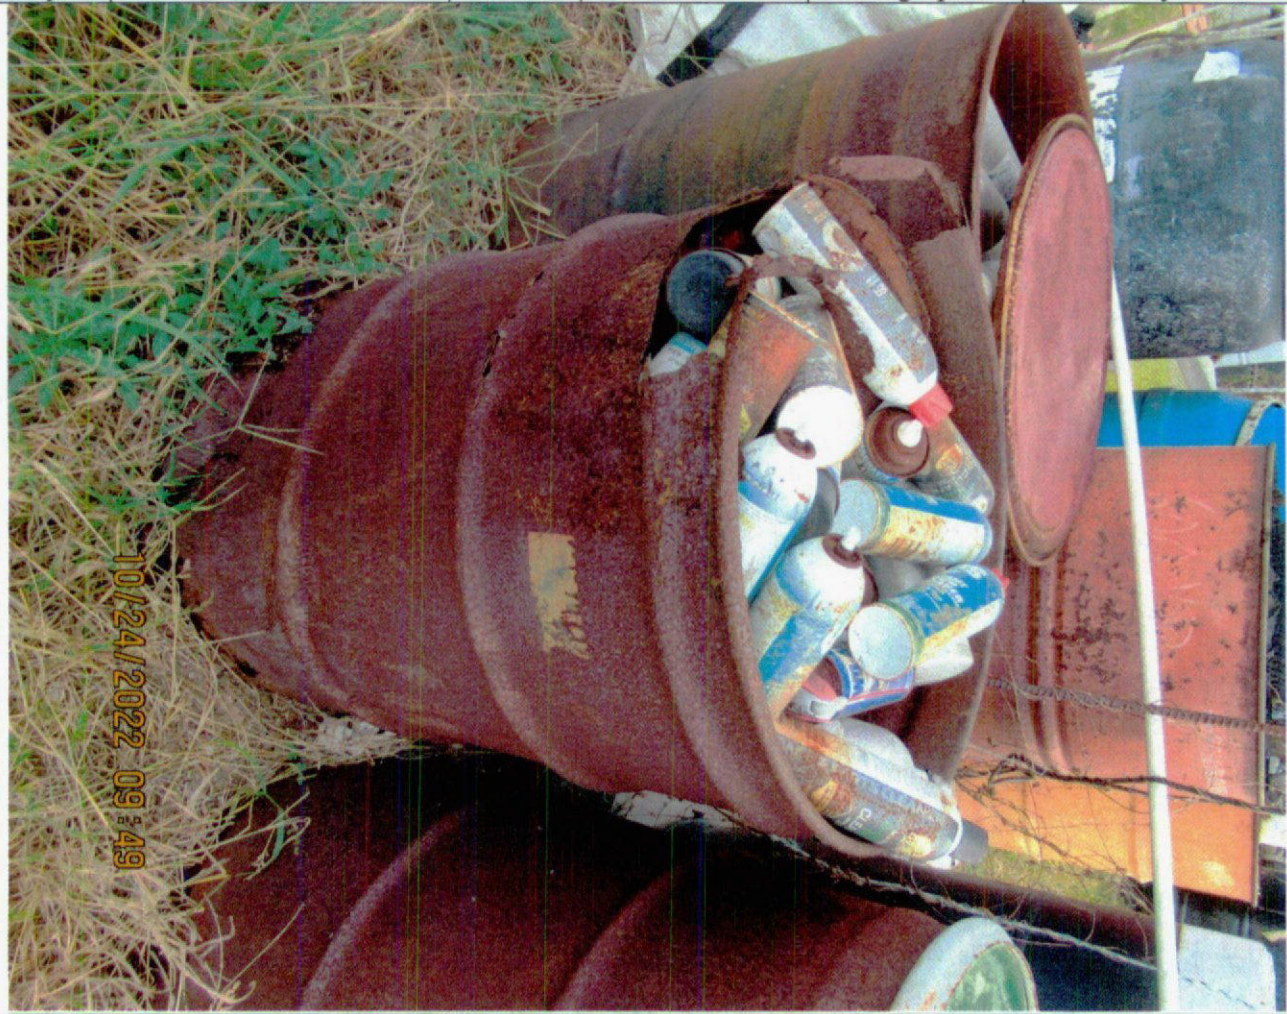
Photo #: 18 Of 81 Date: 10/24/2022 Time: 9:49 AM  
 Description: I observed an open top drum of aerosol cans. The drum was full, lacking labels, and not closed. Mr. Harris confirmed this was hazardous waste generated by ERS.

The container of hazardous waste aerosols was not closed, which is a violation of LAC 33:V.1009.A.6.

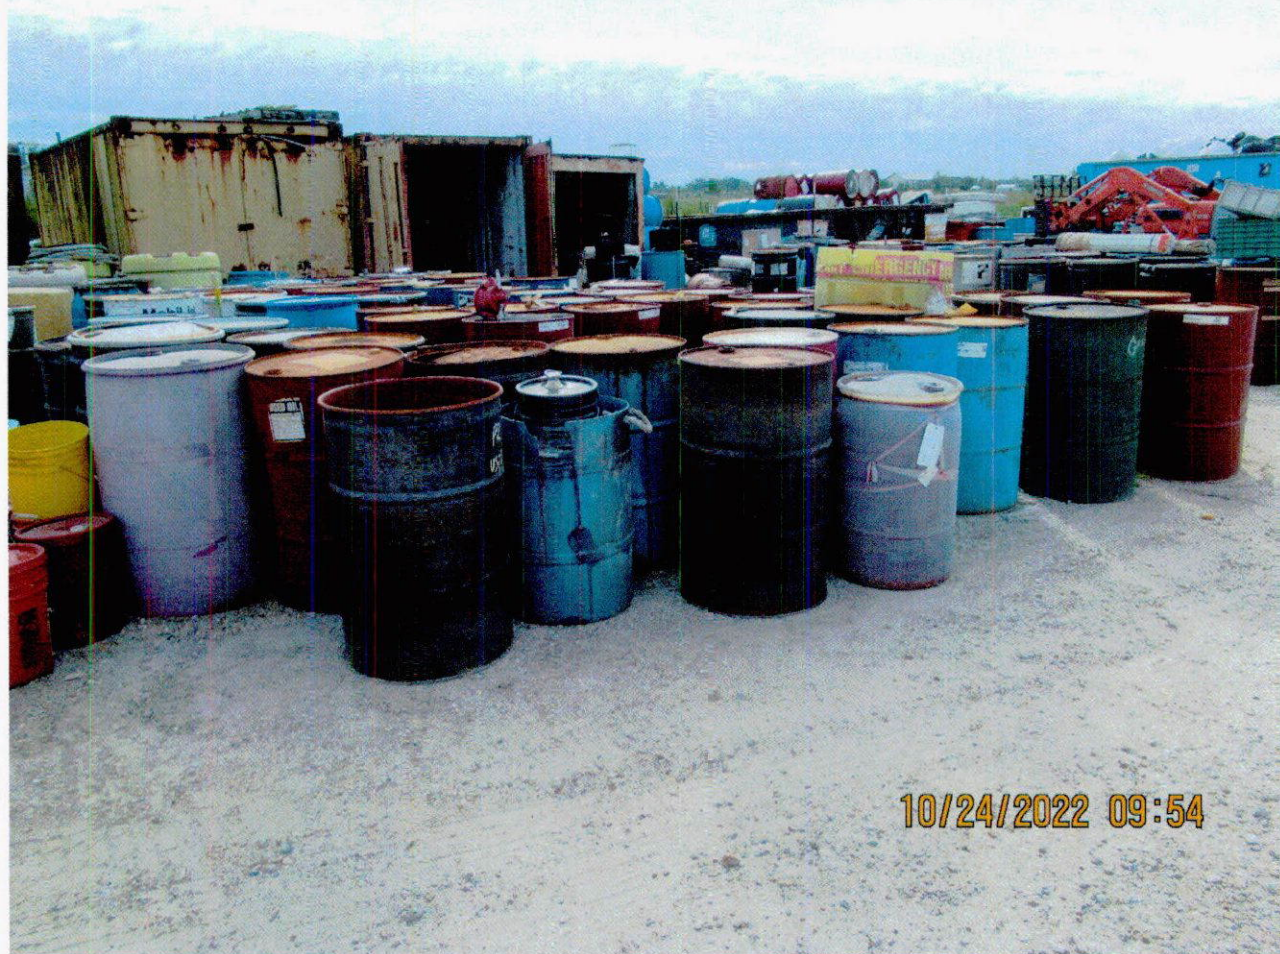
Photo #: 19 Of 81 Date: 10/24/2022 Time: 9:54 AM  
 Description: Several drums of used oil, oily water, and some hazardous waste drums were observed on the east side of the facility. The drums, specifically used oil drums, were on earthen ground and did not have an adequate secondary containment system.

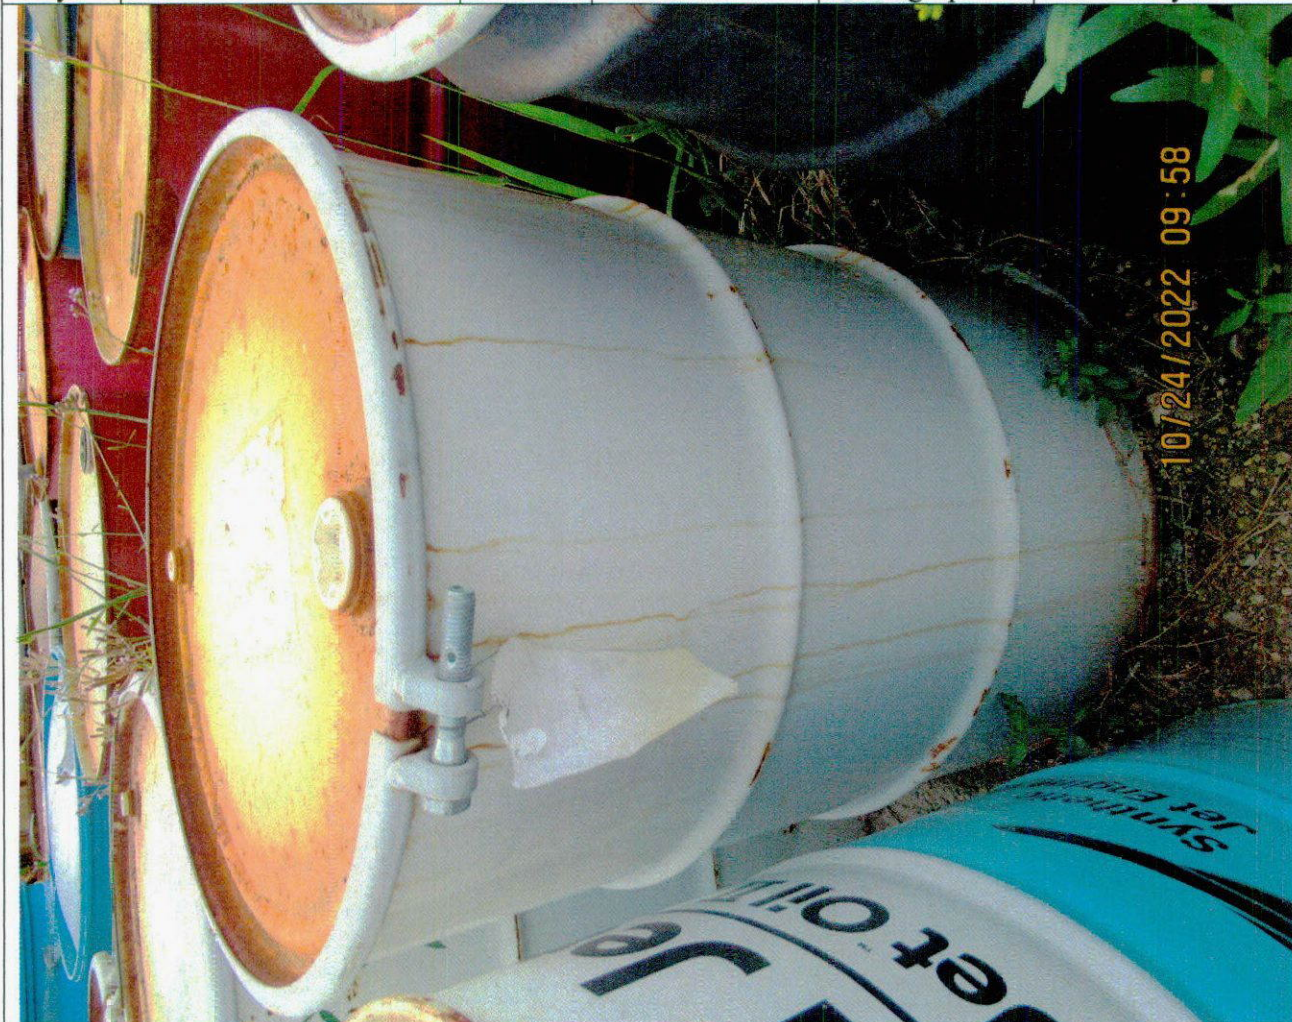
Photo #: 21 Of 81 Date: 10/24/2022 Time: 9:58 AM  
 Description: Photograph demonstrating the condition of another drum storing used oil.

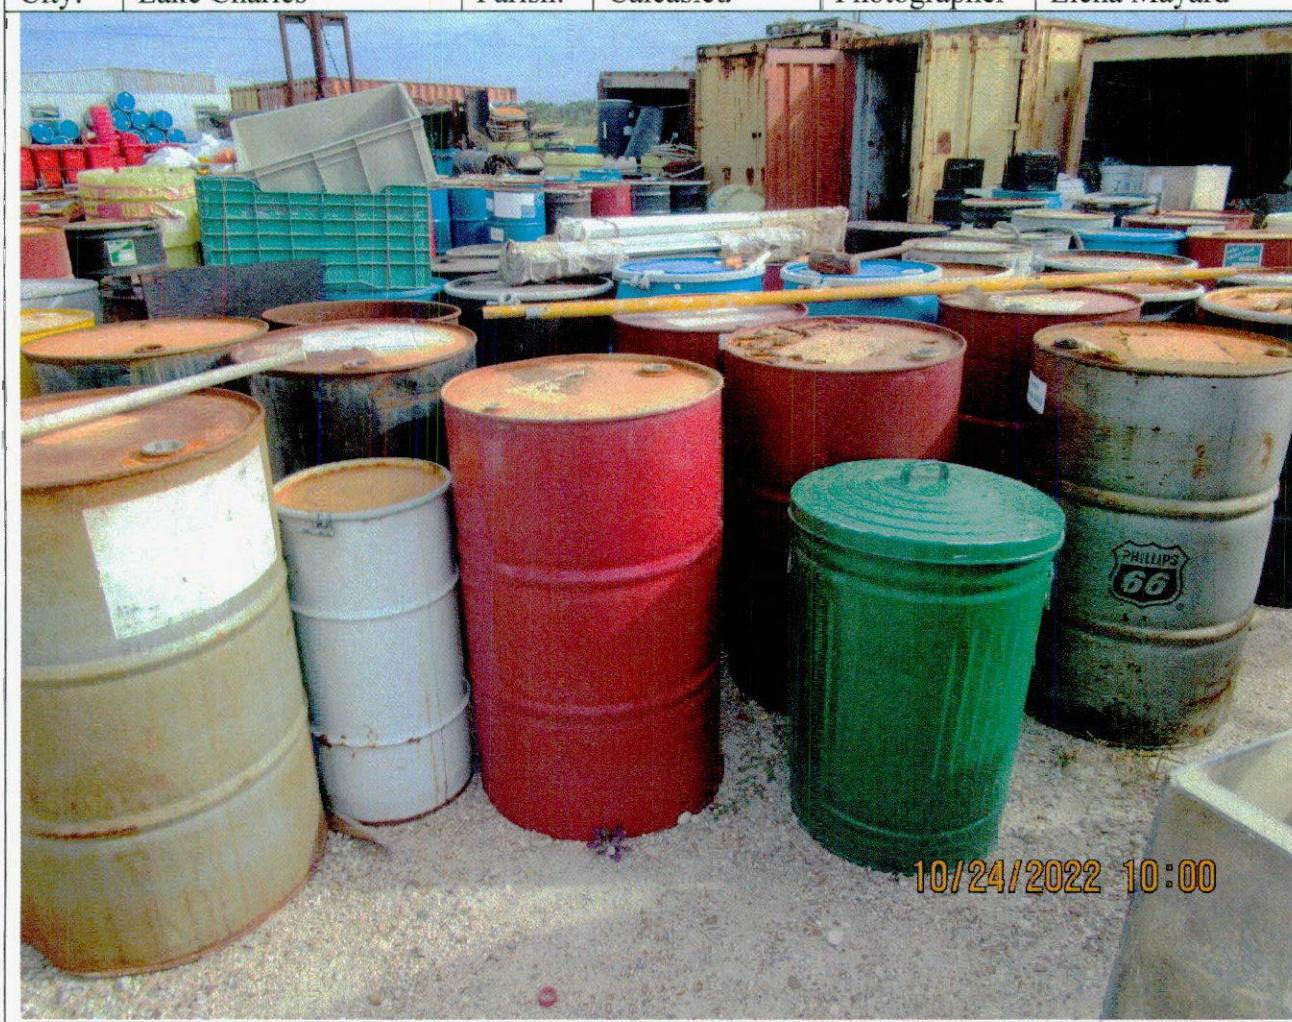
Photo #: 22 Of 81 Date: 10/24/2022 Time: 10:00 AM  
 Description: Angle demonstrating the excessive amount of waste stored onsite. The drums are showing signs of deterioration. The drums are storing used oil, oily water, oil contaminated solids, and hazardous waste.

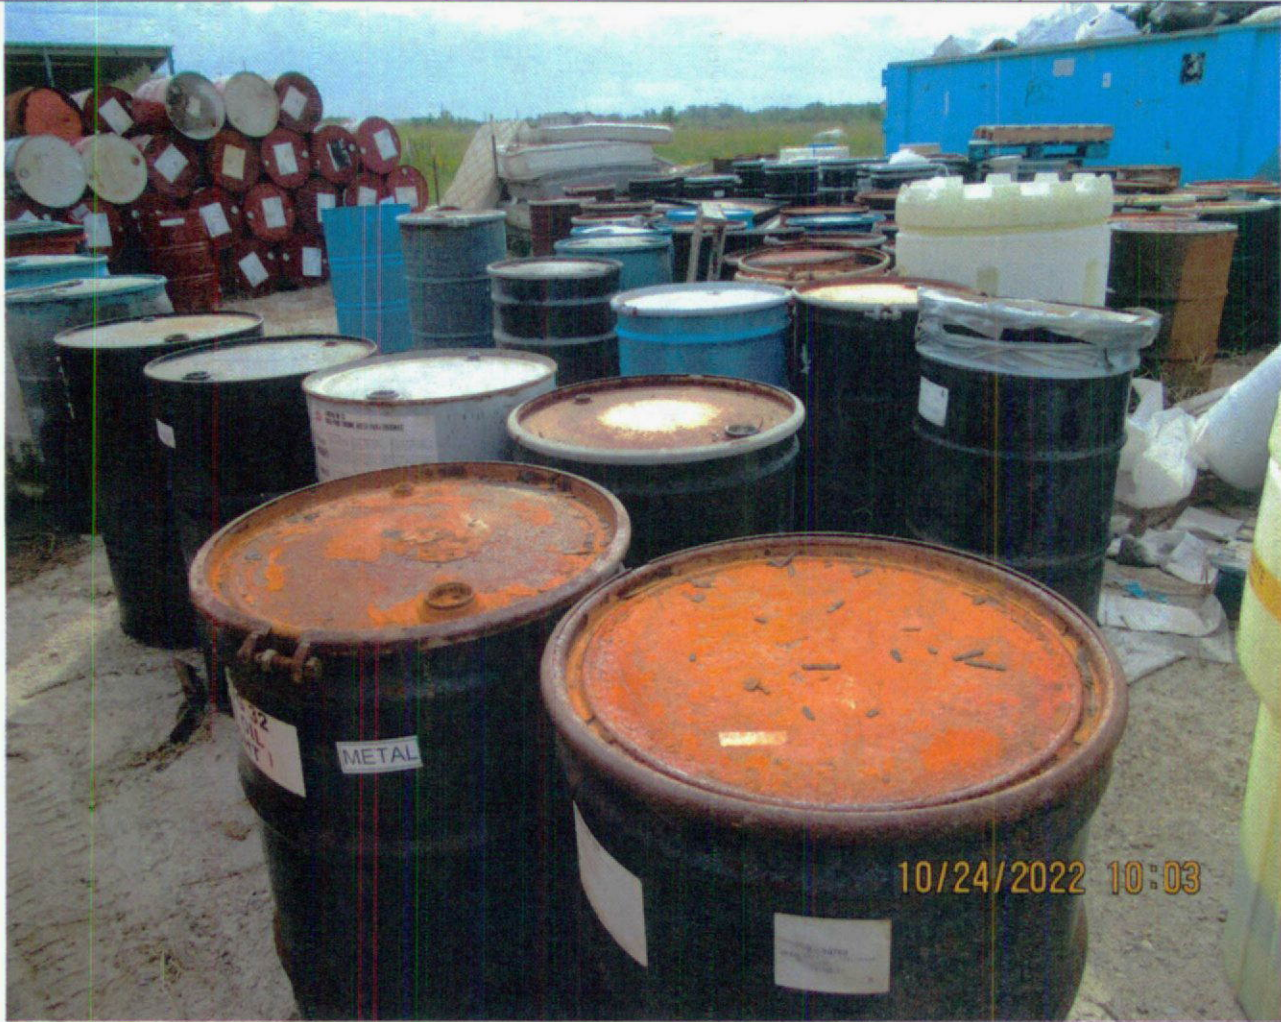
Photo #: 23 Of 81 Date: 10/24/2022 Time: 10:13 AM  
 Description: Several drums were not adequately labeled as used oil. The drums are significantly rusted.

The facility failed to clearly label or mark containers and aboveground tanks used to store used oil at transfer facilities with the words "Used Oil," which is a violation of LAC 33:V.4035.H.1.

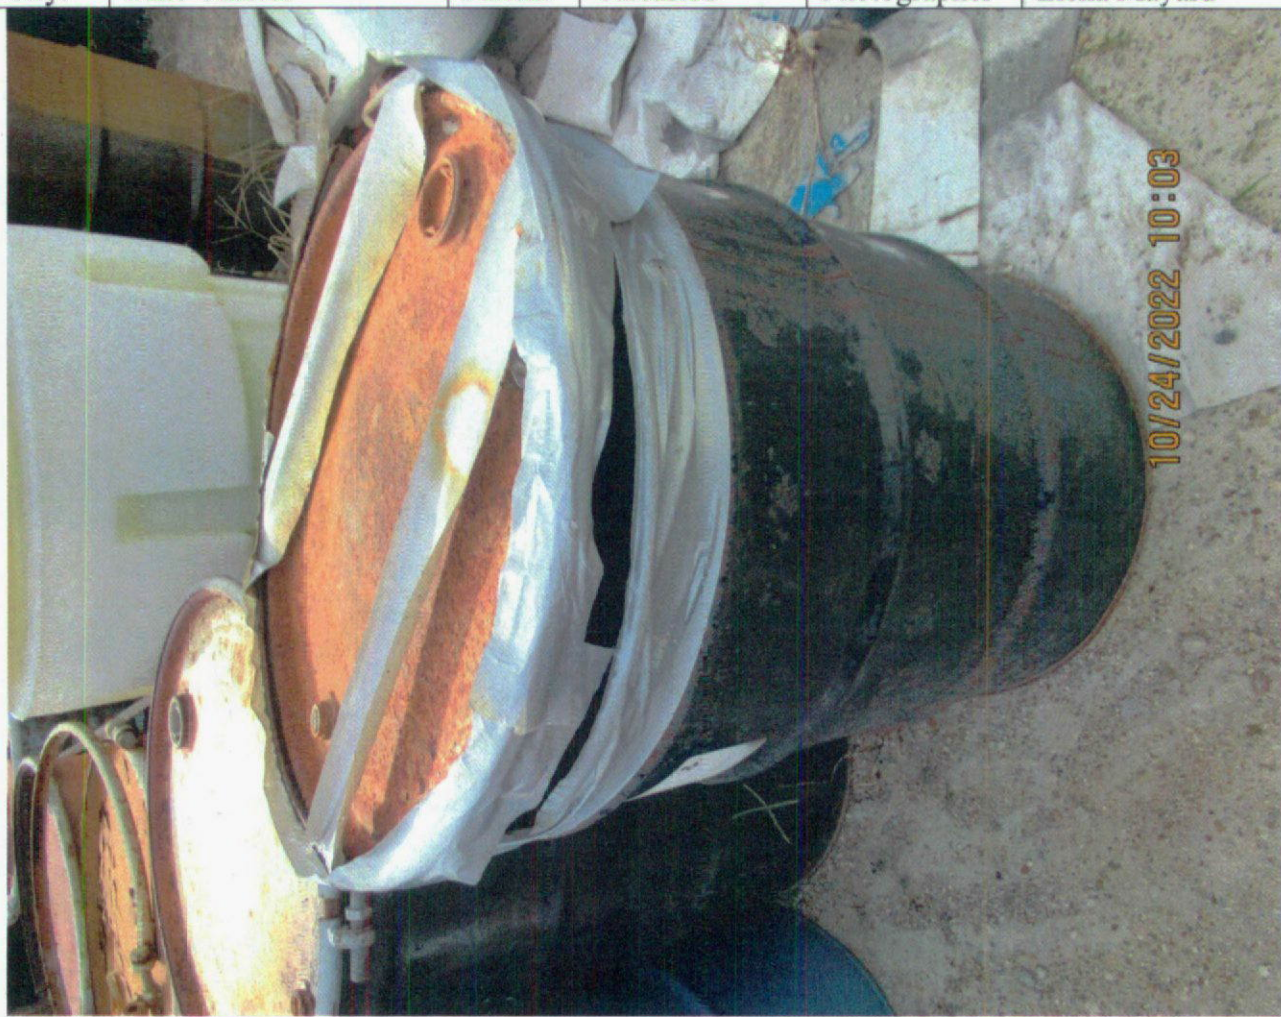
Photo #: 24 Of 81 Date: 10/24/2022 Time: 10:03 AM  
 Description: Drum of paint chips that was duct-taped. The lid is not secure and the drum is not labeled. The facility representatives were unable to determine if this was characteristic hazardous waste or non-hazardous waste.

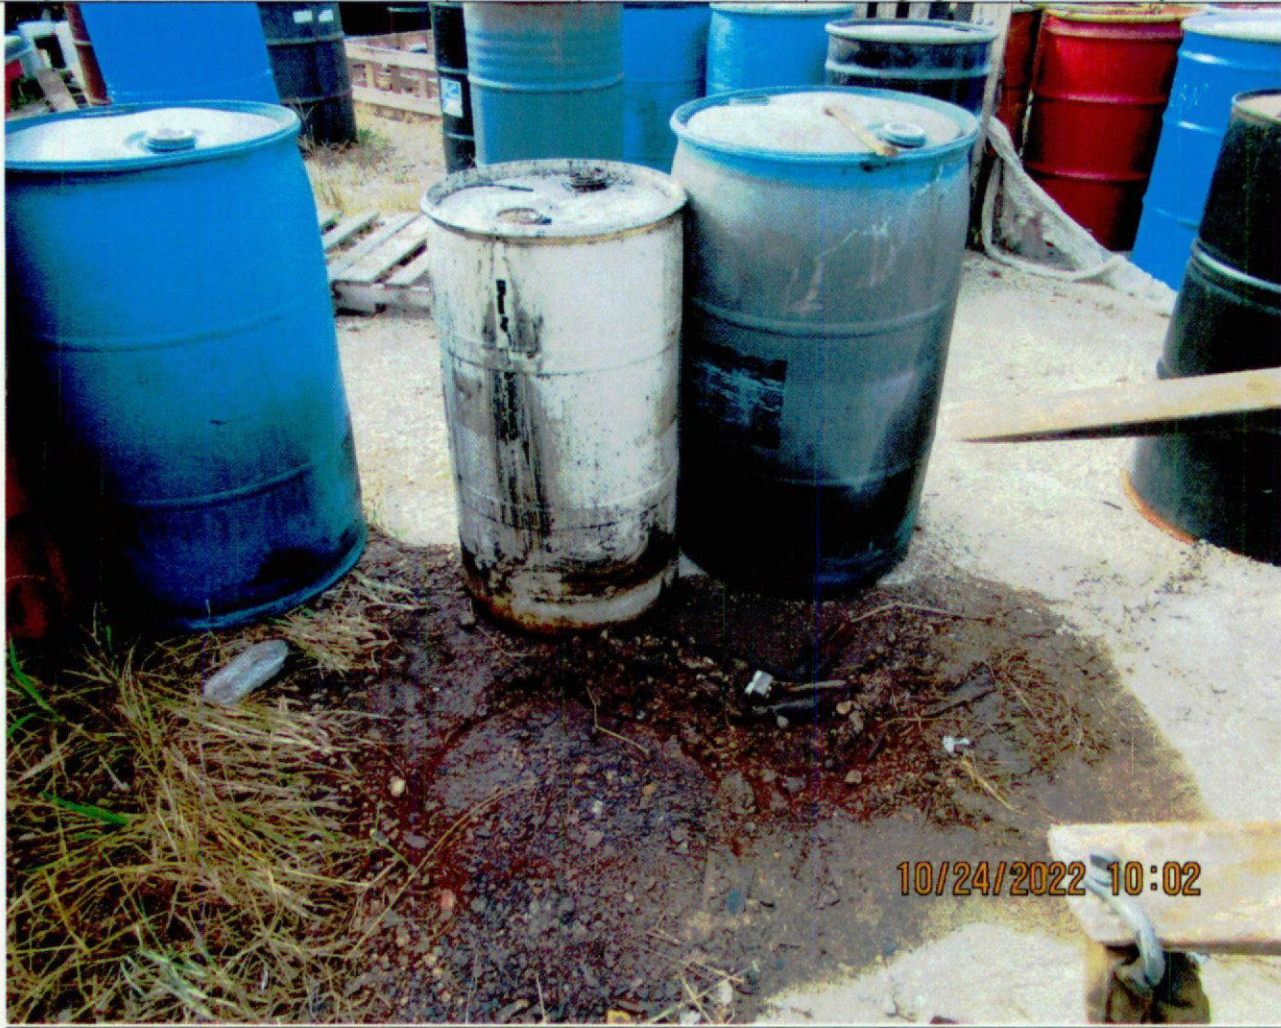
Photo #: 25 Of 81 Date: 10/24/2022 Time: 10:02 AM  
 Description: I observed a spill of used oil. These drums are not in a secondary containment system. The drums were positioned on earthen ground.

The facility failed to have a secondary containment system for the containers used to store used oil in this area, which is a violation of LAC 33:V.4035.E.

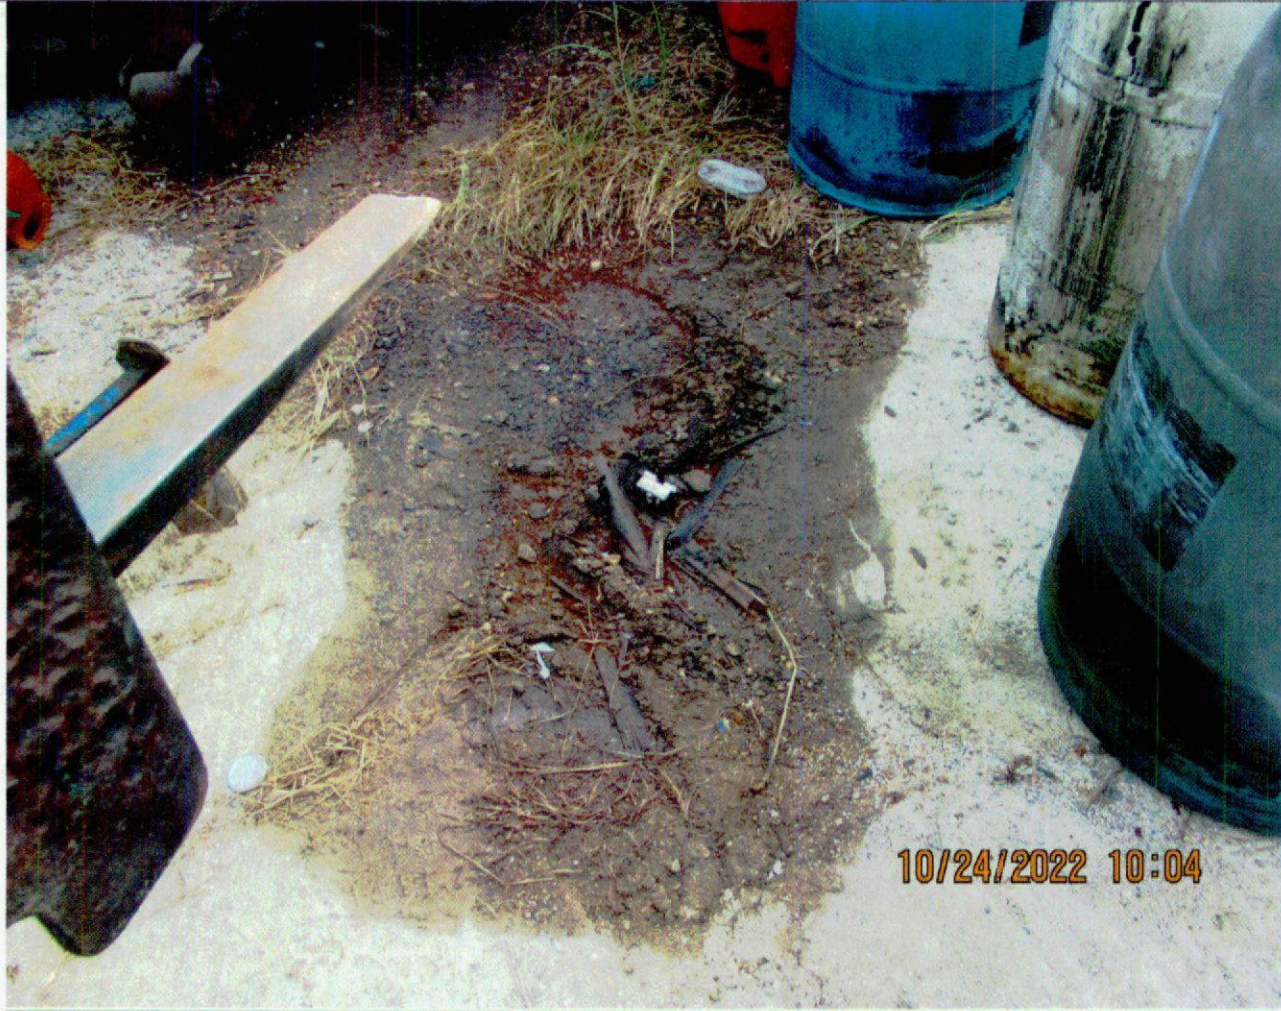
Photo #: 26 Of 81 Date: 10/24/2022 Time: 10:04 AM  
 Description: Different angle of the spill noted in Photograph 25.

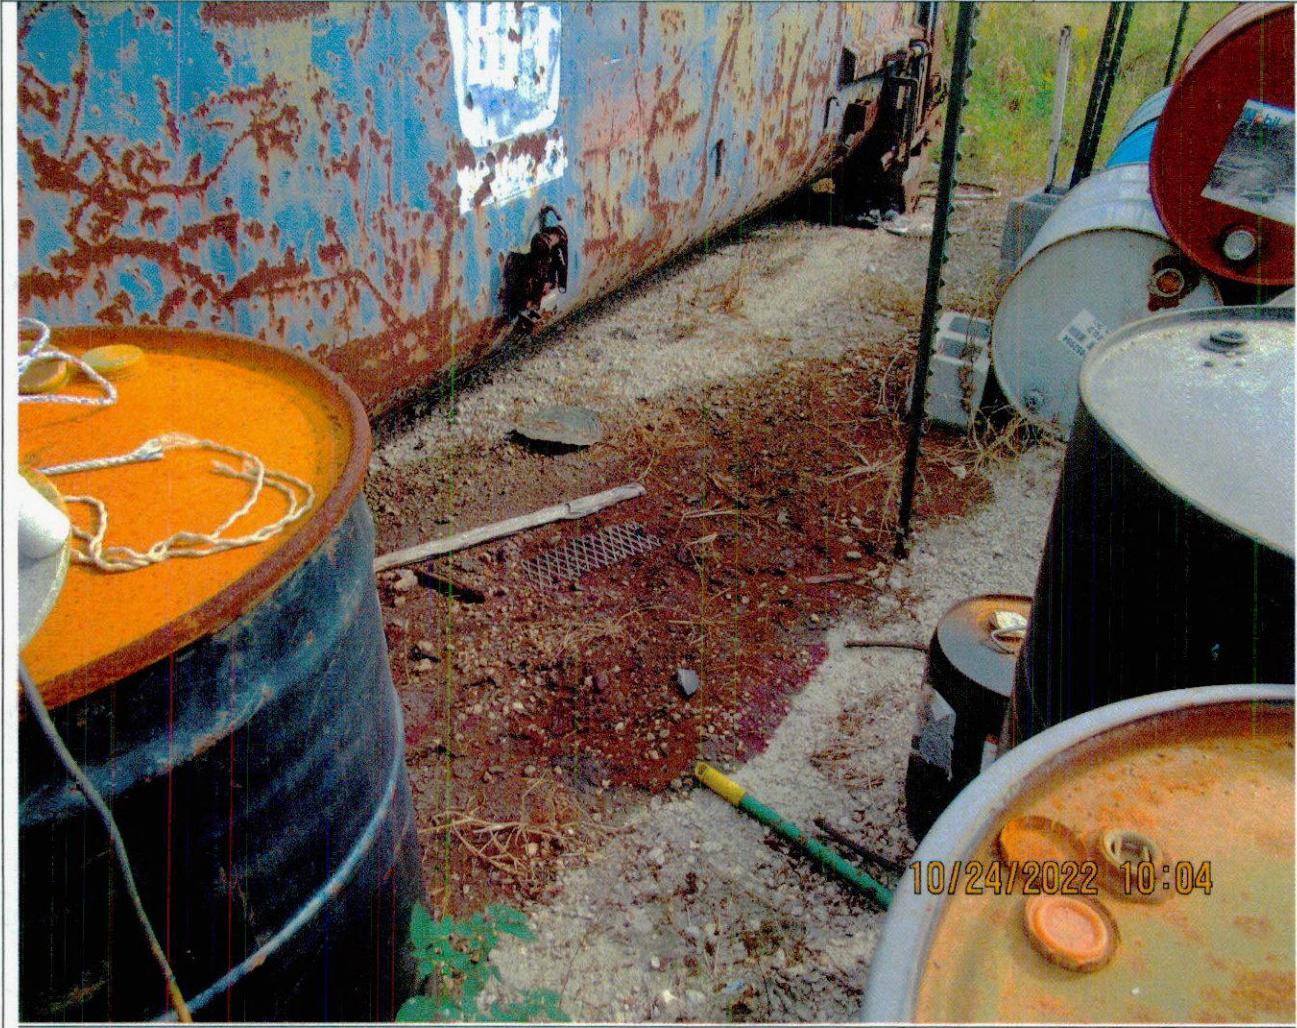
Photo #: 27 Of 81 Date: 10/24/2022 Time: 10:04 AM  
Description: Another spill/release was discovered during the facility tour.

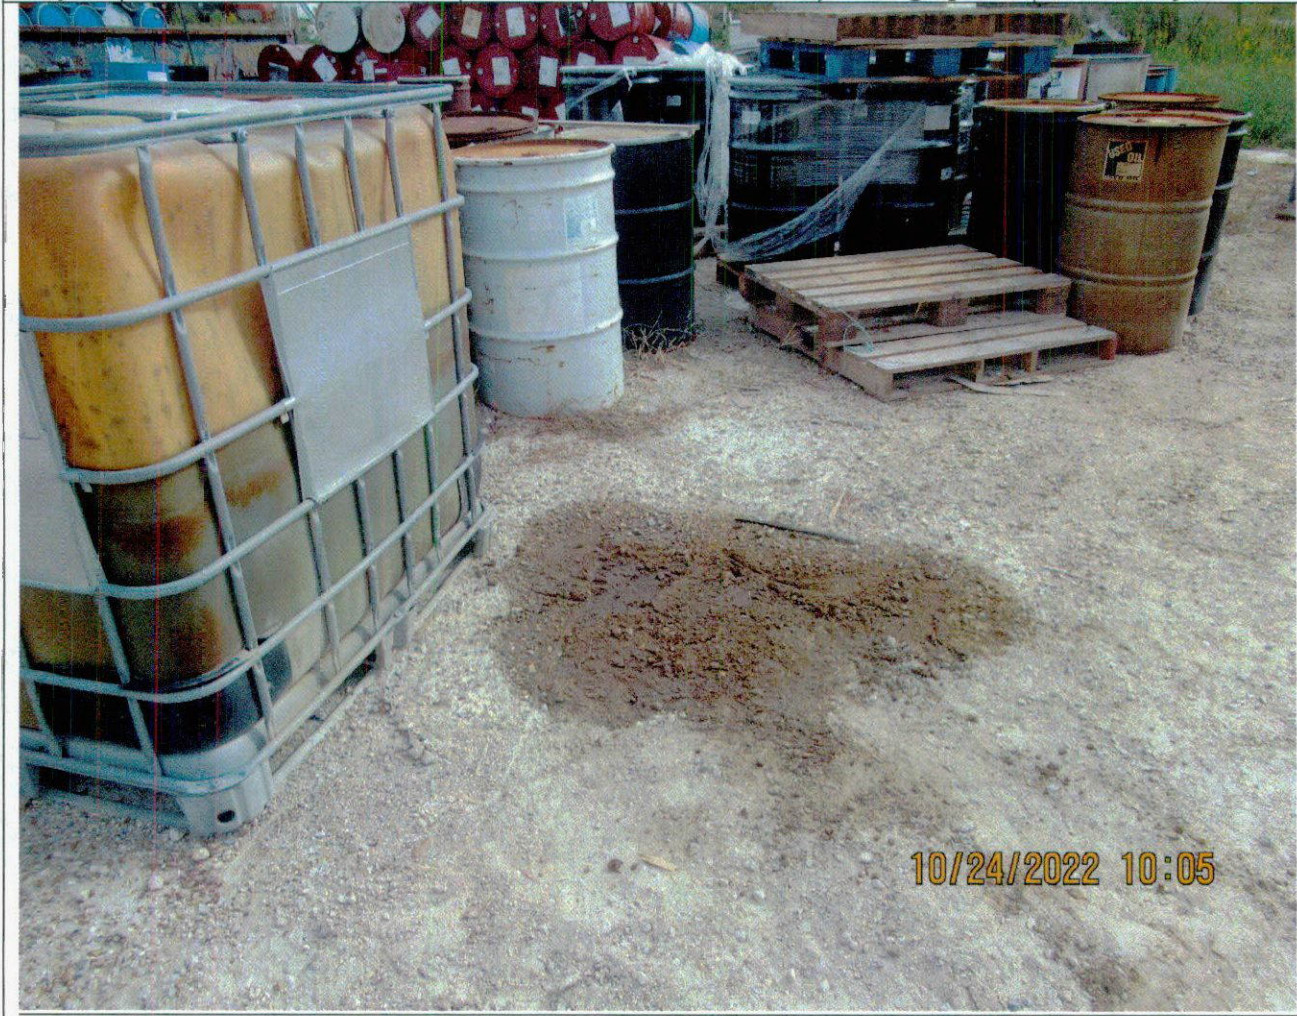
Photo #: 28 Of 81 Date: 10/24/2022 Time: 10:05 MA  
Description: Third spill noted during the facility tour.

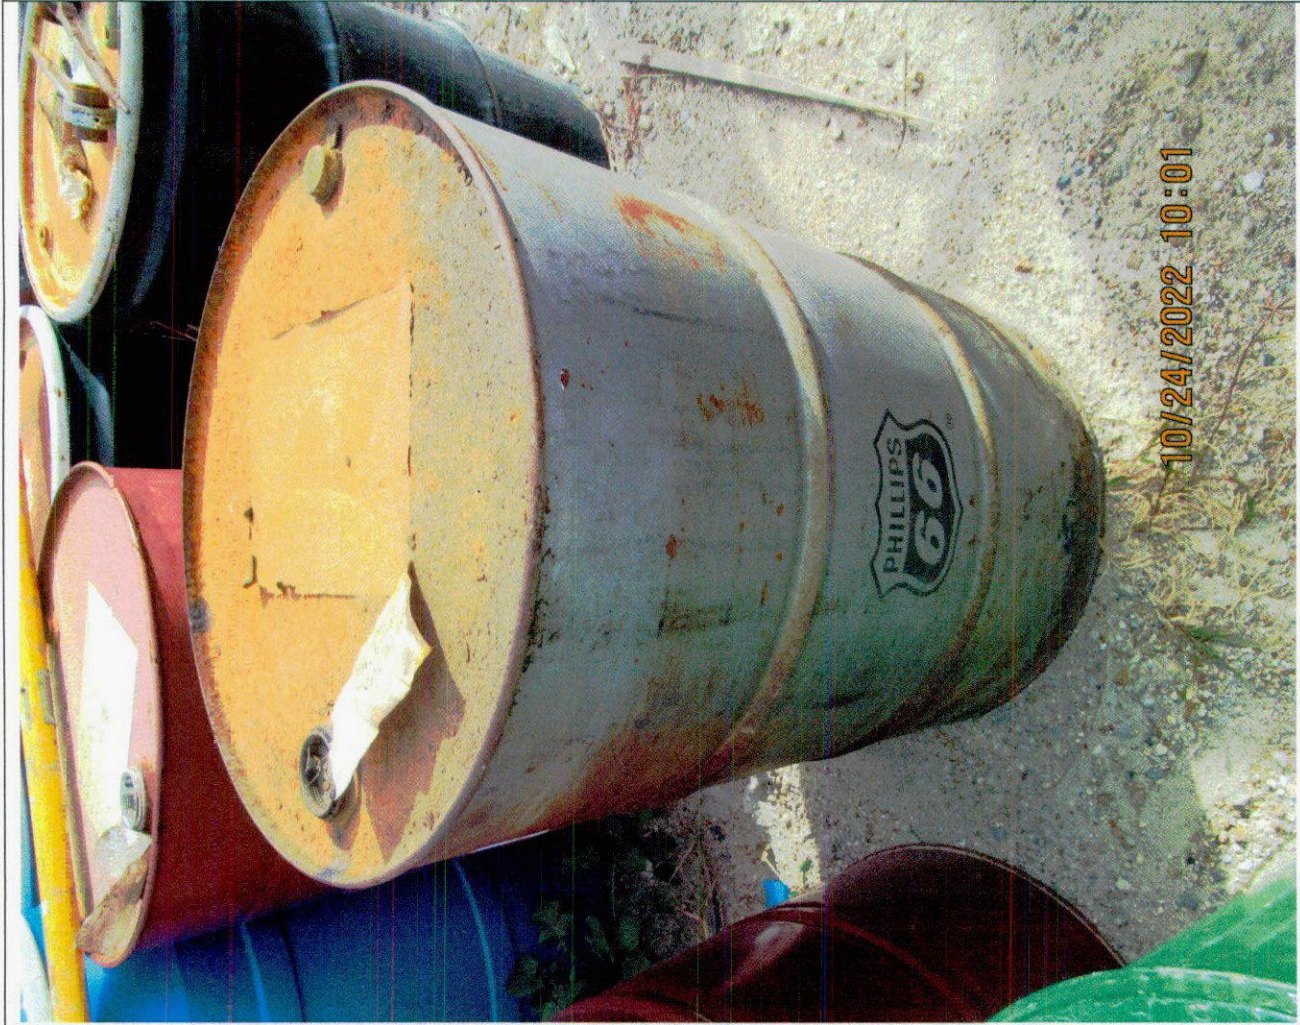
Photo #: 29 Of 81 Date: 10/24/2022 Time: 10:05 AM  
 Description: 55-gallon drum of used oil that was picked up and transported by ERS to their facility on 8/3/2022, according to the label. This drum of used oil has been onsite for greater than the allowed 35 days for used oil transfer facilities.

The facility held shipments of used oil for more than 35 days, which is a violation of LAC 33:V.4035.B.
