INSPECTION REPORT

| Type of Inspection | Focused Compliance Inspection (FCI) | | | |
| Facility or Site Name | Environmental Response Services, Inc. (ERS) | | | |

**Southwest Regional Office  
Hazardous Waste Inspection Report**

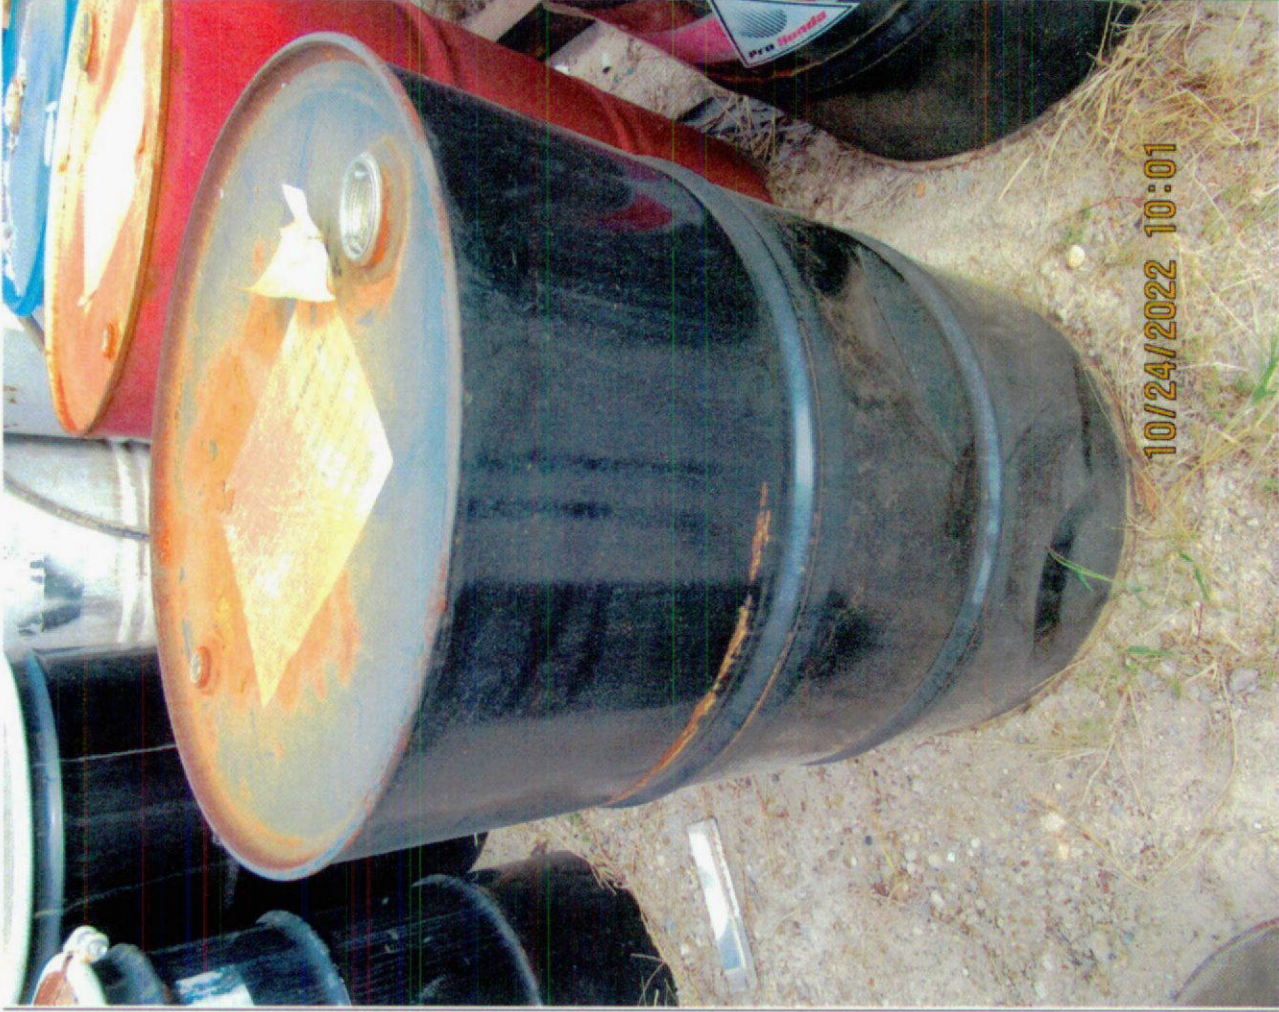
Photo #: 32 Of 81 Date: 10/24/2022 Time: 10:01 AM

Description: 55-gallon drum of used oil that has been onsite since 11/9/2021. The tag for this drum is shown in Photograph 31.

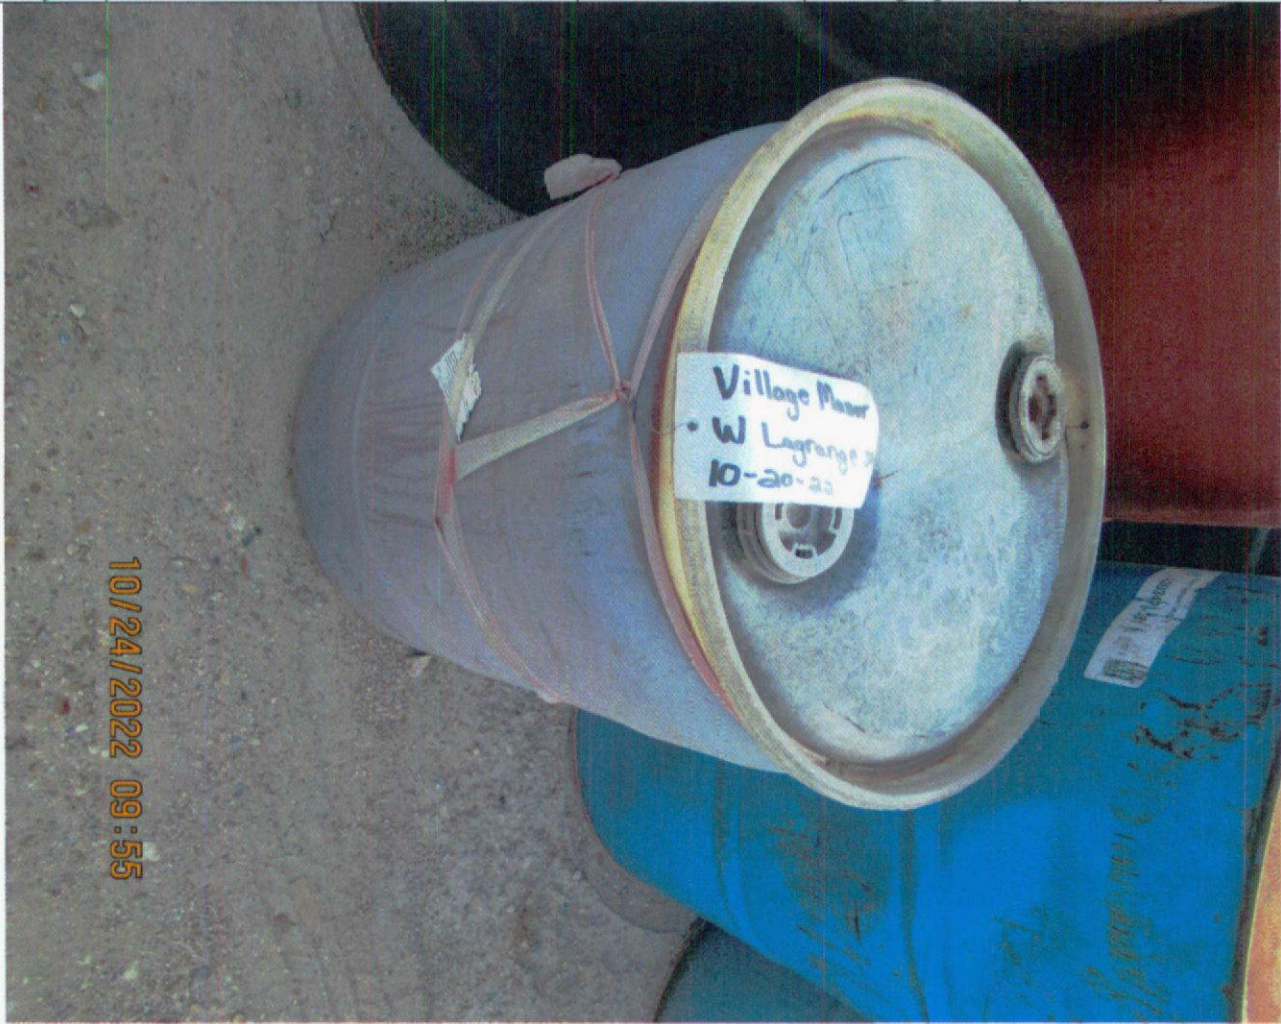
Photo #: 33 Of 81 Date: 10/24/2022 Time: 9:55 AM

Description: Drum that is lacking labels indicating the contents.

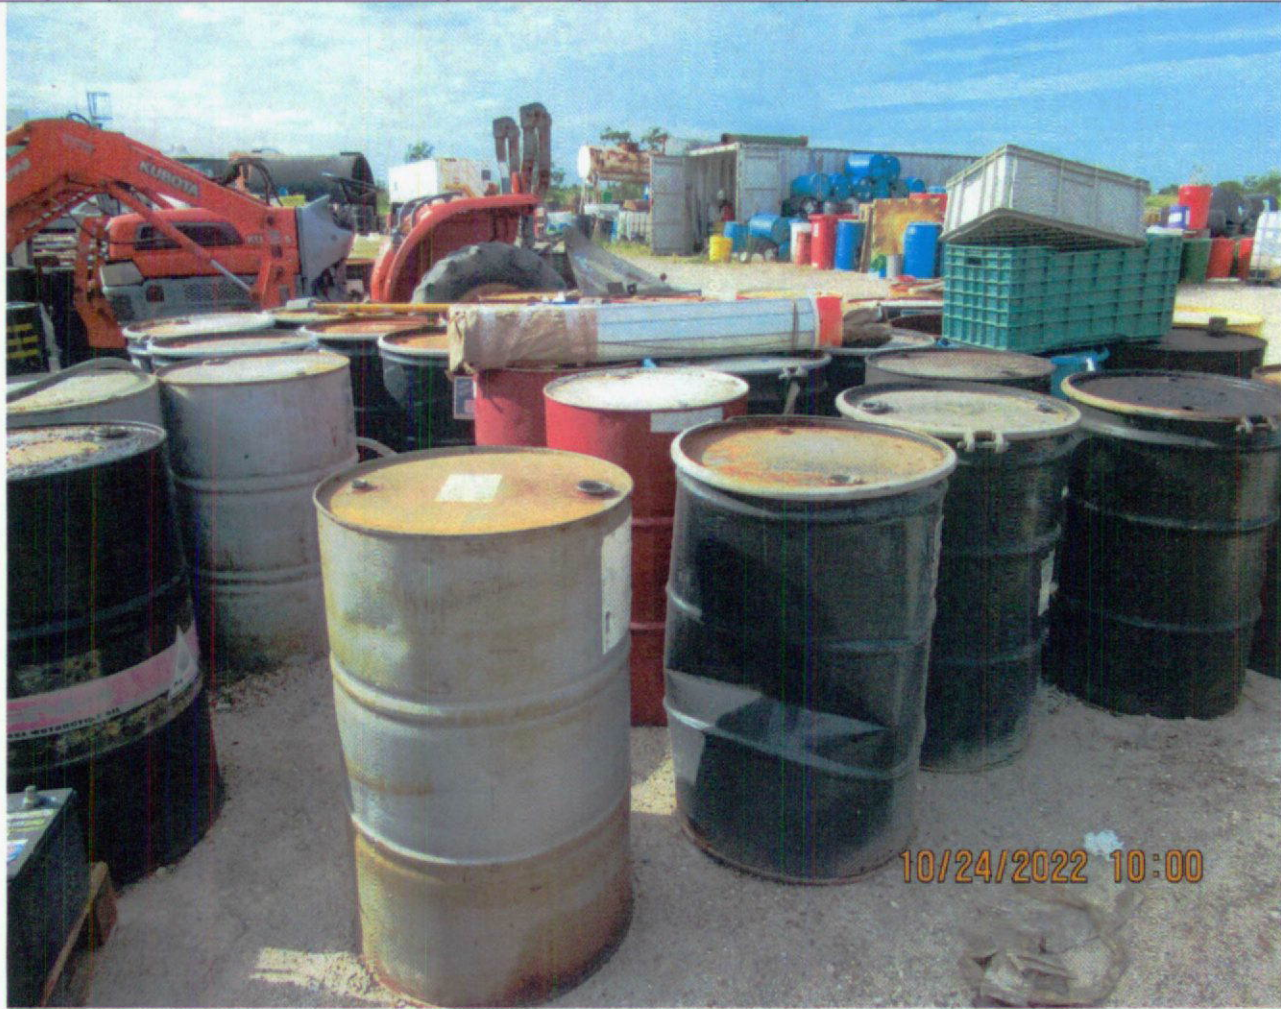
Photo #: 34 Of 81 Date: 10/24/2022 Time: 10:00 AM

Description: Another angle demonstrating the large amount of waste the facility has onsite. There are several drums of used oil directly on the ground. Several of the drums did not have labels.

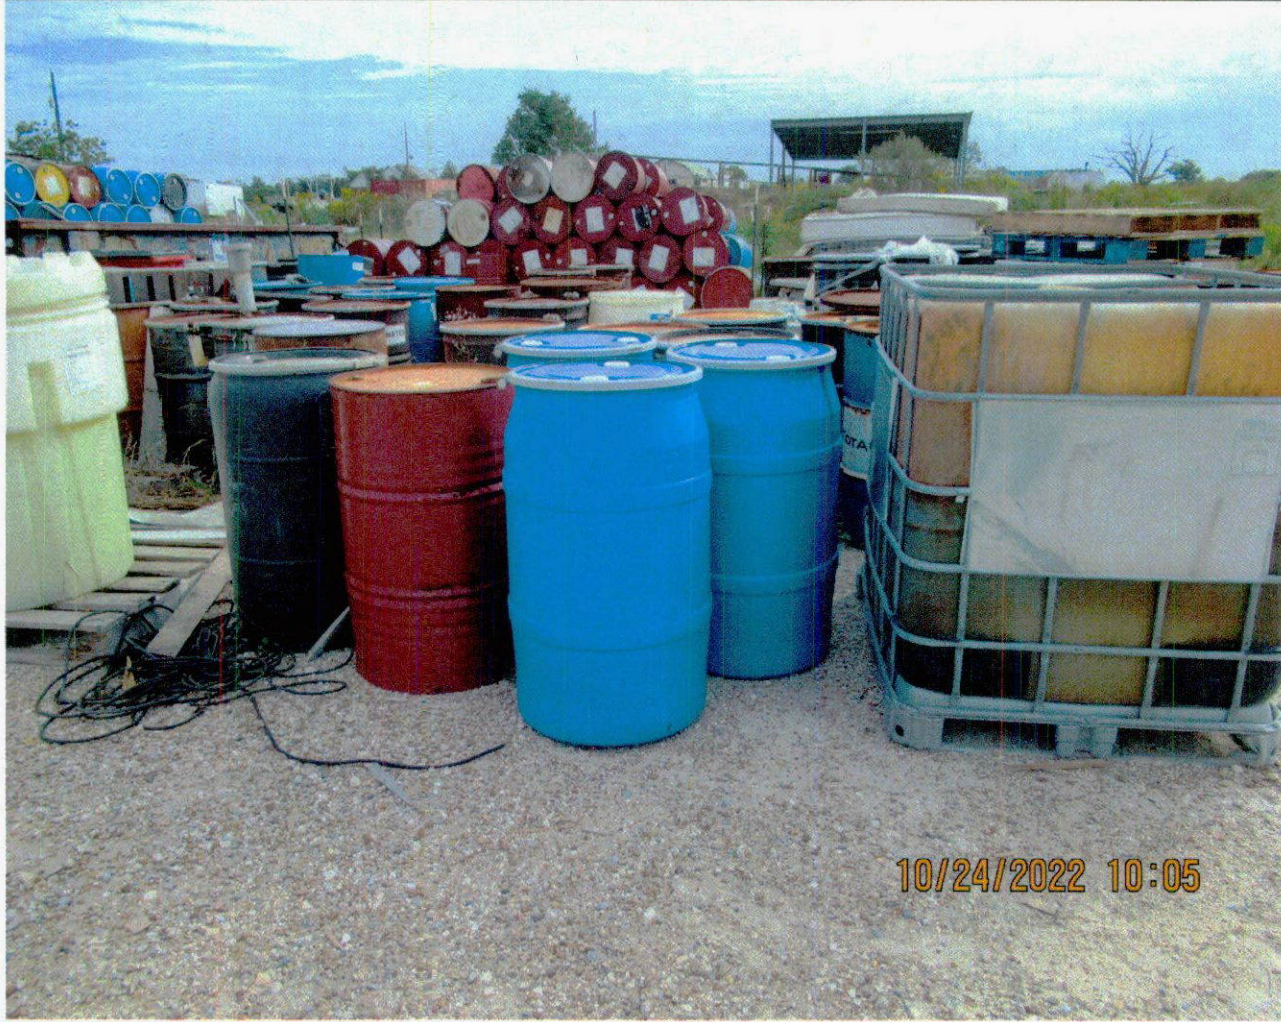
Photo #: 35 Of 81 Date: 10/24/2022 Time: 10:05 AM  
 Description: Another angle demonstrating the large amount of waste the facility has onsite. There are several drums of used oil directly on the ground. Several of the drums did not have labels.

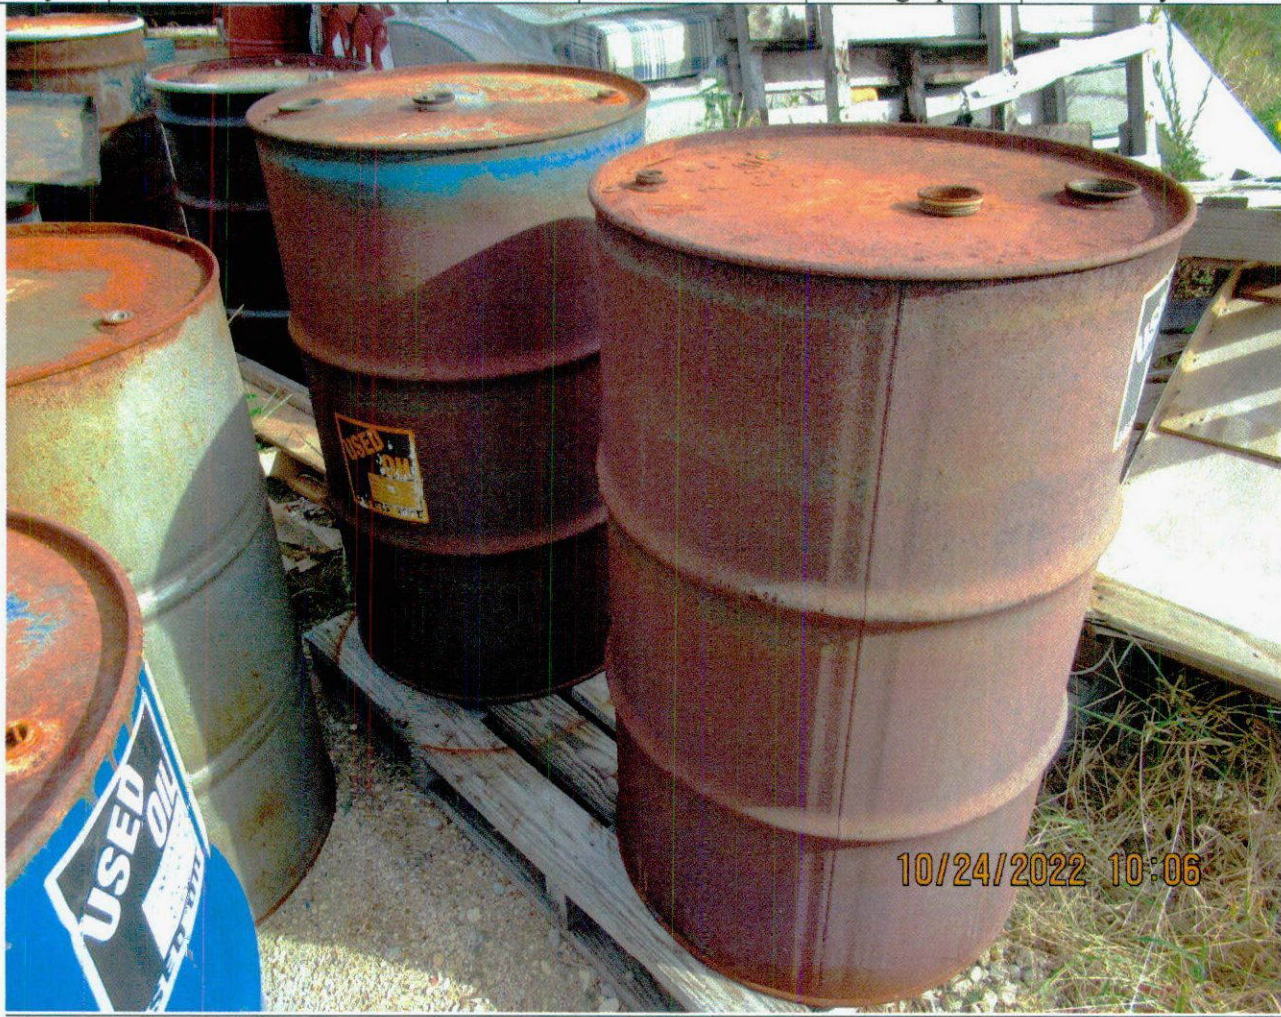
Photo #: 36 Of 81 Date: 10/24/2022 Time: 10:06 AM  
 Description: Severely rusted and deteriorated drums of used oil.

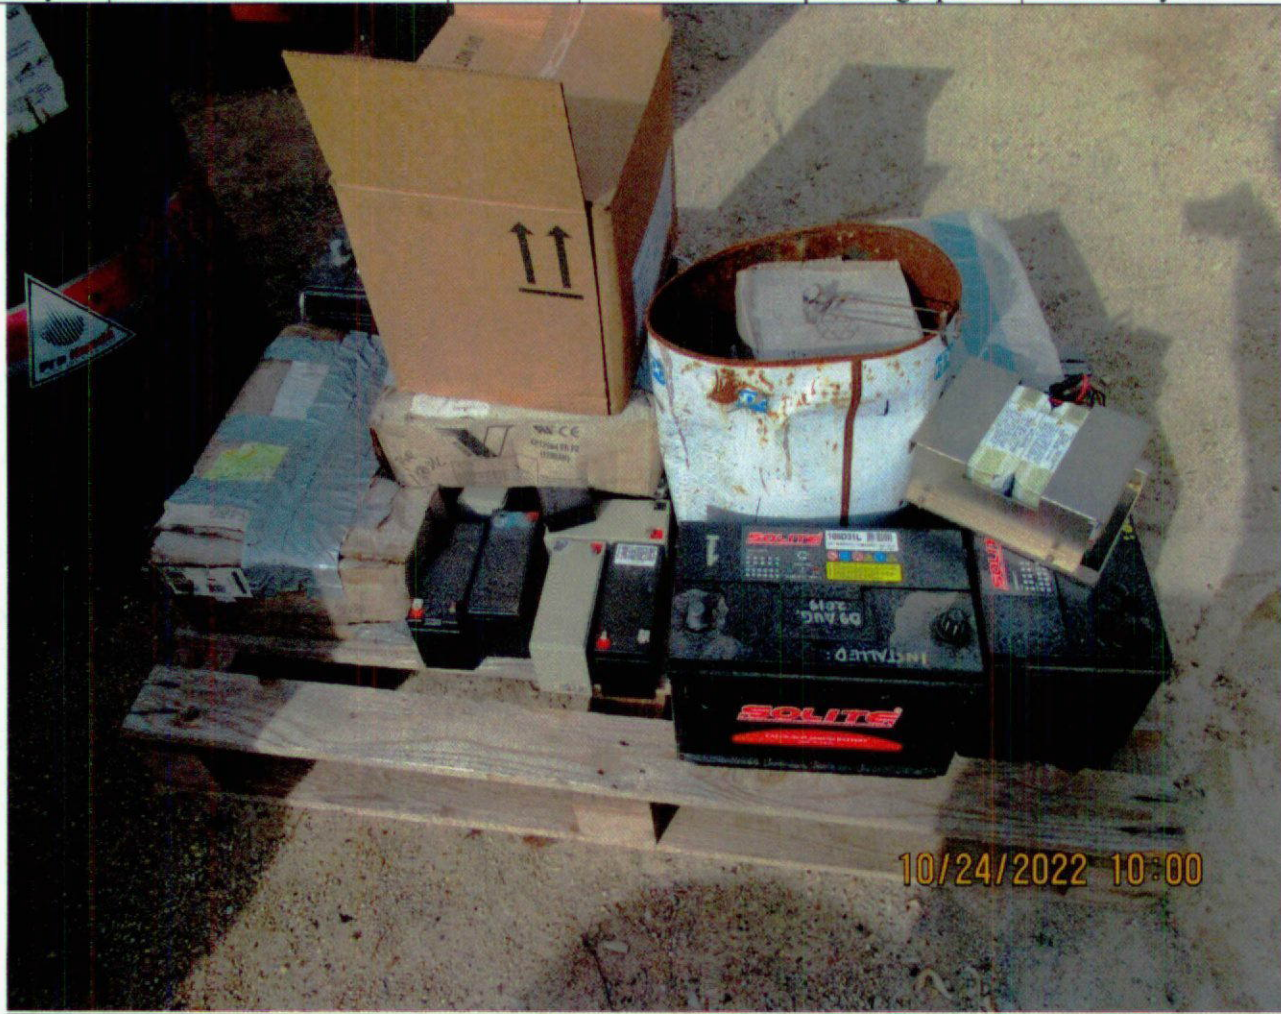
Photo #: 38 Of 81 Date: 10/24/2022 Time: 10:00 AM

I observed a pallet of used batteries (Attachment 3, Photograph 38). Mr. Harris was unsure of how long these batteries have been onsite. The used batteries did not have adequate labels or markings. **The facility failed to clearly label or mark universal waste batteries (e.g., each battery), or a container in which the batteries are contained, with any one of the following phrases: "Universal Waste—Battery(ies)," or "Waste Battery(ies)," or "Used Battery(ies)." This is a violation of LAC 33:V.3823.A.1.** I also observed empty drums stored adjacent to this area (Attachment 3, Photographs 39-40).

Description: I observed a pallet of used batteries. Mr. Harris was unsure of how long these batteries have been onsite. The used batteries did not have adequate labels or markings.

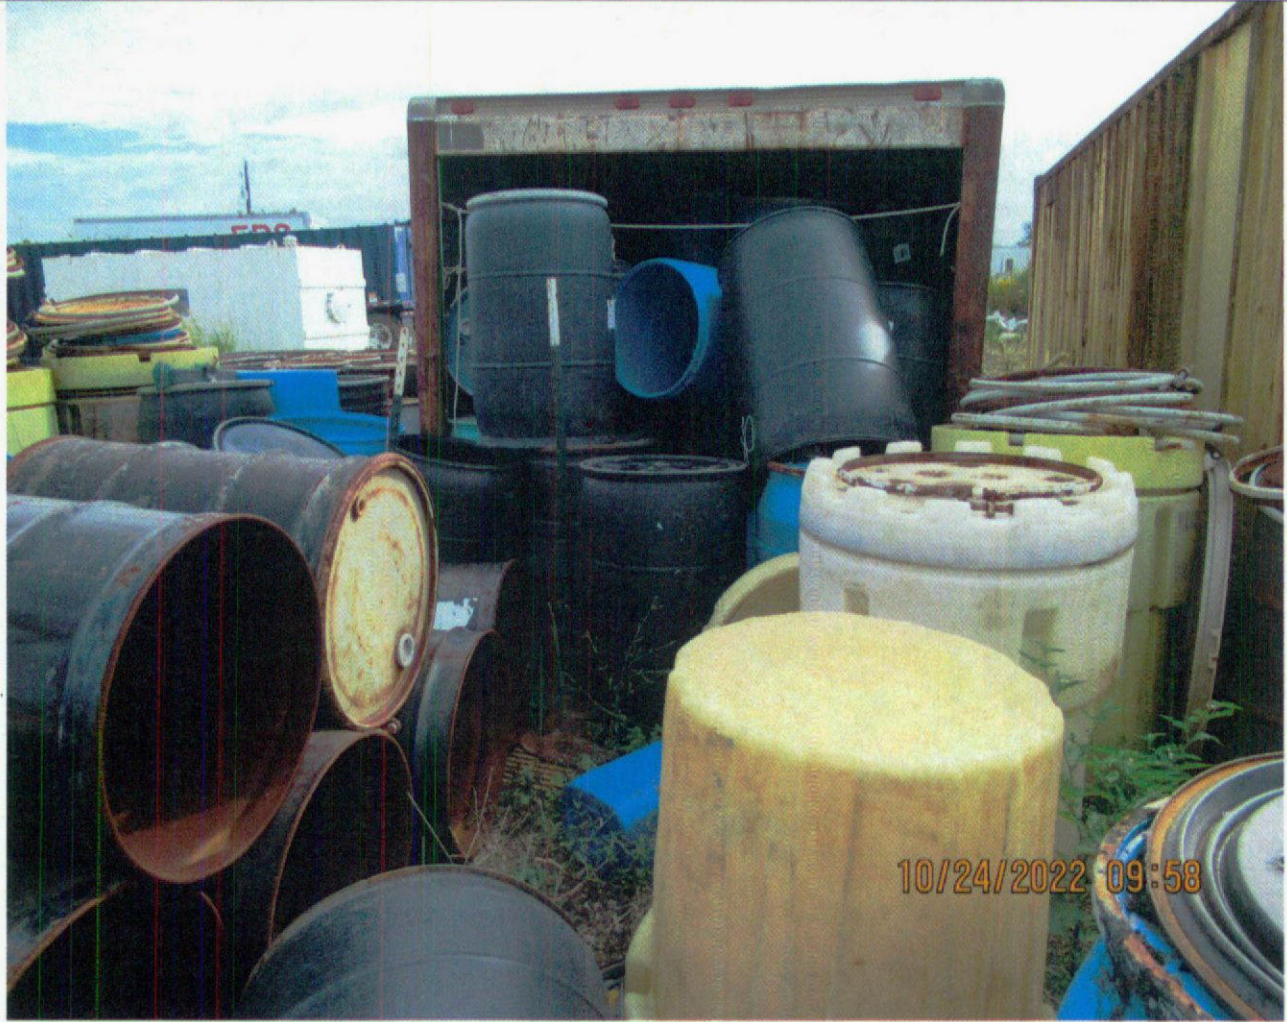
Photo #: 39 Of 81 Date: 10/24/2022 Time: 9:58 AM  
 Description: The facility also stores empty drums adjacent to the waste storage areas.

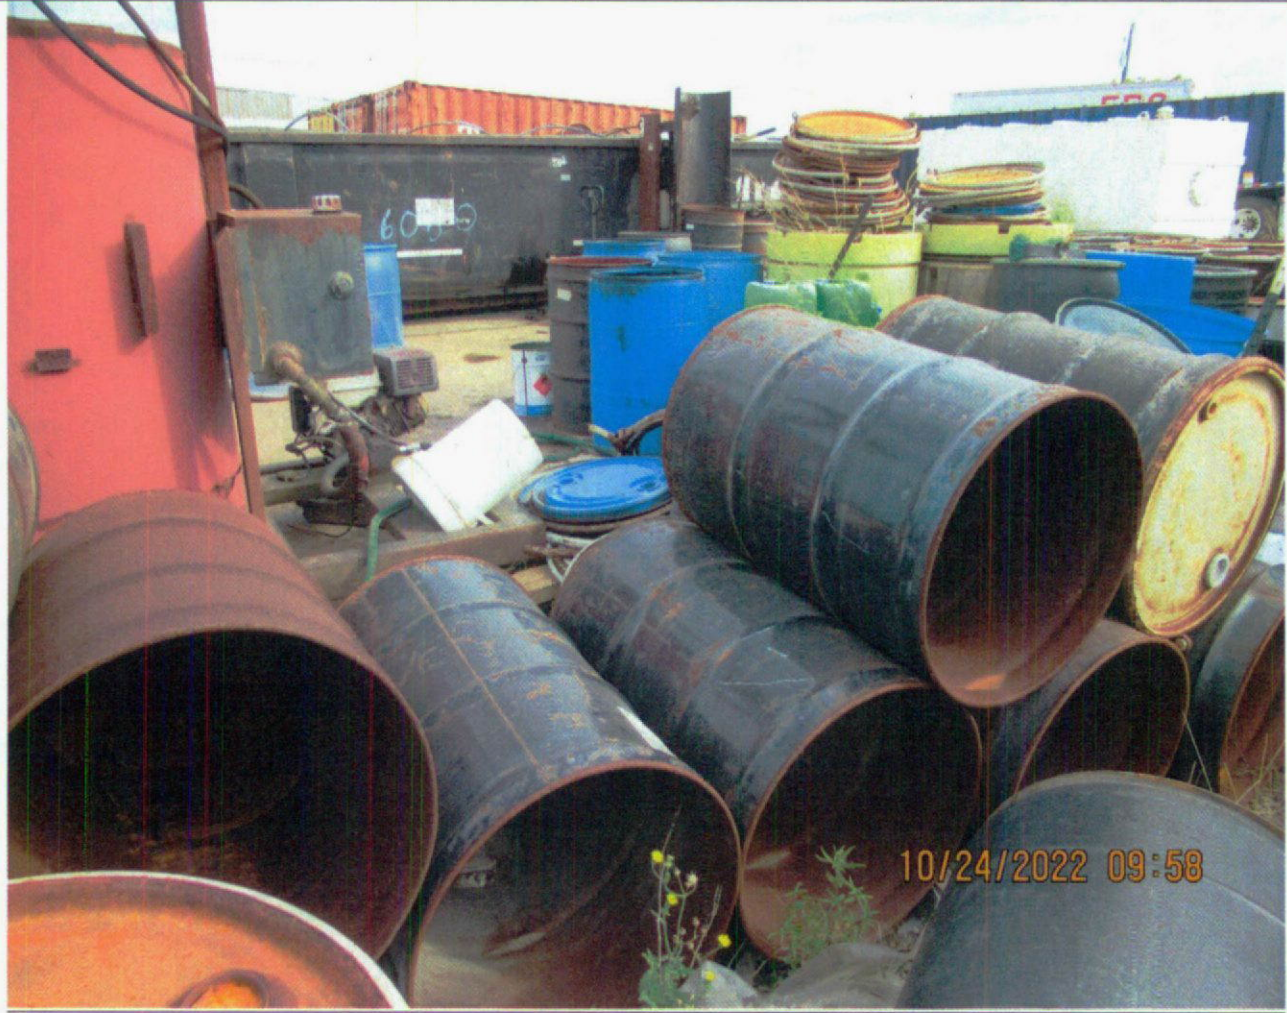
Photo #: 40 Of 81 Date: 10/24/2022 Time: 9:58 AM  
 Description: Storage area for empty drums.

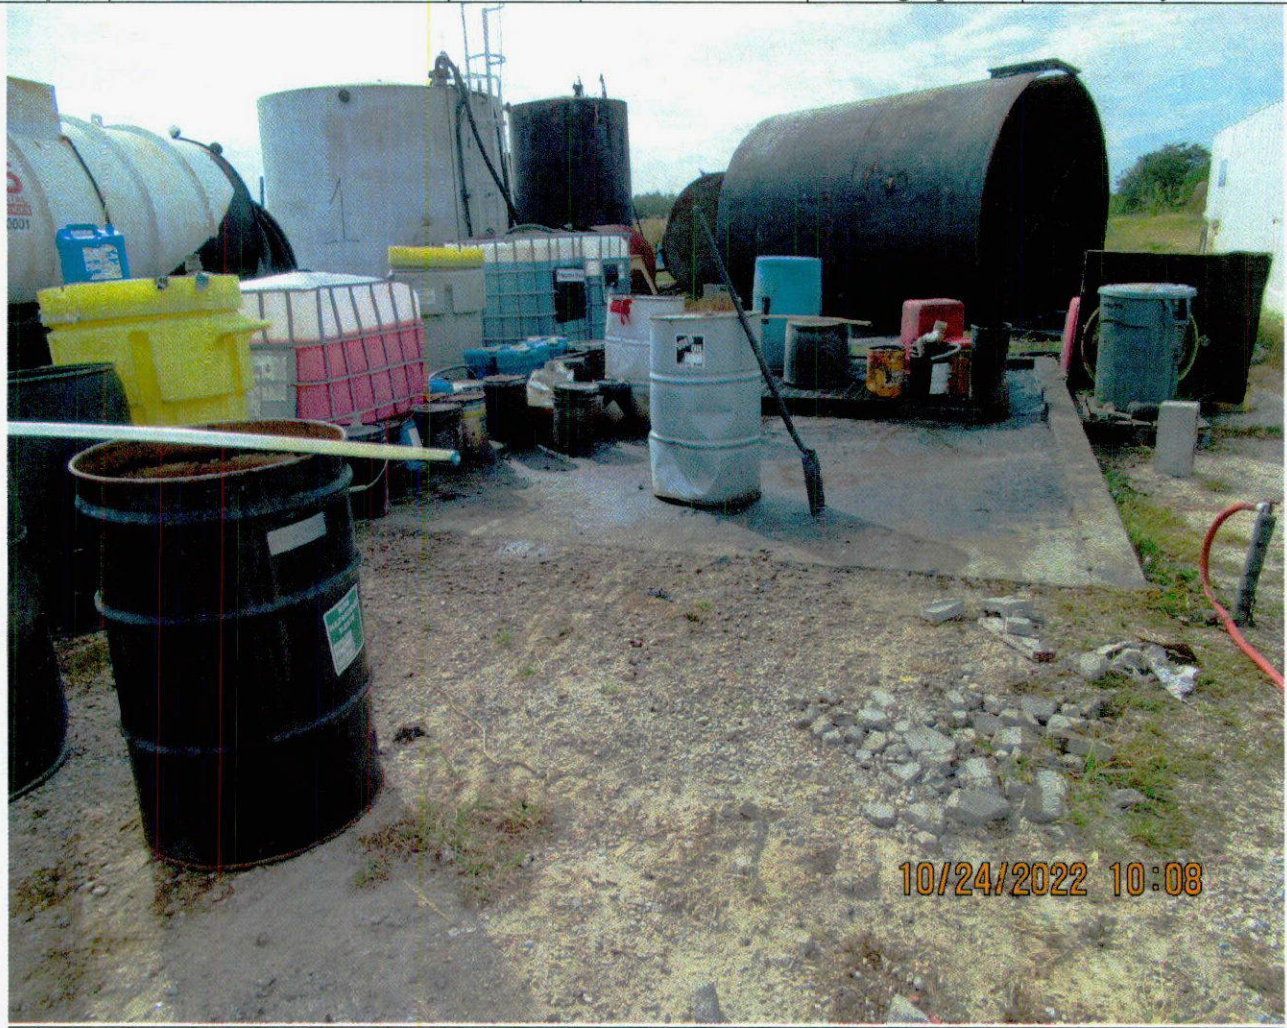
Photo #: 41 Of 81 Date: 10/24/2022 Time: 10:08 AM

Description: I observed a wash pad with various containers of different capacities. Some stored used oil, others stored chemical products. According to facility representatives, the wash pad drains to a sump, which is pumped out by ERS themselves and stored in one of their onsite tanks.

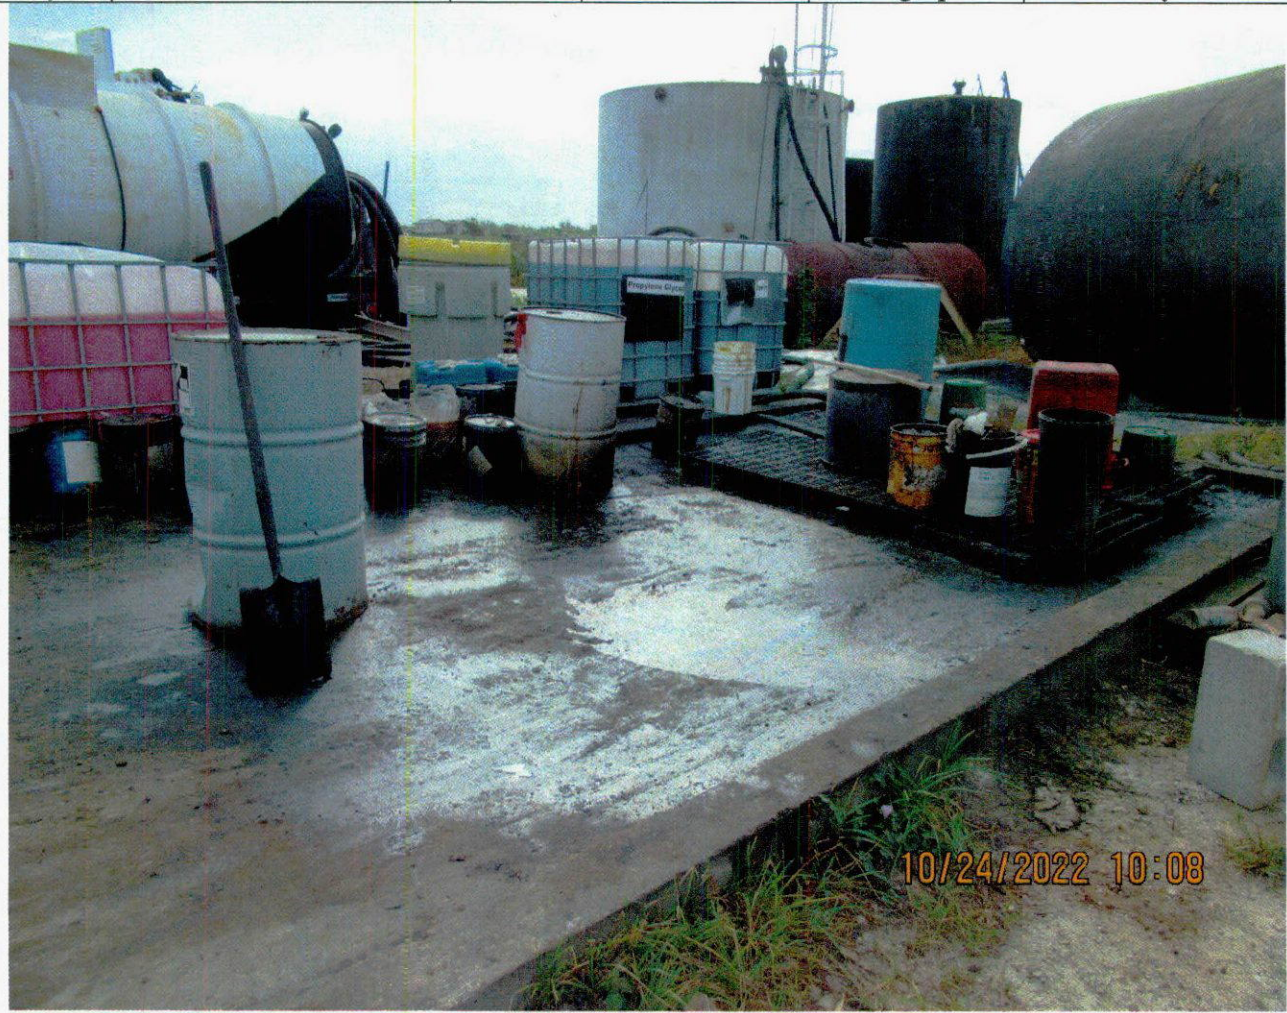
Photo #: 42 Of 81 Date: 10/24/2022 Time: 10:08 AM

Description: Another angle of the wash pad and various containers of used oil and chemical products.

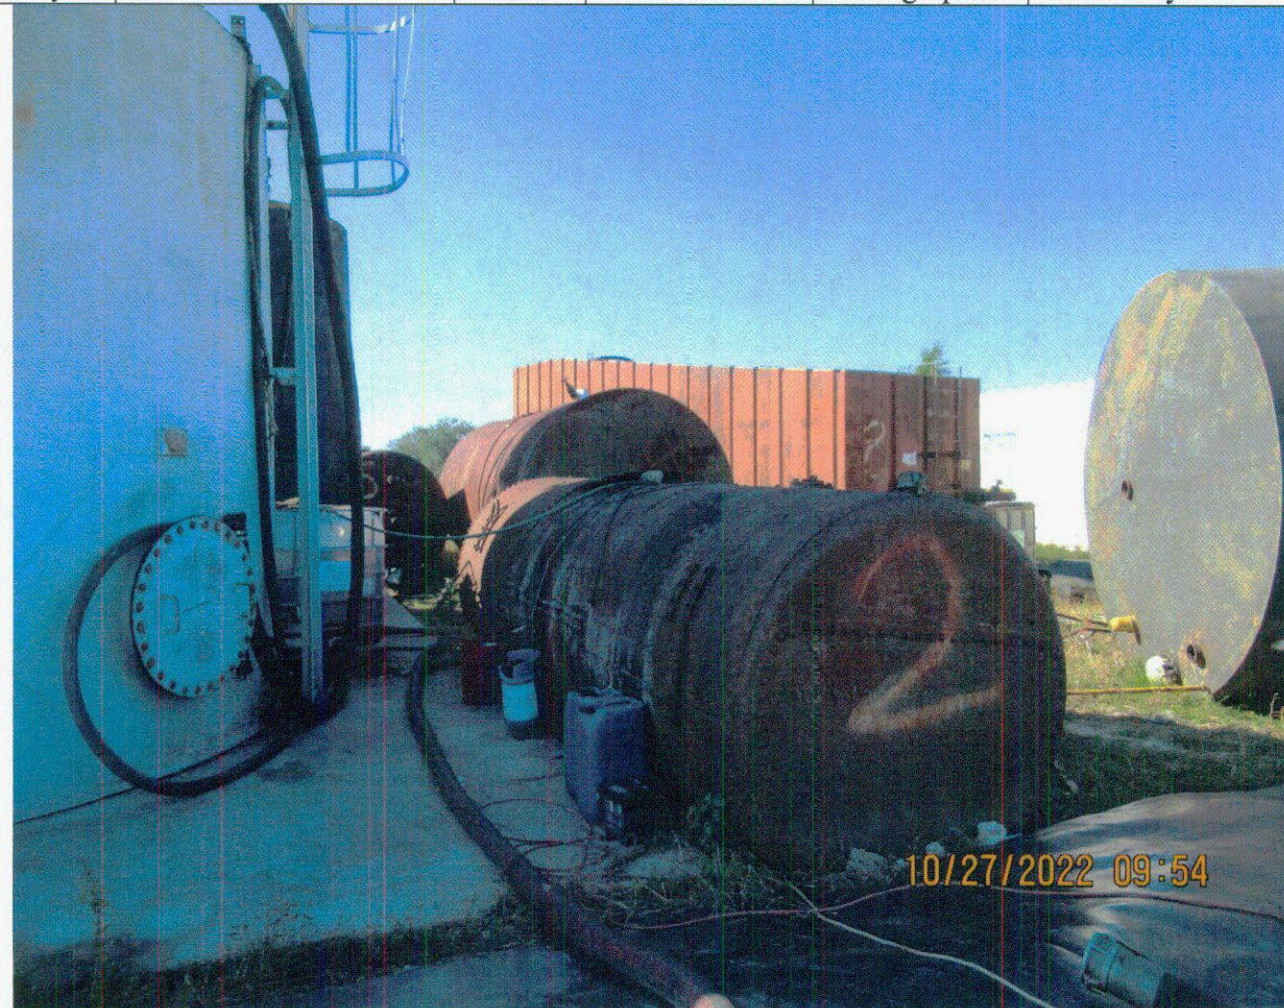
Photo #: 44 Of 81 Date: 10/27/2022 Time: 9:54 AM

Description: Two horizontal tanks of 4,000-gallon and 6,000-gallon capacities are located within the containment system. One tank was knocked over during Hurricane Laura.

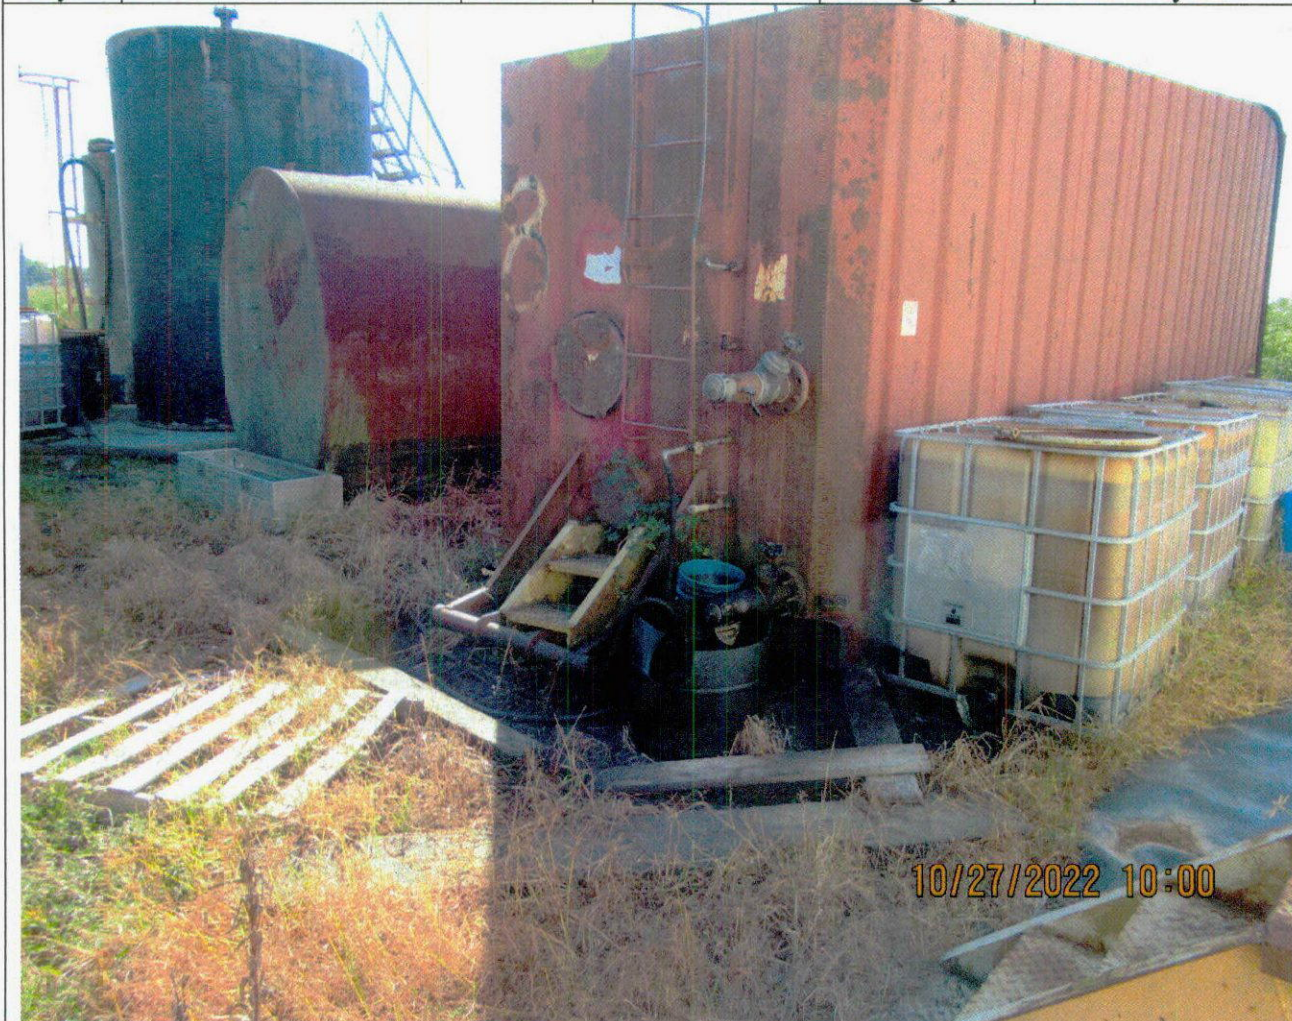
Photo #: 45 Of 81 Date: 10/27/2022 Time: 10:00 AM  
 Description: A 21,000-gallon frac tank was located within the containment system, along with four totes.

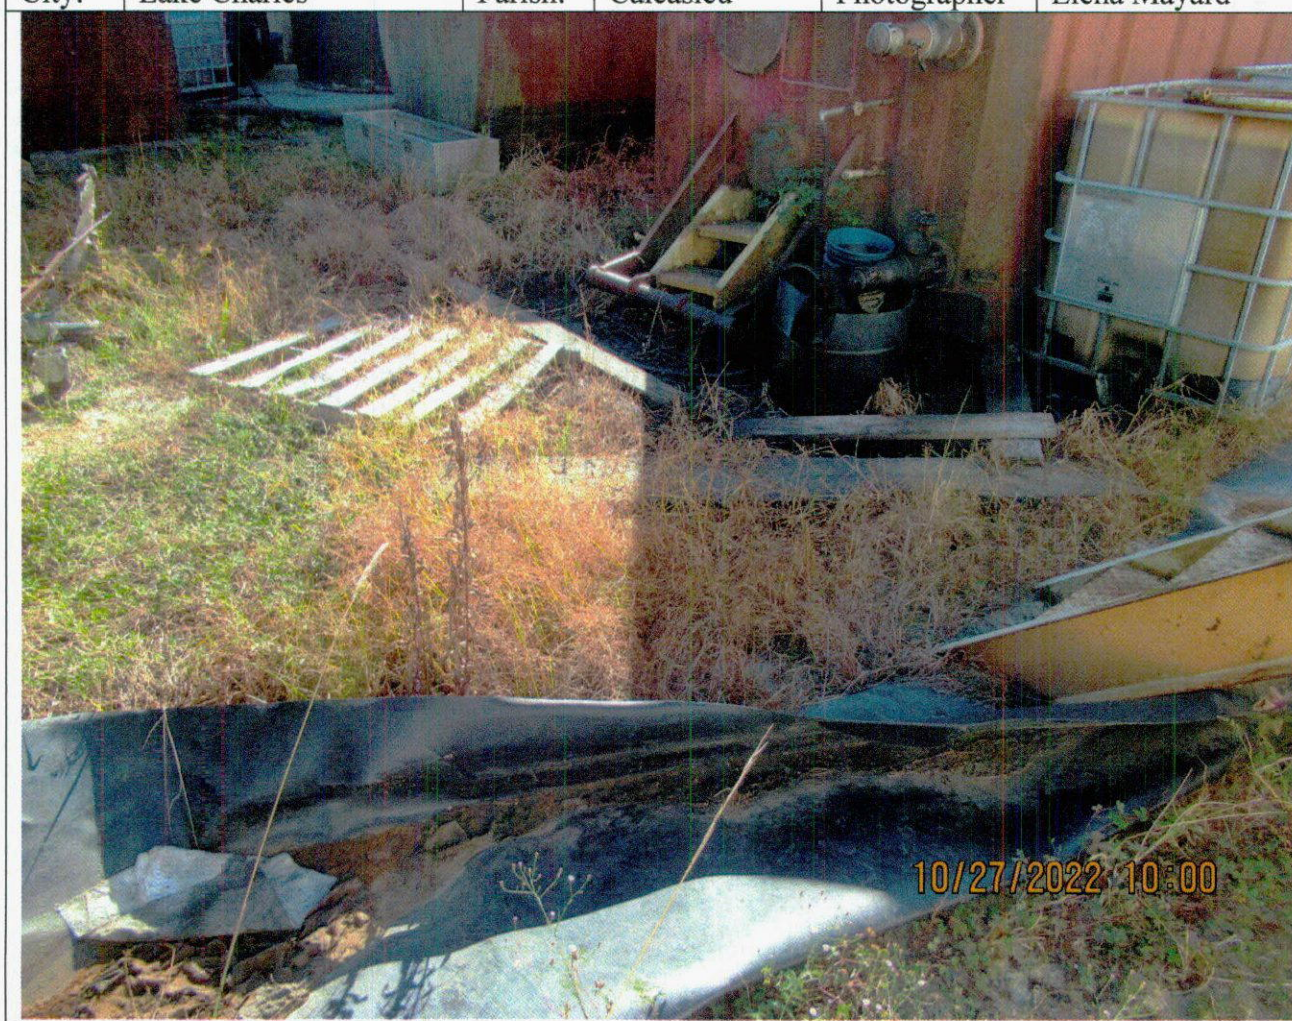
Photo #: 46 Of 81 Date: 10/27/2022 Time: 10:00 AM  
 Description: A poly liner surrounds the containment system.

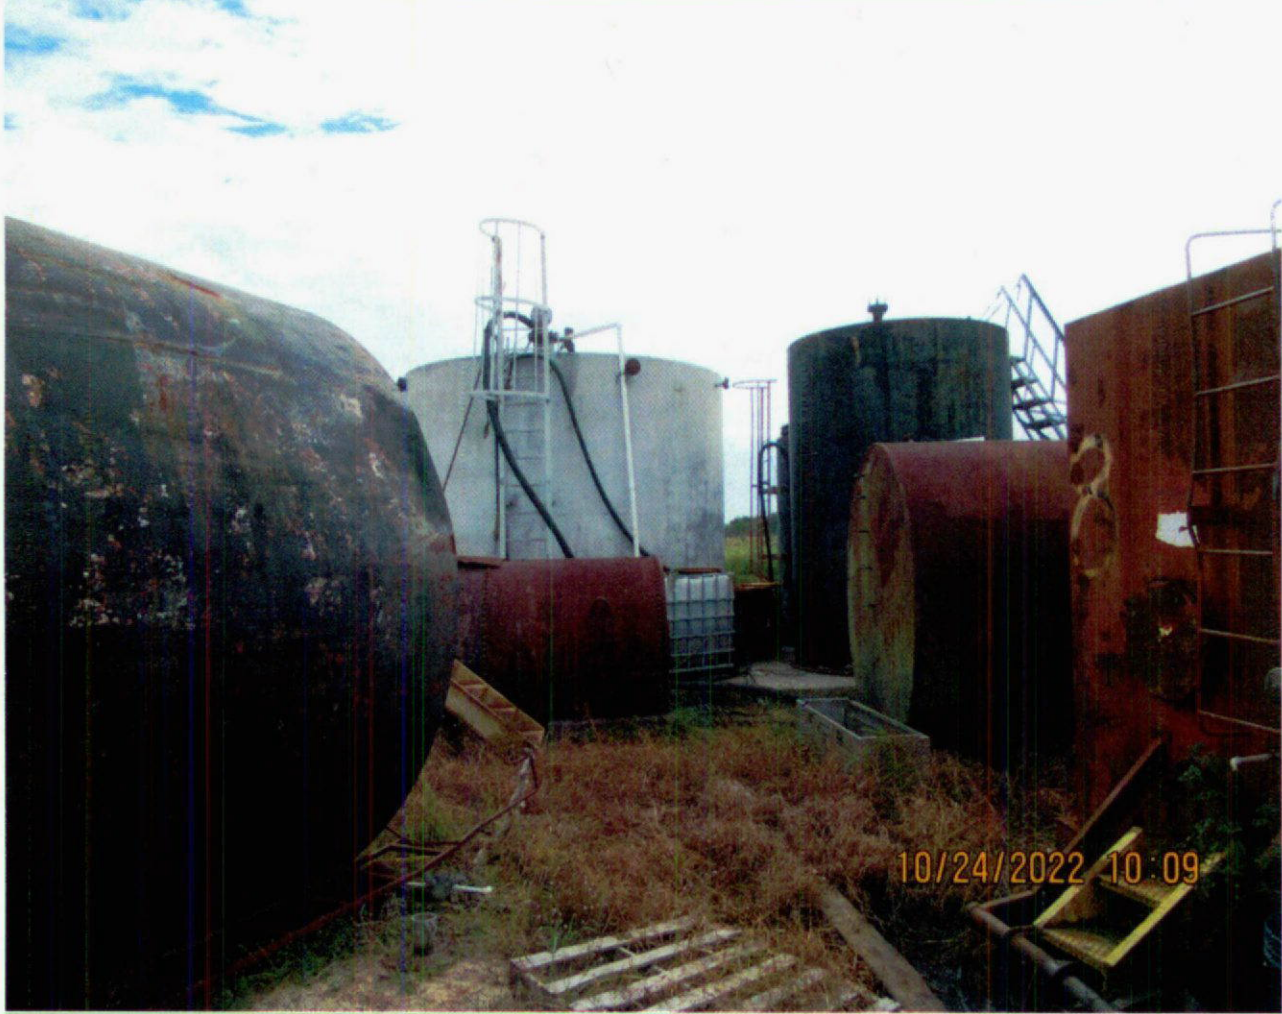
Photo #: 47 Of 81 Date: 10/24/2022 Time: 10:09 AM  
 Description: The aboveground tanks used to store used oil were not clearly labeled or marked with the words "Used Oil."

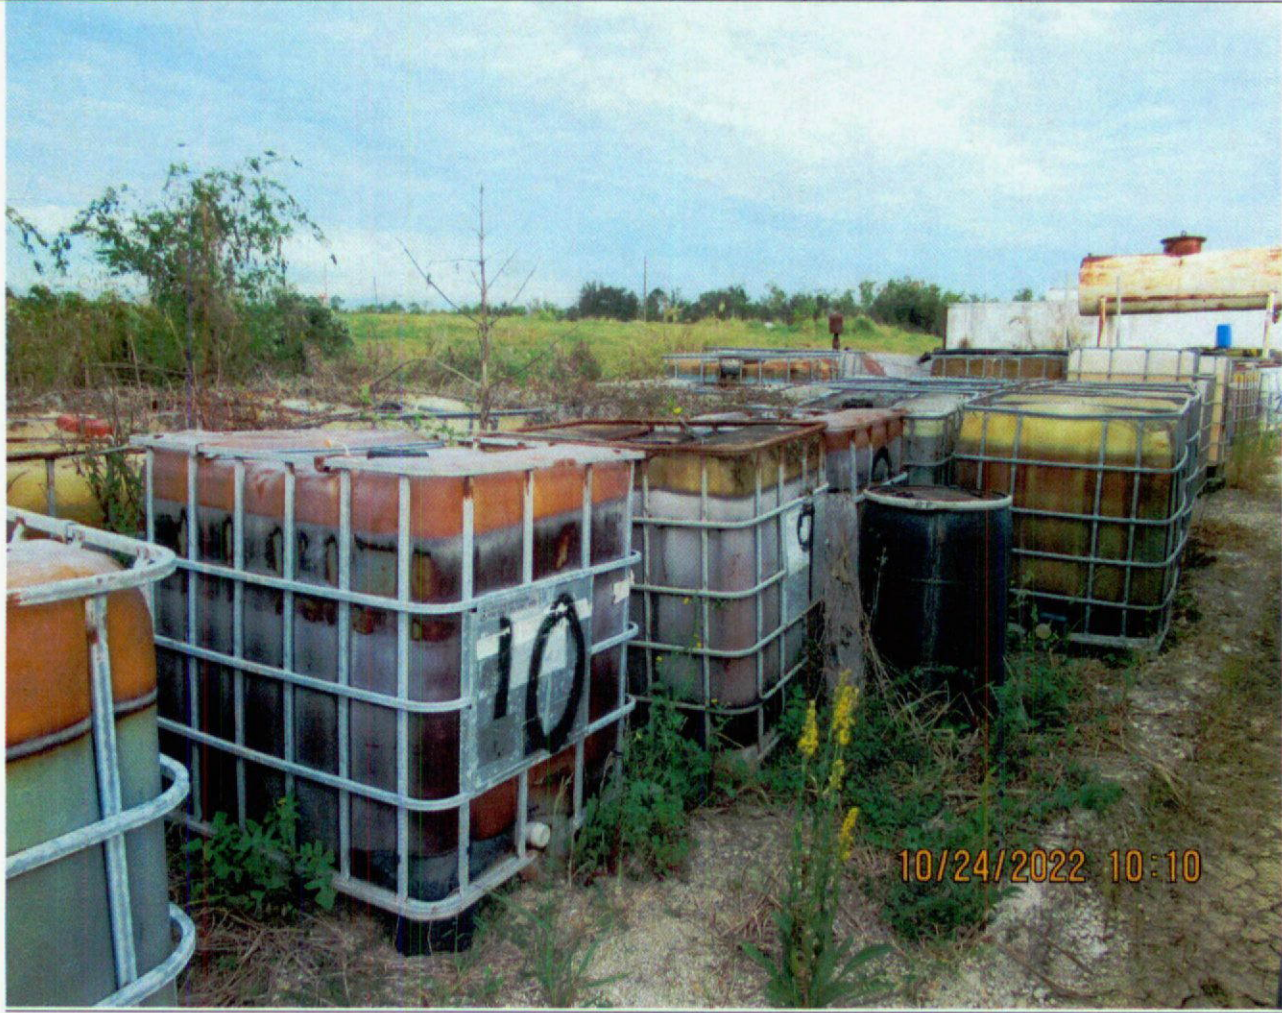
Photo #: 48 Of 81 Date: 10/24/2022 Time: 10:10 AM  
 Description: On the southwestern corner of the facility, I observed several totes of 275 to 300-gallon capacities. The facility representatives stated the totes were storing used oil and oily water. The totes were directly on the ground without adequate containment.

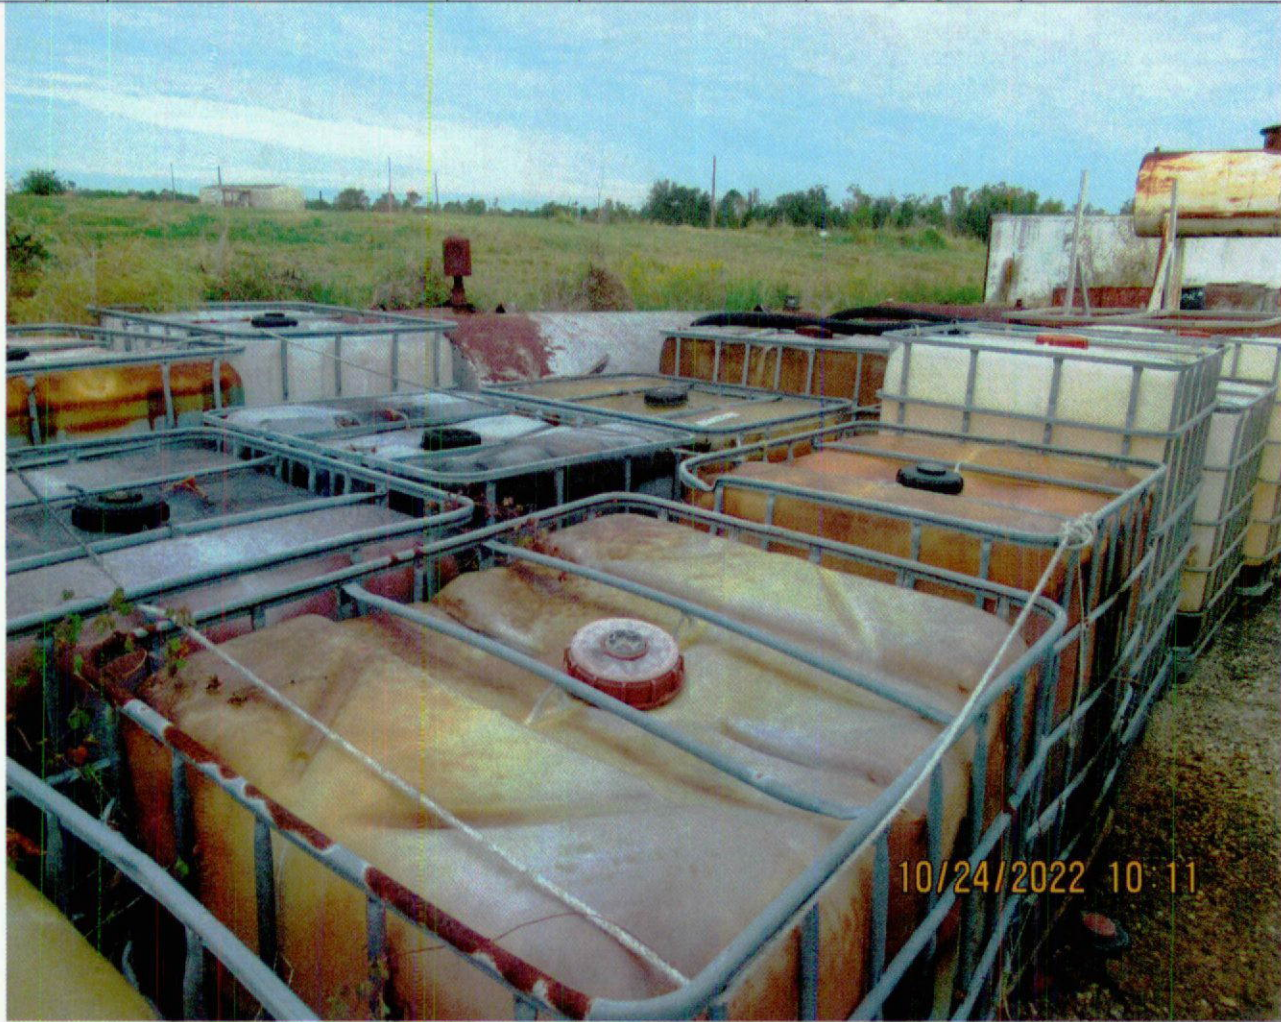
Photo #: 49 Of 81 Date: 10/24/2022 Time: 10:11 AM  
 Description: Another angle of used oil and oily water totes. These totes were not labeled adequately.

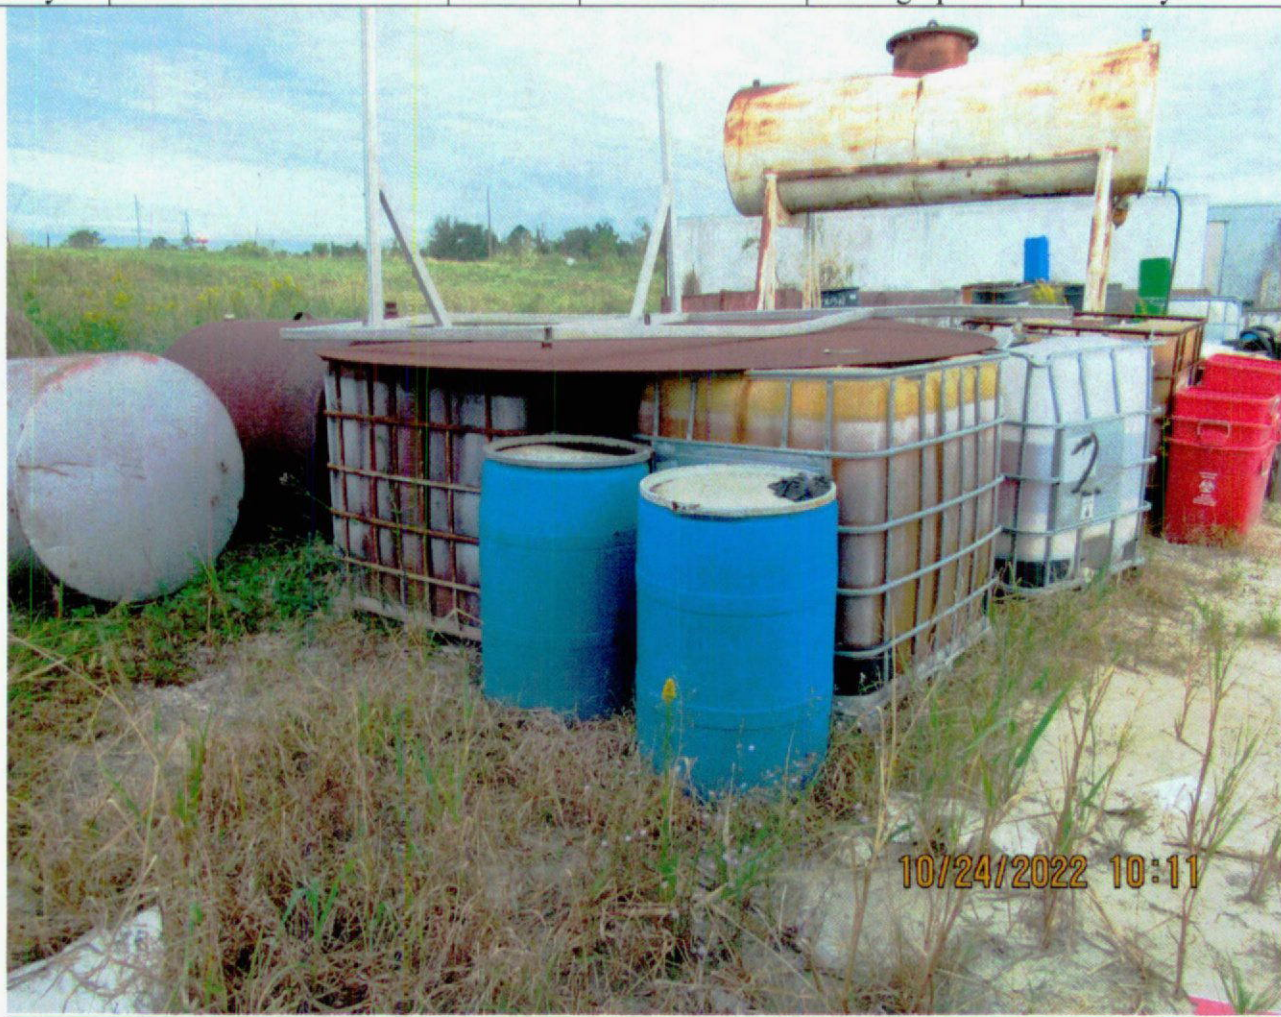
Photo #: 50 Of 81 Date: 10/24/2022 Time: 10:11 AM  
 Description: More used oil storage areas at the facility. The totes were not adequately labeled.
