INSPECTION REPORT

| Type of Inspection | Focused Compliance Inspection (FCI) | | | |
| Facility or Site Name | Environmental Response Services, Inc. (ERS) | | | |

**Southwest Regional Office  
Hazardous Waste Inspection Report**

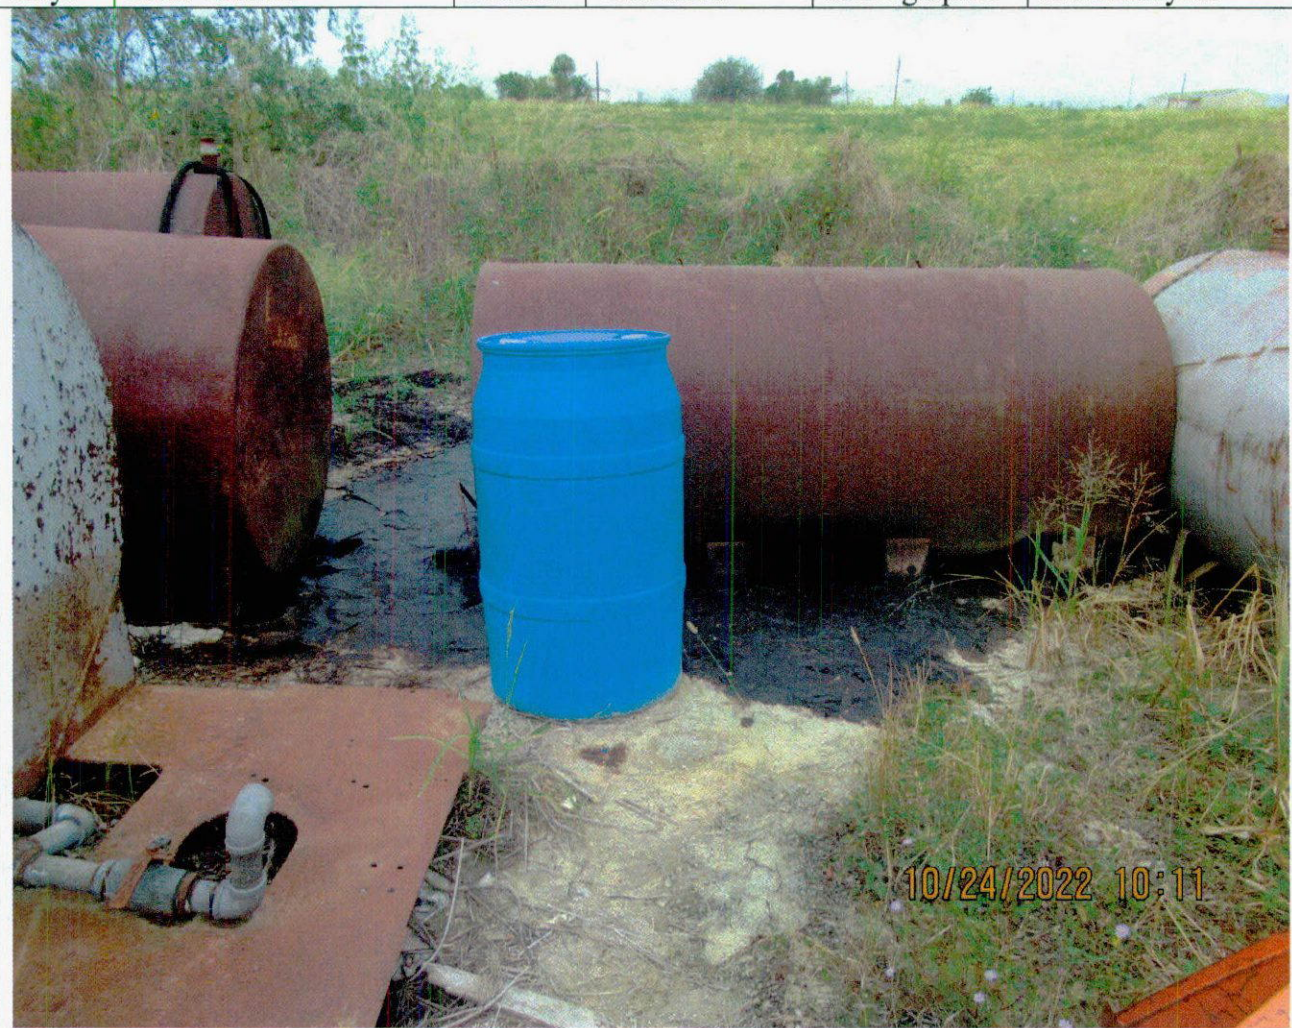
Photo #: 51 Of 81 Date: 10/24/2022 Time: 10:11 AM  
 Description: I noted a spill coming from one of these horizontal tanks. The facility representatives stated this was used oil. The tanks were not adequately labeled.

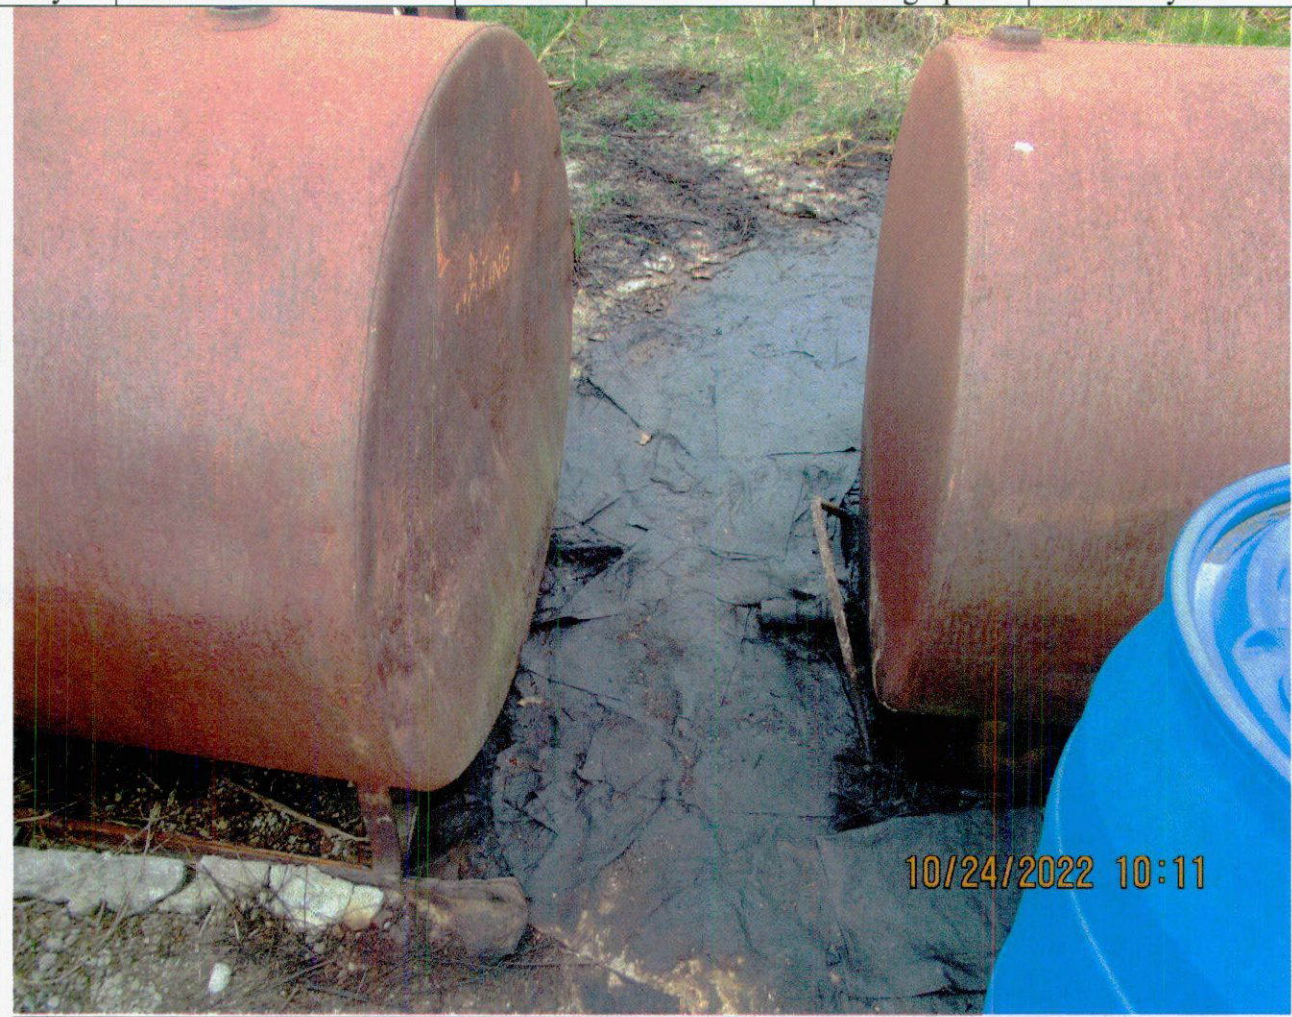
Photo #: 52 Of 81 Date: 10/24/2022 Time: 10:11 AM  
 Description: The facility has applied absorbent pads to the impacted area as an attempt to mitigate the release. The absorbent pads were left there and the spill was not cleaned up.

The facility failed to comply with LAC 33:V.4035.I, by not performing the following cleanup steps: (1) stop the release; (2) contain the released used oil; (3) clean up and manage properly the released used oil and other materials; and (4) if necessary, repair or replace any leaking used oil storage containers or tanks prior to returning them to service.

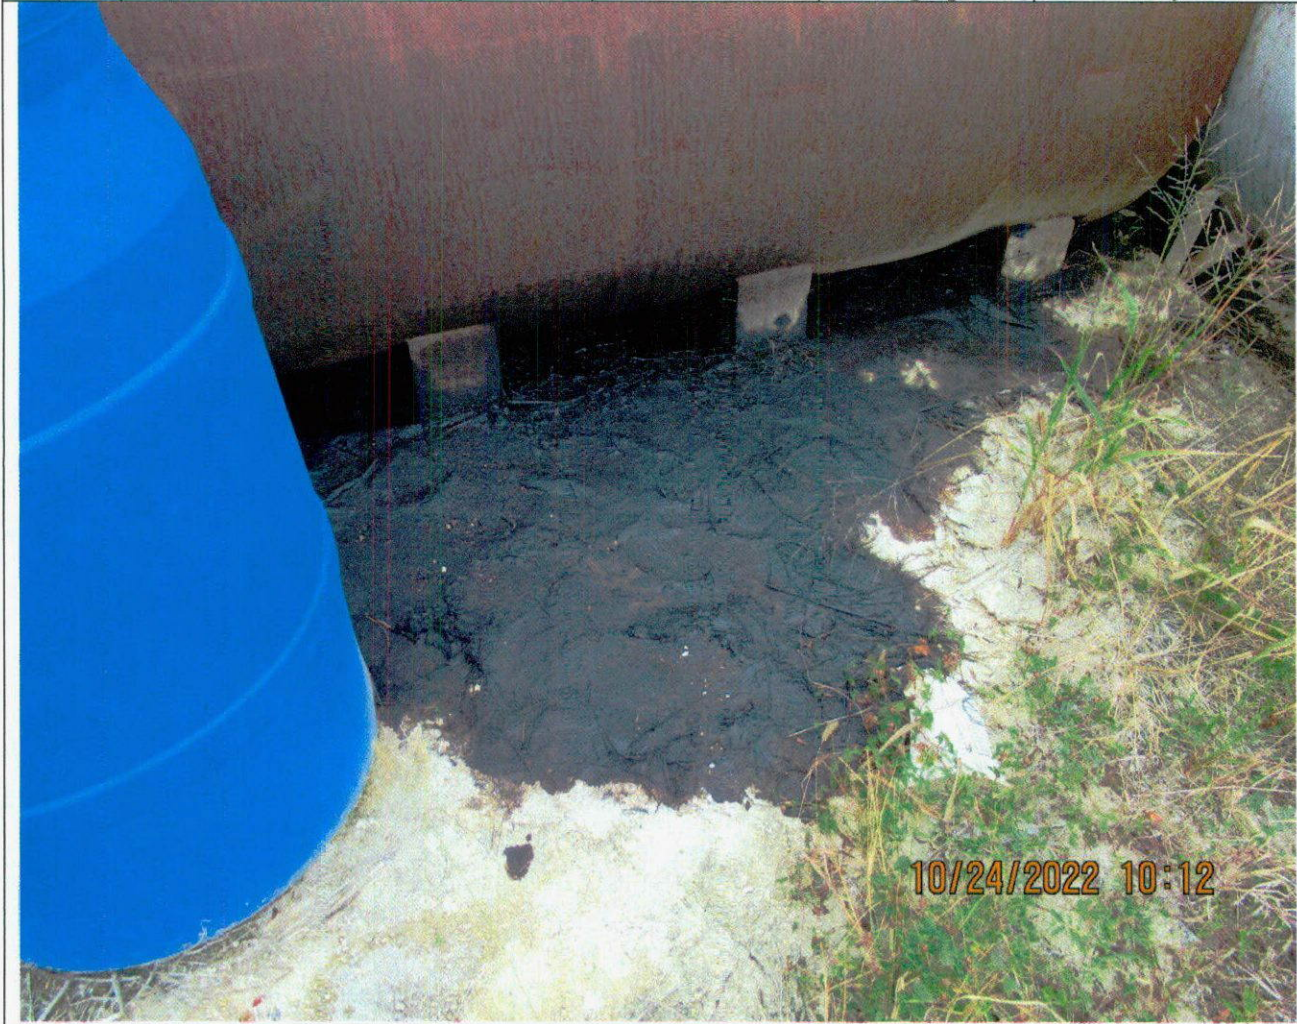
Photo #: 53 Of 81 Date: 10/24/2022 Time: 10:12 AM  
Description: Used oil spill that was not cleaned by the facility.

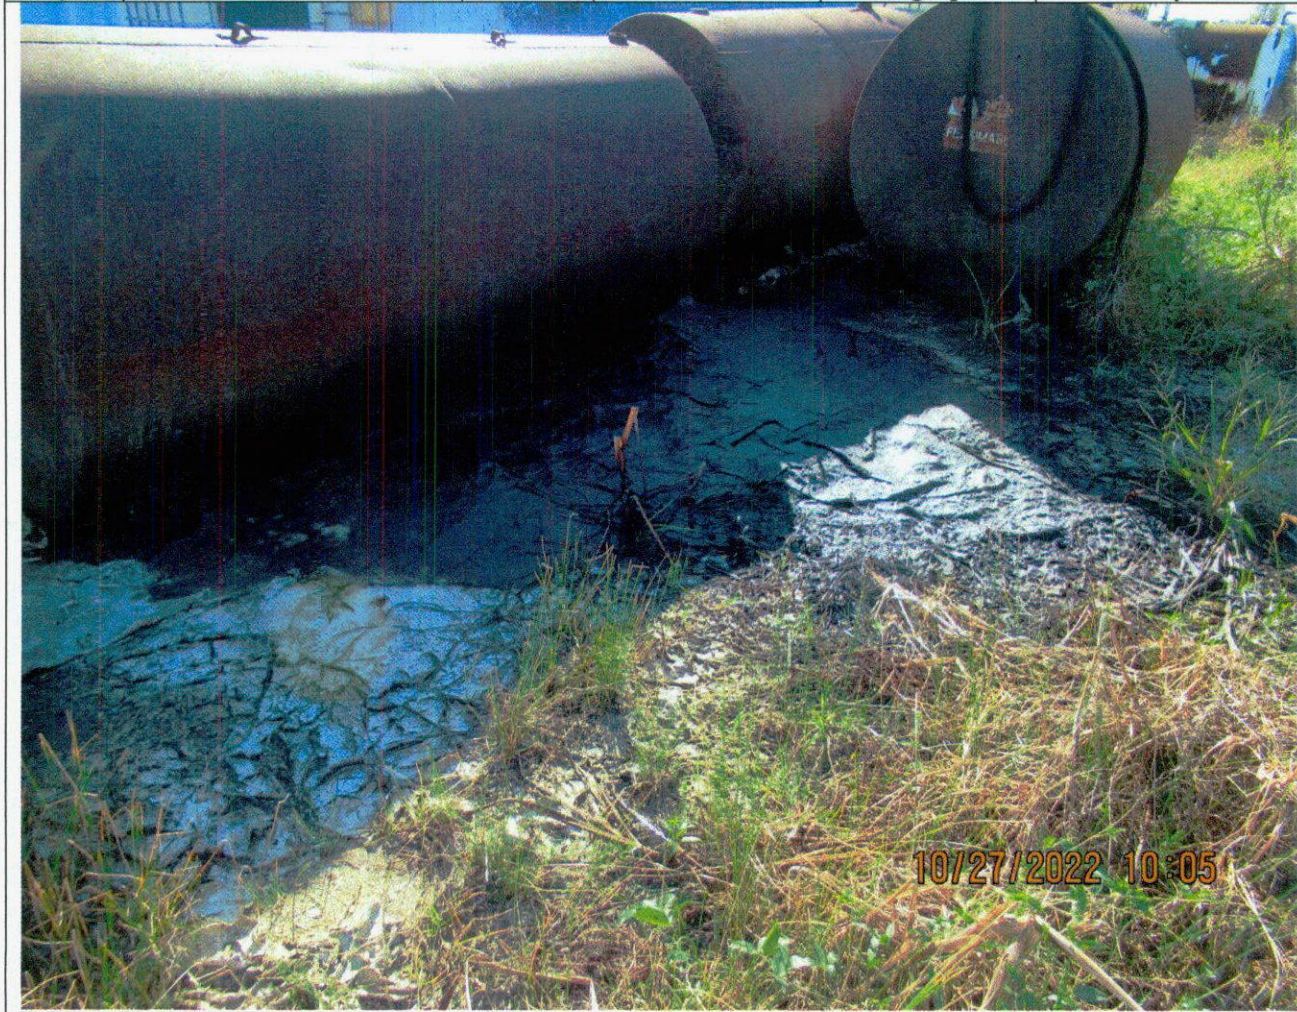
Photo #: 54 Of 81 Date: 10/27/2022 Time: 10:05 AM  
Description: Opposite side of the tanks where the used oil spill was noted. The spill had migrated into the grass on the west side of the facility. The facility representatives applied absorbent pads and they were left there for some time.

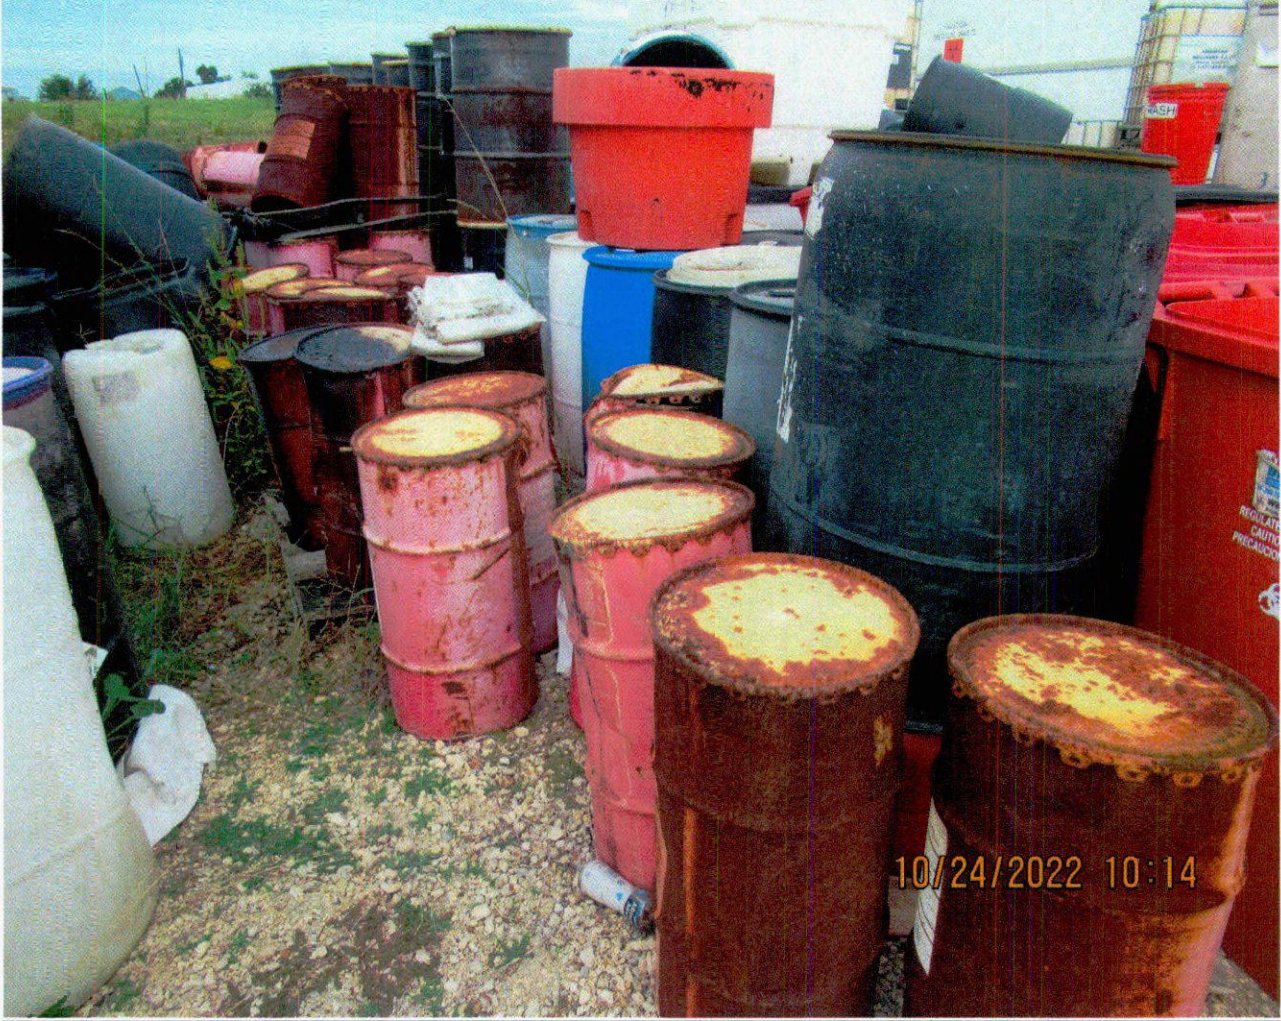
Photo #: 55 Of 81 Date: 10/24/2022 Time: 10:14 AM  
 Description: According to Mr. Clark, the several drums observed here contain high-temperature grease from a rig operated by Noble Drilling. The drums are severely corroded.

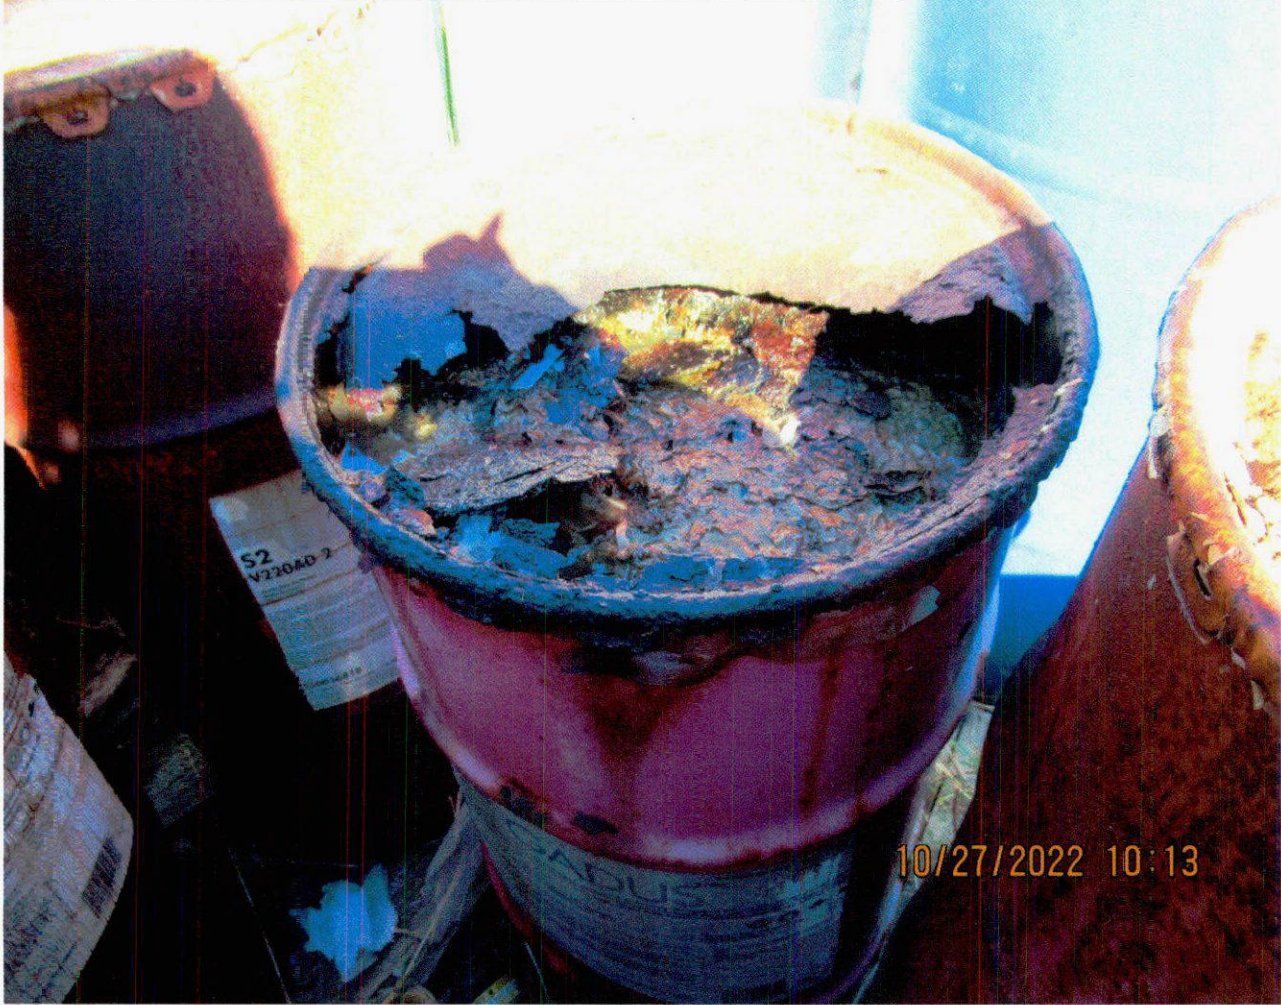
Photo #: 56 Of Date: 10/27/2022 Time: 10:13 AM  
 Description: Drum of high-temperature grease that had a rusted lid.

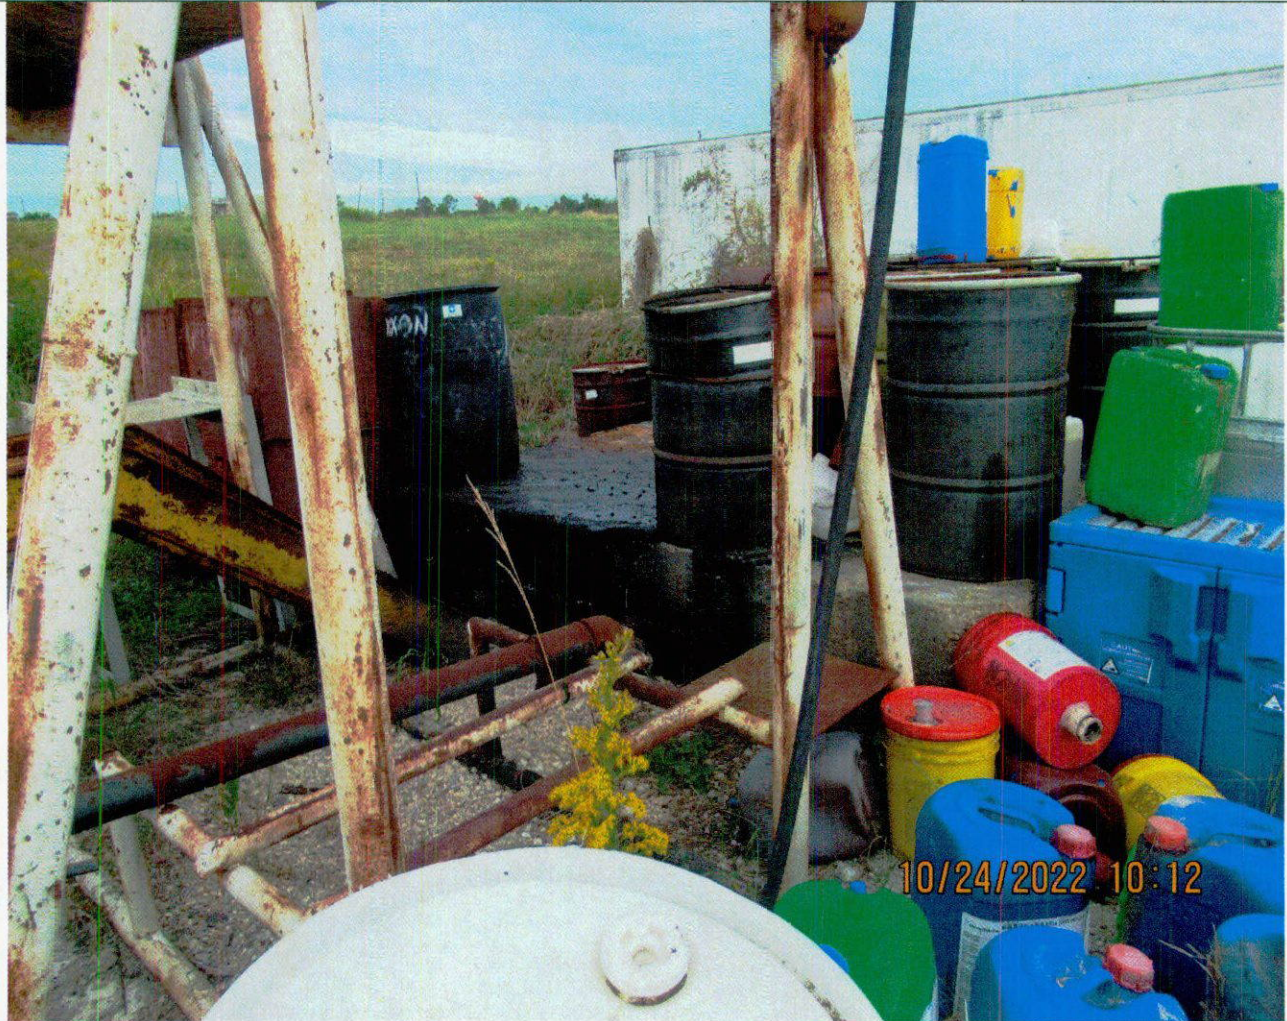
Photo #: 57 Of 81 Date: 10/24/2022 Time: 10:12 AM  
Description: I observed several 5-gallon to 55-gallon containers, and one 275-gallon tote that stored used cooking oils, according to the facility. I also observed evidence of leaking containers and spills of this cooking oil.

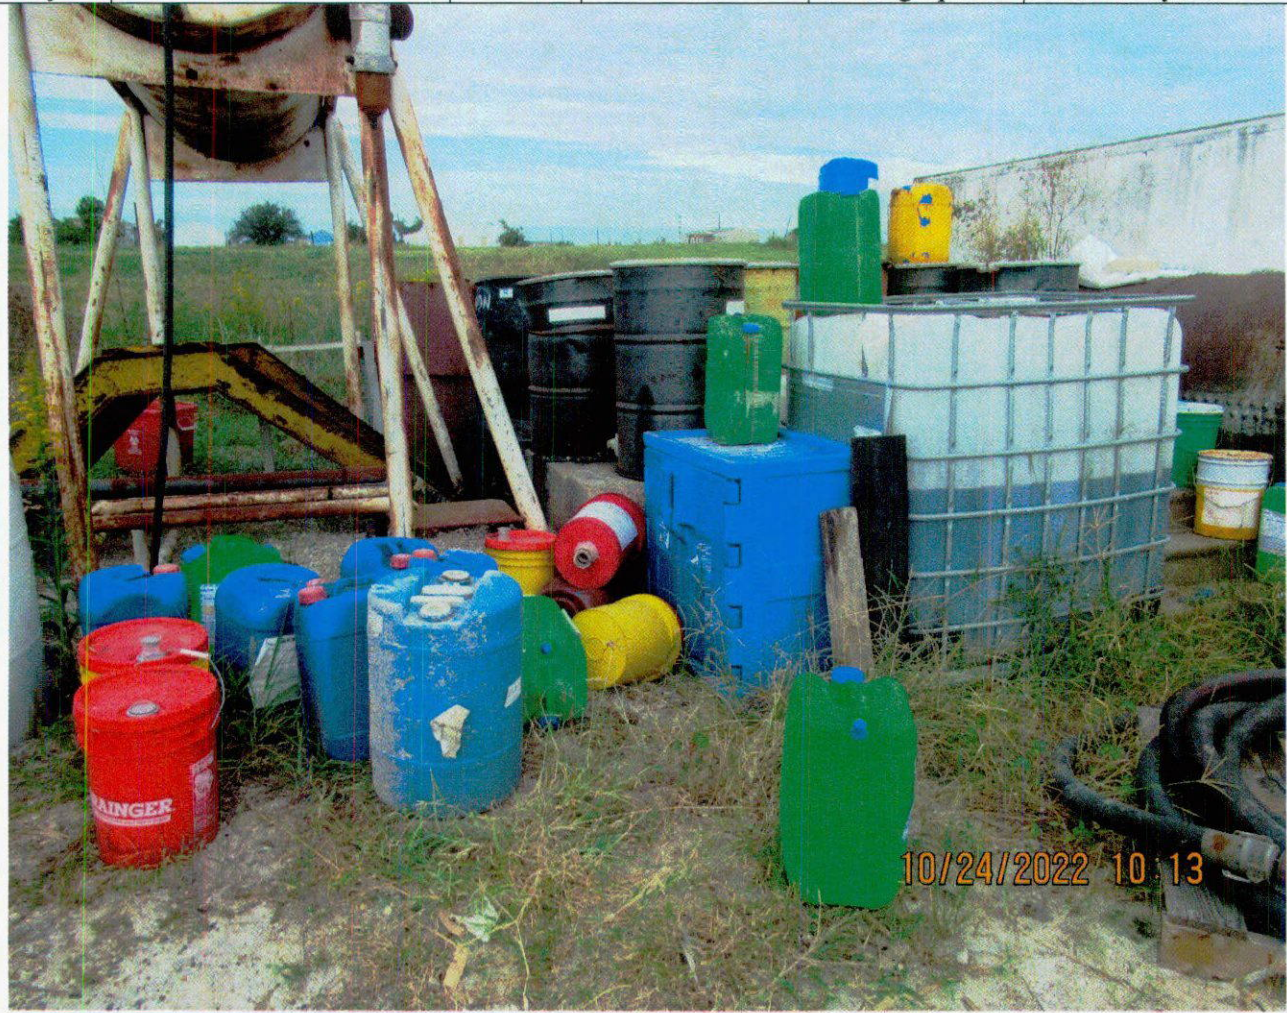
Photo #: 58 Of 81 Date: 10/24/2022 Time: 10:13 AM  
Description: Several 5-gallon to 55-gallon containers, and one 275-gallon tote that stored used cooking oils.

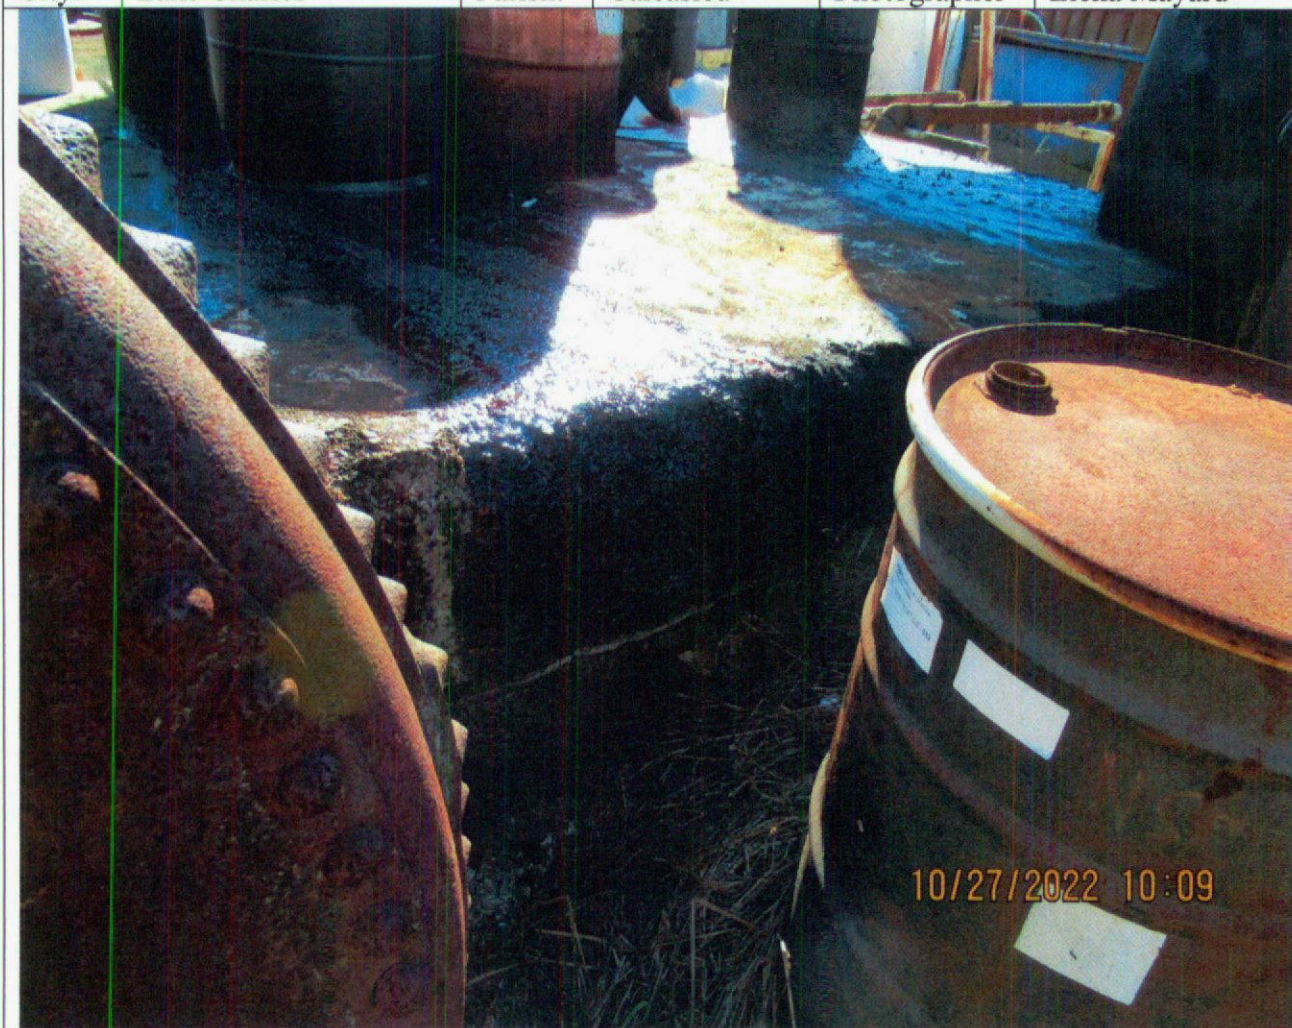
Photo #: 59 Of 81 Date: 10/27/2022 Time: 10:09 AM  
 Description: I observed leaking containers of used cooking oil.

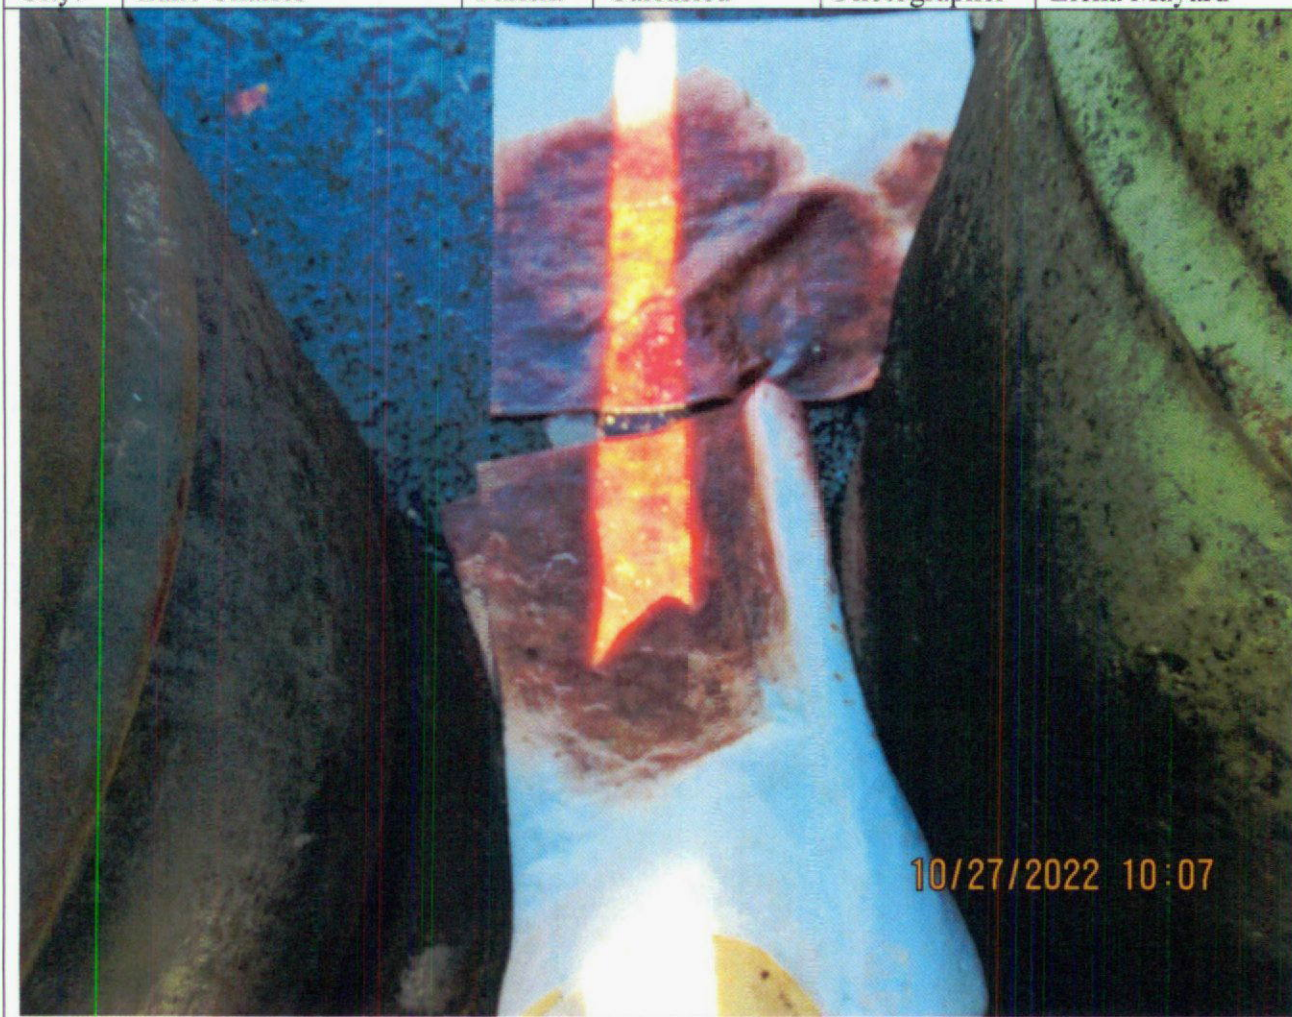
Photo #: 60 Of 81 Date: 10/27/2022 Time: 10:07 AM  
 Description: Used cooking oil spill in which the facility attempted to mitigate the spill.

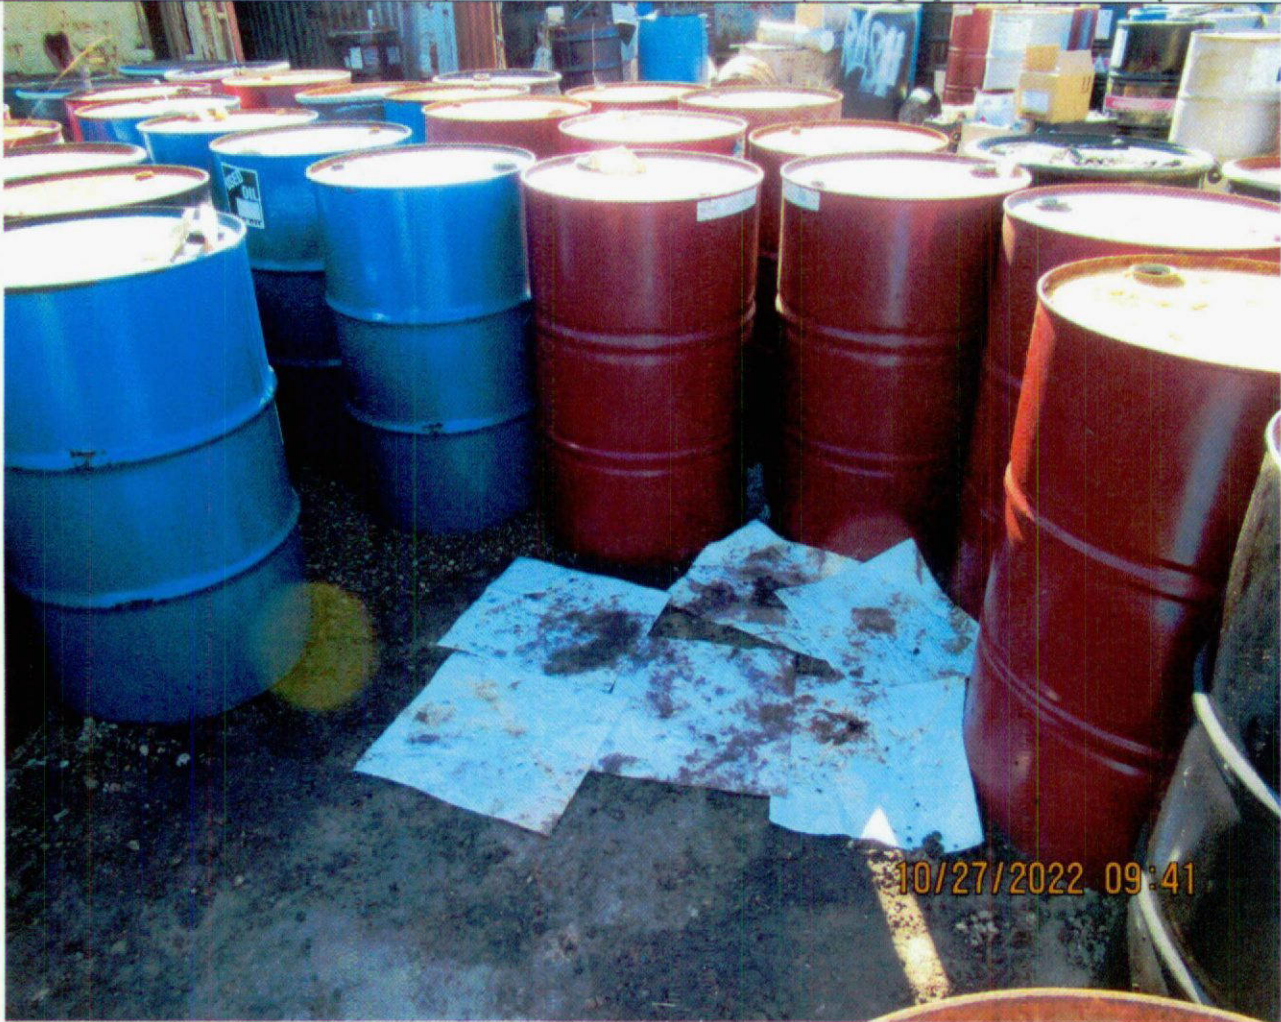
Photo #: 61 Of 81 Date: 10/27/2022 Time: 9:41 AM  
 Description: Several used oil drums in which some were stored on a concrete pad and others on the earthen ground. Some spillage was noted in this area.

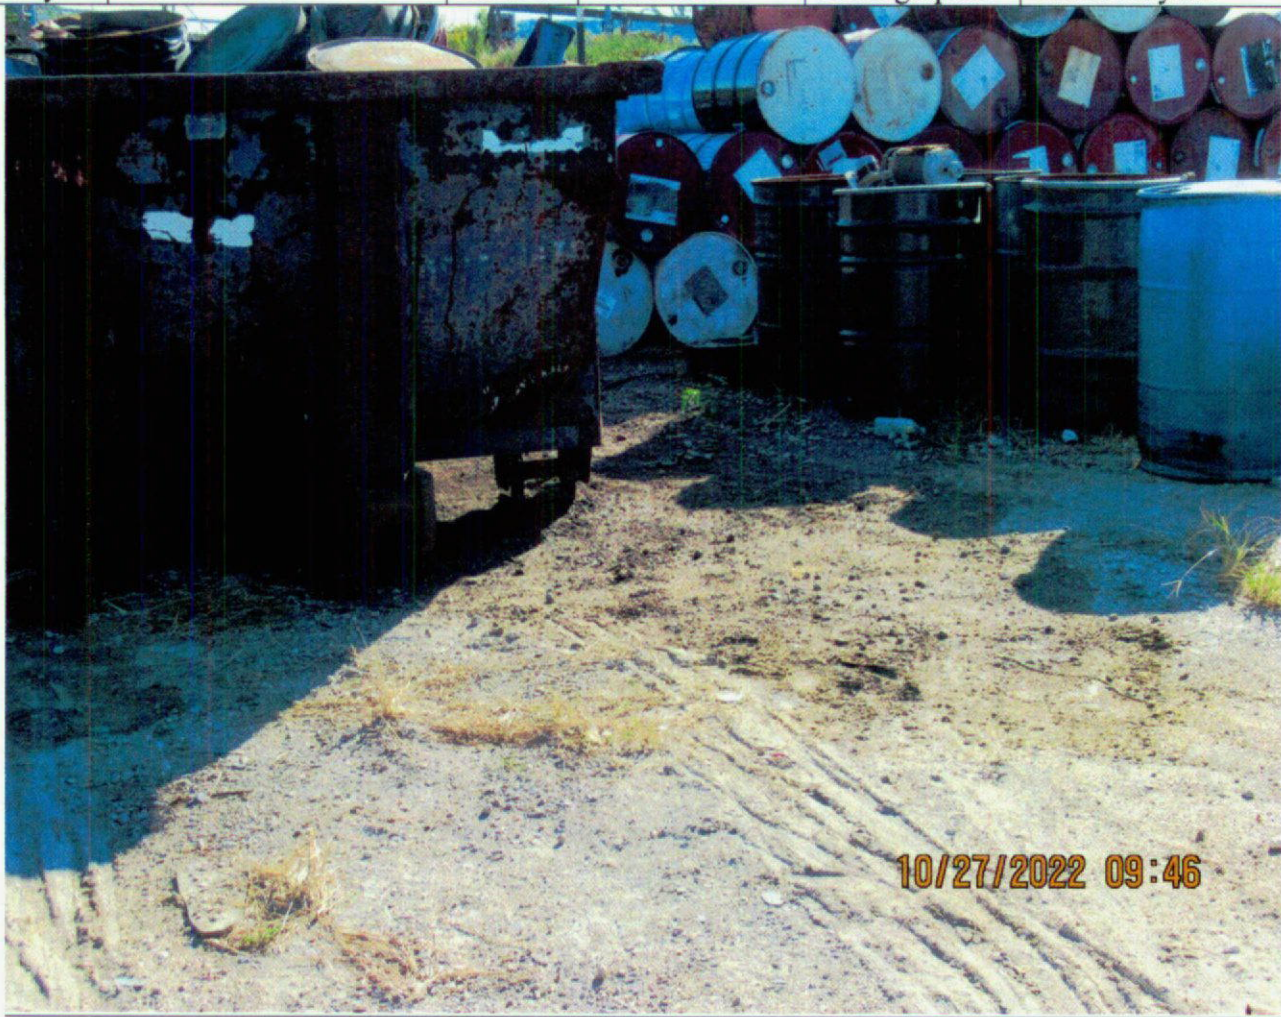
Photo #: 62 Of 81 Date: 10/27/2022 Time: 9:46 AM  
 Description: Evidence of a spill coming from a roll-off container that was storing crushed drums.

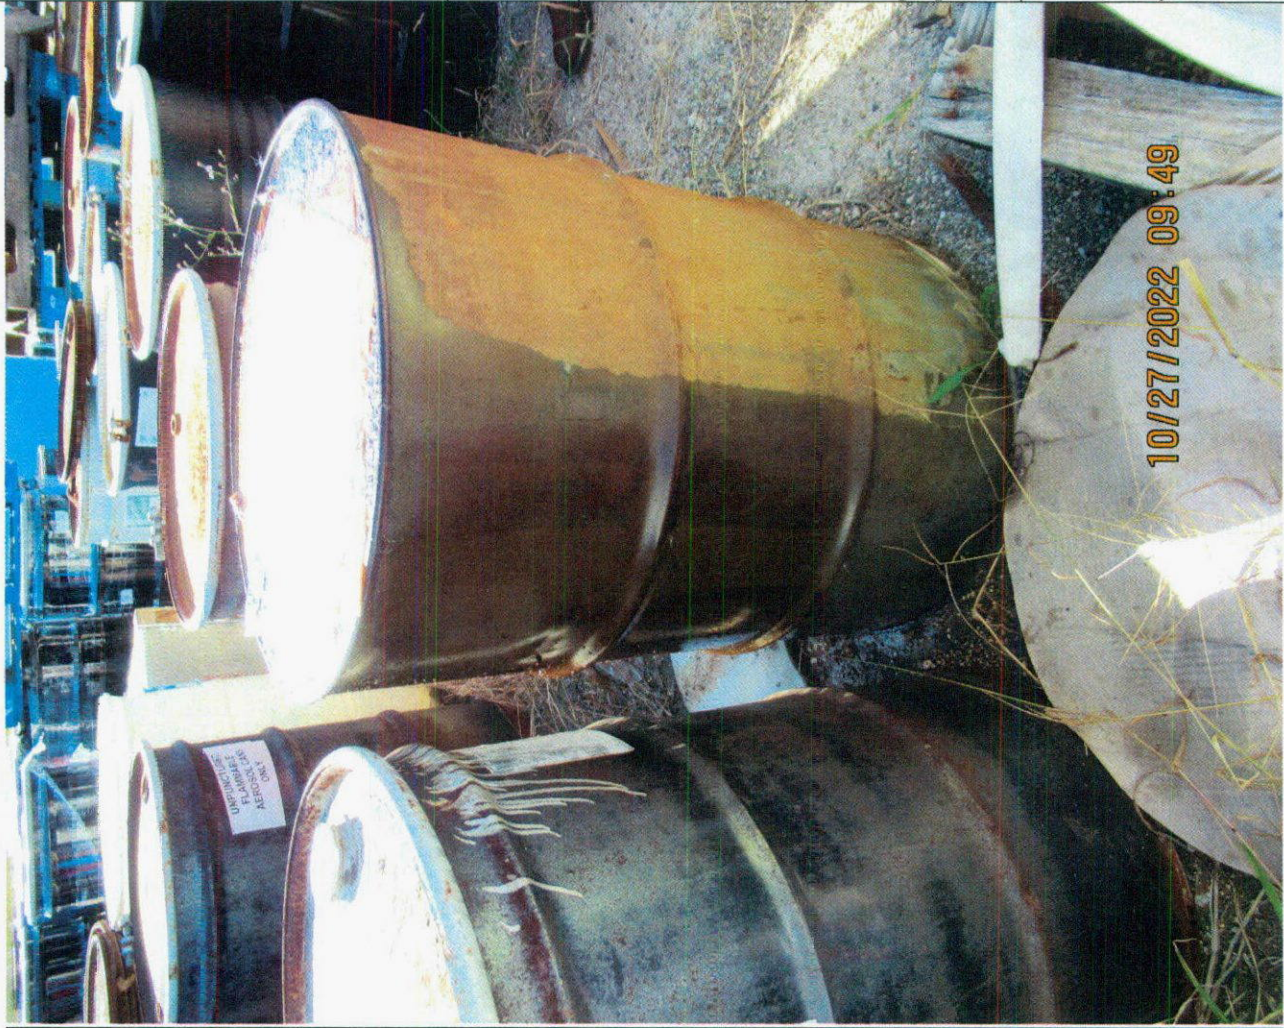
Photo #: 63 Of 81 Date: 10/27/2022 Time: 9:49 AM  
 Description: Drum of used oil that was leaking. The drum was in deteriorated and rusty condition.

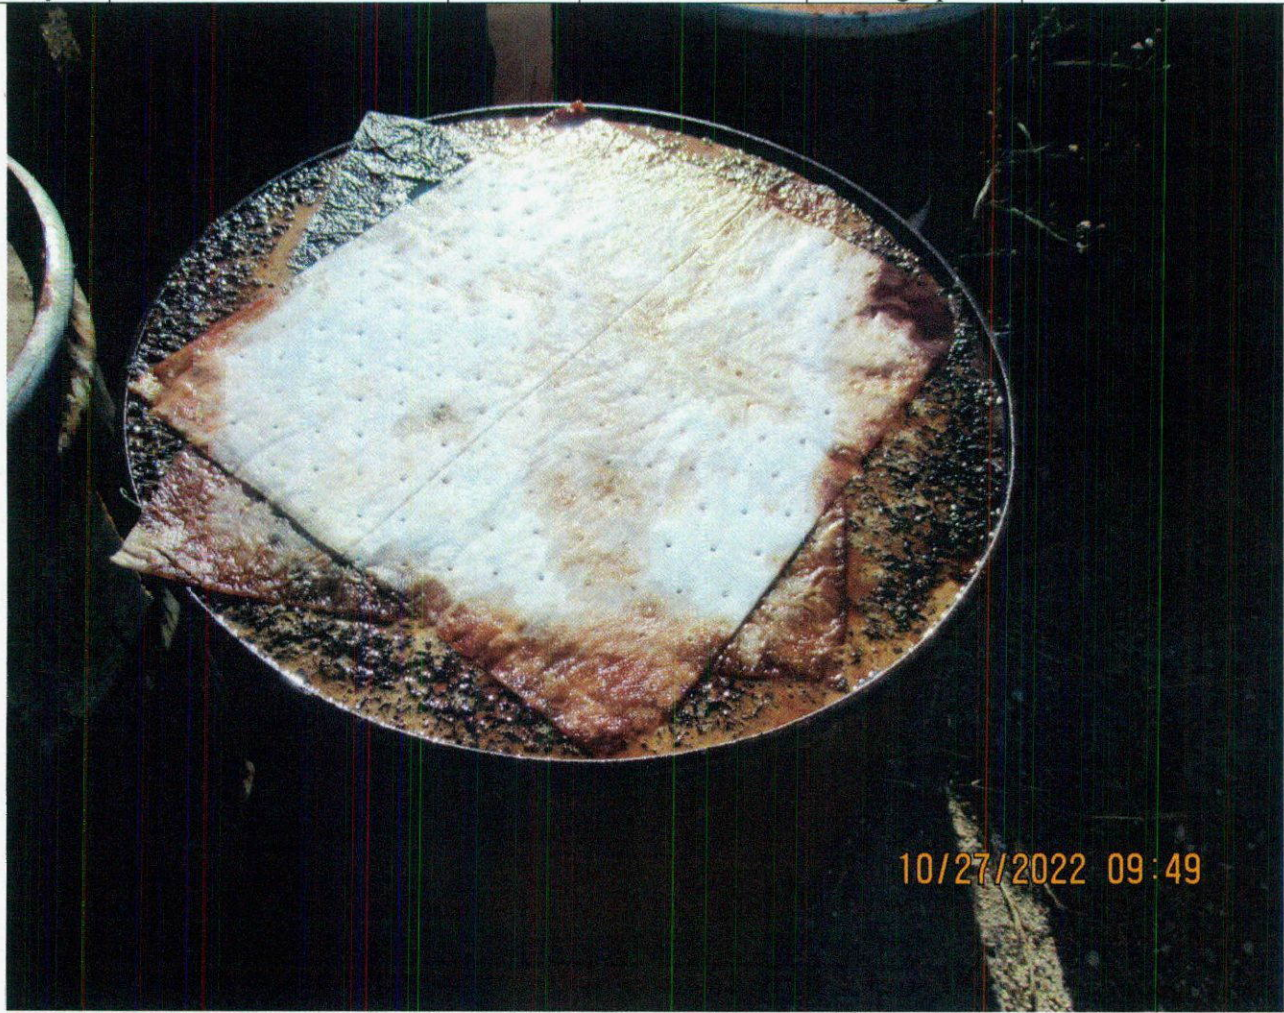
Photo #: 64 Of 81 Date: 10/27/2022 Time: 9:49 AM  
 Description: Angle of the top of the leaking drum in Photograph 63.

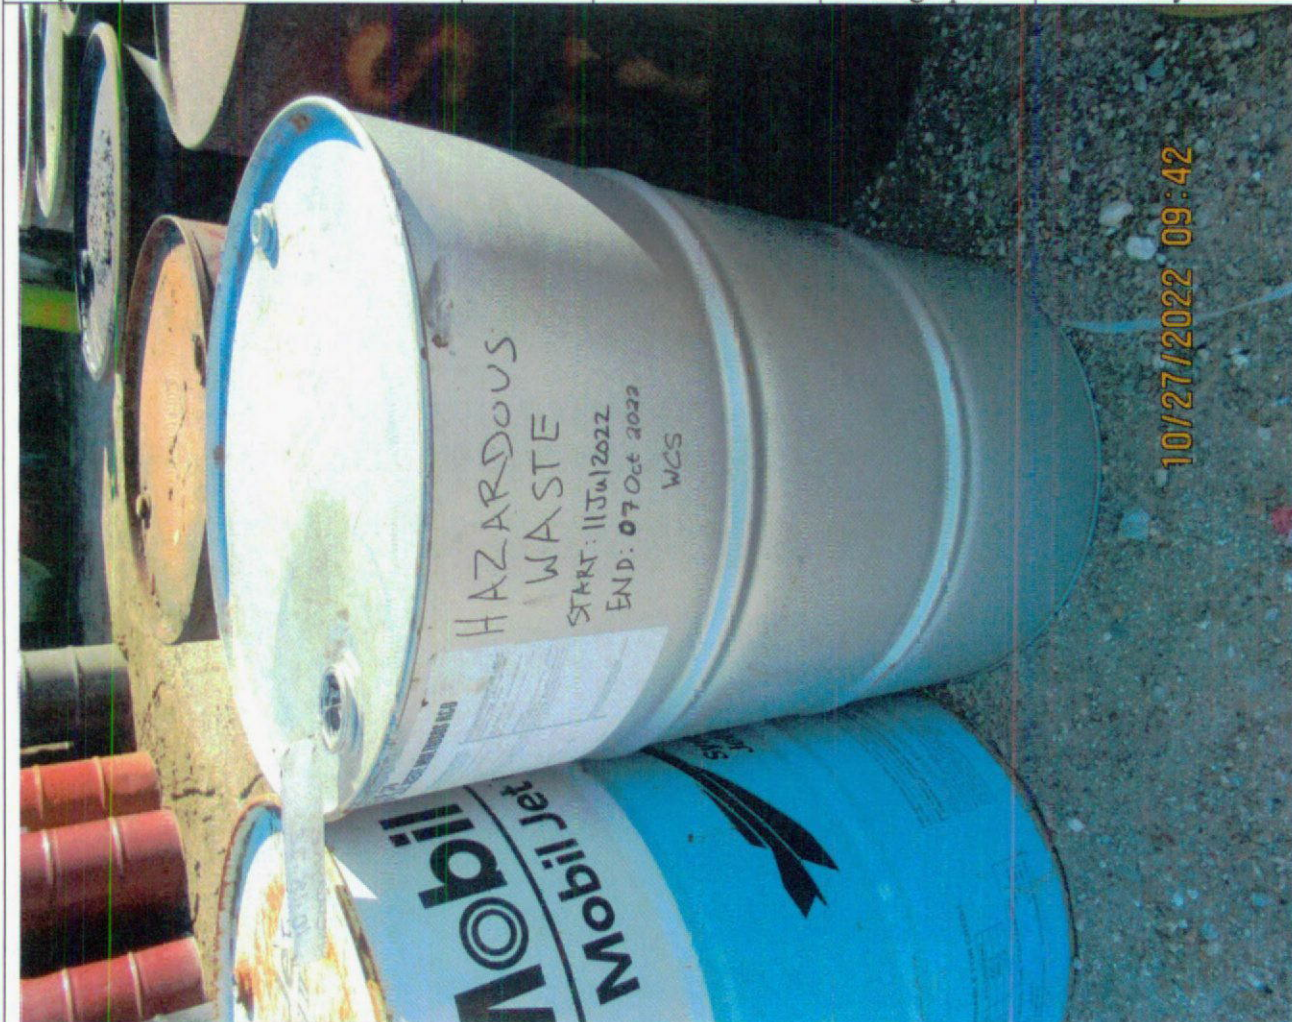
Photo #: 65 Of 81 Date: 10/27/2022 Time: 9:42 AM

Description: Drum of hazardous waste picked up from a facility on 10/18/2022. The drum contained a “flashy material,” according to the tag.

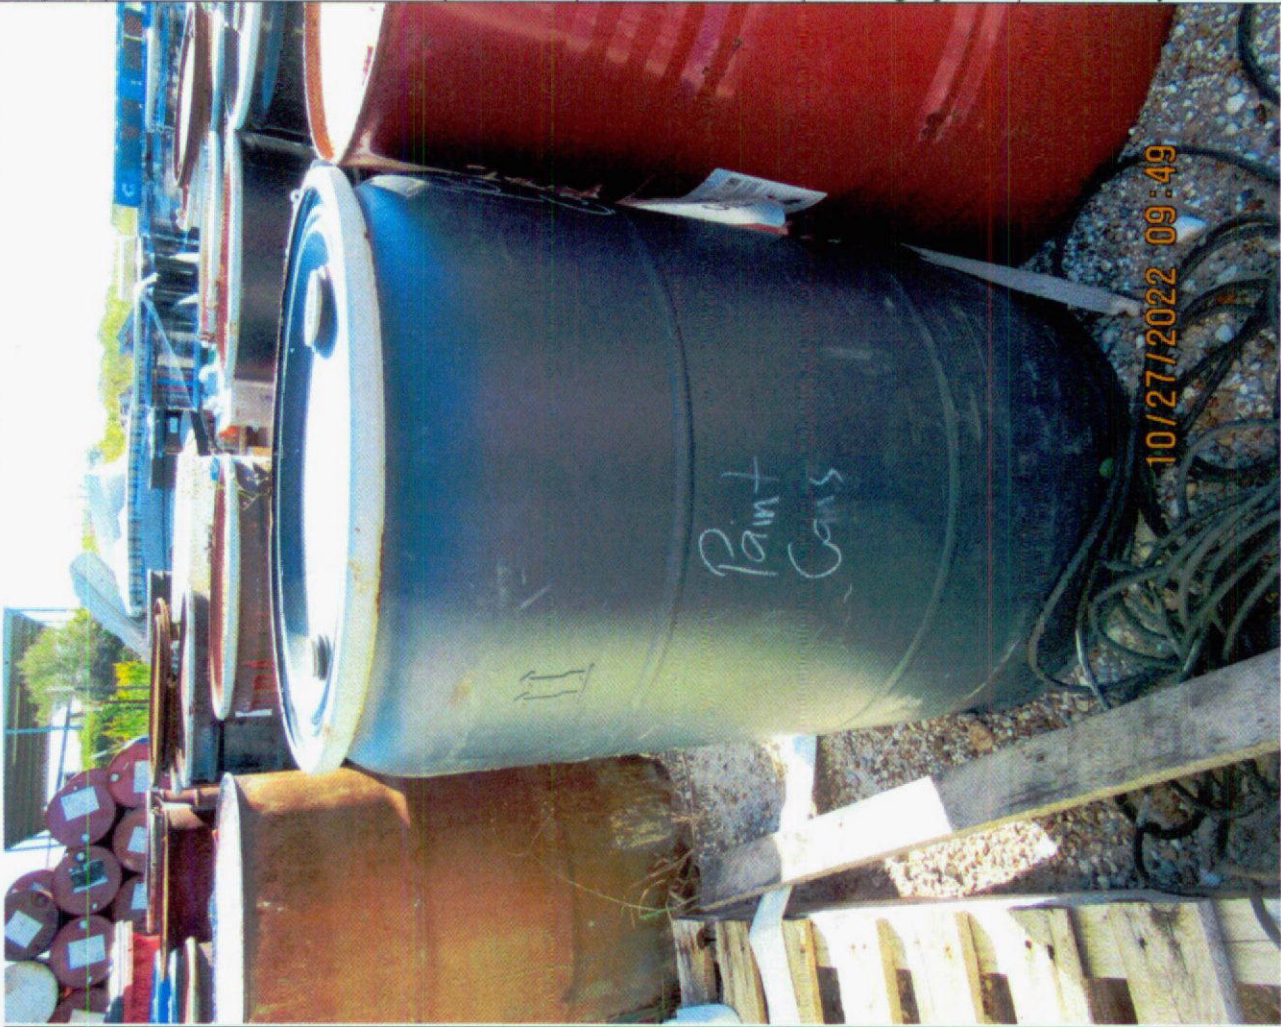
Photo #: 67 Of 81 Date: 10/27/2022 Time: 9:49 AM  
 Description: Drum of paint cans that is not labeled to distinguish if it is hazardous or non-hazardous waste.

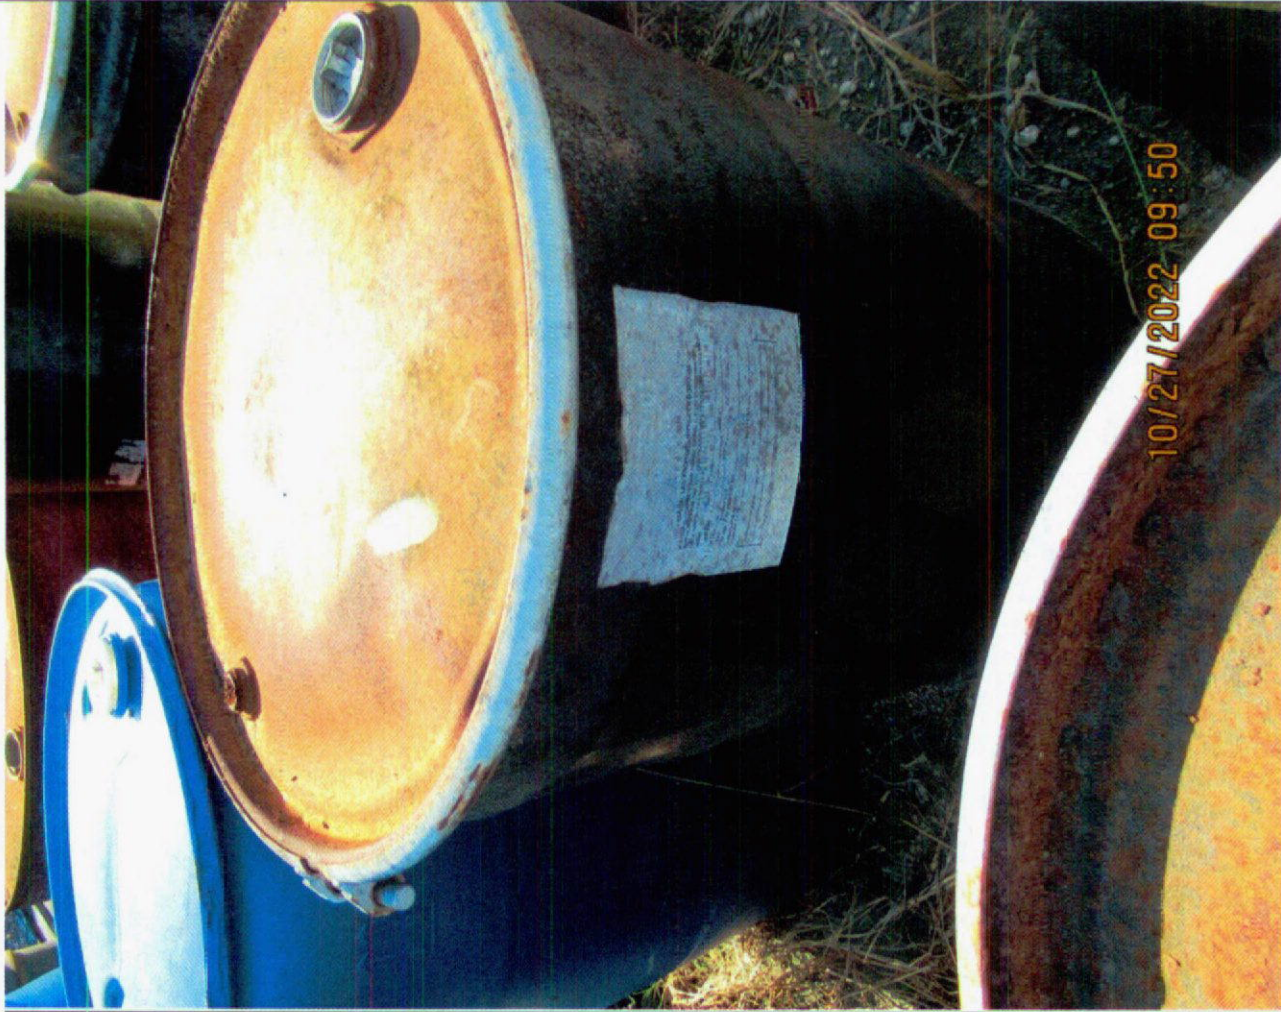
Photo #: 68 Of 81 Date: 10/27/2022 Time: 9:50 AM  
 Description: Drum with a hazardous waste label. The drum is showing signs of rusting. The label was deteriorated; therefore, the contents of the drum could not be identified.
