INSPECTION REPORT

| Type of Inspection | Focused Compliance Inspection (FCI) | | | |
| Facility or Site Name | Environmental Response Services, Inc. (ERS) | | | |

**Southwest Regional Office  
Hazardous Waste Inspection Report**

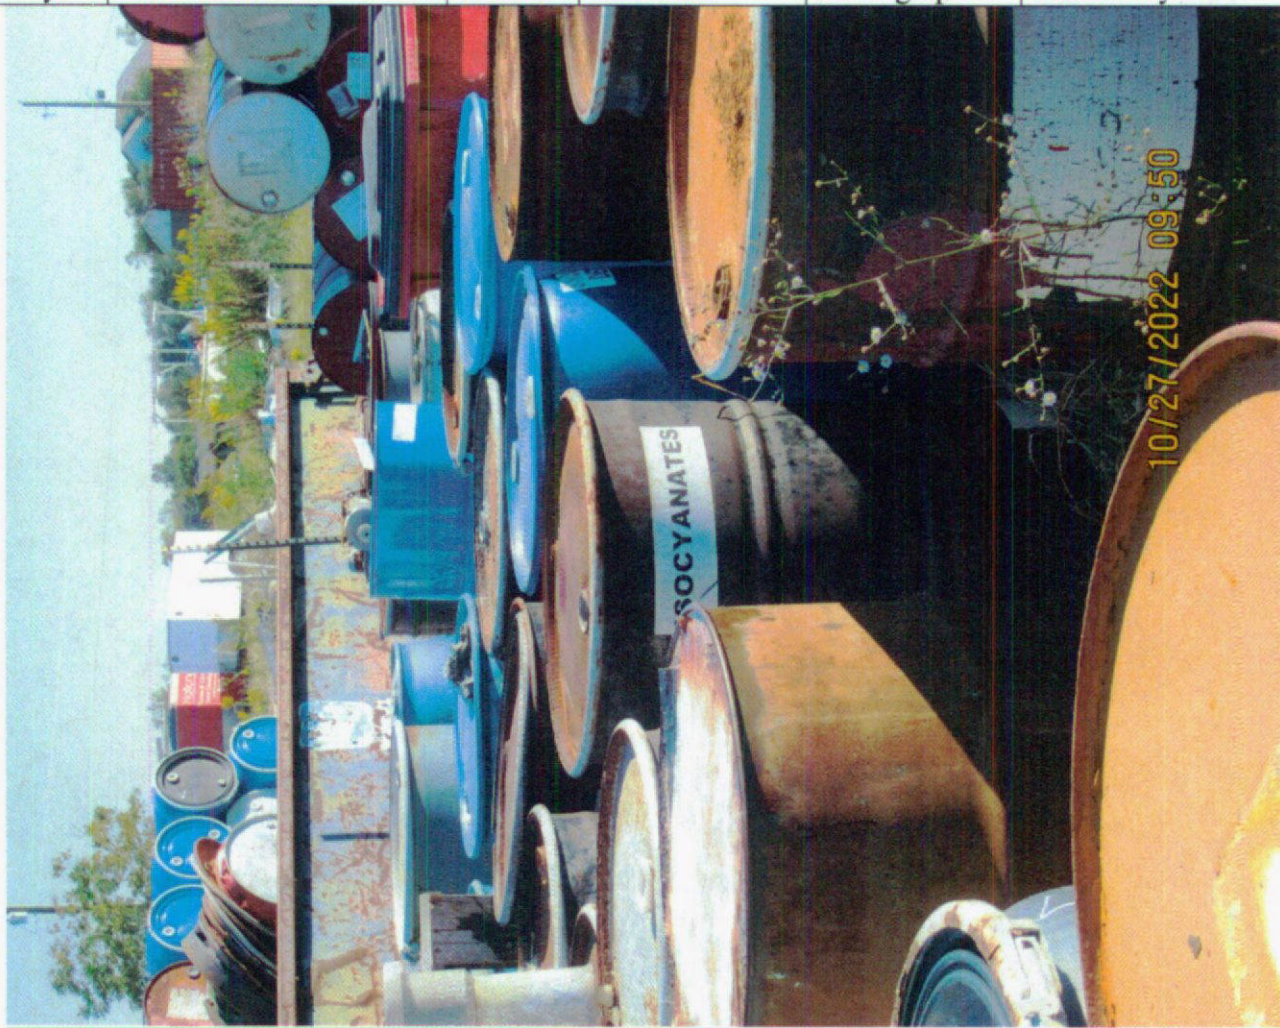
| Photo #: | 69 | Of | 81 | Date: | 10/27/2022 | Time: | 9:50 AM |

| Description: Photograph demonstrating the substantial amount of waste storage at the facility. | | | | | | | |

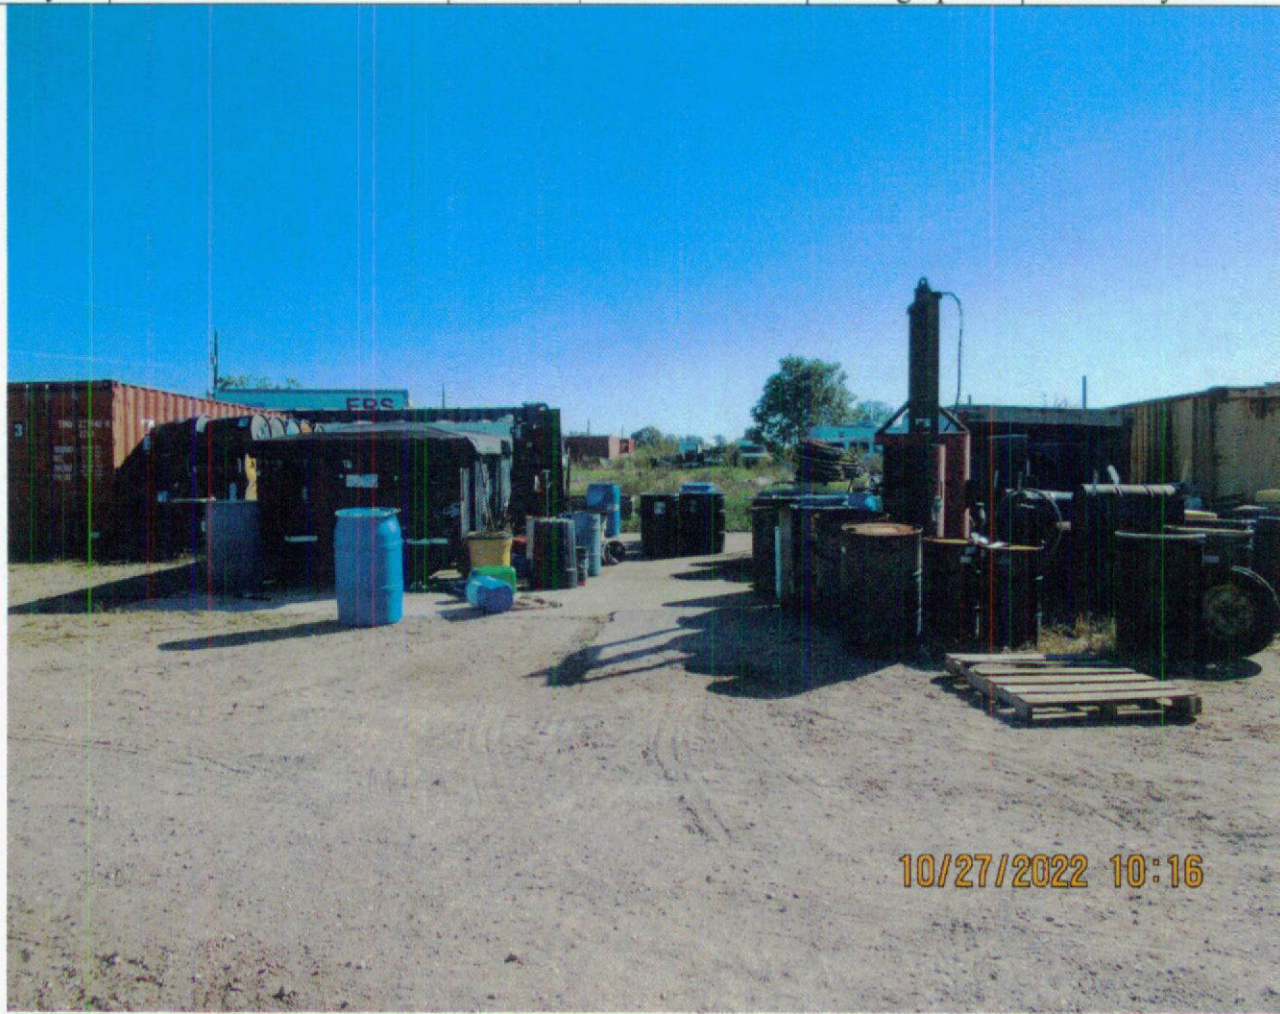
| Photo #: | 70 | Of | 81 | Date: | 10/27/2022 | Time: | 10:16 AM |

| Description: More used oil and oily water storage. Some drums are on the concrete pad, others are directly on earthen ground. | | | | | | | |

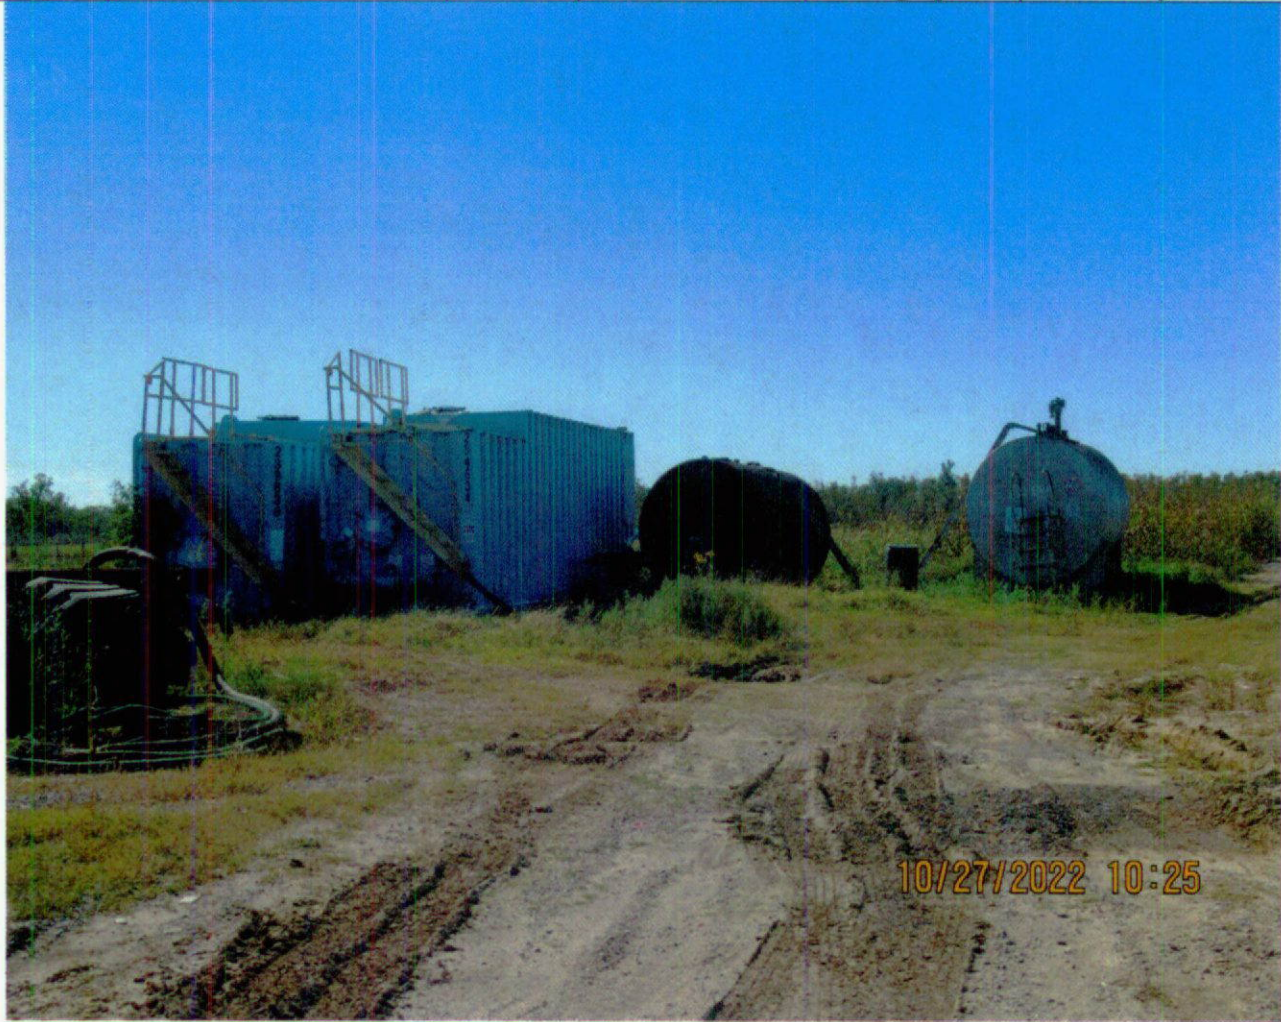
Photo #: 71 Of 81 Date: 10/27/2022 Time: 10:25 AM

Description: I observed a total of 7 frac tanks and 2 aboveground on the adjacent property to the east. Mr. Clark confirmed that the tanks are storing used oil and oily water. This photograph shows 2 frac tanks and 2 aboveground tanks. The tanks were not adequately labeled. Mr. Clark stated the tanks are not double-walled. The tanks have no secondary containment system.

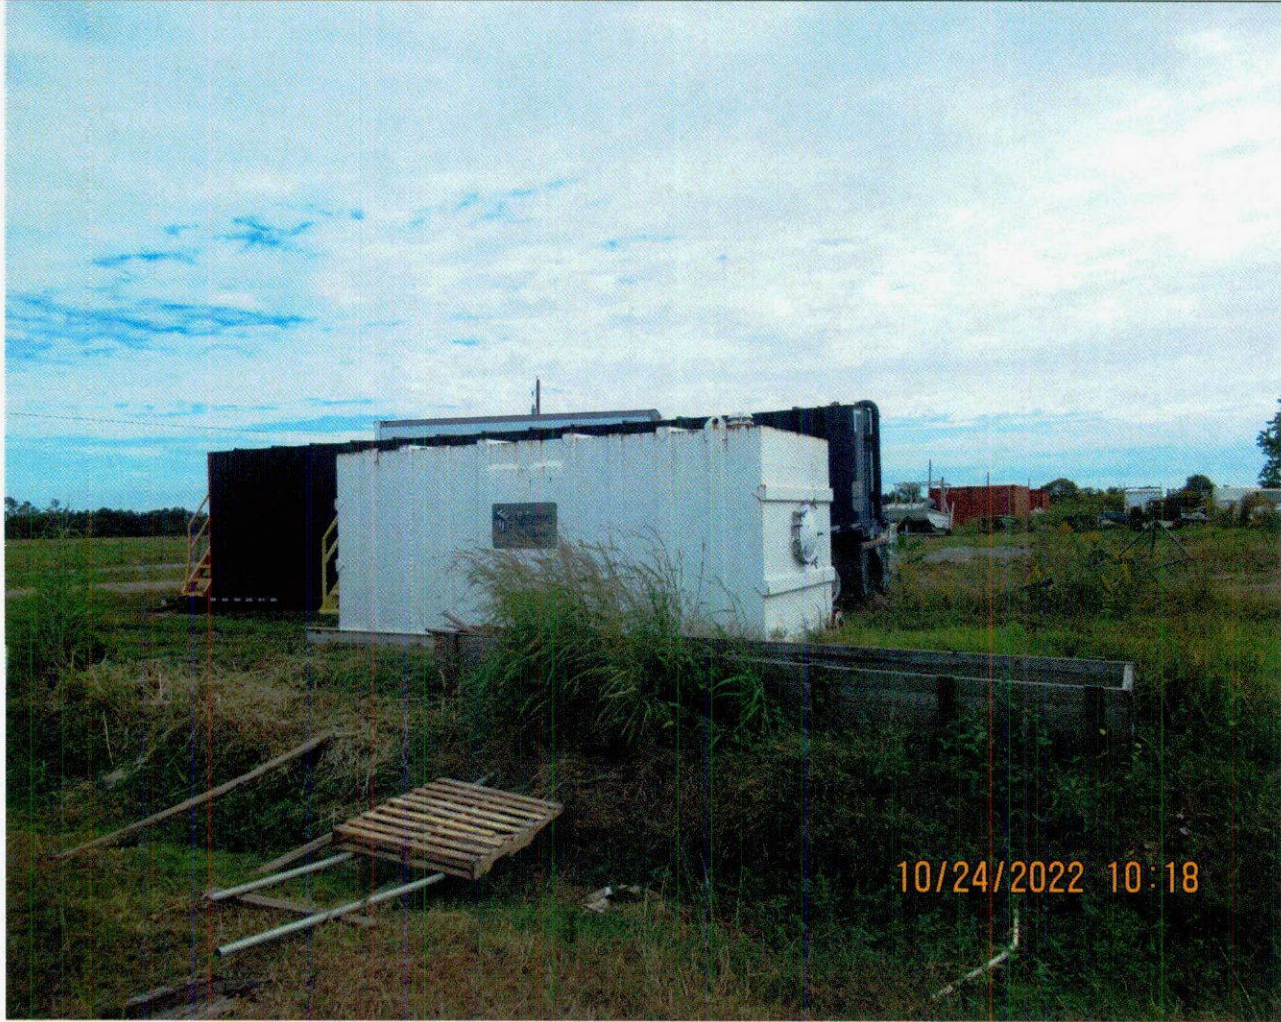
Photo #: 73 Of 81 Date: 10/24/2022 Time: 10:18 AM

Description: Two additional frac tanks without adequate labels and secondary containment systems.

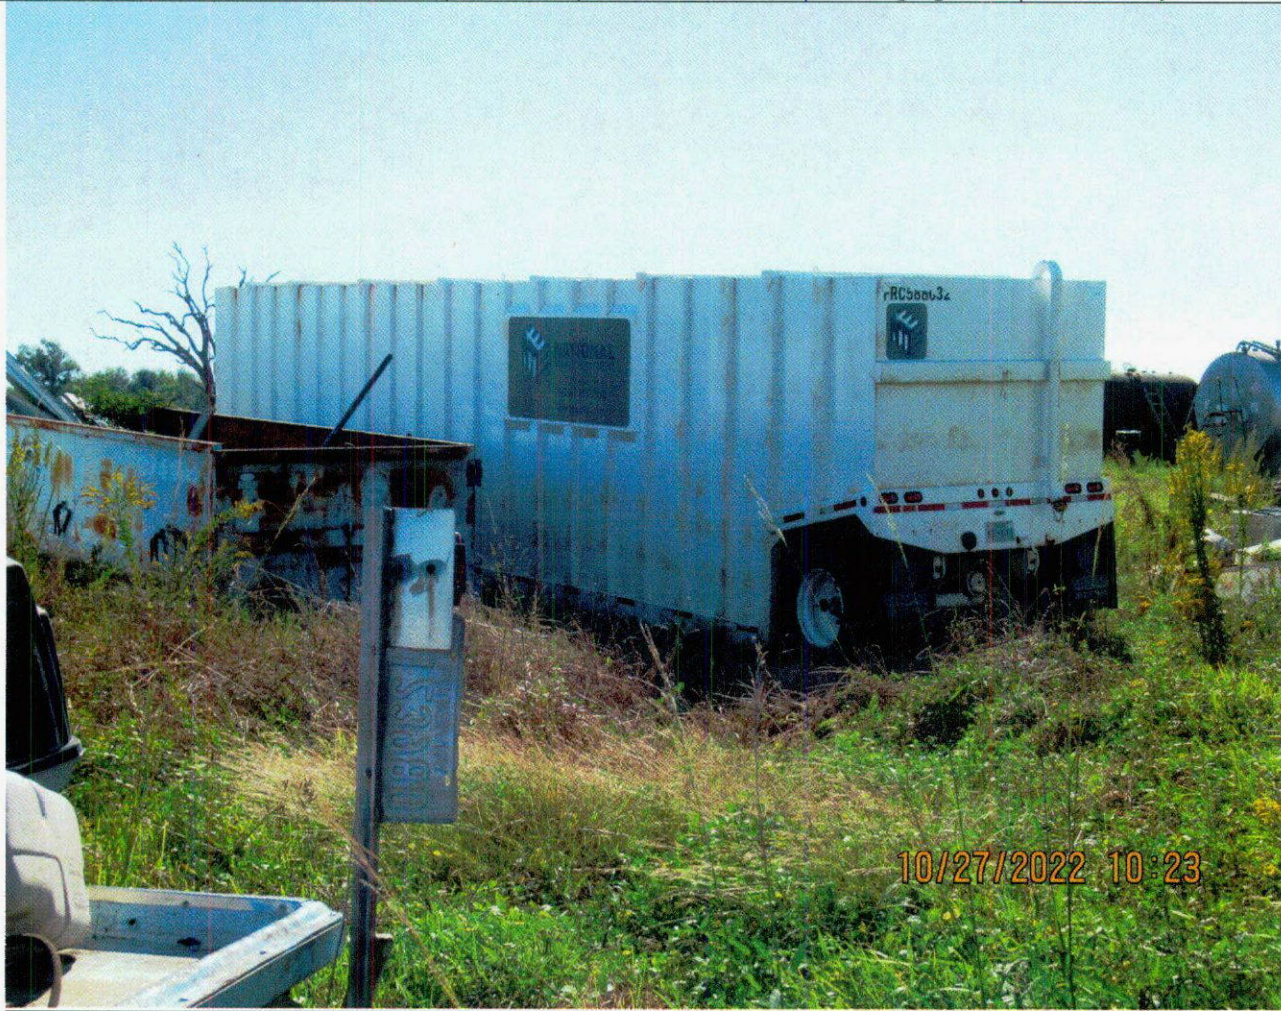
Photo #: 74 Of 81 Date: 10/27/2022 Time: 10:23 AM

Description: 7<sup>th</sup> frac tank at the facility storing used oil. The tank was not adequately labeled and did not have a secondary containment system.

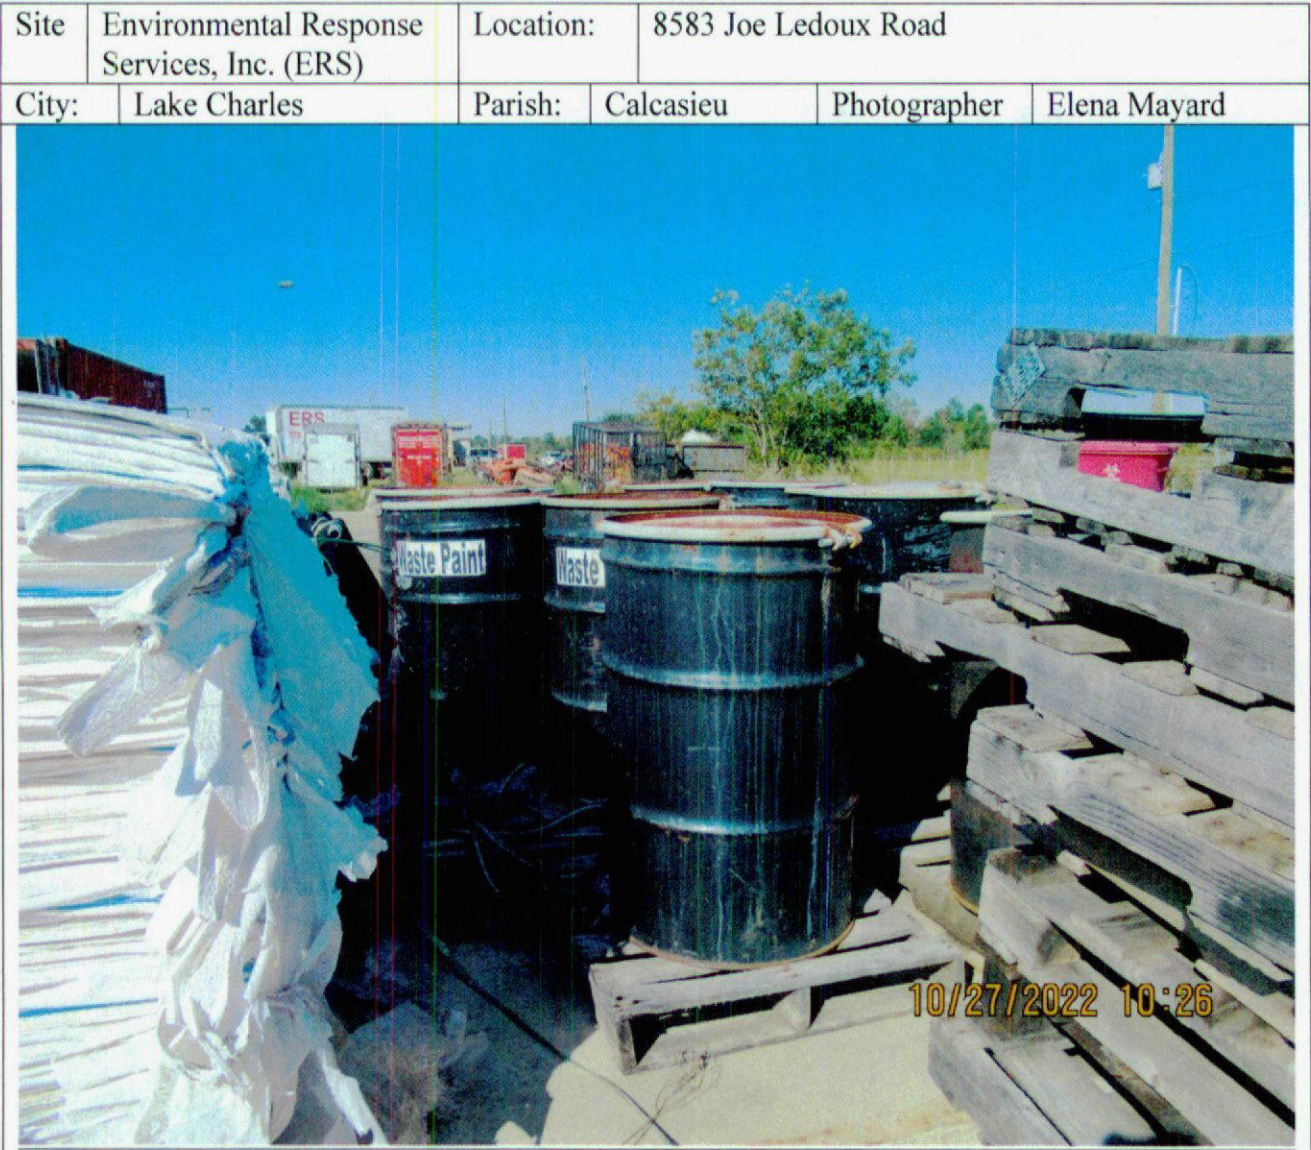
Photo #: 75 Of 81 Date: 10/27/2022 Time: 10:26 AM  
Description: seven additional drums that were observed on the adjacent property. The labels indicate it was waste paint, but there was no indication if the waste was hazardous or non-hazardous.

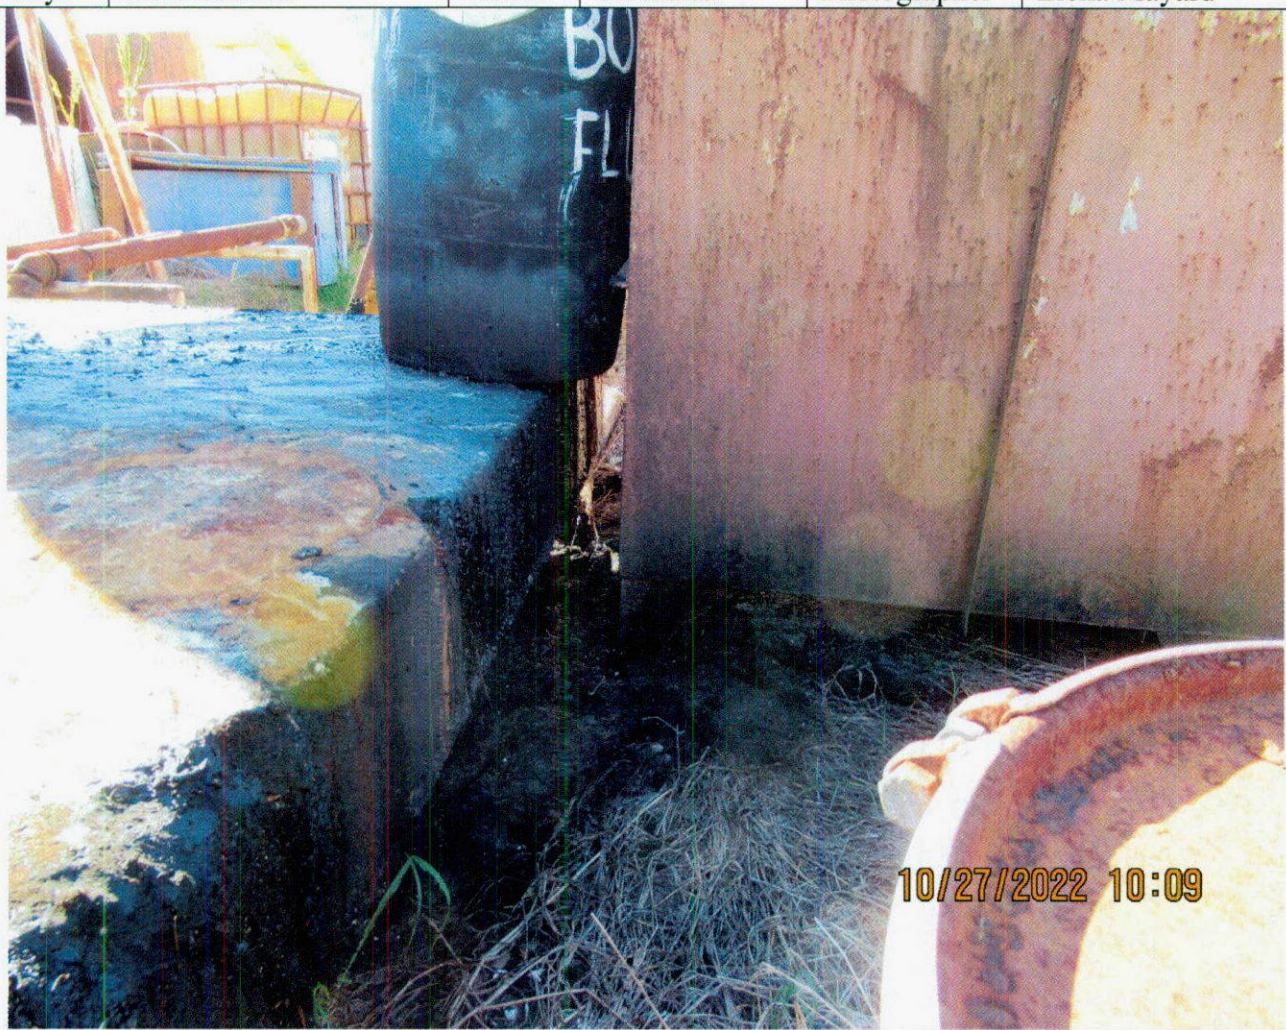
| Photo #: | 81 | Of | 81 | Date: | 10/24/2022 |

| Description: Spill of used cooking oil was observed migrating from this concrete slab onto earthen ground. The facility failed to properly dispose of solid waste. | | | | | |

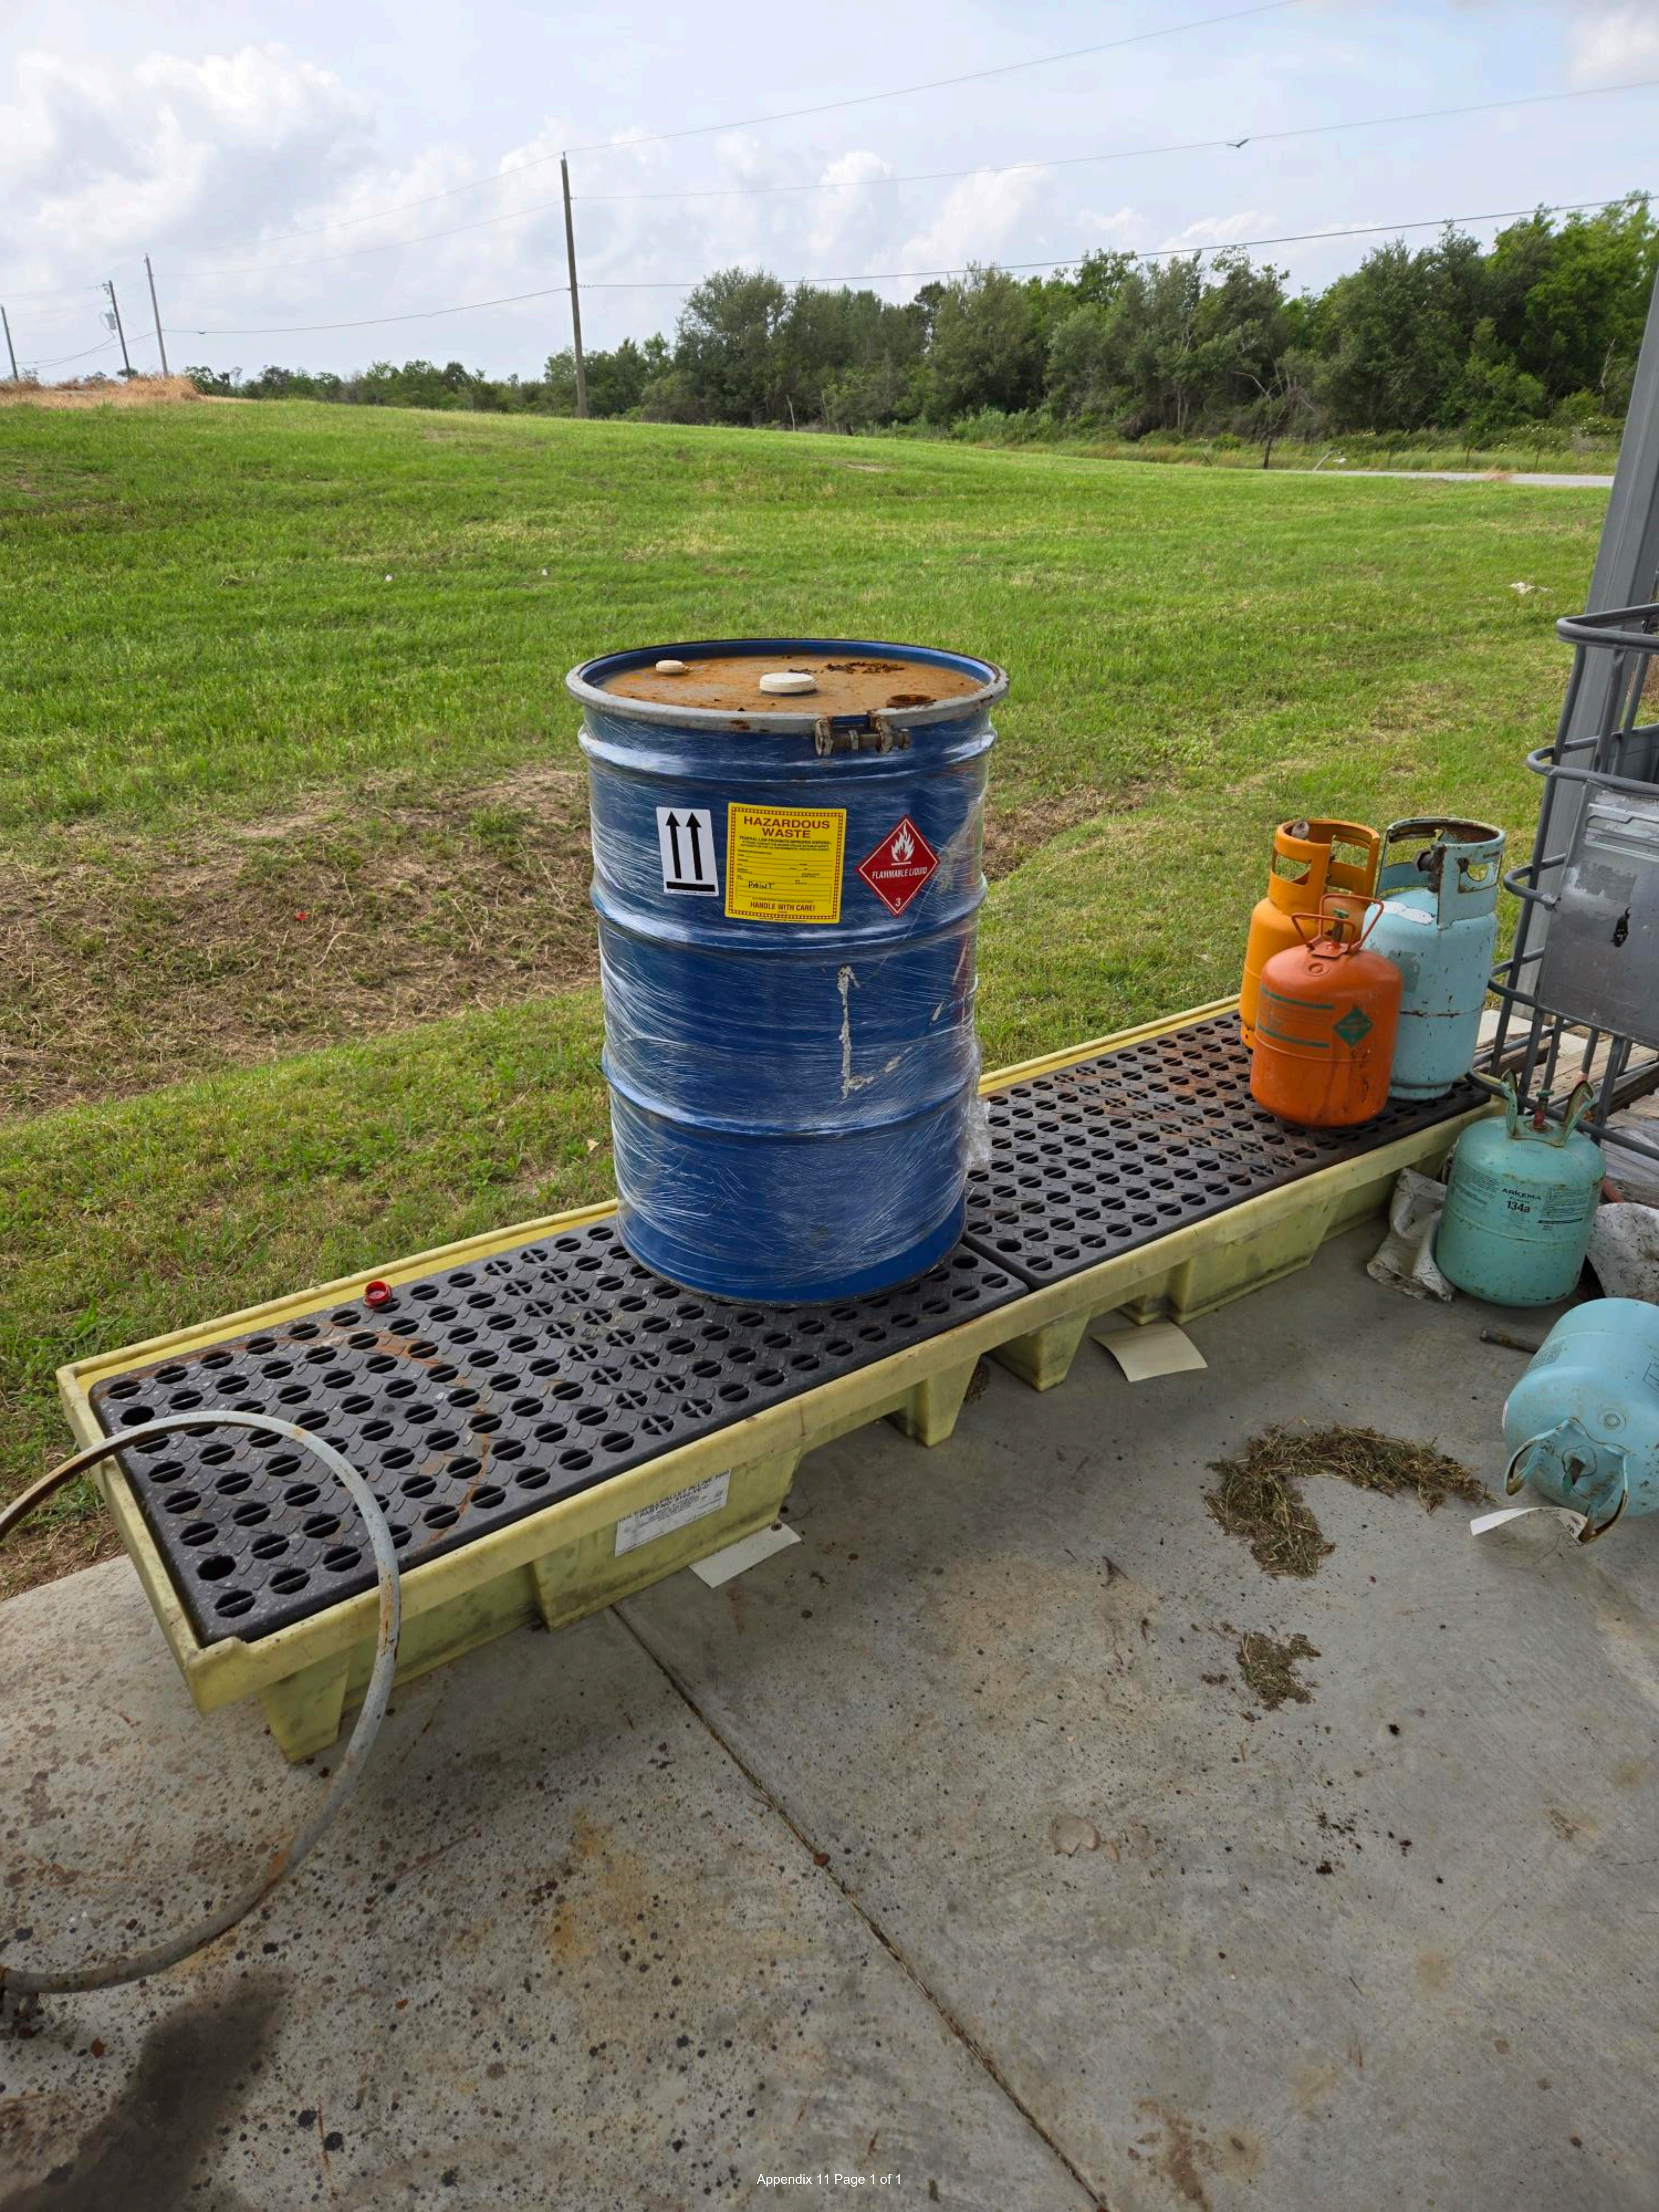
APPENDIX 11.

PHOTO OF WASTE PAINT DRUM IN FOLLOW-UP EMAIL FROM ERS APRIL 25

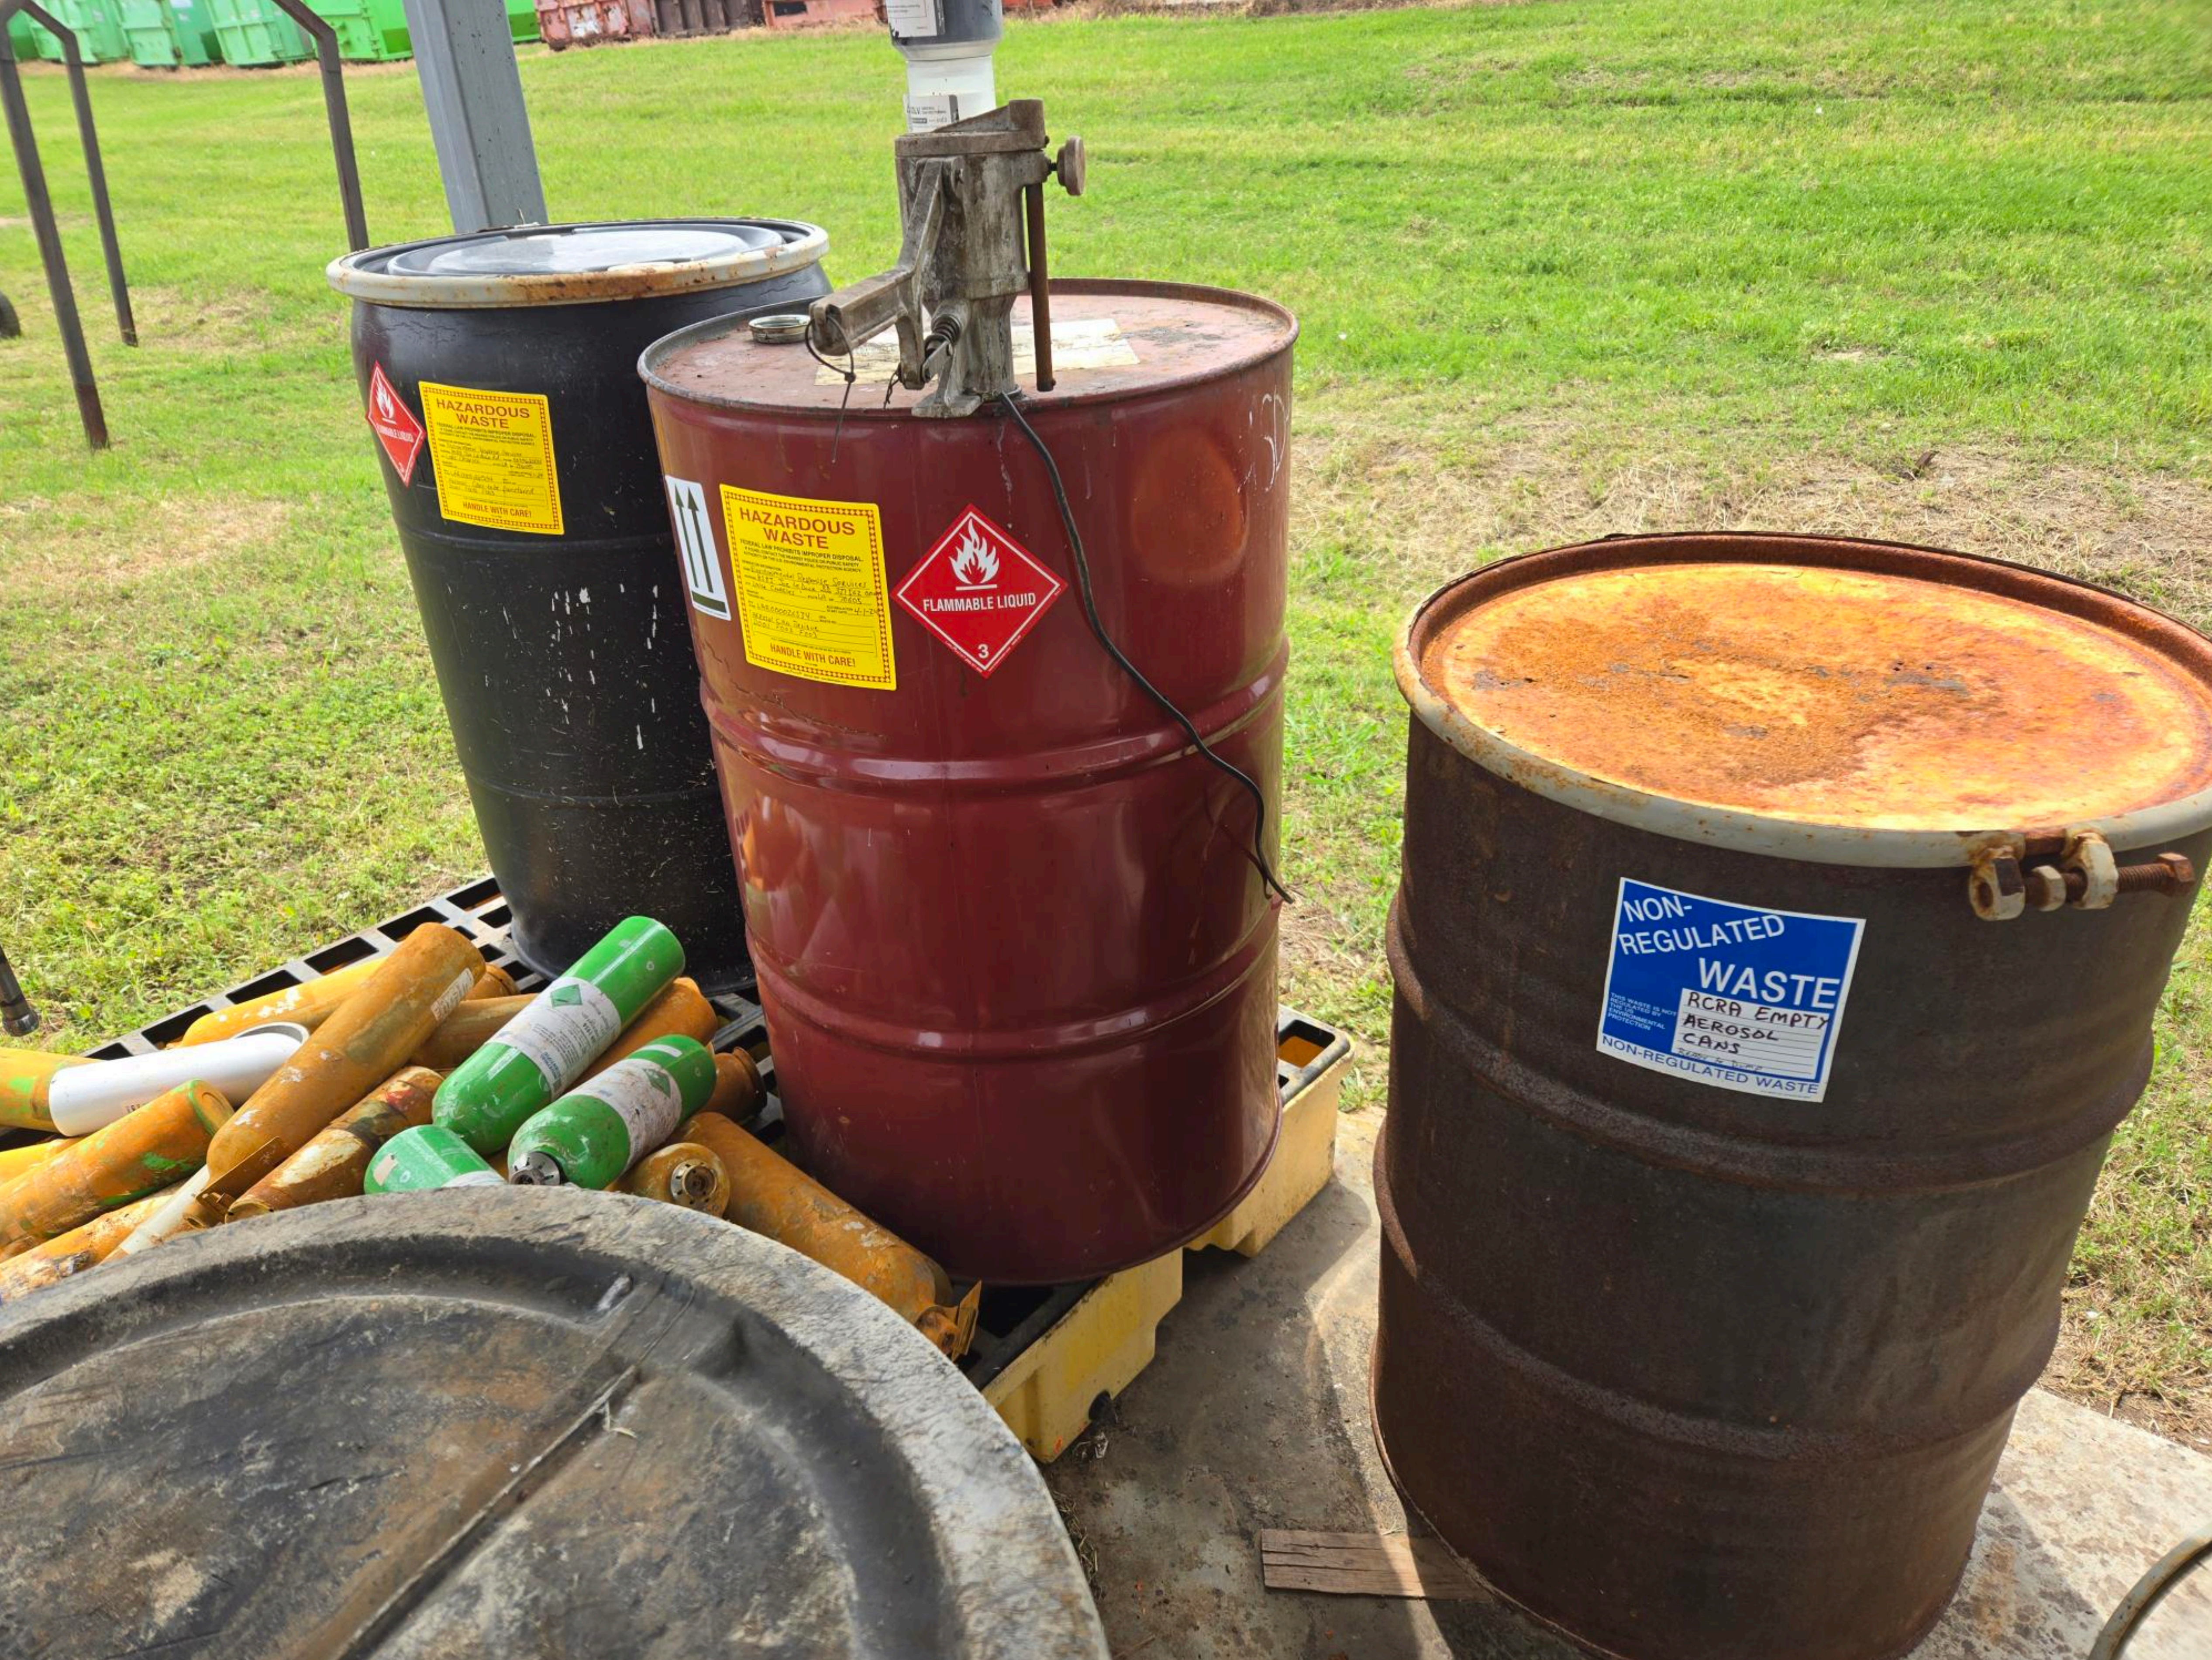
APPENDIX 12.

PHOTO OF AEROSOL CAN MANAGEMENT DRUMS IN FOLLOW-UP EMAIL FROM ERS APRIL 25
