**Region 6 - Enforcement & Compliance Assurance Division**  
**INSPECTION REPORT**

| Company Name: | <b>RCP Production, LLC</b> | |
| Facility Name: | <b>TD Murphy B-3 SWD Tank Battery</b> | |

EPA conducted a follow-up inspection on the RCP Production, LLC / TD Murphy B-3 SWD Tank Battery for a release from the tank battery that had occurred on 03/12/2024. EPA collected Total Dissolved Solids (TDS) readings from areas sampled during the 03/12/2024 and 04/02/2024 inspections.

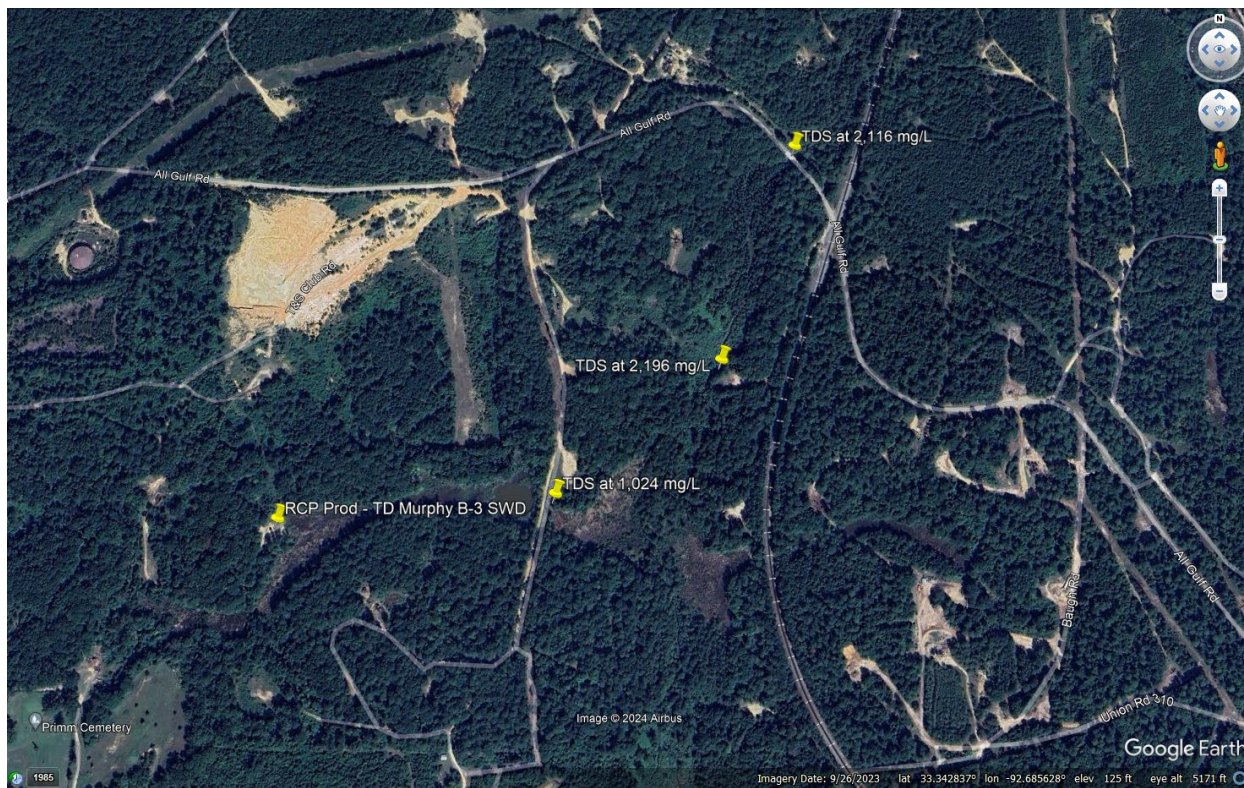
**Aerial Image 1.** Overview of the area of the release and the associated RCP Production – TD Murphy B-3 SWD well and downstream TDS readings for the impacted wetland and unnamed tributary (UT) of Smackover Creek. Google Earth image date 09/26/2023.

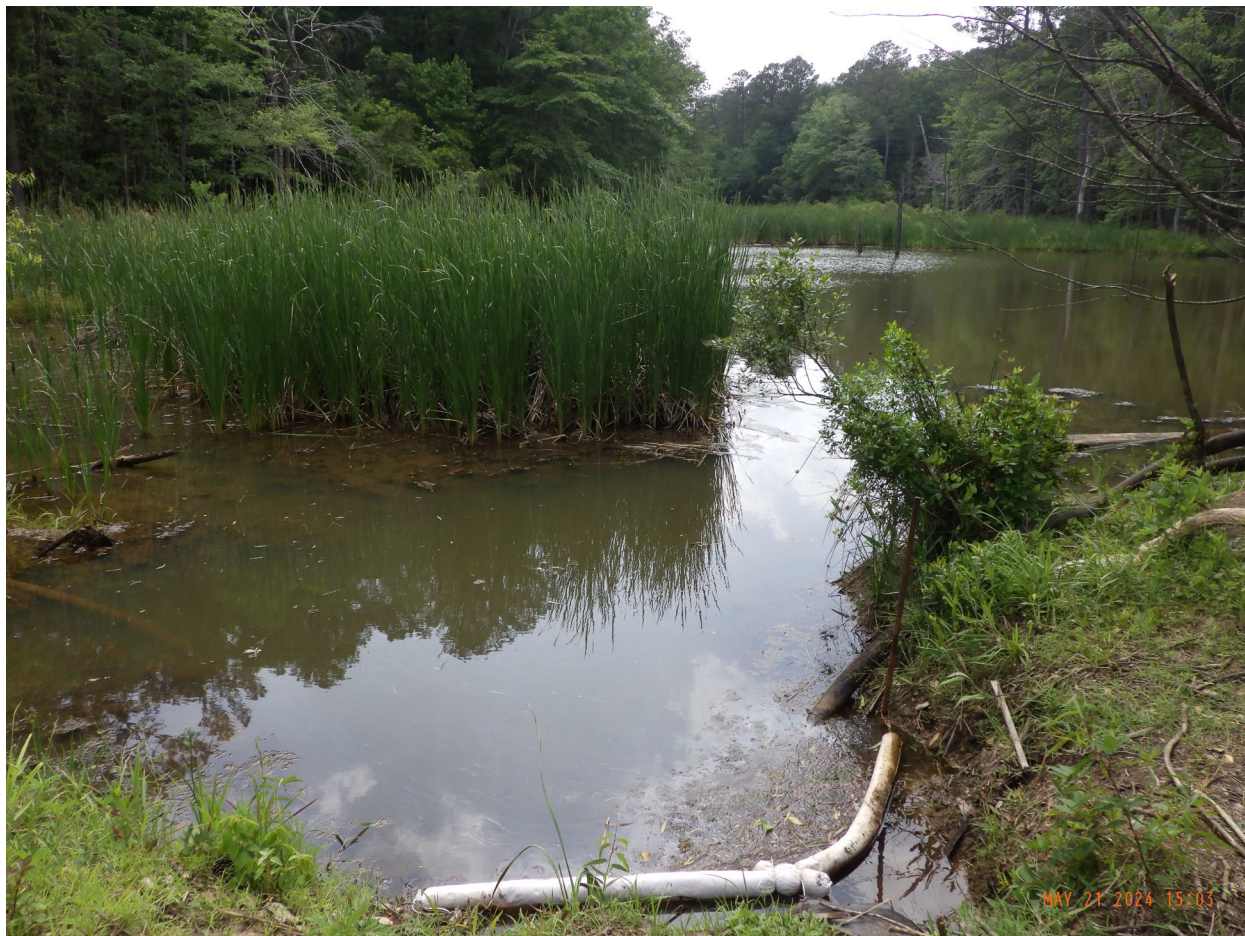
Photo No. 1

I observed the pool in the impacted wetland downstream of the TD Murphy B-3 SWD tank battery. New booms were noted at the influent-side of the road culvert, see Appendix 1 (Photograph Log), Photo No. 1. For additional GPS location and photo metadata, see Appendix 1.

**Description:** Looking W-NW, this photo showed new booms placed downstream of the RCP Production, LLC – TD Murphy B-3 SWD crude oil and saltwater release into a wetland documented in the 03/12/2024 and 04/02/2024 inspections.

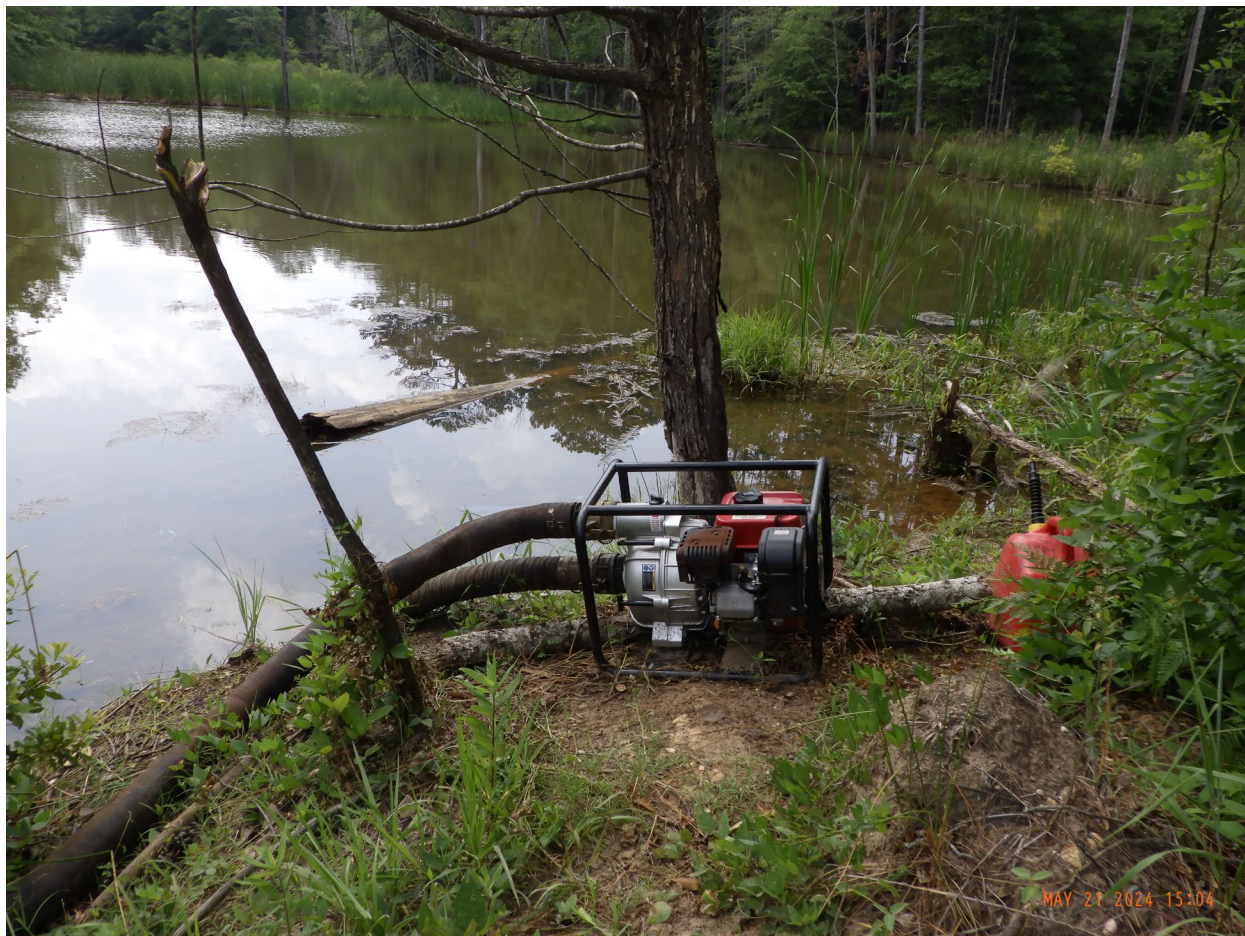
Photo No. 2

I observed a pump at the pool in the impacted wetland downstream of the TD Murphy B-3 SWD tank battery. The operator, Rod Phillips, stated the pump was used to transfer water from the pool to a pumper truck, which is routed back to the SWD well. See Photo No. 2.

**Description:** Looking NW, this photo showed a pump setup at the pool in the wetland downstream of the TD Murphy B-3 SWD release.

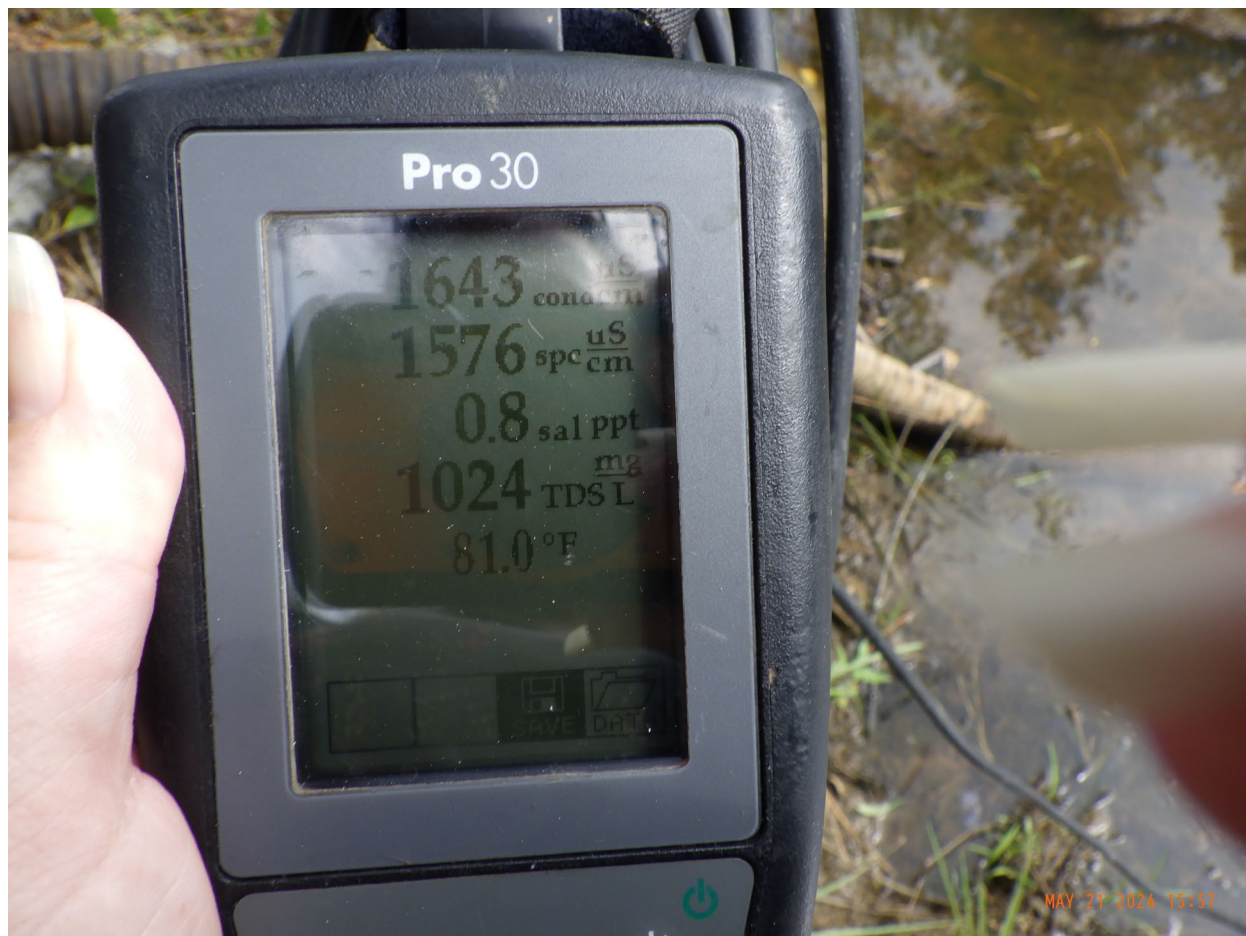
Photo No. 3

I collected a TDS reading of 1,024 mg/L at the pool in the impacted wetland downstream of the TD Murphy B-3 SWD tank battery. See Photo No. 3.

**Description:** Looking SW, this photo showed the TDS reading of 1,024 mg/L at the pool in the wetland downstream of the TD Murphy B-3 SWD release.

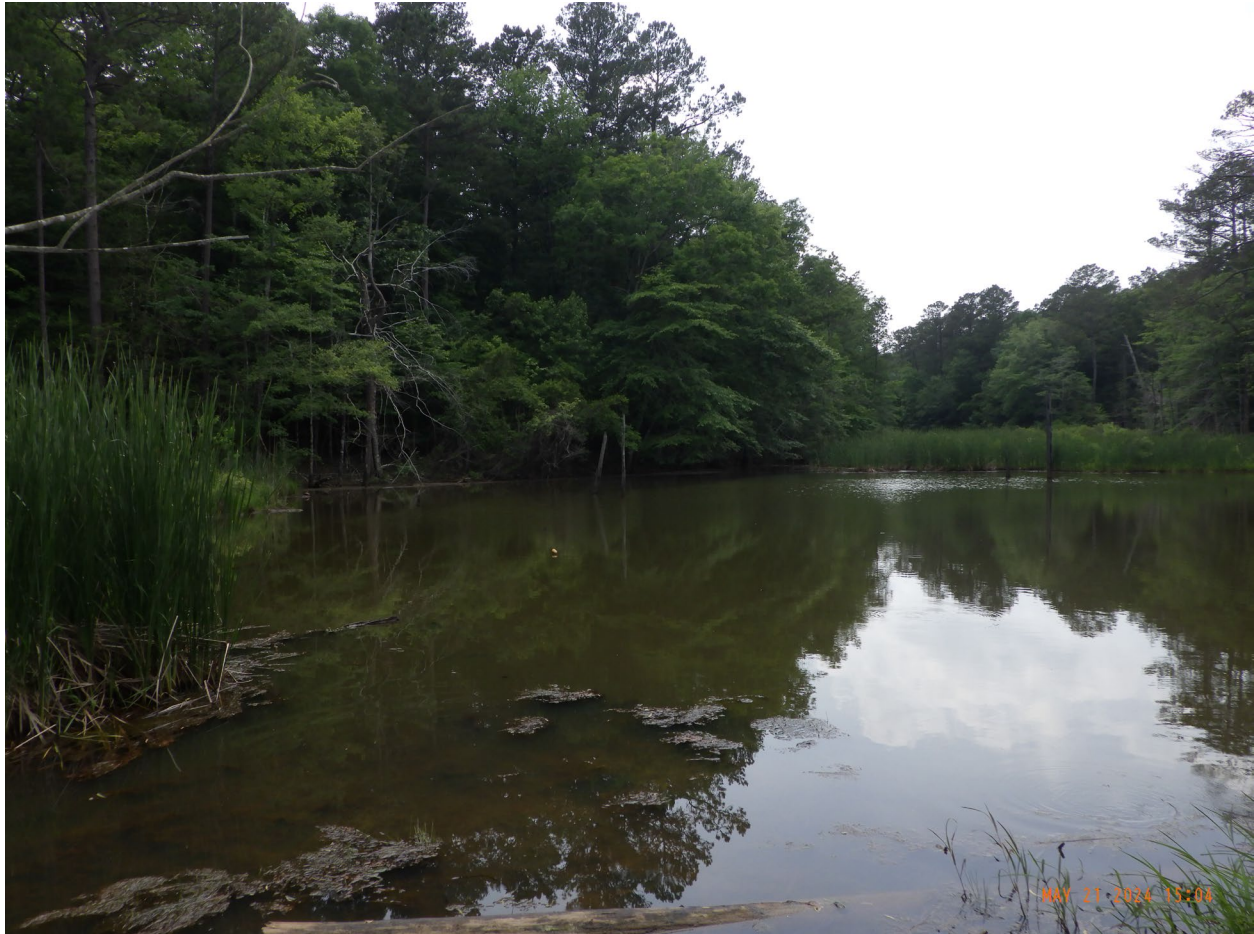
Photo No. 4

I observed the area upstream of the pool in the impacted wetland, where the TDS sample was collected. See Photo No. 4.

**Description:** Looking NW, this photo showed the view upstream of the TDS reading in Photo No. 3.

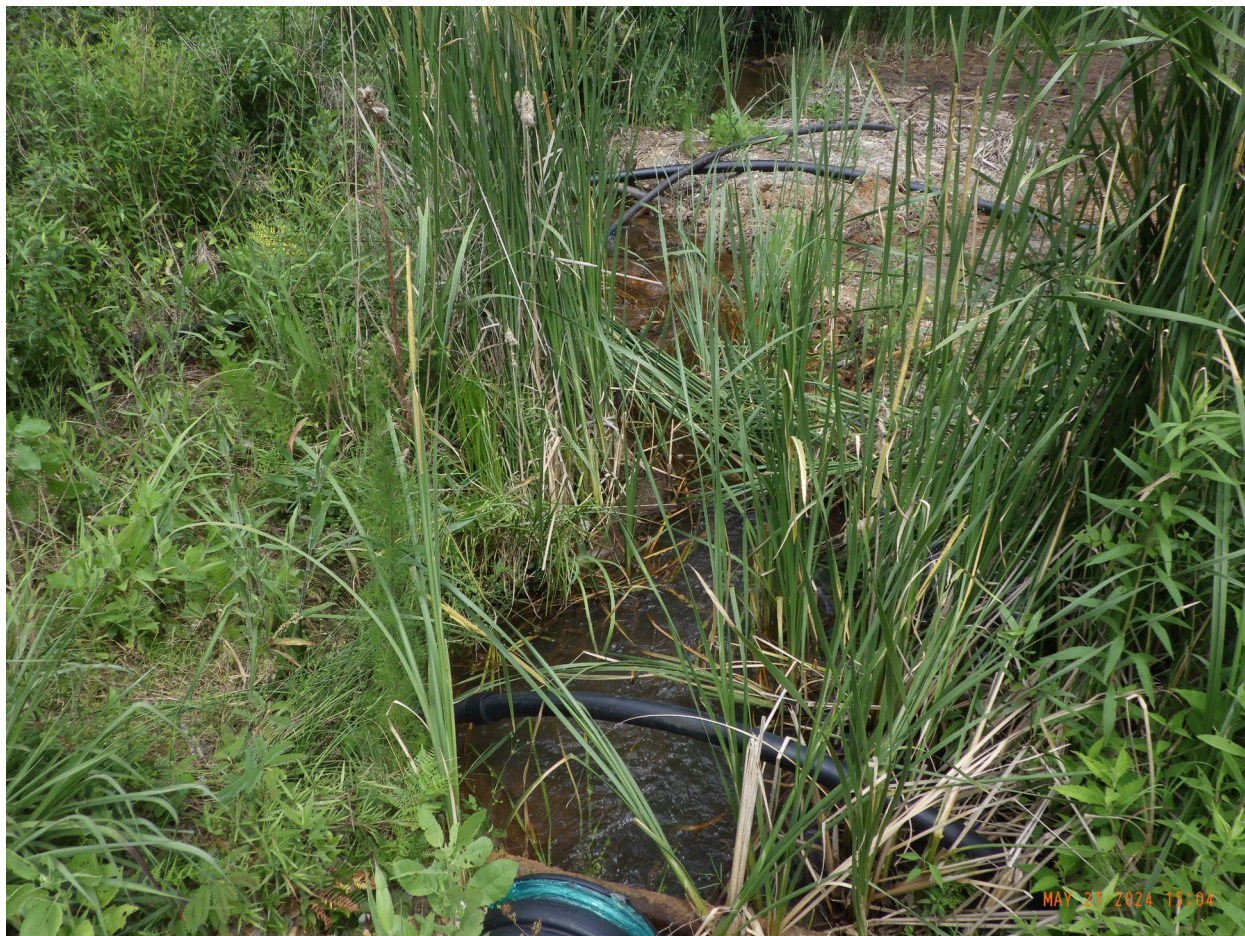
I observed the area downstream of the pool in the impacted wetland, where the TDS sample was collected. See Photo No. 5 and No. 6.

**Description:** Looking E-NE, this photo showed the view downstream of the TDS reading in Photo No. 3.

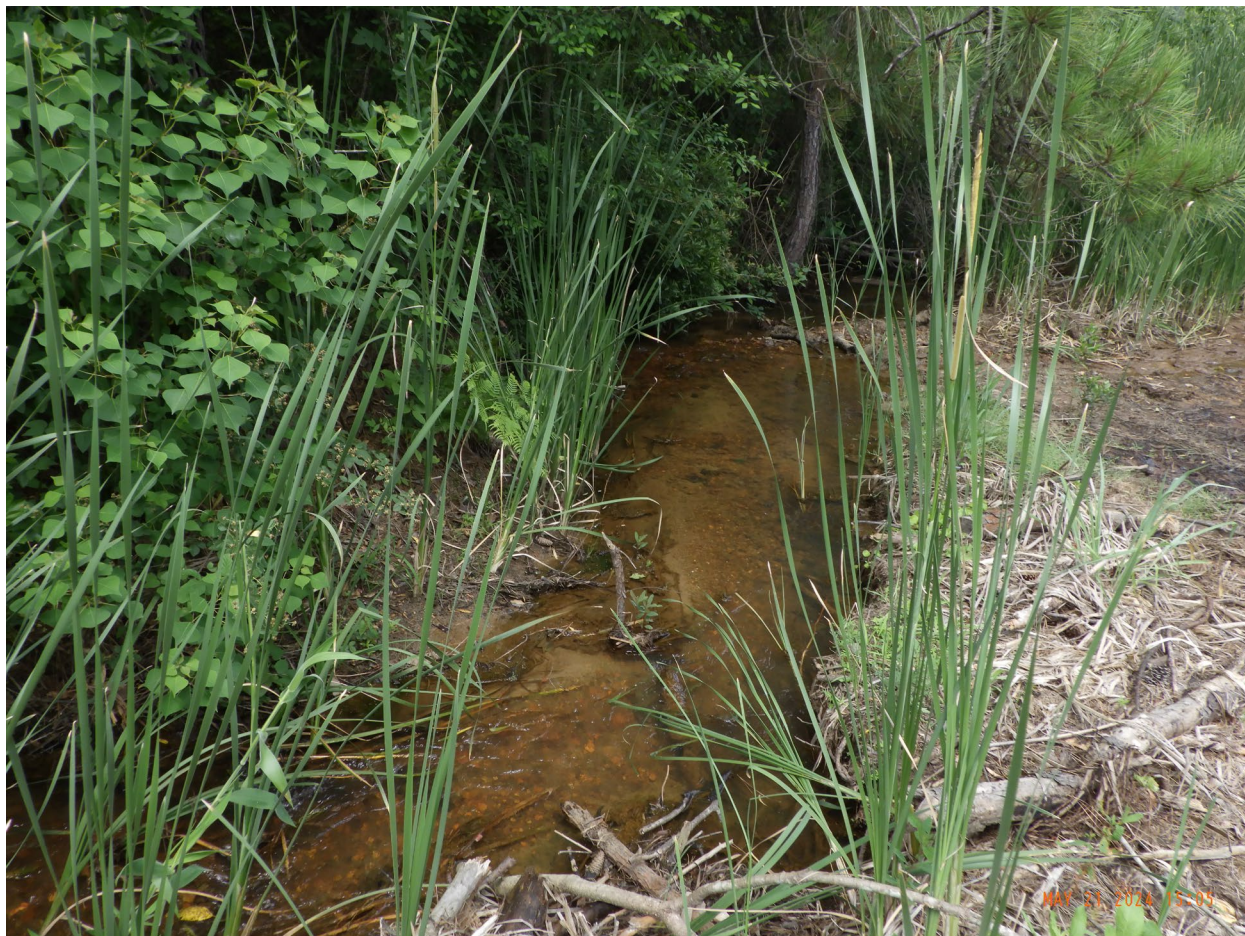
Photo No. 6

**Description:** Looking N-NE, this photo showed an additional view of the downstream location in Photo No. 5.

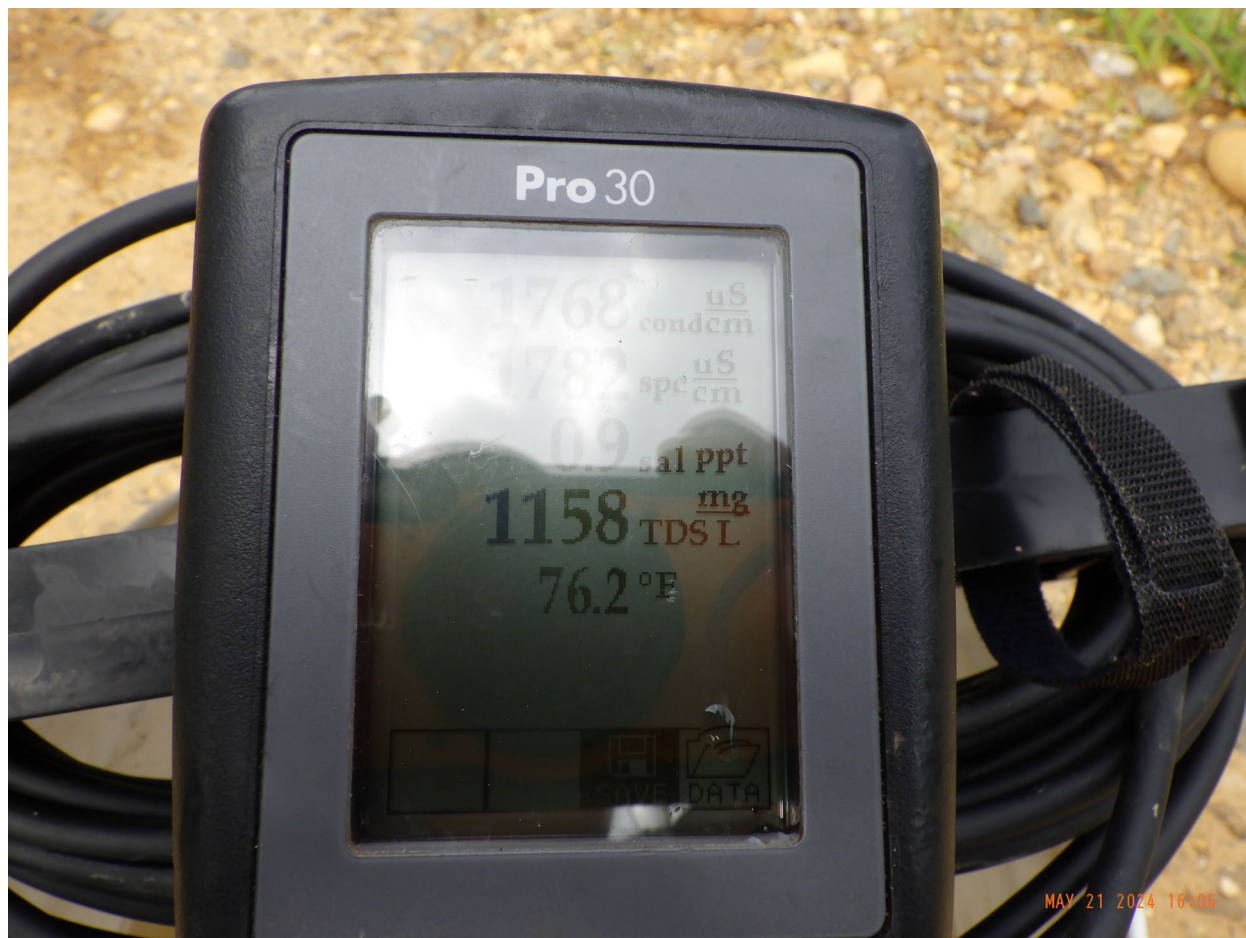
Photo No. 7

I collected a TDS reading of 1,158 mg/L from a sample from a bucket filled with water pumped from the pool in the impacted wetland for comparison with the operator's meter and the EPA-issued meter. See Photo No. 7.

**Description:** Looking NE, this photo showed the TDS reading of 1,158 mg/L from a sample collected by the pump in Photo No. 2. The sample was used to compare the operator's meter with the EPA-issued meter.

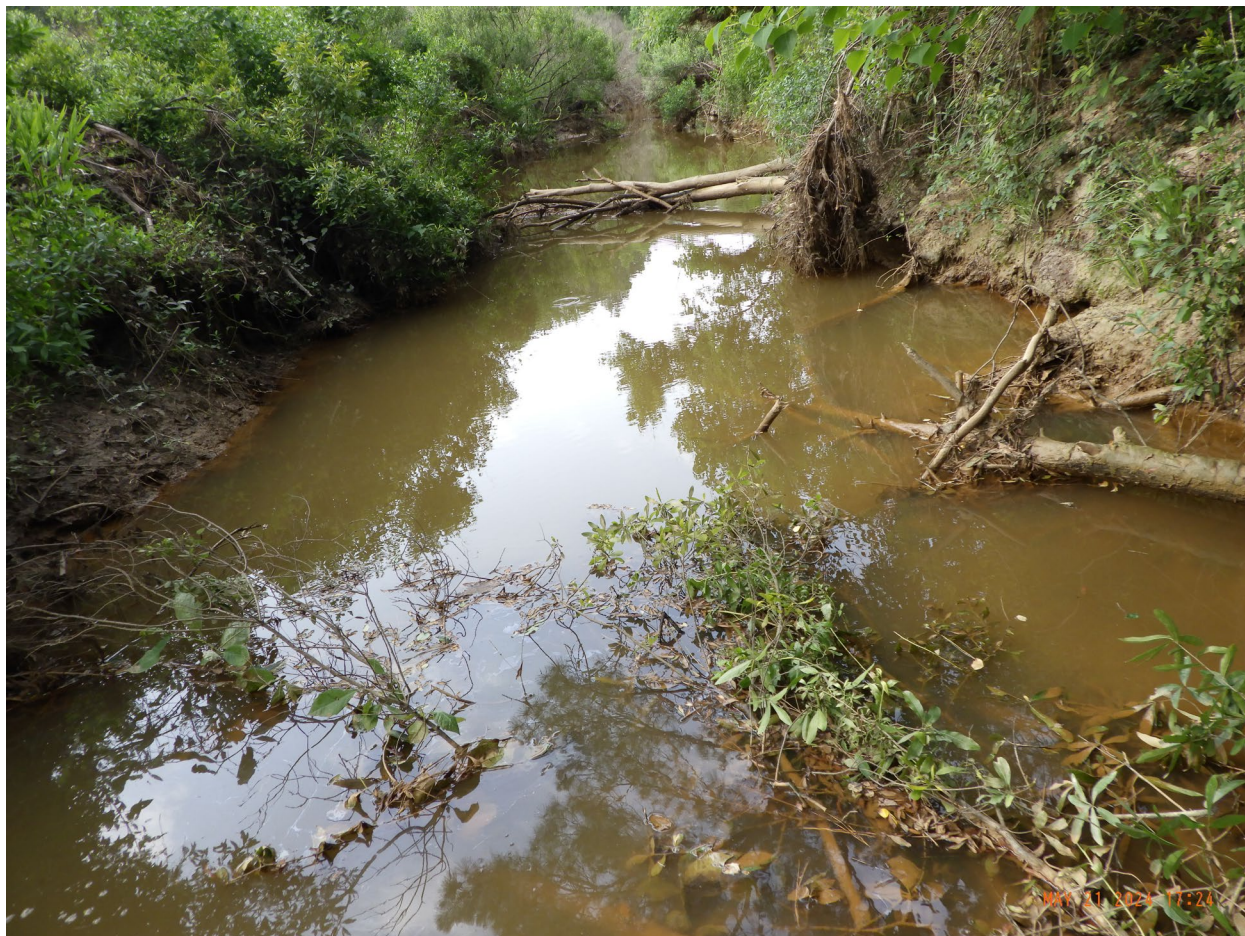
Photo No. 13

I observed downstream at the collection site, where the TDS reading was collected. See Photo No. 13.

**Description:** Looking N, this photo showed the downstream view of the receiving stream, UT of Smackover Creek, for the TDS reading in Photo No. 11.
