UNPERMITTED INDUSTRIAL FACILITY STORMWATER INSPECTION CHECKLIST

| <b>Facility or Site Name:</b> | One More Time, Inc. | |
| <b>Facility Address:</b> | 4144 Bandini Blvd | |

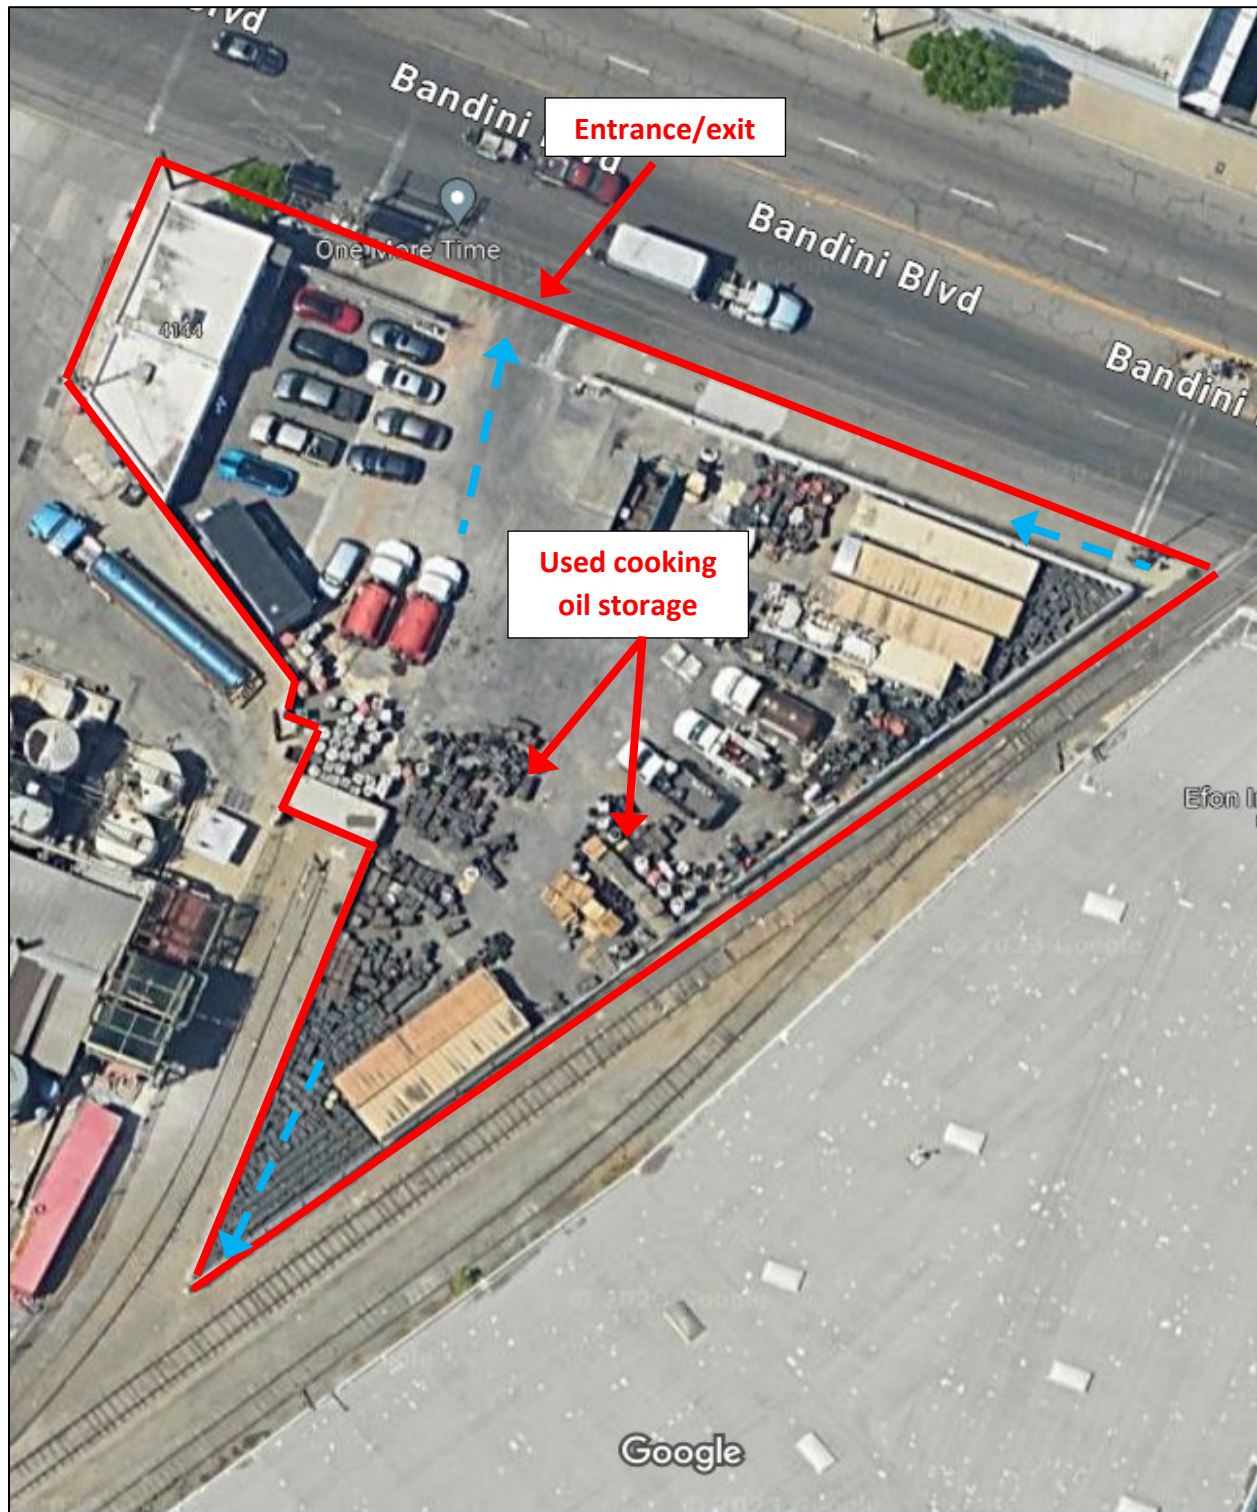
**Figure 1.** Google Earth view of the Facility (dated 2023). The red arrows depict the observed entrance and areas of note, the blue lines depict potential stormwater flow direction, and the red lines show the approximate observed Facility boundary.

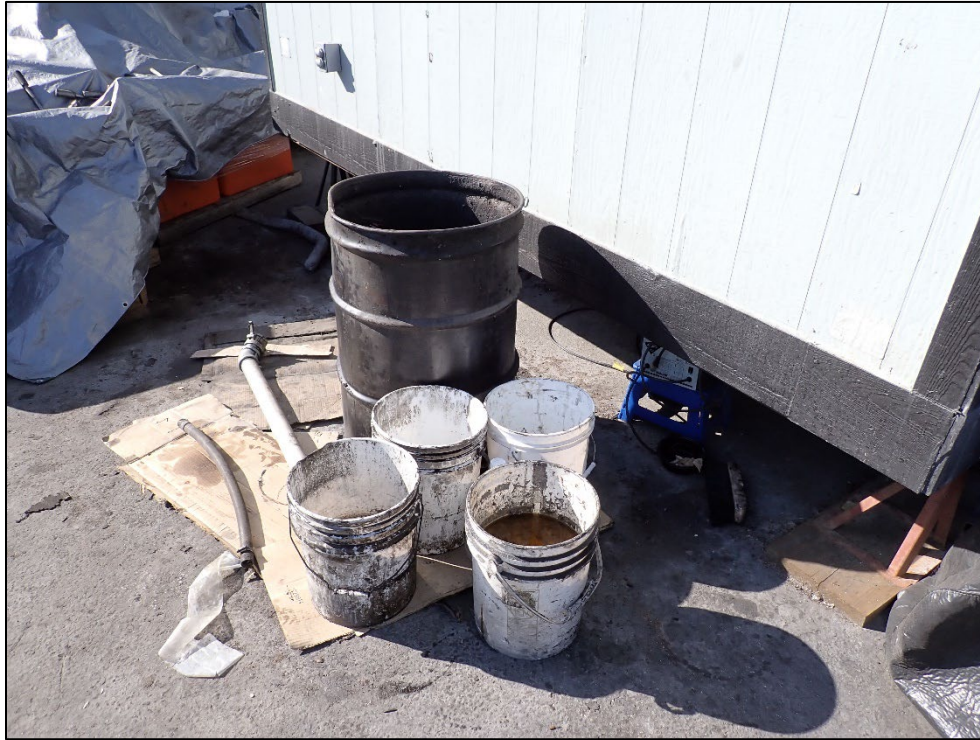
**Photograph 1.** View of a 35-gallon drum and four 5-gallon buckets containing used cooking oil stored outside without secondary containment or cover.

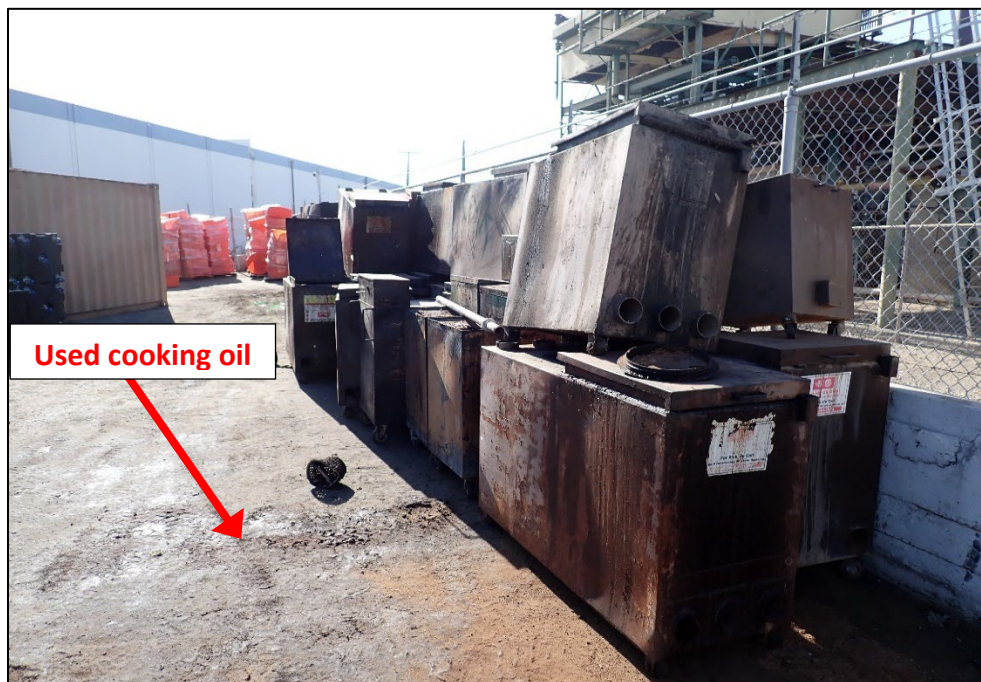
| Pollutant Sources | Note location, quantity/size, design issues, any O&M deficiencies (including the nature and extent), potential pollutants, and evidence of exposure to stormwater. Are BMPs in place to minimize or eliminate stormwater discharges from industrial activities? |
|---|---|
| Liquid Storage (e.g., Tanks, Liquid Storage Drums) | The Facility was storing used cooking oil in two (2) estimated 100-gallon metal tanks and 50-60 plastic tanks of varying sizes (refer to <u>Appendix B, Photographs 2, 3, 4, 6, and 7</u> ). The plastic tanks contained residual oils, were uncovered, and were exposed to stormwater. |

| Pollutant Sources | <b>Note location, quantity/size, design issues, any O&amp;M deficiencies (including the nature and extent), potential pollutants, and evidence of exposure to stormwater. Are BMPs in place to minimize or eliminate stormwater discharges from industrial activities?</b> |
|---|---|
| <b>Spills/Leaks Handling</b> | The EPA Inspection team observed several locations throughout the Facility where used cooking oil had been spilled on the ground and staining was observed on the ground surface. Spill kits were not observed at the Facility (refer to <a href="#">Appendix B, Photographs 2, 4, 6, 7, and 8</a> ). |

- 1) The EPA Inspection Team observed several locations throughout the Facility where used cooking oil had been spilled and staining was observed on the ground surface (refer to Appendix B, Photographs 2, 4, 6, 7, and 8). Spill kits were not observed at the Facility.
- 2) The EPA Inspection Team observed one 35-gallon drum and four 5-gallon buckets containing used cooking oil stored outside without cover and exposed to stormwater (refer to Appendix B, Photograph 1).
- 3) The Facility stored used cooking oil in two (2) estimated 100-gallon metals tanks and 50-60 plastic tanks and grease traps of varying volumes (refer to Appendix B, Photograph 2, 3, 4, 6, and 7). These tanks and grease traps contained residual oils, were uncovered, and were exposed to stormwater.

**Photograph 2.** View, facing south, of used grease traps stored without cover or secondary containment. The containers contained residual amounts of used cooking oil and grease. Note the spilled oil on the ground surface.

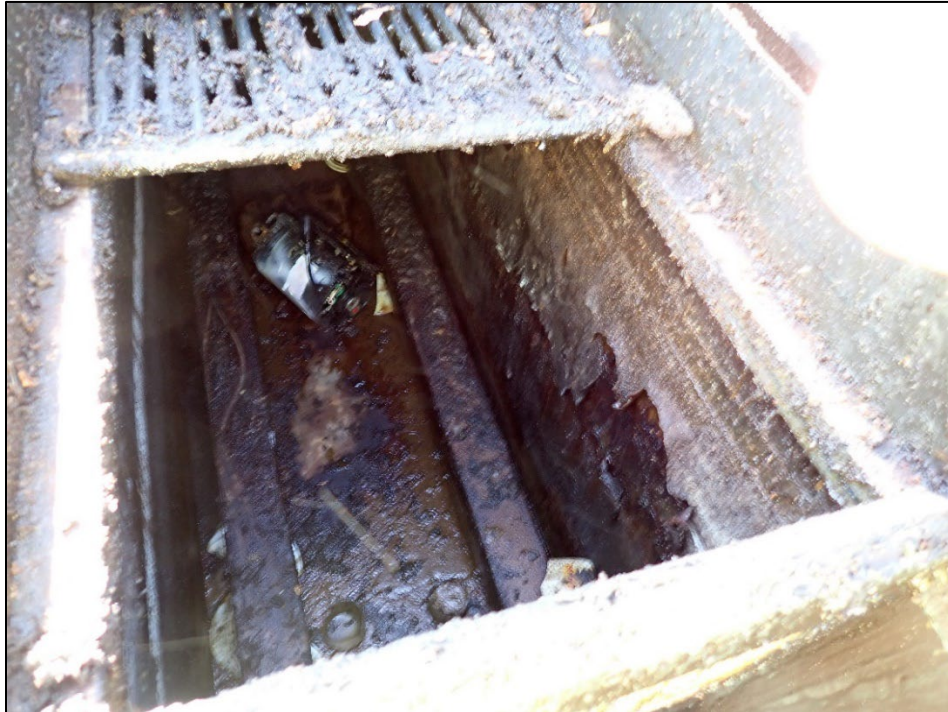
| Pollutant Sources | Note location, quantity/size, design issues, any O&M deficiencies (including the nature and extent), potential pollutants, and evidence of exposure to stormwater. Are BMPs in place to minimize or eliminate stormwater discharges from industrial activities? |
|---|---|
| Storage of Industrial Materials or Products | The Facility stores plastic and metal tanks containing used cooking oil. The EPA Inspection Team observed empty grease traps at the Facility (refer to <u>Appendix B, Photographs 2 and 3</u> ). See the Section titled, "Liquid Storage (e.g., Tanks, Liquid Storage Drums)" for additional information. |

**Photograph 3.** View of used cooking oil and grease inside one of the containers shown in Photograph 2.

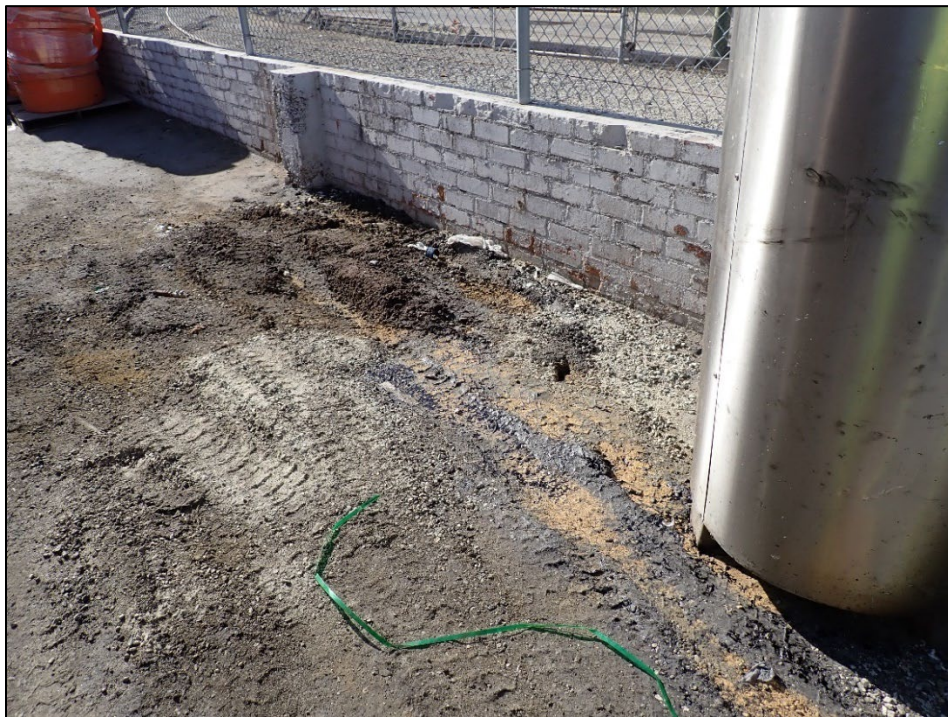
**Photograph 4.** View of spilled used cooking oil on the ground adjacent to a 100-gallon used cooking oil tank by the Facility's western boundary.

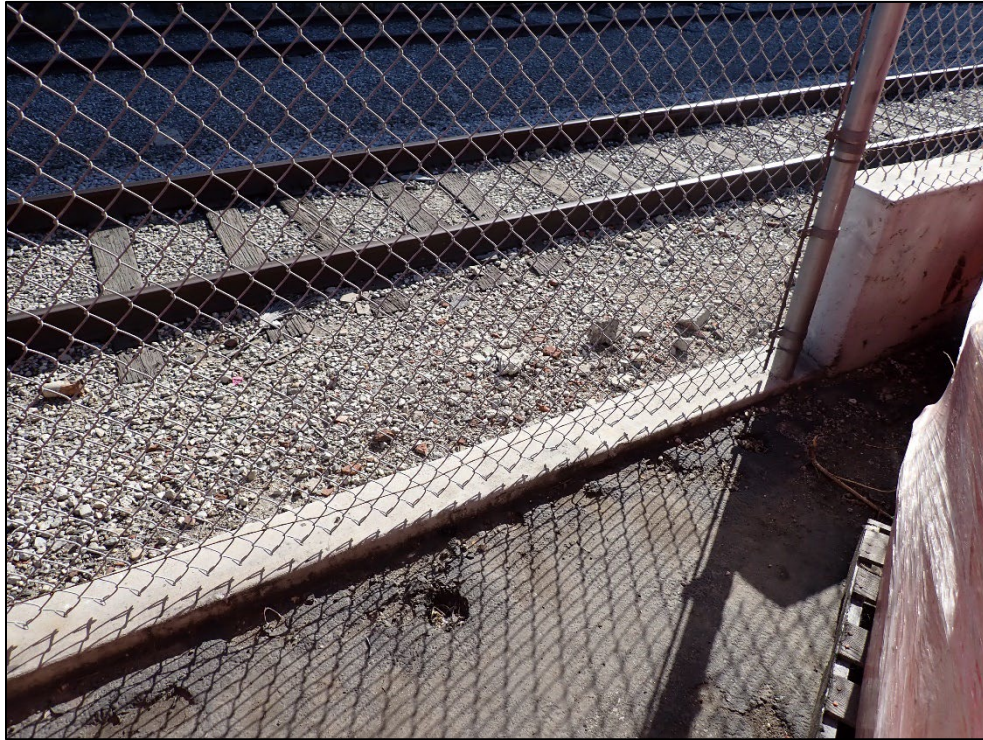
**Photograph 5.** View, facing south, of the Facility's southern boundary. The perimeter of the Facility, aside from the entrance/exit, was enclosed by a concrete wall or concrete berm.

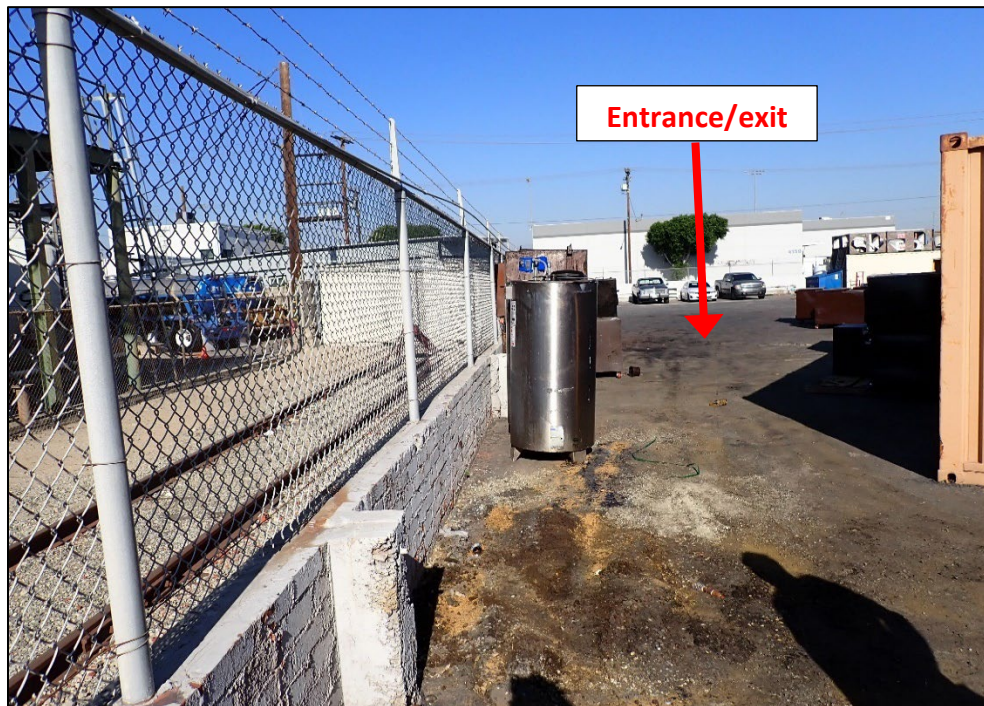
**Photograph 6.** View, facing north, of the Facility's western boundary. Note the spilled used cooking oil on the ground surface adjacent to the 100-gallon used oil tank.

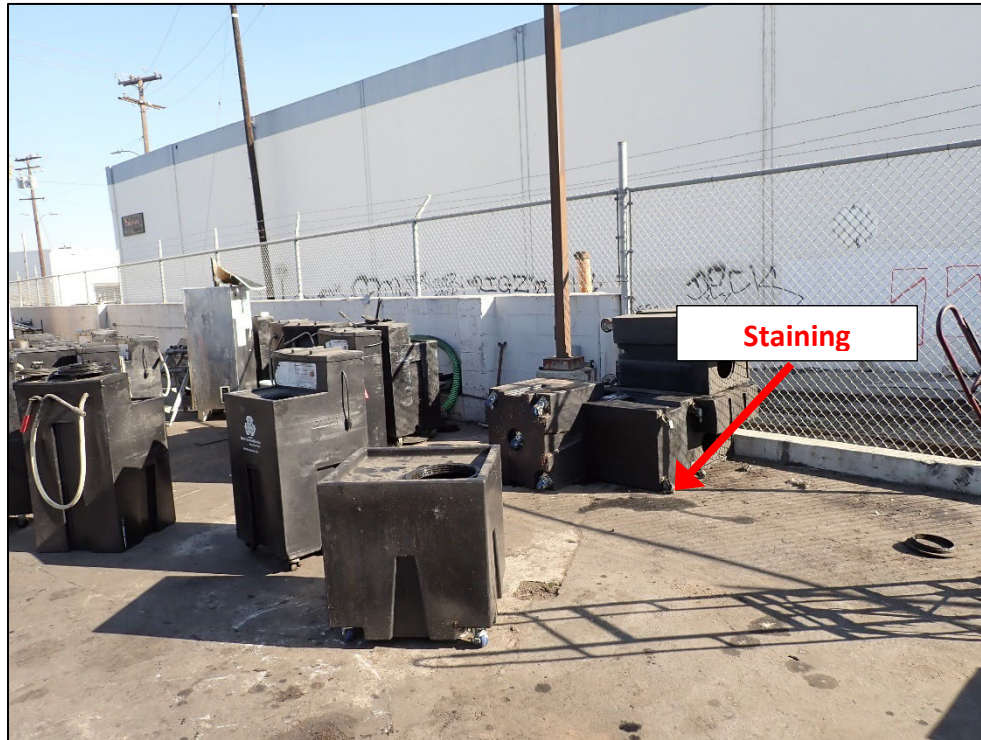
**Photograph 7.** View, facing east, of open used cooking oil containers stored in the eastern portion of the Facility. The containers held residual amounts of used cooking oil. Note the cooking oil stains on the ground surface.

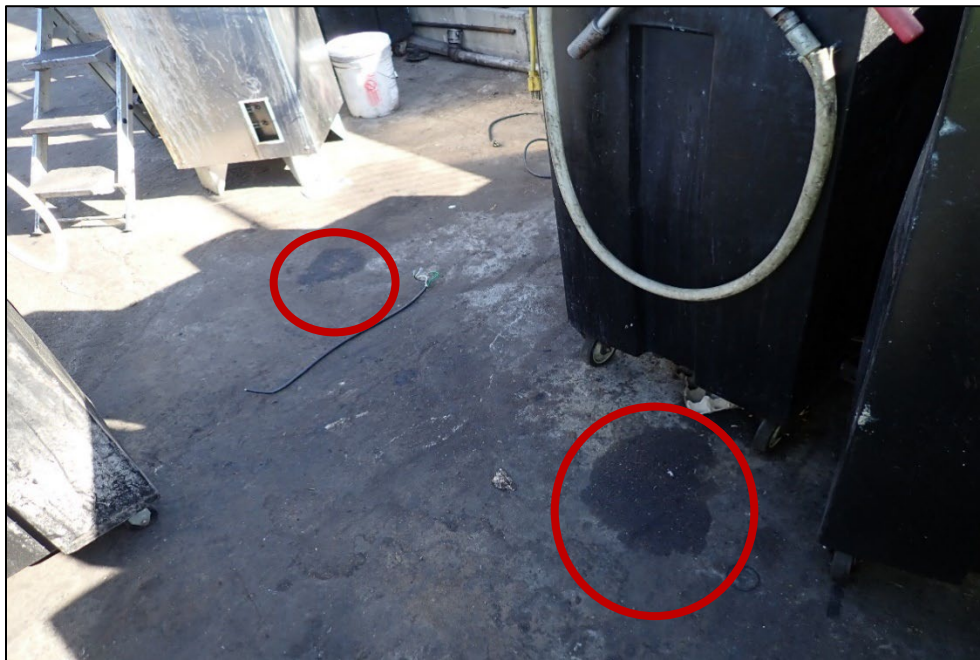
| <b>Evidence of pollutants migrating offsite (stains, deposits, ponding) at discharge points, into Receiving Waters or in MS4</b> | Staining and spilled used cooking oil was observed on the ground surface throughout the Facility (refer to <u>Appendix B, Photographs 2, 4, 6, 7, and 8</u> ). |

**Photograph 8.** View of used cooking oil stains on the ground surface in front of an empty used cooking oil container in the eastern portion of the Facility.

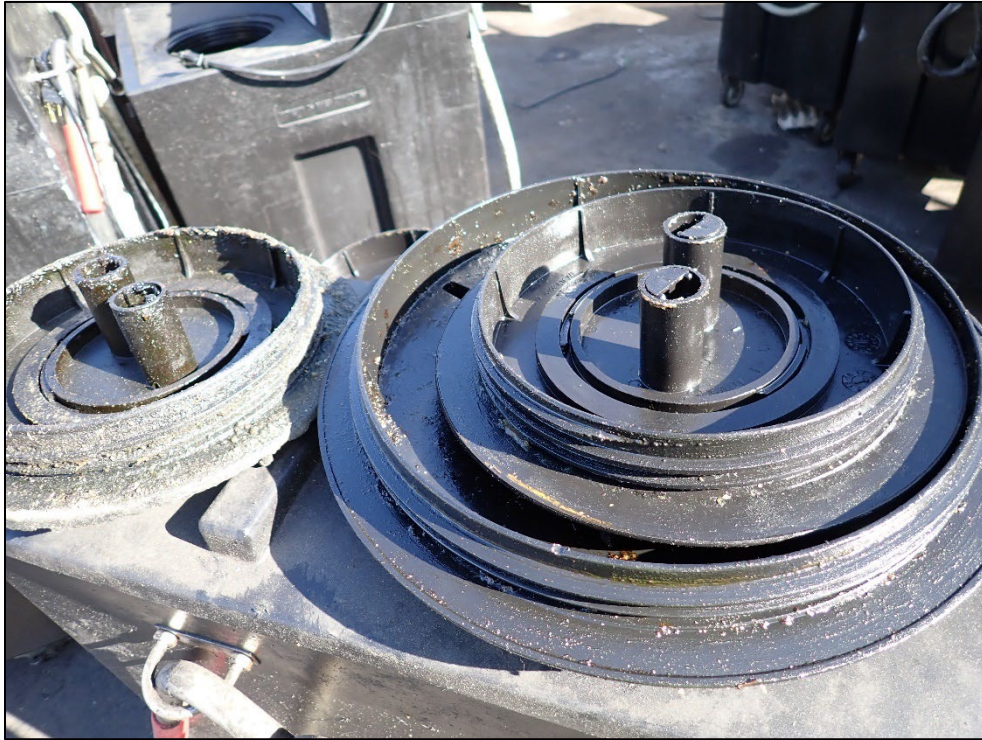
**Photograph 9.** View of used cooking oil container lids stored outside without cover and exposed to stormwater.

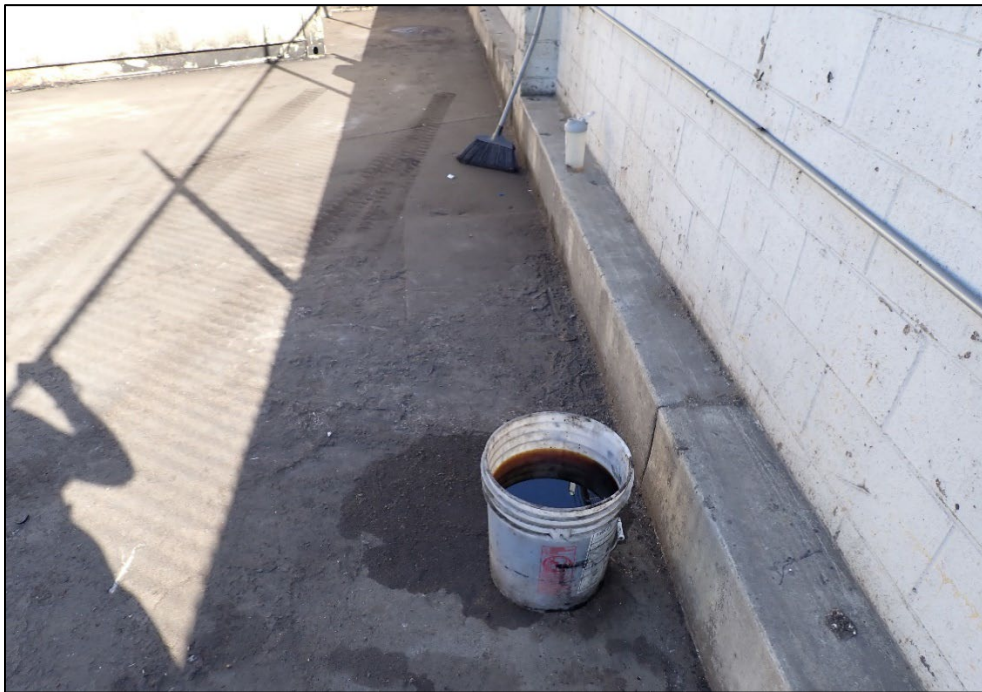
**Photograph 10.** View, facing north, of a 5-gallon bucket containing used cooking oil stored without cover and exposed to stormwater. Note the staining on the ground around the bucket.

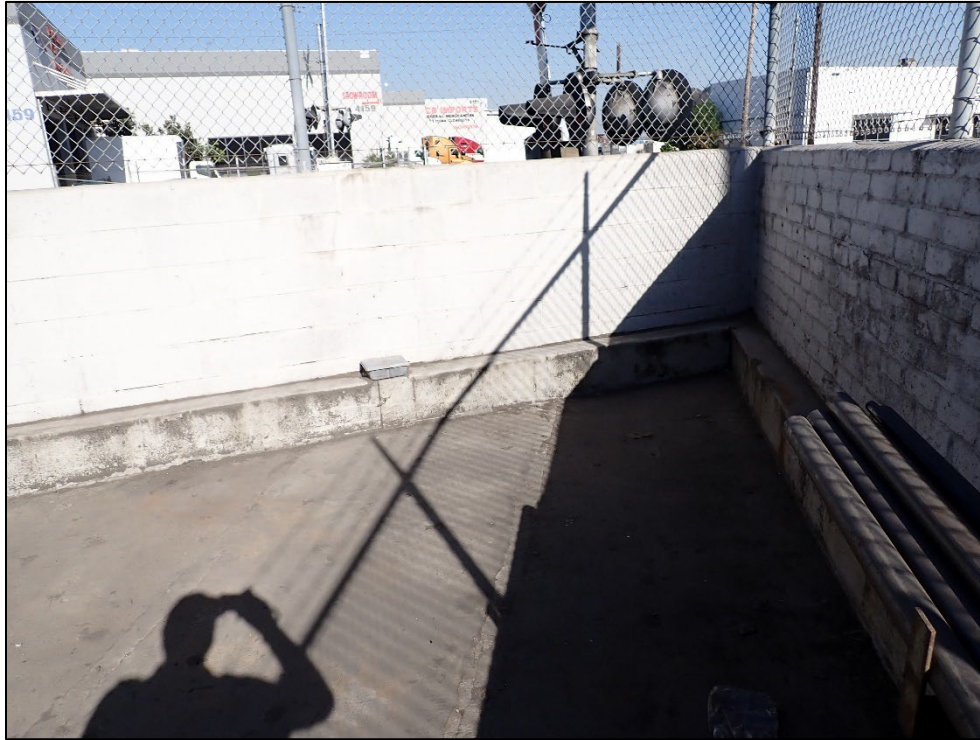
**Photograph 11.** View, facing north, of the Facility's northeastern boundary.

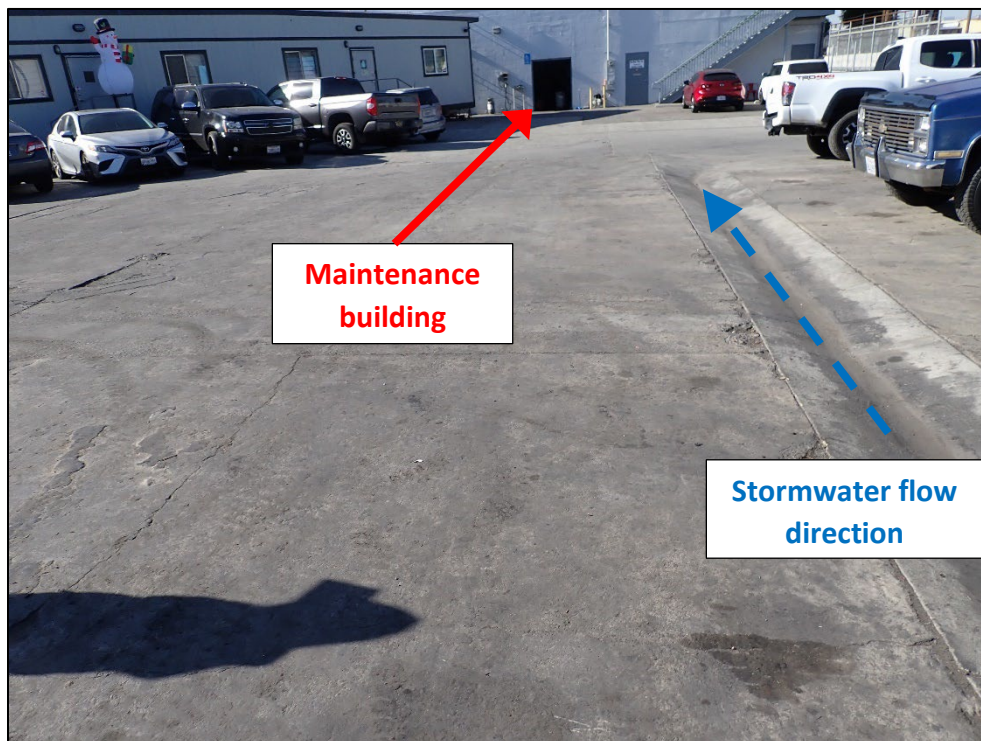
| Pollutant Sources | <b>Note location, quantity/size, design issues, any O&amp;M deficiencies (including the nature and extent), potential pollutants, and evidence of exposure to stormwater. Are BMPs in place to minimize or eliminate stormwater discharges from industrial activities?</b> |
|---|---|
| <b>Fueling Stations/Equipment Maintenance Areas &amp; Cleaning Areas</b> | The Facility representative stated there is no vehicle or equipment fueling onsite nor does the Facility clean the grease traps. The Facility conducts minor machinery maintenance inside a building onsite (refer to <a href="#">Appendix B, Photograph 12</a> ). The Facility representative stated there are no floor drains in the building. |
| <b>Number and description of each potential Stormwater Discharge Point from the Facility</b> | The EPA Inspection Team observed one potential stormwater discharge point at the entrance/exit onto Bandini Boulevard (refer to <a href="#">Appendix B, Photographs 12 and 13</a> ). |

**Photograph 12.** View, facing west, of the center of the Facility. This area had a shallow trench that conveyed stormwater towards the entrance/exit of the Facility.

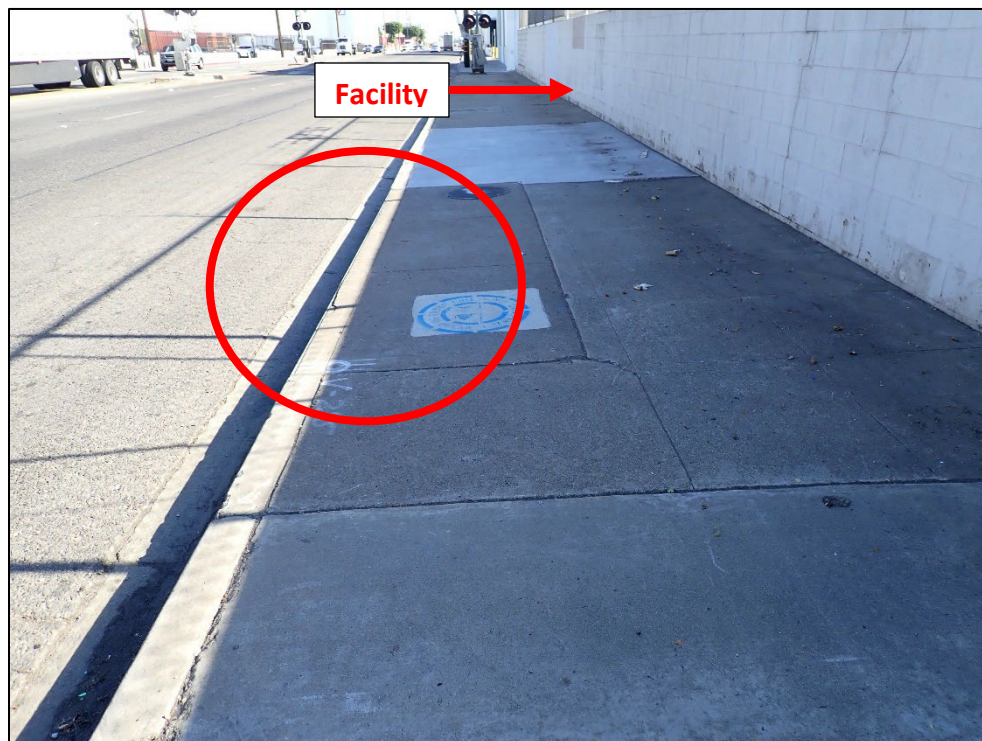
**Photograph 14.** View, facing east, of a curb inlet located directly to the east of the Facility's entrance/exit. The curb inlet connects to the Los Angeles County MS4.
