**UNITED STATES ENVIRONMENTAL PROTECTION AGENCY  
REGION 3  
Four Penn Center  
1600 JFK Blvd.  
Philadelphia, Pennsylvania 19103-2029**

**Report Title:** Clean Water Act Compliance Inspection Report  
**Inspection Date(s):** 09/22/2023  
**Regulatory Program(s):** National Pollutant Discharge Elimination System (NPDES)  
**Type of Activity:** Industrial Wastewater and Industrial Stormwater  
**Site/Facility Name:** SPI Pharma, Inc.  
**Permittee(s):** SPI Pharma, Inc.  
**Site/Facility Operator:** SPI Pharma, Inc.  
**Site/Facility Address:** 40 Cape Henlopen Drive  
Lewes, DE 19958  
**Latitude:** 38.790952 **Longitude:** -75.103954  
**County:** Sussex County  
**Permit Number:** DE0000060  
**NAICS Code:** 325412 **SIC:** 2834  
**Unique Project #:** 3E23WN126A

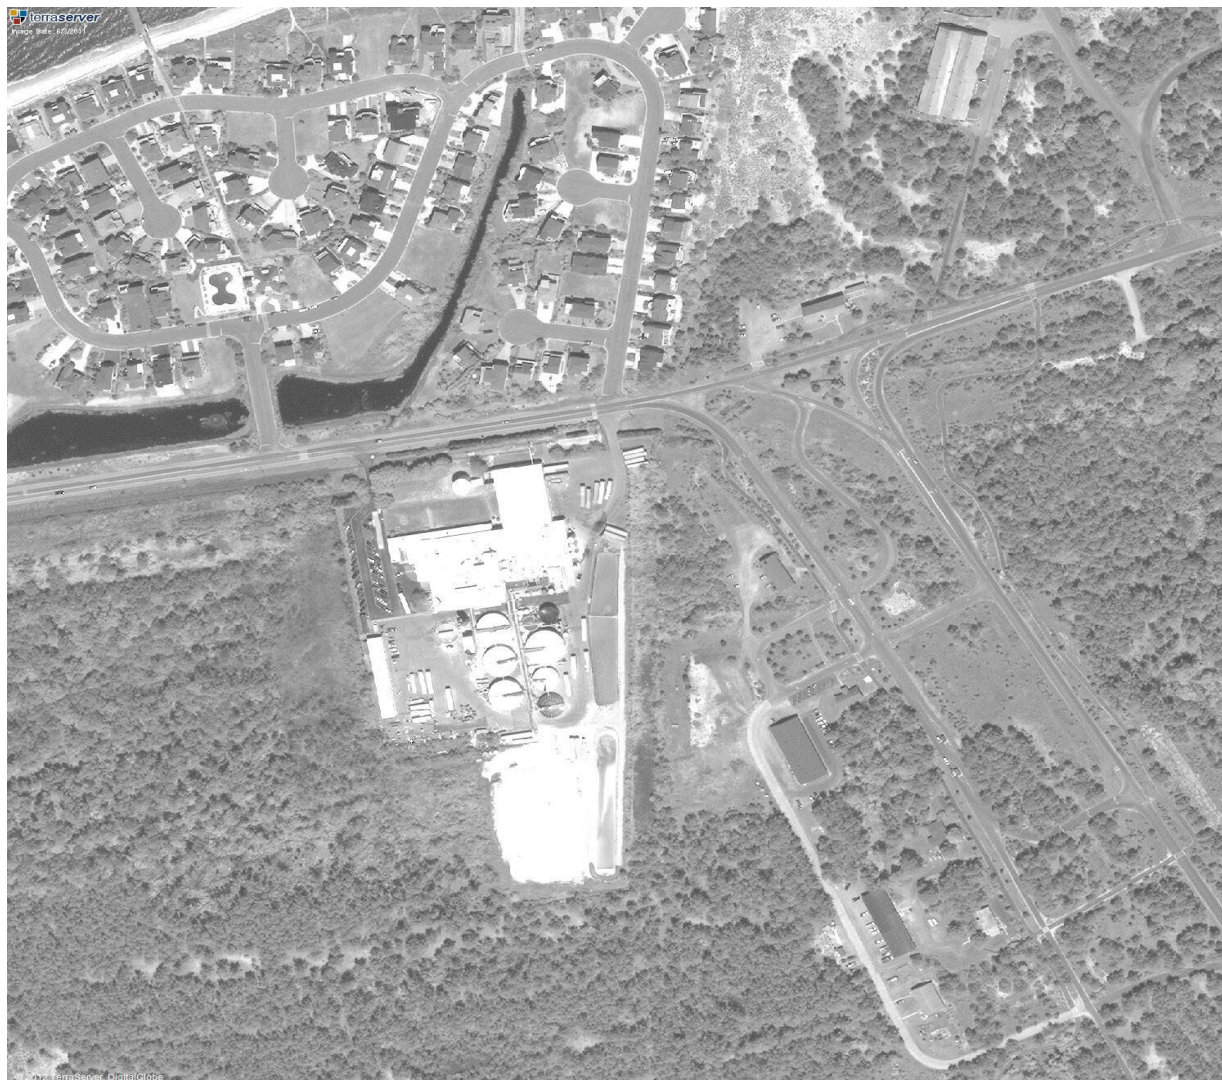
**Figure 1- Facility Map**

The Facility (Figure 1) encompasses about 13 acres of industrial activity exposed to storm water. The site is divided into 4 storm water drainage areas, each with its own outfall. Outfall 001 is a combined process and storm water discharge, and handles the majority of the site's storm water discharge. Outfall 002 handles storm water runoff from the front of the facility's lawn and roof drainage from the 14,000-sq. ft. warehouse and 3,450-sq. ft. of office. Outfall 003 receives runoff from the front third of the employee parking lot – about 2,000-sq. ft. of paved area. Outfall 004 drains a maintenance and material storage area of 85,000-sq. ft., which is also paved. See Attachment D - Storm Water Plan, for additional detail on the four outfalls.
