INSPECTION REPORT

| Type of Inspection | Focused Compliance Inspection (FCI) | | | |
| Facility or Site Name | South Texas Cement LLC | | | |
| Type of Operation | South Texas Cement LLC (STC) receives Portland cement and then stores it onsite before loading out on to trucks and railcars. | | | |

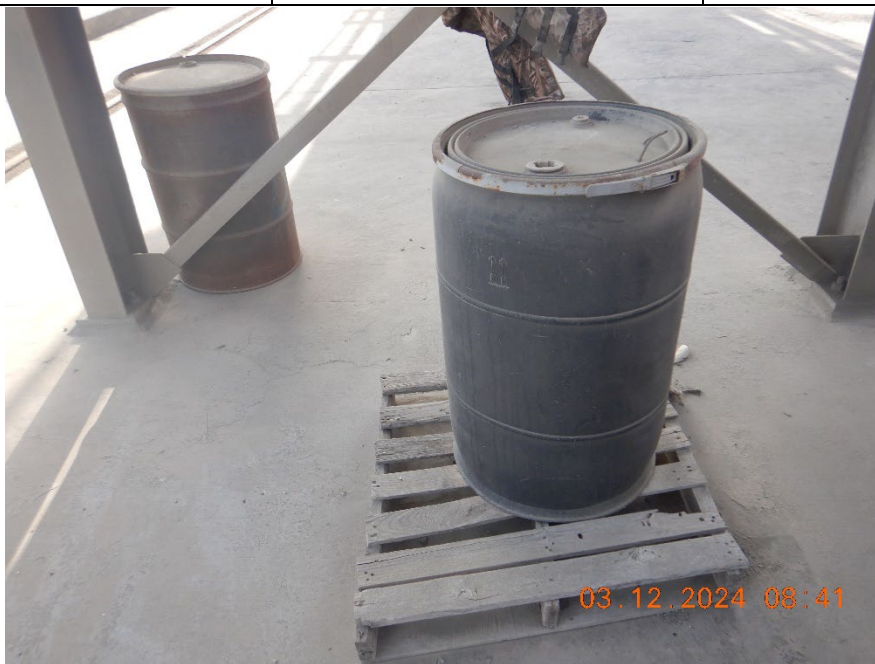
**Photo No. 1**

Description: View of two unlabeled, unknown 55-gallon waste drums found on the dock space that were left by a ship.

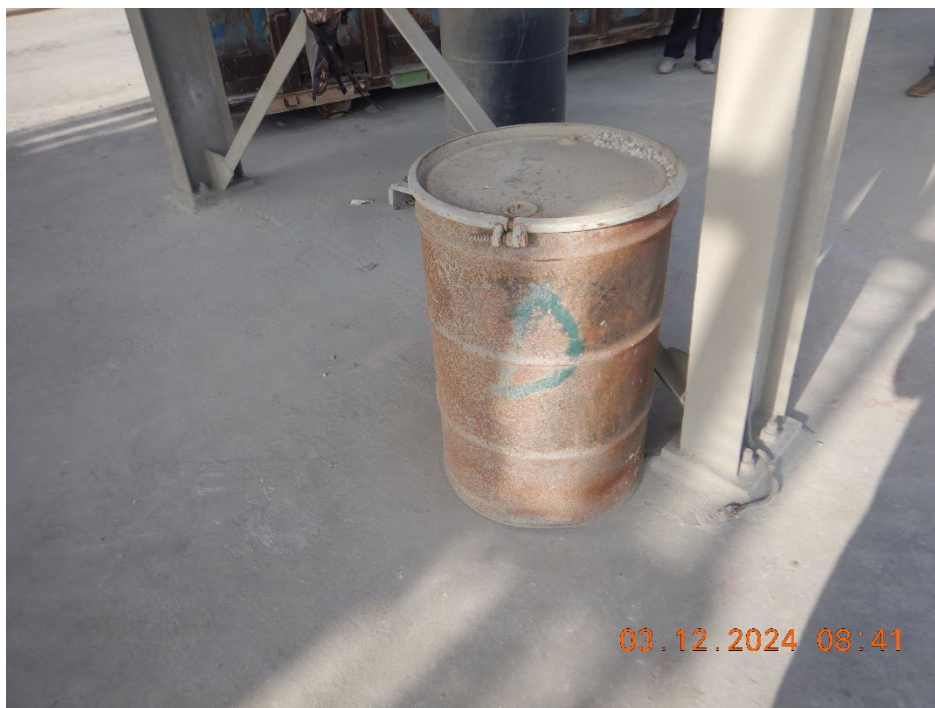
Photo No. 2

Description: View of two unlabeled, unknown 55-gallon waste drums found on the dock space that were left by a ship.

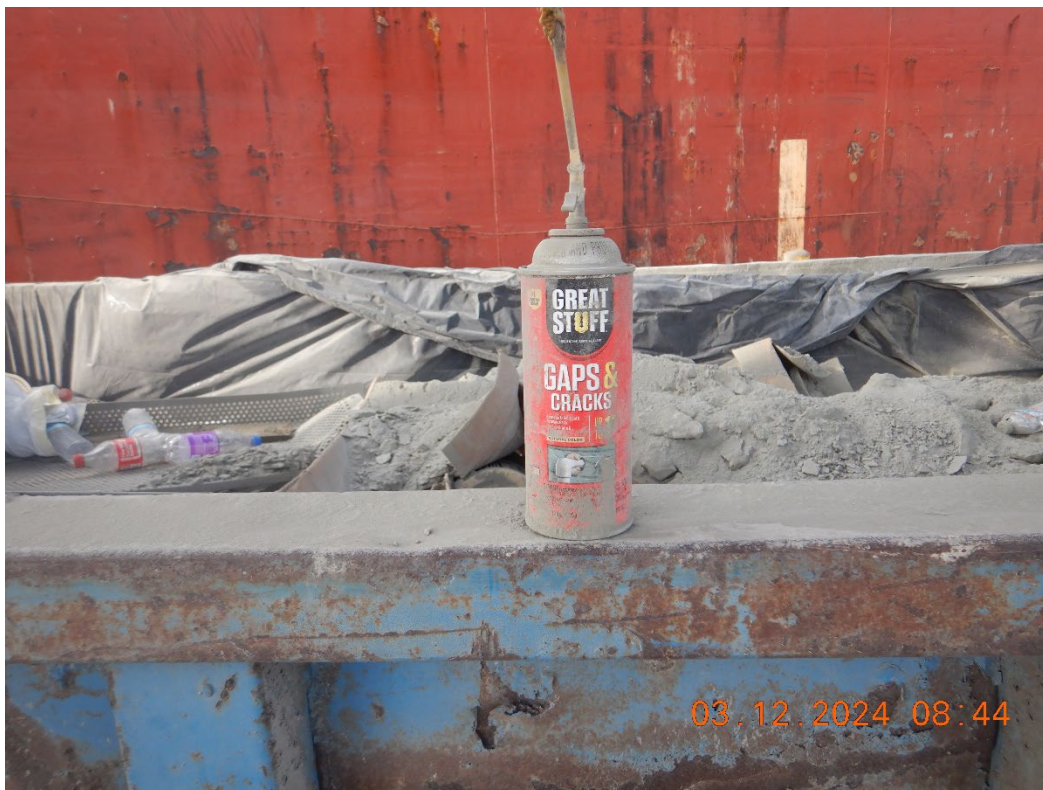
Photo No. 3

Description: Discarded foam sealant canister found in a roll-off dumpster on the dock. No apparent AOCs noted.

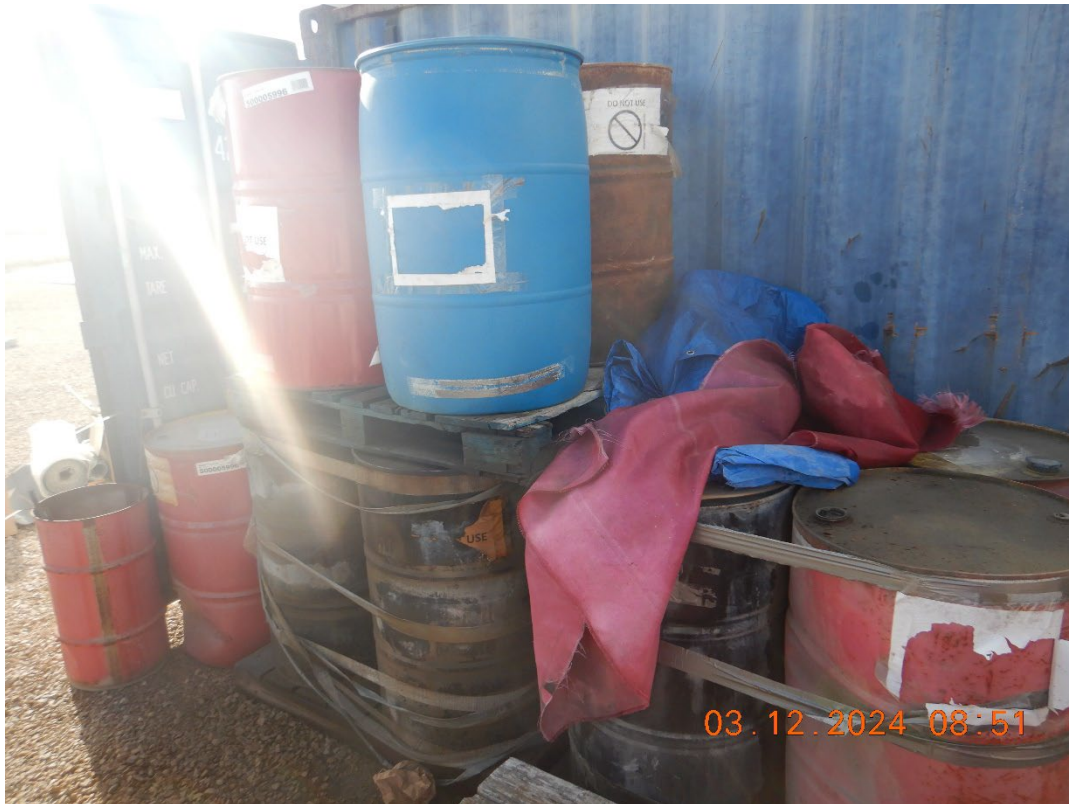
Photo No. 4

| <b>Tenant:</b> South Texas Cement LLC | | |
|---|---|---|
| <b>AOC #2</b> – STC did not clearly label containers used to store used oil with the words “Used Oil”. | <b>Citation:</b> 40 CFR 279.22(c)(1) | Section: 2.1 |

Description: Overview of several unlabeled used oil drums found in the Conex Area.

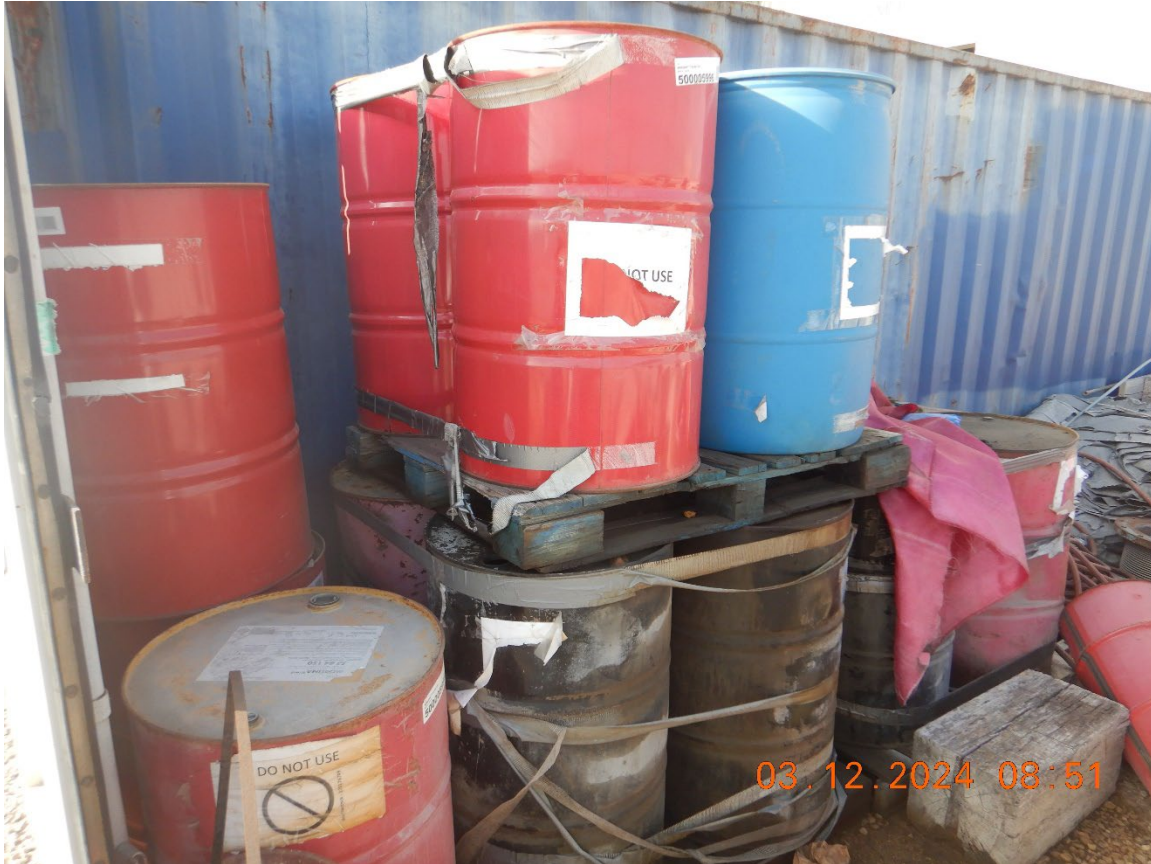
Photo No. 5

Description: Another view of several unlabeled used oil drums found in the Conex Area.

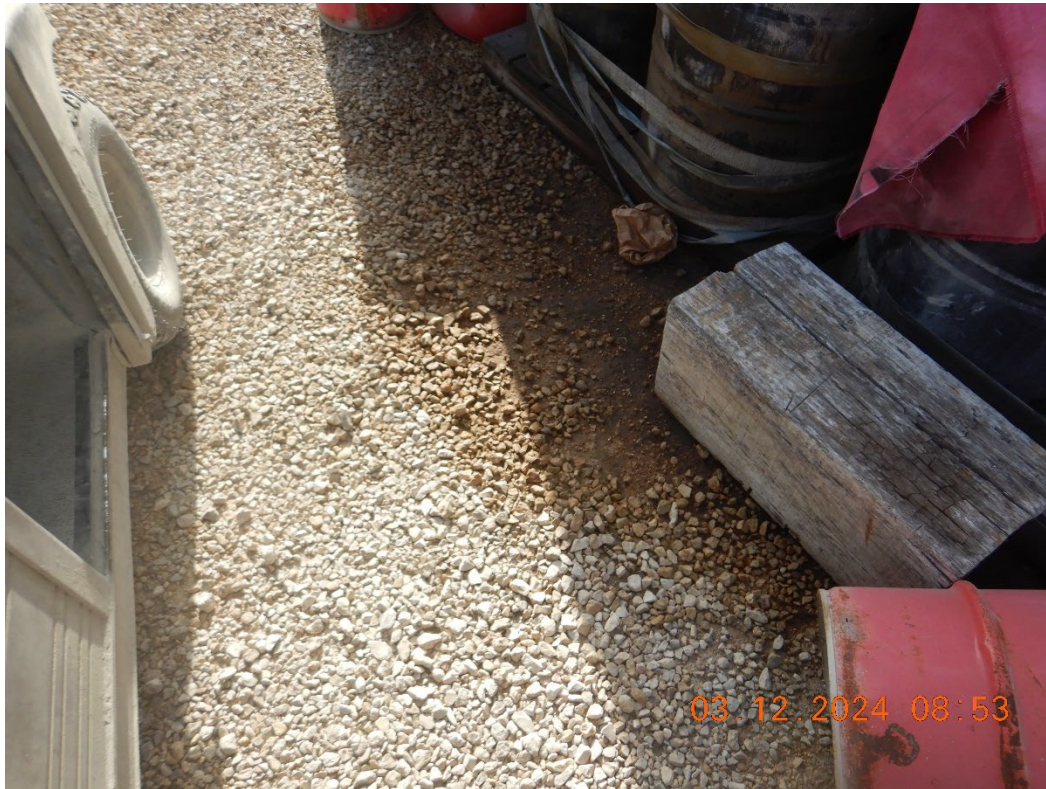
Photo No. 6

| <b>Tenant:</b> South Texas Cement LLC | | |
|---|---|---|
| <b>AOC #3</b> – STC did not adequately respond to a release of used oil. | <b>Citation:</b> 40 CFR 279.22(d) | Section: 2.1 |

Description: View of oil found on the ground below used oil drums in the Conex Area.

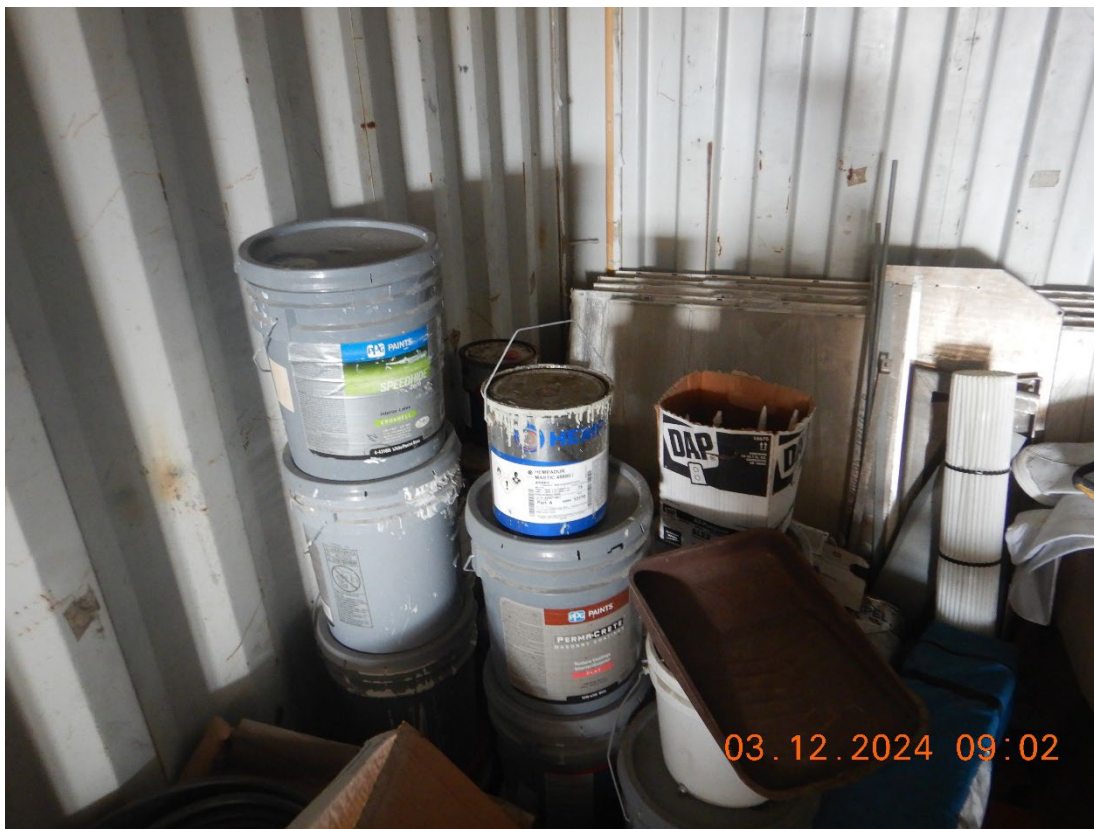
Photo No. 7

Description: View of paint being stored in the back of the gray Conex box at the Conex Area.

The paint went to the local landfill and we are awaiting documentation from them of the proper disposal. This is how we will handle any future paint disposals.

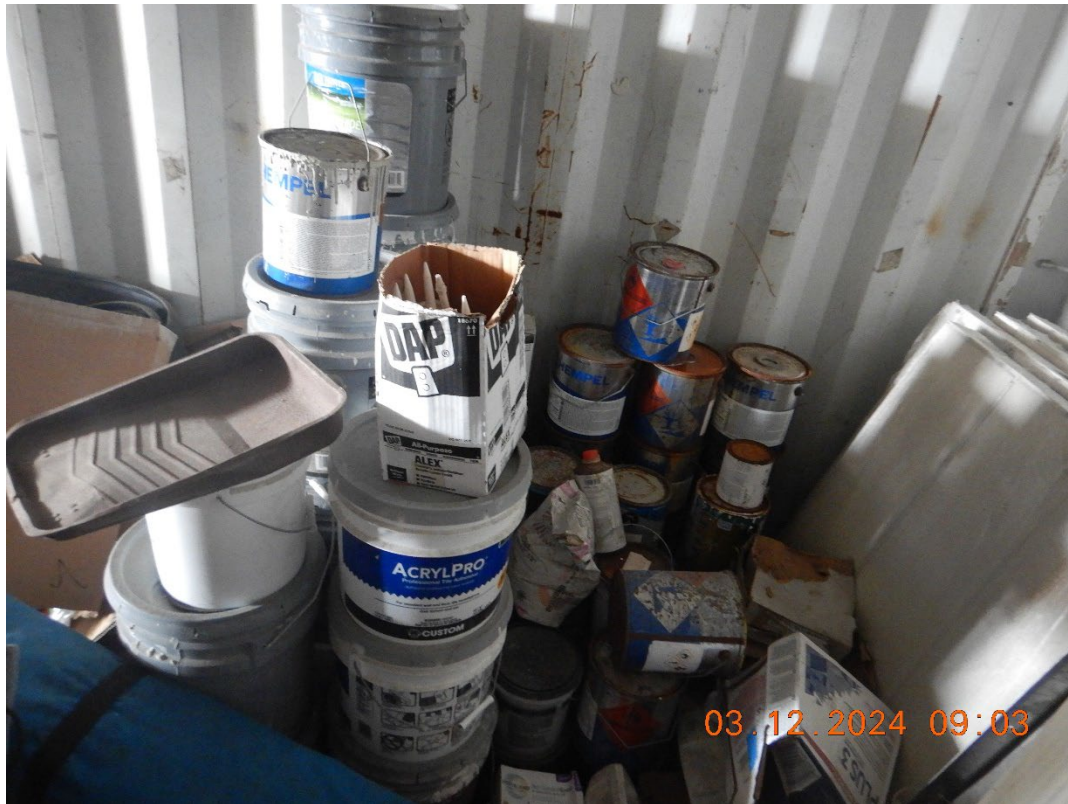
Photo No. 8

Description: Another view of paint being stored in the back of the gray Conex box at the Conex Area.

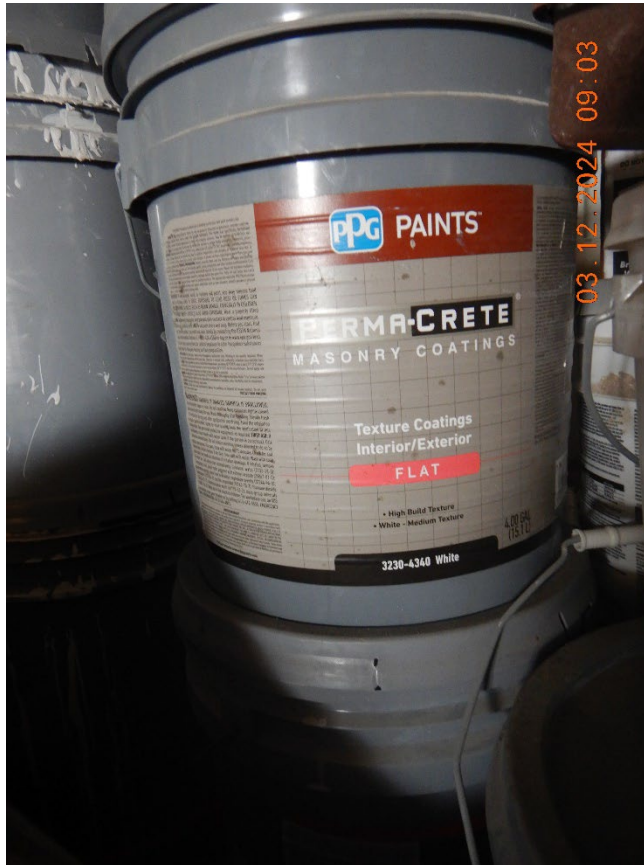
Photo No. 10

Description: Closeup view of paint being stored in the back of the gray Conex box at the Conex Area.

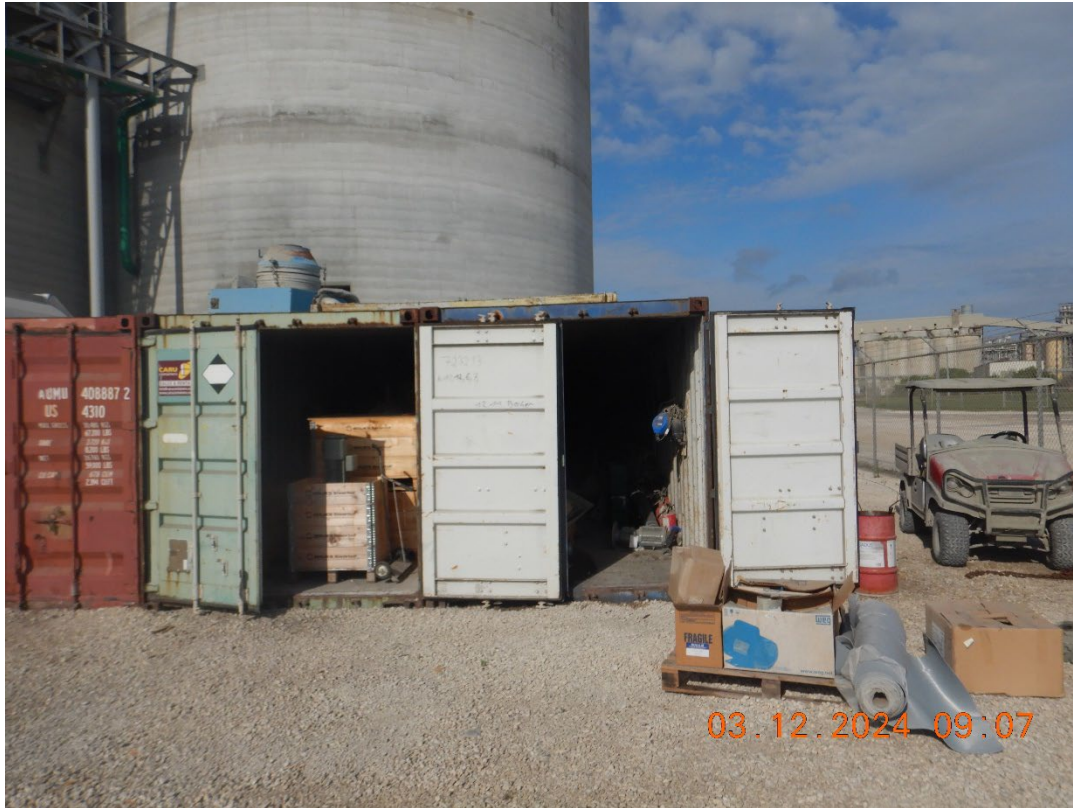
Photo No. 11

Description: Overview of the Conex Area.

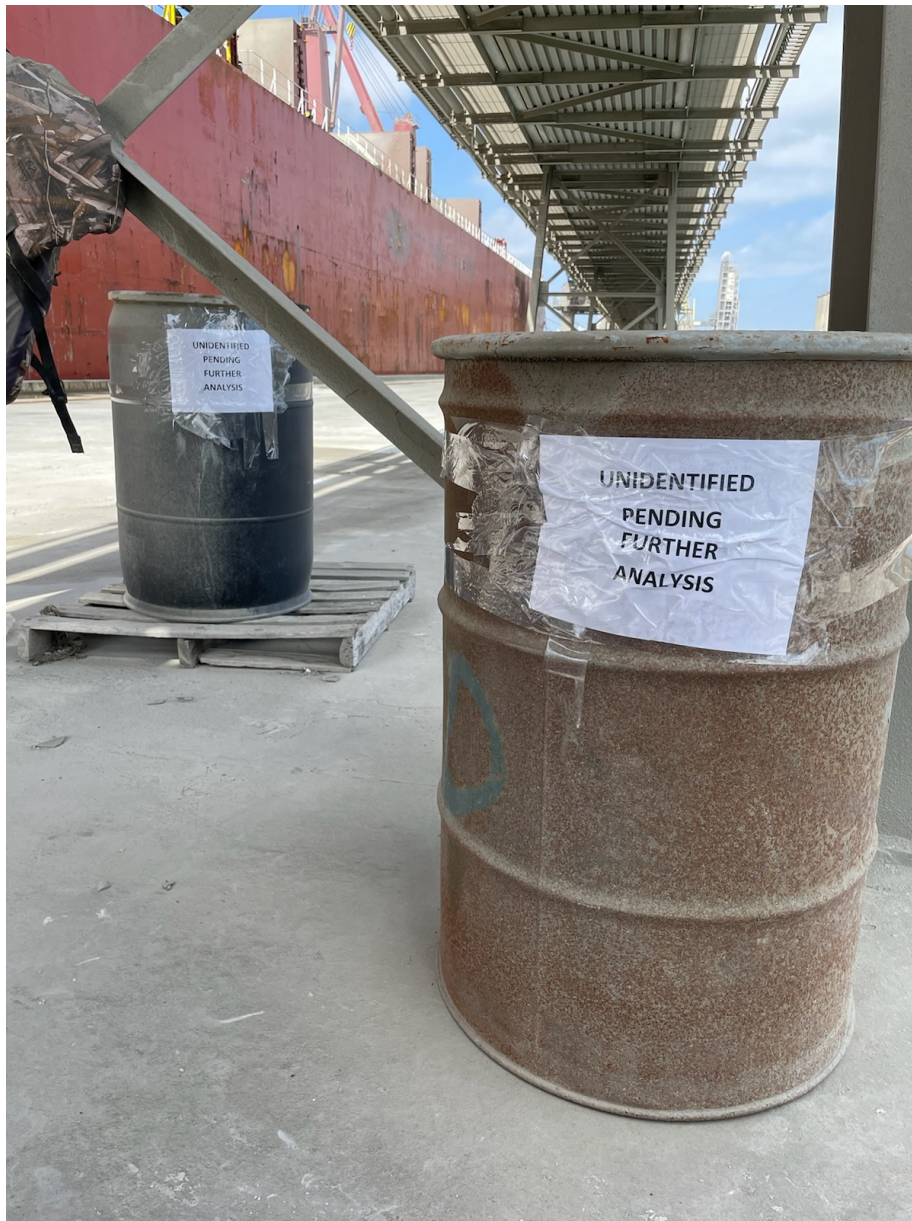
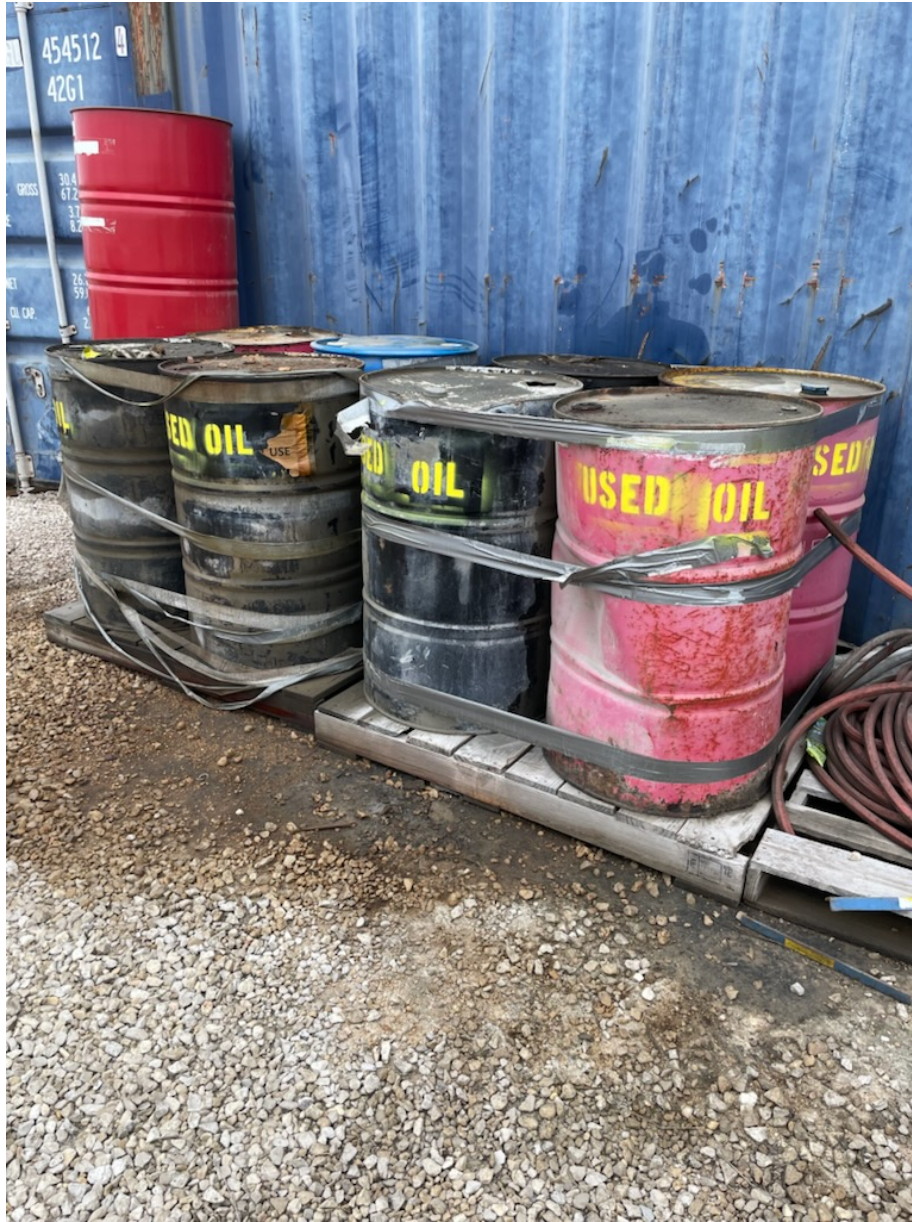
We have addressed the issues below per recommendations. I have included pictures for consideration. We had a total of 11 barrels of the used oil.

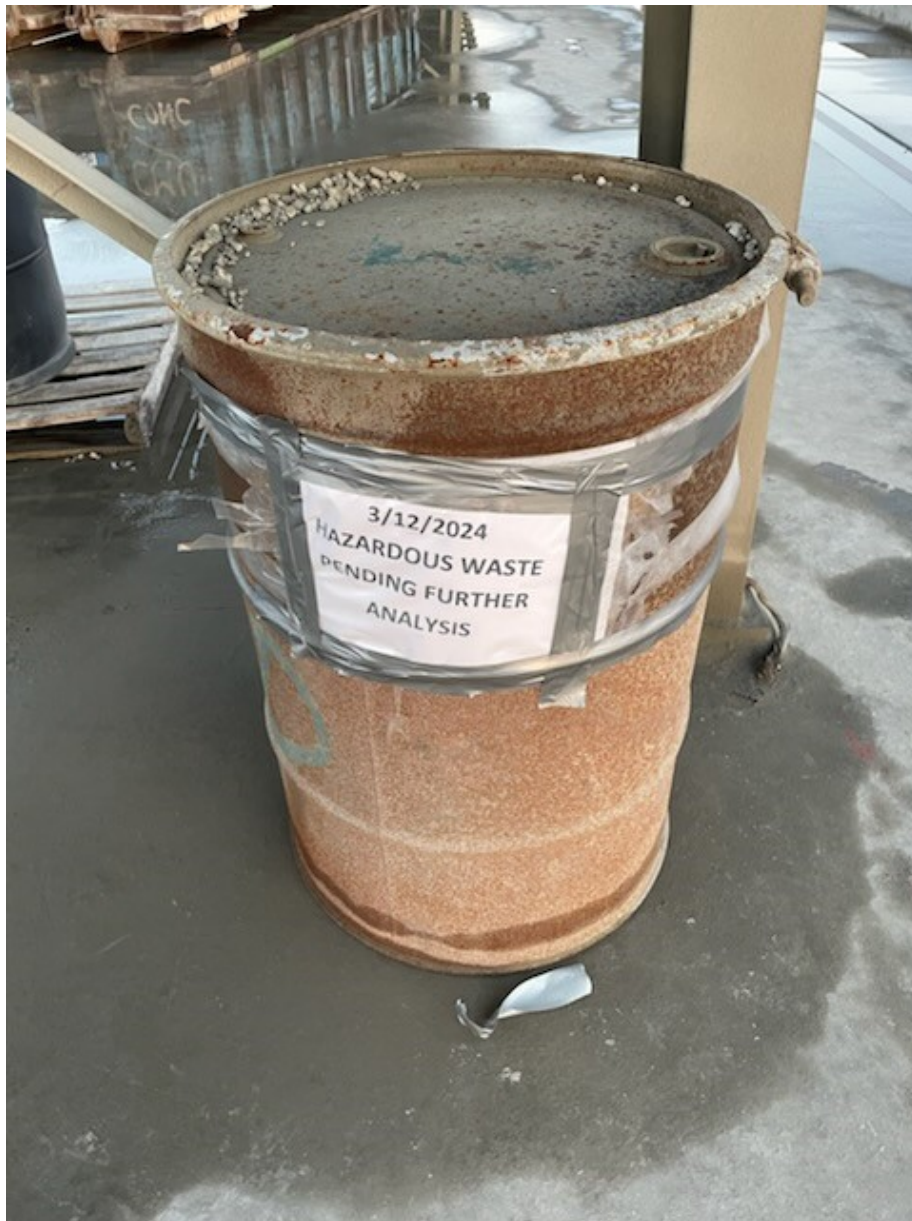
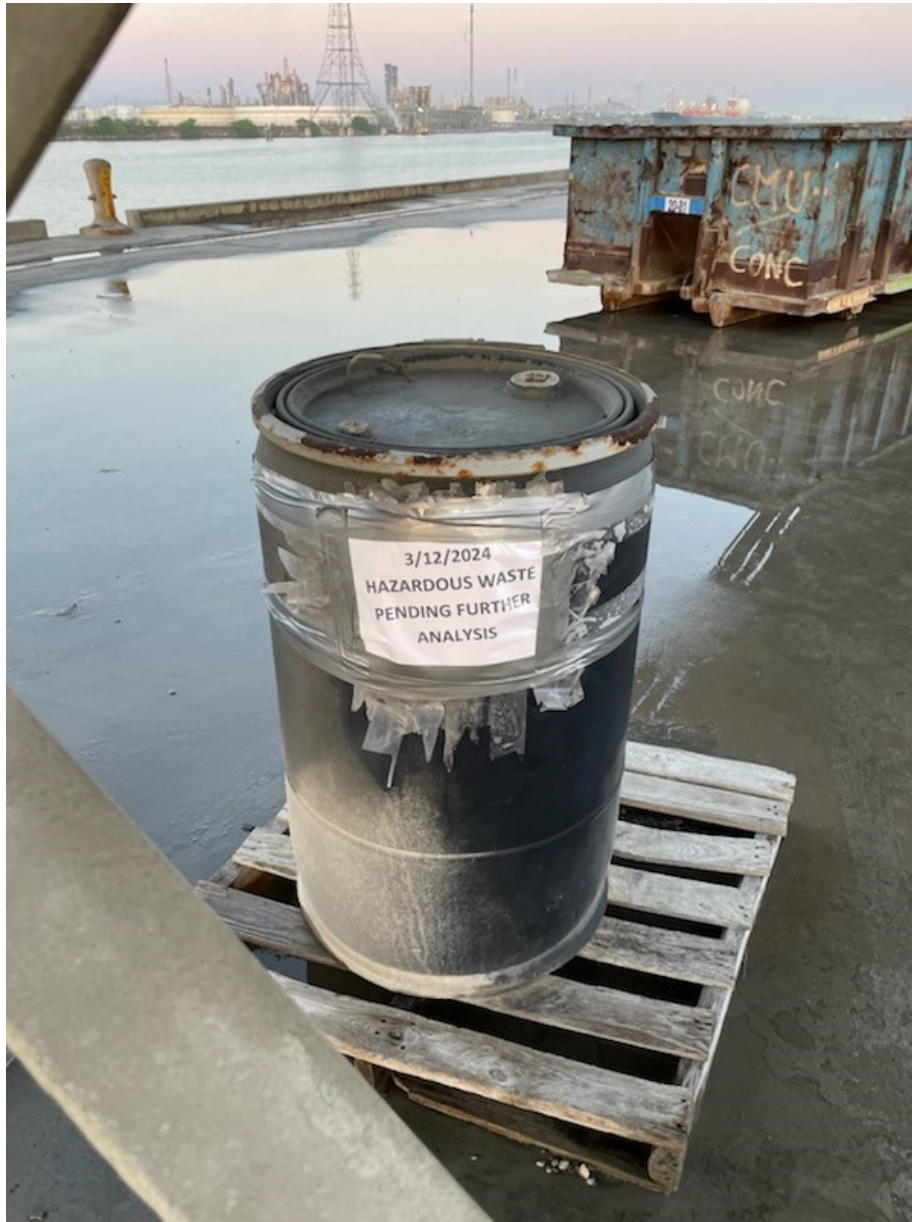
New Barrel pictures with updated labels.

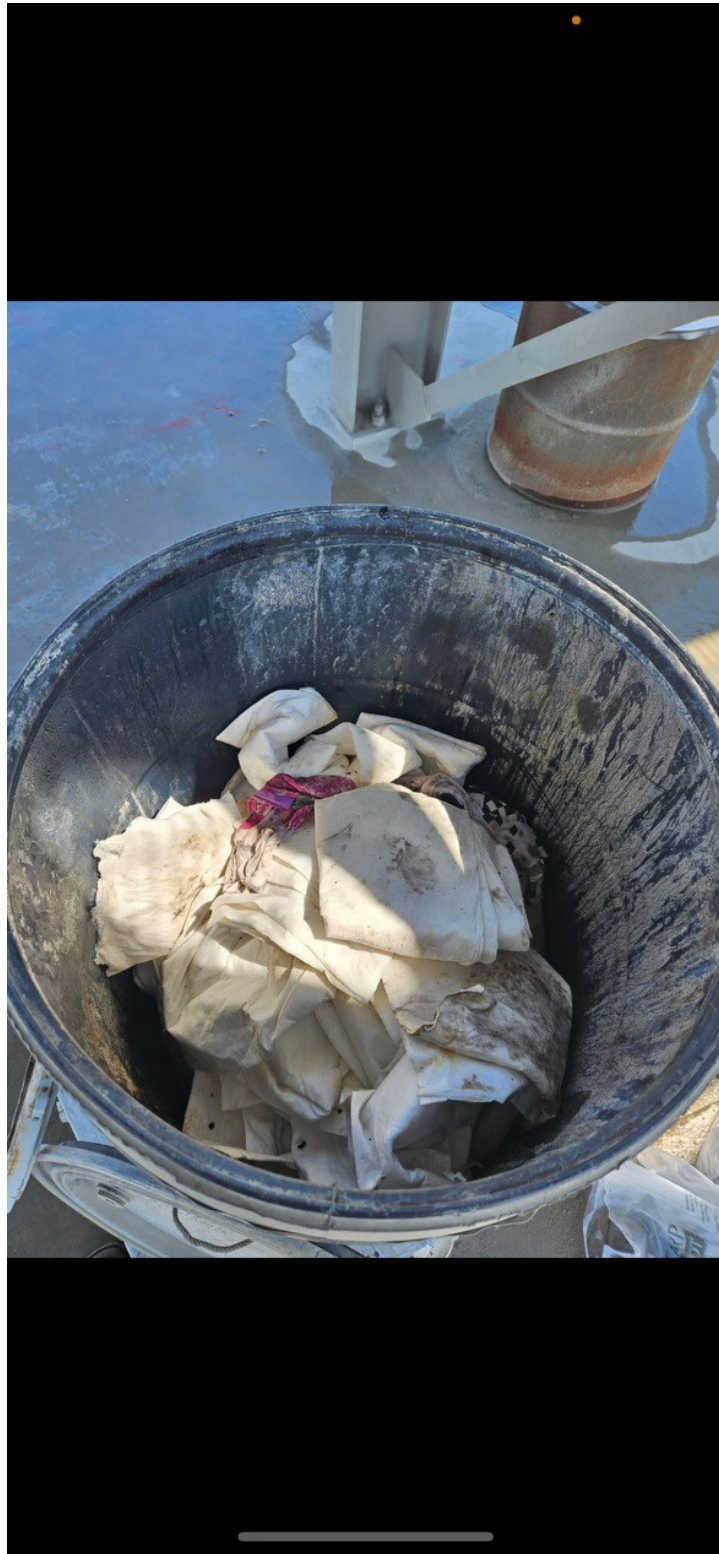
We discovered on Friday that the metal barrel on the dock did in fact belong to the cleaning crew (BIS), it was a drum of diesel for their machines. The black plastic barrel contained used cloth and absorbent cleaning pads. The cleaning company indicated to me they would come and label the drum as diesel and remove from the dock as need be, or leave it for cleaning the next vessel on 4/3/24, then remove it. Our intention on the black barrel was to dispose of it, but wanted to check in with you for proper guidance. I have attached a picture of the black barrel refuse.
