## U.S. Environmental Protection Agency Region 5

**Purpose:** Industrial User Pretreatment Compliance Inspection

**Facility:** Green Plains Mount Vernon LLC  
8999 W Franklin Road  
Mount Vernon, IN 47620

**Inspection Date:** February 23-24, 2021

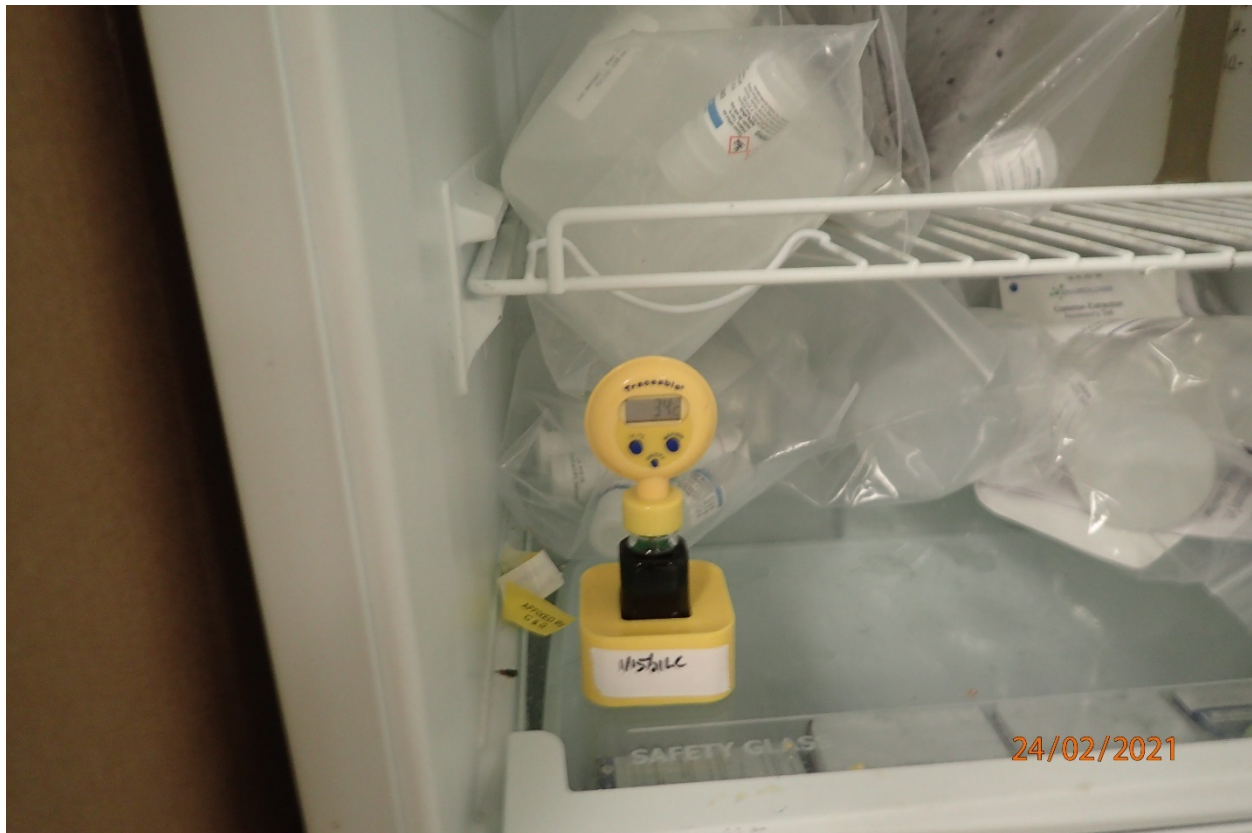
Photo Number: P2240004

Description: Thermometer inside the refrigerator in the laboratory

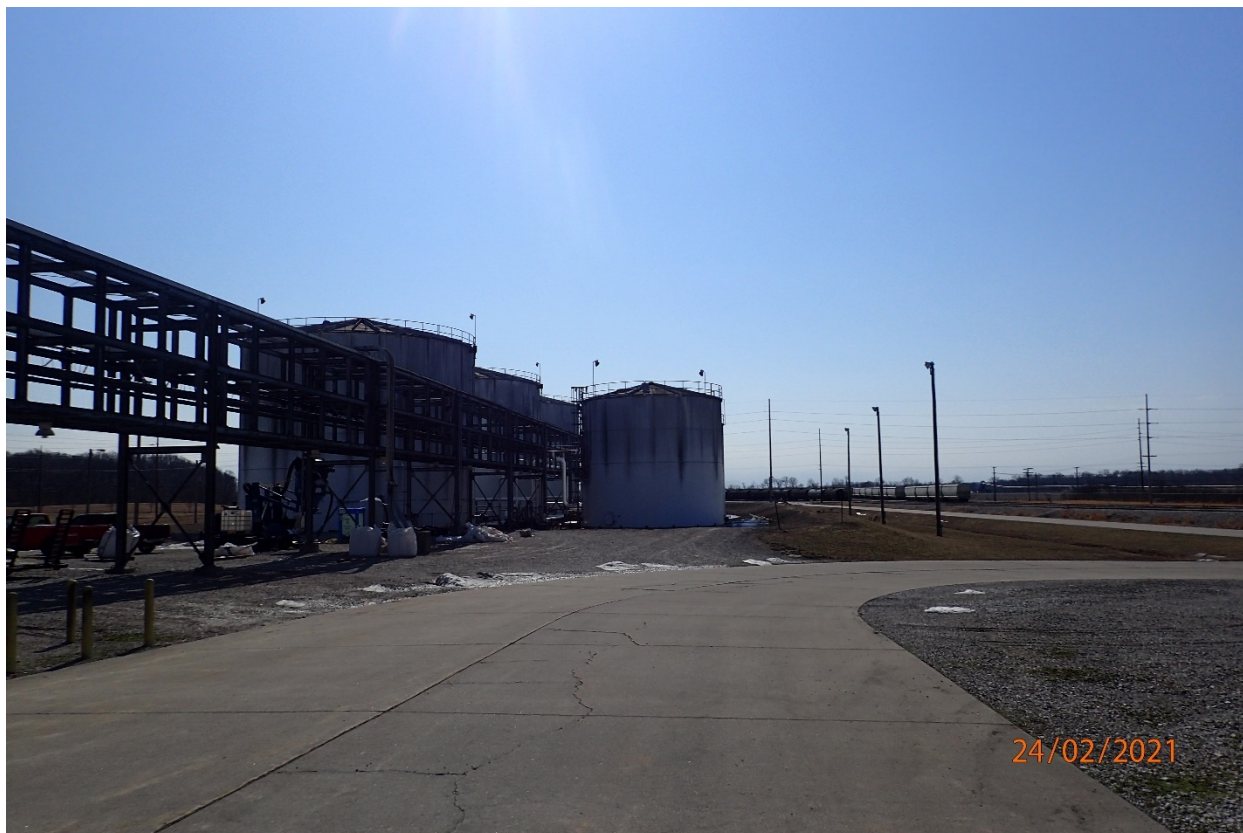
Photo Number: P2240009

Mr. Labhart escorted us to Ethanol Storage, Denaturing Tank, and Shifter Tank area located south of the truck loading area on the southwest side of the facility (photo 9). These 7 tanks are housed in a large rectangular diked area to contain any spill. I asked Mr. Labhart if the facility has had any such product spillage in this diked area since its 2016 acquisition and he confirmed that the facility has not had any spill in the diked area. While at this location, we inspected the Ethanol and Corn Oil Truck Loading Area (photo 10). Mr. Labhart stated that the spill during loading of the ethanol or corn oil would flow to the drain at the Truck Loading Area (photo 12) and flow through underground piping to the Spill Containment Area (photo 11).

Description: Ethanol Storage, Denaturing Tank, and Shifter Tank

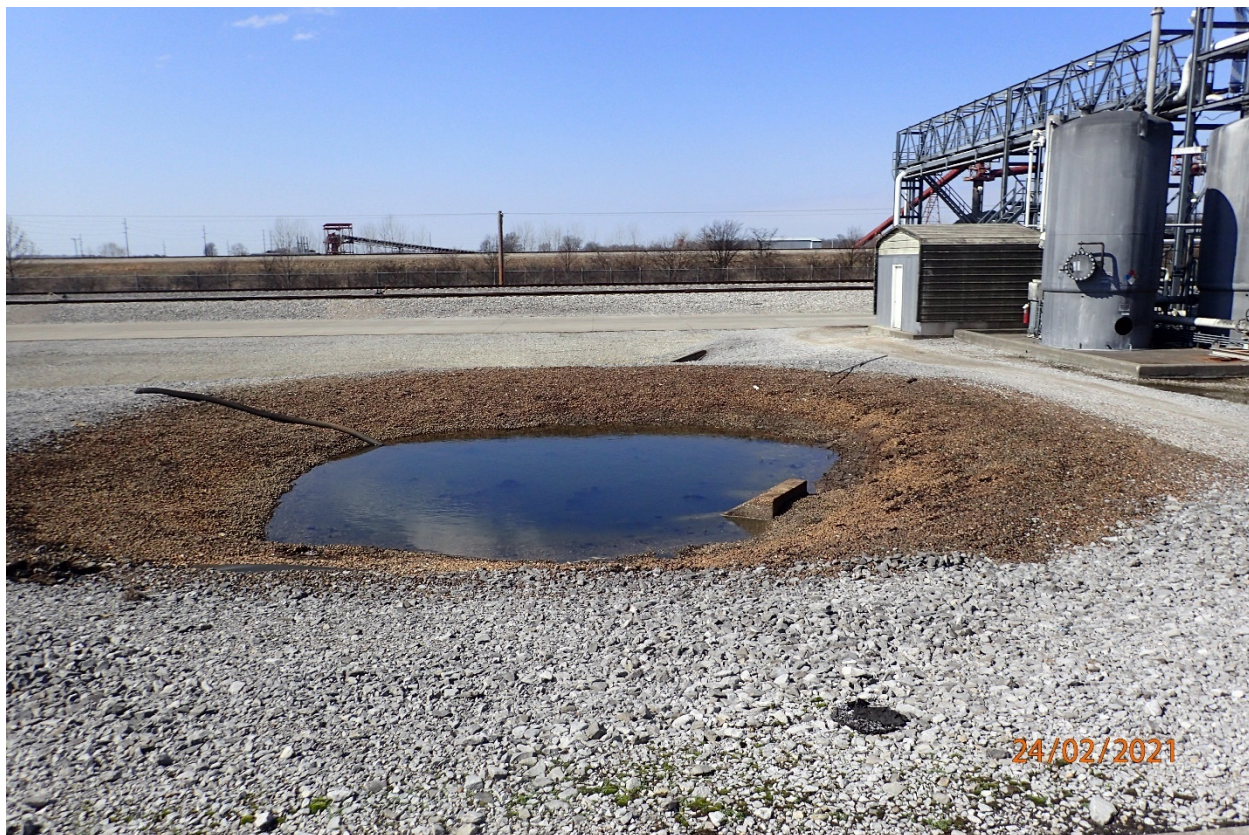
Photo Number: P2240011

Description: Spill Containment for the Truck Loading Area for the Corn Oil and Ethanol

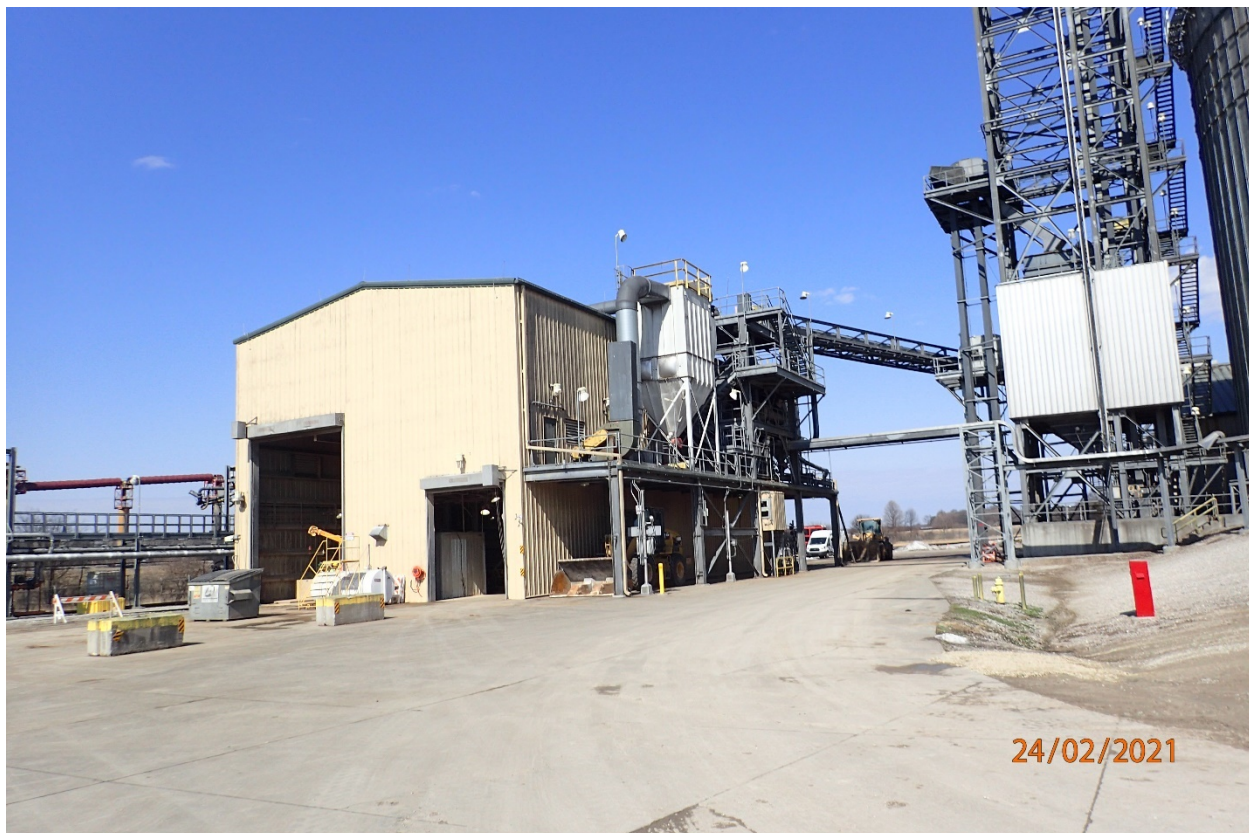
Photo Number: P2240013

We then proceeded to the first step of grain receiving area (photo 13), where grains are received via rail cars (photo 14). We noticed Corn oil storage near the rail lines without secondary containment (photo 17).

Description: Grain Receiving Area

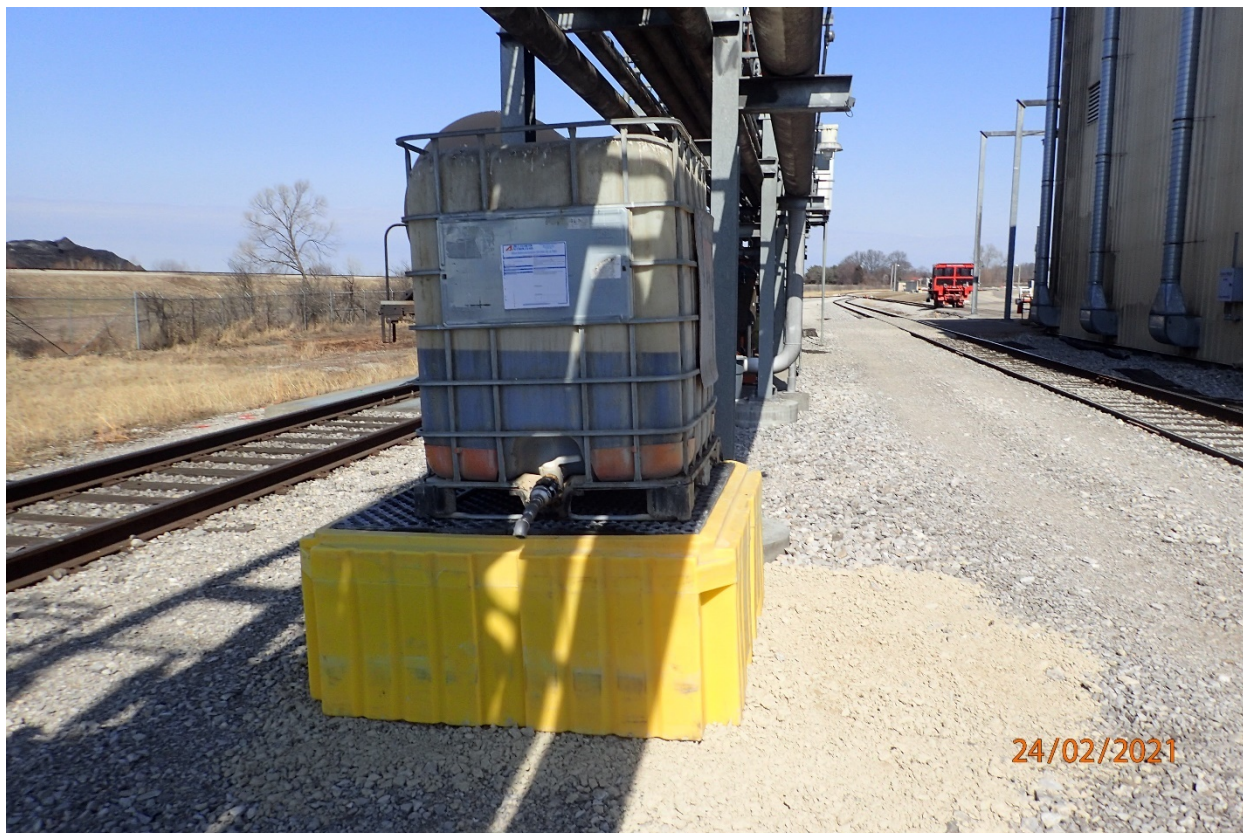
Photo Number: P2240016

Description: Corn Oil with 2<sup>nd</sup> containment.

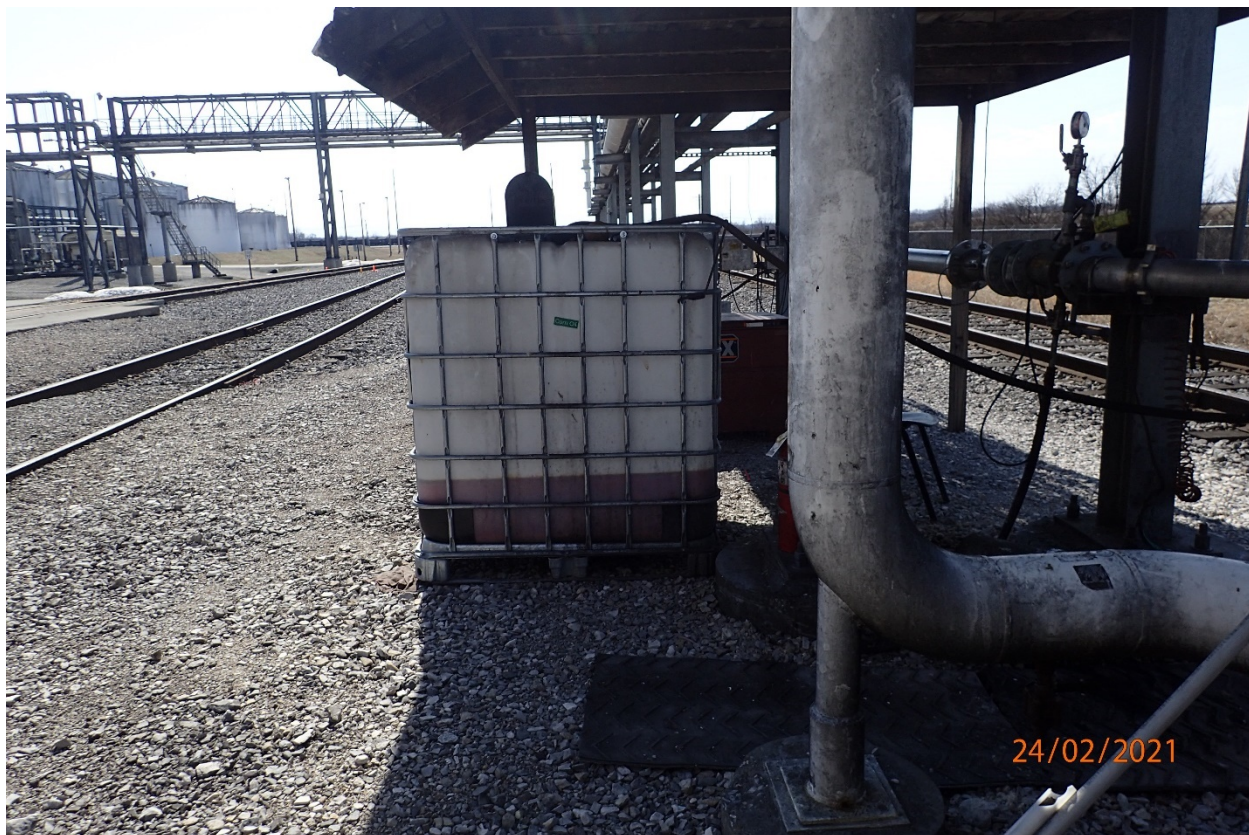
Photo Number: P2240017

Description: Corn oil storage near the rail lines without secondary containment

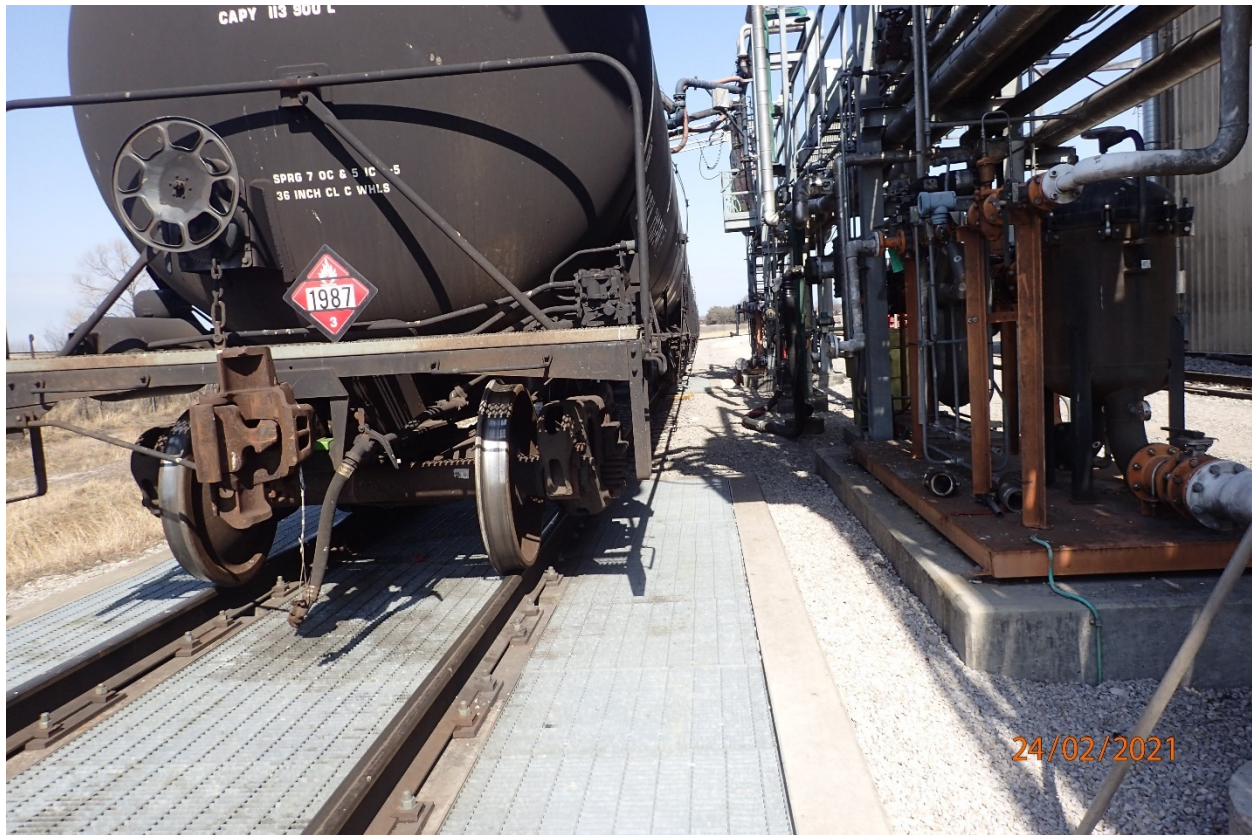
Photo Number: P2240018

Ethanol is filled in the rail cars from the top. Mr. Labhart stated that they have not had ethanol spill at the rail lines and there have only been rare occurrences of corn oil spills, which are first captured in the catch basin on the rail lines (photo 19). The facility has a dedicated containment area (located between the rail track and fence) to capture any corn oil and ethanol spills (photo 20), which would pump off any spill collected from the containment area for off-site disposal.

Description: Ethanol is filled in the rail cars from the top

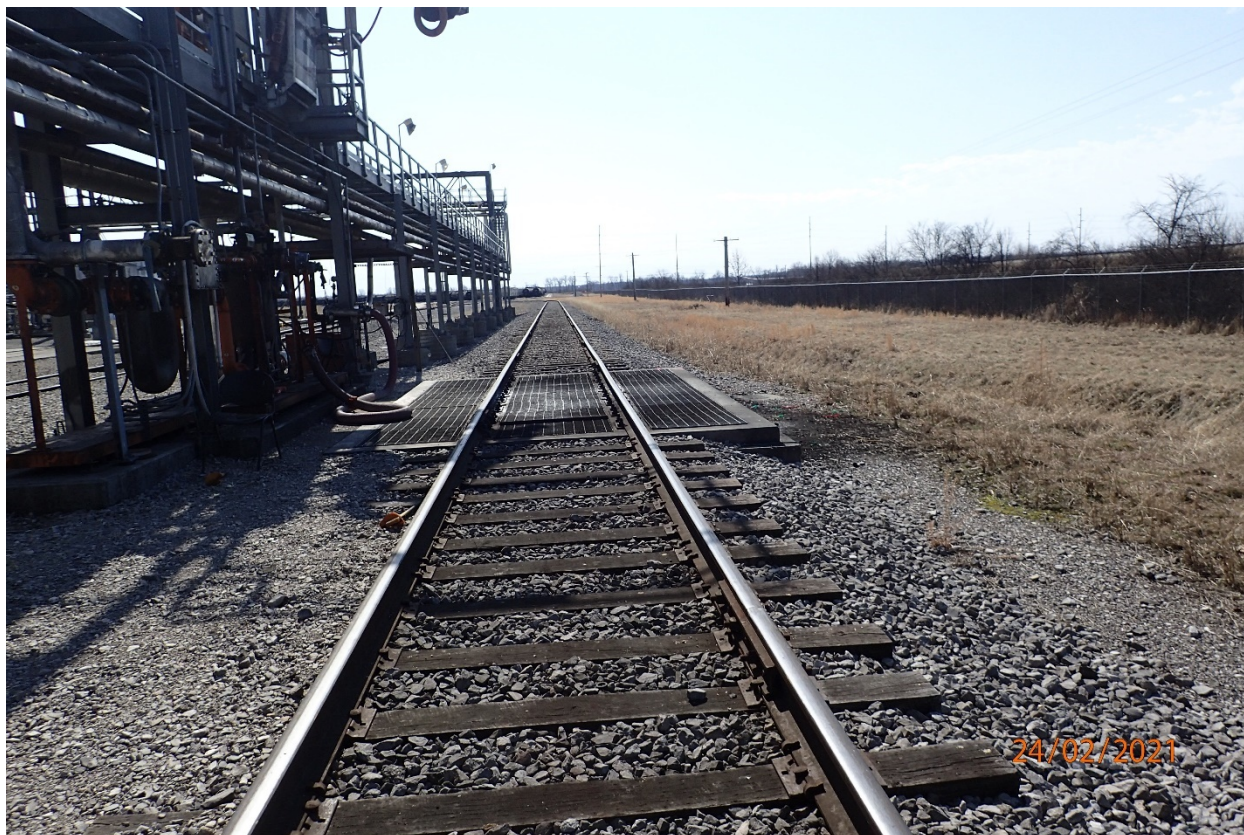
Photo Number: P2240019

Description: The catch basin on the rail lines to capture any corn oil spillage

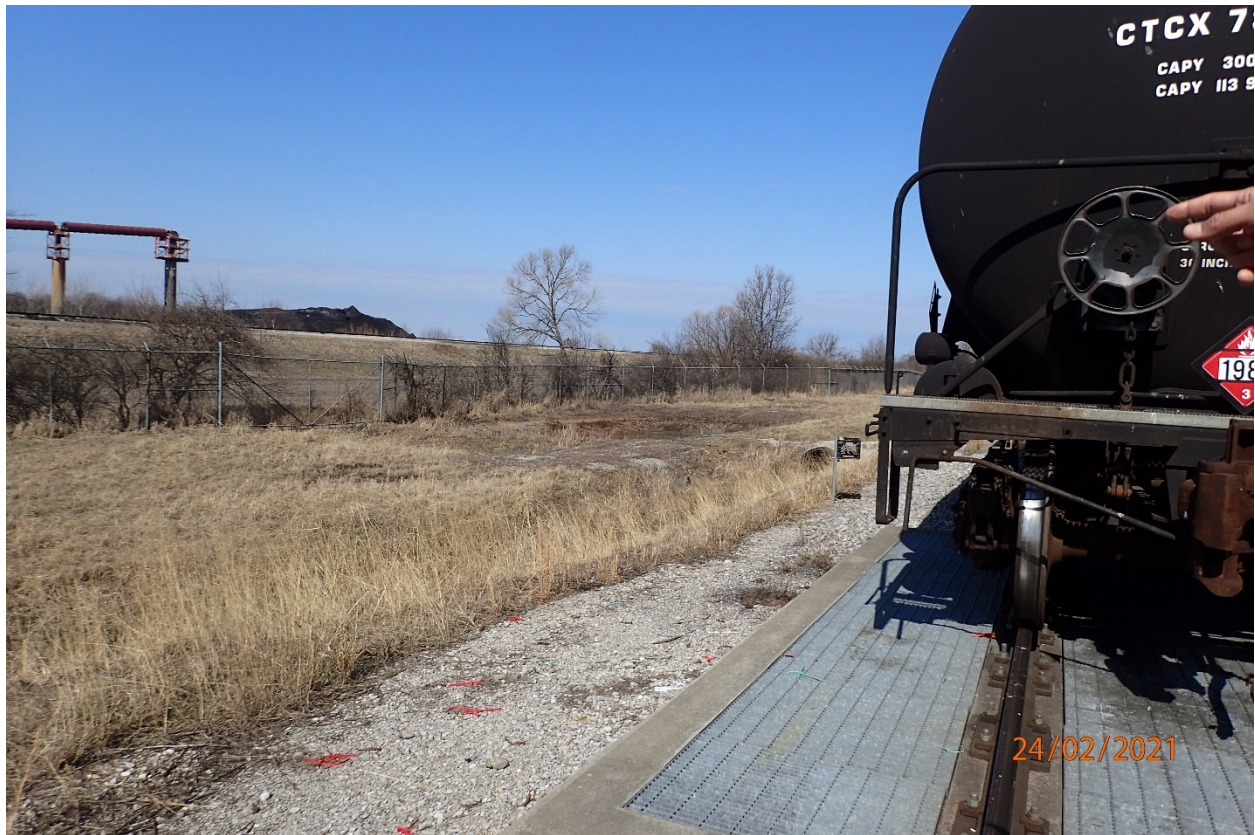
Photo Number: P2240020

Description: Containment area between the rail track and fence - for corn oil and/or ethanol spill

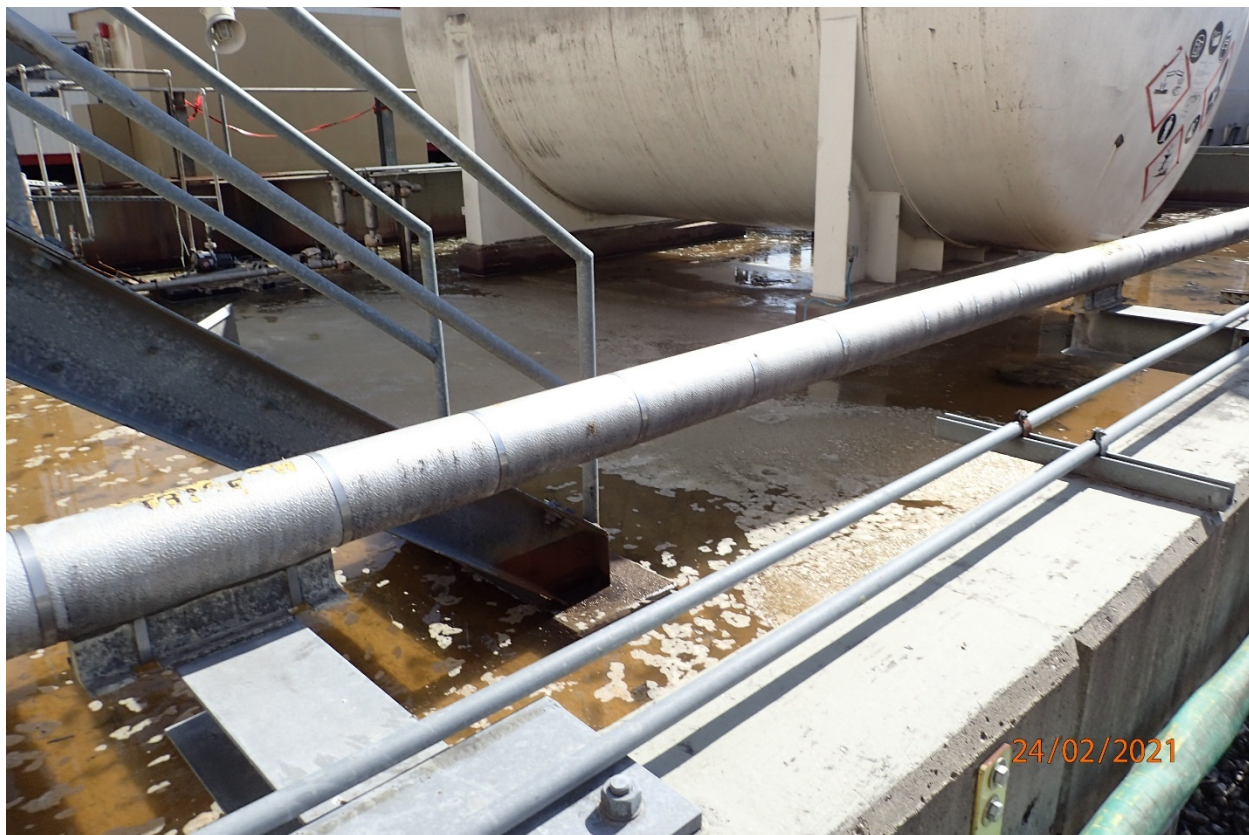
Photo Number: P2240021

Description: Above Ground Chemical Storage Area with concrete secondary containment

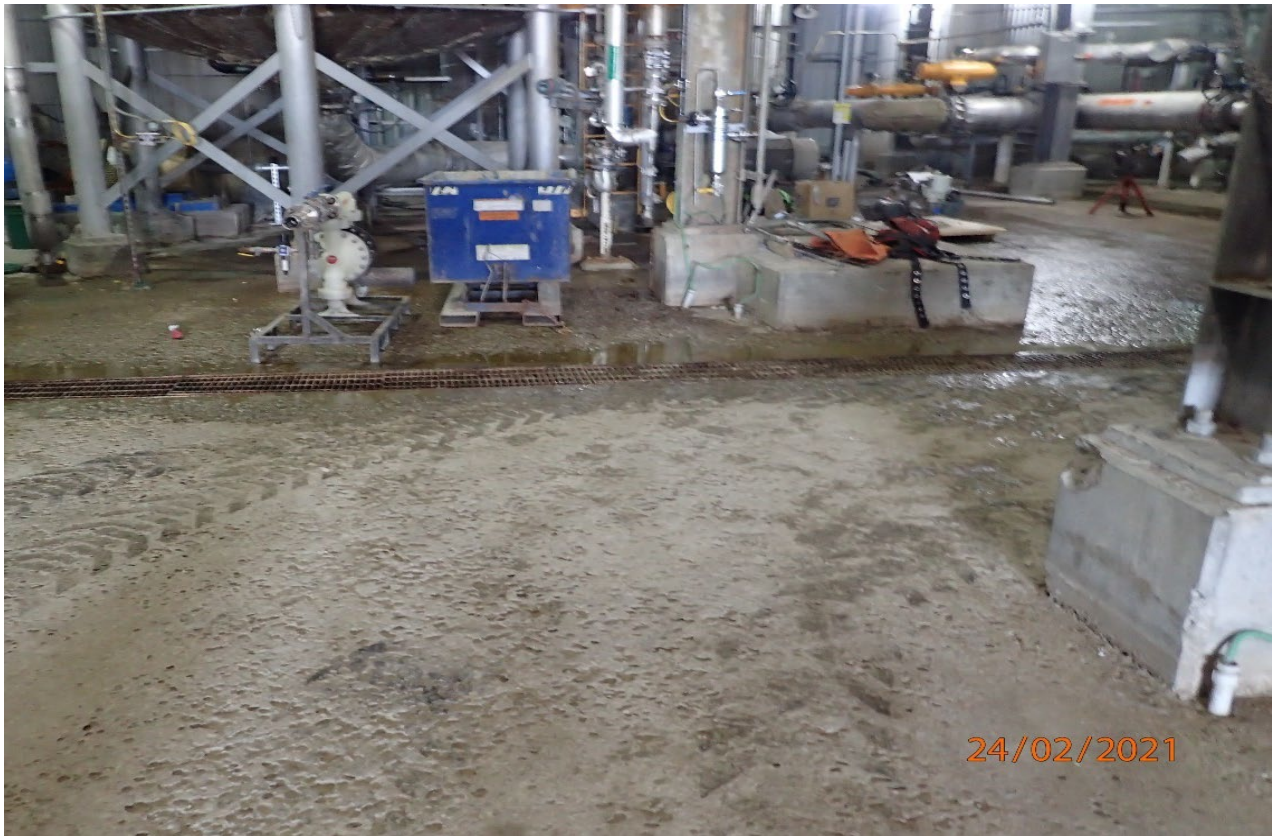
Photo Number: P2240024

Drains within the cook building (photo 24) collect water from the floor washing to an underground holding tank, which would pump the water (photo 25) to the digester tank T-7002. Antibiotics used for fermentation are stored in the Cook Building (photo 26).

Description: Drains within the Cook Building

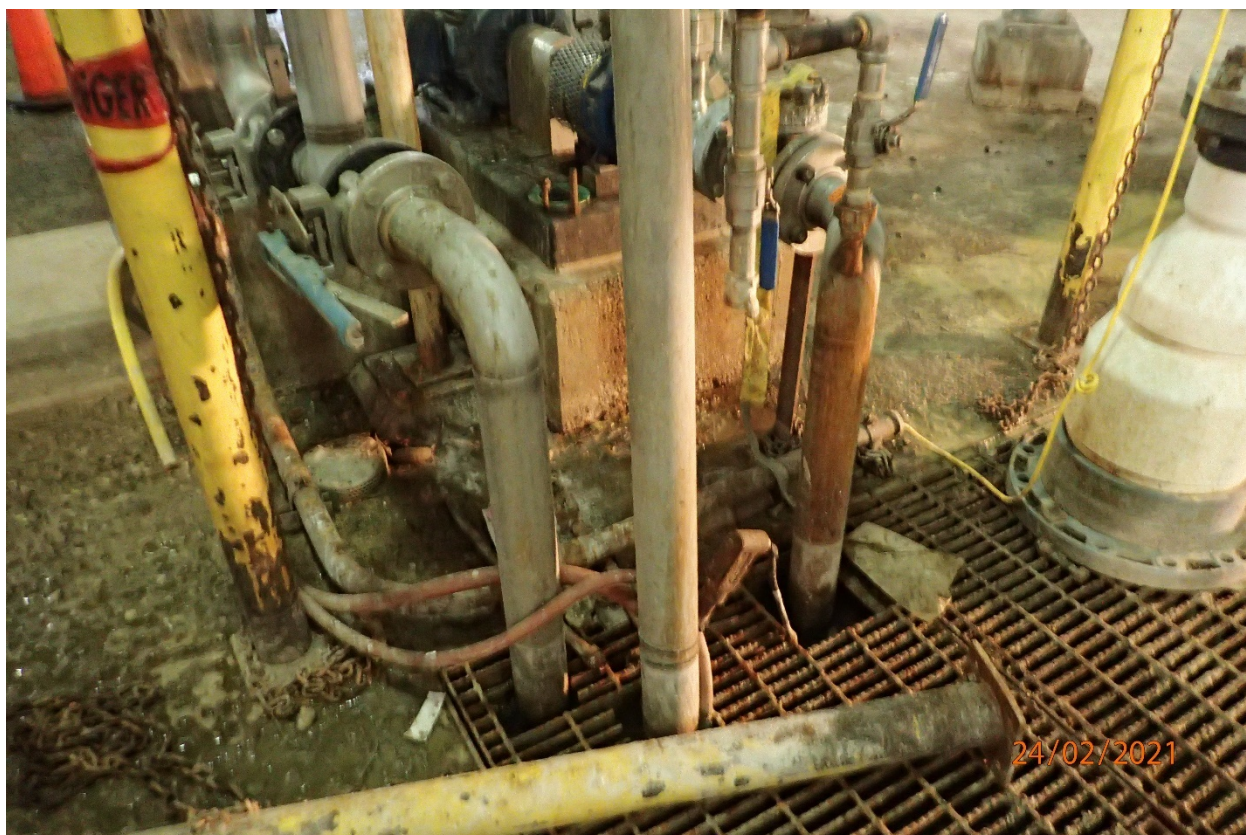
Photo Number: P2240025

Description: Pump area within the Cook Building for the wastewater collected in the drains within the Cook Building

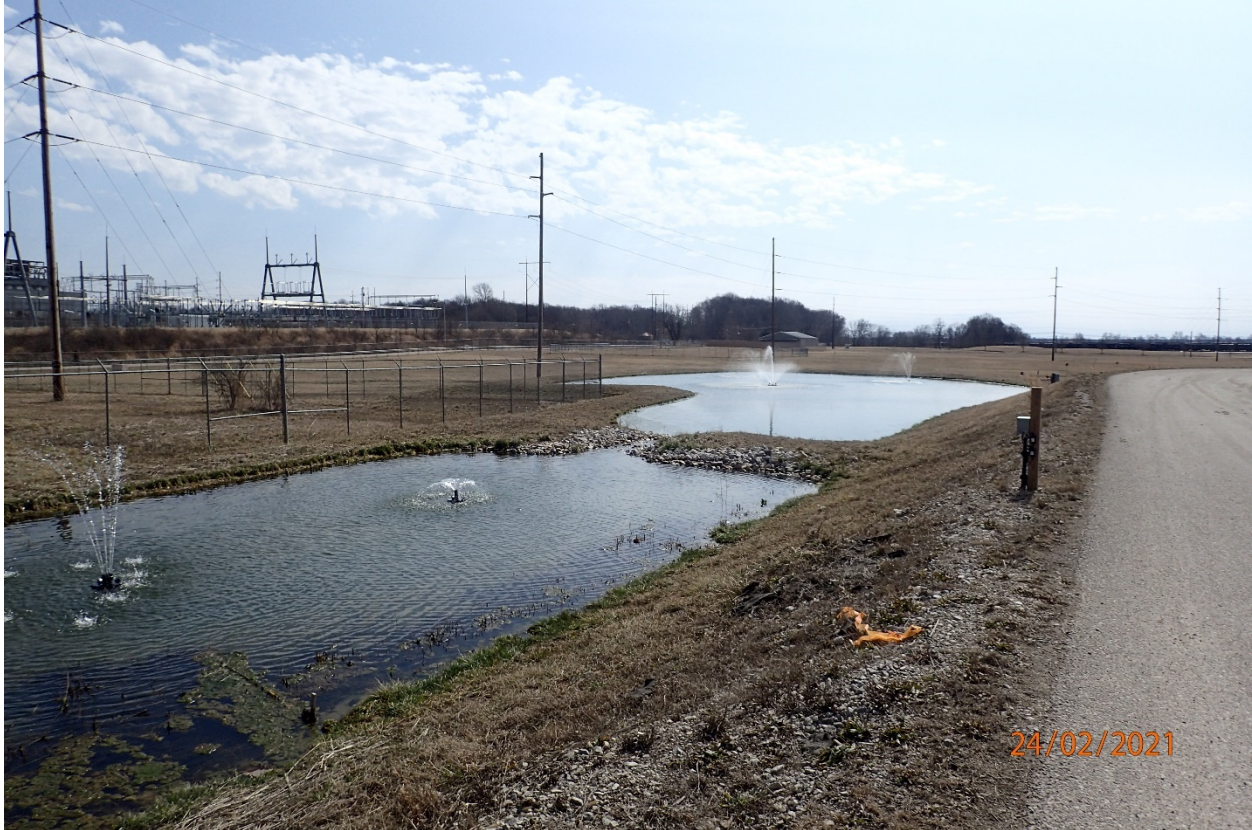
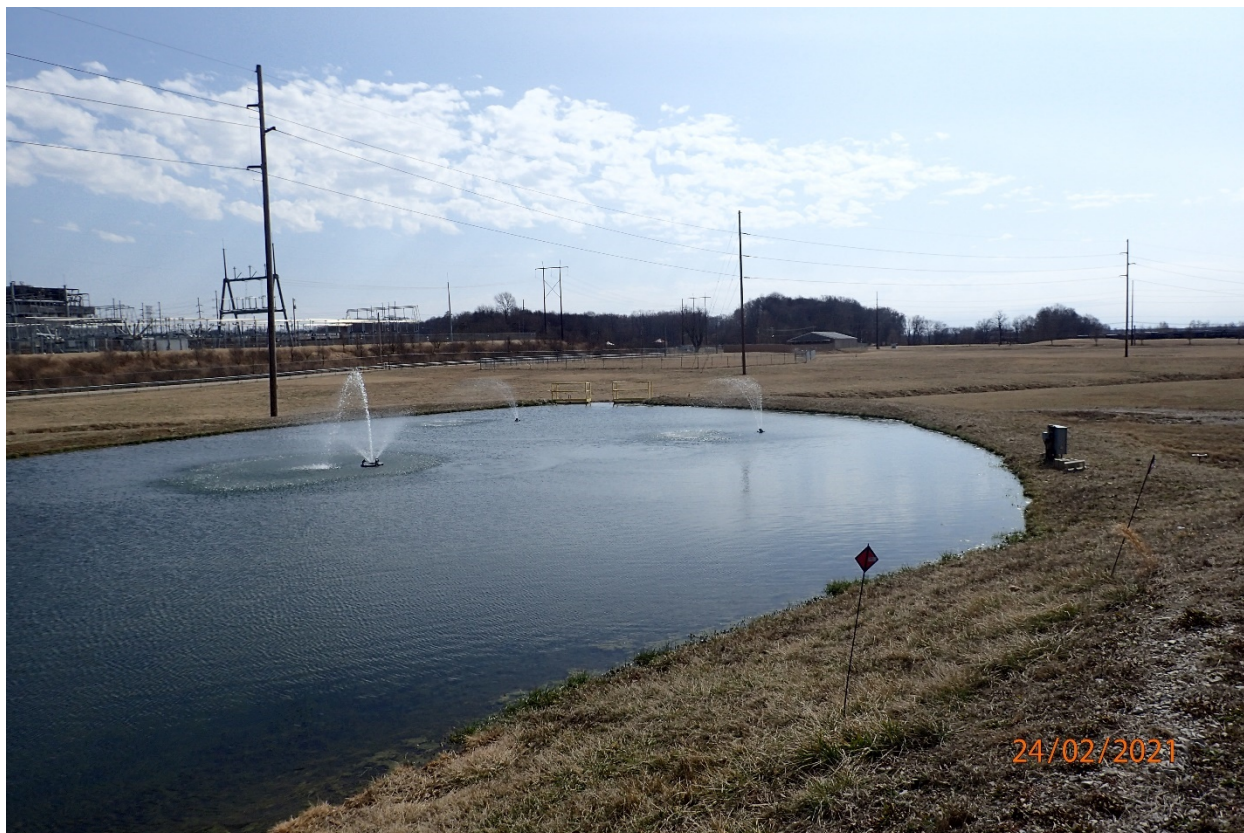
Photo Number: P2240027

The inspection continued to the mixing pond area located on the southeast side of the facility. Aeration sprinklers have been installed in small and larger mixing ponds for further cooling of non-contact boiler and cooling tower blowdown water (photos 27 thru' 29). Grab samples are collected from one of the two locations prior to discharge from Outfall 001S (photos 30 & 31).

Description: Sprinklers in the smaller cooling area of the mixing pond

Description: Sprinklers in the larger cooling area of the mixing pond

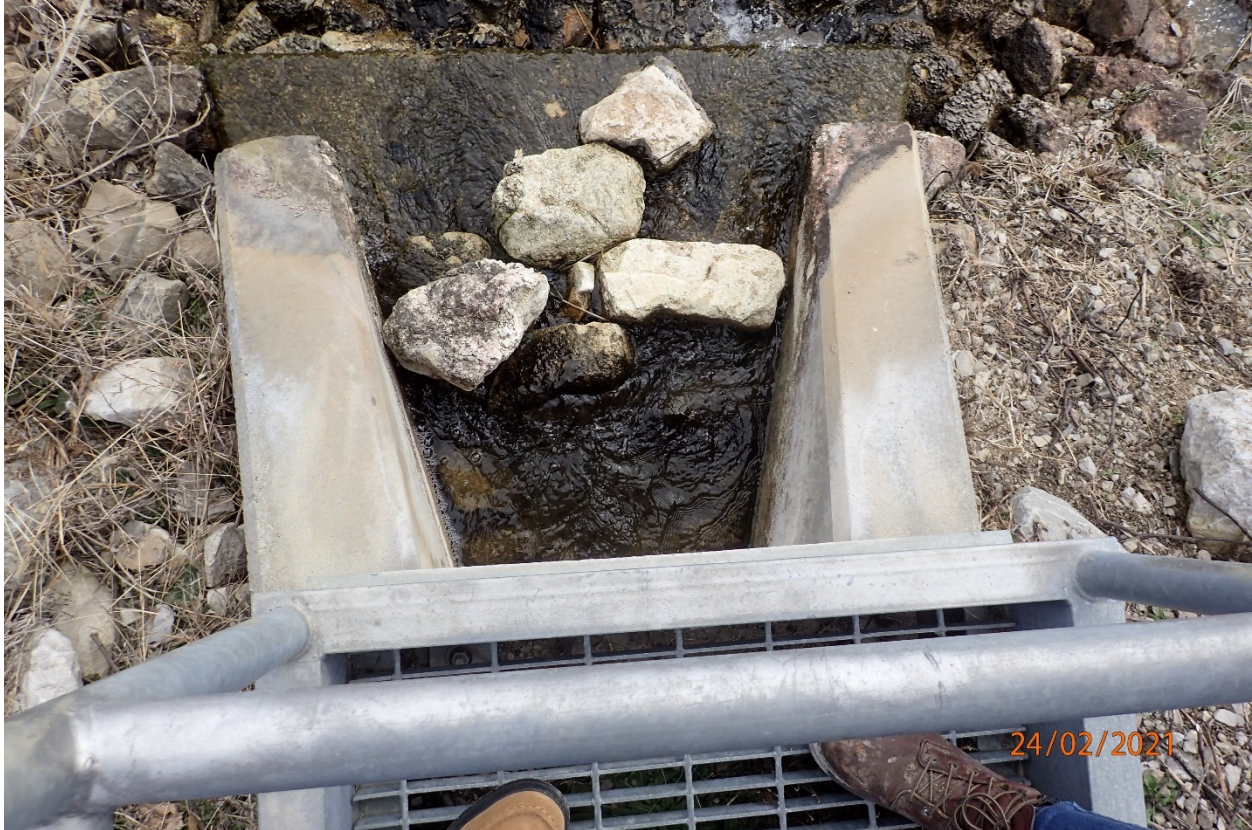
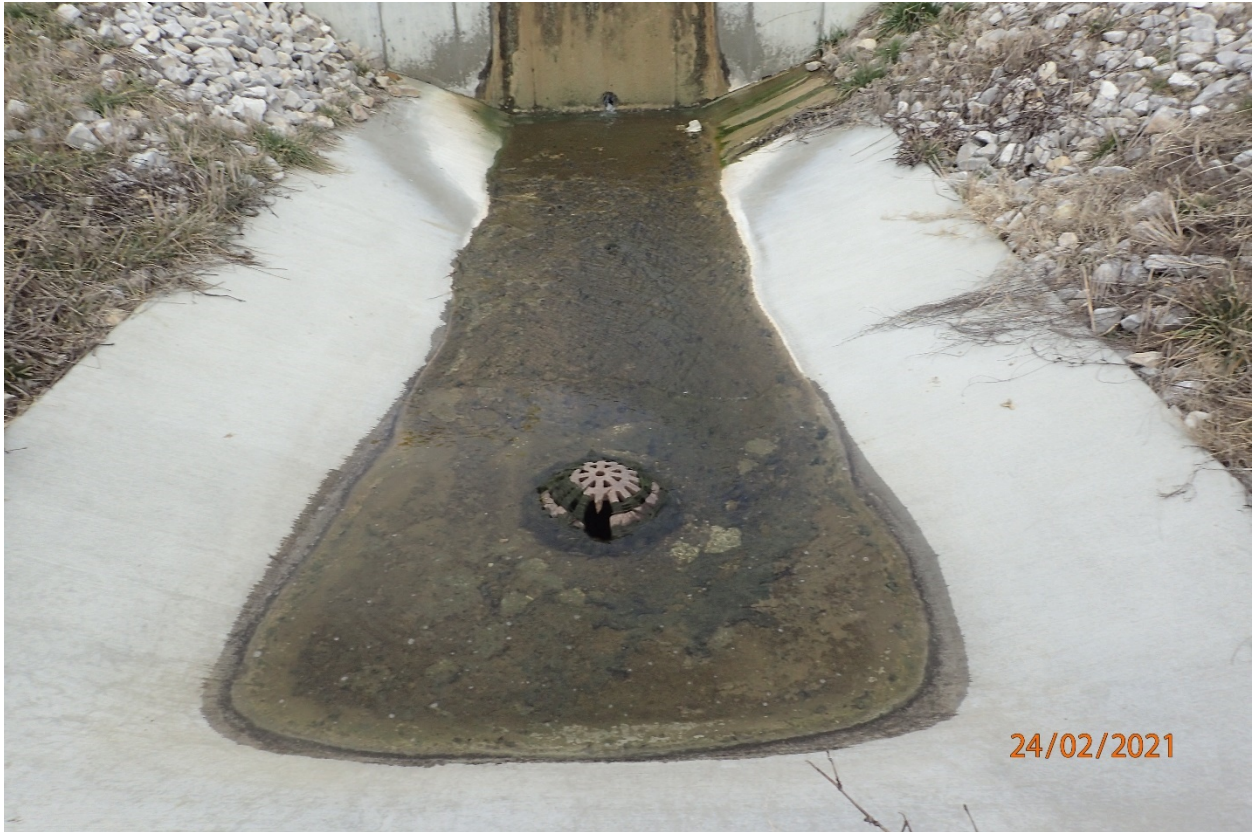
Photo Number: P2240030

Description: Outfall 001s into the unnamed waterway

Description: Another sampling location for outfall 001S

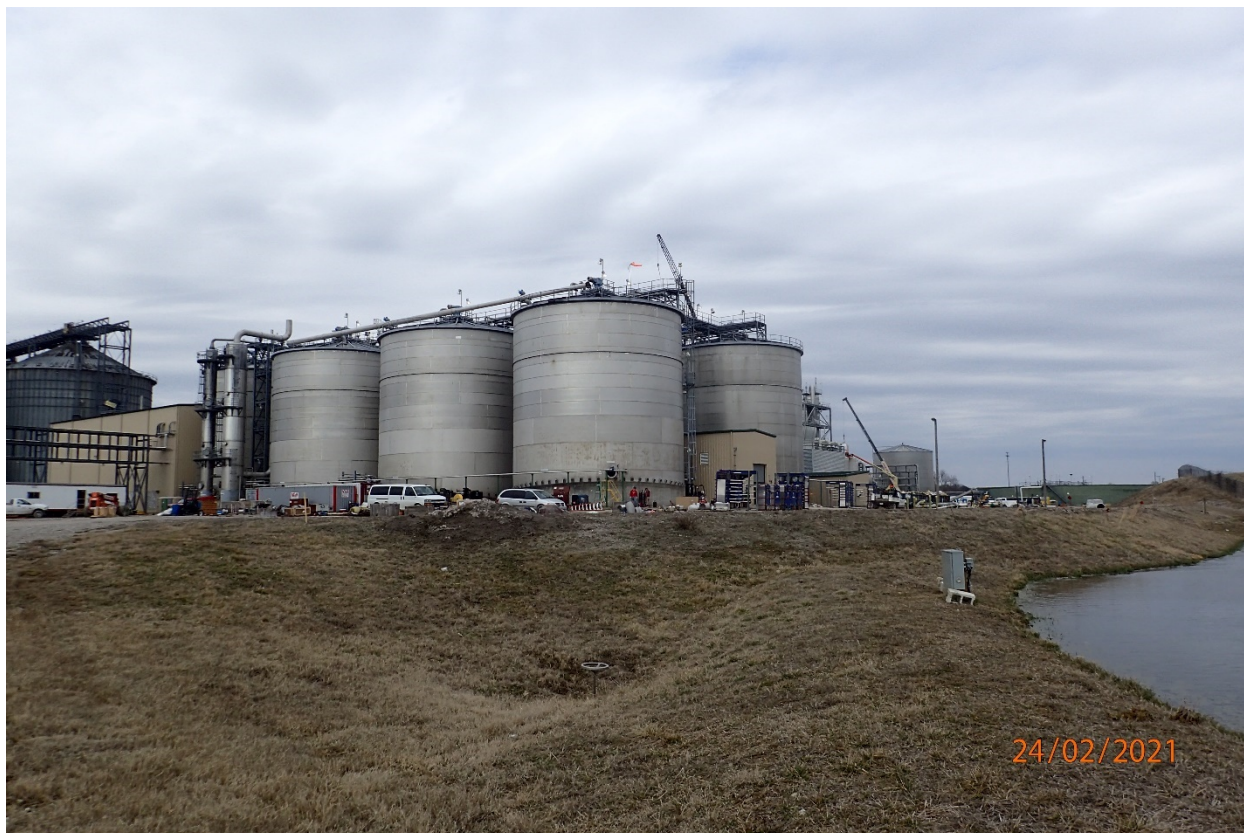
Photo Number: P2240033

We walked past the six large (1 million-gallon each) Fermentation Tanks (photo 32). Prior to 2021, these tanks were operated as continuous fermentation. Mr. Labhart stated that these tanks will operate as batch fermentation tanks after March 2021. They will remain at their existing locations. Each tank is currently being upgraded and retrofitted to the batch operation.

Description: 1 million-gallon Fermentation Tanks (six)

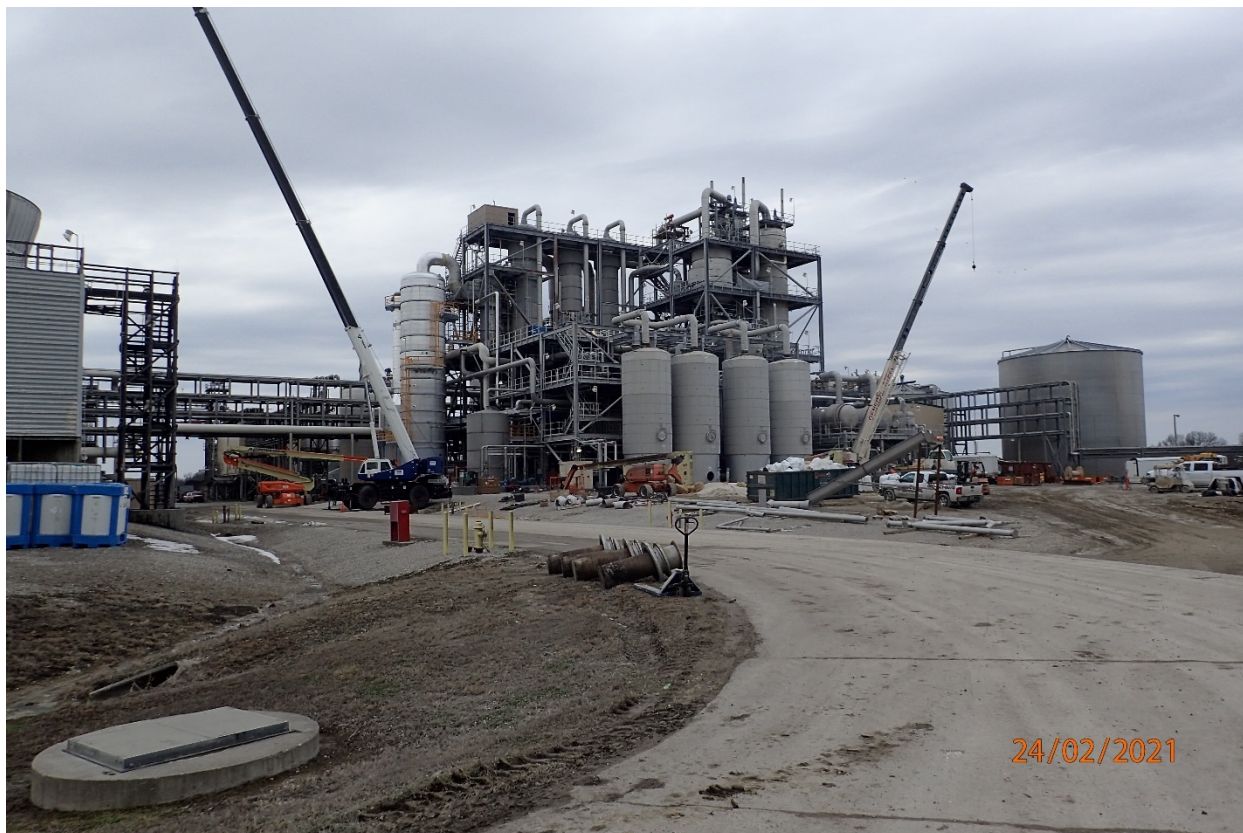
Photo Number: P2240034

Mr. Labhart escorted us to the Distillation Area, Beer Well, Evaporation Tanks, Eductor Tank area (photo 34) and cooling towers (3 chillers – photo 36). On our way to these process areas, we noticed an oil sheen in the stormwater culvert located east of the cooling tower. I asked Mr. Rezac for the potential source of the oil and he stated that the source could have been from the parked maintenance vehicles near the culvert. Mr. Rezac mentioned that the oil sheen couldn't have resulted from the non-contact sump pump malfunctioning (as they have in the past), since the plant was not in the operation at that time.

Description: Distillation Area, Beer Well, Evaporation tanks, and the eductor tank

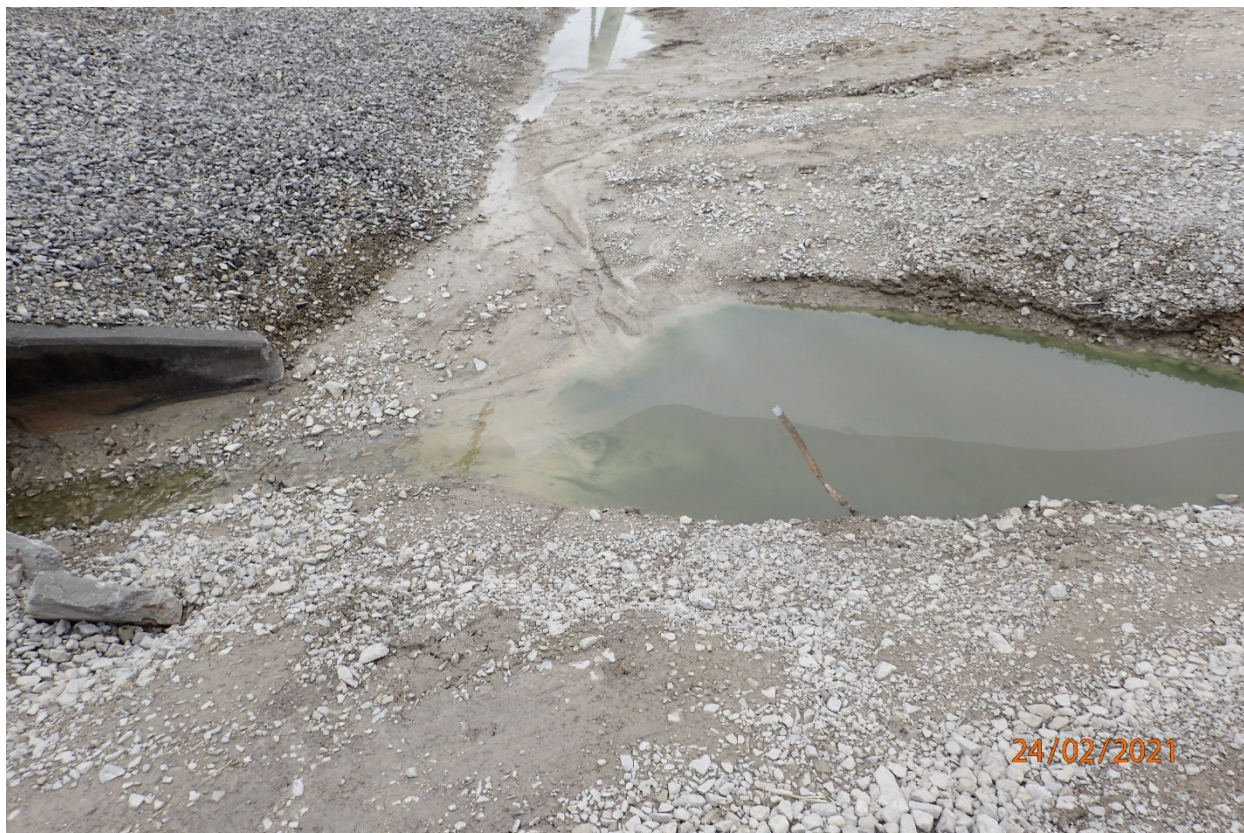
Photo Number: P2240035

During the closing conference, we had not discussed the concern related to the oil sheen observed in the stormwater culvert located east of the cooling tower. Mr. Rezac stated that the

Description: Stormwater culvert – noticeable oil sheen

source could have been from the parked maintenance vehicles near the culvert and that he would look into preventing similar occurrences in the future.

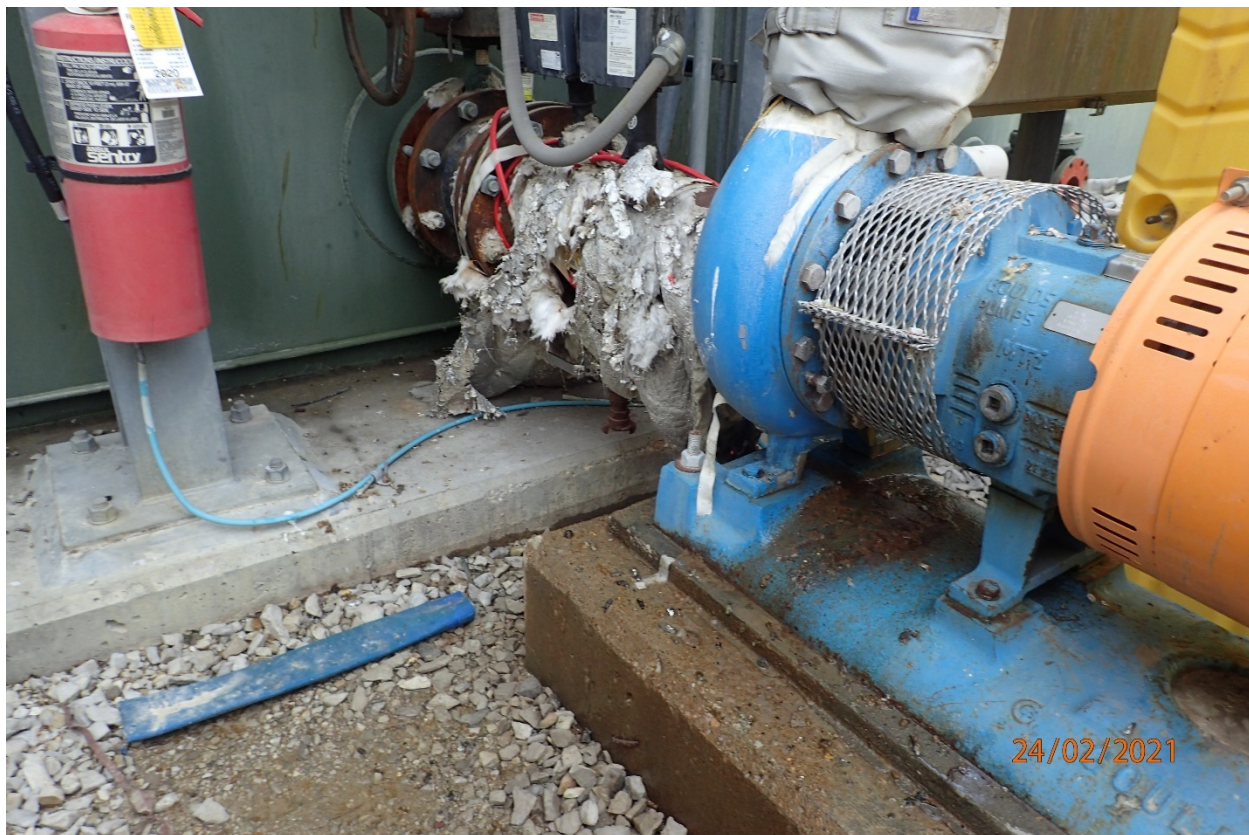
Photo Number: P2240042

Mr. Labhart stated that the discharge from Outfall 002 (discharges into the unnamed ditch to the Ohio River) consists of treated process wastewater from the ethanol production as well as storm water. Wastewater from the ethanol process is sent to a 750,000-gallon Equalization Tank (T-7001) followed by the wastewater holding tank T-7002 (photo 43). From there, the wastewater is fed to the wastewater treatment system (digester) consisting of aeration, flocculation, and clarification. The wastewater treatment system had an average discharge of approximately 0.36 MGD. Due to recent plant modifications, wastewater discharges from the new batch fermentation and P24 distillation would be significantly reduced. The batch process is a net "water negative" system. The continuous process ran as a "water positive" system. The batch process consumes more water in the process and discharges less. The wastewater digester will remain shut down and will be eliminated from the process when the facility starts to use the batch process. Mr. Labhart stated that the facility is in the process of procuring a vendor to empty and clean the digester. We inspected the wastewater discharge sampling collection point at the bottom of the Digester (photo 42), which is out of commission at present.

Description: Sampling collection point at the bottom of the Digester
