## U.S. Environmental Protection Agency Region 5

**Purpose:** Industrial User Pretreatment Compliance Inspection

**Facility:** Green Plains Mount Vernon LLC  
8999 W Franklin Road  
Mount Vernon, IN 47620

**Inspection Date:** February 23-24, 2021

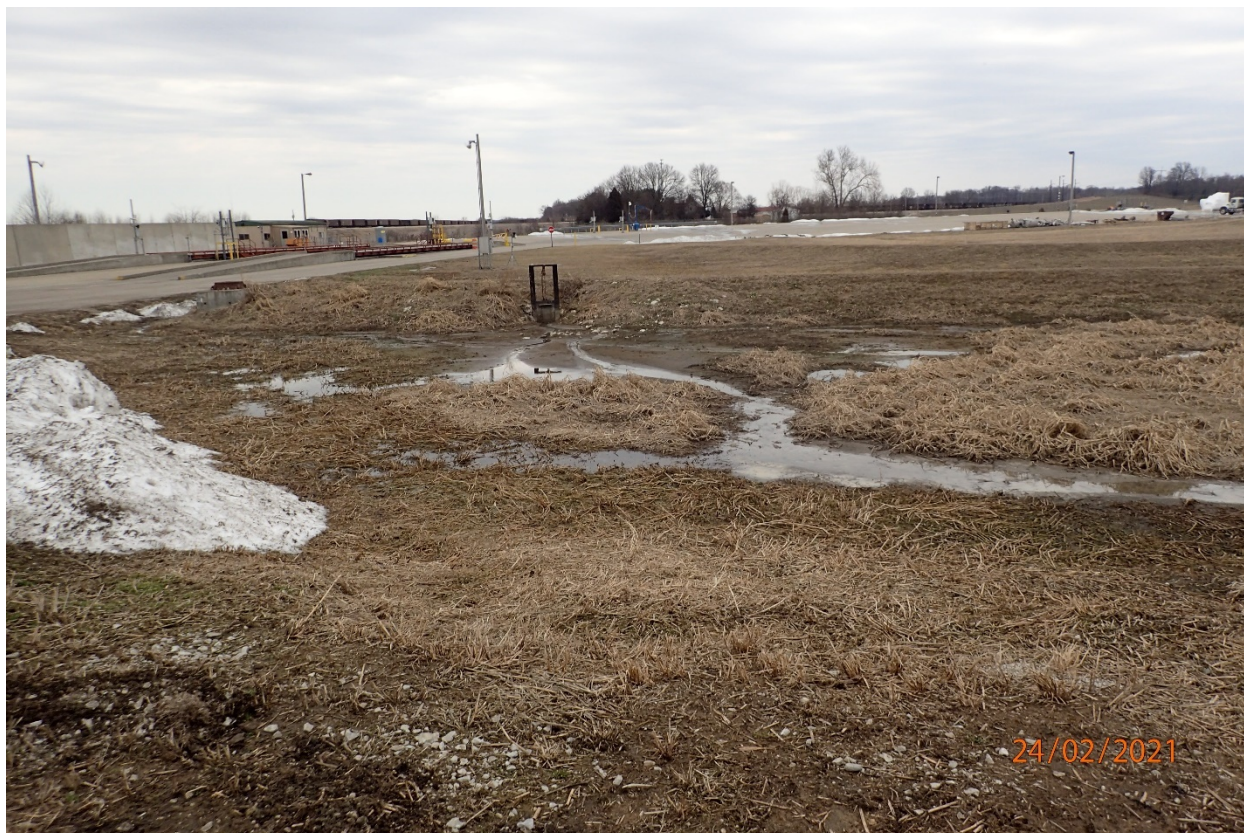
Photo Number: P2240044

The inspection continued to the northwest side of the facility where we inspected outfall, discharge, and sampling locations for Outfall 002 and Outfall 002S (photos 44, 48, 49). Before we ended the facility walk-through, we inspected the Wet Distillers Grains storage area (photo 45) and the newly installed evaporator and beer well (photo 51). Finally, we entered the energy center building to inspect the flow meter that measures the flow from RO reject water, softener regenerant, boiler blowdown, non-contact cooling water and condensate from heat exchangers

Description: Sluice Gate at Stormwater Outfall 002S

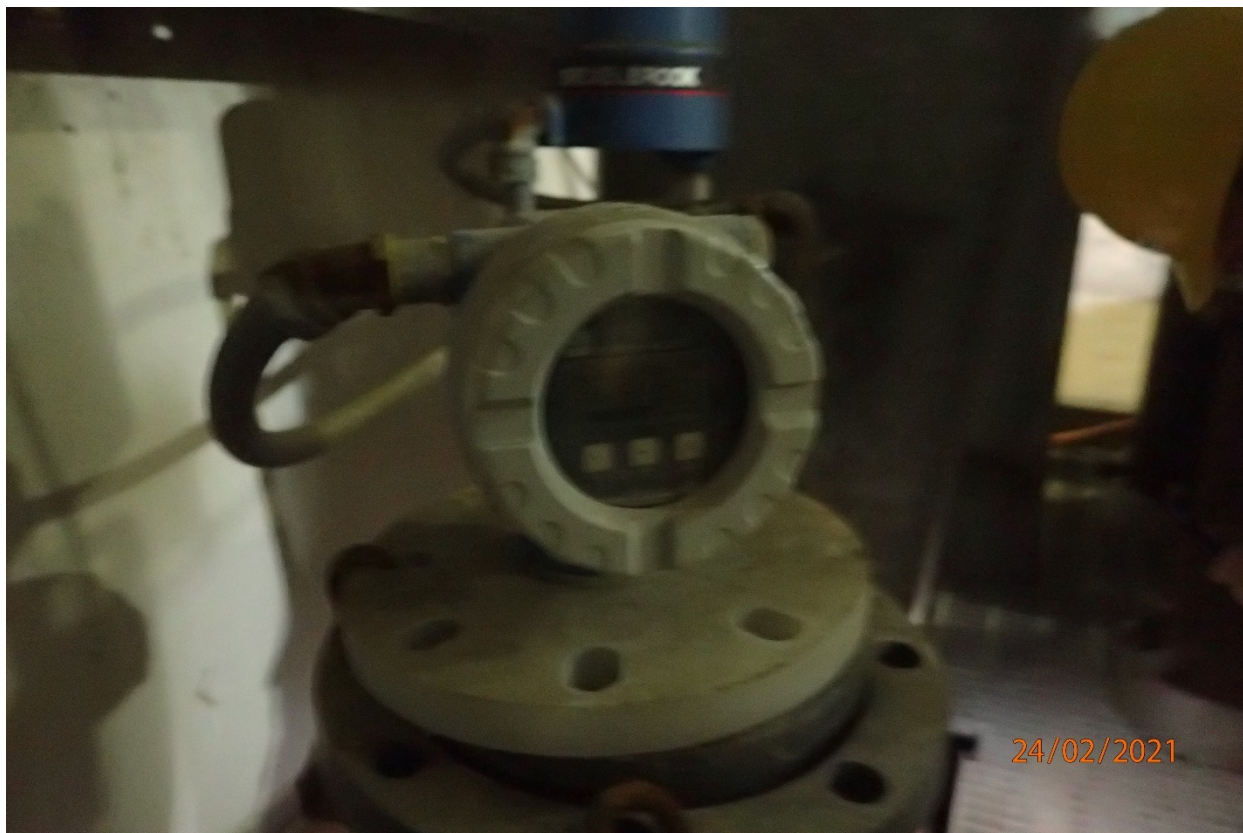
Photo Number: P2240054

Description: Level meter that is triggered when the water level reaches a certain height in the tank

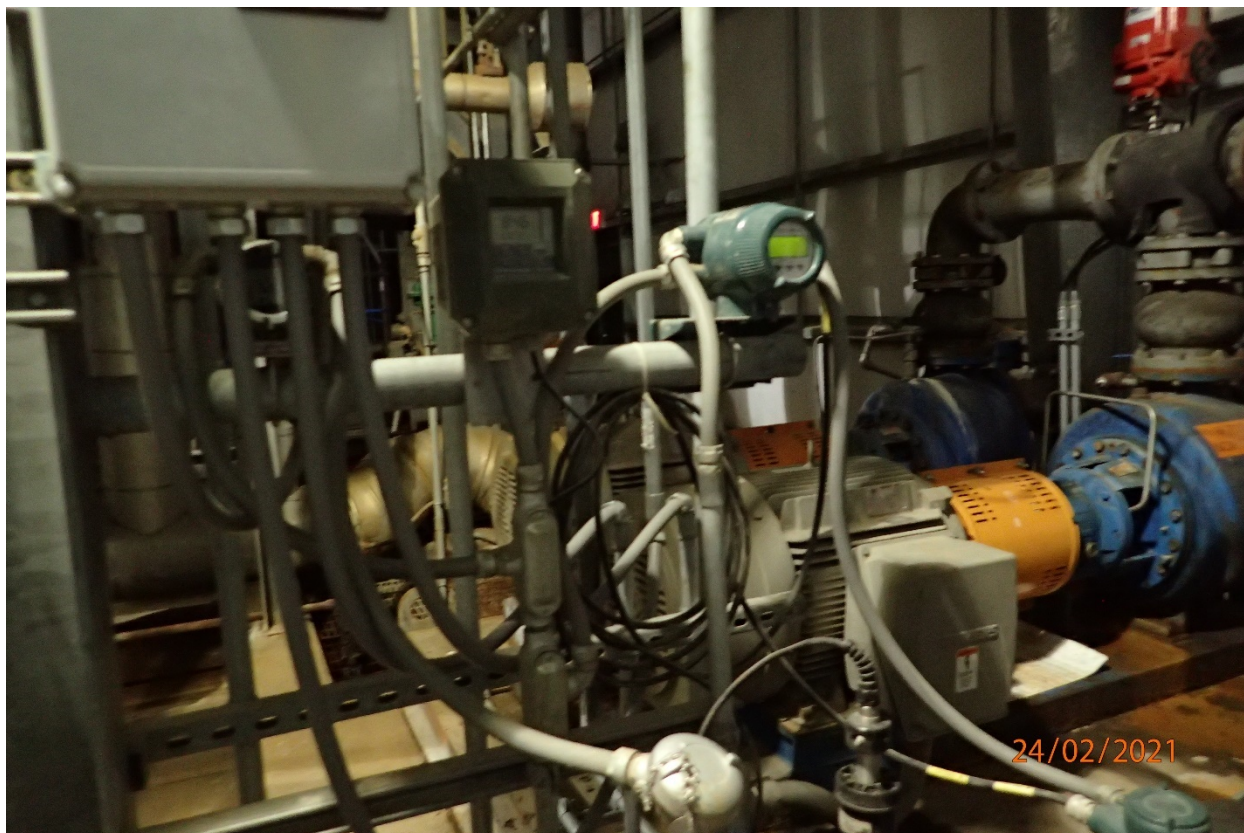
Photo Number: P2240055

Description: Flow meter to measure flow leading to outfall 001S
