## **RCRA Inspection Report**

Glasforms Inc. BLDG #6  
3850 Pinson Valley Rd.  
Birmingham, Alabama 35217  
EPA ID No: ALR000053165

November 02, 2021

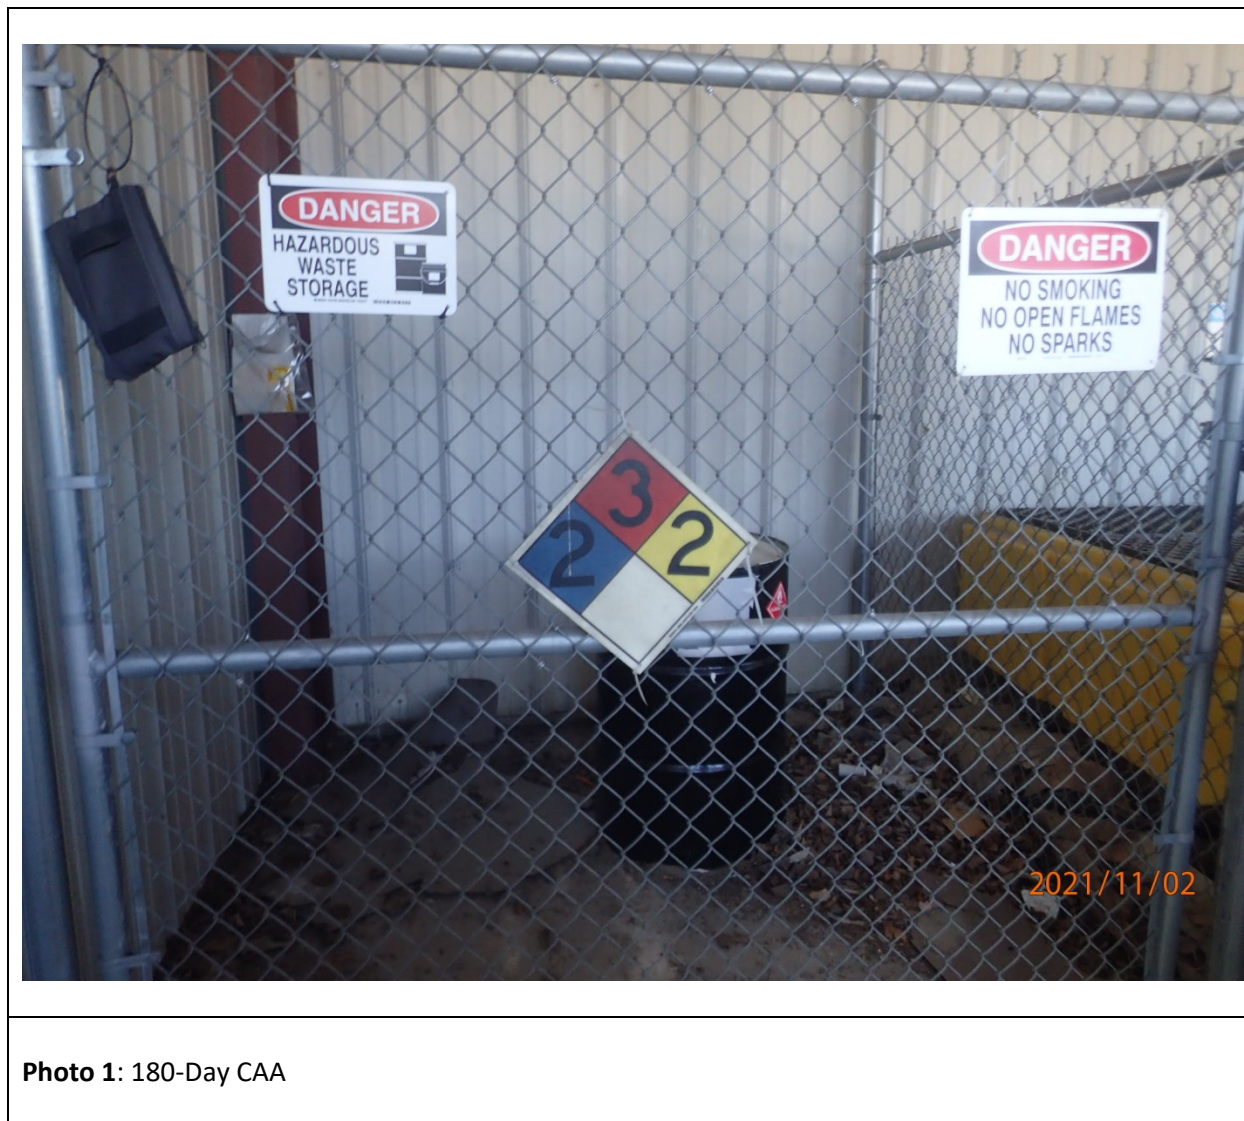
**Photo 1:** 180-Day CAA

The 180-Day CAA is located in a shed right outside of Building #6. The CAA is accessed through a chain-linked fence which was locked when we approached. The inspectors observed the following hazardous wastes:

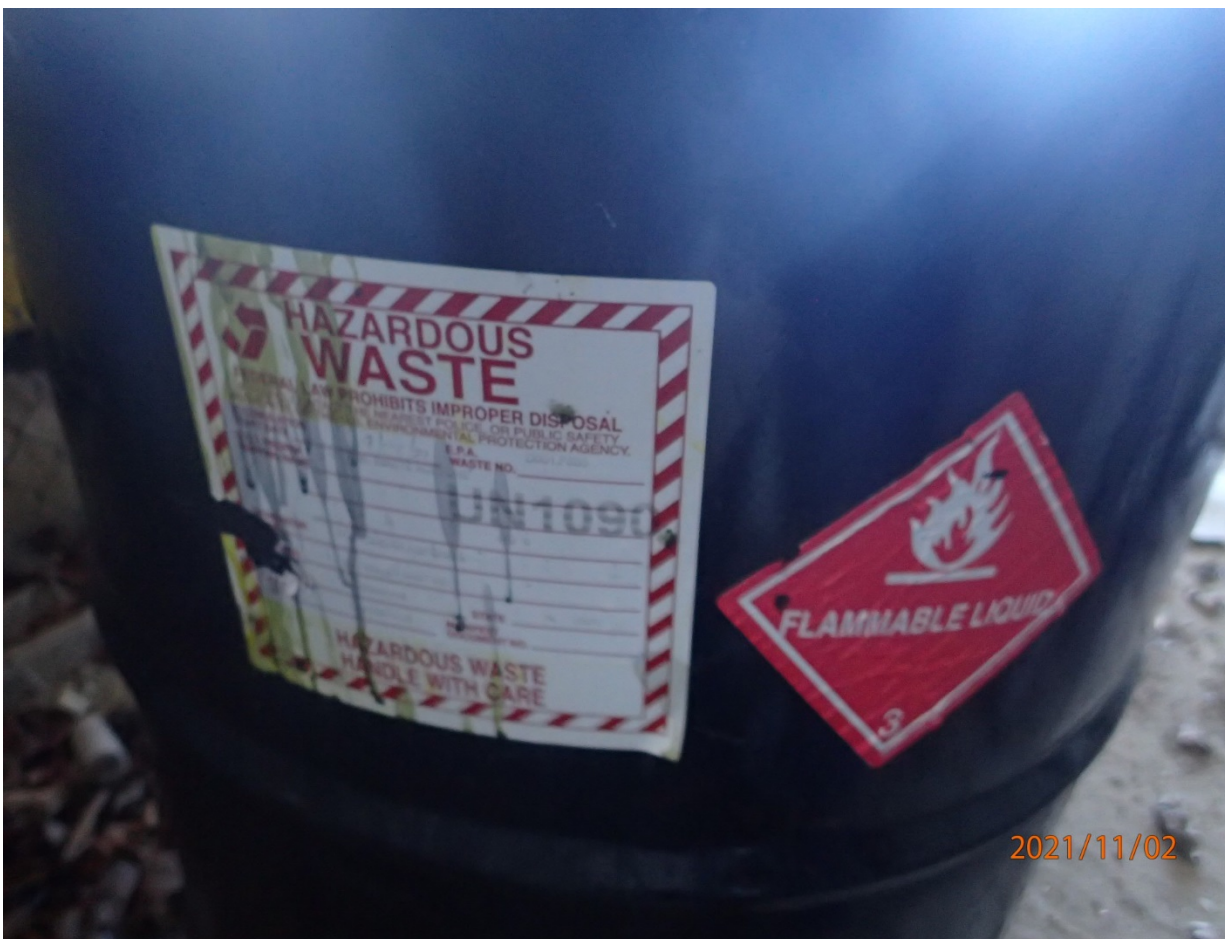
- One (1) 55-gallon drum of waste acetone. The container was closed and labeled with the words “Hazardous Waste” and marked with an indication of hazard. The drum was dated 09/23/2021. (Photos #1 and #2)

**Photo 2:** One (1) 55-gallon drum of waste acetone. The container was closed and labeled with the words “Hazardous Waste” and marked with an indication of hazard. The drum was dated 09/23/2021.

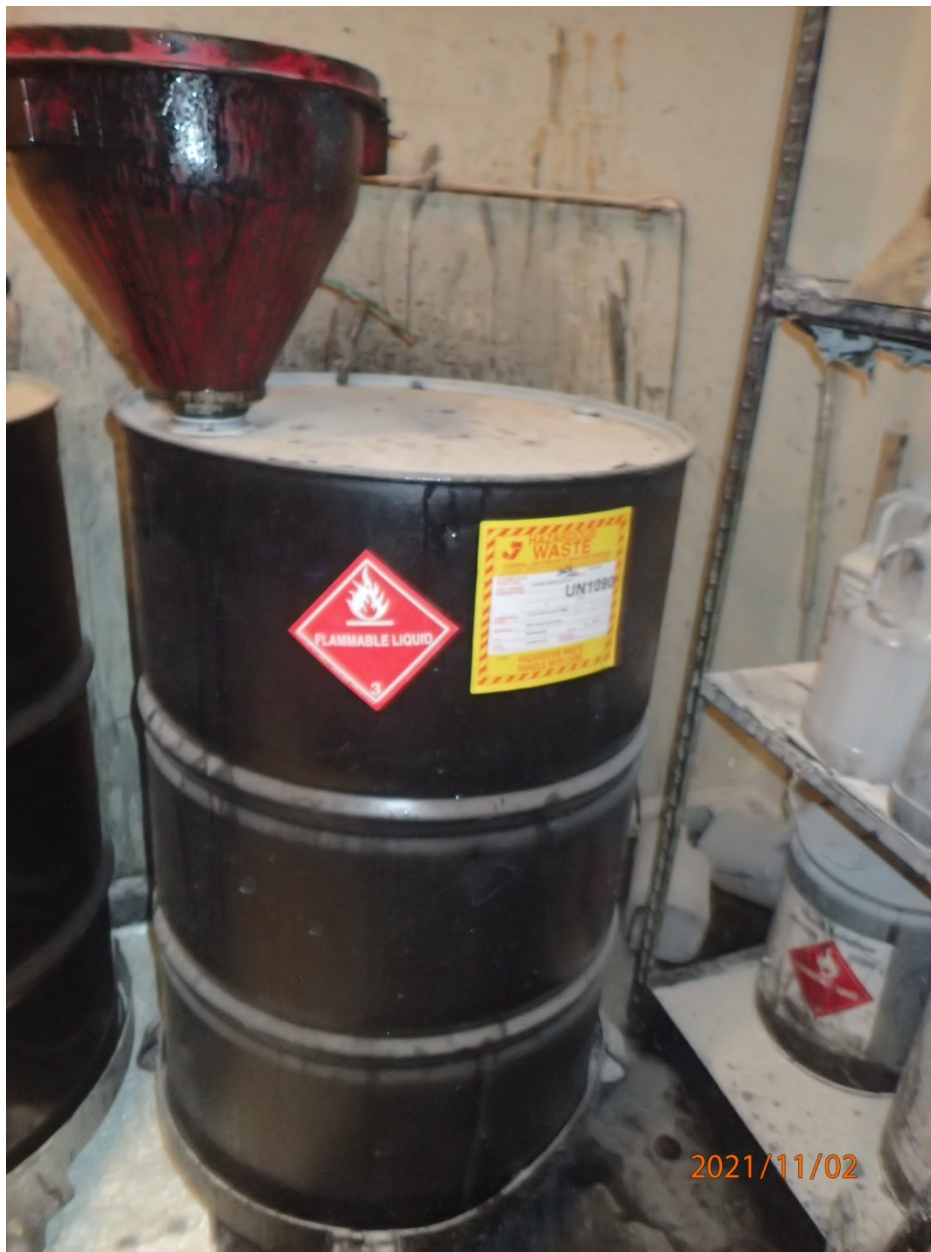
- One (1) 55-gallon SAA hazardous waste drum containing waste acetone. The container was closed and labeled with the words “Hazardous Waste” and marked with an indication of hazard. (Photo #3).

**Photo 3:** One (1) 55-gallon SAA hazardous waste drum containing waste acetone. The container was closed and labeled with the words "Hazardous Waste" and marked with an indication of hazard.
