## **RCRA Inspection Report**

Kith Kitchens - Florence  
4184 Rushton Street  
Florence, AL 35630  
Lauderdale County  
EPA ID Number: ALR000067983

**COMPLIANCE EVALUATION INSPECTION PHOTOGRAPHS**

**January 25, 2024**

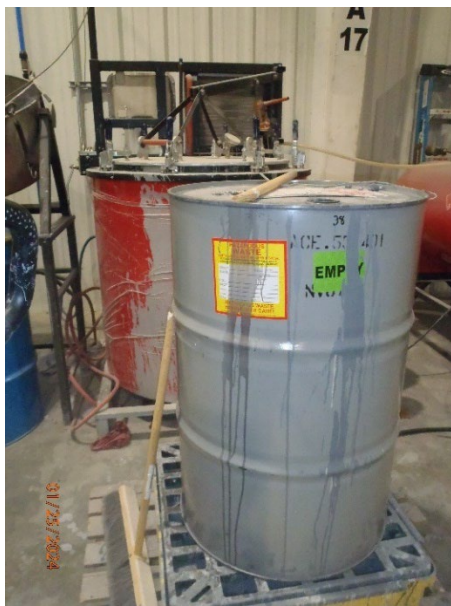
Picture 1 – Solvent Distillation Area SAA drum - full

Next to the Primer Booth 2 is the Solvent Distillation Area. At the time of the inspection, the inspectors observed a solvent still, and two 55-gallon hazardous waste drums (Pictures 1-6). The gray drum was full and contained liquid paint and solvent waste ready to move to the hazardous waste central accumulation area (CAA). The drum was sitting on a secondary containment pallet, closed, labeled, and dated. However, the hazardous waste label was streaked and the markings on the label were hard to read. Additionally, the drum was missing its required flammable hazardous material placard.

**Pursuant to ADEM Admin. Code r. 335-14-3-.01(7)(a)5(i)b. [40 C.F.R. § 262.17(a)(5)(i)], which is a condition of the LQG Permit Exemption, a generator must mark or label its containers with the following: an indication of the hazards of the contents.**

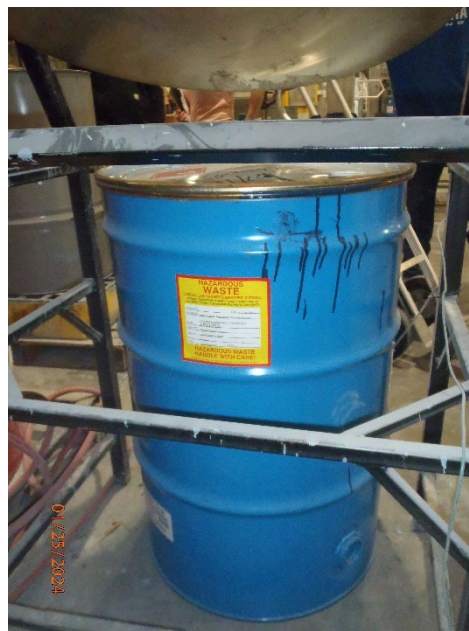
Picture 4 – Solvent Distillation Area still solids SAA drum

The blue drum contained solid paint and solvent waste debris. The drum was labeled, placarded, but not closed because the lid ring was not attached. Mr. Horton immediately had the drum ring placed on the drum.

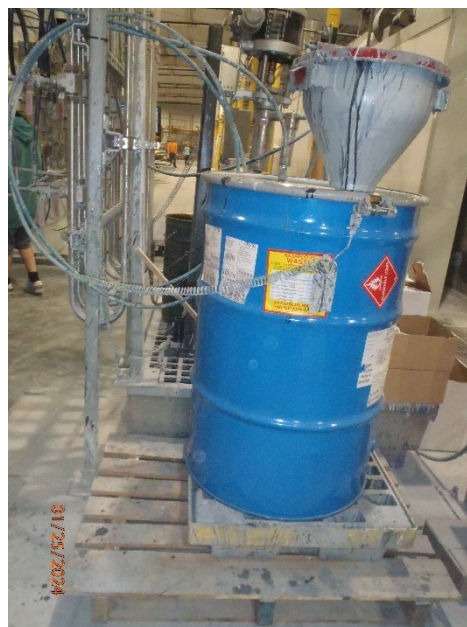
Picture 7 – Superfici Paint Line SAA drum

The inspectors then walked two of the Superfici Paint Lines. The inspectors observed the 55-gallon SAA drums of liquid paint and solvent waste. The drums were observed closed, labeled, and placarded (Pictures 8 and 10). Each drum sat on a secondary containment pallet.

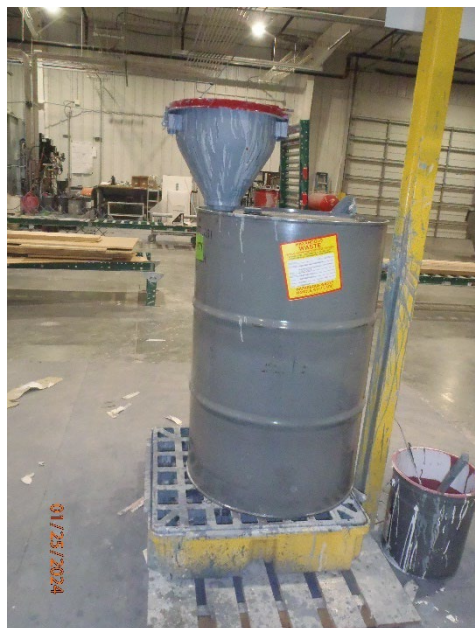
Picture 6 – Primer Booth 2 SAA drum

The inspectors observed that Primer Booth 2 had a satellite accumulation area (SAA) with a 55-gallon drum of waste paint. The drum was closed and labeled but missing the flammable hazardous material placard (Picture 7). The drum was sitting on a secondary containment pallet; however, at the time of the inspection, the inspectors noticed dried paint and debris inside. The inspectors recommended regular clean outs per shift as a part of their housekeeping.

**Pursuant to ADEM Admin. Code r. 335-14-3-.01(6)(b)6.(i) [40 C.F.R. § 262.15(a)(5)(ii)], which is a condition of the SAA Permit Exemption, a generator is required to mark or label its containers with an indication of the hazards of the contents.**

| Observation | Corrective Action | Attached File/Documentation |
|---|---|---|
| 7. Primer Booth 2 – needed updated ID of hazards – current one was covered in paint. | New hazardous waste label and hazard indication sticker were applied to the drum at the East Satellite Accumulation Area. Labels and hazard indication will be promptly replaced in the event they become obscured for any reason. | SAAEast.pdf |

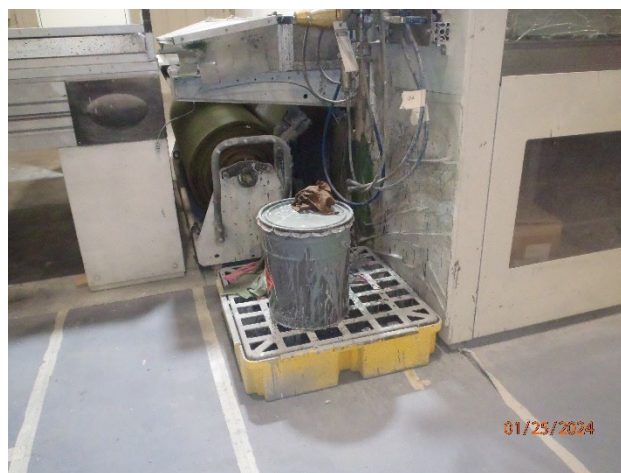
Picture 8 – Superfici Paint Booth flush bucket

In front of one of the Superfici Paint Booths was a 5-gallon container of waste paint and solvent flushed from the system during paint changeovers (Picture 9). The container was used to collect flushed waste paint and then dump into the SAA drum by the end of the shift. The container was not labeled. Mr. Horton immediately had the container labeled.

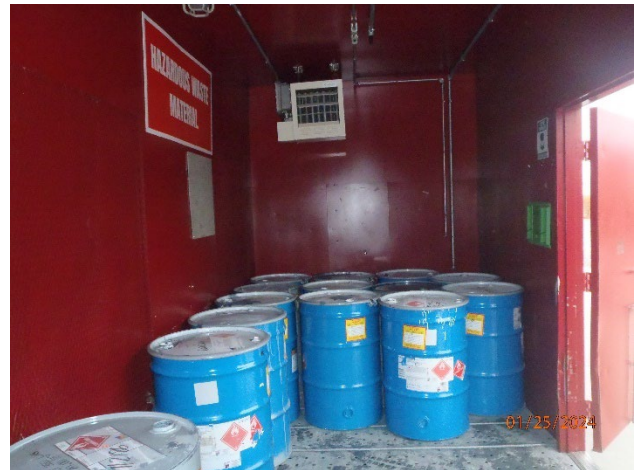
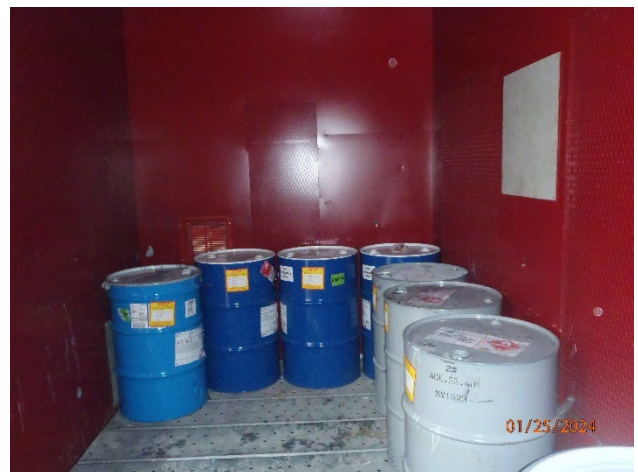
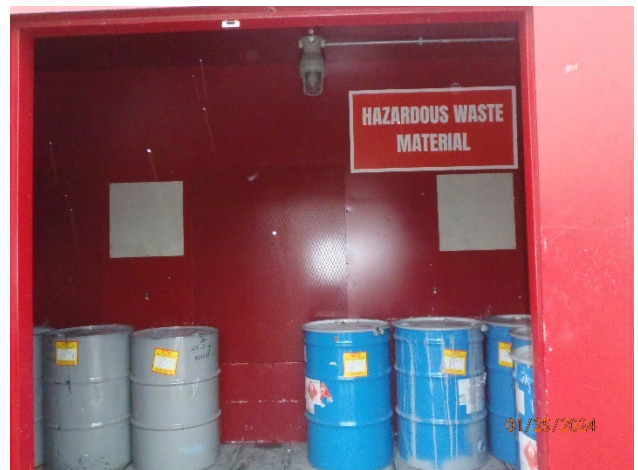
The CAA was stored inside a Convex Secureall container (Pictures 12-15). The inspectors observed that the exterior was placarded with "Danger", "No Smoking" and "Authorized Personnel Only" signs and the door was locked. Inside the container were 20 55-gallon drums of hazardous paint waste with the oldest drum date of January 9, 2024. The drums were closed, labeled, and dated.

The floor of the container was grated for secondary containment. However, at the time of the inspection, there was no aisle space between the drums.

**Pursuant to ADEM Admin. Code r. 335-14-3-.01(7)(a)6 [40 C.F.R. § 262.17(a)(6)], which incorporates ADEM Admin. Code r. 334-14-3-.14(6) [40 C.F.R. § 262.255], and is a condition of the LQG Permit Exemption, a generator is required to maintain aisle space to allow the unobstructed movement of personnel, fire protection equipment, spill control equipment, and decontamination equipment to any area of facility operation in an emergency, unless aisle space is not needed for any of these purposes.**

| Observation | Corrective Action | Attached File/Documentation |
|---|---|---|
| 6. Central Accumulation Area aisle space is not sufficient. | <p>A second Central Accumulation Area has been added for the storage of hazardous waste drums to prevent inadequate aisle space.</p> <p>This new location will adhere to all storage requirements listed in 40 CFR 262.17, including separate weekly inspections.</p> <p>This location is also displayed on the Contingency Plan Quick Reference Guide – Site Overview Map.</p> <p>Signage for this storage area has been ordered but not yet received. Photographs documenting the installation of these signs will be sent in a follow up email with the sweeper water characterization results.</p> | Signage Receipt.pdf |

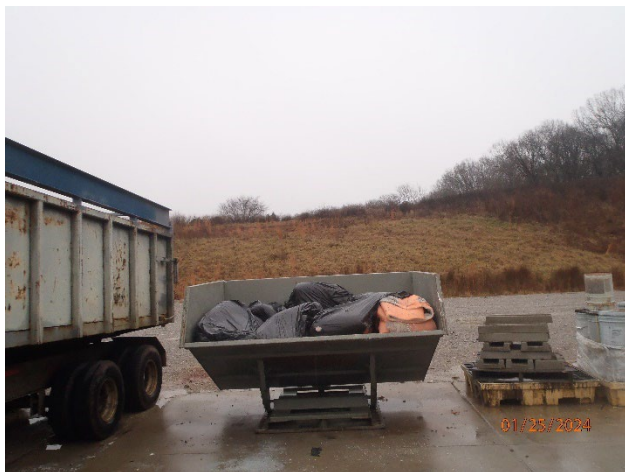
Picture 10 – Discarded Paint Booth filter roll-off

Outside the building was a gray dumpster with trash bags filled with spent paint filters and belt sanders (Picture 11). Mr. Horton explained that the paint filters had been analyzed and were non-hazardous. The spent filters were permitted by ADEM to be disposed of at Morgan Decatur Landfill.
