REPORT OF COMPLIANCE EVALUATION INSPECTION  
(CONSTRUCTION STORM WATER)

**Ioway Creek Restoration and Flood Mitigation-Construction**

2000 feet each side of South Duff Avenue

FEBRUARY 9 AND 10, 2022

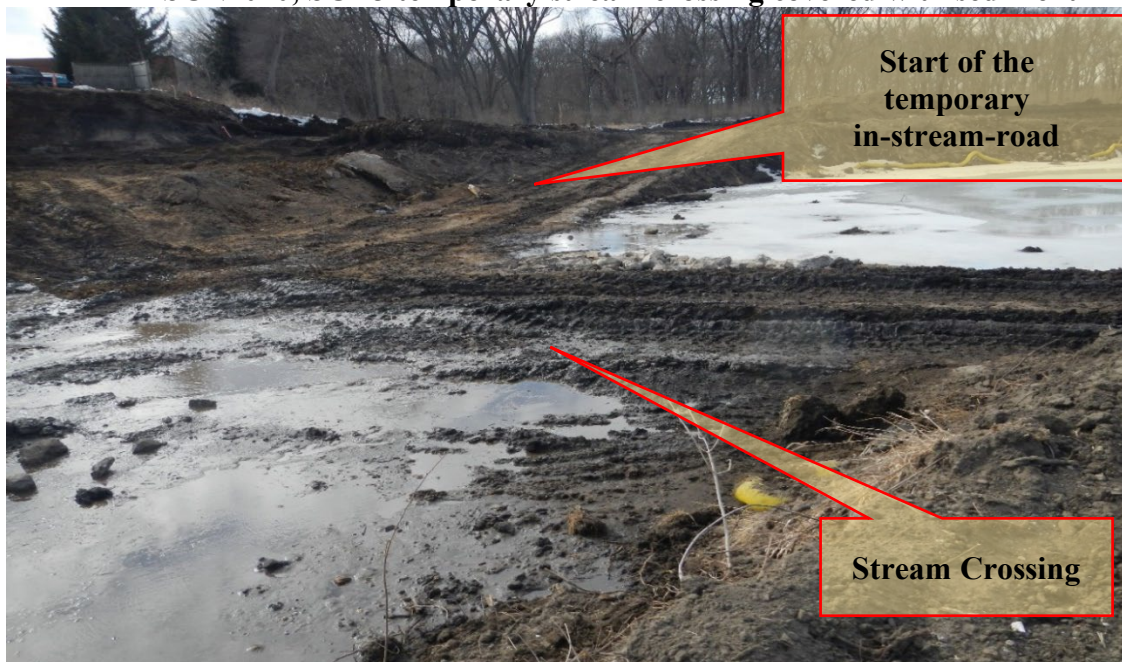
12. I pointed out to Mr. Moore that the temporary stream crossings CS #2 and CS #3 and the in-stream-road appeared to be constructed from dirt. I also pointed out because of the ongoing vehicular activities on the temporary stream crossings SC #3 and the in-stream-road, significant amount of sediment entered and were entering the waters of Ioway Creek (Stream) (DSCN1044, 1050, and DSCN1068-1070) as shown in DSCN1070 below.

**DSCN1070, SC #3 temporary stream crossing covered with sediment**

Therefore, I issued Notice of Preliminary Findings Number 2 (NOPF #2) for the improper design and maintenance of the temporary stream crossing SC #3 and allowing the sediment to enter the Stream. NOPF #2 should also include the temporary in-stream-road and temporary stream crossing SC #2.

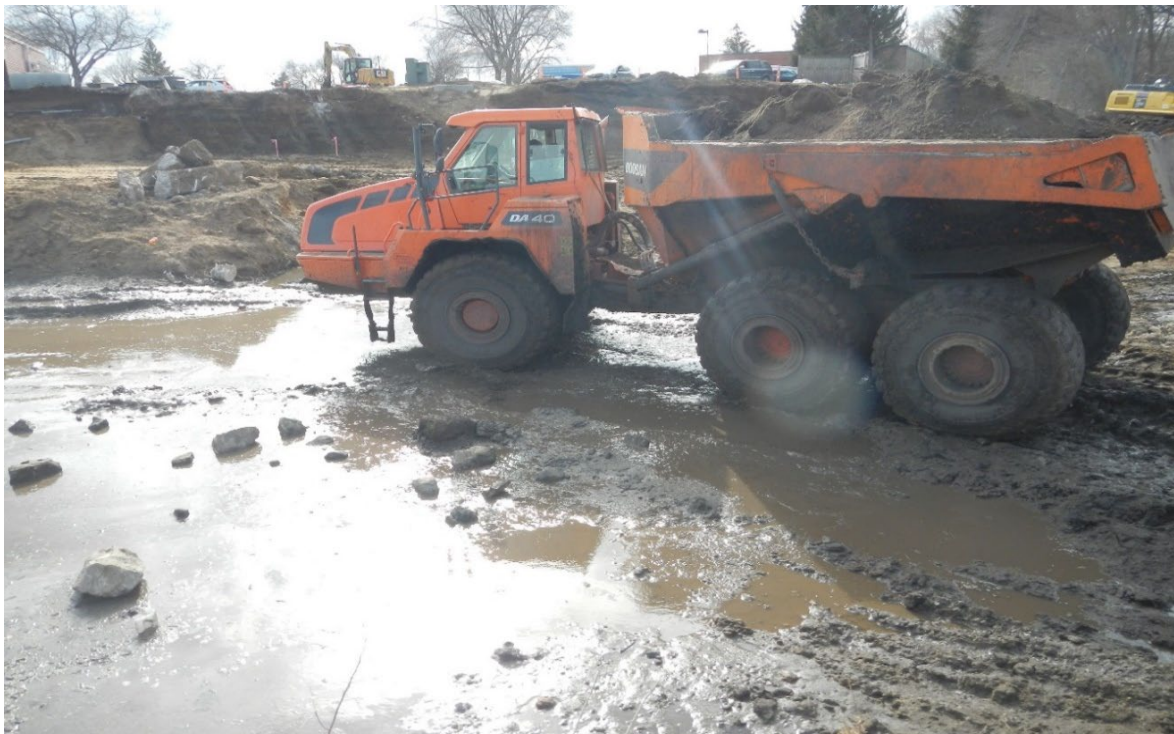
15. IDOT 2547.02 requires furnishing the fill materials but not obtain it from the stream unless specifically allowed elsewhere in the contract documents. Mr. Moore pointed out to me that the current stream crossings and the in-stream road are temporary structures and are constructed from a 12 to 18-inch layer of rocks to allow pathway for trucks to haul dirt from the site to a nearby farm. He added, hauling of dirt should be completed in three days. I informed him, based on my observation, trucks were continuously driving over temporary stream crossing SC #3 and the temporary in-stream-road, causing dirt/sediment to accumulate and completely cover the structures as shown in DSCN1069 below.

**DSCN1069, Dirt truck crossing Ioway Creek over SC #3 stream crossing**

16. In addition to my NOPF #2, IDOT Section 2547.03.D. requires the operator to maintain the temporary structures to prevent unnecessary erosion and other non-point sources of pollution.

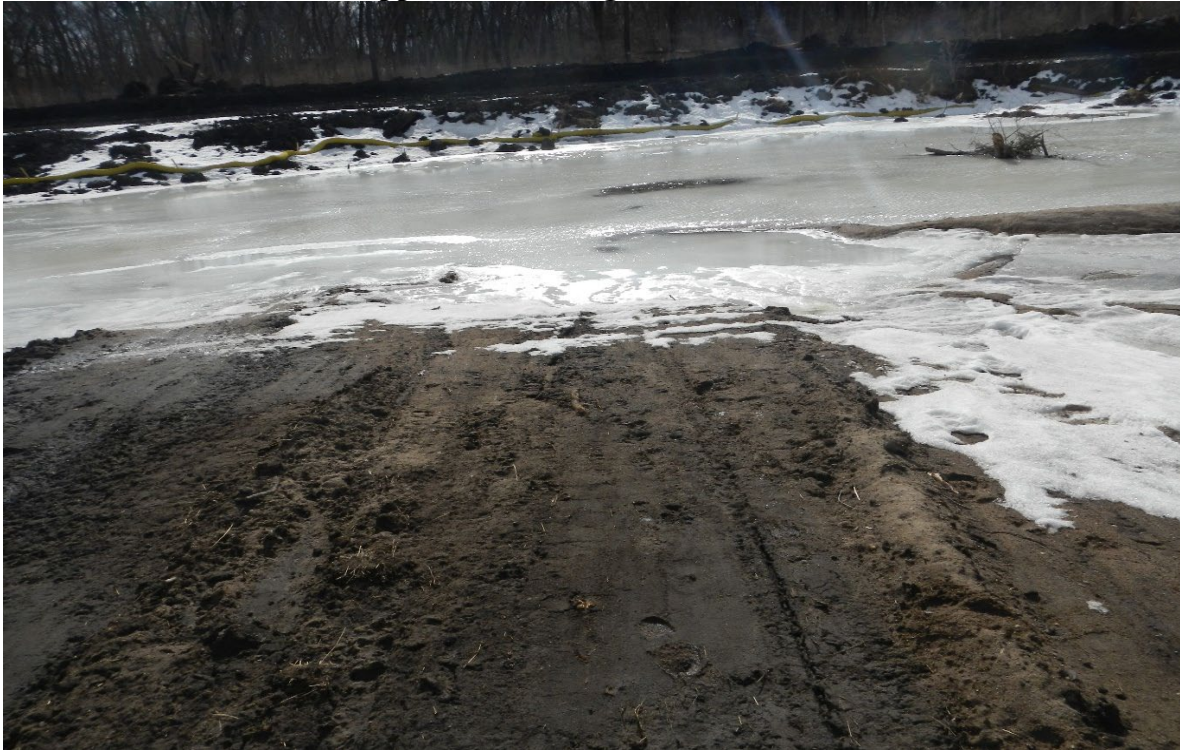
20. As mentioned above in item 15, according to inspection reports and Mr. Moore, SC #1 was removed. However, I pointed out to site personnel that the inactive temporary stream crossings SC #1 appeared to be abandoned for an extended period of time but not completely removed as shown in DSCN1073 below. In addition, IDOT Section 2547.03.E. requires the permittee to completely remove temporary structures and return affected areas to preconstruction conditions within 30 calendar days of no longer being needed. According to site inspection records (Attachment 4), the inactive temporary crossings SC #1 was constructed prior to May 24, 2021, and was removed on December 27, 2021, after the IDNR site visit on December 22, 2021. Therefore, the permittee did not comply with the requirements of IDOT Section 2547.03.E. as required by the SWPPP.

**DSCN1073, SC #1, appeared submerged under the waters of the Stream**

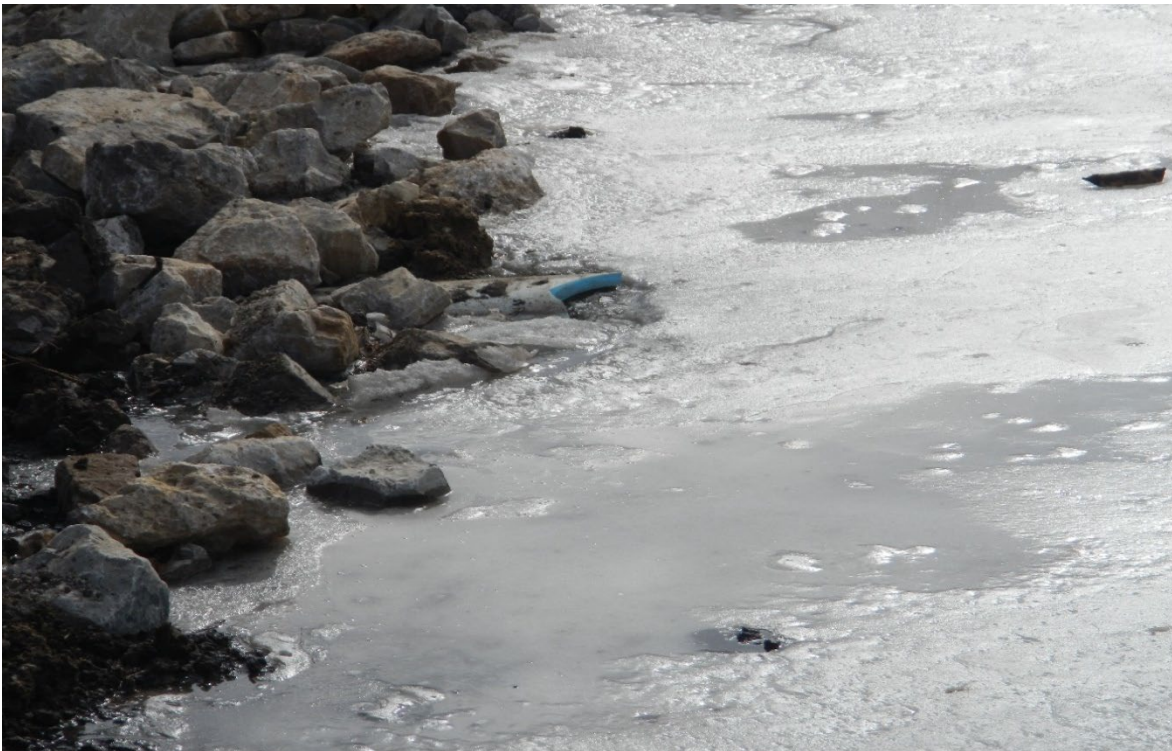
22. I observed one 12-inch pipe that ran beneath SC #3 (DSCN1071). Mr. Moore indicated that there are two 12-inch pipes beneath SC #3 but only one was visible. However, sediment was accumulating at the inlet of the 12-inch pipe. as shown in DSCN1071 below.

**DSCN1071, Inlet of 12-inch pipe beneath Stream Crossing SC #3**

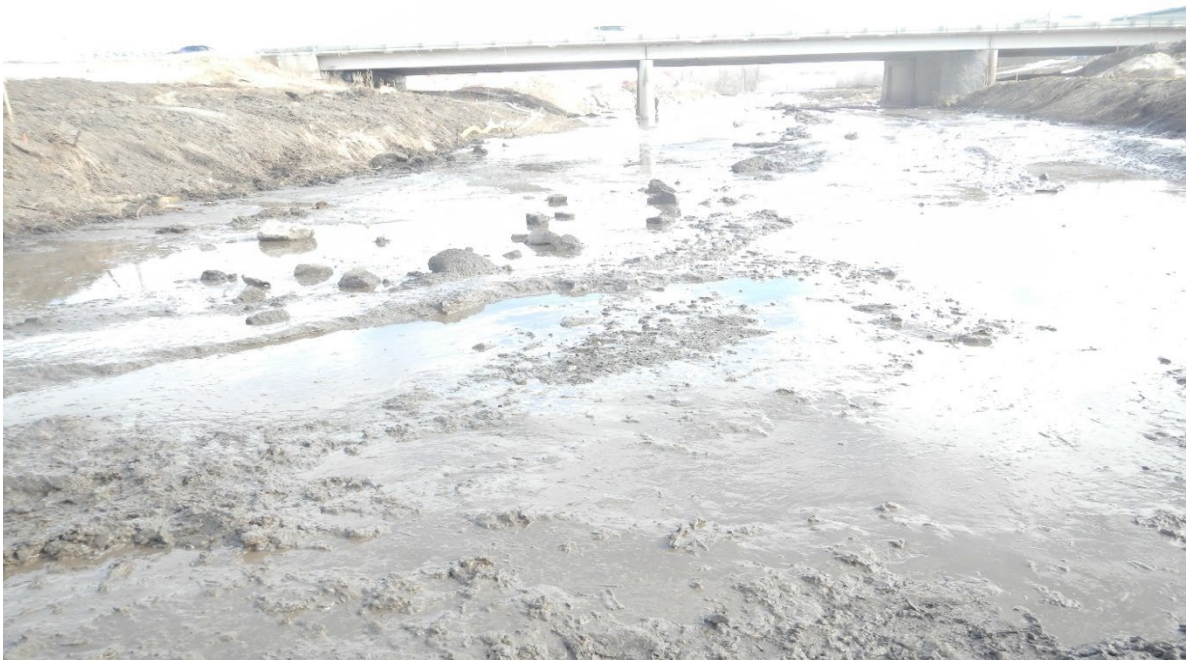
24. I pointed to Mr. Moore that trucks were driving fast, and dirt was falling off them into the Stream. I also pointed out to him that there was a significant amount of sediment in the Stream and the water was significantly muddy and murky. Moreover, I mentioned that maintaining of the temporary crossing CS #3 and the temporary in-stream-road did not exist to prevent sediment from entering the Stream. Therefore, I issued a NOPF #1 for the significant accumulation of sediment in the Stream. The sediment extended approximately 380 feet starting at SC #3 250 feet west of the Bridge to approximately 50 feet east of the Bridge at the end of the temporary in-stream-road ramp exiting the Stream as shown in DSCN1066 below.

**DSCN1066, Sediment extended approximately 380 feet downstream from SC #3**

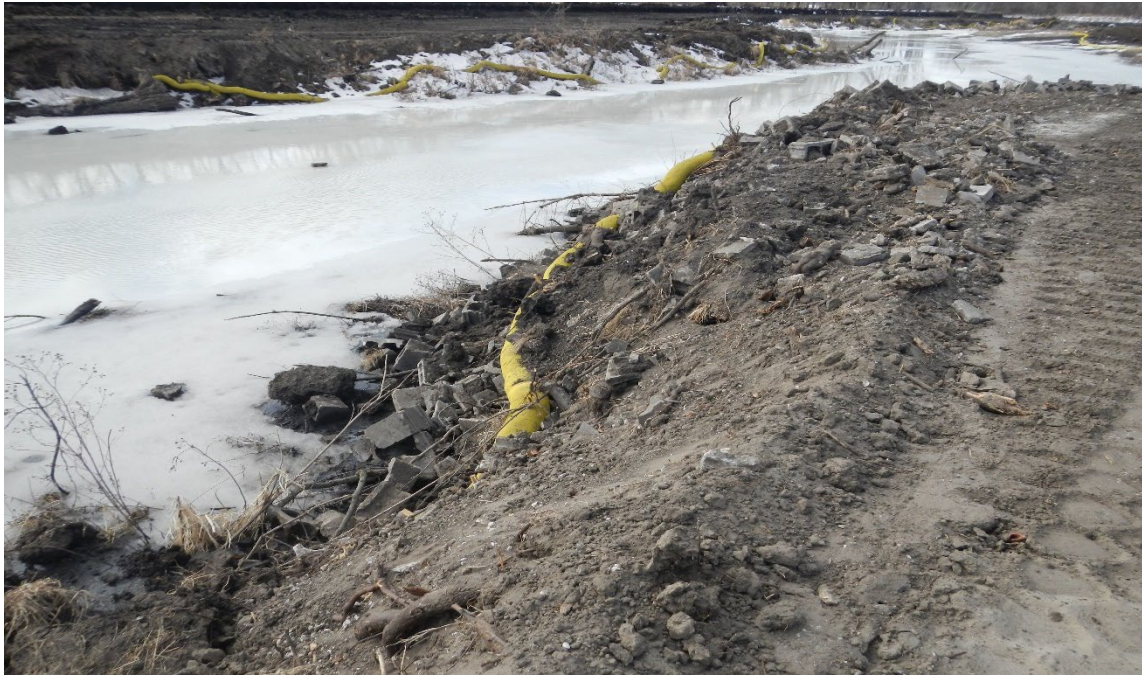
25. I issued NOPF #3 for the inadequate use and poor maintenance of sediment and erosion controls on site. The only method of sediment control on site was the use of wattles. Wattles were installed incorrectly either at the bottom of the Stream bank, on the bank itself, or at the top edge of the bank (see photos in Attachment 7 and DSCN1074 below). Overall, all wattles in place were ineffective. One exception is a small section of wattles at the far end of the east section of the project (SE and NE quadrant) installed at the top edge of the bank that appeared somewhat effective. Even though this small section appeared somewhat effective (DSCN1086 and 1087), there were issues. Some sections were not anchored all the way to the ground, and some sections had dirt on top of them from dirt falling off the trucks while hauling dirt off site and grading ground.

scheduled to be installed by Green Tech on December 22 and 23, 2021 along the SE quadrant as soon as the grading is completed. Wattles, however, were installed in place of silt fence. Wattles were installed in the SE and NE quadrants in the end of December 2021, and in the NW and SW quadrants on January 3, 2022. There was no explanation in the SWPPP of why wattles were used in lieu of silt fence as required by the SWPPP. Wattles were also used during the first phase of the project as mentioned in item 4 above.

**DSCN1072, Ineffective use of sediment controls throughout the site**

29. I informed site personnel that preventing and controlling sediment from entering the waters of the United States and installing erosion and sediment controls correctly should be the responsibility of whom the SWPPP identified. Based on the sound judgment of the site operators/inspectors, I added that structural controls and non-structural controls can be modified, added, or removed but such activities shall be documented. I also informed site personnel that the SWPPP is an active and an ongoing document.
