## **RCRA Inspection Report**

Nouryon Functional Chemicals, LLC  
13440 Highway 43 North  
Axis, Alabama 36505

EPA ID# ALD008161176

August 02, 2022

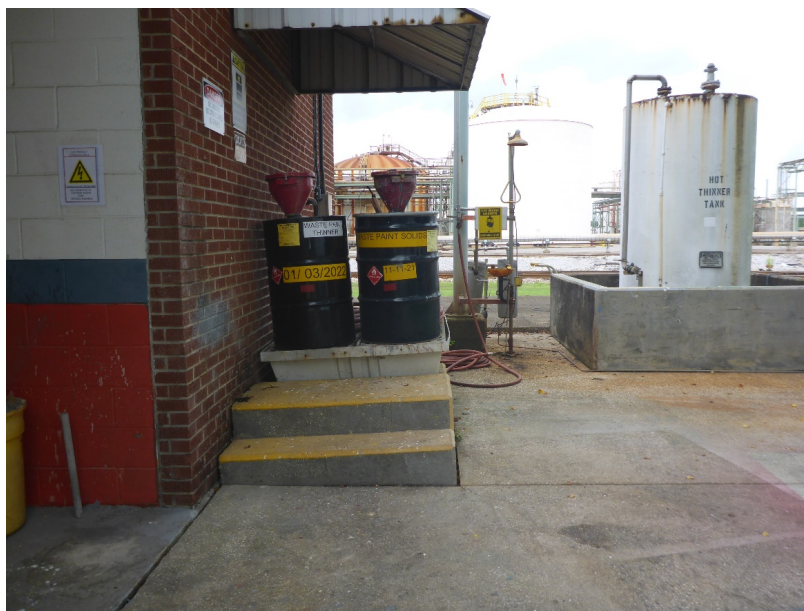
Nouryon manages two SAAs in the Paint Shop Area (Photo 1). Hazardous waste paint thinner is accumulated in the first SAA as D001 hazardous waste flammable liquid (toluene/methanol). The inspectors observed one 55-gallon drum in this SAA. The container was labeled as hazardous waste, identified with a flammable liquid DOT hazard placard, and identified as containing hazardous or toxic wastes. Hazardous waste paint solids are accumulated in the second SAA as D001 hazardous waste paint solids. The inspectors observed one 55-gallon drum in this SAA. The drum was labeled as hazardous waste, identified with a flammable liquid DOT hazard placard, and identified as containing hazardous or toxic wastes.

**Photo 1:** Two SAAs in the Paint Shop Area. One SAA is used to accumulate hazardous waste paint thinner as D001, F003, F005 hazardous waste flammable liquid (toluene, methanol), the other is used to accumulate hazardous waste paint solids as D001, F003, F005 hazardous waste paint related material.

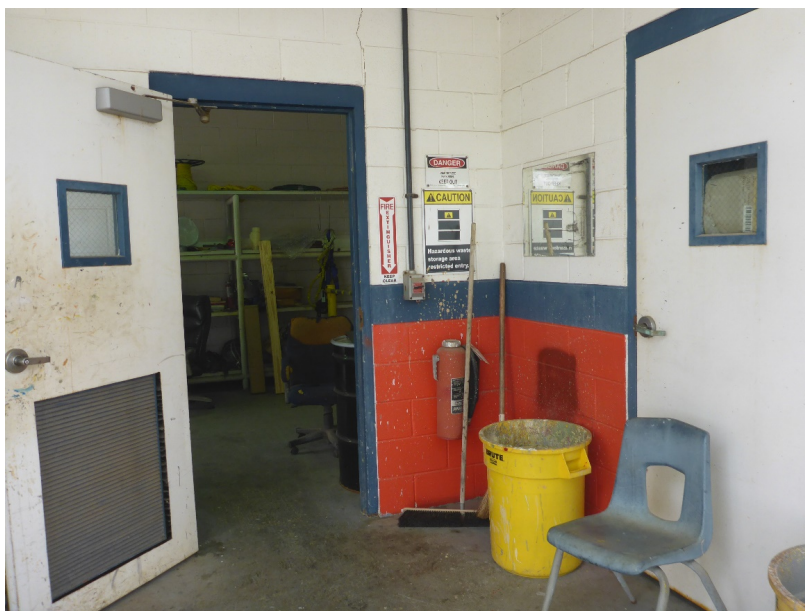
Paint Shop CAA: Nouryon manages a CAA inside the Paint Shop. The area (Photo 2) is identified with signs reading “danger,” “unauthorized personnel keep out,” “caution hazardous waste storage area,” and “no smoking,” and it is equipped with a fire extinguisher, spill control equipment, and an emergency shower and eyewash station. Facility personnel stated that all employees who work in this area carry two-way hand-held radios, which can be used to summon emergency assistance.

The inspectors observed one 55-gallon drum on a portable secondary containment unit in this CAA. The drum was labeled as hazardous waste flammable liquids (oils/xylene) and dated July 14, 2022. It was identified with a flammable liquid DOT hazard placard and identified as containing hazardous or toxic wastes.

**Photo 2:** Entrance to the Paint Shop CAA. Signs reading “danger,” “unauthorized personnel keep out,” “caution hazardous waste storage area,” and “no smoking.”

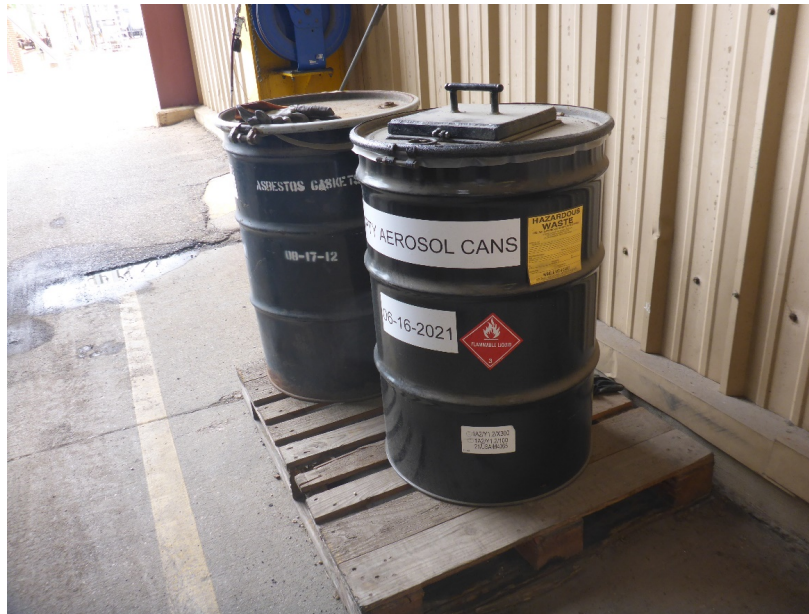
The first SAA, which is located in a covered area leading into the Maintenance Shop, is used to accumulate empty aerosol cans (Photo 3). The inspectors observed one 55-gallon drum on a wooden pallet in this SAA. The drum was labeled D001 hazardous waste (acetone, toluene), identified with a flammable liquid DOT hazard placard, and identified as containing hazardous or toxic wastes. The inspectors also observed a second 55-gallon drum for accumulating asbestos gaskets in this area.

**Photo 3:** Maintenance Shop SAA for accumulating empty aerosol cans as D001 hazardous waste (acetone, toluene).

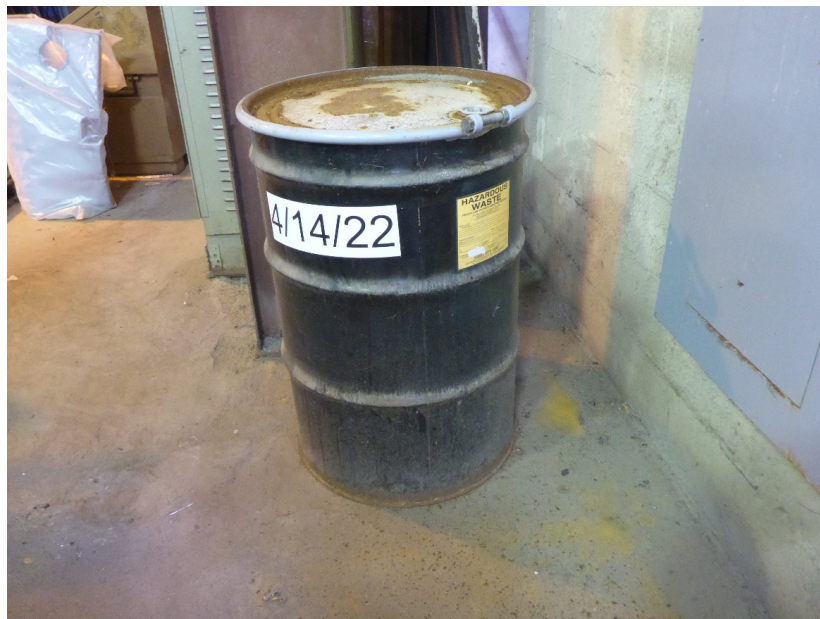
The second SAA (Photo 4), which is located behind the bead blast unit inside the Maintenance Shop, is used to accumulate grit blast media generated in the bead blast unit. The inspectors observed one 55-gallon drum in this SAA. The drum was labeled D004, D006 hazardous waste grit blast media and identified as containing hazardous or toxic waste.

**Photo 4:** Maintenance Area SAA for accumulating spent grit blast media as D004, D006 hazardous waste solids.

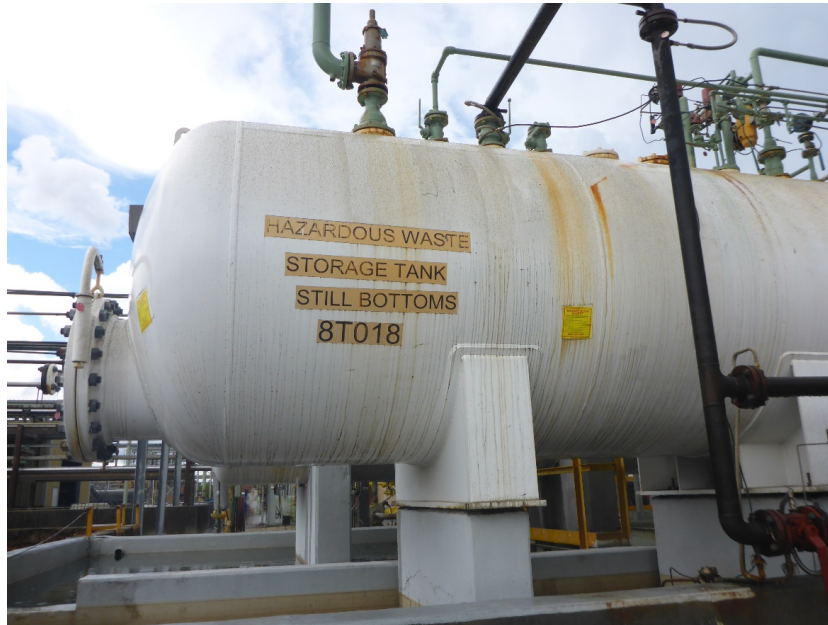
Hazardous Waste Tank 8T018: According to facility personnel, the CS<sub>2</sub> production process includes a distillation step to remove impurities from the CS<sub>2</sub> finished product. The concentration of removed impurities increases over time until the distillation bottoms must be pumped from the process tank to the 5,000-gallon hazardous waste storage tank, Tank 8T018 (Photo 5). The inspectors observed this tank, which was identified as D001, D018 hazardous waste flammable liquid (carbon disulfide, benzene) on a label indicating that the contents of the tank are hazardous or toxic wastes. The inspectors also observed an accumulation start date of June 29, 2022, on the tank's hazardous waste label.

**Photo 5:** 5,000-gallon hazardous waste storage tank, Tank 8T018.

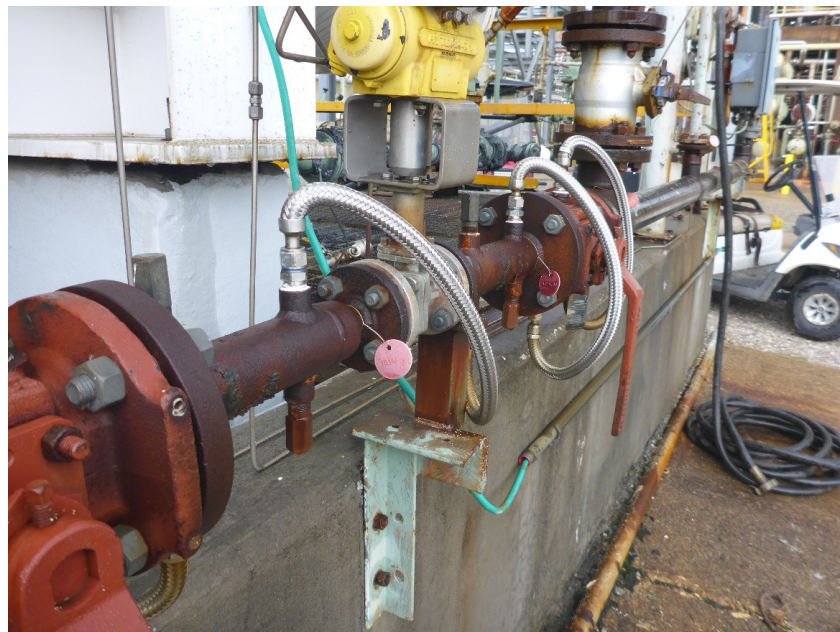
The inspectors observed tags (numbers 1250, 1310, 1310.5, 1314, 1314.3, 1315, and 1316) on equipment associated with hazardous waste Tank 8T018 (Photo 6).

Air Monitoring Records: On September 19, 2022, Mr. Mitchell submitted records of air monitoring conducted between January 01, 2021, and July 31, 2022, under the facility's leak detection and repair (LDAR) program of the Title V Permit. The records indicate that ancillary equipment associated with Tank 8T018, including the observed tagged equipment, is monitored as part of the LDAR program.

**Photo 6:** Equipment tags to identify Tank 8T018 ancillary equipment that is subject to air monitoring under RCRA Subpart BB.

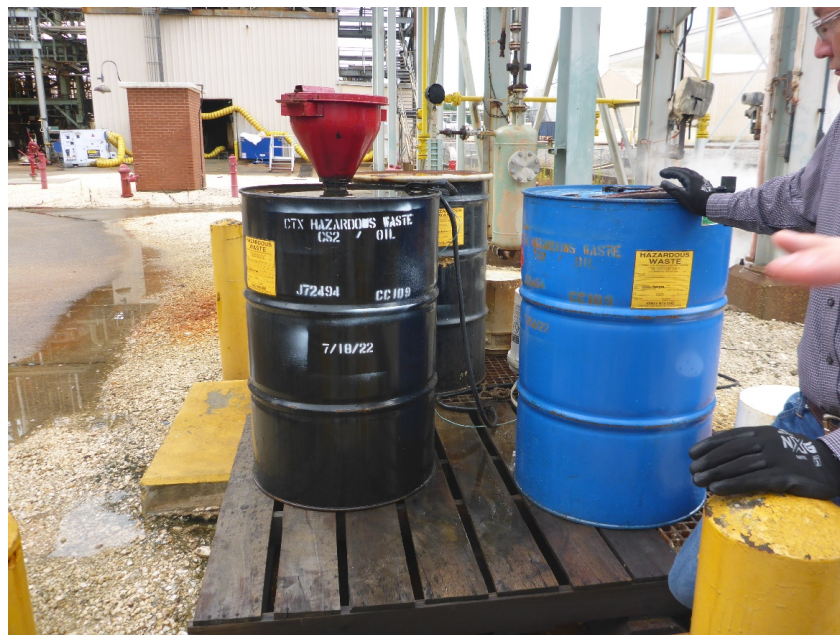
Crystex SAA: Nouryon manages two SAAs (Photo 7) in the Crystex Plant Area for managing hazardous waste generated in the Crystex Plant. Any liquids that drain from process equipment during decontamination or maintenance activities are accumulated in a 5-gallon bucket and brought to the first SAA. The inspectors observed two 55-gallon drums in this SAA. Both drums were labeled D001, D018 hazardous waste flammable liquids (oils, xylene) and identified as containing hazardous or toxic wastes. One drum was partially full, and the other, which was equipped with a funnel, was completely full. The total volume of hazardous waste in this SAA had exceeded 55-gallons, but neither of the drums was marked with an accumulation start date.

The Crystex Plant process equipment includes two filter houses for filtering material in the process. Facility personnel stated that only one filter is in use at any given time, and the filters may be changed when that filter house is not in use. Filter changes occur on an as-needed basis and may occur once every few months or several times in a single week. Used filters are accumulated as hazardous waste in the Crystex Plant's second SAA. The inspectors observed one 55-gallon drum in this SAA. The drum was labeled as hazardous waste flammable liquids (D001, D018 - Filters), and identified as containing hazardous or toxic wastes.

**Photo 7:** Two SAAs in the Crystex Plant Area. One SAA is used to accumulate hazardous waste liquids that are generated from decontamination and maintenance activities as D001, D018 hazardous waste flammable liquid (oils, xylene), the other is used to accumulate used filters that are generated in the Crystex Plant as D001, D018 hazardous waste solids.

Facility personnel immediately marked an accumulation start date on the full 55-gallon drum and moved it to the facility's hazardous waste CAA.
