**INSPECTION REPORT**

<b>Inspection Date:</b>	7/28/22	Inspection Announced: No
<b>Time:</b>	Entry: 9:15 AM (CST)	Exit: 10:45 AM (CST)
<b>Media:</b>	Water	
<b>Statute (s)/Program(s):</b>	Clean Water Act, National Pollutant Discharge Elimination System (NPDES), Industrial	
<b>Type of inspection:</b>	CEI - Compliance Evaluation Inspection	
<b>Access:</b>	Granted	
<b>Permittee Name:</b>		
APS Grupa LLC		
<b>Facility or Site Name:</b>		
APS Grupa LLC		
<b>Facility/Site Physical Address:</b>		
10459 S. Muskegon		
<b>(city, state, zip code)</b>		
Chicago, Illinois 60617		
<b>County/Parish:</b>		
Cook		
<b>Permit Number:</b>

The Facility is a starch and phosphate distributor and a contract packaging facility. The Facility has been operating at the 10459 S. Muskegon location for approximately 2 years. The Facility is not currently covered under an NPDES Permit, but the EPA was informed during this inspection that an application for an Industrial User (IU) Permit has been submitted to the Metropolitan Water Reclamation of Greater Chicago (MWRD). Along with the permit application, the Facility is also currently working with consultants from Gabriel Environmental to develop a Stormwater Poll

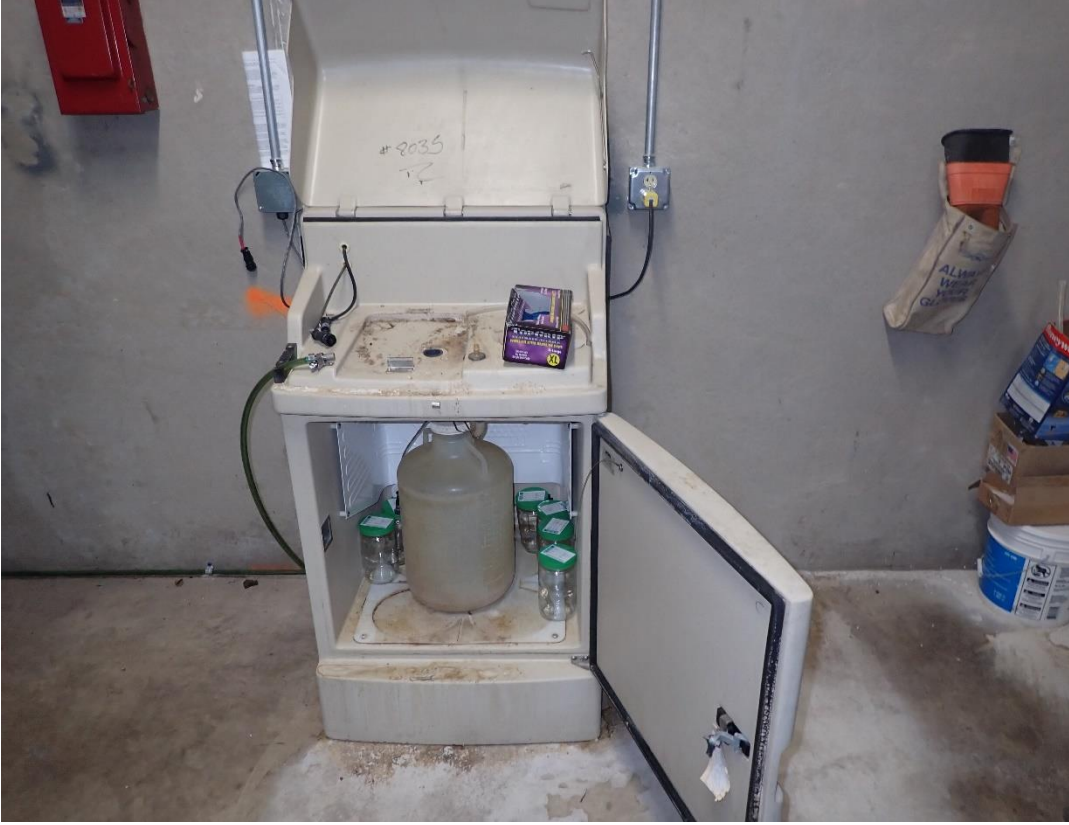
<b>Photo No.:</b> 1	<b>Time:</b> 9:41AM		
<b>Direction Photo Taken:</b>			
<b>Photo Description:</b> 24 Hour Sigma Composite Sampler.			
		<b>File:</b> APS_Grupa_001

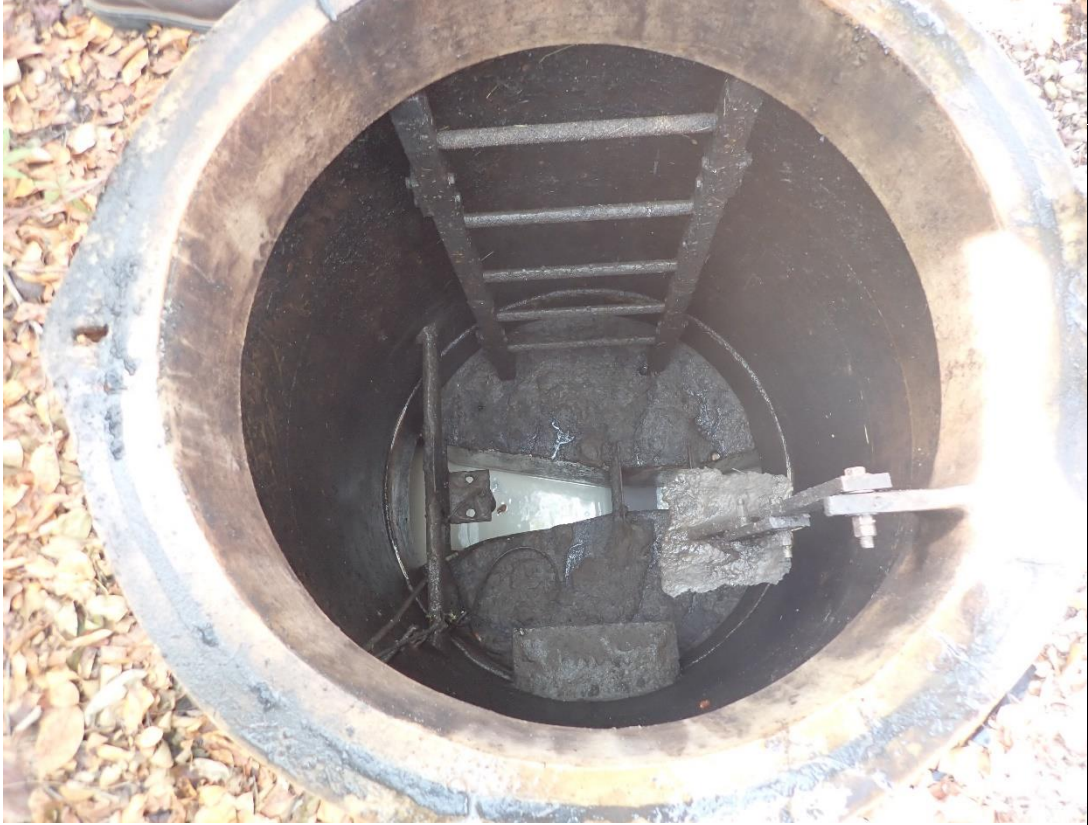
<b>Photo No.:</b> 2	<b>Time:</b> 9:45AM		
<b>Direction Photo Taken:</b> Down			
<b>Photo Description:</b> Sampling location for facility with a combined wastestream.		<b>File:</b> APS_Grupa_002

No.	
MS5-OB-001	Current planned facility sampling location includes waste from both sanitary and industrial wastewater sources. However, the permit application to MWRD states that the Facility does not currently have plans to adjust their categorical pretreatment limits with a CWF. 40 CFR § 403.6 outlines the method for calculating alternative pollutant limits at industrial facilities where regulated process effluent is mixed with other wastewaters prior to treatment.
MS5-OB-002	Facility composite sampler set up inside to take 24-hour samples. Thermometer not present within sampler. Sampling and holding requirements under 40 CFR Part 136 requires certain parameters to be preserved under a certain temperature. A thermometer is needed to confirm the temperature.
MS5-OB-003	Chemical storage within the Facility is located near a drain leading to the Facility settling tank. No secondary containment was present to prevent spills or other chemical releases from entering the Facilities treatment system.

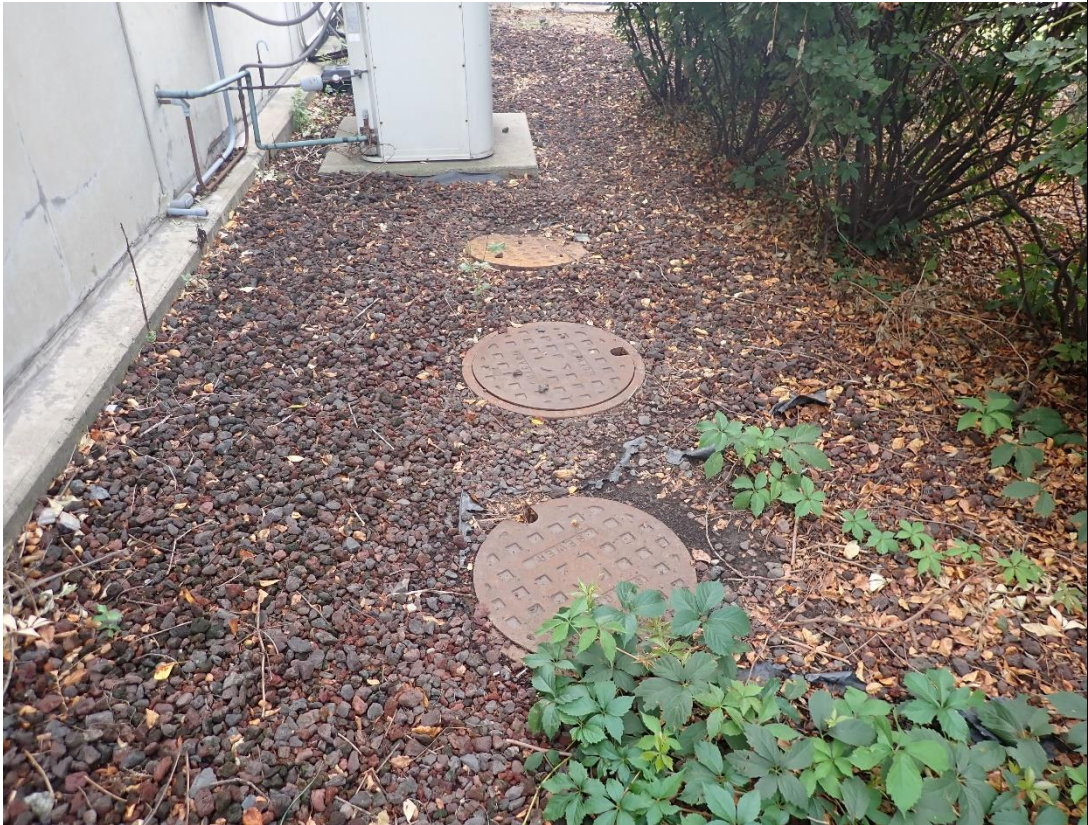
<b>Photo No.:</b> 3	<b>Time:</b> 9:48AM		
<b>Direction Photo Taken:</b> South			
<b>Photo Description:</b> Settling tank prior to discharge and sampling location.			
		<b>File:</b> APS_Grupa_003

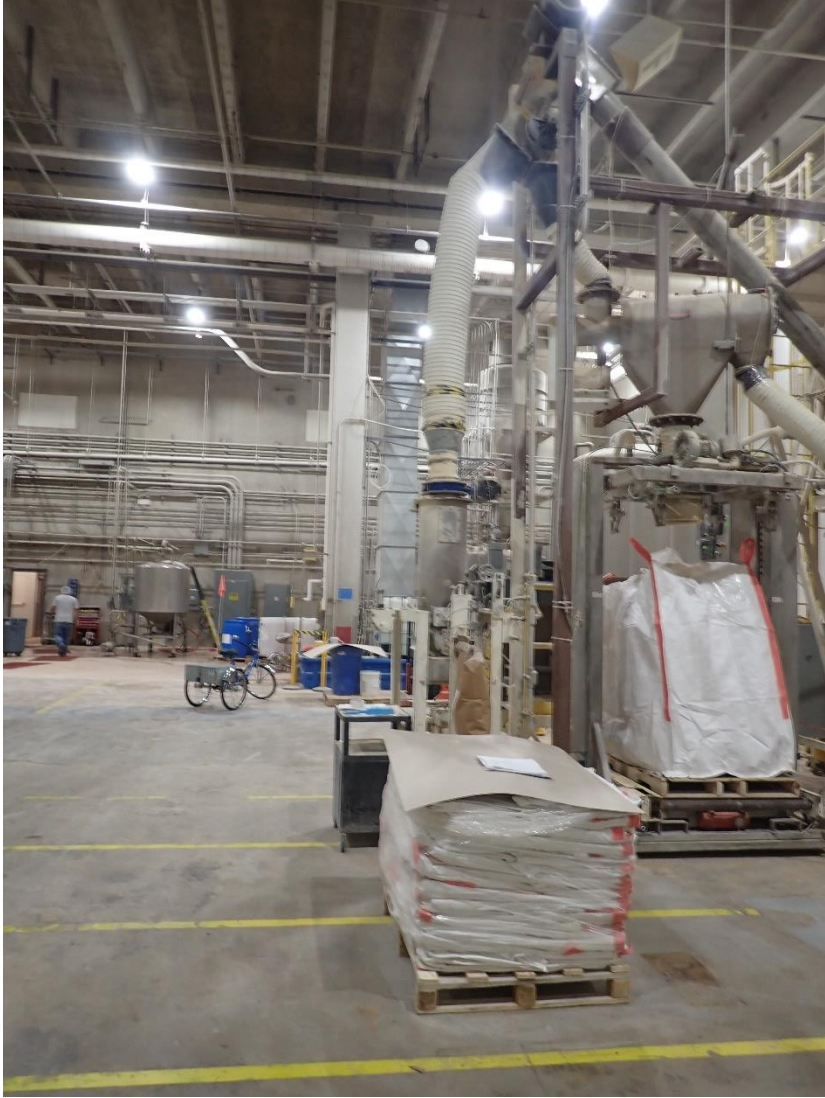
<b>Photo No.:</b> 4	<b>Time:</b> 9:57AM		
<b>Direction Photo Taken:</b> North			
<b>Photo Description:</b> Beginning of Facility soy process where water addition occurs.			
		<b>File:</b> APS_Grupa_004

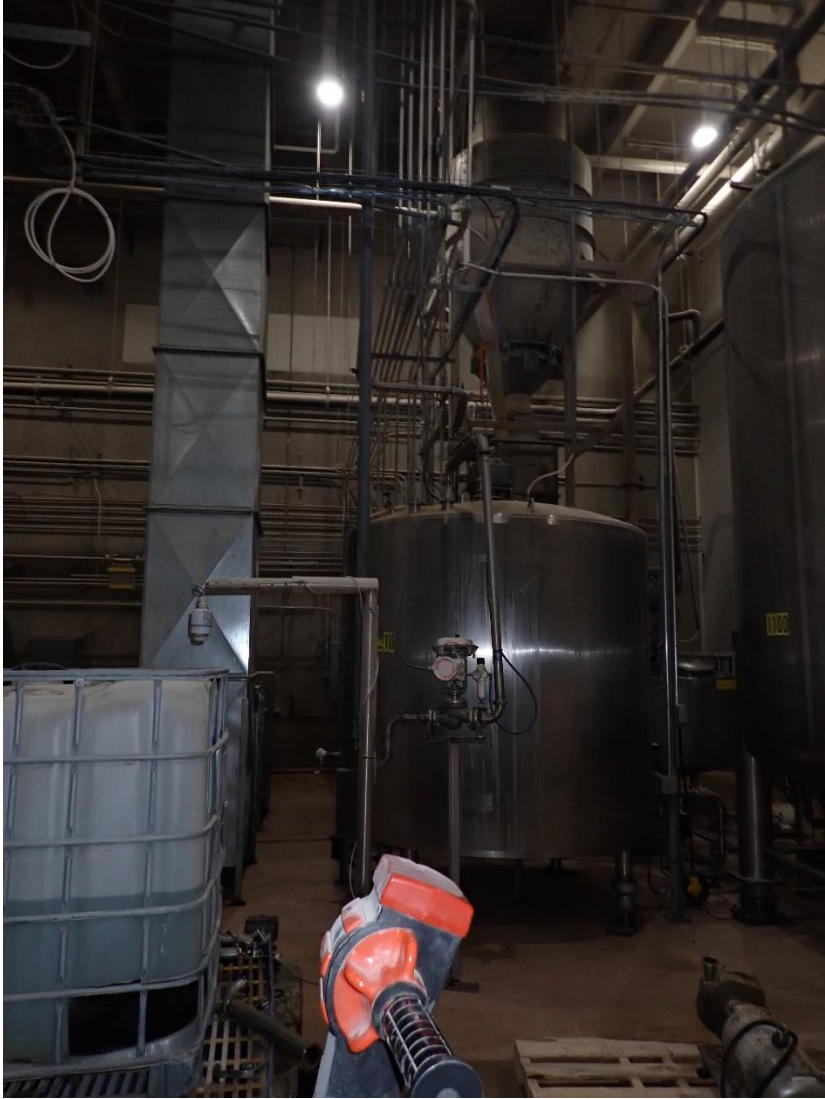
<b>Photo No.:</b> 5	<b>Time:</b> 9:59AM		
<b>Direction Photo Taken:</b> South			
<b>Photo Description:</b> Beginning of Facility soy process where water addition occurs.			
		<b>File:</b> APS_Grupa_005

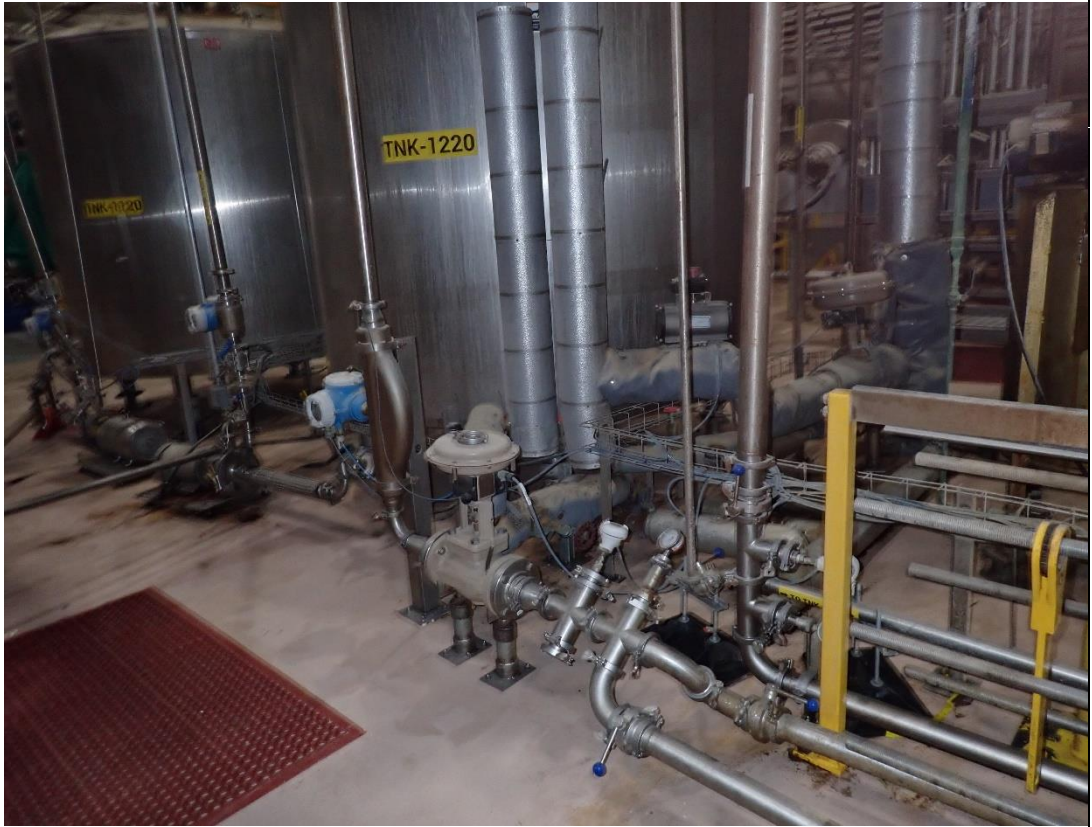
<b>Photo No.: 6</b>	<b>Time:</b>
-------------------------	--------------

**Photo Description:**  
Facility water flow  
process prior to heat  
exchange.

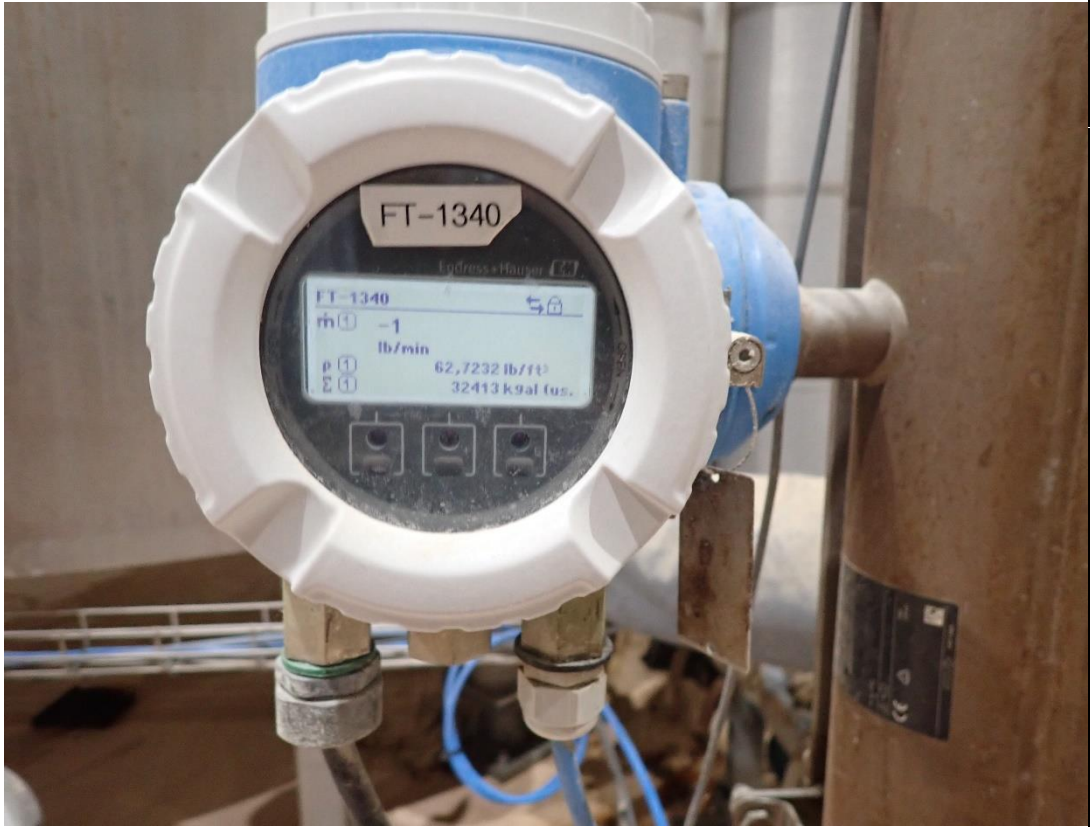
<b>Photo No.:</b> 7	<b>Time:</b> 10:00AM
-------------------------	-------------------------

**Photo Description:**  
Internal monitoring  
flow meter.

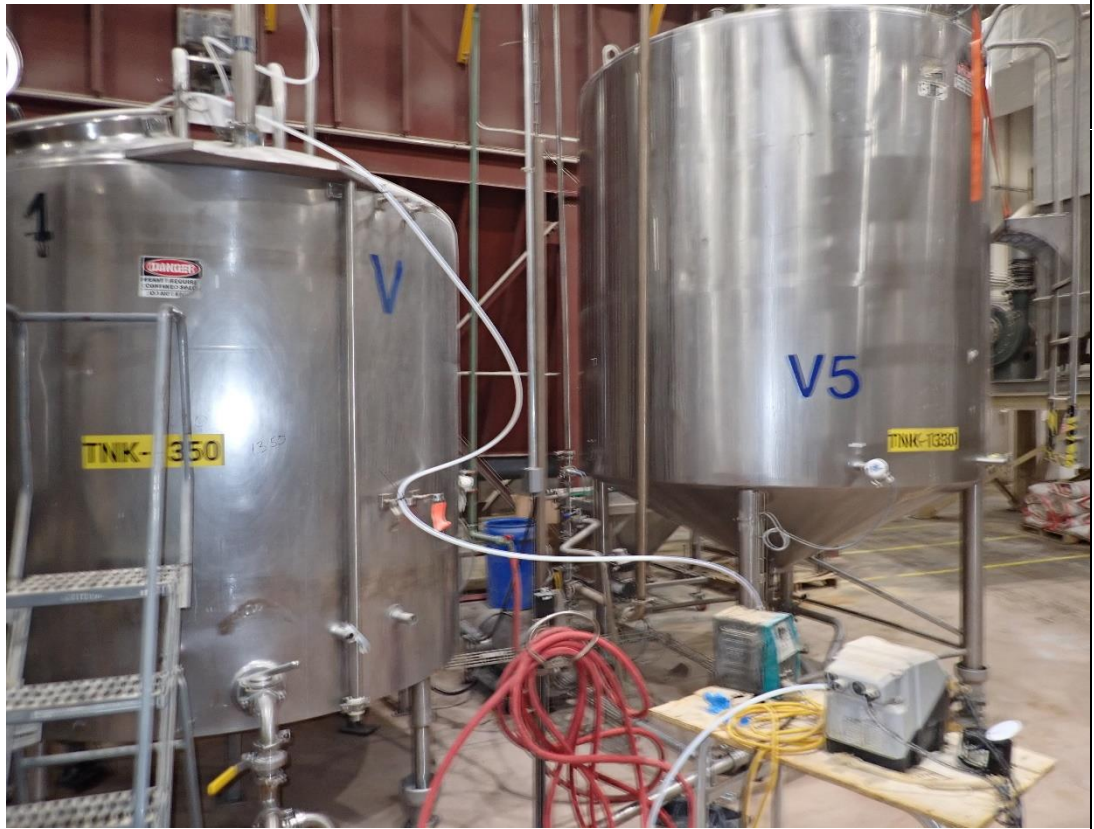
<b>Photo No.:</b> 8	<b>Time:</b> 10:01AM
---------------------	-------------------------

**Photo Description:**  
Tank V5, where pH adjustment is performed when necessary.

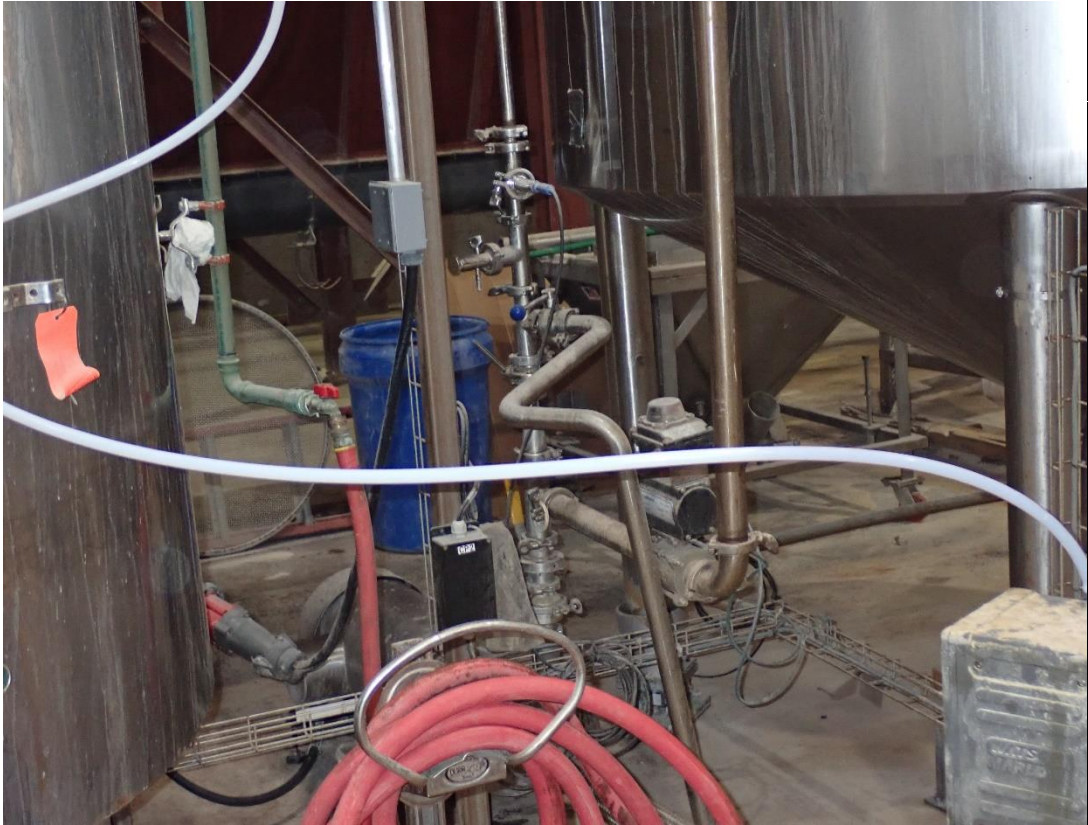
<b>Photo No.:</b> 9	<b>Time:</b>		
<b>Direction Photo Taken:</b> 10:01AM			
<b>Photo Description:</b> pH meter reading connection to V5 for pH adjustment.			
		<b>File:</b> APS_Grupa_009

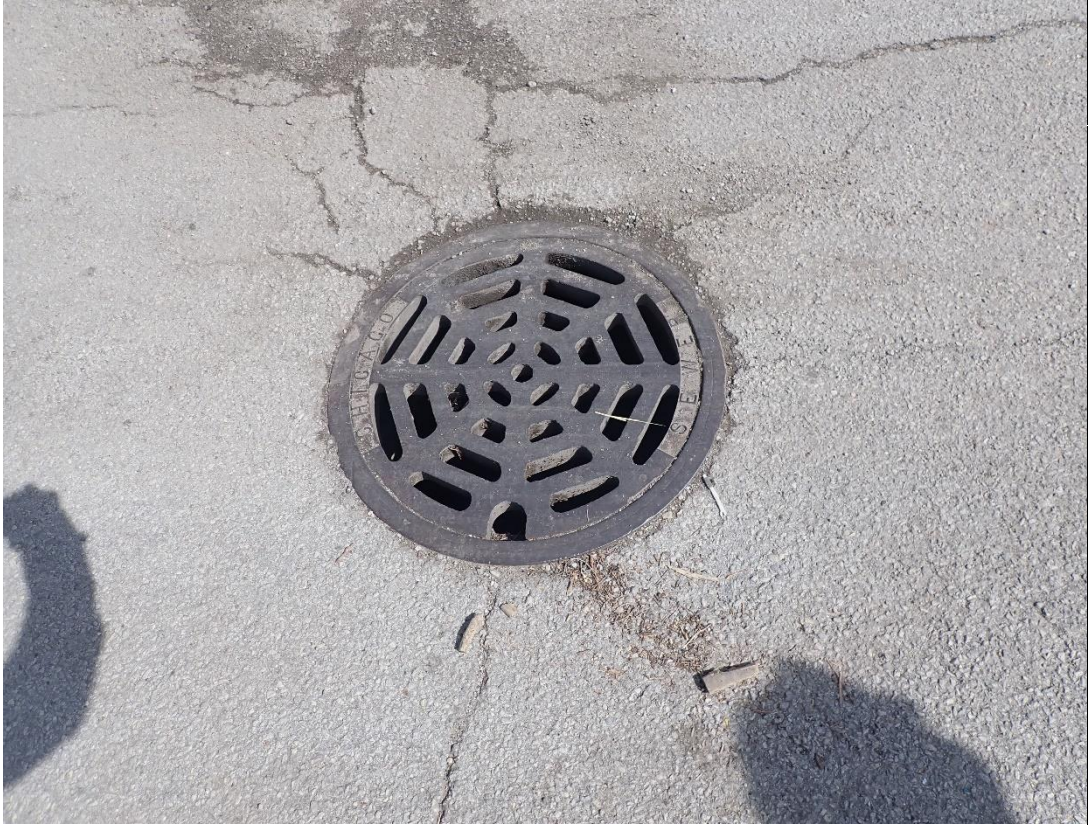
<b>Photo No.:</b> 10	<b>Time:</b> 10:06AM		
<b>Direction Photo Taken:</b> Down			
<b>Photo Description:</b> Stormwater manhole in driveway on south side of facility.			
		<b>File:</b> APS_Grupa_010

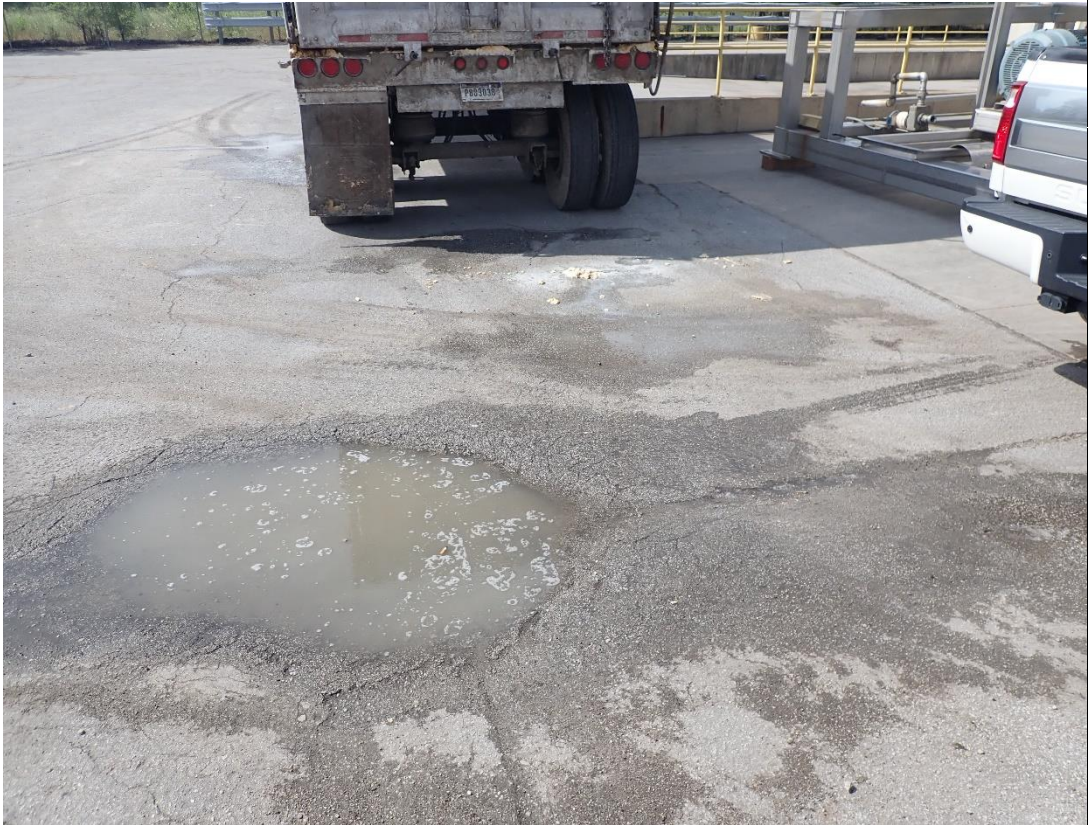
MS5-OB-005	Truck loading area in back South side of Facility contained some soy waste on the ground. Food waste has potential to enter the stormwater system at the Facility, bypassing the treatment systems.

<b>Photo No.:</b> 11	<b>Time:</b> 10:08AM		
<b>Direction Photo Taken:</b> South			
<b>Photo Description:</b> Truck loading area south side of facility.			
		<b>File:</b> APS_Grupa_011

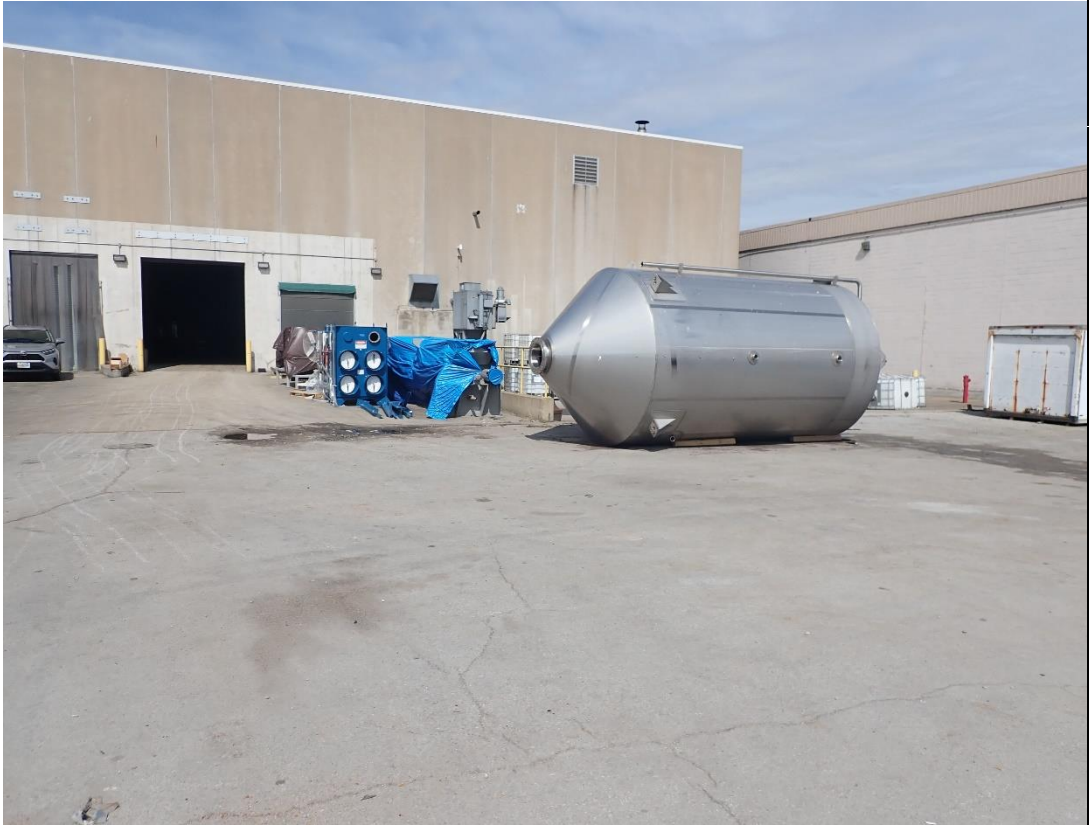
<b>Photo No.:</b> 13	<b>Time:</b> 10:10AM		
<b>Direction Photo Taken:</b> West			
<b>Photo Description:</b> Loading dock area and new tank awaiting installation in soy process.			
<b>File:</b> APS_Grupa_013

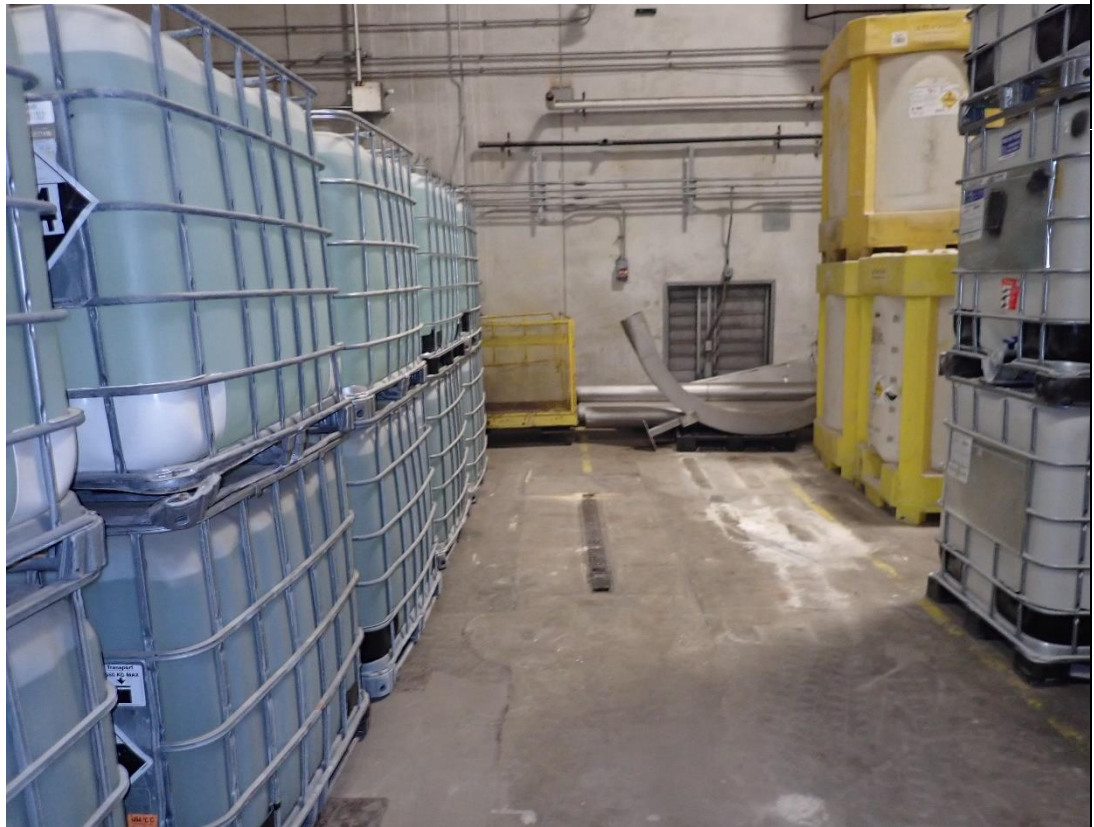
<b>Photo No.: 14</b>	<b>Time:</b> 10:13AM
----------------------	-------------------------

**Photo Description:**  
Chemical storage area inside facility.  
Drain leads to Facility's wastewater treatment system and settling tank

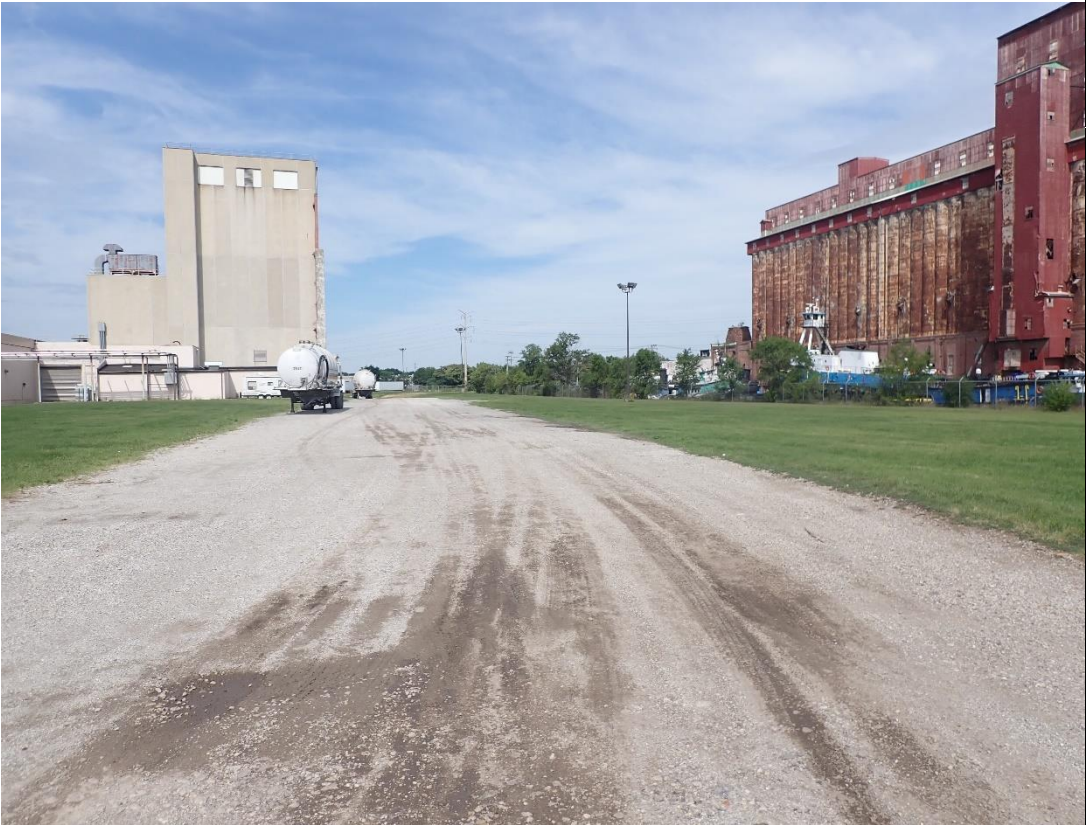
<b>Photo No.:</b> 16	<b>Time:</b> 10:18AM		
<b>Direction Photo Taken:</b> West			
<b>Photo Description:</b> Driveway from front parking lot.			
		<b>File:</b> APS_Grupa_016

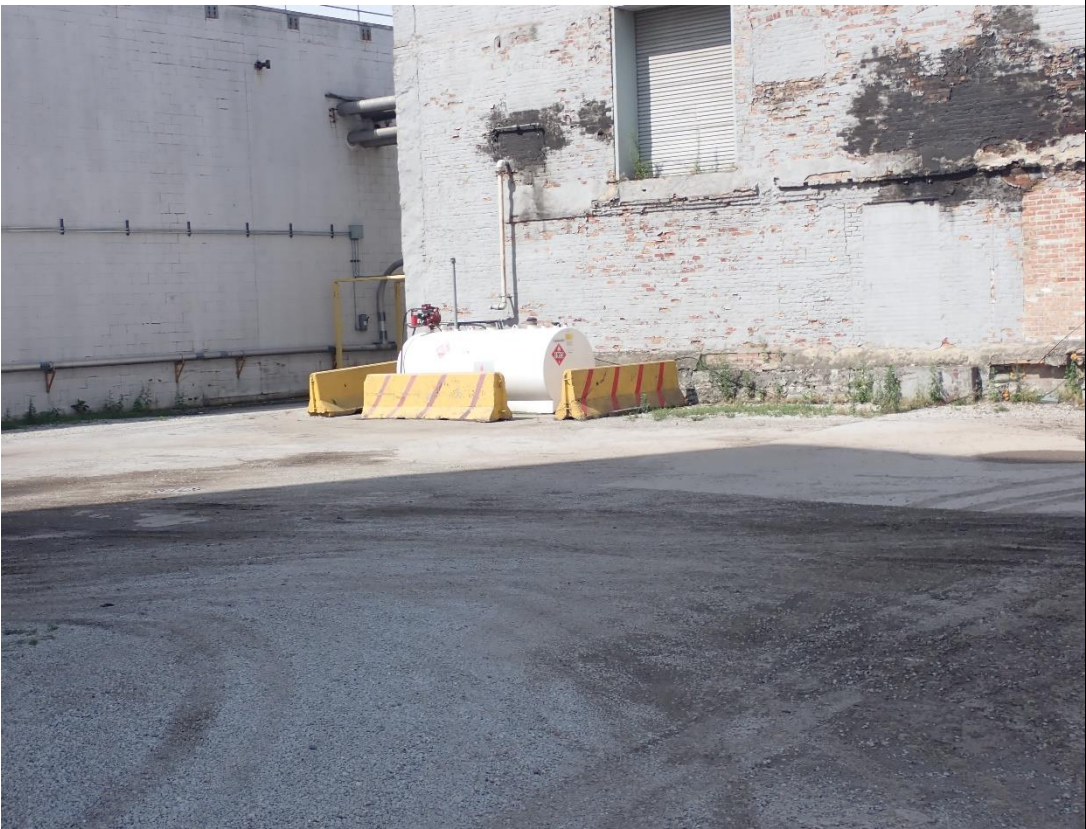
<b>Photo No.:</b> 17	<b>Time:</b> 10:21AM		
<b>Direction Photo Taken:</b> West			
<b>Photo Description:</b> Fuel Tank located on the North side of facility.			
		<b>File:</b> APS_Grupa_017

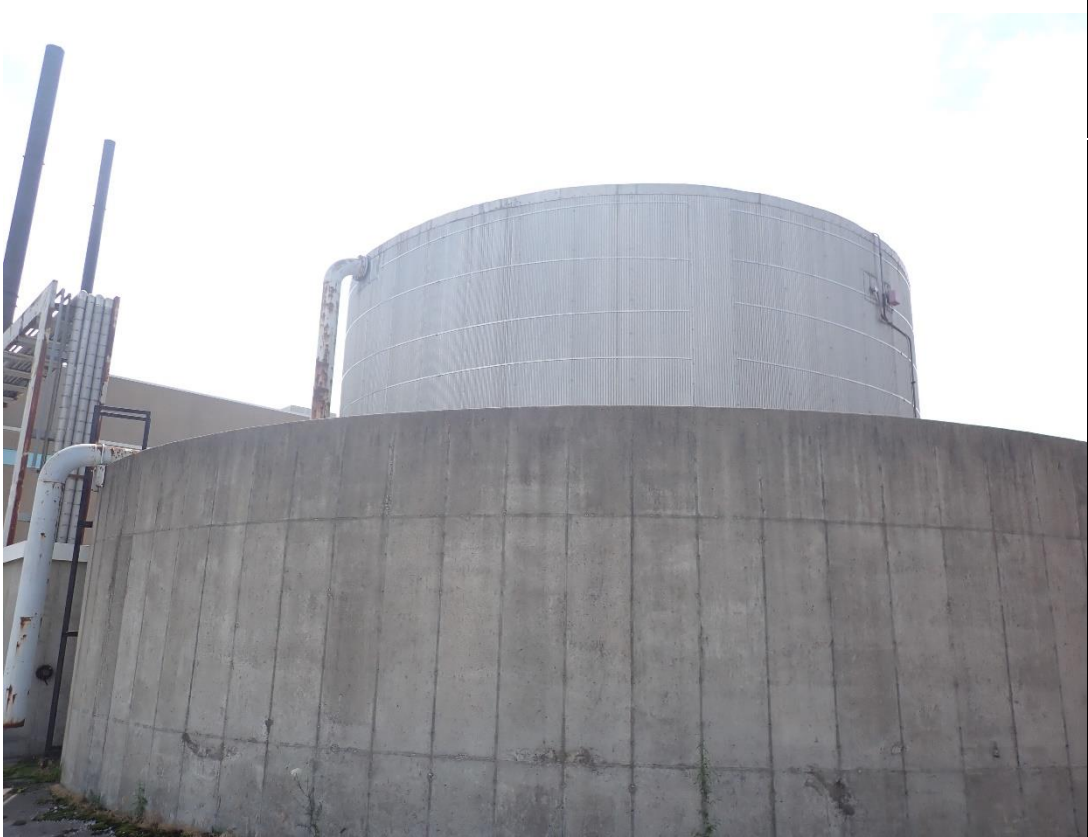
<b>Photo No.:</b> 18	<b>Time:</b> 10:24AM		
<b>Direction Photo Taken:</b> Southeast			
<b>Photo Description:</b> Water tower for fire suppression.			
		<b>File:</b> APS_Grupa_018
