# US POSTAL SERVICE CHELSEA VMF CLEAN WATER ACT PHOTOGRAPH LOG

*ALL PHOTOGRAPHS WERE TAKEN BY MICHAEL PRESCOTT USING A HEWLETT  
PACKARD PHOTOSMART M547*

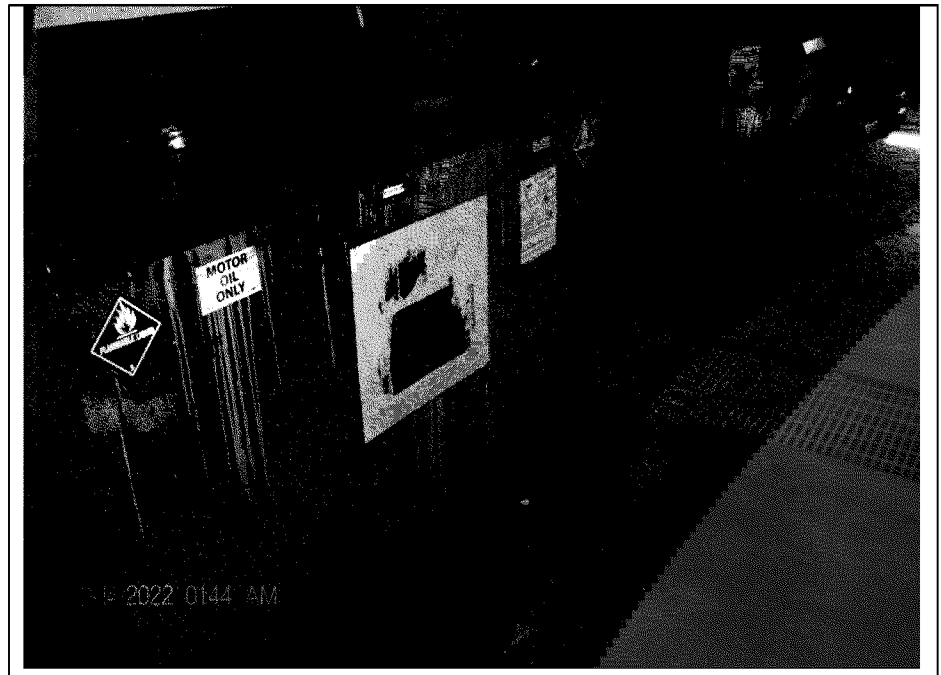
**PHOTO #:** 1

**COMMENTS:** A 330-gallon  
aboveground storage tank (AST) for  
new oil next to a trench drain  
connected to an oil water separator  
and the sanitary sewer.

**SITE LOCATION:** Maintenance bay inside VMF Building

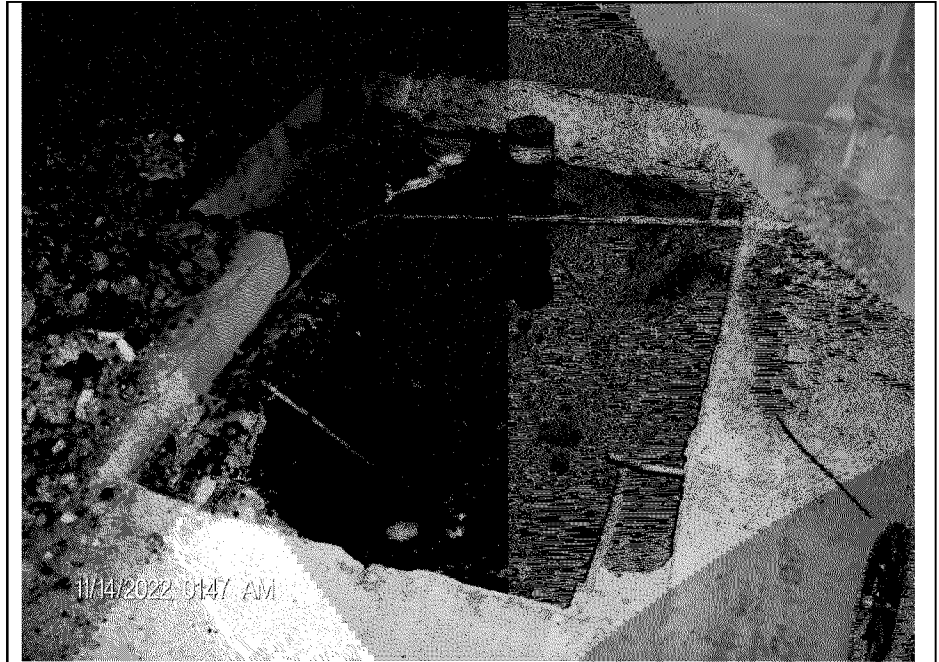
**PHOTO #:** 2

**COMMENTS:** Excavated area in floor exposing sanitary sewer pipes.

**SITE LOCATION:** Old car wash bay inside VMF Building

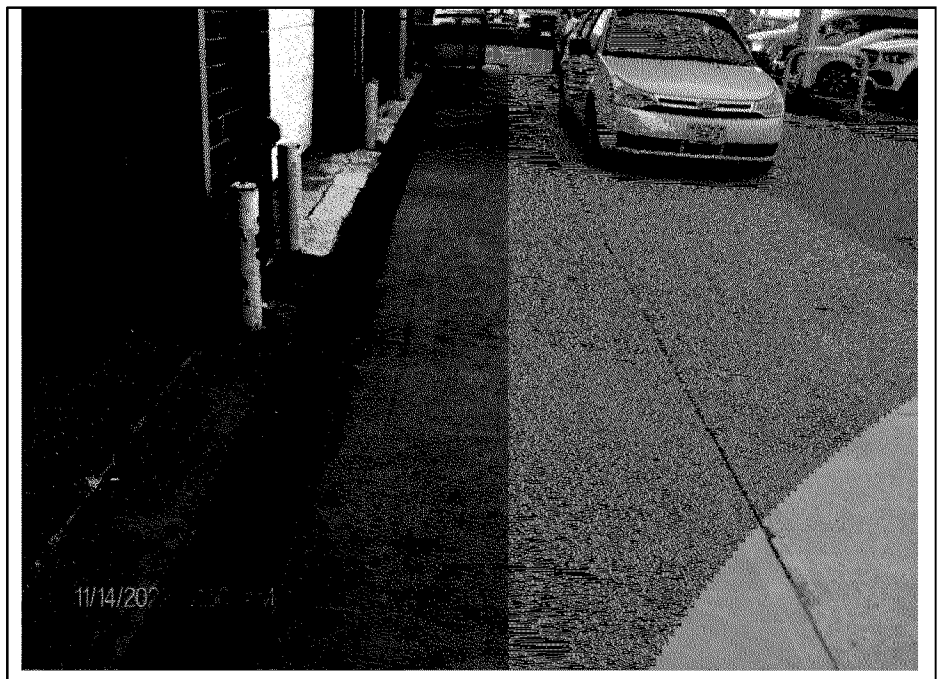
**PHOTO #:** 3

**COMMENTS:** Trench drain outside VMF building connected to storm sewer.

**SITE LOCATION:** Paved area in front of the VMF

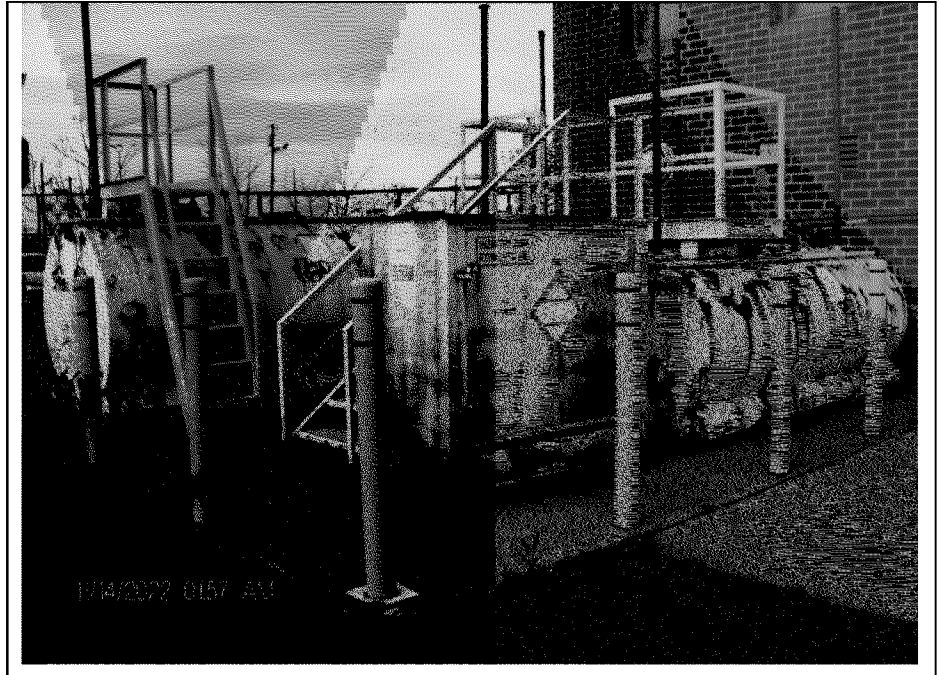
**PHOTO #:** 4

**COMMENTS:** View of three ASTs and HAZMAT locker with peeling paint and rust due to the corrosive salt air.

**SITE LOCATION:** Paved area in back of the VMF

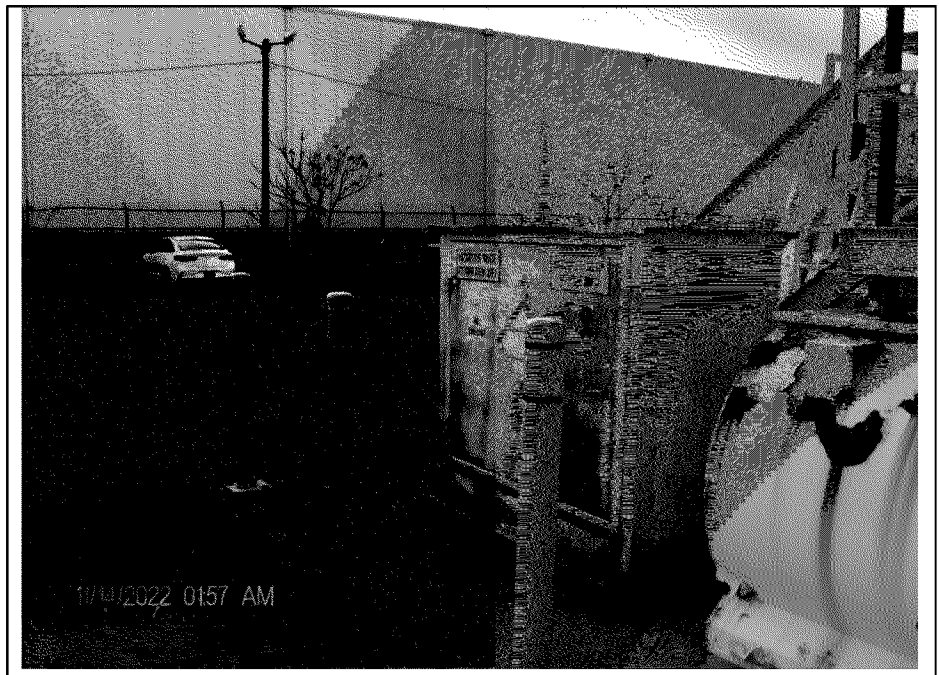
**PHOTO #:** 5

**COMMENTS:** View of HAZMAT locker and used antifreeze AST with peeling paint and rust looking towards the stormwater drain in the paved area.

**SITE LOCATION:** Paved area in back of the VMF

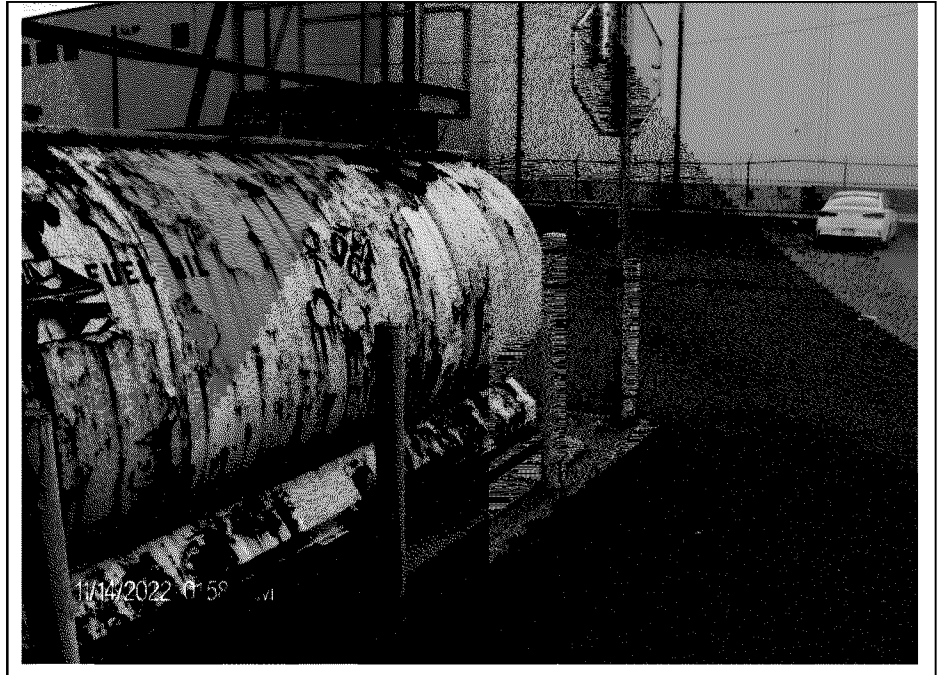
**PHOTO #:** 6

**COMMENTS:** View of heating oil AST with peeling paint and rust looking towards the stormwater drain in the paved area.

**SITE LOCATION:** Paved area in back of the VMF

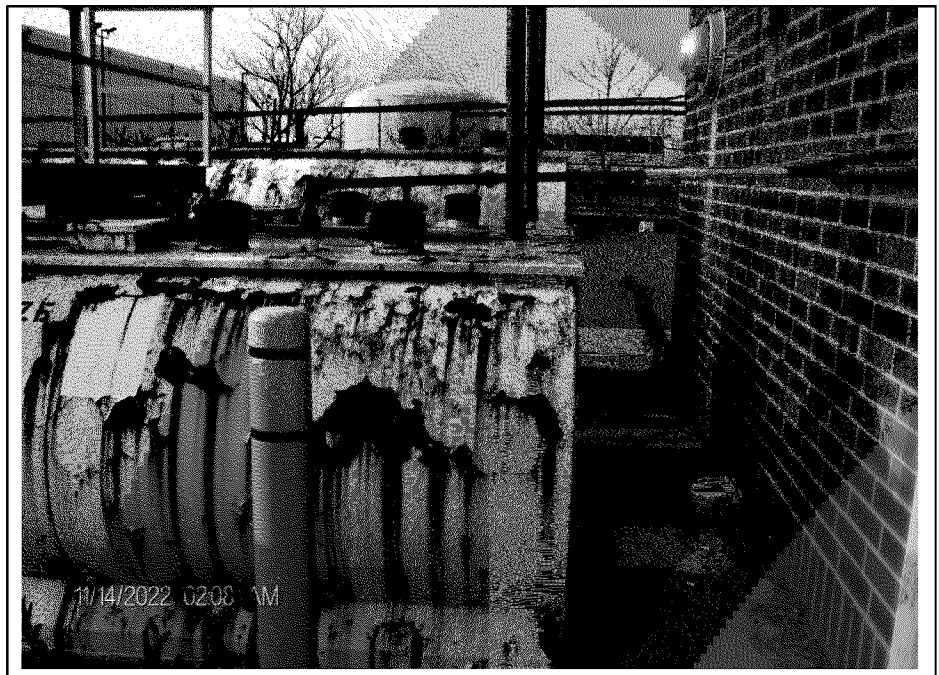
**PHOTO #:** 7

**COMMENTS:** View of three ASTs with peeling paint and rust and the connecting piping into the building.

**SITE LOCATION:** Paved area in back of the VMF

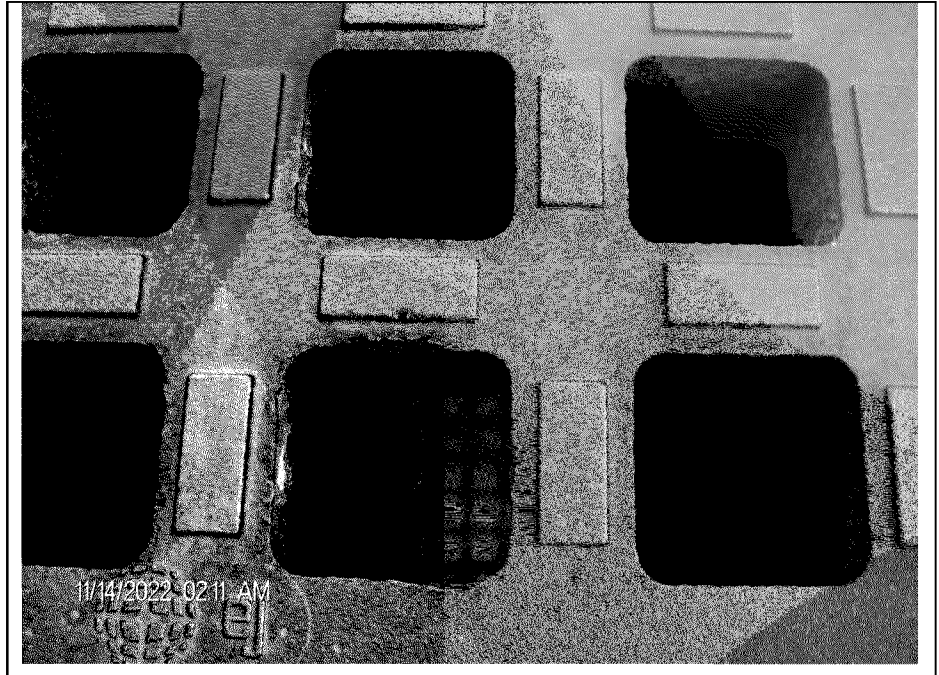
**PHOTO #:** 8

**COMMENTS:** View of stormwater drain in back of the VMF near the ASTs with a slight oil sheen on the surface of the water.

**SITE LOCATION:** Paved area in back of the VMF

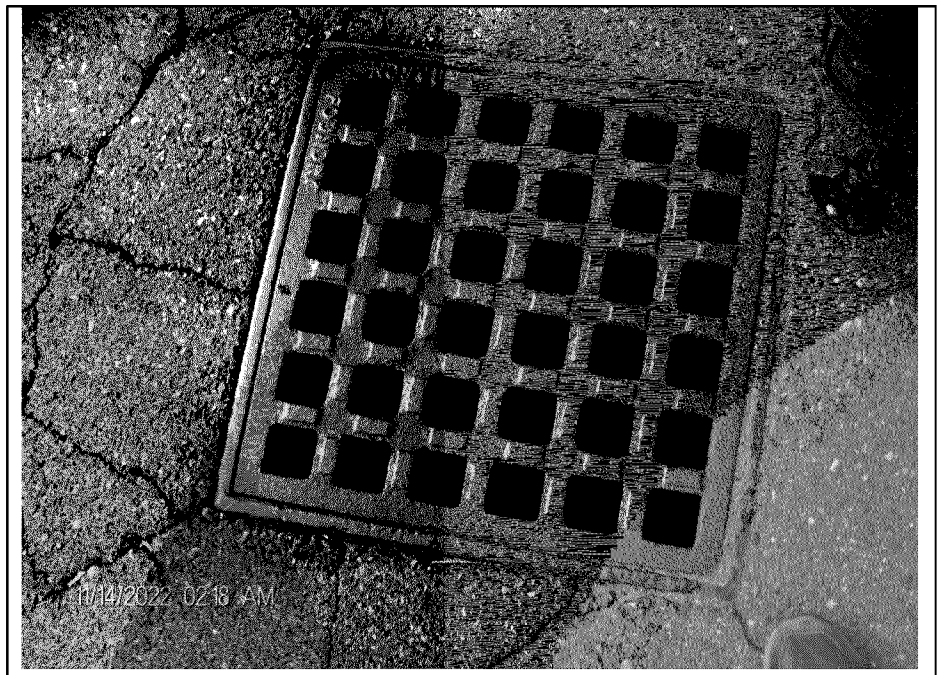
**PHOTO #:** 9

**COMMENTS:** View of stormwater drain in front of the VMF.

**SITE LOCATION:** Paved area in front of the VMF

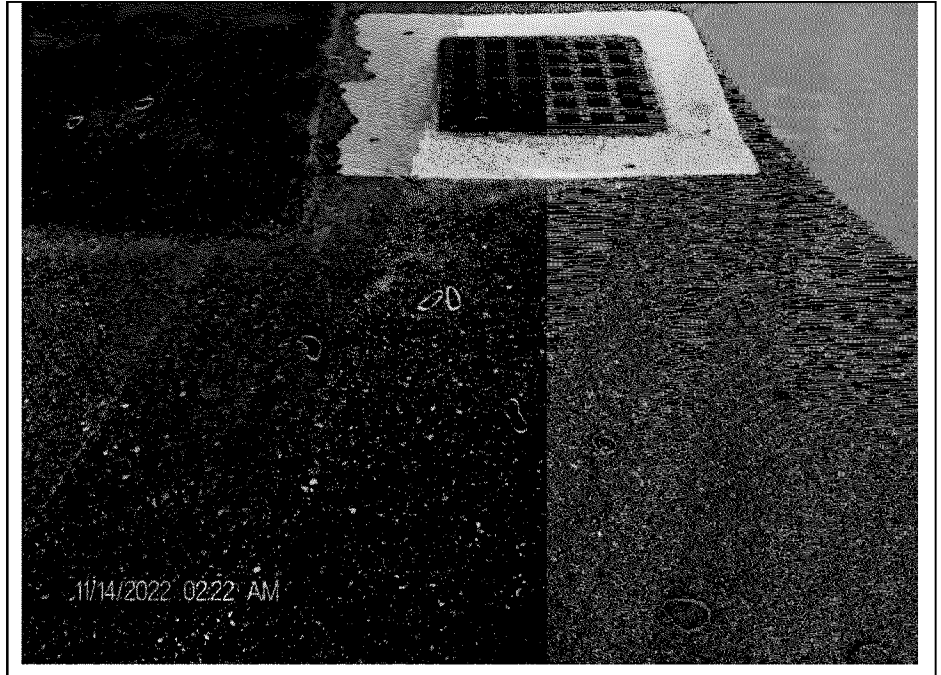
**PHOTO #:** 10

**COMMENTS:** Stormwater drain in paved area near the adjacent USPS mailing facility with rubber bands all around the drain.

**SITE LOCATION:** Paved area near adjacent USPS mailing facility
