INSPECTION REPORT

| Type of Inspection | Focused Compliance Inspection (FCI) | | | |
| Facility or Site Name | Valley Solvents & Chemicals | | | |
| City, State, Zip Code | Corpus Christi, TX 78409 | | | |

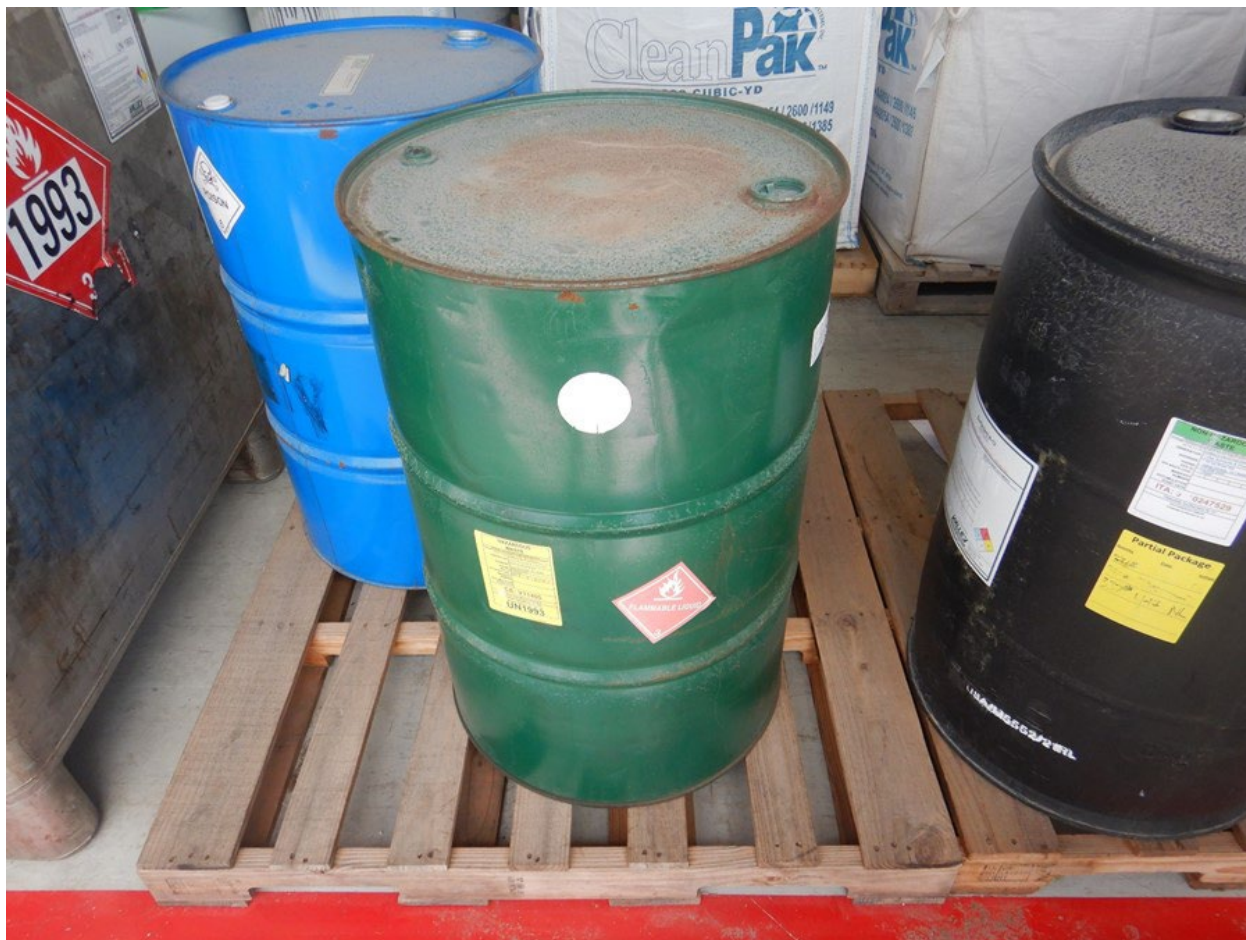
Photo No. 1

Valley Solvents' non-conforming area was delineated with red lines on the floor (see Appendix 1 – Photo 5). A 55-gallon drum of mixed solvents was observed in the non-conforming chemical storage area with a hazardous waste label without an accumulation date (see Appendix 1 – Photos 1 and 2). Facility personnel stated that this drum had been incorrectly labeled as hazardous waste. Russell Ide, the Director of Environmental Services for Valley Solvents, provided a document with follow-up explanations to the inspection teams observations (see Appendix 2). Mr. Ide explained that the drum was accidentally labelled as hazardous waste due to a personnel error, and that it had not been evaluated for potential reuse yet. After the inspection, Mr. Ide indicated that Valley Solvents personnel have relabeled the drum correctly as non-conforming product and begun the evaluation process. He also indicated that warehouse personnel had been retrained on the company's procedures to help prevent this issue from reoccurring (see Appendix 2).

Description: View of a 55-gallon drum of mixed solvents in the non-conforming area with a hazardous waste label and no accumulation date.

[This drum should have been labelled "non-conforming product" as it had not yet been evaluated for potential re-use. It was accidentally mis-labeled as "hazardous waste" due to personnel error. We have re-labelled the drum and begun the evaluation process. We have also re-trained our warehouse personnel on the procedures to help prevent this from re-occurring.](#)

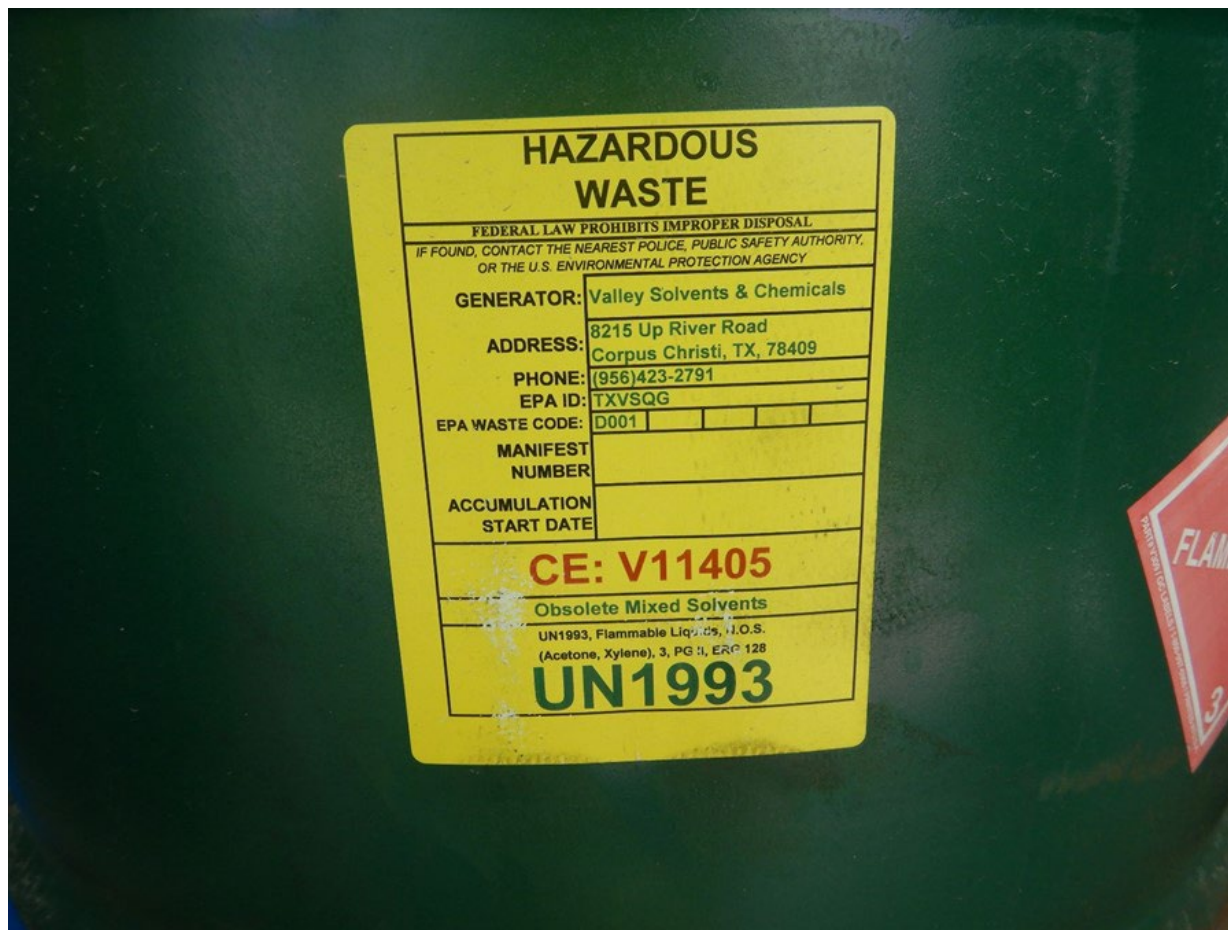
Photo No. 2

Description: View of the hazardous waste label on the drum of mixed solvents shown in Photo No. 1 in the non-conforming area.

- A 55-gallon drum of mixed solvents was observed in the non-conforming chemical storage area with a hazardous waste label without an accumulation date. Facility personnel stated that this drum was incorrectly labeled as hazardous waste.

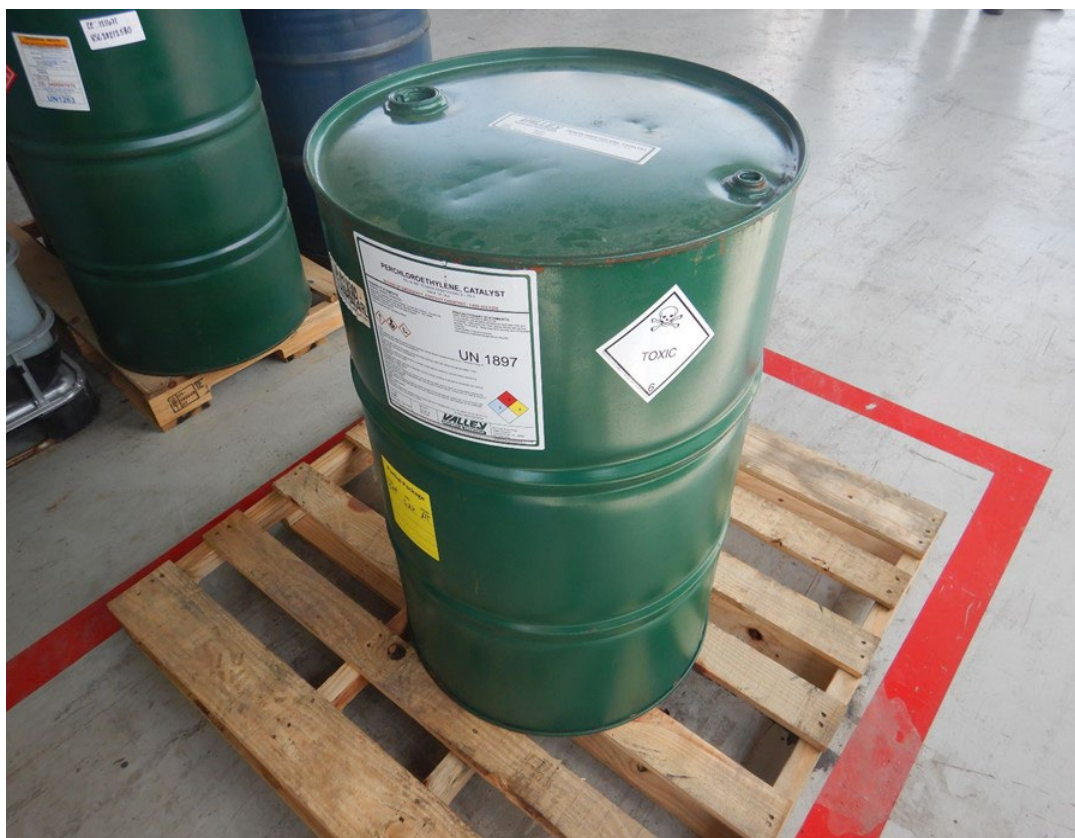
Photo No. 3

The inspection team also observed a 55-gallon drum containing water and a trace amount of perchloroethylene (PERC) catalyst that reportedly had been decanted from a tote of non-conforming PERC catalyst (see Appendix 1 – Photos 3 and 4). The inspection team requested waste determination documentation for the drum, which Mr. Ide included with his response (see Appendix 3). Valley Solvents received a tote of non-conforming PERC catalyst as a return from a customer. The off-spec material was able to be resold to another customer, however, when Valley Solvents was preparing it for shipment, they discovered that the off-spec product was contaminated with water. Valley Solvents had decanted the water into a drum while attempting to retain as much PERC catalyst within the tote as possible. The 55-gallon drum observed on-site is believed to contain water with trace PERC catalyst, with the label stating the material was transferred into the drum on 5/22/2024 and that the material weighed 471 pounds (see Appendix 1 – Photo 6). Mr. Ide explained that the drum was being evaluated to determine whether the water and trace PERC catalyst mixture could be reused or sold (see Appendix 2). He explained that if Valley Solvents determined that neither option was viable, the material would be deemed waste, and a hazardous waste determination would be made at that time. He added that the material would then be shipped offsite in accordance with EPA waste regulations (see Appendix 2). Mr. Ide also included Valley Solvents' policy "OP-2320," which describes the procedures related to non-conforming packages, containers, and products (see Appendix 4).

Description: View of a 55-gallon drum of water and trace amounts of perchloroethylene catalyst in the non-conforming area.

See attached Life Cycle documentation for details on the source of this drum. As per Valley policy OP-2320, the drum itself will be evaluated for potential re-use or re-sale; if Valley determines neither option is viable, the material will be deemed waste. A hazardous waste determination will be made at that time, and the material will be shipped in accordance with EPA waste regulations.

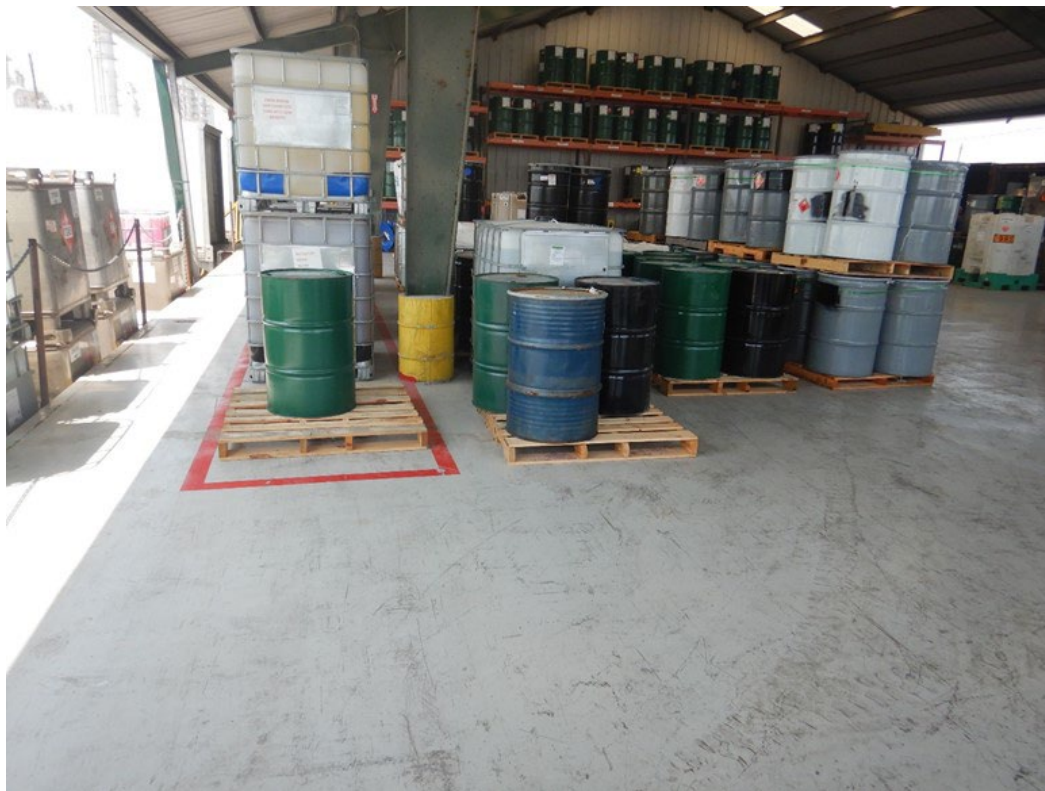
Photo No. 5

Description: Overview of Valley Solvents' non-conforming area, with red lines designating the area.

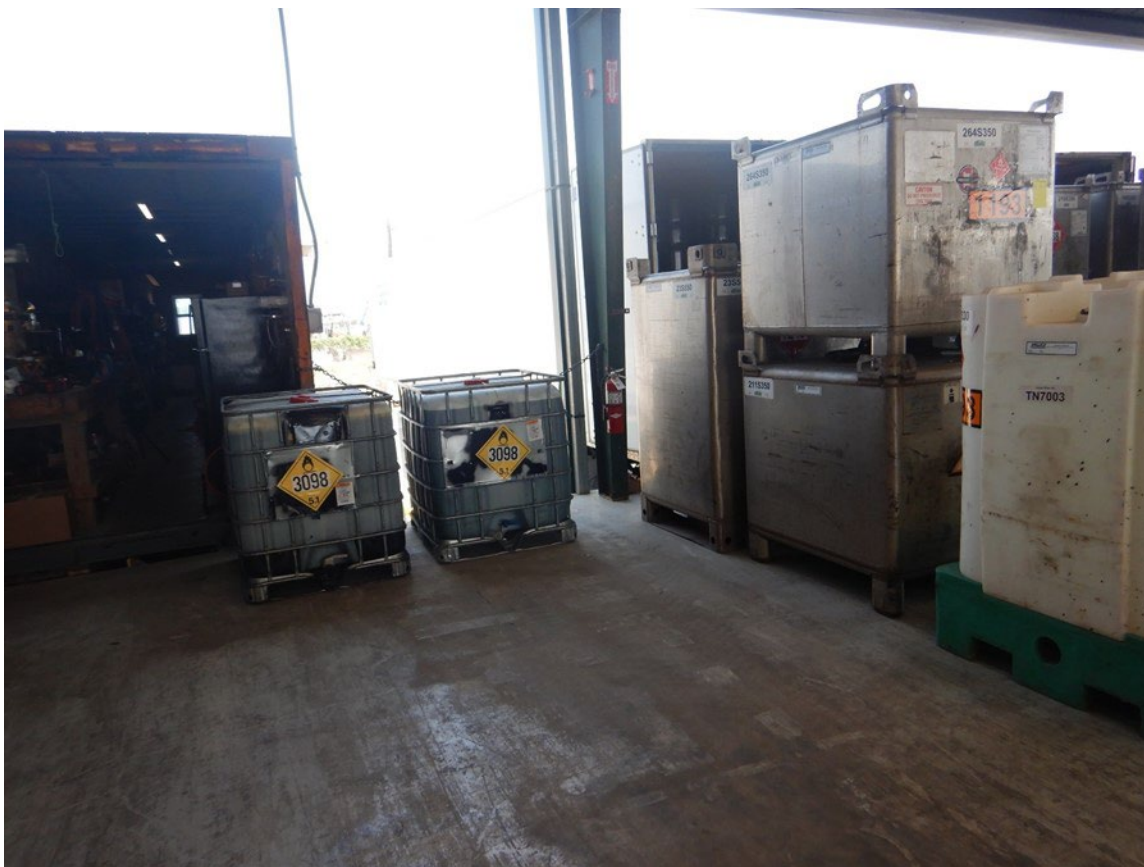
Photo No. 7

The inspection team observed incompatible waste stored in the truck bay. Oxidizing liquid waste totes containing phosphoric acid from a galvanizing operation were stored adjacent to flammable product totes (see Appendix 1 – Photos 7 and 8) [**AOC #3** – *Valley Solvents did not separate hazardous waste from other incompatible materials properly - 40 CFR 262.17(a)(1)(vii)(C)*]. In his follow-up document, Mr. Ide explained that these materials were in the process of being loaded and were accidentally placed next to each other in the truck bay (see Appendix 2). He explained that Valley Solvents modified its storage area locations to incorporate dedicated areas for oxidizing liquids and trained employees on the new storage locations (see Appendix 2). He also included Valley Solvents' policy "OP-4110," regarding hazardous waste storage (see Appendix 5).

Description: View of incompatible oxidizing liquid waste totes containing phosphoric acid adjacent to flammable product totes in the truck bay.

The products in question were in the process of being loaded, and were accidentally placed next to each other in the staging area. Valley has modified its storage area locations to incorporate dedicated areas for oxidizing liquids and has trained employees on the new storage locations (see attached OP-4110 Hazardous Waste Storage).

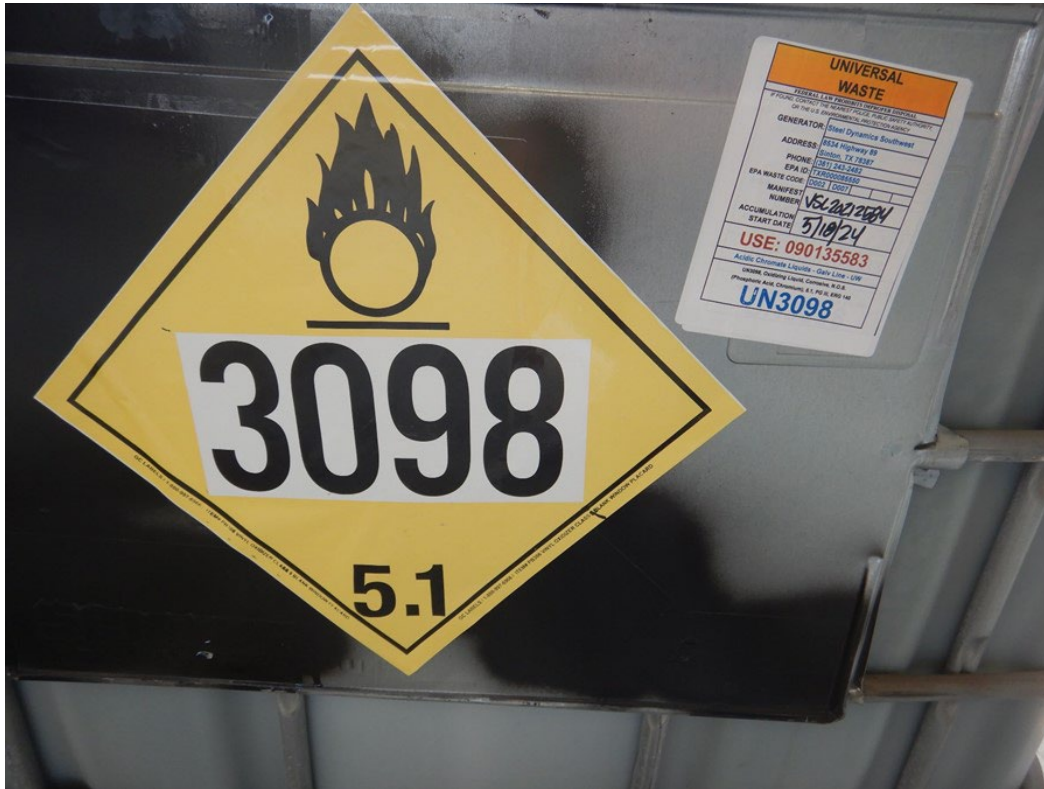
Photo No. 8

Description: View of a label on the incompatible oxidizing liquid waste totes containing phosphoric acid adjacent to flammable product totes in the truck bay.
