**Region 6 - Enforcement & Compliance Assurance Division**  
**INSPECTION REPORT**

| Inspection Date(s): | August 13, 2024 | |
| Regulatory Program(s) | NPDES Stormwater/ CWA 402 | |
| Facility Name: | Shoppes at Painted Tree | |

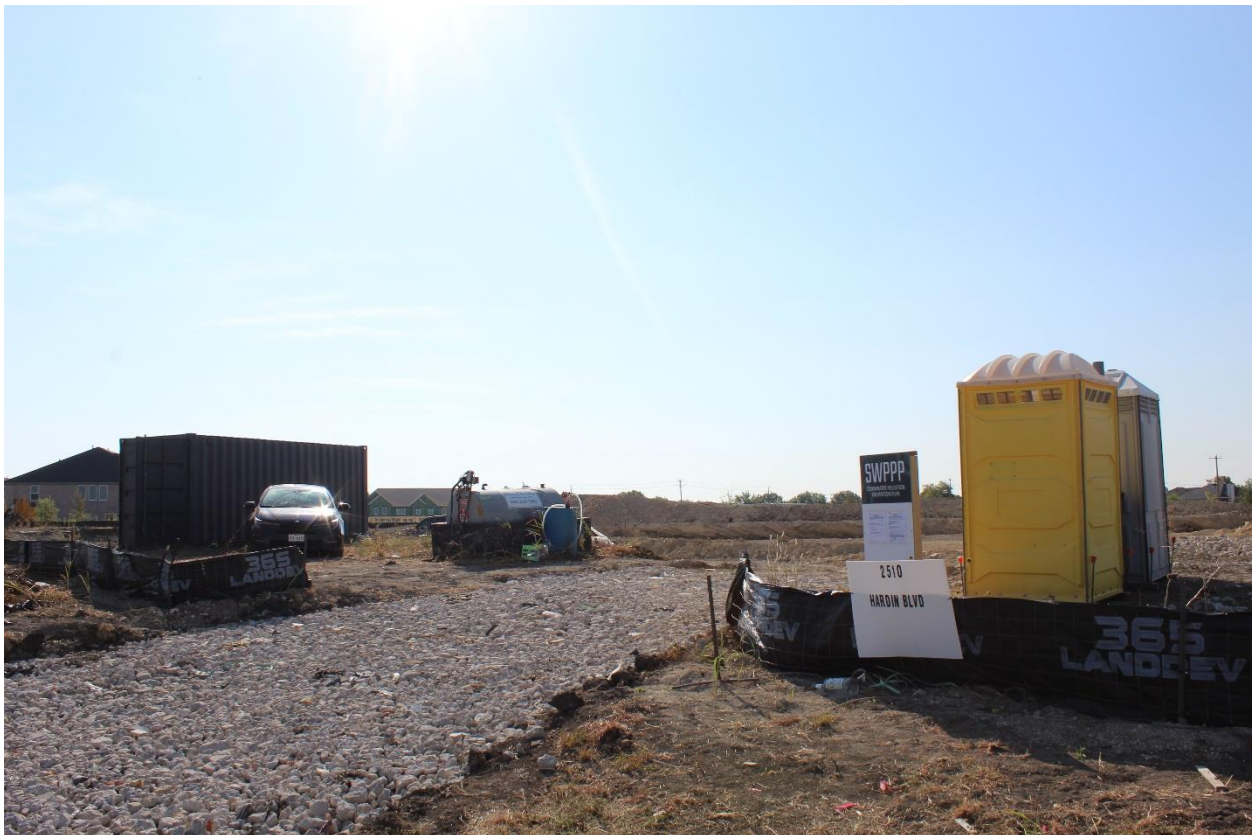
Photo no. 1

Description: The Construction Site Notice (CSN) (TXR1596RK) posted at the construction entrance off S Hardin Blvd.

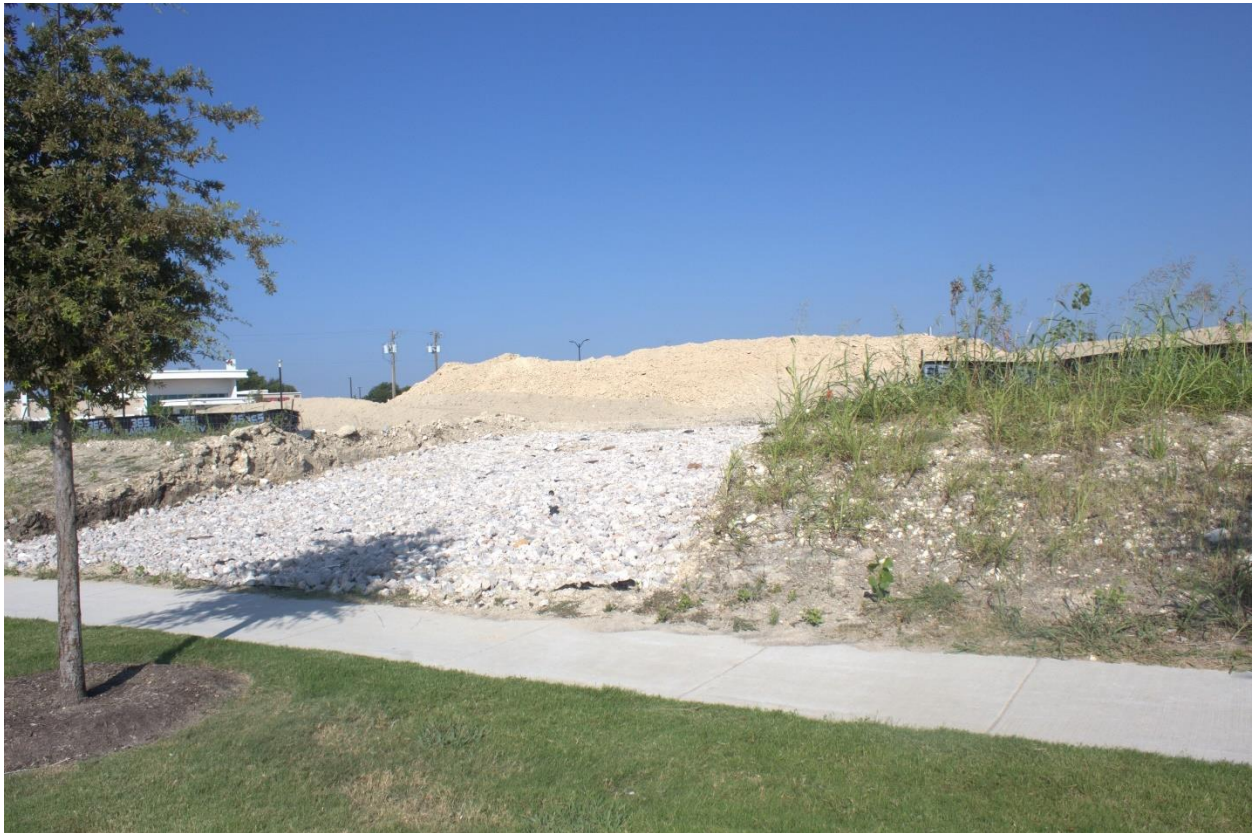
Photo no. 3

Description: Stabilized rock construction entrance/exit off Bastrop St.

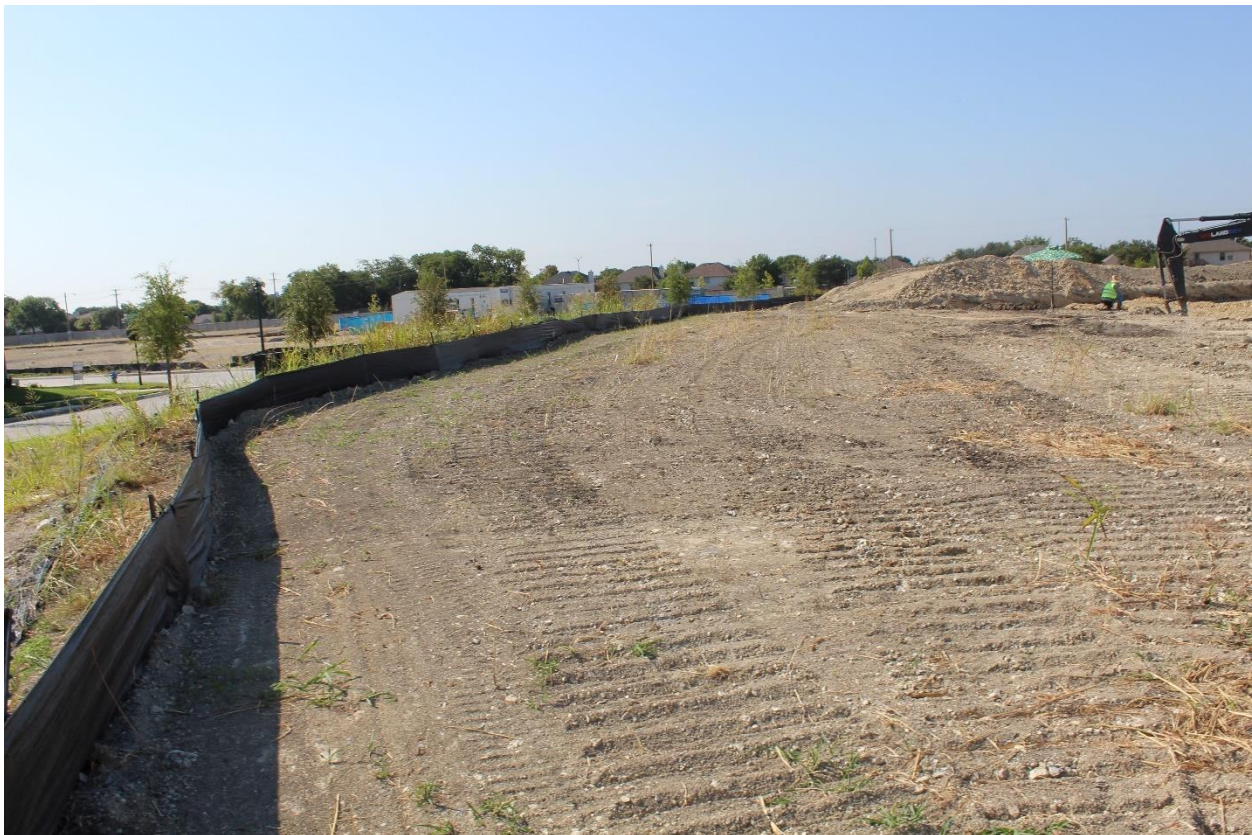
Photo no. 4

Description: Silt fence installed around the perimeter of the site.

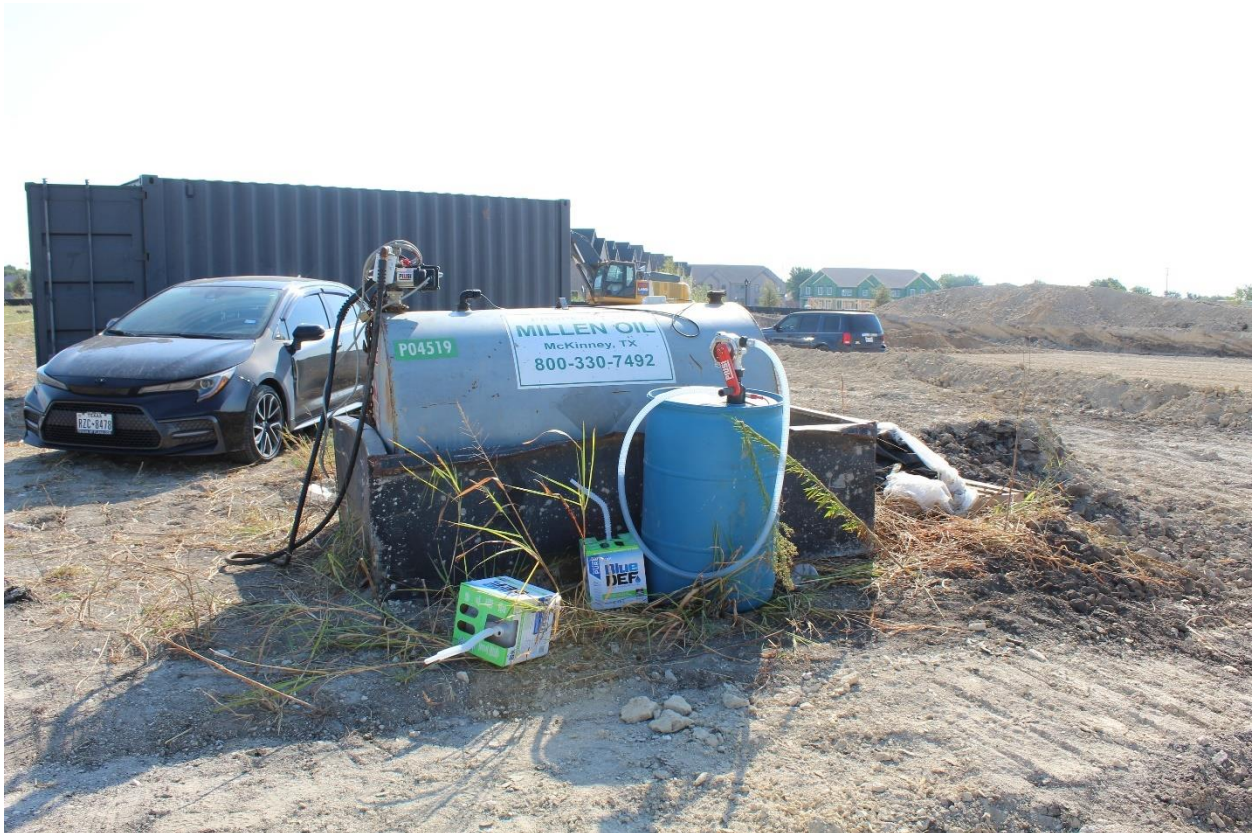
Photo no. 5

- The inlet near the northwest corner of the site did not have BMPs installed **(Appendix 1, Photo 9)**. Mr. Cunningham emailed me a photo of the inlet on August 19, 2024, showing that inlet protection had been installed **(Appendix 2, Photo 1)**.
- A section of approximately 4-6 feet of silt fence was not properly installed (the silt fence was not trenched) near the construction entrance off S Hardin Blvd **(Appendix 1, Photo 10)**. At approximately 3:50 PM when I arrived back on-site, the silt fence had been properly re-installed **(Appendix 2, Photo 2)**.
- Blue Def was being improperly stored and/or disposed of near the fuel storage tank **(Appendix 1, Photo 5)**. At approximately 3:50 PM when I arrived back on-site, all Blue Def containers had been removed **(Appendix 2, Photo 3)**.

Description: One (1) fuel storage tank in secondary containment near the construction entrance/exit off S Hardin Blvd. Blue Def was observed on the ground near the fuel storage tank.

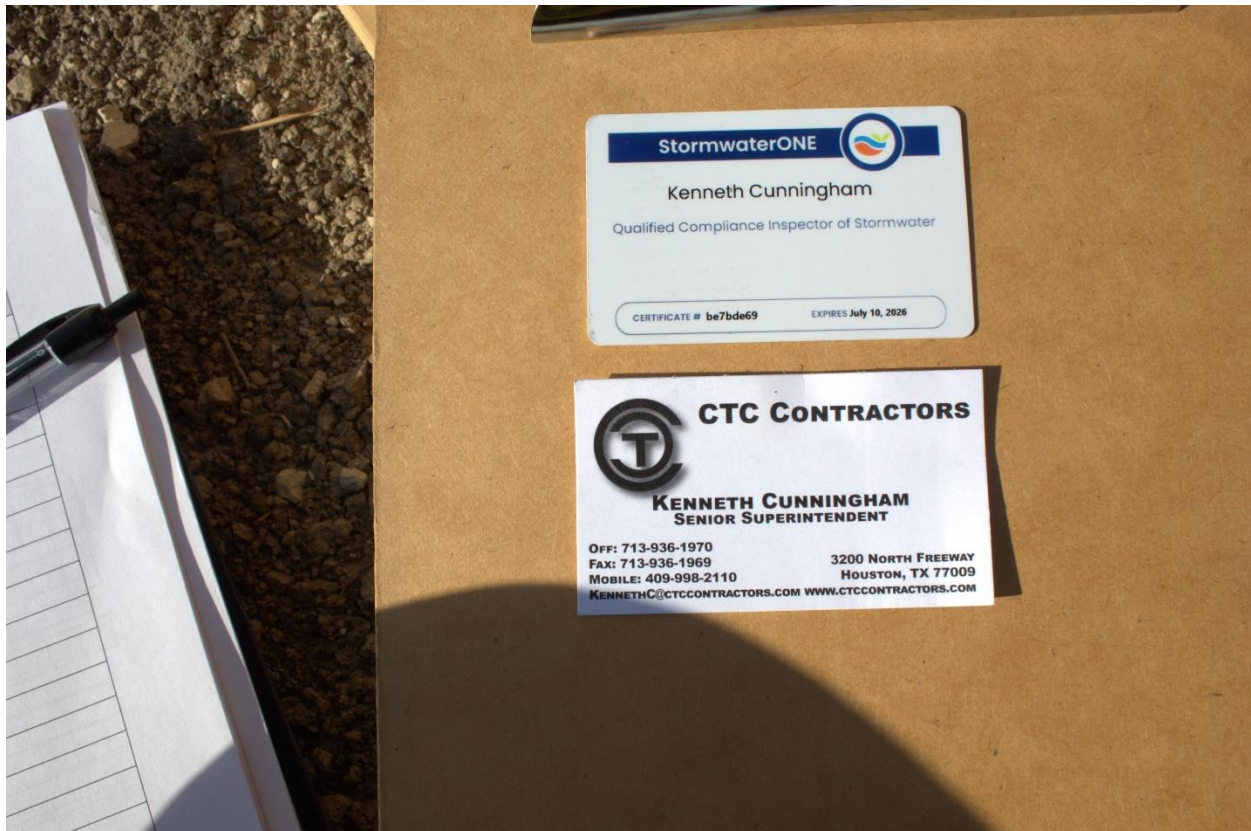
Description: Mr. Cunningham's stormwater inspector credentials and business card.

Date of Photo: 08/13/2024    Photographer: Destinee Agwuna

- The Construction Site Notice (CSN) (TXR1596RK) was posted at the construction entrance/exit off S Hardin Blvd (**Appendix 1, Photos 1-2**).
- The site entrance/exit off S Hardin Blvd and Bastrop St were both stabilized with rock materials (**Appendix 1, Photo 3**).
- Silt fence was installed around the perimeter of the site (**Appendix 1, Photo 4**).
- One (1) fuel storage tank in secondary containment was observed near the construction entrance/exit off S Hardin Blvd (**Appendix 1, Photo 5**).
- Mr. Cunningham informed me that he is the stormwater inspector for the site and showed me his credentials as a Qualified Compliance Inspector of Stormwater (QCIS), which he earned through StormwaterONE (certificate # be7bde69, expires July 10, 2026) (**Appendix 1, Photo 6**).

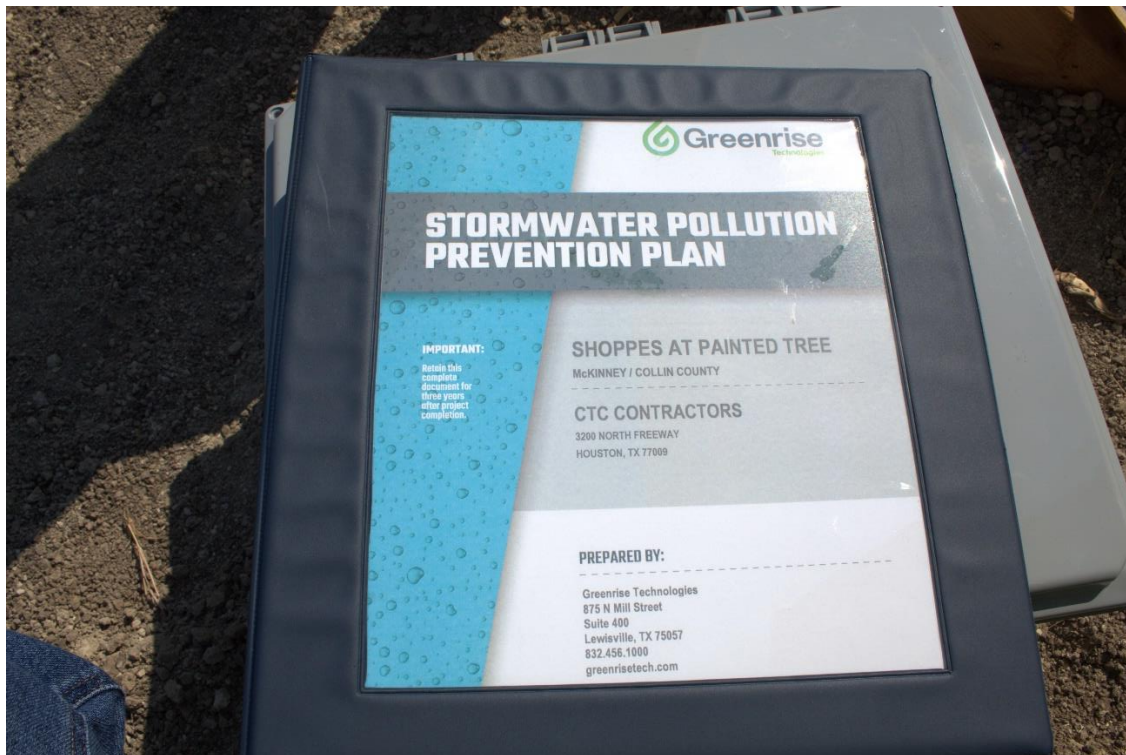
Photo no. 7

Description: The SWPPP sitting on top of the gray lock box located near the CSN off S Hardin Blvd.

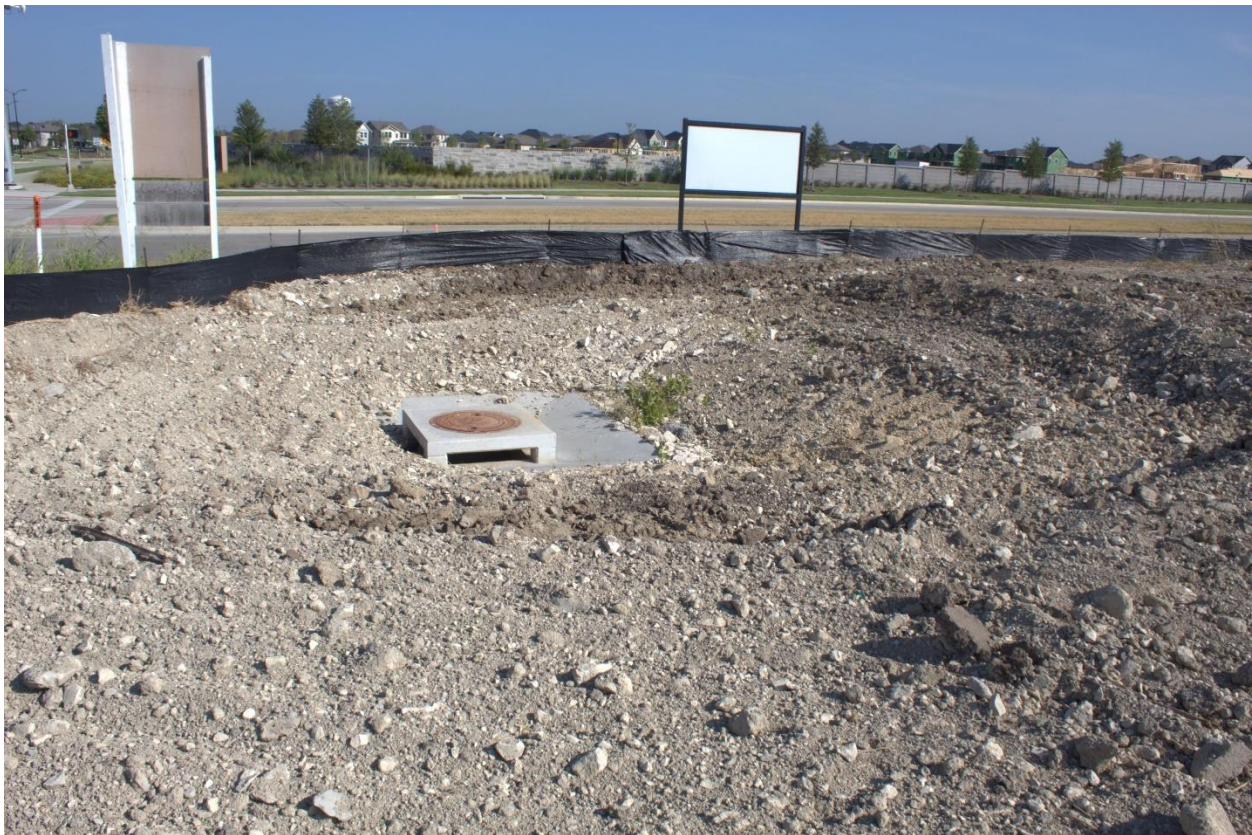
Photo no. 9

Description: The inlet near the northwest perimeter of the site with no BMPs installed.

- On August 19, 2024, at approximately 9:20 AM I called Mr. Cunningham and asked if the inlet protection had been installed at the northwest corner of the site. Mr. Cunningham confirmed that the inlet protection had been installed and emailed me photo proof **(Appendix 2, Photo 1)**.

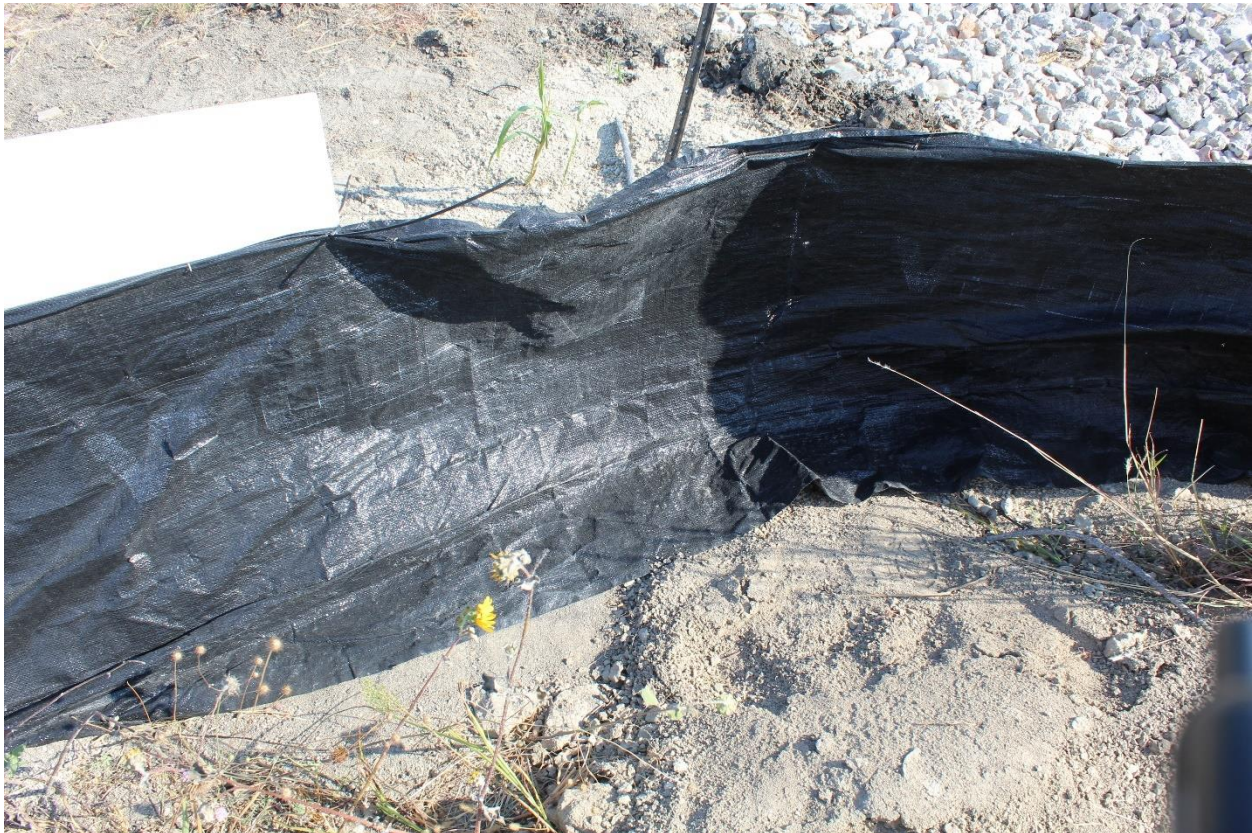
Photo no. 10

Description: Silt fence not properly trenched near the construction entrance off S Hardin Blvd.

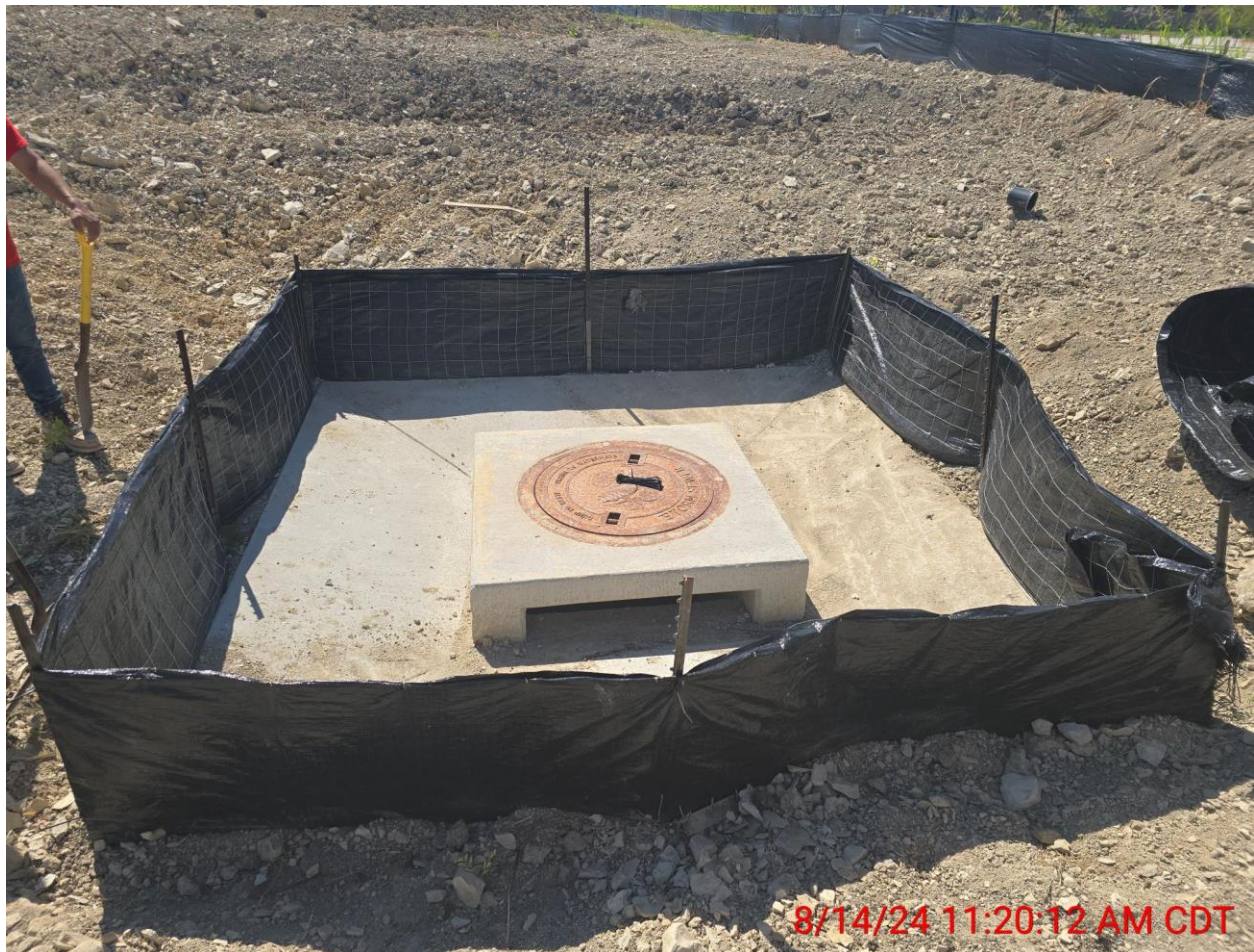
UNITED STATES ENVIRONMENTAL PROTECTION AGENCY  
Appendix 2: Corrected Items Photograph Log  
Photo no. 1

Description: Photo demonstrating that the inlet protection had been installed at the northwest corner of the site. The photo was taken and sent by Mr. Cunningham.

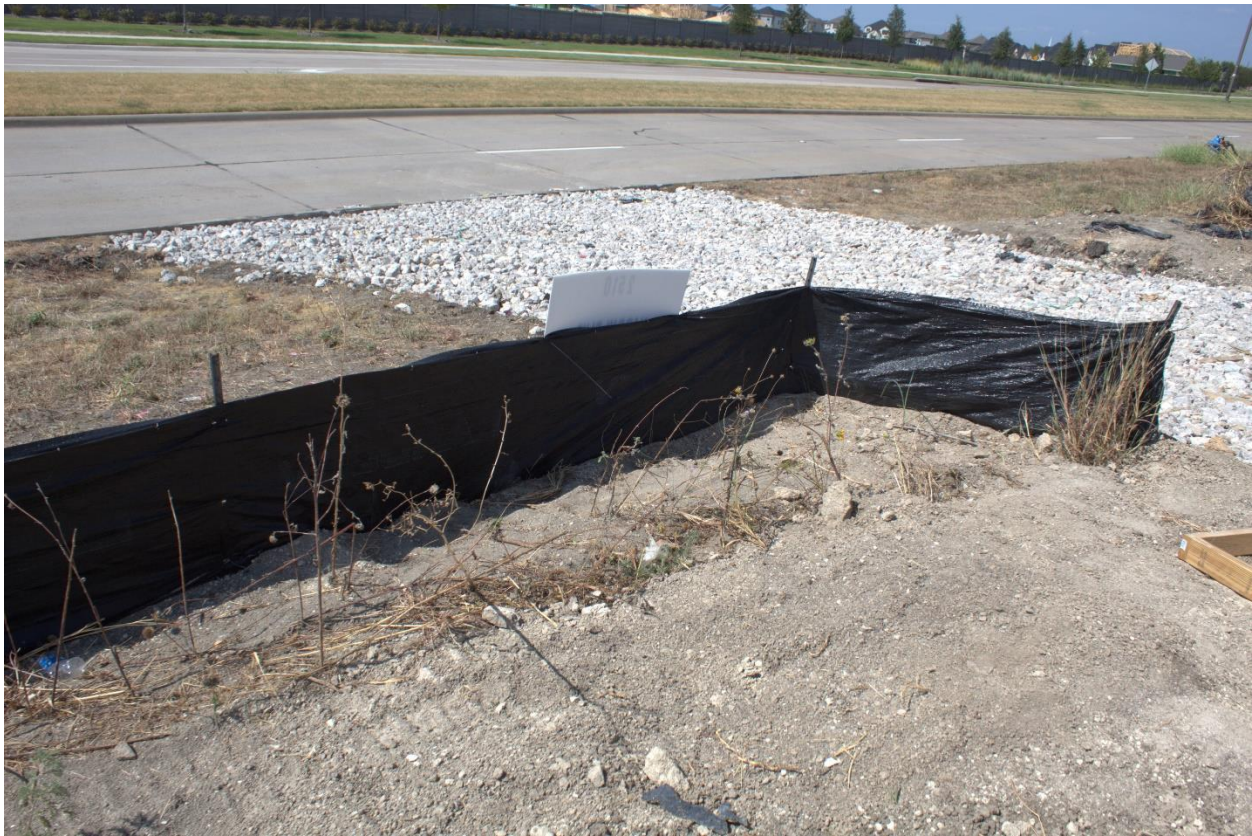
UNITED STATES ENVIRONMENTAL PROTECTION AGENCY  
**Appendix 2: Corrected Items Photograph Log**  
Photo no. 2

Description: Photo demonstrating that the silt fence near the construction entrance off S Hardin Blvd had been re-installed and properly trenched. Photo was taken by EPA R6 inspector Destinee Agwuna.
