## **RCRA Inspection Report**

Signal Plating, Inc. TND063778377  
1608 Camden Street  
Chattanooga, Hamilton County, Tennessee 37406

May 23, 2023

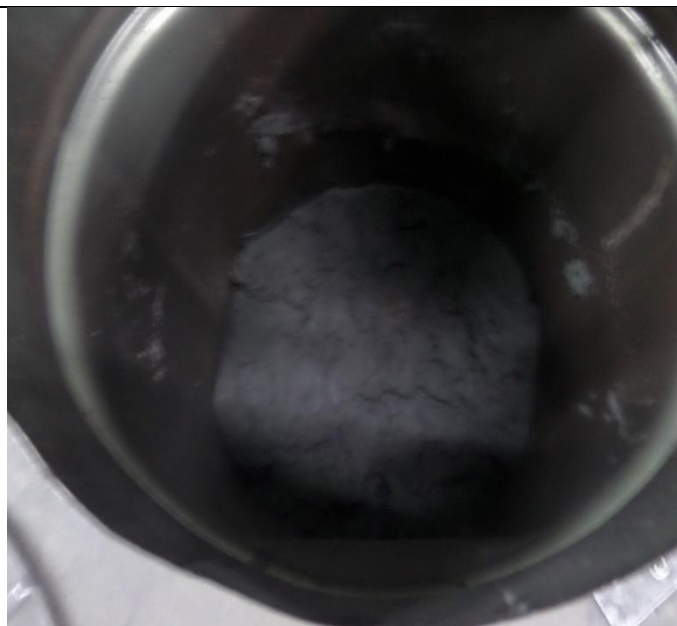
The polishing operation is conducted in a separate area adjacent to the warehouse area. Metal parts are polished prior to plating or prior to shipment to the customer. Polishing is conducted using a stationary granulated grinder in a vented collection hood and with hand-held grinders. Metal dust is captured in the collection system and accumulated in a container under an exhaust chute (Photograph 1). The inspectors observed two 5-gallon containers accumulating metal dust. Metal pieces are accumulated in a container. Signal representatives indicated the metal dust and metal pieces are disposed as municipal trash. A waste determination was not available for review at the time of the inspection.

Polishing Area. Inspectors observed metal polishing dust in the container. Photograph 1 taken at 10:00 a.m.

**Pursuant to Tenn. Comp. R. & Regs. 0400-12-01-.03(1)(b) [40 C.F.R. § 262.11], a person who generates a solid waste, as defined in TN Rule 0400-12-01-.02(1)(b) [40 C.F.R. § 261.2], must use the steps articulated in TN Rule 0400-12-01-.03(1)(b) [40 C.F.R. § 262.11] to make an accurate determination as to whether that waste is a hazardous waste in order to ensure wastes are properly managed according to applicable RCRA regulations.**

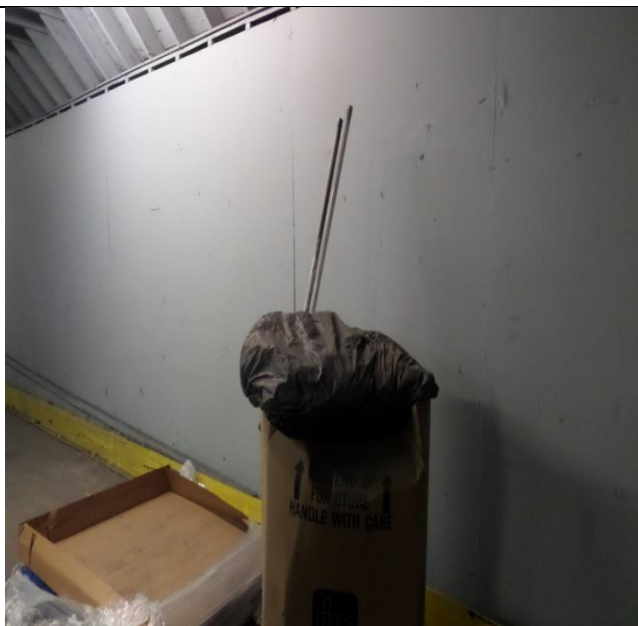
The inspectors observed an open cardboard container in this area accumulating packing material and two four-foot fluorescent lamps. The container was not closed, not marked or labeled with the words "universal waste" and not marked with a date (Photograph 2).

Ramp Area. Inspectors observed two four-foot fluorescent lamps in the container. Photograph 2 taken at 10:06 a.m.

**Pursuant to Tenn. Comp. R. & Regs. 0400-12-01-.12(2)(d)4.(i) [40 C.F.R. § 273.13(d)(1)], a SQHUW must contain any lamp in containers or packages that are structurally sound, adequate to prevent breakage, and compatible with the contents of the lamps. Such containers and packages must remain closed and must lack evidence of leakage, spillage or damage that could cause leakage under reasonably foreseeable conditions.**

**Pursuant to Tenn. Comp. R. & Regs. 0400-12-01-.12(2)(e)5. [40 C.F.R. § 273.14(e)], a SQHUW must label or mark each lamp or container of lamps clearly with one of the following phrases: “Universal Waste-Lamp(s),” or “Waste Lamp(s),” or “Used Lamps.”**

**Pursuant to Tenn. Comp. R. & Regs. 0400-12-01-.12(2)(f)1. [40 C.F.R. § 273.15(a) and (c)], a SQHUW may accumulate universal waste no longer than one year and must be able to demonstrate the length of time that the universal waste has accumulated from the date that it became a waste or was received. The handler may make this demonstration by following F.A.C. Chapter 62-730.185(1) [40 C.F.R. § 273.15(c)(1-6).**

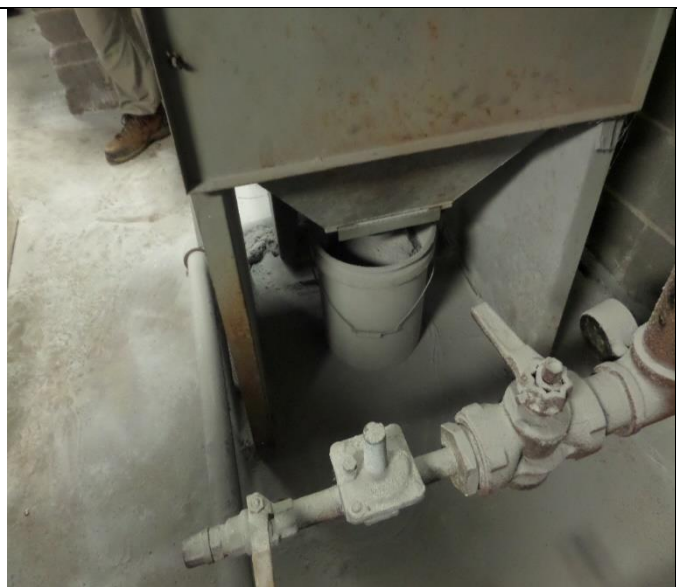
Aluminum oxide blast media is used on the metal parts inside the blast cabinet. The cabinet's baghouse behind the cabinet is shaken when full and the blast media is accumulated in a container. The inspectors observed an open 5-gallon container under the blast cabinet and a 55-gallon container behind the blast cabinet accumulating spent blast media. The inspectors observed blast media on the floor surrounding the blast cabinet (Photographs 3 and 4). A waste determination was not available for review at the time of the inspection.

Blast Cabinet Area. Inspectors observed spent blast media in an open 5-gallon container and on the floor. The blast cabinet was not operating. Photograph 3 taken at 10:13 a.m.

**Pursuant to Tenn. Comp. R. & Regs. 0400-12-01-.03(1)(b) [40 C.F.R. § 262.11], a person who generates a solid waste, as defined in TN Rule 0400-12-01-.02(1)(b) [40 C.F.R. § 261.2], must use the steps articulated in TN Rule 0400-12-01-.03(1)(b) [40 C.F.R. § 262.11] to make an accurate determination as to whether that waste is a hazardous waste in order to ensure wastes are properly managed according to applicable RCRA regulations.**

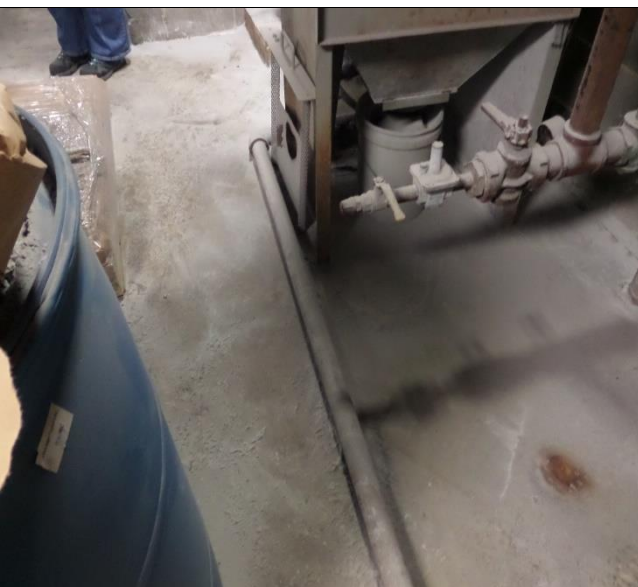
Blast Cabinet Area. Inspectors observed spent blast media in an open 5-gallon container and on the floor. Photograph 4 taken at 10:14 a.m.

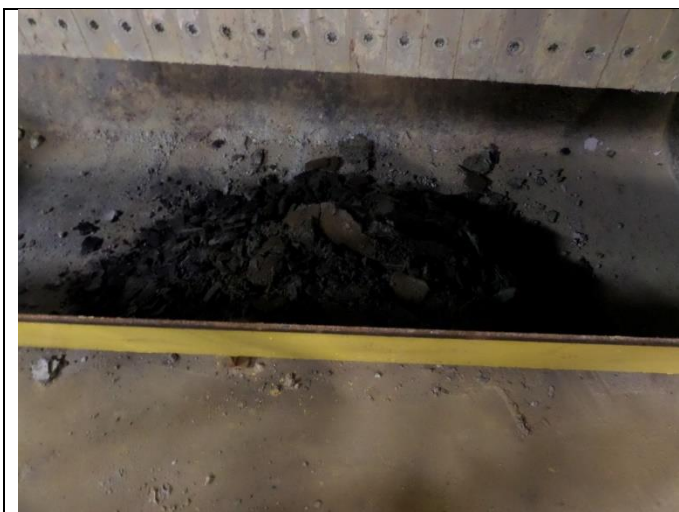
The treatment system consists of several treatment and holding tanks to process the wastewater. The rinse water generated from the rinse bath is discharged directly to the POTW. The cleaners and acid solutions are discharged to a holding sump and pumped to a tank for pH adjustment and coagulation. The wastewater is next mixed in a tank, flocculated, settled in a tank, and pumped to a clarifier. Solids accumulated in the bottom of the clarifier are pumped to the settling tank. The clarified wastewater is then discharged to a holding tank for pH adjustment and then discharged to the POTW. Waste solids are pumped from the settling tank to a plate and frame filter press. Press filtrate is returned to the treatment system for treatment. The inspectors observed filter press solid was accumulating in a container under the filter press. The inspectors observed the container was not closed and not marked or labeled (Photograph 5). The filter press solid is shipped quarterly. Signal representatives indicated the nickel/chromium filter press solid is nonhazardous waste.

Nickel/Chromium Wastewater Treatment Line. Inspectors observed nickel/chromium solids generated from the filter press were accumulated in a container. Signal representatives indicated the solids are nonhazardous waste. Photograph 5 taken at 10:51 a.m.

**Pursuant to Tenn. Comp. R. & Regs. 0400-12-01-.03(1)(b) [40 C.F.R. § 262.11], a person who generates a solid waste, as defined in TN Rule 0400-12-01-.02(1)(b) [40 C.F.R. § 261.2], must use the steps articulated in TN Rule 0400-12-01-.03(1)(b) [40 C.F.R. § 262.11] to make an accurate determination as to whether that waste is a hazardous waste in order to ensure wastes are properly managed according to applicable RCRA regulations.**

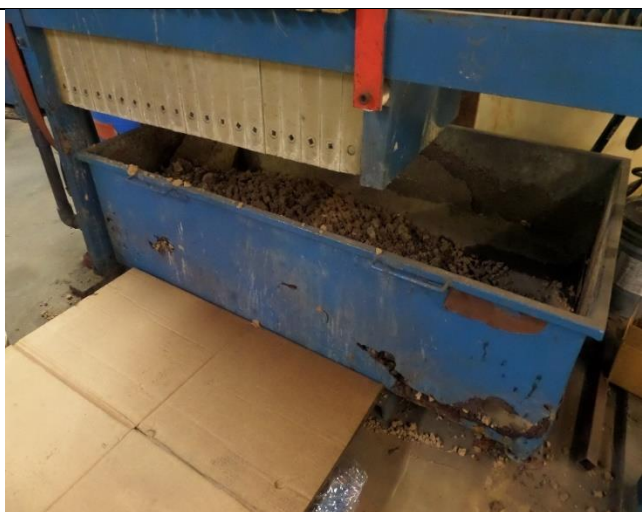
The treatment system consists of several treatment and holding tanks to process the wastewater from the barrel line rinse baths. The rinse water generated from the zinc rack line rinse bath is discharge directly to the POTW. The wastewater from the barrel line is discharged to a holding sump and then pumped to a tank for pH adjustment. The wastewater is next flocculated, mixed in a tank and then discharged to a clarifier. The clarified wastewater is then discharged to the POTW. Waste solids accumulated in the bottom of the clarifier are pumped to a plate and frame filter press. Press filtrate is returned to the treatment system for treatment. The filter press solid is accumulated in a container. The inspectors observed filter press solid was accumulating in a container under the filter press. The inspectors observed the container was not closed, not in good condition and not marked or labeled. The inspectors observed filter press solid on the floor under the container (Photographs 6 and 7). The filter press solid is shipped quarterly. Signal representatives indicated the zinc filter press solid generated from treating barrel line wastewater is nonhazardous waste.

Zinc Wastewater Treatment Line. Inspectors observed zinc solids generated from the filter press were accumulated in a container that was not in good condition. Signal representatives indicated the solids are nonhazardous waste. Photograph 6 taken at 10:57 a.m.

**Pursuant to Tenn. Comp. R. & Regs. 0400-12-01-.03(1)(b) [40 C.F.R. § 262.11], a person who generates a solid waste, as defined in TN Rule 0400-12-01-.02(1)(b) [40 C.F.R. § 261.2], must use the steps articulated in TN Rule 0400-12-01-.03(1)(b) [40 C.F.R. § 262.11] to make an accurate determination as to whether that waste is a hazardous waste in order to ensure wastes are properly managed according to applicable RCRA regulations.**

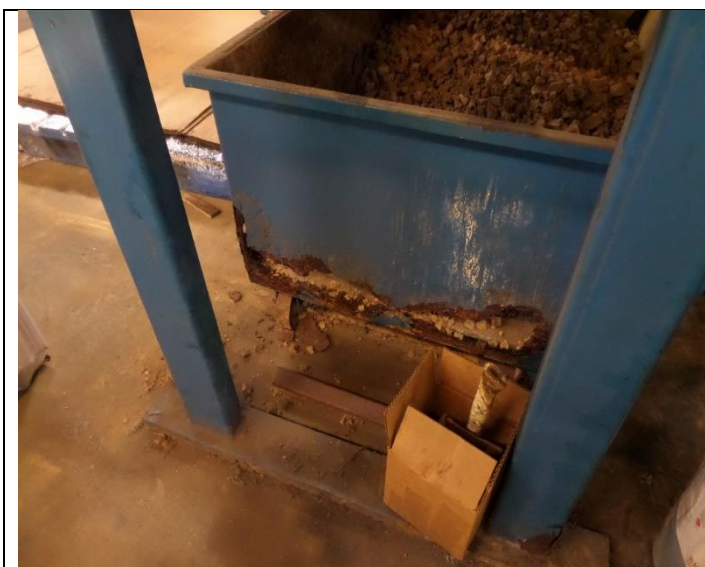
Zinc Wastewater Treatment Line. Inspectors observed zinc solids generated from the filter press were accumulated in a container that was not in good condition. Inspectors observed the release of solids to the floor. Signal representatives indicated the solids are nonhazardous waste. Photograph 7 taken at 10:59 a.m.

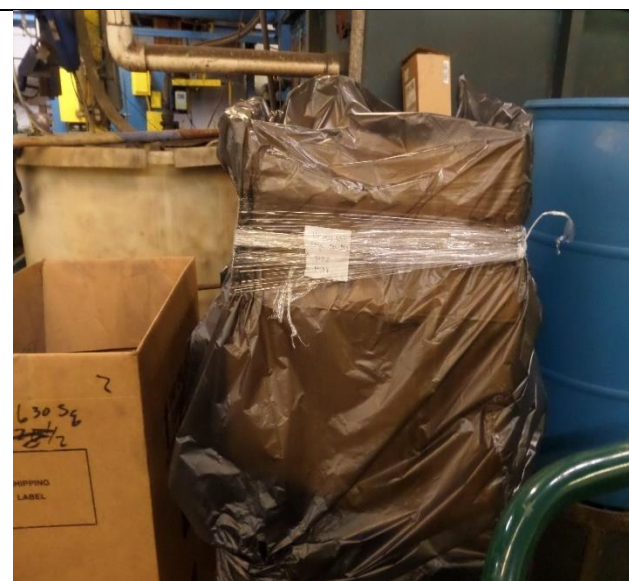
The inspectors observed one closed container accumulating four-foot fluorescent lamps in this area. The container was not marked or labeled with the words “universal waste” and not marked with a date. Signal subsequently consolidated the two lamps observed in the ramp area with lamps in this container. Signal representatives marked the container with the words “universal waste lamps” and marked the container with the date December 19, 2022 (Photographs 8 and 9).

Zinc Wastewater Treatment Line. Inspectors observed a container of four-foot universal waste lamps. Signal representatives marked the container with the words "universal waste lamps" and marked the container with the date December 19, 2022. Photograph 8 taken at 11:06 a.m.

Zinc Wastewater Treatment Line. Inspectors observed a container of four-foot universal waste lamps. Signal representatives marked the container with the words “universal waste lamps” and marked the container with the date December 19, 2022. Consolidated the two lamps from the ramp area to this container. Photograph 9 taken at 11:06 a.m.

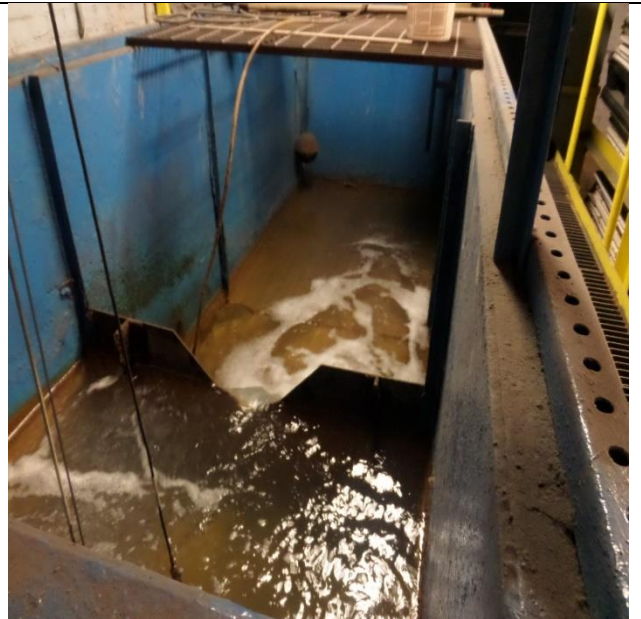
The permitted discharge point to the City of Chattanooga POTW is in the basement. The inspectors observed the wastewater is discharged over a weir into a concrete basin that is connected to the POTW (Photograph 10).

Basement. Inspectors observed the treated wastewater is discharged over a weir into a concrete basin that is connected to the POTW. Photograph 10 taken at 11:26 a.m.

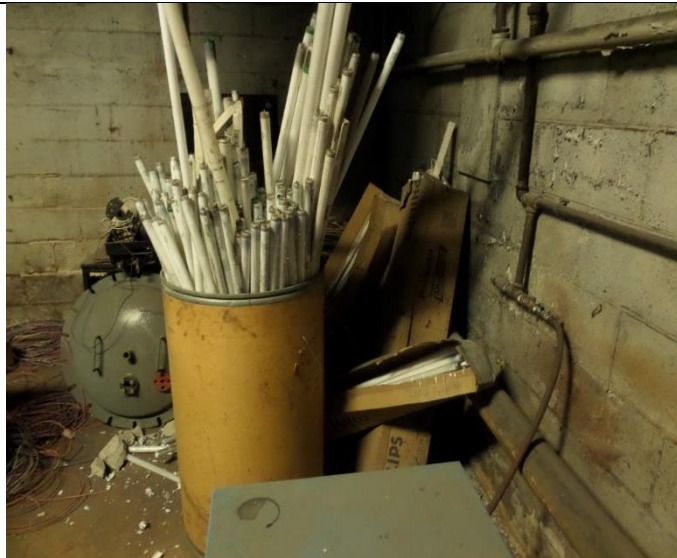
The inspectors observed several four-foot fluorescent lamps accumulating in five containers. The containers were not closed, not marked, or labeled with the words “universal waste” and not marked with a date (Photographs 11 and 12).

The inspectors also observed broken fluorescent lamps accumulating on the floor next to the five containers of fluorescent lamps (Photographs 11 and 12). Signal cleaned up the broken lamps prior to the inspectors leaving the facility.

Basement. The inspectors observed several containers accumulating fluorescent lamps were not closed, not marked or labeled “universal waste lamps” and not dated. Observed broken lamps on the concrete floor. Photograph 11 taken at 11:33 a.m.

Basement. The inspectors observed several containers accumulating fluorescent lamps were not closed, not marked or labeled “universal waste lamps” and not dated. Observed broken lamps on the concrete floor. Photograph 12 taken at 11:33 a.m.

**Pursuant to Tenn. Comp. R. & Regs. 0400-12-01-.12(2)(d)4(i)(I) [40 C.F.R. § 273.13(d)(1)], a SQHUW must contain any lamp in containers or packages that are structurally sound, adequate to prevent breakage, and compatible with the contents of the lamps. Such containers and packages must remain closed and must lack evidence of leakage, spillage or damage that could cause leakage under reasonably foreseeable conditions.**

**Pursuant to Tenn. Comp. R. & Regs. 0400-12-01-.12(2)(d)4(i)(I) [40 C.F.R. § 273.13(d)(2)], a SQHUW must immediately clean up and place in a container any lamp that is broken and must place in a container any lamp that shows evidence of breakage, leakage, or damage that could cause the release of mercury or other hazardous constituents to the environment. Containers must be closed, structurally sound, compatible with the contents of the lamps and must lack evidence of leakage, spillage or damage that could cause leakage or releases of mercury or other hazardous constituents to the environment under reasonably foreseeable conditions.**

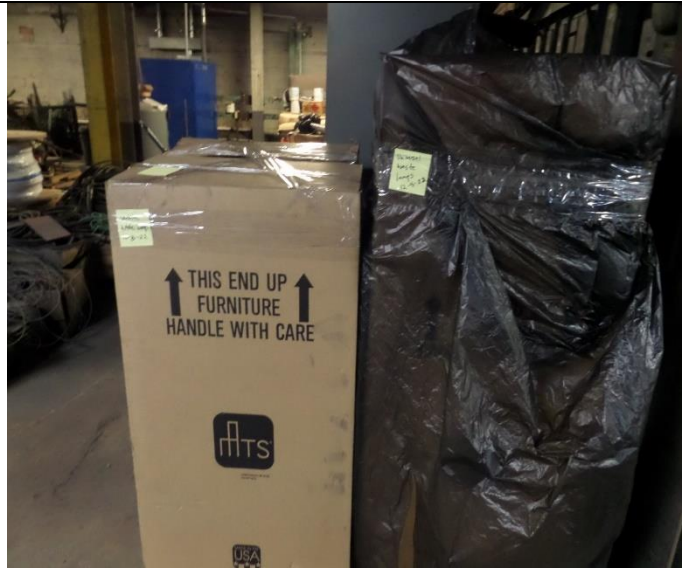
The inspectors returned to the maintenance shop after the record review. The inspectors observed the waste lamps were accumulated in two four-foot containers. The inspectors observed the containers were closed, marked with the words “universal waste lamps” and one container

marked with the date December 3, 2023 and the other container marked with the date December 5, 2023 (Photograph 13). The inspectors observed Signal representatives responded to the release of broken lamps (Photograph 14). The broken lamps were accumulated in a closed container.

Basement. The inspectors observed Signal representatives consolidated the fluorescent lamps in closed containers, marked the containers with the words “universal waste lamps” and marked the containers with the date December 3, 2023 or December 5, 2023. Photograph 13 taken at 12:07 p.m.

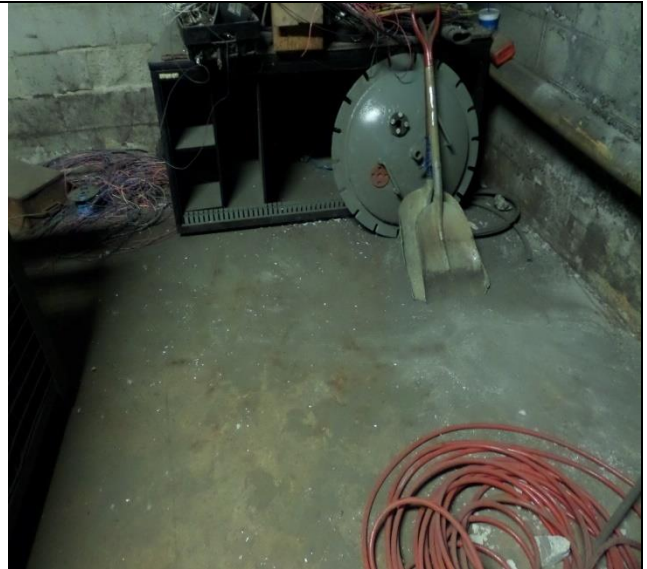
Basement. The inspectors observed Signal cleaned the release of broken lamps to the concrete floor. Photograph 14 taken at 12:07 p.m.

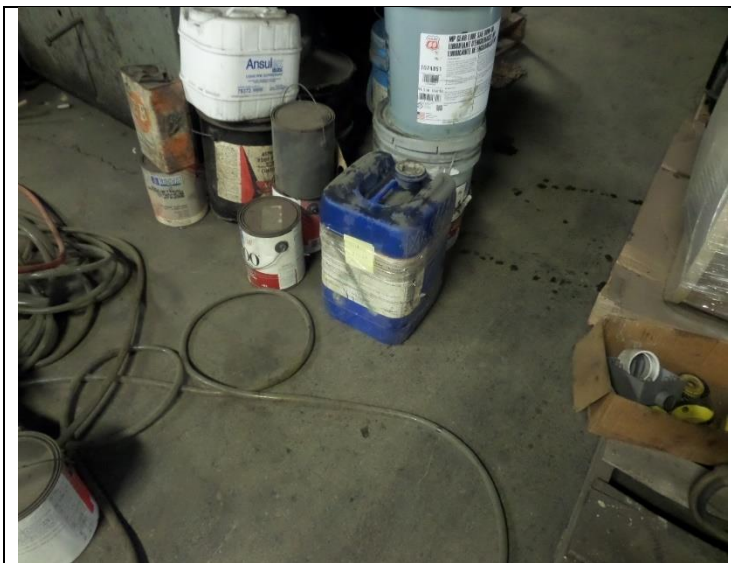
The maintenance shop is in the basement. The inspectors observed a 5-gallon container accumulating used oil. The container was not closed and not marked or labeled with the words “used oil”. Signal closed the container and marked it with the words “used oil” (Photograph 15).

Basement. The inspectors observed Signal close and mark the container with the words “used oil”. Photograph 15 taken at 2:08 p.m.

**Pursuant to Tenn. Comp. R. & Regs. 0400-12-01-.11(3)(i) [40 C.F.R. § 279.22(c)(1)], containers and aboveground tanks used to store used oil at generator facilities must be labeled or marked clearly with the words “Used Oil.”**
