**Subj:** Medfield MA WWTP Inspection Report, as it relates to the Clean Water Act

A. *Facility Name:* Medfield Wastewater Treatment Plant

A. *Date(s) of inspection:* 7/18/2022

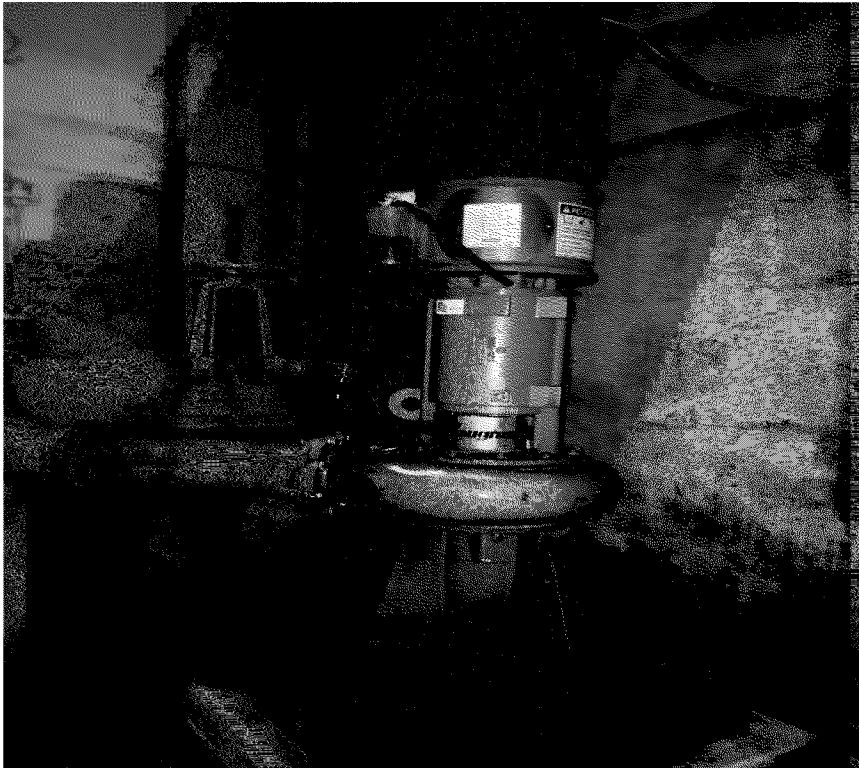
Mr. Donovan explained that the teeth to clean the bars are made of plastic and continually break. They have spare parts, but they will be looking to replace the unit with one that is more durable. Next stop was the pump room. It housed the three pumps that convey influent into the grit chamber (one of the 3 pumps pictured below)

One pump was online at the time of the inspection. Mr. Donovan explained that at this time of year the plant usually was handling roughly 300,000 gallons/day and that they can operate with one pump on-line and the other two in standby mode. Prior to the influent leaving the pump room Polyaluminum Chloride (PAC) solution is added to the influent to increase coagulation within the grit chamber. PAC is added to influent just prior to leaving the pump room as shown below.

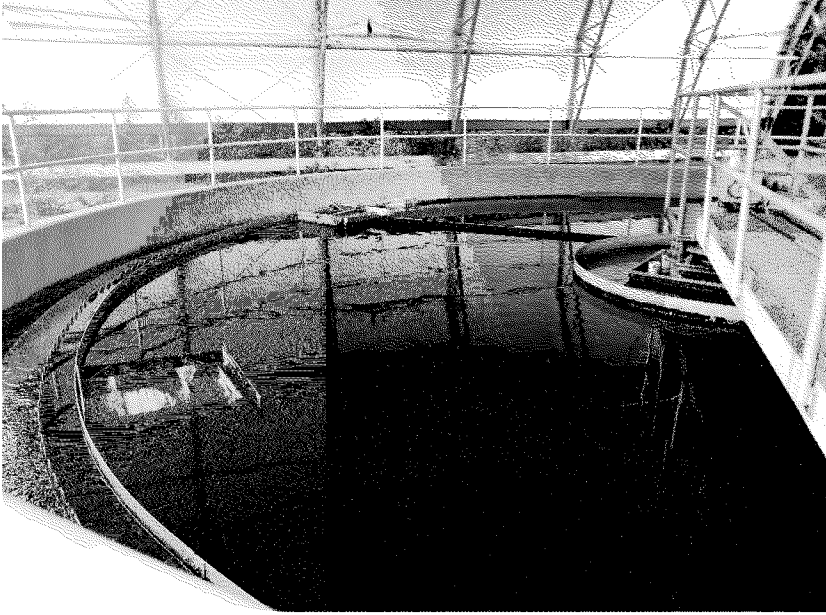
(one of the secondary clarifiers under cover)

The clarifiers are covered by an awning to prevent the growth of algae. Both clarifiers were online and operating at the time of the inspection. From the secondary clarifiers the effluent goes to the sand filter.

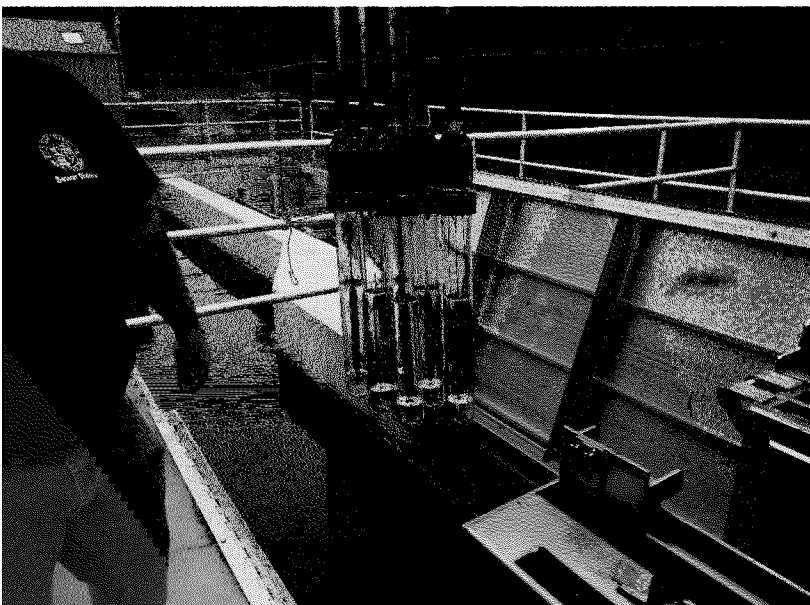
The final step of the wastewater treatment process is the UV system. Four banks of UV light bulbs are attached to arms and submerged into treated wastewater channel.

(picture showing UV Bulbs removed from effluent channel)

Many of these bulbs were offline during the inspection, and biologic material was visible on some bulbs. The appearance of the final effluent before UV treatment (below)

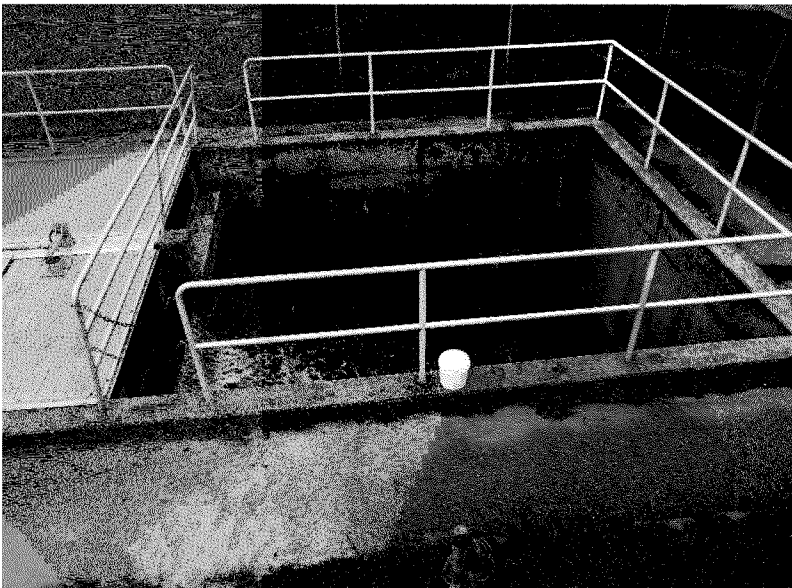
Effluent after UV treatment flowing down cascading steps to the outfall.
