INSPECTION REPORT

| <b>Type of Inspection</b> | Focused Compliance Inspection (FCI) | | | |
| <b>Facility or Site Name</b> | C-Port 2, LLC | | | |

**SECTION II – OBSERVATIONS****Tenant:** C-Port 2, LLC**Section:** 2**Date:** 4/16/24, 1:35 P.M.**Contains AOC:** Yes**Contains CBI:** No**Lead Inspector:** Brook McKeown**Attendees:** Matt Labat (QHSE Manager), Craig Boudreaux (Site Manager)

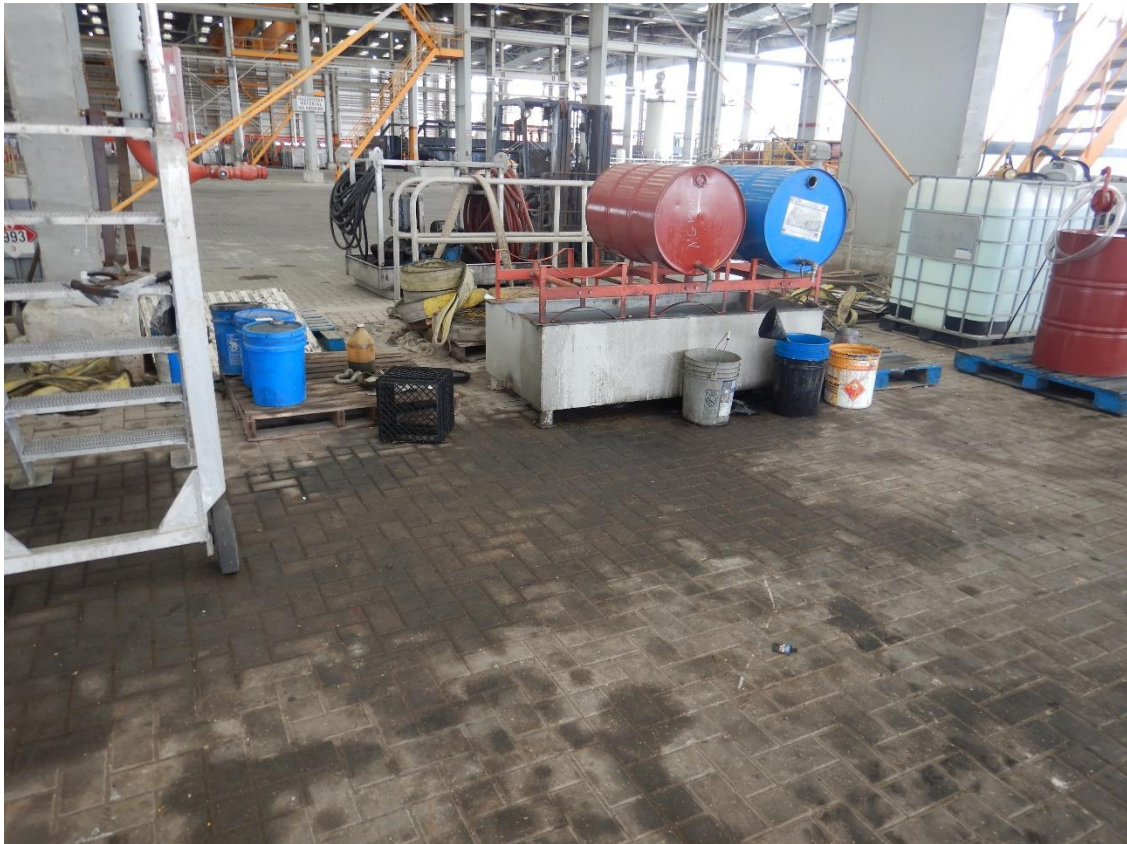
**Photo No. 1**

After the opening meeting, the inspection team conducted a visual walkthrough of the facility and dock areas. At approximately 2:40 PM, the inspection team first observed Slip 5, which is currently not under a long-term lease. The inspection team observed a poly tote that was about 90 percent full and labeled with a DOT 1993 flammability placard. CP2 personnel stated that the tote contained diesel fuel from drip pans that will be managed as nonhazardous waste or may be reused. The inspection team also observed a 55-gallon drum used to accumulate used diesel filters and rags that is managed as nonhazardous waste. There was also a station for oil product dispensing in Slip 5. The inspection team observed catch buckets beneath the oil dispensing valves and what appeared to be staining on the ground around the oil dispensing station (see Appendix 1 – Photos 1 and 2). The ground did not appear to have an impermeable coating or other material to prevent releases to the environment, and the waste determination of the stained material was not known [**AOC #1:** *The stained materials from a prior spill at the oil dispensing station did not have a waste determination for whether they were hazardous or not. – 40 CFR 262.11*].

| Tenant: C-Port 2, LLC | | |
|---|---|---|
| <b>AOC #1</b> – The stained materials from a prior spill at the oil dispensing station did not have a waste determination for whether they were hazardous or not. | <b>Citation:</b> 40 CFR 262.11 | Section: 2 |

Description: View of oil product drums at a dispensing station in Slip 5. The inspection team observed staining on the ground that appeared to be from the oil dispensing.

- CP2 added a containment structure at the oil dispensing station in Slip 5 to prevent any spills of oil directly to the ground (photos provided in Appendix 4).

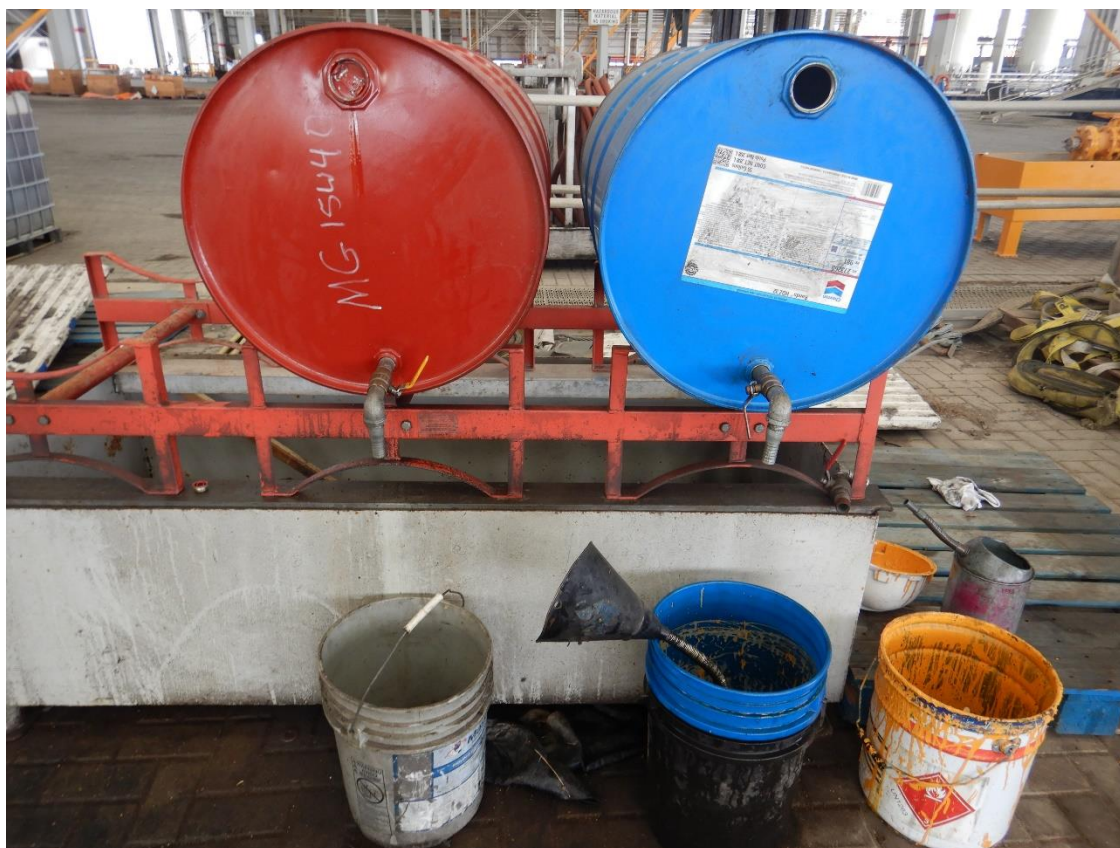
Photo No. 2

Description: View of oil product drums at a dispensing station in Slip 5.

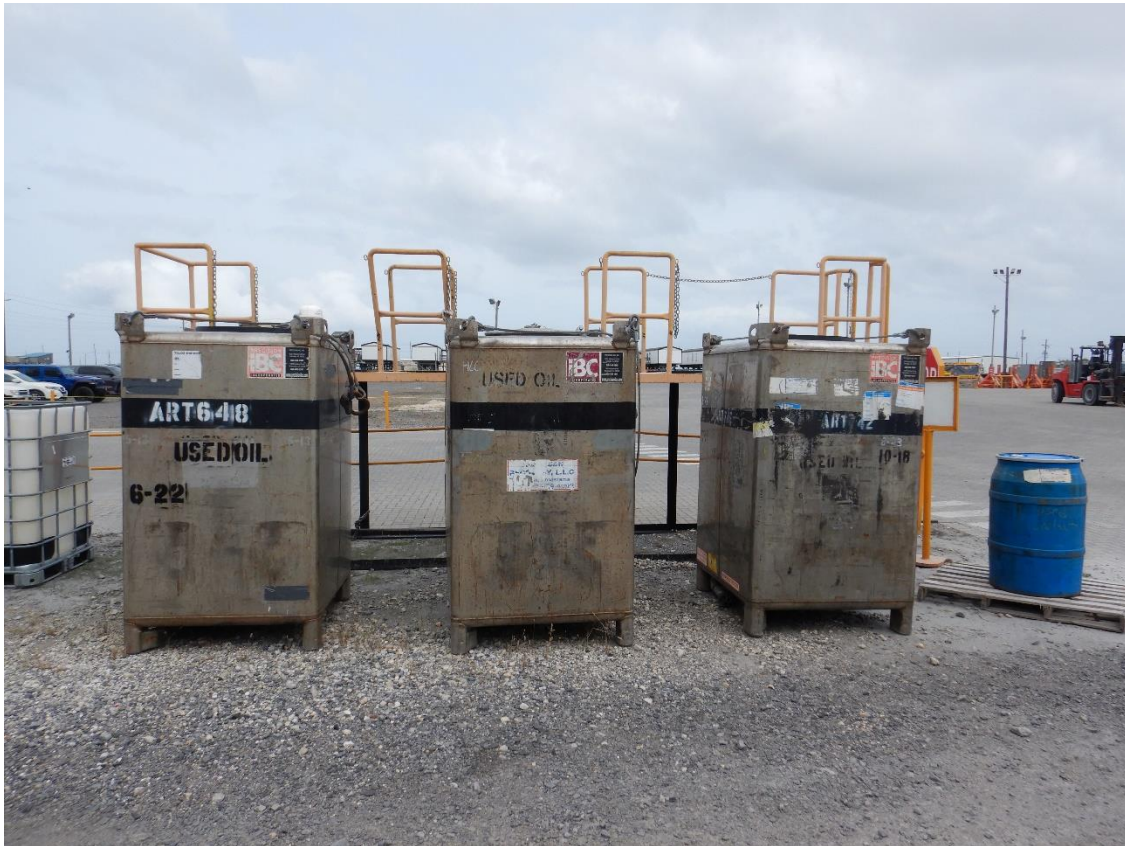
**Photo No. 3**

Description: View of three marine containers used to accumulate used oil at CP2.

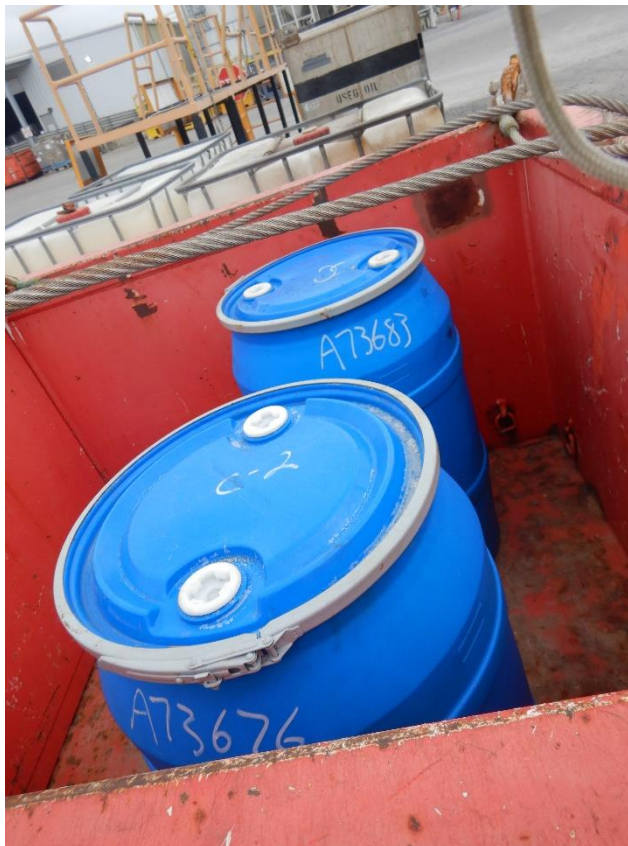
Photo No. 4

| Tenant: C-Port 2, LLC | | |
|---|---|---|
| <b>AOC #2</b> – Containers used to store used oil were not labeled with the words “used oil”. | <b>Citation:</b> 40 CFR 279.22(c)(1) | Section: 2 |

Description: View of an open-top drum basket with two 55-gallon drums. The drums likely contained used oil based on discussion with facility representatives, but the drums were not labeled "used oil".

- CP2 stated that additional training was conducted with facility personnel to address drum labeling and that a news bulletin was sent to facility personnel to inform them of the labeling requirements for used oil. Appendix 4 includes a photo from CP2 of drums that have been properly labeled on site as an example.

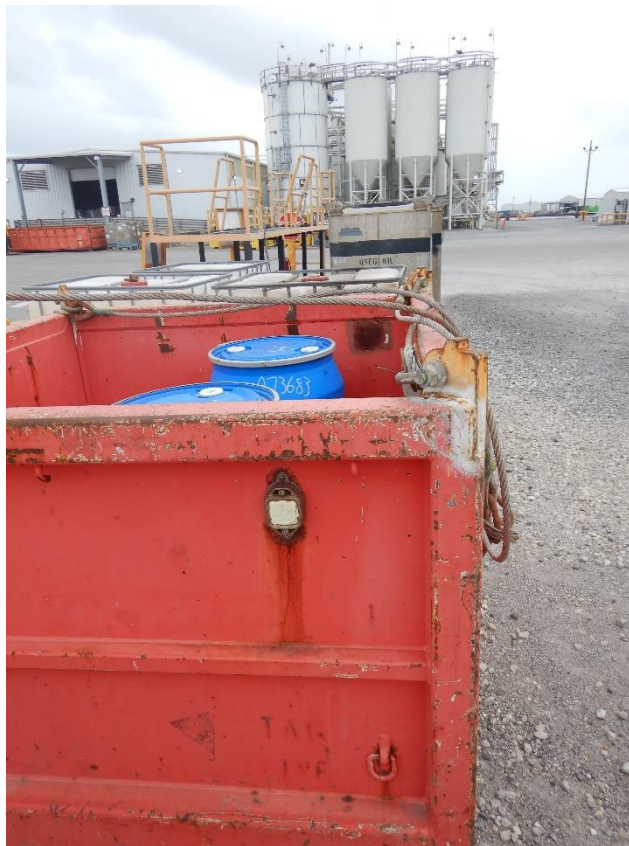
**Photo No. 5**

Description: View of an open-top drum basket with two 55-gallon drums.

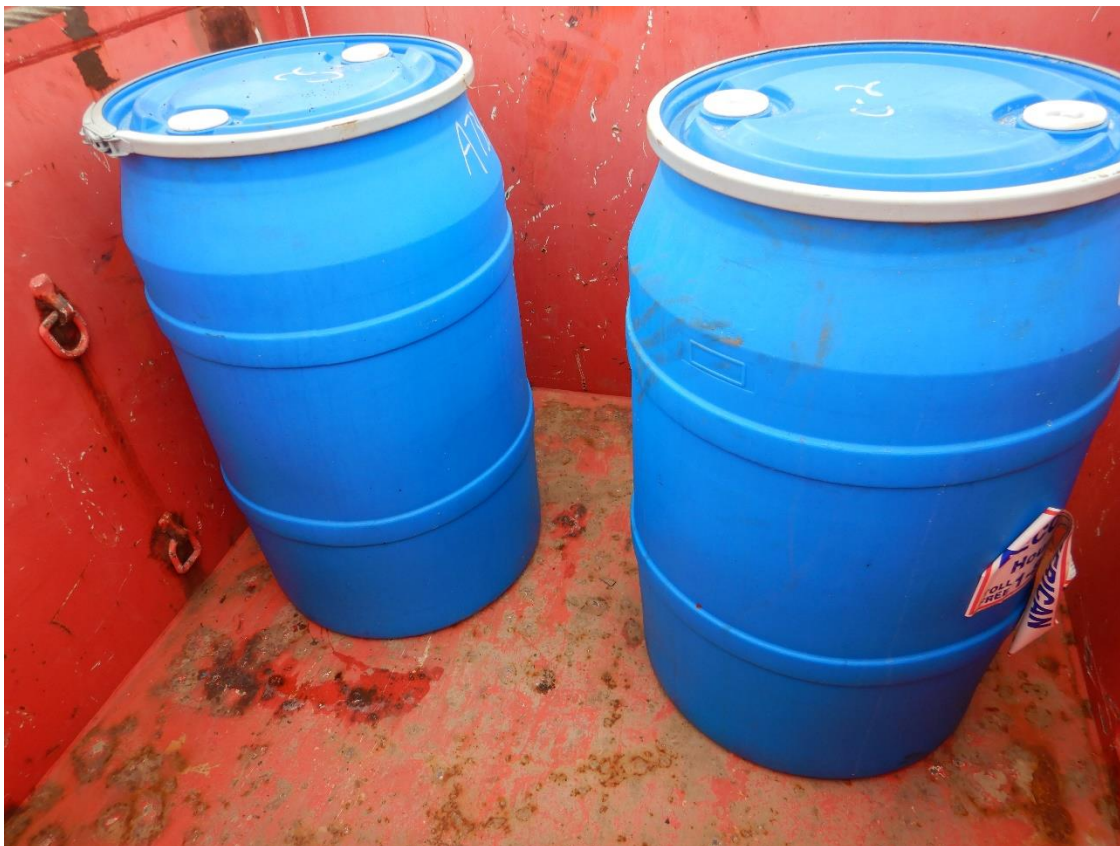
Photo No. 6

Description: View of an open-top drum basket with two 55-gallon drums. The drums likely contained used oil based on discussion with facility representatives, but the drums were not labeled "used oil" (same drums shown in Photo No. 4).

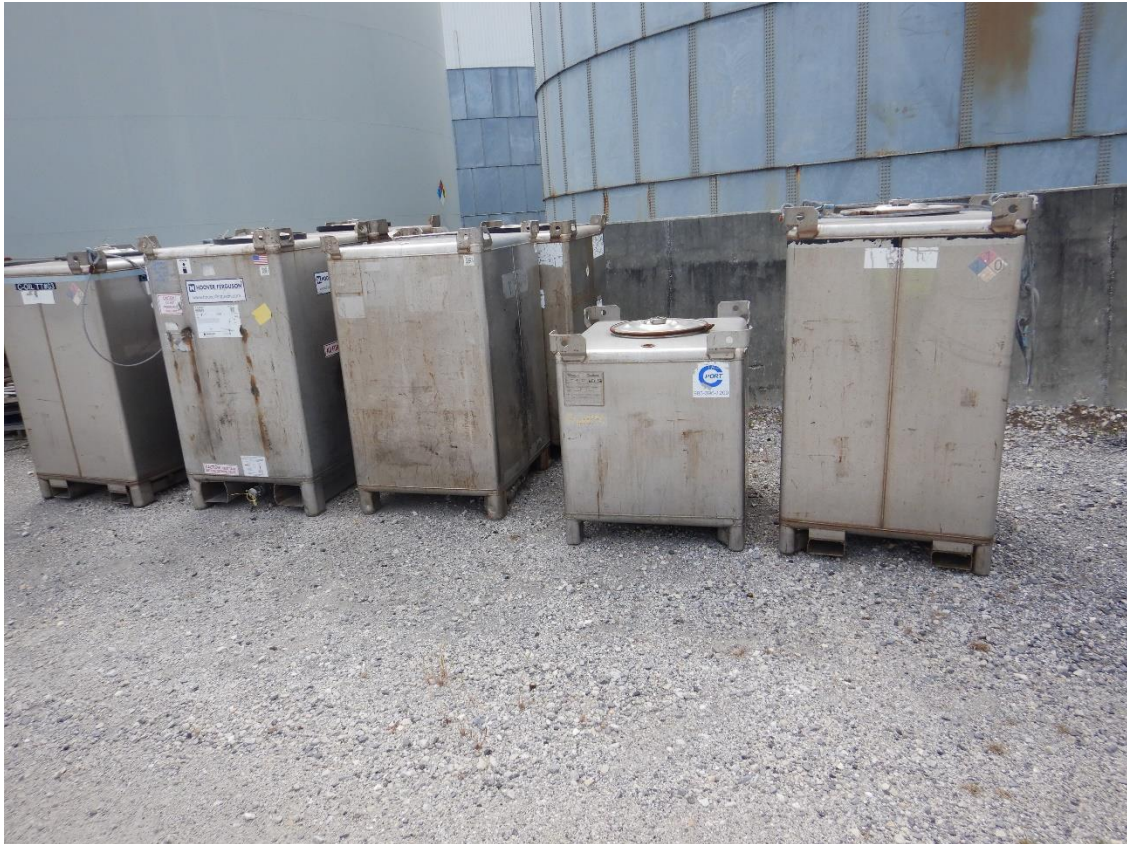
Photo No. 7

Description: View of empty marine containers stored on site and managed as scrap due to defects.

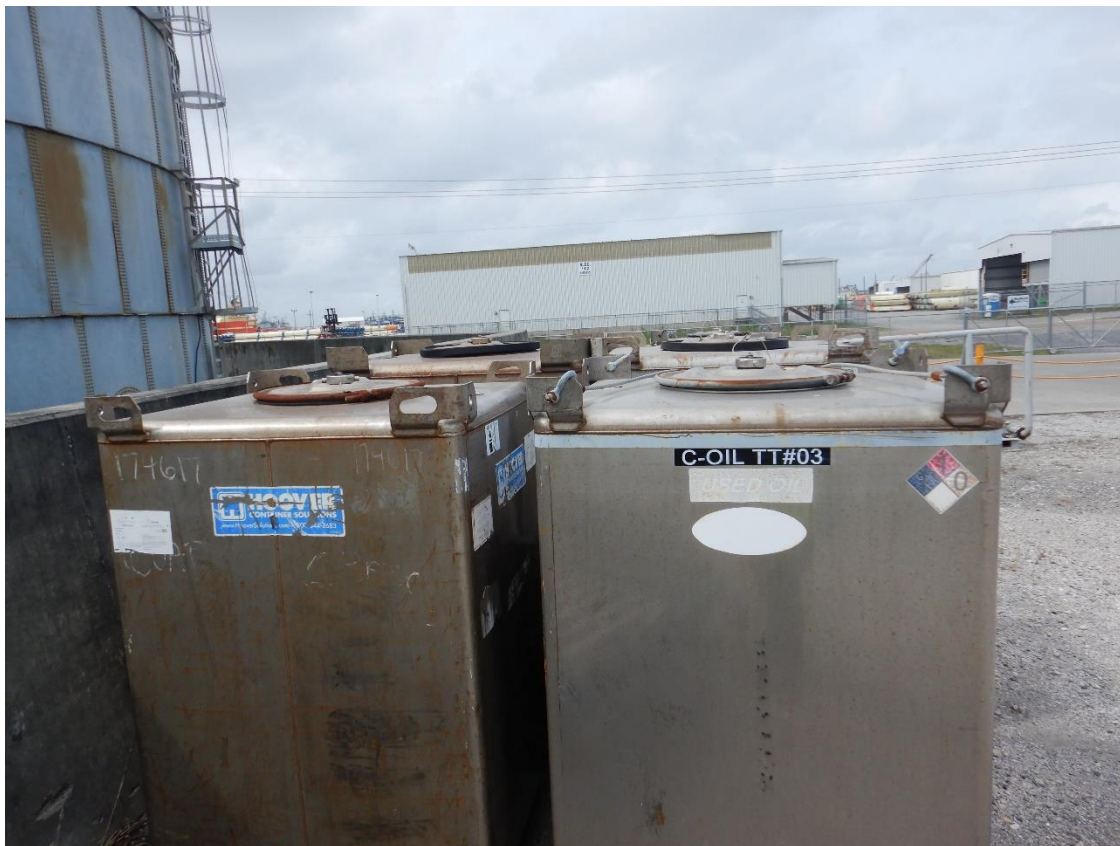
Photo No. 8

Description: View of empty marine containers stored on site and managed as scrap due to defects.

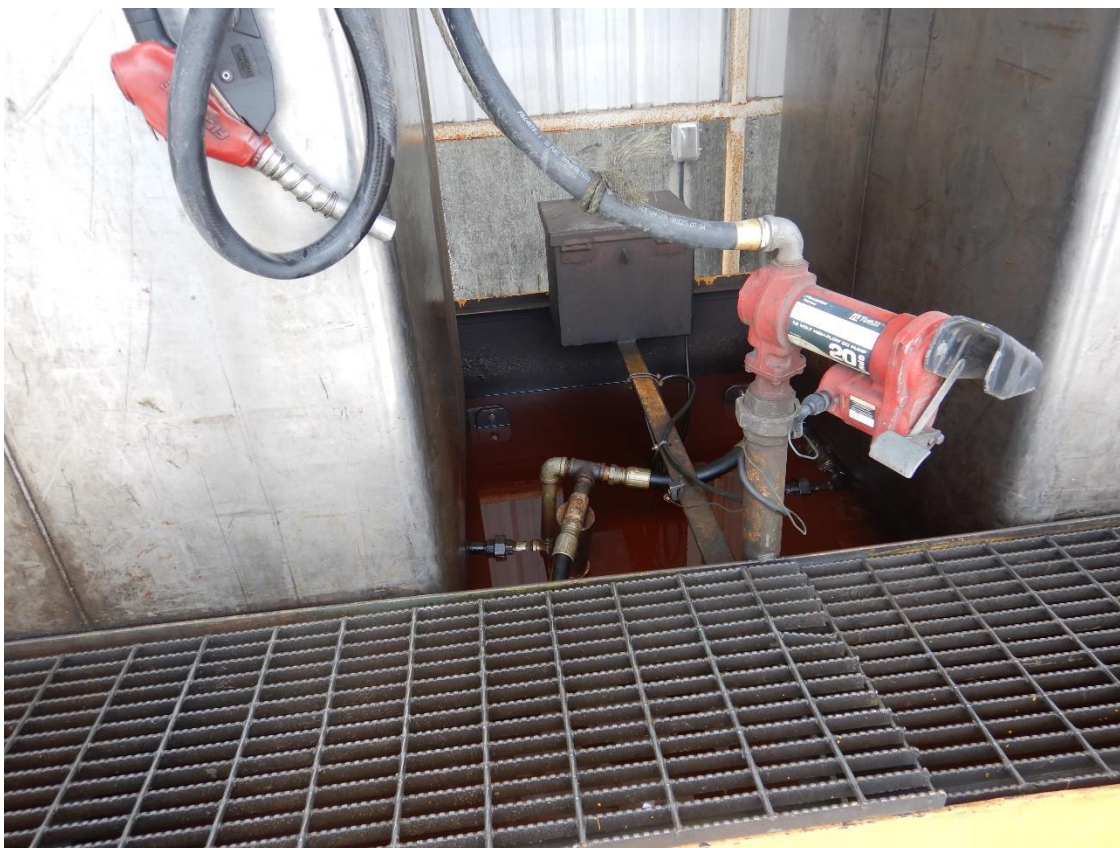
Photo No. 9

- Oil dispensing stations that appeared to have oily water accumulated in the secondary containment (see Appendix 1 – Photos 9 and 10).
- Four non-empty drums with attached manifests identifying them as used oil received from Jackson Offshore to be sent to EIE Services LLC in Houma, LA with CP2 as a transfer site (see Appendix 1 – Photos 11 through 17). The manifest for the drums indicated that the used oil may have been on site for greater than 35 days since it was most recently dated in February 2024 [**AOC #3:** *Containers of used oil for transfer were stored on site for more than 35 days, which would make CP2 subject to regulation as a used oil processor and re-refiner. – 40 CFR 279.45(a)*].

Description: View of an oil dispensing station secondary containment that had oily water residuals present at the time of the inspection.

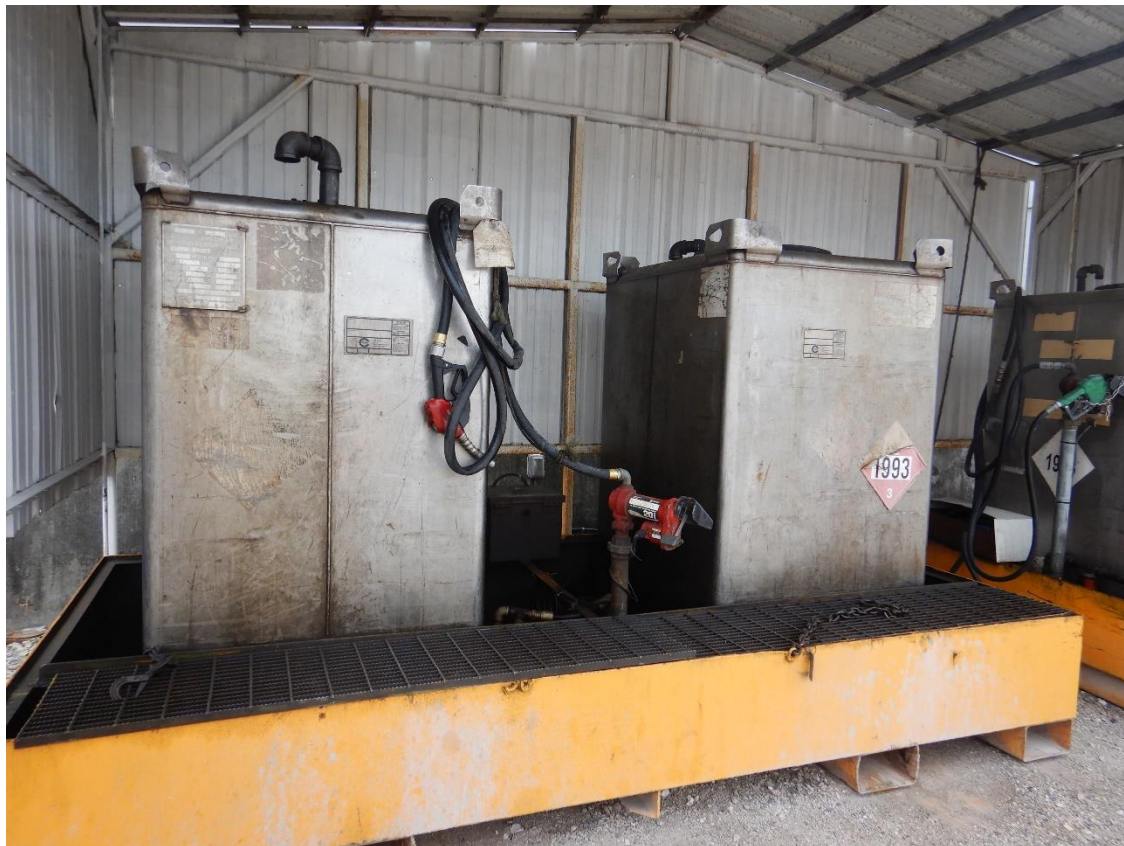
Photo No. 10

Description: View of an oil dispensing station on site.

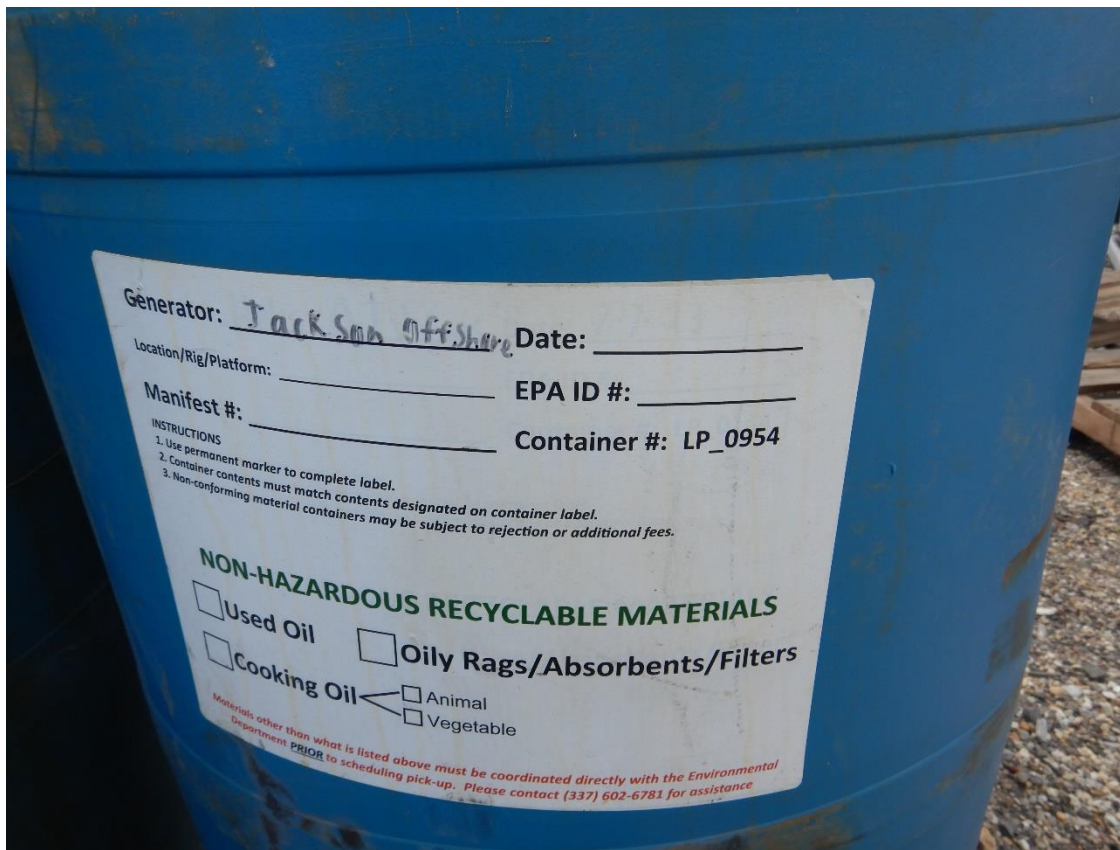
Photo No. 12

Description: View of a label on a 55-gallon drum in the Waste Storage Area, with the drum identifying Jackson Offshore as the generator.

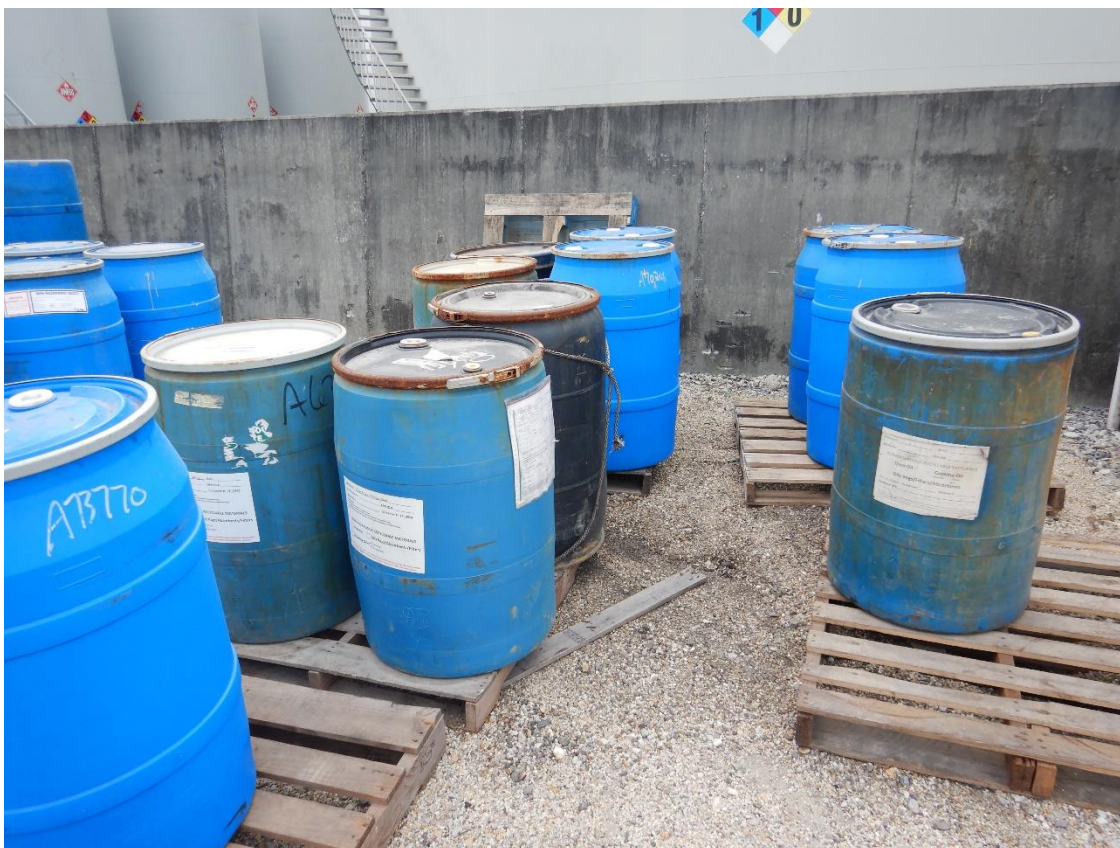
Photo No. 13

| Tenant: C-Port 2, LLC | | |
|---|---|---|
| <b>AOC #3</b> – Containers of used oil for transfer were stored on site for more than 35 days, which would make CP2 subject to regulation as a used oil processor and re-refiner. | <b>Citation:</b> 40 CFR 279.45(a) | Section: 2 |

Description: View of used oil drums staged in the Waste Storage Area at CP2. Several of the containers shown in the image were received from Jackson Offshore.

- CP2 made revisions to the site waste management plan and to the internal monthly walkthrough inspection checklist in order to prevent used oil containers from being onsite for greater than 35 days when being transferred. Revisions to the documents are shown in Appendix 4.

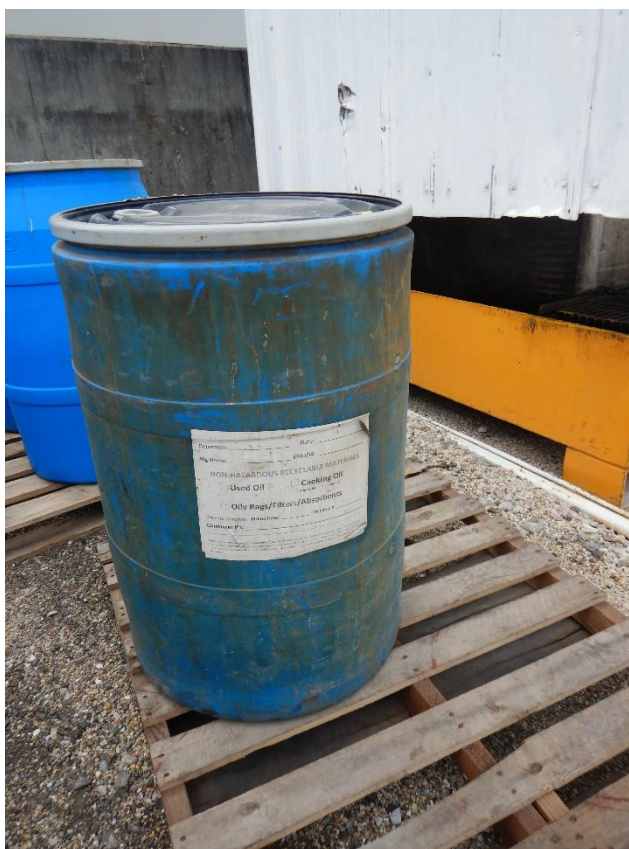
Photo No. 14

Description: View of a 55-gallon drum in the Waste Storage Area, with the drum label identifying Jackson Offshore as the generator.

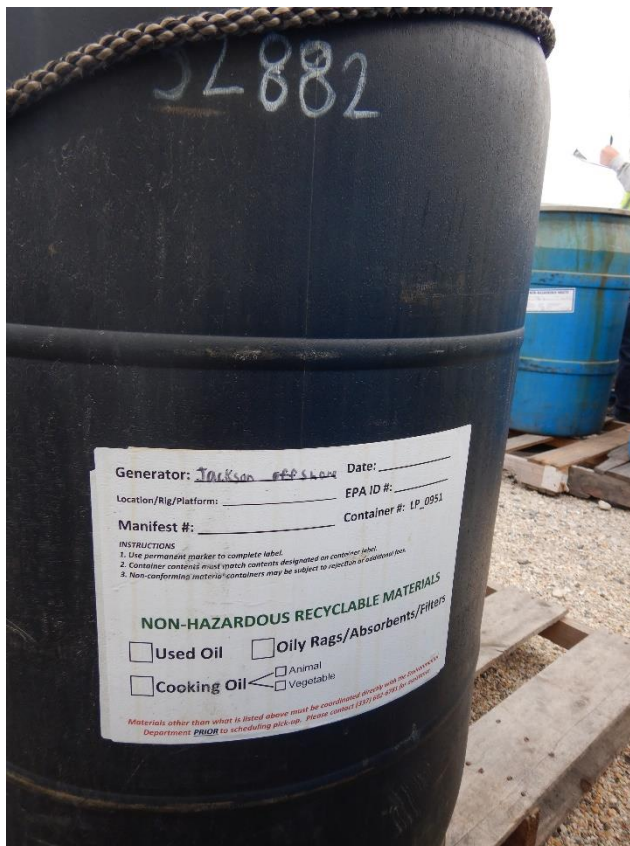
Photo No. 15

Description: View of a 55-gallon drum in the Waste Storage Area, with the drum label identifying Jackson Offshore as the generator.

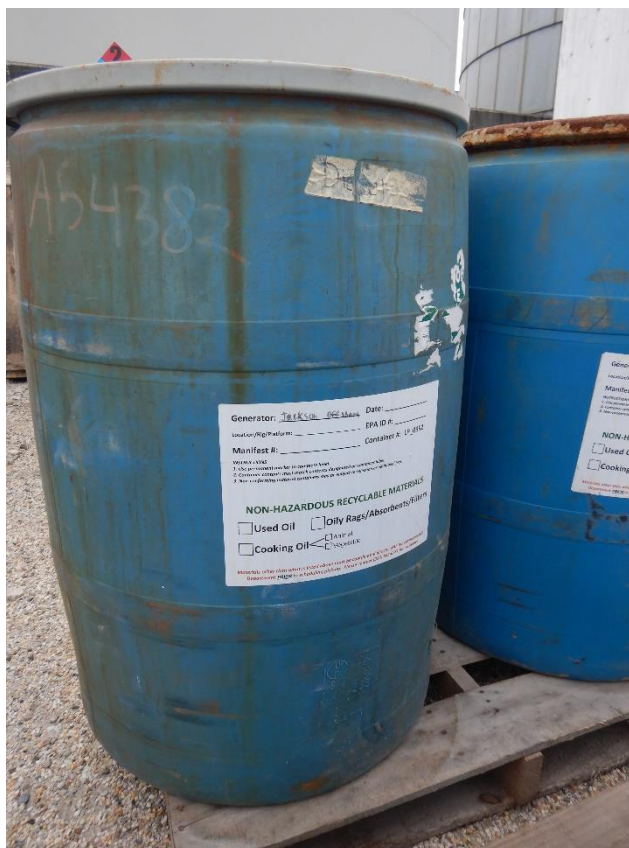
Photo No. 16

Description: View of a 55-gallon drum in the Waste Storage Area, with the drum label identifying Jackson Offshore as the generator.

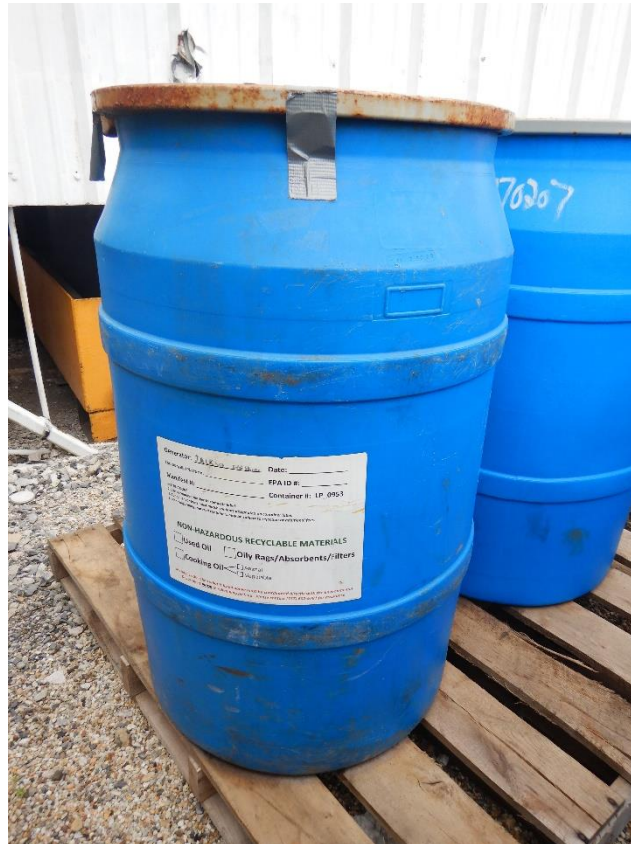
Photo No. 17

Description: View of a 55-gallon drum in the Waste Storage Area, with the drum label identifying Jackson Offshore as the generator.

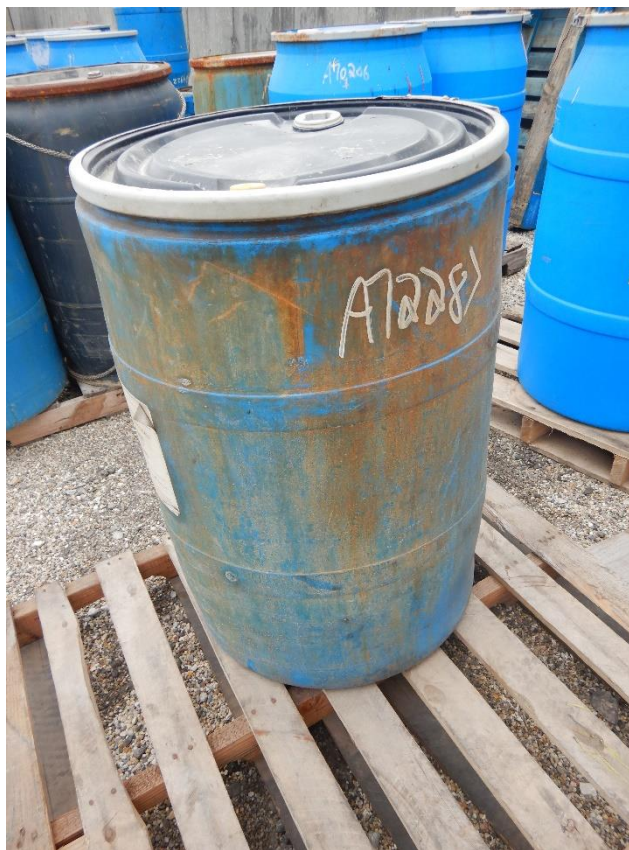
Photo No. 18

Description: View of a 55-gallon drum of used oil or used oil-related material that had a blank label and was staged in the Waste Storage Area.

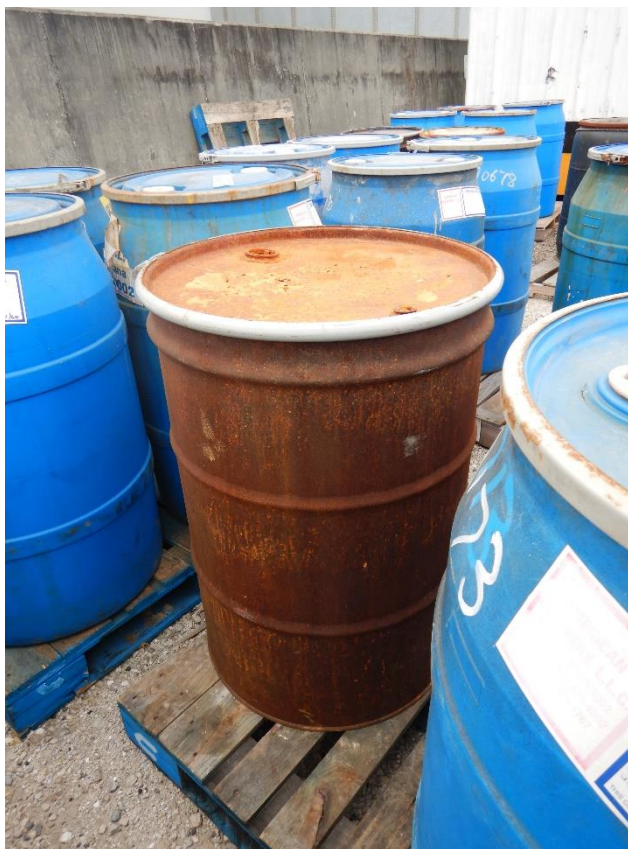
Photo No. 19

- One drum without a label and showing signs of corrosion (see Appendix 1 – Photo 19). Inspector Wieber tapped the side of the drum and lifted one side to confirm that it was non-empty. The CP2 personnel stated that it is likely used oil. The inspection team also observed fifteen drums of used oil or used oil-related material with American Recovery tracking numbers and either no label, a blank label, or a label with illegible writing on it (examples shown in Appendix 1 – Photos 18, 20, and 21). Drums were confirmed to be non-empty by lifting one side. [**AOC #2:** *Containers used to store used oil were not labeled with the words “used oil”. – 40 CFR 279.22(c)(1)*]. The fifteen drums with American Recovery tracking numbers that were not properly or clearly labeled as used oil included the following tracking numbers: A70207, A70206, A70697, A70681, A70690, A71188, A73172, A73173, A70867, A70674, A70075, A70676, A70662, A70687, and A72287. An example of a drum with a completed and legible label is provided in Photo 22, Appendix 1.

Description: View of a 55-gallon drum of used oil or used oil-related material that showed signs of corrosion and had no label.

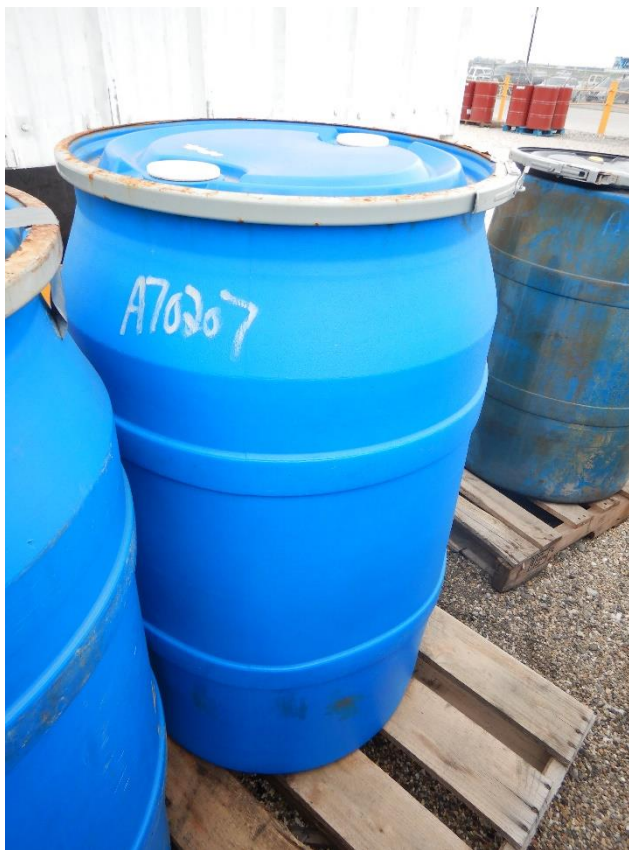
Photo No. 20

Description: View of a 55-gallon drum of used oil or used oil-related material that had no label besides the American Recovery tracking number.

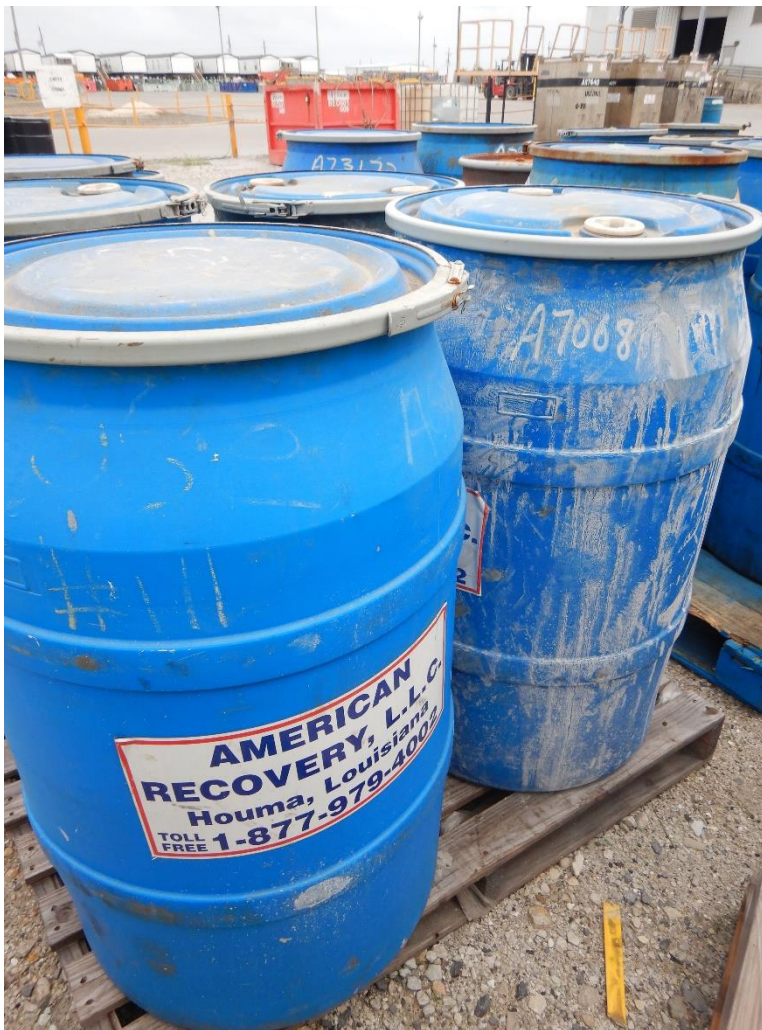
Photo No. 21

Description: View of 55-gallon drums of used oil or used oil-related material that had no labels identifying their contents.

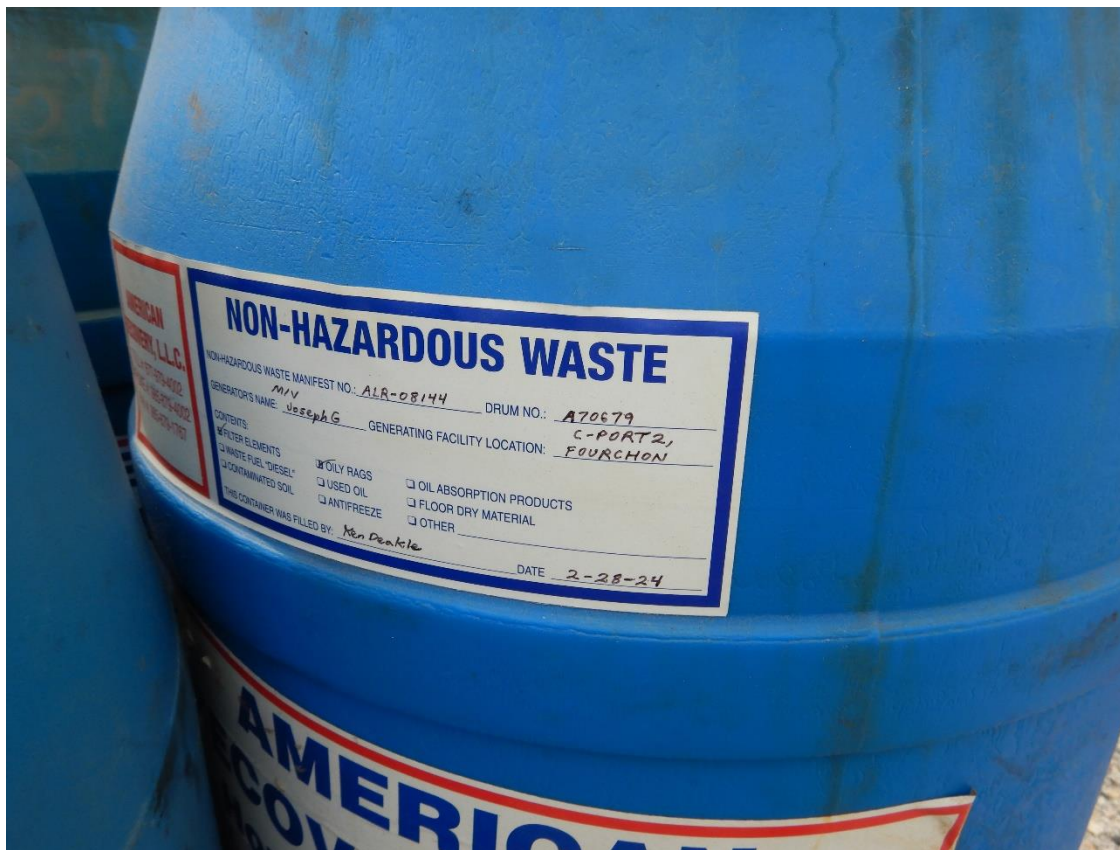
Photo No. 22

Description: View of a 55-gallon drum in the Waste Storage Area containing used oil-related materials. The drum had a completed label.

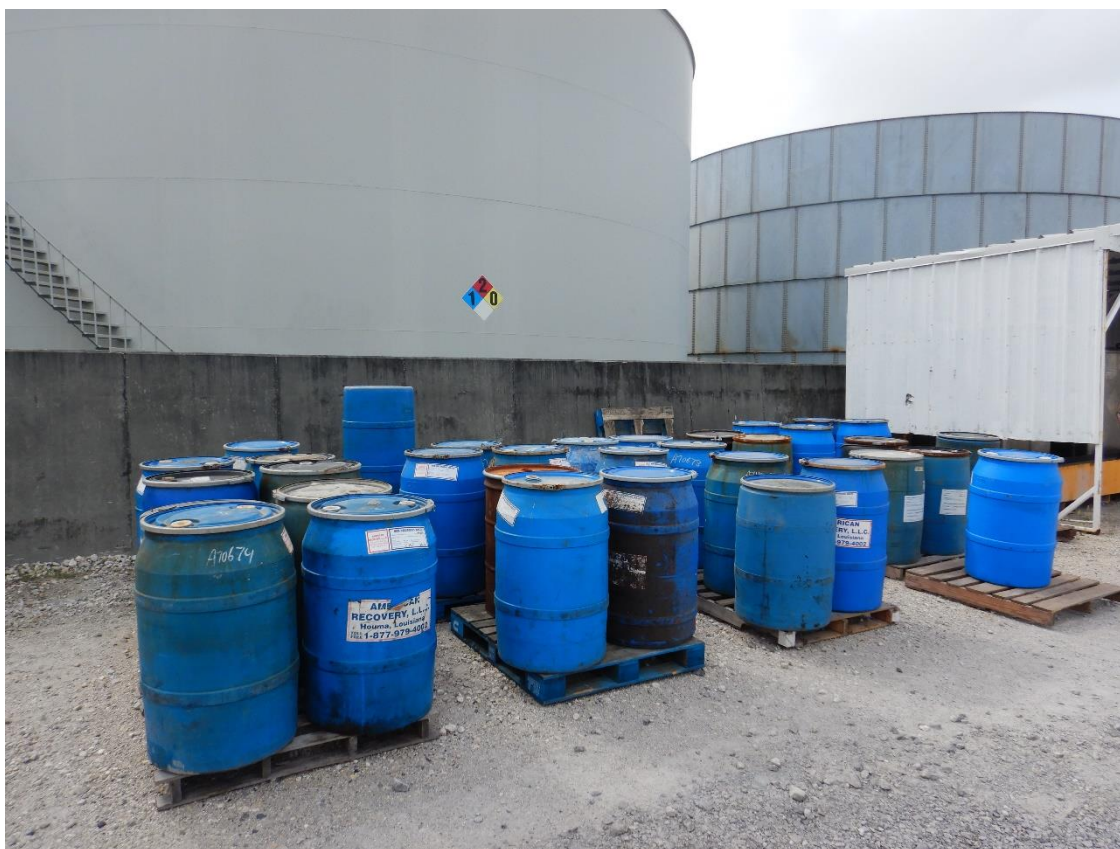
Photo No. 23

An overview of the drums stored onsite is included in Photo 23, Appendix 1. The inspection team noted that there was no secondary containment for the used oil drums that had been received onsite from third parties for transfer [**AOC #4:** *Containers used to store used oil that had been received by CP2 for transfer were not equipped with secondary containment. – 40 CFR 279.45(d)*].

Description: Overview of the drum staging area for used oil in the Waste Storage Area.

- CP2 is looking into moving their used oil storage to Slip 2 which is a covered area and setting up a containment berm as secondary containment for used oil on site. Appendix 4 includes a photo of several drums inside a containment berm in Slip 2.

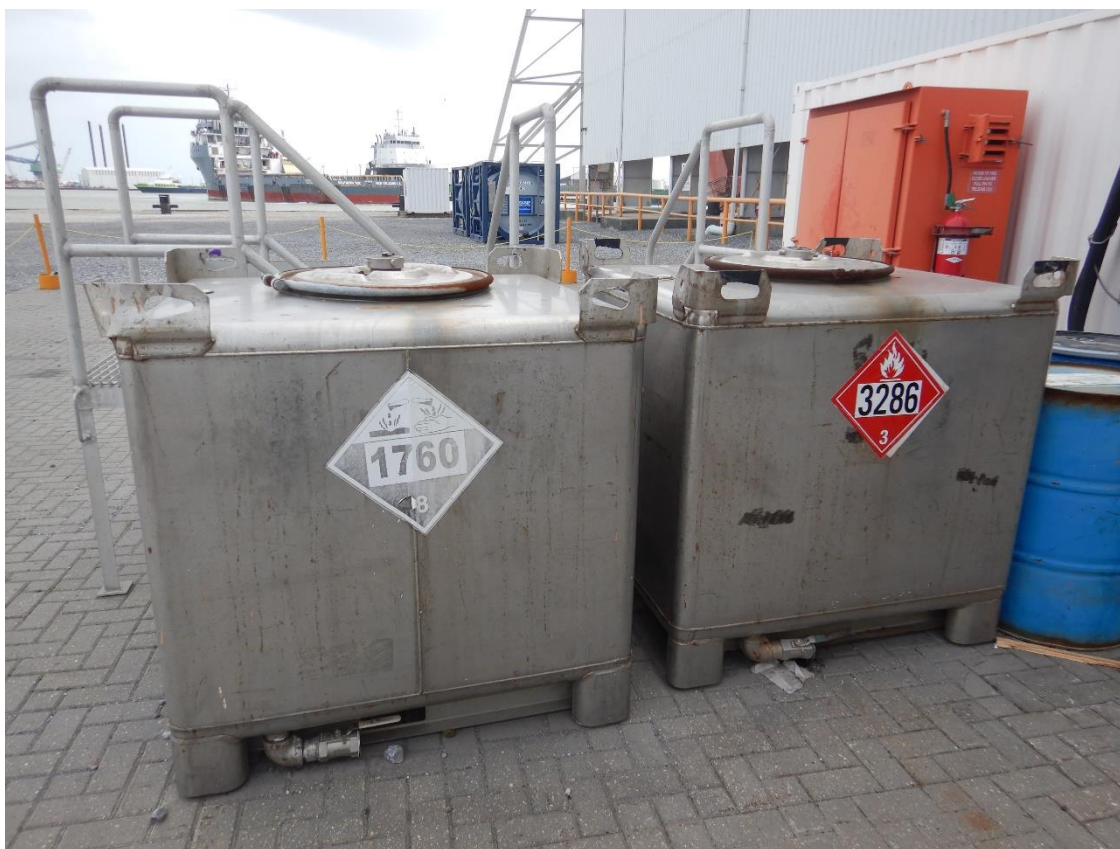
Photo No. 24

The inspection team then observed a roped-off area near Slip 9 with various containers and cargo. The area was used as product storage for sulfide scavenger and asphaltene inhibitor additives and contained a few other containers. The inspection team observed a 55-gallon drum of oily rags with an American Recovery tracking number, and two metal totes with DOT hazard labels (see Appendix 1 – Photos 24 and 25). The CP2 personnel stated that the metal totes contained residual sulfide scavenger and asphaltene inhibitor from pumping off the material, and that the material is under the custody of Shell. During email follow-up, Shell stated that CP2 had custody of the containers. It is not clear which entity is managing the material, and CP2 and Shell may be co-generators of the material at the location. The two metal totes and the drum of oily rags were not clearly labeled with their contents and should have a waste determination made if they are being managed as waste [**AOC #5:** *CP2 and/or Shell did not make a waste determination on the two metal totes of drilling additives and the 55-gallon drum of oily rags staged on site. – 40 CFR 262.11*].

| Tenant: C-Port 2, LLC | | |
|---|---|---|
| <b>AOC #5</b> – CP2 and/or Shell did not make a waste determination on the two metal totes of drilling | <b>Citation:</b> 40 CFR 262.11 | Section: 2 |

Description: View of metal totes containing residual sulfide scavenger and asphaltene inhibitor from pumping off the material and staged in a tenant-owned area. The totes were only labeled with a DOT hazard sticker at the time of the inspection.

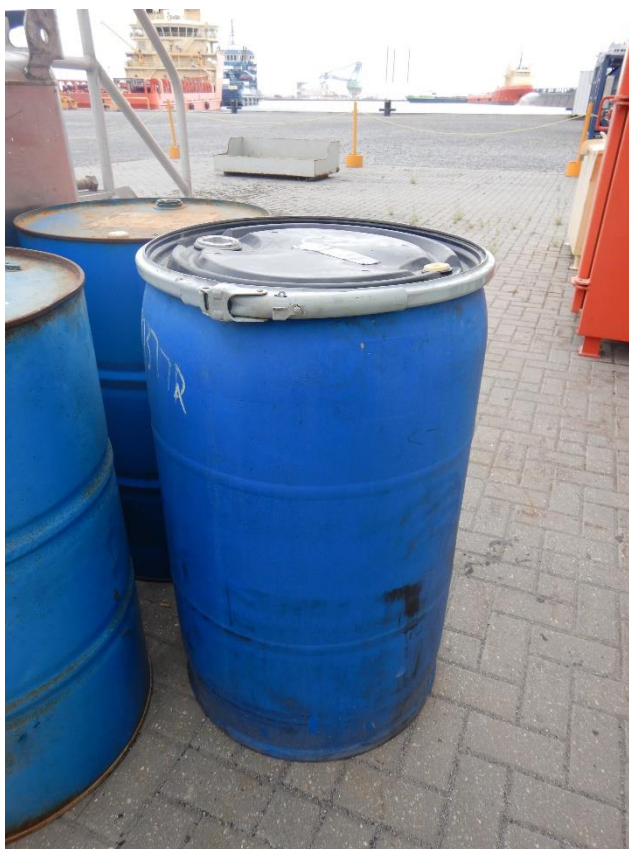
Photo No. 25

Description: View of a 55-gallon drum staged in a tenant-owned area. Facility personnel stated that the drum contained used oil rags.
