## **RCRA Inspection Report**

InChem – Rock Hill, LLC EPA ID# SCD981014780  
800 Cel-River Road  
Rock Hill, South Carolina 29730

April 13, 2021

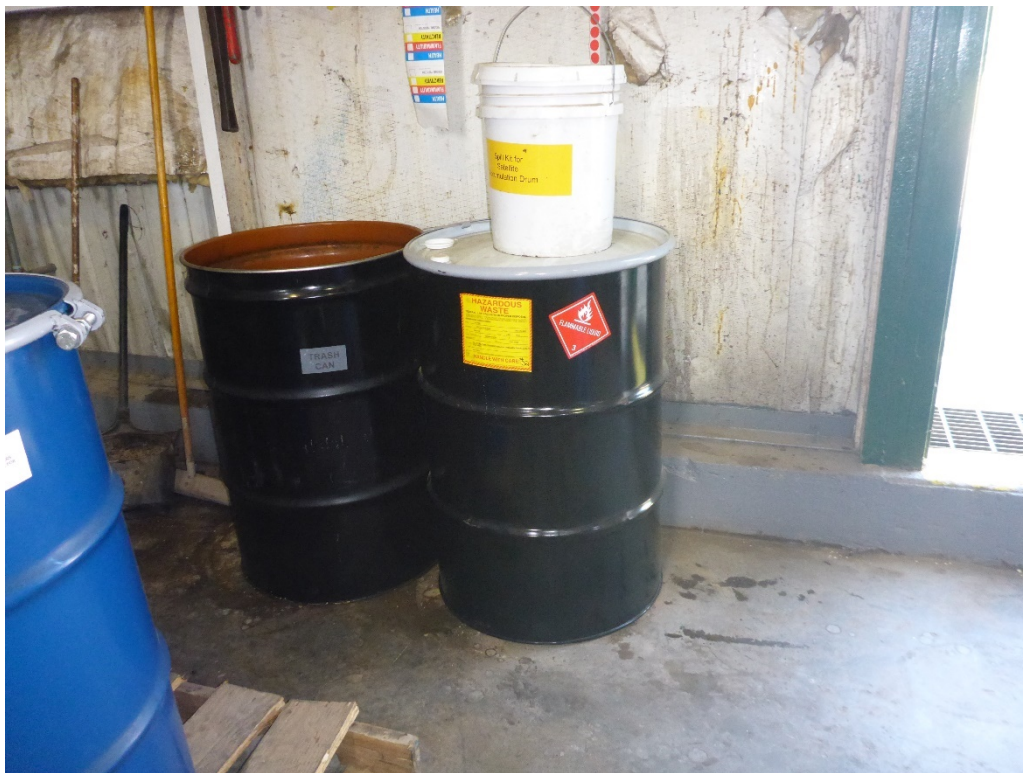
**Distillation Area SAA:** InChem manages one SAA in the distillation area for managing hazardous waste flammable solvents generated in this building. The inspectors observed an emergency shower and a fire extinguisher in this room, and one 55-gallon drum in the SAA (Photo 1). The drum was located near the exit door with a 5-gallon spill kit bucket. The drum was closed, labeled D001 / D035 hazardous waste flammable liquids (MEK), and identified with a flammable liquid DOT hazard placard. Between campaign runs, employees clean the floors using a shop vacuum, and the liquids accumulated by the vacuum are poured into this accumulation drum.

**Photo 1:** One 55-gallon drum and a 5-gallon spill kit bucket located in the Distillation Area SAA. The drum was closed, labeled D001 / D035 hazardous waste flammable liquids (MEK), and identified with a flammable liquid DOT hazard placard.

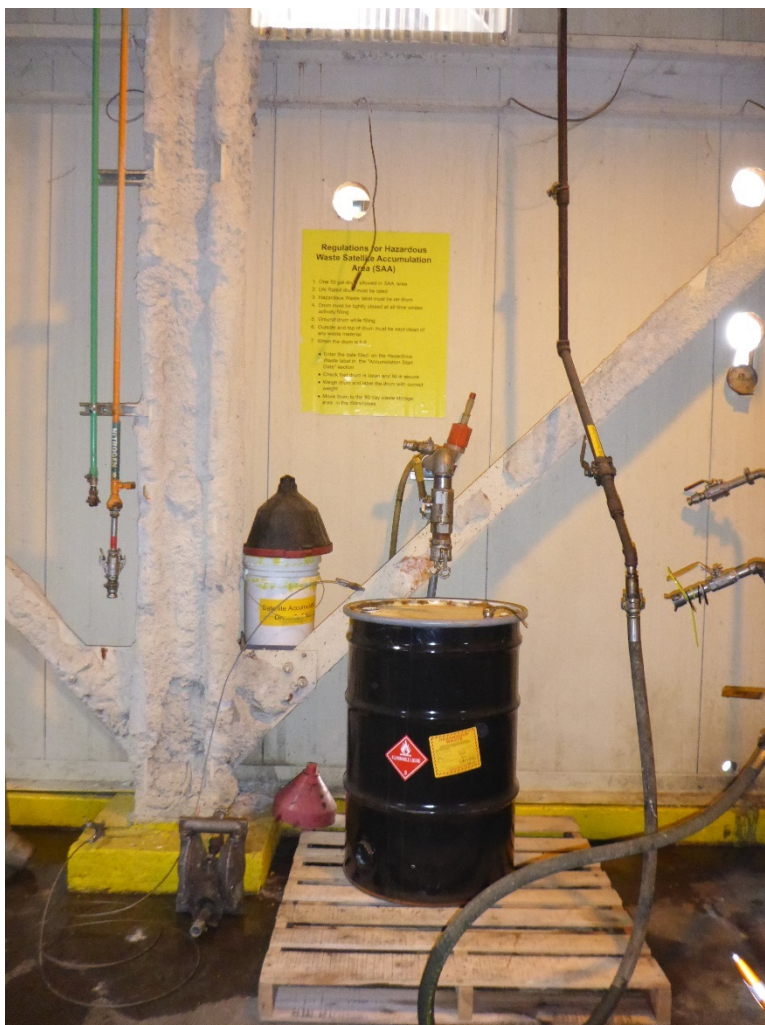
West Plant SAA: InChem manages one SAA in the West Plant K5/K6 area for managing hazardous waste flammable solvents generated in the West Plant. The waste is generated from draining process lines, and sampling material in the process units. The inspectors observed one 55-gallon drum in this SAA (Photo 2). The drum was located on a wooden pallet next to the wall beneath a pipe and valve, which can drain material from the upper level of the West Plant. The drum was closed, labeled D001 / F003 hazardous waste flammable liquid (methanol / ethanol) cleaning alcohols, and identified with a flammable liquid DOT hazard placard. The inspectors observed a fire extinguisher in the West Plant.

**Photo 2:** One 55-gallon drum located in the West Plant SAA. The drum was closed, labeled D001 / F003 hazardous waste flammable liquid (methanol / ethanol) cleaning alcohols, and identified with a flammable liquid DOT hazard placard.

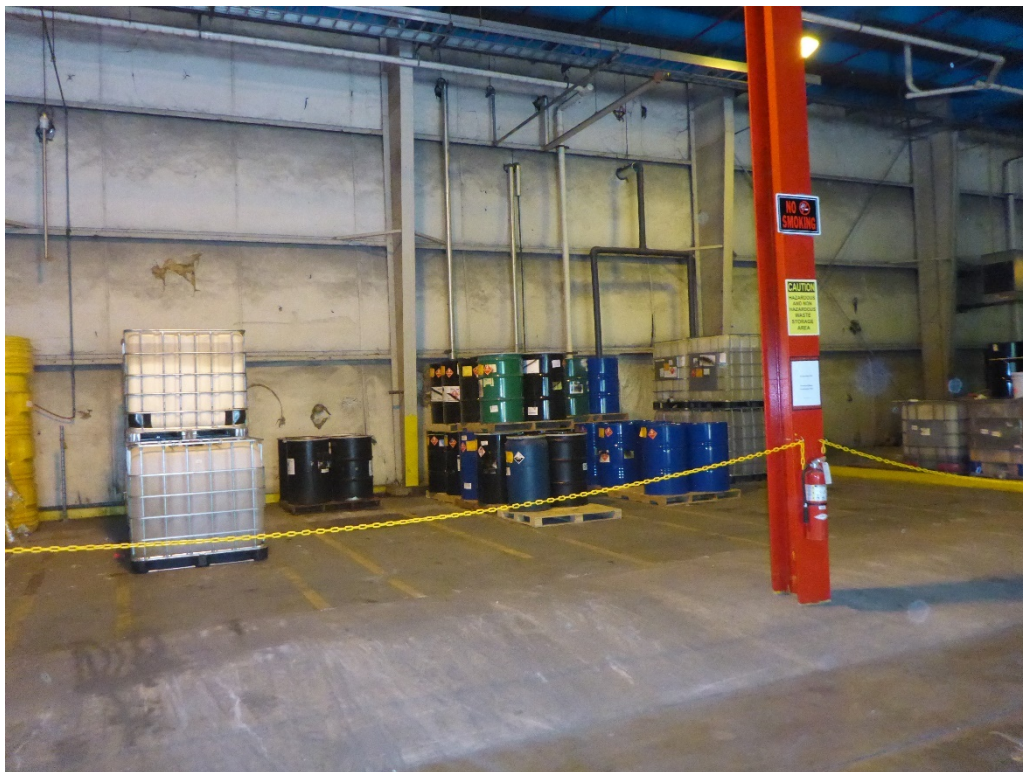
Warehouse CAA: InChem manages a hazardous waste CAA in the warehouse. The area is on a concrete floor, and it is surrounded on three sides with a concrete berm (Photo 3). The fourth side is equipped with a concrete hump to allow for forklift travel. Yellow lines have been painted on the floor in this area to designate six rows for storing waste containers with adequate aisle space. The area was identified with a sign which read “caution, hazardous and non-hazardous waste storage area.” InChem manages ignitable waste in this CAA, and the inspectors observed a “No Smoking” sign on the steel beam in the middle of the entrance to this area.

**Photo 3:** Warehouse CAA on concrete floor surrounded on three sides with a concrete berm and a concrete hump on the fourth side. Yellow lines are painted on the floor to designate six rows for storing waste containers with aisle spacing. The area was identified with signs which read “caution, hazardous and non-hazardous waste storage area,” and “no smoking.”

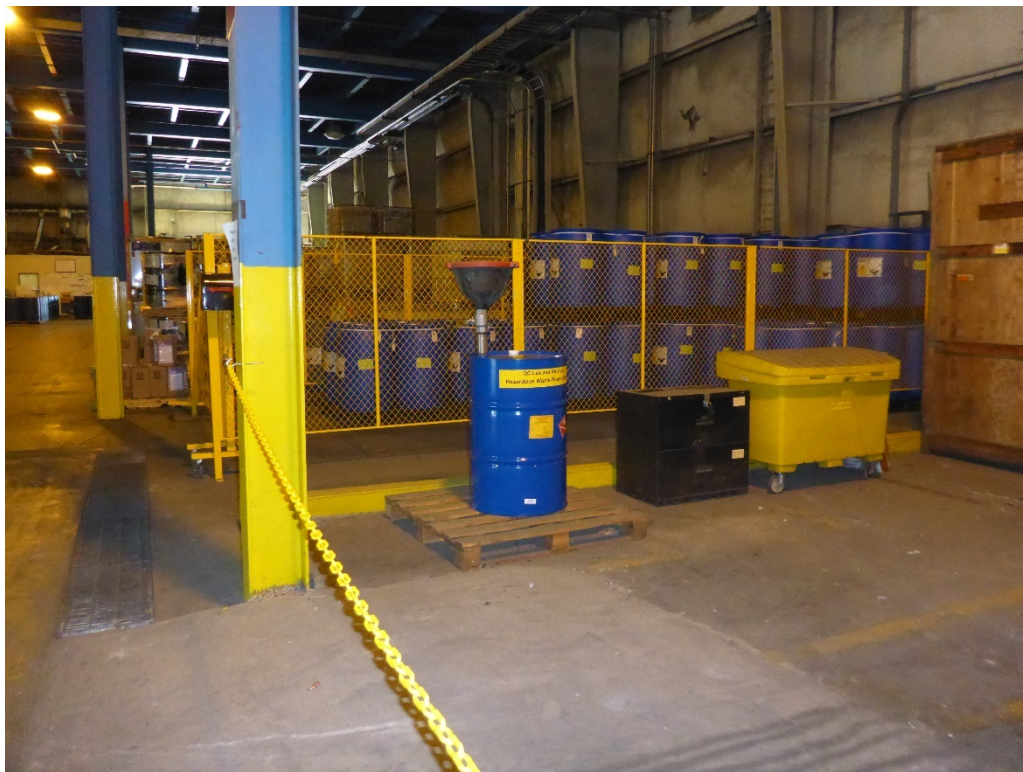
The inspectors also observed one 55-gallon drum on a wooden pallet to the left of the six rows of containers (Photo 4). The container was labeled as the "QC lab and R & D lab hazardous waste pour-up drum." It was equipped with a closed funnel in the bung; labeled as D001 / F003

hazardous waste flammable liquids (methanol / ethanol); and identified with a flammable liquid DOT hazard placard.

**Photo 4:** Warehouse CAA 55-gallon QC and R & D lab hazardous waste pour-up drum.

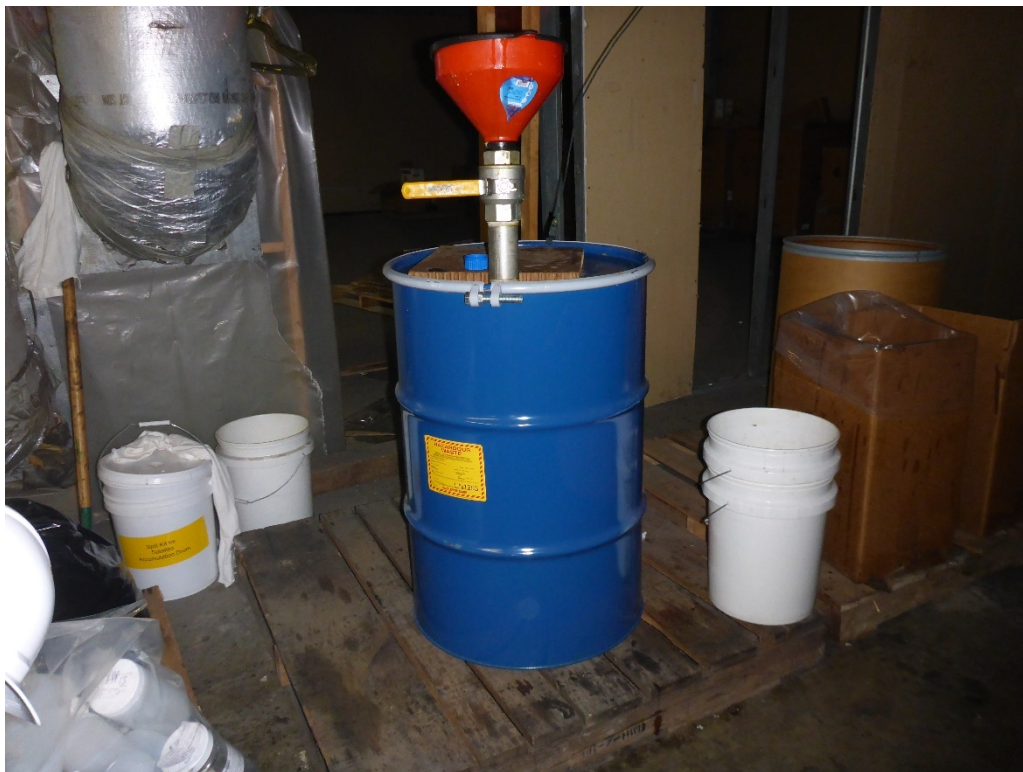
Quality Control (QC) Laboratory SAA: InChem's QC Laboratory is located on the second floor of the warehouse building. To reach the entrance of the laboratory, inspection participants climbed the metal stairs located on the outside of the warehouse building. InChem manages two SAAs in the QC Laboratory for managing hazardous waste flammable solvents generated in laboratory testing of on-site samples. The inspectors observed one 55-gallon drum in the first SAA (Photo 5). The drum was located on a wooden pallet just outside of the laboratory door. The container was equipped with a closed funnel lid; it was labeled D001 / F003 hazardous waste flammable liquids; and it was identified as UN1993 (flammable liquid).

**Photo 5:** One 55-gallon drum located in one of the QC Laboratory SAAs. The drum was equipped with a closed funnel; it was labeled D001 / F003 hazardous waste flammable liquids; and it was marked as UN 1993 (flammable liquid).

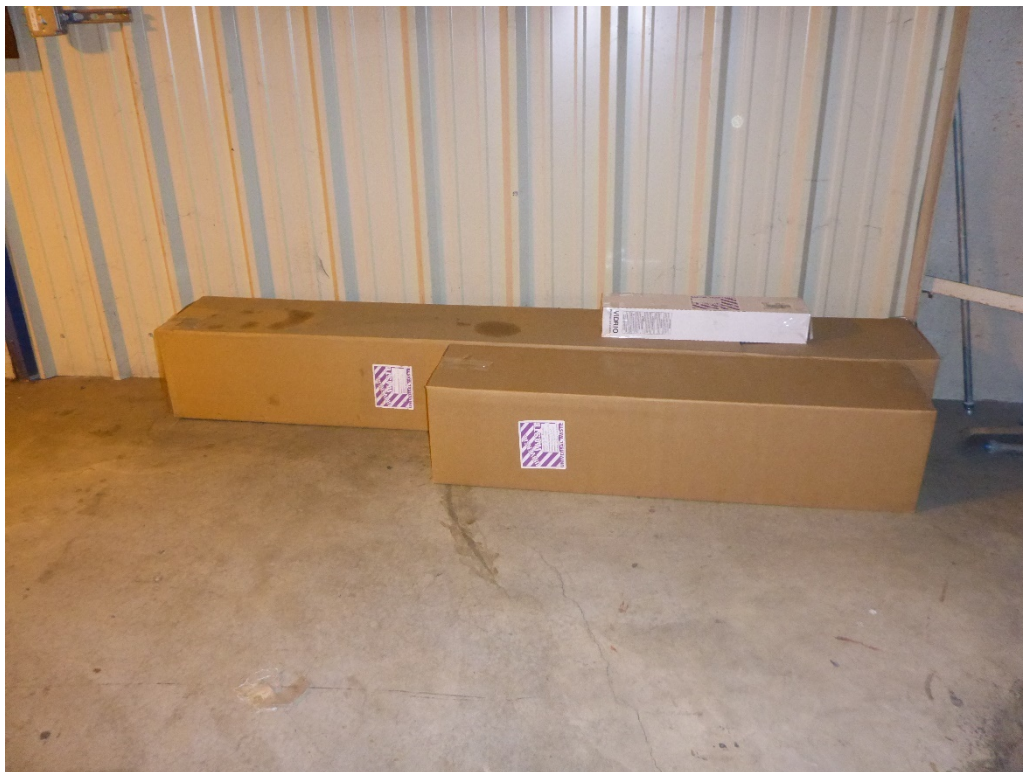
Universal Waste Management Area: InChem manages universal waste lamps inside the warehouse on the second floor of the building. The inspectors observed three boxes of used lamps in this area during the inspection (Photo 6). The boxes were all closed, labeled as universal hazardous waste, and dated. The two-foot box of lamps was dated 02/23/21 and the four-foot box was dated 11/18/20. The eight-foot box was dated 12/20/18, which is over two years prior to the inspection. No records of universal waste shipments were provided during the inspection.

**Pursuant to 25 S.C. Code Ann. Regs. 61-79.273.15(a) [40 C.F.R. § 273.15(a)], a small quantity handler of universal waste may accumulate universal waste for no longer than one year from the date the universal waste is generated.**

**Photo 6:** Three boxes of used fluorescent lamps inside the warehouse on the second floor of the building. All boxes were closed and labeled universal waste lamps. The two-foot box was dated 02/23/21, the four-foot box was dated 11/18/20, and the eight-foot box was dated 12/20/18.
