## Clean Water Act Section 404: Site Visit/Case Development

| Site Name | Salinas Waterfront Investment, Corp. (hereinafter as "SWI") | | | | |
| Site Address* | Tax Parcel 417-000-006-04-998 (hereinafter as "the Property") | | | | |

## Attachment B - Photolog

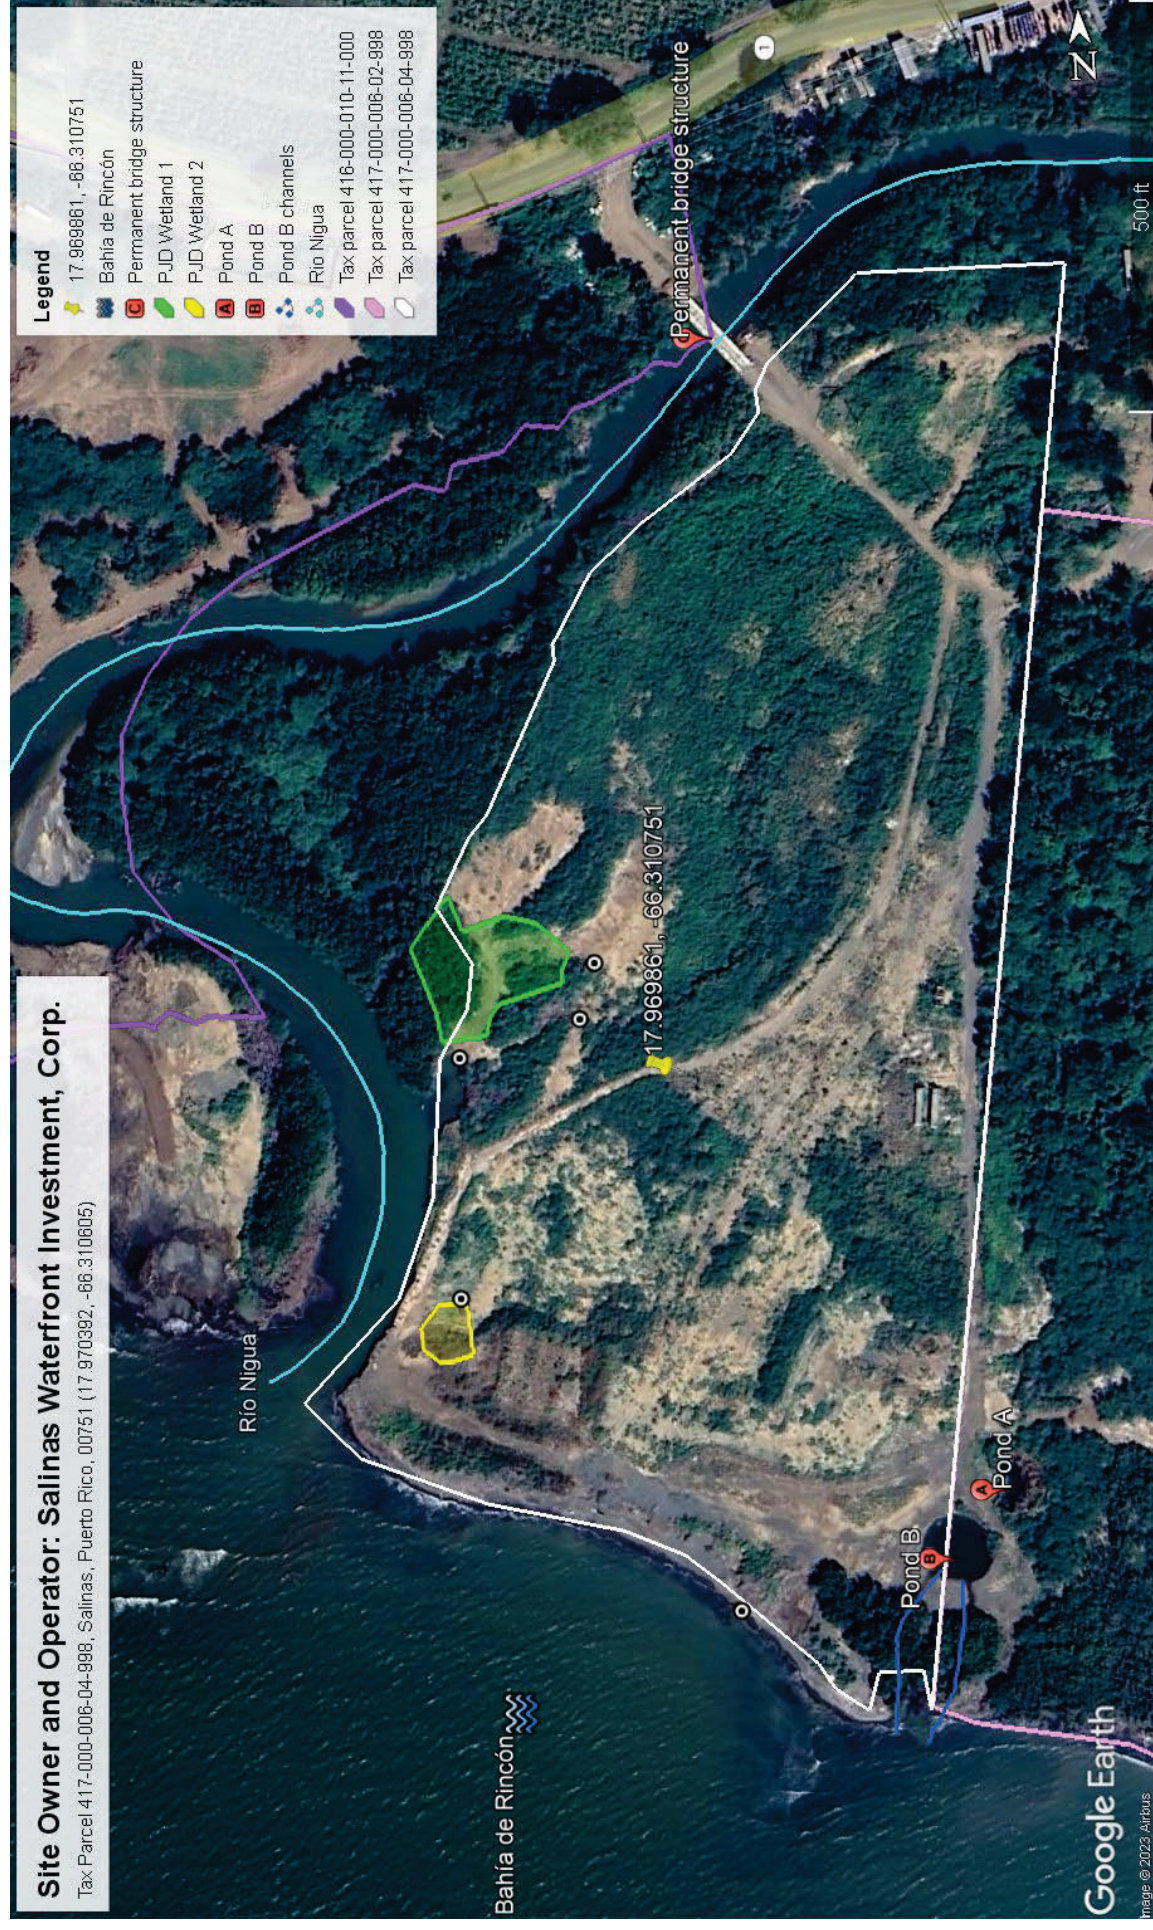
# Attachment A: Map with GPS Points

| <p>During the inspection, EPA collected GPS data (see Attachment A), photographs (see Attachment B), and handwritten notes. Observations were recorded with the understanding that the inspection occurred during the dry season. No soil pits were dug during this inspection.</p> <p>EPA began the inspection by the permanent bridge structure off PR-1 onto Mr. González's property, tax parcel 416-000-010-11-000 to the west. EPA observed a ditch in front of the bridge preventing vehicular access to the Site. EPA walked the remainder of the inspection. EPA walked southeast towards two ponds that were found on the Site, Pond A and Pond B. Both ponds are operated by SWI but is located either fully or partially on tax parcel 417-000-006-02-998, to the east of the SWI property, owned by Mr. Felipe Alvarado Lorenzi. See Attachment A for a map of the Site containing details of the inspection findings including GPS data points.</p> <p>Pond A contained cattail vegetation and open water; however, no surface connection to Pond B or any WOTUS was observed. Pond B had two man made channels running south, through forested vegetation, to Bahía de Rincón. There was no active flow of water through the channels at the time of the inspection. However, publicly available aerial imagery available of the site confirmed hydrology of Pond B to be connected to Bahía de Rincón.</p> <p>From the ponds, EPA walked west towards Rio Nigua. EPA walked around where the PJD identified wetlands were identified. No disturbances to soils, hydrology, or vegetation were observed in the area of Wetland 2. Wetland 1 appears to have earthmoving activity through and around the area.</p> | | | |

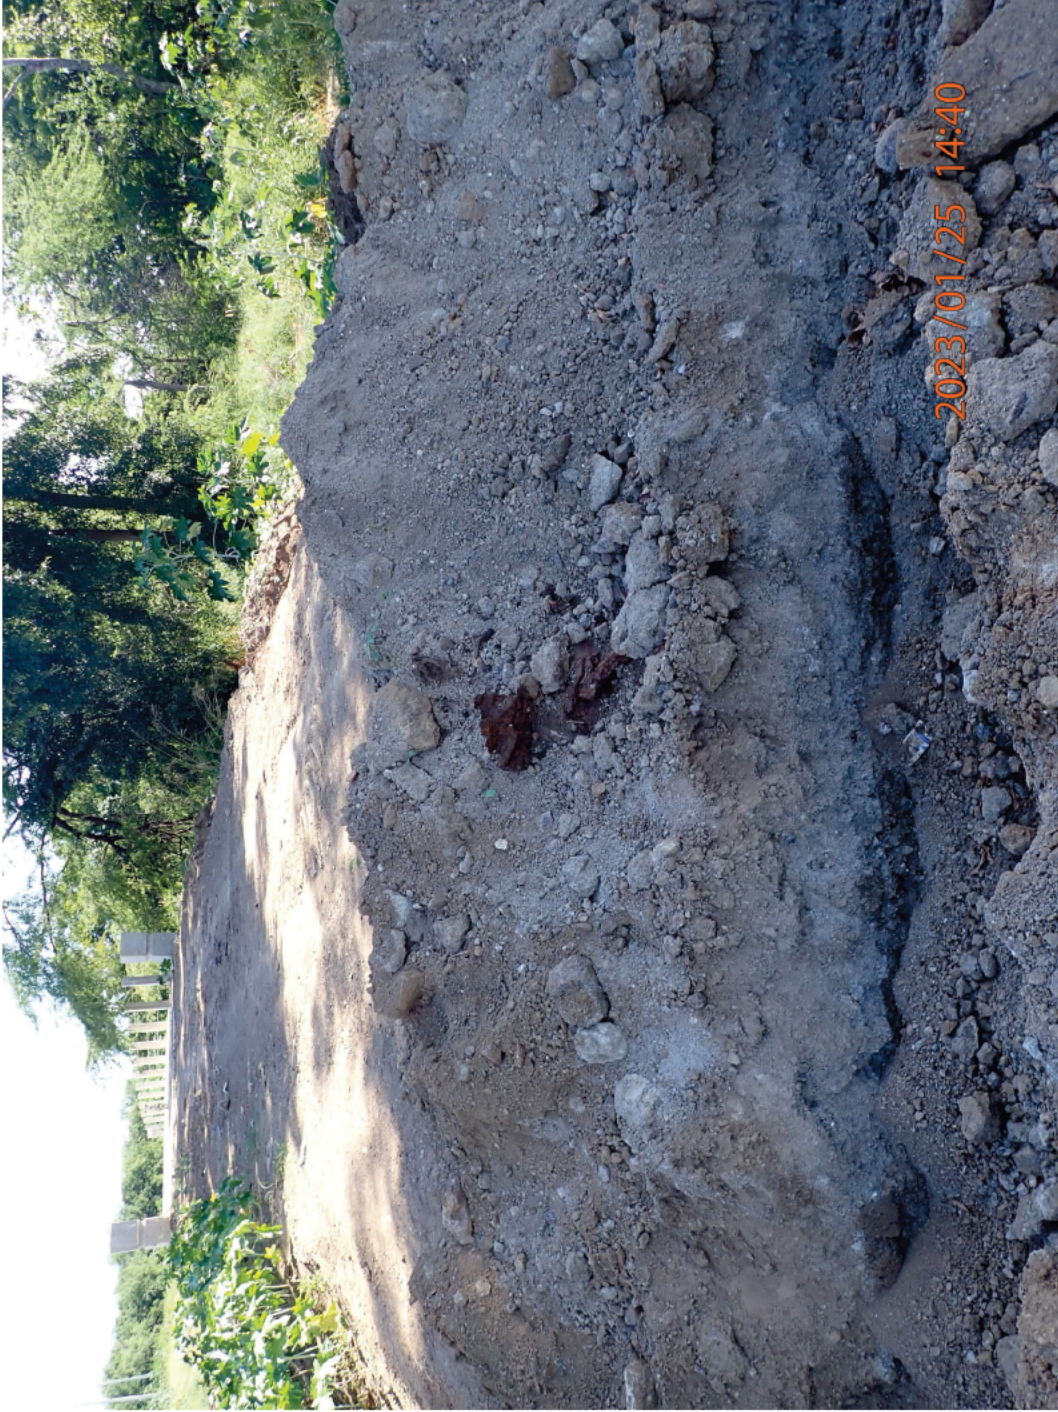
**Photo ID:** P1250559

**Description:** Upon entering the adjacent property, tax parcel number 416-000-010-11-000 in the Municipality of Salinas, Puerto Rico, on the way to enter the Site, a permanent bridge structure can be seen . A ditch was observed in front of the bridge structure, preventing vehicular access.

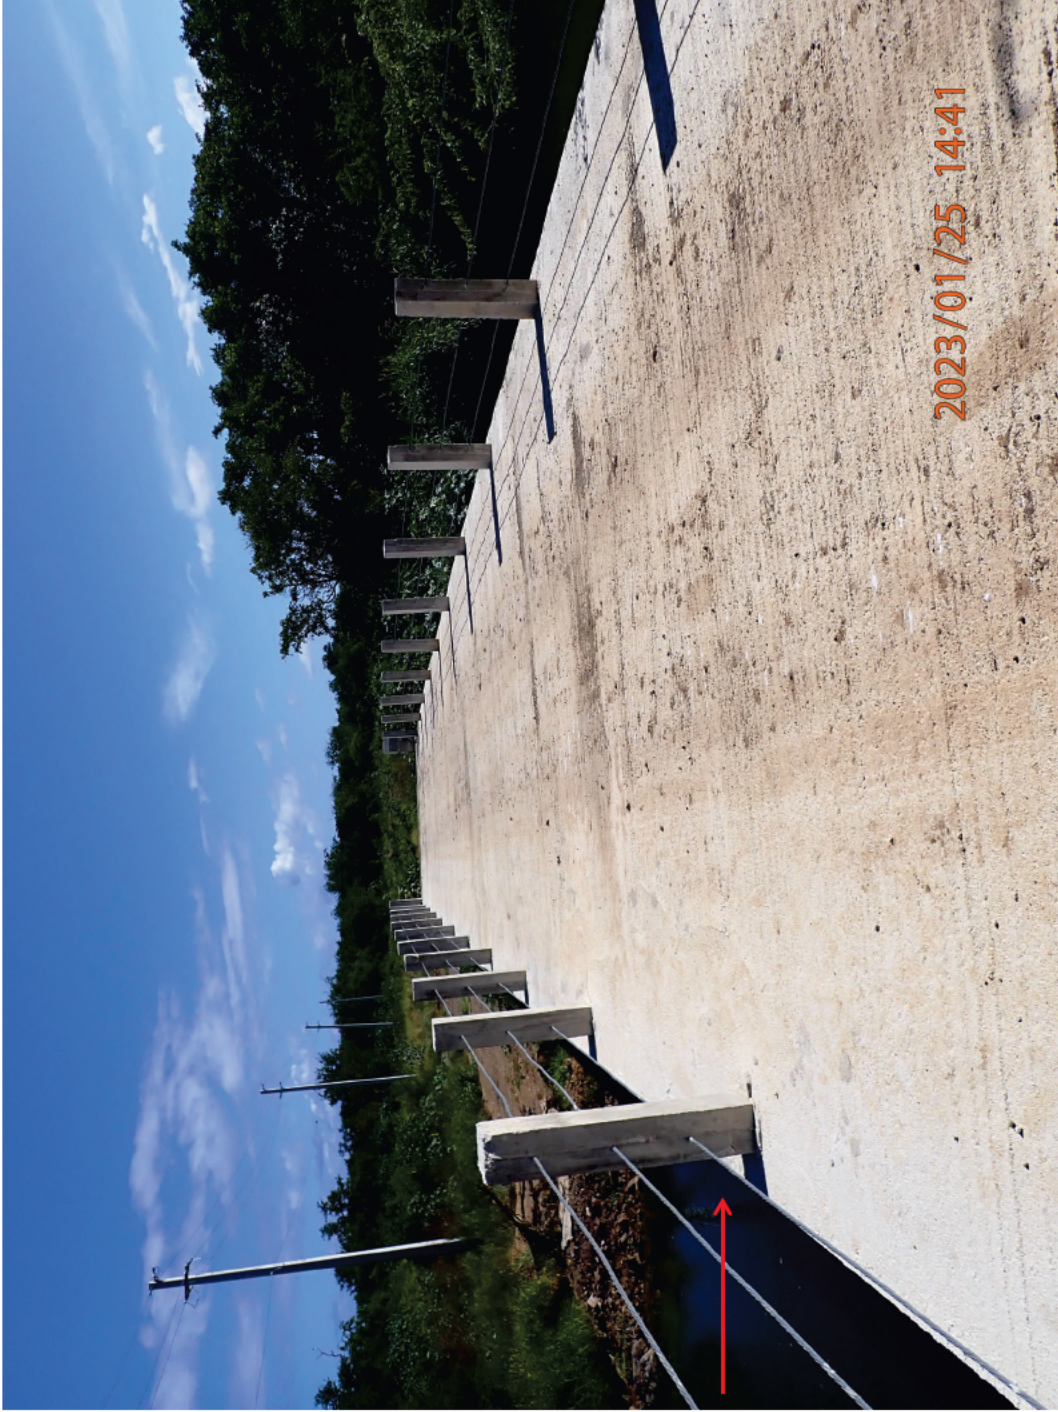
**Photo ID:** P1250560

**Description:** View of the Site from the top of the permanent bridge structure over Rio Nigua.

\*Red arrows marks the direction of the flow.

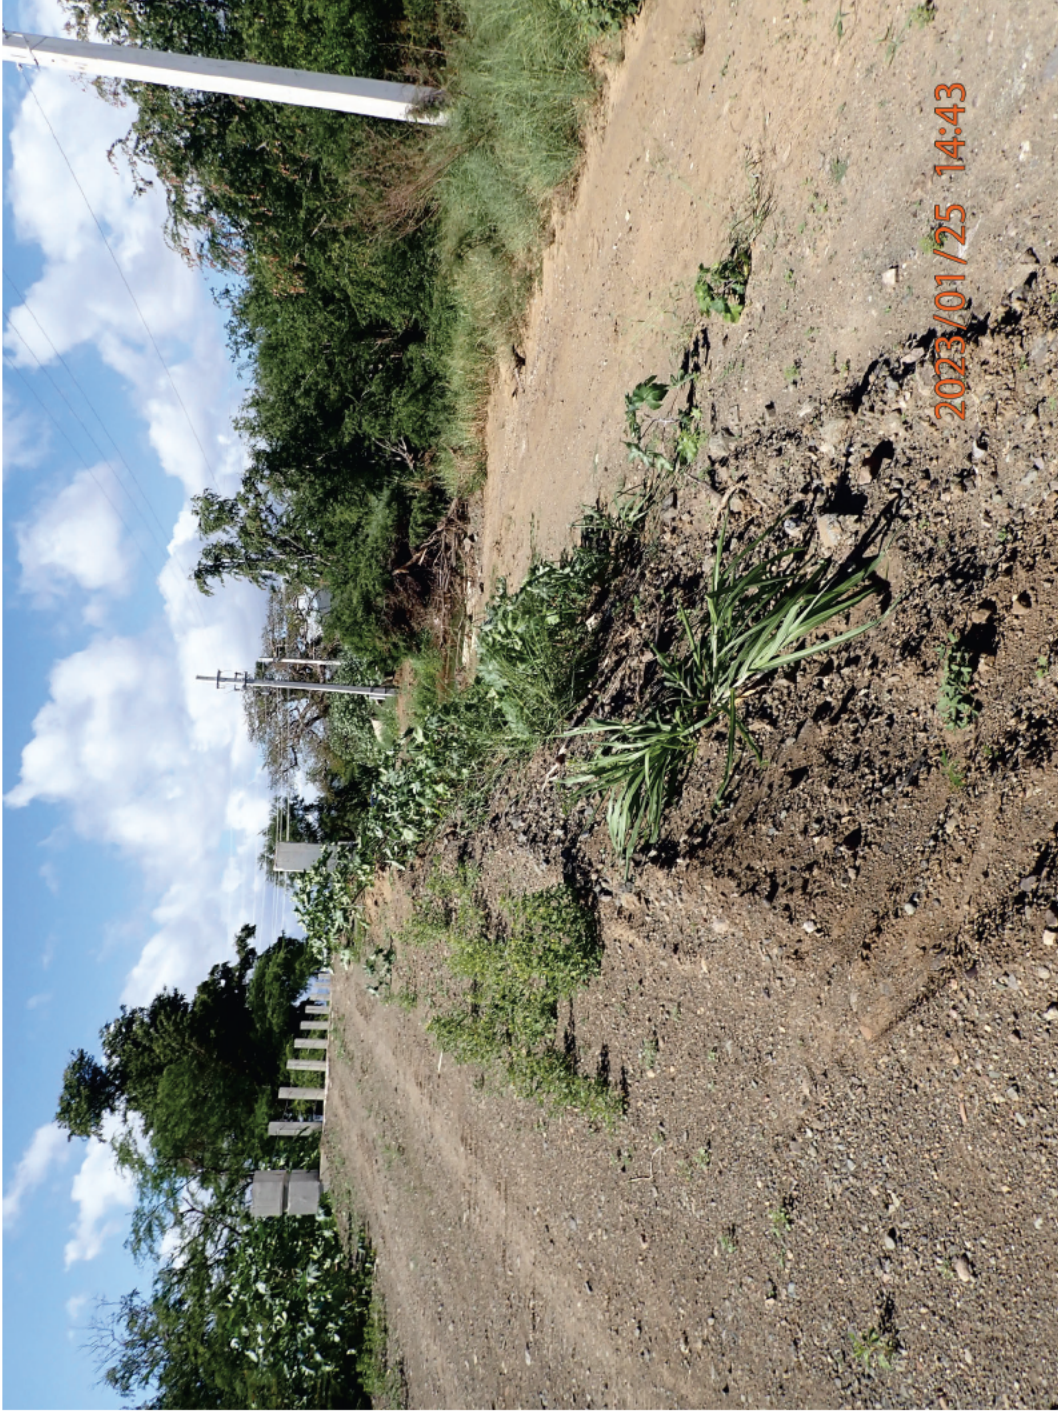
**Photo ID:** P1250564

**Description:** View from the Site: The permanent bridge (to the left) and the empty space (to the right) previously occupied by a Corps permit SAJ-2015-03878(JD-JJR) authorized temporary bridge structure (no longer present at the time of the inspection).

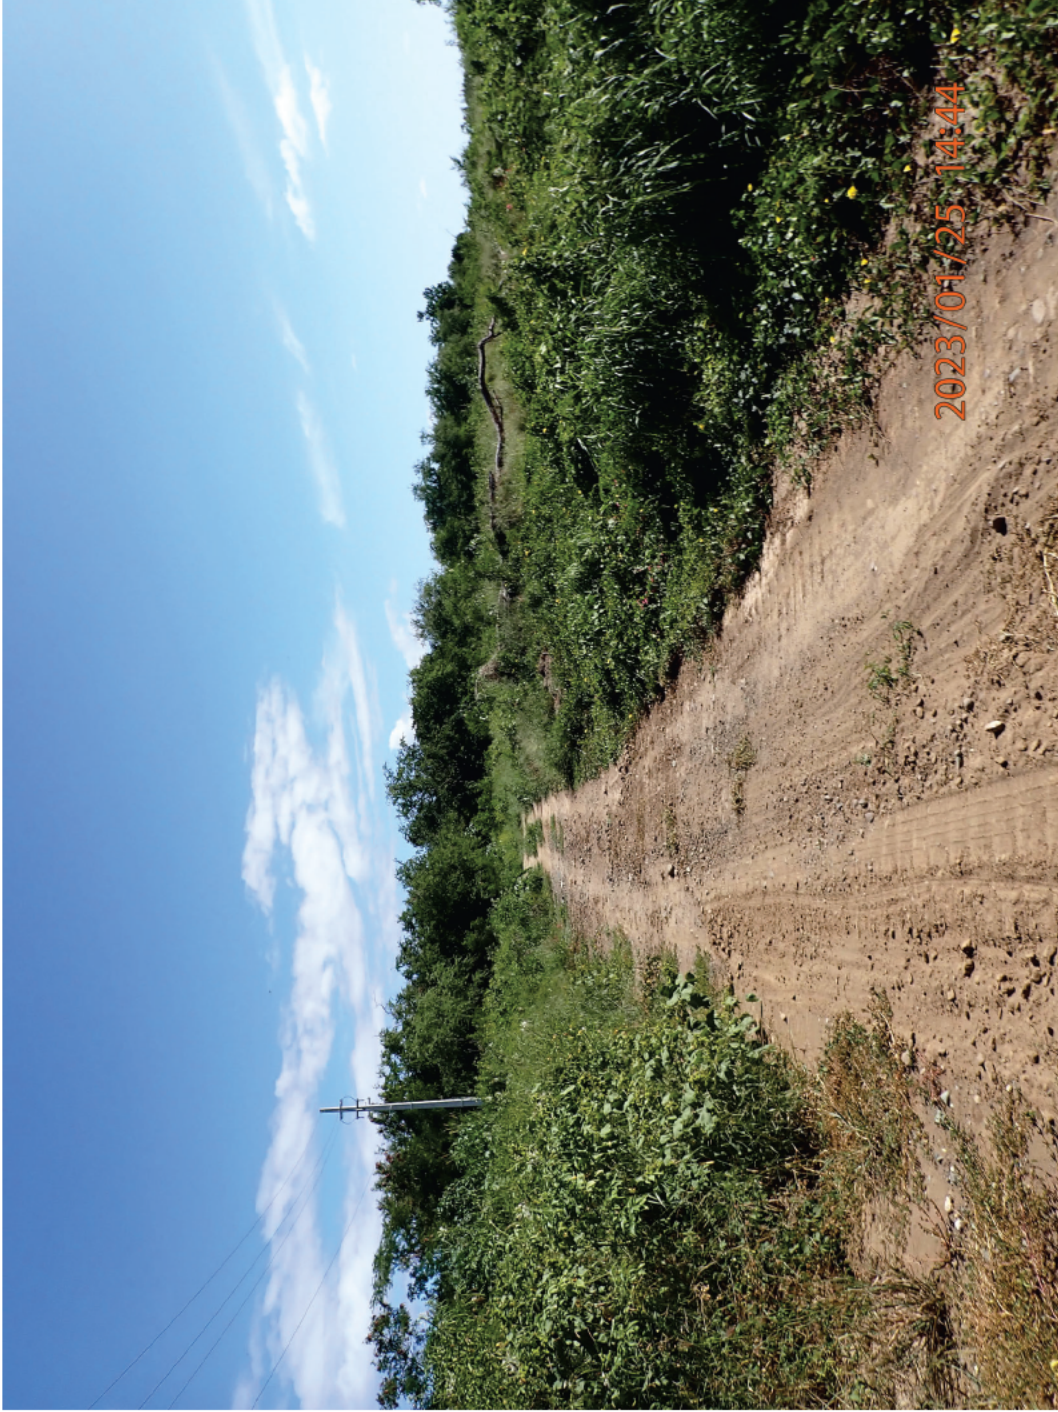
**Photo ID:** P1250565

**Description:** Upon entering the Site, a long dirt can be seen. EPA was able to utilize this road to reach the rest of the Site to the south.

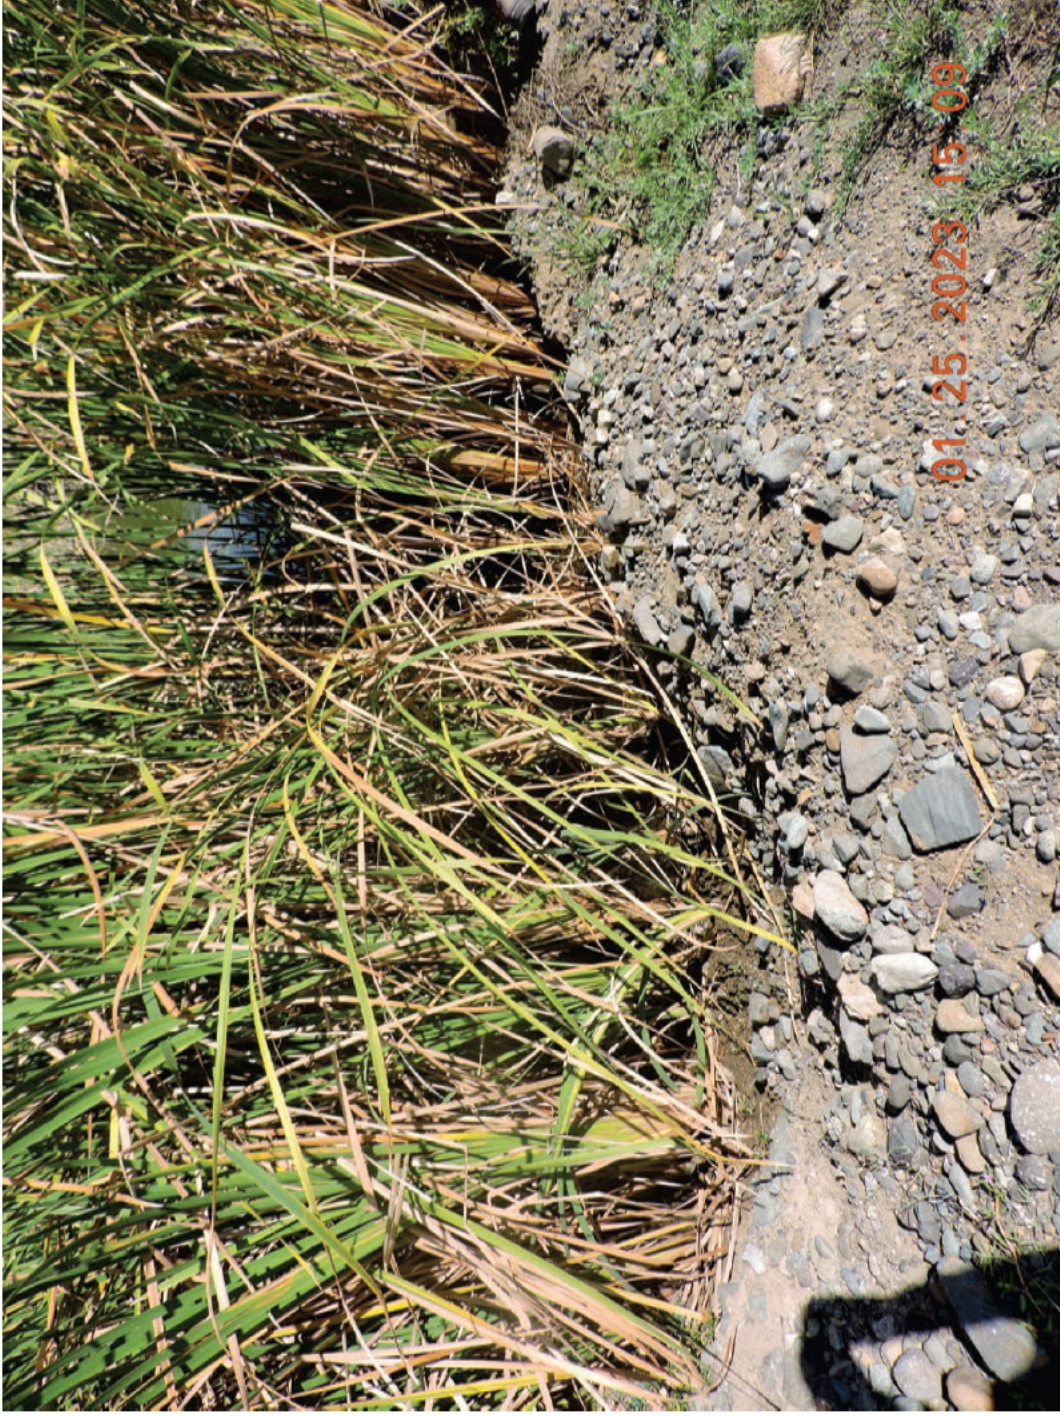
**Photo ID:** DSCN1914

**Description:** Pond A with cattail vegetation found at the Site.

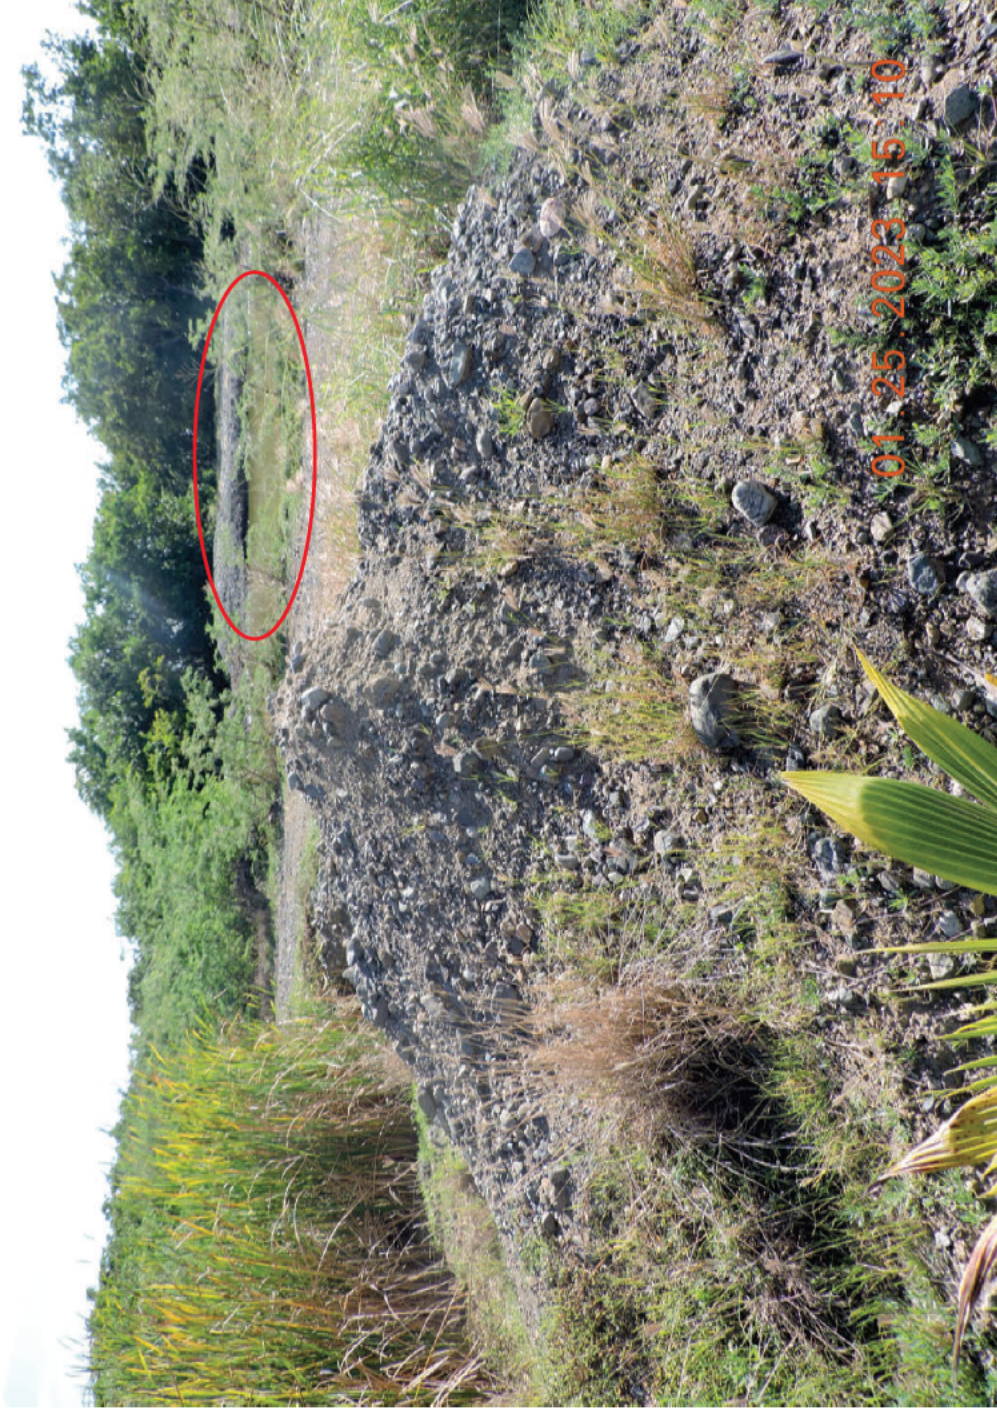
**Photo ID:** DSCN1917

**Description:** Fill pile found adjacent to pond with cattail A (on the left) on the southeast portion of the Site.

Pond B (circled) can be seen ahead.

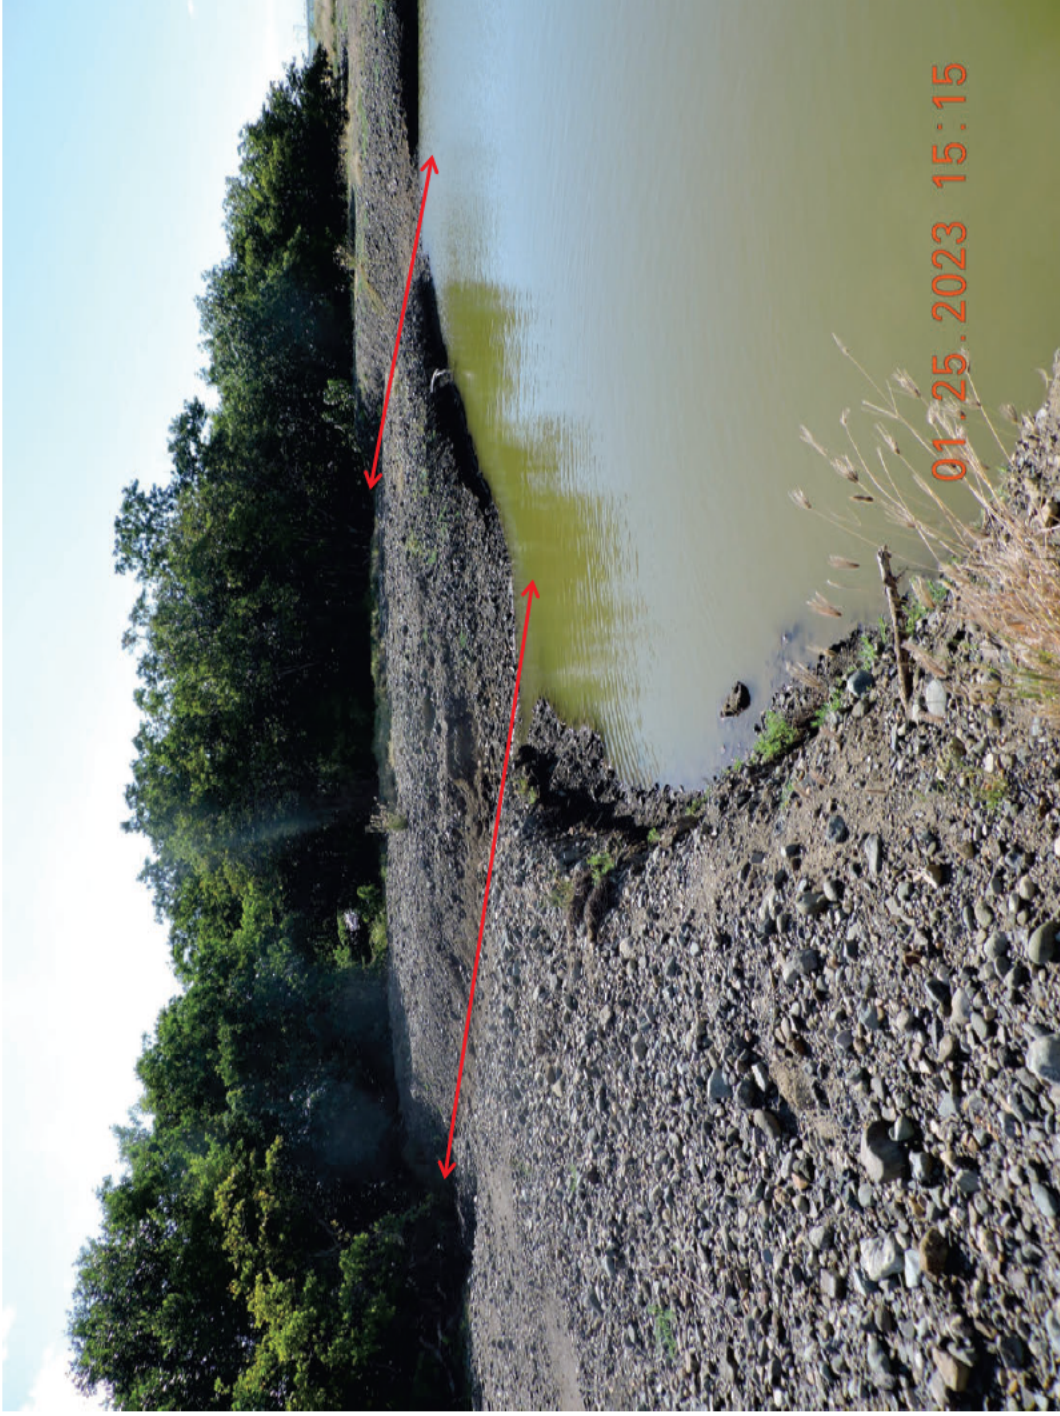
**Photo ID:** DSCN1918

| The wetlands identified in the Corps PJD appear to have been impacted by earth moving activities on the site. There also appears to be an unauthorized aquaculture pond with two man-made channels hydrologically connecting the pond to Bahía de Rincón. | | | |

**Description:** Pond B with two channels, hydraulically connecting the pond to Bahía de Rincón through the trees to the left.

\*Red arrows marks the direction of the flow.

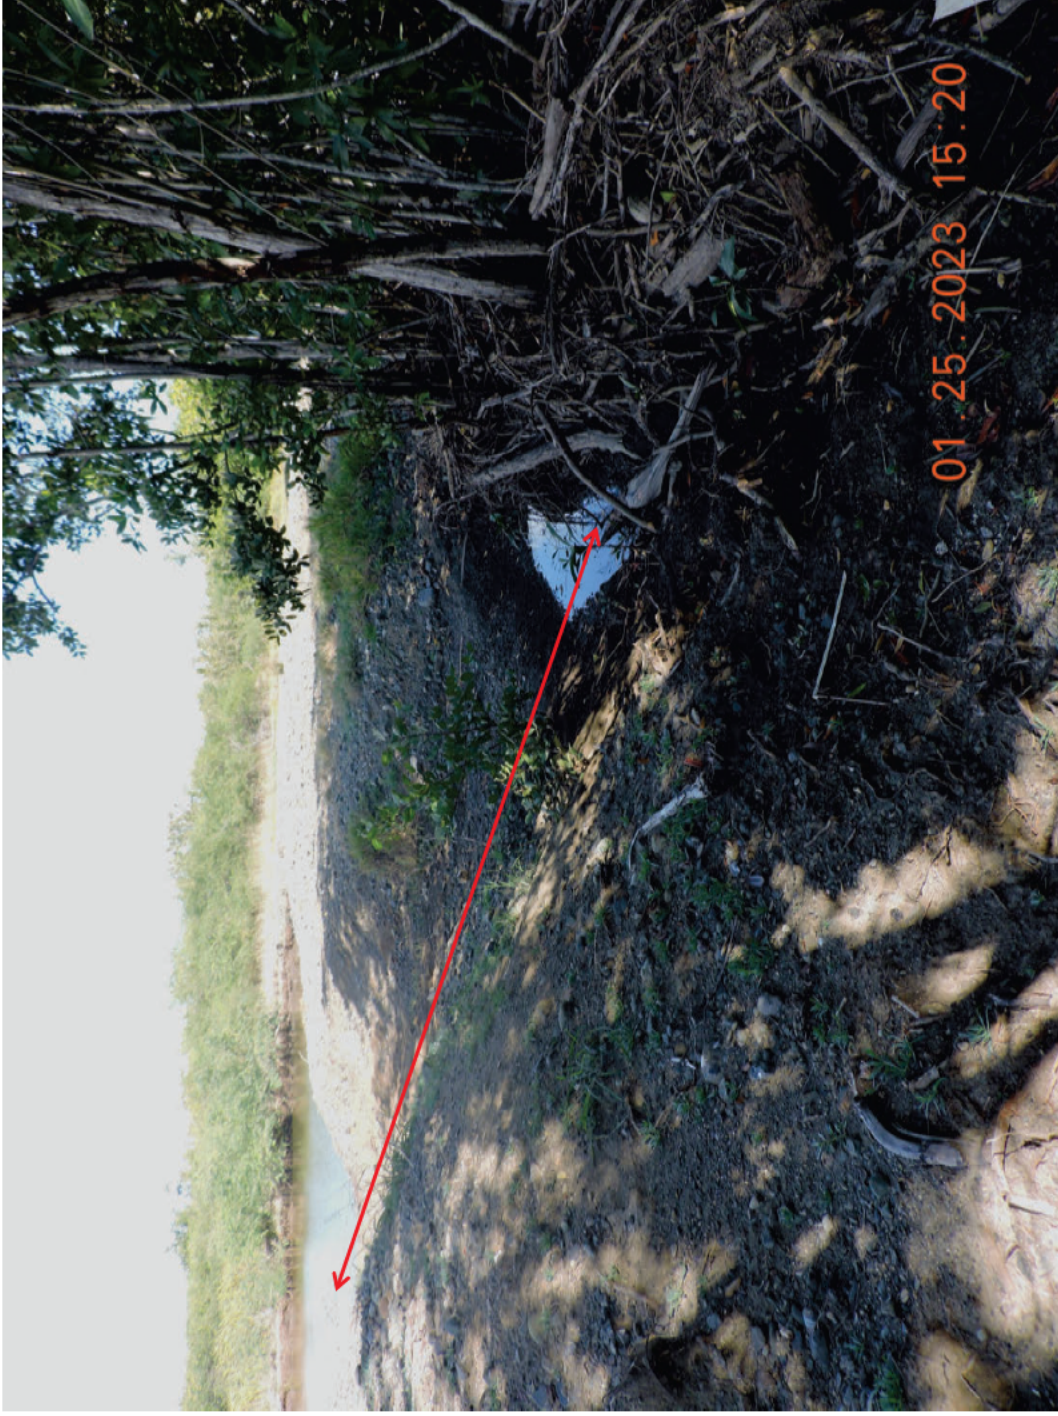
**Photo ID:** DSCN1920

**Description:** Pond B with two channels, hydraulically connecting the pond to Bahía de Rincón through the trees to the right.

\*Red arrows marks the direction of the flow.

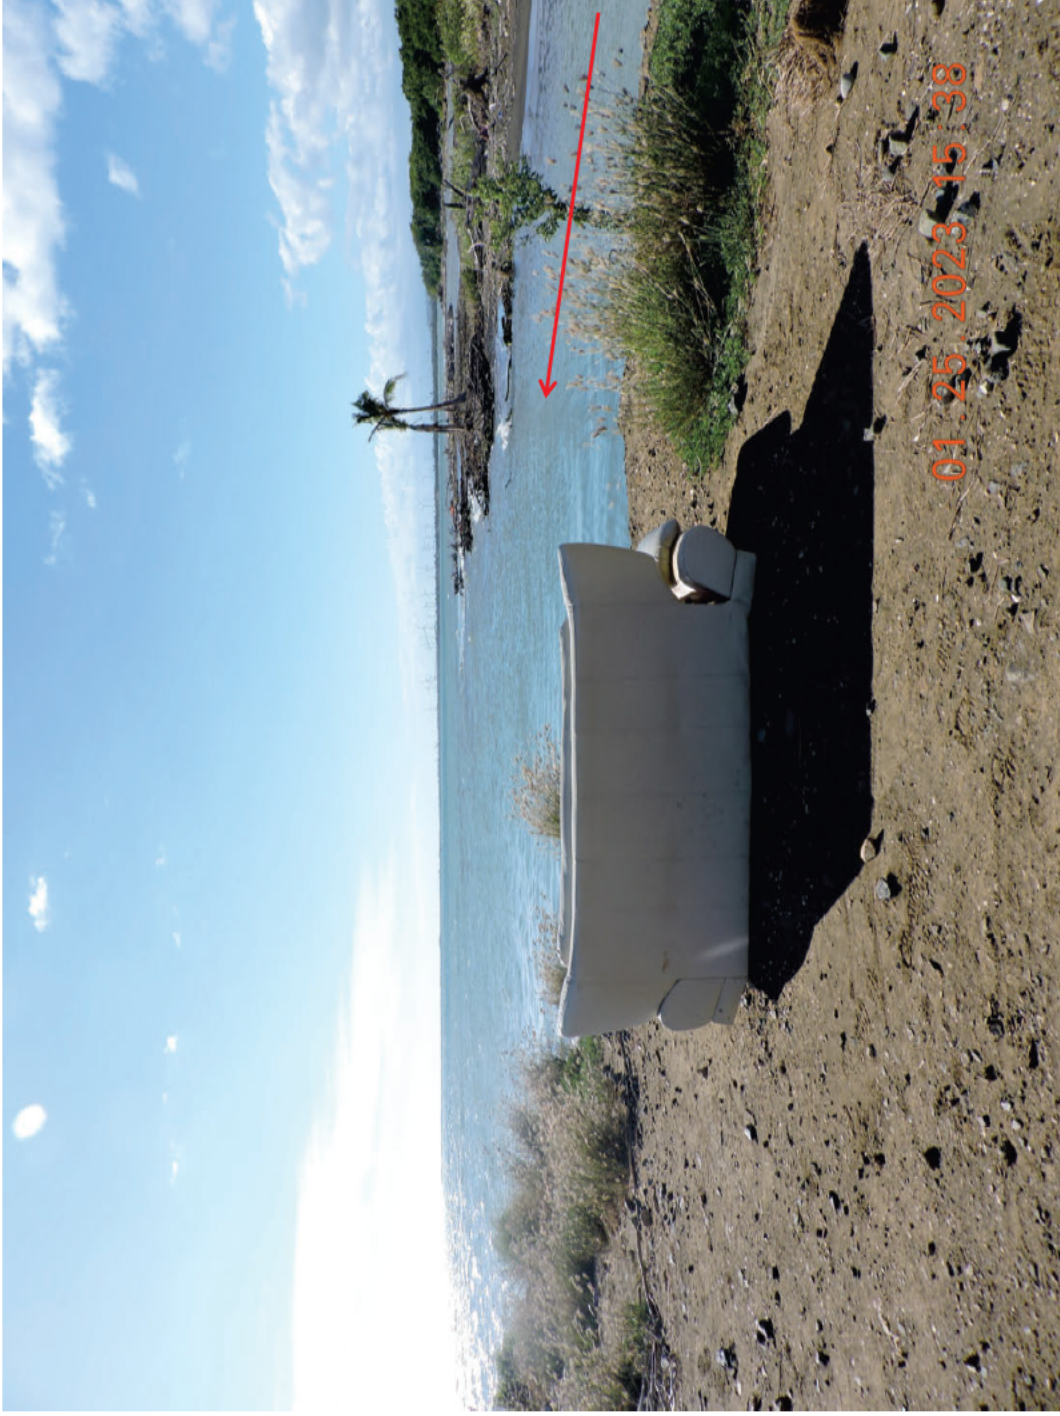
**Photo ID:** DSCN1940

**Description:** View of the southern coast of the Site where Bahía de Rincón and Río Nigua meet.

\*Red arrows marks the direction of the flow.

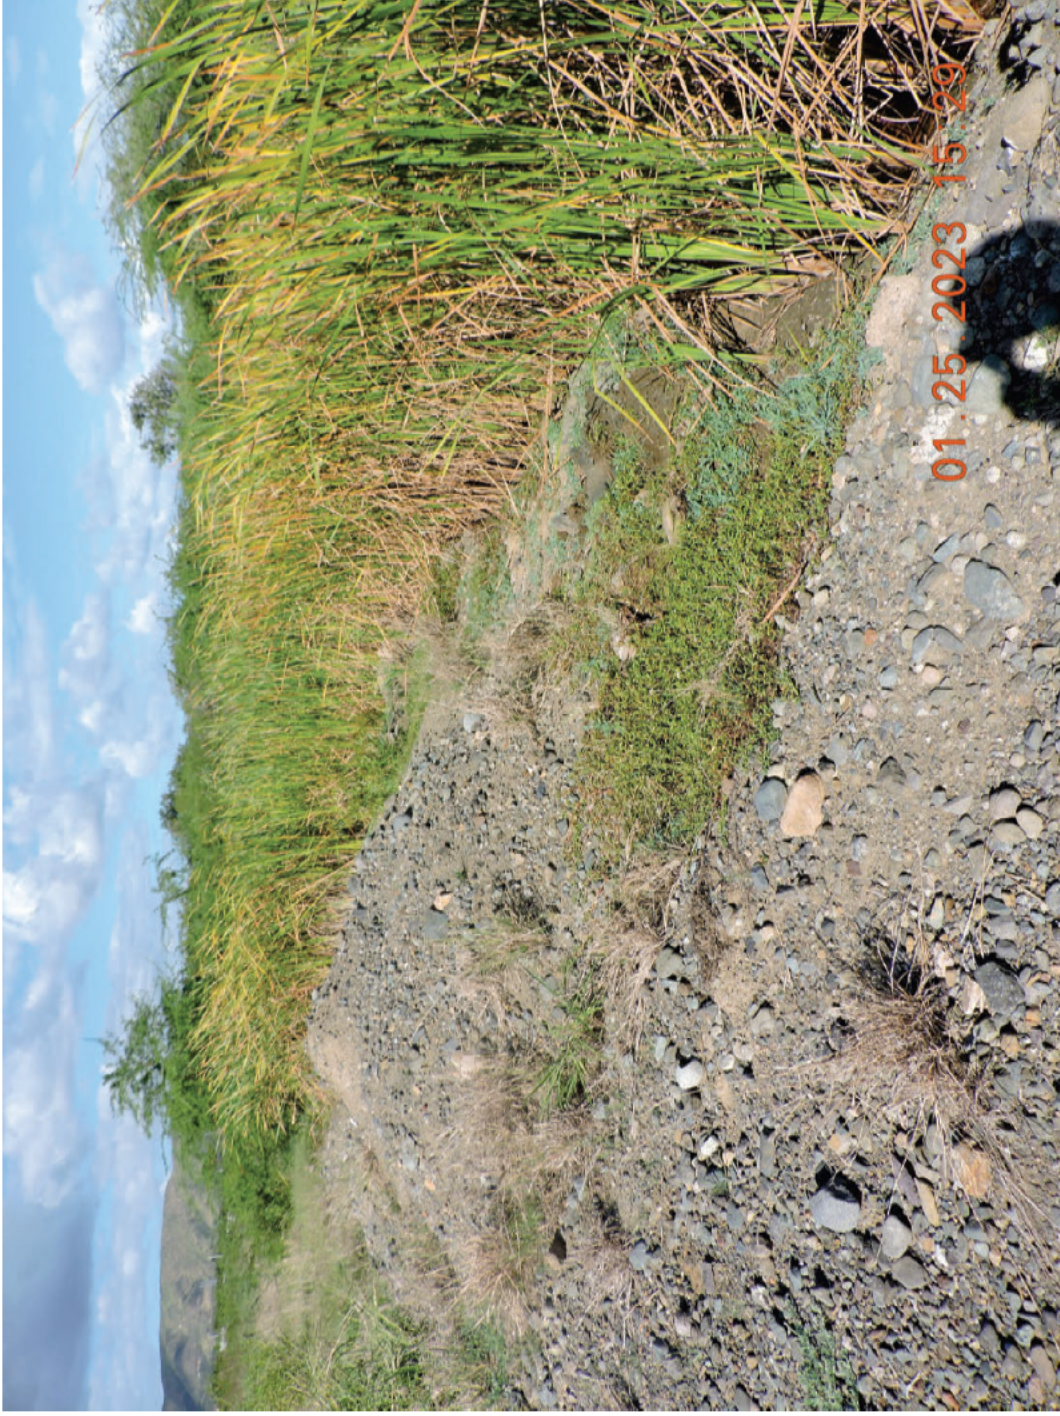
**Photo ID:** DSCN1934

**Description:** View of vegetation marked as Wetland 1 in the preliminary jurisdictional determination associated with USACE permit SAJ-2015-03878.
