## Clean Water Act Section 404: Site Visit/Case Development

| Site Name | Johnson County Road Department | | | | |

| Inspection Purpose | Initial site visit | | |

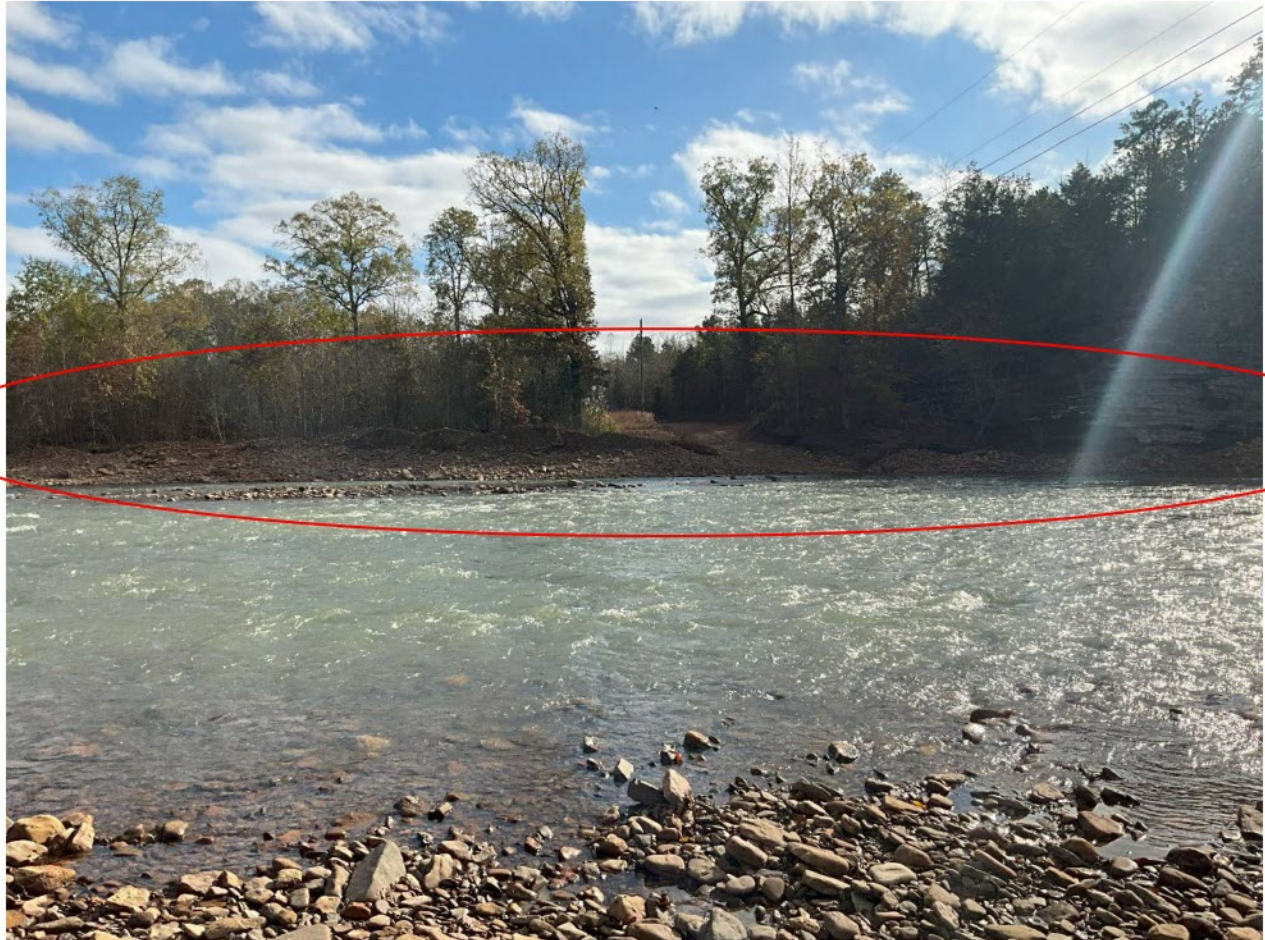
Photo No. 1

| Photo File Name | Date and Time of Photo | Photographer | Description |
|---|---|---|---|
| IMG_0116 | 11/07/2024, 2:06 PM | Chelsey Sherwood | Showing the area of the low-water stream crossing where work was conducted. Note: large piles of dredge and fill material piled throughout the stream and riparian areas. Picture taken facing south from river left bank towards river right bank. |

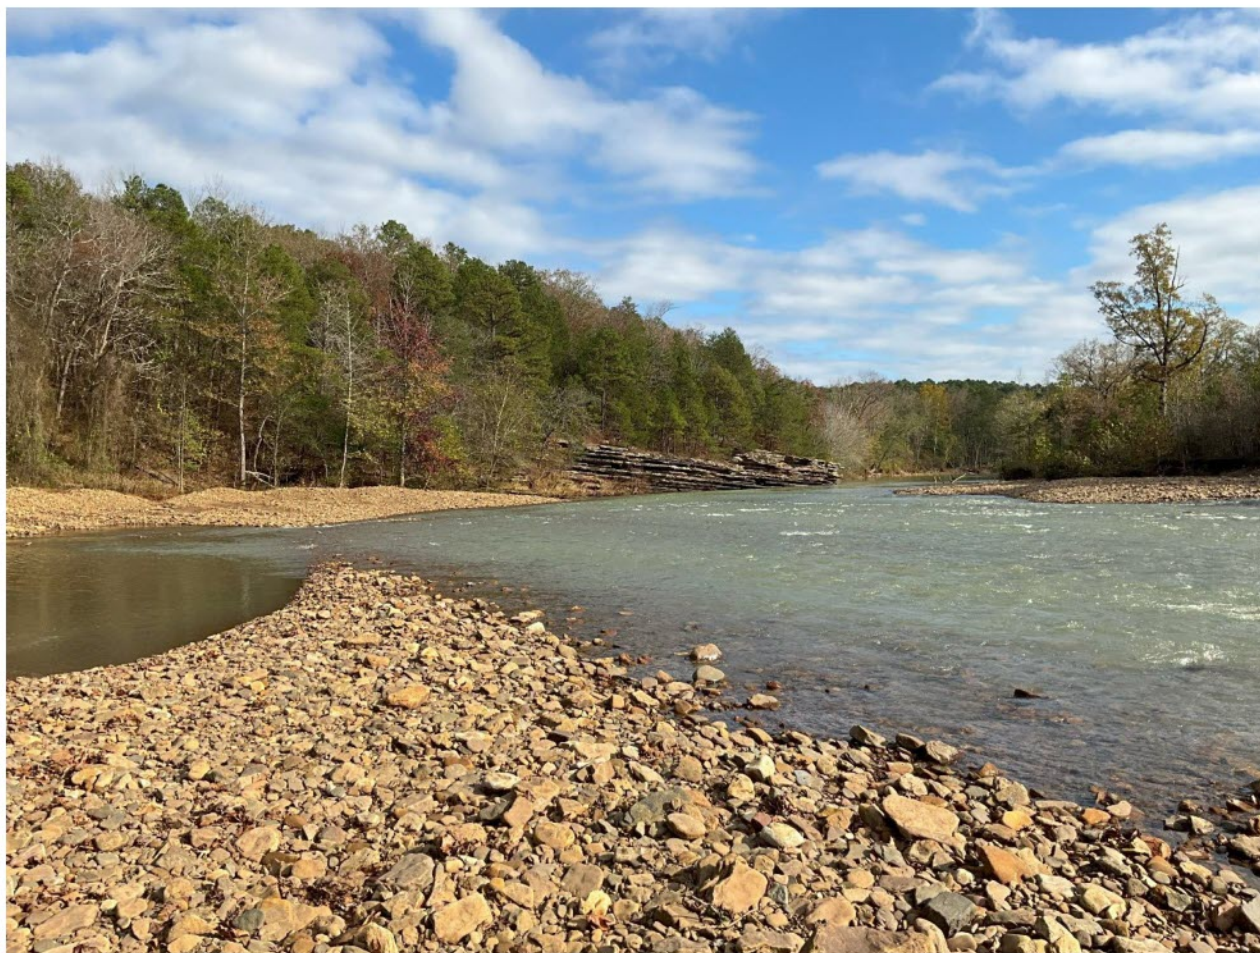
Photo No. 2

| Photo File Name | Date and Time of Photo | Photographer | Description |
|---|---|---|---|
| IMG_0117 | 11/07/2024, 2:07 PM | Chelsey Sherwood | Showing graded stream and the large piles of dredge and fill material piled throughout the stream and riparian areas. Picture taken facing east, downstream. |

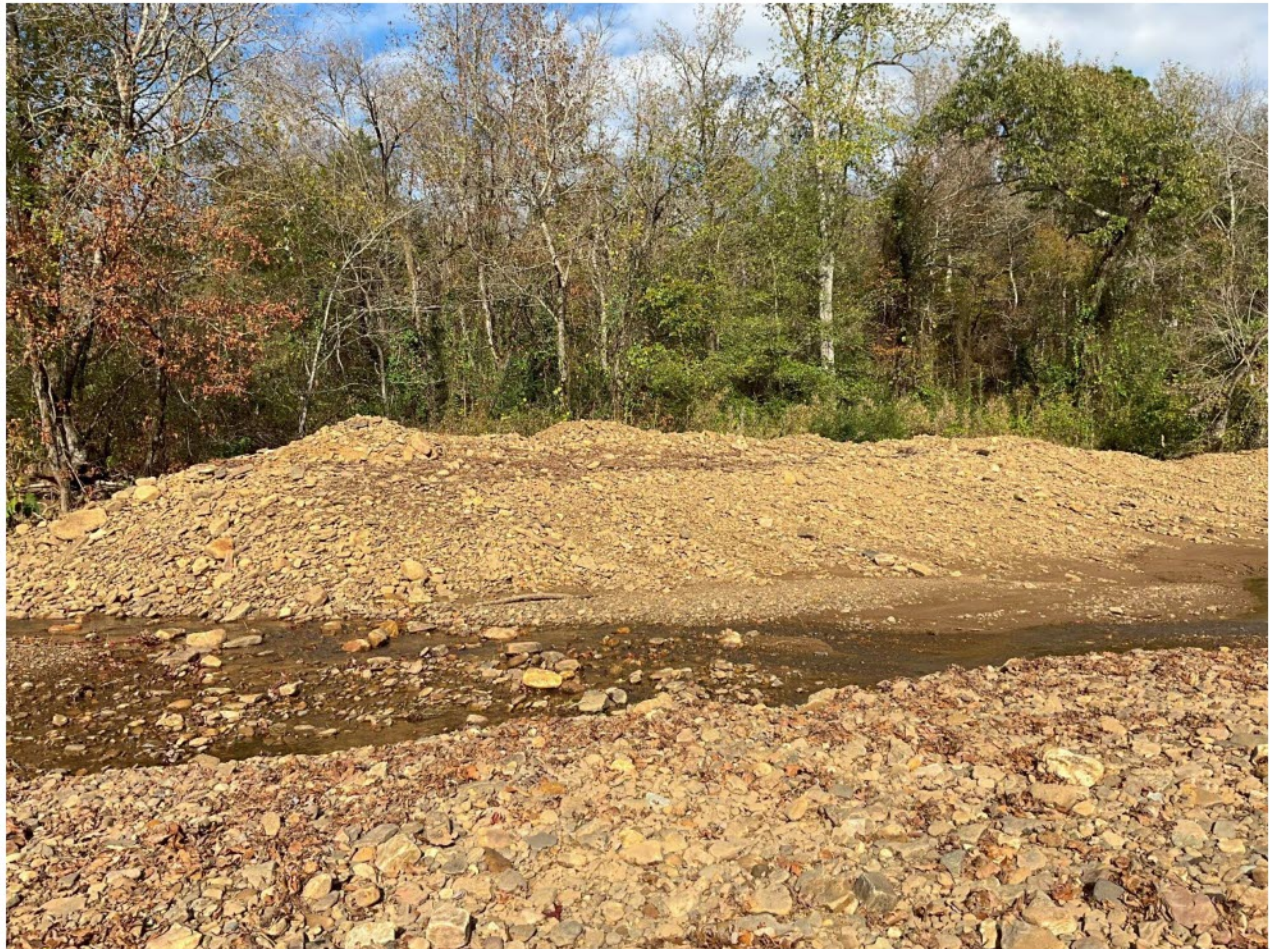
Photo No. 3

| Photo File Name | Date and Time of Photo | Photographer | Description |
|---|---|---|---|
| IMG_0118 | 11/07/2024, 2:07 PM | Chelsey Sherwood | Showing the large piles of dredge and fill material piled throughout the stream and riparian areas on river left. Picture taken facing northeast. |

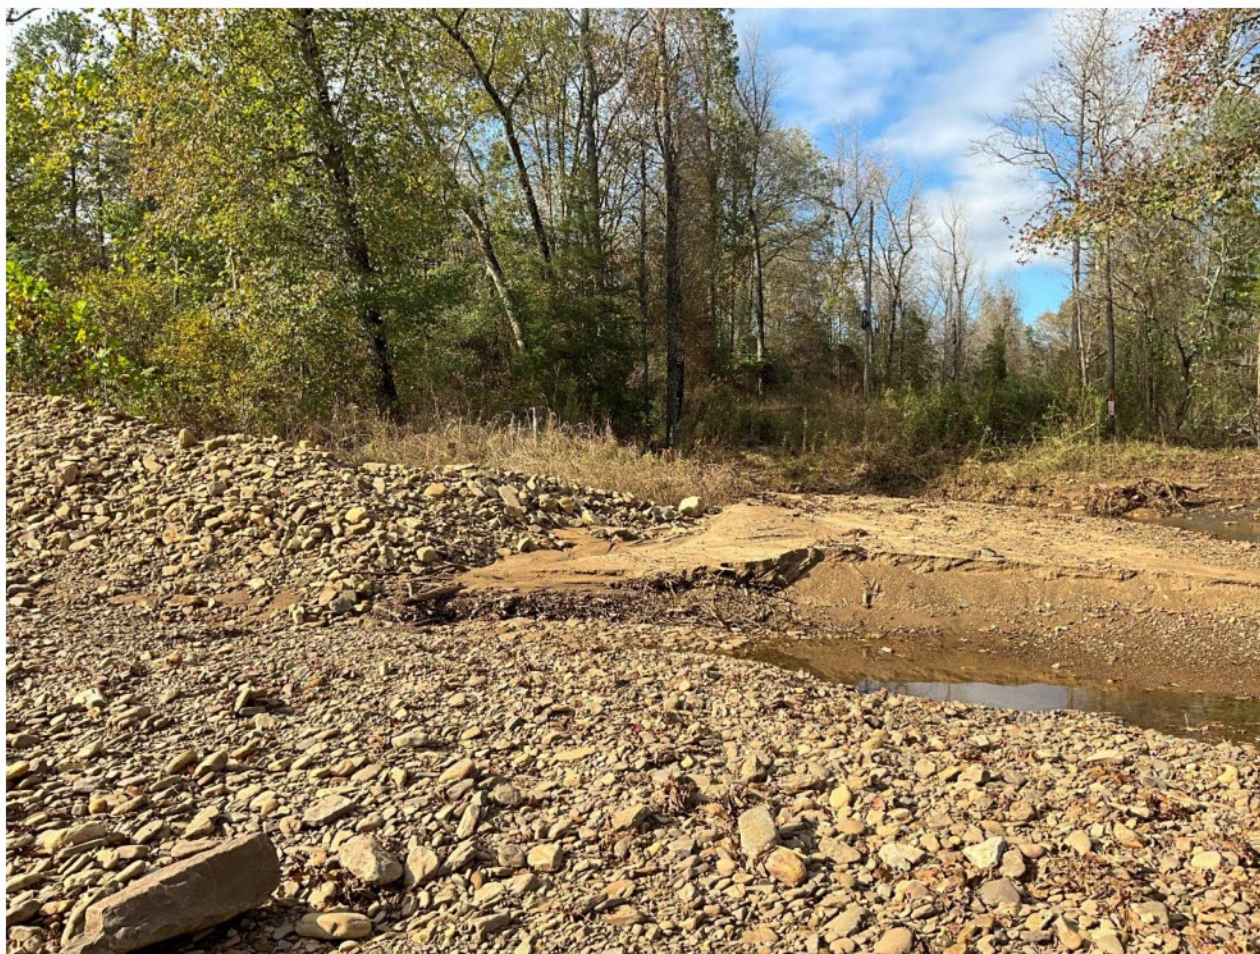
Photo No. 4

| Photo File Name | Date and Time of Photo | Photographer | Description |
|---|---|---|---|
| IMG_0119 | 11/07/2024, 2:07 PM | Chelsey Sherwood | Showing erosion in low-water crossing area and piles of dredge and fill material below Ordinary High Water Mark. Picture taken facing northwest. |

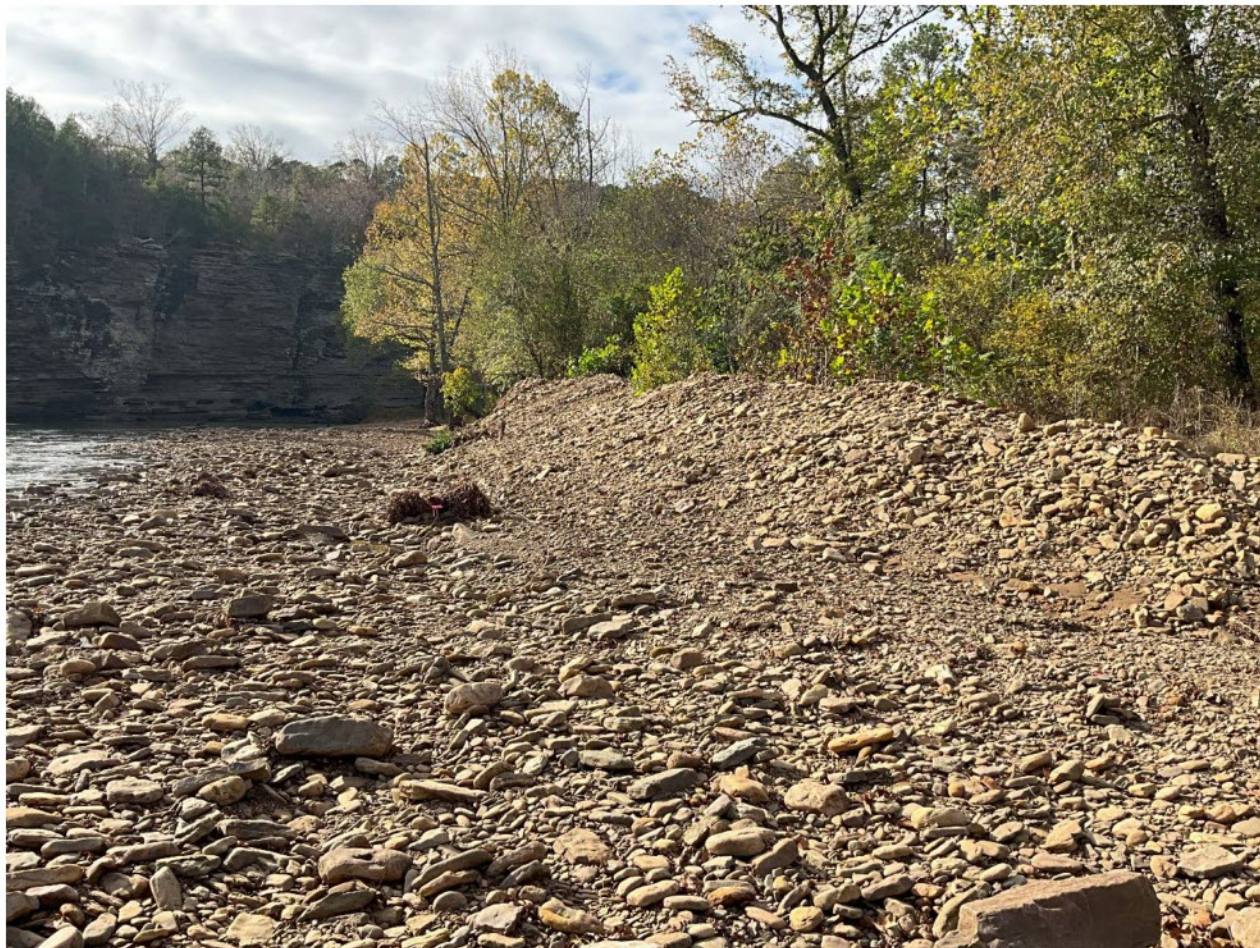
Photo No. 5

| Photo File Name | Date and Time of Photo | Photographer | Description |
|---|---|---|---|
| IMG_0120 | 11/07/2024, 2:07 PM | Chelsey Sherwood | Showing the graded stream and large piles of dredge and fill material piled throughout the stream and riparian areas. Picture taken facing west. |

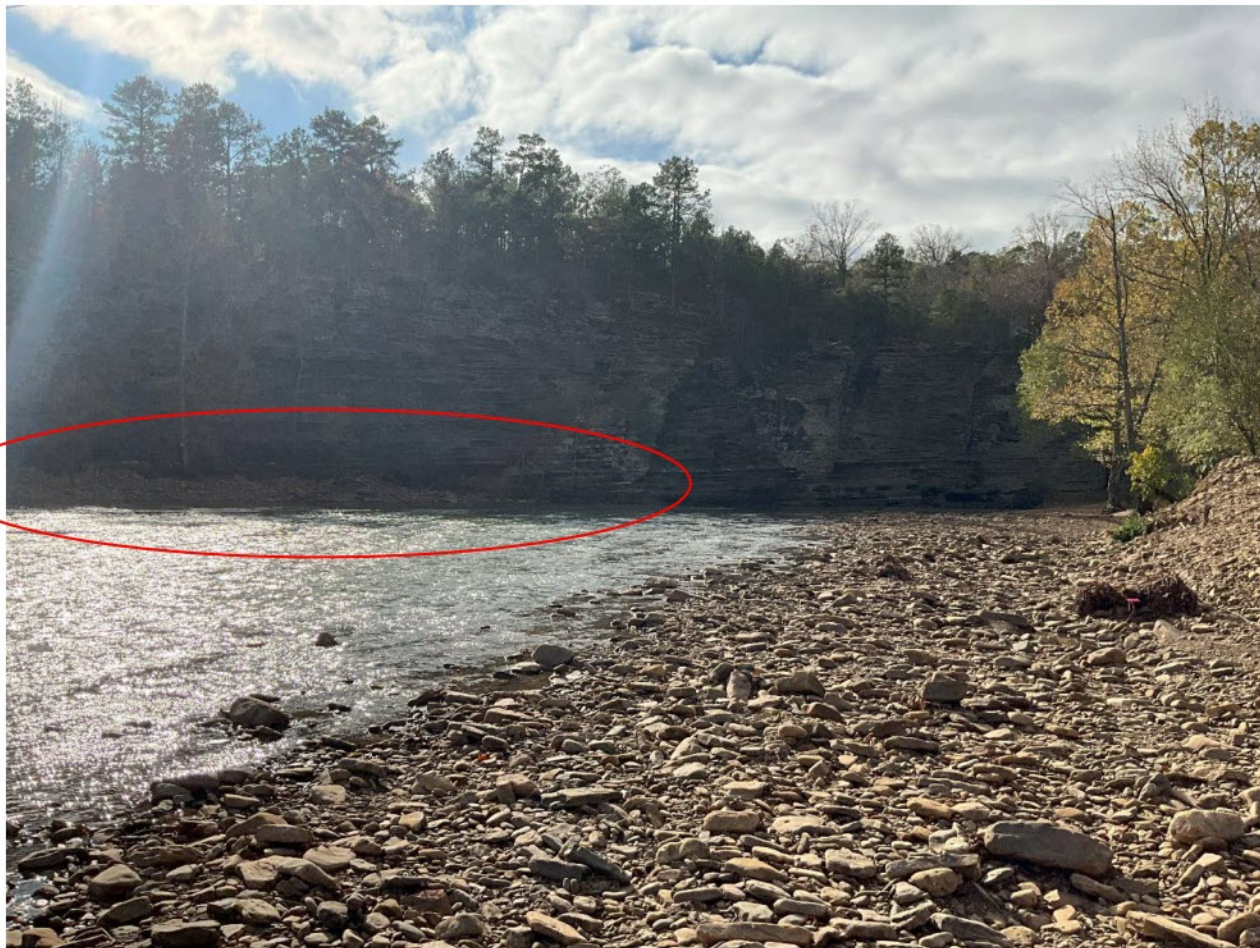
Photo No. 6

| Photo File Name | Date and Time of Photo | Photographer | Description |
|---|---|---|---|
| IMG_0121 | 11/07/2024, 2:08 PM | Chelsey Sherwood | Showing the graded stream and piles of dredge and fill material. Picture taken facing southwest, upstream. |

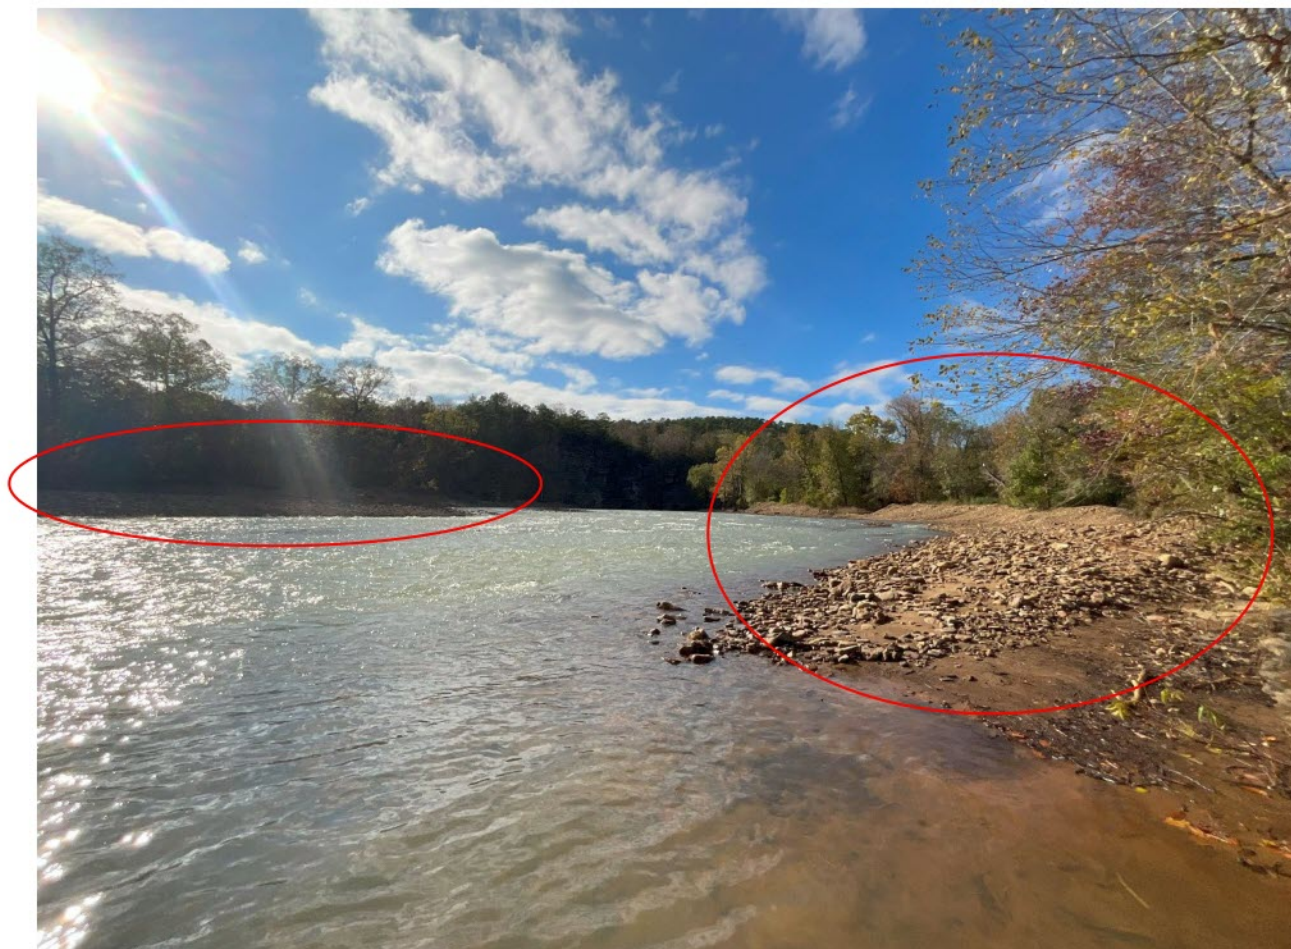
Photo No. 7

| Photo File Name | Date and Time of Photo | Photographer | Description |
|---|---|---|---|
| IMG_0122 | 11/07/2024, 2:17 PM | Chelsey Sherwood | Showing the graded stream and large piles of dredge and fill material piled throughout the stream and riparian areas. Picture taken facing west, upstream. |

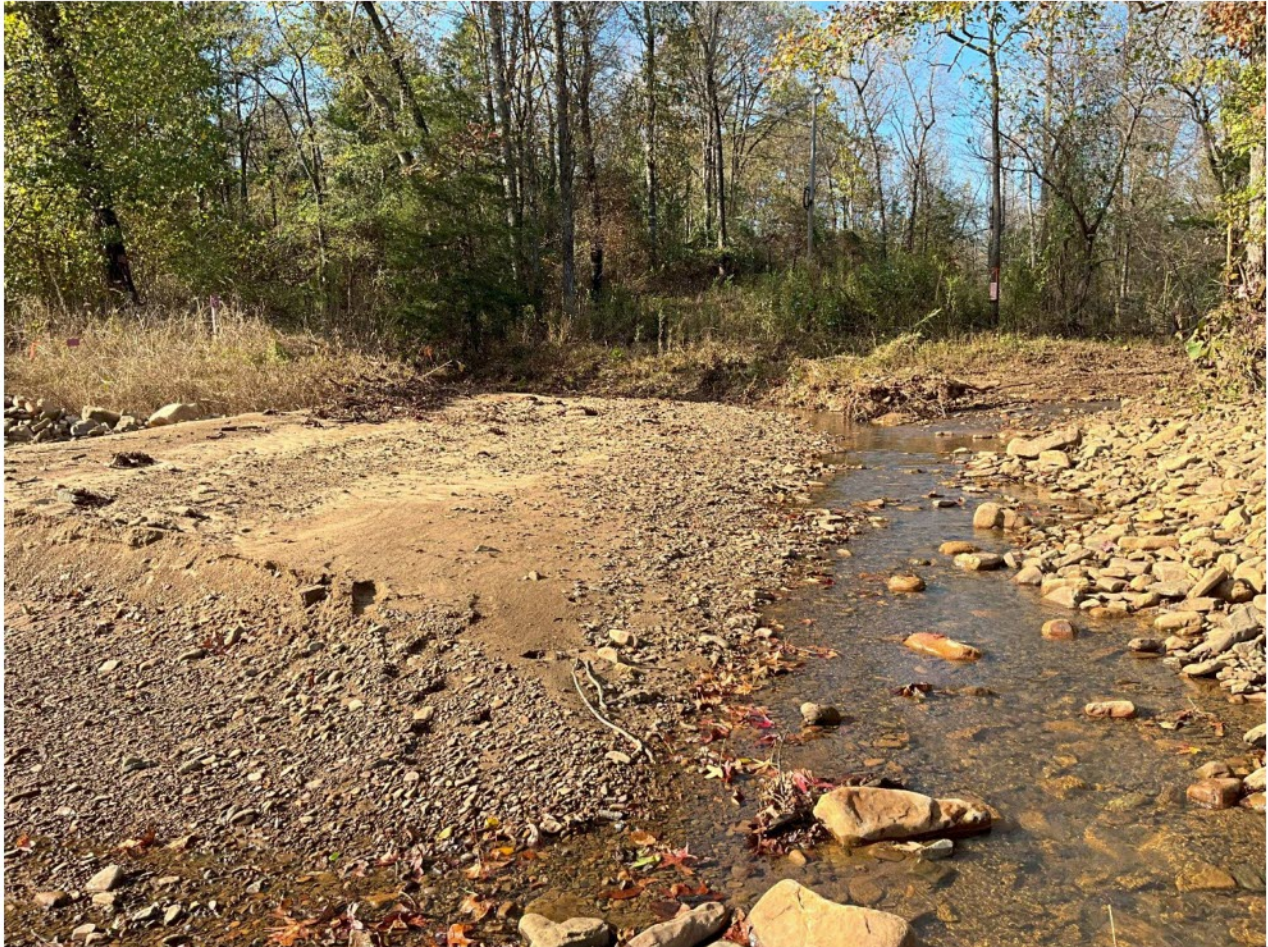
Photo No. 8

| Photo File Name | Date and Time of Photo | Photographer | Description |
|---|---|---|---|
| IMG_0124 | 11/07/2024, 2:22 PM | Chelsey Sherwood | Showing low-water crossing area. Picture taken facing northwest. |

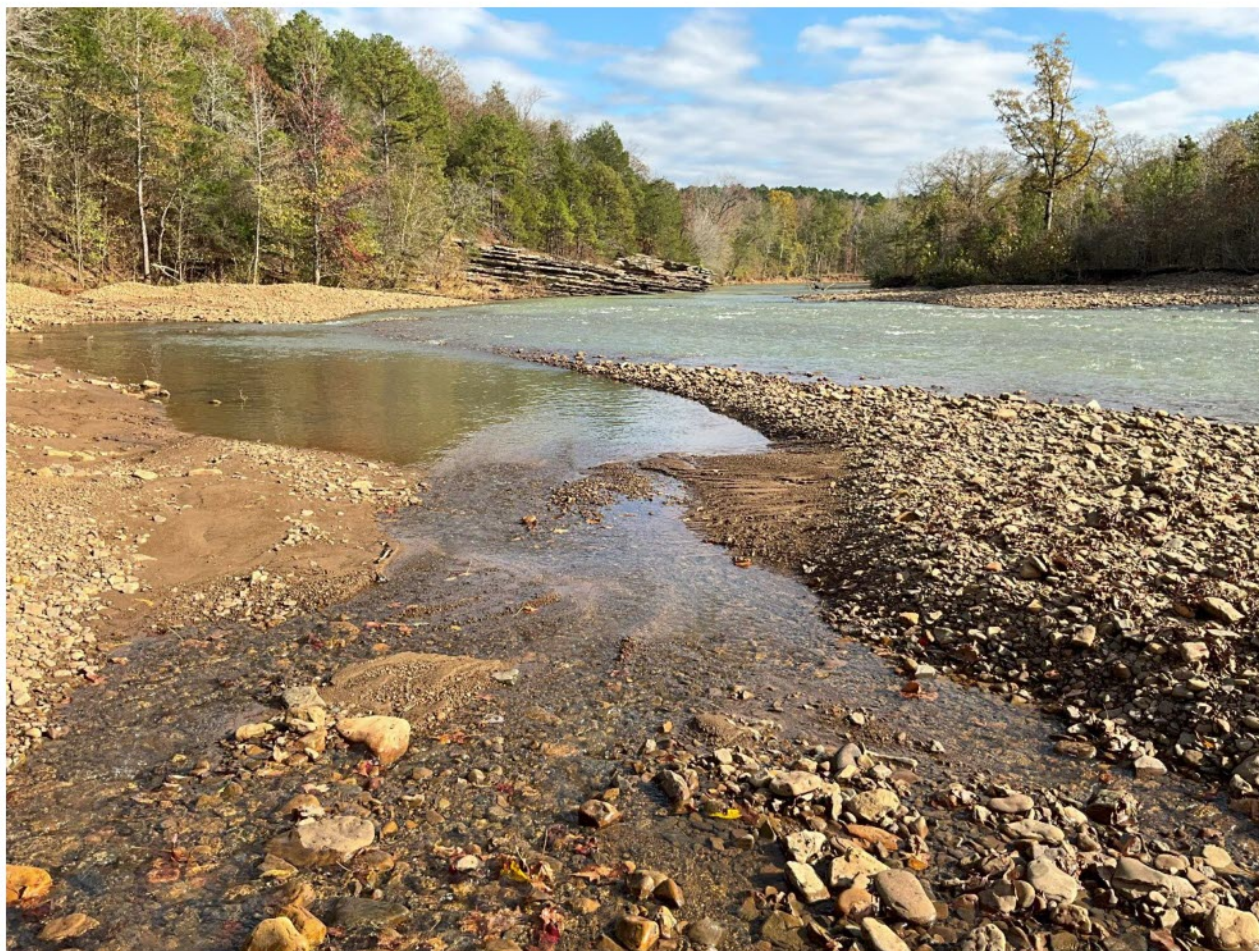
Photo No. 9

| Photo File Name | Date and Time of Photo | Photographer | Description |
|---|---|---|---|
| IMG_0125 | 11/07/2024, 2:22 PM | Chelsey Sherwood | Showing graded stream channel and the large piles of dredge and fill material piled throughout the stream and riparian areas. Picture taken facing southeast, downstream. |

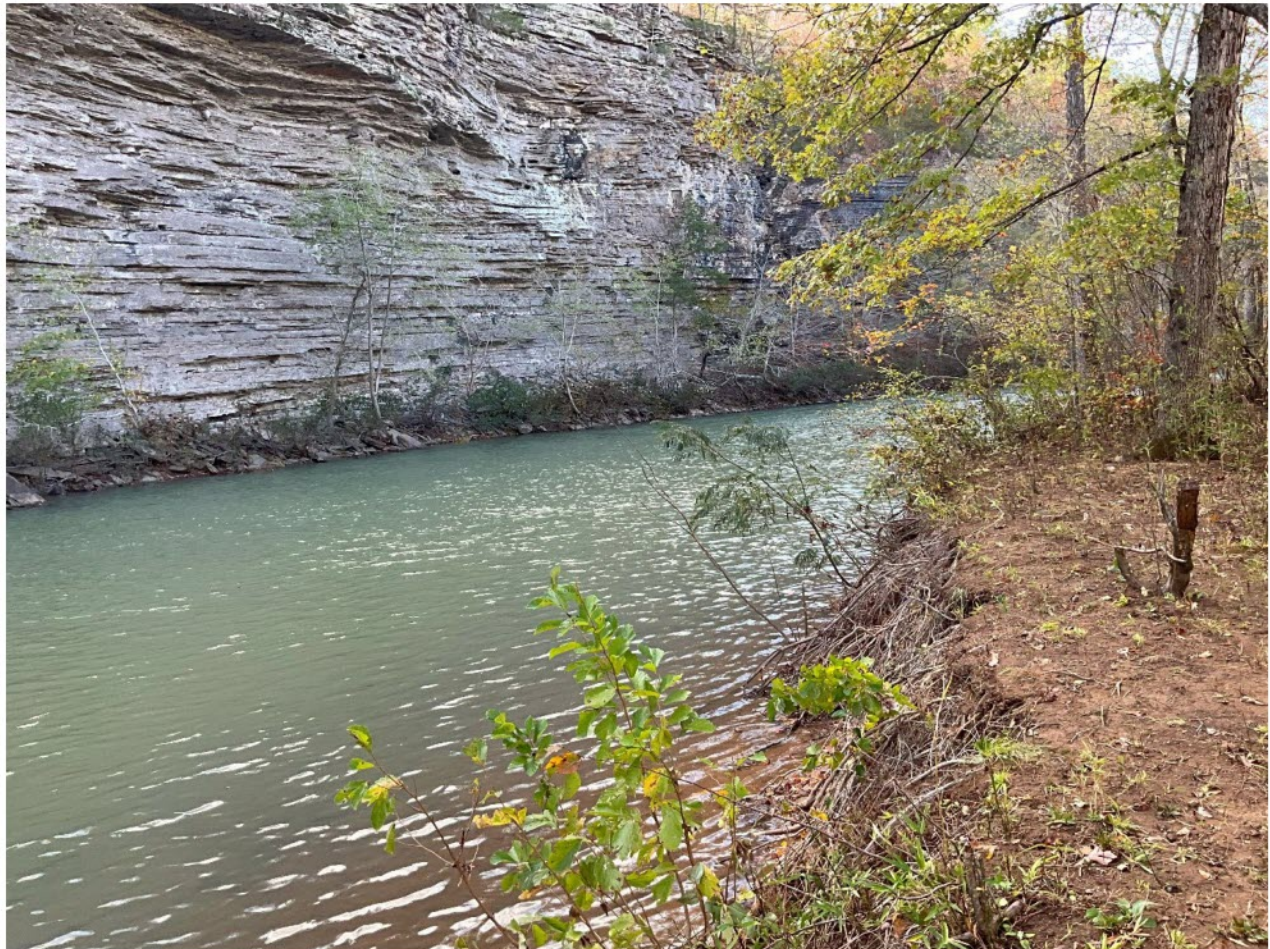
Photo No. 10

| Photo File Name | Date and Time of Photo | Photographer | Description |
|---|---|---|---|
| IMG_0126 | 11/07/2024, 2:30 PM | Chelsey Sherwood | Showing stream channel and banks upstream of the unauthorized activities. Picture taken facing west, upstream. |

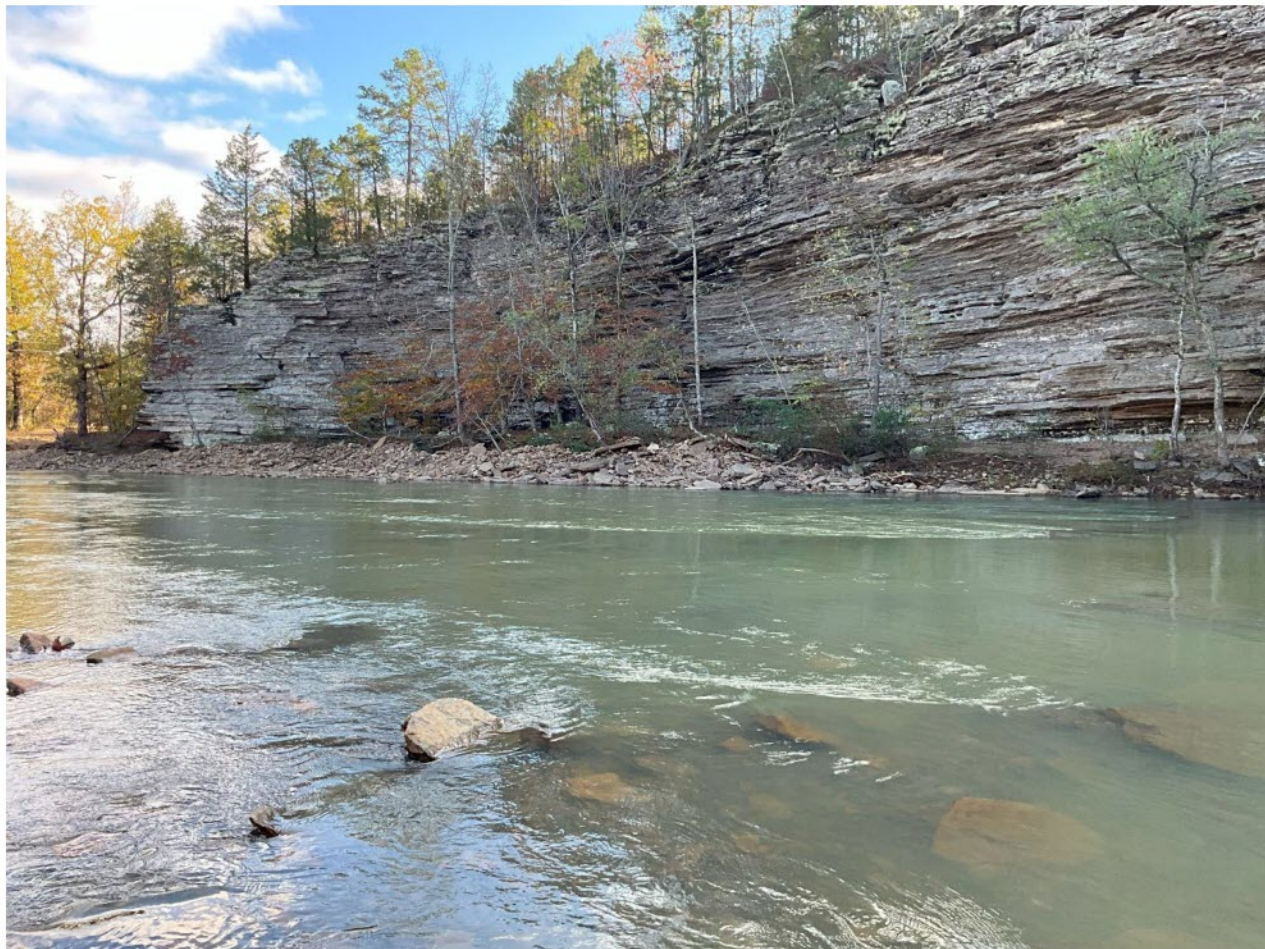
Photo No. 11

| Photo File Name | Date and Time of Photo | Photographer | Description |
|---|---|---|---|
| IMG_0127 | 11/07/2024, 2:35 PM | Chelsey Sherwood | Showing piles of dredge and fill material on river right. Picture taken facing south, towards river right bank. |

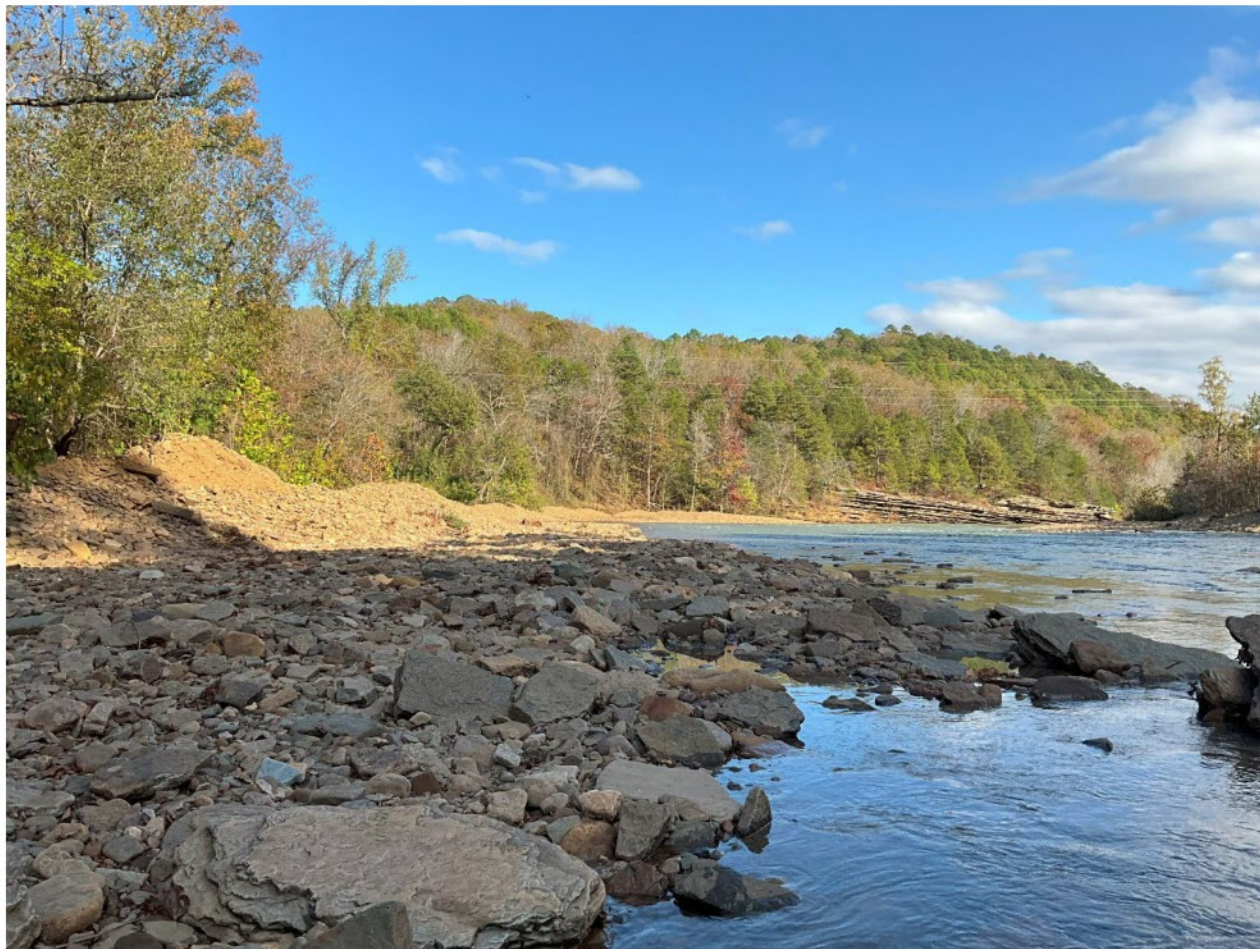
Photo No. 12

| Photo File Name | Date and Time of Photo | Photographer | Description |
|---|---|---|---|
| IMG_0128 | 11/07/2024, 2:35 PM | Chelsey Sherwood | Showing the large piles of dredge and fill material piled throughout the stream and riparian areas. Picture taken facing east, downstream. |

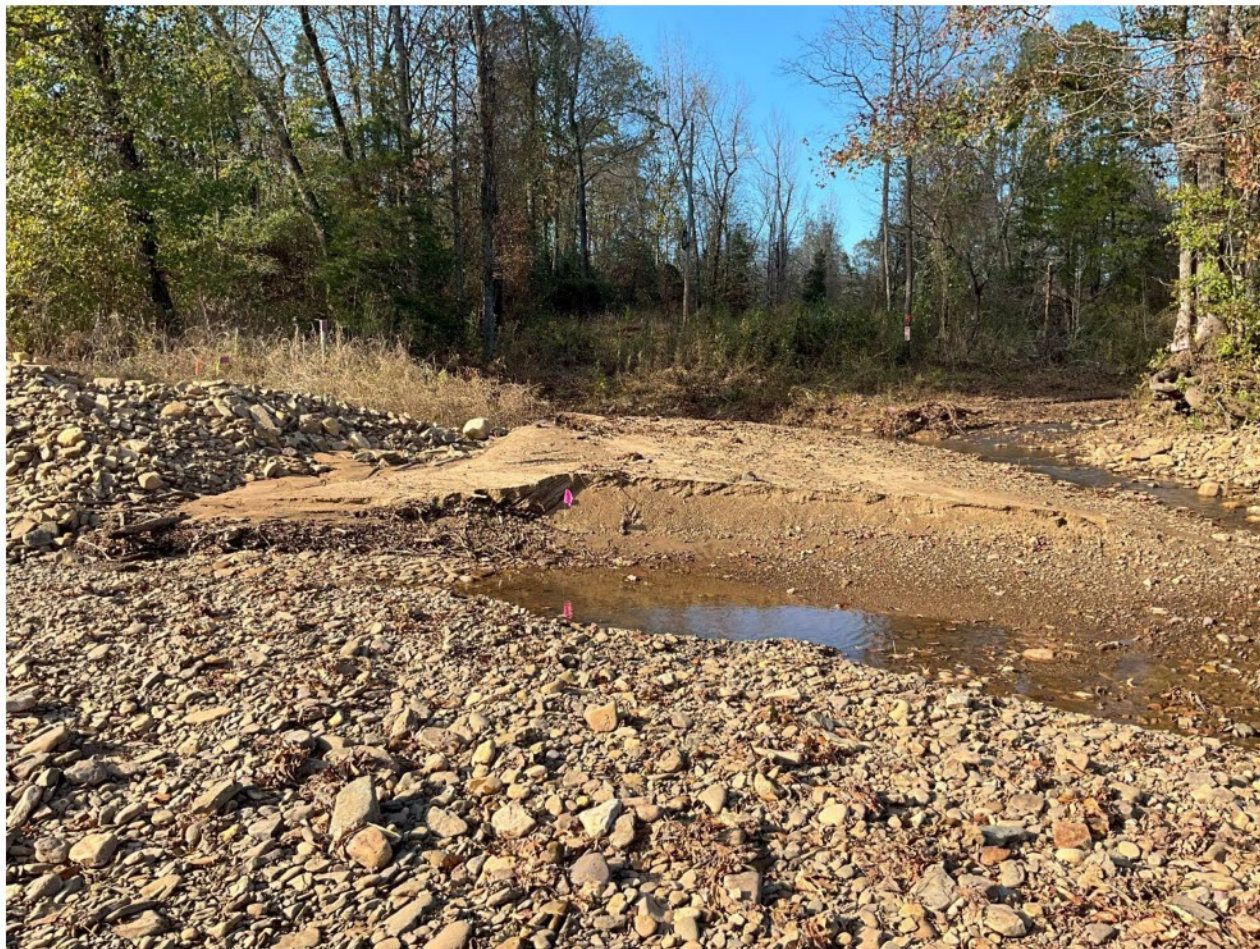
Photo No. 13

| Photo File Name | Date and Time of Photo | Photographer | Description |
|---|---|---|---|
| IMG_0129 | 11/07/2024, 2:41 PM | Chelsey Sherwood | Showing erosion along low-water crossing area and piles of dredge and fill material in stream. Picture taken facing northwest. |

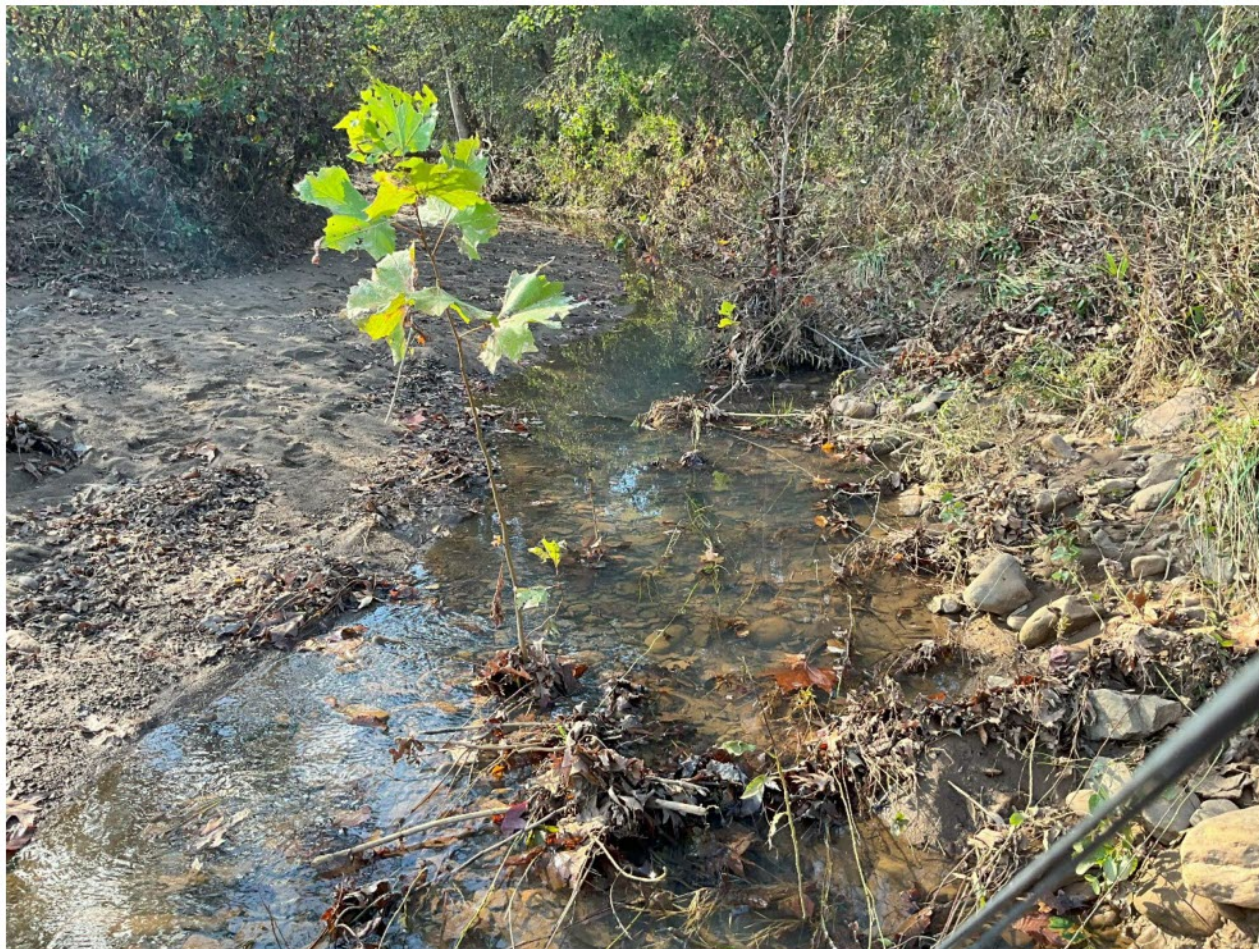
Photo No. 14

| Photo File Name | Date and Time of Photo | Photographer | Description |
|---|---|---|---|
| IMG_0130 | 11/07/2024, 2:45 PM | Chelsey Sherwood | Showing wrack lines in the side channel of stream. Note: fish observed in channel. Picture taken facing west, upstream. |

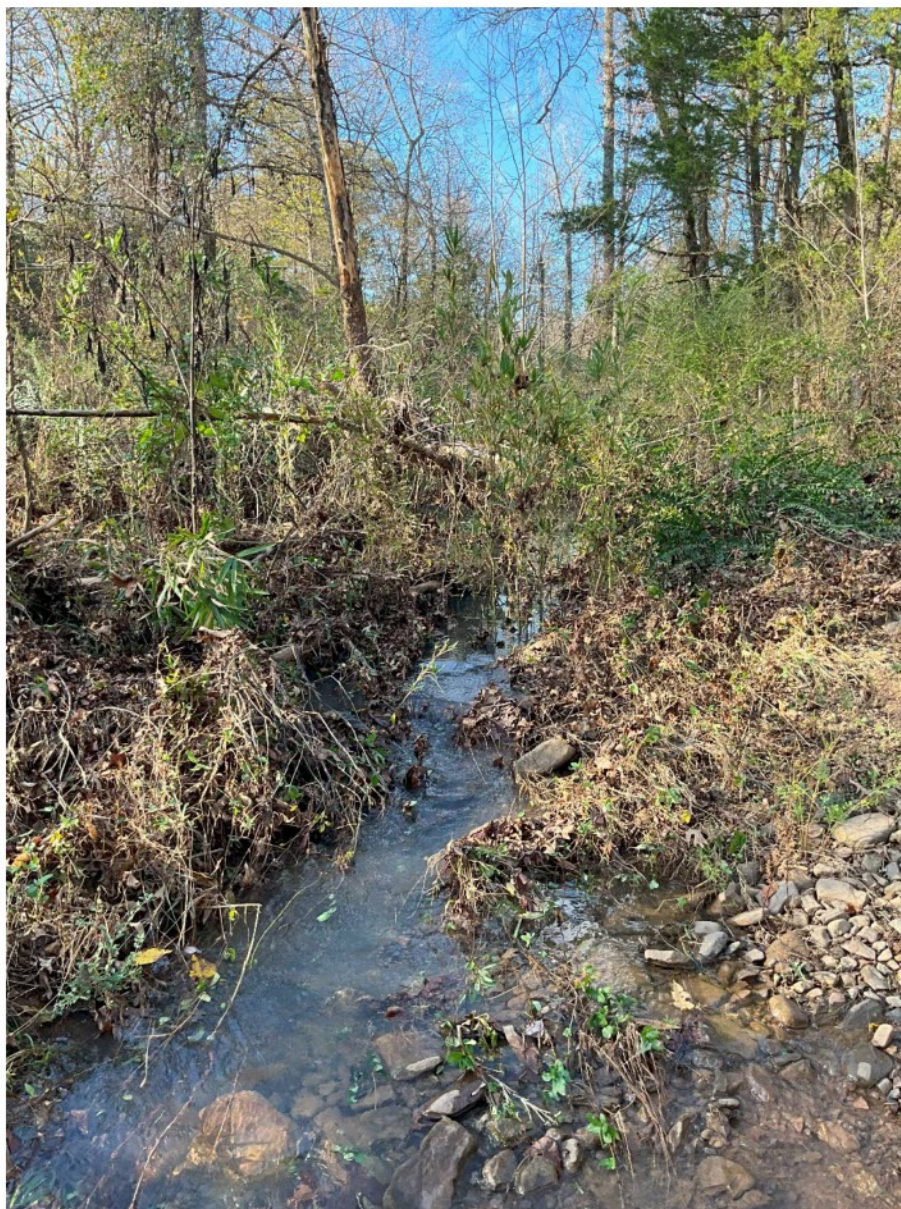
Photo No. 15

| Photo File Name | Date and Time of Photo | Photographer | Description |
|---|---|---|---|
| IMG_0131 | 11/07/2024, 2:51 PM | Chelsey Sherwood | Showing unnamed tributary to Little Piney Creek. Picture taken facing northwest, upstream. |
