## **RCRA Inspection Report**

Safety-Kleen Systems, Inc. (SK)  
7024 Commercial Drive  
Morrow, GA 30260

EPA ID#: GAD981265424  
NAICS #: 562112-Hazardous Waste Collection

October 29, 2024, 9:05 AM

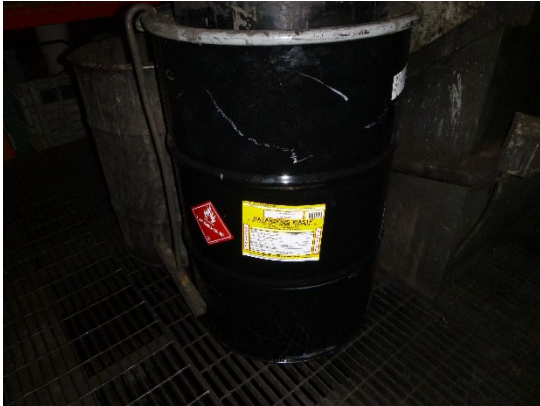
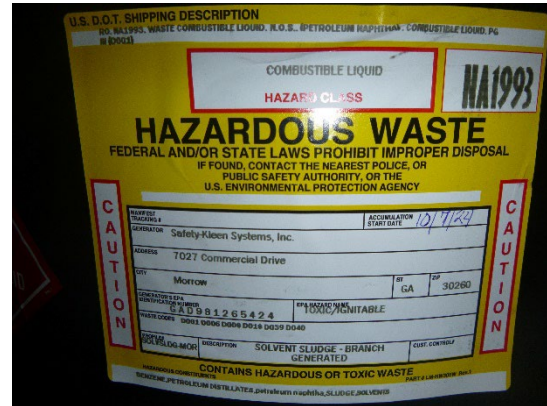
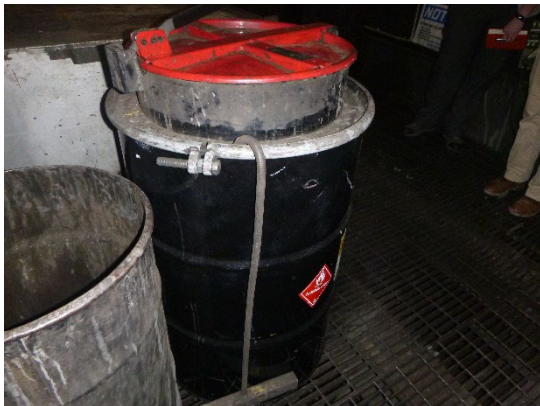
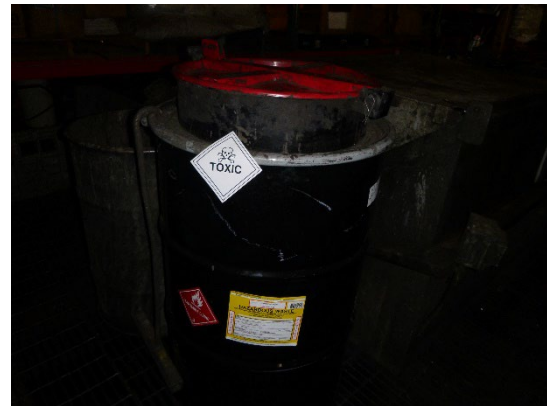
SK manages a SAA in this area for managing hazardous waste spent solvent sludge that is generated by the waste return process. This hazardous waste generally includes contaminated wipes and clean out debris from the Return and Fill Station. The inspectors observed one (1) 55-gallon steel container in this SAA. The container was located directly adjacent to one of the Return and Fill Stations and within 8 – 10 feet of the other return station, and it was equipped with a clampable hinged easy access lid, which was securely closed. The container was marked as hazardous waste “Solvent Sludge – Branch Generated, SOLVSLDG-MOR (D001, D006, D008, D018, D039, and D040)” and identified with toxic and flammable hazards in small lettering on the hazardous waste label. It was dated October 17, 2024. Additionally, there was a DOT flammable sticker on the container. It was recommended that they add a larger Toxic DOT label to the container to ensure this hazard was clearly visible. Facility personnel placed a toxic label on the container immediately (Photographs 1 – 4).

**Photograph 1:** Fill and Return Station SAA 55-gallon container.

**Photograph 2:** Fill and Return Station SAA Hazardous Waste Label.

**Photograph 3:** Fill and Return Station SAA 55-gallon container.

**Photograph 4:** Fill and Return Station SAA container with temporary "Toxic" placard.

The facility was requested to add “toxic” placards to several containers during the inspection due to very small written “toxic” on the hazardous waste labels. SK personnel placed those placards prior to the inspection team departure.

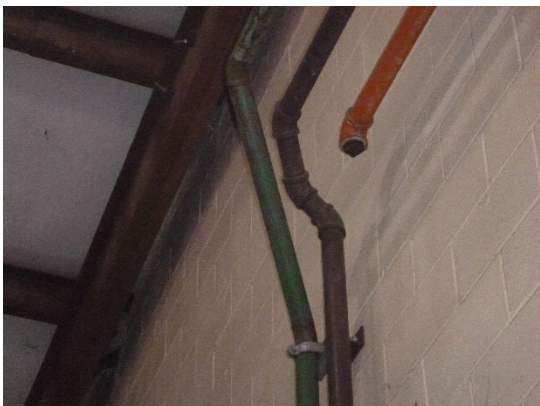
Inspectors followed the piping from the Return and Fill Station pour boxes to the outside wall of the building. All connections and the pump under the walkway were identified with legible numbered tags. (Photographs 6, 7, 8, and 9) The inspectors noted several joints along the ceiling within the Return and Fill Station building that appeared to be threaded and were not identified with a numbered tag. The EPA Inspectors took photographs and requested the facility provide up close photographs and information on whether the joints were welded or only threaded (Photographs 5, 16, and 17).

**Photograph 5:** Hazardous waste piping along Ceiling, which is untagged.

The inspectors reviewed a diagram of the piping system during the inspection. This diagram showed tags located at all the areas where inspectors observed tags during the inspection. It did not show tags on the connections within the Return and Fill Station building that inspectors noted may require tags.

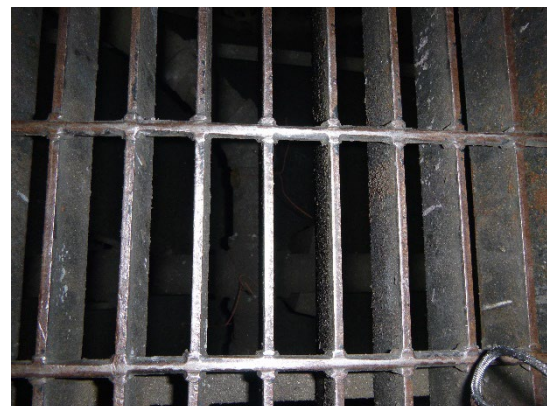
**Photograph 6:** Hazardous waste piping from Return and Fill Station boxes.

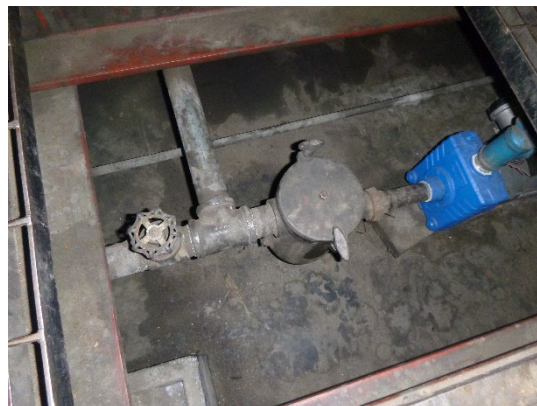
**Photograph 8:** Tagged filter and pump under grate in Fill and Return Station.

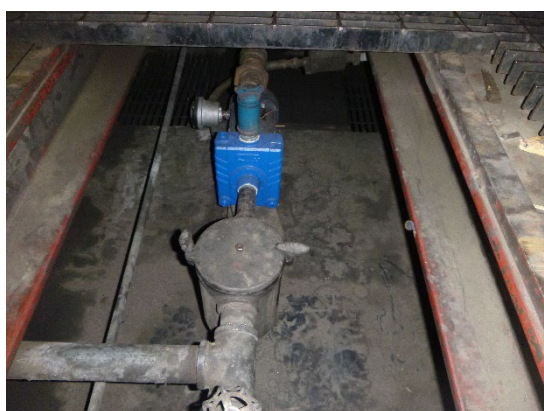
**Photograph 9:** Tagged filter and pump under Fill and Return Station.

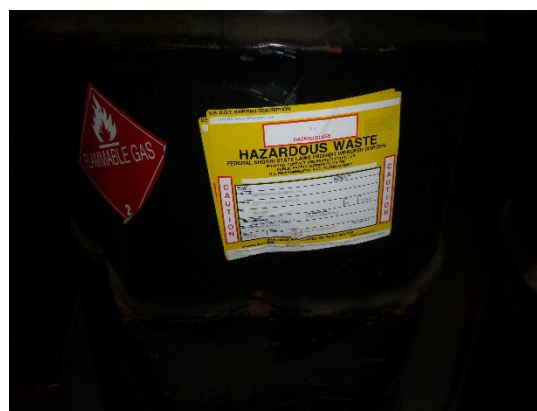
The facility manages an SAA in this area. The inspectors observed that it held a double doored steel cabinet with samples of used oil, oily water, and spent solvents. These samples were held for 90 days in this locker, then moved to the 55-gallon steel container in a SAA next to the

**Photograph 10:** Hazardous Waste label on SAA container in permitted warehouse.

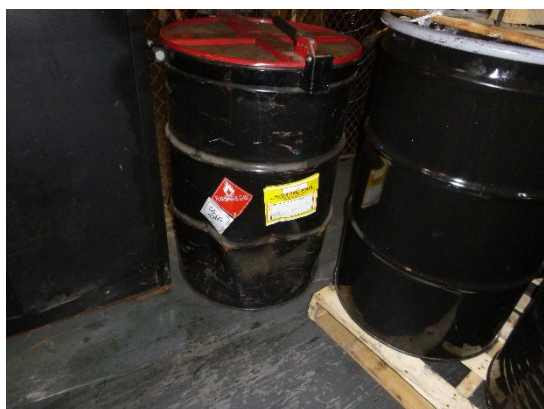
cabinet. The inspectors observed the steel 55-gallon container had a clamp down lid. The bottom area of the container was dented. Inspectors later observed the container being hit by a pallet when facility staff were moving a pallet in the receiving area (Photographs 10 and 11). At the time of the inspection this container was storing waste aerosols from adhesive used to affix labels to product containers. It contained only a small quantity of aerosols. The contents were described as flammable aerosols with a profile of CRQ-MOR. The hazardous waste codes identified were D001, D035, and L02. The indicated hazards were toxic and ignitable. The inspectors observed that the container was marked with the words "Hazardous Waste" and an indication of the hazards. There was only a flammable DOT placard on the container; it was suggested that they place a toxic placard for higher visibility of the hazard as the word toxic on the Hazardous Waste label was very small and only visible up close. Further, it was requested that the 55-gallon container be replaced and moved to a location where it was less likely to be damaged.

**Photograph 11:** SAA container in permitted warehouse, showing signs of denting.

**Pursuant to Ga. Comp. R. and Regs. 391-3-11-.08(1) [40 C.F.R. § 262.15(a)(1)], which is a condition of the LQG Permit Exemption, if the hazardous waste is placed in containers, the large quantity generator must comply with the following: if a container holding hazardous waste is not in good condition, or if it begins to leak, the large quantity generator must immediately transfer the hazardous waste from this container to a container that is in good condition, or immediately manage the waste in some other way that complies with the conditions for exemption of this section.**

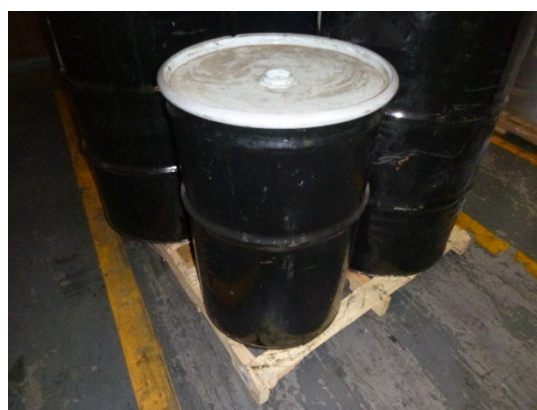
certain lanes with yellow “Hazardous Waste” labels. The inspectors observed six (6) lanes for storing containers, as well as a staging/reconfiguration lane which ran parallel to the left side of the supply storage fencing. Only two (2) of the regular lanes had containers with waste material in them. Only one (1) of the regular lanes and the side lane were used for storing hazardous waste at the time of inspection, the other lanes contained product, empty containers, or non-hazardous waste. In Lane #1 inspectors observe one (1) 30-gallon steel drum which was unlabeled and unmarked (Photograph 12). Inspectors asked the facility what the unmarked drum was, and they were told it was regular tap water. Inspectors asked why there would be an unmarked drum of water in the CAA, the facility stated that it was definitely water. Rodney Matthews had personal knowledge because he filled the drum. It was to be used for priming a piece of customer equipment and the customer no longer needed it, so it was returned by the driver and placed there temporarily before emptying.

**Photograph 12:** Unlabeled 30-gallon container in permitted container area holding "water".

**Pursuant to Section I. General Permit Conditions, I.G.5., Special Conditions Applicable to Entire Facility, of the State of Georgia Department of Natural Resources, Environmental Protection Division Hazardous Waste Permit Number HW-028 (S&CA)-2, the Permittee is prohibited from storing any waste, with the exception of dry-cleaning waste and paint material, derived from a product which did not originate at a Safety-Kleen facility without first obtaining an analysis of each customer's waste prior to the first shipment of that waste to the Morrow, Georgia facility. [Note: This condition does not apply to wastes from conditionally exempt small quantity generators as defined in Section 261.5 of the Georgia Rules for Hazardous Waste Management or waste handled on a transfer basis.]**

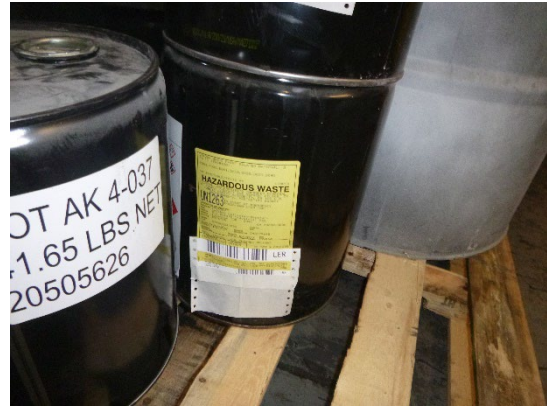
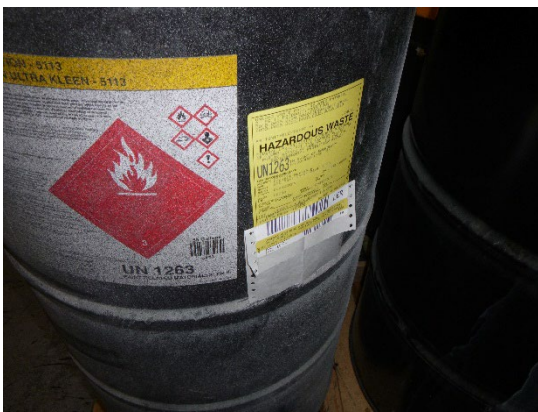
Lane #5 contained two (2) five-gallon steel containers holding paint gun cleaner waste (D001, D018, D035, D039, D040, F003, and F005). They were indicated as being toxic and flammable and had an accumulation date of October 28, 2024. There was also one (1) 55-gallon steel container storing paint gun cleaner waste (D001, D018, D035, D039, D040, F003, and F005). It was indicated as being toxic and flammable and had an accumulation date of October 28, 2024. All containers were in good condition and closed. The containers were also labeled with the words “Hazardous Waste”, an indication of the hazards, the waste profile numbers, applicable waste codes, and the accumulation dates. It was requested that SK place larger toxic placards on the containers because the word toxic was very small on the hazardous waste labels (Photographs 13, 14, and 15). Inspectors noted that aisle space was in accordance with the permit.

**Photograph 13:** 5-gallon hazardous waste container in permitted container storage.

**Photograph 14:** 5-gallon hazardous waste container in permitted container storage.

**Photograph 15:** 55-gallon hazardous waste container in permitted container storage.

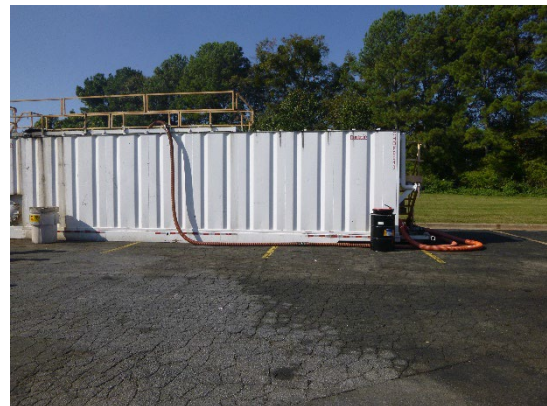
The facility maintains a portable 18,000-gallon steel frac tank on site approximately 50 yards from the tank farm. This tank is used for the separation of oily water and subsequent pumping out of oil sludge and water. The facility indicated that the frac tank and oily water totes received inside were pumped down and shipped out every “couple” of days. There was a 55-gallon steel drum with a clamp down lid located next to the frac tank which held wipes with oily water residue for the operators pumping down the frac tank.

**Photograph 18:** Frac Tank in parking lot.

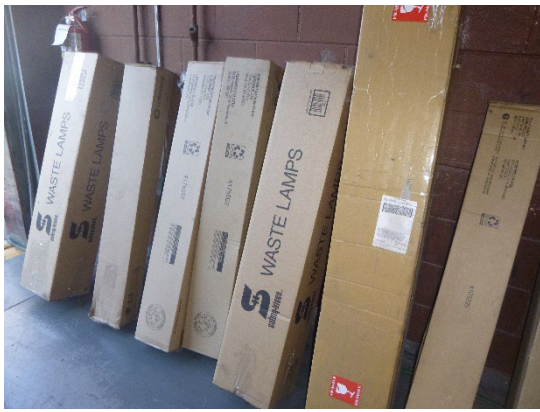
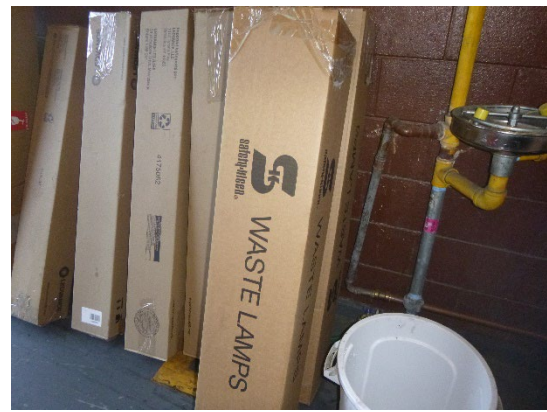
Also in this area, inspectors noted there were 17 four-foot boxes of waste lamps. Of these boxes five (5) were labeled and dated, eight (8) were not labeled universal waste lamps, waste lamps, or used lamps, and four (4) were not dated for accumulation (Photographs 19 and 20). Inspectors indicated that this was a concern and staff labeled the waste lamp boxes appropriately and with the date October 28, 2024, prior to the inspectors departing the facility (Photographs 22 and 23). All boxes were closed.

**Photograph 19:** Boxes containing universal waste lamps, some unlabeled.

**Photograph 20:** Labeled waste lamp box.

**Pursuant to Ga. Comp. R. and Regs. 391-3-11-.18 [40 C.F.R. § 273.14(e), each lamp or a container or package in which such lamps are contained must be labeled or marked clearly with one of the following phrases: “Universal Waste—Lamp(s),” or “Waste Lamp(s),” or “Used Lamp(s)”.**

**Pursuant to Ga. Comp. R. and Regs. 391-3-11-.18 [40 C.F.R. § 273.15(c), a small quantity handler of universal waste who accumulates universal waste must be able to demonstrate the length of time that the universal waste has been accumulated from the date it becomes a waste or is received.**

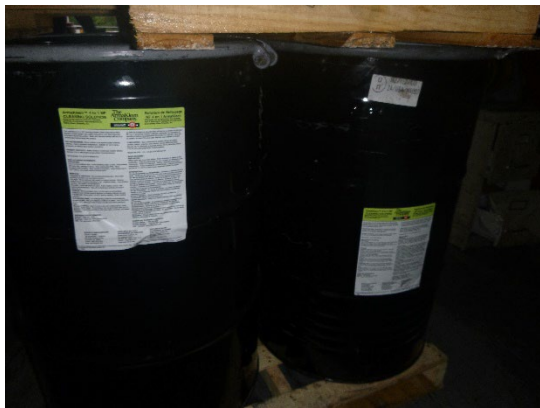
Inspectors also noted two (2) steel containers which were not labeled at all. After looking into these containers, the facility personnel were able to determine they were new solvent that had not been labeled but had been returned from the customer site (Photograph 21).

**Photograph 21:** 55-gallon containers of product after facility added labels.

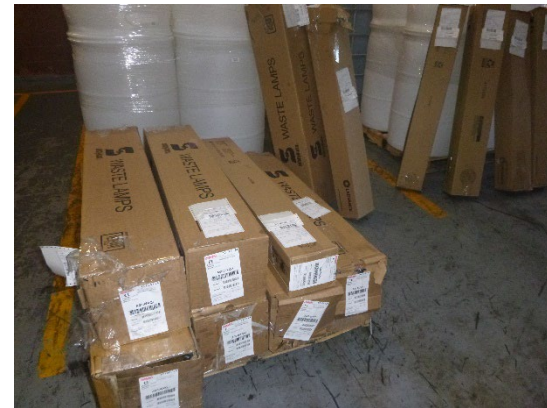
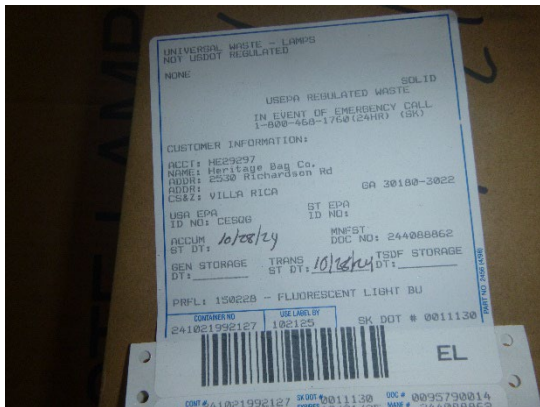
**Photograph 22:** Universal waste lamp boxes with labels indicating Waste-Lamps and date.

**Photograph 23:** Label affixed to waste lamp which also indicated accumulation date.

Further, the facility placed labels and dates on universal waste lamps as noted during the inspection. The inspection team went to verify this labeling prior to departure.
