DOCUMENT DESCRIPTION: Consultant Report - Fiber Release During Activities Involving a Caterpillar Brake Brand

**Report of Results: MVA8473**

**Fiber Release During Activities  
Involving a Caterpillar Brake Band**

**MVA Scientific Consultants  
3300 Breckinridge Boulevard  
Suite 400  
Duluth, GA 30096**

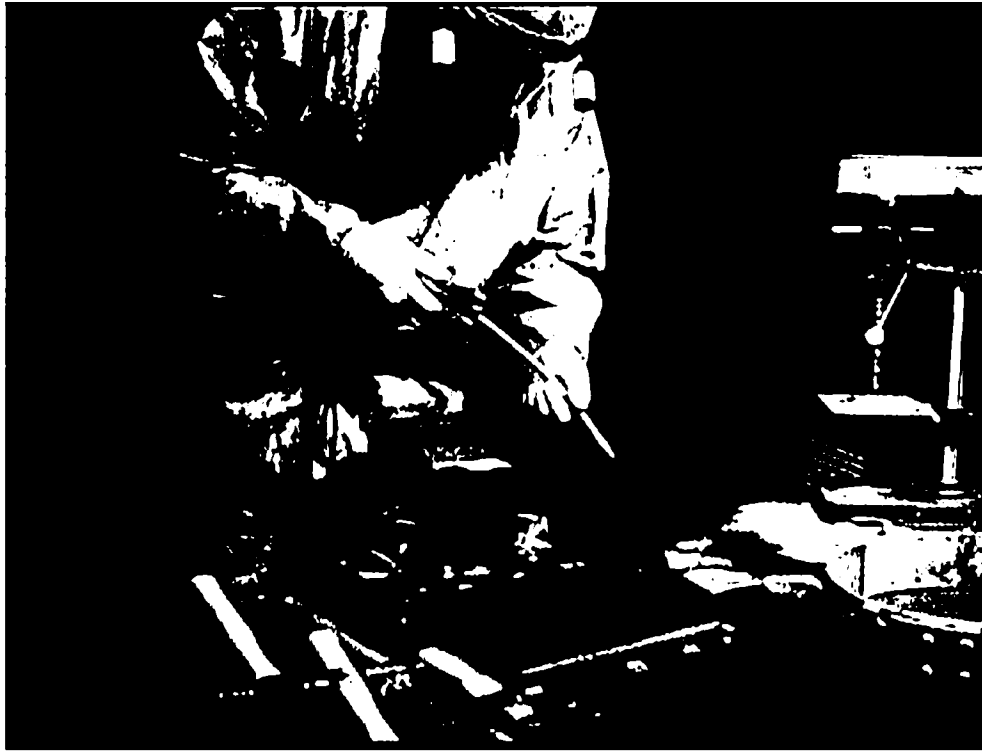
**Figure 7.** Using compressed air in cleaning up the dust and debris from removing rivets and drilling the Caterpillar Brake Band.

A ball-peen hammer and drift (punch) were used to remove the rivets from the brake unit. Holes were drilled in the composite brake material using a drill press (Central Machinery Model 44506). Compressed air (60 psi) was used to blow the debris off the brake material and the equipment after removal of the rivets and drilling the holes. A hand-held grinding tool with a 3.5 cm diameter abrasive blade was used to make one cut across the brake piece. The flow rates of the two personal samples collected for each test were 0.52 and 1.91 liters per minute. The area sample was collected at 5 liters per minute.
