**Class I and II Well Inspection Form**  
**US Environmental Protection Agency – Region 4**  
**Underground Injection Control Program**  
61 Forsyth Street SW, MC 9T25, Atlanta, Georgia, 30303  
Phone: (404)562-9424

Facility Name: *Blackjack Plant* \_\_\_\_\_  
Street Address: *4940 Blackjack Plant Road* \_\_\_\_\_  
City: *Jay* \_\_\_\_\_ County: *Santa Rosa* \_\_\_\_\_ State: *FL* \_\_\_\_\_ Zip: *32535* \_\_\_\_\_  
Nature of Business: *Oil and gas production* \_\_\_\_\_  
Facility Owner/Operator: *Black Creek Energy, LLC* \_\_\_\_\_ Phone: *(601) 431-5386* \_\_\_\_\_  
Email: *harris.butler@butlerroyals.com* \_\_\_\_\_  
Facility Contact (if different): *Michael Wetzel* \_\_\_\_\_ Phone: *(850) 324-6271* \_\_\_\_\_  
O/O Mailing Address: *140 Virginia Street, Suite 402* \_\_\_\_\_  
City: *Richmond* \_\_\_\_\_ County: *NA* \_\_\_\_\_ State: *VA* \_\_\_\_\_ Zip: *23209* \_\_\_\_\_

Well Name & #: *St. Regis Paper Co (SRPC) #15W* \_\_\_\_\_  
Well Type (see table): *Enhanced Recovery (EOR)* \_\_\_\_\_ State Permit: API # *0911320147* \_\_\_\_\_  
Latitude (°N): *30.858246°N* \_\_\_\_\_ Longitude (°W): *-87.135445°W* \_\_\_\_\_ Elevation (ft): *178'* \_\_\_\_\_  
Injection Method

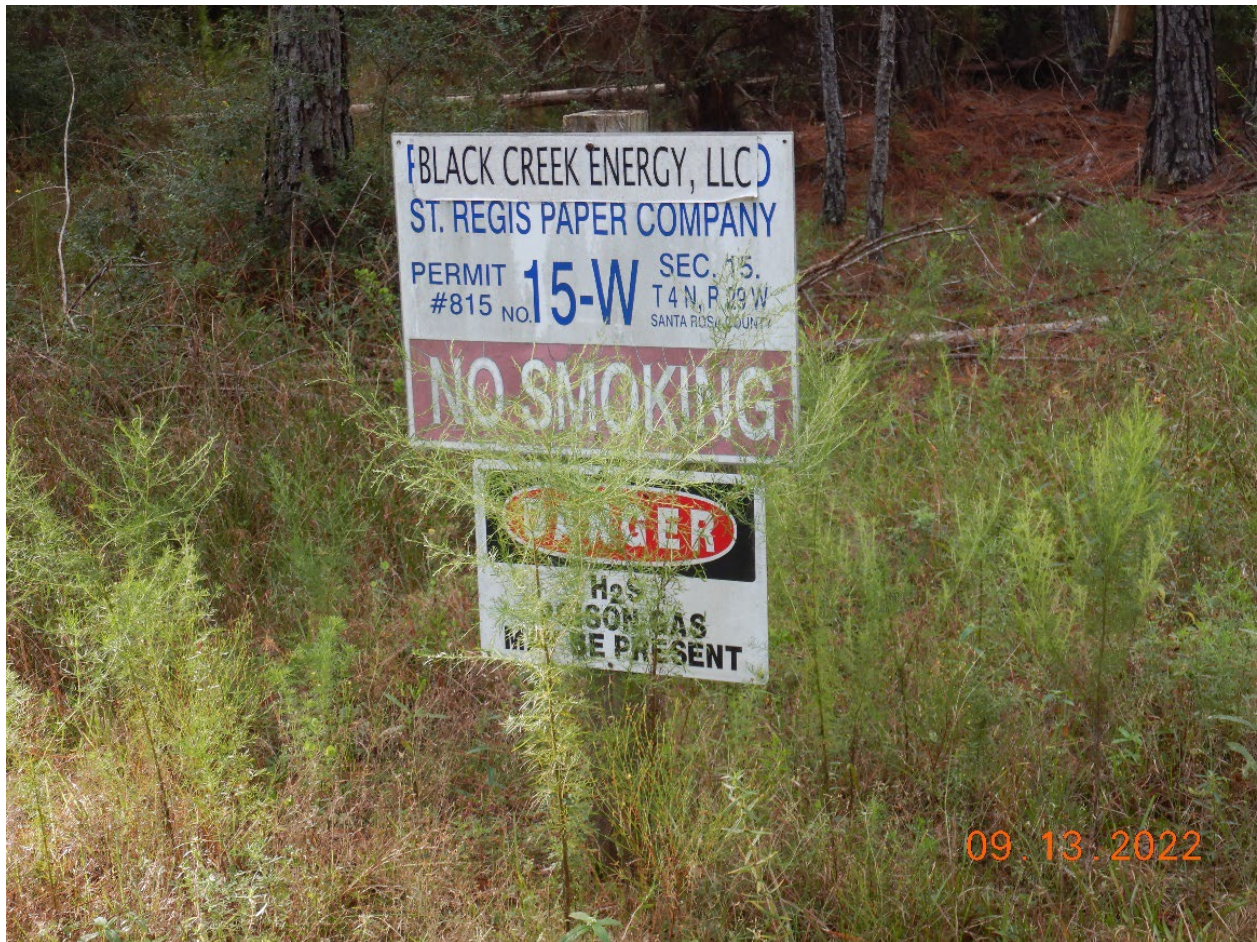
Description: *Looking south, St. Regis Paper Company #15-W sign alongside access road.* \_\_\_\_\_

**Photograph 1:** Looking south, St. Regis Paper Company #15-W sign alongside access road.

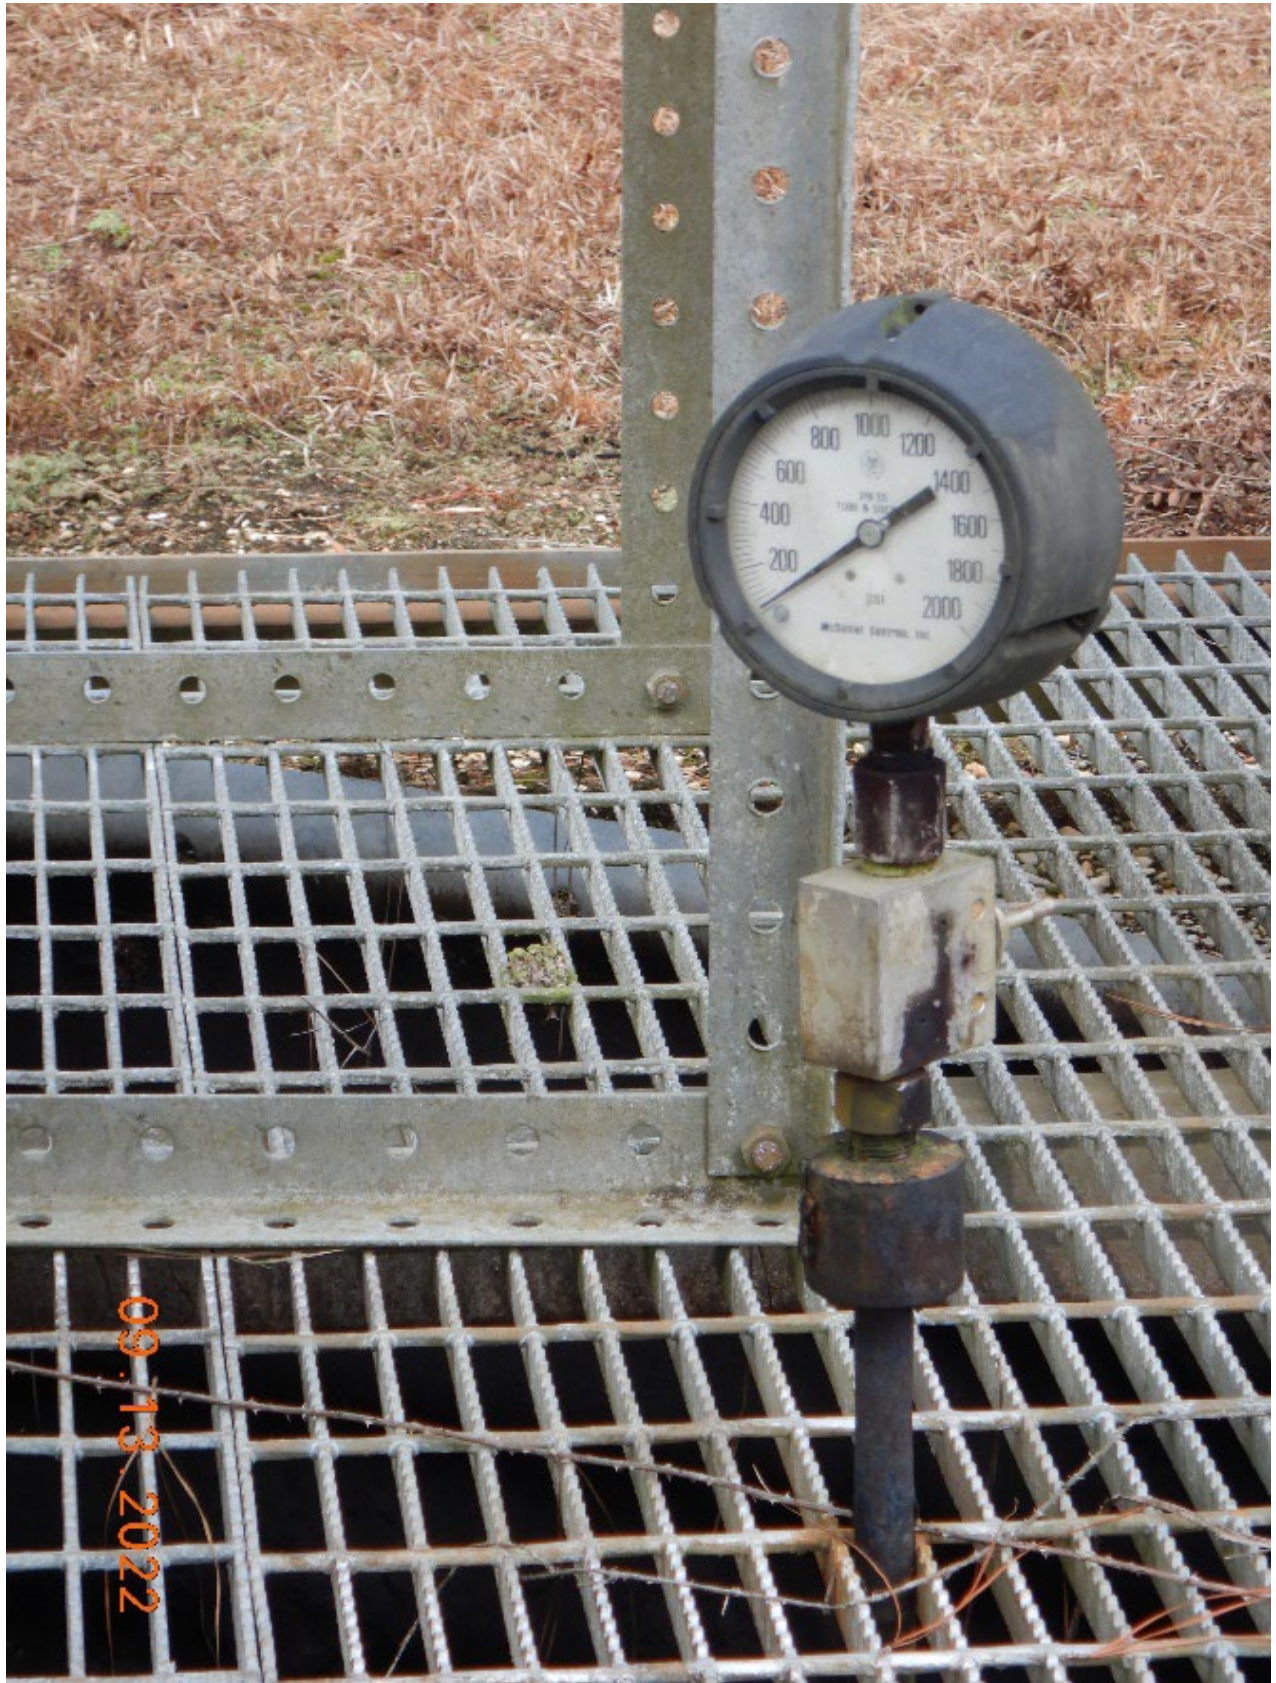
Description: *Looking west, closeup view of surface pressure gauge reading 0 psi.* \_\_\_\_\_

**Photograph 2:** Looking west, closeup view of surface pressure gauge reading 0 psi.

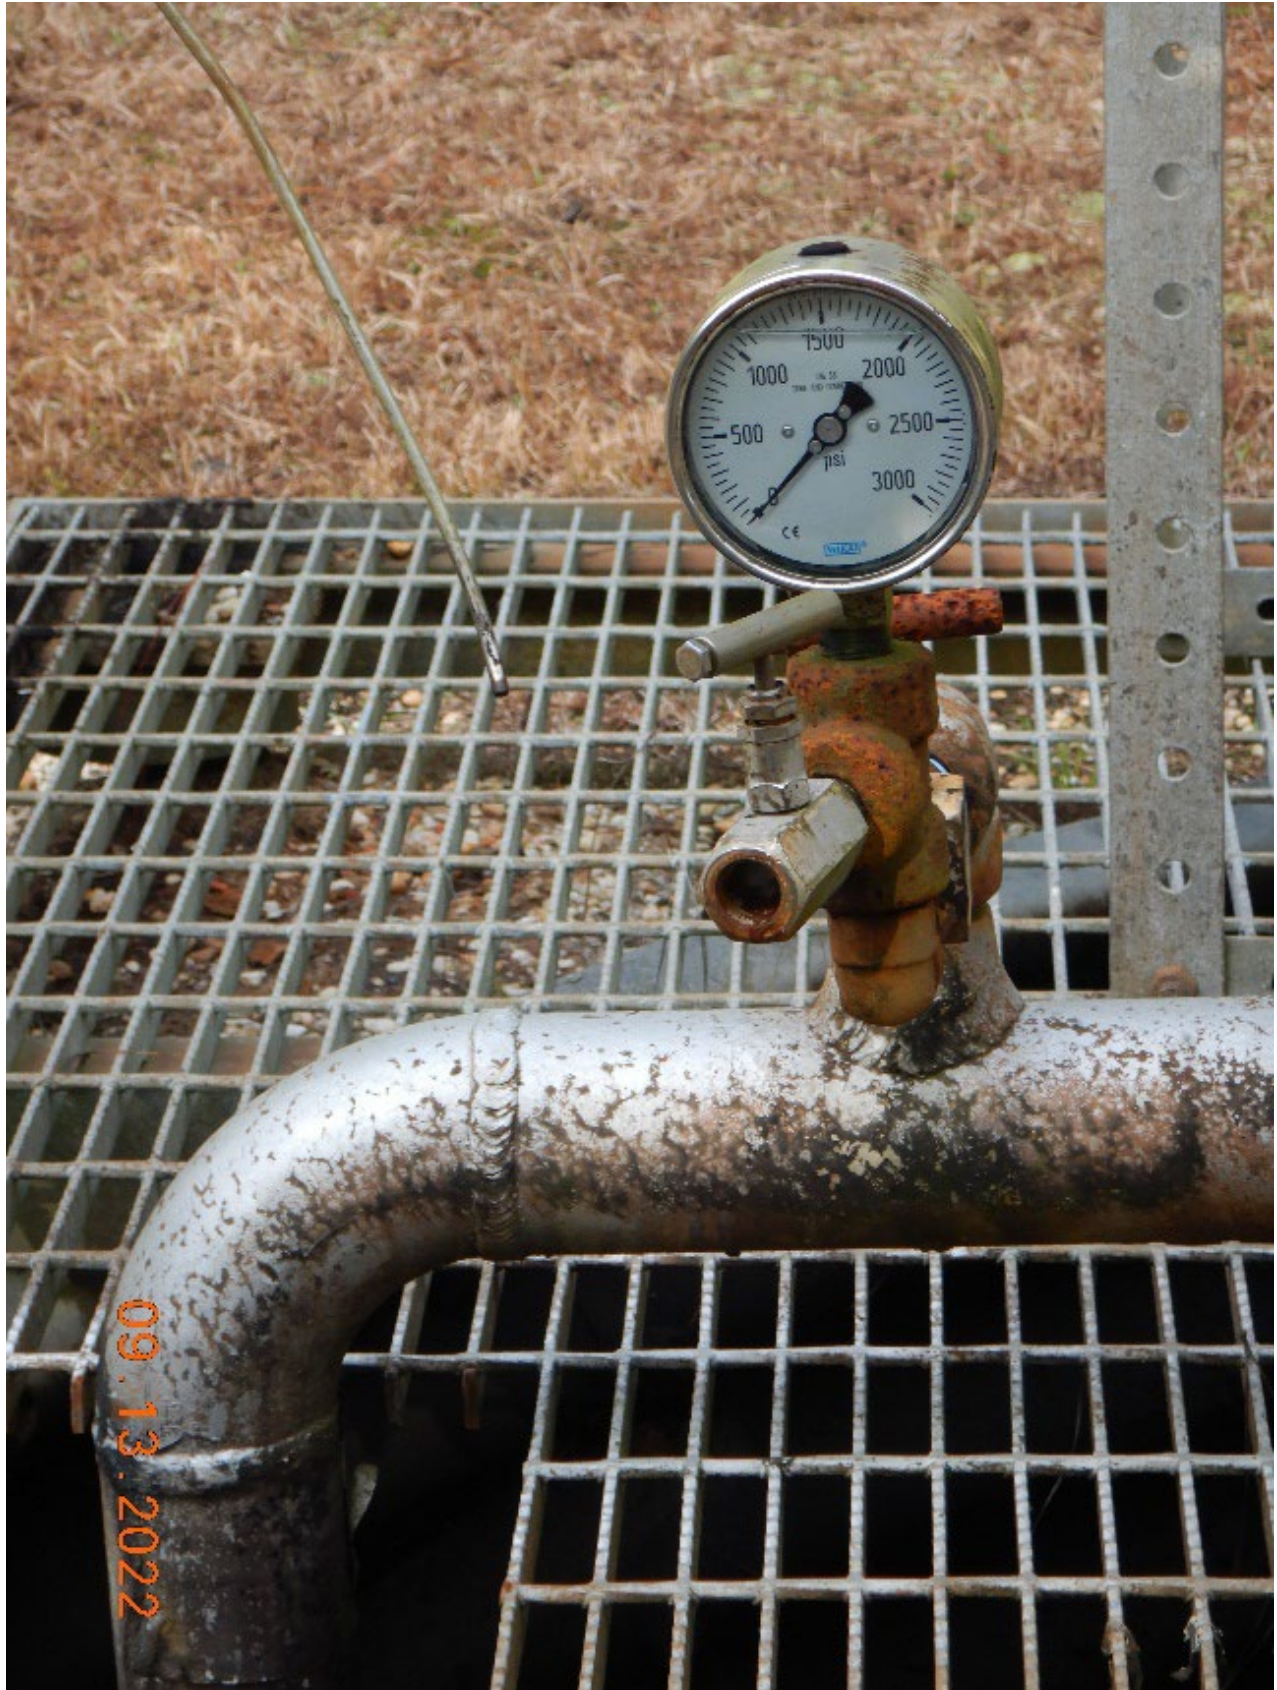
Description: *Looking west, closeup view of production casing pressure gauge reading 0 psi.* \_\_\_\_\_

**Photograph 3:** Looking west, closeup view of production casing pressure gauge reading 0 psi.

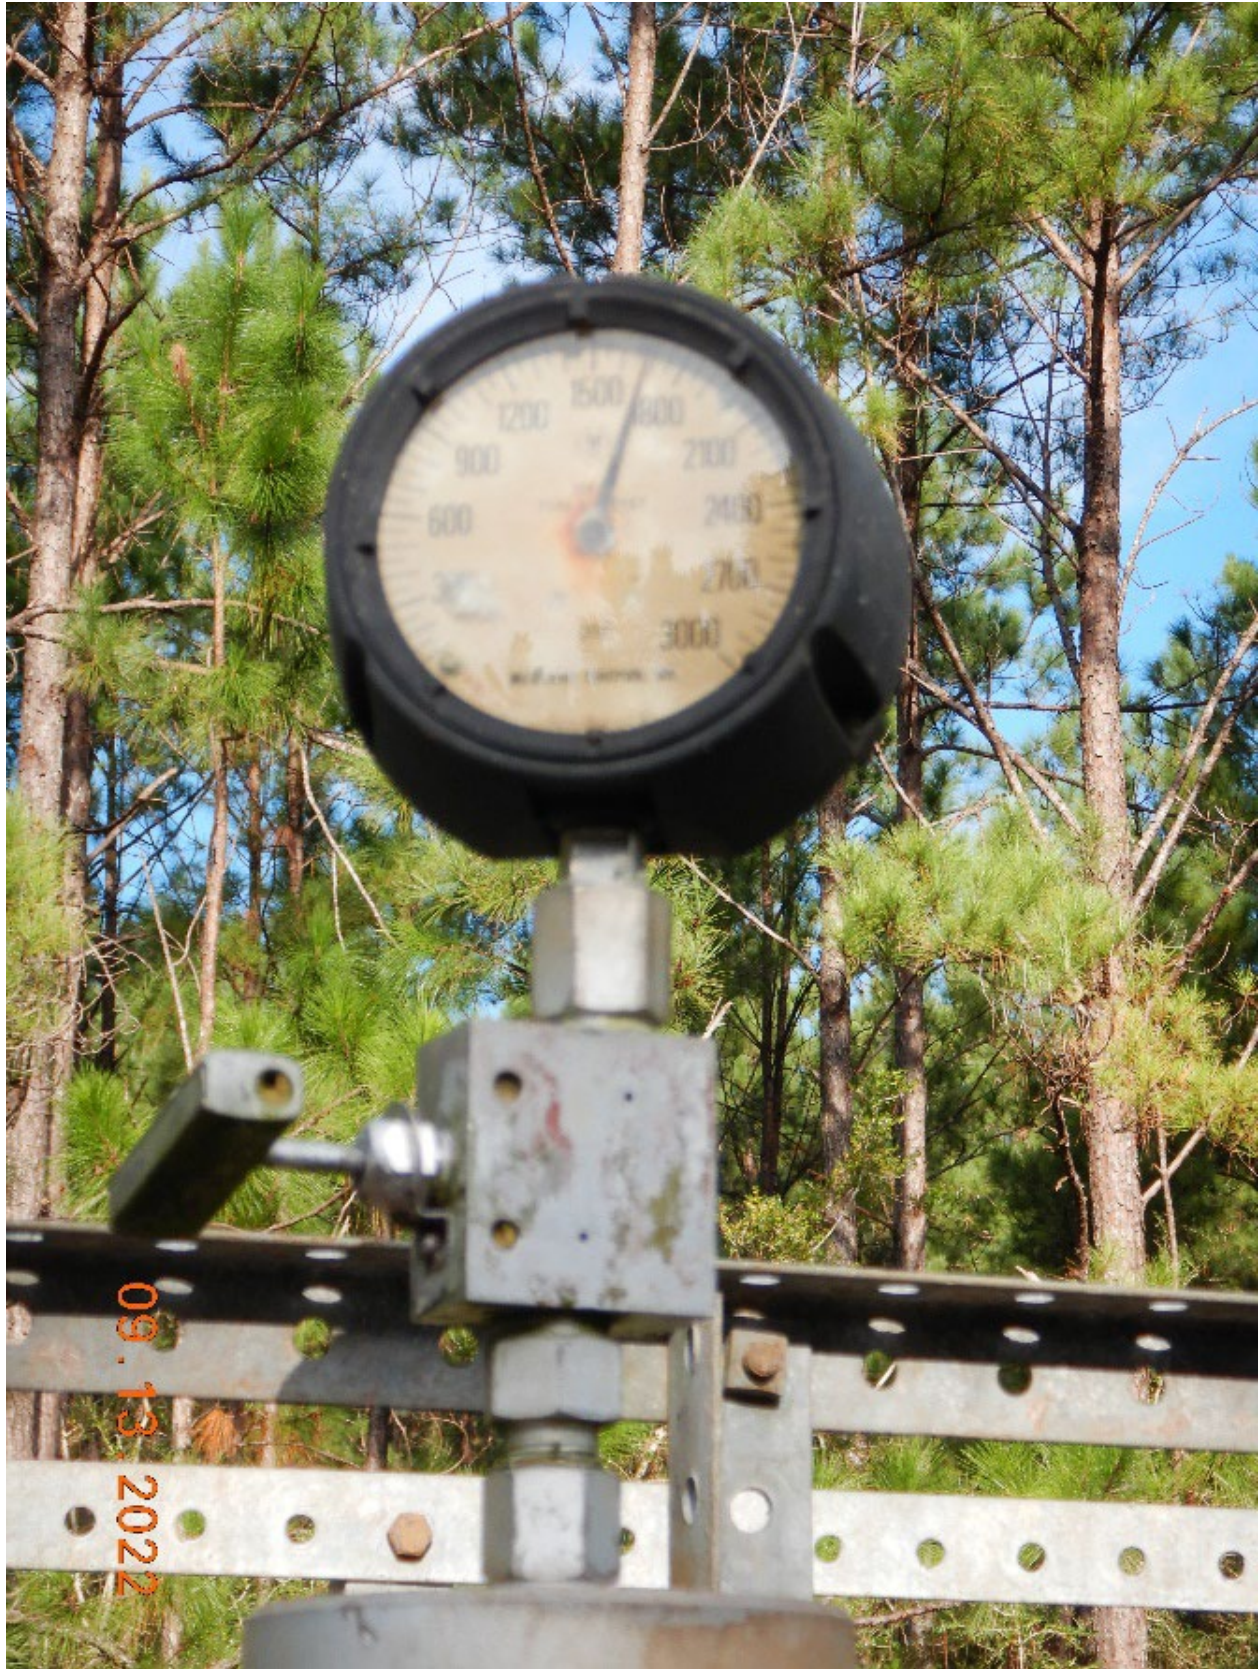
Description: *Looking west, closeup view of internal pressure gauge reading 1,680 psi.* \_\_\_\_\_

**Photograph 4:** Looking west, closeup view of internal pressure gauge reading 1,680 psi.

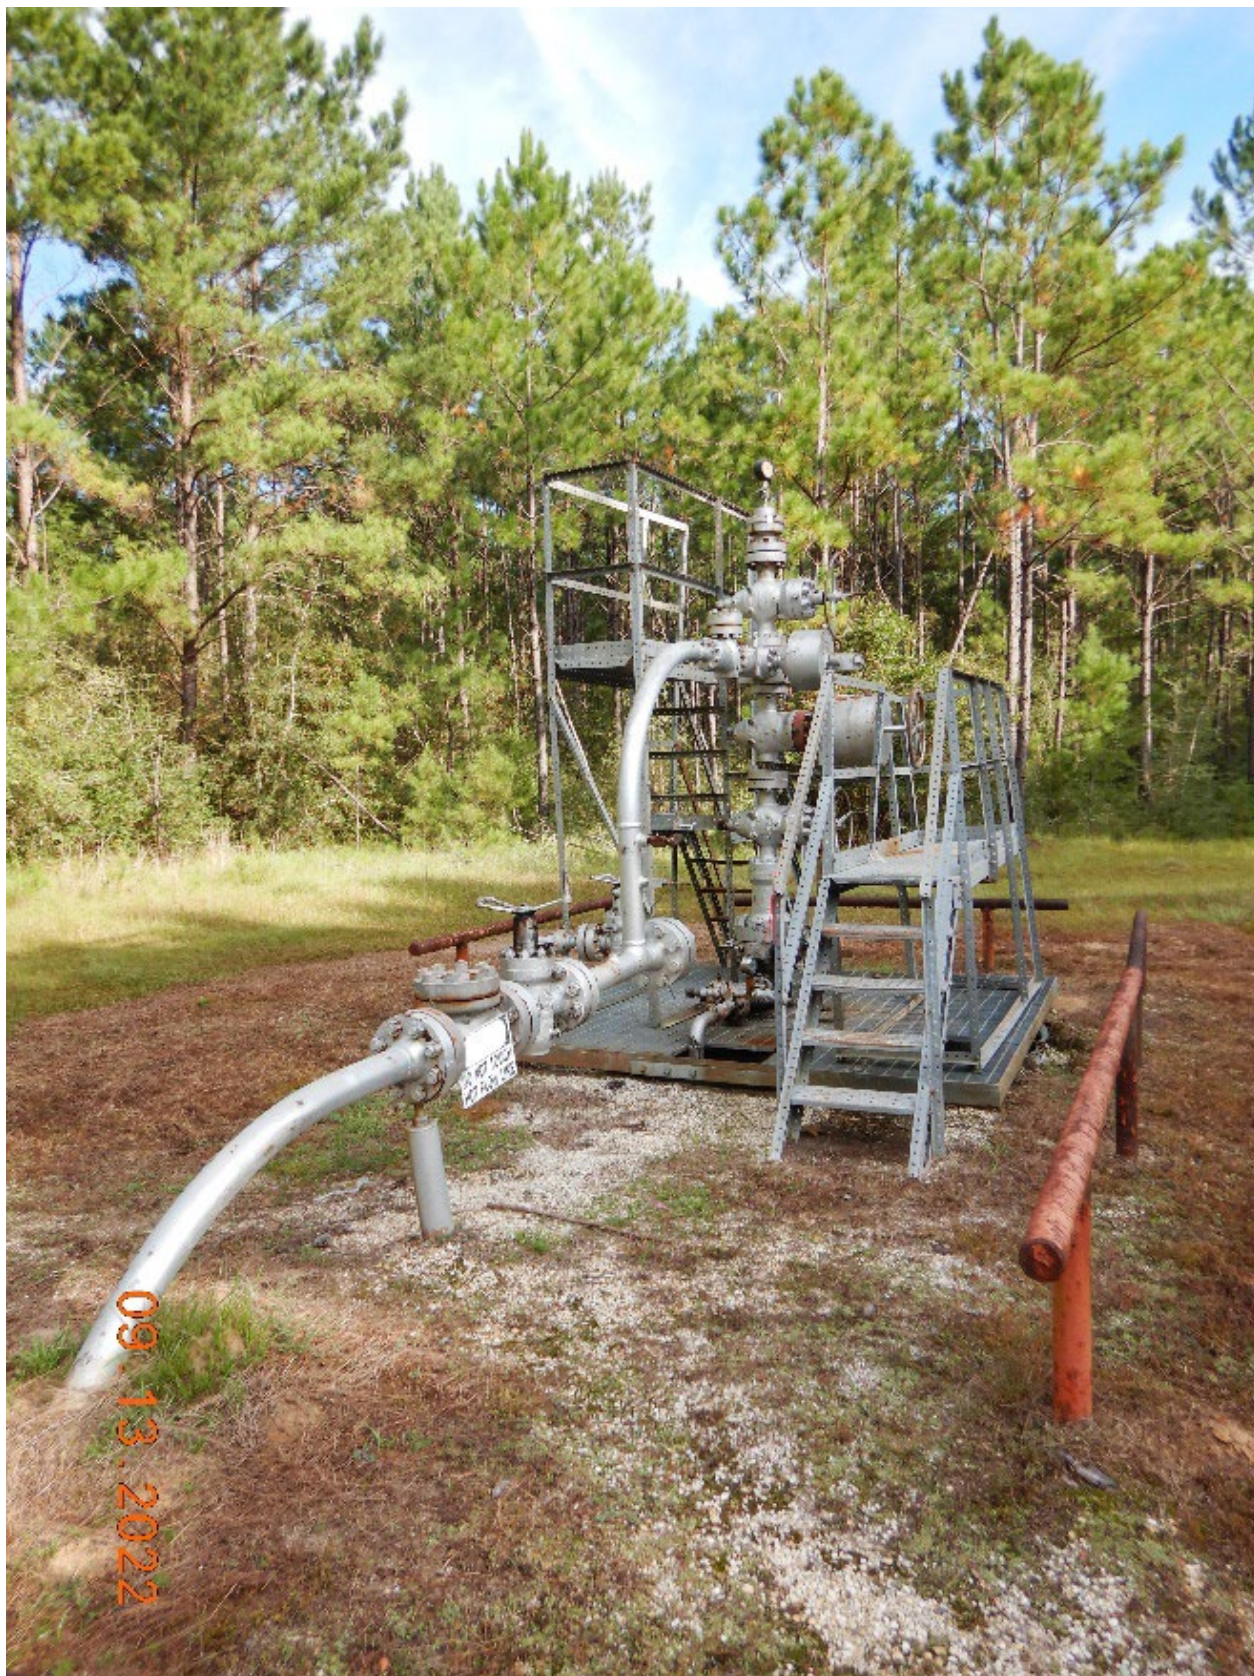
Description: *Looking north, site overview including well head, pressure gauges, valves, and access stairs.* \_\_\_\_\_

**Photograph 5:** Looking north, site overview including well head, pressure gauges, valves, and access stairs.

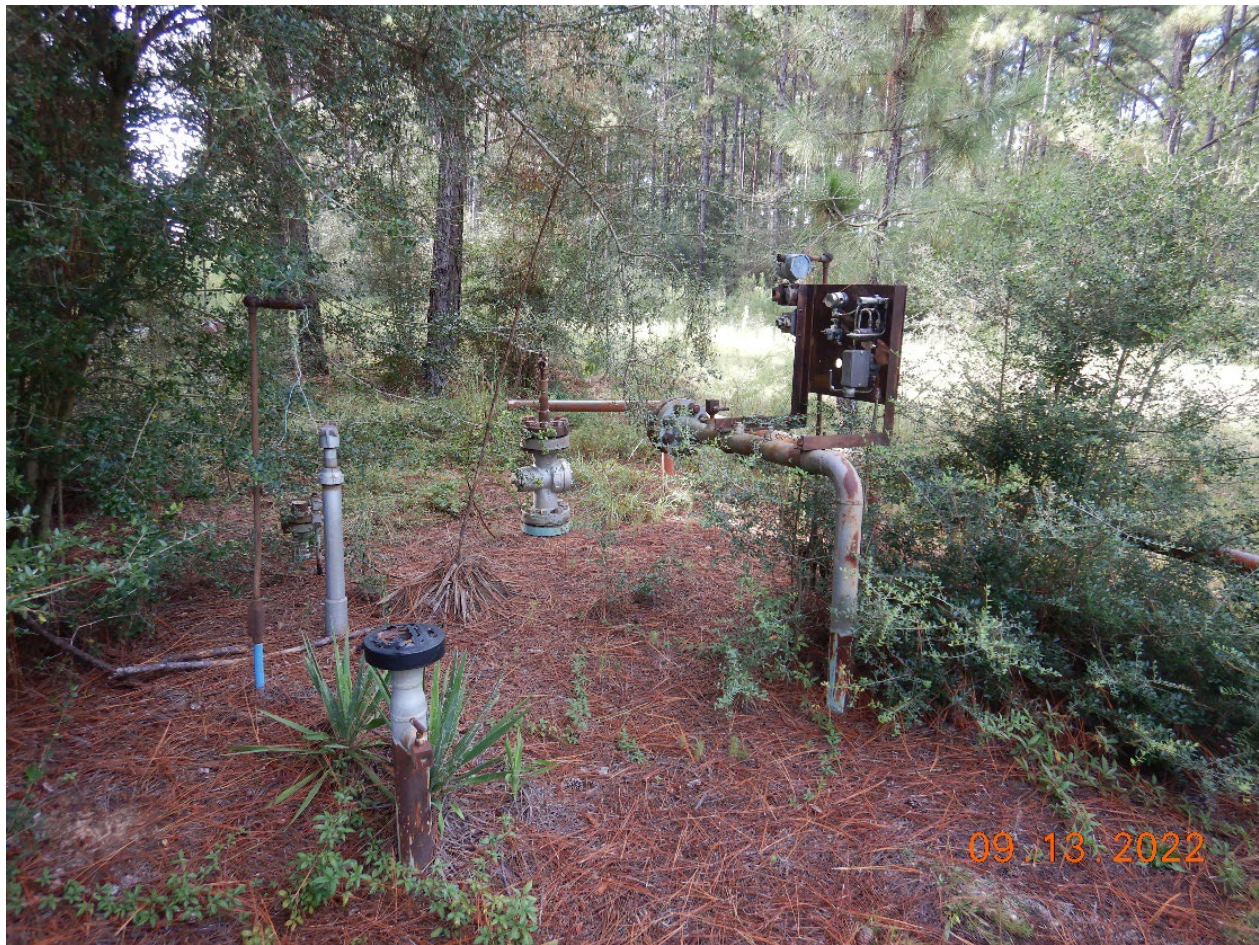
Description: *Looking east, view of pressure relief system formerly attached to well, which used to convey unused nitrogen back to the Black Creek gas plant. It is disconnected and sealed off.* \_\_\_\_\_

**Photograph 6:** Looking east, view of pressure relief system formerly attached to well, which used to convey unused nitrogen back to the Black Creek gas plant. It is disconnected and sealed off.
