## **RCRA Inspection Report**

Jackson Plating Company  
228 West Lorenz Boulevard  
Jackson, Mississippi 39213  
Hinds County

EPA ID No.: MSD008181562

October 21, 2021, at 9:00 a.m.

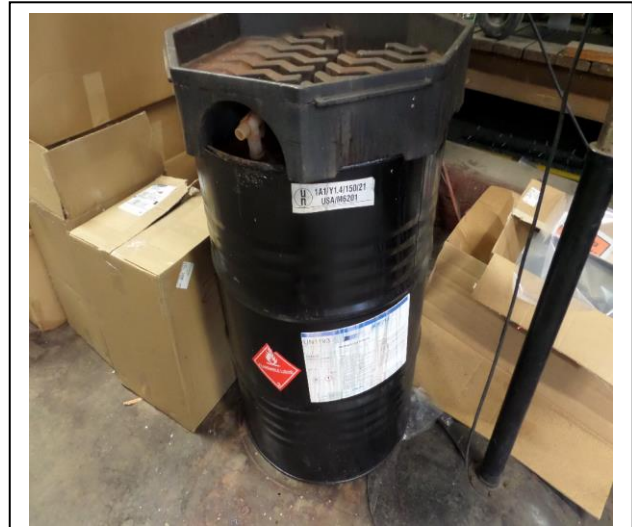
The inspectors observed two 20-gallon part washers containing methyl ethyl ketone (MEK) in this area next to the wall. The MEK is used to clean the aluminium part. Inspectors observed four 55-gallon containers next to the anodizing line accumulating waste MEK generated from the part washers. Mr. Mike Dixon who works in this area indicated that each 55-gallon container was accumulating a different amount of waste MEK. The inspectors observed waste MEK was not being added or removed from the containers and the containers were not kept closed. The inspectors also observed the containers were not labeled or marked with the words hazardous waste and the containers were not labeled or marked with a date. The containers were labeled with a hazard indicator (Photographs 1 through 7). The inspectors ask Mr. Barr and Mr. Johnathan Slawson to determine the amount of waste MEK in each 55-gallon container and would return after inspecting the other areas of the facility.

JPC. Anodizing Room. Anodizing Room. Inspectors observed a 55-gallon container near the Anodizing Line accumulating waste MEK. The container was not closed and not labeled/marked with the words hazardous waste. Photograph 2 taken at 11:02 a.m.

The inspectors return to this area and Mr. Johnathan Slawson who works in the maintenance department indicated that three 55-gallon containers were accumulating waste MEK at the time of the inspection. The facility consolidated the waste MEK from three 55-gallon containers into two 55-gallon containers (one was full the other was three-quarters full). The containers were transferred to the Tool Room's 90-Day Accumulation Area.

**Pursuant to 11 Miss. Admin. Code Pt. 3, R. 1.3 [40 C.F.R. § 262.15(a)(4)], which is a condition of the SAA Permit Exemption, a generator is required to keep containers of hazardous waste closed at all times during accumulation, except when adding, removing, or consolidating waste; or when temporary venting of a container is necessary for the proper operation of equipment, or to prevent dangerous situations, such as build-up of extreme pressure.**

**Pursuant to 11 Miss. Admin. Code Pt. 3, R. 1.3 [40 C.F.R. § 262.15(a)(5)(i)], which is a condition of the SAA Permit Exemption, a generator is required to mark or label its containers with the words "Hazardous Waste".**

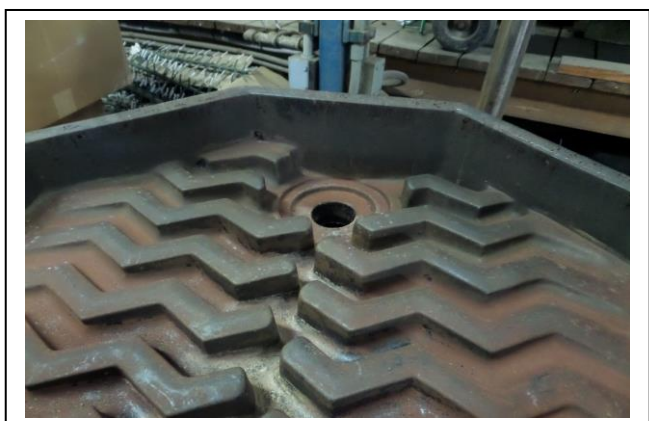
JPC. Anodizing Room. One 55-gallon container, near the Anodizing Line accumulating waste MEK, was not closed and not marked with the words hazardous waste. Photograph 3 taken at 11:02 a.m.

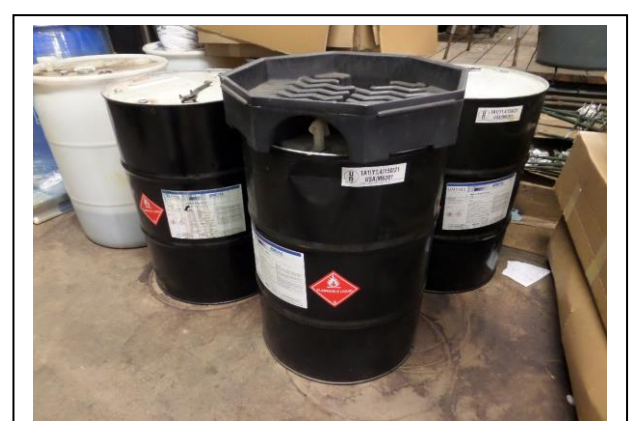
JPC. Anodizing Room. Inspectors observed four 55-gallon containers near the Anodizing Line. One 55-gallon container appeared to be accumulating waste MEK. The container was not closed and not labeled/marked with the words hazardous waste. Photograph 4 taken at 11:03 a.m.

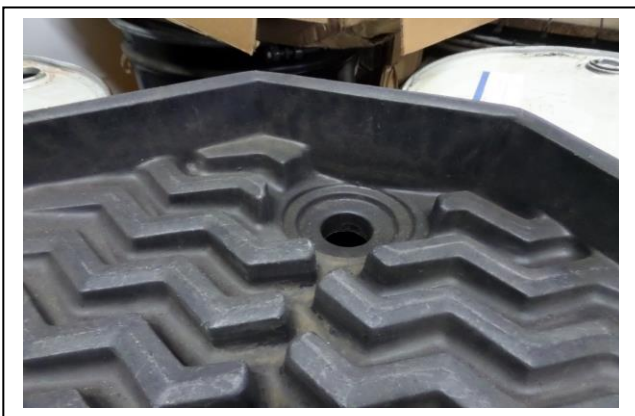
JPC. Anodizing Room. Inspectors observed four 55-gallon containers near the Anodizing Line. One 55-gallon container appeared to be accumulating waste MEK. The container was not closed and not labeled/marked with the words hazardous waste. Photograph 5 taken at 11:03

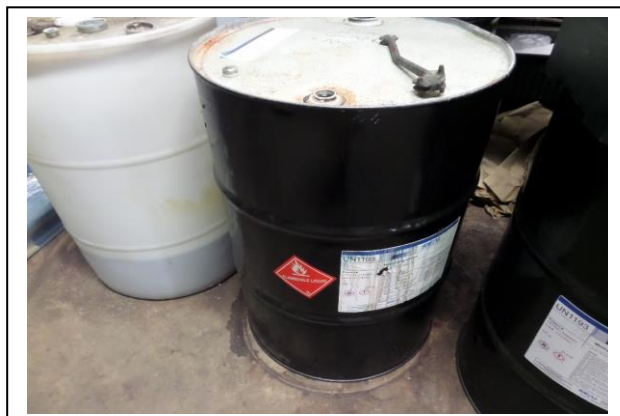
JPC. Anodizing Room. Inspectors observed four 55-gallon containers near the Anodizing Line. One 55-gallon container appeared to be accumulating waste MEK. The container was not closed and not labeled/marked with the words hazardous waste. Photograph 6 taken at 11:03 a.m.

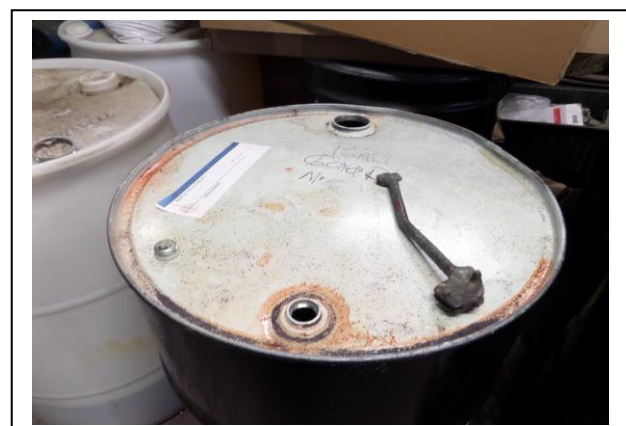
JPC. Anodizing Room. Inspectors observed four 55-gallon containers near the Anodizing Line. One 55-gallon container appeared to be accumulating waste MEK. The container was not closed and not labeled/marked with the words hazardous waste. Photograph 7 taken at 11:03 a.m.

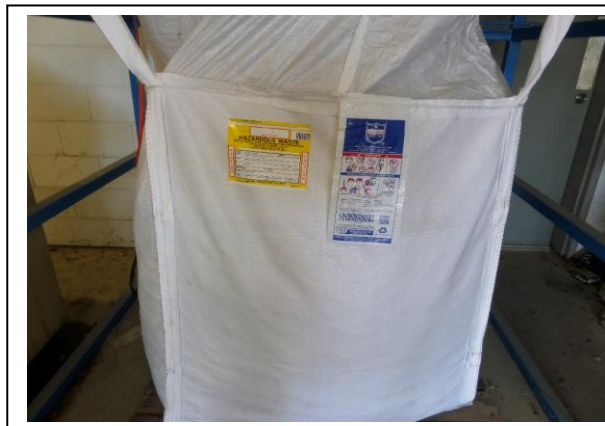
The 90-Day or Less Accumulation Area (90-Day Area) is in the Tool Room. The inspectors observed a one cubic yard container on a pallet accumulating hazardous waste filter cake (D006, F006). The inspectors observed the container was connected to a chute and position under an open hopper. The inspectors observed the container was in good condition, labeled with the words hazardous waste, labeled with a hazard indicator, marked with the word "toxic", and marked with the date October 6, 2021 (Photographs 8, 9, and 11).

JPC. Tool Room 90-Day Area. Inspectors observed a one-cubic yard container accumulating of F006 filter cake. The hopper above the container was not closed. Photograph 8 taken at 11:18 a.m.

**Pursuant to 11 Miss. Admin. Code Pt. 3, R. 1.3 [40 C.F.R. § 262.17(a)(1)(iv)(A)], which is a condition of the LQG Permit Exemption, a container holding hazardous waste must always be closed during accumulation, except when it is necessary to add or remove waste.**

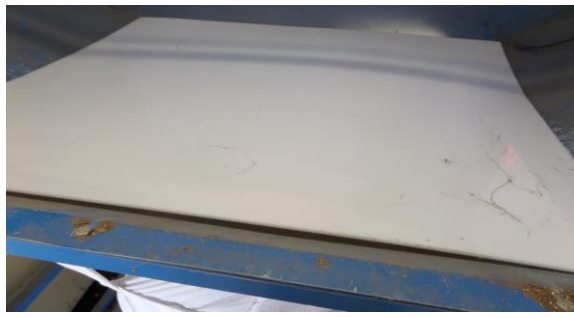
JPC. Tool Room 90-Day Area. Inspectors observed a one-cubic yard container accumulating of F006 filter cake. The hopper above the container was not closed. The facility closed the top of the hopper. Photograph 9 taken at 11:23 a.m.

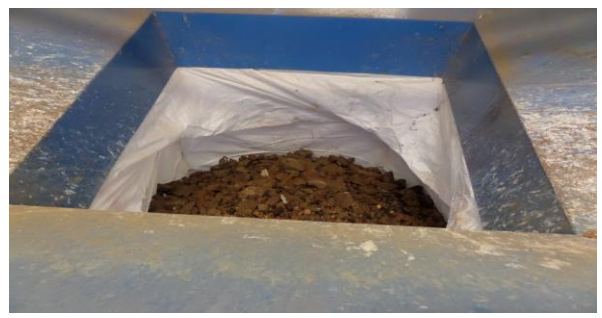
The plate and frame press generates hazardous waste filter cake from the WWTF. Inspectors observed a 134-gallon portable metal collection hopper positioned under the plate and frame press. Hazardous waste filter cake is initially accumulated in the hopper and transferred to a one-cubic yard container in the 90-Day or Less Accumulation Area. The inspectors observed the hopper was empty (Photograph 10).

JPC. Tool Room 90-Day Area. Inspectors observed a one-cubic yard container accumulating of F006 filter cake. The hopper above the container was not closed. Photograph 10 taken at 11:23 a.m.

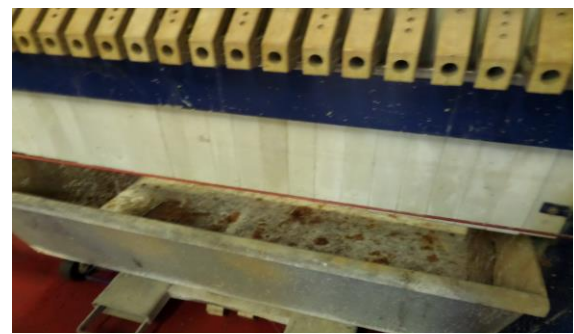
JPC. Tool Room 90-Day Area. Inspectors observed a 134-gallon portable metal collection hopper positioned under the plate and frame press. The hopper was empty. Photograph 11 taken at 11:23 a.m.

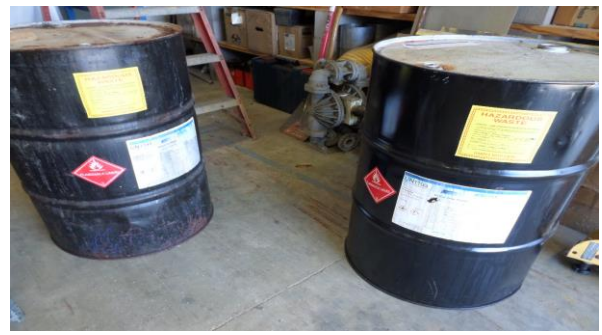
The inspectors observed the two 55-gallon containers accumulating waste MEK were transferred from the Anodizing Room to the 90-Day Area. The containers were closed, in good condition, labeled with the words hazardous waste, labeled with a hazard indicator, and marked with the date October 21, 2021 (Photographs 12, 13, and 14).

JPC. Tool Room 90-Day Area. Inspectors observed the containers of waste MEK were closed, in good condition, labeled with the words hazardous waste, labeled with a hazard indicator and marked with the date October 21, 2021. Photograph 12 taken at 12:58 p.m.

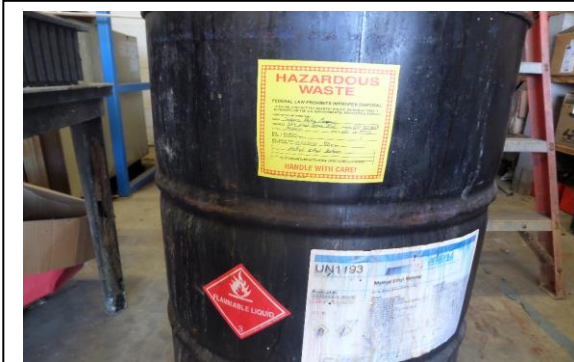
JPC. Tool Room 90-Day Area. Inspectors observed the containers of waste MEK were closed, in good condition, labeled with the words hazardous waste, labeled with a hazard indicator and marked with the date October 21, 2021. Photograph 13 taken at 12:58 p.m.

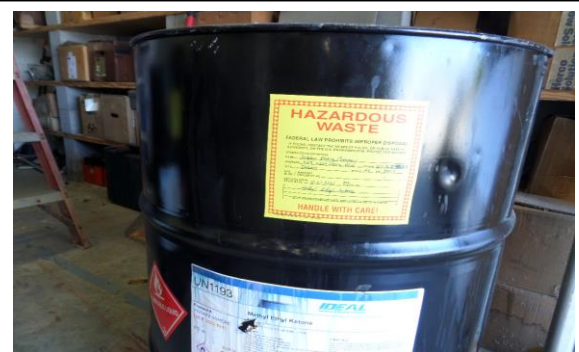
JPC. Tool Room 90-Day Area. Inspectors observed the containers of waste MEK were closed, in good condition, labeled with the words hazardous waste, labeled with a hazard indicator and marked with the date October 21, 2021. Photograph 14 taken at 12:58 p.m.
