## **RCRA Inspection Report**

University of South Alabama  
307 University Boulevard North  
Mobile, Alabama 36688

March 29, 2023

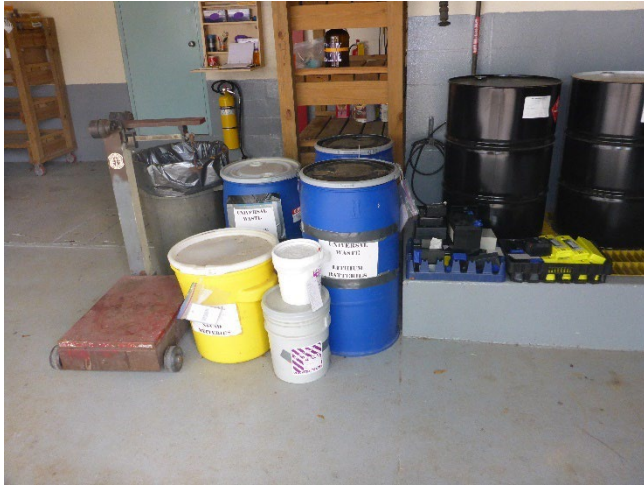
The inspectors also observed one 55-gallon drum labeled used oil; one 20-gallon container labeled universal waste NiCad batteries; one 30-gallon container labeled universal waste alkaline batteries; one 30-gallon container labeled universal waste nickel metal batteries; one 30-gallon container labeled universal waste lithium batteries; one 5-gallon container labeled universal waste odd group of dead batteries; and one 1-gallon container labeled universal waste zinc batteries near the roll-up door and the flammable liquid barrel storage area (Photo 1).

**Photo 1:** One 55-gallon drum labeled used oil; one 20-gallon container labeled universal waste NiCad batteries; one 30-gallon container labeled universal waste alkaline batteries; one 30-gallon container labeled universal waste nickel metal batteries; one 30-gallon container labeled universal waste lithium batteries; one 5-gallon container labeled universal waste odd group of dead batteries; and one 1-gallon container labeled universal waste zinc batteries observed near the roll-up door and the flammable liquid barrel storage area.

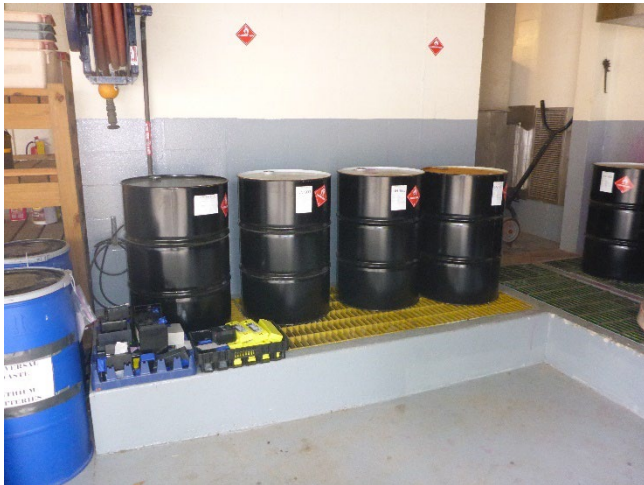
The inspectors observed a total of six 55-gallon drums of waste flammable liquid (xylene, toluene) in the flammable liquid bulking and barrel storage area (Photo 2 and 3). Each of these containers was labeled D001, F003, F005 hazardous waste and identified with a DOT flammable liquid hazard placard, but none were identified with an indication that the contents are also toxic. Each container was also marked with one of the following accumulation start dates: February 2, 2023, February 8, 2023, February 16, 2023, March 2, 2023, March 16, 2023, and March 29, 2023. Anne Foster stated that only organic solvents are consolidated in these 55-gallon drums, and that all chlorinated solvents remain in the original lab containers, which are eventually shipped off-site in lab packs.

**Photo 2:** Four 55-gallon drums of waste flammable liquid (xylene, toluene) in the flammable liquid barrel storage area of the TSD Building.

**Pursuant to RCRA Hazardous Waste Facility Permit ALD079474037, which incorporates ADEM Admin. Code r.335-14-9-.05(1) [40 C.F.R. § 268.50(a)(2)(i)(C)], an owner/operator of a hazardous waste treatment, storage, or disposal facility that stores hazardous waste restricted from land disposal under subpart C of RCRA section 3004 in containers must clearly mark each container to identify its contents with an indication of the hazards of the contents.**

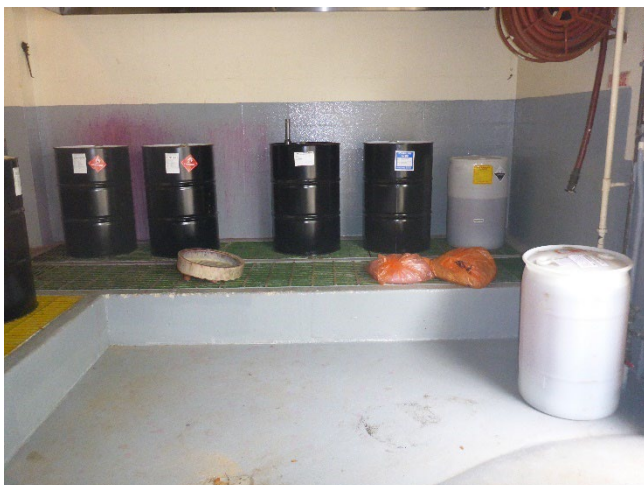
The inspectors also observed one 55-gallon drum labeled nonhazardous waste, one 55-gallon drum labeled nonregulated waste, one 30-gallon drum labeled hazardous waste flammable liquid (formaldehyde, methanol), one 55-gallon drum labeled hazardous waste AEL, and two orange bags of ethidium bromide solution in the flammable liquid barrel storage and bulking area (Photo 3).

- The drum of waste flammable liquid (formaldehyde, methanol) was labeled D001, F003 hazardous waste, identified with a DOT corrosive hazard placard, and dated August 15, 2022. Personnel explained that the contents of the drum meet DOT's definition of a corrosive

material, but do not meet the EPA definition of a hazardous waste exhibiting the characteristic of corrosivity.

- The drum of hazardous waste AEL was identified with the DOT toxic, corrosive, and flammable hazard placards and dated September 19, 2022, but it was not marked with the EPA Hazardous Waste Code.
- Anne Foster explained that the two orange bags contain ethidium bromide solution, and the bags have been set in this area to dry out before they are added to the 55-gallon drum of nonhazardous waste.

**Photo 3:** Two 55-gallon drums of waste flammable liquid (xylene, toluene), one 55-gallon drum of non-hazardous waste, one 55-gallon drum of nonregulated waste, one 30-gallon drum of hazardous waste flammable liquid (formaldehyde, methanol), and two orange bags observed in the flammable liquid barrel bulking area of the TSD Building; and one 55-gallon drum of hazardous waste AEL on the floor next to the bulking area.

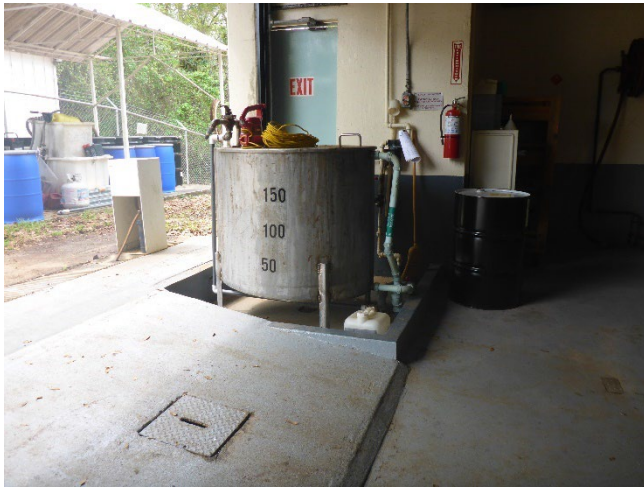
Finally, the inspectors observed the 250-gallon neutralization tank, which was empty at the time of the inspection (Photo 4). Personnel explained that the tank is used approximately once every one or two months. According to the neutralization records, the tank was not used between July 21, 2022, and January 17, 2023. Since then, the tank has been used a total of four times, with the most recent use on March 7, 2023.

**Photo 4:** 250-gallon neutralization tank, which was empty at the time of the inspection.

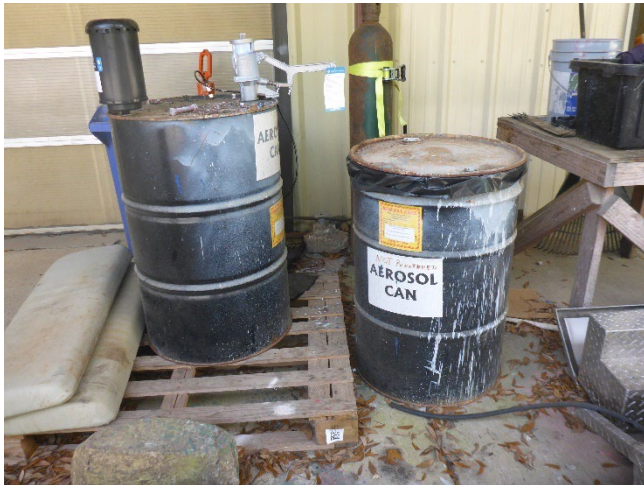
The USA manages one SAA in the Landscaping / Grounds Maintenance Area for managing used aerosol cans and another for managing the contents of punctured aerosol cans. The inspectors observed one 55-gallon drum in each SAA (Photo 5). Each drum was labeled as hazardous waste and marked with an indication that its contents are flammable.

**Photo 5:** One 55-gallon drum of hazardous waste paint related material from puncturing aerosol cans and one 55-gallon drum of hazardous waste aerosol cans in SAAs at the Landscaping/Grounds Maintenance Area.

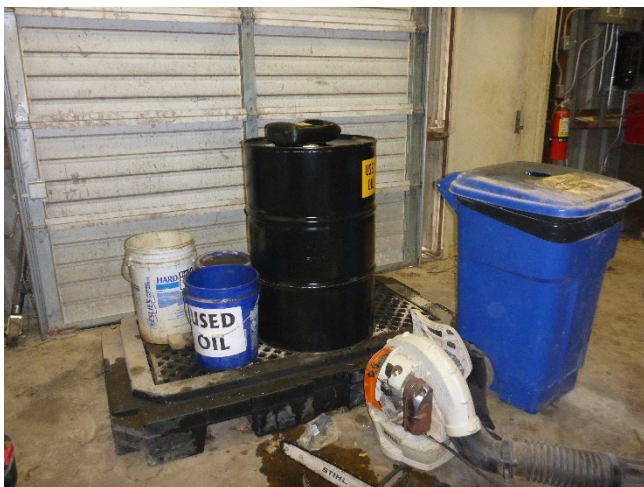
The USA also accumulates used oil and oil contaminated materials in the Landscaping / Grounds Maintenance Area. The inspectors observed a secondary containment pallet holding one 55-gallon drum of used oil, one 5-gallon bucket containing an oil filter and absorbent material, one 10-gallon bucket containing oil contaminated rags and one 3-gallon container of sharpening compound (Photo 6). Next to the containment pallet, the inspectors also observed a trash can containing oil contaminated rags. The 55-gallon drum, 5-gallon bucket, 10-gallon bucket, and trash can were each labeled with the words “used oil”.

**Photo 6:** A secondary containment pallet holding one 55-gallon drum of used oil, one 5-gallon bucket containing an oil filter and absorbent material, one 10-gallon bucket containing oil contaminated rags and one 3-gallon container of sharpening compound observed next to a trash can containing oil contaminated rags in the Landscaping/Grounds Maintenance Area.

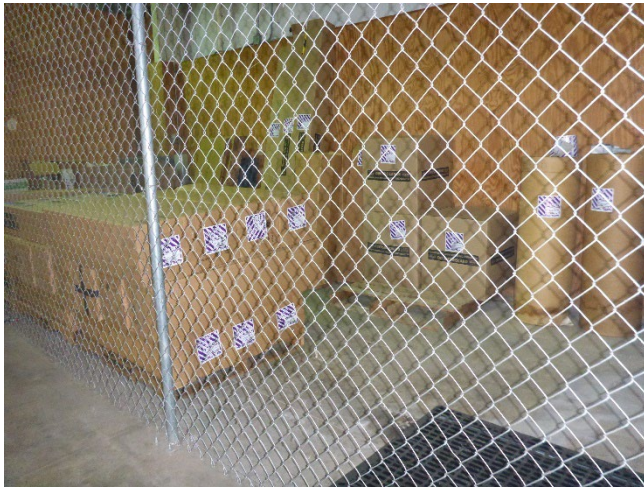
The USA manages universal waste in a caged area within the Maintenance Division (Photo 7). The inspectors observed two 4-foot cylinders; three 2-foot square boxes; three 4-foot boxes; three 8-foot boxes, and three pallets, each containing approximately eighteen 4-foot boxes in this area. Each box was labeled universal waste lamps and marked with an accumulation start date. Facility personnel stated that the USA ships universal waste off-site three or four times each year, and the oldest date observed on any container was April 22, 2022.

**Photo 7:** Two 4-foot cylinders; three 2-foot square boxes; three 4-foot boxes; three 8-foot boxes, and three pallets, each containing approximately eighteen 4-foot boxes observed in the Maintenance Division. Each box was labeled universal waste lamps and marked with an accumulation start date. Facility personnel stated that the USA ships universal waste off-site three or four times each year, and the oldest date observed on any container was April 22, 2022.

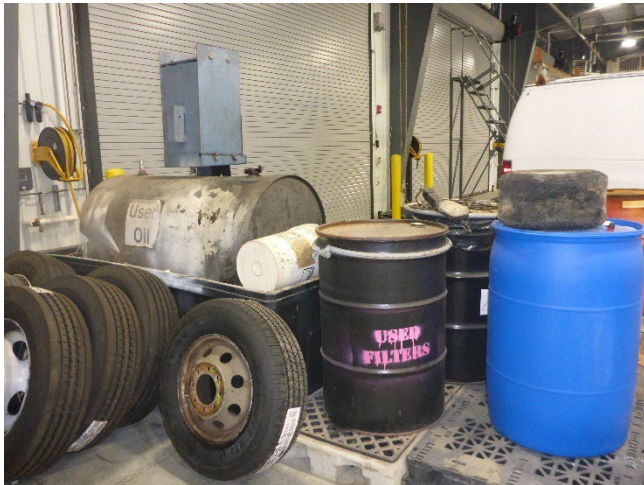
The USA also accumulates used oil and oil contaminated materials at the Transportation Department. The inspectors observed one 200-gallon tank containing used oil, one 55-gallon drum containing used oil filters, and one 55-gallon drum containing oil contaminated rags in this area (Photo 8). The tank was labeled with the words “used oil”.

**Photo 8:** One 200-gallon tank containing used oil, one 55-gallon drum containing used oil filters, and one 55-gallon drum containing oil contaminated rags observed in the Transportation Department. The tank was labeled with the words “used oil”.

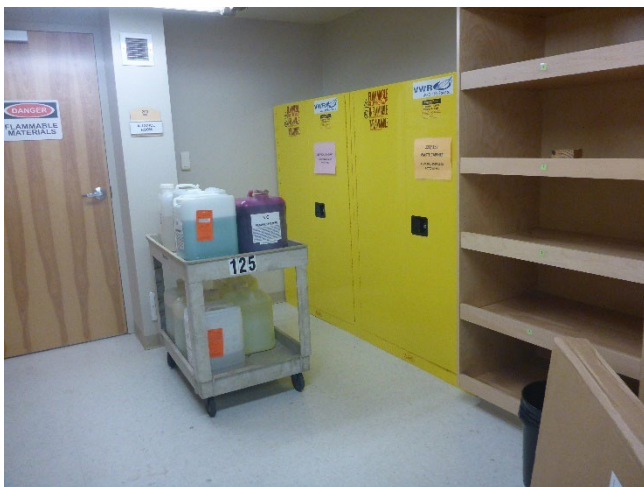
The inspectors also observed the Solvent Room, which contained two flammable cabinets and a mobile cart for holding carboys of hazardous waste (Photo 9). The inspectors observed two one-liter bags of alkaline batteries inside the flammable cabinet, and nine five-gallon carboys on the mobile cart. Each carboy was labeled with the words “hazardous waste” and marked with an indication of the hazards associated with that waste.

**Photo 9:** Nine five-gallon carboys observed on the mobile cart in the Solvent Room. Each carboy was labeled with the words “hazardous waste” and marked with an indication of the hazards associated with that waste.

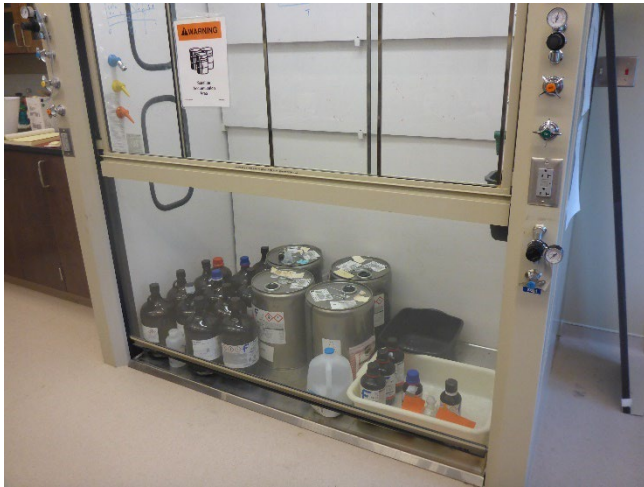
The USA manages one SAA in the Shelby Engineering Building for managing hazardous waste that is generated in the 4310 Green Chemistry Laboratory. The inspectors observed four 5-gallon pails, twelve 2-liter jugs, and about six <½-liter containers in this SAA (Photo 10). The contents of the containers, which were located inside a laboratory hood, included both product and waste materials. Laboratory personnel maintain an active list of the contents under the laboratory hood on an inventory sheet, which was taped to the side of the hood. It appeared that hazardous waste was contained in only three of the smaller containers. Two of the waste containers were

identified with a hazardous waste tag, but the word “hazardous” waste covered by duct tape on one of the waste tags. The third container was not identified with a hazardous waste tag. None of the containers were marked with an indication of the hazards of its contents, and personnel immediately added this information to the hazardous waste tags.

**Photo 10:** Four 5-gallon pails, twelve 2-liter jugs, and about six <math>\frac{1}{2}</math>-liter containers observed in the 4310 Green Chemistry Laboratory SAA. The contents of the containers included both product and waste materials. It appeared that hazardous waste was contained in only three of the smaller containers. Two of the waste containers were identified with a hazardous waste tag, but the word “hazardous” waste covered by duct tape on one of the waste tags. The third container was not identified with a hazardous waste tag. None of the containers were marked with an indication of the hazards of its contents, and personnel immediately added this information to the hazardous waste tags.

**Pursuant to ADEM Admin. Code r.335-14-3-.01(5)(a)5. [40 C.F.R. § 262.15(a)(5)], which is a condition of the SAA Permit Exemption, a generator is required to mark or label its containers with the words “Hazardous Waste” and with an indication of the hazards of the contents.**

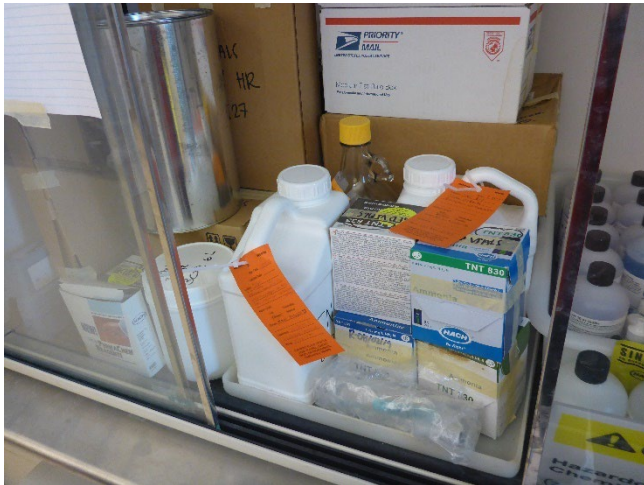
The USA manages another SAA in the Shelby Engineering Building for managing hazardous waste that is generated in the 4311 Environmental Engineering Lab. The inspectors observed two ½-gallon containers of hazardous waste corrosives under a laboratory hood in this area (Photo 11). Each container was closed, labeled with the words “hazardous waste”, and marked with an indication of the hazards of its contents.

**Photo 11:** Two  $\frac{1}{2}$ -gallon containers of hazardous waste corrosives observed under a laboratory hood in the 4311 Environmental Engineering Laboratory SAA. Each container was closed, labeled with the words “hazardous waste”, and marked with an indication of the hazards of its contents.
