## **RCRA Inspection Report**

ECOFLO Incorporated  
2750 Patterson St.  
Greensboro, NC 27407

EPA ID#: NCD980842132  
NAICS #: 562211 - Hazardous waste treatment  
and disposal

March 5, 2025 at 10:00 AM

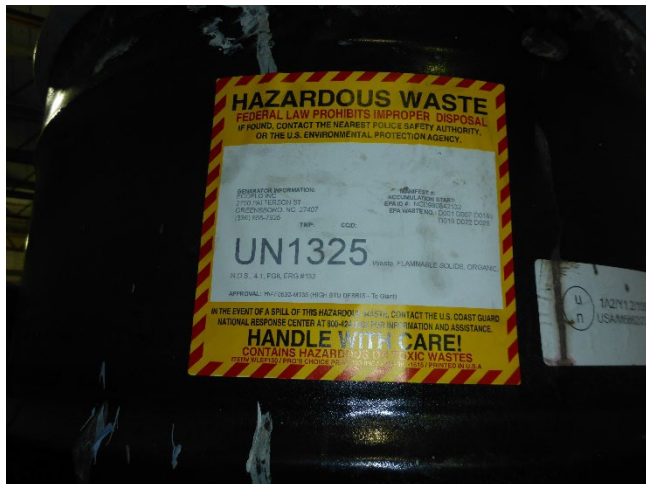
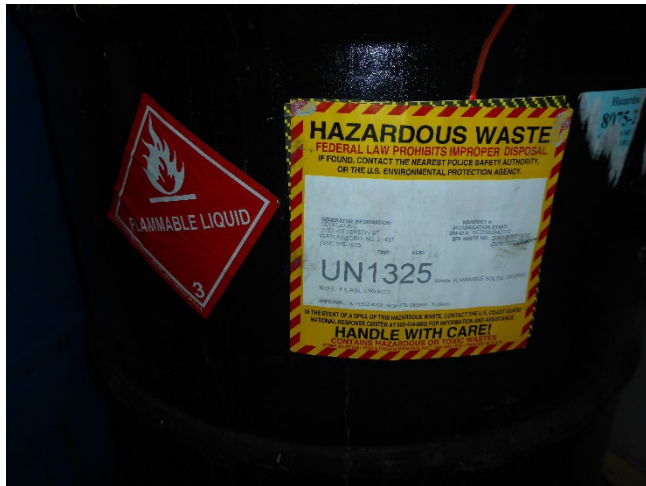
1. Row 8: Two 55- gallon containers of consolidated HHW and hazardous waste, which were each labeled as toxic or hazardous waste and identified as flammable solids, but were not marked with a storage start date (Photos 1 and 2);
2. Row 7: One 55-gallon container of hazardous waste, which was not marked with a storage start date;
3. Row 13: Four 55-gallon containers of hazardous waste, which were not marked with storage start dates;
4. Row 16: One cubic yard box of hazardous waste, which was not marked with a storage start date; and
5. Row 18: One cubic yard box of hazardous waste, which was not marked with a storage start date.

**Photo 1 (P1010539.JPG):** Hazardous waste container label Row 8 Flammable Storage Area.

**Photo 2 (P1010540.JPG):** Hazardous waste container label Row 8 Flammable Storage Area.

**Pursuant to Permit Condition III.C. Management of Containers, the Permittee shall manage containers in accordance with 40 C.F.R. § 264.173 as adopted in 15A NCAC 13A .0109 and as described in Section D-1 of the approved permit application. Specifically, Section D-1(a)(1) of the approved permit application states that containers are marked according to DOT and EPA specifications appropriate to their contents. These markings include the date received.**

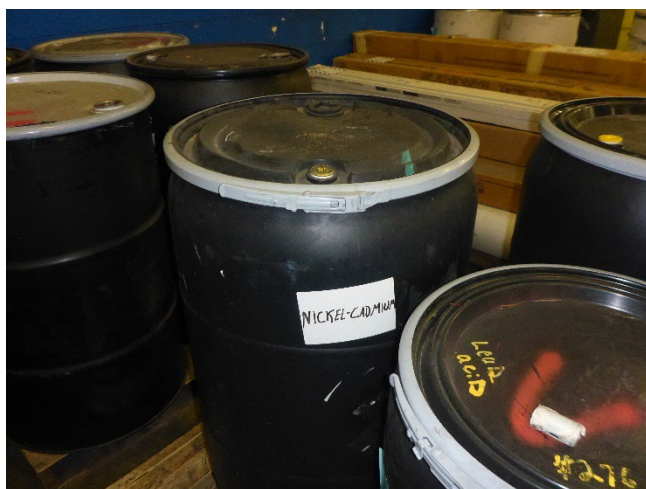
The inspectors also observed used batteries in the universal waste storage area. The inspectors observed one pallet of loose used batteries. The batteries were not label. The inspectors observed one 5-gallon bucket labeled as universal waste batteries and the corresponding battery type; one 15-gallon container and seven 30-gallon containers, dated February 28, 2025 and labeled as universal waste lithium batteries; four 55-gallon containers, dated March 3, 2025 and labeled as universal waste Nickel-Cadmium batteries; three 55-gallon containers, labeled as universal waste lead-acid batteries; and one 30-gallon container, labeled as only “Nickel Cadmium” and not marked with an accumulation start date (Photo 3).

**Photo 3 (P1010541.JPG):** Universal waste battery container labeled as "Nickel-Cadmium" in the Universal Waste Area.

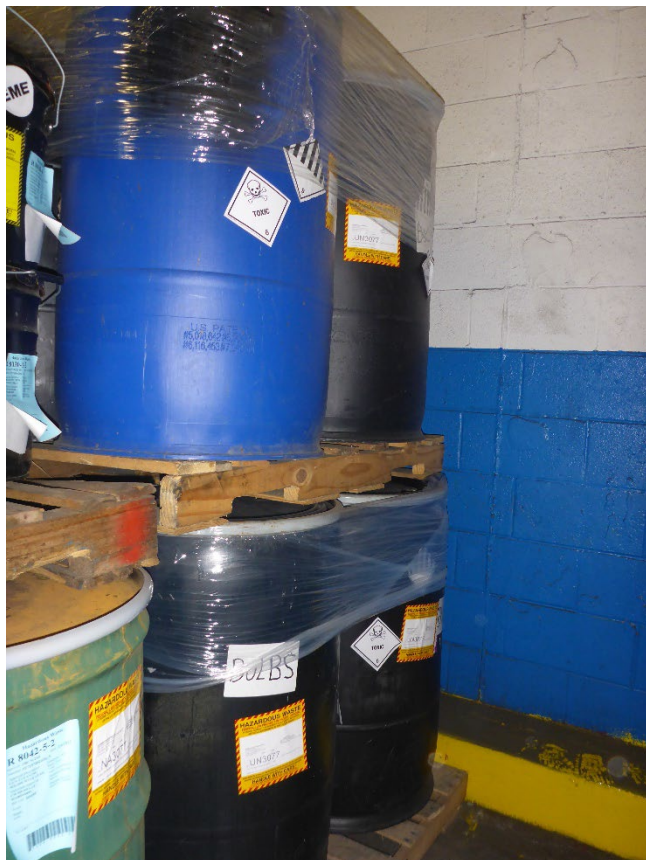
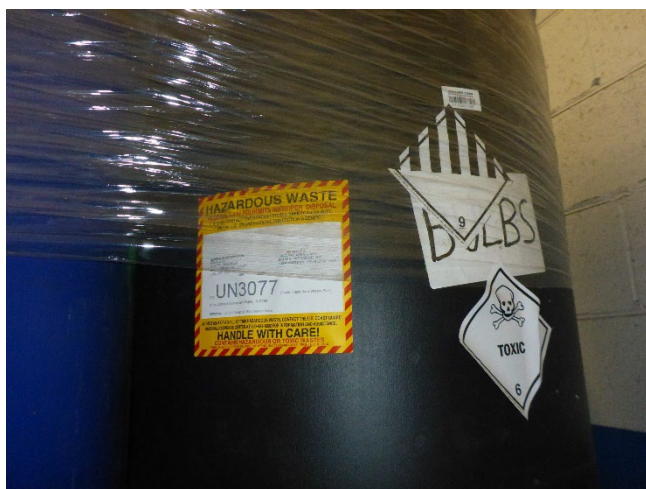
The inspectors observed sixteen 55-gallon containers labeled “Crushed Fluorescent Bulbs,” identified with the hazardous waste code D009, and labeled as toxic (Photos 4 and 5). The containers also were labeled with the words “Bulbs,” “UNIV HHW,” and “Waste, Hazardous Waste Solid.” The generator on the label was listed as ECOFLO. The containers were not marked with an accumulation start date, with an internal tracking label (blue label), or with an

identification number. Six containers contained a manifest ID ending in 7701. Multiple labels with conflicting information on the same container does not clearly and consistently communicate the identity and hazards of the contents of the container.

**Photo 4 (P1010541.JPG):** Hazardous waste contains with crushed mercury containing lamps NHTC/Compatible Storage Area.

**Photo 5 (P1010541.JPG):** Hazardous waste container label, "crushed mercury containing bulbs" NHTC/Compatible Storage Area.

**Pursuant to Permit Condition III. C. Management of Containers, the Permittee shall manage containers in accordance with 40 C.F.R. § 264.173 as adopted in 15A NCAC 13A .0109 and as described in Section D-1 of the approved permit application. Specifically, Section D-1(a)(1) of the approved permit applications states that containers are marked according to DOT and EPA specifications appropriate to their contents. These markings include DOT shipping information; EPA waste codes; date received; and ID number allowing reference to the material characterization form and manifest.**

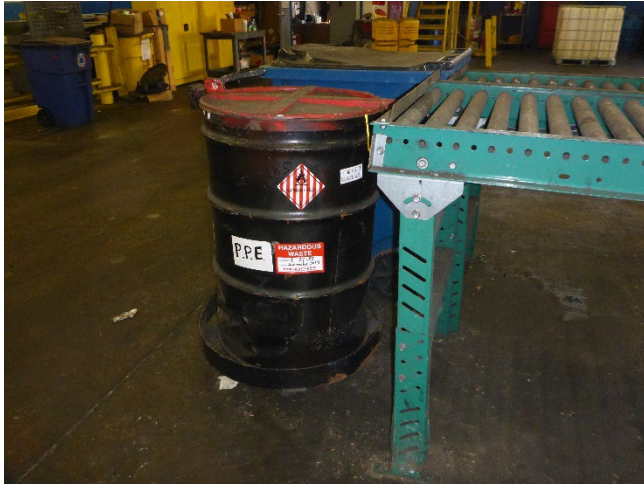
The facility manages a SAA outside the Decant Room for managing hazardous waste PPE that is generated in the processing areas. The inspectors observed one 55-gallon container in this SAA (Photo 6). The container was located in front of the start of the conveyor belt to the Decant Room, and it was equipped with a lid, which was closed. The container was marked as waste flammable solids, hazardous or toxic wastes, and identified as used PPE.

**Photo 6 (P1010541.JPG):** Container in SAA for managing used PPE in front of the Decant Room.

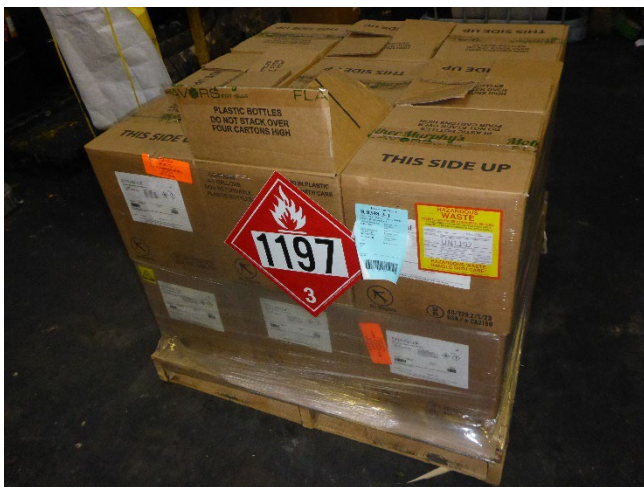
Located adjacent to the flammable pour up area the inspectors observed a pallet of 18 cubic foot cardboard boxes (Photo 8). The boxes were shrink-wrapped together, and identified with a single hazardous waste label, which identified the contents as D001 hazardous waste extracts, flavoring liquid. These containers were being stored and will be handled as part of the flammable pour up waste.

**Photo 8 (P1010541.JPG):** Boxes of hazardous waste waiting for pour up in the Pour Up Area.
