## EPA Region 10 Enforcement Division

### INSPECTION REPORT

| Type of Inspection | CEI - Compliance Evaluation Inspection | | | |
| Company Name | Cellnetix Pathology and Laboratories | | | |

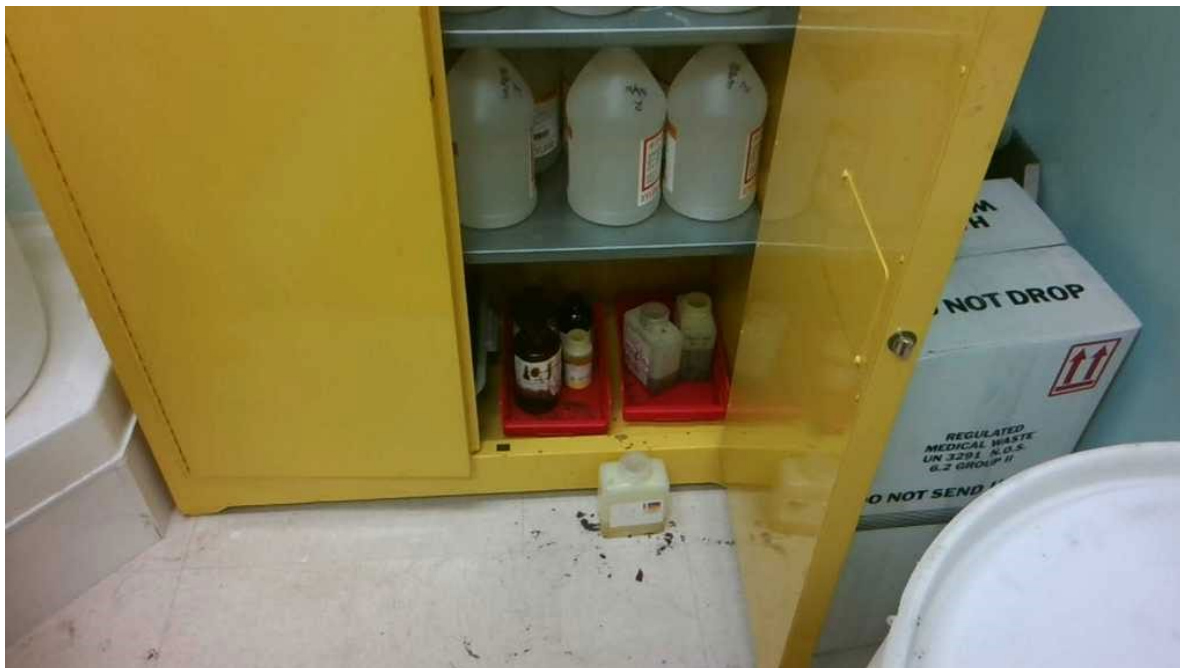
| [Title] | IMG-202208231015371537327507.jpg | |

At the time of the inspection, I saw a yellow flammable storage cabinet that held several quart-size SAA containers of the following lab wastes:

- waste silver (ammoniacal silver)
- waste picric acid
- waste chromic acid
- waste gold chloride

These SAA containers were all labeled with the words hazardous waste and hazard indicators.

| View of yellow flammable storage cabinet that held quart-size SAA containers of waste ammoniacal silver, waste picric acid, waste chromic acid, and waste gold chloride. | | |

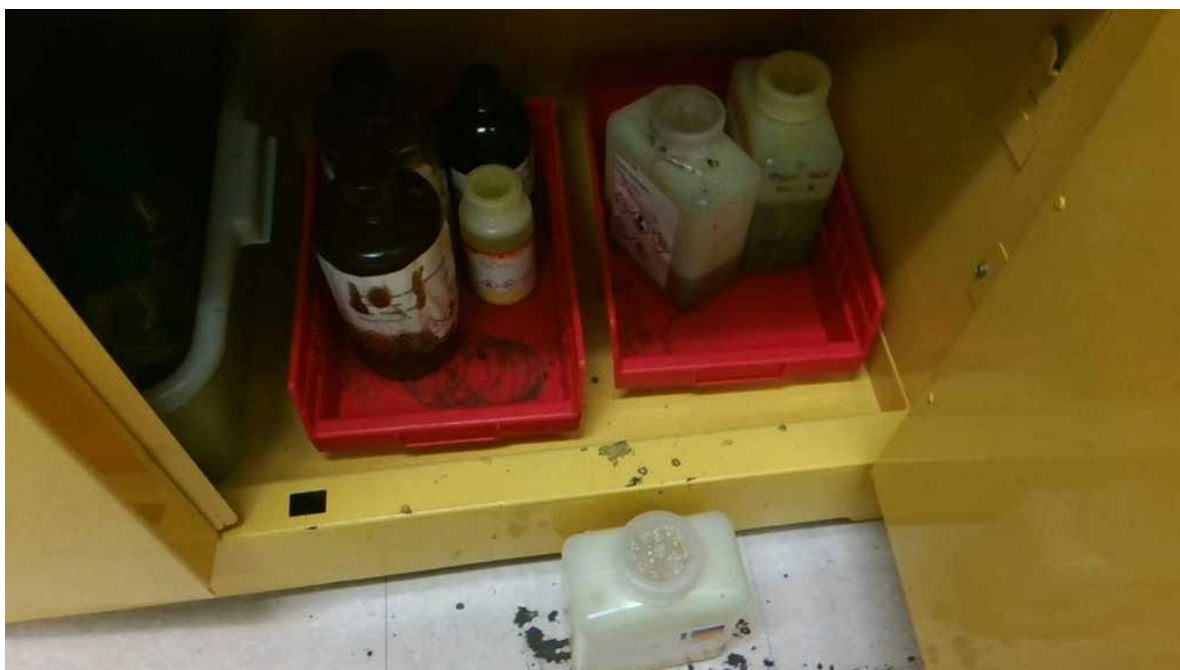
| [Title] | IMG-202208231015471547335149.jpg | |

| Close-up view of the SAA containers. | | |

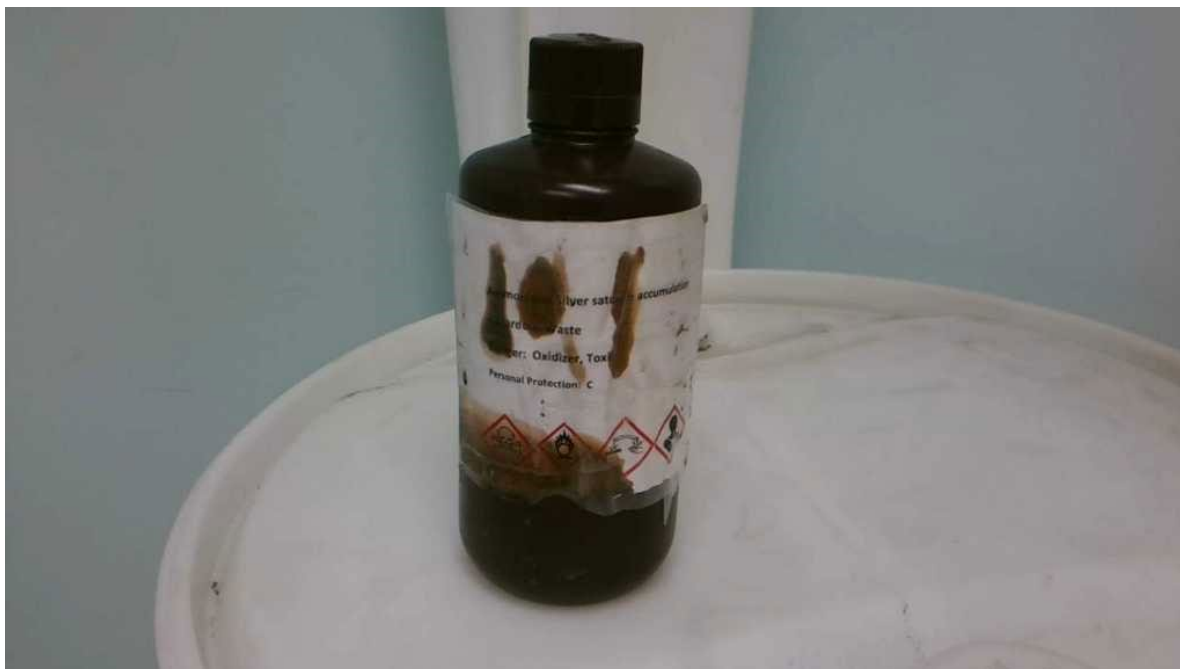
| [Title] | IMG-202208231016311631160153.jpg | |

| Close-up view of the waste ammoniacal silver SAA container. | | |

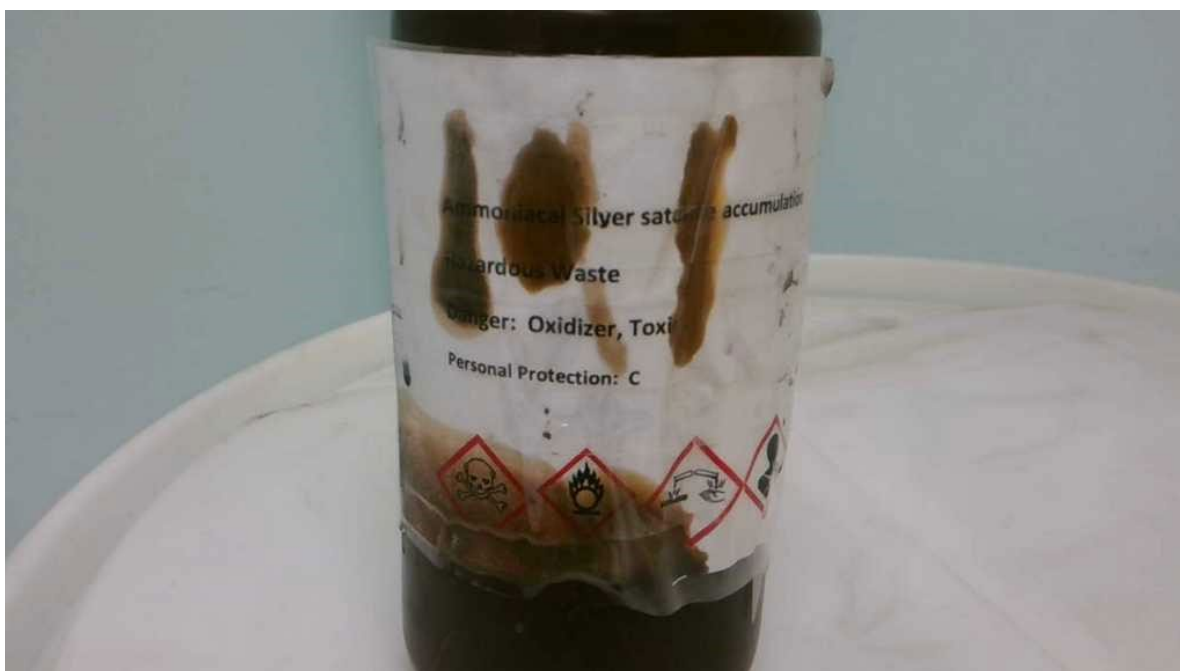
| [Title] | IMG-202208231016361636209404.jpg | |

| Close-up view of the waste ammoniacal silver SAA container. | | |

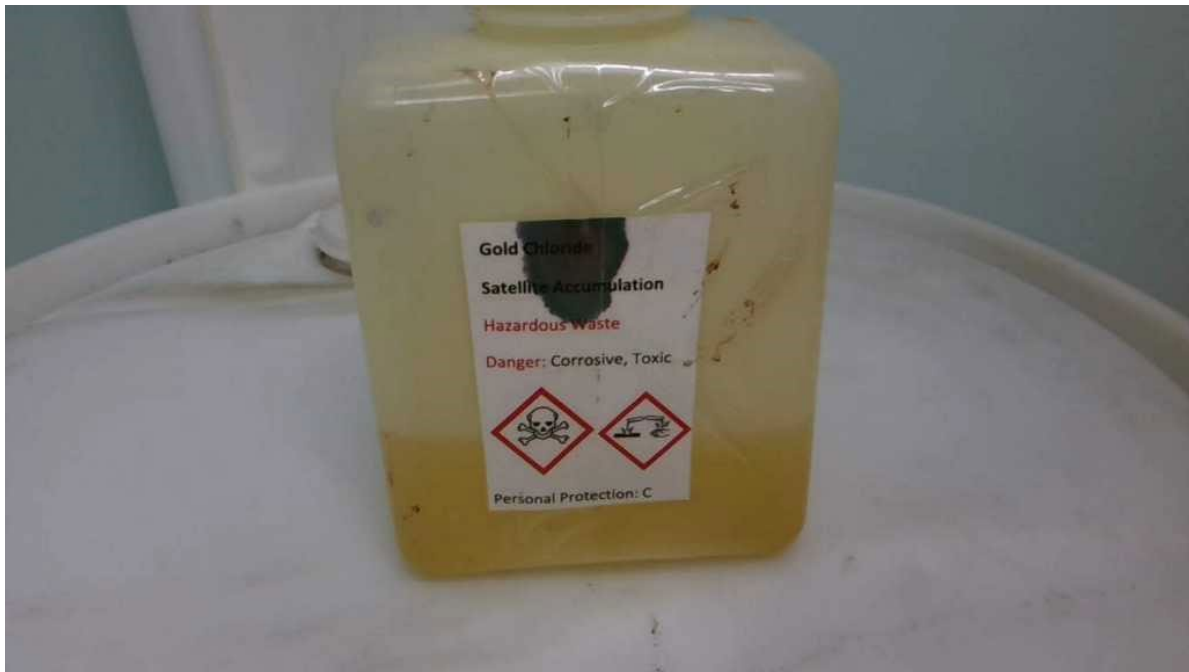
| [Title] | IMG-202208231016501650182052.jpg | |

| Close-up view of the waste gold chloride SAA container. | | |

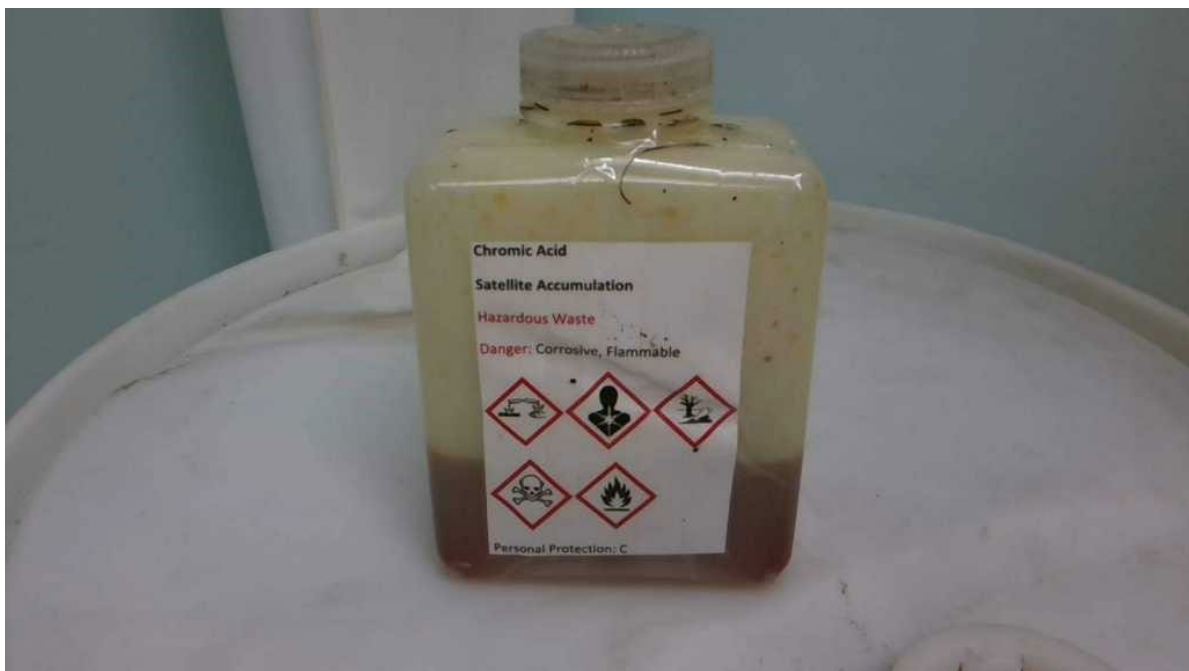
| [Title] | IMG-20220823101705175199327.jpg | |

| Close-up view of the waste chromic acid SAA container. | | |

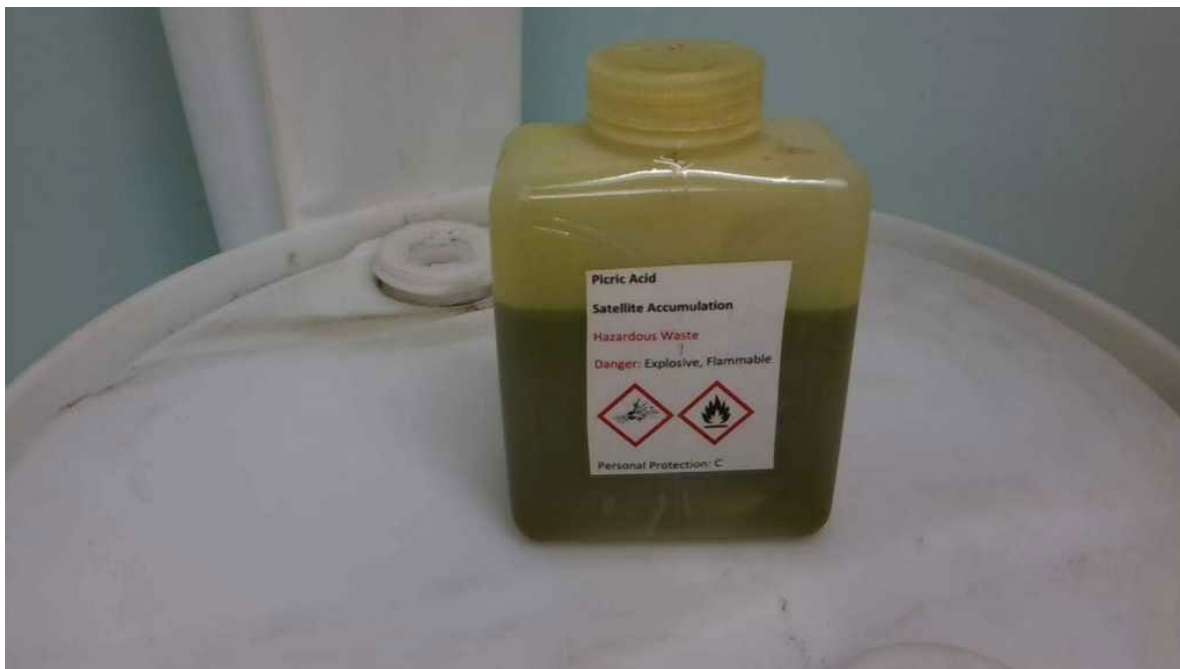
| [Title] | IMG-202208231017221722172090.jpg | |

| Close-up view of the waste picric acid SAA container. | | |

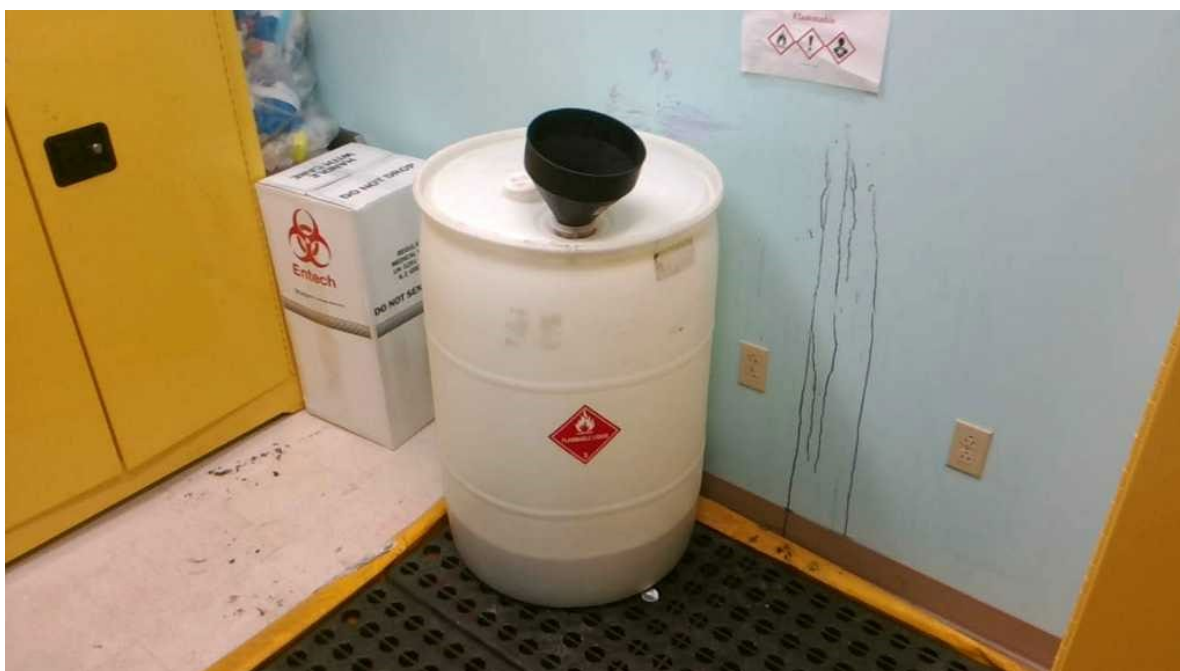
| [Title] | IMG-202208231021432143330157.jpg | |

During the inspection, I saw a 55-gallon SAA container being utilized to accumulate waste solvent (Stains/Reagents). Ms. Mugridge confirmed that the waste solvent in the container was hazardous waste. At the time of the inspection, the container was not labeled with the words "Hazardous Waste." A funnel was in the bung opening so the container was not closed. The container was labeled with a hazard indicator.

| Building: Medical Plaza 1 | Area: Cellnetix Suite 410 | Sub-area: Chemical room |
|---|---|---|
| During the inspection, I saw a 55-gallon SAA container being utilized to accumulate hazardous waste solvent (Stains/Reagents). At the time of the inspection, the container was not labeled with the words "Hazardous Waste" and was not closed. | <b>Citations:</b><br><br>262.15(a)(4), 262.15(a)(5)(i) | <b>Sections:</b> |

| View of 55-gallon container being utilized as a SAA container to accumulate hazardous waste solvent. The container was not labeled with the words "Hazardous Waste" and was not closed. The container was labeled with a hazard indicator. | | |

Ms. Mugridge removed the funnel and screwed the bung back into the bung hole, closing the container, and she also labeled it with the words "Hazardous Waste" while I was present.

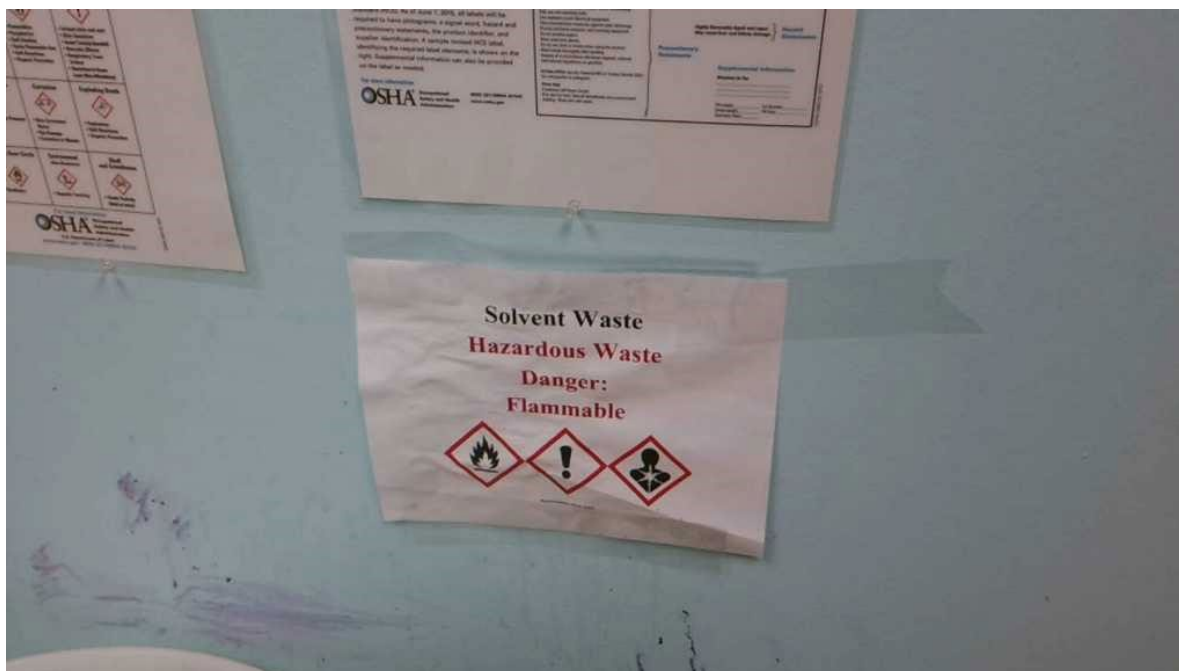
| [Title] | IMG-202208231021532153253777.jpg | |

| View of the signage on wall adjacent to the hazardous waste solvent SAA container. | | |

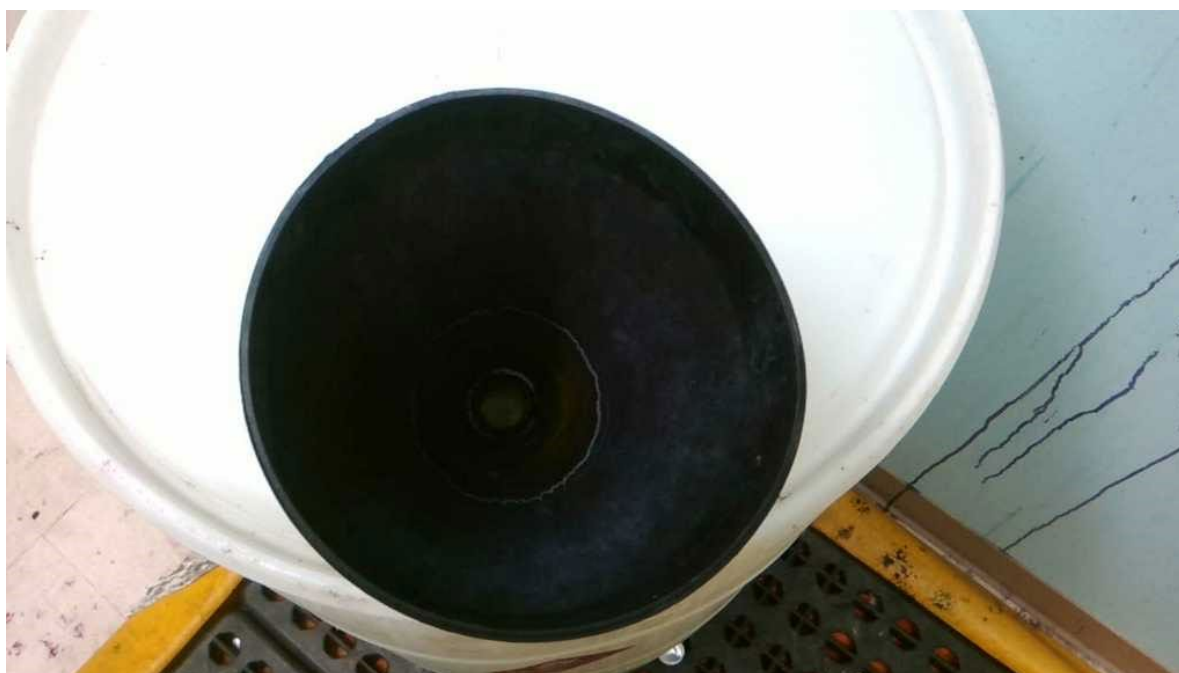
| [Title] | IMG-202208231021582158296444.jpg | |

| View looking down into the funnel, showing that the hazardous waste solvent SAA container was not closed. | | |

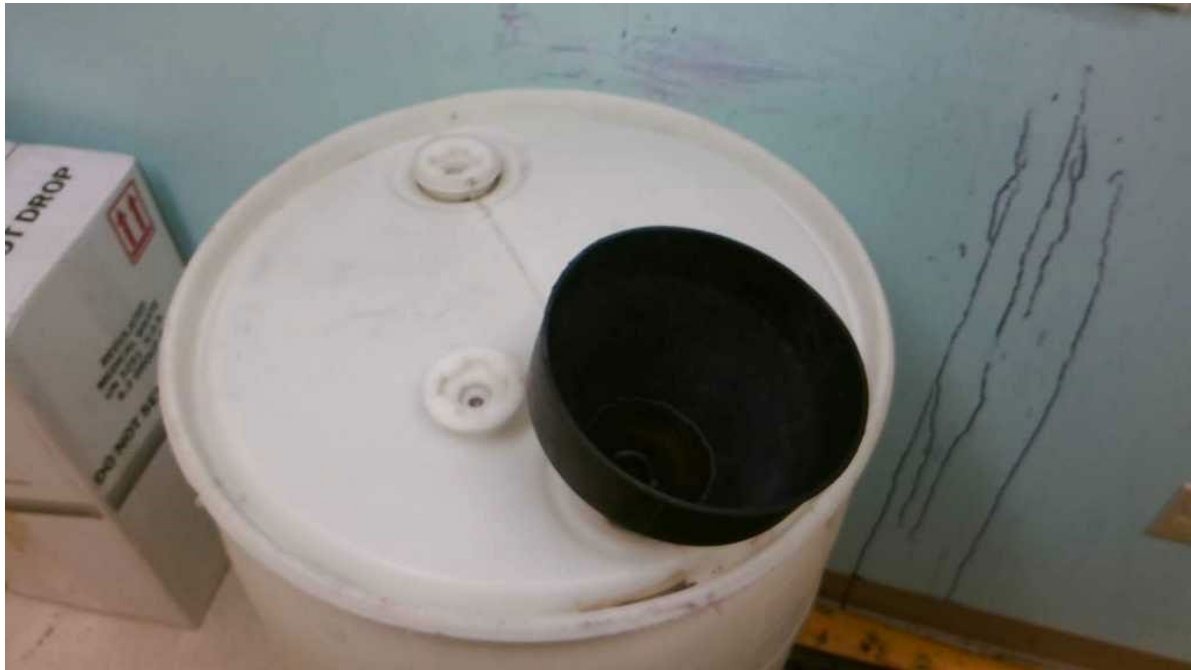
| [Title] | IMG-20220823102206226244563.jpg | |

| View of the funnel, showing that the hazardous waste solvent SAA container was not closed. | | |

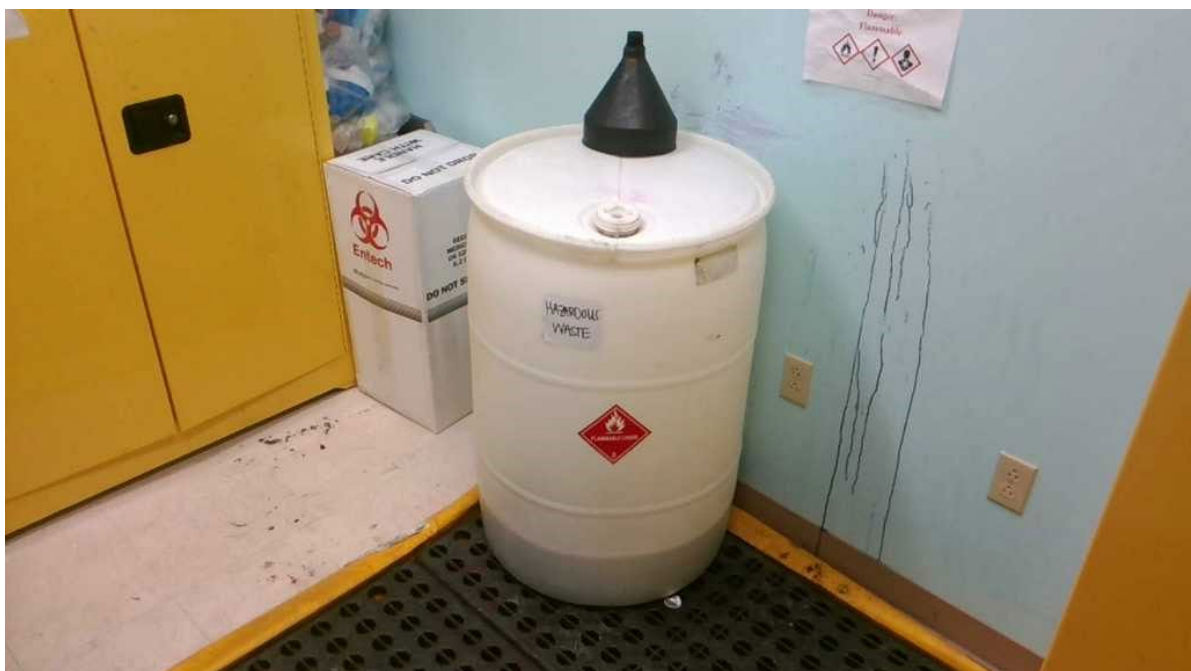
| [Title] | IMG-202208231025442544324256.jpg | |

| View of the hazardous waste solvent SAA container after Ms. Mugridge closed the container and labeled it with the words "Hazardous Waste" during the inspection. | | |

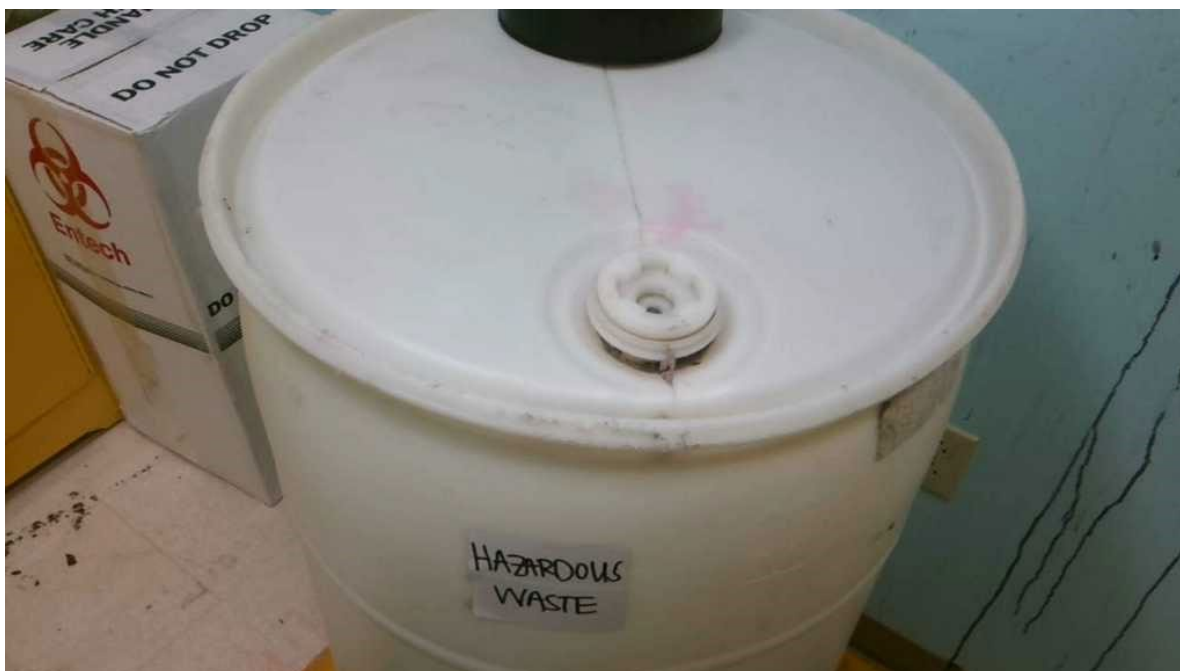
| [Title] | | IMG-202208231025542554264759.jpg | |

| Close-up view after being labeled and closed. | | | |

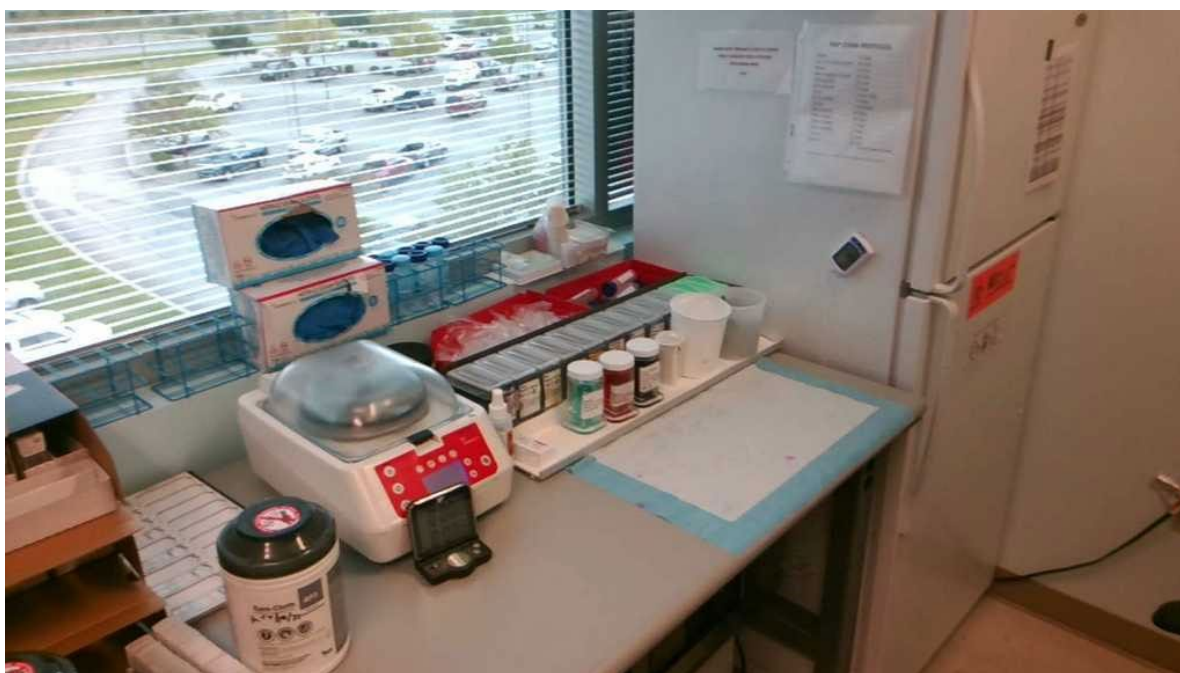
| [Title] | | IMG-202208230956445644519380.jpg | |

| According to Ms. Mugridge, when stains and reagents become dirty the waste stains and reagents (D001) are poured into a one-gallon transfer container. The transfer container is then taken into the Chemical Room and the contents are poured into a 55-gallon satellite accumulation area (SAA) container. | | | |

| View of the stains and reagents that, when dirty, are managed as waste solvent. | | | |

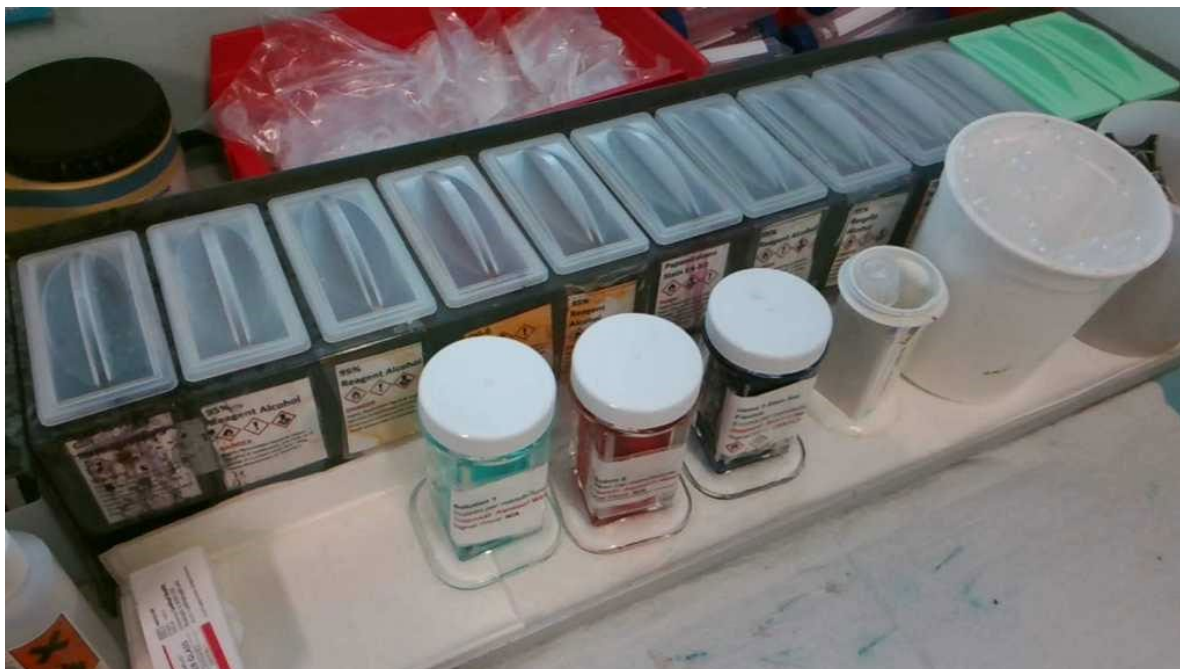
| [Title] | IMG-202208230956535653461377.jpg | |

| Close-up view of the stains and reagents that, when dirty, are managed as waste solvent. | | |

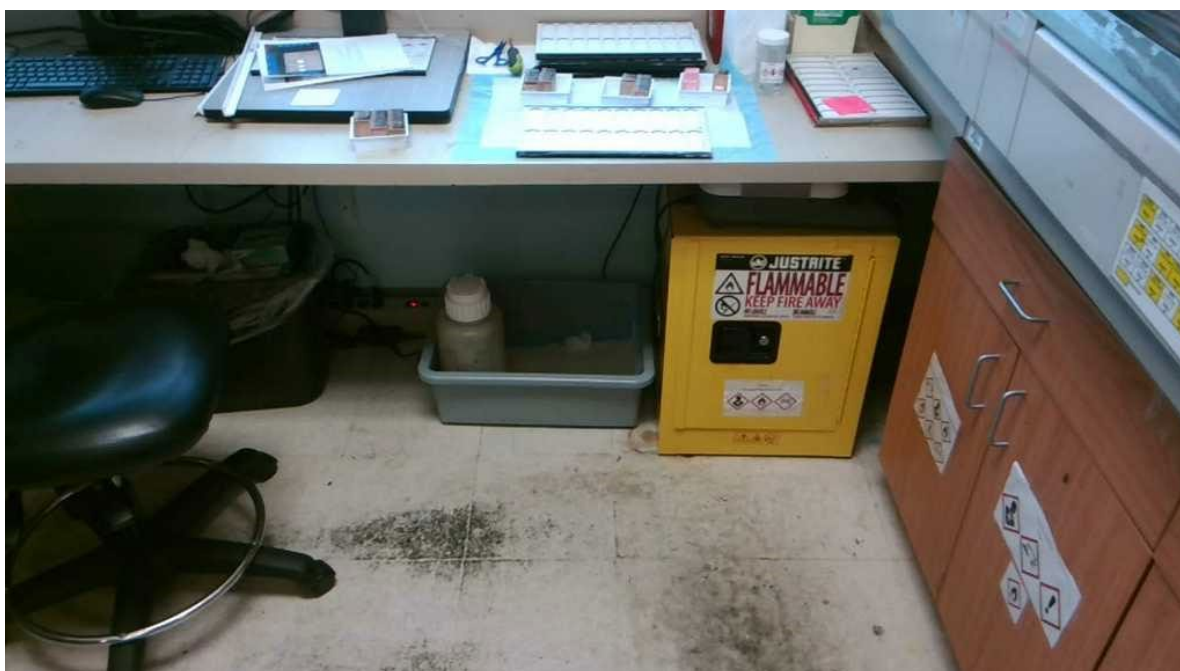
| [Title] | IMG-20220823100136136460203.jpg | |

During the inspection, Ms. Mugridge showed me another area where waste stains and reagents were generated. Ms. Mugridge told me that when they are generated, the waste stains and reagents will be hazardous waste. Adjacent to this area, there was a small plastic tote that held two one-gallon containers. Only one container was present when the photo was taken. At the time of the inspection, these two containers were empty. Ms. Mugridge told me they will be used to collect and then transfer the hazardous waste stain and reagents to an SAA in the Chemical Room. These containers were not labeled with the words hazardous waste or a hazard indicator. I explained to Ms. Mugridge that the containers will need to be labeled with the words hazardous waste and a hazard indicator before any hazardous waste enters them.

| View of one of the two transfer containers that will be used to transfer the waste solvent to a waste solvent SAA container. | | |

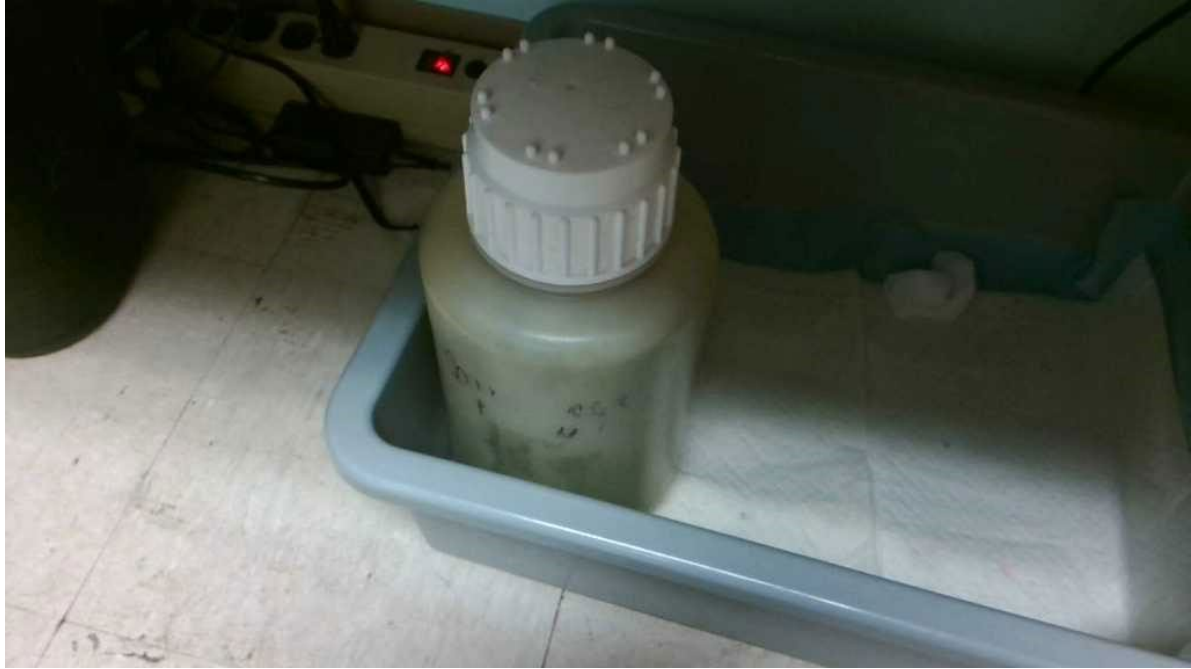
| [Title] | IMG-20220823100144144307001.jpg | |

| Close-up view of one of the two transfer containers that will be used to transfer waste solvent to a waste solvent SAA container. | | |
