**Region 6 Compliance Assurance and Enforcement Division  
INSPECTION REPORT**

| Inspection Date(s): | 9/12/2018 | | |
| Facility Name: | <b>Cimarron Wastewater Treatment Plant</b> | | |
| Identification/Permit Number: | NM0031038 | | |

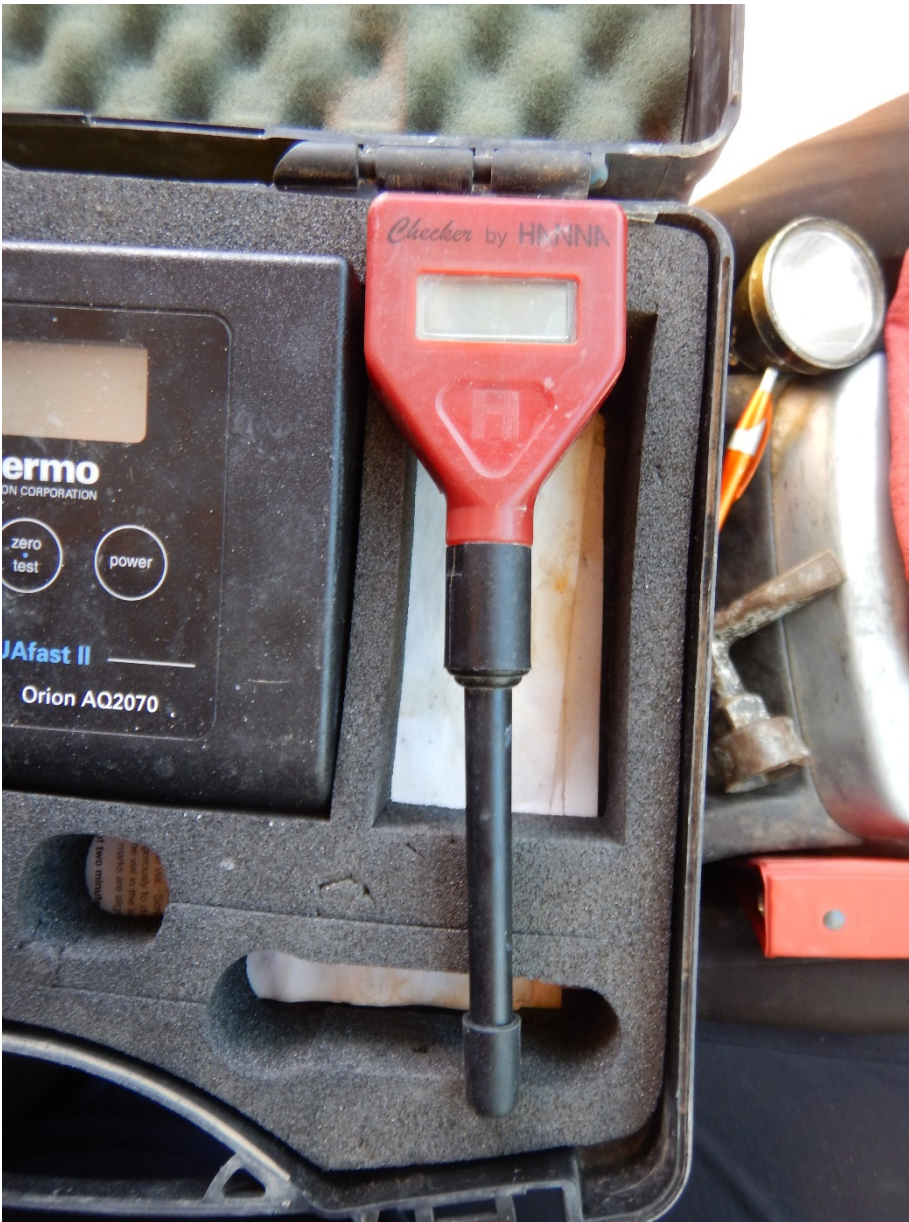
Photo No. 1

Permittee's pH monitor (see photo 1 in Appendix 1) does not meet the requirements of the method stated in 40 CFR 136.3. Facility personnel were not familiar with calibration of instrument, and instrument must be able to be calibrated and maintain said calibration for the duration of testing. No evidence was presented to show the existence of a quality control program for the analyses run by the permittee (pH and TRC).

Description: pH meter

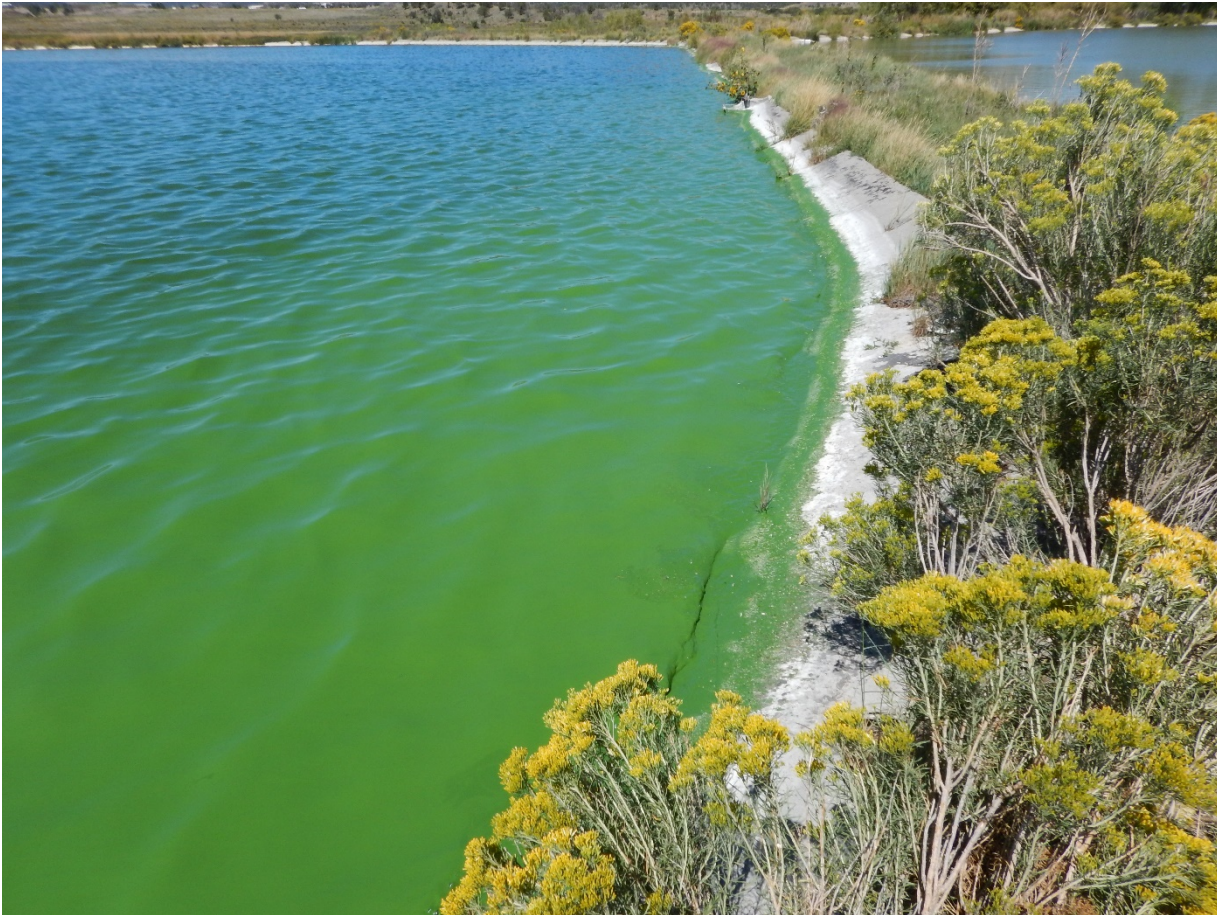
Photo No. 2

The lagoon liner and the lagoon freeboard concrete are cracking and visually appear to be failing in several locations (see Photos 2 and 3 in Appendix 1) with weeds growing out of the cracks. There is an abundance of algae in the lagoons, sludge wasting has never occurred, and due to the constant mixing of the SolarBees, there is a high likelihood of solids flowing out the outfall during discharge events.

Description: View of algae and lagoon freeboard concrete cracking with weeds growing out of cracks.

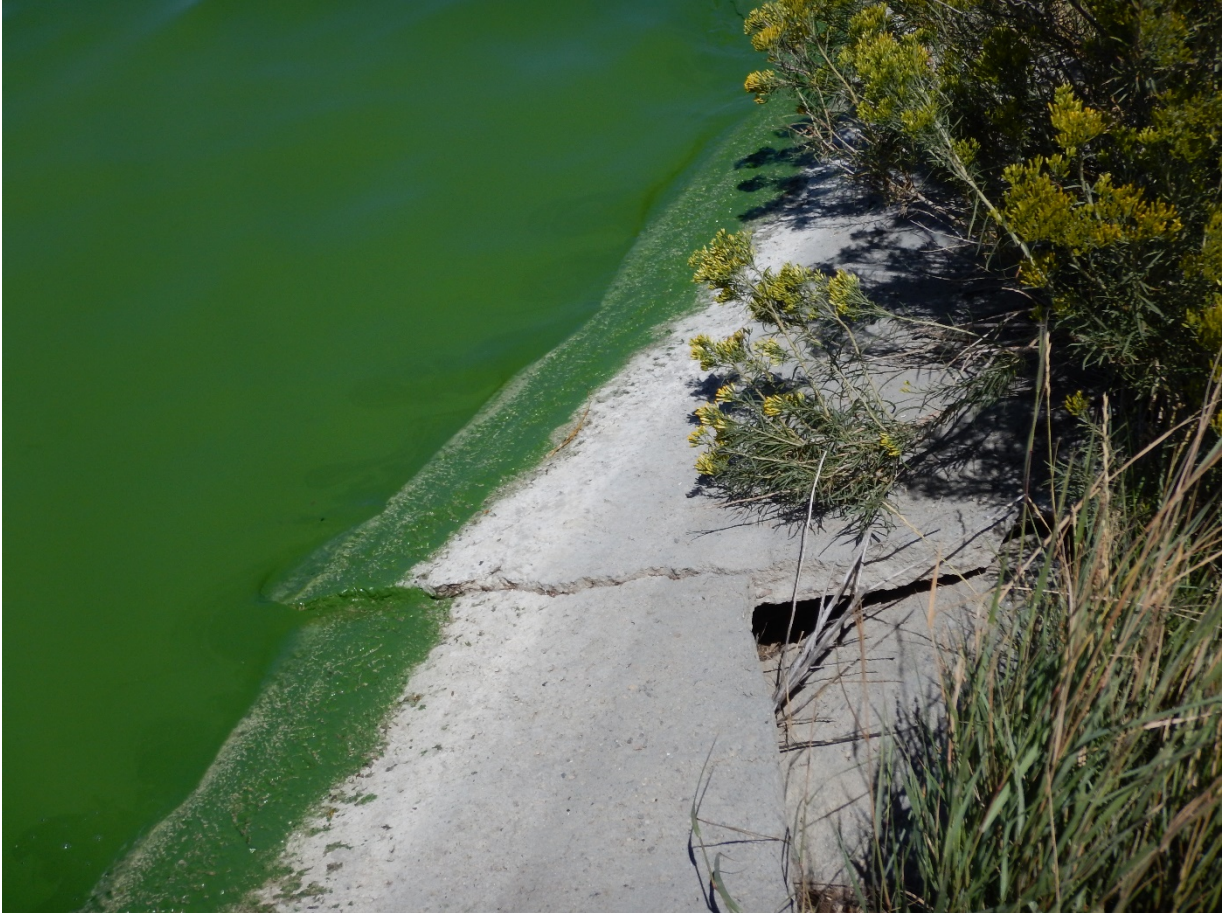
Photo No. 3

Description: Second view of algae and lagoon freeboard concrete cracking with weeds growing out of cracks.

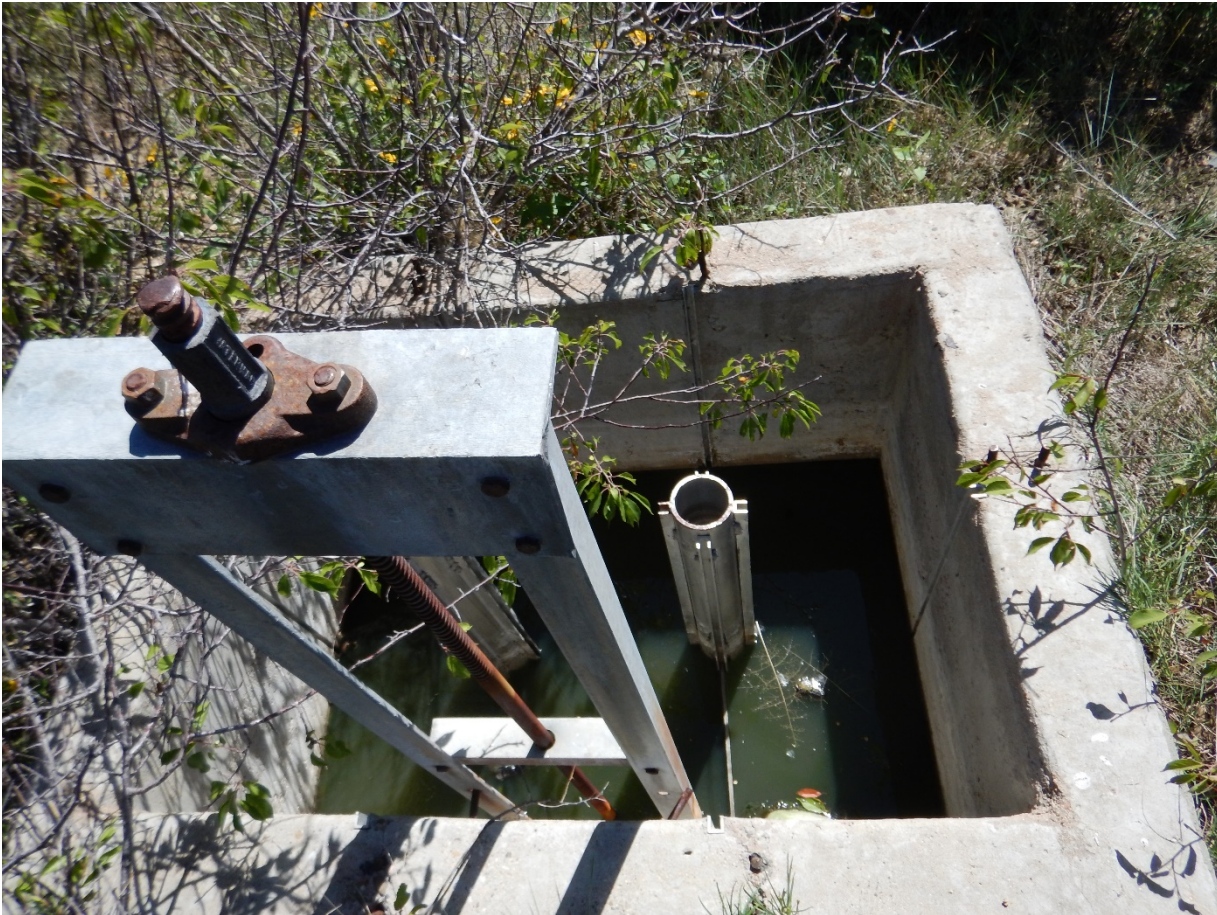
Photo No. 4

Description: Manual gate valve used to initiate discharge.

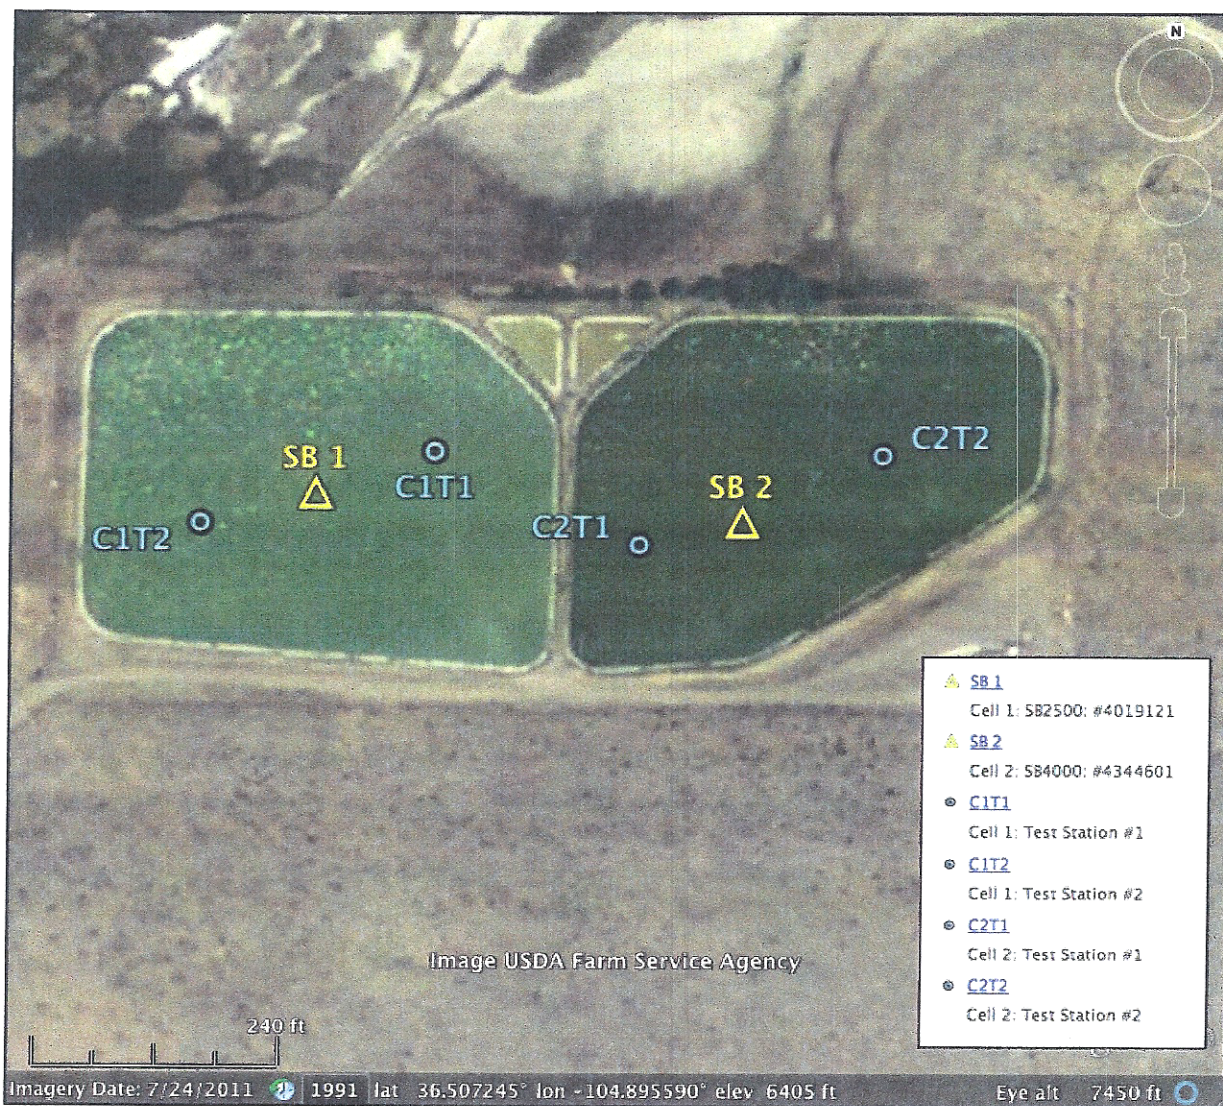
Service Report From November 08, 2016

## Village of Cimarron Cimarron Wastewater Treatment Ponds

A complete inspection of both machines and all electronics was performed, as well as general maintenance and cleaning. Everything was confirmed to be operating properly and in good condition at the crew's departure.
