## Region 6 Compliance Assurance and Enforcement Division

### INSPECTION REPORT

| Company Name: | Sal Gonzalez Racing Stables (Rodríguez Stables) | | |
| Identification/Permit Number: | NMU002087 | | |

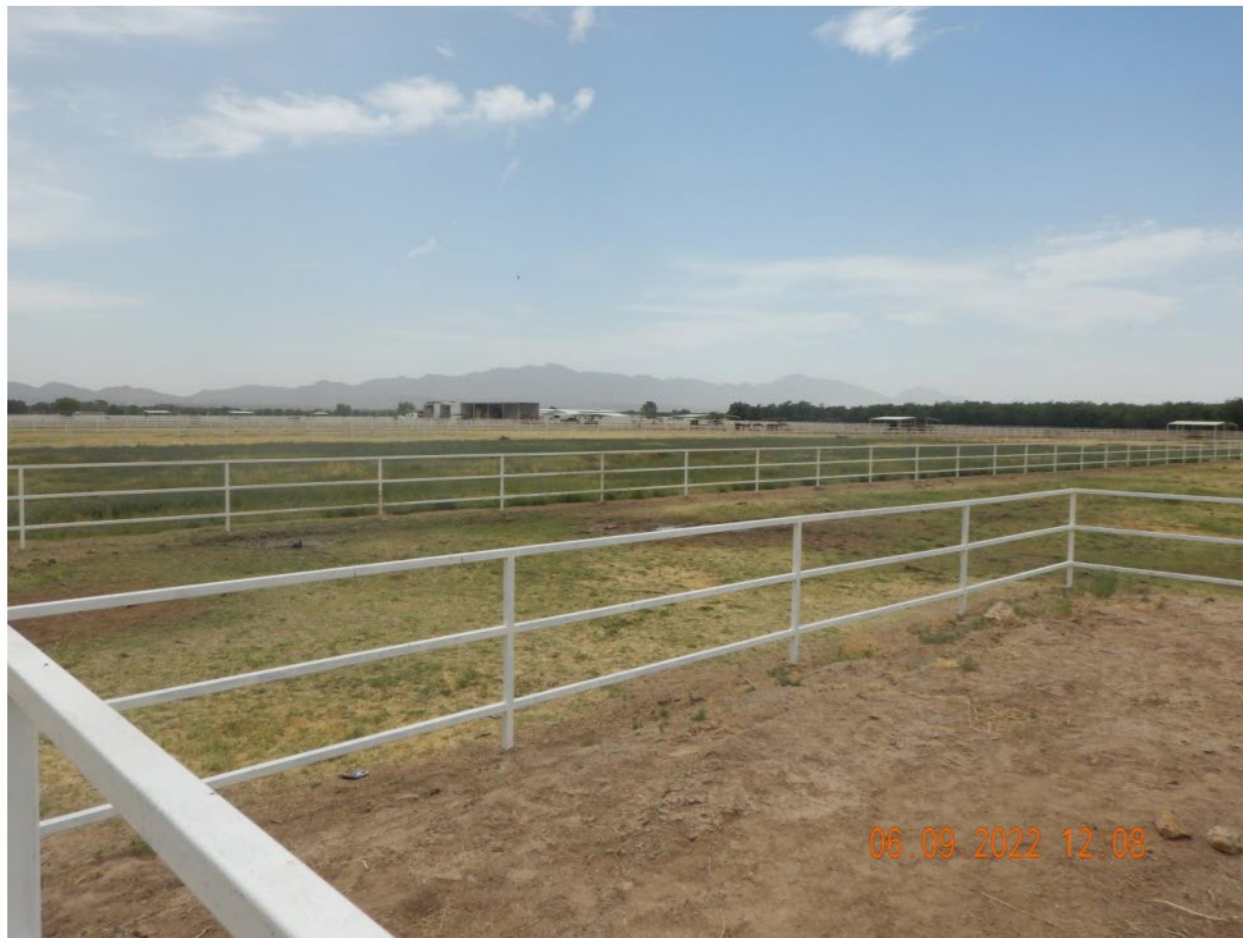
Photo No. 1

Photograph File Name: DSCN1065.JPG  
Date of Photograph: 06/09/2022  
Latitude and Longitude: 32.02329, -106.63962  
Orientation: N  
Map Datum: WGS-84  
Time of Photo: 12:08 PM  
Photographer: Jack Arias  
Description: This image shows confined/open/covered pens surrounded by a metal fence.

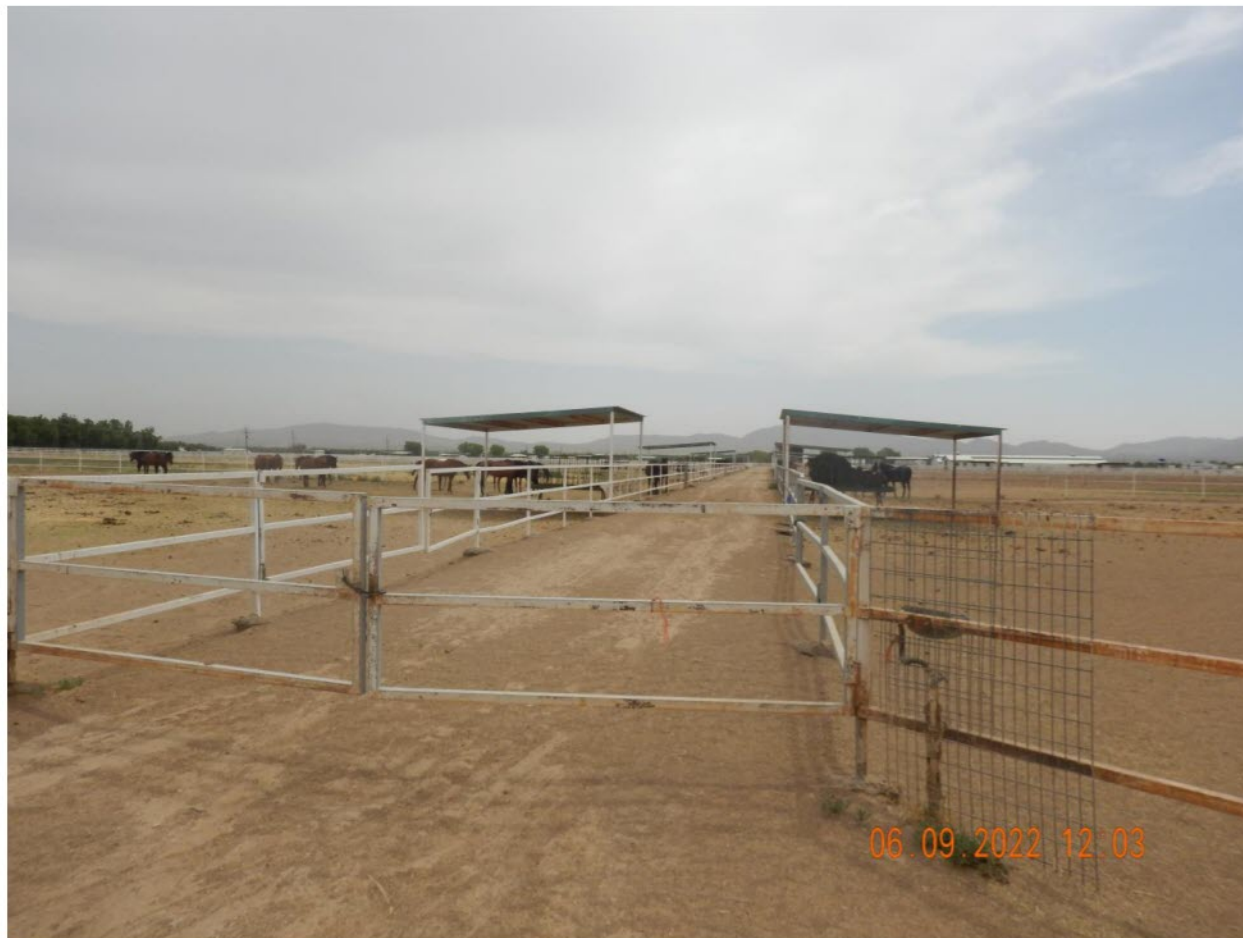
Photo No. 2

Photograph File Name: DSCN1059.JPG  
Date of Photograph: 06/09/2022  
Latitude and Longitud: 32.023274, -106.642889  
Orientation: N  
Map Datum: WGS-84  
Time of Photo: 12:03 PM  
Photographer: Jack Arias  
Description: This image shows horses and confined/open/covered pens surrounded by a metal fence.

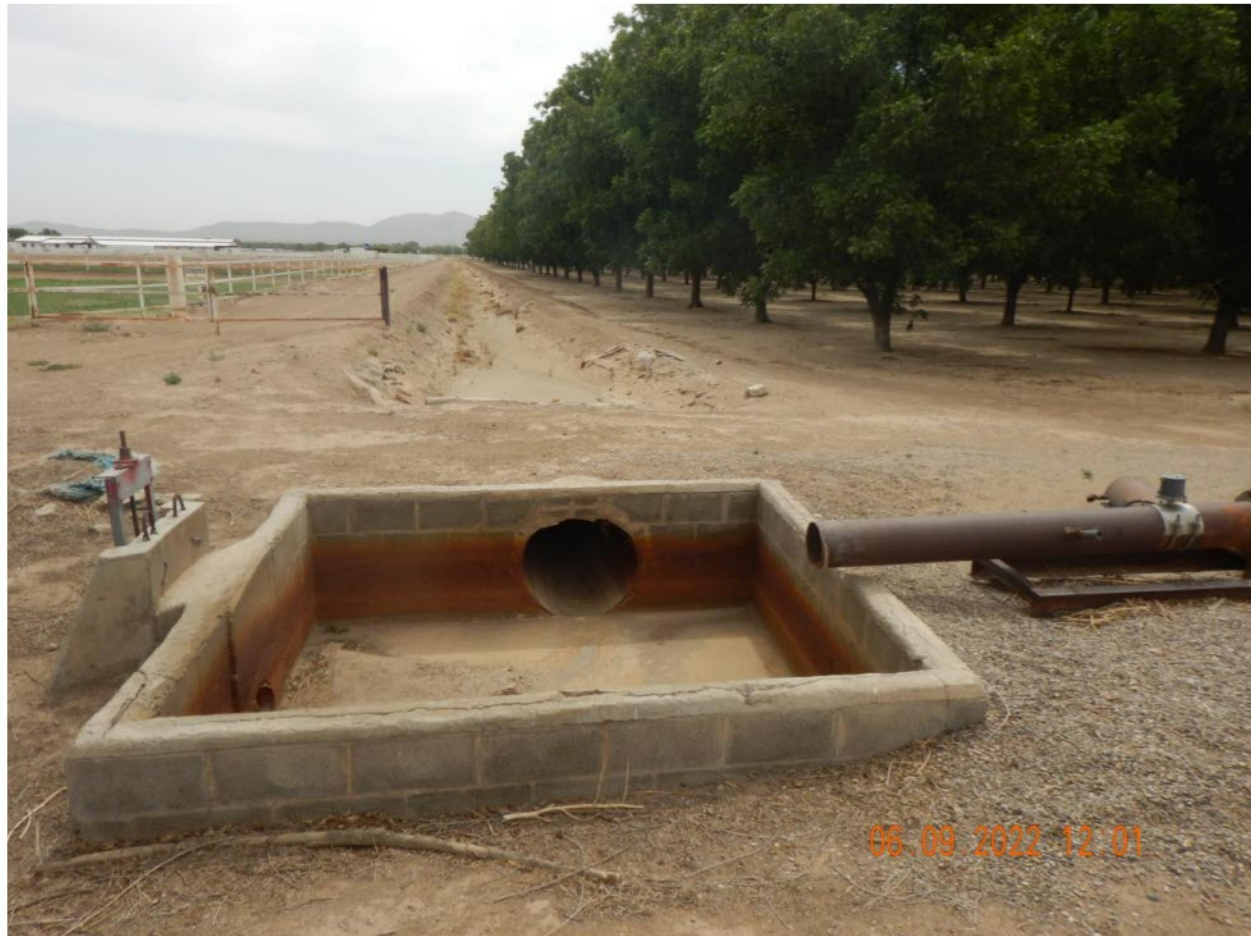
Photo No. 3

Sal Gonzalez Racing Stables (Rodríguez Stables) and undefined runoff control ditch system that forms part of the RSC system are connected to Three Saints Lateral Ditch system and the Rio Grande River (See Photo Nos. 3 - 6 in Appendix 1).

Photograph File Name: DSCN1057.JPG  
Date of Photograph: 06/09/2022  
Latitude and Longitude: 32.021814, -106.642616  
Orientation: N  
Map Datum: WGS-84  
Time of Photo: 12:01 PM  
Photographer: Jack Arias  
Description: This image shows a well, water pump, and control area that form part of the Retention Control Structures (RCS).

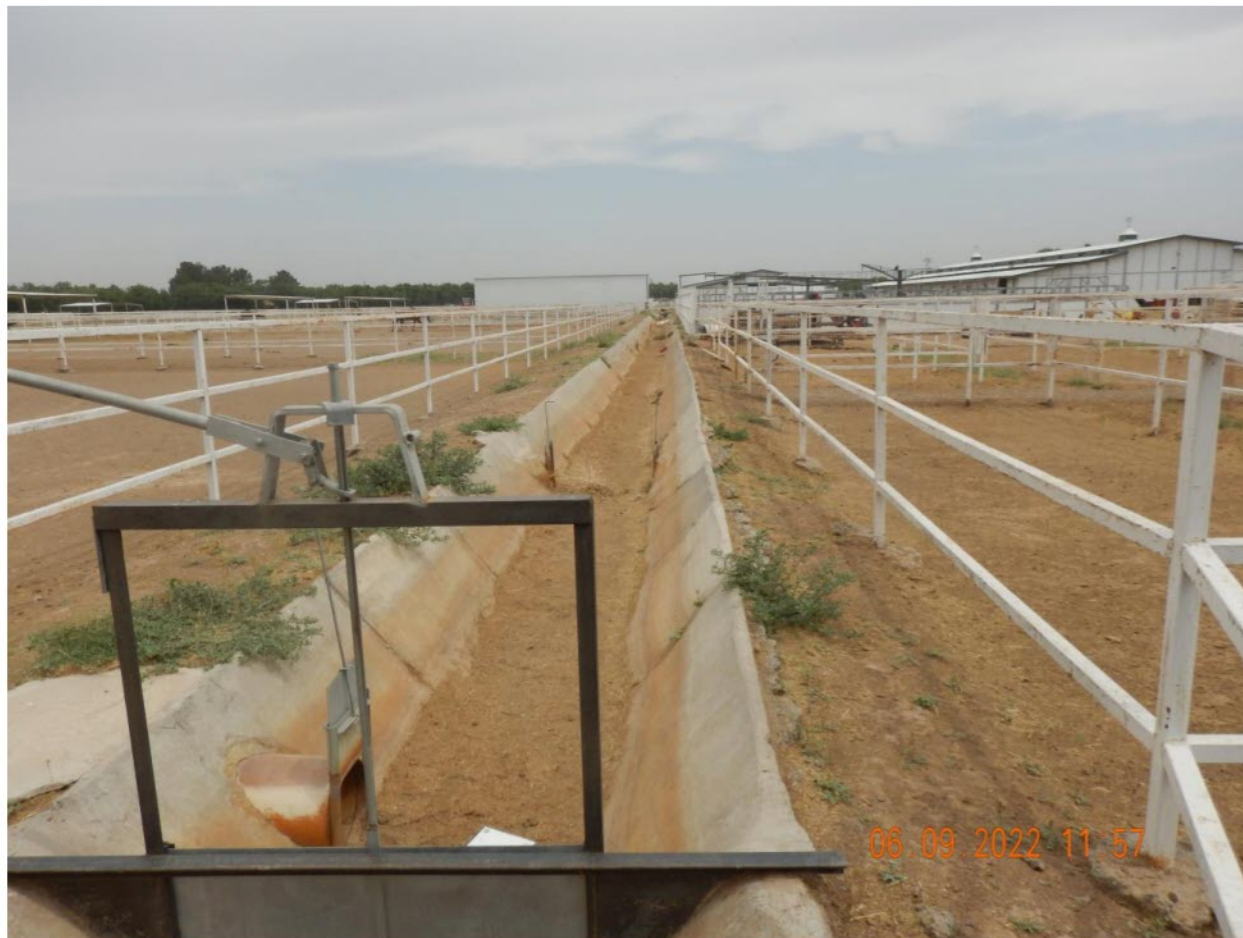
Photo No. 4

Photograph File Name: DSCN1050.JPG  
Date of Photograph: 06/09/2022  
Latitude and Longitude: 32.156890, -106.668190  
Orientation: NW  
Map Datum: WGS-84  
Time of Photo: 11:57 AM  
Photographer: Jack Arias  
Description: This image shows a control ditch inside the facility that form part of the Retention Control Structures (RCS).

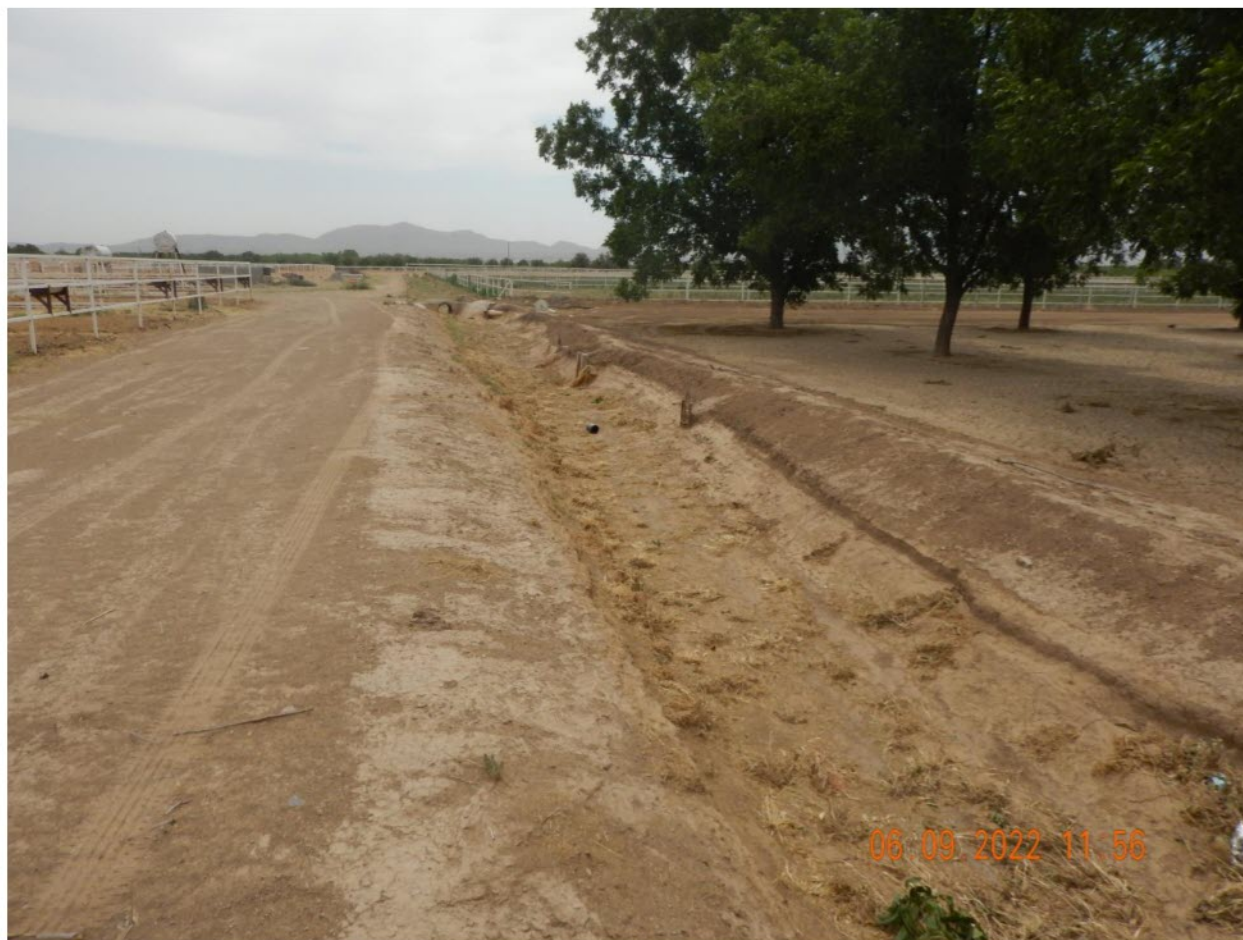
Photo No. 5

Description: This image shows a control ditch around the facility that form part of the Retention Control Structures (RCS).

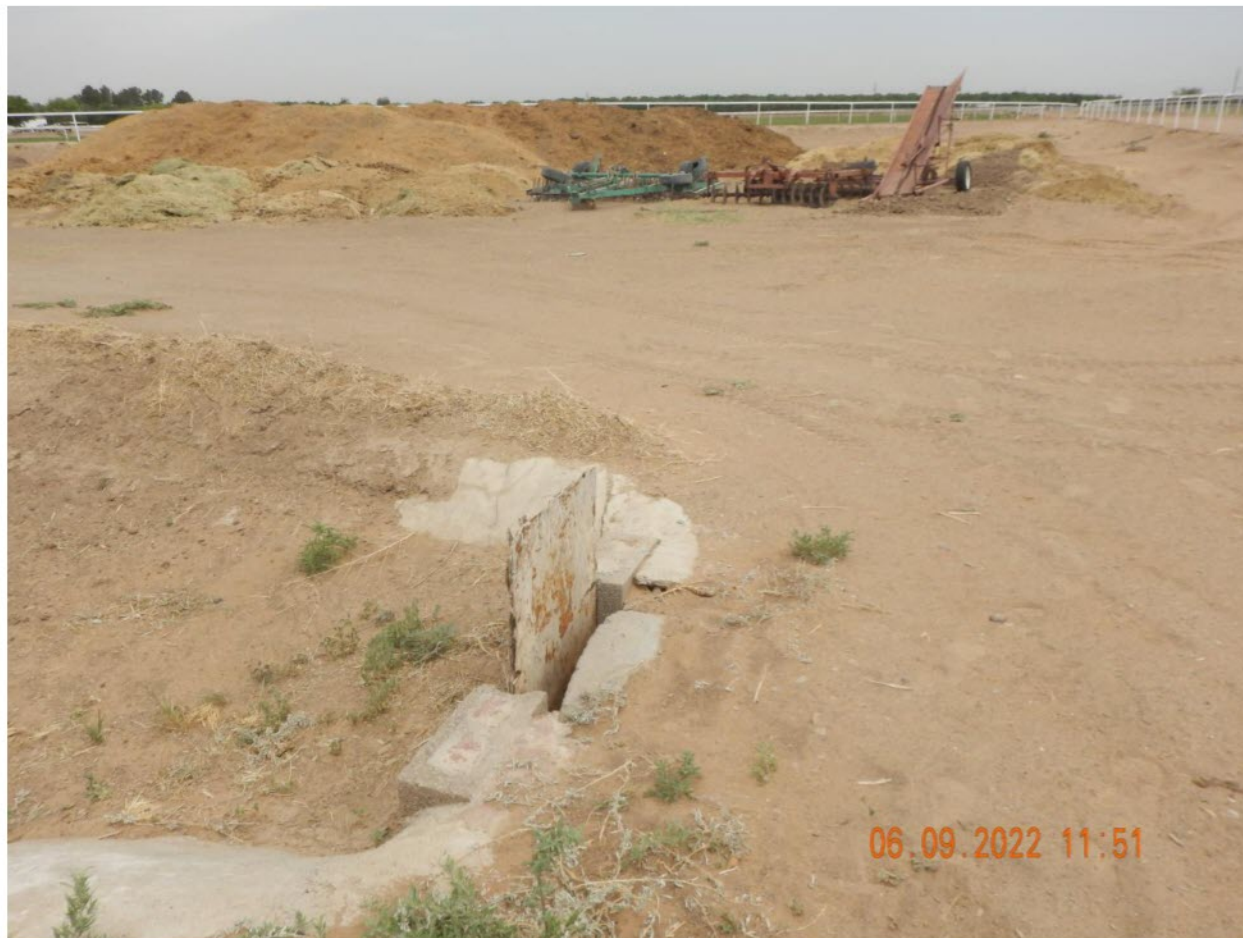
Photo No. 6

We observe buildup of manure solids, unknown barrels, and gasoline tanks outside pens and next to control ditch system. Manure solids and unknown barrels should be removed appropriately. Also, the gasoline tanks need containment walls to prevent spills of gasoline into control ditch system. Areas of concern should be regraded and leveled to allow proper runoff and reduce risk of wastewater and chemicals intrusion into Three Saints Lateral Ditch system and the Rio Grande River (See Photo Nos. 6 - 10 in Appendix 1).

This image shows a buildup of manure solids outside pens and next to a control ditch inside the facility.

1. Buildup of manure solids, unknown barrels, and gasoline tanks outside pens and next to control ditch system.
2. Undefined runoff control ditch system that forms part of the RSC system are connected to Three Saints Lateral Ditch system and the Rio Grande River.
3. Areas of concern should be regraded and leveled to allow proper runoff and reduce risk of wastewater and chemicals intrusion into Three Saints Lateral Ditch system and the Rio Grande River

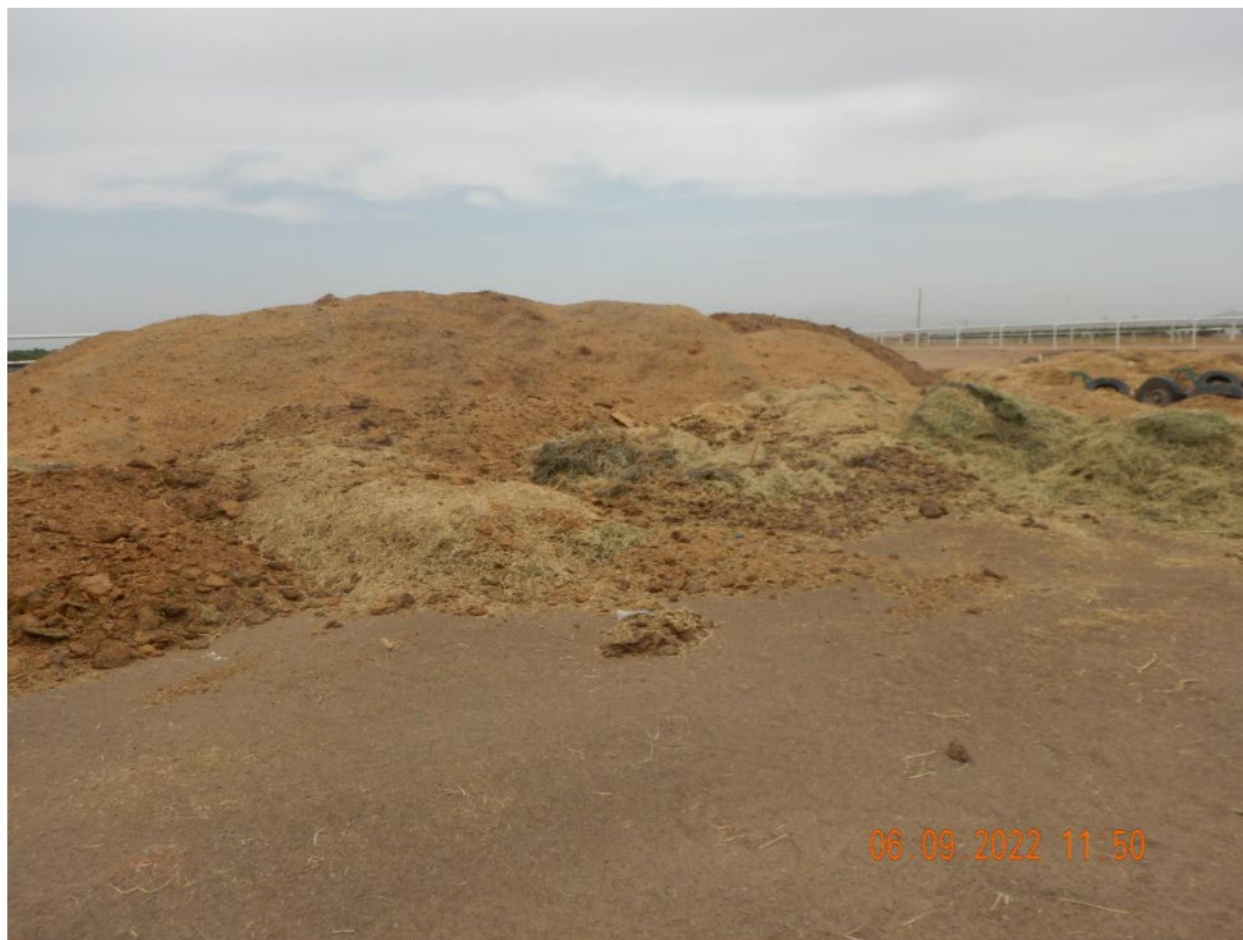
Photo No. 7

Photograph File Name: DSCN1039.JPG  
Date of Photograph: 06/09/2022  
Latitude and Longitud: 32.022838, -106.637264  
Orientation: S  
Map Datum: WGS-84  
Time of Photo: 1:47 PM  
Photographer: Jack Arias  
Description: This image shows a buildup of manure solids outside pens and next to a control ditch inside the facility.

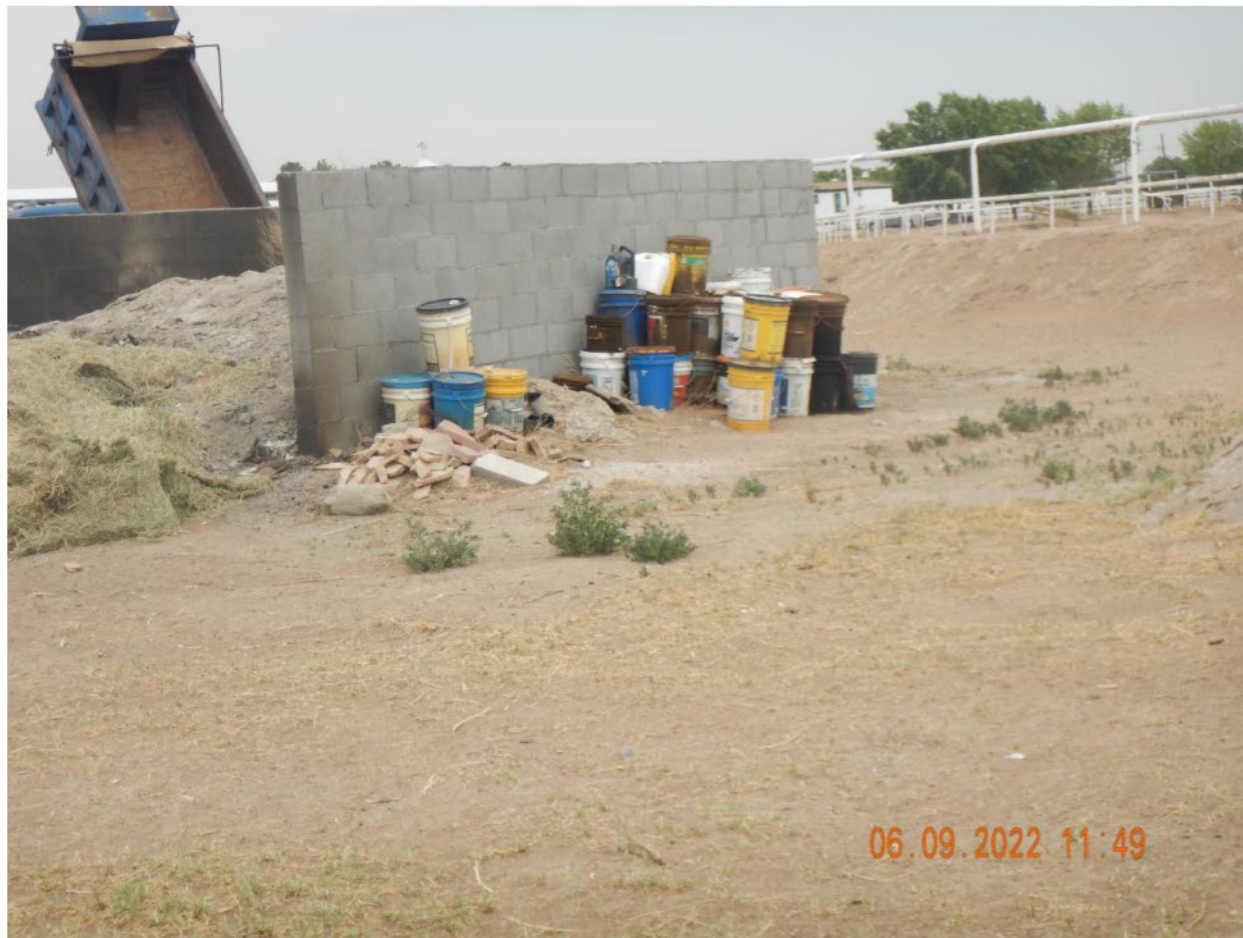
Photo No. 8

Photograph File Name: DSCN1038.JPG  
Date of Photograph: 06/09/2022  
Latitude and Longitud: 32.022625, -106.637884  
Orientation: S  
Map Datum: WGS-84  
Time of Photo: 11:49 AM  
Photographer: Jack Arias  
Description: This image shows unknow barrels outside pens and next to a control ditch inside the facility.

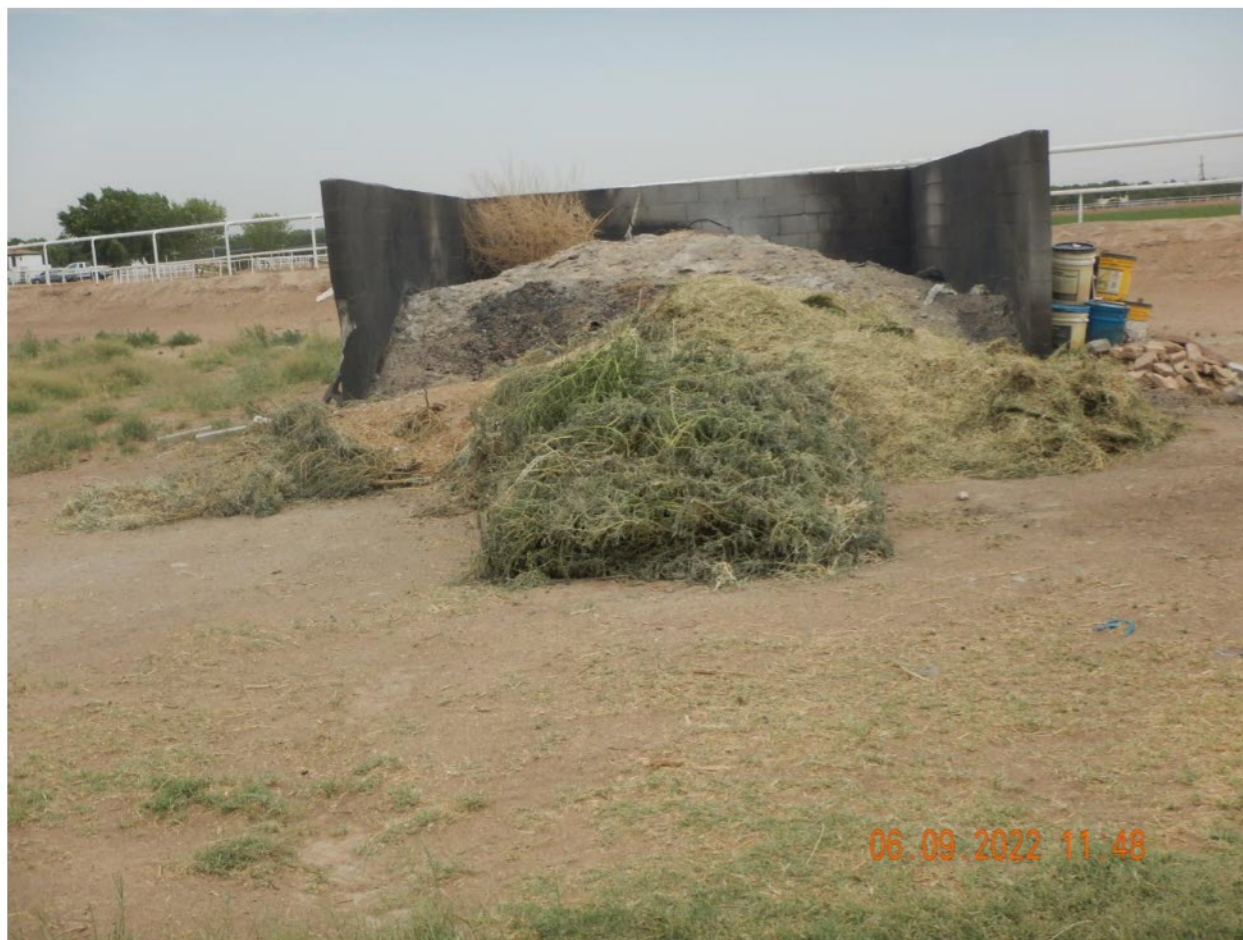
Photo No. 9

Photograph File Name: DSCN1037.JPG  
Date of Photograph: 06/09/2022  
Latitude and Longitud: 32.022625, -106.637884  
Orientation: S  
Map Datum: WGS-84  
Time of Photo: 11:48 PM  
Photographer: Jack Arias  
Description: This image shows unknow trash and barrels outside pens and next to a control ditch inside the facility.

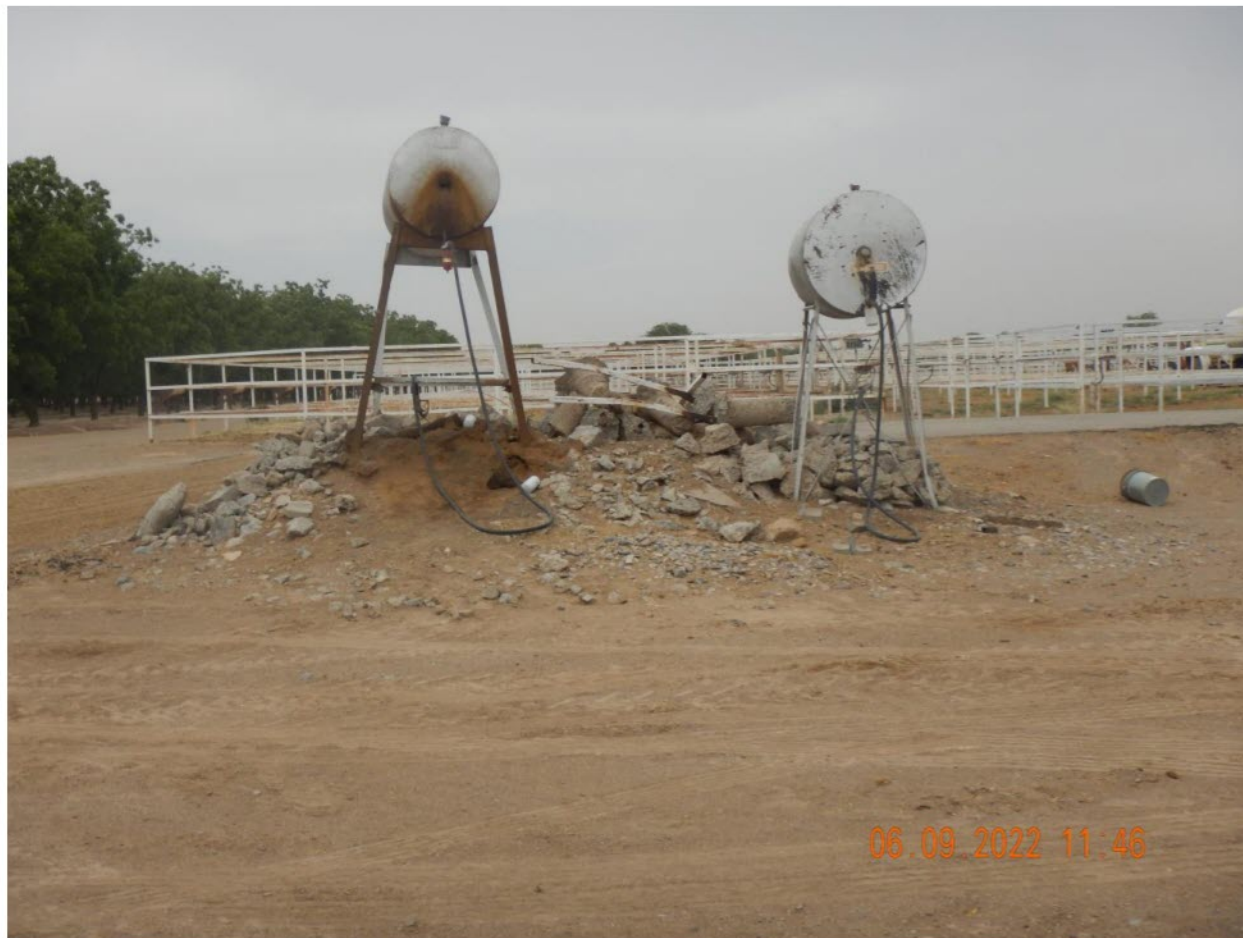
Photo No. 10

Photograph File Name: DSCN1031.JPG  
Date of Photograph: 06/09/2022  
Latitude and Longitud: 32.022585, -106.639072  
Orientation: S  
Map Datum: WGS-84  
Time of Photo: 11:46 PM  
Photographer: Jack Arias  
Description: This image shows gasoline tanks outside pens and next to a control ditch inside the facility.

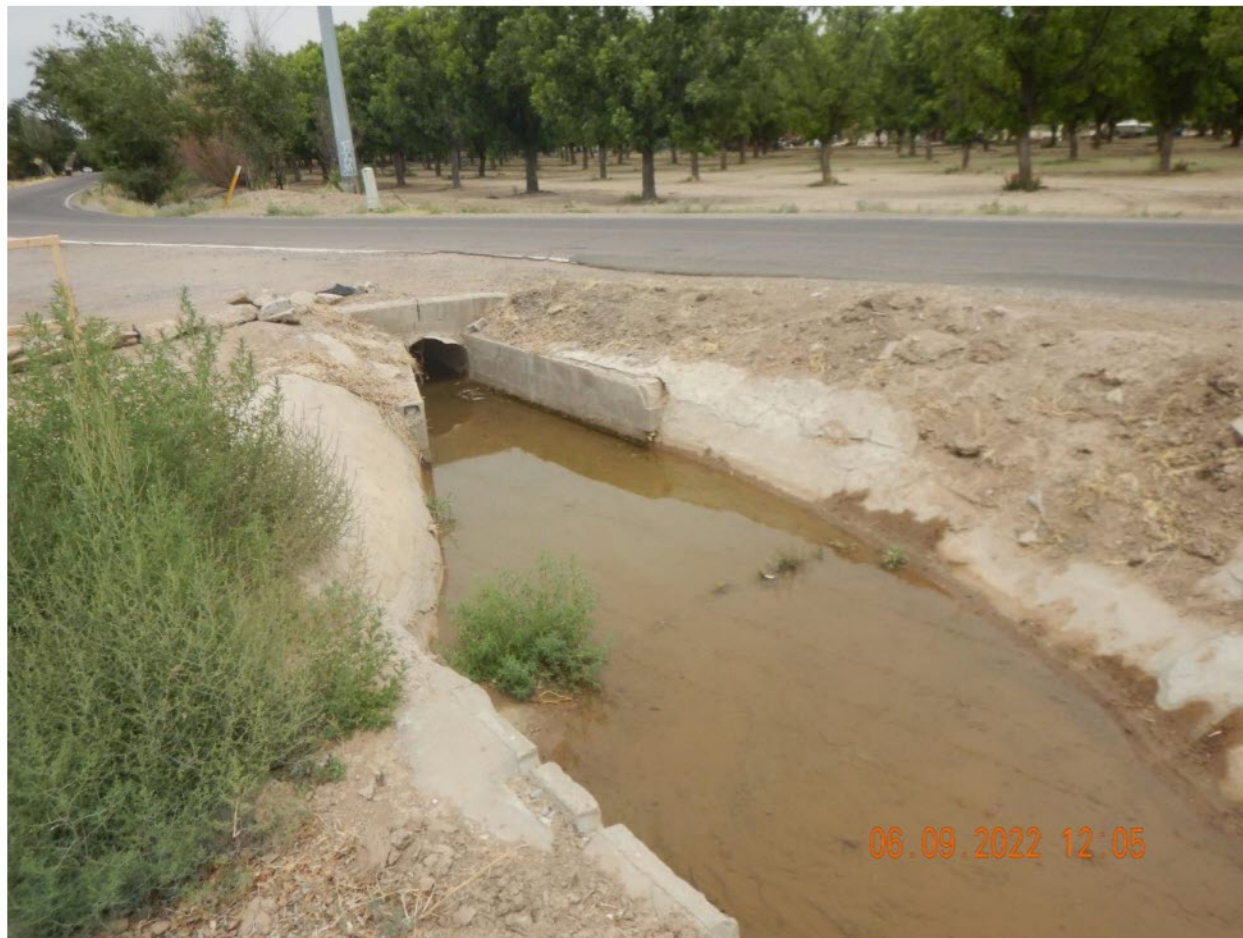
Photo No. 11

Photograph File Name: DSCN1060.JPG  
Date of Photograph: 06/09/2022  
Latitude and Longitude: 32.024688, -106.643138  
Orientation: NW  
Map Datum: WGS-84  
Time of Photo: 12:05 PM  
Photographer: Jack Arias  
Description: This image shows a control ditch (part of the facility) that is connected with Three Saints Lateral Ditch system and the Rio Grande River.
