Clean Water Act Section 404: Site Visit/Case Development

Site Name: Empire Gas Company, Inc. (hereinafter as "Empire Gas")

Attachment A: Site Map with GPS Data

Attachment B: Photolog

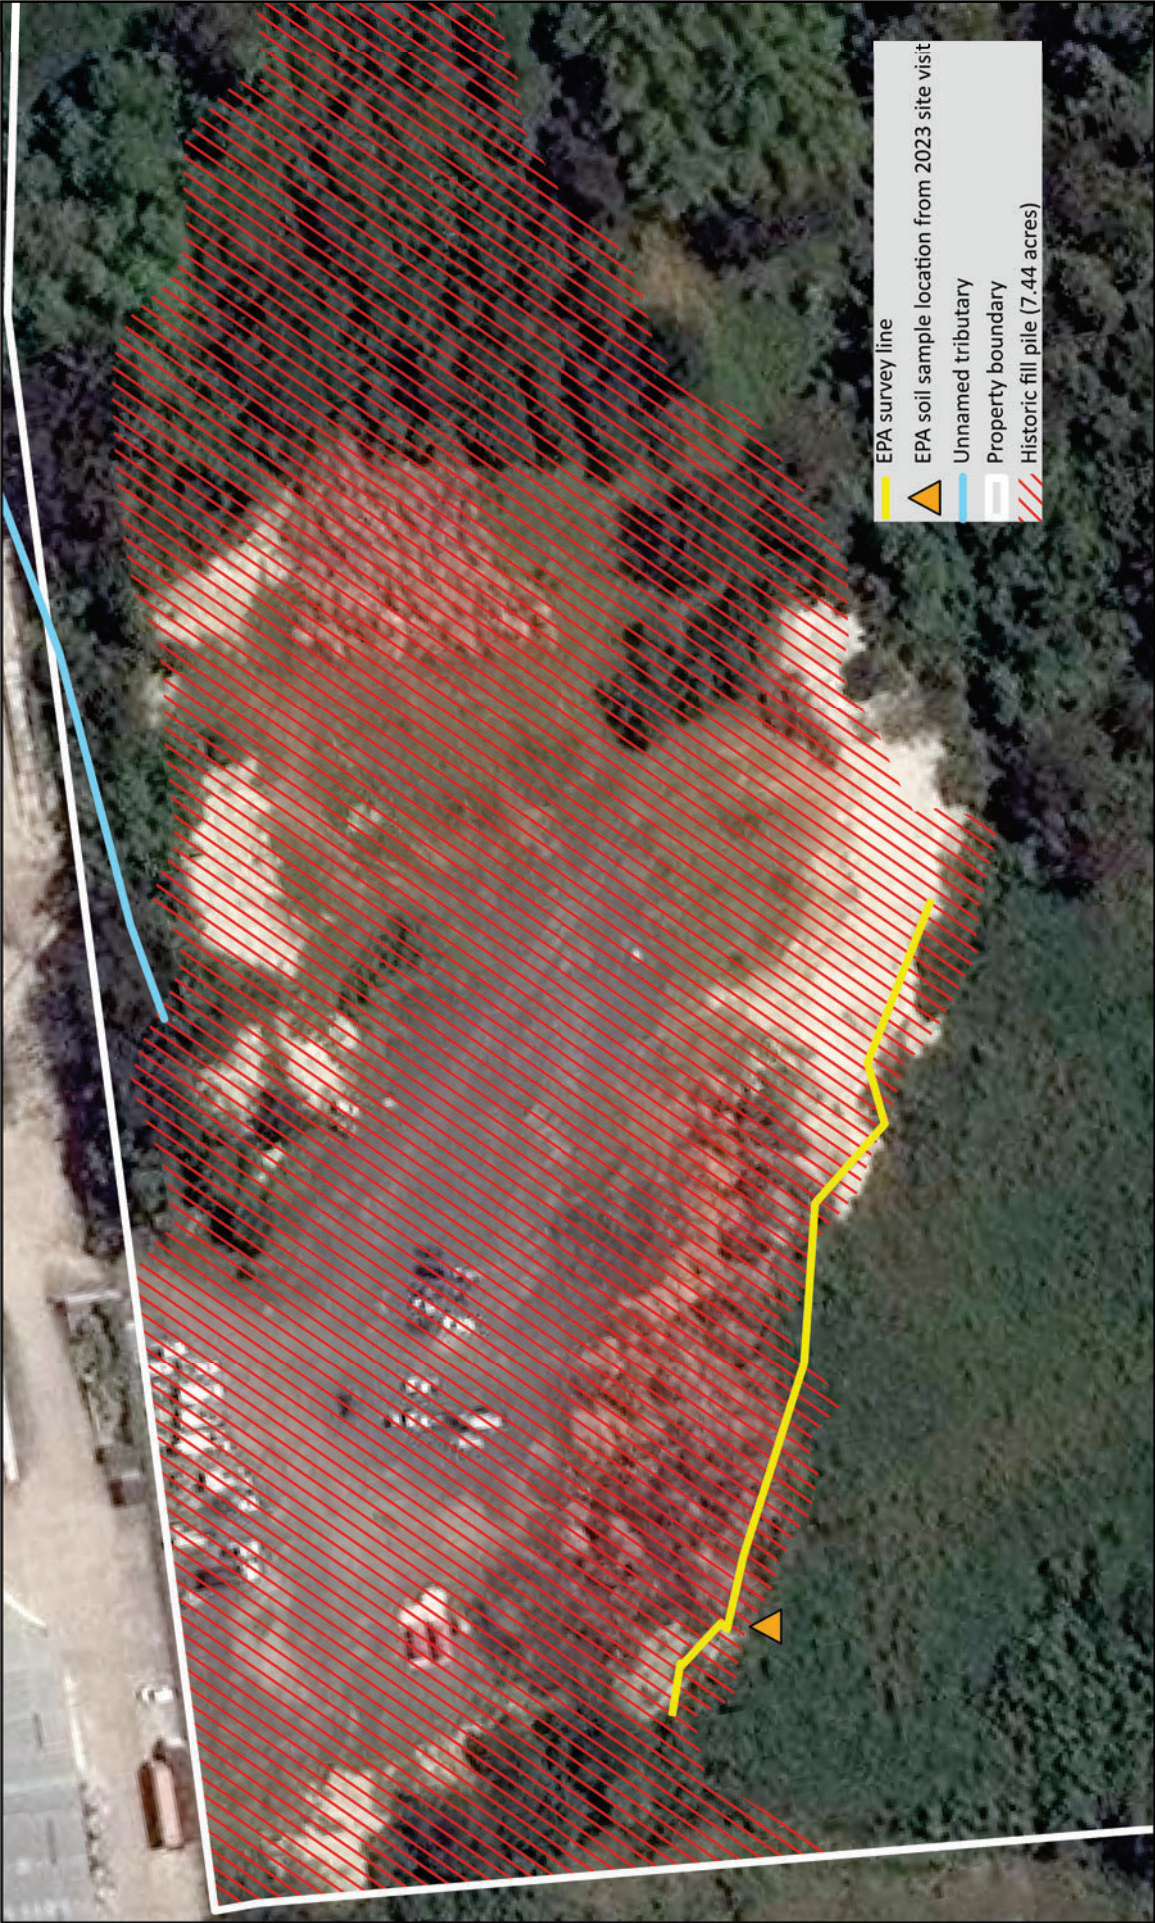
EPA walked along the edge of the historic fill material pile to the furthest extent practicable (GPS points were taken at the extent limit). See Attachment A for a map containing details of the inspection findings.

Historic fill pile (7.44 acres)

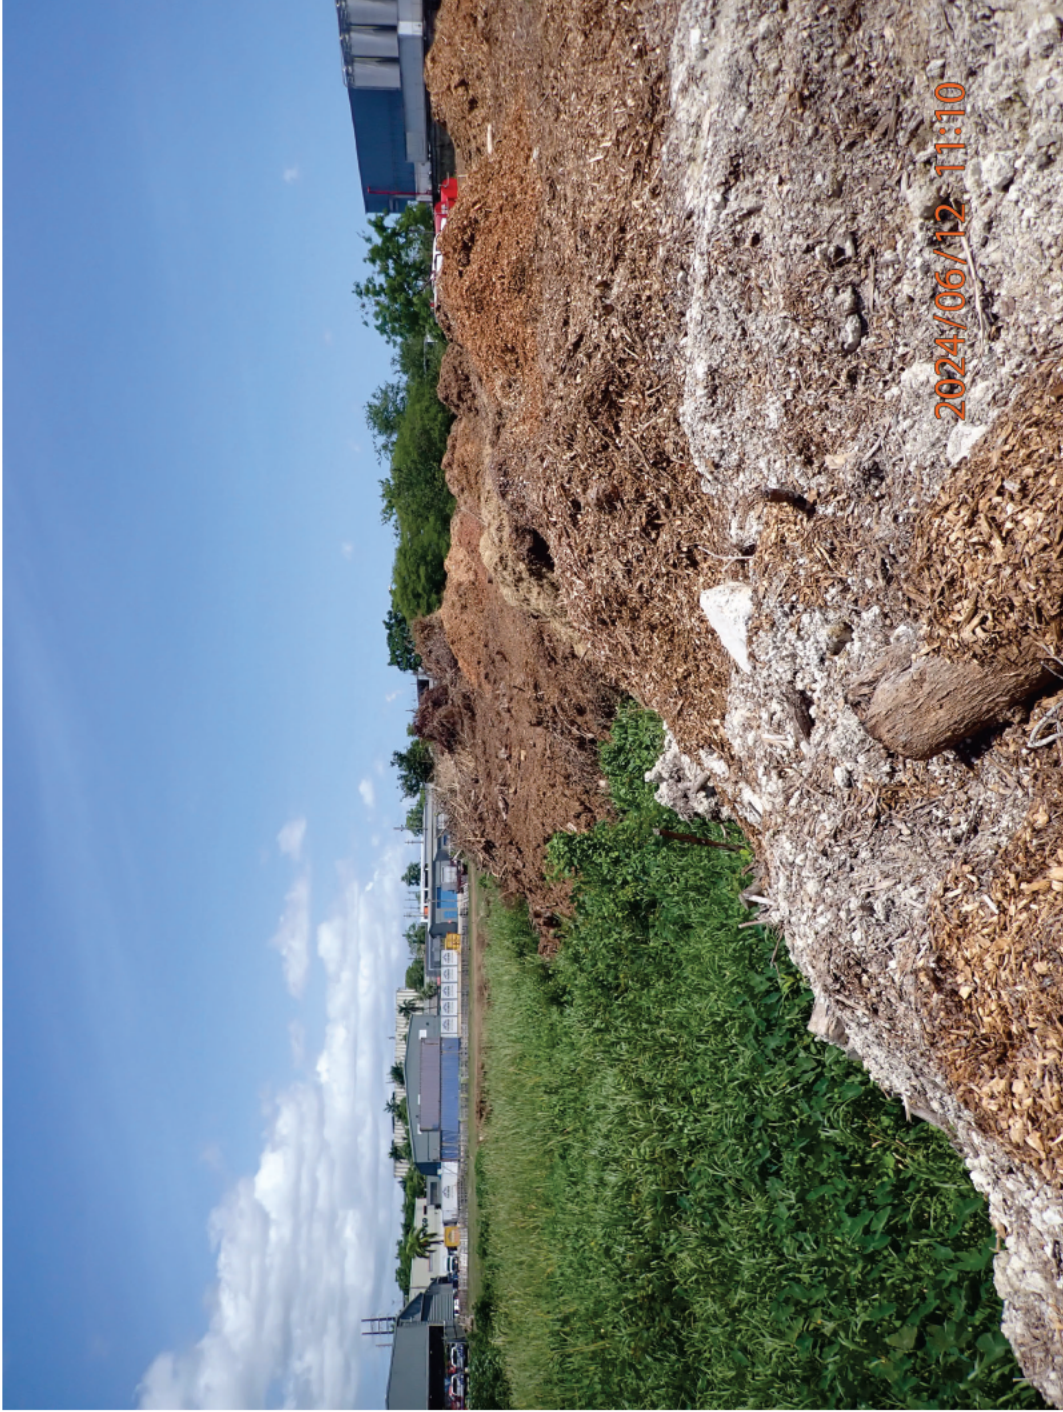
Date: June 12, 2024
Time: 11:10 AM
Photographer: Sofia Olivero Lora
Photo ID: P6121032

Description: View along the southern edge of the fill pile on the property. EPA observed new vegetative debris and aggregate material along the edge and slope of the historic fill pile, material that was not present at the time of EPA's last visit in 2023.

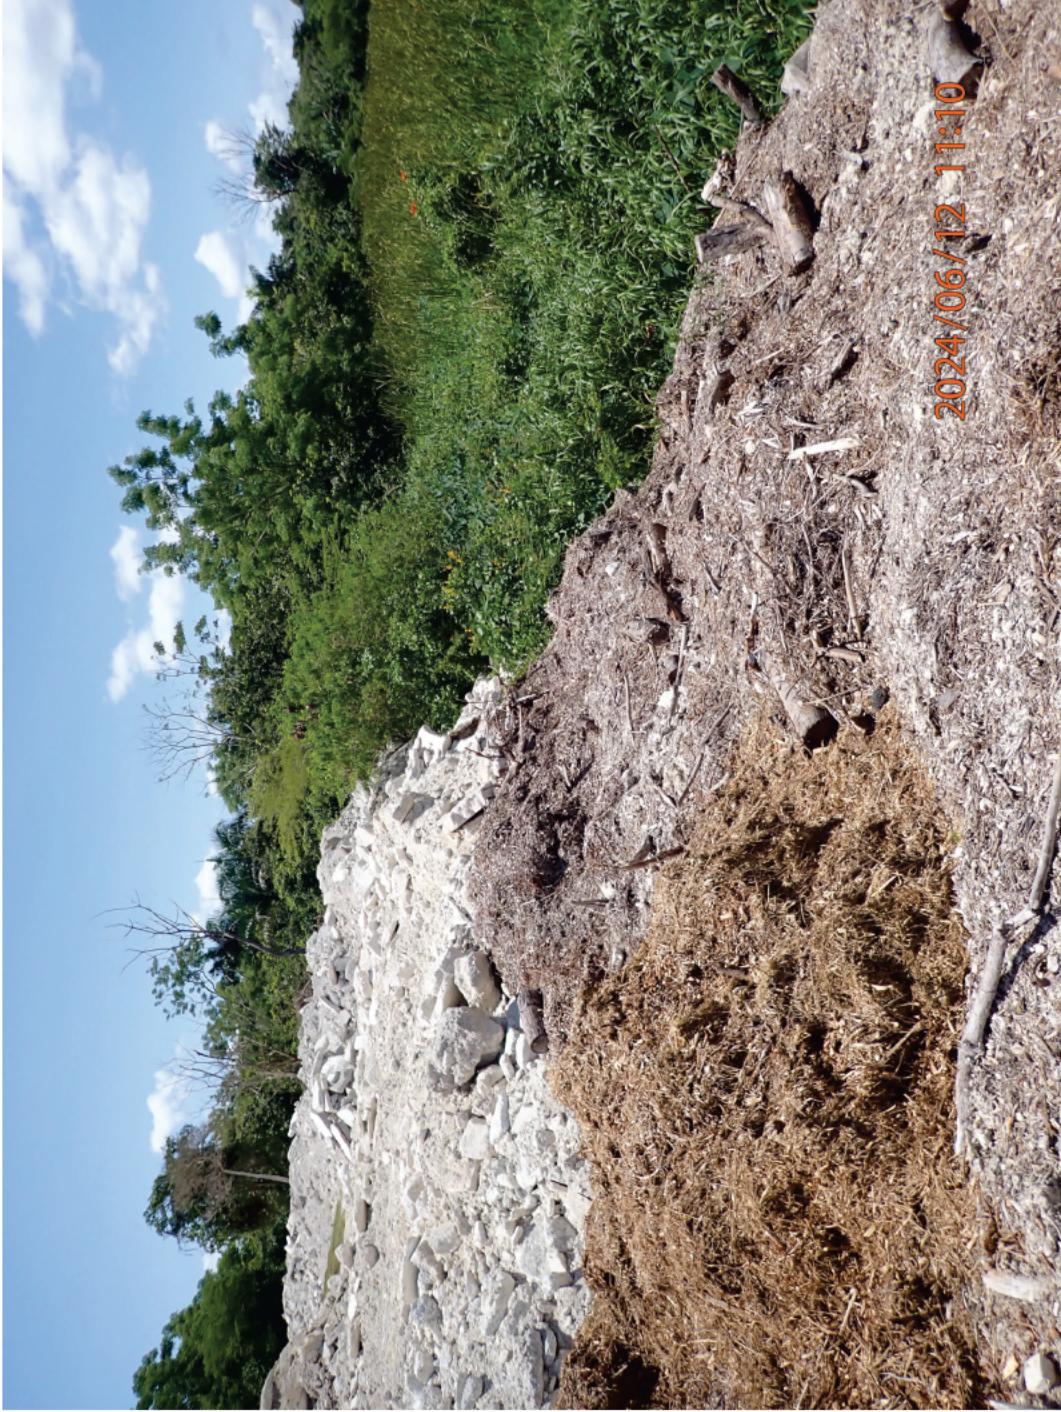
Photo ID: P6121033

Description: View along the southern edge of the fill pile on the property. EPA observed new vegetative debris and aggregate material along the edge and slope of the historic fill pile.

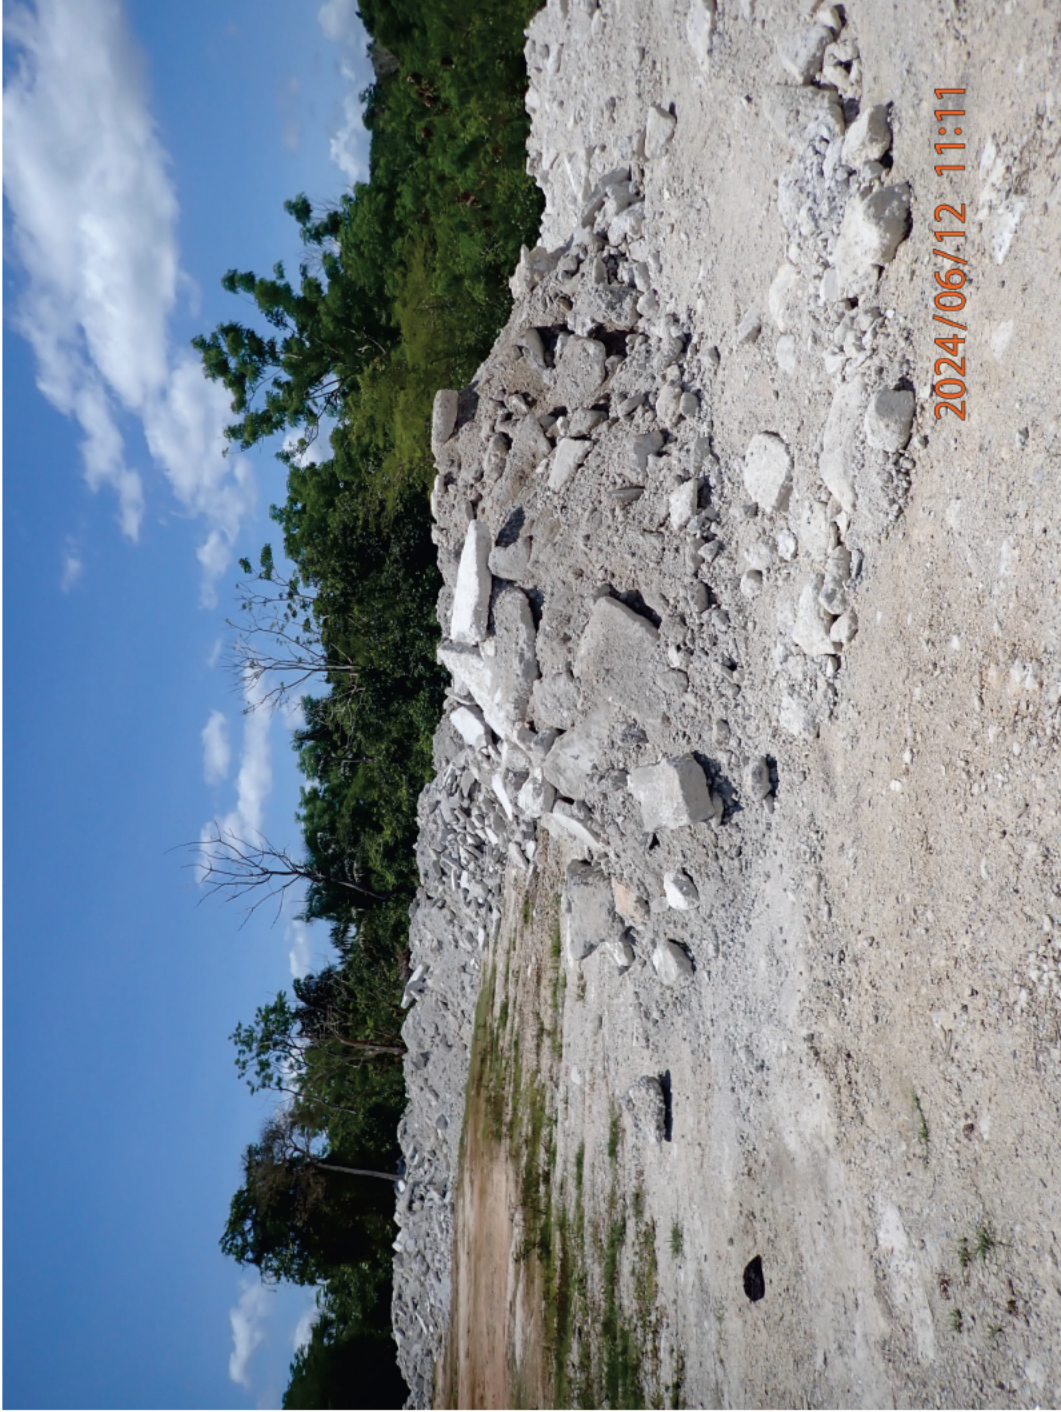
Photo ID: P6121034

Description: View along the southern edge of the fill pile on the property. EPA observed new vegetative debris and aggregate material along the edge and slope of the historic fill pile.

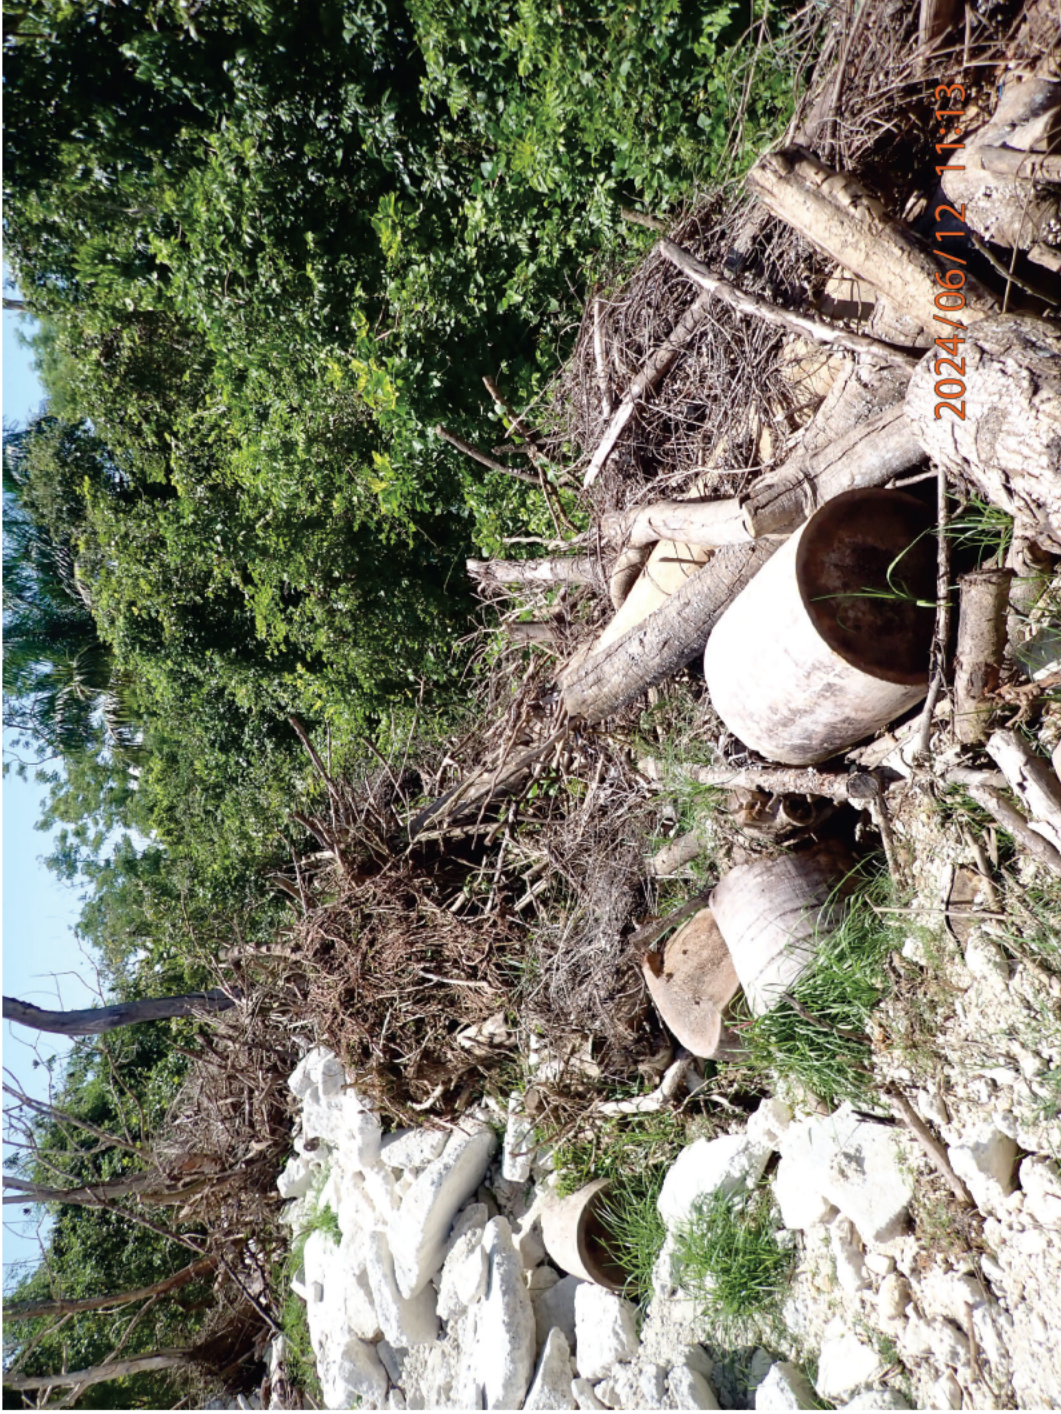
Photo ID: P6121035

Description: View along the southern edge of the fill pile on the property. EPA observed new vegetative debris and aggregate material along the edge and slope of the historic fill pile.

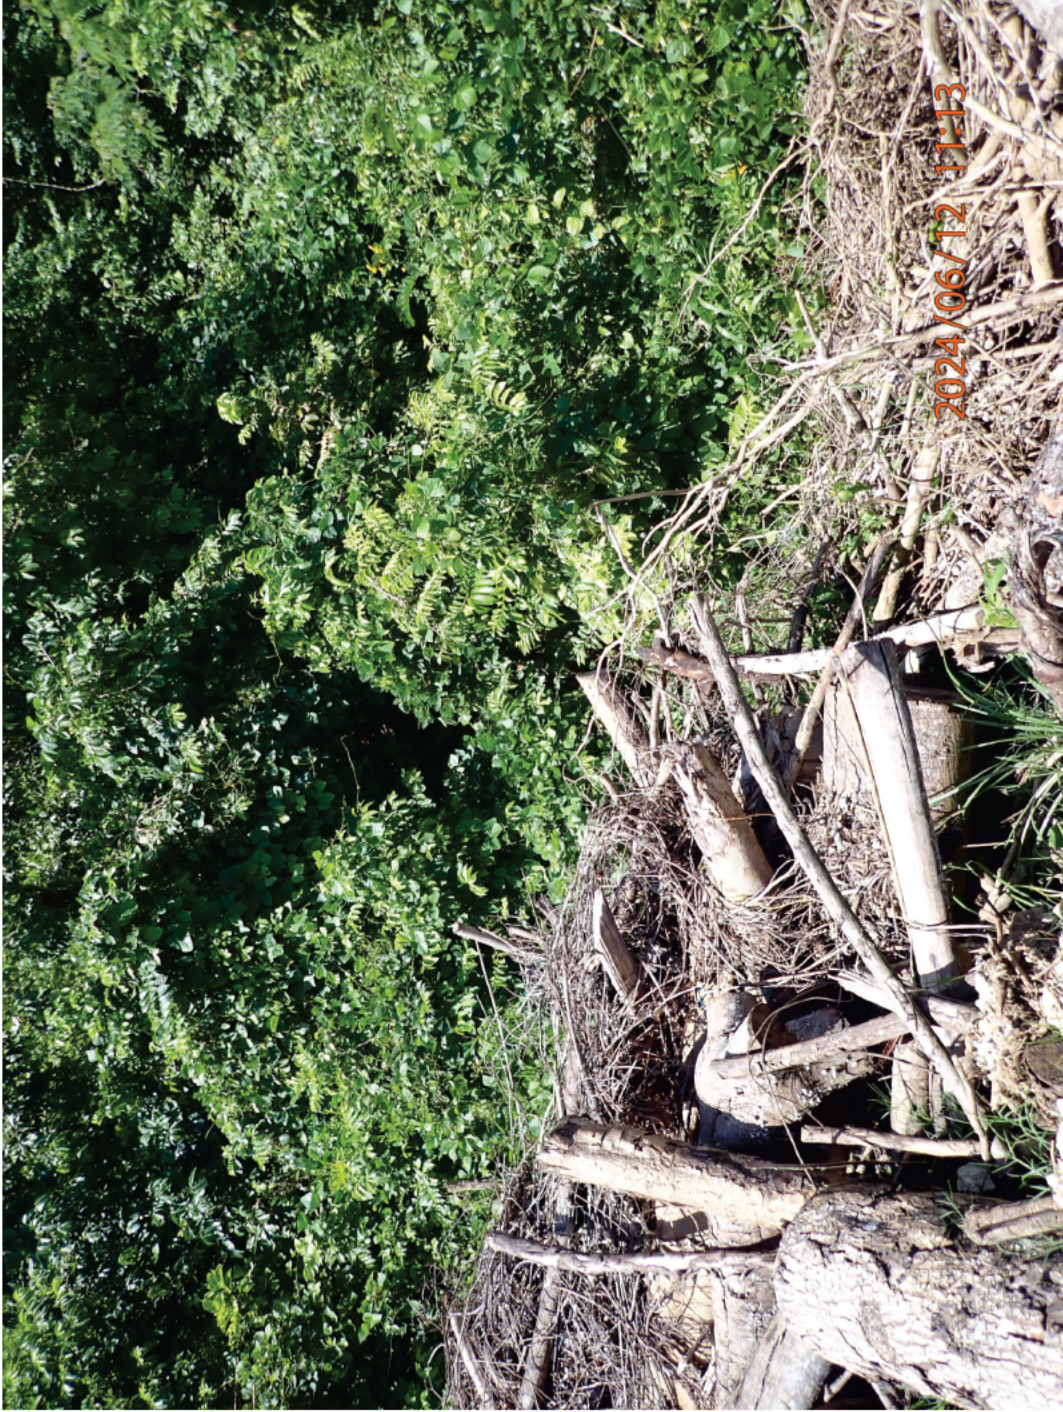
Photo ID: P6121036

Description: View along the edge of the fill pile on the property. The undisturbed area surrounding the fill pile can be seen from the top of the fill pile.

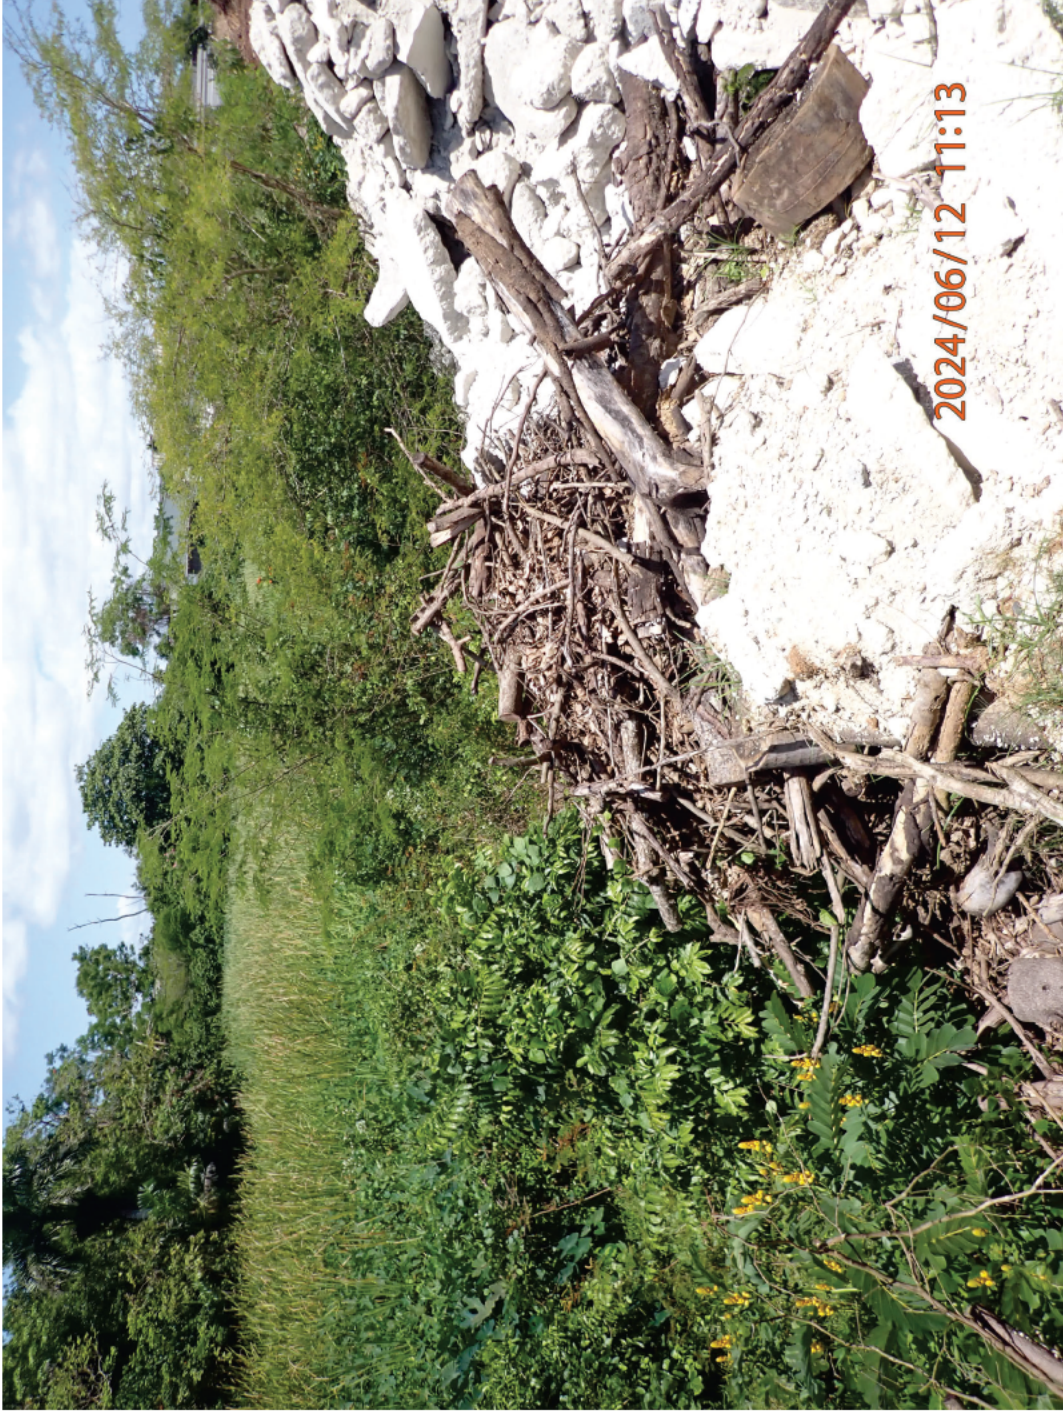
Photo ID: P6121037

Description: View along the edge of the fill pile on the property.

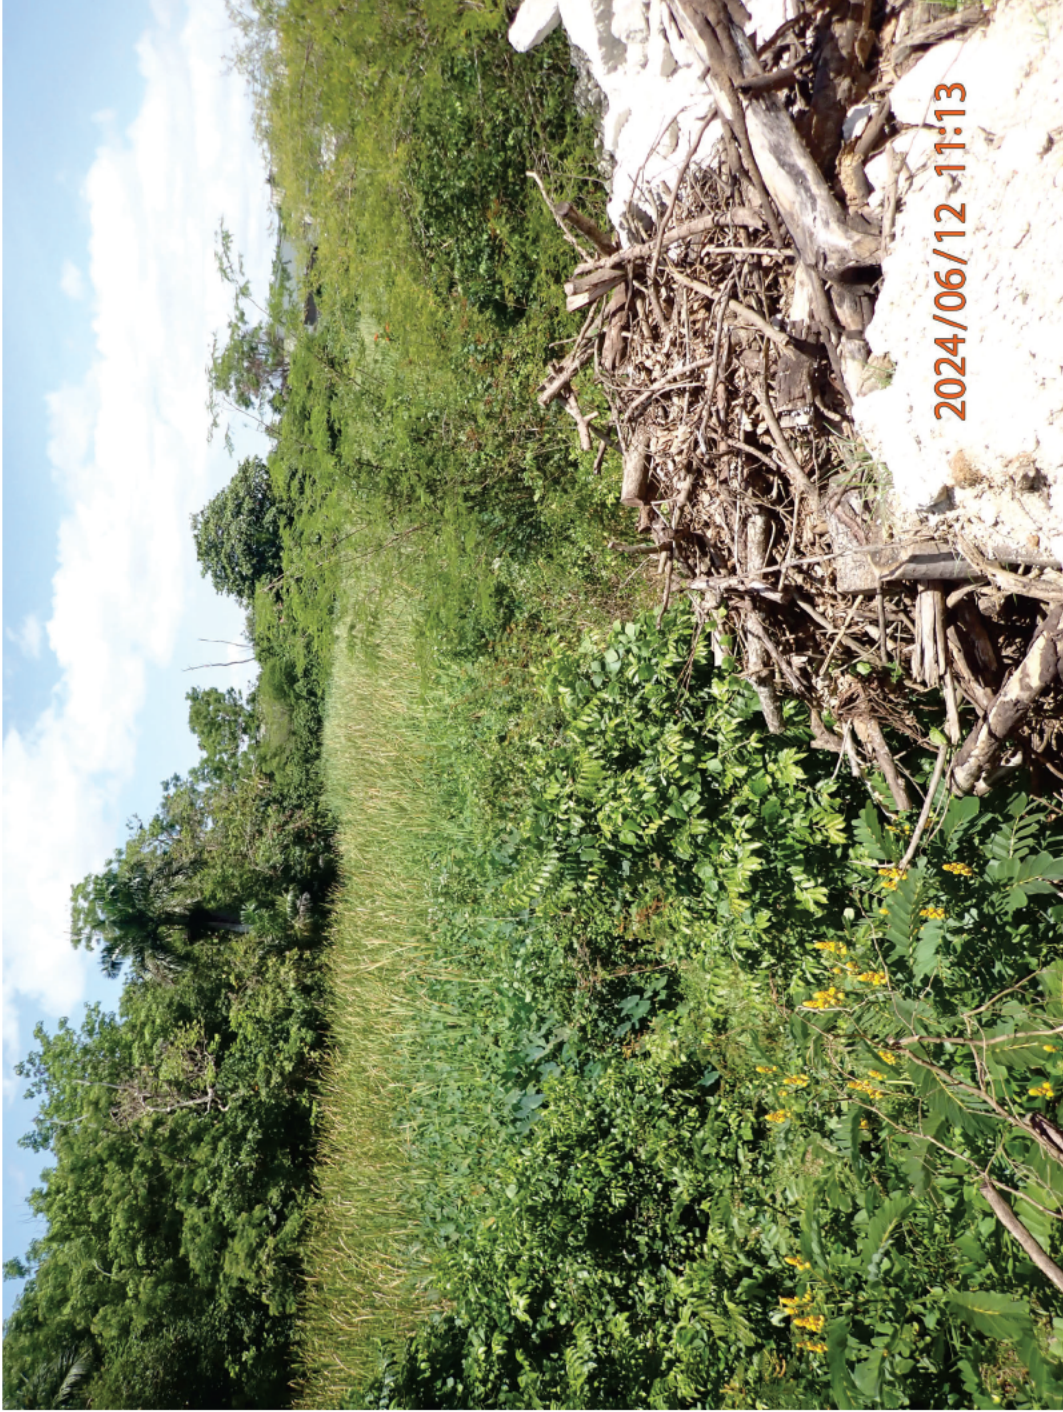
Photo ID: P6121038

Description: View along the edge of the fill pile on the property.

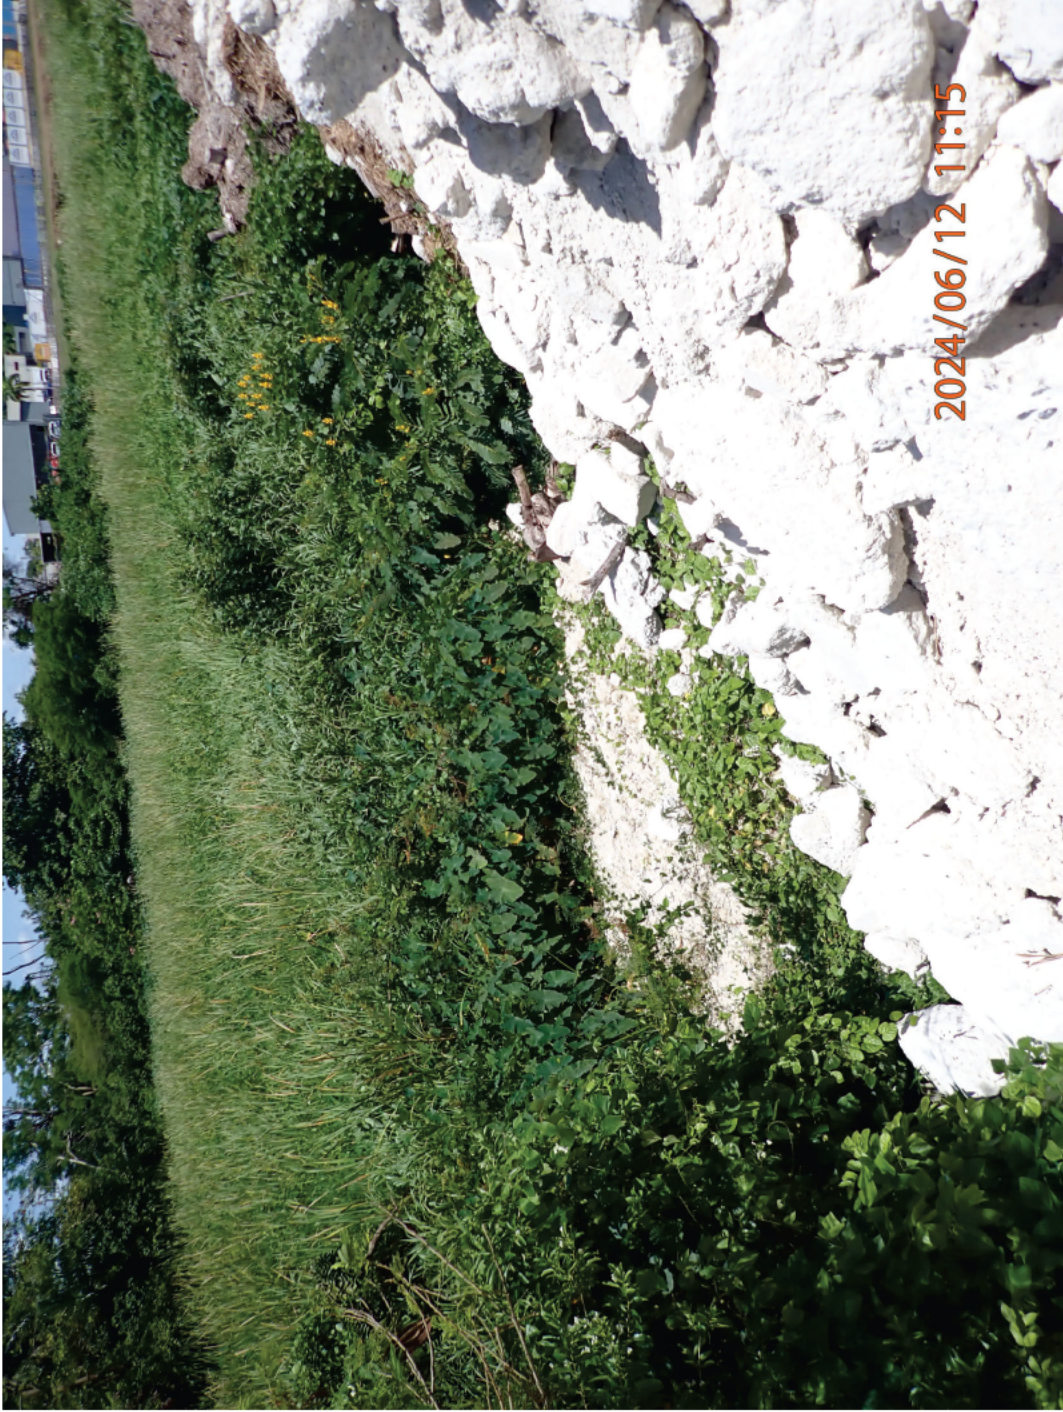
Photo ID: P6121039

Description: View along the edge of the fill pile on the property. The undisturbed area surrounding the fill pile can be seen from the top of the fill pile.

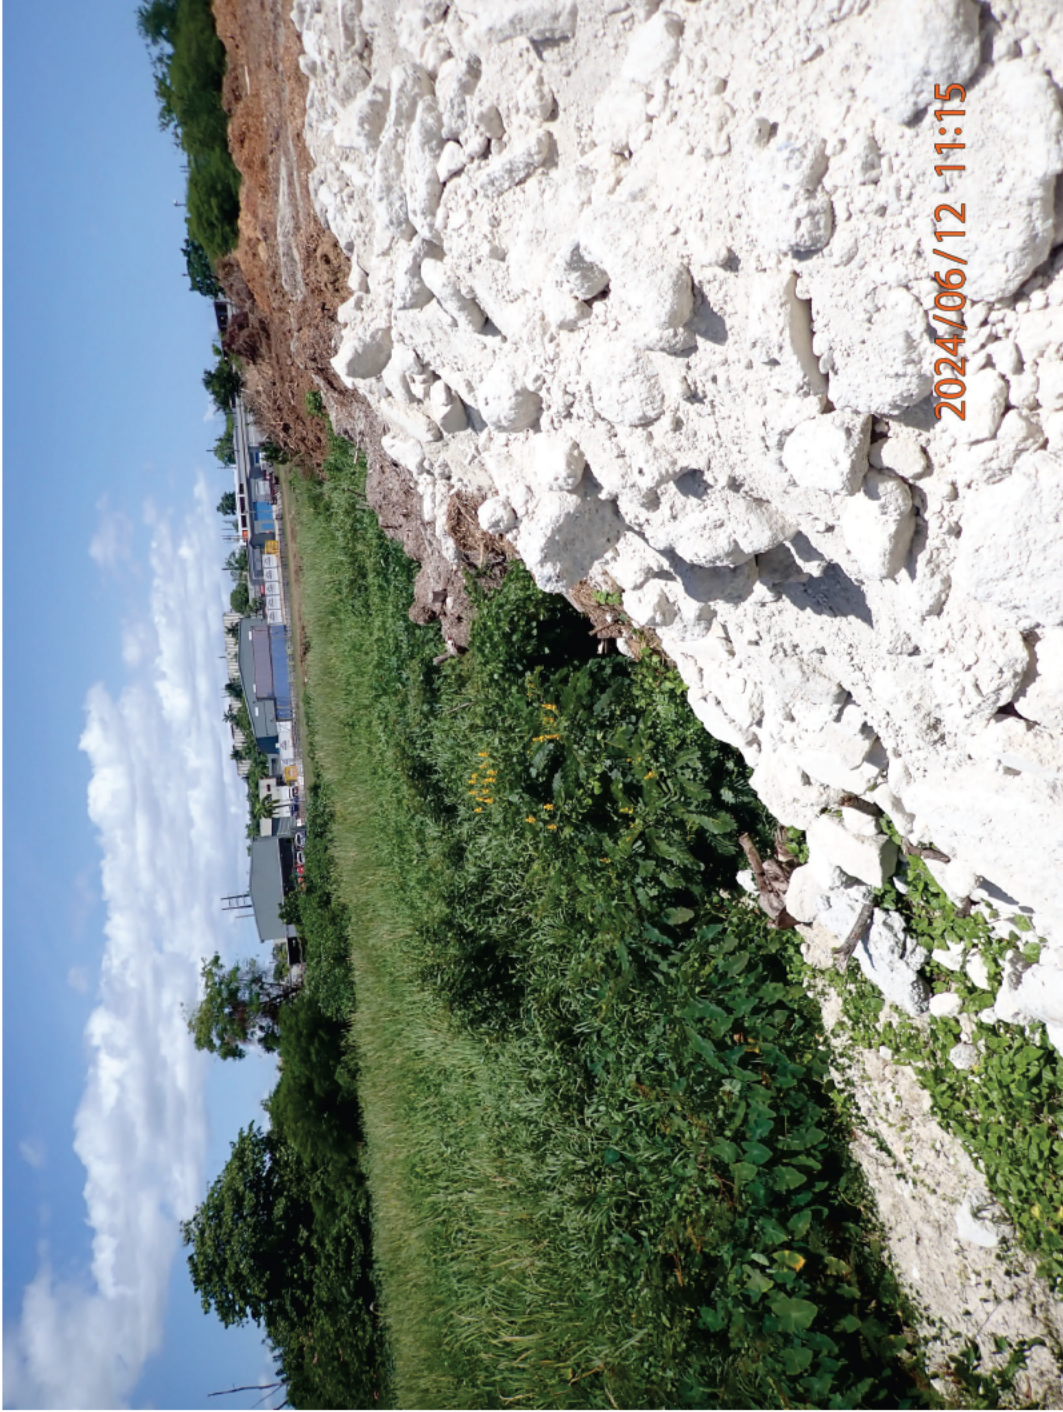
Photo ID: P6121040

Description: View along the southern edge of the fill pile on the property. EPA observed new vegetative debris and aggregate material along the edge and slope of the historic fill pile.

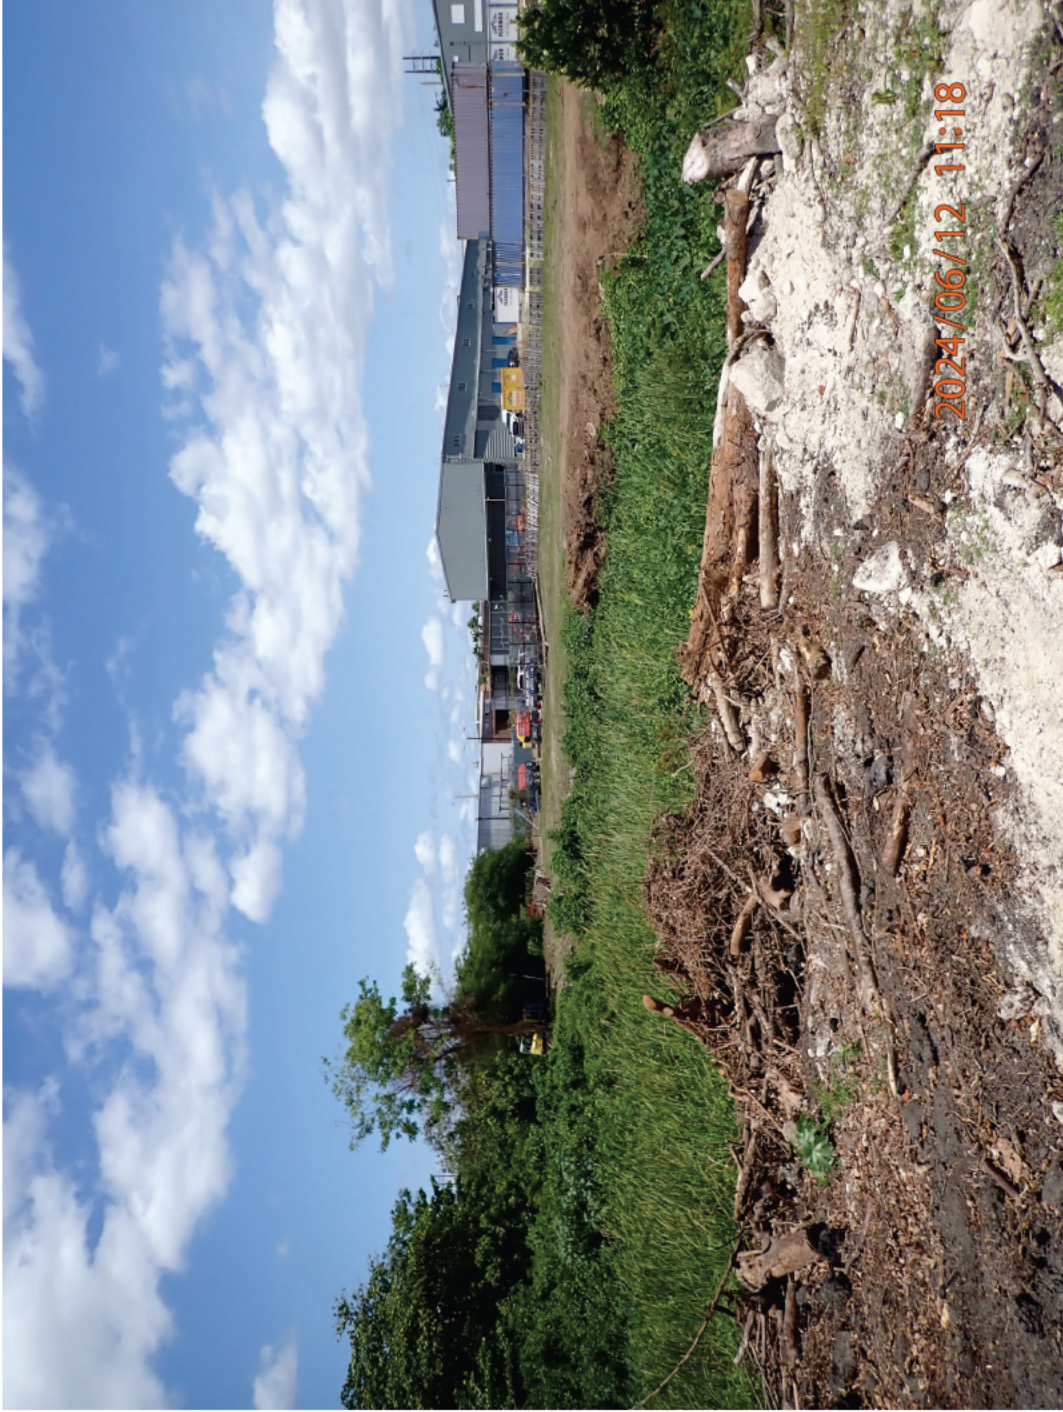
Photo ID: P6121042

Description: View along the edge of the fill pile on the property.
