**Region 6 - Enforcement & Compliance Assurance Division**  
**INSPECTION REPORT**

| Regulatory Program(s) | Water (CWA) Brine Program (Oil & Gas inspection) | |
| Company Name: | <b>Arkansas Production Services, LLC</b> | |
| Facility Name: | <b>Avera-Effie Johnson Tank Battery</b> | |

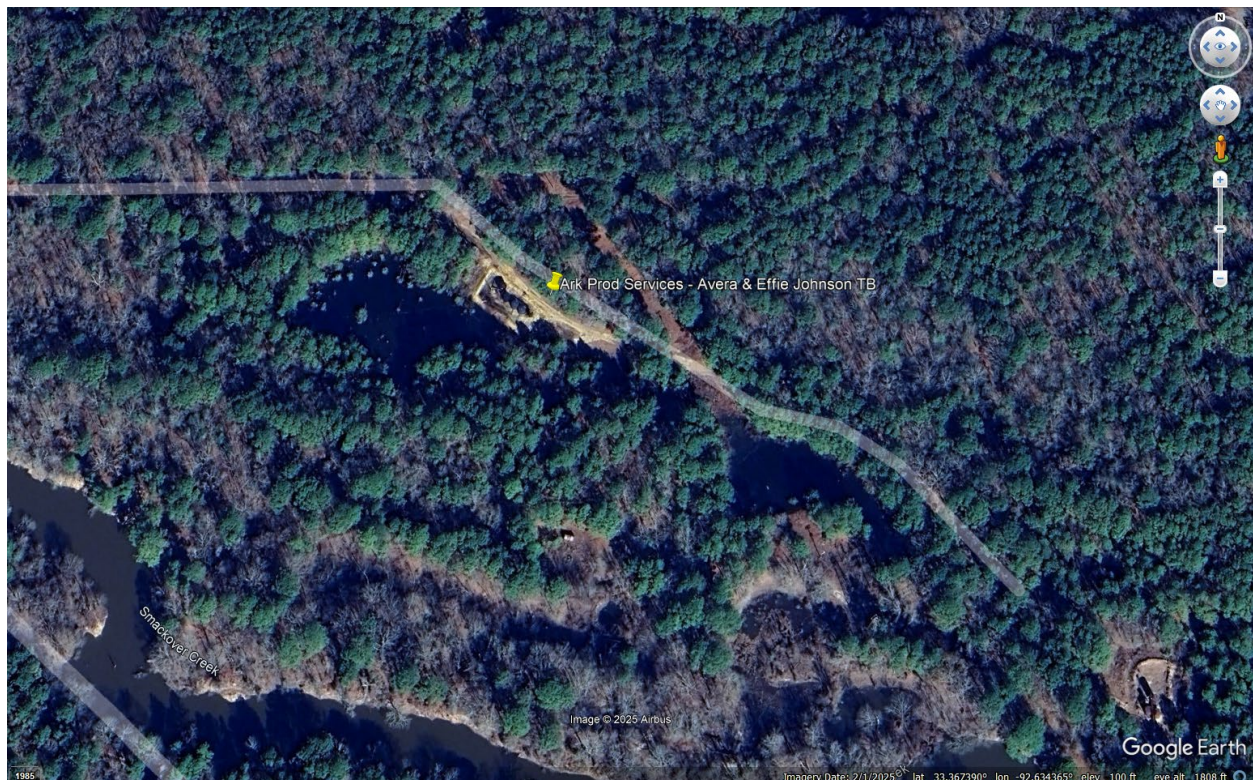
EPA conducted an inspection on the Arkansas Production Services, LLC / Avera-Effie Johnson Tank Battery facility, which contains five (5) tanks for crude oil and saltwater separation and storage, one (1) active production well, and one (1) inactive production well.

**Map 1.** Aerial imagery (Google Earth dated 02/01/2025) of the Arkansas Production Services, LLC / Avera-Effie Johnson Tank Battery facility.

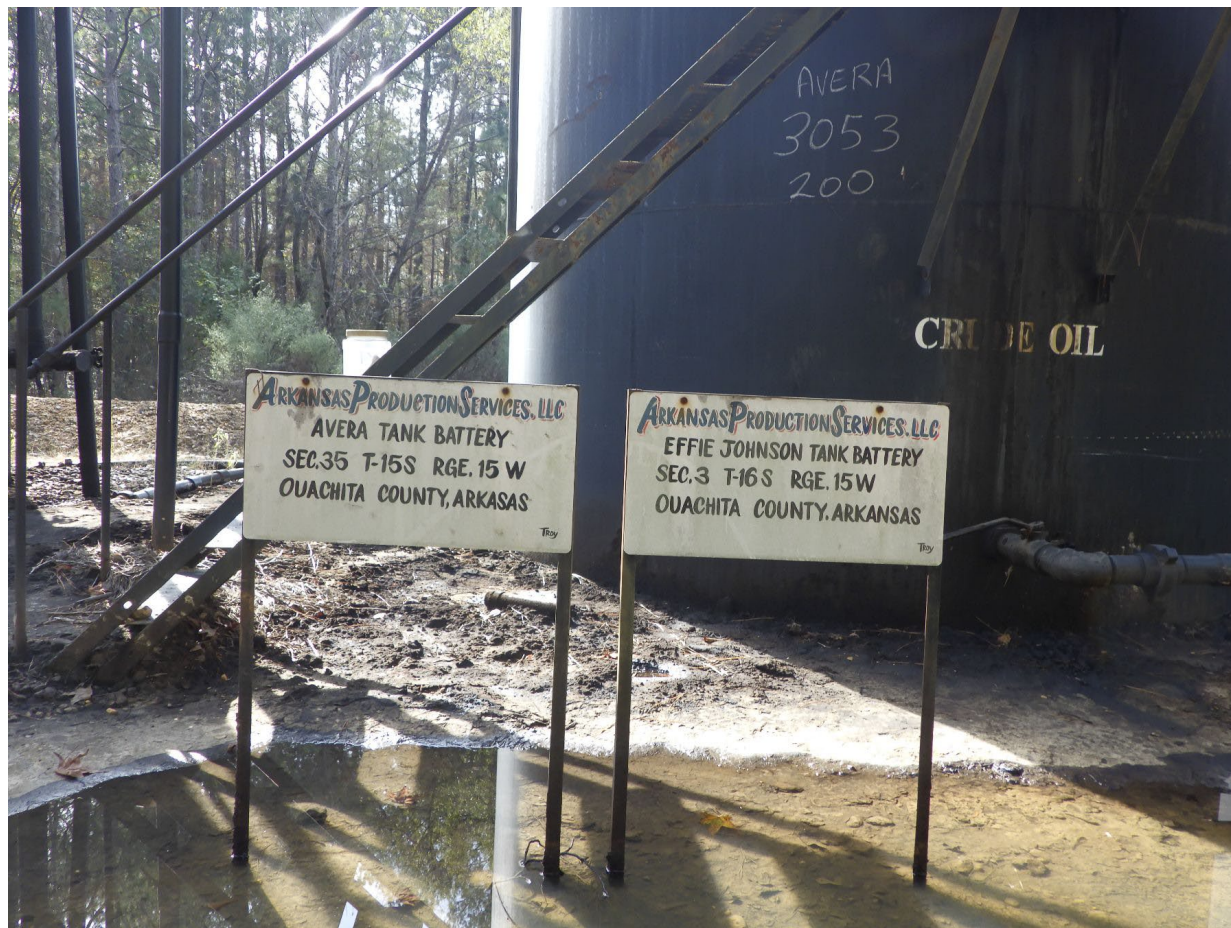
Photo No. 1

I observed the facility signage and an overview of the facility; see Appendix 1 (Photographs Log), Photos No. 1 and No. 2. For additional GPS location and photo metadata, see Appendix 1.

| Description: | Looking W, this photo shows the signage identifying the company and lease names for the facility. | | |

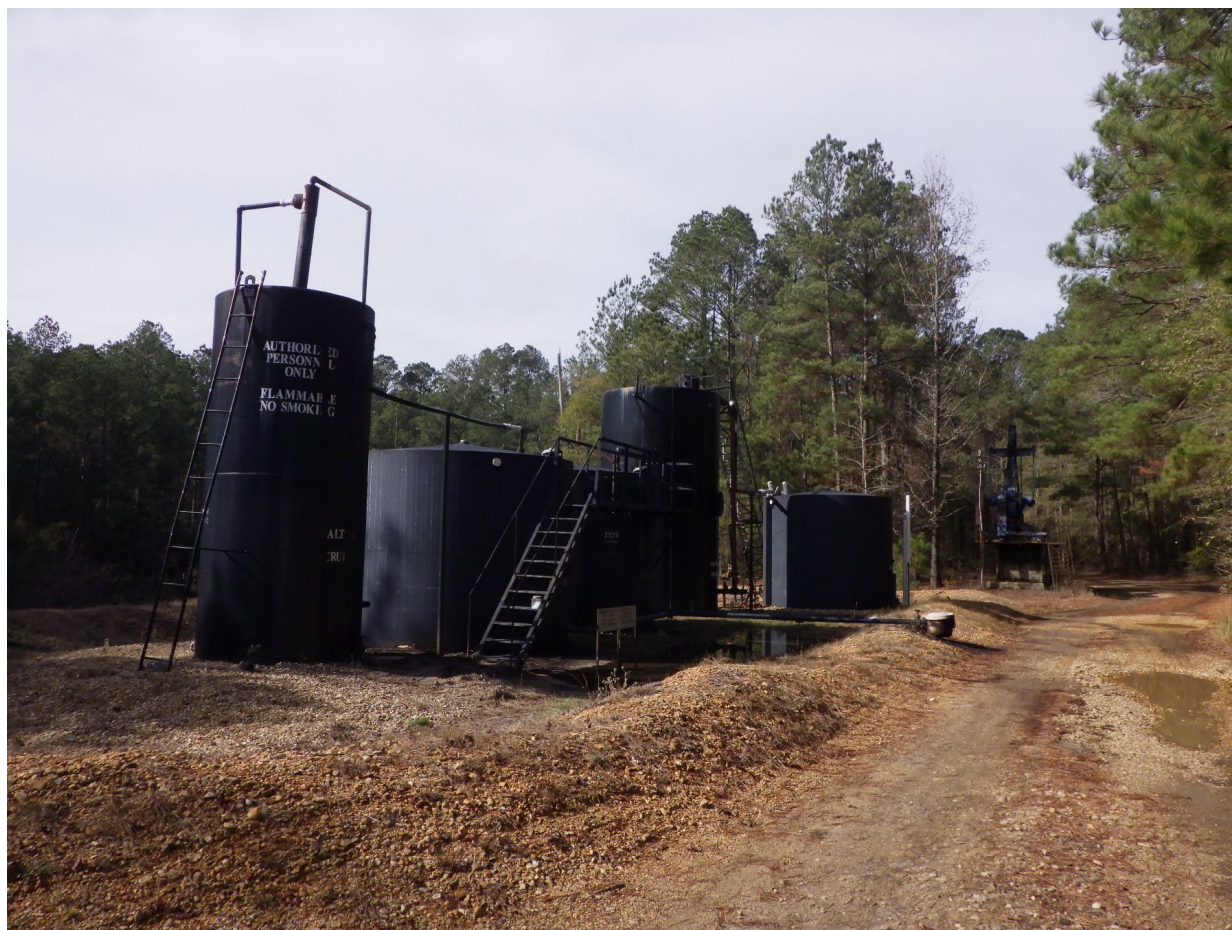
Photo No. 2

| Description: | Looking WNW, this photo shows an overview of the facility with storage tanks for crude oil and saltwater inside containment. | | |

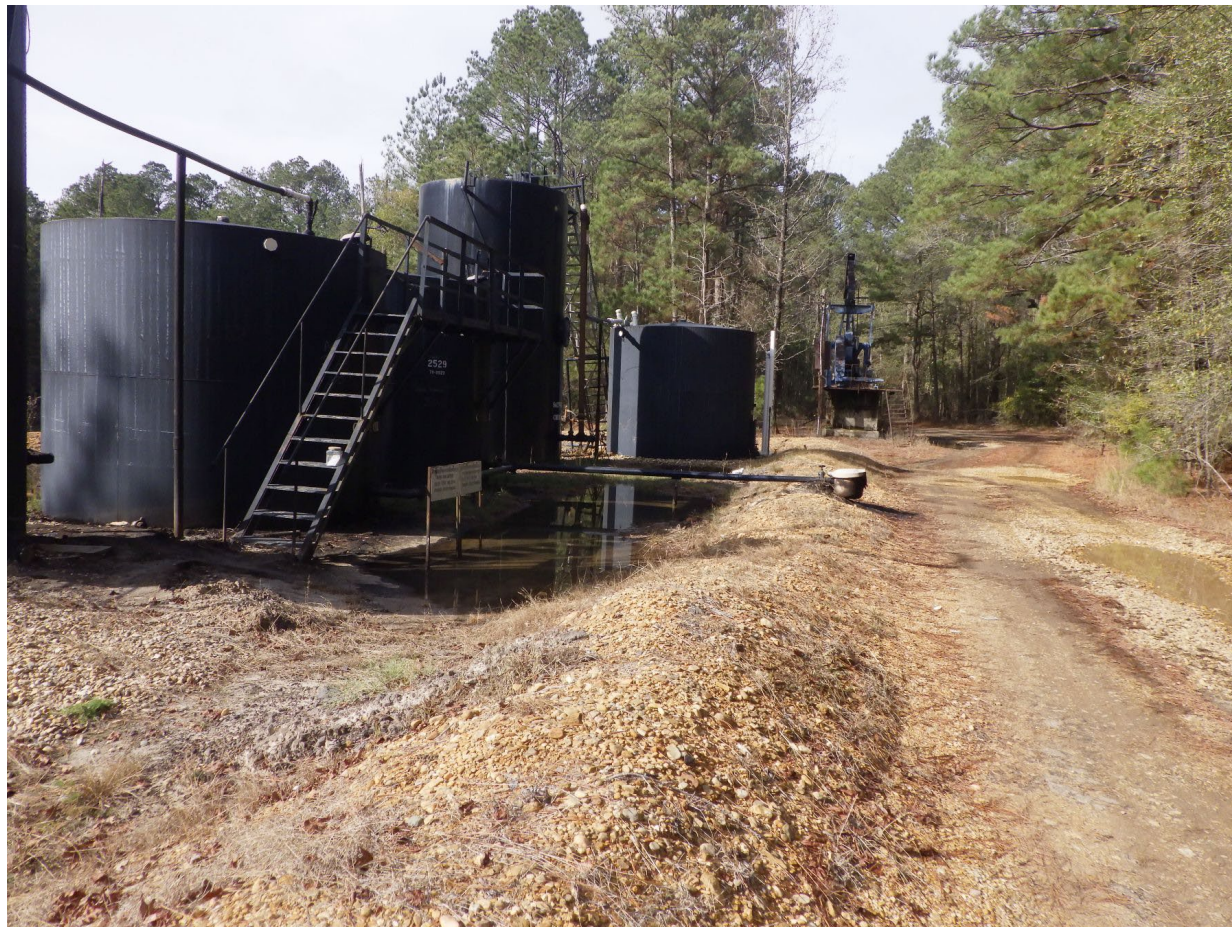
Photo No. 3

I observed the front side of the tank battery, see Photo No. 3.

| Description: | Looking NW, this photo shows the front side of the tank battery. | | |

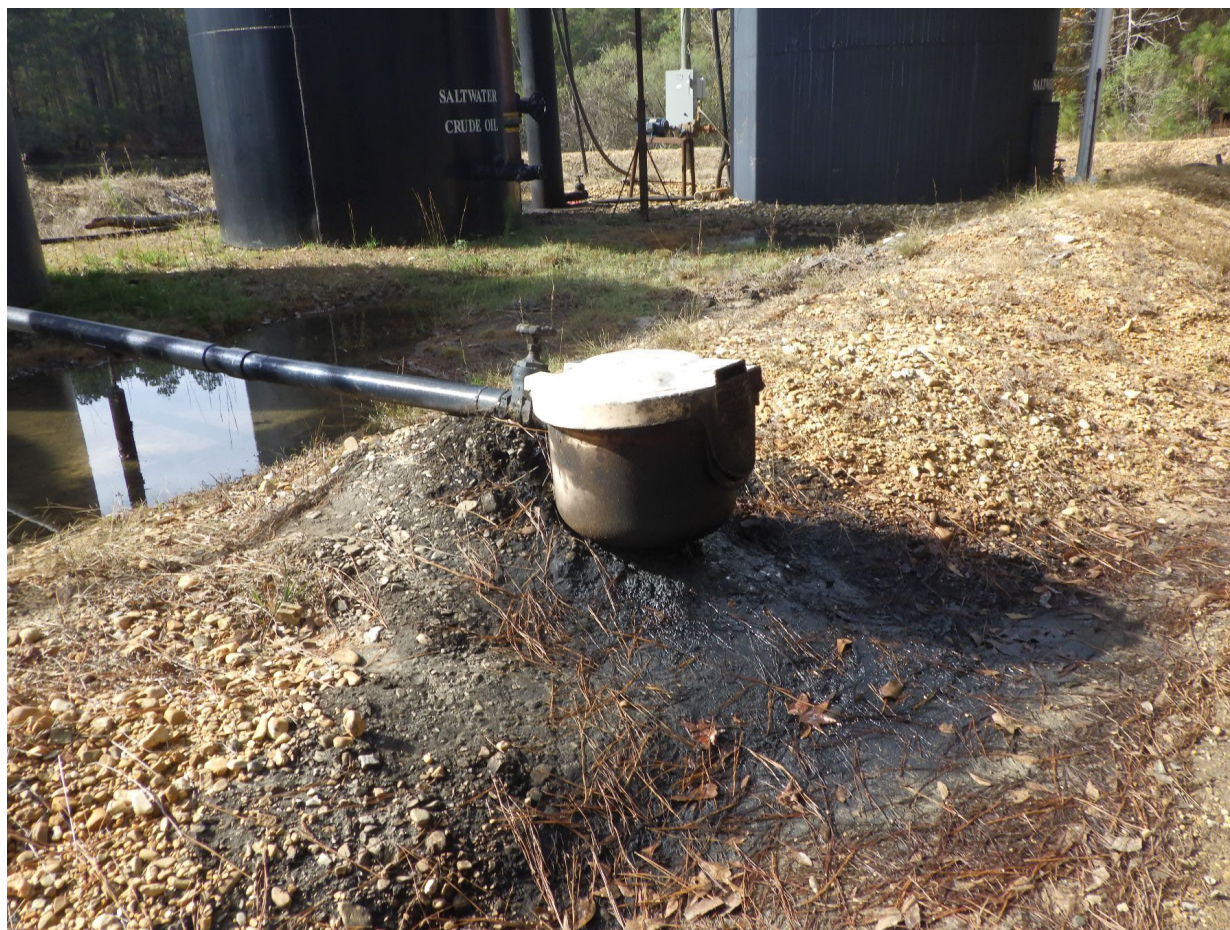
Photo No. 4

I observed the transfer/product line and catchment bucket with residual oil outside containment, see Photo No. 4.

- Loose crude oil outside containment at the transfer/product catchment bucket (Photo No. 4),
- A low area in the berm (Photos No. 8 and No. 9), and
- An active leak of crude oil from overhead piping at the tank battery (Photos No. 11 and No. 12).

| Description: | Looking NW, this photo shows loose oil around the transfer/production line with a catchment bucket in place. | | |

Inspector will conduct follow-up phone calls with the company representative(s) over the coming weeks and months to ensure areas of concern are properly addressed.

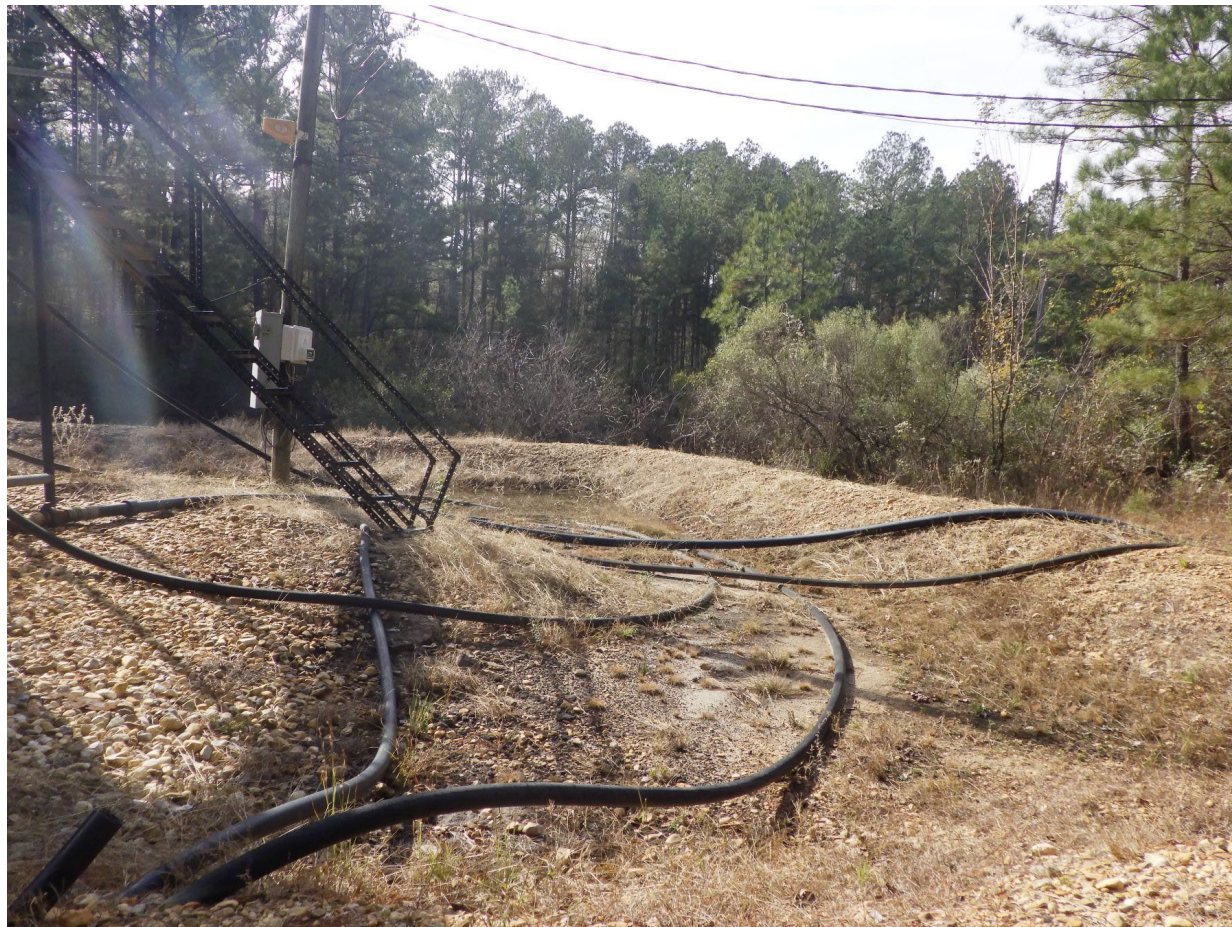
Photo No. 5

I observed the right side of the tank battery with the sump area in the background, see Photo No. 5.

| Description: | Looking W, this photo shows the tank battery (right side) with flowlines inside and outside the tank battery. | | |

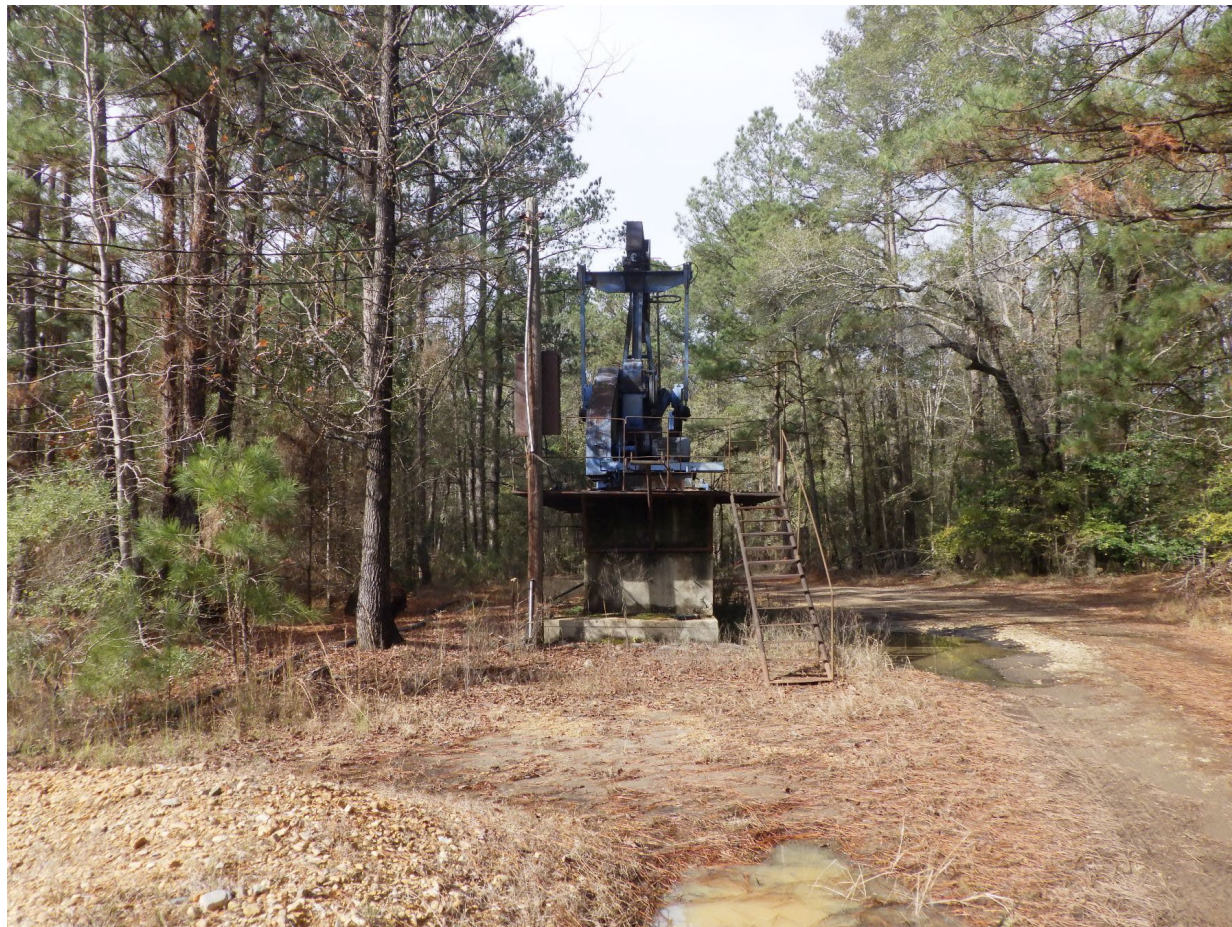
Photo No. 6

I observed the active production well onsite, elevated due to flooding potential, see Photo No. 6.

| Description: | Looking NW, this photo shows a production well (active) with pumpjack adjacent to the facility. | | |

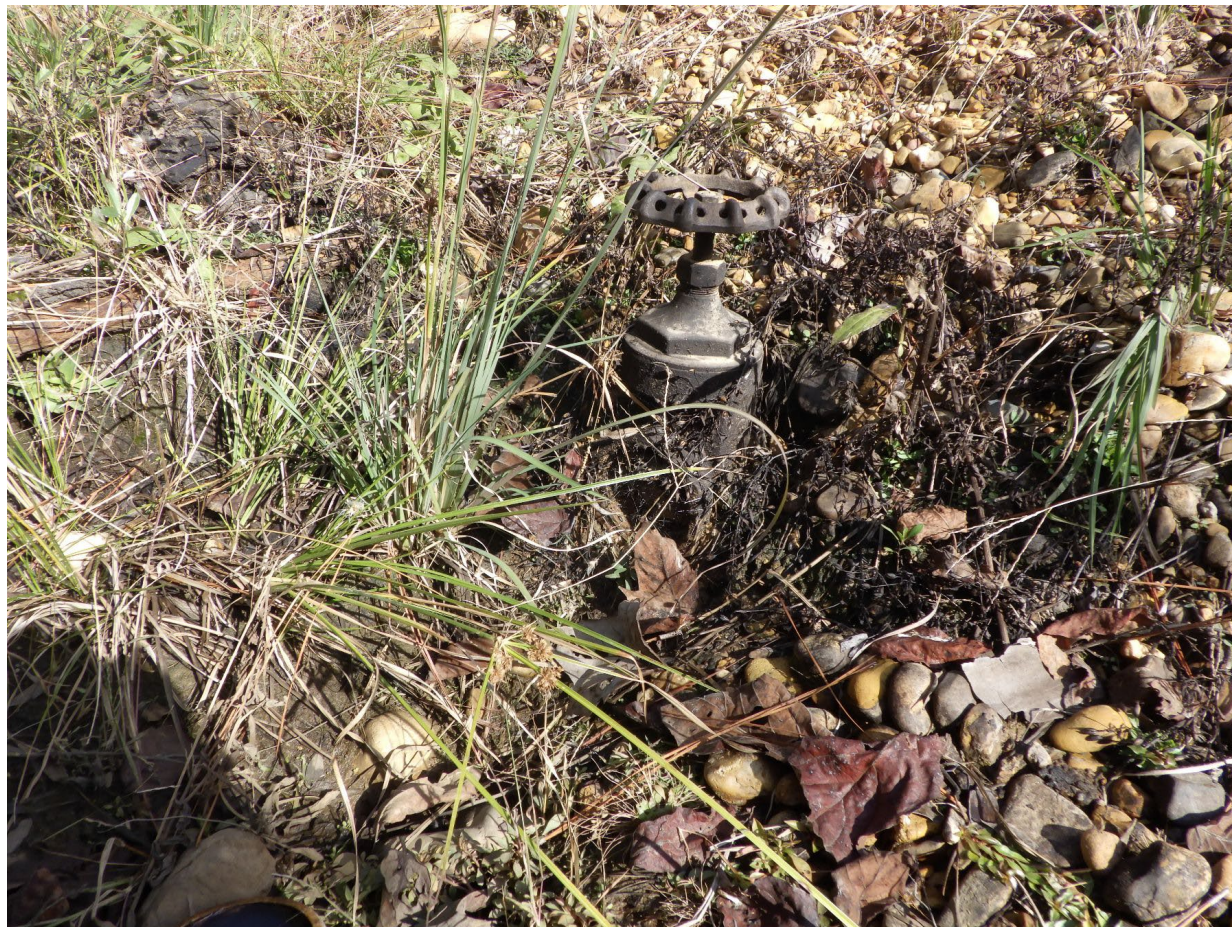
Photo No. 7

I observed the drainpipe for secondary containment with a closed valve and cap, see Photo No. 7.

| Description: | Looking NNE, this photo shows the valve for the drainpipe for the containment. | | |

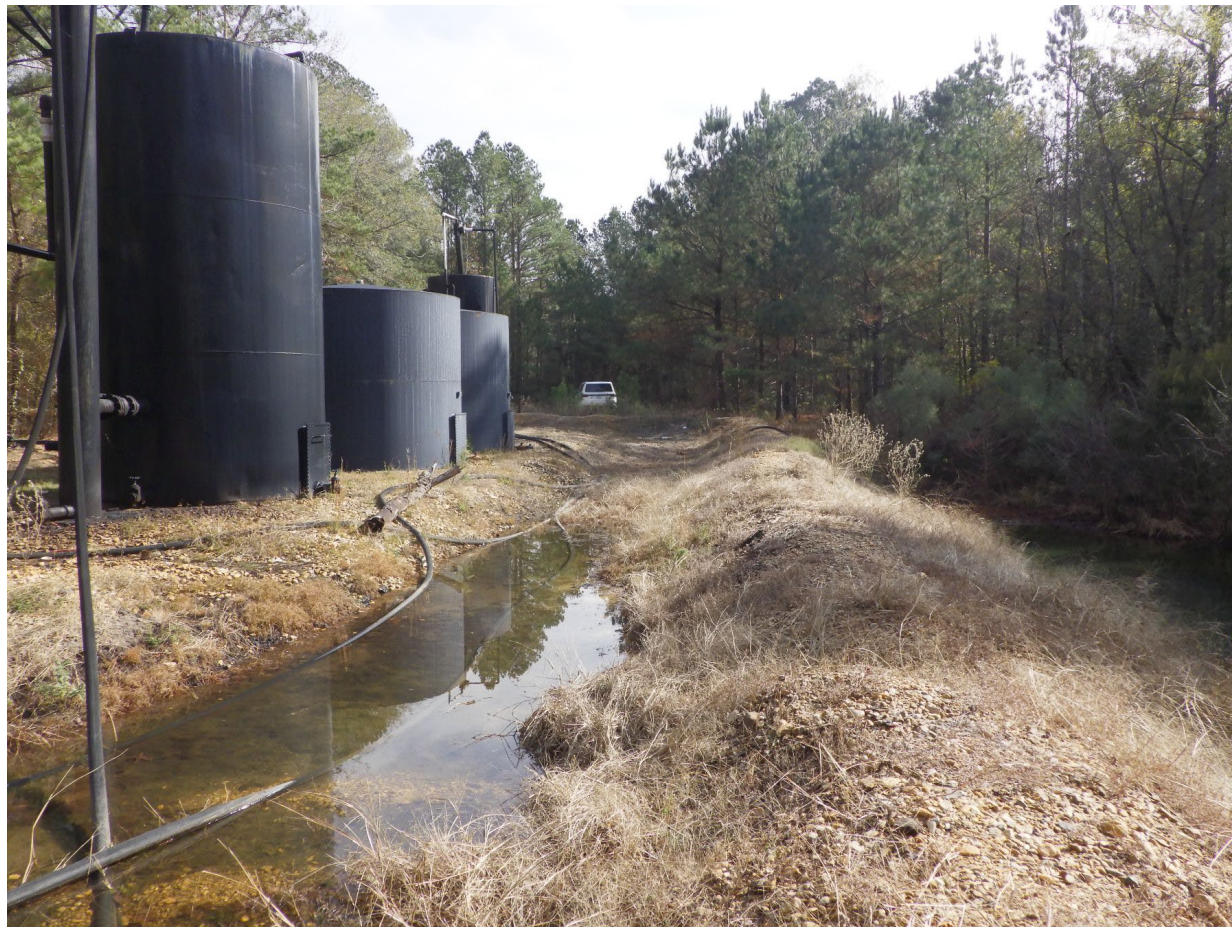
Photo No. 8

I observed the backside of the tank battery with the sump area in the foreground, see Photo No. 8.

| Description: | Looking E, this photo shows the tank battery from the backside with accumulated stormwater in the sump area of the containment. | | |

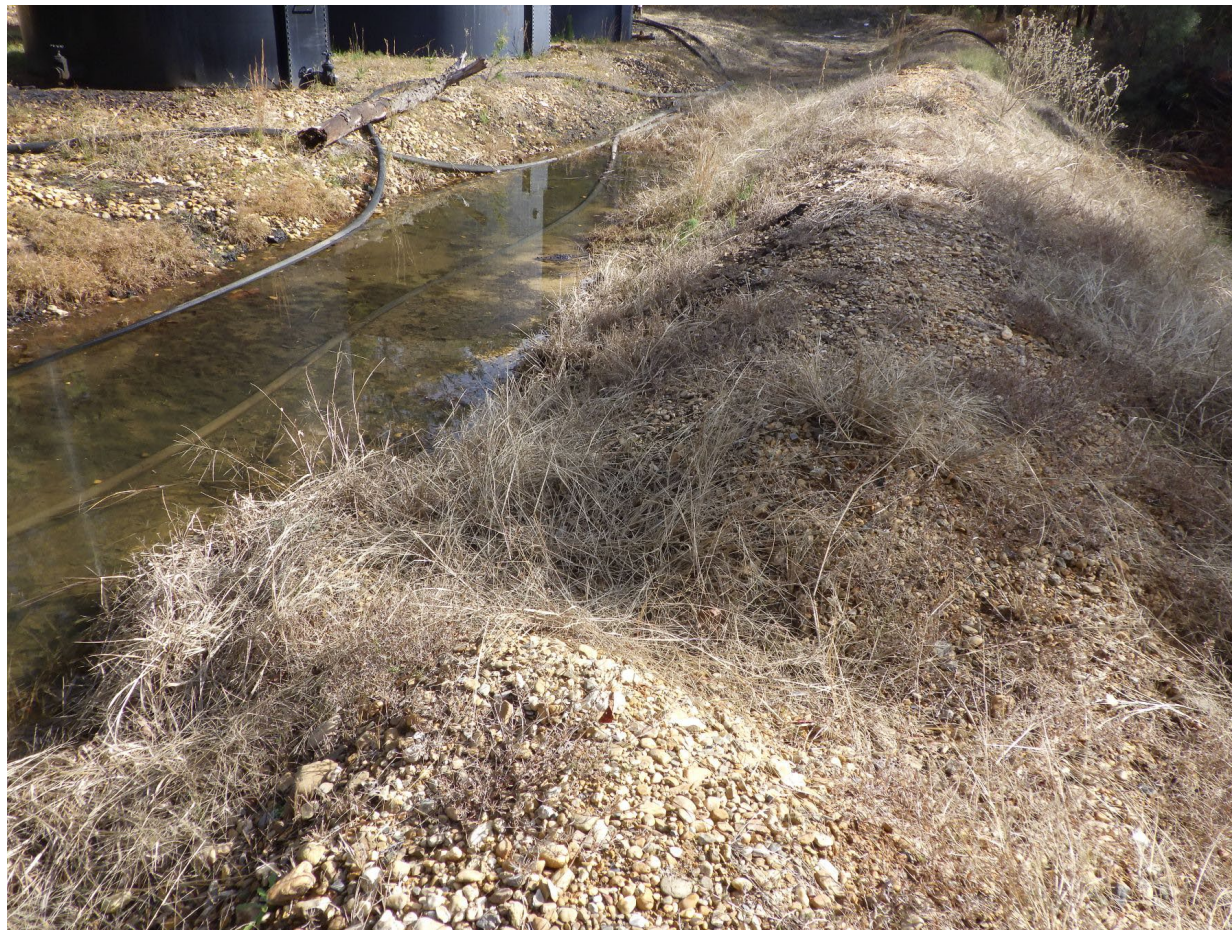
Photo No. 9

I observed a low area in the containment berm on the backside of the berm, see Photo No. 9.

| Description: | Looking NE, this photo shows a low area within the levee of the containment. | | |

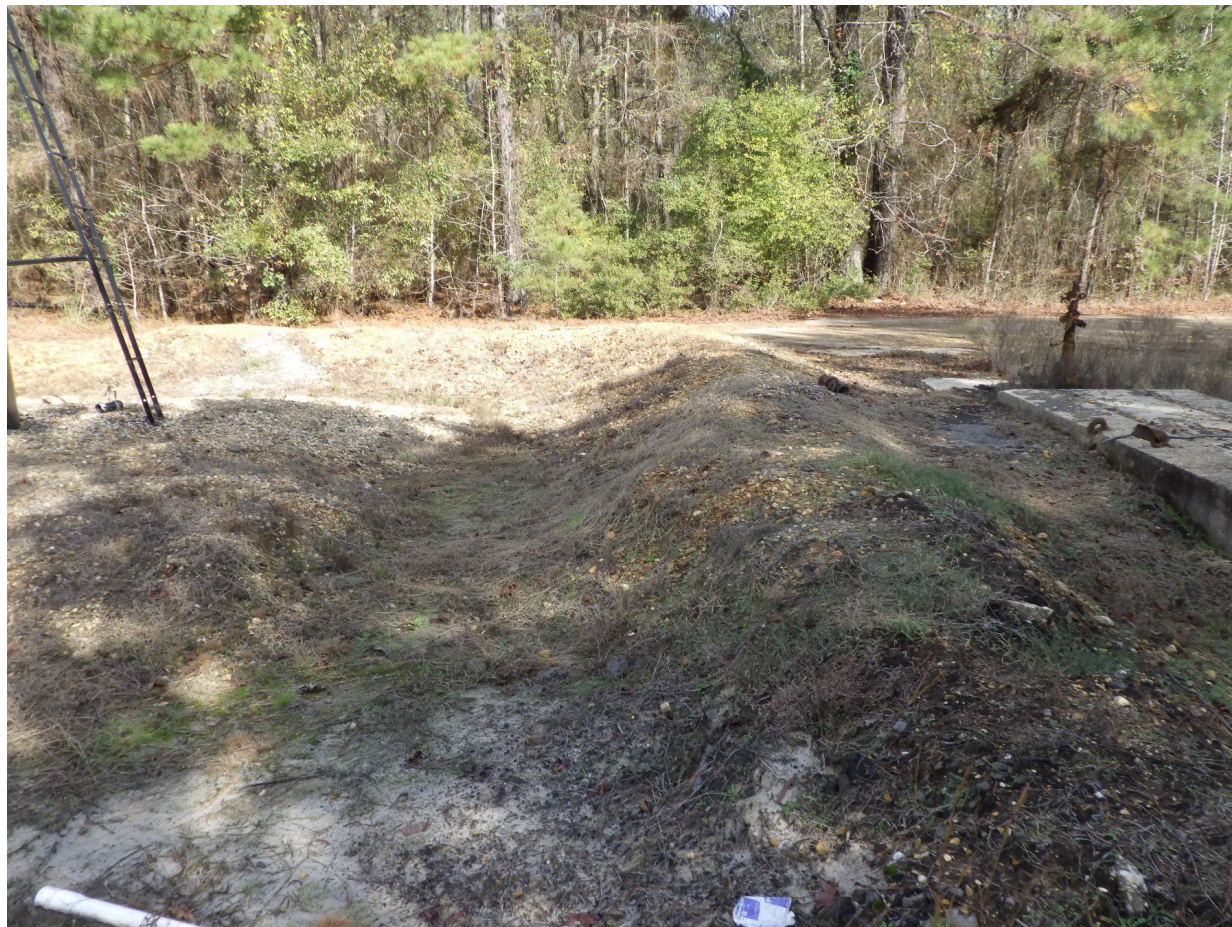
Photo No. 10

I observed the left side of the tank battery with an adjacent inactive production wellhead and concrete pad, see Photo No. 10.

| Description: | Looking NNE, this photo shows the containment (left side) with a production well (inactive) adjacent to the facility. | | |

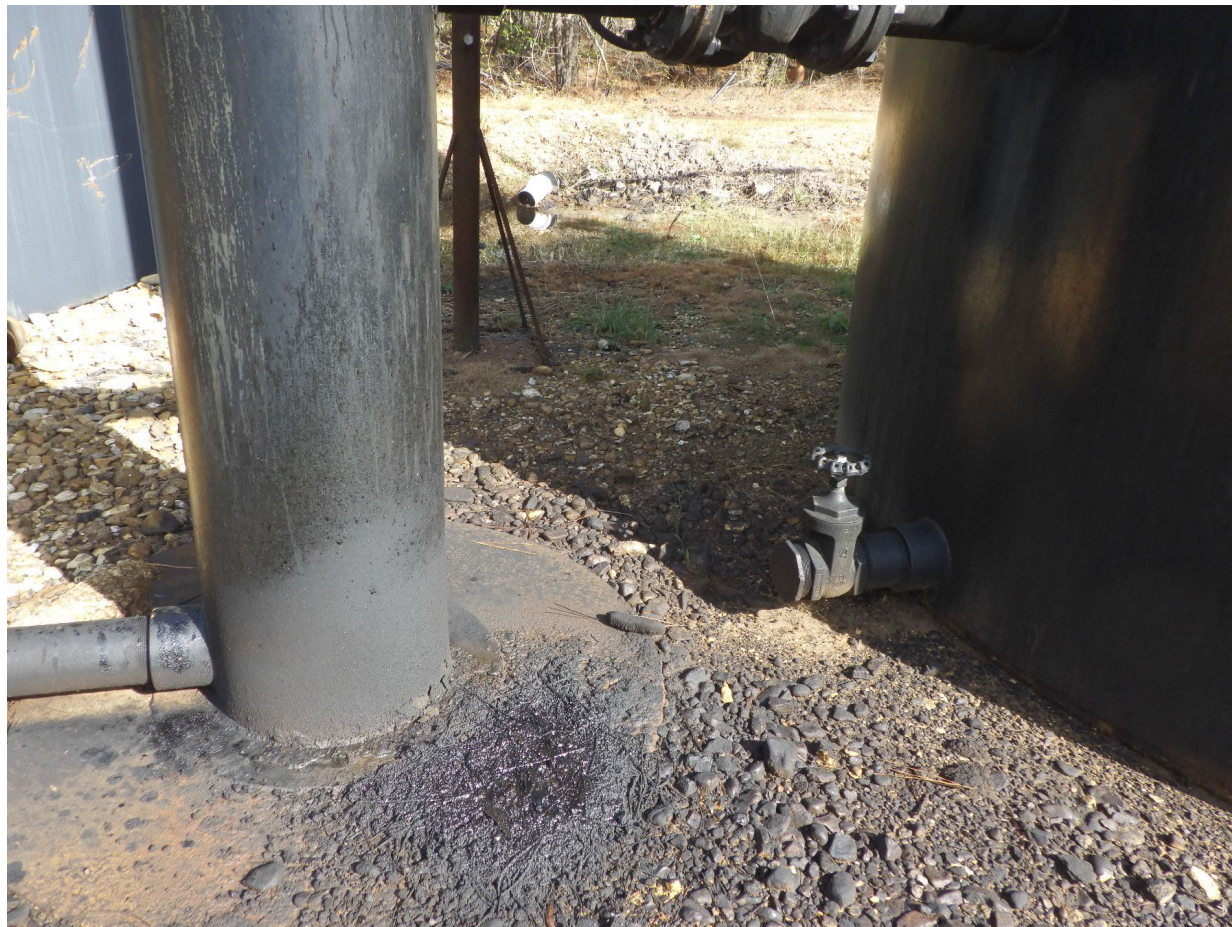
Photo No. 11

I observed an active leak from overhead piping at the tank battery, see Photos No. 11 and No. 12.

| Description: | Looking NNE, this photo shows oil leaking from overhead piping inside containment. | | |

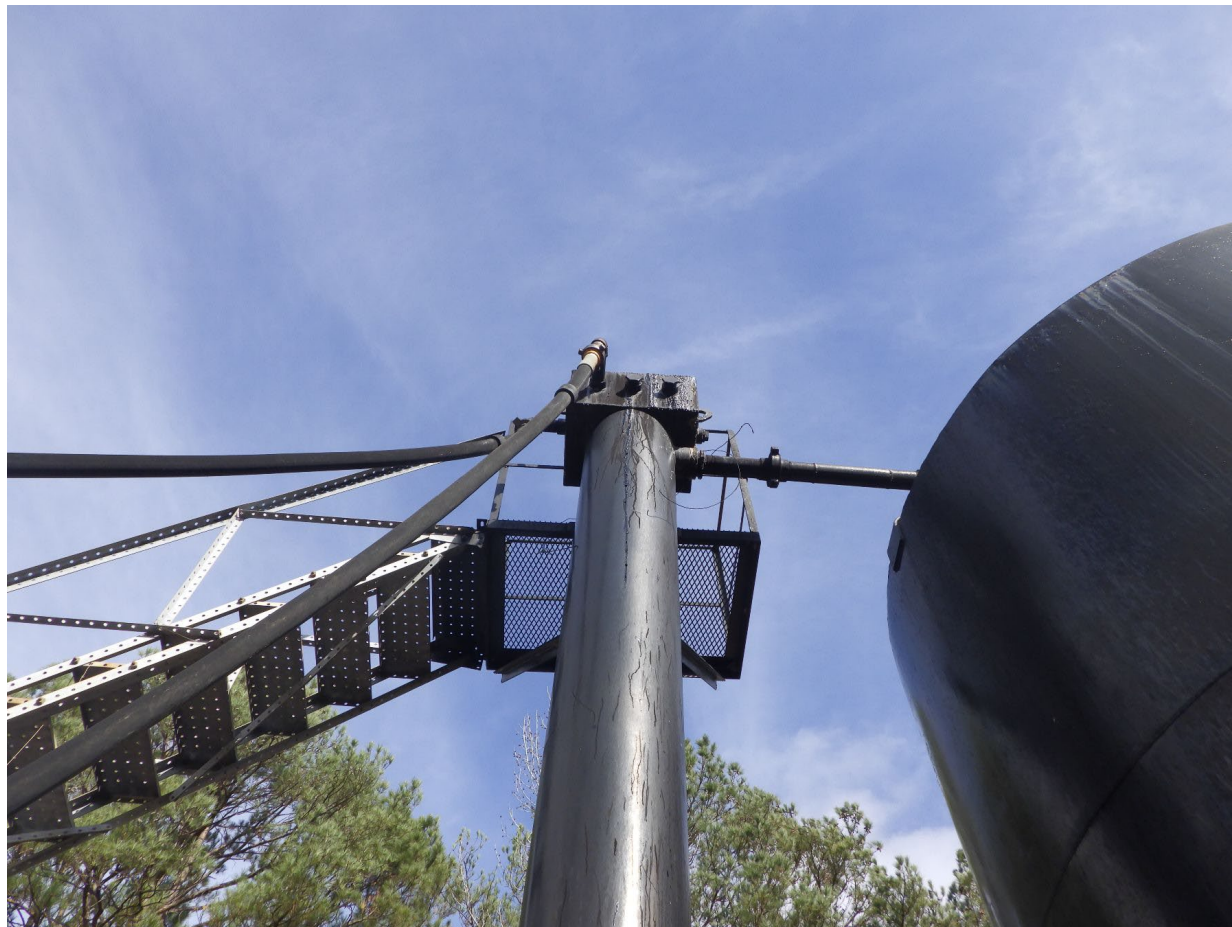
Photo No. 12

| Description: | Looking NNW, this photo shows the source of the leak shown in Photo #11. I observed pipe supports during the inspection. | | |
