## **RCRA Inspection Report**

Safety-Kleen Systems, Inc.  
3023 Dial Street  
Whistler, Alabama 36612

EPA ID# ALD071951628

March 27, 2023

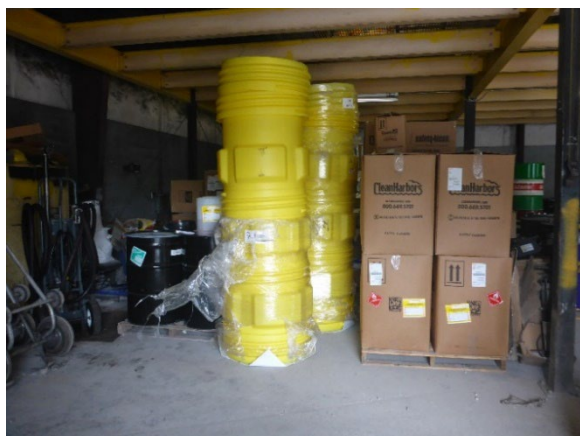
The inspectors observed containers of hazardous and nonhazardous waste and empty overpack drums in the row farthest from the warehouse entrance (Photo 1). The next row held approximately six pallets with cardboard boxes of hazardous and nonregulated waste brought here by Clean Harbors personnel (Photo 1). The third row held three pallets, which were stacked two-high and contained a total of twenty-four empty 55-gallon drums, and three pallets, which were not stacked and contained two 35-gallon drums of hazardous waste empty aerosol cans, one 30-gallon drum of hazardous waste paint, one 55-gallon drum of hazardous waste paint solids, and five 55-gallon drums of used oil (Photo 2). The fourth row contained seven 55-gallon drums of used oil and absorbents and several empty 5-gallon containers (Photo 2). The fifth row contained one pallet, which was stacked two-high and contained four 35-gallon drums labeled D039 hazardous waste liquid, and six 35-gallon drums labeled used cleaning solution petroleum naphtha, non-USEPA regulated waste (Photo 2). The next three rows contained clean parts washing solvent, which will be distributed to customer locations, on wooden pallets stacked up to three pallets high (Photo 2 and 3). The final two rows contained more cardboard boxes of hazardous and nonregulated waste brought here by Clean Harbors, and other waste containers (Photo 3 and 4), including four 55-gallon drums of branch-generated debris (Photo 5).

**Photo 1 (Ten-day Warehouse):** Rows one and two in the ten-day warehouse.

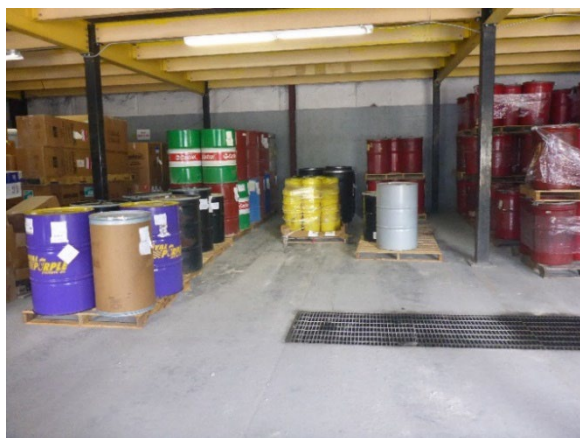
**Photo 2 (Ten-day Warehouse):** Rows three, four, five and six in the ten-day warehouse.

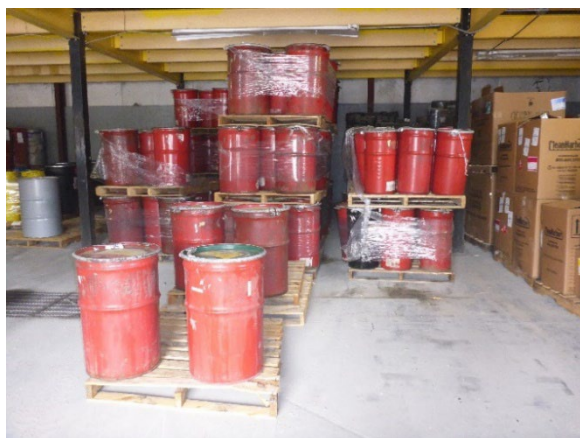
**Photo 3 (Ten-day Warehouse):** Rows six, seven and eight, containing clean parts washing solvent.

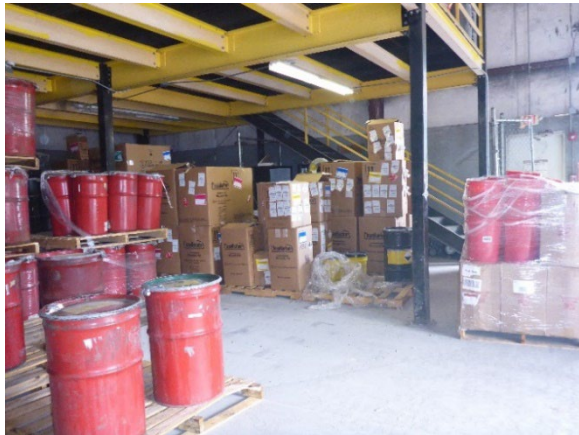
**Photo 4 (Ten-day Warehouse):** Red drums of clean solvent in rows seven and eight, and of cardboard boxes of hazardous and nonregulated waste brought here by Clean Harbors in rows nine and ten.

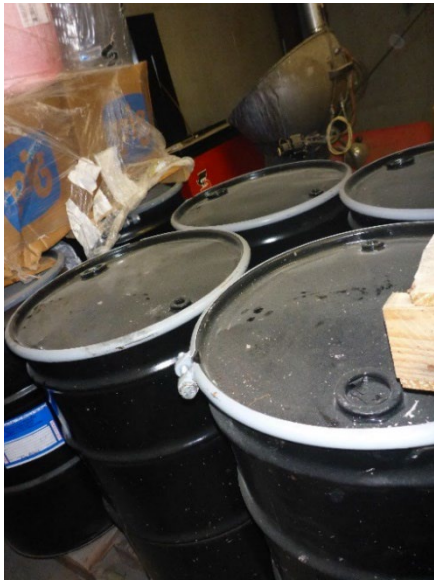
In an email to the inspectors on March 28, 2023, Paul Andrews provided SK's 2023 U.S. National Outbound Waste Shipments summary sheet, which identifies the profile number, DOT shipping description, and EPA Hazardous Waste Codes for branch generated waste. Paul Andrews stated that the PPE/Debris (solids) are included on this summary as "Debris-FB5". According to the summary sheet, contaminated debris identified as Debris-FB5 are hazardous waste environmentally hazardous substances with the EPA Hazardous Waste Codes D004, D005, D006, D007, D008, D009, D010, D011, D018, D019, D021, D022, D023, D024, D025, D026, D027, D028, D029, D030, D032, D033, D034, D035, D036, D037, D038, D039, D040, D041, D042, D043, F002, F003, and F005. The four 55-gallon drums of branch generated debris observed in the second-to-last final row during the inspection were not labeled as hazardous waste or marked with an indication of the hazards of their contents (Photo 5). Furthermore, the containers were stored in an area without sufficient aisle space, and they were not marked with an accumulation start date. In an email to Lanny Sasser on April 11, 2023, Gary Moore stated that the waste in these drums was generated in October 2022.

**Photo 5 (Ten-day Warehouse/CAA):** Four 55-gallon drums of branch-generated debris. Drums were not labeled as hazardous waste, marked with an accumulation start date, or identified with an indication of the hazards of their contents.

**Pursuant to ADEM Admin. Code r. 335-14-3-.01(7)(a)5.(i) [40 C.F.R. § 262.17(a)(5)(i)], which is a condition of the LQG Permit Exemption, a generator is required to mark or label containers with the words "Hazardous Waste"; an indication of the hazards of the contents; the date upon which each period of accumulation begins clearly visible for inspection on each container; and all appropriate EPA hazardous waste numbers associated with the hazardous waste as specified in 335-14-2-.03 and 335-14-2-.04.**

**Pursuant to ADEM Admin. Code r. 335-14-3-.01(7)(b) [40 C.F.R. § 262.17(b)], which is a condition of the LQG Permit Exemption, a large quantity generator who accumulates hazardous waste for more than 90 days is subject to the requirements of 335-14-5 through 9, unless it has been granted an extension to the 90-day period. Such extension may be granted by the Department if hazardous wastes must remain onsite for longer than 90 days due to unforeseen, temporary, and uncontrollable circumstances. An extension of up to 30 days may be granted at the discretion of the Department on a case-by-case basis.**

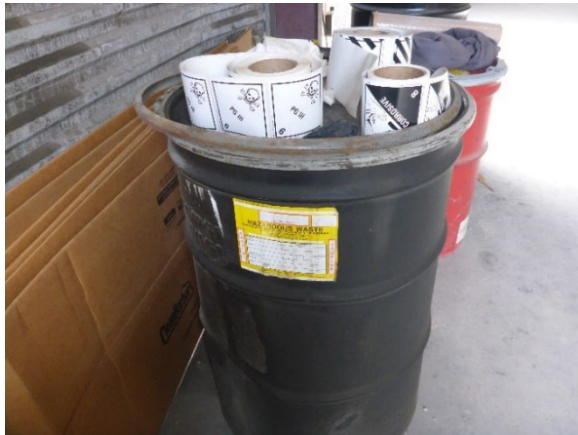
**Photo 7 (Ten-day Warehouse SAA):** Unsecured ring on 55-gallon drum of branch-generated debris. Drum is labeled hazardous waste, but not marked with an indication of the hazards of its contents.

**Pursuant to ADEM Admin. Code r.335-14-3-.01(5)(a)4. [40 C.F.R. § 262.15(a)(5)], which is a condition of the SAA Permit Exemption, a container holding hazardous waste must be closed at all times during accumulation, except: when adding, removing or consolidating waste; or when temporary venting of a container is necessary for the proper operation of equipment, or to prevent dangerous situations, such as build-up of extreme pressure.**

**Pursuant to ADEM Admin. Code r.335-14-3-.01(5)(a)5. [40 C.F.R. § 262.15(a)(5)], which is a condition of the SAA Permit Exemption, a generator is required to mark or label its containers with the words “Hazardous Waste” and with an indication of the hazards of the contents.**

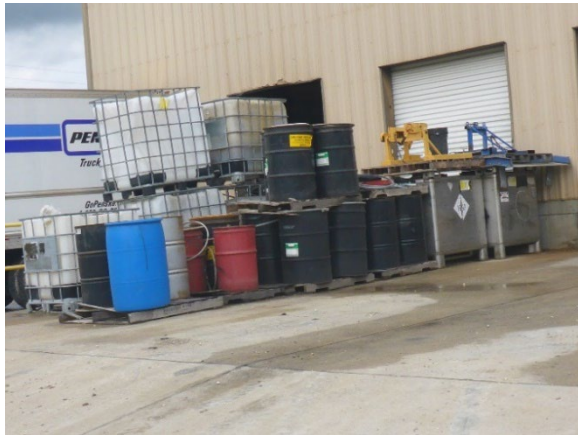
The inspectors observed approximately ten 55-gallon drums labeled nonhazardous waste staged near the bay door outside of the ten-day warehouse (Photo 8). Personnel stated that these drums contain soils that were generated as the result of a spill cleanup event that occurred in February.

**Photo 8 (Facility Yard):** Ten 55-gallon drums labeled nonhazardous waste.

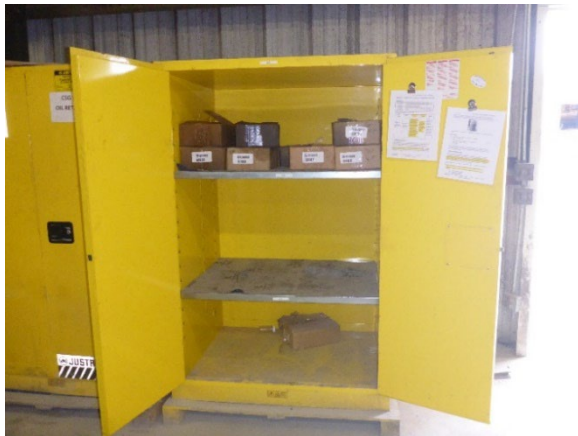
The inspectors observed two storage lockers for storing used oil and vacuum truck retain samples in the Product Storage Warehouse. One flammable locker contained boxes of used oil sample retains (Photo 9) and the other locker contained jars of vacuum truck retain samples (Photo 10). SK’s standard policy is to keep retain samples for at least ninety days, but for no more than 120 days and to remove waste retain samples from the flammable cabinets every thirty days. Aged used oil samples are accumulated as D001 hazardous waste, and aged vacuum truck samples are disposed of as nonhazardous waste. Personnel stated that the facility typically brings a 55-gallon drum to this SAA for accumulating aged used oil samples. They stated that it takes several months to fill a 55-gallon drum, and the full drum is transferred to the CAA located in the ten-day warehouse for storage until it is shipped off-site.

The inspectors did not observe a 55-gallon drum in the SAA at the time of the inspection. However, several boxes of used oil samples were older than 120 days, including one box dated April 2022. The boxes of used oil samples dated prior to November 2022 were not labeled as hazardous waste, were not marked with an indication of the hazards of their contents and were not in containers that were in good condition. Sample jars in some boxes also appeared to be in poor condition, because those boxes were stained and soaked with used oil.

**Photo 9 (Product Storage Warehouse SAA):**  
Flammable locker containing boxes of used oil sample retains and hazardous waste used oil sample retains.

**Pursuant to ADEM Admin. Code r.335-14-3-.01(5)(a)5. [40 C.F.R. § 262.15(a)(5)], which is a condition of the SAA Permit Exemption, a generator is required to mark or label its containers with the words “Hazardous Waste” and with an indication of the hazards of the contents.**

**Pursuant to ADEM Admin. Code r.335-14-3-.01(5)(a)1. [40 C.F.R. § 262.15(a)(5)], which is a condition of the SAA Permit Exemption, if a container holding hazardous waste is not in good condition, or if it begins to leak, the generator must immediately transfer the hazardous waste from this container to a container that is in good condition and does not leak, or immediately transfer and manage the waste in a central accumulation area operated in compliance with 335-14-3-.01(6)(b) or (7)(a).**

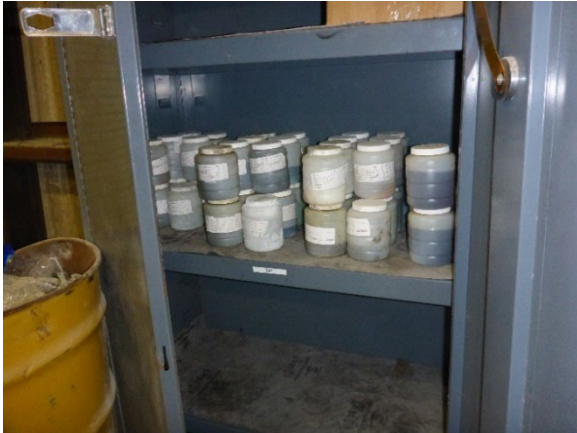
**Photo 10 (Product Storage Warehouse):** Storage locker of vacuum truck retain samples and waste vacuum truck retain samples.
