**Region 6 - Enforcement & Compliance Assurance Division**  
**INSPECTION REPORT**

| Company Name: | <b>H.R. Collier</b> | |
| Facility Name: | <b>Osage Happy Hollow Lease</b> | |

EPA conducted an inspection at the H.R. Collier, Osage Happy Hollow lease where a ruptured poly flowline released a company estimated 5 barrels of crude oil and 1 barrel of saltwater to the land surface. Spill impacts migrated to a nearby unnamed tributary of Little Hominy Creek and travelled generally south, ultimately impacting Little Hominy Creek.

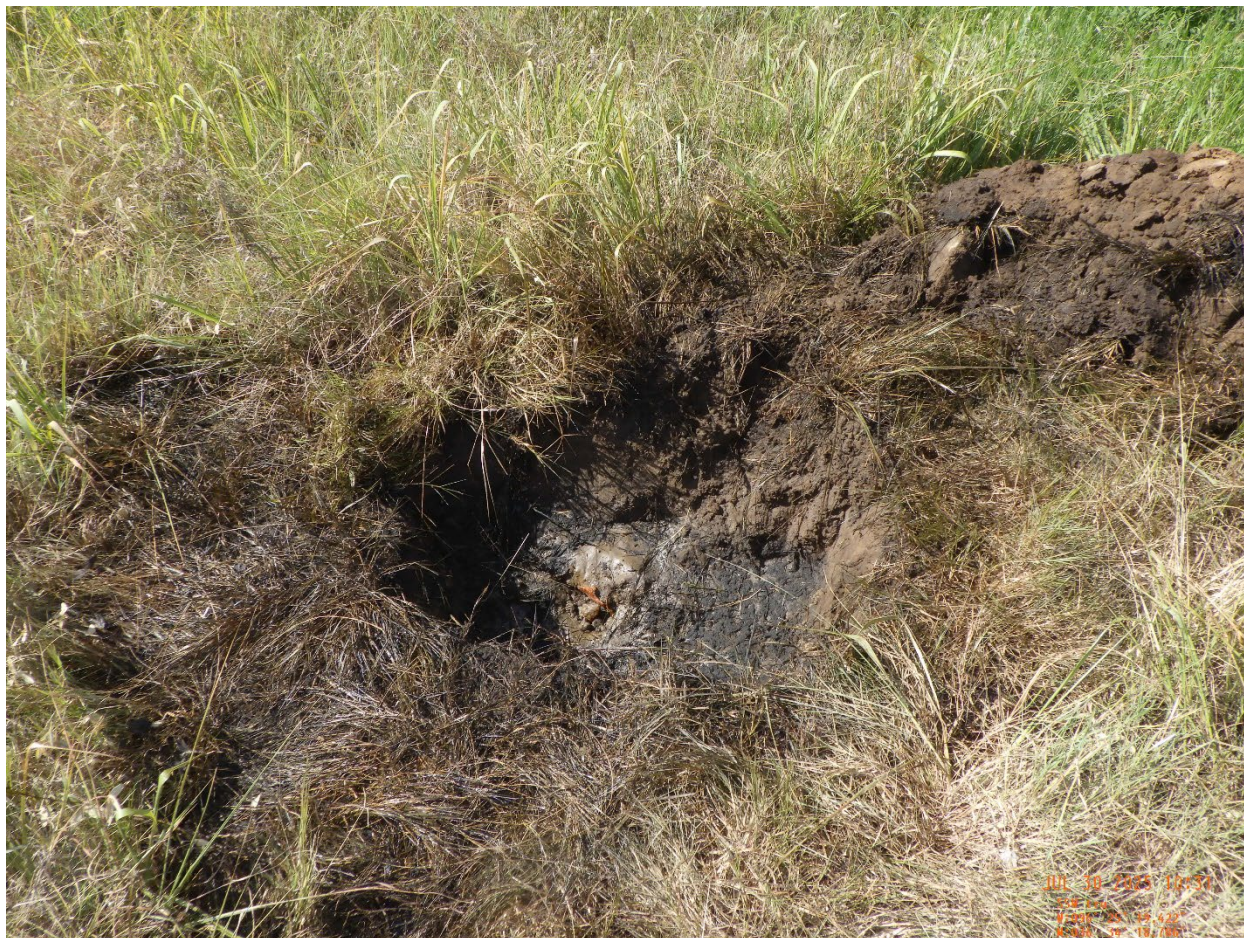
Photo No. 1

I observed the release point of the spill which was a 2" poly production flowline which ruptured during a startup procedure. See photo No. 1. For additional GPS location information and photo metadata, please see Appendix 1 (photo log) attached to this report.

**Description:** This was the release point of the spill, a 2" poly flowline carrying produced water/oil.

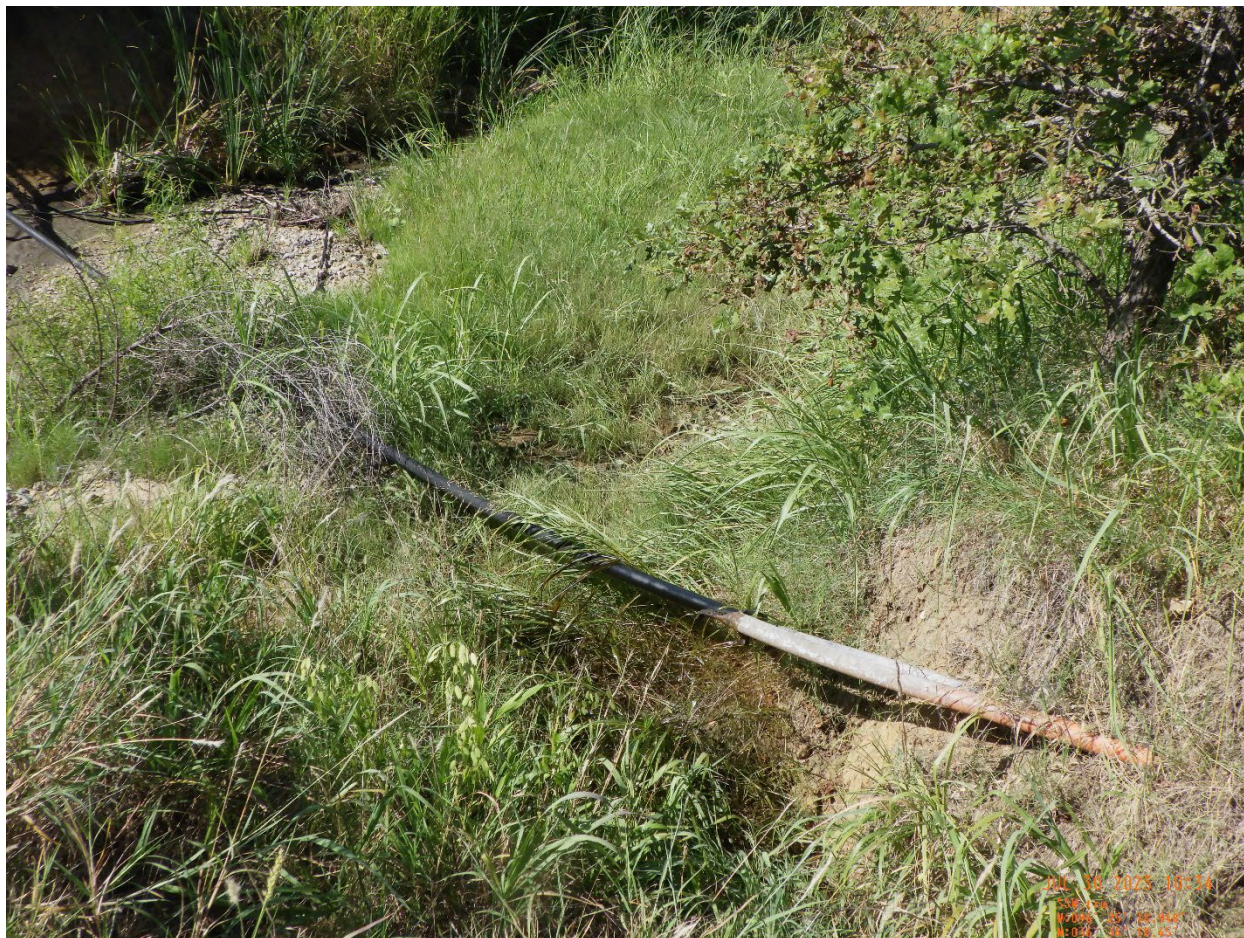
Photo No. 2

I observed the point of entry (POE) into the unnamed tributary of Little Hominy Creek. At the time of the inspection the tributary was dry at the POE. See photo No. 2.

**Description:** This was the point of entry (POE) into the unnamed tributary of Little Hominy Creek. The tributary was dry at this location.

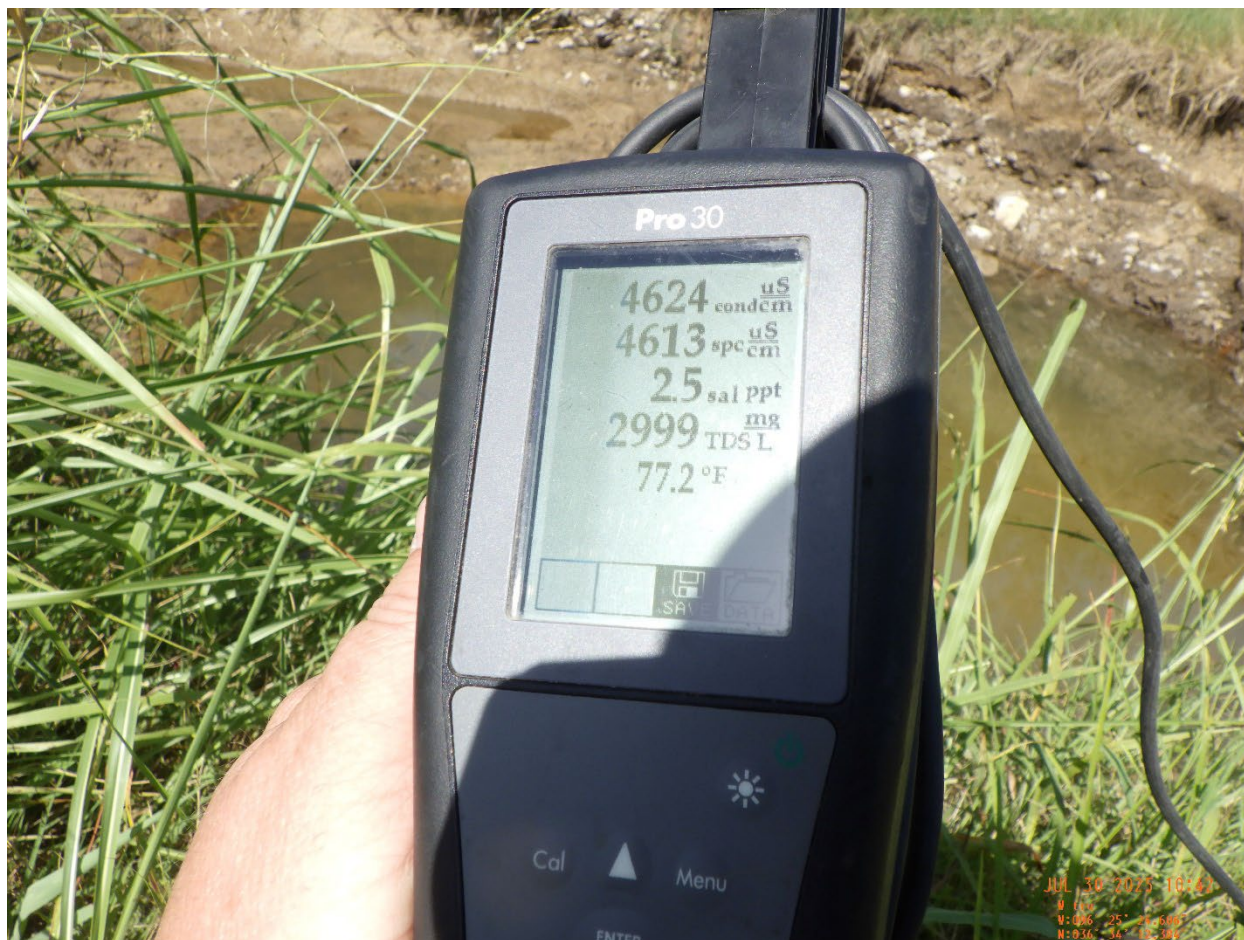
Photo No. 3

Approximately ¼ mile downstream from the POE into the unnamed tributary, I observed a TDS field reading of 2,999 mg/L at the first pool of water available for observance. This was the highest observed TDS field reading of the inspection. At this same location, a small amount of oil was floating on the surface of the water. See photo No. 3 and 4.

**Description:** A TDS field reading of 2,999 mg/L was observed at the first pool of water downstream from the POE in the unnamed tributary of Little Hominy Creek.

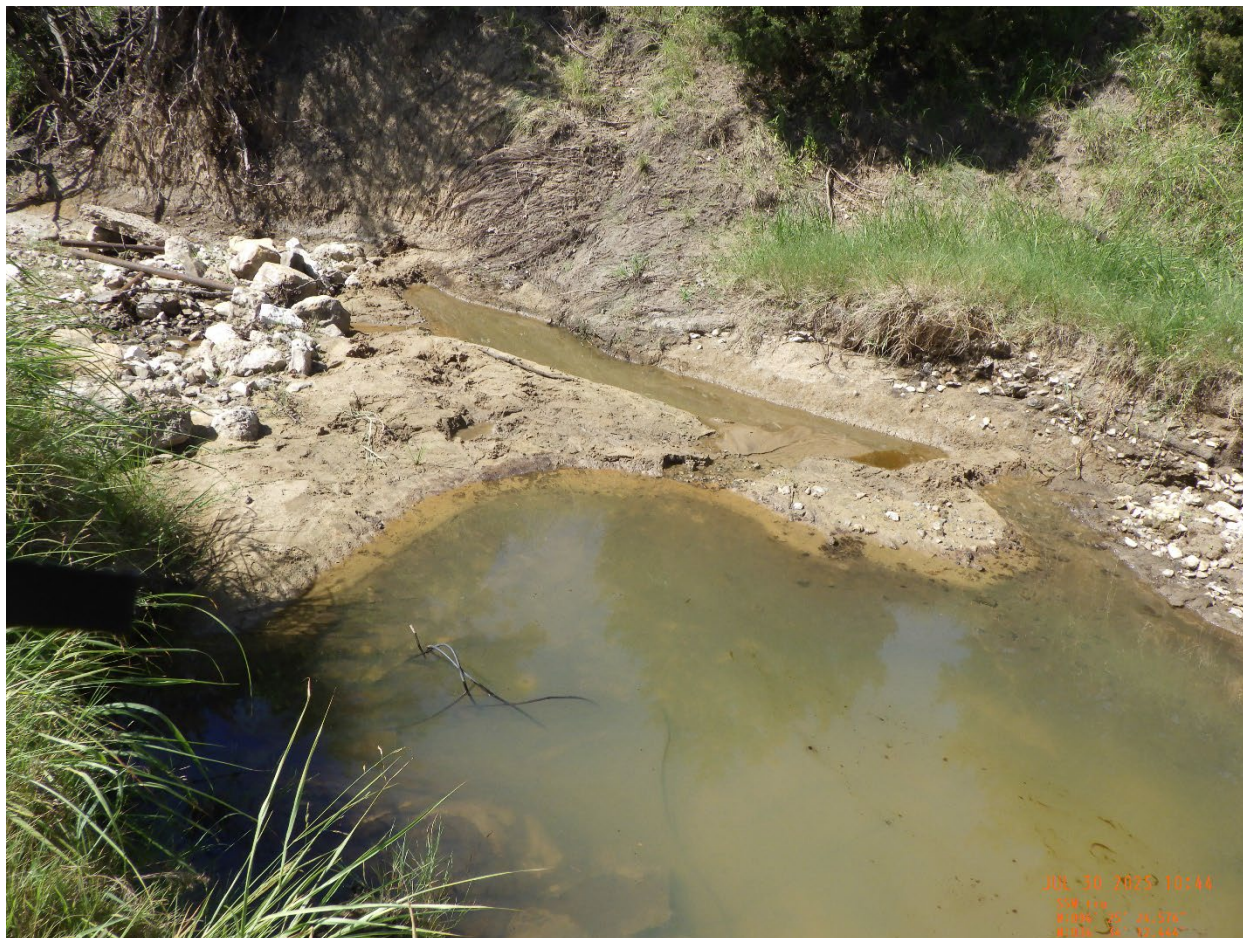
Photo No. 4

**Description:** This was the first pool of water downstream from the POE, the same location where the TDS field reading from photo No. 3 was observed. A small amount of oil was floating on the pool of water.

Cleanup was underway at the time of the inspection. Industrial absorbent material, absorbent pads and absorbent booms were being used to remove oil from the impacted areas.

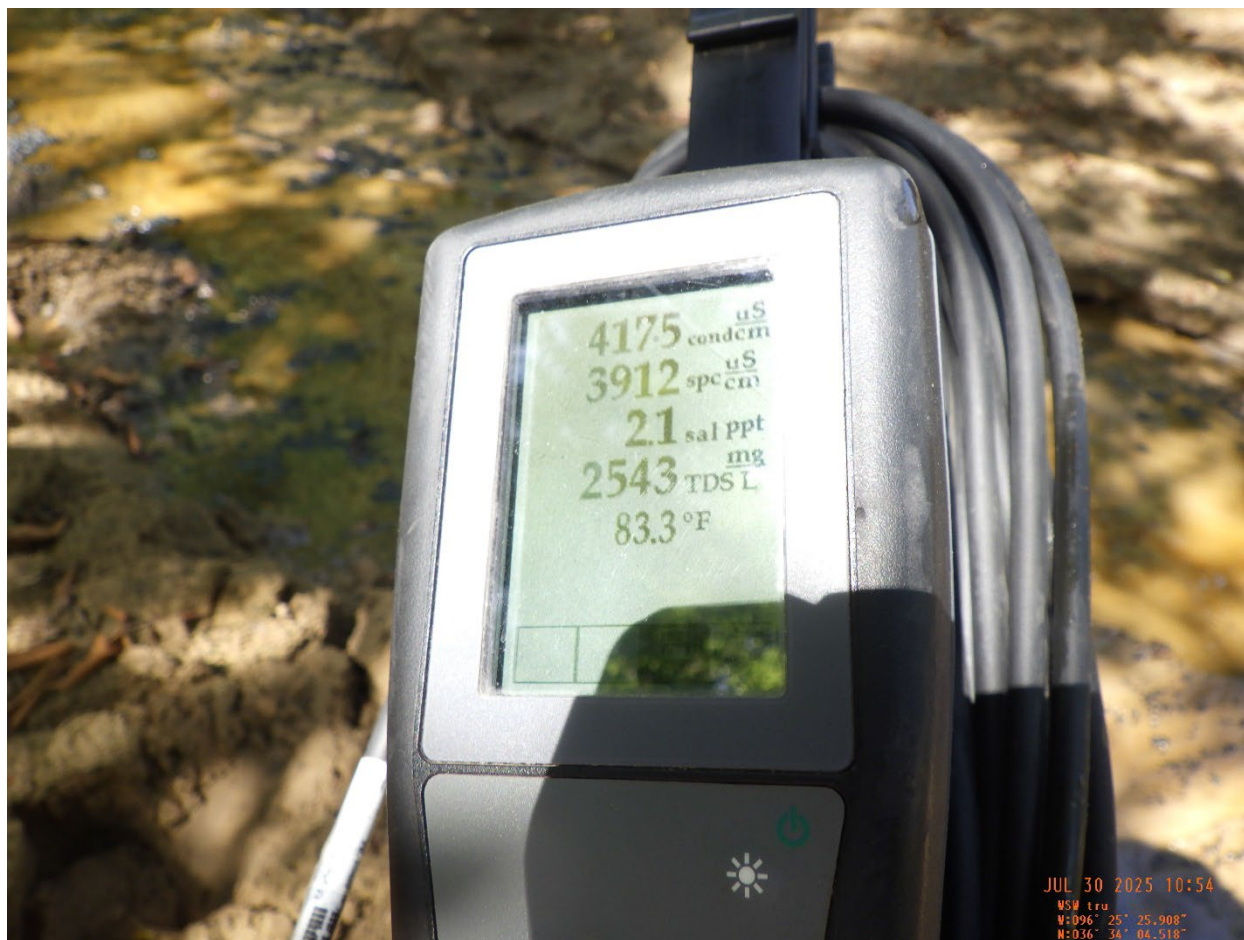
Photo No. 5

Continuing approximately 800 feet downstream, near the confluence of the unnamed tributary and Little Hominy Creek, I observed a TDS field reading of 2,543 mg/L. A small amount of oil was continuing to migrate down the unnamed tributary at the time of the inspection. See photos No. 5 and 6.

**Description:** This was a TDS field reading of 2,543 mg/L observed in the unnamed tributary immediately upstream from the confluence with Little Hominy Creek.

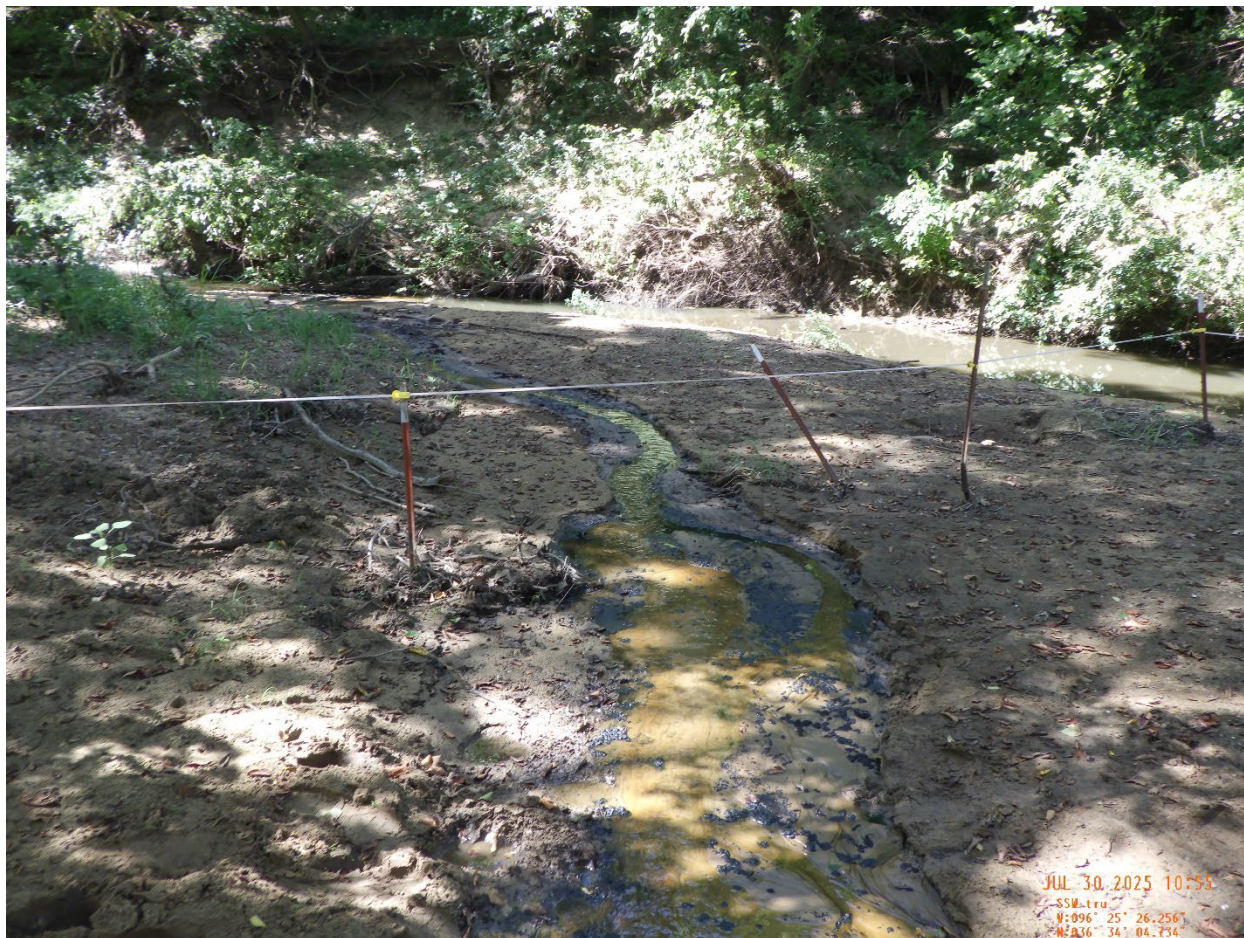
Photo No. 6

**Description:** This was a view along the unnamed tributary looking toward the POE into Little Hominy Creek. Elevated TDS and oil were present at the location.

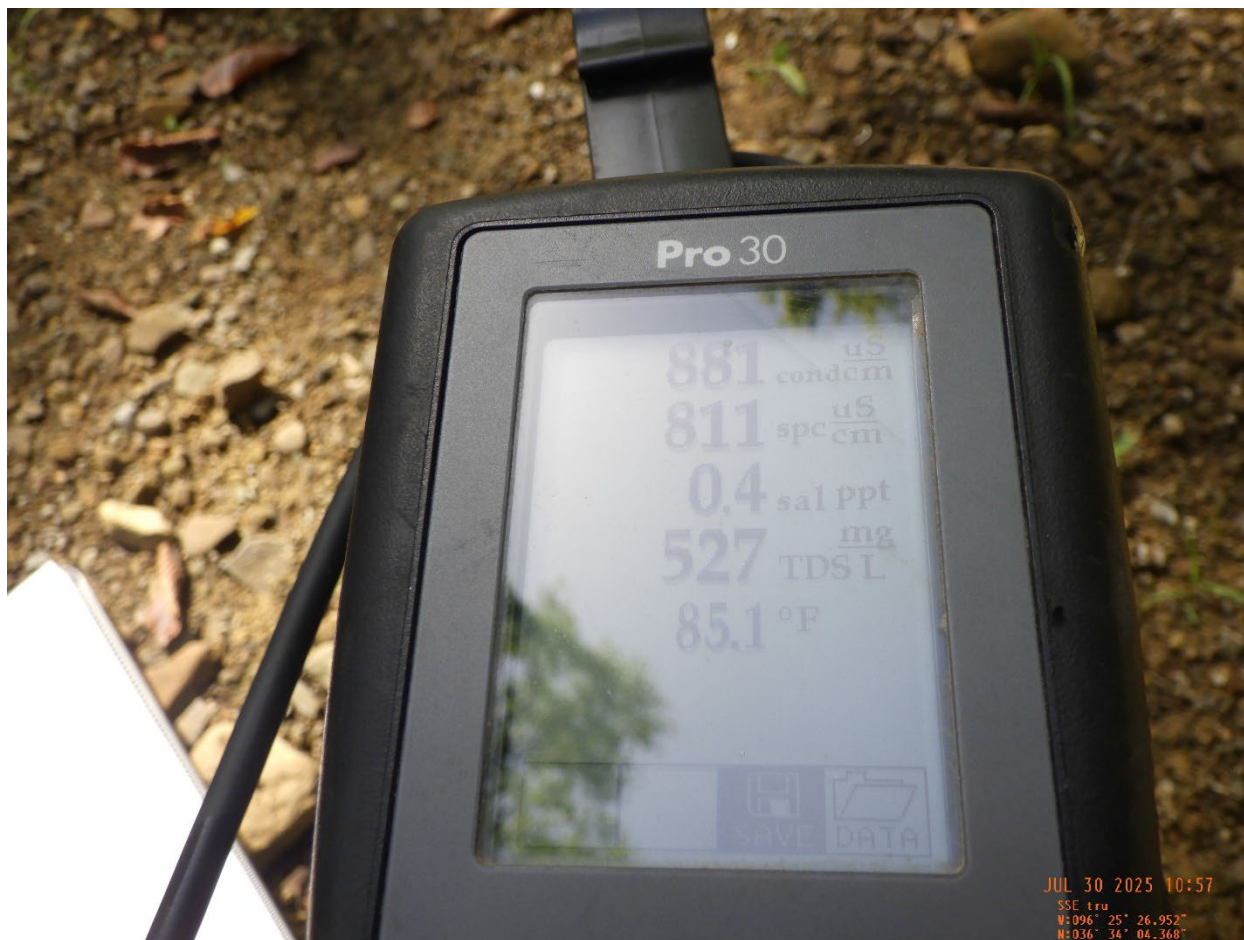
Photo No. 7

Immediately upstream from the confluence of the impacted tributary and Little Hominy Creek, I observed a TDS field reading of 527 mg/L. This reading was observed in an area which was not impacted

by the spill and should be considered when establishing background TDS levels for the area. See photo No. 7.

**Description:** This was a TDS field reading of 527 mg/L taken immediately upstream from the POE into Little Hominy Creek. This reading should be used when considering background TDS levels for the area.

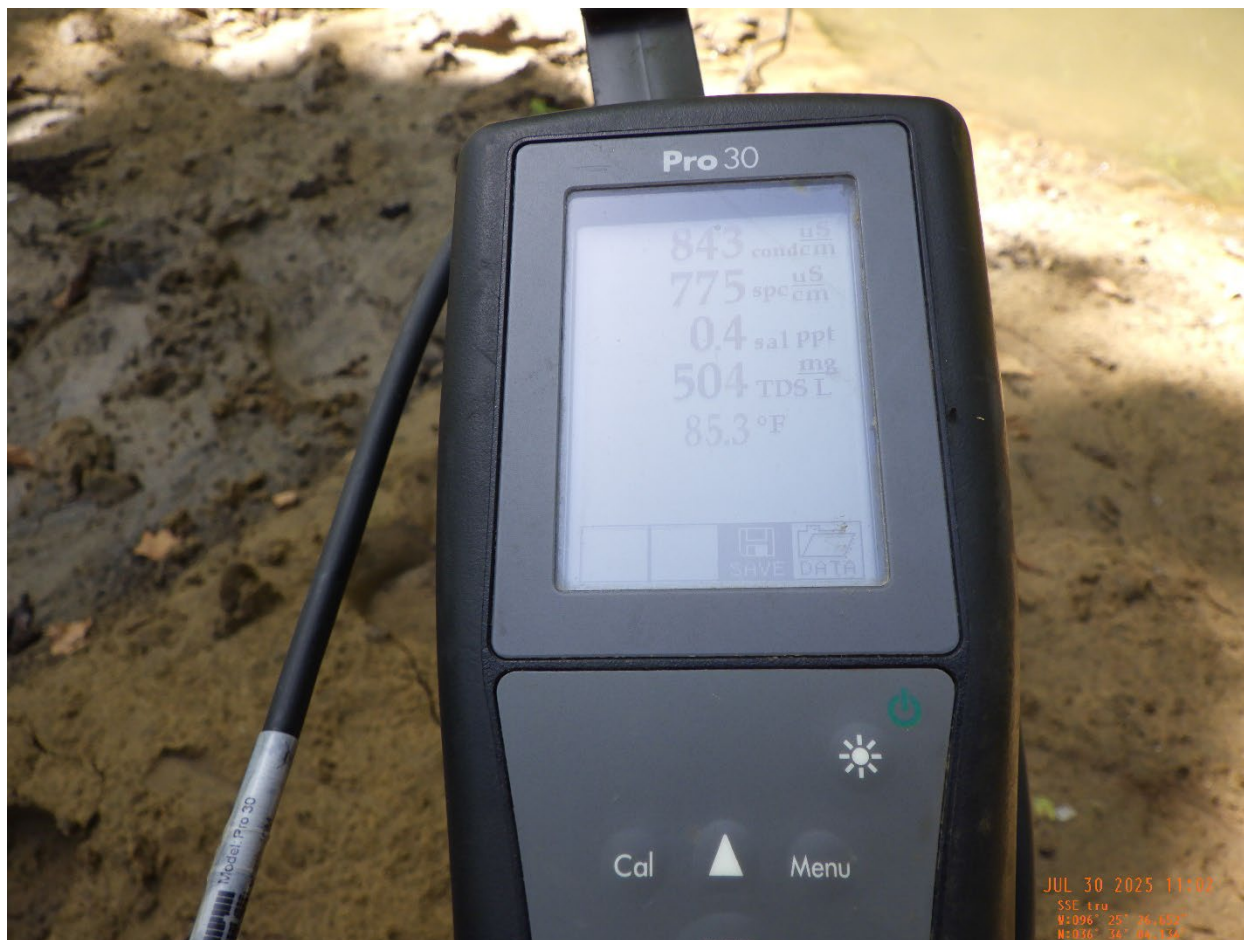
Photo No. 8

At the point of entry (POE) into Little Hominy Creek, I observed a TDS field reading of 504 mg/L. See photo No. 8.

**Description:** This was a TDS field reading of 504 mg/L taken at the POE into Little Hominy Creek.

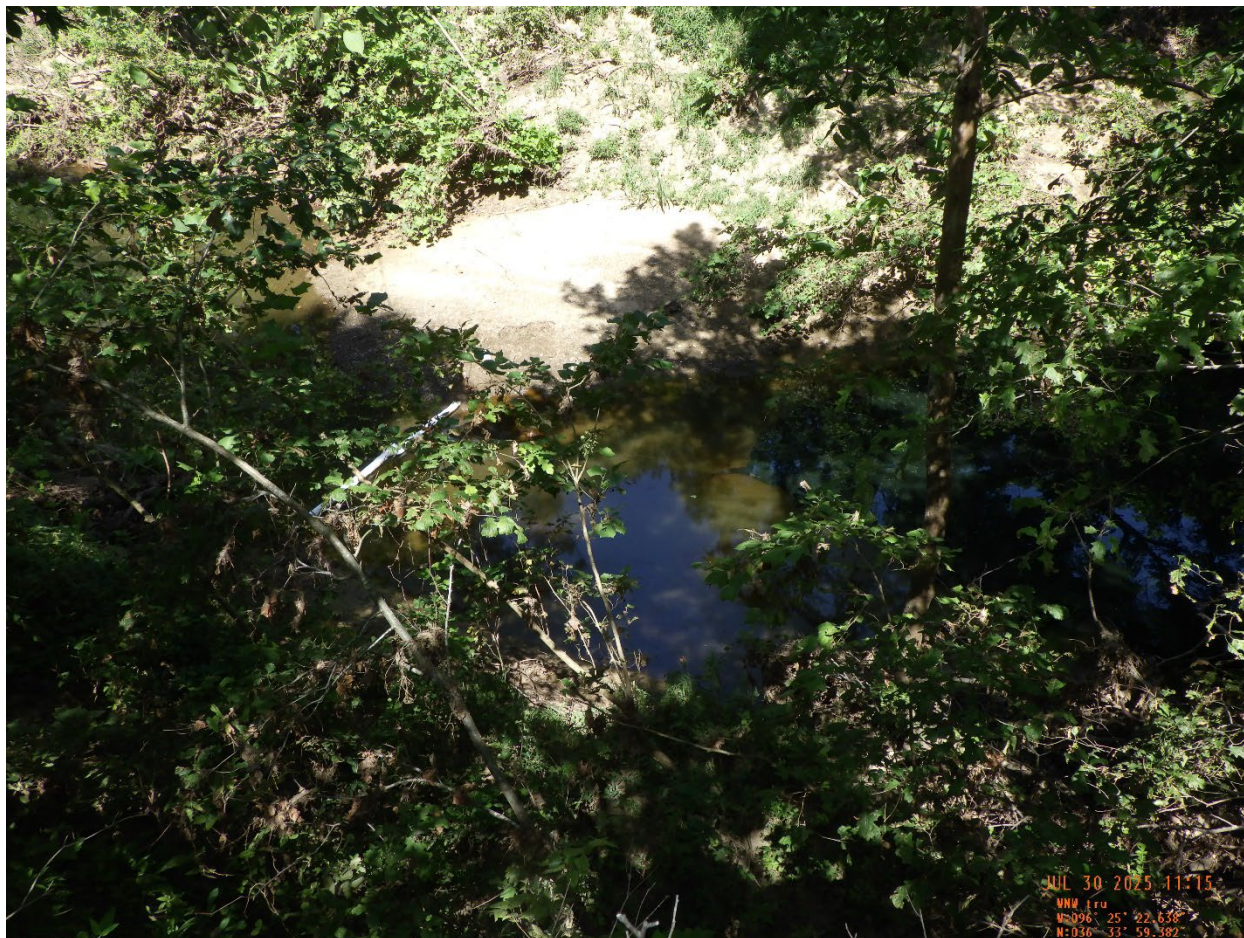
Photo No. 9

Approximately 150 feet downstream from the POE, I observed oil on Little Hominy Creek and a floating containment boom which was placed by the operator to prevent downstream migration of spill impacts. At the time of the inspection, the boom was properly installed and was preventing downstream migration of the oil. This was the end of the observed spill impacts.

**Description:** This was an absorbent containment boom placed in Little Hominy Creek by the operator to prevent downstream migration of spill impacts. Oil was present on Little Hominy Creek which can be seen on the right half of the photo. At the time of the inspection, the boom was properly installed and preventing downstream migration of oil. This was the end of observed spill impacts.
