**Region 6 - Enforcement & Compliance Assurance Division**  
**INSPECTION REPORT**

| Media Program: | RCRA Compliance Evaluation Inspection | |
| Company Name: | Latch Oil Inc. | |

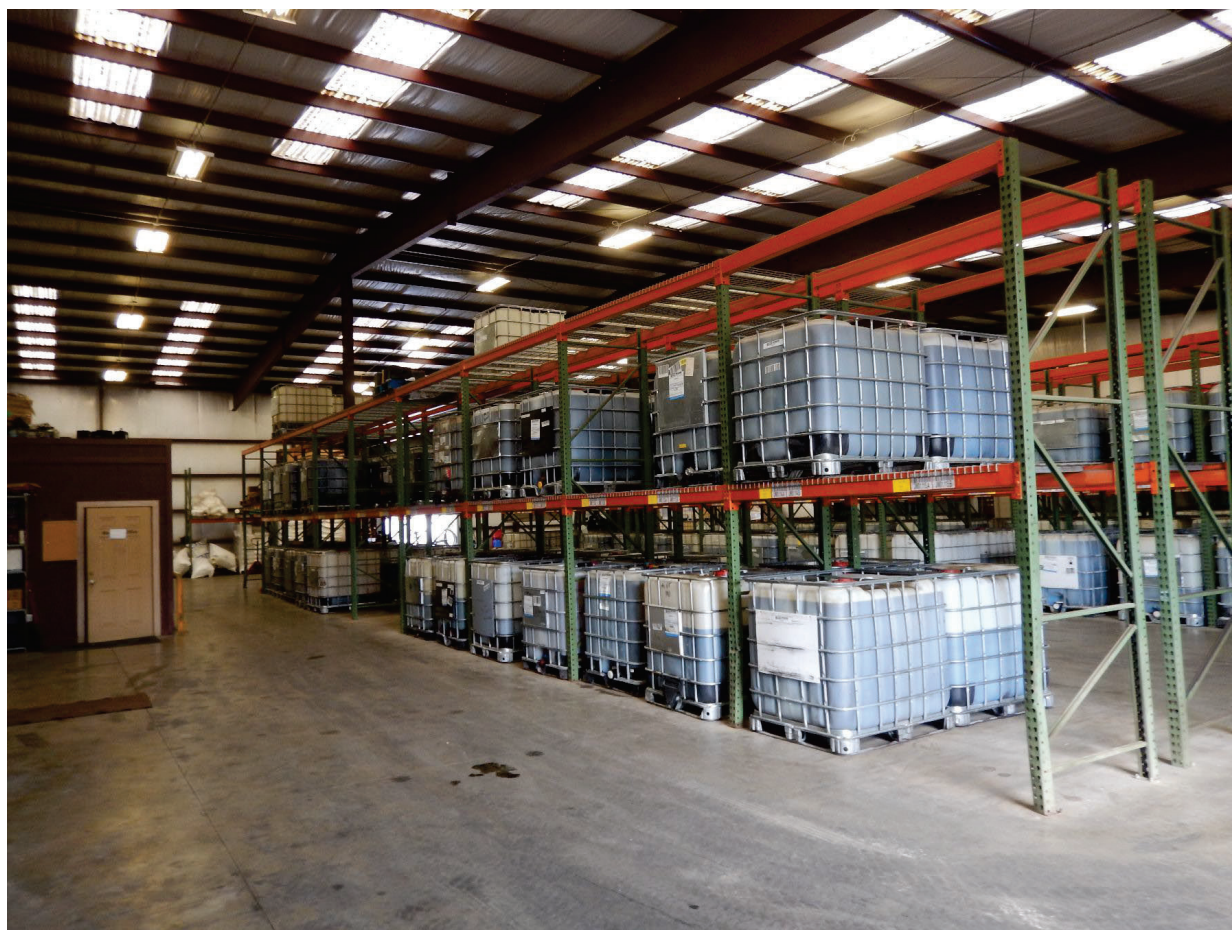
Photo No. 1

In the warehouse, I observed metal racks with totes and drums. All the containers I observed in the warehouse had product labels or handwritten product information (Appendix 1, Photos 1-3). No wastes were observed in the warehouse area.

| Description: | One rack of products in the product warehouse facing northwest. | | |

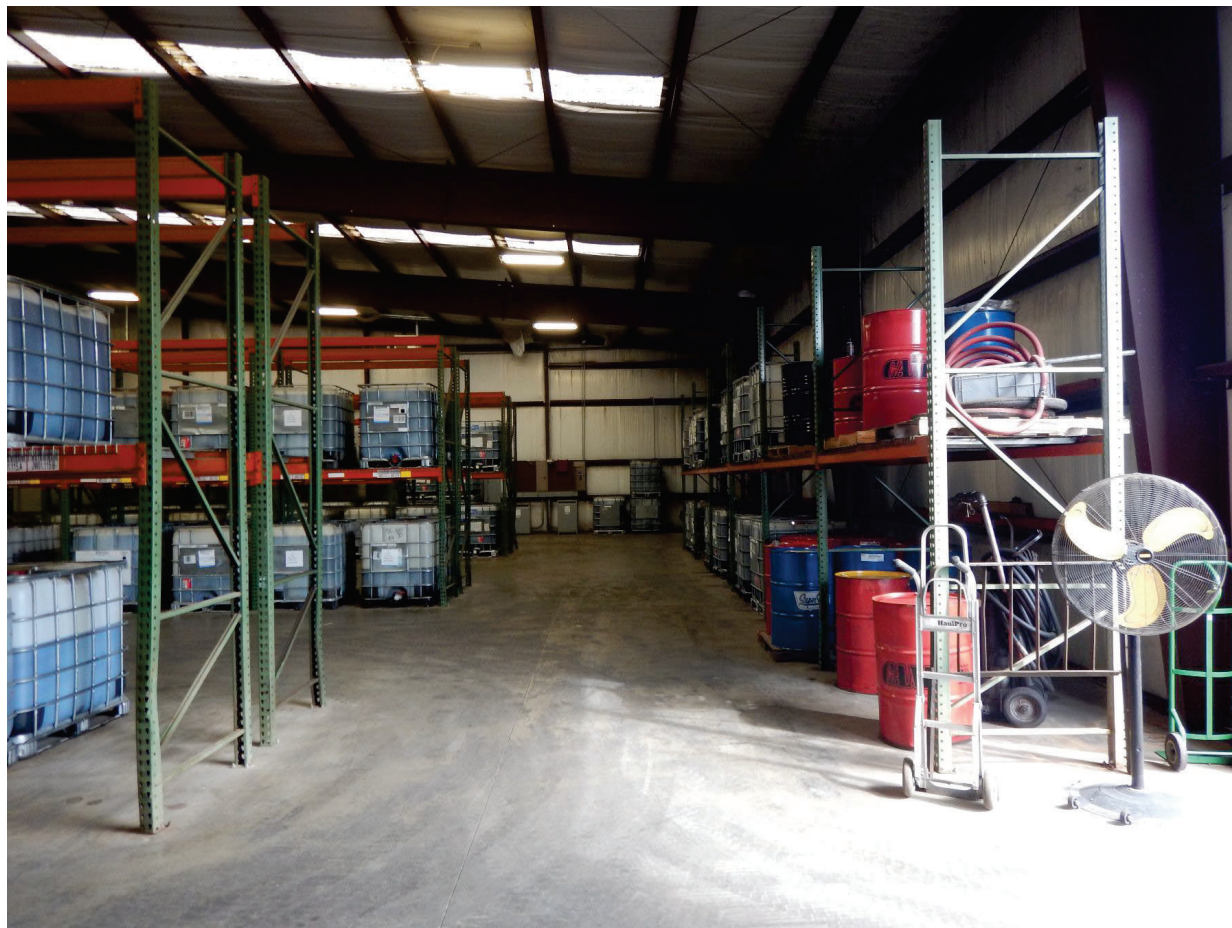
Photo No. 2

| Description: | East aisle of product warehouse facing north. | | |

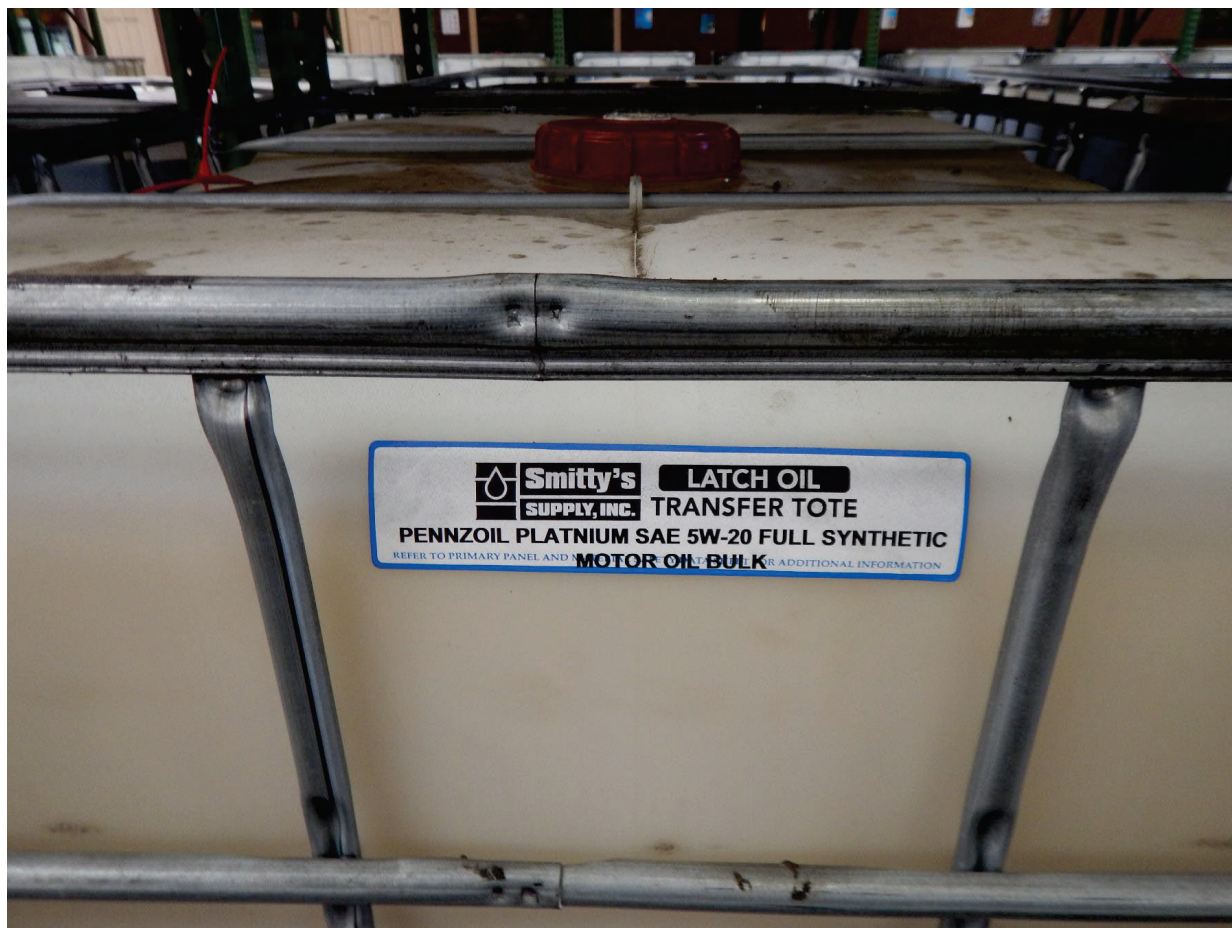
Photo No. 3

| Description: | Product label on container showing Latch Oil and Latch Oil names. | | |

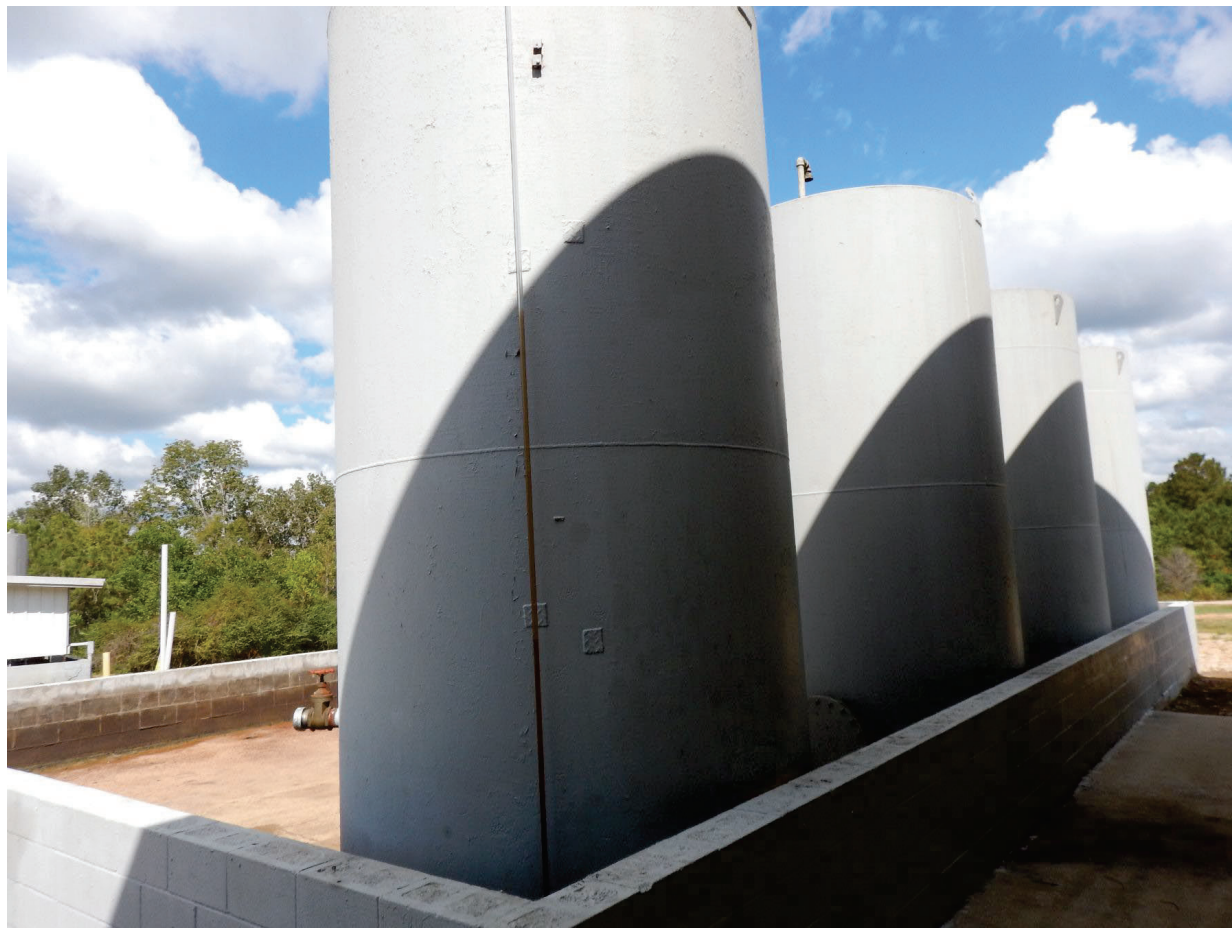
Photo No. 5

Outside of the warehouse on the west side of the main building, I observed a small tank battery with 5 above ground storage tanks in secondary containment. All the tanks had handwritten product labeling (Appendix 1, Photos 4-5).

| Description: | First set of 5 product tanks on the west side of the main building facing northwest. | | |

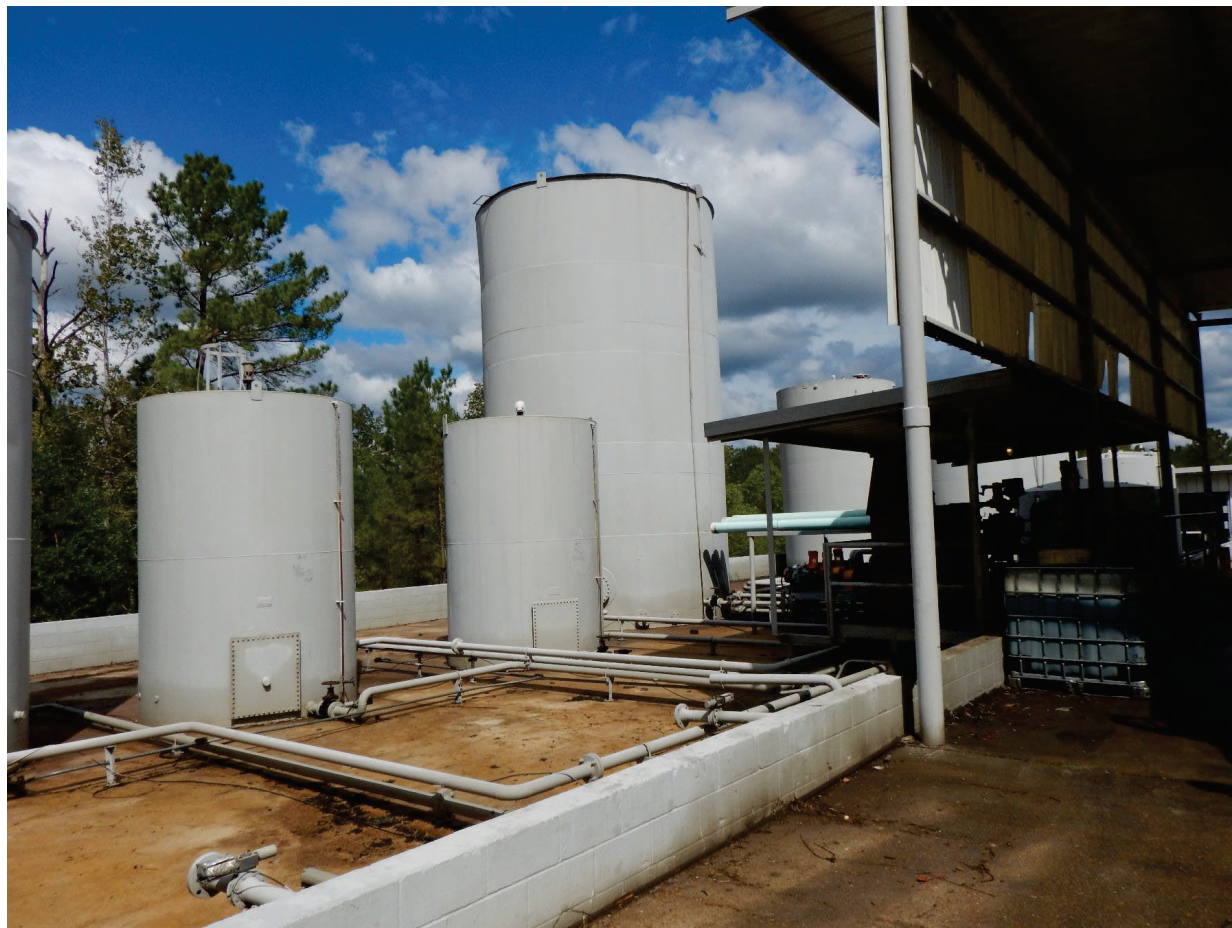
Photo No. 6

Continuing to walk west, I came to a second tank battery with 13 above ground storage tanks in secondary containment. All the tanks had handwritten product labeling (Appendix 1, Photo 6). No wastes were observed in the tank batteries.

| Description: | Second set of 13 product tanks on the west side of facility property facing northwest. | | |

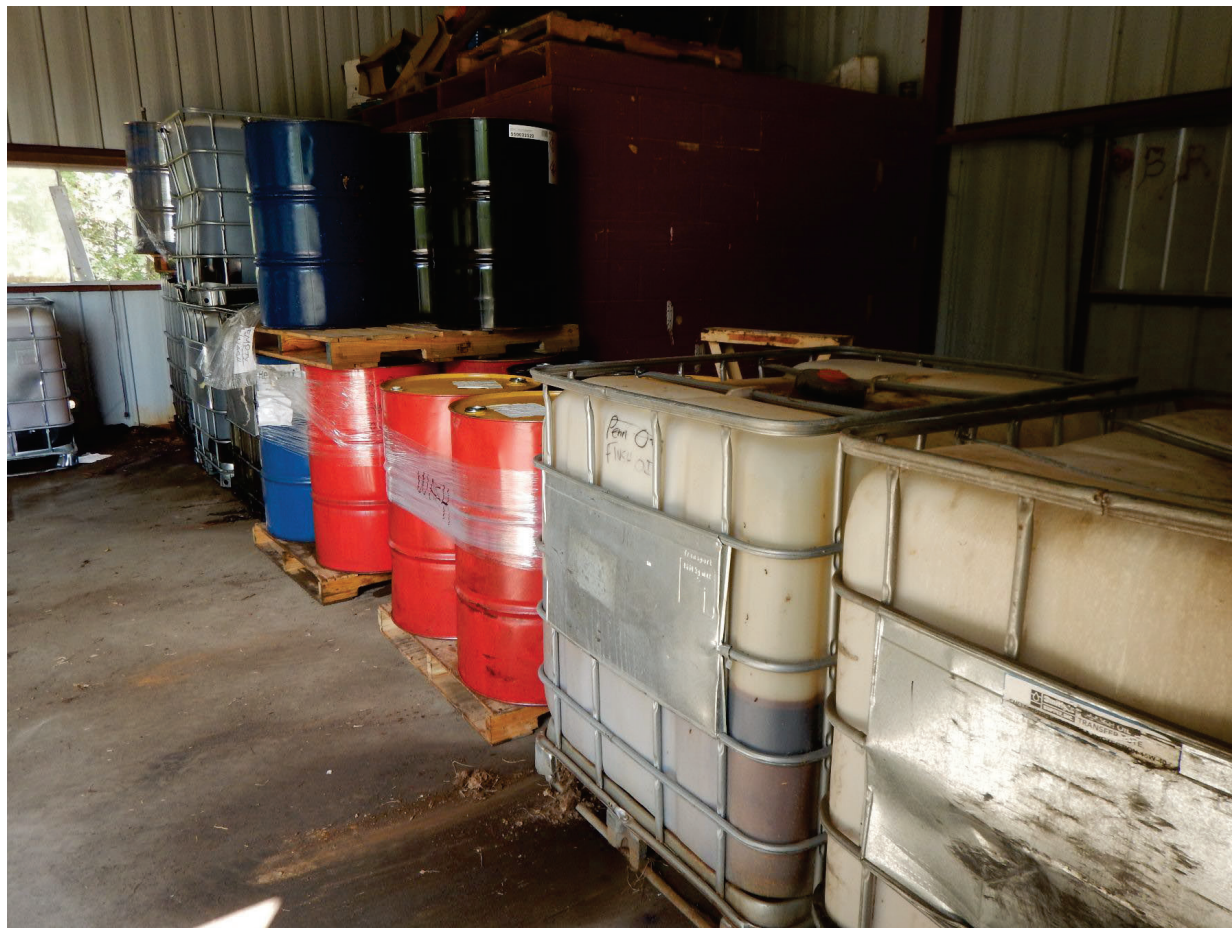
Photo No. 7

Walking south to the southwest corner of the facility, I observed a large storage shed. In the storage shed, I observed several totes and drums labeled “flush”. I asked Mr. Bond what the flush material was, and he said it was product flushed out of the hoses used to fill the above ground product storage tanks. He also said the flush containers are normally sent back to Smitty’s in Roseland as product, but since the incident on August 22, 2025, the product is being held at this facility (Appendix 1, Photo 7). No wastes were observed in the large storage shed.

| Description: | Wash containers filled with product to be sent back to Independence facility. These containers are in a building called the "shed" on the southwest corner of the facility property. | | |

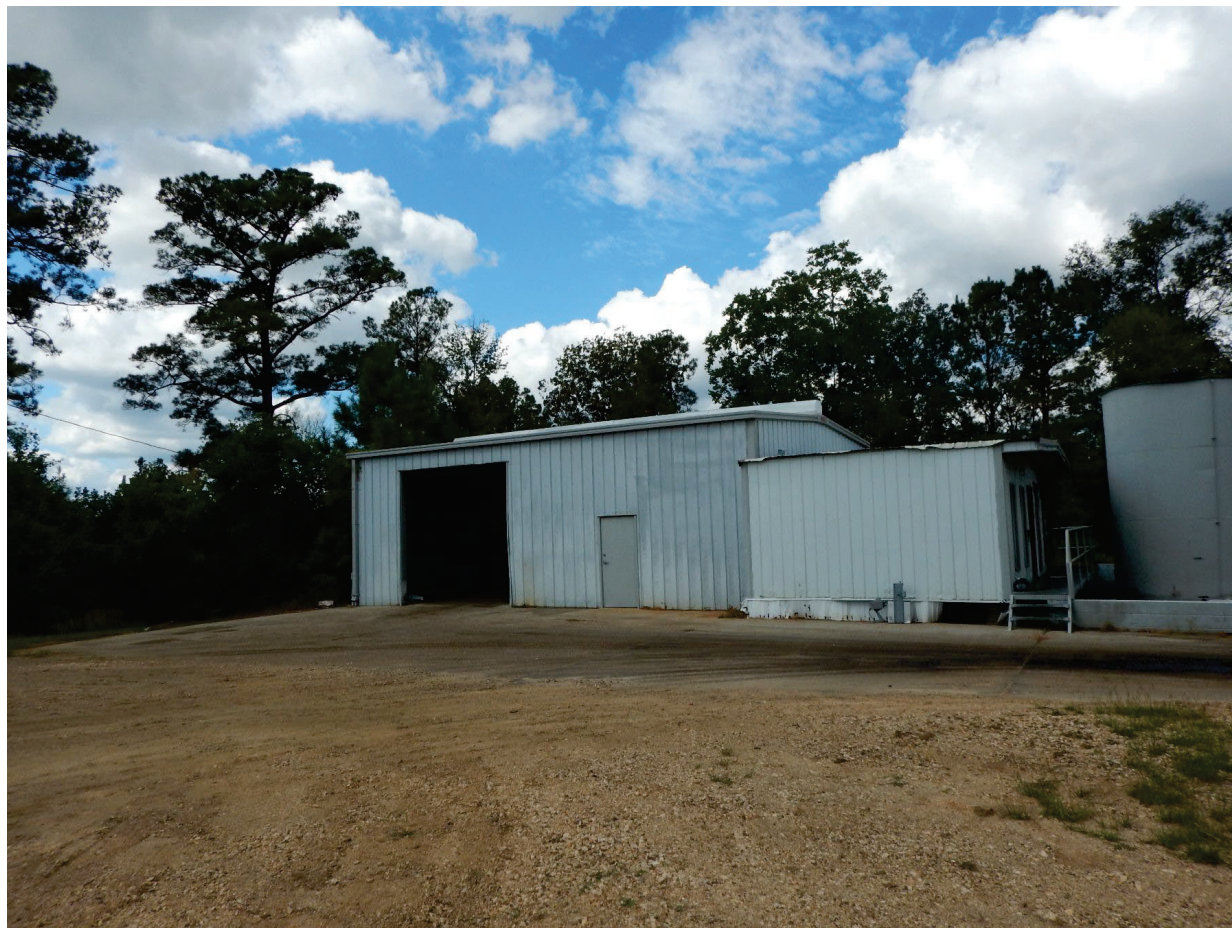
Photo No. 8

| Description: | Outside of "shed" on the southwest corner of the facility facing west southwest. | | |

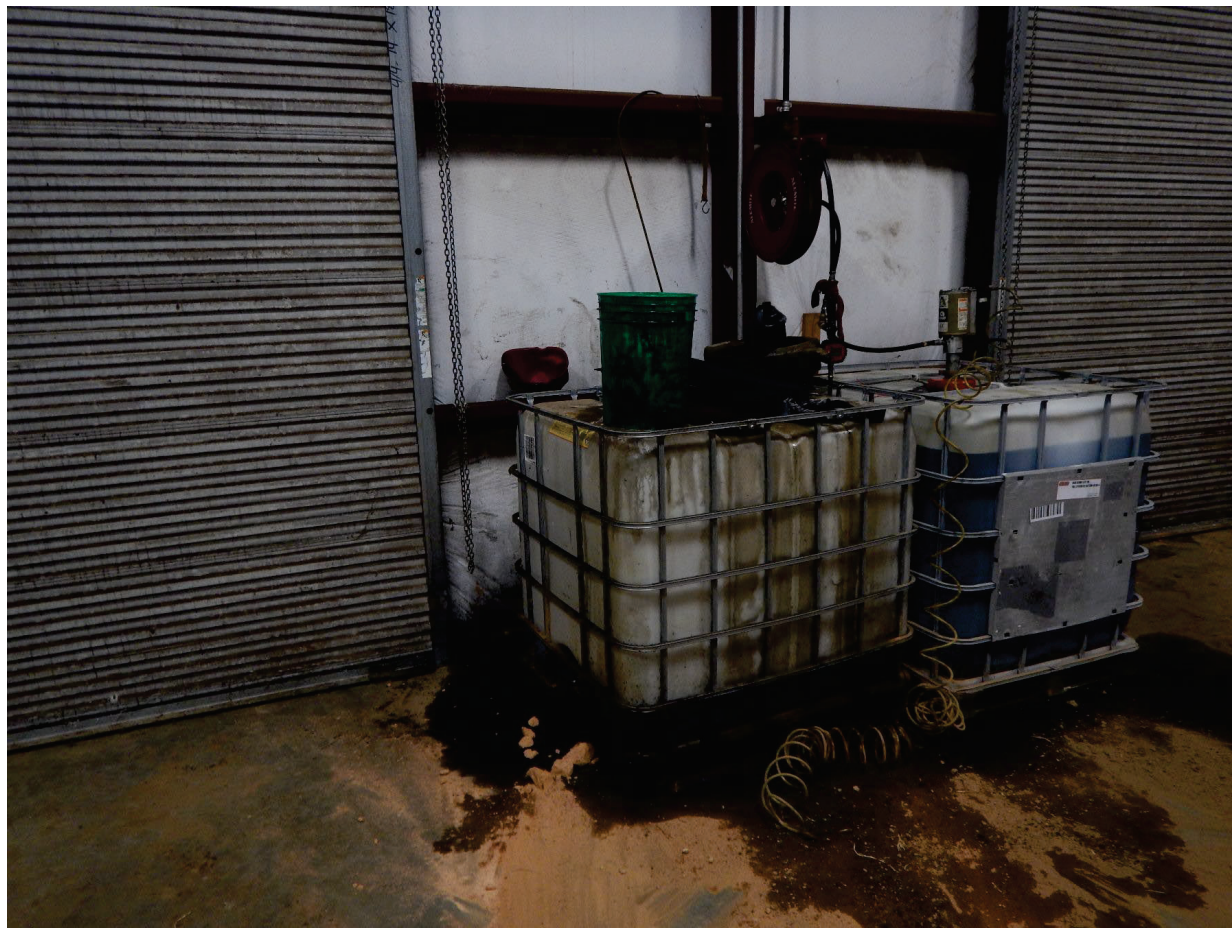
Photo No. 9

I then walked back through the warehouse to the east side of the facility to take a look at the maintenance building on the far east side of the property. In the maintenance building, I observed floor trenches filled with dirt. One of the trenches was only half filled with dirt and I could visually see an oily material in the bottom of the concrete trench. I asked Mr. Bond about the trenches, and he said he did not know for sure why they were being filled in. I could visually see the concrete in the bottom of the trench, so the oily material observed was a thin layer of residue. I also observed a tote of used oil that was not labeled and either appeared to be leaking, or possibly used oil had been spilled when filling the tote (Appendix 1, Photos 9-11).

**AOC 1: Used oil tote in the maintenance building.** A used oil tote in the maintenance building was not labeled with the words “Used Oil” per 40 CFR § 279.22, and was either leaking or used oil was spilled when filling.

| Description: | Totes stored in the maintenance building on the east side of the facility property. Tote on the left contains used oil and was not labeled and appeared to be leaking. Tote on the right is product. | | |

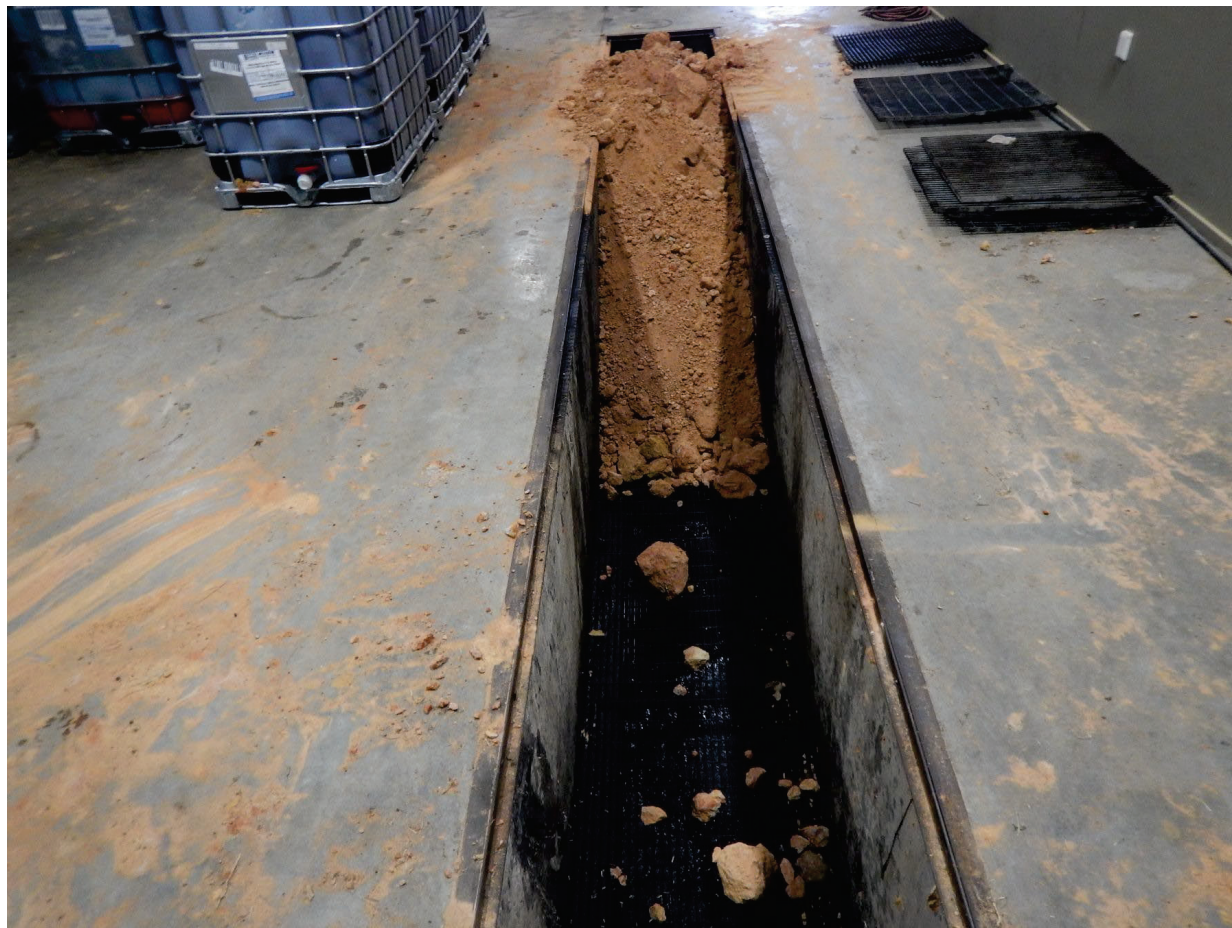
Photo No. 10

| Description: | Floor trench in maintenance building that is half filled in with dirt. | | |

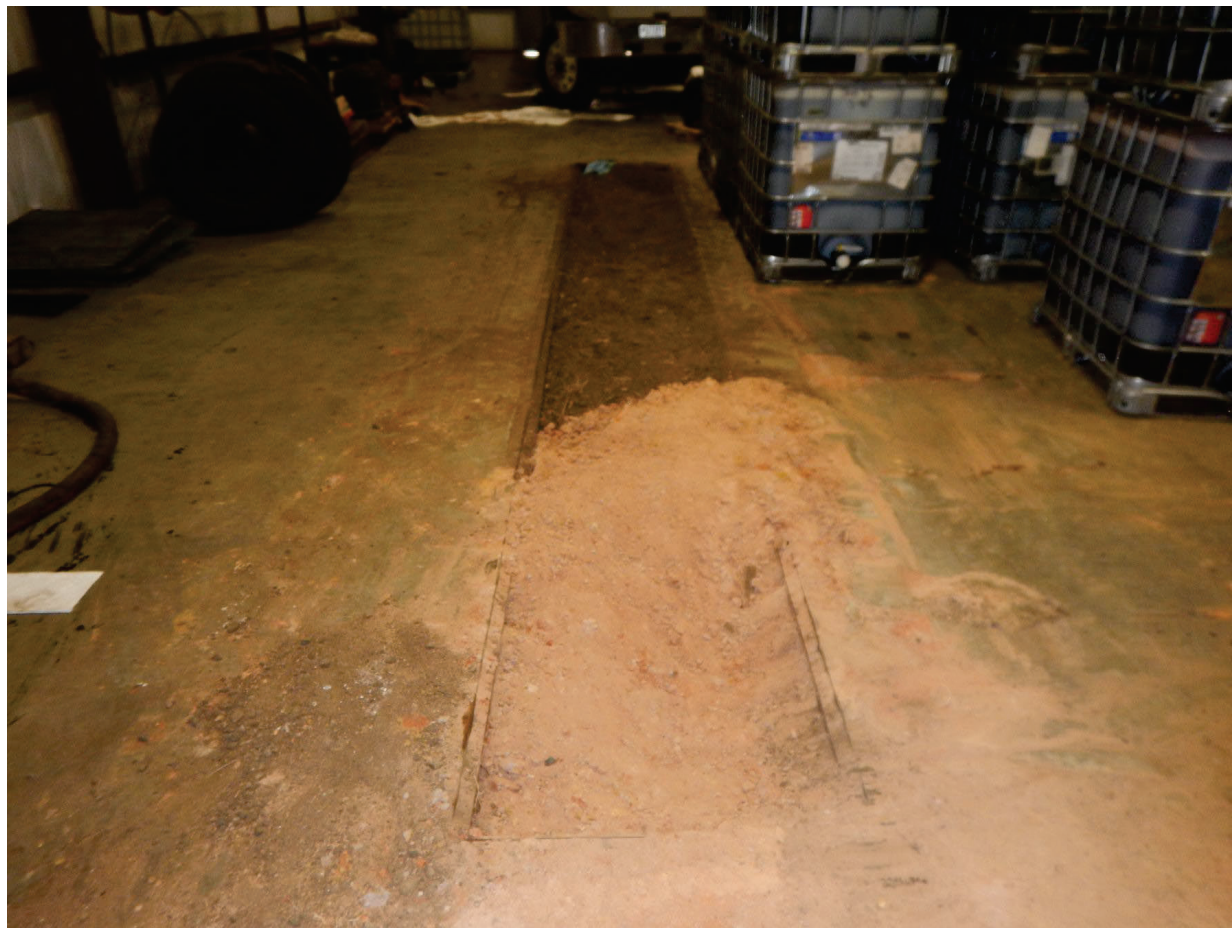
Photo No. 11

| Description: | Trench in maintenance building that is completely filled with dirt. | | |

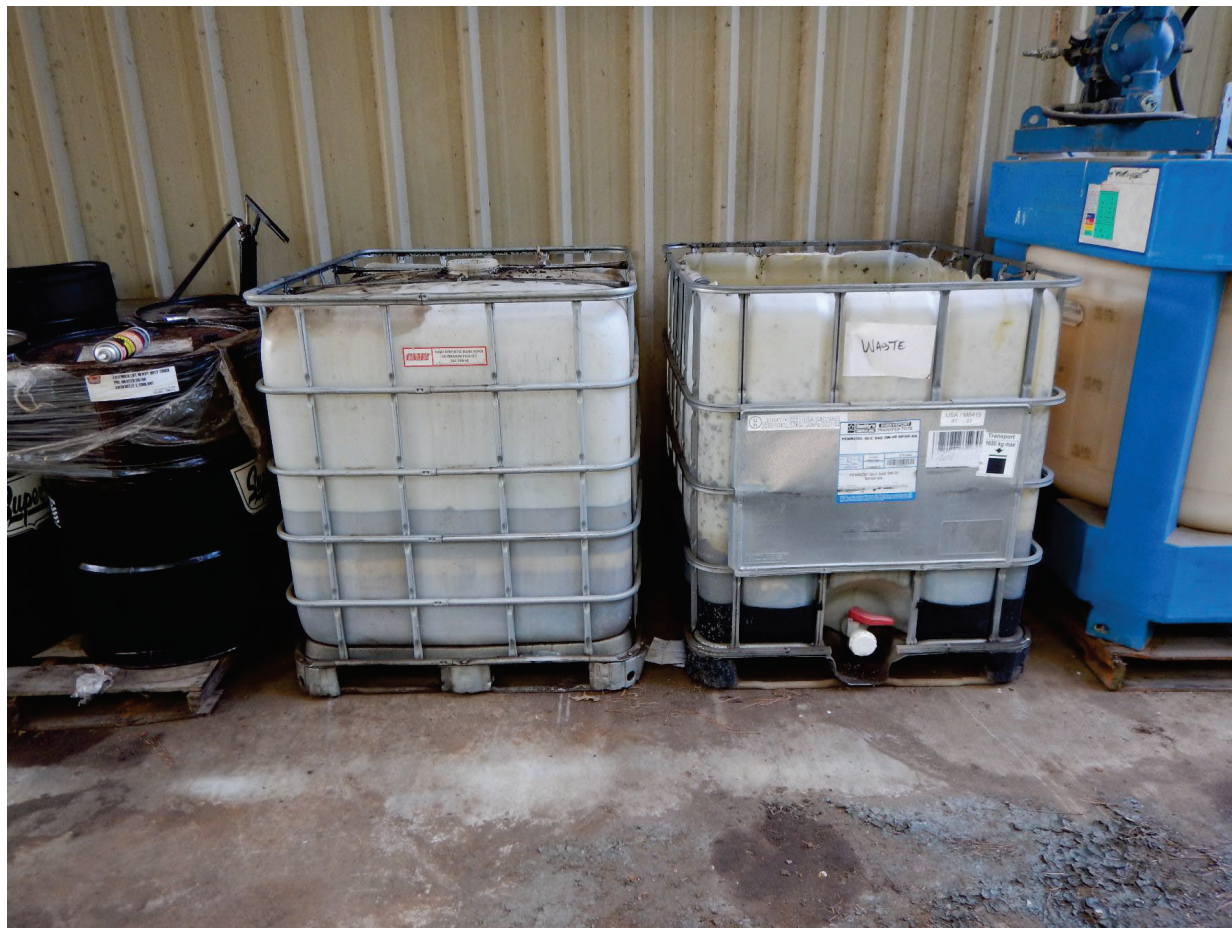
Photo No. 12

I then walked out and around the outside of the maintenance building to look at a covered storage area on the east side of the maintenance building. In this covered storage area, I observed one tote with the top partially cut off that appeared to be used oil and did not have a label. I observed another tote in the storage area that had the top cut off and was labeled “waste”. This “waste” tote contained oily dry sweep and absorbent pads (Appendix 1, Photo 12). I asked Mr. Bond what the waste was, and he said he did not know. I also asked Mr. Bond if a hazardous waste determination had been made, and he said he did not know.

**AOC 2: Used oil tote and waste tote in covered storage area on east side of maintenance building.** The used oil tote, with the top partially cut off, was not labeled as “Used Oil” per 40 CFR § 279.22, and the waste tote, that had the top completely cut off, was labeled as waste but with no indication of the contents indicating a potential labeling issue per 40 CFR § 262. Mr. Bond was also unsure of any waste determinations made for this waste tote that would be a requirement per 40 CFR § 262.11.

| Description: | 2 Totes stored on the east side of the maintenance building. Left tote is not labeled and appeared to be used oil. Right tote labeled "waste" and has oily dry sweep and absorbent pads inside. | | |
