## **RCRA Inspection Report**

Lanxess Corporation  
2151 King Street Extension  
Charleston, South Carolina 29405  
Charleston County

EPA ID: SCD003358389  
NAICS: 325199 - All Other Basic Organic Chemical  
Manufacturing

April 9, 2024, at 9:00 a.m. EDT

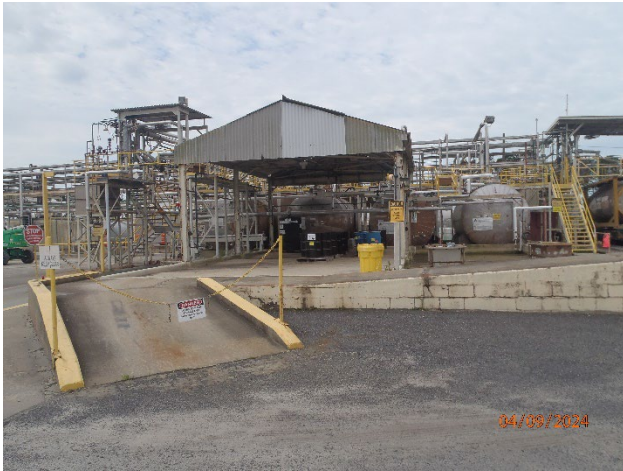
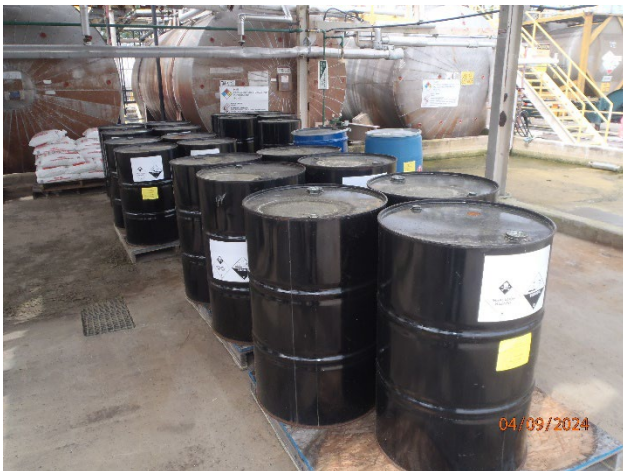
The secondary containment appeared in good condition, and twenty 55-gallon (approximately 1,100-gallons) containers of hazardous waste were stored in this area. The oldest container was dated January 31, 2024. The inspectors observed hazardous waste containers of PCL Reactor Waste, corrosive, inhalation hazard, D002, D003, D004, D006, and Contaminated PPE and Sample Bottles, D002. Mr. Kowal explained that decontamination equipment is kept under water that is treated with hydrogen peroxide, H<sub>2</sub>O<sub>2</sub>. This prevents a reaction if the PCl<sub>3</sub> is released.

Picture 1 – Inorganic HWCAA

Picture 2 – Inorganic HWCAA

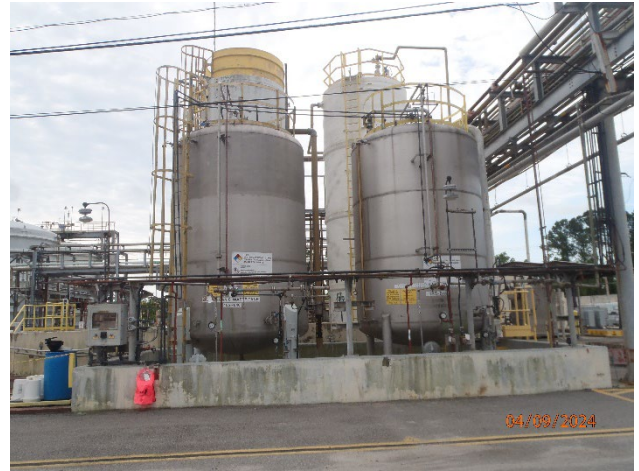
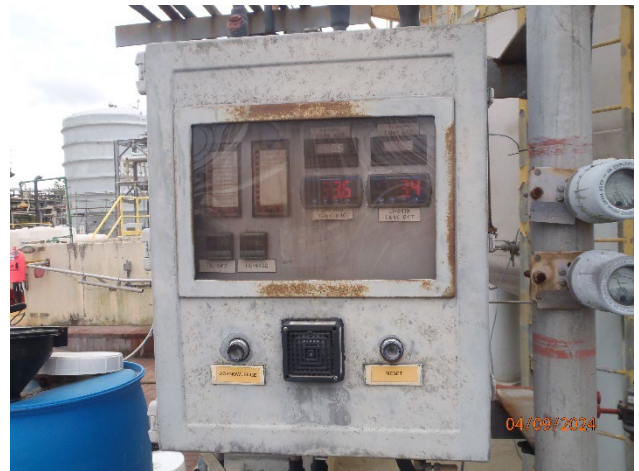
The facility has two 10,000-gallon RCRA Permitted hazardous waste tanks, 646 and 647 (Pictures 4-5). Tank 646 contains organic flammable chlorine hazardous waste that are shipped out in a tanker truck, and Tank 647 contains organic flammable hazardous waste with high BTUs that will be burned. The Permit Application indicates that the organic content of the hazardous waste managed in the RCRA Permitted tanks may be as high as 100%. Therefore, the tanks are subject to the RCRA Organic Air Emission Standards found in 40 C.F.R. 264 Subparts BB and CC.

Picture 4 – Hazardous Waste Tanks 646 and 647

Picture 5 – Hazardous Waste Tank level

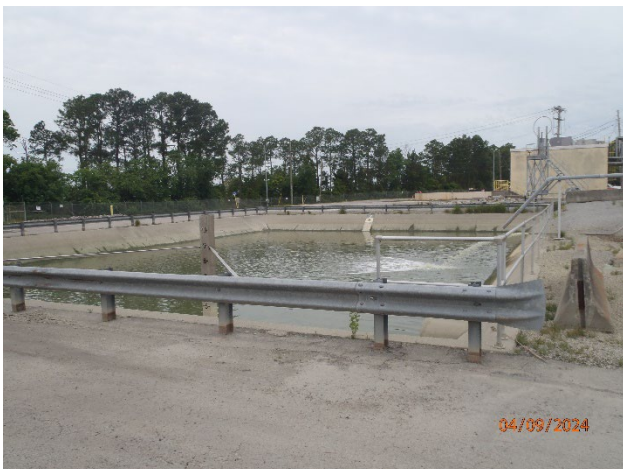
Mr. Kowal explained that stormwater from the facility's hard surfaces is captured in grates and conveyed to the North Lake (Picture 3).

Picture 3 – North Lake stormwater runoff

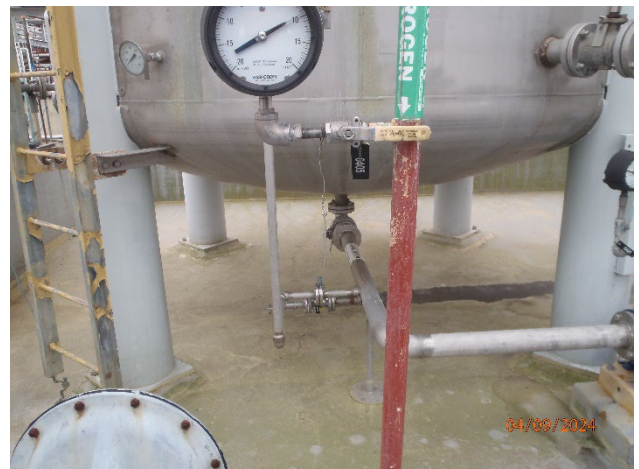
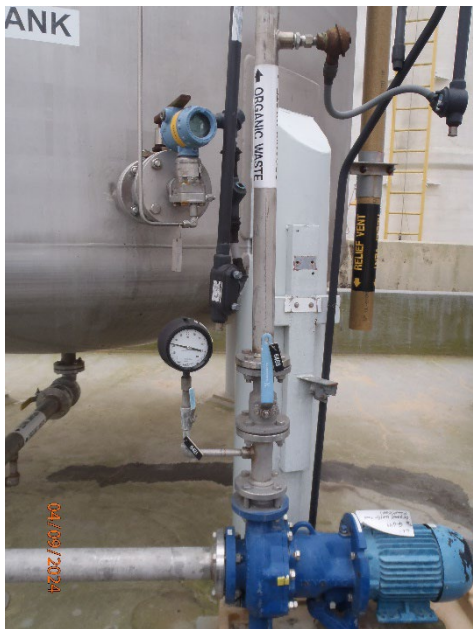
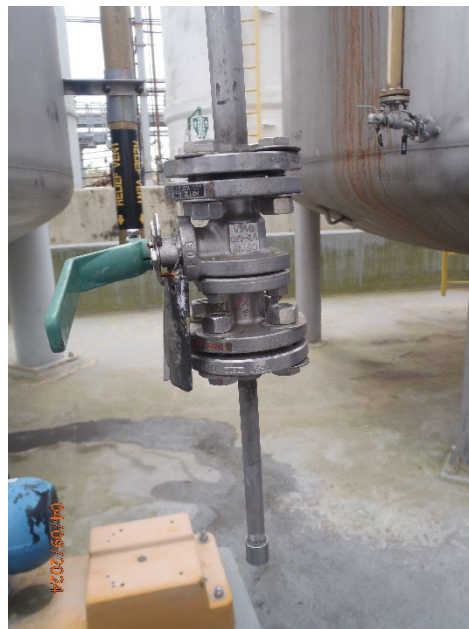
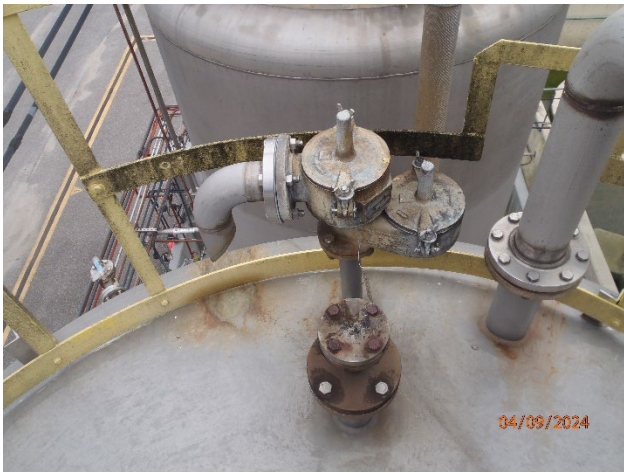
At the time of the inspection, the inspectors observed the tanks appeared to be in good condition, however no Subpart BB tags were on the tank or its ancillary equipment, and the equipment was not marked to readily identify and distinguish each component from the other equipment (Pictures 6-9, 11).

Picture 6 – Hazardous Waste Tank missing BB tags

Picture 7 – Hazardous Waste Tank missing BB tags

Picture 9 – Hazardous Waste Tank sample port missing BB tags

Picture 11 – Hazardous Waste Tank roof missing BB tags

**Pursuant to Condition IV.C.3 (Air Emission Standards) of the RCRA Permit and S.C. Code Ann. Regs. 61-79.264.200 [40 C.F.R. § 264.200] which incorporates S.C. Code Ann. Regs. 61-79.264.1050(d) [40 C.F.R. § 264.1050(d)], each piece of equipment to which this subpart applies shall be marked in such a manner that it can be distinguished readily from other pieces of equipment.**

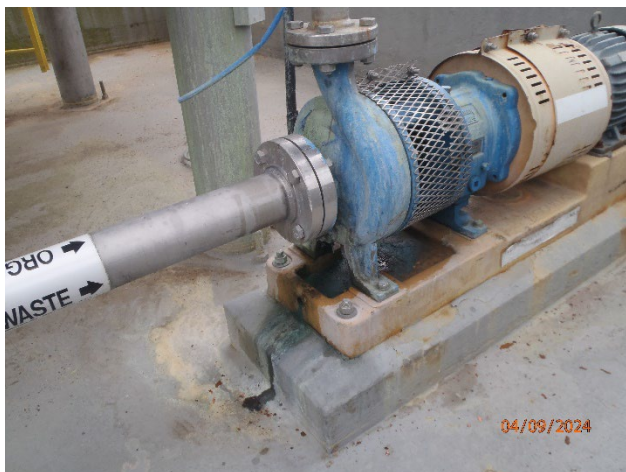
Tank 647 conservation vent equipment tag #85-CV-6479 was short bolted and needed to be leveled with a nut. The inspectors observed that Tank 647 had a recirculation pump in hazardous waste service, leaking into the secondary containment (Picture 8). In addition, the secondary containment concrete is corroded under the sample port and needs repair (Pictures 9-10). The sample port associated with Tank 647, is an open-ended line equipped with a threaded cap. The area had two fire extinguishers and an eyewash.

Picture 8 – Hazardous Waste Tank 647 recirc pump leaking

**Pursuant to Condition IV.C.3 (Air Emission Standards) of the RCRA Permit and S.C. Code Ann. Regs. 61-79.264.200 [40 C.F.R. § 264.200], which incorporates S.C. Code Ann. Regs. 61-79.264.1052(b)(2) and (c) [40 C.F.R. § 264.1052(b)(2) and (c)], (b)(2) If there are indications of liquids dripping from the pump seal, a leak is detected. (c)(1) When a leak is detected, it shall be repaired as soon as practicable, but not later than 15 calendar days after it is detected, except as provided in § 265.1059, and (2) A first attempt at repair (e.g., tightening the packing gland) shall be made no later than 5 calendar days after each leak is detected.**

**Pursuant to Condition II.A. (Design and Operation of Facility) of the RCRA Permit and S.C. Code Ann. Regs. 61-79.264.31 [40 C.F.R. § 264.31], an owner or operator is required to maintain and operate its facility to minimize the possibility of a fire, explosion, or any unplanned sudden or non-sudden release of hazardous waste or hazardous waste constituents to air, soil, or surface water which could threaten human health or the environment.**

**Pursuant to Condition IV.F. (Recordkeeping and Reporting) and S.C. Code Ann. Regs. 61-79.264.196(b)(2) [40 C.F.R. § 264.196(b)(2)], if the release was to a secondary containment system, all released materials must be removed within 24 hours or in as timely a manner as is possible to prevent harm to human health and the environment.**

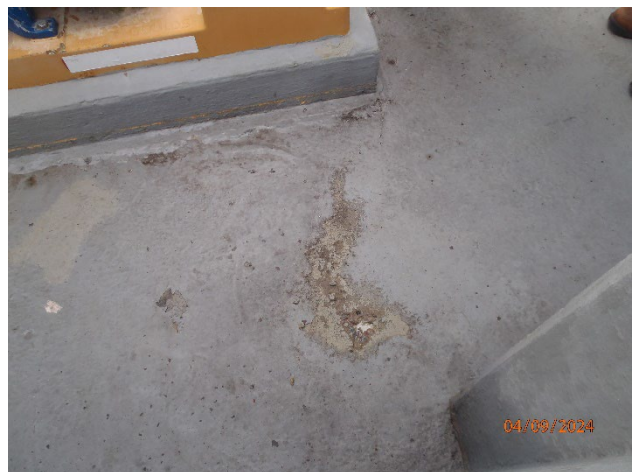
The daily tank inspection records for 2022-2024 were reviewed. The inspectors observed that the tank inspections were conducted every day at 8 AM for both tanks. The forms did not document the leaking recirculation pump nor the corroded secondary containment under the sample port. In addition, the January 30, 2022, March 9, 2022, and March 21, 2022, daily tank inspection forms were blank.

Picture 10 – Hazardous Waste Tank secondary containment corroded

**Pursuant to Condition IV.D.4 (Tank System Closure or Repair) and S.C. Code Ann. Regs. 61-79.264.193(e)(1)(iii) [40 C.F.R. § 264.193(e)(1)(iii)], an owner or operator accumulating hazardous waste in tanks must have a secondary containment system that satisfies the requirement of external liner systems must be free of cracks or gaps.**

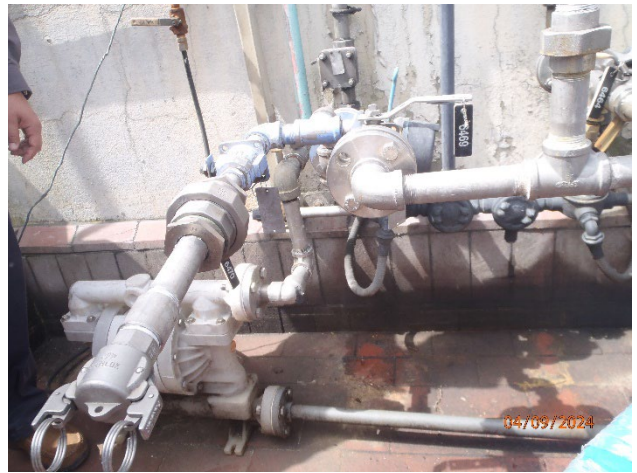
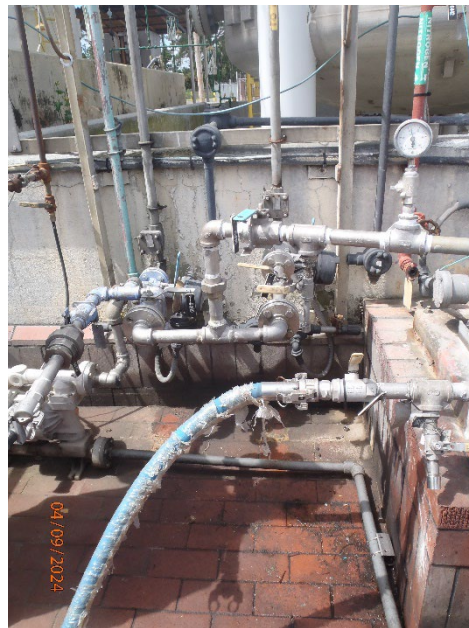
Beside the tank secondary containment is a hazardous waste tote unloading area. The inspectors observed the secondary containment flooring is acid brick with a floor drain sump (Pictures 12-13). The satellite accumulation area (SAA) with a blue 55-gallon container of Tank 646 Waste Organic Liquids D001, D002, D028, sat in the corner on a secondary containment pallet. The container was closed and labeled. The secondary containment is intentionally kept full of water in the event there is a release of phosphorus. The phosphorus is kept submerged in water because it is a highly reactive metal and when it is exposed to air it auto-ignites. When exposed to air, it is oxidized rapidly to phosphorus pentoxide. The inspectors observed that the piping for the hazardous waste tote unloading was missing a bolt from the flange (Pictures 14-15). The inspectors found the bolt and nut and the facility reinserted them during the inspection.

Picture 14 – HW tote unloading pump missing bolt

Picture 15 – HW tote unloading pump and piping

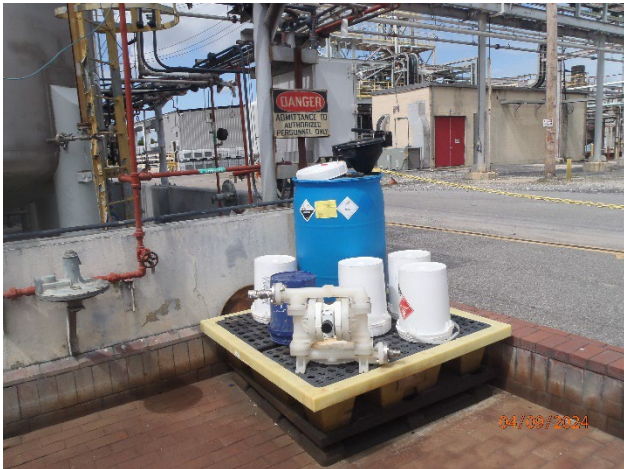
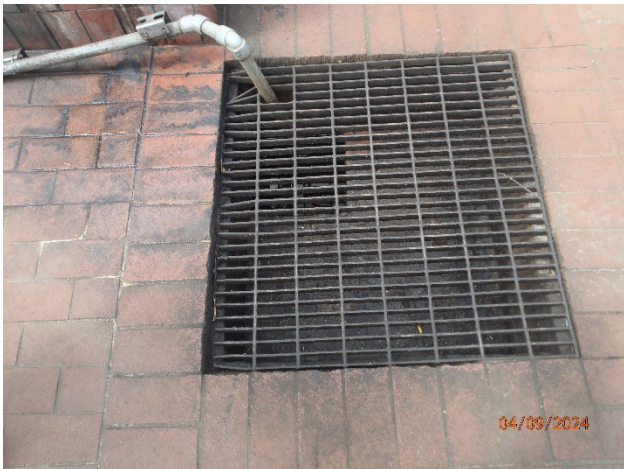
Picture 12 – HW tote unloading area

Picture 13 – HW tote unloading sump

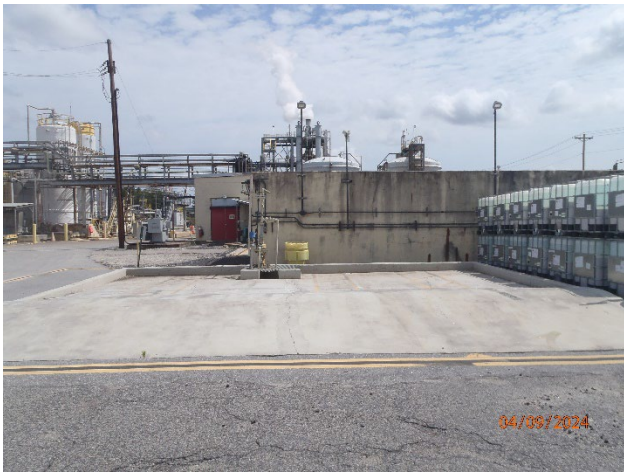
At the time of the inspection, the HWCAA Organic Waste Pad was empty (Picture 16). Next to the Organic Waste Pad was a non-hazardous waste storage area with thirty-four 275-gallon totes of Trichloropropylphosphate (TCPP) Phosphorus Flame Retardants Wastes Levagard PP and Wastewater (Pictures 17-19). Near the Organic Waste Pad was the South Lake (Picture 20). Piping to the lake allows pumping out of the lake during emergency responses.

Picture 16 – Organic Waste Pad

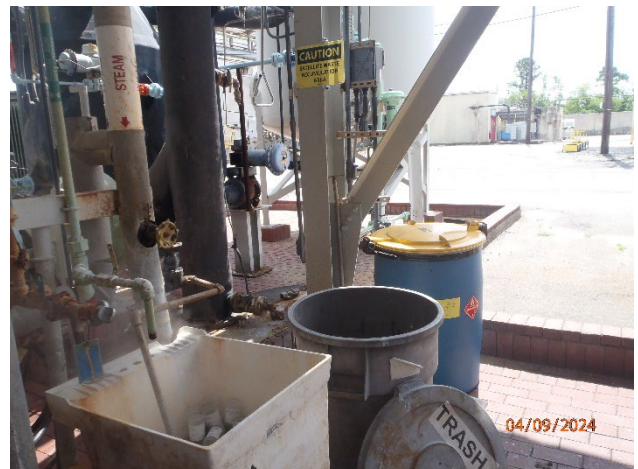
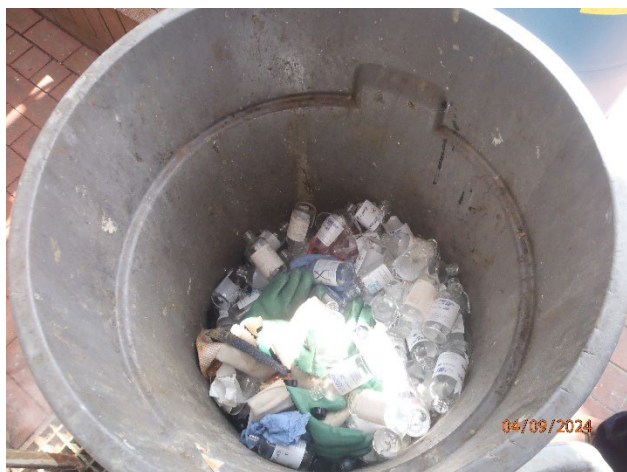
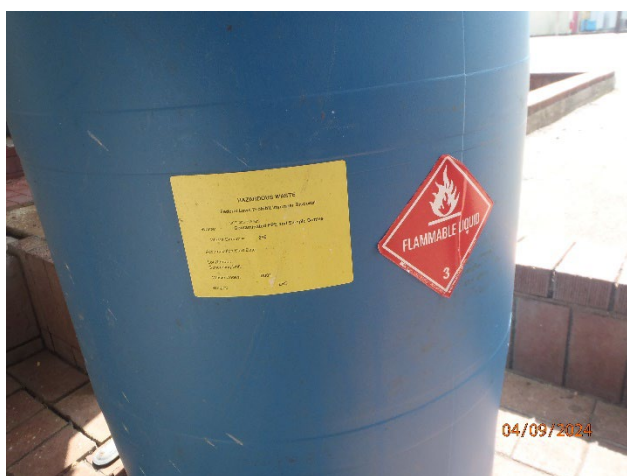
The BRIQUEST Unit manufactures Ethephon, a cotton growth regulator. The inspectors observed a SAA for managing contaminated personal protective equipment (PPE) and sample bottles, D001, flammable liquid (Pictures 21-23). The 55-gallon container in this SAA was closed and labeled. The spent bottles are triple rinsed and discarded in a gray trash can.

Picture 21 – BRIQUEST Unit SAA

Picture 22 – BRIQUEST Unit SAA

Picture 23 – BRIQUEST Unit SAA

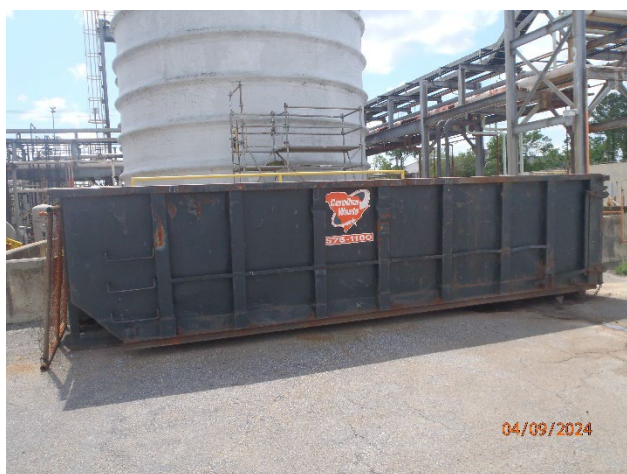
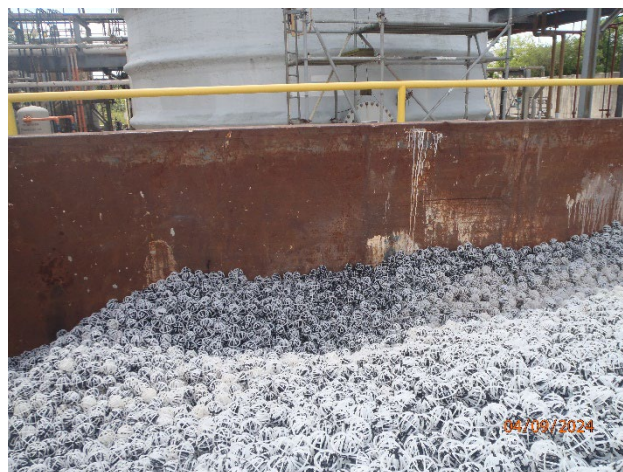
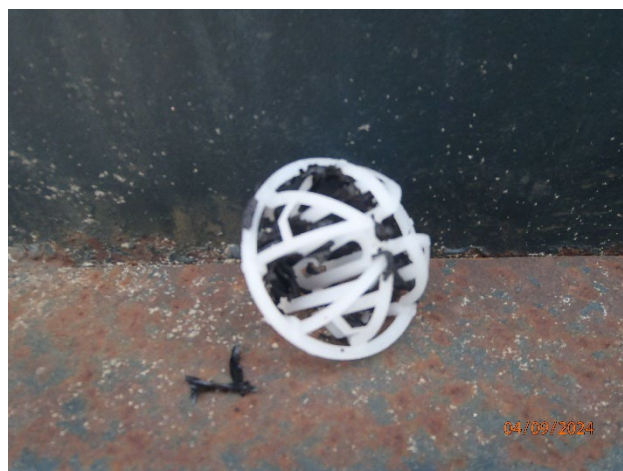
Next to the Thermal Oxidizer Unit (TOU) was a 20-cubic yard roll-off with discarded packing from the air strippers (Pictures 24-26). Mr. Kowal explained the packing increases the surface area to make the water drops smaller which allows the volatile organic compounds to become vapor. The packing pulls out the vapor which is burned in the TOU at 1700°F. Mr. Kowal stated that the packing was analyzed using the toxic characteristic leaching procedure (TCLP) and passed.

Picture 25 – TOU Roll-off packing from air strippers

Picture 26 – TOU Roll-off packing from air strippers

Picture 24 – TOU Roll-off

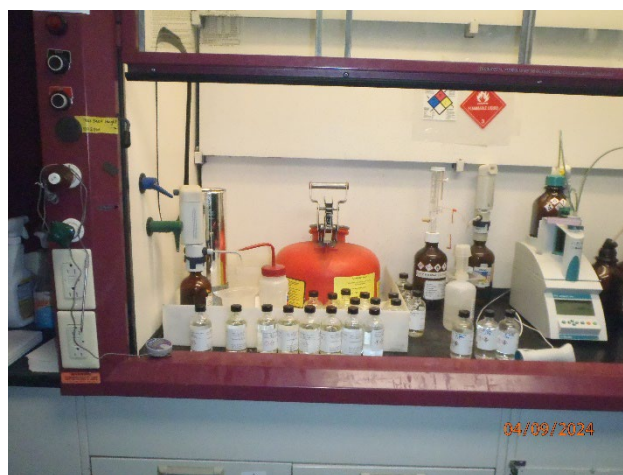
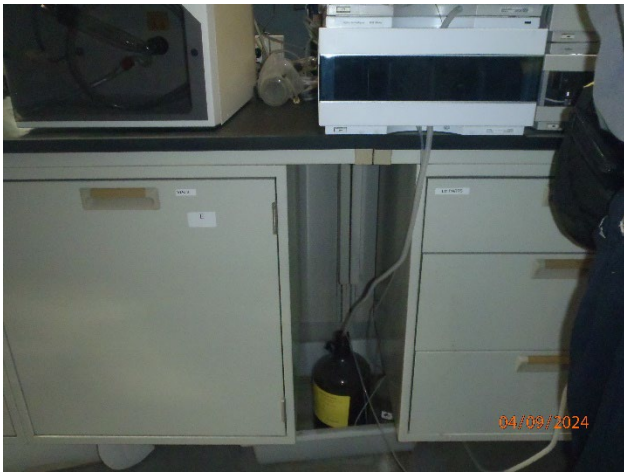
The laboratory had two SAAs (Pictures 27-28). The first SAA held a red fire can of Tank 646 Waste Organic Liquids in Fumehood 2. The container was closed and labeled. The second SAA held a 4-liter amber jar for spent high-performance liquid chromatography (HPLC) liquid. The jar was labeled but not closed and had the tubing in the opening. Inside the container was a 100 mL of spent liquid waste inside.

Picture 27 – Lab red can SAA

Picture 28 – Lab HPLC SAA

**Pursuant to S.C. Code Ann. Regs. 61-79.262.15(a)(4) [40 C.F.R. § 262.15(a)(4)], which is a condition of the SAA Permit Exemption, a generator is required to keep containers of hazardous waste closed at all times during accumulation, except when adding, removing, or consolidating waste; or when temporary venting of a container is necessary for the proper**

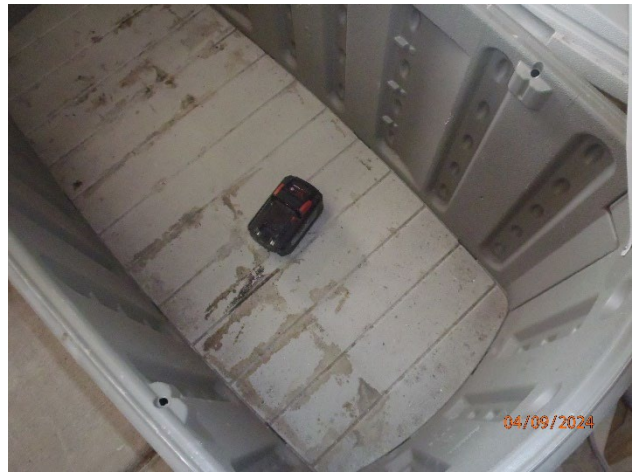
The second container held a single spent lithium battery that was placed in the wrong container (Picture 31). The facility was not able to demonstrate that the spent battery waste was accumulated less than one year, but it was immediately moved to the Storeroom to be added to the other universal waste batteries.

Picture 31 – Universal Waste Batteries – lithium battery

**Pursuant to S.C. Code Ann. Regs. 61-79.273.15(a) and (c) [40 C.F.R. § 273.15(a) and (c)], a SQHUW may accumulate universal waste no longer than one year and must be able to demonstrate the length of time that the universal waste has accumulated from the date that it became a waste or was received.**

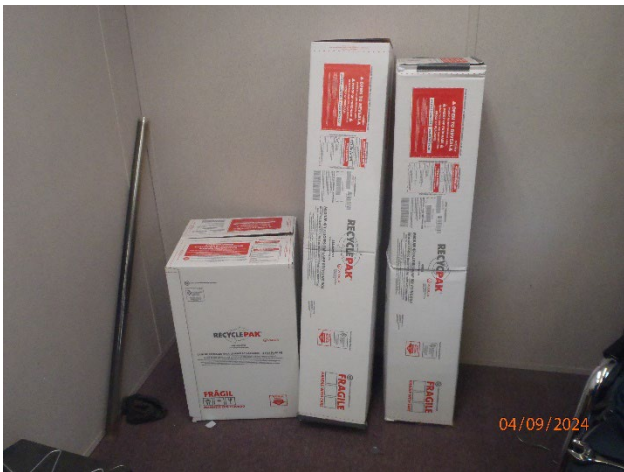
The universal waste storage area was in an office. The inspectors observed two 4-foot universal waste lamp boxes, and one square box of spent U-lamps (Picture 29). The boxes were closed, labeled and the oldest date was June 19, 2023. The square box was labeled as 'Other' instead of universal waste.

Picture 29 – Universal Waste Storage

**Pursuant to S.C. Code Ann. Regs. 61-79.273.14(e) [40 C.F.R. § 273.14(e)], a SQHUW must label or mark each lamp or container of lamps clearly with one of the following phrases: "Universal Waste-Lamp(s)," or "Waste Lamp(s)," or "Used Lamps."**

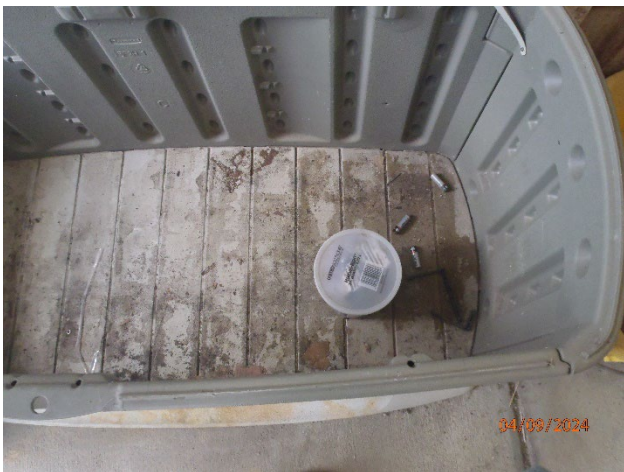
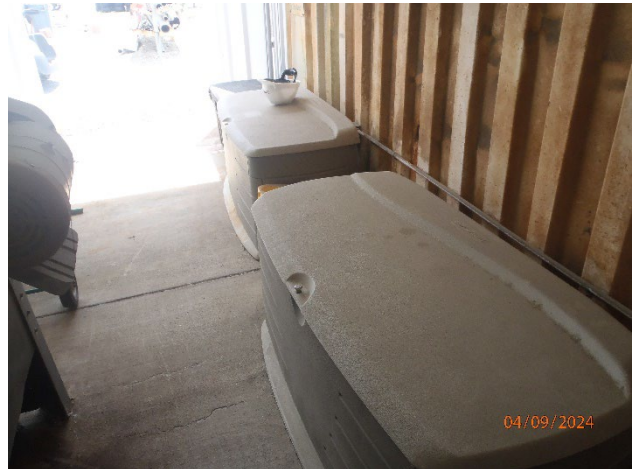
The universal waste batteries were kept in an exterior storage building. Two large Rubbermaid containers were used to separate the batteries. The first container was for spent lead acid batteries but contained a small plastic container of corroded lead acid batteries (Pictures 30, 32). The container was not labeled, and the facility was not able to demonstrate the waste was accumulated less than one year for the batteries.

Picture 32 – Universal Waste Batteries

Picture 30 – Universal Waste Batteries - lead acid

**Pursuant to S.C. Code Ann. Regs. 61-79.273.14(a) [40 C.F.R. § 273.14(a)], a SQHUW must label or mark each Universal Waste battery or container or tank in which the batteries are contained clearly with one of the following phrases: "Universal Waste - Battery(ies)," or "Waste Battery(ies)," or "Used Battery(ies)."**

**Pursuant to S.C. Code Ann. Regs. 61-79.273.15(a) and (c) [40 C.F.R. § 273.15(a) and (c)], a SQHUW may accumulate universal waste no longer than one year and must be able to demonstrate the length of time that the universal waste has accumulated from the date that it became a waste or was received.**

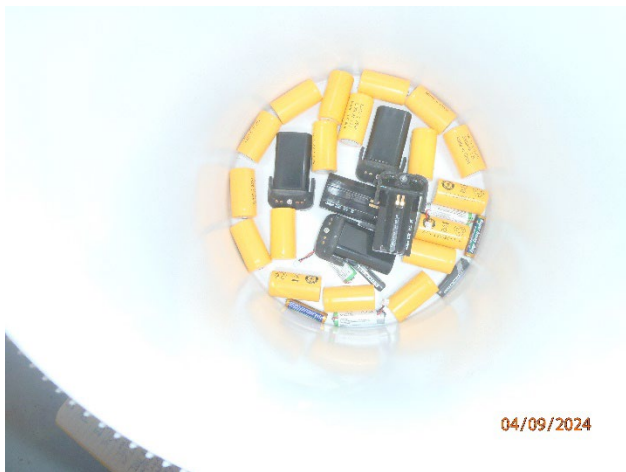
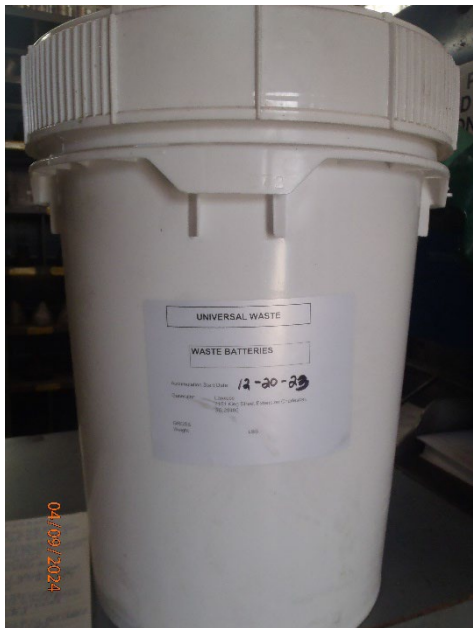
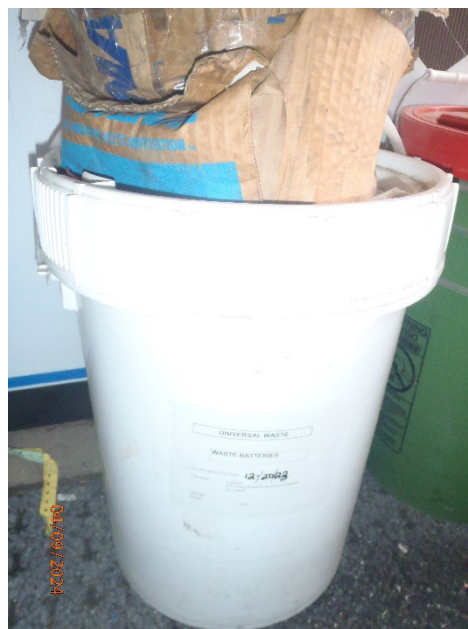
The universal waste batteries were stored in two 5-gallon containers near the service window (Pictures 33-36). The spent lithium battery was added to one of the 5-gallon containers. The inspectors observed a container of spent nickel cadmium batteries, and a container of spent

Picture 33 – Storeroom universal waste batteries

Picture 34 – Storeroom universal waste batteries

Picture 35 – Storeroom universal waste batteries

Picture 36 – Storeroom universal waste batteries

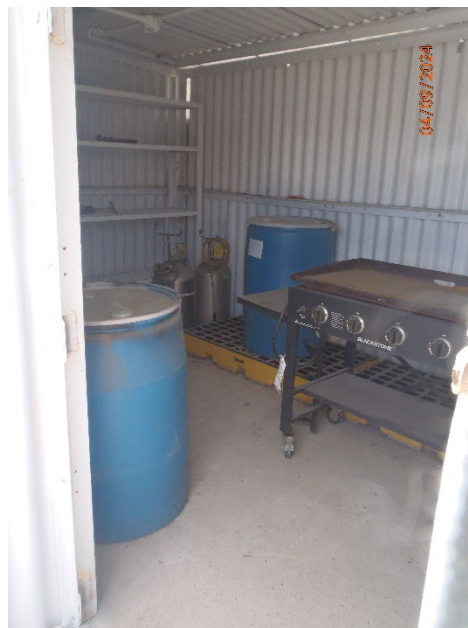
A 55-gallon container of used oil was sitting on a secondary containment pallet (Picture 37). The container was closed and labeled, and the pallet was clean. However, the container was labeled as non-hazardous waste hydraulic oil and absorbent when it should be labeled as used oil contaminated debris. Mr. Gadsden immediately relabeled the container.

Picture 37 – Used Oil Building

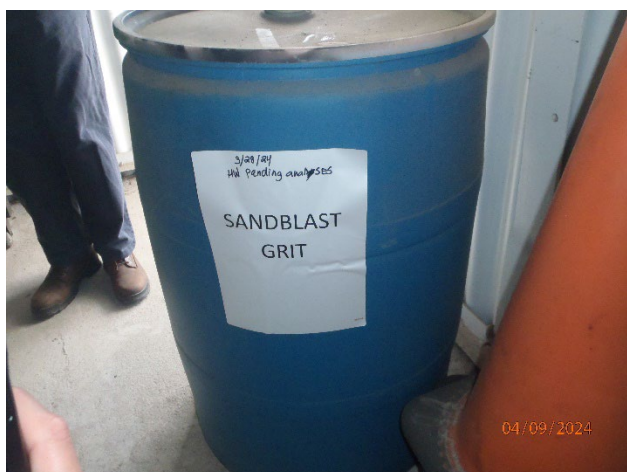
A 55-gallon container of spent sand blast grit was stored in this building (Picture 38). Mr. Gadsden stated the spent grit was being stored until the facility completes a hazardous waste analysis on the material. The material had not yet been sampled or sent for analysis. The inspectors explained that the label needed to state the contents was pending analysis and required a start accumulation date. Mr. Gadsden added the pending analysis statement and the date March 28, 2024. A spill kit was observed in the building.

Picture 38 – Used Oil Building spent sandblast grit

**Pursuant to S.C. Code Ann. Regs. 61-79.262.11 [40 C.F.R. § 262.11], a person who generates a solid waste, as defined in S.C. Code Ann. Regs. 61-79.261.2 [40 C.F.R. § 261.2], must make an accurate determination as to whether that waste is a hazardous waste in order to ensure wastes are properly managed according to applicable RCRA regulations articulated in S.C. Code Ann. Regs. 61-79.262.11 [40 C.F.R. § 262.11].**
