## Region 6 - Enforcement & Compliance Assurance Division

### INSPECTION REPORT

| Company Name: | <b>LaRay Oil, LLC</b> | |
| Facility Name: | <b>Thompson #1 SWD</b> | |

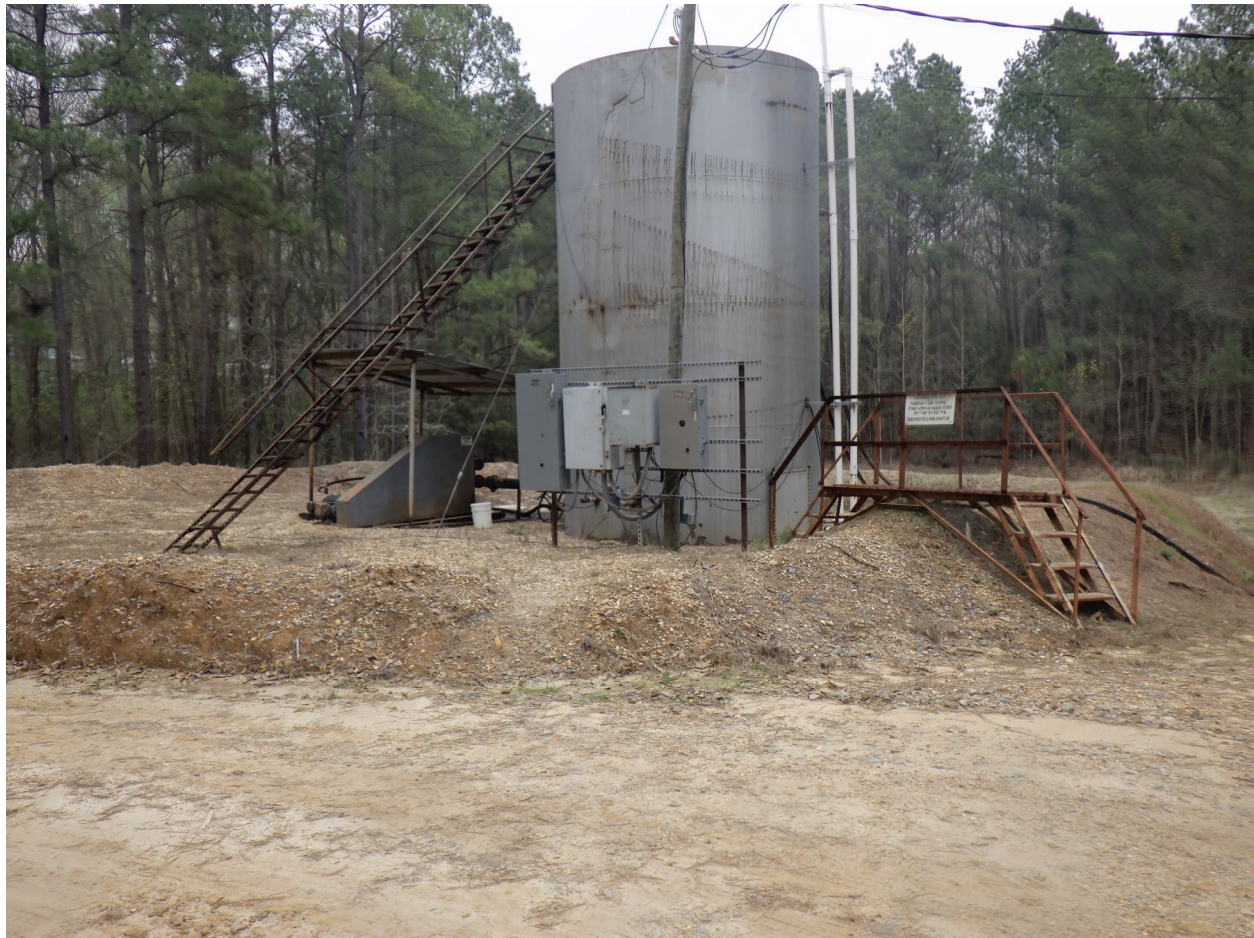
Photo No. 2

**Description:** This photo was taken looking E-NE at the facility showing an overview of the facility.

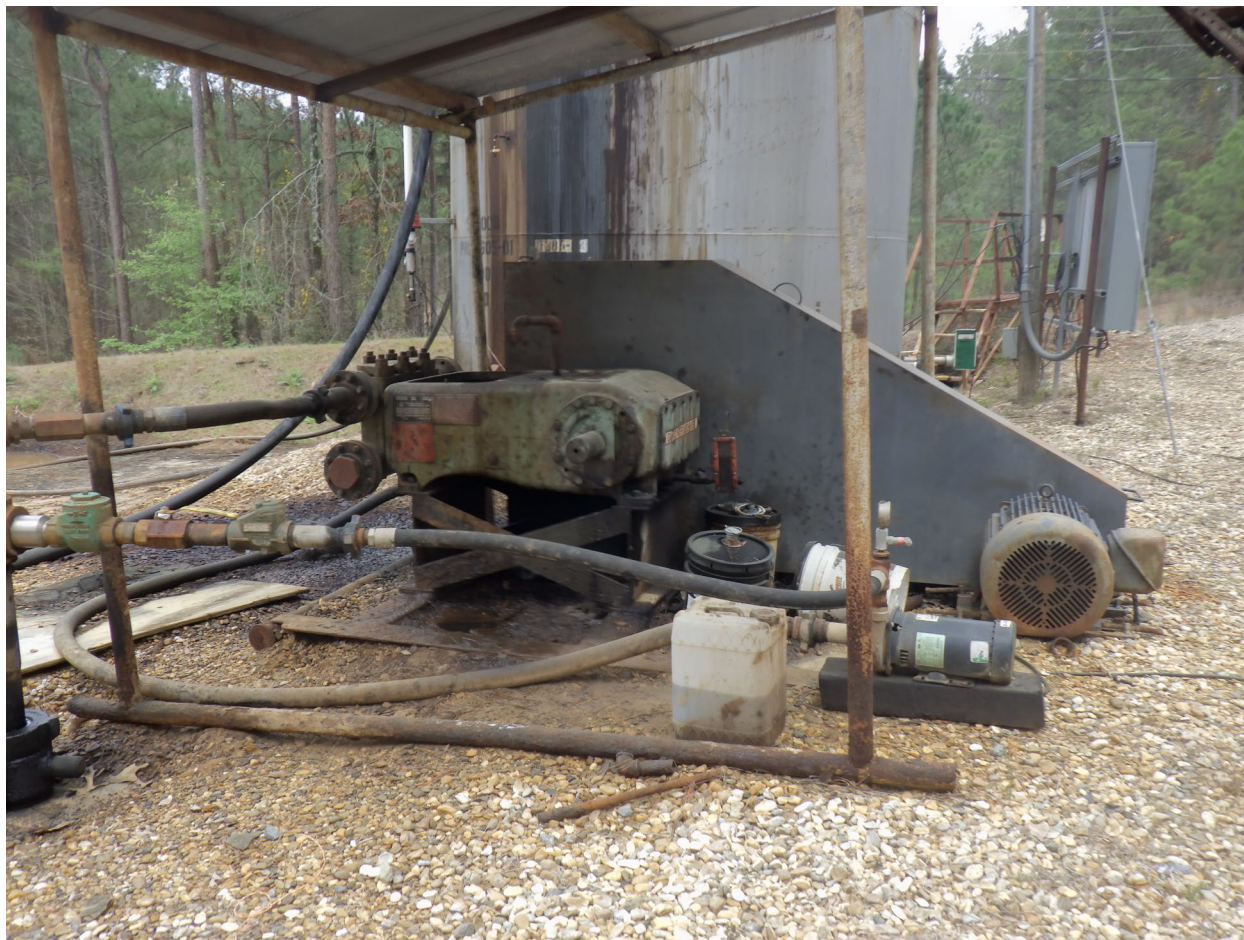
Photo No. 3

**Description:** This photo was taken looking S-SE showing the pump for the saltwater disposal well (SWD).

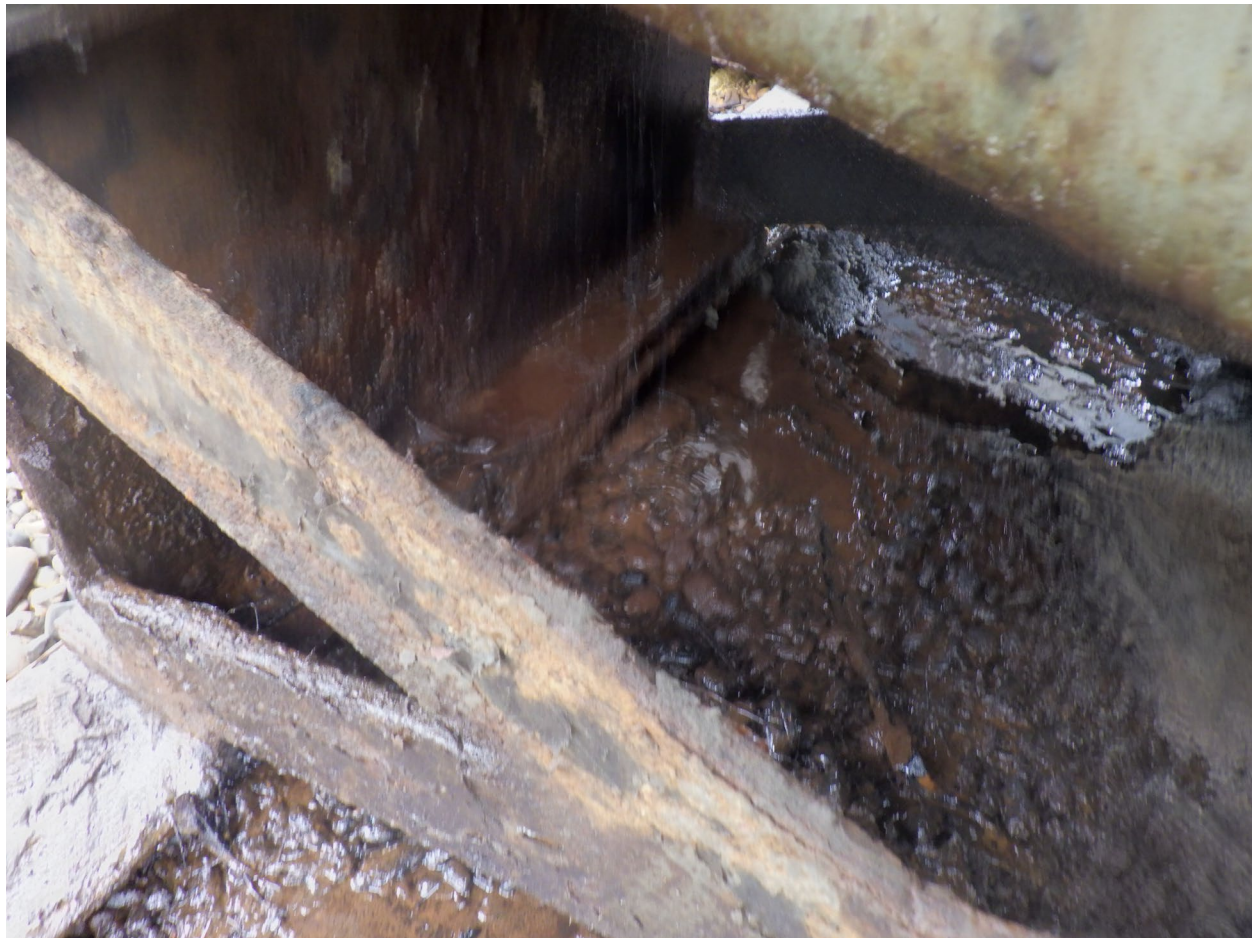
I observed the pump for the SWD well to have an active leak during the inspection. The release from the pump was collecting and commingling with fluid inside secondary containment, see Photo No. 4 through No. 8.

**Description:** This photo was taken looking SE showing a closeup of a leak at the pump for the SWD.

The active release of saltwater at the SWD pump inside secondary containment was stopped by Mr. Newton by repair of the leaking pump at the SWD. Mr. Newton indicated, during the inspection, that he would replace the leaking valve at the drainpipe for the secondary containment.

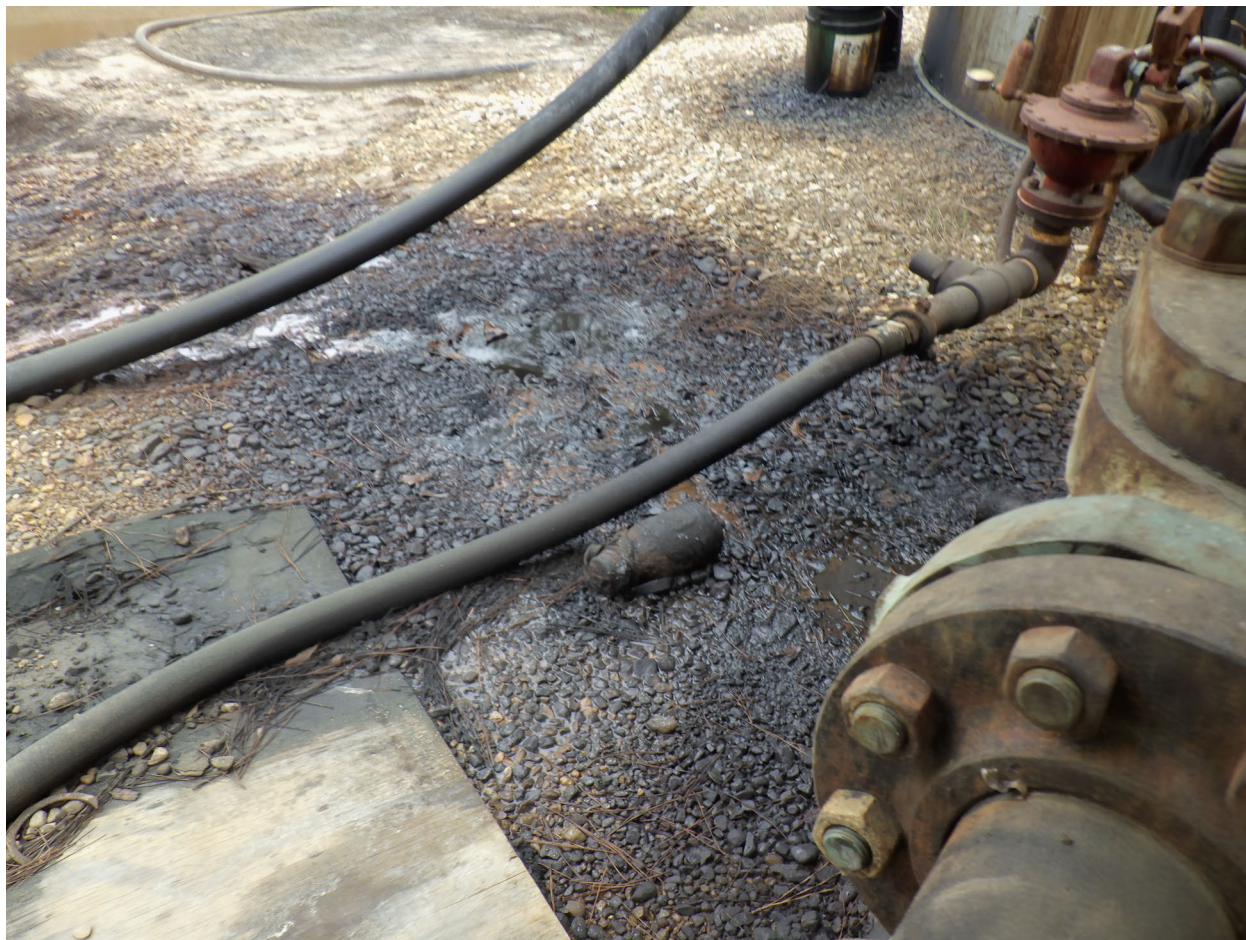
Photo No. 5

**Description:** This photo was taken looking S showing the flowpath of the leak from the pump for the SWD into secondary containment.

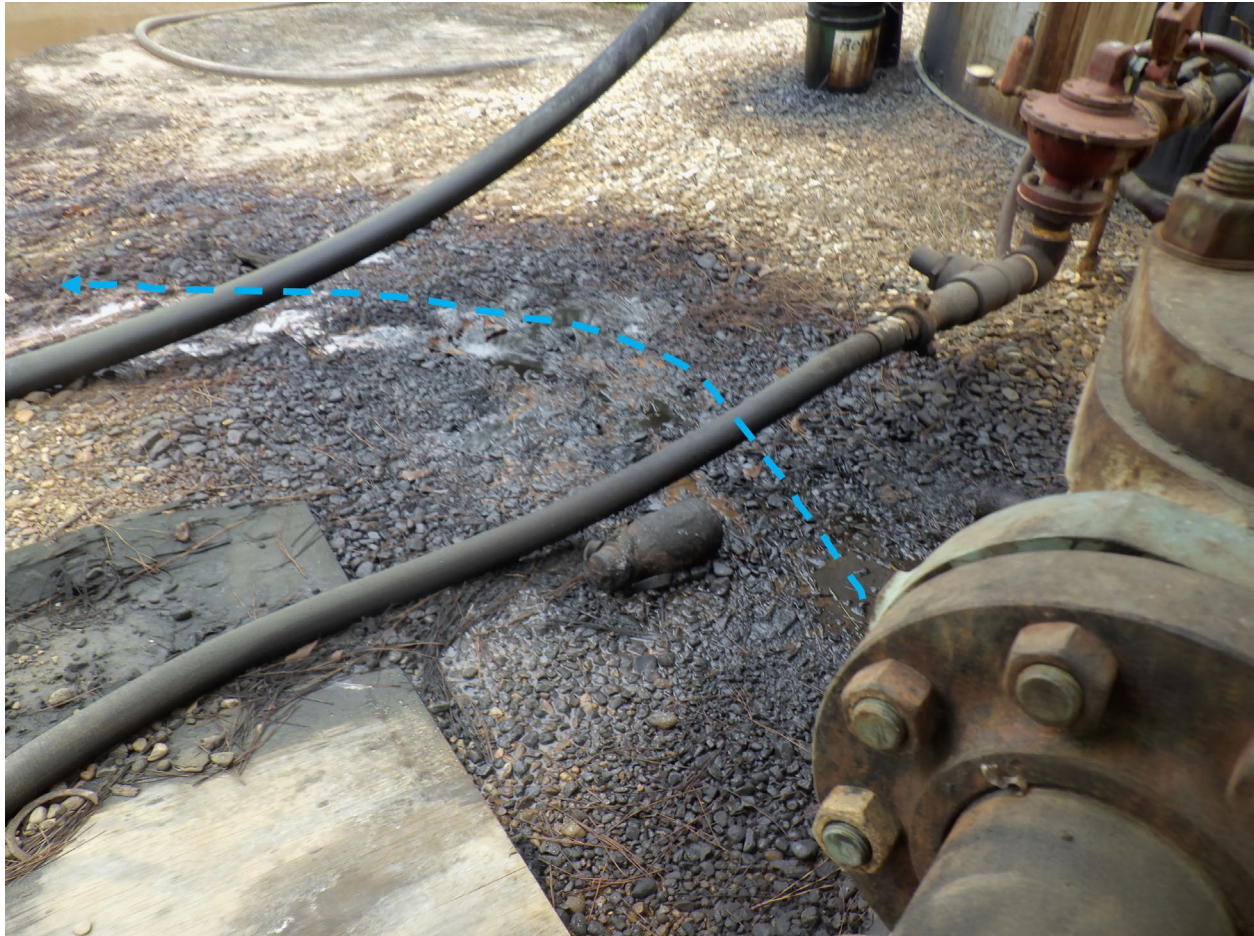
Photo No. 6

**Description:** This photo was taken looking S showing the flowpath of the leak from the pump for the SWD into secondary containment.

**EDIT:** flowpath line of SWD pump leak (dash) added for clarity.

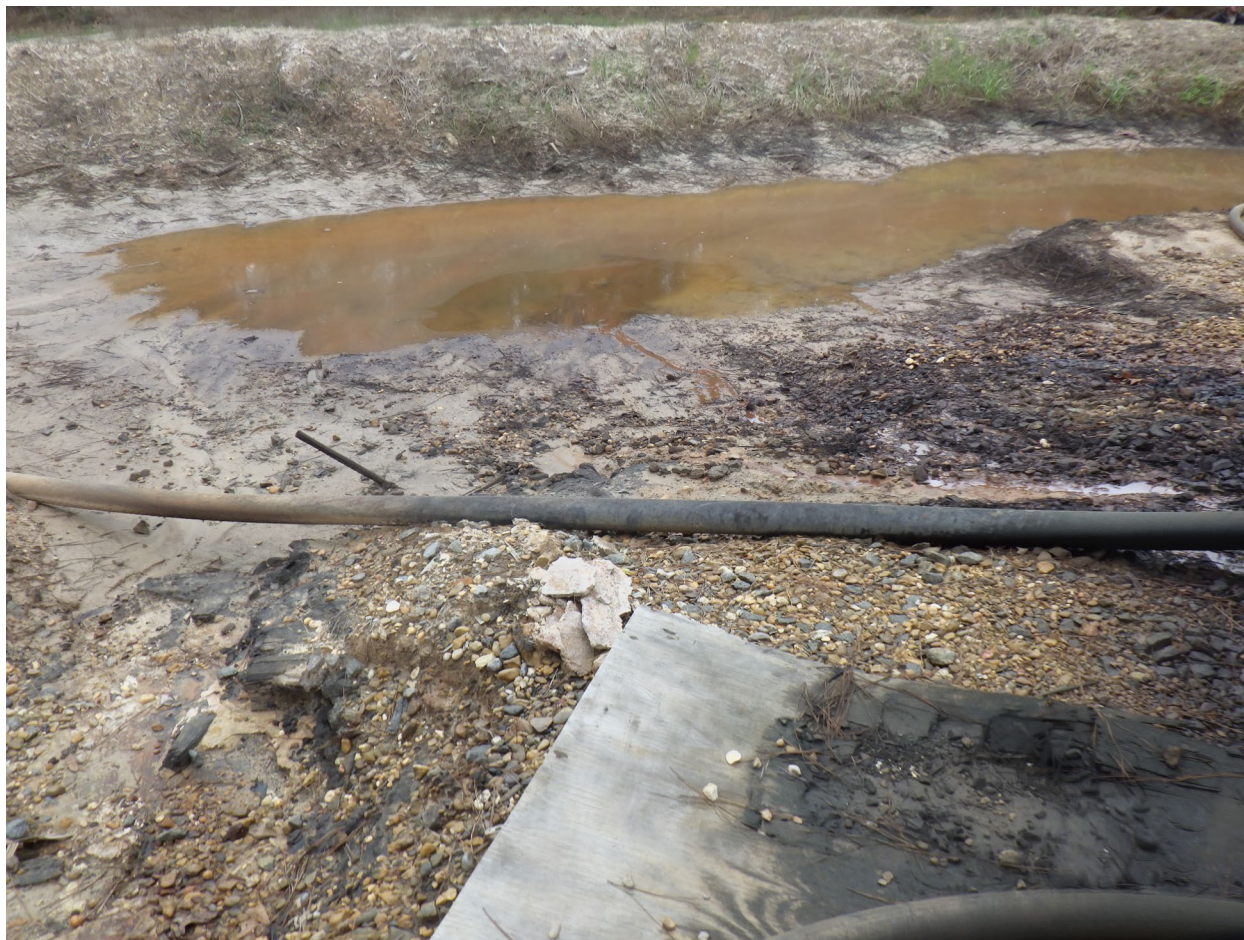
Photo No. 7

**Description:** This photo was taken looking E-SE showing the continued flowpath of the leak from the pump for the SWD into secondary containment in Photo No. 4-6.

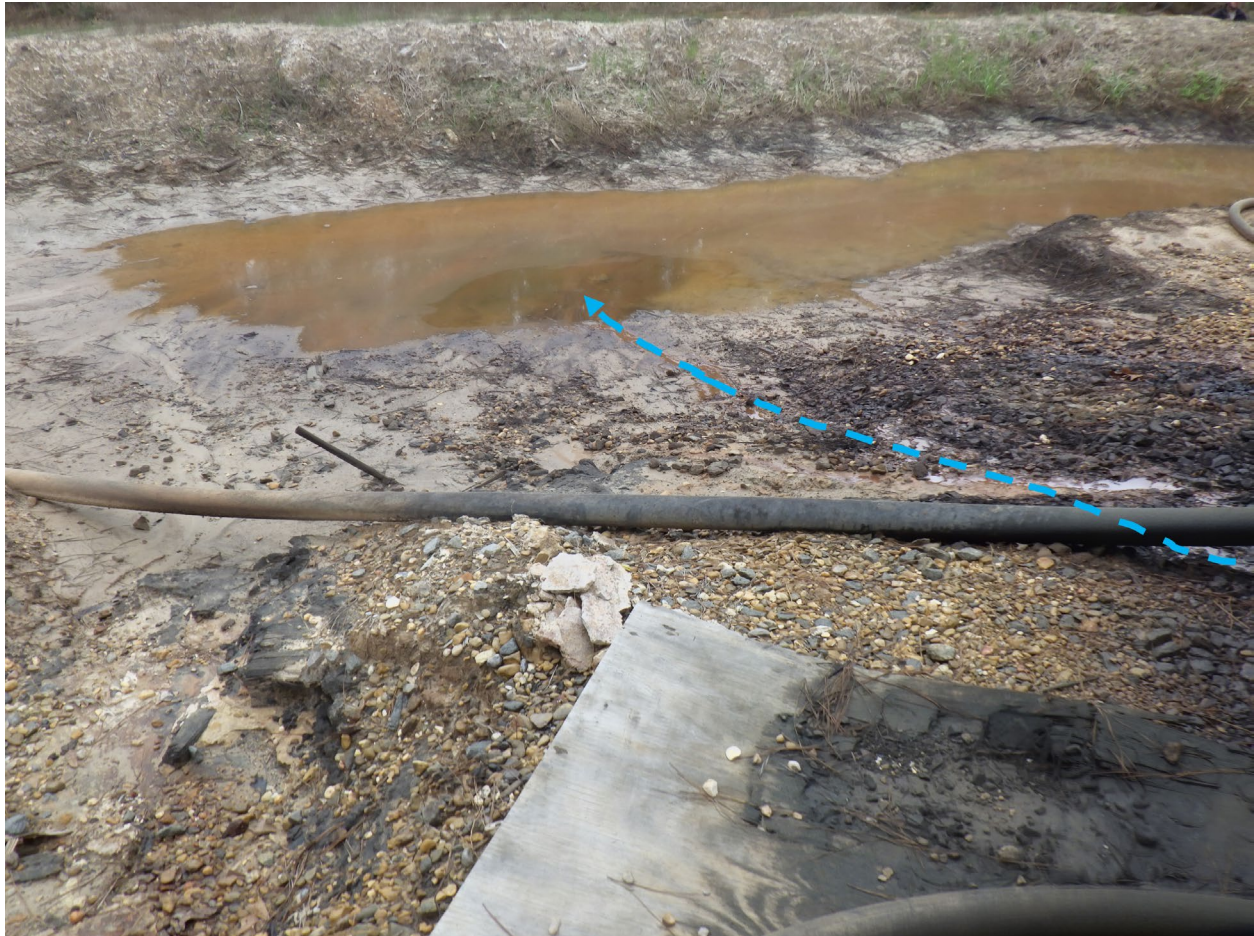
Photo No. 8

**Description:** This photo was taken looking E-SE showing the continued flowpath of the leak from the pump for the SWD into secondary containment in Photo No. 4-6.

**EDIT:** flowpath line of SWD pump leak (dash) added for clarity.

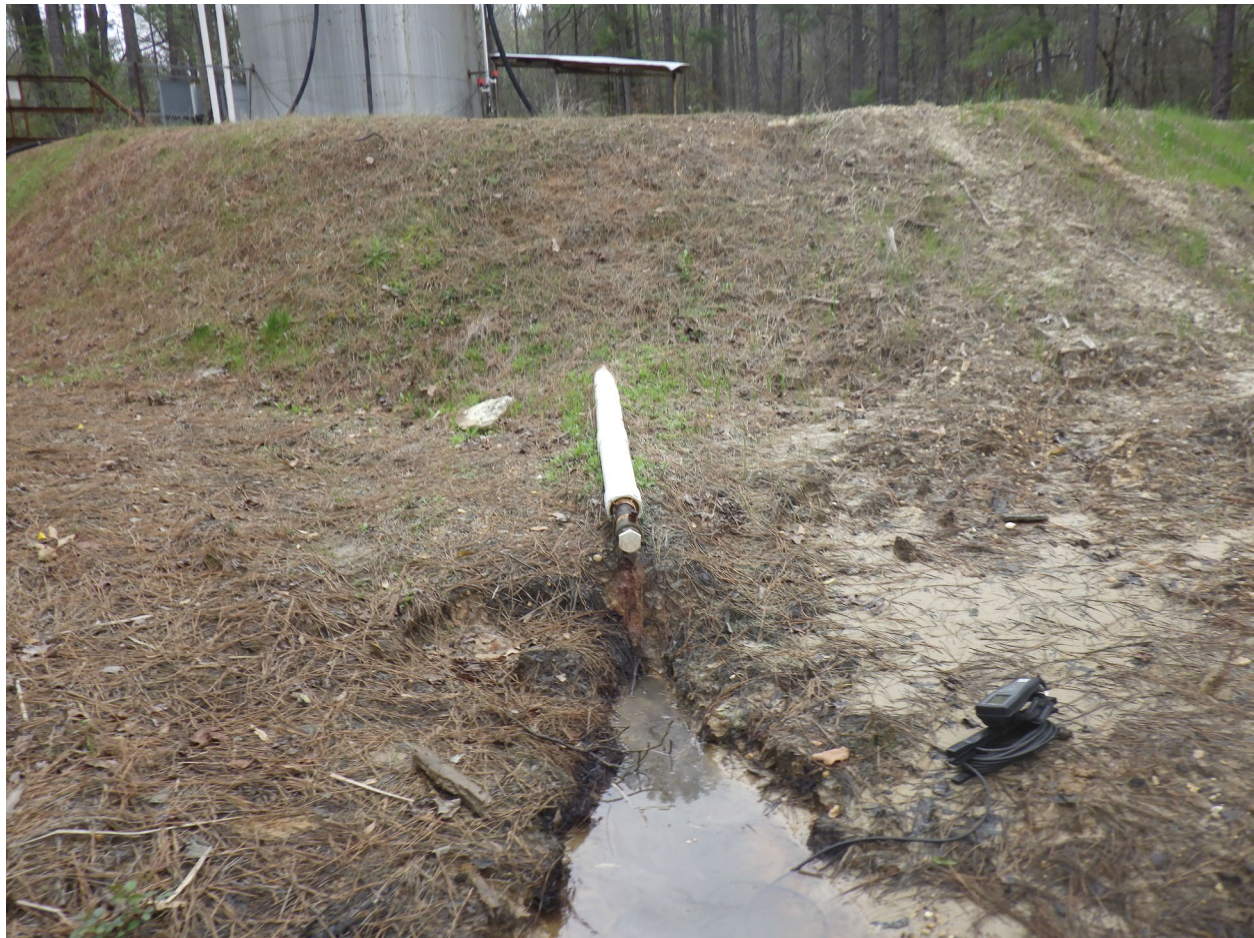
Photo No. 9

I observed the drainpipe for secondary containment to have an active leak at the valve on the pipe, see Photo No. 9. There was a cap on the drainpipe.

**Description:** This photo was taken looking NW showing the drainpipe from the secondary containment; active leak noted at drainpipe.

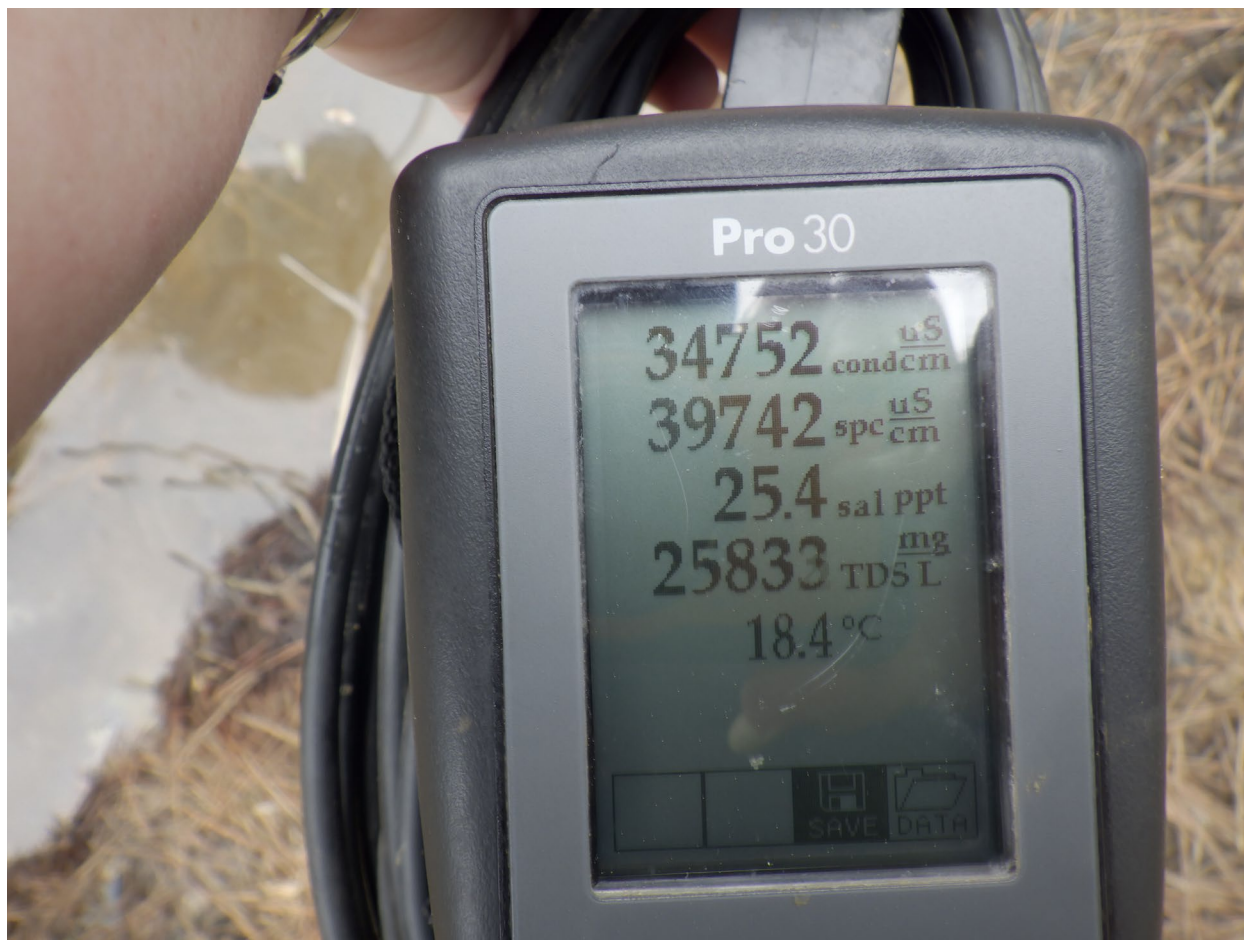
A Total Dissolved Solids (TDS) reading of 25,833 mg/L was taken in a pool below the leaking drainpipe for the secondary containment, see Photo No. 10 through No. 14. This conveyance discharges to an intermittent, unnamed tributary (UT) of Holmes Creek.

**Description:** This photo was taken looking E showing the Total Dissolved Solids (TDS) reading in the pool of water below the drainpipe in the secondary containment for the facility.

| TSD / Temperature | 25833 mg/L at 18.4 degC |

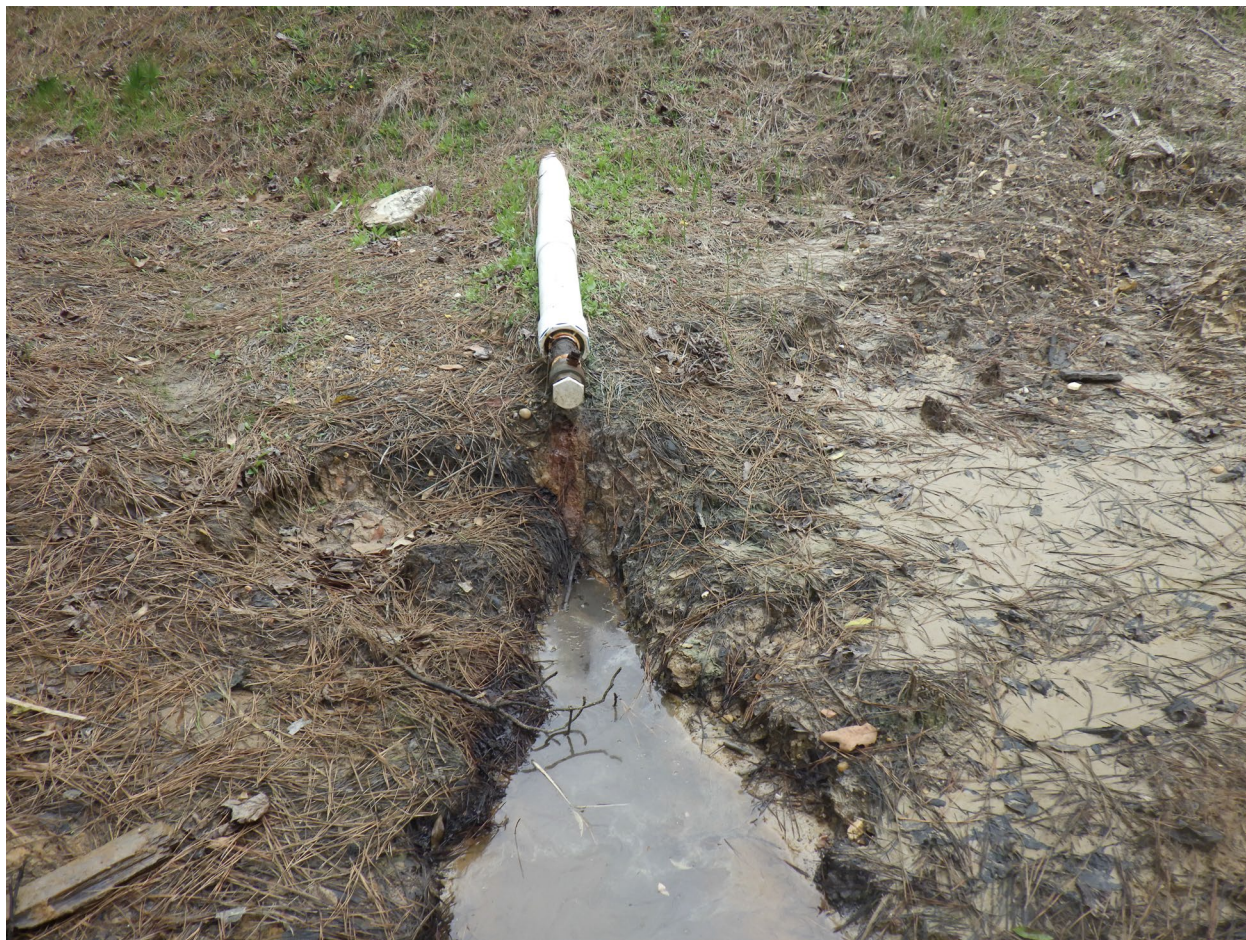
Photo No. 11

**Description:** This photo was taken looking NW showing the area upstream of the TDS sample location in Photo No. 10.

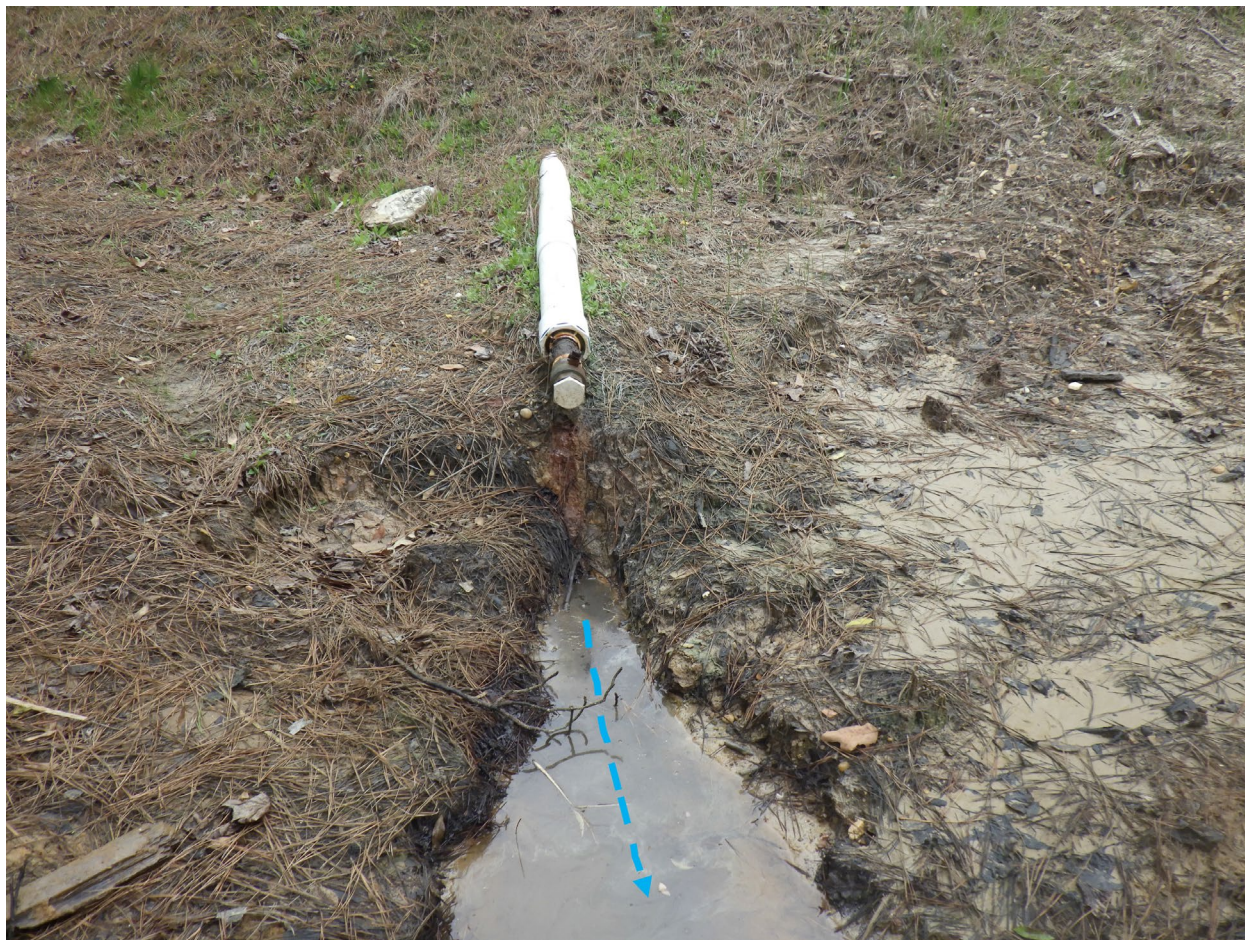
Photo No. 12

**Description:** This photo was taken looking NW showing the area upstream of the TDS sample location in Photo No. 10.

**EDIT:** flowpath line of drainpipe (dash) added for clarity.

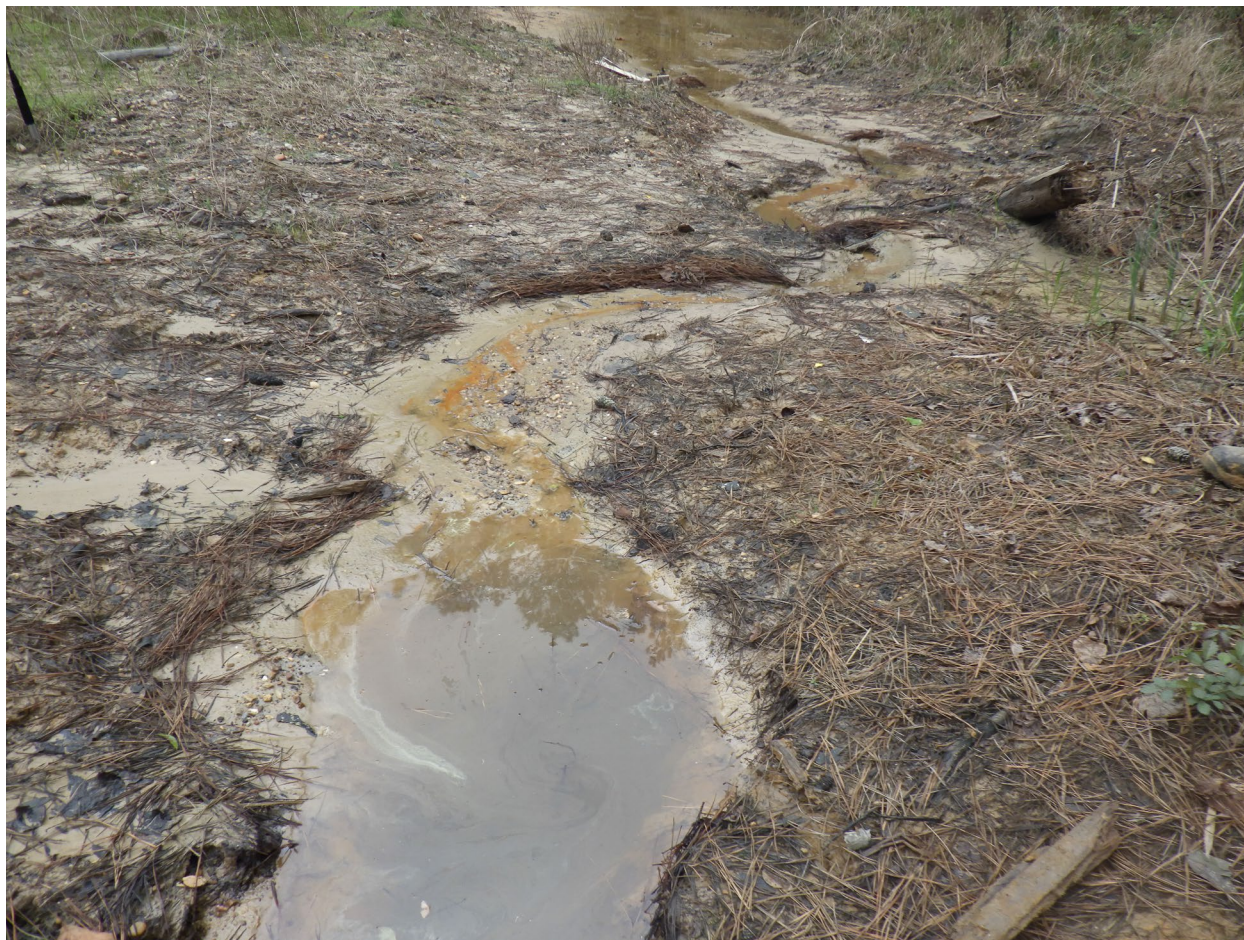
Photo No. 13

**Description:** This photo was taken looking SE showing the area downstream of the TDS sample location in Photo No. 10.

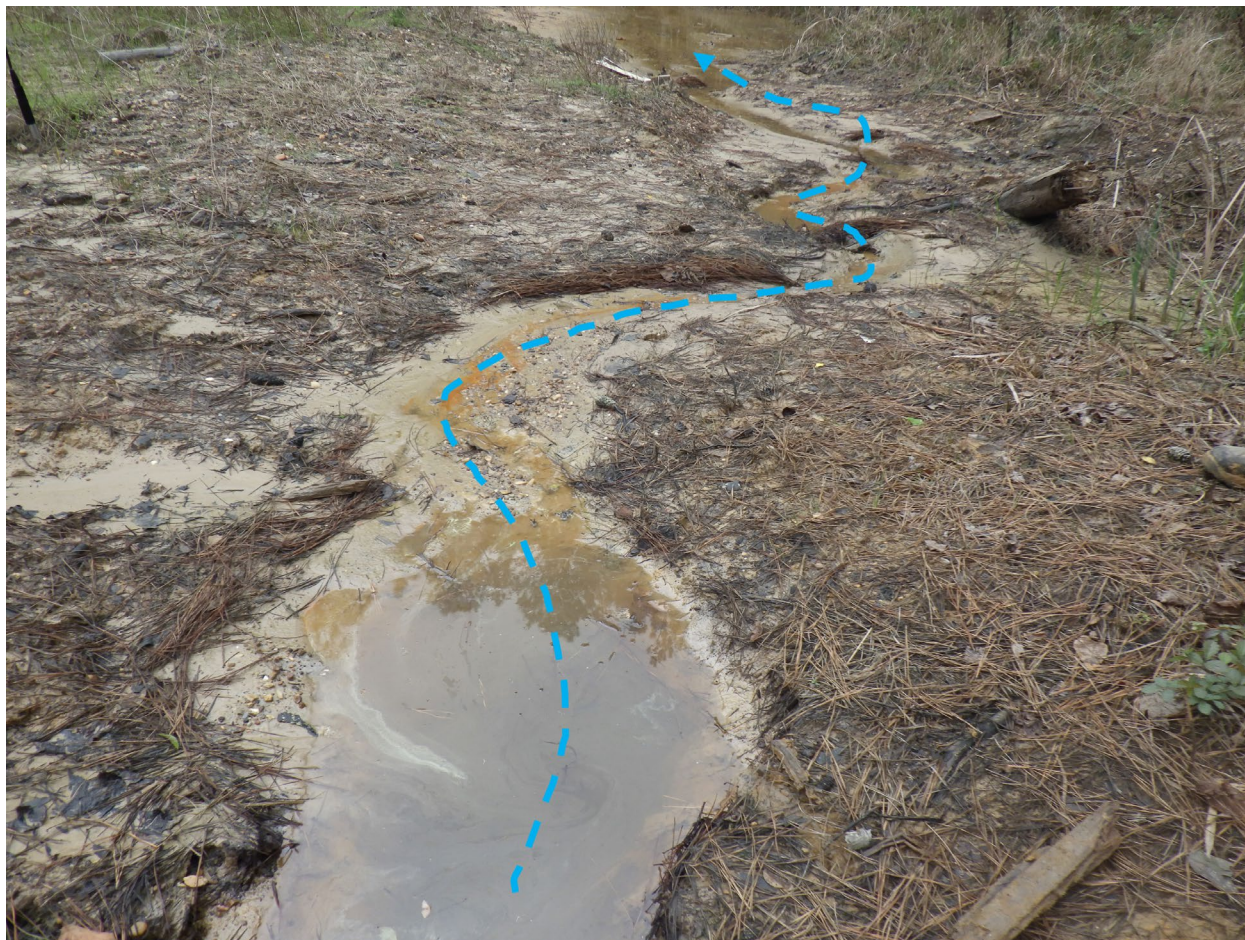
Photo No. 14

**Description:** This photo was taken looking SE showing the area downstream of the TDS sample location in Photo No. 10.

**EDIT:** flowpath line of drainpipe (dash) added for clarity.

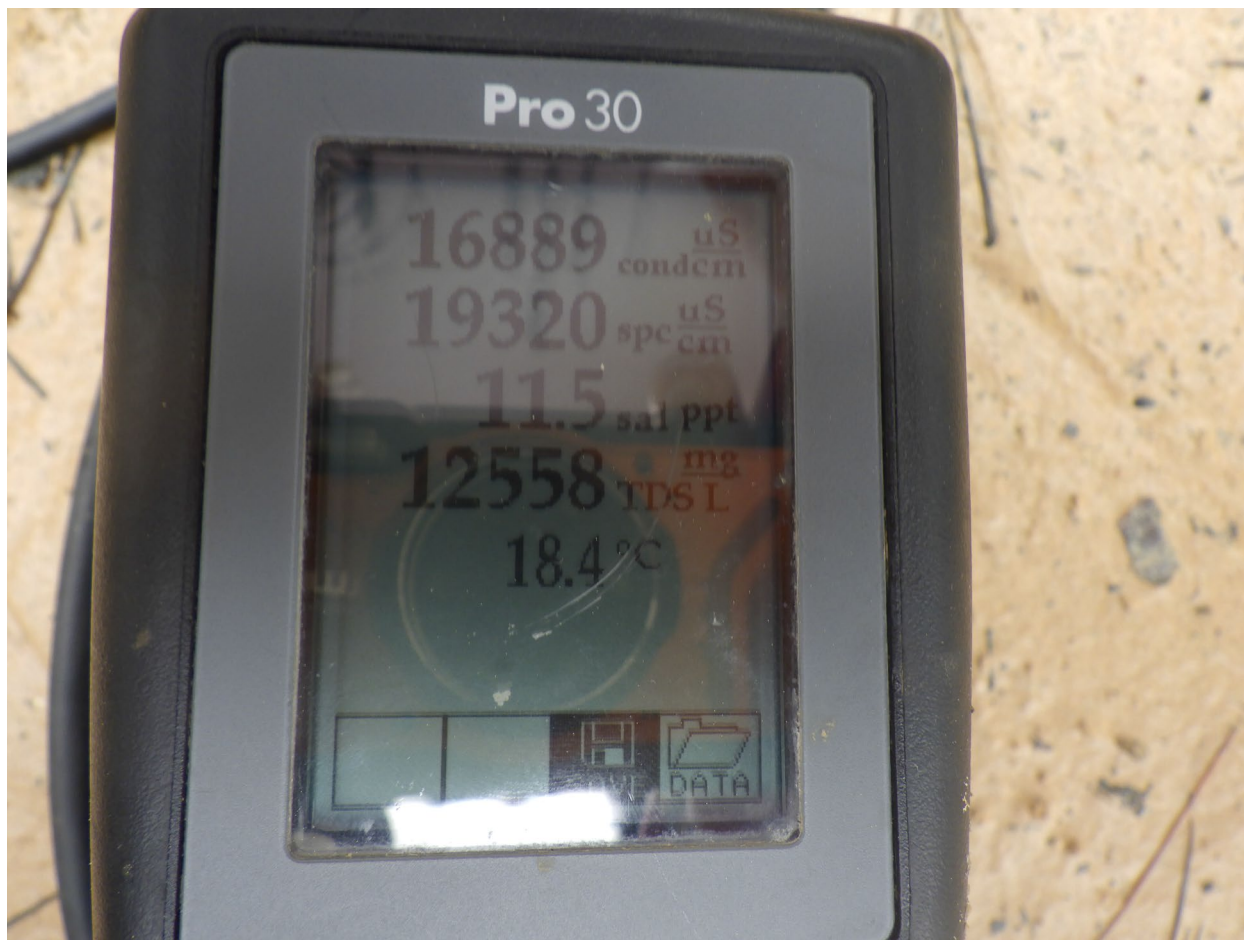
Another TDS reading of 12,558 mg/L was taken directly downstream in the same conveyance as the first TDS reading, see Photo No. 15 through No. 19.

**Description:** This photo was taken looking S-SW showing the TDS reading downstream of the pool of water below the drainpipe in the secondary containment for the facility.

| TSD / Temperature | 12558 mg/L at 18.4 degC |

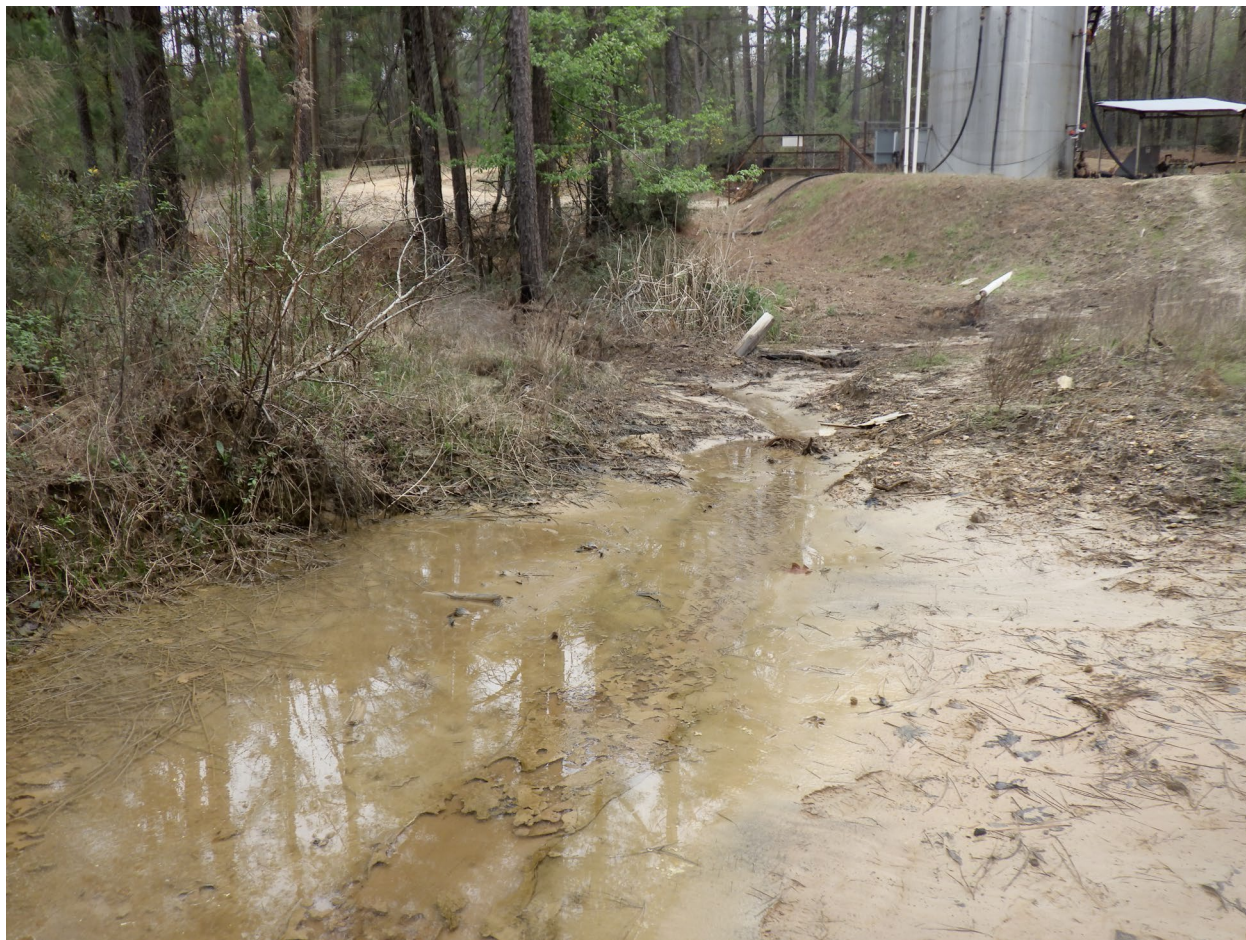
Photo No. 16

**Description:** This photo was taken looking W showing the area upstream of the TDS sample location in Photo No. 15.

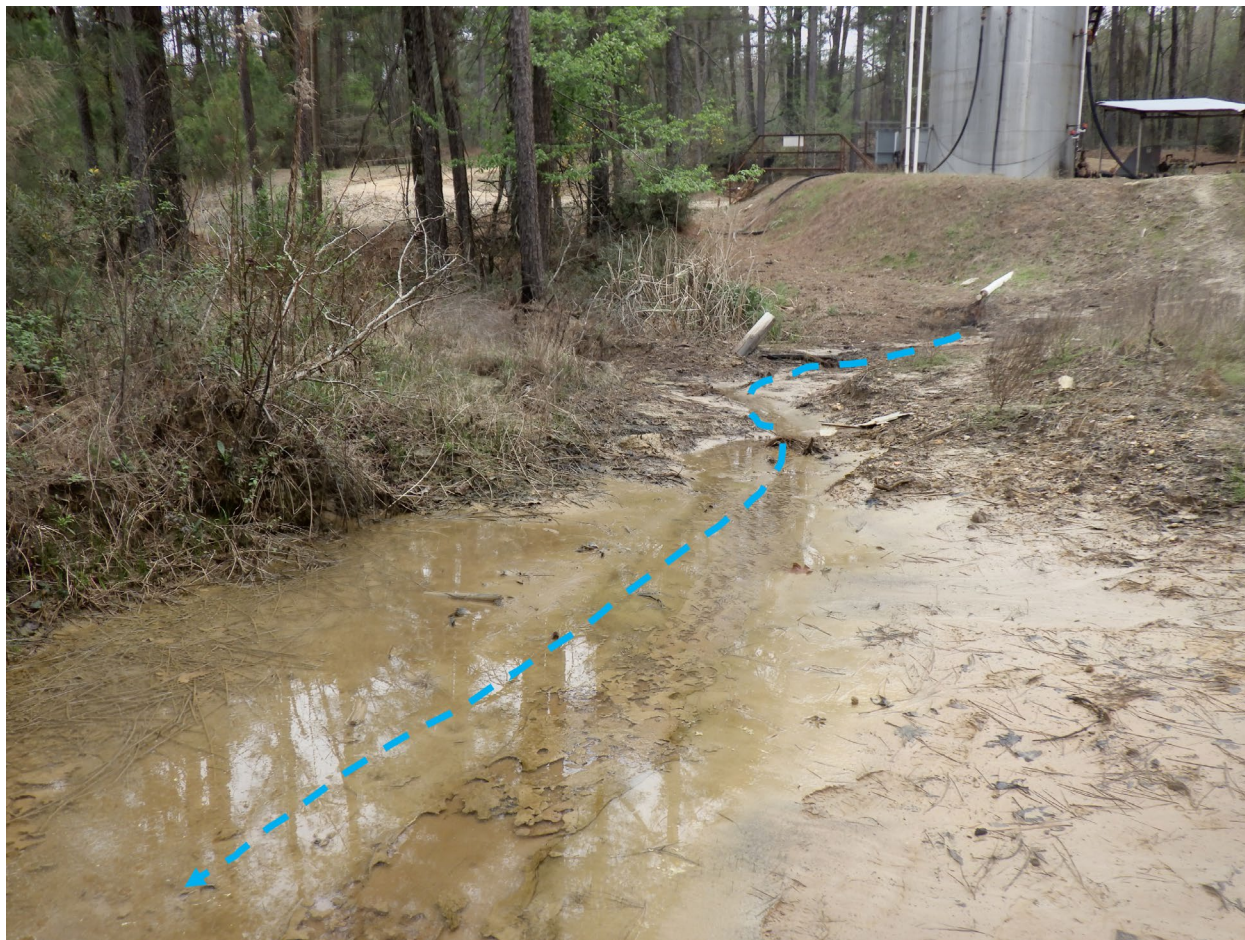
Photo No. 17

**Description:** This photo was taken looking W showing the area upstream of the TDS sample location in Photo No. 15.

**EDIT:** flowpath line of drainpipe (dash) added for clarity.

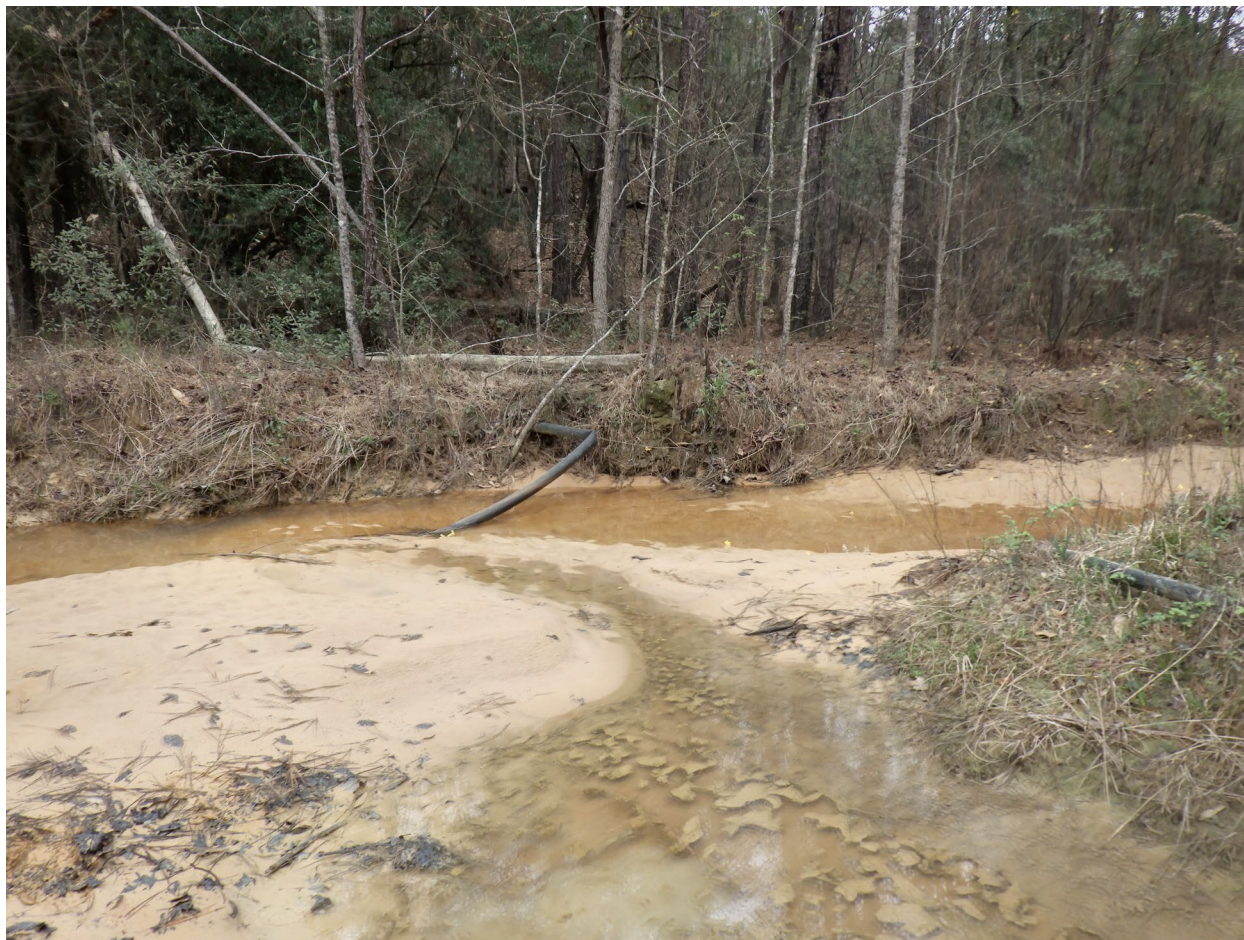
Photo No. 18

**Description:** This photo was taken looking SE showing the area downstream of the TDS sample location in Photo No. 15.

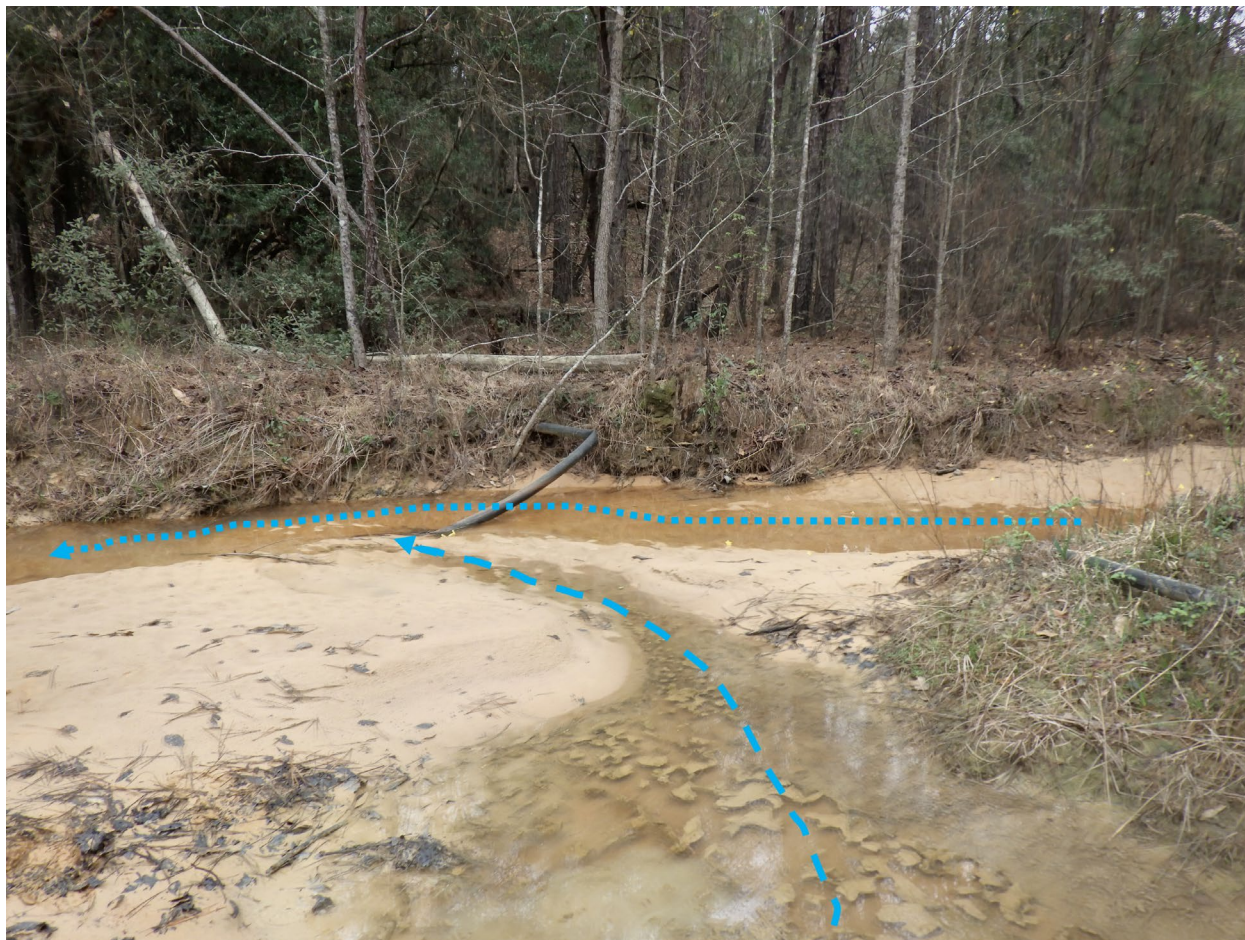
Photo No. 19

**Description:** This photo was taken looking SE showing the area downstream of the TDS sample location in Photo No. 15.

**EDIT:** flowpath line of drainpipe (dash) and flow direction of receiving stream (dotted) added for clarity.
