## Region 6 - Enforcement & Compliance Assurance Division

### INSPECTION REPORT

| Company Name: | <b>LaRay Oil, LLC</b> | |
| Facility Name: | <b>Thompson #1 SWD</b> | |

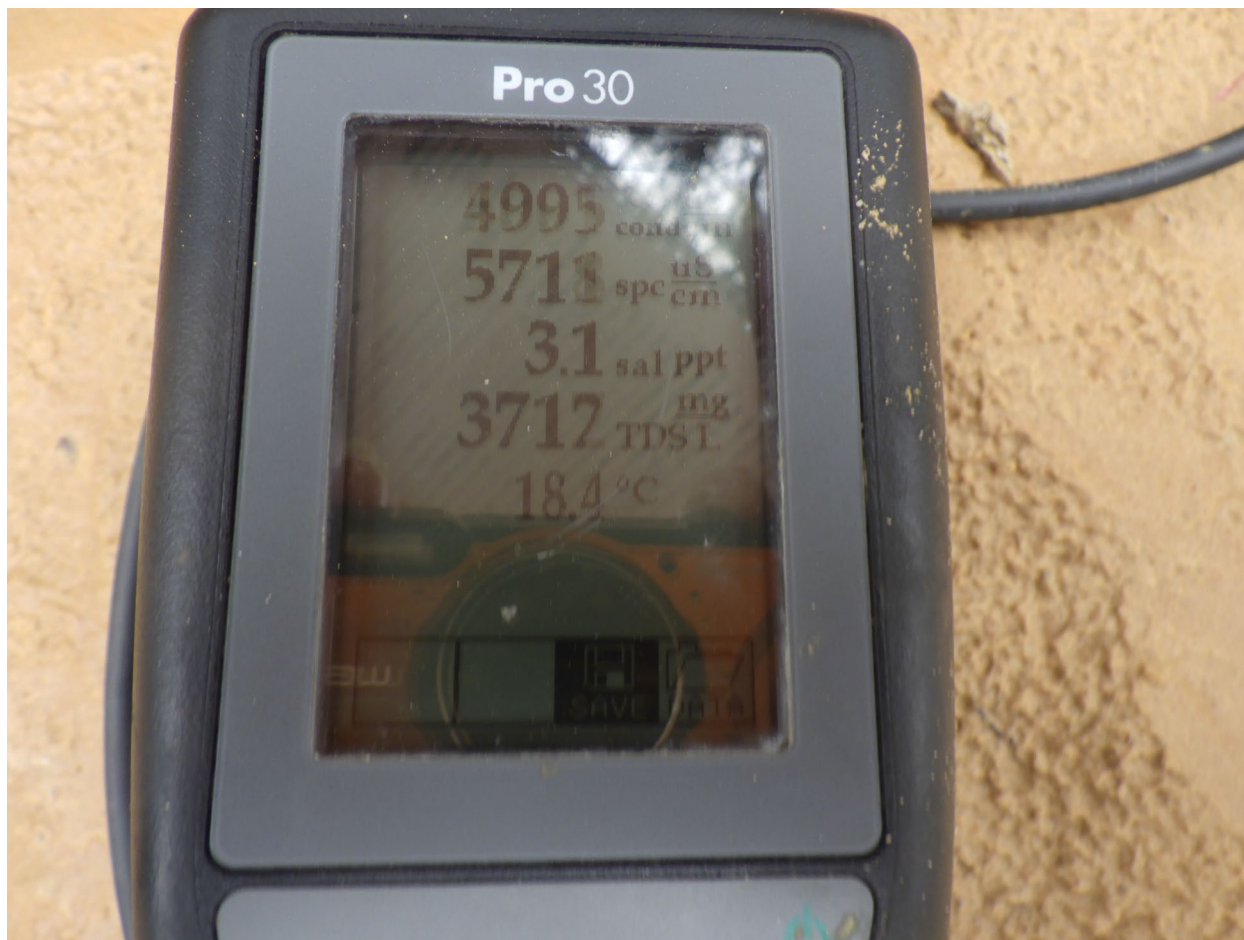
A TDS reading of 3,712 mg/L was taken at the point of entry (POE) for the conveyance of the drainpipe into the receiving stream, see Photo No. 20 through No. 26.

**Description:** This photo was taken looking SE showing the TDS reading of the flowpath at the point of entry (POE) with the receiving stream.

| TSD / Temperature | 3712 mg/L at 18.4 degC |
