**Region 6 - Enforcement & Compliance Assurance Division**  
**INSPECTION REPORT**

| Media Program: | RCRA Compliance Evaluation Inspection | |
| Company Name: | <b>Waste Control Specialists LLC</b> | |
| Facility Name: | <b>Waste Control Specialists</b> | |

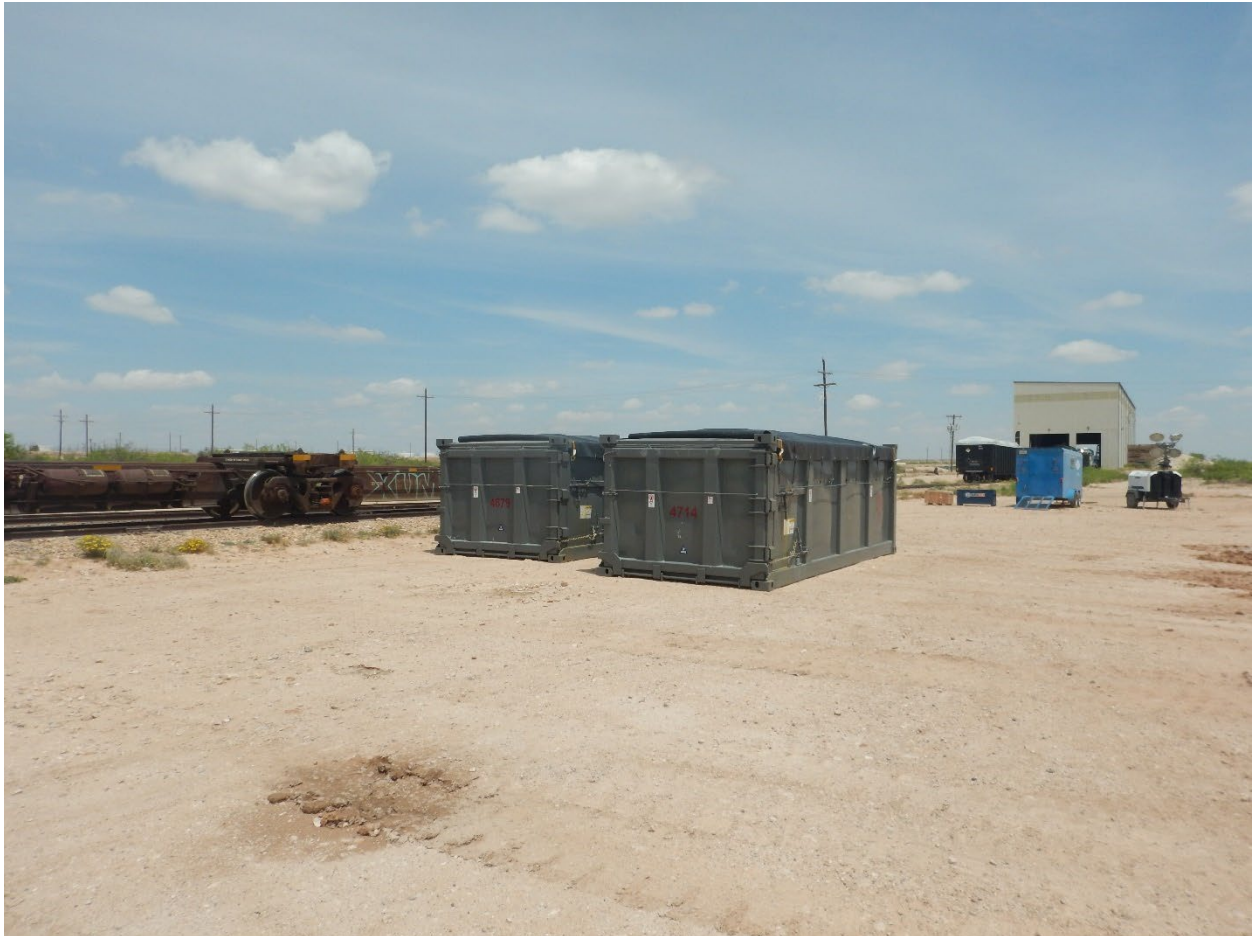
Photo No. 1

| Description: Two containers of waste from the East Palestine train derailment. Picture taken in NE direction. | |

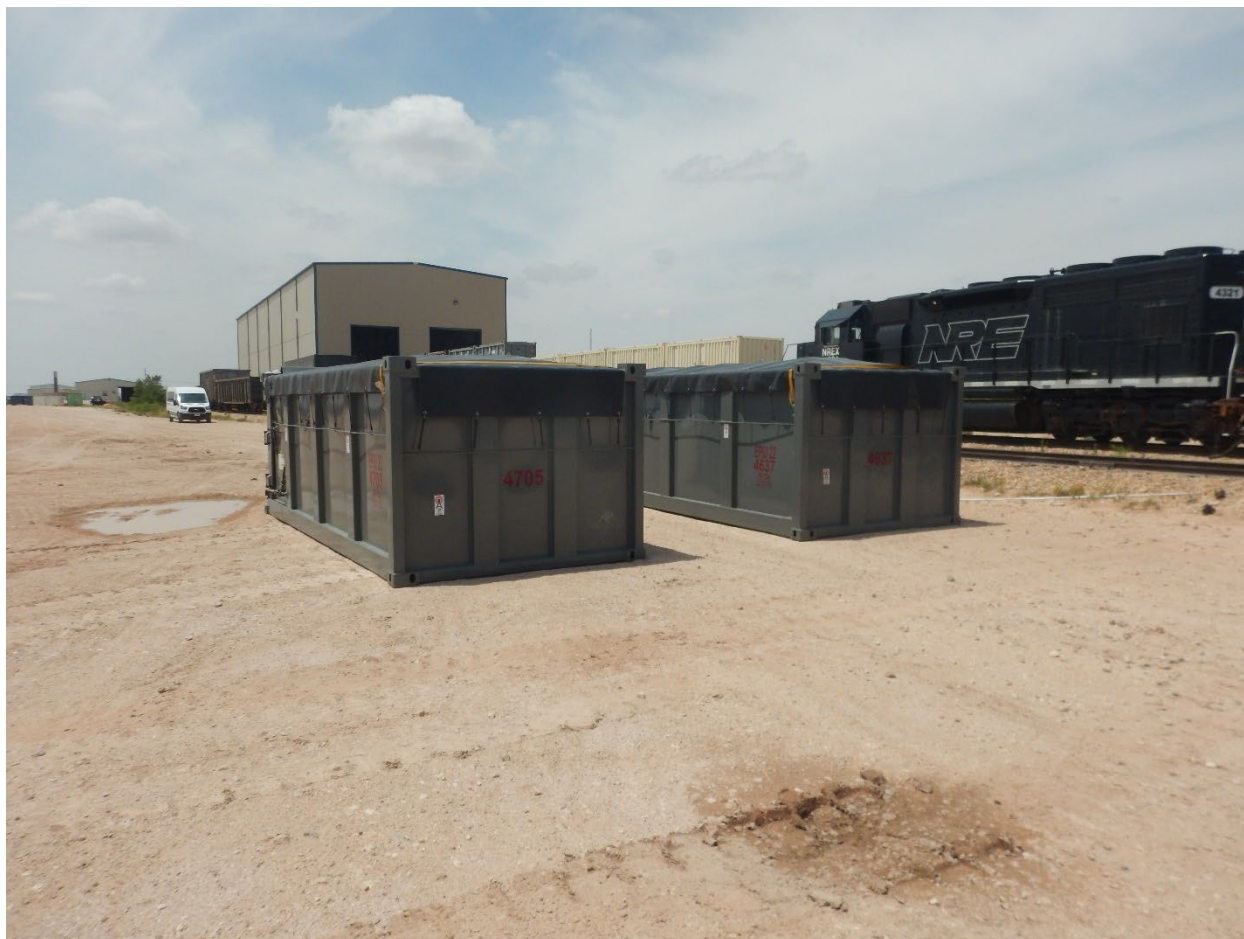
Photo No. 2

| Description: Two containers of waste from the East Palestine train derailment. Picture taken in NW direction. | |

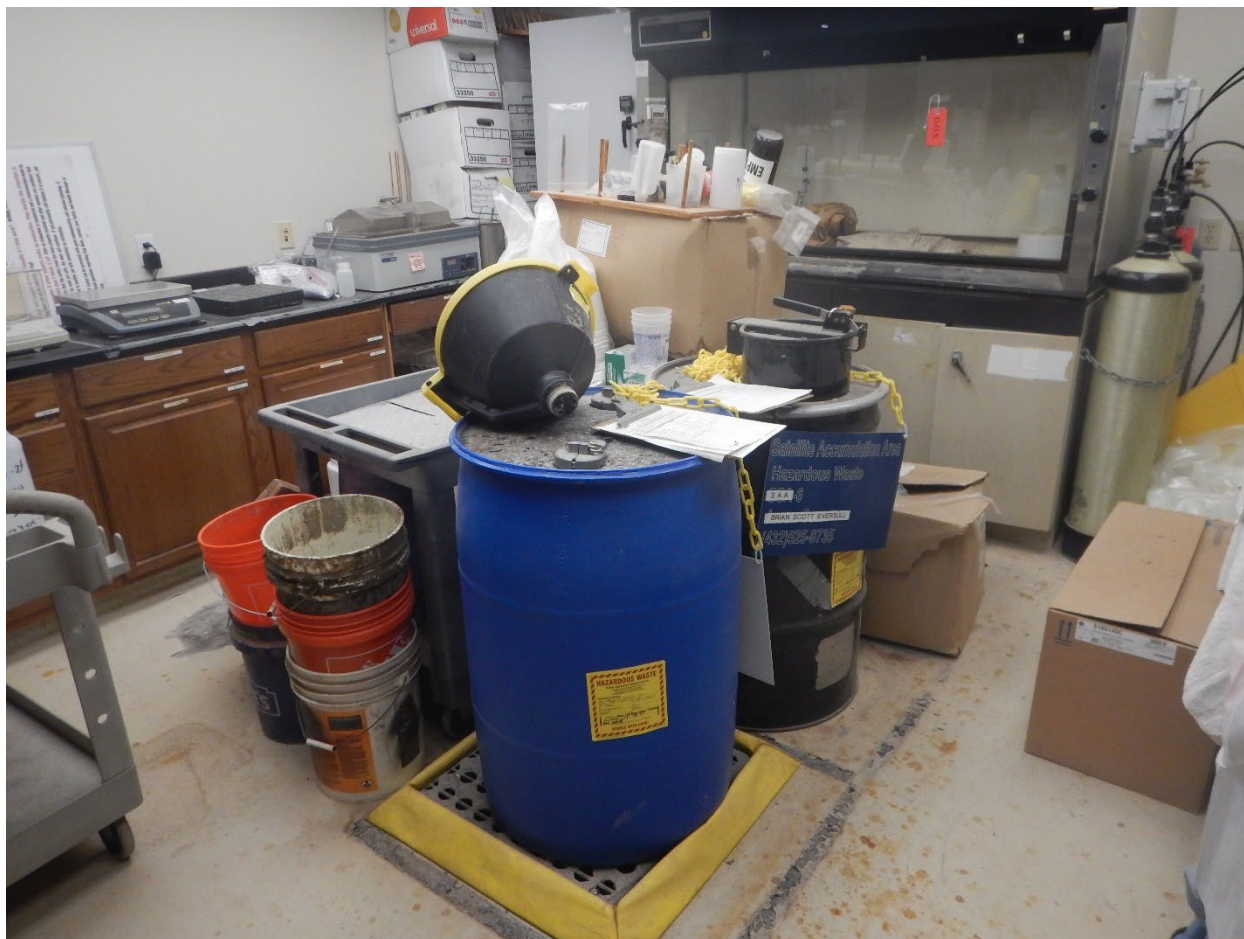
Photo No. 3

We observed two 55-gallon drums in the Satellite Accumulation Area (SAA) inside the laboratory. One of the drums was full and the other was half full, therefore more than 55-gallons had been accumulating. The last record in the logbook was 11/23/2021. SAA can only accumulate 55-gallons of waste any amount over that must be removed within 3 days.

| Description: Two 55-gallon drums used for the accumulation of hazardous laboratory waste in the facility laboratory. WCS claimed this is a Satellite Accumulation Area. | |

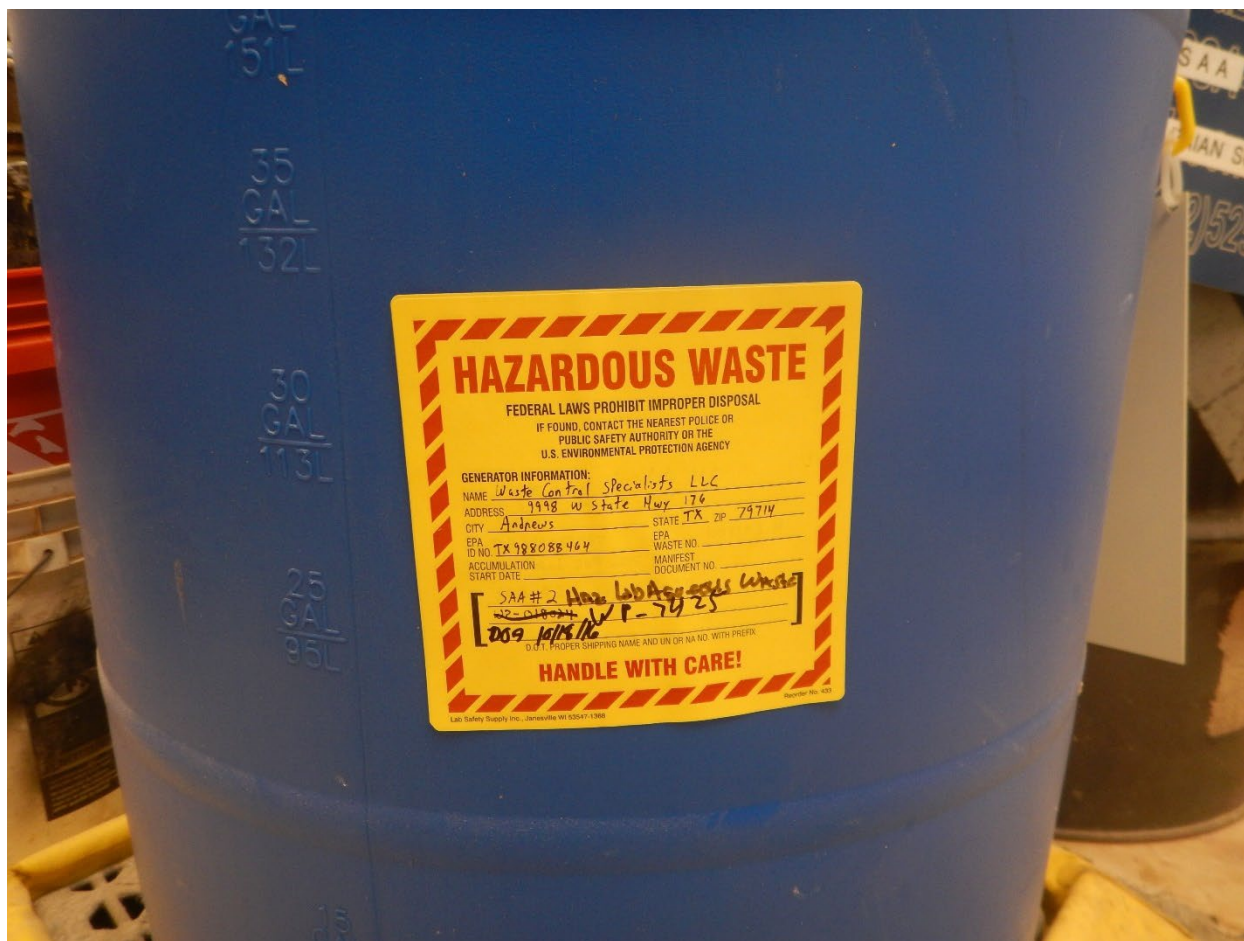
Photo No. 4

| Description: Label on one of the two containers of laboratory waste in the facility laboratory. | |

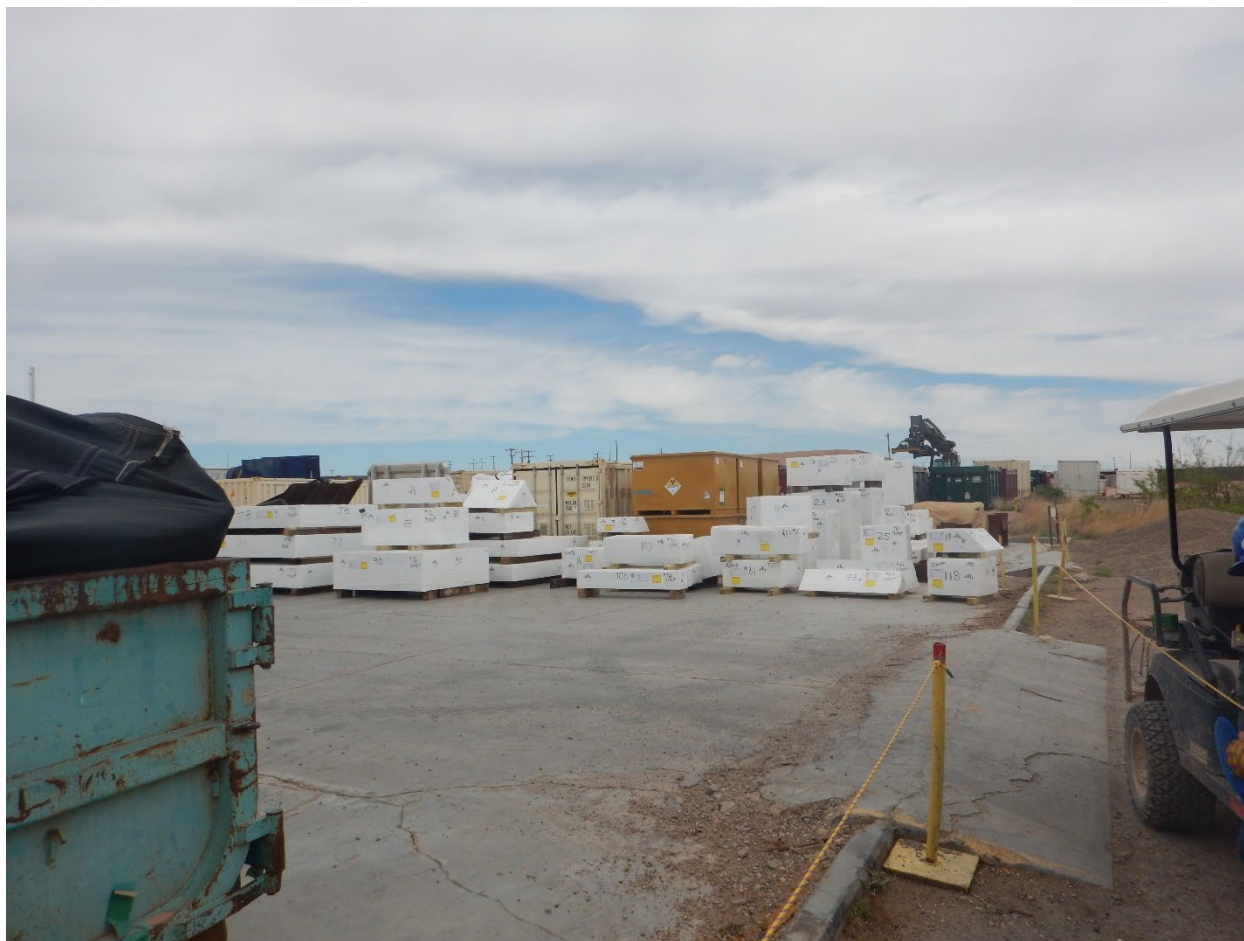
Photo No. 6

This unit is named Bin Storage Unit 2 and we identified concerns of aisle spacing photographed in Photo No. 6-9 in Appendix 1.

| Description: Hazardous Waste containers in Bin Storage Unit #2. Radiation hazard prevented inspection access. Aisle spacing does not appear to allow unobstructed movement of personnel, fire protection equipment, spill control equipment, and decontamination equipment. (40 CFR §264.35) | |

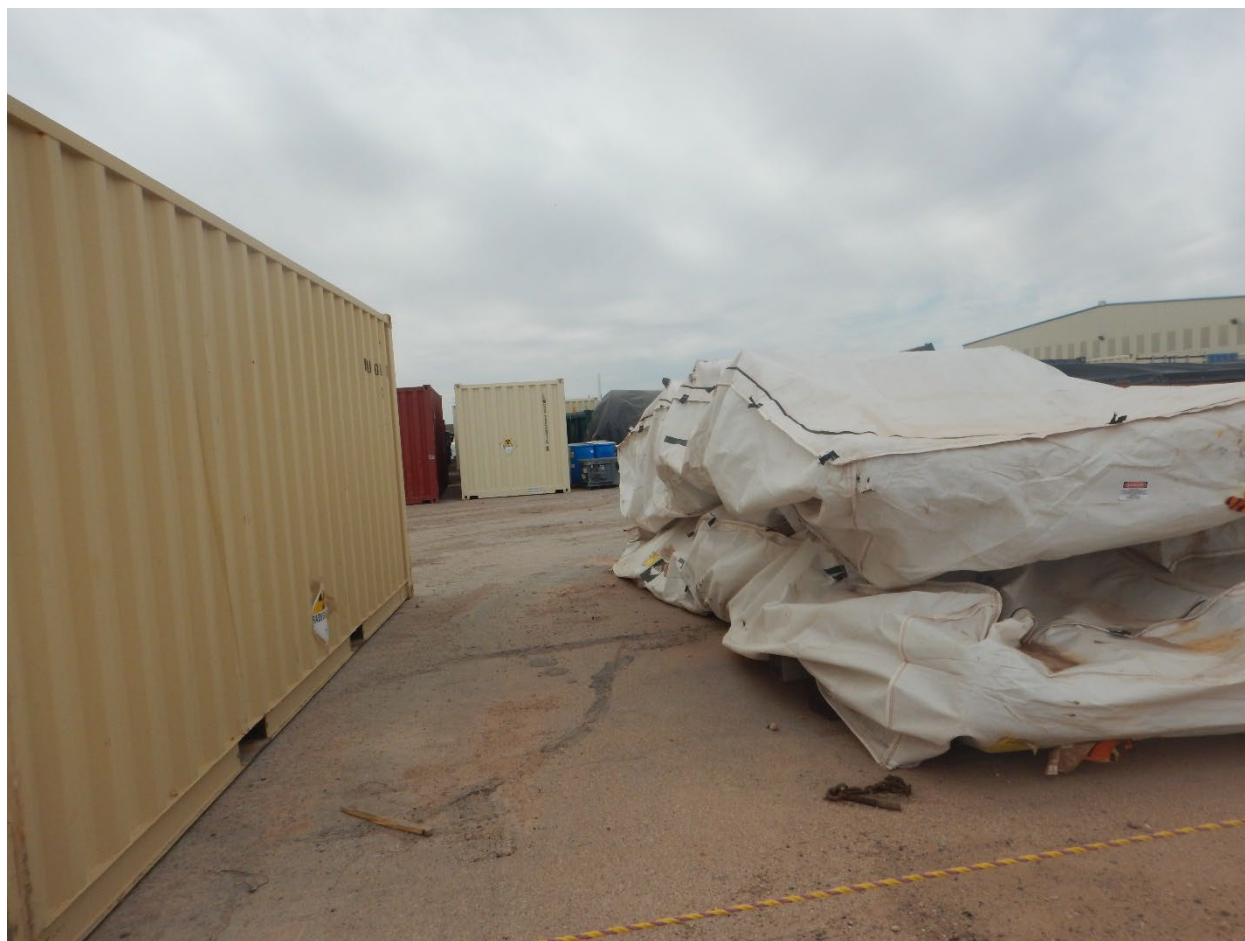
Photo No. 7

| Description: Hazardous Waste containers in Bin Storage Unit #2. Radiation hazard prevented inspection access. Aisle spacing does not appear to allow unobstructed movement of personnel, fire protection equipment, spill control equipment, and decontamination equipment. (40 CFR §264.35) | |

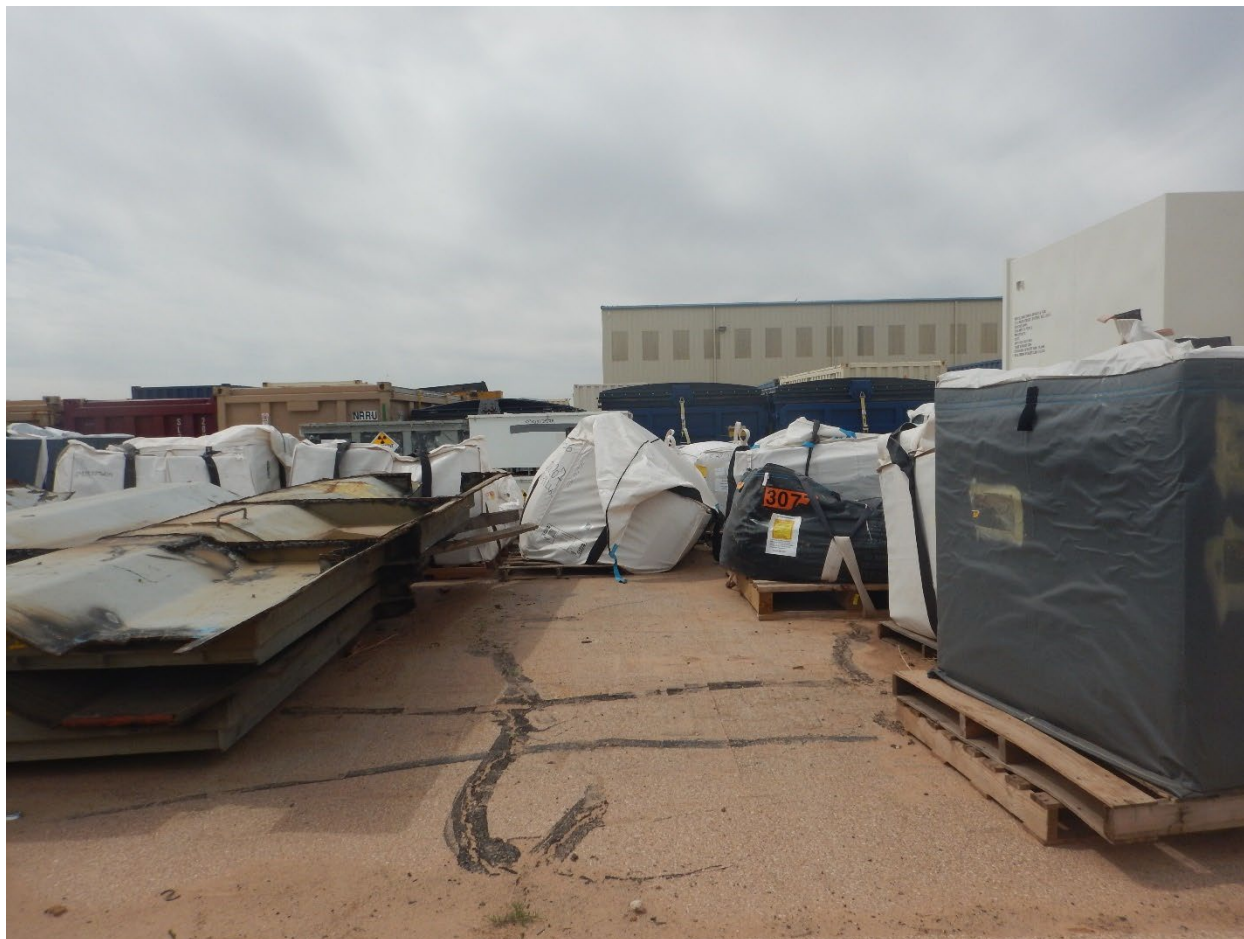
Photo No. 8

| Description: Hazardous Waste containers in Bin Storage Unit #2. Radiation hazard prevented inspection access. Aisle spacing does not appear to allow unobstructed movement of personnel, fire protection equipment, spill control equipment, and decontamination equipment. (40 CFR §264.35) | |

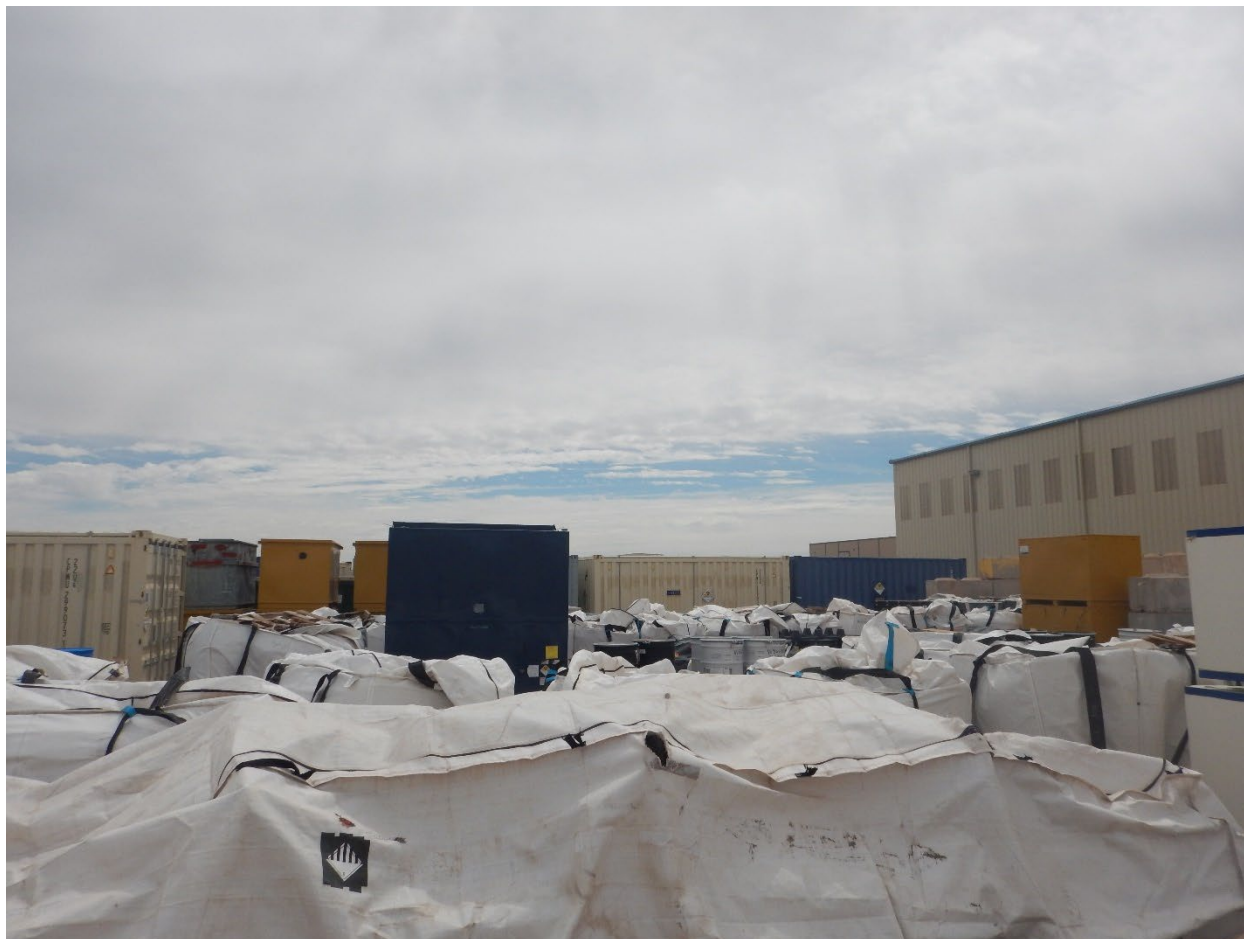
Photo No. 9

| Description: Hazardous Waste containers in Bin Storage Unit #2. Radiation hazard prevented inspection access. Aisle spacing does not appear to allow unobstructed movement of personnel, fire protection equipment, spill control equipment, and decontamination equipment. (40 CFR §264.35) | |

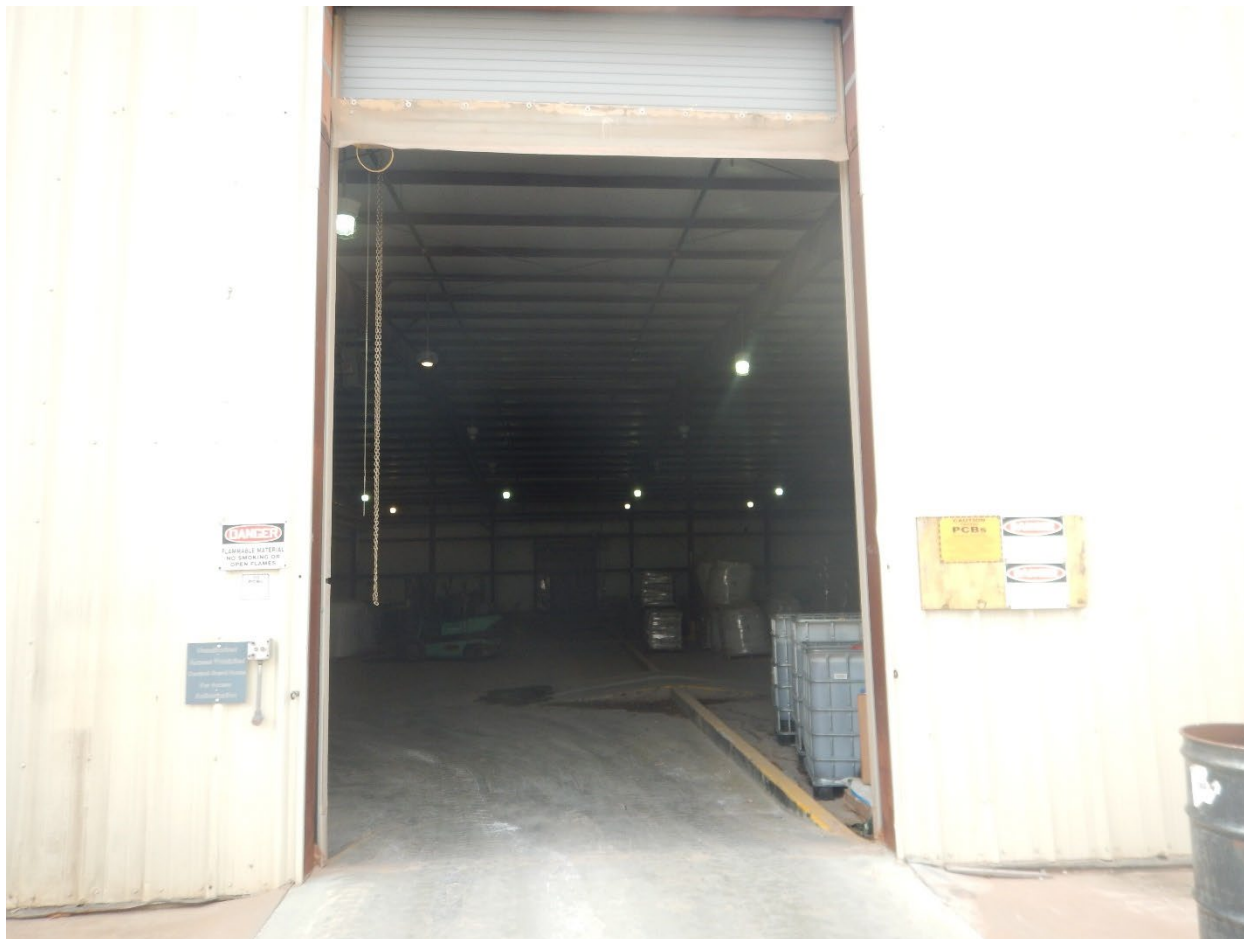
Photo No. 10

| Description: Entrance to the Container Storage Building. (TCEQ Permit Unit #4) | |

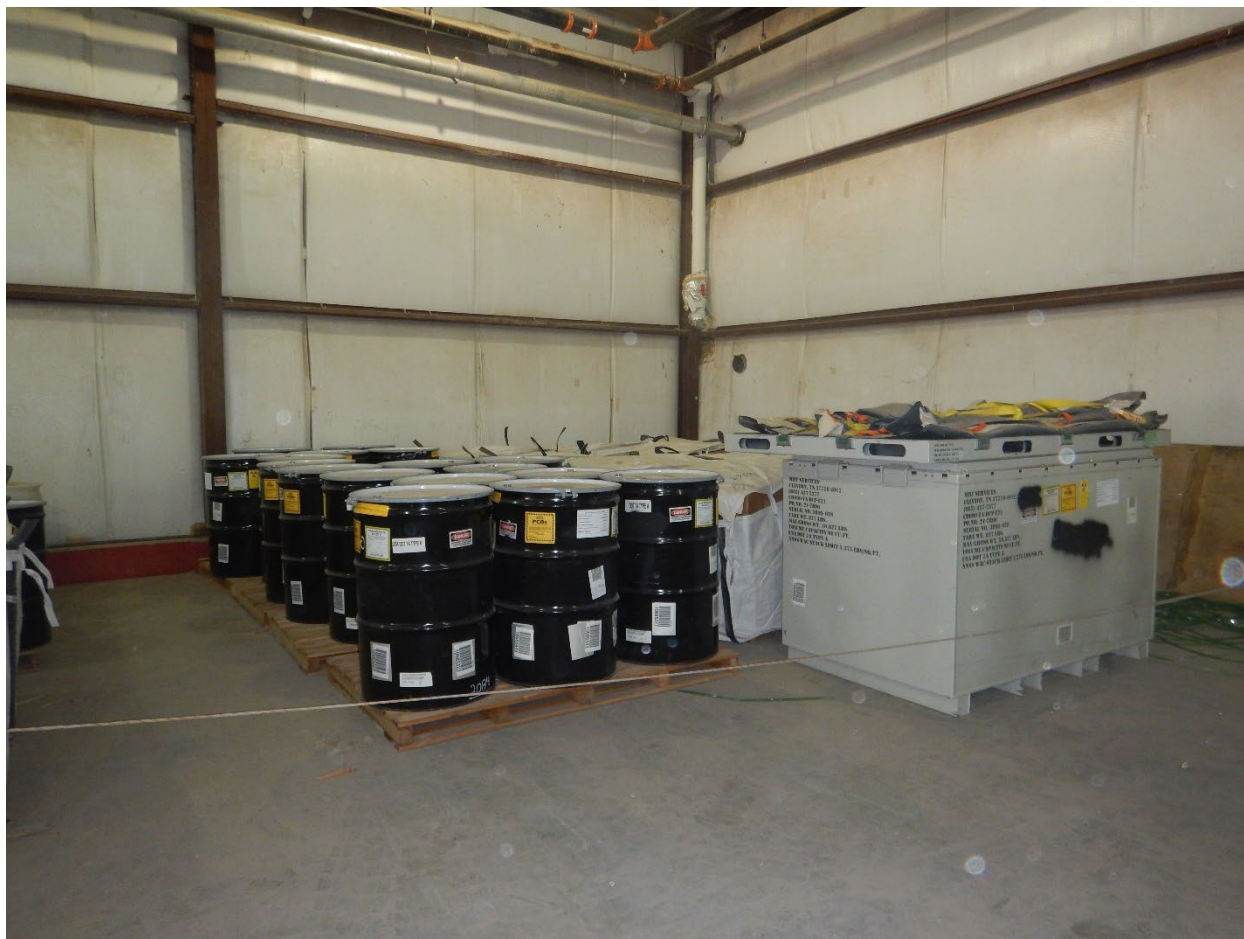
This unit is named Container Storage Building (CSB) and is comprised of Compartments 1 through 10. We identified concerns of aisle spacing photographed in Photo No. 11 in Appendix 1.

1. TCEQ Permit Unit Number 004 (Container Storage Building): Concerns regarding adequate aisle spacing pursuant to 40 CFR §264.35. What we observed does not seem to meet the 24-inch requirement in Permit but marked 'Yes' on Daily Inspection Report.
2. TCEQ Permit Unit Number 006 (Bin Storage Unit 2): Concerns regarding adequate aisle spacing pursuant to 40 CFR §264.35. What we observed does not seem to meet the 24-inch requirement in Permit but marked 'Yes' on Daily Inspection Report.
3. Laboratory: Concerns that total amount of waste in the drums in this SAA contain more than 55-gallons of hazardous waste and was not disposed accordingly pursuant to 40 CFR §262.15(a)(6).

| Description: Hazardous waste containers stored in the Container Storage Building. Aisle spacing does not appear to allow unobstructed movement of personnel, fire protection equipment, spill control equipment, and decontamination equipment. (40 CFR §264.35). | |

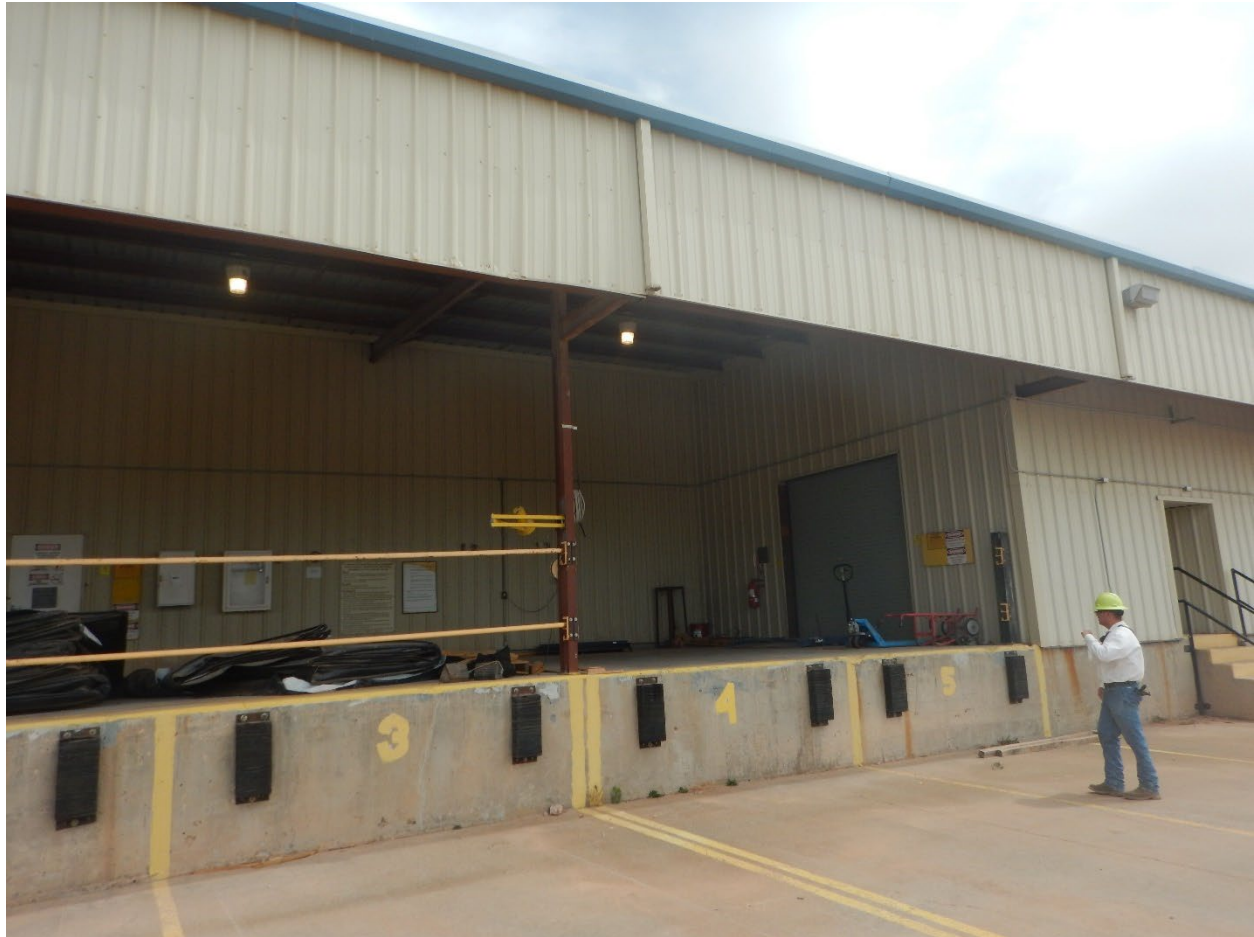
Photo No. 12

| Description: South side of the Container Storage Building facing NE direction. (TCEQ Permit Unit #4) | |

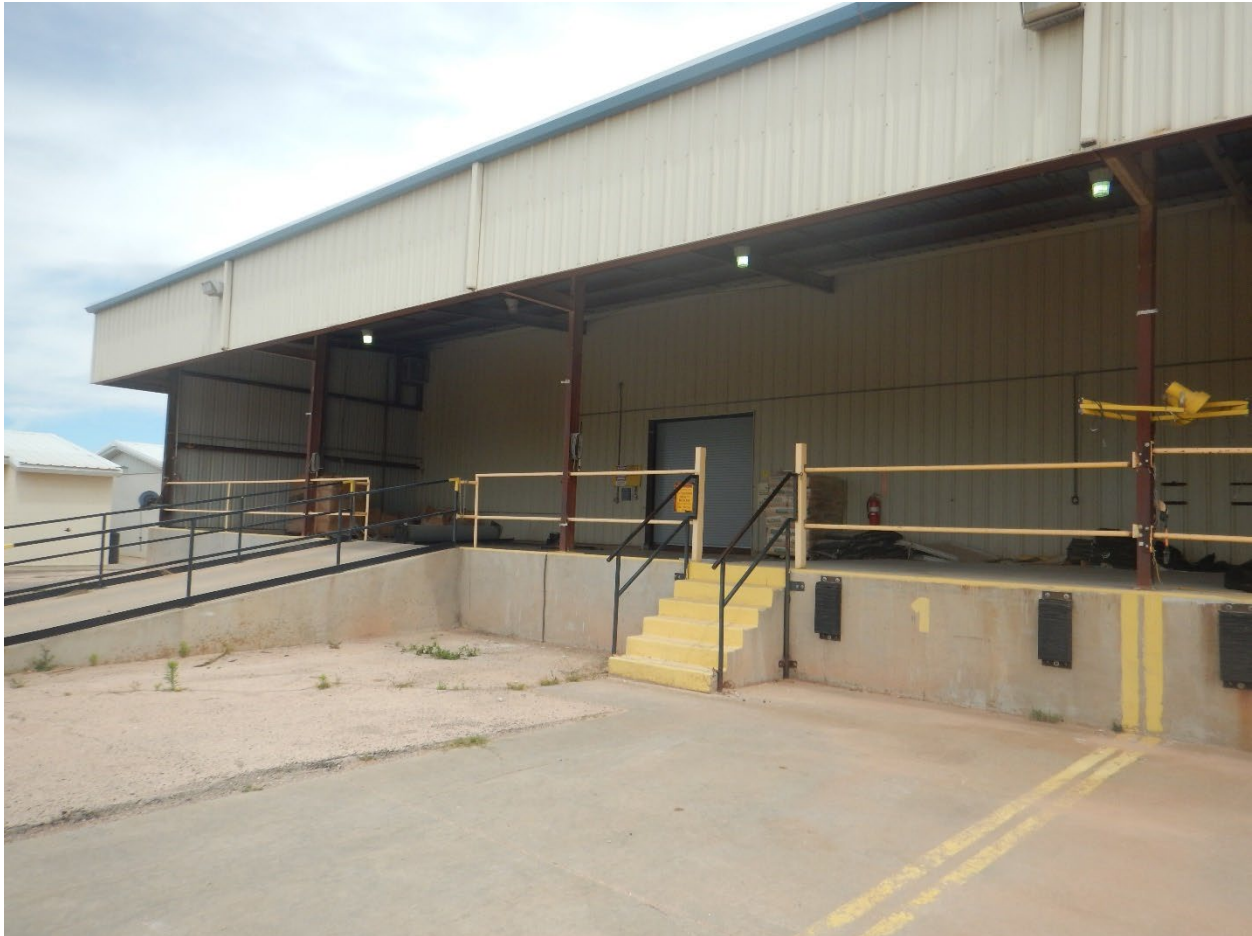
Photo No. 13

| Description: South side of the Container Storage Building facing NW direction. (TCEQ Permit Unit #4) | |

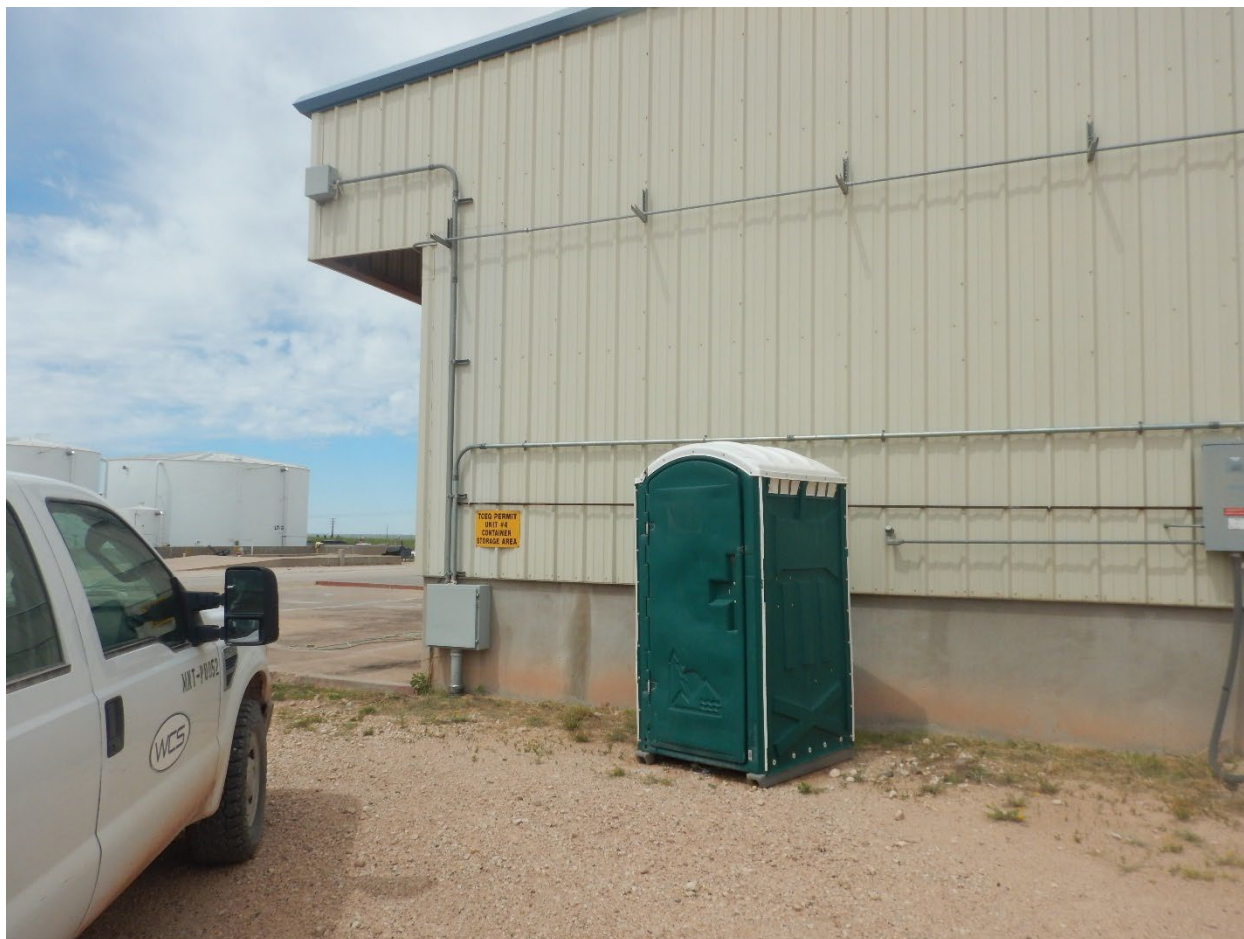
Photo No. 14

| Description: East side of Container Storage Building facing W direction. (TCEQ Permit Unit #4) | |
