RCRA COMPLIANCE EVALUATION INSPECTION

Beiersdorf Inc.
6 Vreeland Road
Florham Park, New Jersey

NJR000083717

April 8, 2025

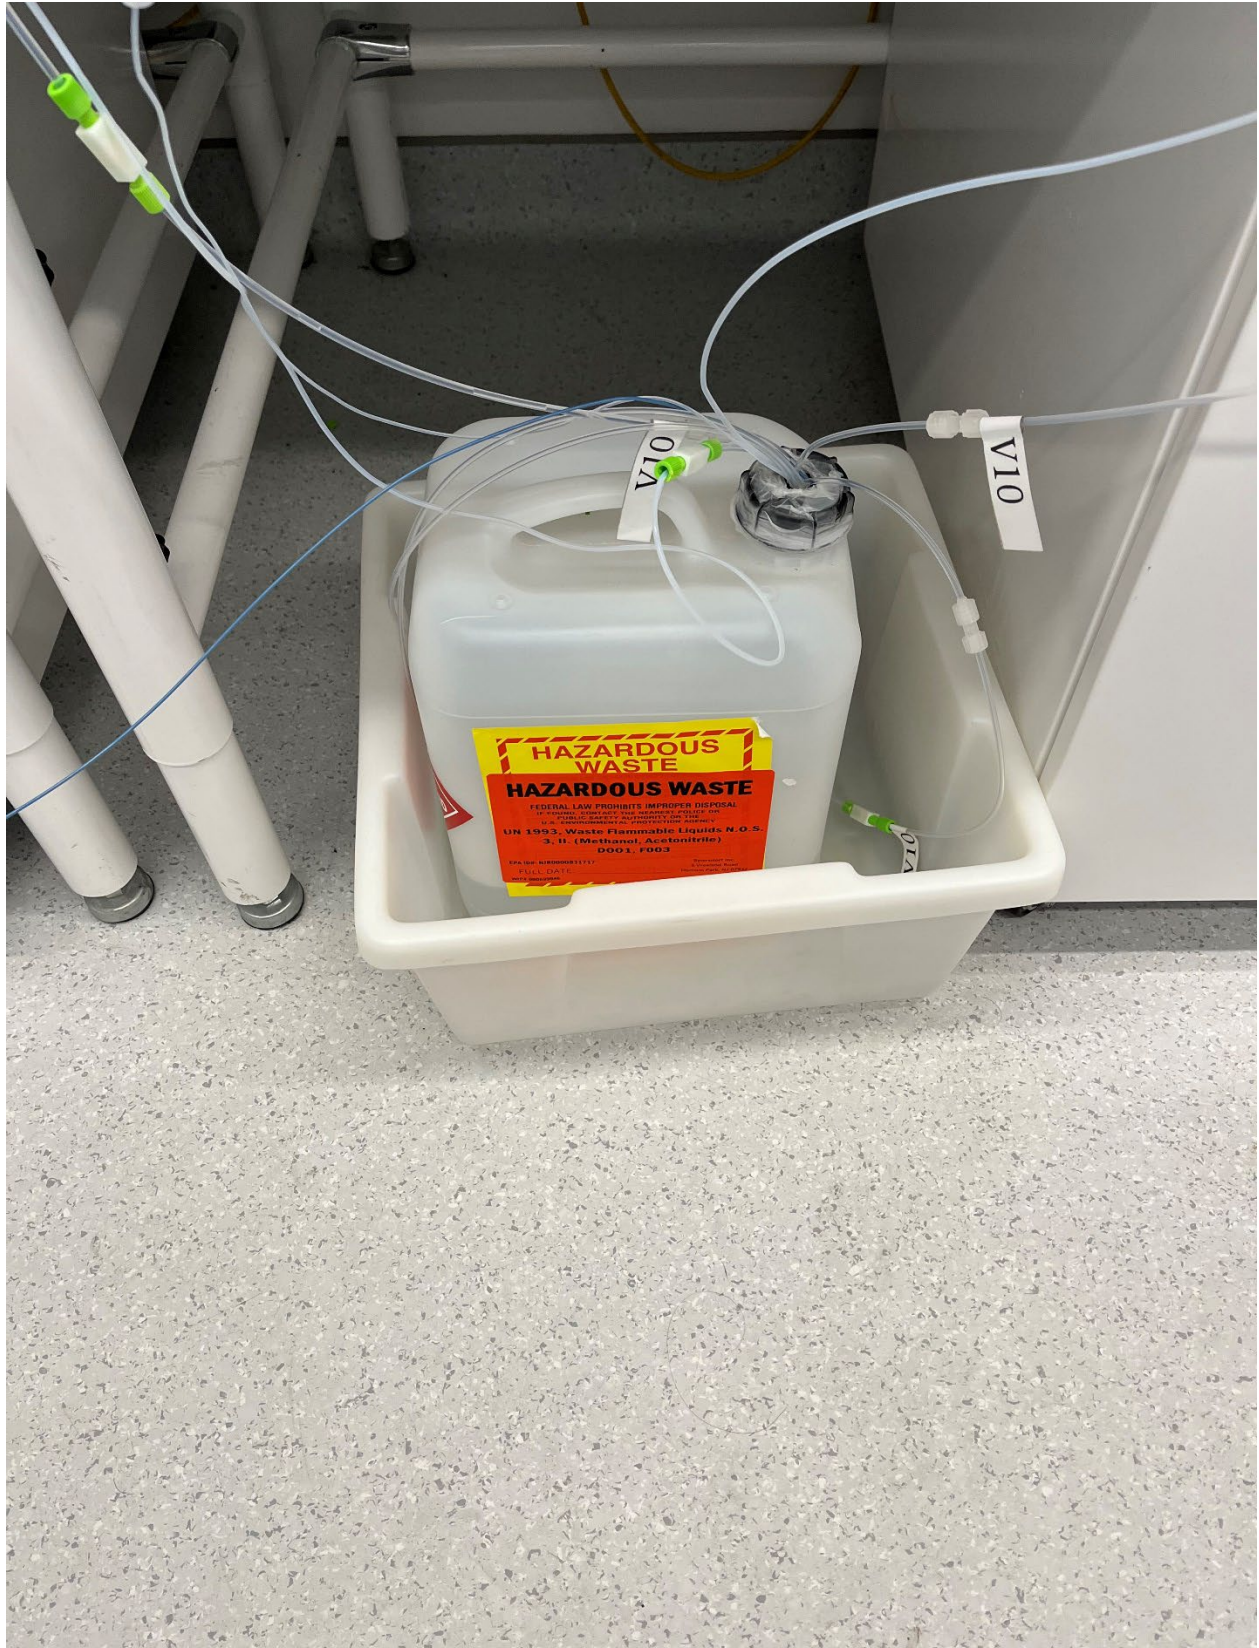
Most of the hazardous waste is generated in the Analytical Laboratory. Solvents are used for extractions in the high-performance liquid chromatography (HPLC) machines. Waste flammable liquids, containing methanol and acetonitrile, drain into a 2-gallon satellite waste accumulation container. The satellite container has a hazardous waste label and a flammable liquid label. When the satellite container is full, the full date is marked on the label, and it is transferred to the Central Accumulation Area.

Photo #1: A satellite container that collects waste flammable liquids from the HPLC machines.

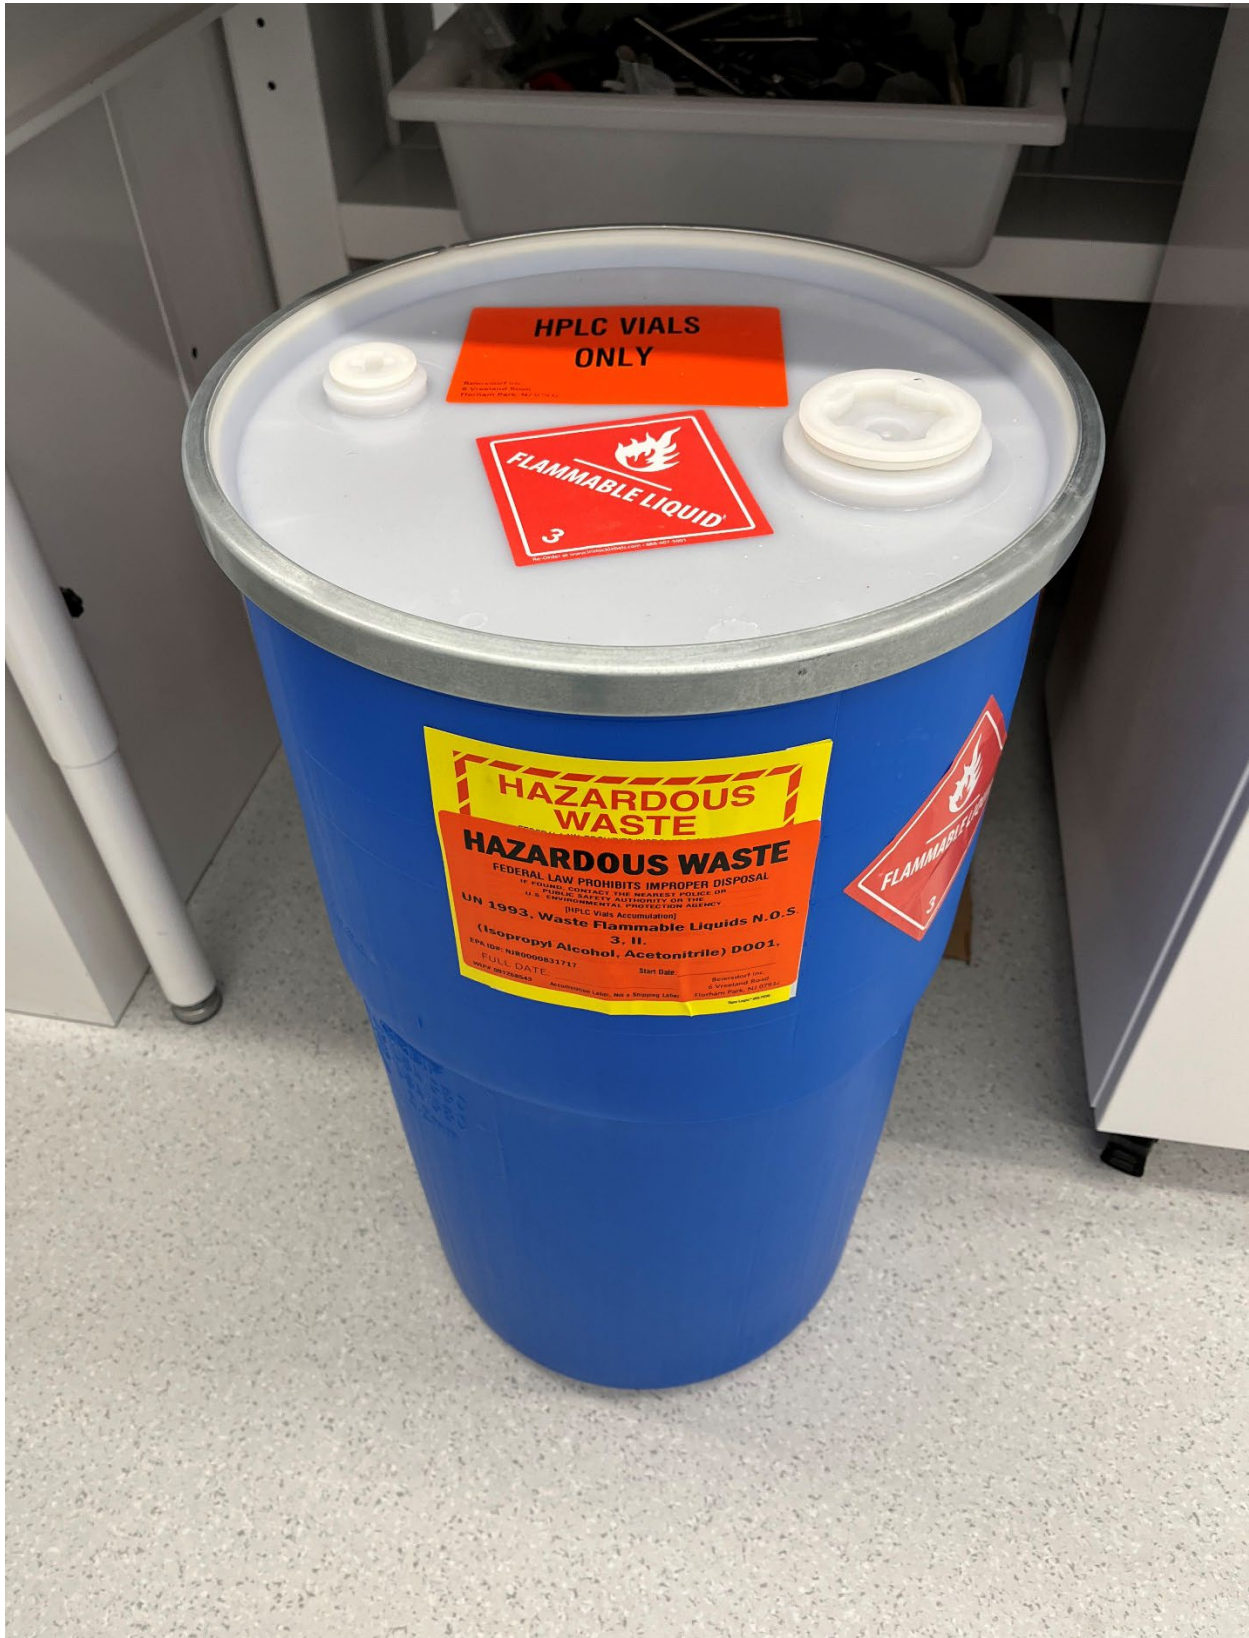
Glass vials from the HPLC machines are placed in a 20-gallon satellite container, which has a hazardous waste label and a flammable liquid label. Each vial contains a waste flammable liquid, consisting of isopropyl alcohol and acetonitrile. When the satellite container becomes full, the full date is marked on the label, and it is transferred to the Central Accumulation Area.

Photo #2: A satellite container for the glass vials containing waste flammable liquids.

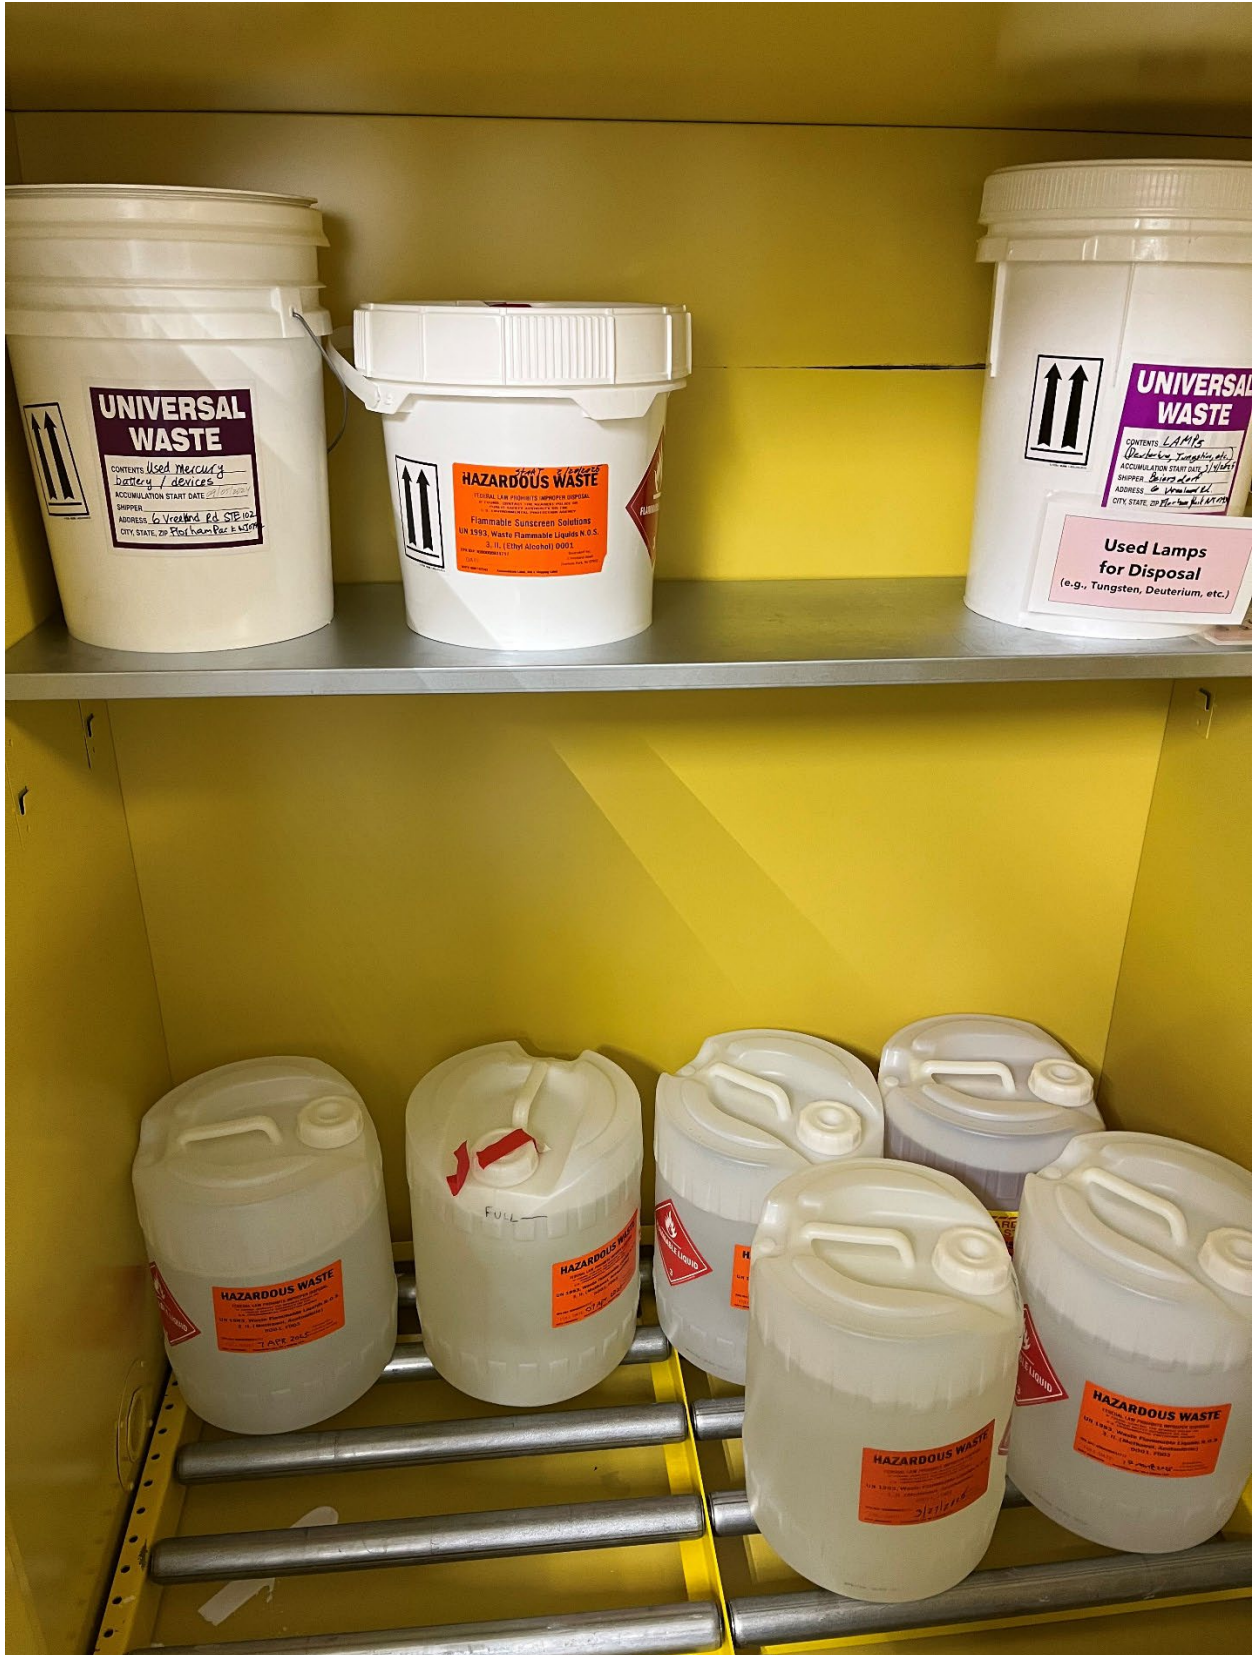
On the day of the inspection, there were 8 containers of hazardous waste being stored in the Central Accumulation Area: one 55-gallon drum of waste flammable liquids and seven 2-gallon containers of waste flammable liquids. All the containers were labelled as hazardous waste with accumulation start dates and flammable labels.

There were three containers of universal waste being stored in the Central Accumulation Area. The containers had universal waste labels and were marked with the contents and accumulation start dates.

Photo #3: Containers of hazardous waste and universal waste in the Central Accumulation Area.

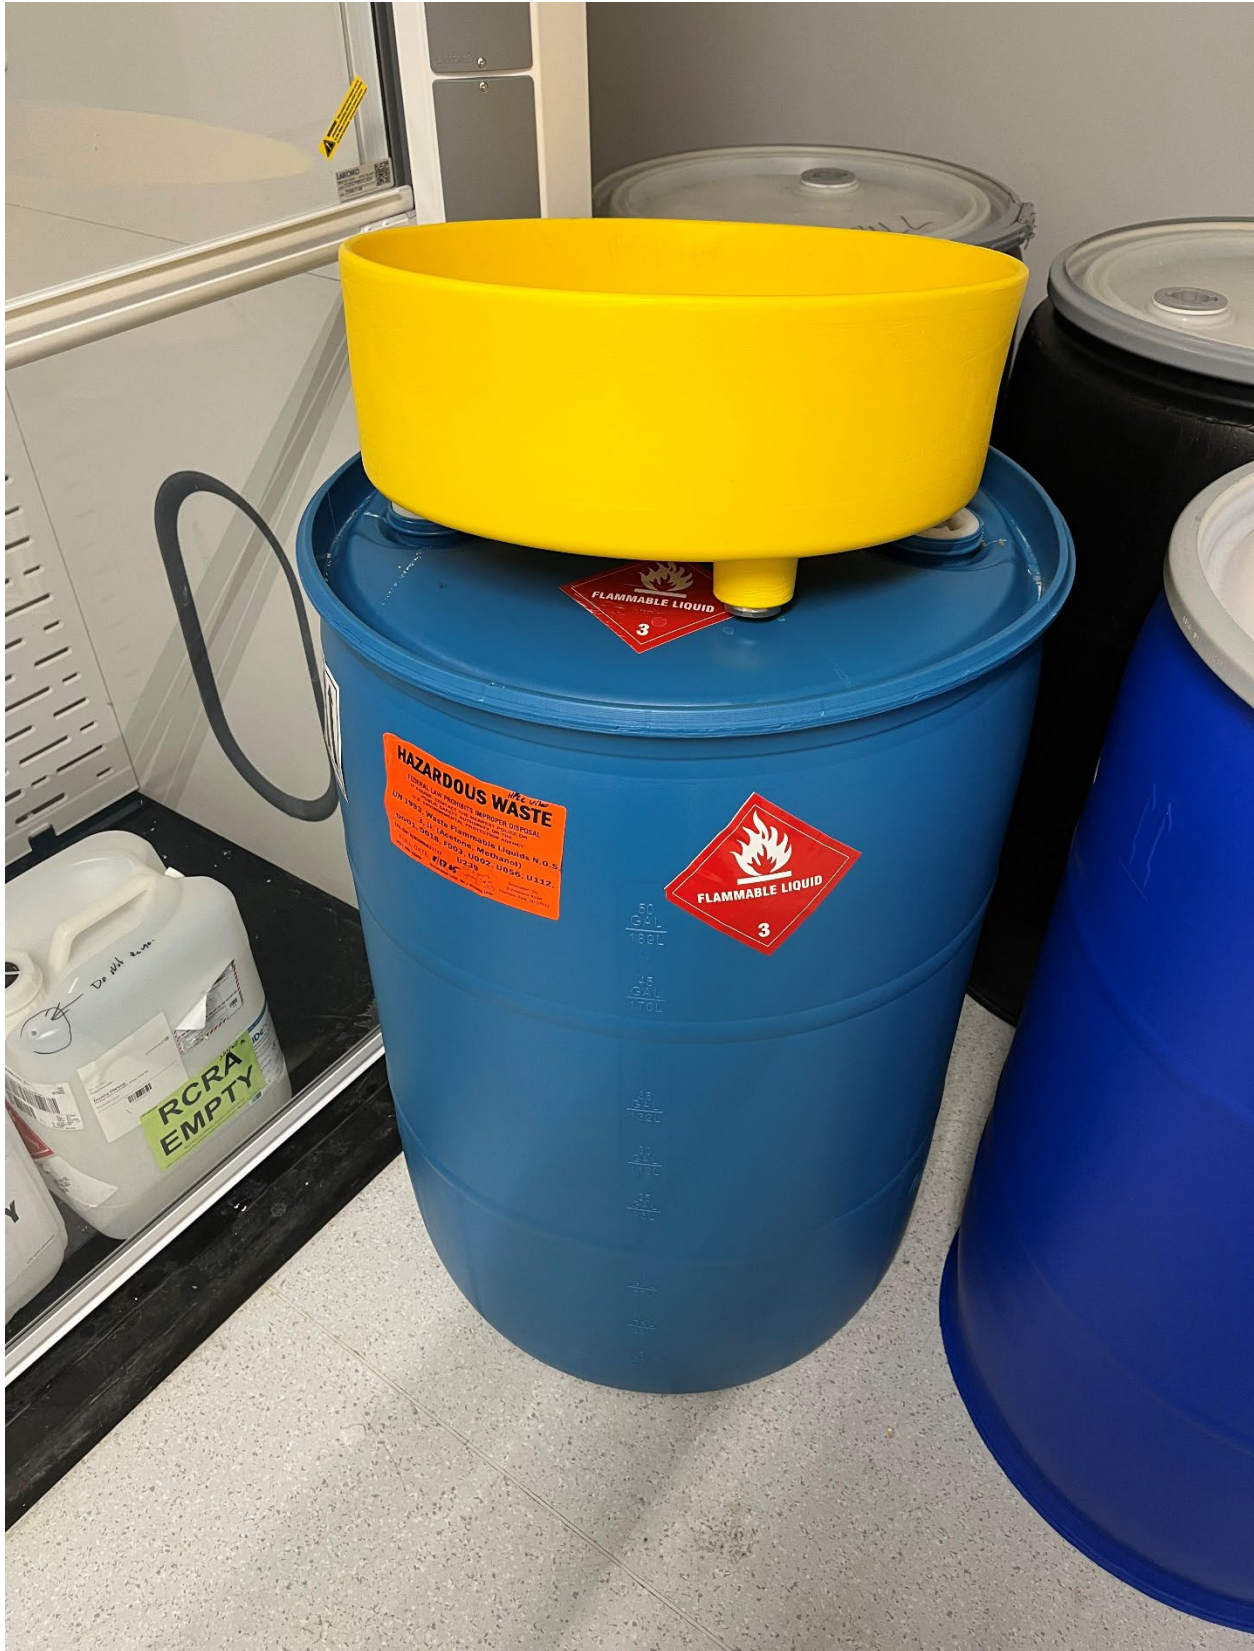
Photo #4: A container of waste flammable liquids in the Central Accumulation Area.

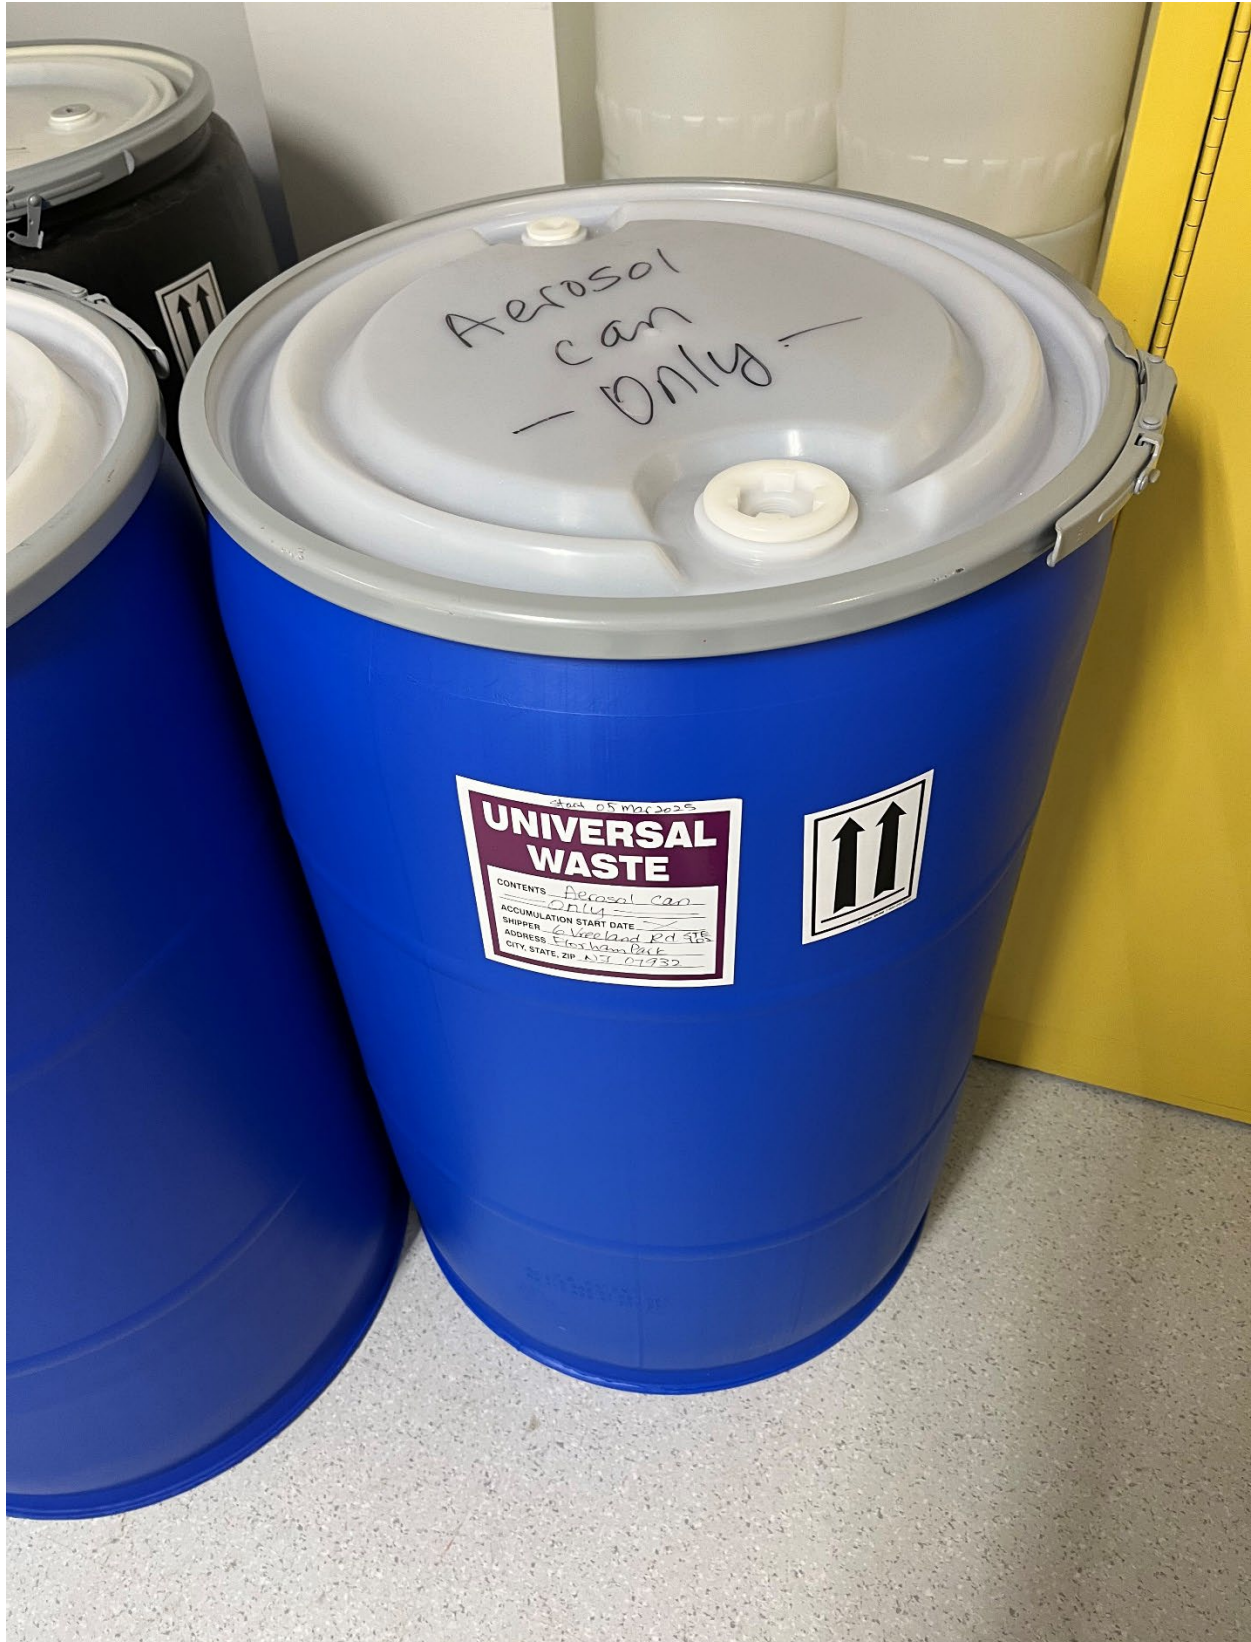
Universal waste, consisting of aerosol cans, used mercury devices, and used lamps, is placed in separate 5-gallon containers with universal waste labels. The containers are stored in the Central Accumulation Area.

Photo #5: A container of universal waste in the Central Accumulation Area.
