## **RCRA Inspection Report**

Sherwin Williams Company  
400 Bert Schulz Boulevard  
Winter Haven, Polk County, Florida 33881

March 21, 2023

Sherwin Williams Company  
RCRA CEI Photographs

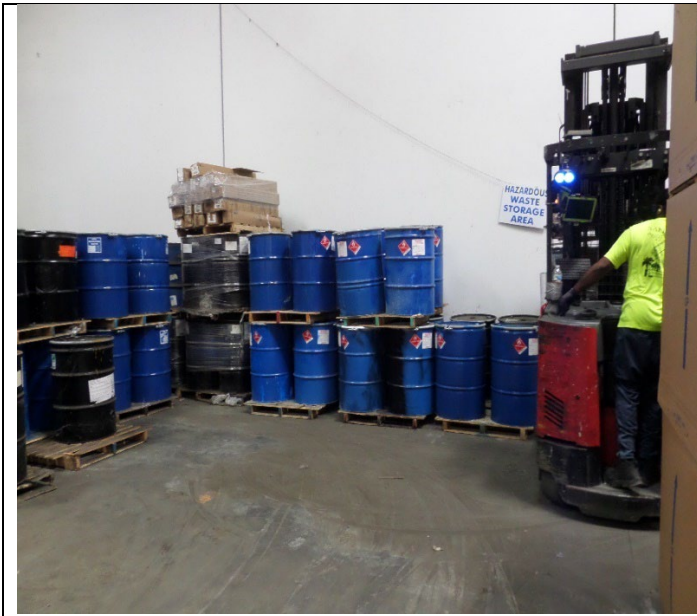
The central accumulation area (CAA) is in the Walmart Building. Hazardous waste, nonhazardous waste, used oil and universal waste lamps and batteries are accumulated in the same general area against the wall near a corner of the building. A spent lead-acid battery area is located next to the CAA. The inspectors observed a sign on the wall with the words "hazardous waste storage area" indicating the area for containers accumulating hazardous waste (Photograph 1). The inspectors observed spill, emergency, and communication equipment. The inspectors observed 20 55-gallon containers on wooded pallets. The inspectors observed four pallets were stacked two pallets high, with four 55-gallon containers per pallet, for a total of 16 55-gallon containers. One pallet with four containers was on the floor. The five pallets were positioned next to each other against the wall (Photographs 1 and 2). The inspectors could not observe the hazardous waste label, the accumulation start date and hazard indicator(s) on several containers. The inspectors asked the facility to move some of the pallets so that the containers could be inspected. After the facility moved the pallets, the inspectors observed the containers were closed, in good condition, labeled with the words "hazardous waste" and marked with dates in December 2022, January, February or March 2023. Two 55-gallon containers were dated December 6, 2022, exceeding the 90-day or less accumulation. The inspectors observed 17 containers were marked with the D001, D035 and F-listed waste codes and three containers were marked with a D001 waste code on the hazardous waste label. All the containers were labeled with a flammable hazard indicator. Seventeen containers with a D035 waste code were not marked or labeled with a toxic hazard indicator. SWC representatives marked the containers with

Central Accumulation Area (CAA). Observed needed aisle space. Facility rearranged containers and provided aisle space. Photograph 1 taken at 11:25 a.m.

the word “toxic” to indicate the hazard (Photographs 3 through 7). The SWC representatives provided adequate aisle space and labeled the 17 containers (D001, D035) with a toxic hazard indicator.

**Pursuant to F.A.C. Chapter 62-730.160(4) [40 C.F.R. § 262.17(a)(6)], which incorporates F.A.C. Chapter 62-730.160(1) [40 C.F.R. § 262.255] and is a condition of the LQG Permit Exemption, The large quantity generator must maintain aisle space to allow the unobstructed movement of personnel, fire protection equipment, spill control equipment, and decontamination equipment to any area of facility operation in an emergency, unless aisle space is not needed for any of these purposes.**

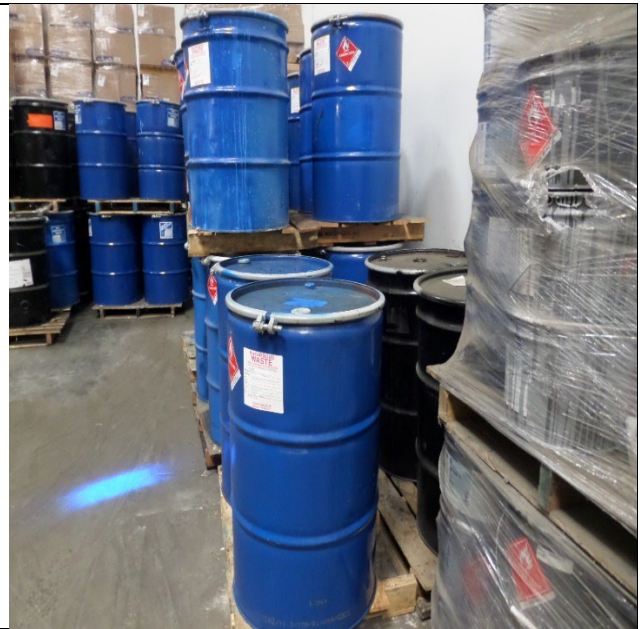
CAA. Observed needed aisle space. Photograph 2 taken at 11:35 a.m.

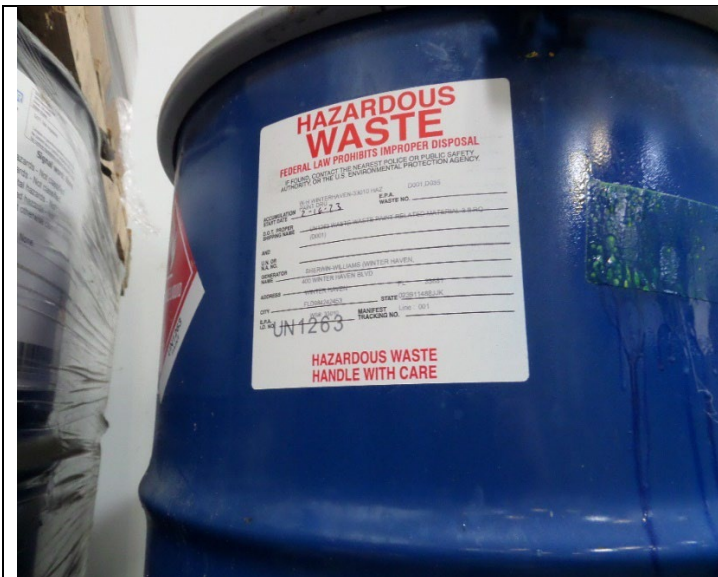
CAA. Observed a 55-gallon container accumulating hazardous waste (D001, D035), not marked or labeled with a toxic hazard indicator. Facility wrote toxic on the label. Photograph 3 taken at 11:38 a.m.

**Pursuant to F.A.C. Chapter 62-730.160(1) [40 C.F.R. § 262.17(a)(5)(i)(B)], which is a condition of the LQG Permit Exemption, a generator must mark or label its containers with an indication of the hazards of the contents (examples include, but are not limited to, the applicable hazardous waste characteristic(s) (i.e., ignitable, corrosive, reactive, toxic); hazard communication consistent with the Department of Transportation requirements at 49 CFR part 172 subpart E (labeling) or subpart F (placarding); a hazard statement or pictogram consistent with the Occupational Safety and Health Administration Hazard Communication Standard at 29 CFR 1910.1200; or a chemical hazard label consistent with the National Fire Protection Association code 704).**

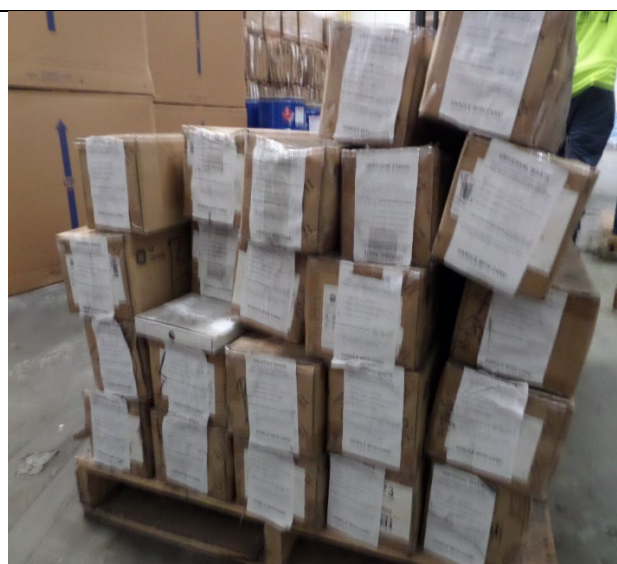
The inspectors asked the facility to move the wooden pallet of universal waste lamps from the top of a double stacked pallet of containers. The facility moved the pallet to the floor and removed the shrink wrap so that the universal waste containers could be inspected. The inspectors observed 23 four-foot boxes accumulating spent lamps. The boxes were closed, in good condition, labeled with words “universal waste” and marked with dates less than one year. The oldest date observed on a box was April 20, 2022 (Photograph 8).

CAA. Observed containers of four-foot universal waste lamps. Photograph 8 taken at 11:52 a.m.

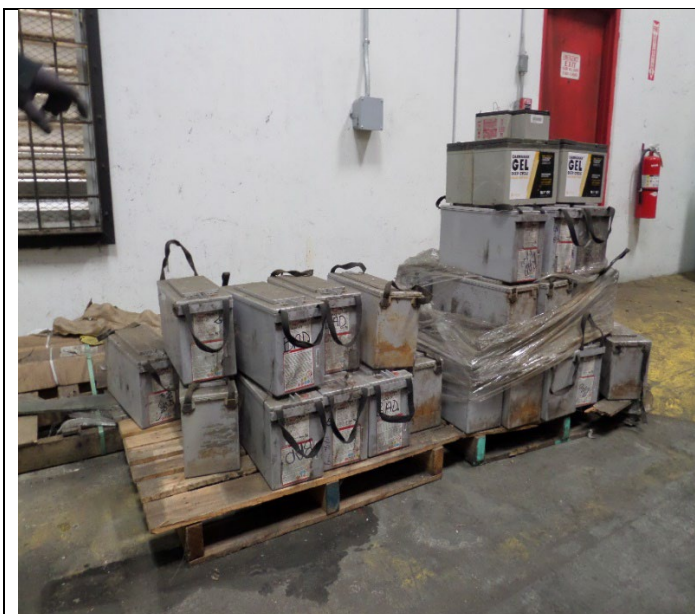
The inspectors observed 28 batteries with a product label and the word “NexSys”, four batteries with the product label and the word “GEL” and six small security system batteries on a wooden pallet. The batteries were not marked or labeled with the words “universal waste” and not marked with a date (Photographs 9 and 10). SWC representatives explained battery replacement dates are maintained on a log and the dates for the batteries can be provided. The inspectors requested SWC submit the documentation for the battery accumulation dates as a deliverable. The inspectors returned to this area in the afternoon after the record review. SWC representatives labeled each battery with the words “universal waste” and marked each battery with the date

CAA. Observed universal waste batteries not marked or labeled universal waste and not dated. Facility labeled and dated the batteries. Photograph 9 taken at 12:11 p.m.

**Pursuant to F.A.C. Chapter 62-730.185(1) [40 C.F.R. § 273.34(a)], a LQHUW must label or mark the universal waste batteries (*i.e.*, each battery), or a container or tank in which the batteries are contained, must be labeled or marked clearly with any one of the following phrases: “Universal Waste - Battery(ies),” or “Waste Battery(ies),” or “Used Battery(ies)”.**

**Pursuant to F.A.C. Chapter 62-730.185(1) [40 C.F.R. § 273.35(c)], a LQHUW must be able to demonstrate the length of time that the universal waste has been accumulated from the date it becomes a waste or is received. The handler may make this demonstration by following F.A.C. Chapter 62-730.185(1) [40 C.F.R. § 273.35(c)(1-6).**

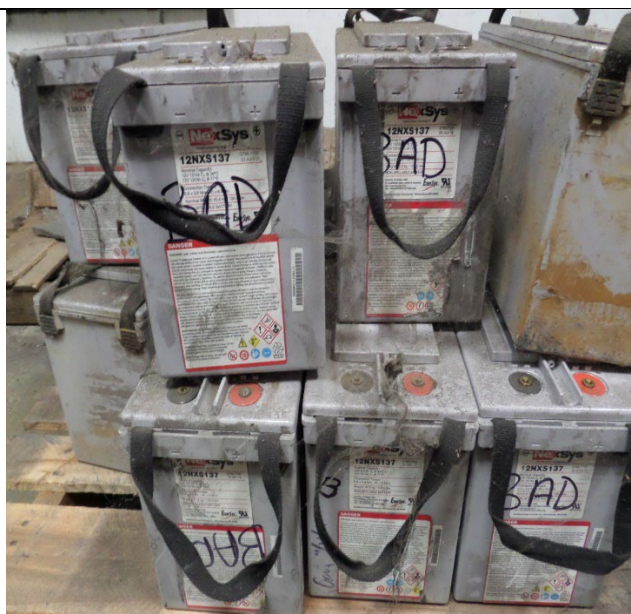
CAA. Observed universal waste batteries not marked or labeled universal waste and not dated. Facility labeled and dated the batteries. Photograph 10 taken at 12:11 p.m.

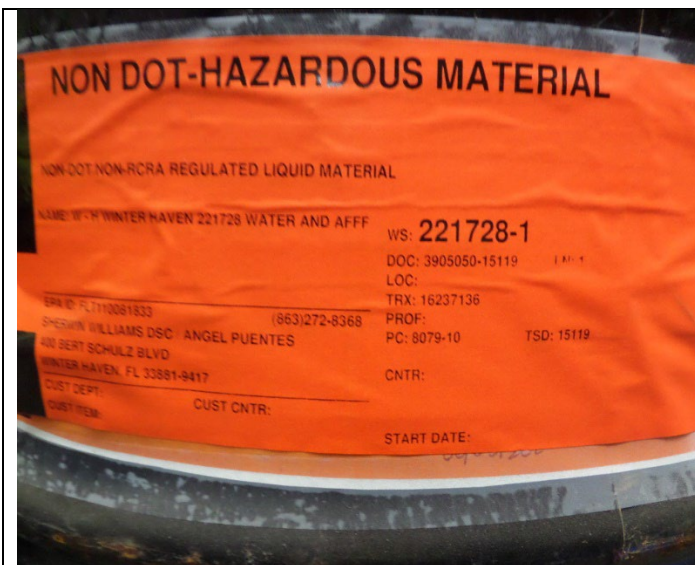
The inspectors observed several containers accumulating nonhazardous waste on wooden pallets stacked two pallets high. The containers were labeled with the words “NonDOT Non RCRA Regulated Liquid Material”. The containers were closed and in good condition (Photographs 11 and 12).

CAA. The inspectors observed several containers accumulating nonhazardous waste on wooden pallets stacked two pallets high. Photograph 11 taken at 12:18 p.m.

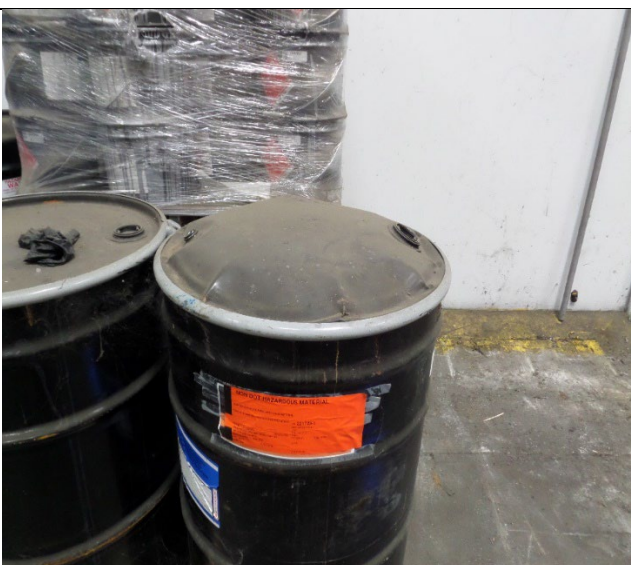
The inspectors observed several containers accumulating nonhazardous waste on wooden pallets stacked two pallets high. Photograph 12 taken at 12:18 p.m.

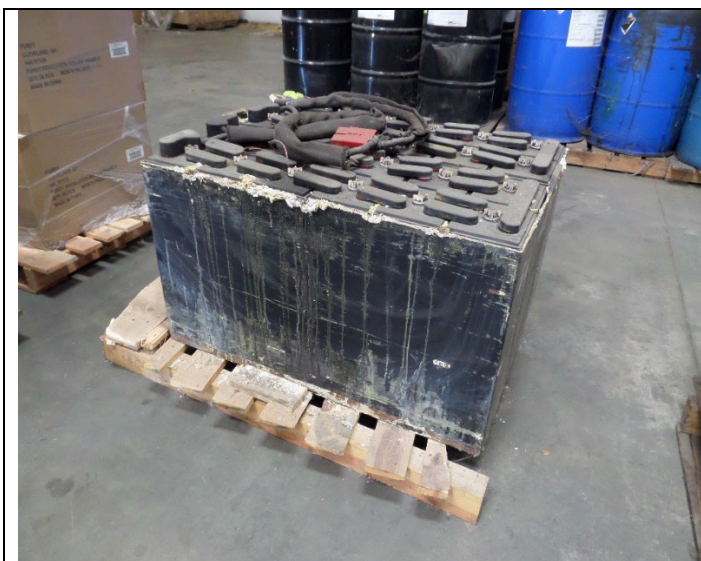
The inspectors also observed one “Sitdown Equipment” lead-acid battery on a wooden pallet. The inspectors observed the battery was leaking from the top of the casing, along the side of the battery to the wooden pallet and onto the concrete floor (Photographs 13 and 14). The inspectors returned to this area in the afternoon after the record review. SWC representatives removed the battery from this area for on-site management and responded to the release from the battery. The inspectors requested SWC submit a record for the off-site shipment of the battery and a record of the cleanup of waste battery material as a deliverable. SWC representatives provided a copy of the billing receipt from Absolute Motive Power (AMP) for the shipment of the battery, prior to inspectors leaving the facility.

CAA. The inspectors observed one “sitdown equipment” battery leaking and not marked as universal waste and not dated. Facility managed the battery and shipped it off-site for disposal. Photograph 13 taken at 12:21 p.m.

**Pursuant to F.A.C. Chapter 62-730.160(1) [40 C.F.R. § 262.17(a)(1)(ii)], which is a condition of the LQG Permit Exemption, if a container holding hazardous waste is not in good condition, or if it begins to leak, the large quantity generator must immediately transfer the hazardous waste from this container to a container that is in good condition, or immediately manage the waste in some other way that complies with the conditions for exemption of this section.**

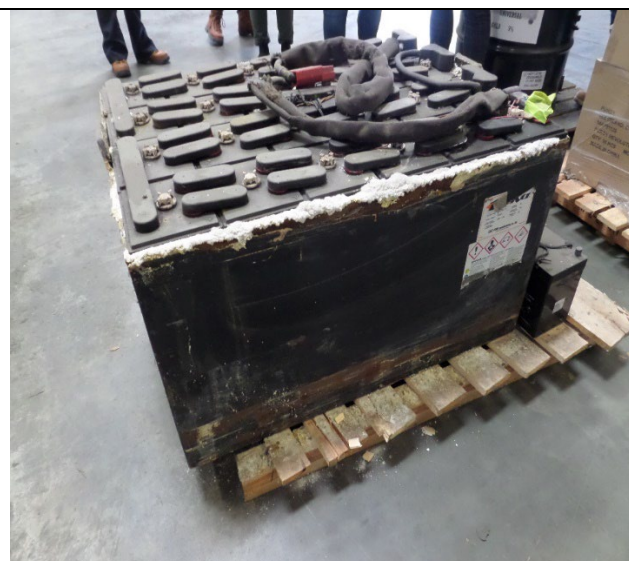
CAA. The inspectors observed one “sitdown equipment” battery leaking and not marked as universal waste and not dated. Facility managed the battery and shipped it off-site for disposal. Photograph 14 taken at 12:21 p.m.

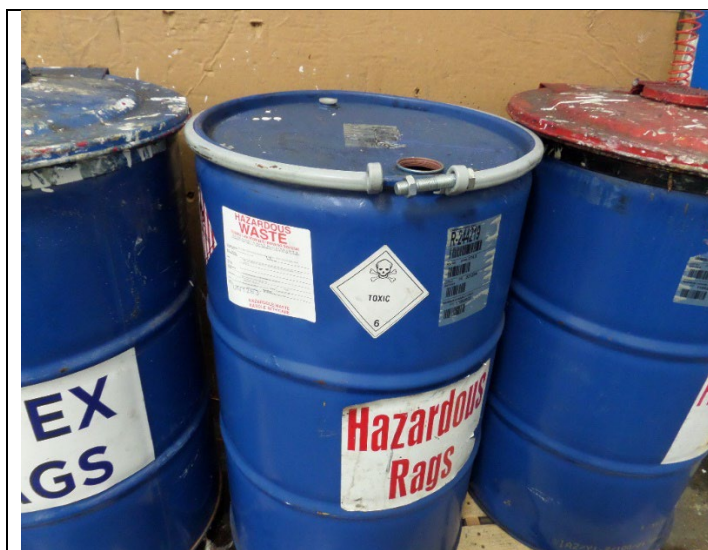
The inspectors observed one 55-gallon SAA container accumulating hazardous waste paint liquid (D001, D005, D035, F003), one 55-gallon SAA container accumulating hazardous waste paint solid (D001, D005, D035, F003), one 55-gallon SAA container accumulating hazardous waste bleach (D002), one 55-gallon SAA container accumulating hazardous waste muriatic acid (D002), three 55-gallon SAA containers accumulating various hazardous deck wash solutions, one 55-gallon SAA container accumulating hazardous waste liquid from punctured aerosol cans (D001, D035) and one 55-gallon SAA container accumulating hazardous waste paint (D001, F003) in the repour room SAA. The containers were in good condition and labeled with the words "hazardous waste". The top bung cap for the 55-gallon SAA container of hazardous waste paint liquid (D001, D005, D035, F003) was not kept closed and was not marked or labeled with a toxic hazard indicator (Photograph 15). The 55-gallon SAA container accumulating hazardous waste paint solid (D001, D005, D035, F003) was not marked or labeled with a toxic hazard indicator (Photograph 16). The 55-gallon SAA container accumulating hazardous waste liquid from punctured aerosol cans (D001, D035) was not marked or labeled with a toxic hazard indicator. The SWC representatives closed the container and marked or labeled the containers with toxic hazard indicators.

Repour Room. The top bung cap for the 55-gallon container of hazardous waste paint liquid was not kept closed and was not marked or labeled with a toxic hazard indicator. The facility closed and labeled the container. Photograph 15 taken at 1:05 p.m.

**Pursuant to F.A.C. Chapter 62-730.160(1), [40 C.F.R. § 262.15(a)(4)], which is a condition of the SAA Permit Exemption, a generator is required to keep containers of hazardous waste closed at all times during accumulation, except when adding, removing, or consolidating waste; or when temporary venting of a container is necessary for the proper operation of equipment, or to prevent dangerous situations, such as build-up of extreme pressure.**

**Pursuant to F.A.C. Chapter 62-730.160(1) [40 C.F.R. § 262.15(a)(5)(ii)], which is a condition of the SAA Permit Exemption, a generator must mark or label its containers with an indication of the hazards of the contents (examples include, but are not limited to, the applicable hazardous waste characteristic(s) (i.e., ignitable, corrosive, reactive, toxic); hazard communication consistent with the Department of Transportation requirements at 49 CFR part 172 subpart E (labeling) or subpart F (placarding); a hazard statement or pictogram consistent with the Occupational Safety and Health Administration Hazard Communication Standard at 29 CFR 1910.1200; or a chemical hazard label consistent with the National Fire Protection Association code 704).**

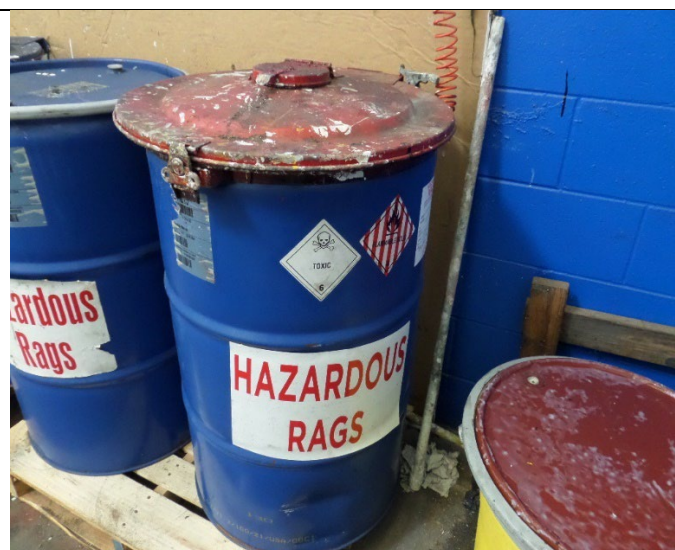
Repour Room. The 55-gallon container accumulating hazardous waste paint solid was not marked or labeled with a toxic hazard indicator. The facility labeled the container. Photograph 16 taken at 1:05 p.m.

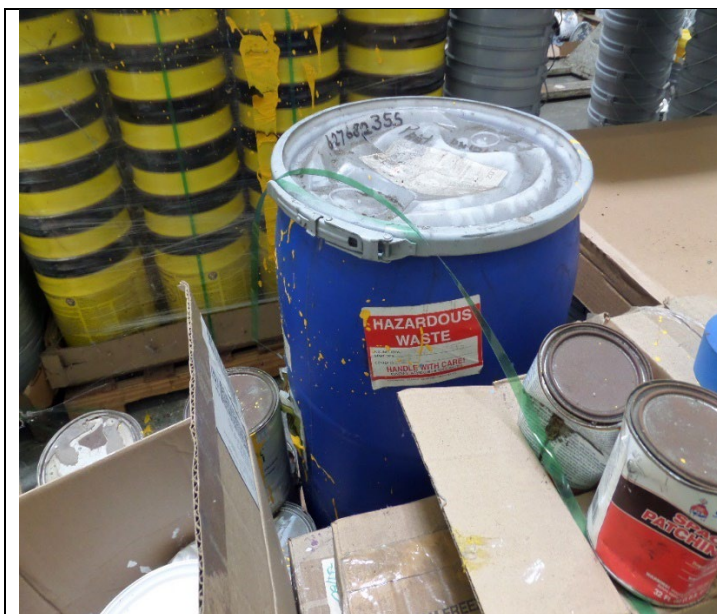
The inspectors observed a 30 to 40-gallon container accumulating waste paint mixed with spill material labeled with the words “hazardous waste”. Butch Loser indicated the waste paint and spill material was generated by FedEx as clean-up material from a spill of the paint and returned to SWC. The inspectors observed the container was accumulating approximately 10 to 15-gallons, was not closed, was not marked with a date and not marked or labeled with a hazard indicator (Photograph 17).

Repour Room. Observed a 30-gallon container accumulating waste paint mixed with absorbent labeled with the words “hazardous waste”. The waste appeared to have been generated by FedEx as clean-up material from a spill of the paint and returned to SWC. The container was not closed, was not marked with a date and not marked or labeled with a hazard indicator. Photograph 17 taken at 1:06 p.m.

**Pursuant to F.A.C. Chapter 62-730.160(1), [40 C.F.R. § 262.17(a)(1)(iv)(A)], which is a condition of the LQG Permit Exemption, a container holding hazardous waste must always be closed during accumulation, except when it is necessary to add or remove waste.**

**Pursuant to F.A.C. Chapter 62-730.160(1), [40 C.F.R. § 262.17(a)(5)(i)(B) and (C)], which is a condition of the LQG Permit Exemption, a generator must mark or label its containers with the following: an indication of the hazards of the contents; and the date upon which**

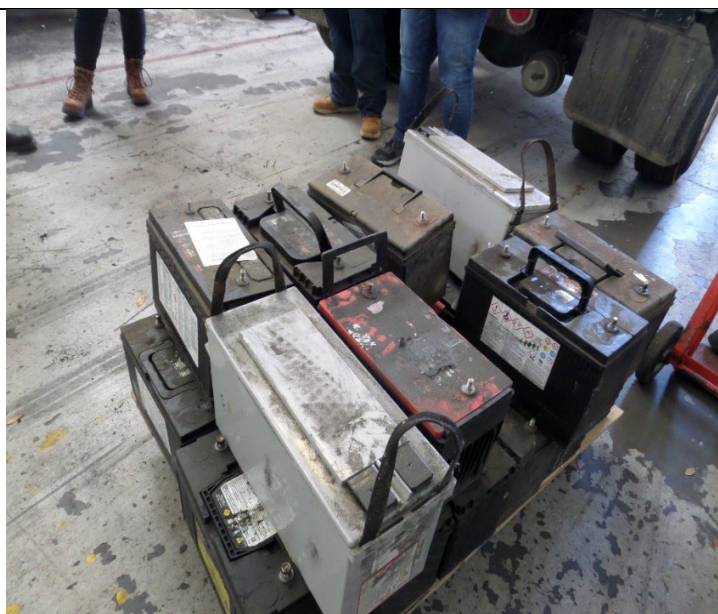
Truck maintenance and repair work on hardware and the floor landing gear generates used oil and grease. Truck touch-up paint work using aerosol paints are performed in the shop. Bobby Hicks, manager for this area indicated universal waste batteries and spent lead-acid batteries are generated from battery replacements. The inspectors observed one 55-gallon container accumulating used oil and one 55-gallon container accumulating oil and water. The containers were closed and labeled with the words “used oil”. The inspectors observed a step can accumulating contaminated cloth rags. The cloth rags are shipped to Cintas for reclamation. Aerosol cans are taken to the Repour Room for processing. The inspectors observed a pallet accumulating 18 lead-acid batteries and two “GEL” batteries. The two GEL batteries were not marked or labeled with the words “universal waste” and not marked with a date (Photograph 18). SWC representatives explained battery replacement dates are maintained on a log and the dates for the batteries can be provided. The inspectors requested SWC submit the documentation for the battery accumulation dates as a deliverable.

Trailer Maintenance Shop. Observed universal waste batteries not marked or labeled universal waste and not dated. Photograph 18 taken at 1:25 p.m.

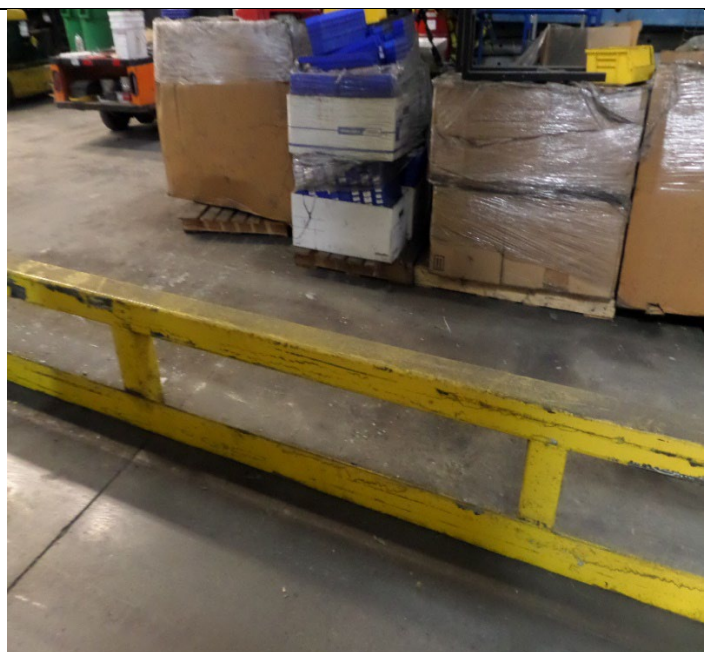
Facility Maintenance Shop. The inspectors returned to this area and observed the two lead-acid batteries were managed for off-site disposal. Photograph 20 taken at 4:52 p.m.

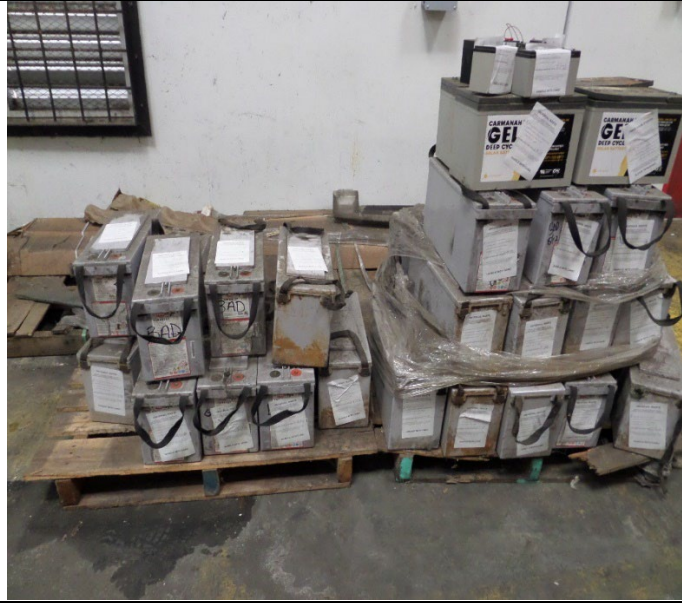
February 18, 2023, March 1, 2023, March 7, 2023 or March 17, 2023 (Photograph 21).

CAA. The inspectors returned to this area and observed the batteries were labeled as universal waste and marked with a date. Photograph 21 taken at 4:59 p.m.
