INSPECTION REPORT

| Type of Inspection | Compliance Evaluation Inspection (CEI) | | |
| Facility or Site Name | Modern American Recycling Services Inc. | | |
| Type of Operation | Modern American Recycling Services (MARS) decommissions oil field platforms and recycles the scrap metal. | | |

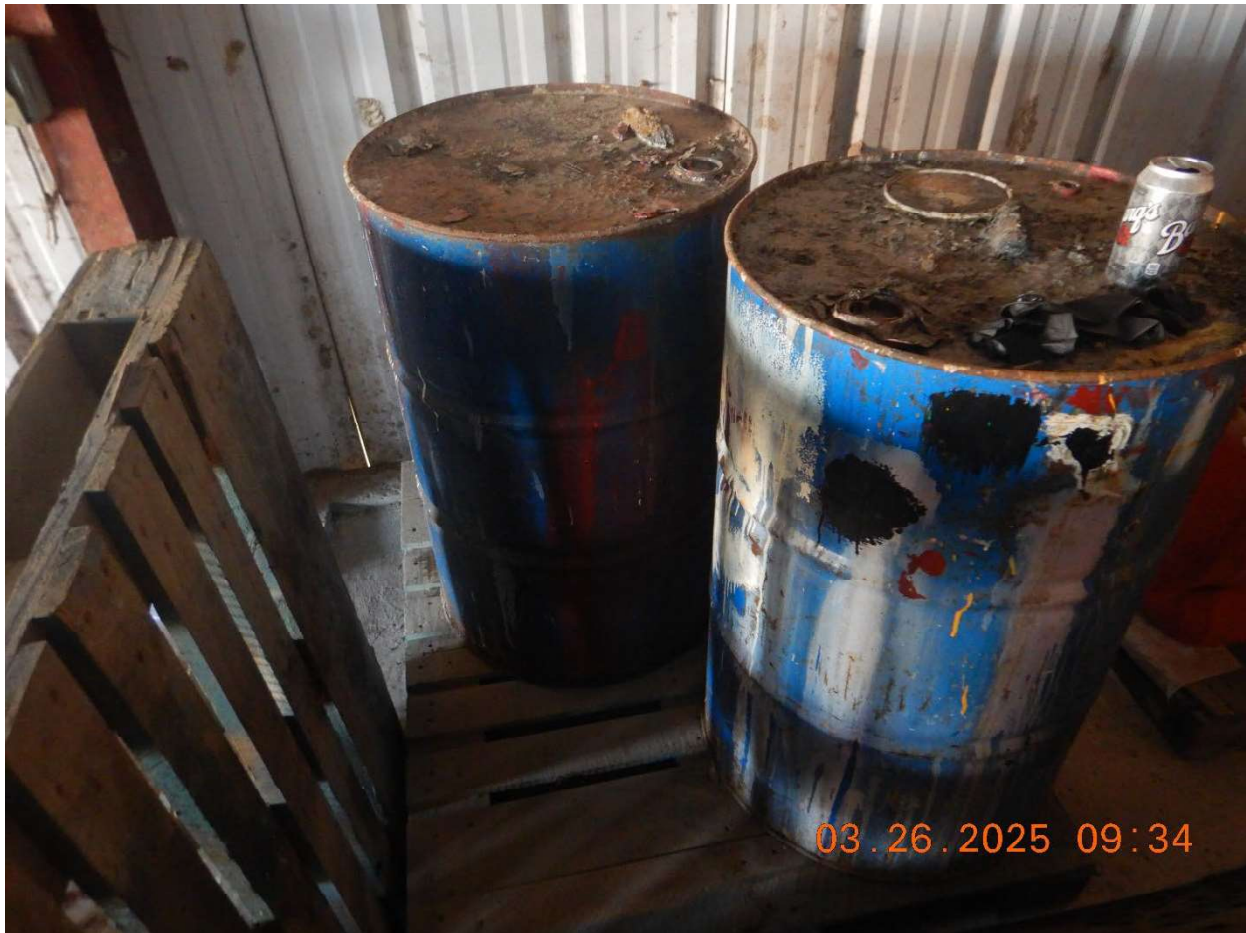
Photo No. 1

Description: Two full 55-gallon drums containing paint-related materials inside the hazardous waste storage area that were not labeled.

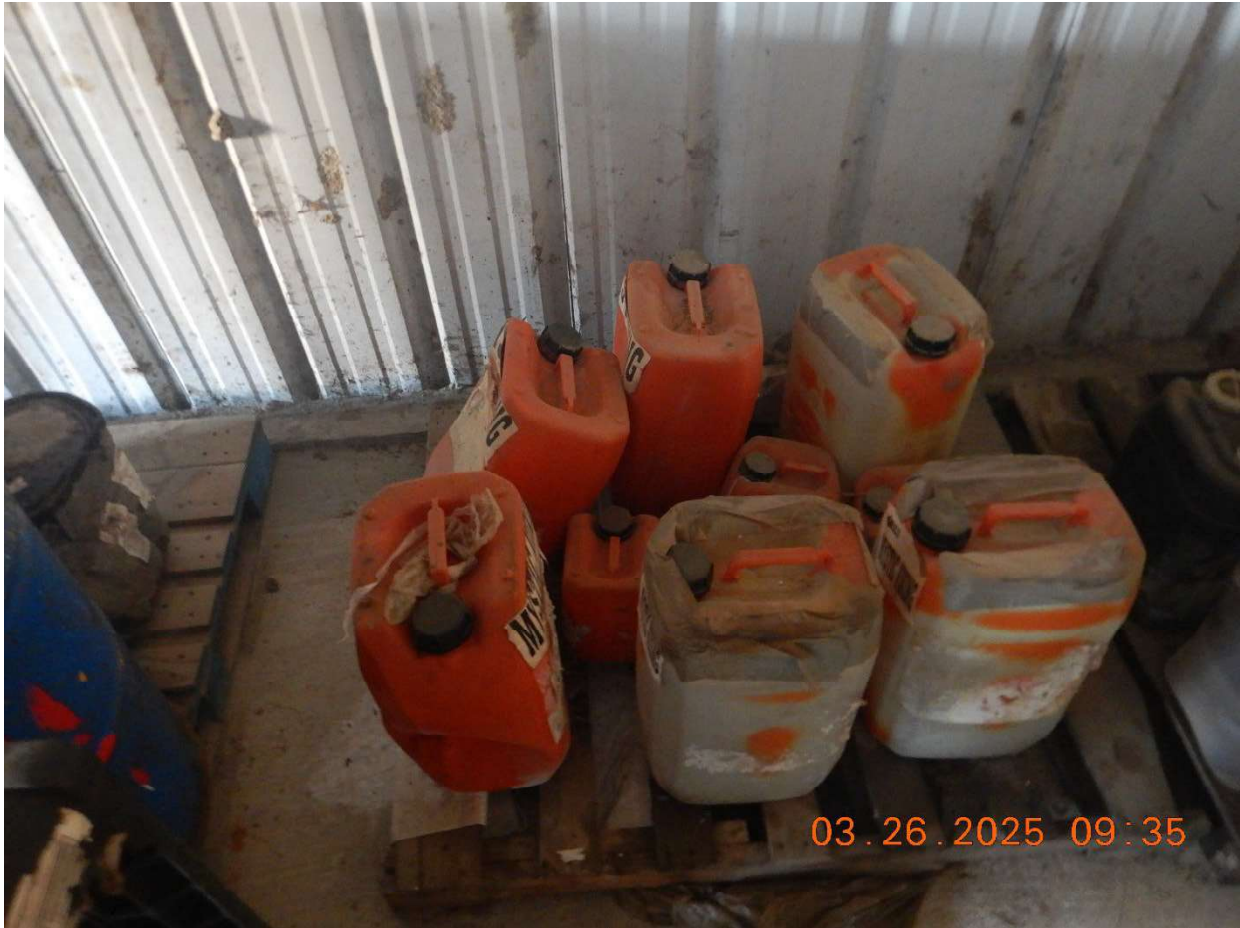
**Photo No. 2**

Description: View of a pallet containing four 1-gallon containers and six 5-gallon containers of undetermined liquid waste inside the hazardous waste accumulation area.

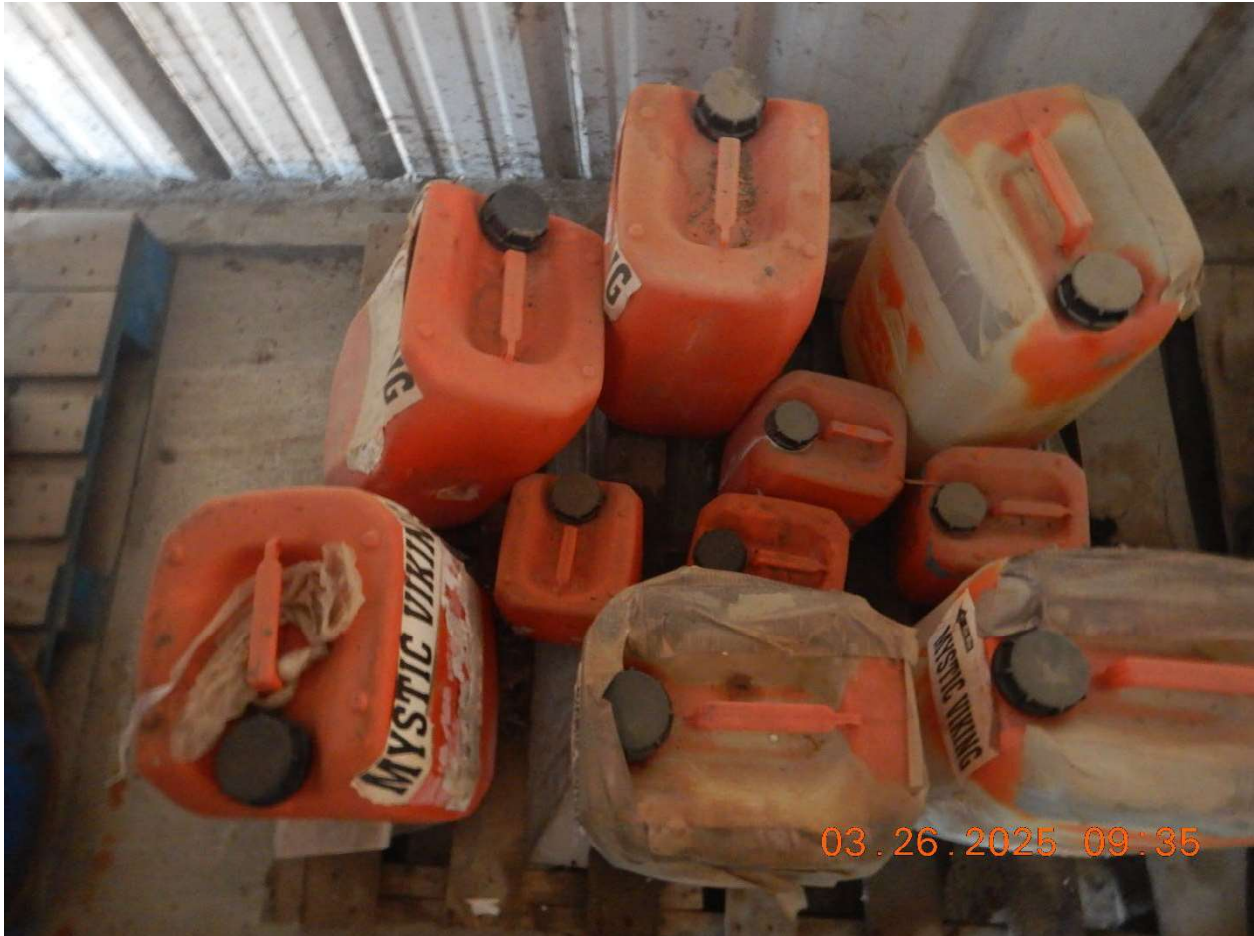
Photo No. 3

Description: Another view of the pallet containing four 1-gallon containers and six 5-gallon containers of undetermined liquid waste inside the hazardous waste accumulation area.

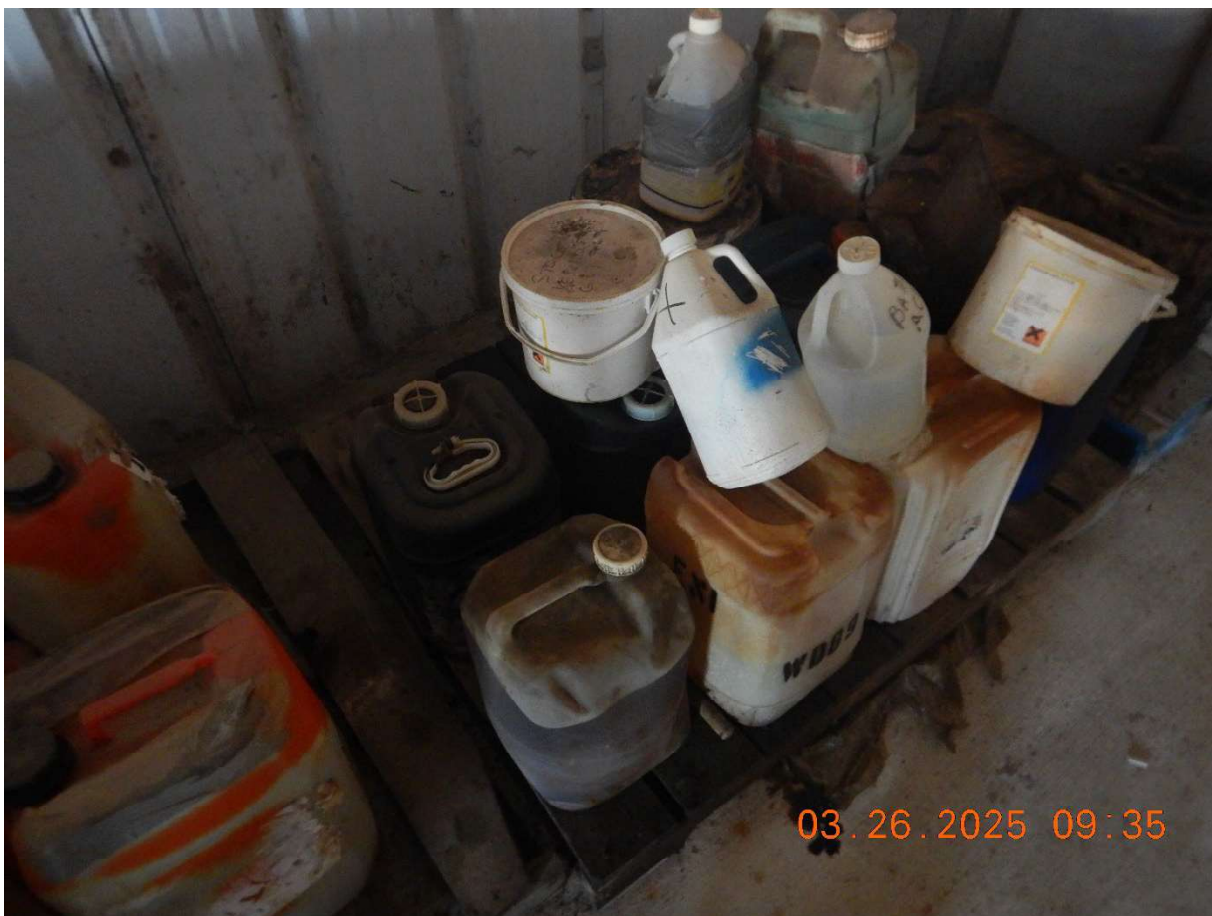
Photo No. 4

Description: View of a pallet containing 1-gallon containers and 5-gallon containers of undetermined liquid waste inside the hazardous waste accumulation area.

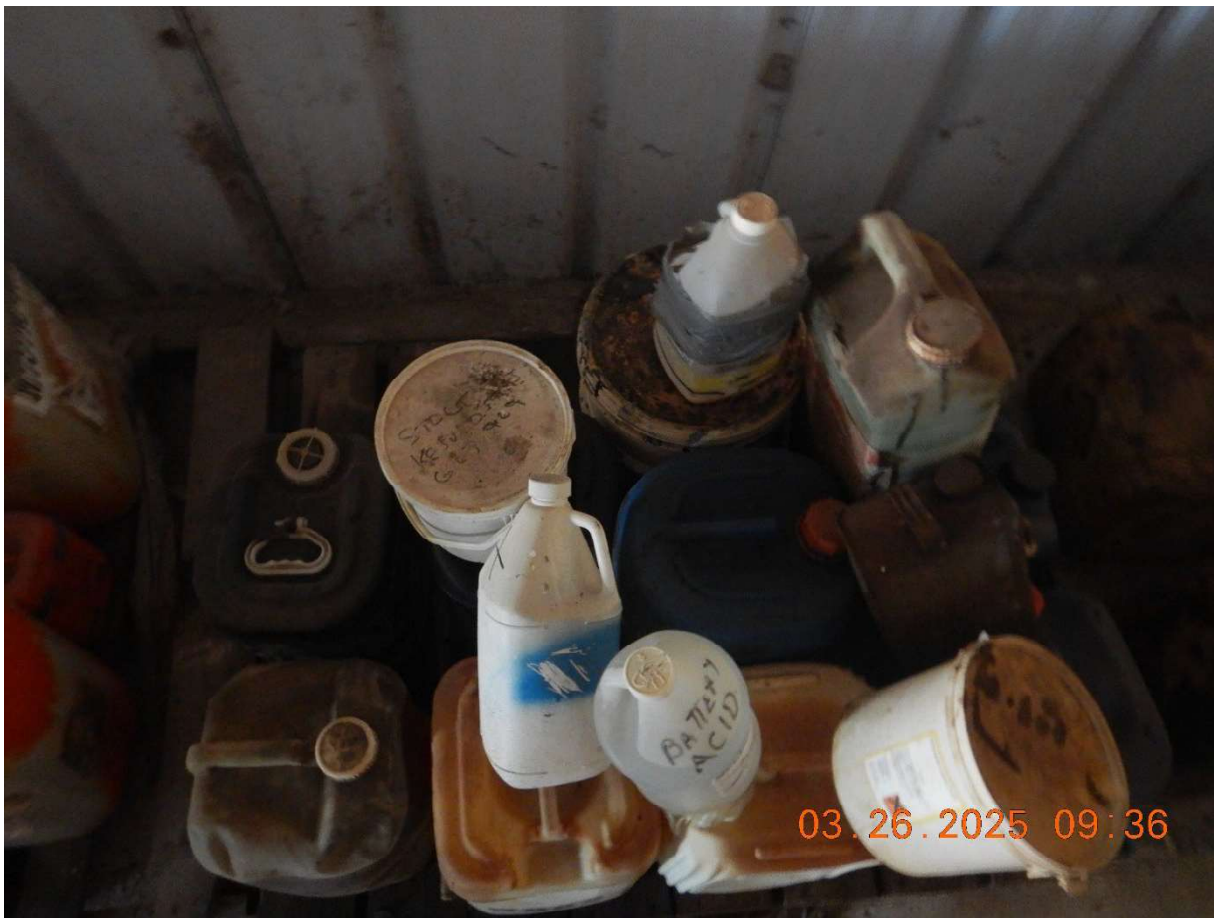
Photo No. 5

Description: Another view of a pallet containing 1-gallon containers and 5-gallon containers of undetermined liquid waste inside the hazardous waste accumulation area.

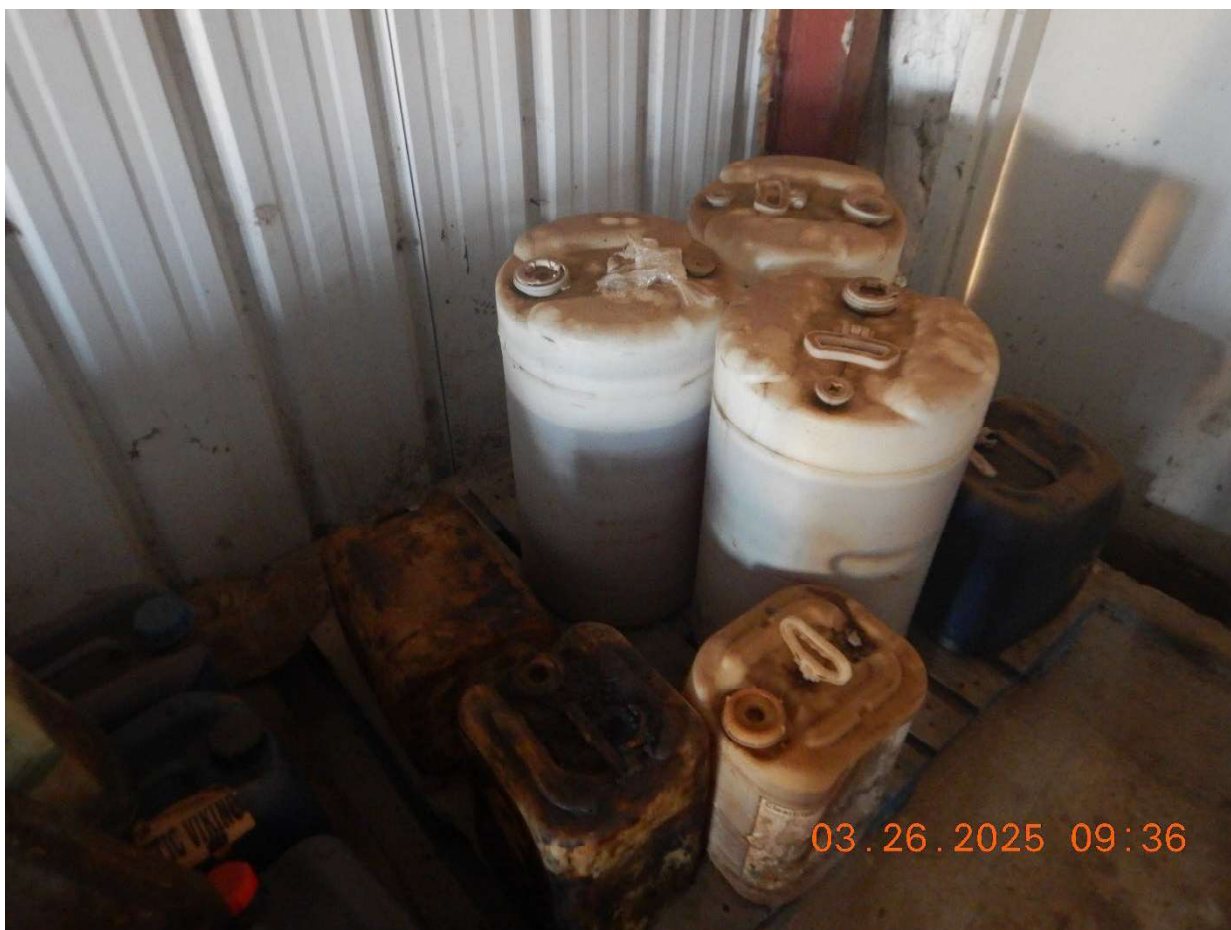
Photo No. 7

Description: View of a pallet containing three 10-gallon containers and four 5-gallon containers of undetermined liquid waste inside the hazardous waste accumulation area.

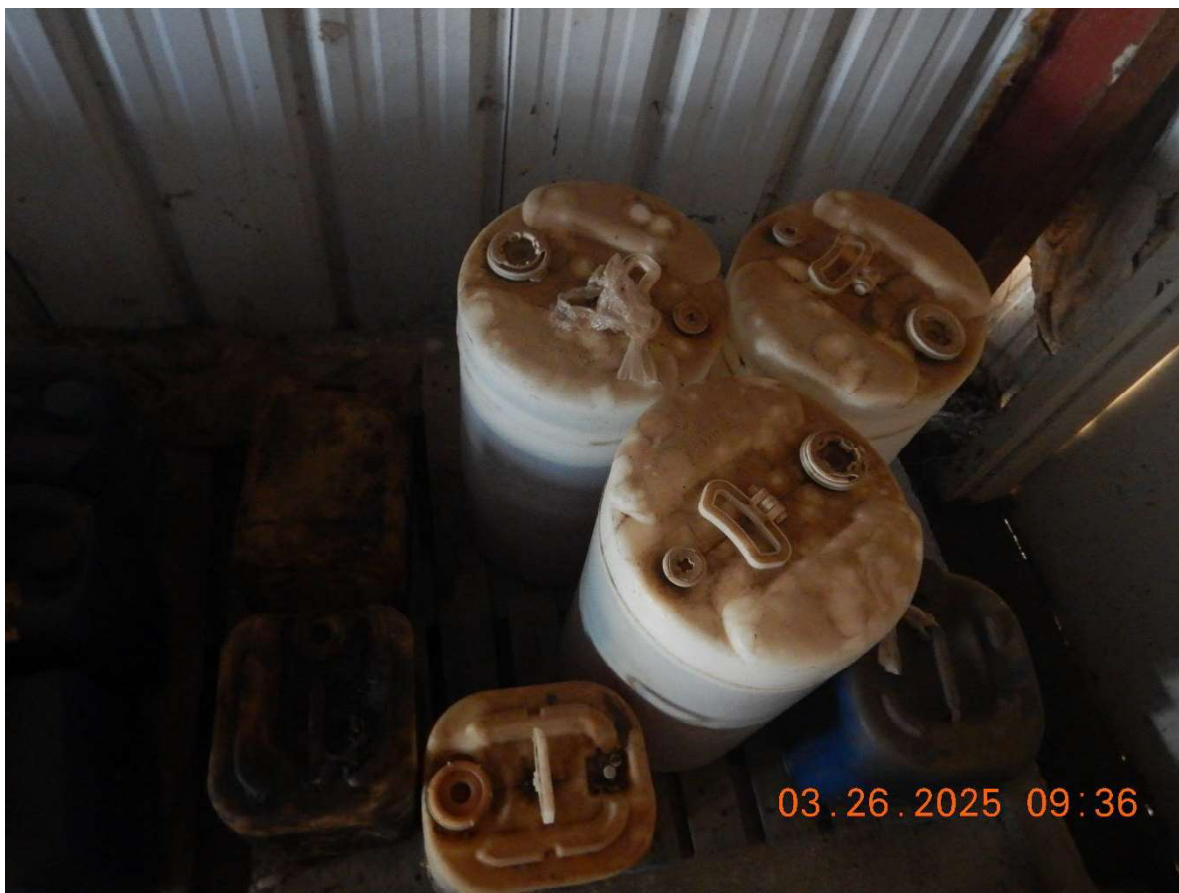
Photo No. 8

Description: Another view of a pallet containing three 10-gallon containers and four 5-gallon containers of undetermined liquid waste inside the hazardous waste accumulation area.

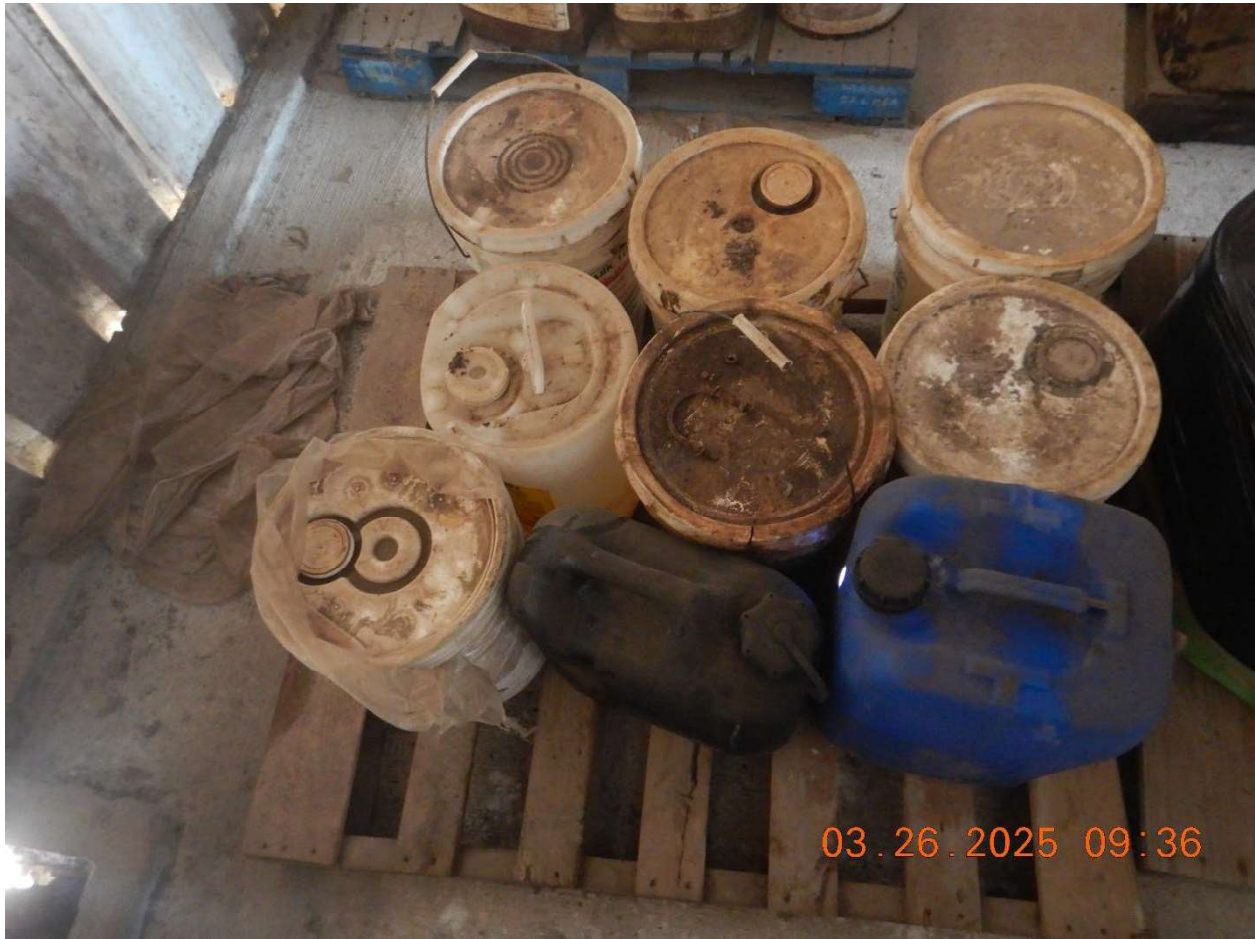
Photo No. 9

Description: View of a pallet containing nine 5-gallon containers of undetermined liquid waste inside the hazardous waste accumulation area.

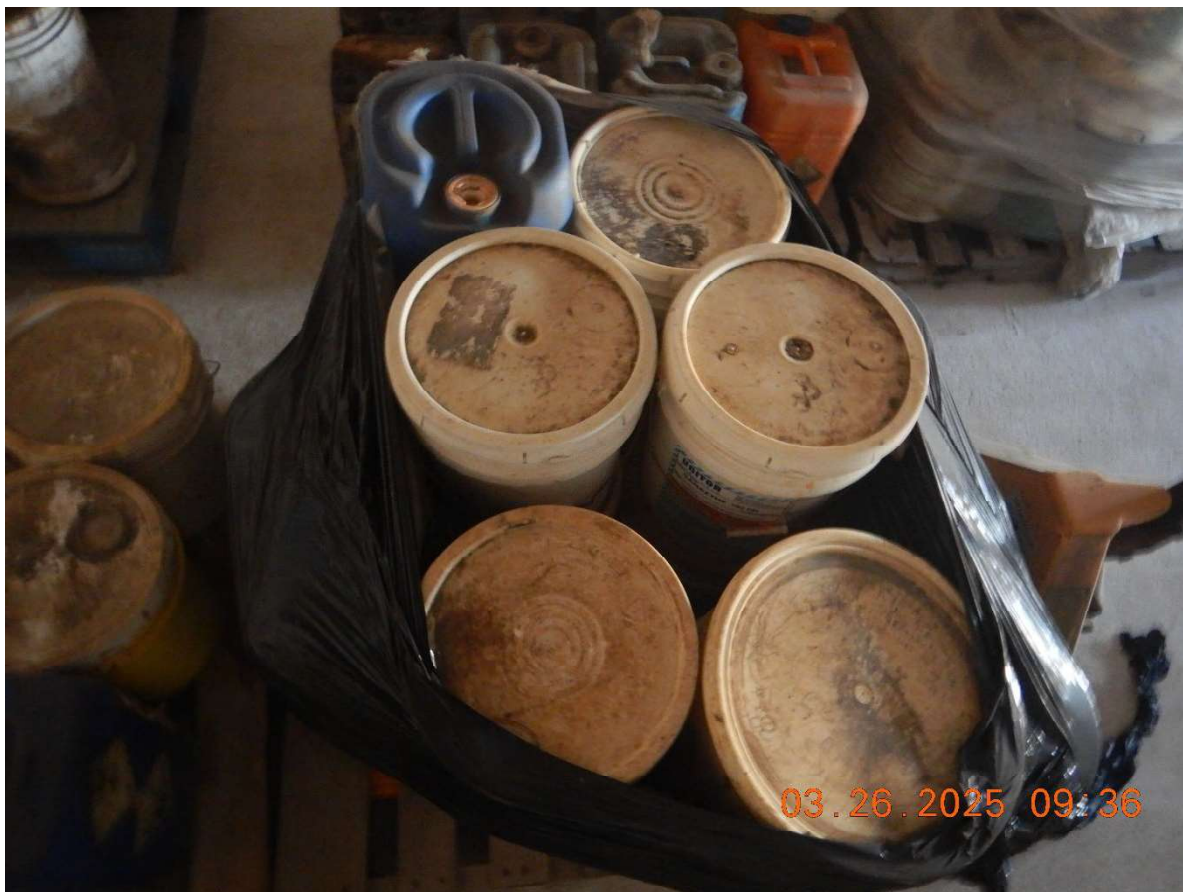
Photo No. 10

Description: View of a pallet containing twelve 5-gallon containers of undetermined liquid waste inside the hazardous waste accumulation area.

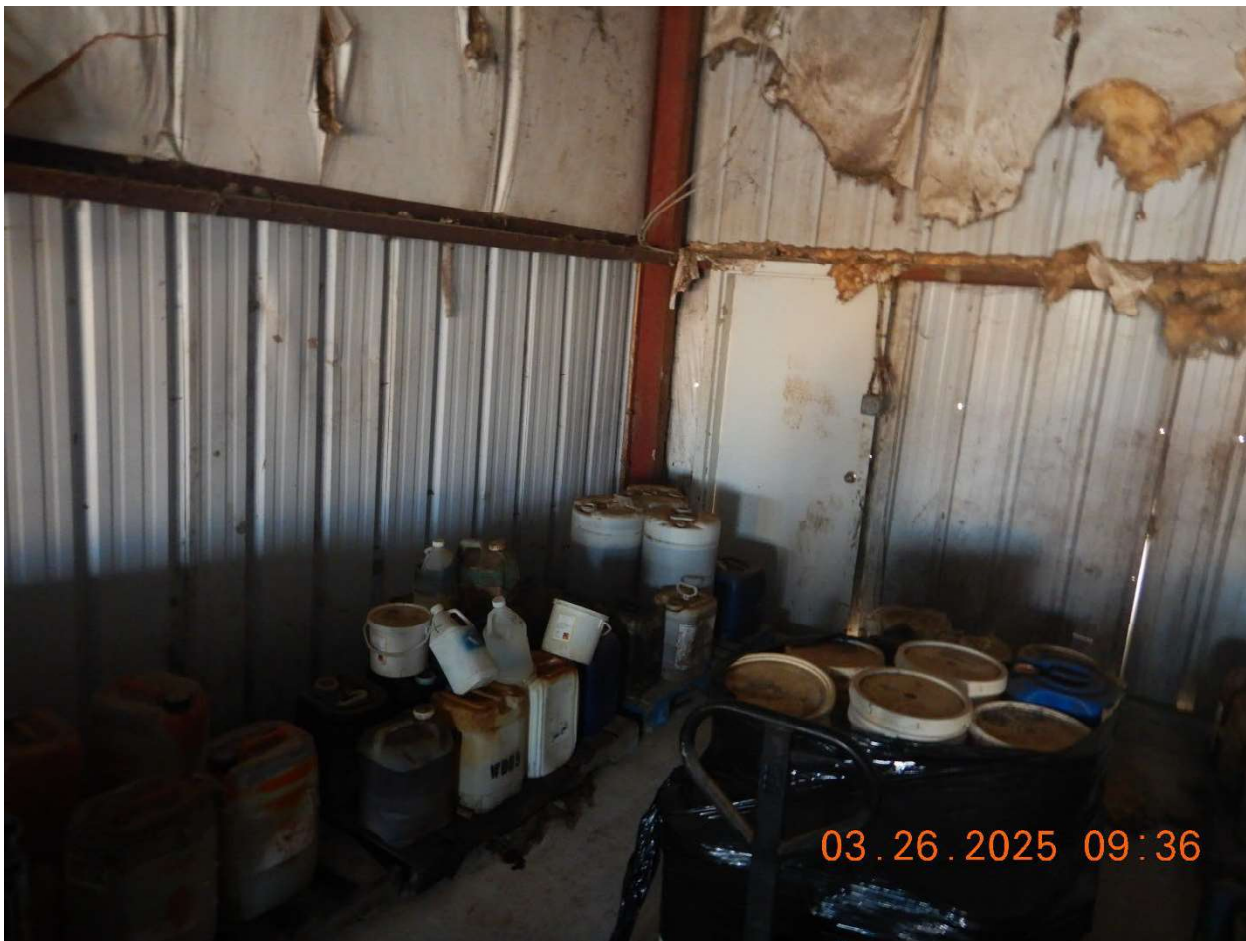
Photo No. 11

Description: Overview of the older tank farm found in the back of the facility in which there was no secondary containment system.

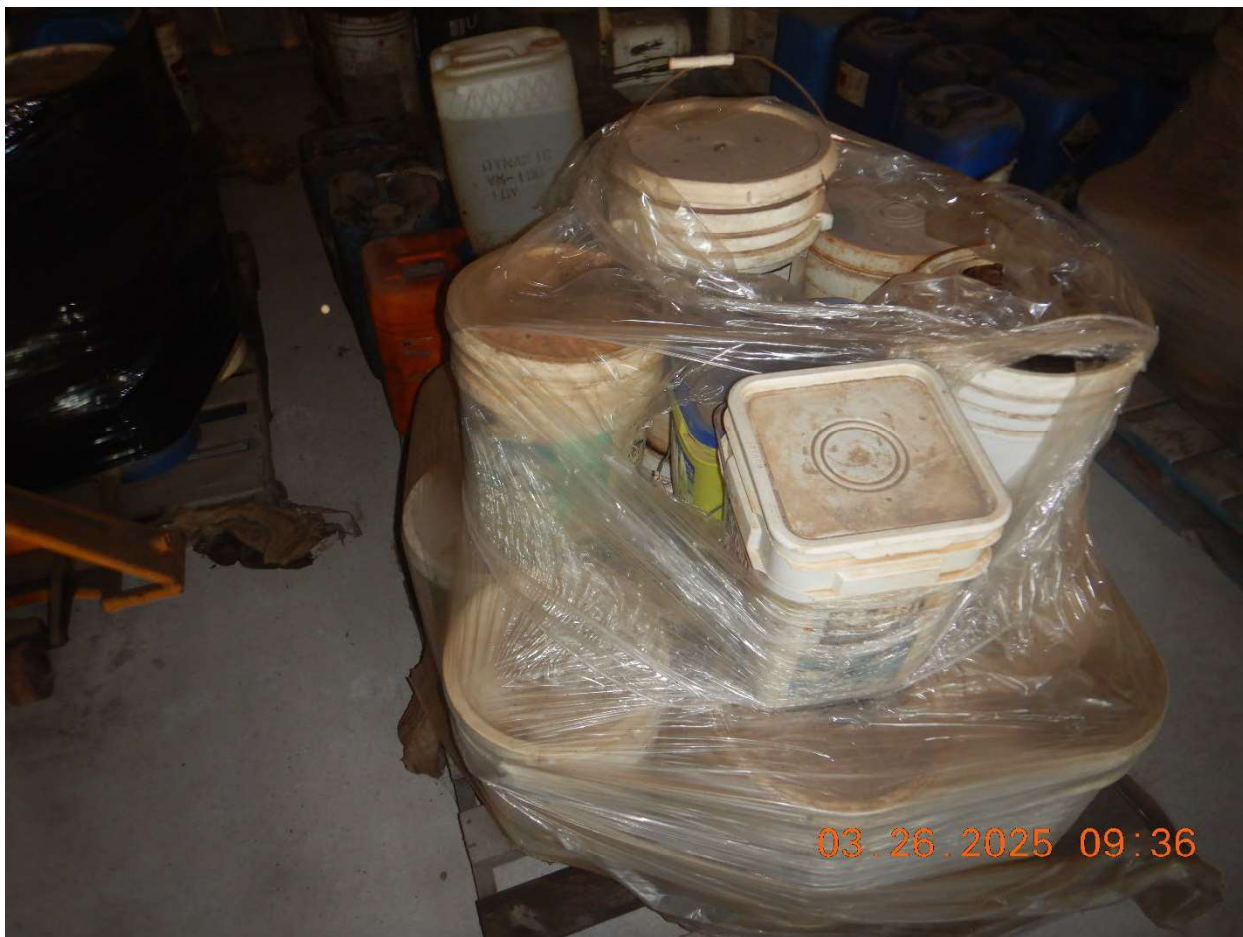
**Photo No. 12**

Description: View of a pallet containing 5-gallon containers of undetermined liquid waste inside the hazardous waste accumulation area.

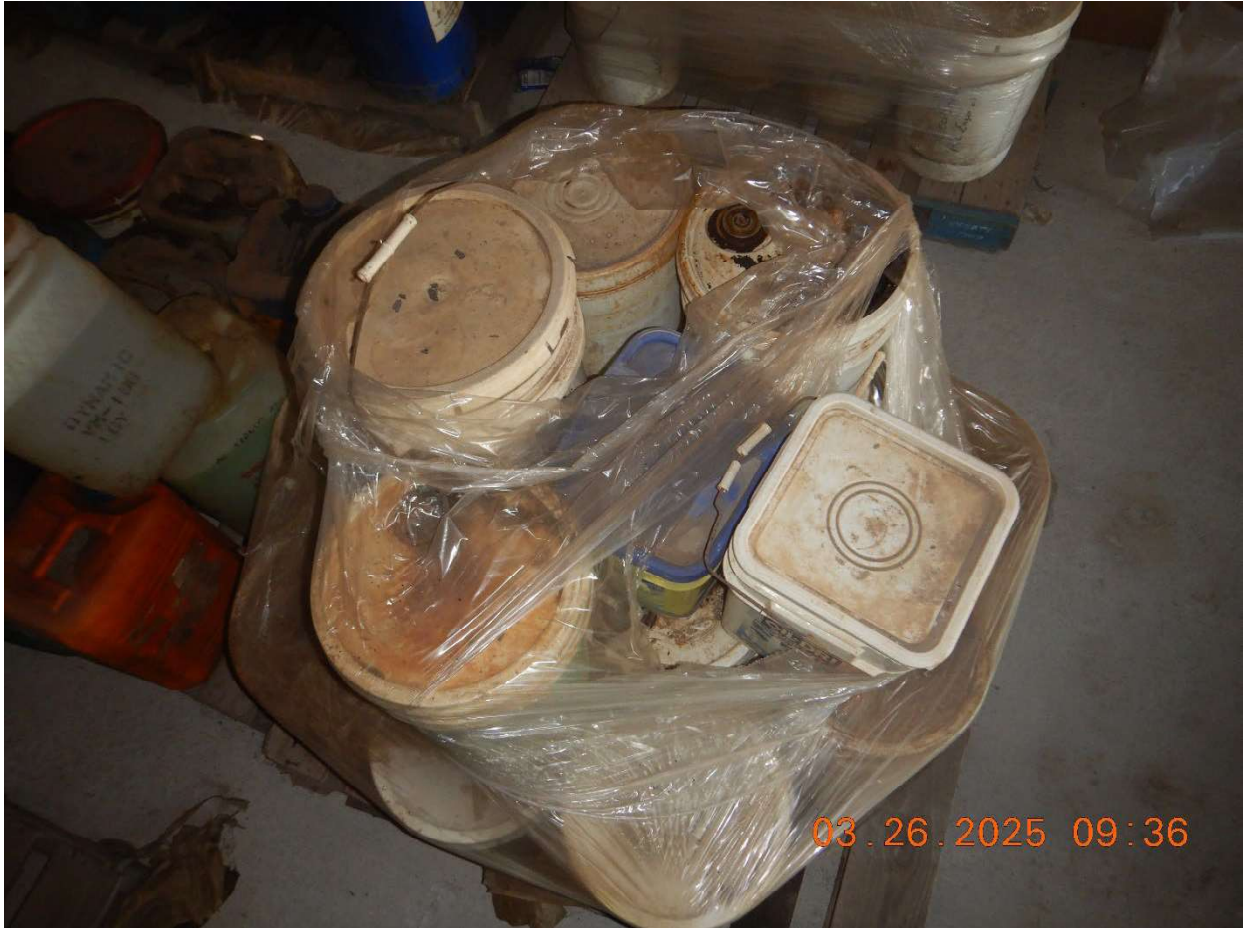
**Photo No. 13**

Description: Another view of a pallet containing 5-gallon containers of undetermined liquid waste inside the hazardous waste accumulation area.

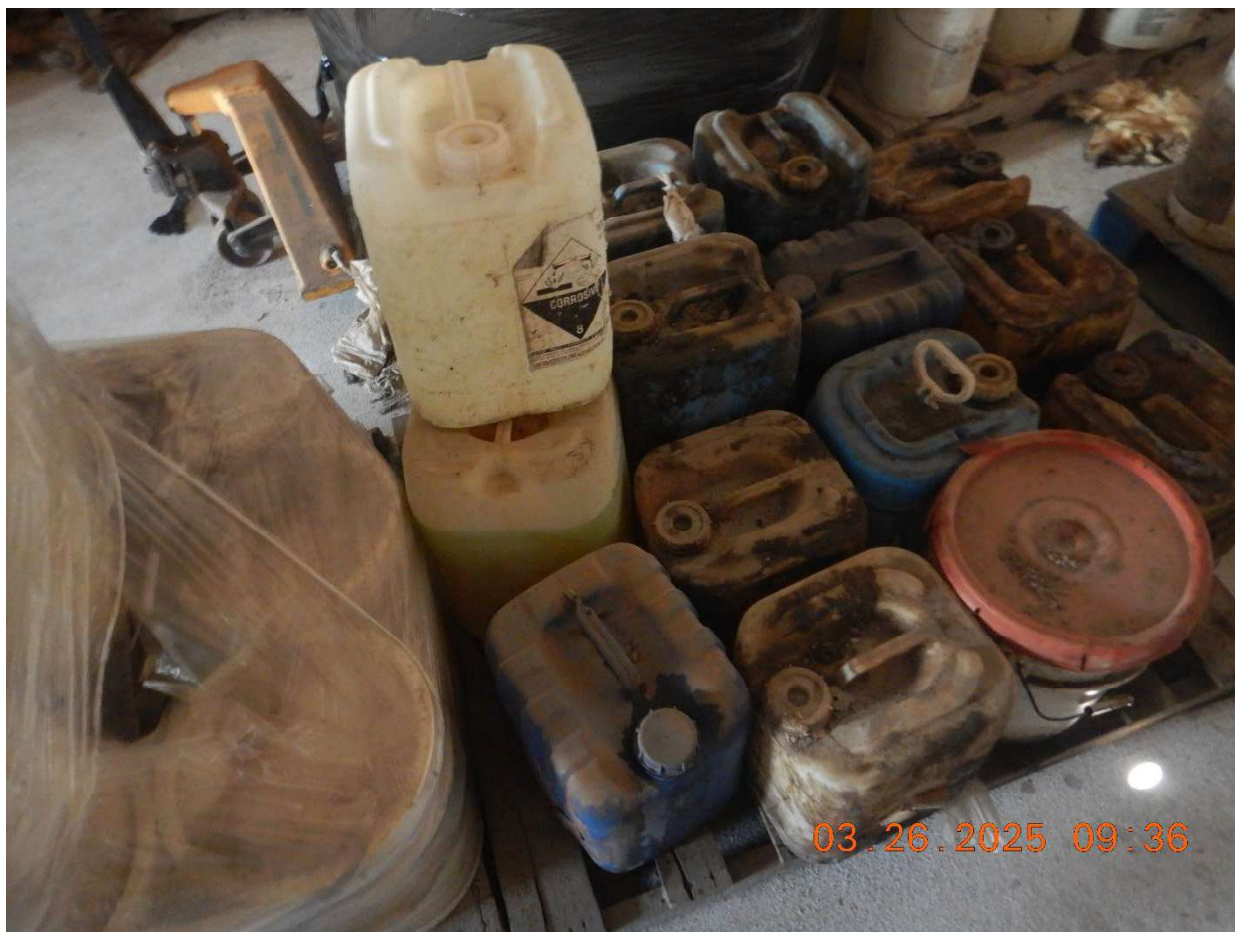
**Photo No. 14**

Description: View of a pallet containing fourteen 5-gallon containers of undetermined liquid waste inside the hazardous waste accumulation area.

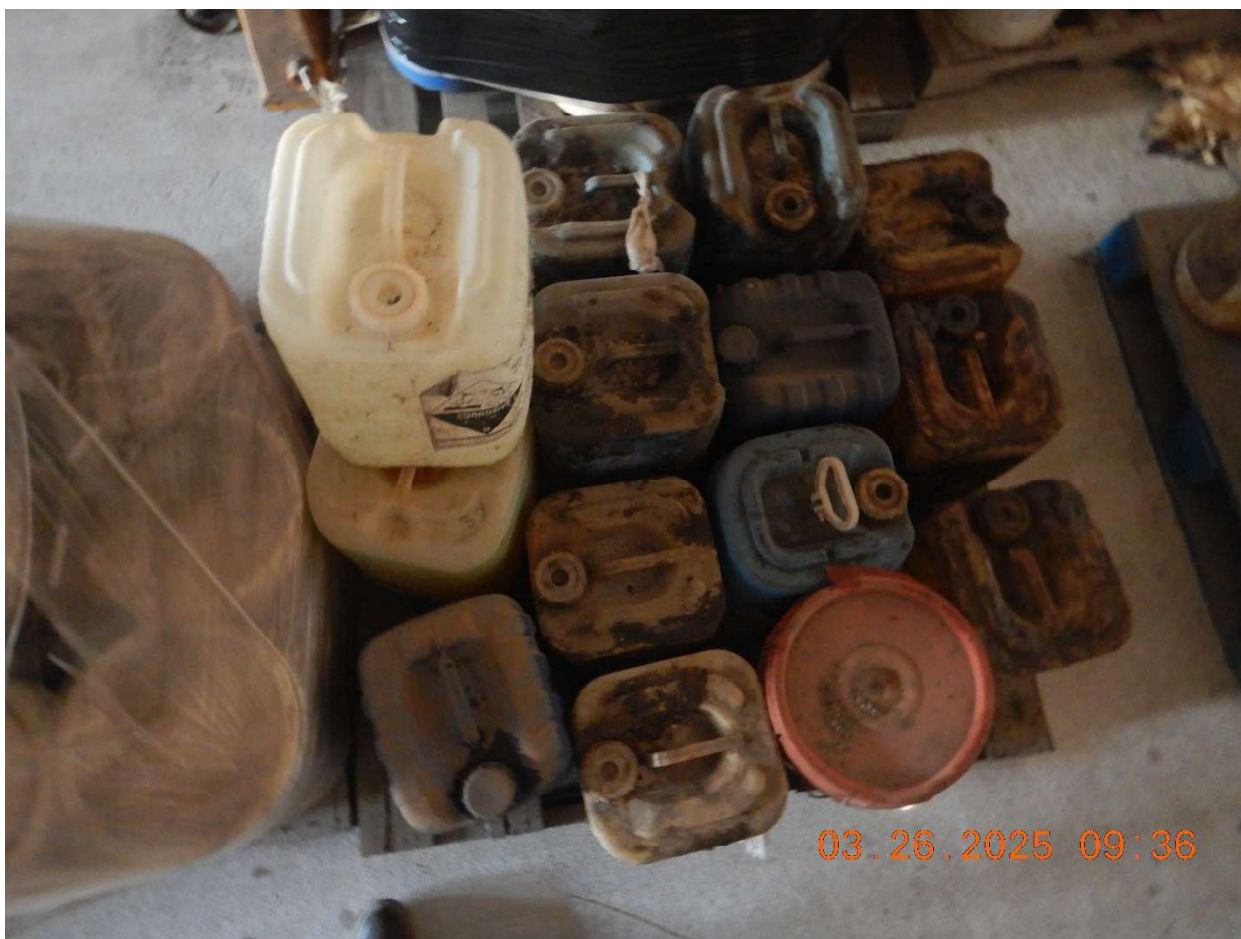
**Photo No. 15**

Description: Another view of a pallet containing fourteen 5-gallon containers of undetermined liquid waste inside the hazardous waste accumulation area.

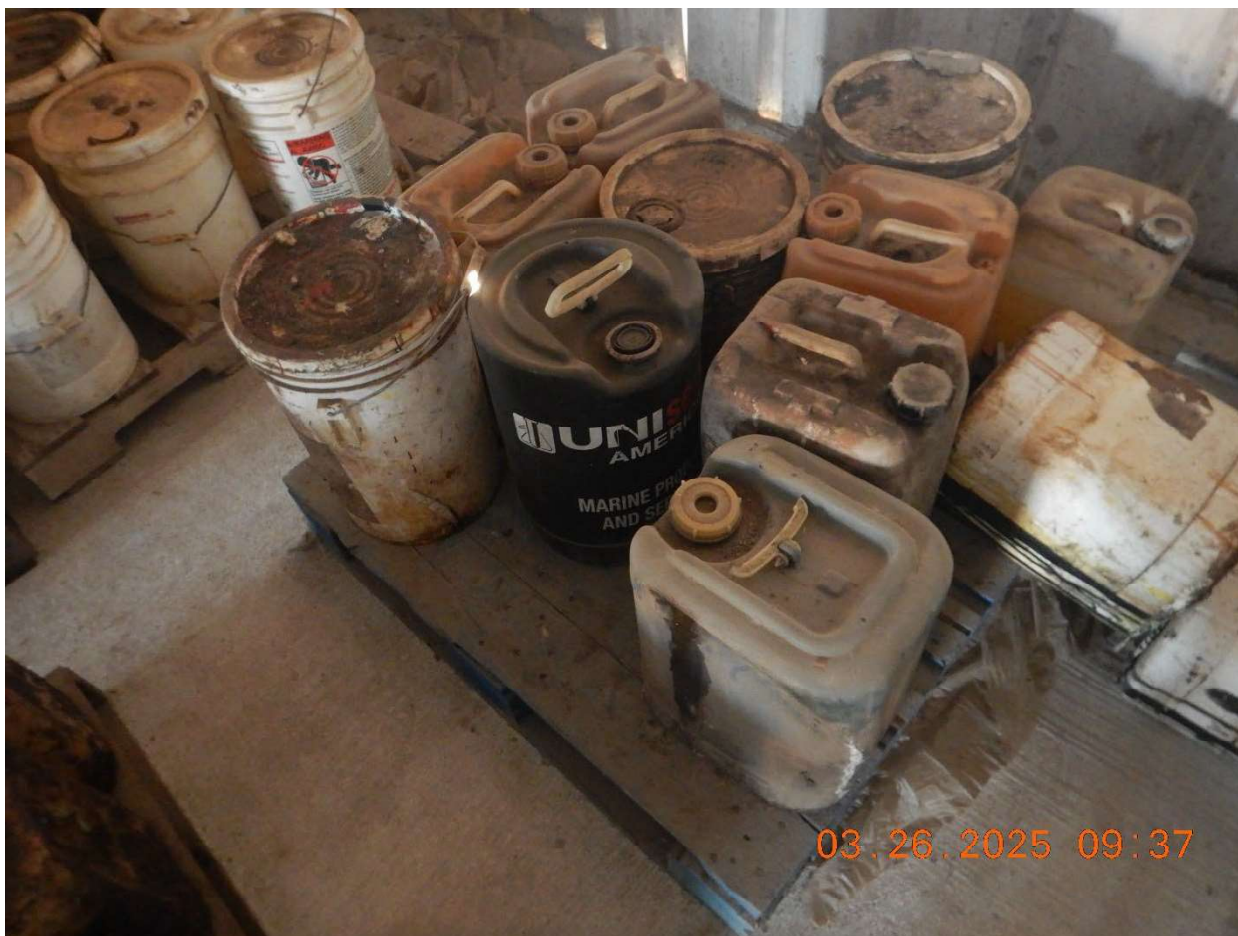
Photo No. 16

Description: View of a pallet containing ten 5-gallon containers of undetermined liquid waste inside the hazardous waste accumulation area.

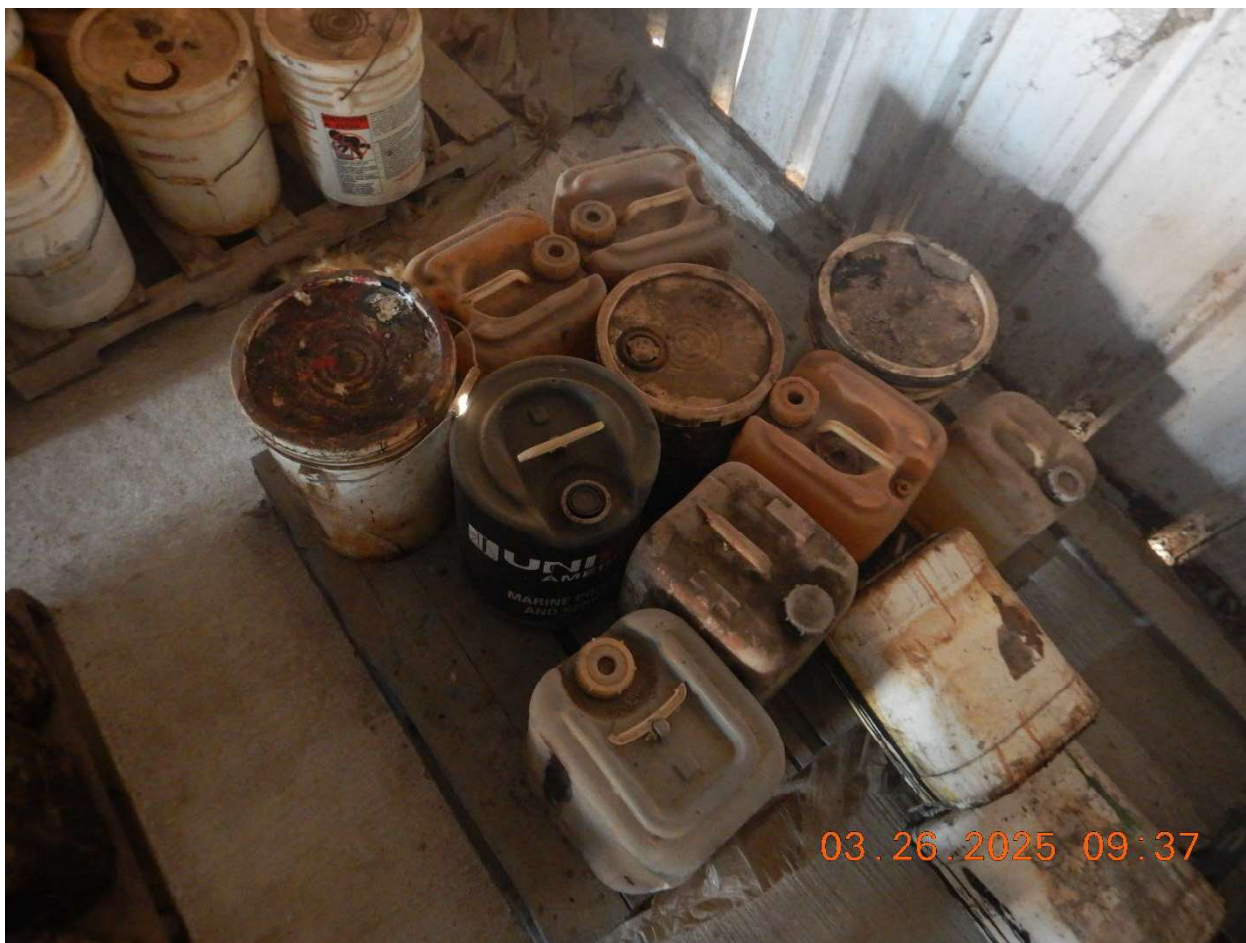
Photo No. 17

Description: Another view of a pallet containing ten 5-gallon containers of undetermined liquid waste inside the hazardous waste accumulation area.

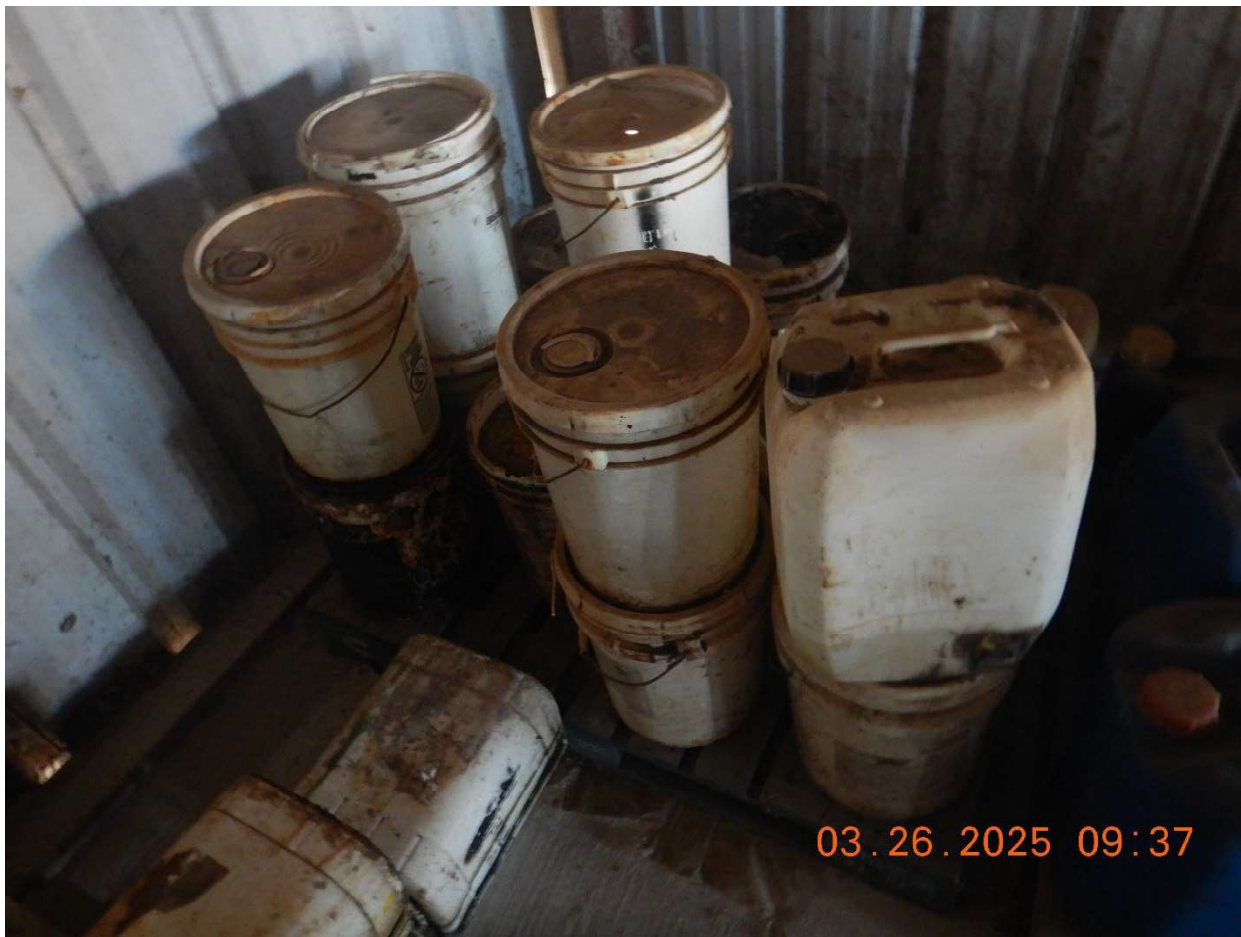
Photo No. 18

Description: View of a pallet containing approximately fourteen 5-gallon containers of undetermined liquid waste inside the hazardous waste accumulation area.

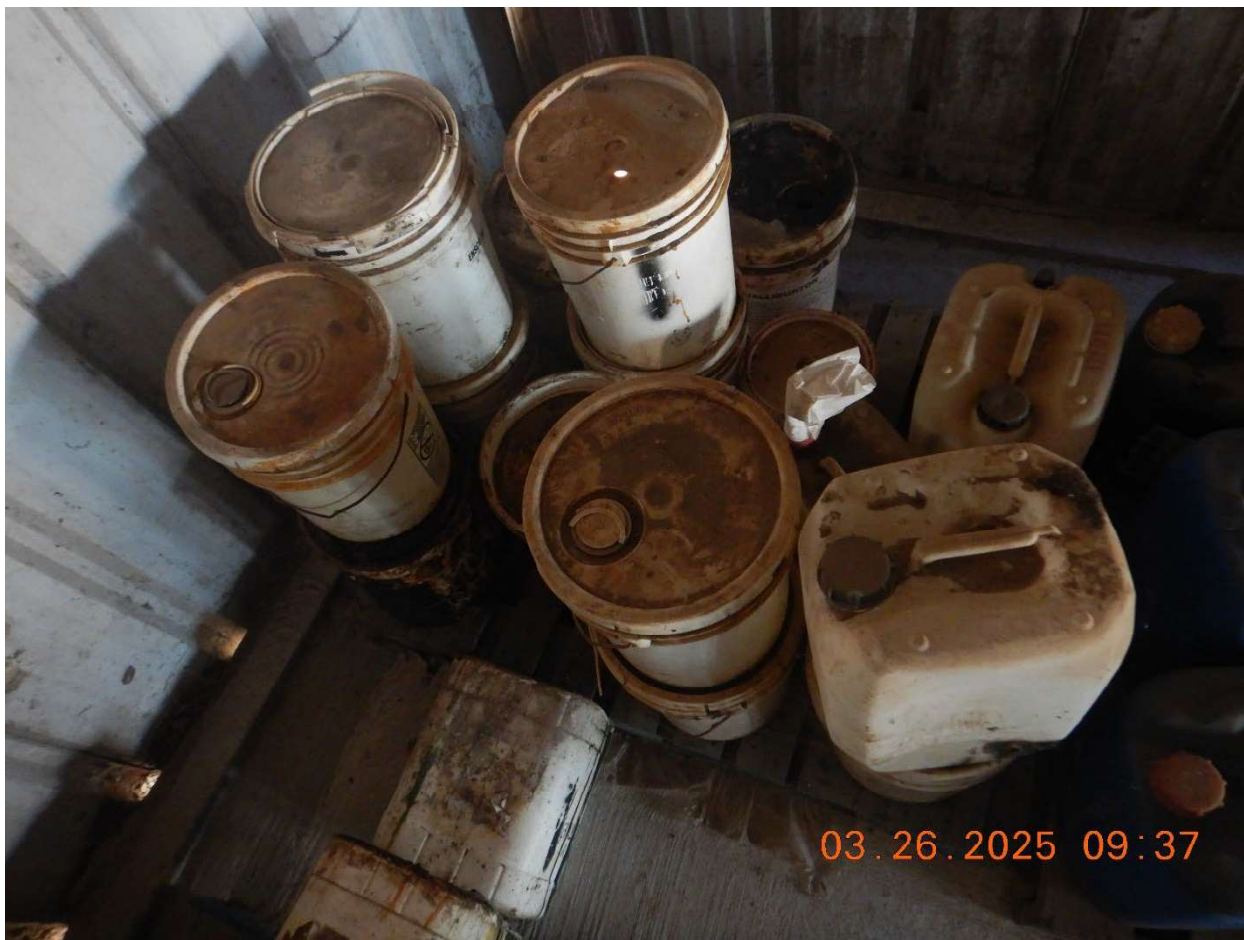
Photo No. 19

Description: Another view of a pallet containing approximately fourteen 5-gallon containers of undetermined liquid waste inside the hazardous waste accumulation area.

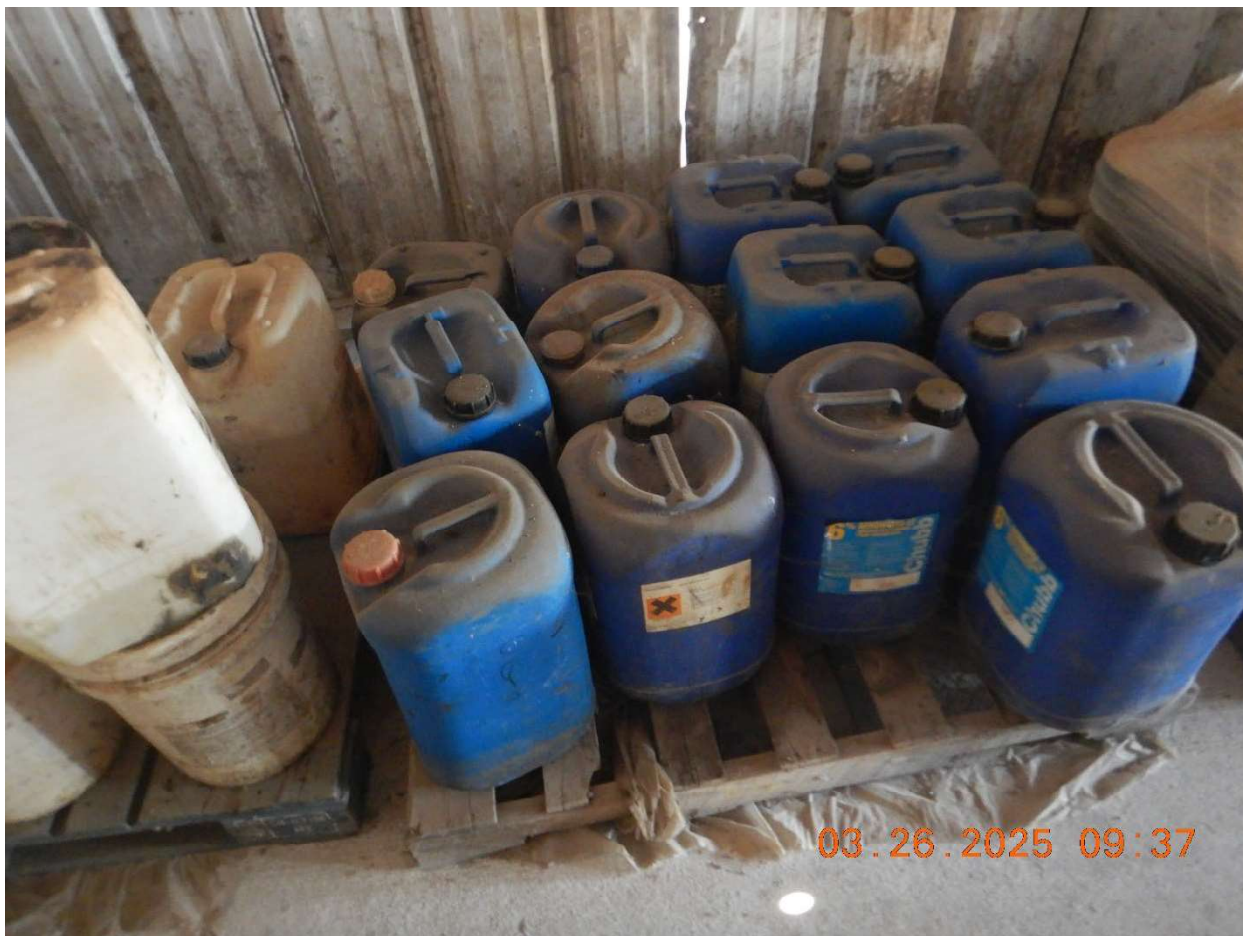
Photo No. 20

Description: View of a pallet containing thirteen 5-gallon containers of undetermined liquid waste inside the hazardous waste accumulation area.
