INSPECTION REPORT

| Type of Inspection | Compliance Evaluation Inspection (CEI) | | |
| Facility or Site Name | Modern American Recycling Services Inc. | | |
| Type of Operation | Modern American Recycling Services (MARS) decommissions oil field platforms and recycles the scrap metal. | | |

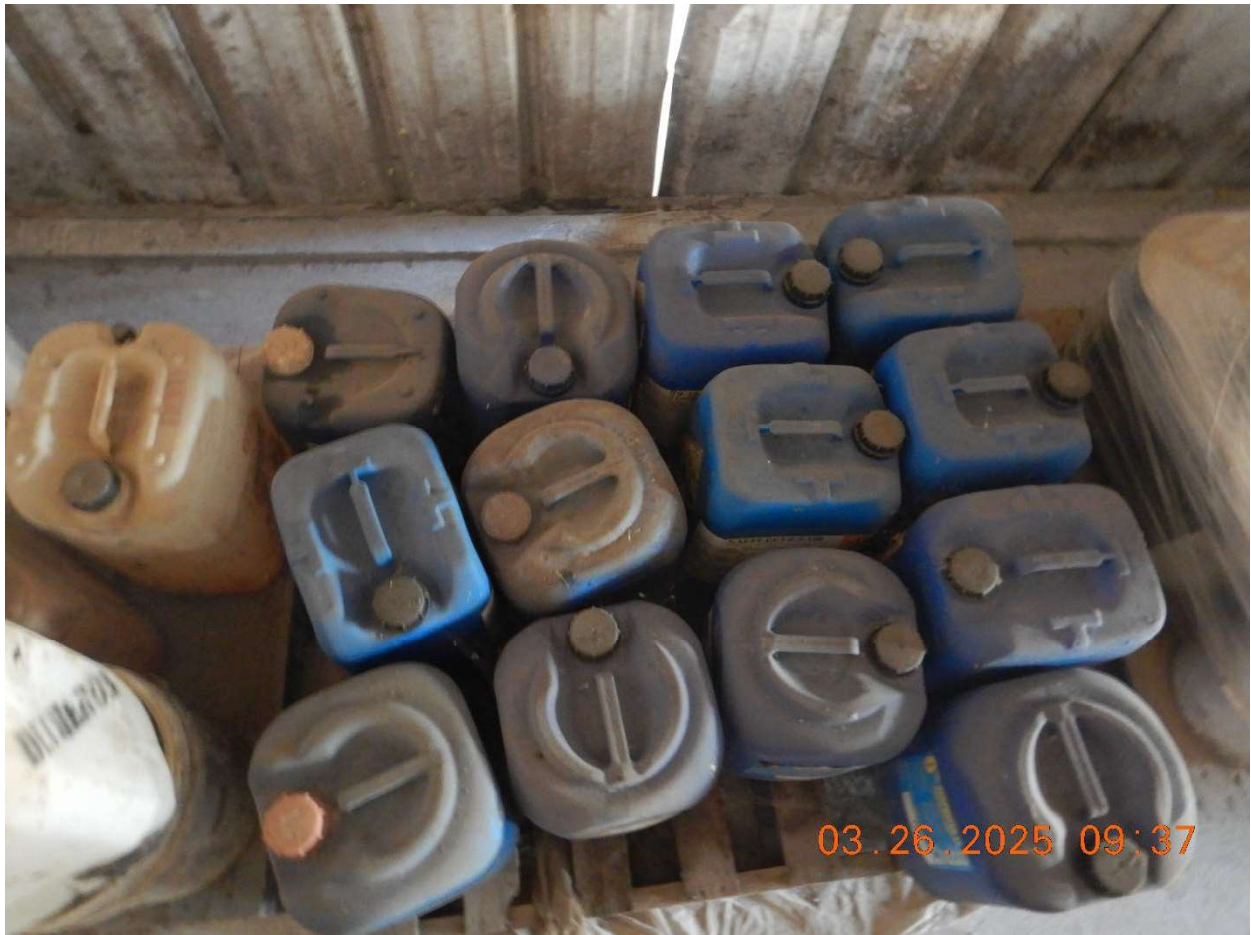
**Photo No. 21**

Description: View of a pallet containing thirteen 5-gallon containers of undetermined liquid waste inside the hazardous waste accumulation area.

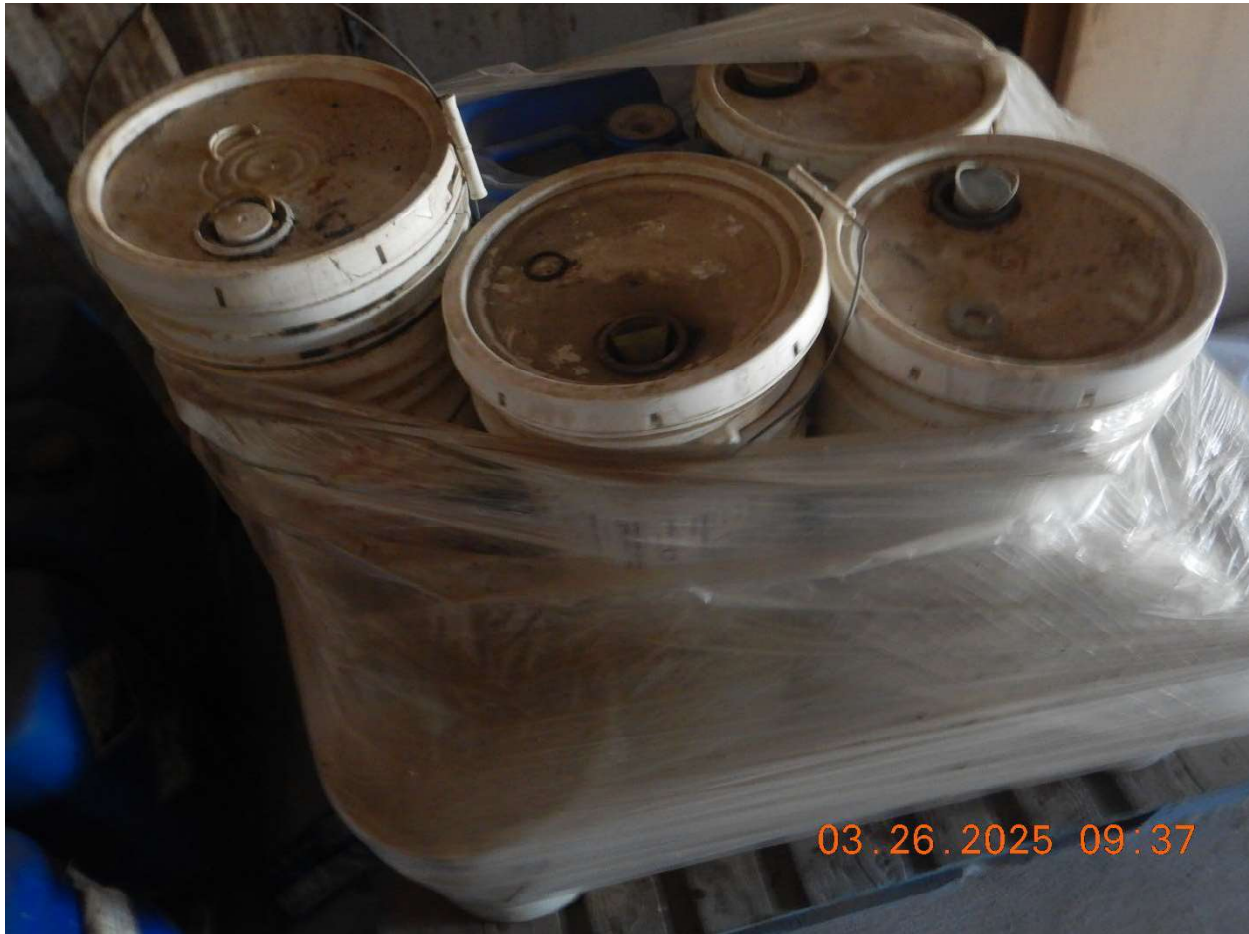
**Photo No. 22**

Description: View of a pallet containing 5-gallon containers of undetermined liquid waste inside the hazardous waste accumulation area.

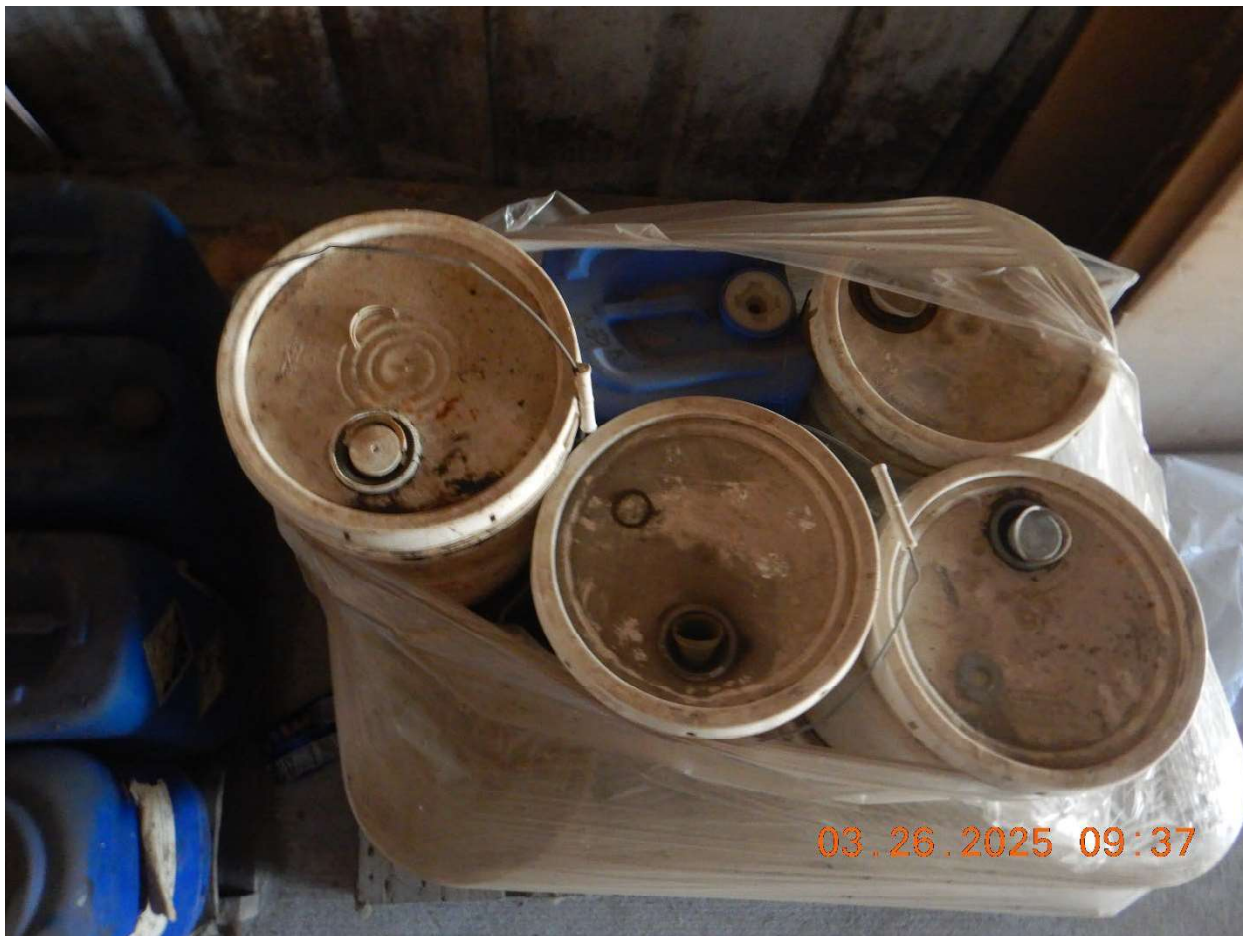
Photo No. 23

Description: Another view of a pallet containing 5-gallon containers of undetermined liquid waste inside the hazardous waste accumulation area.

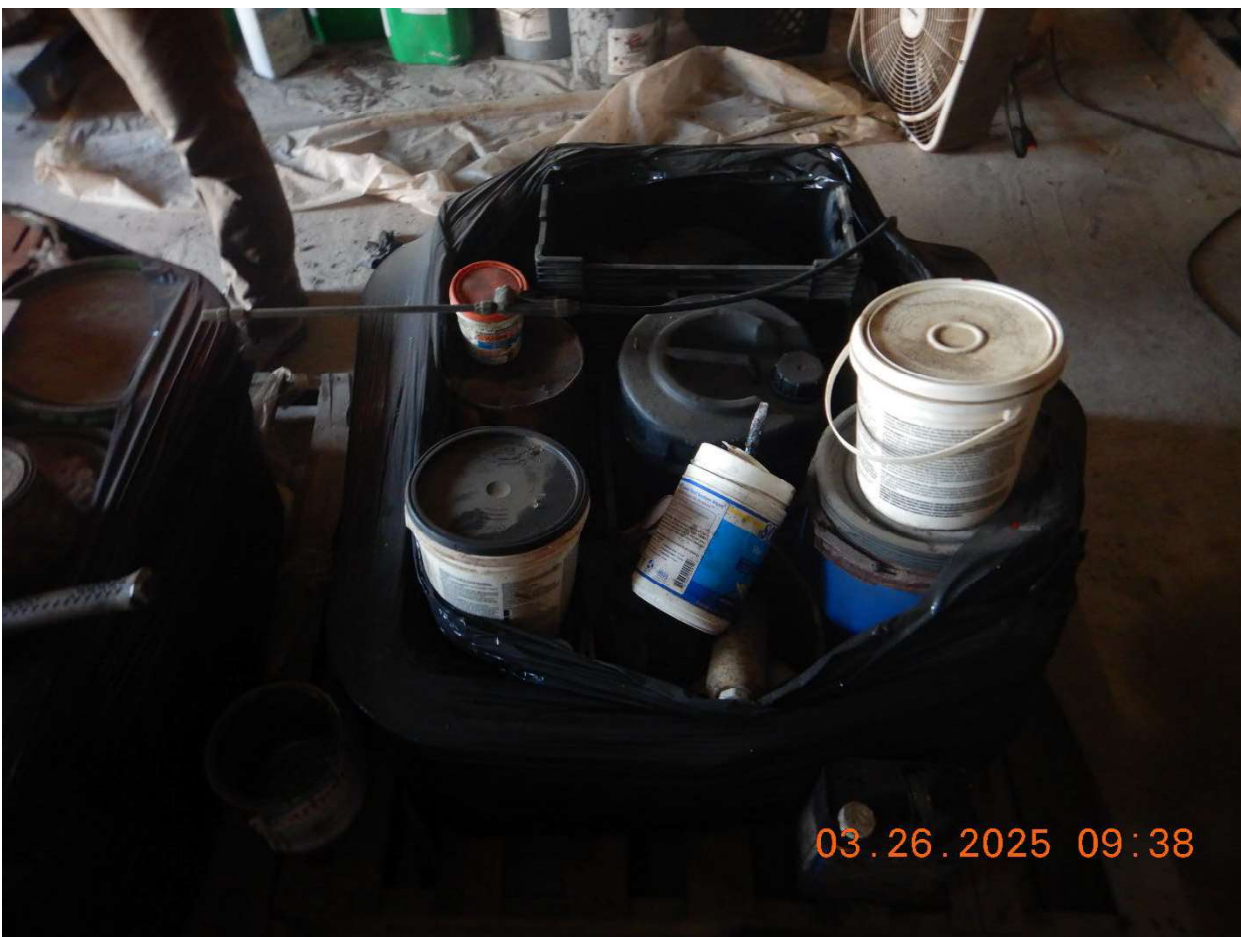
Photo No. 25

Description: View of a pallet containing 5-gallon containers and 1-gallon containers of paint-related waste inside the hazardous waste accumulation area.

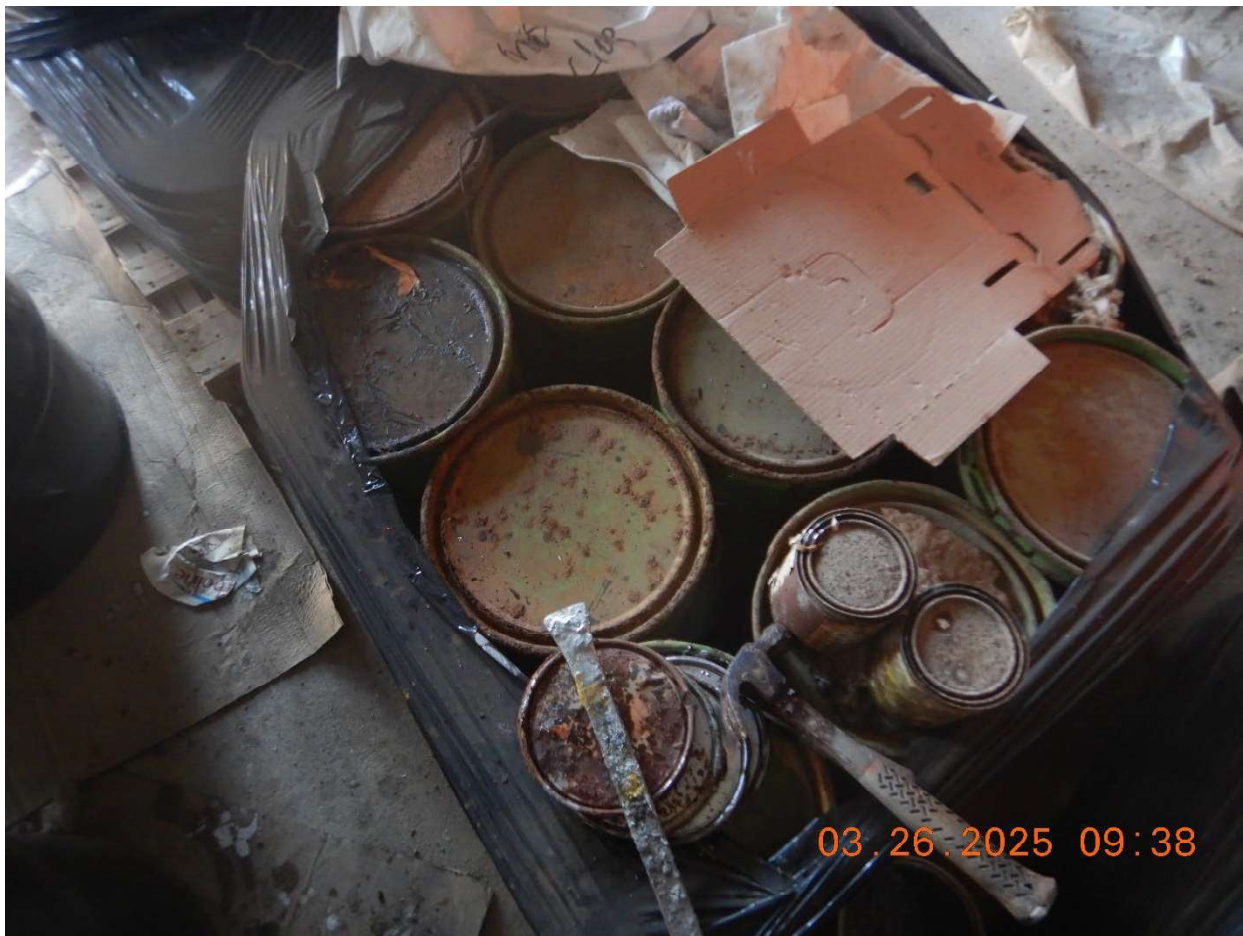
Photo No. 26

Description: View of a pallet containing 5-gallon containers and 1-gallon containers of paint-related waste inside the hazardous waste accumulation area.

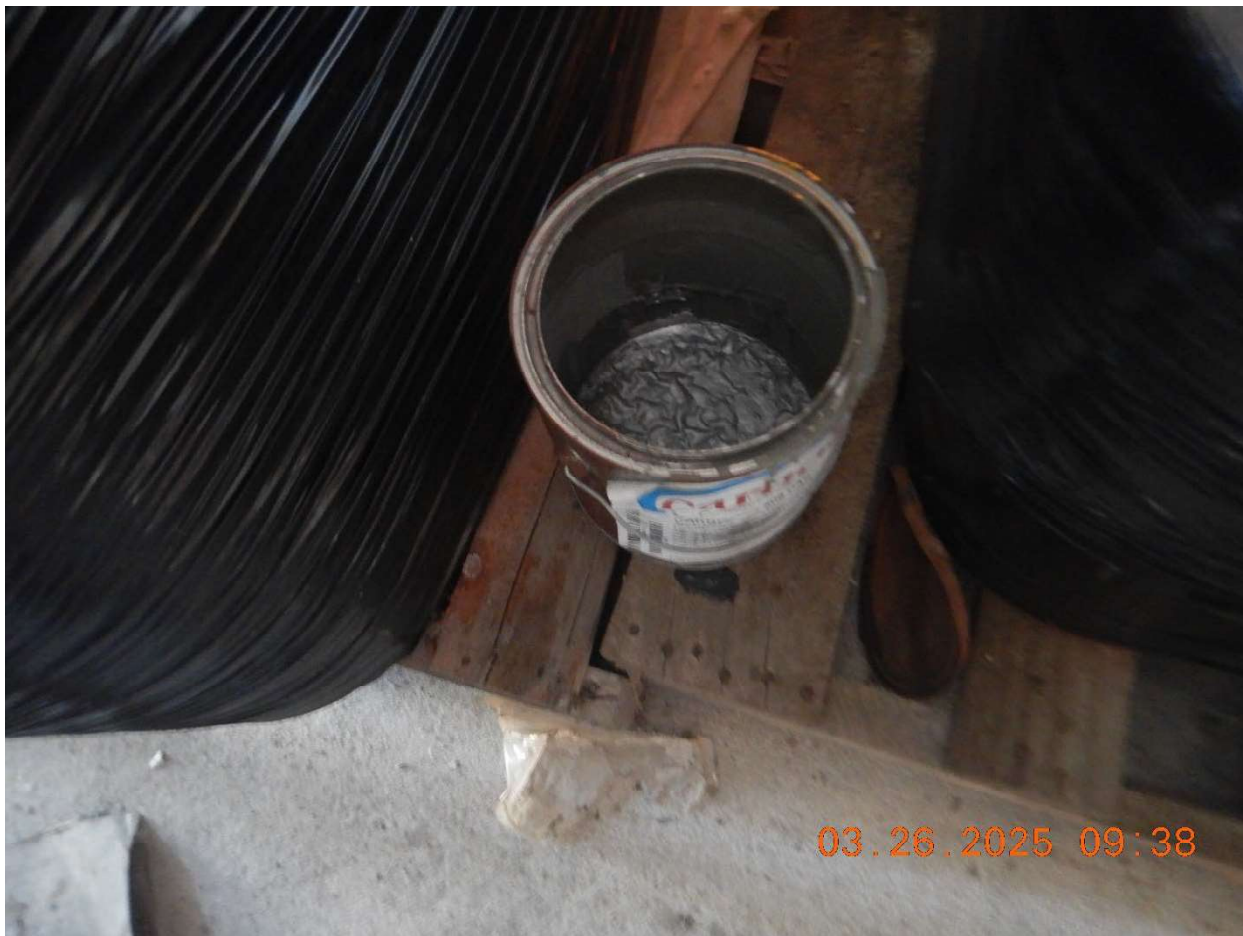
**Photo No. 27**

Description: View of an empty dried 1-gallon paint can inside of the hazardous waste storage area.

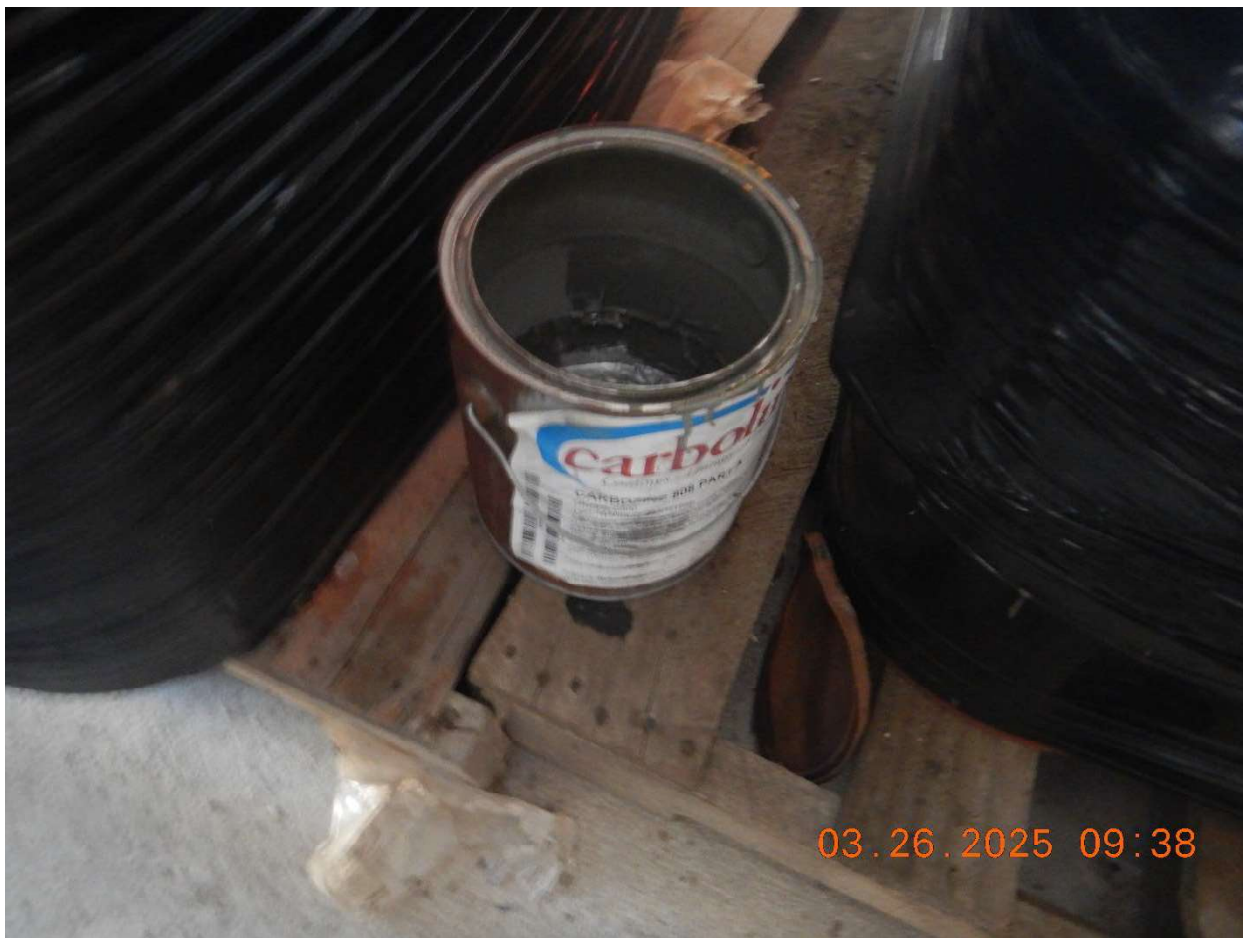
Photo No. 28

Description: Another view of an empty dried 1-gallon paint can inside of the hazardous waste storage area.

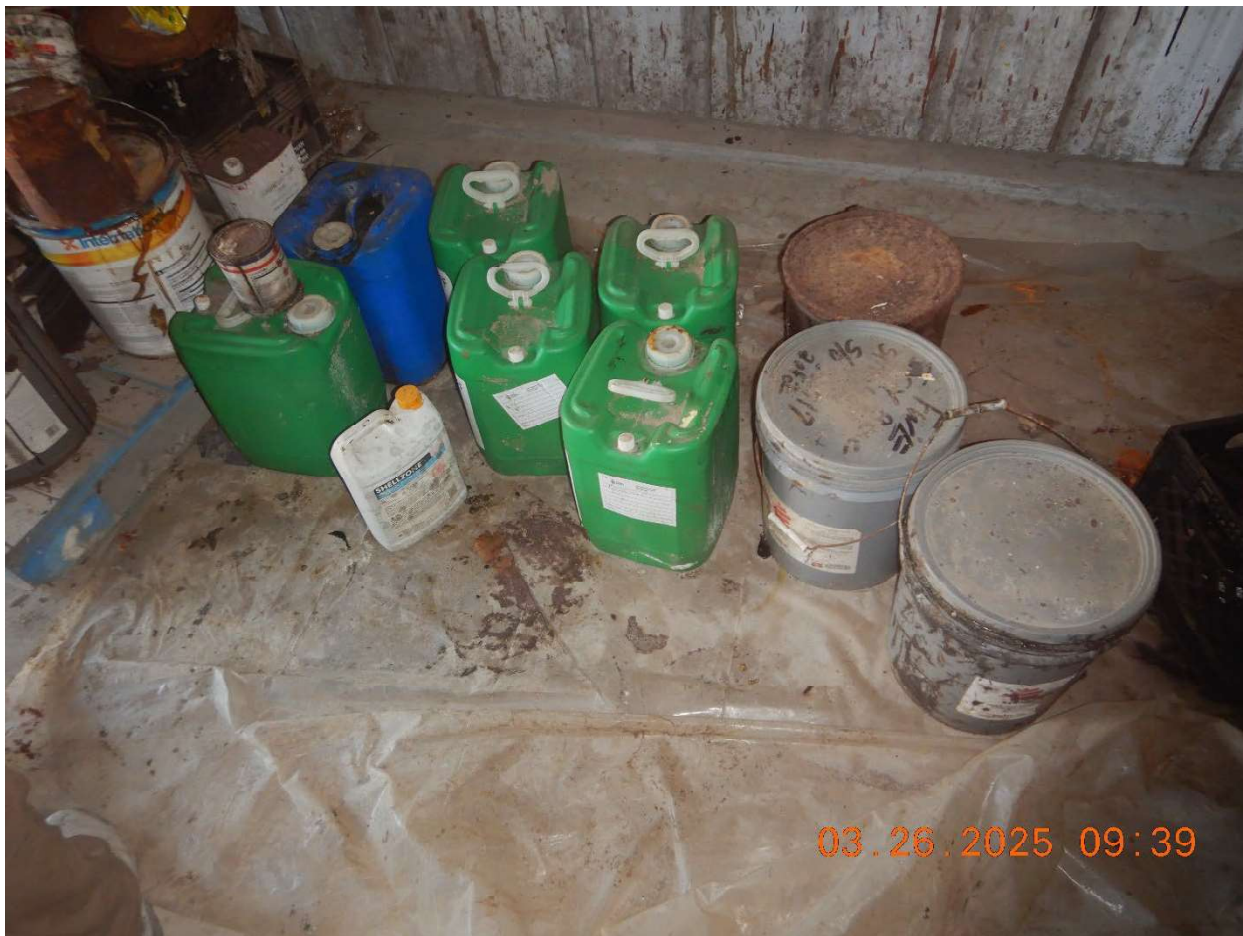
Photo No. 29

Description: View of a pallet containing 5-gallon containers and 1-gallon containers of paint-related waste inside the hazardous waste accumulation area.

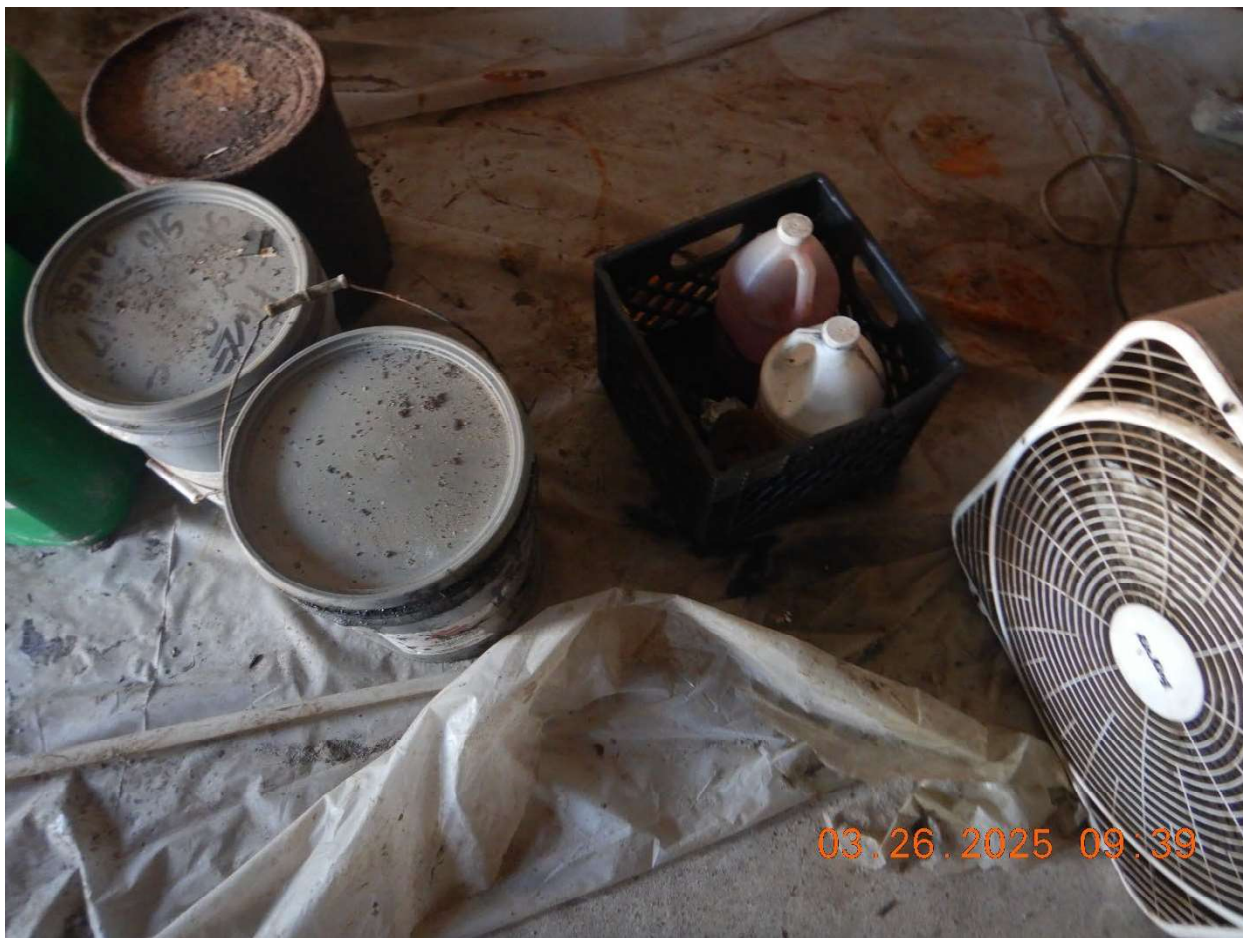
Photo No. 30

Description: Another view of a pallet containing 5-gallon containers and 1-gallon containers of paint-related waste inside the hazardous waste accumulation area..

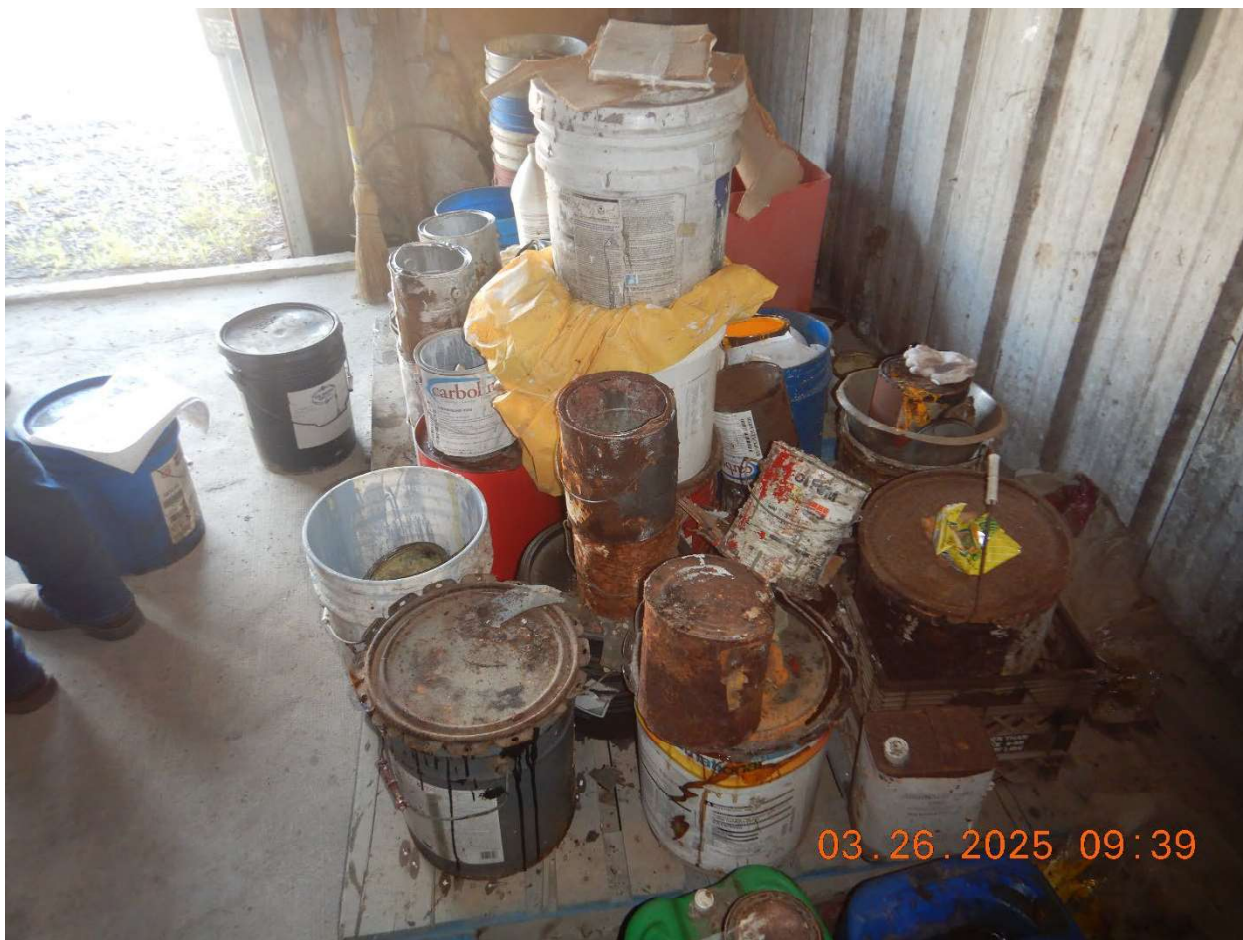
Photo No. 31

Description: View of a pallet containing 5-gallon containers and 1-gallon containers of paint-related waste inside the hazardous waste accumulation area.

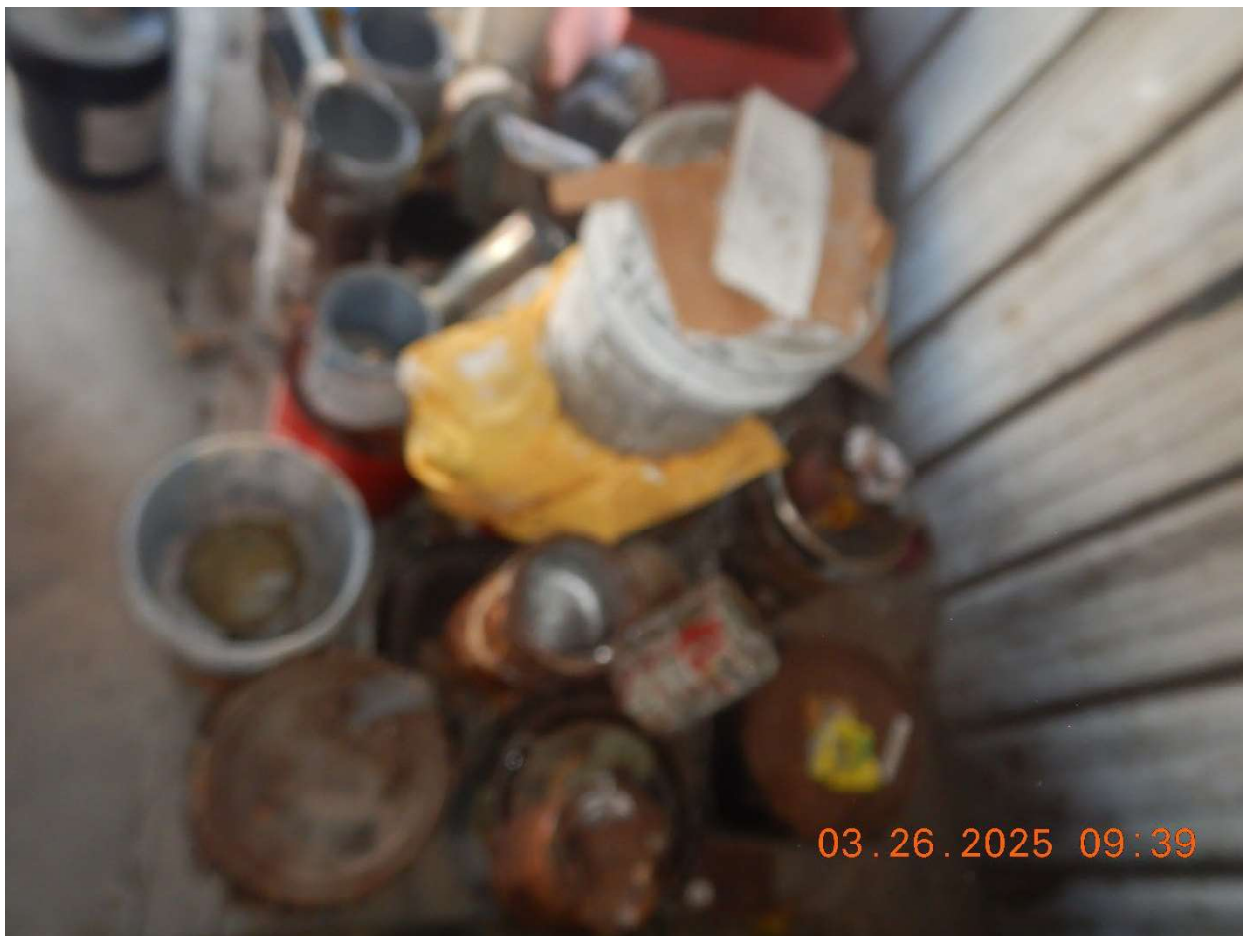
**Photo No. 32**

Description: View of a pallet containing 5-gallon containers and 1-gallon containers of paint-related waste inside the hazardous waste accumulation area.

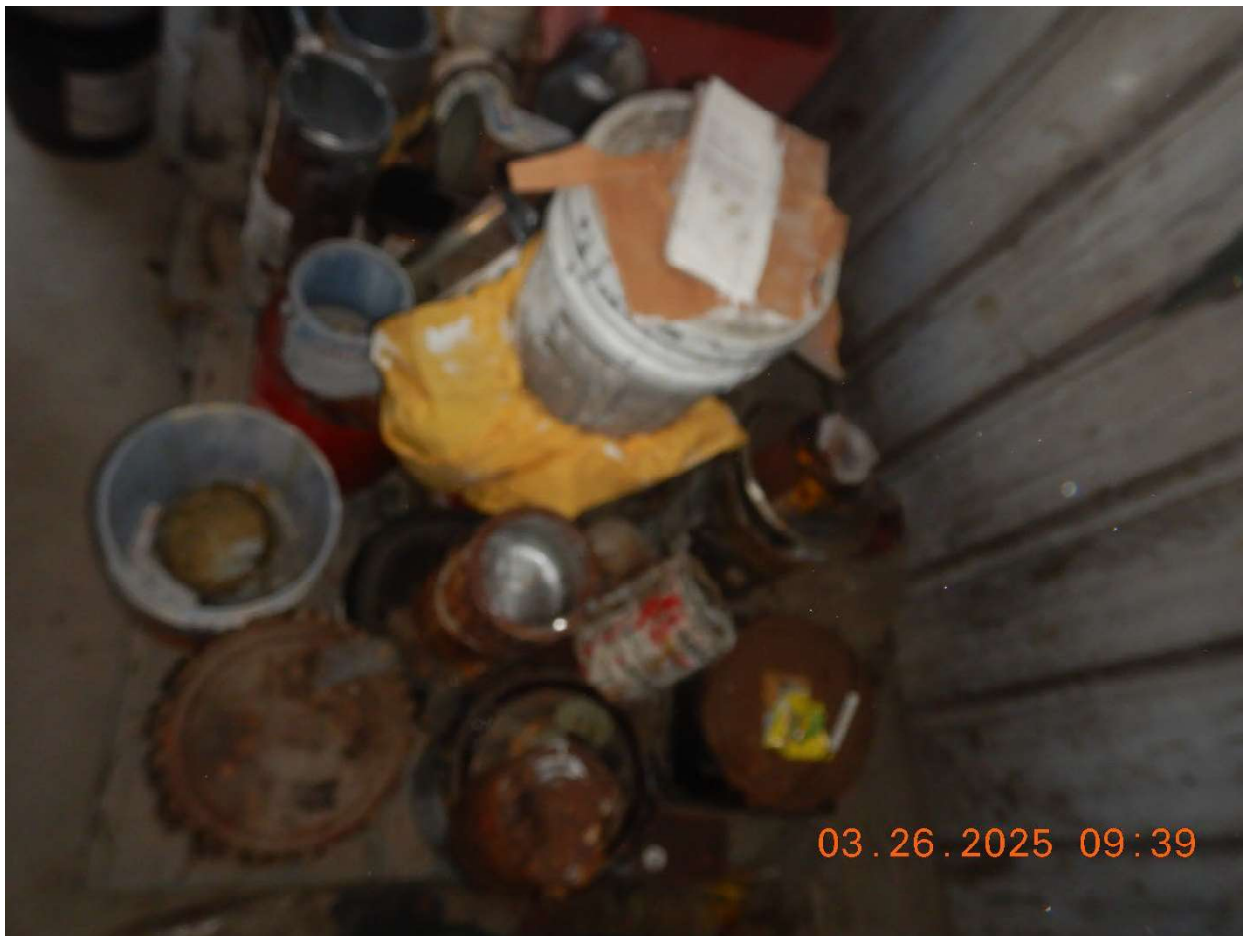
**Photo No. 33**

Description: Another view of a pallet containing 5-gallon containers and 1-gallon containers of paint-related waste inside the hazardous waste accumulation area.

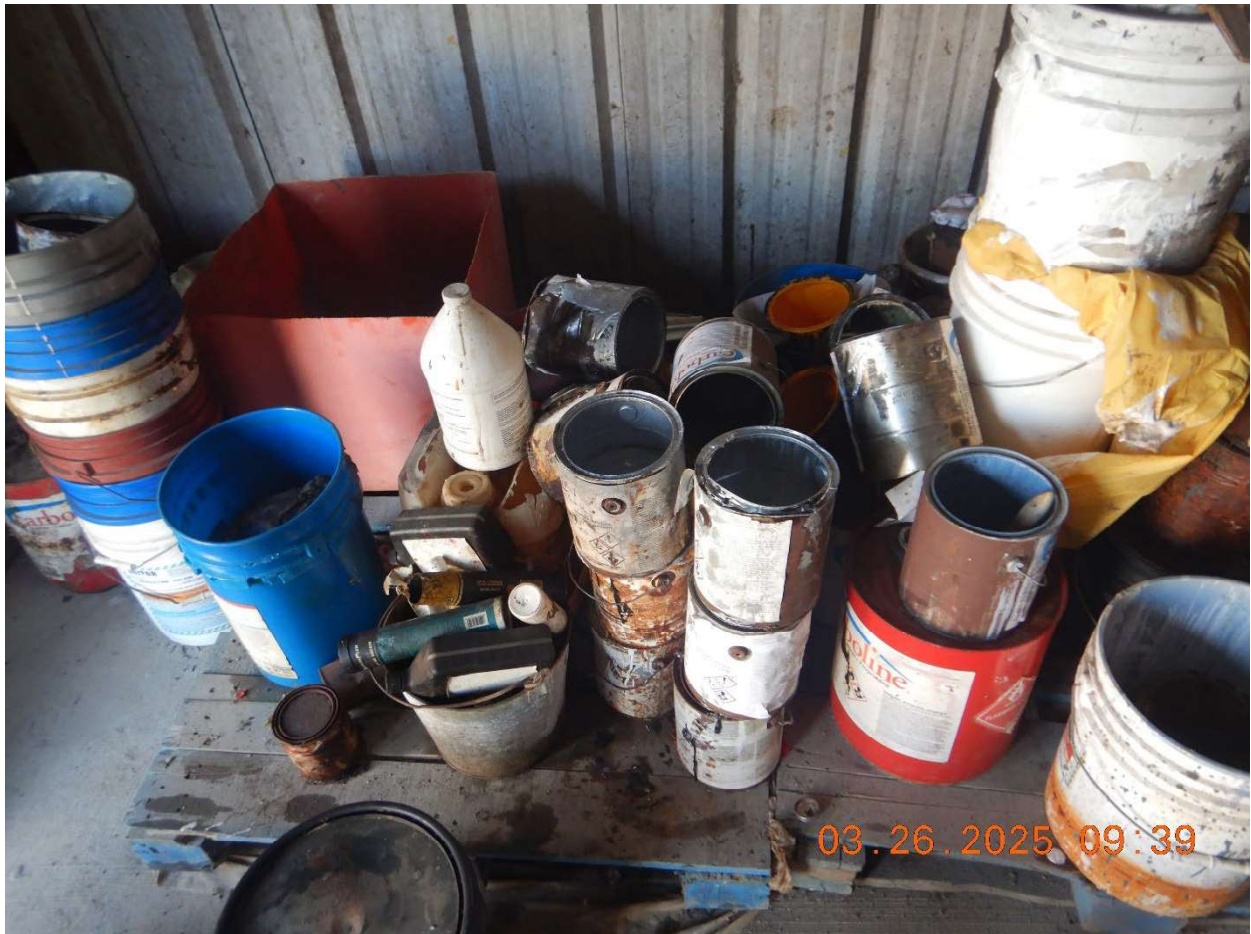
Photo No. 34

Description: View of a pallet containing 5-gallon containers and 1-gallon containers of paint-related waste inside the hazardous waste accumulation area.

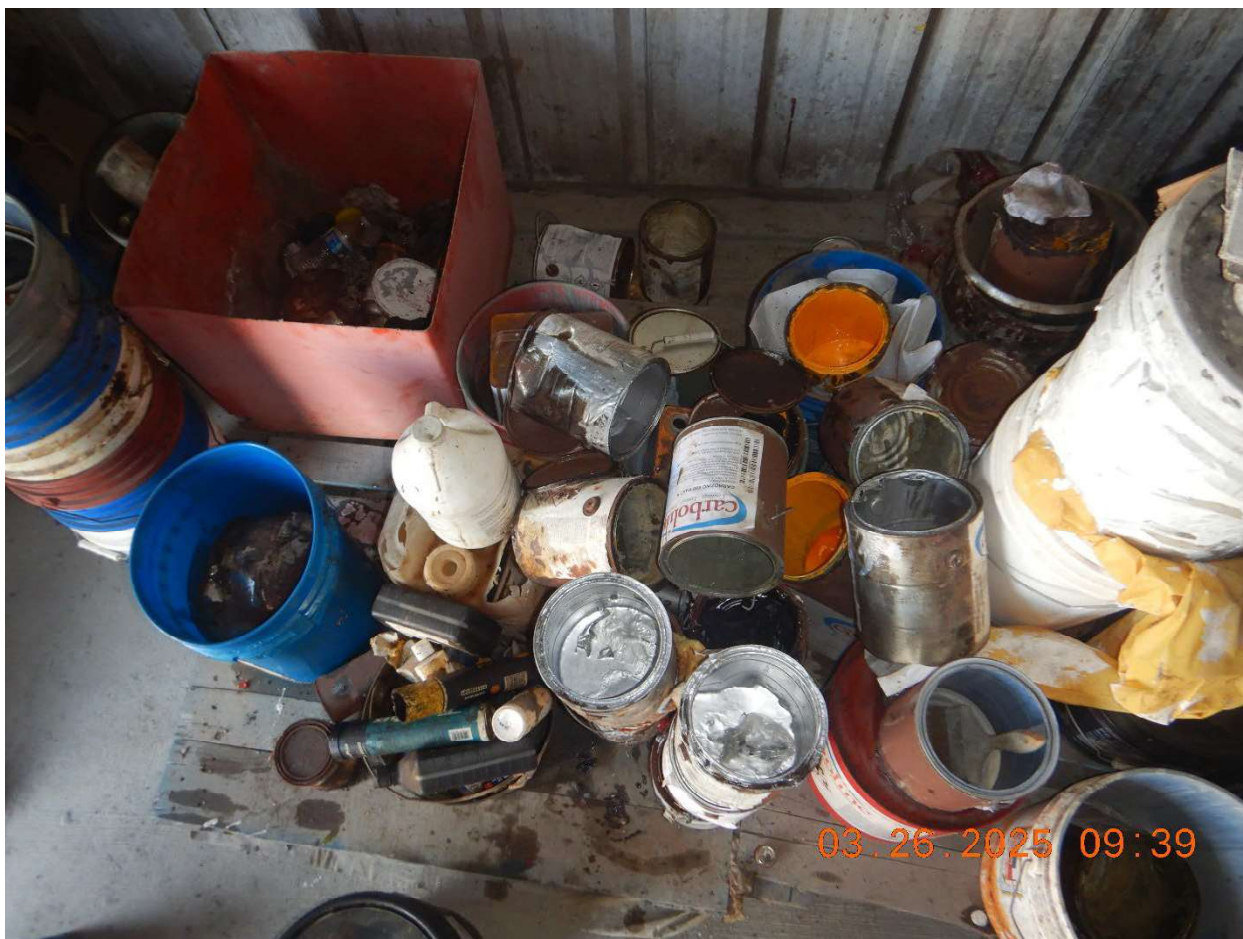
Photo No. 35

Description: Another view of a pallet containing 5-gallon containers and 1-gallon containers of paint-related waste inside the hazardous waste accumulation area.

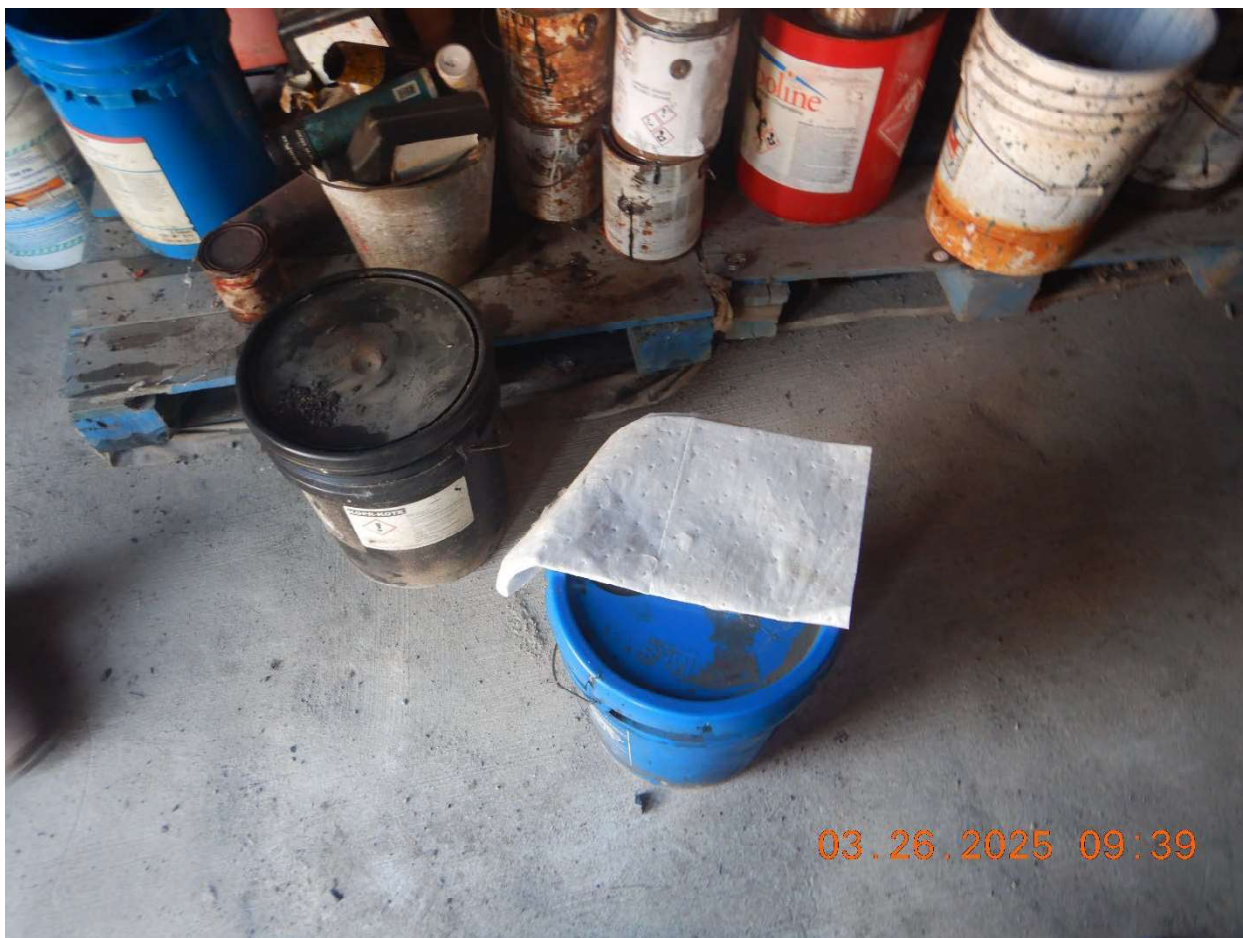
**Photo No. 36**

Description: Another view of a pallet containing 5-gallon containers and 1-gallon containers of paint-related waste inside the hazardous waste accumulation area.

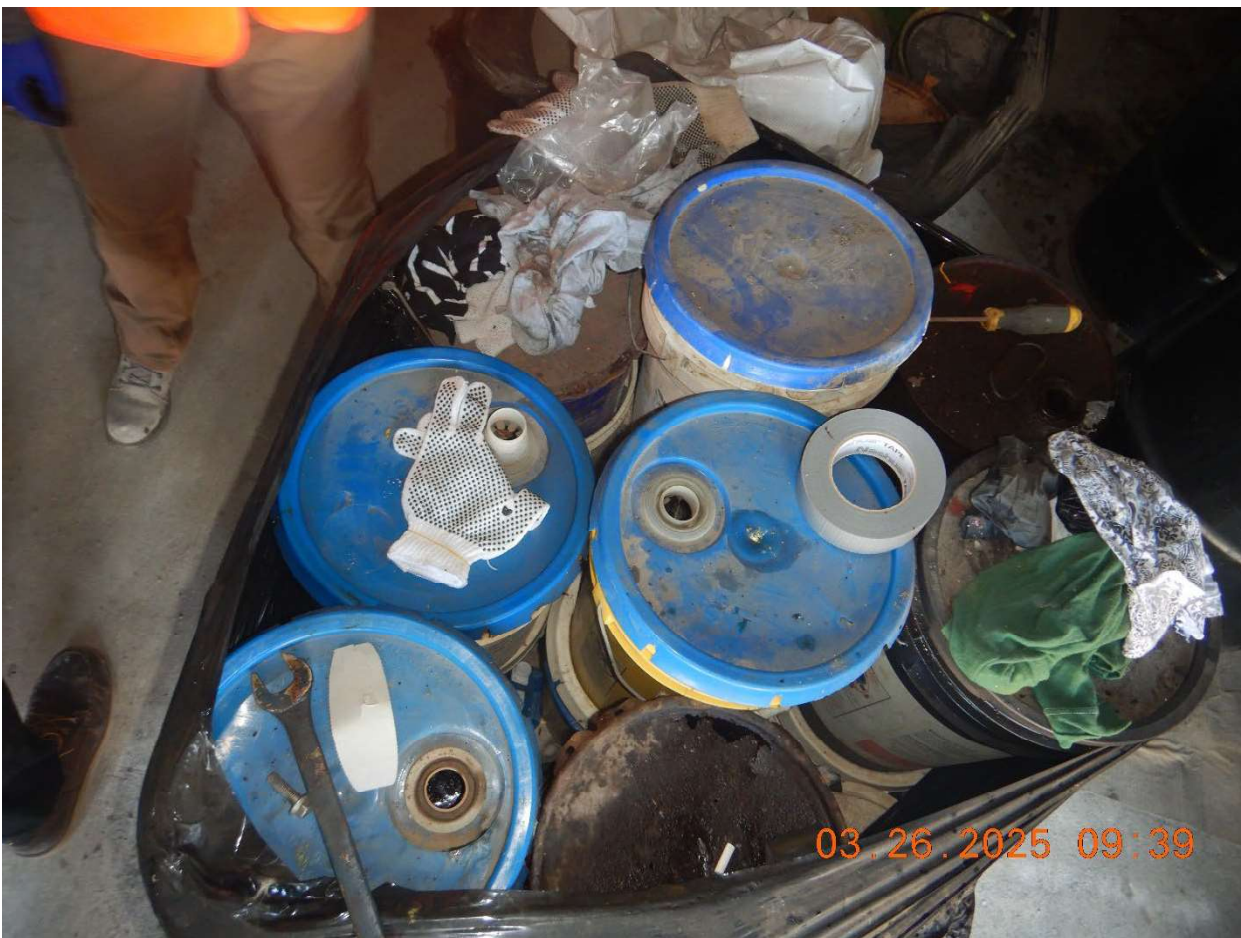
Photo No. 37

Description: Another view of a pallet containing 5-gallon containers and 1-gallon containers of paint-related waste inside the hazardous waste accumulation area.

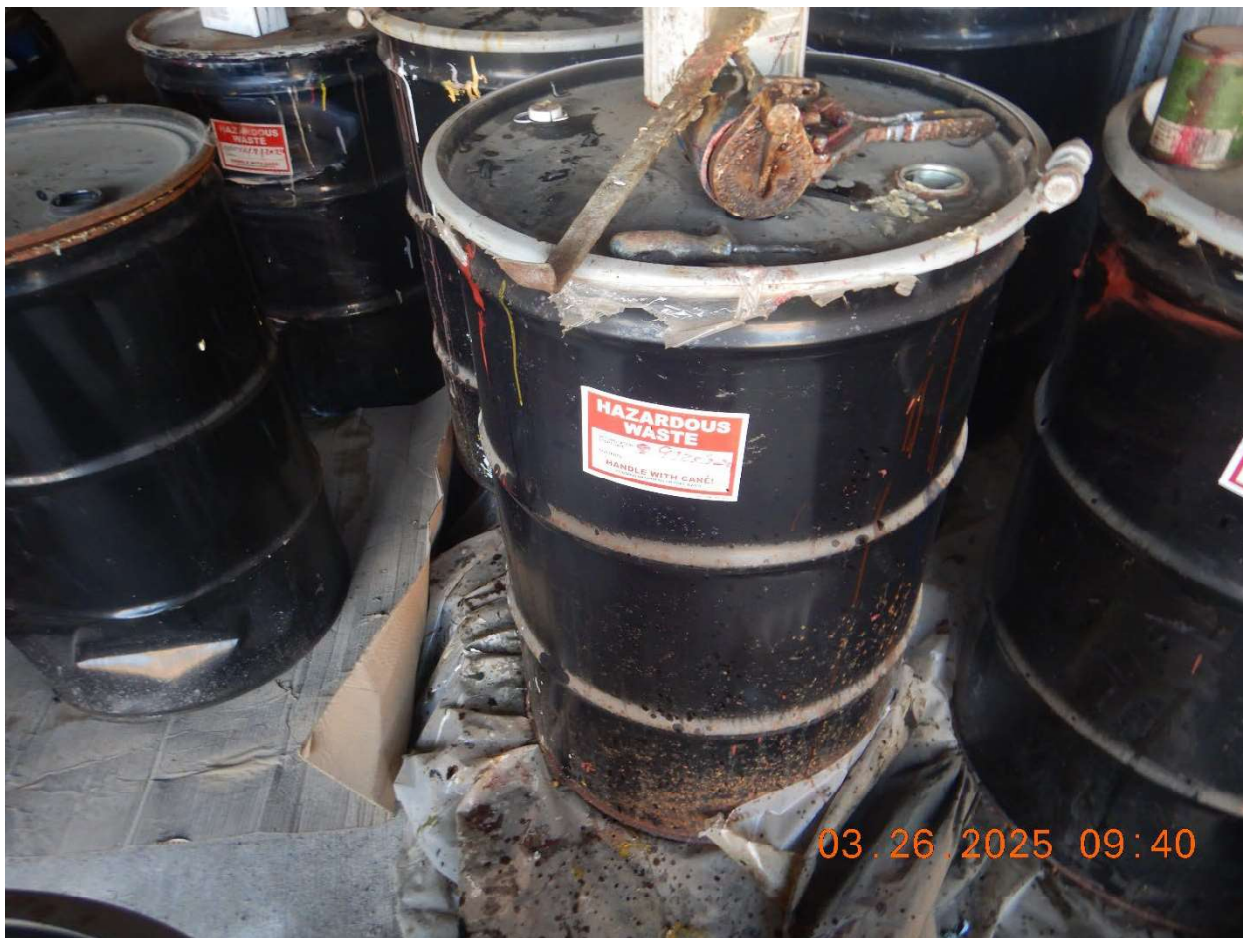
Photo No. 38

Description: View of a full 55-gallon drum inside the hazardous waste storage area with an accumulation start date of 9/25/2024.

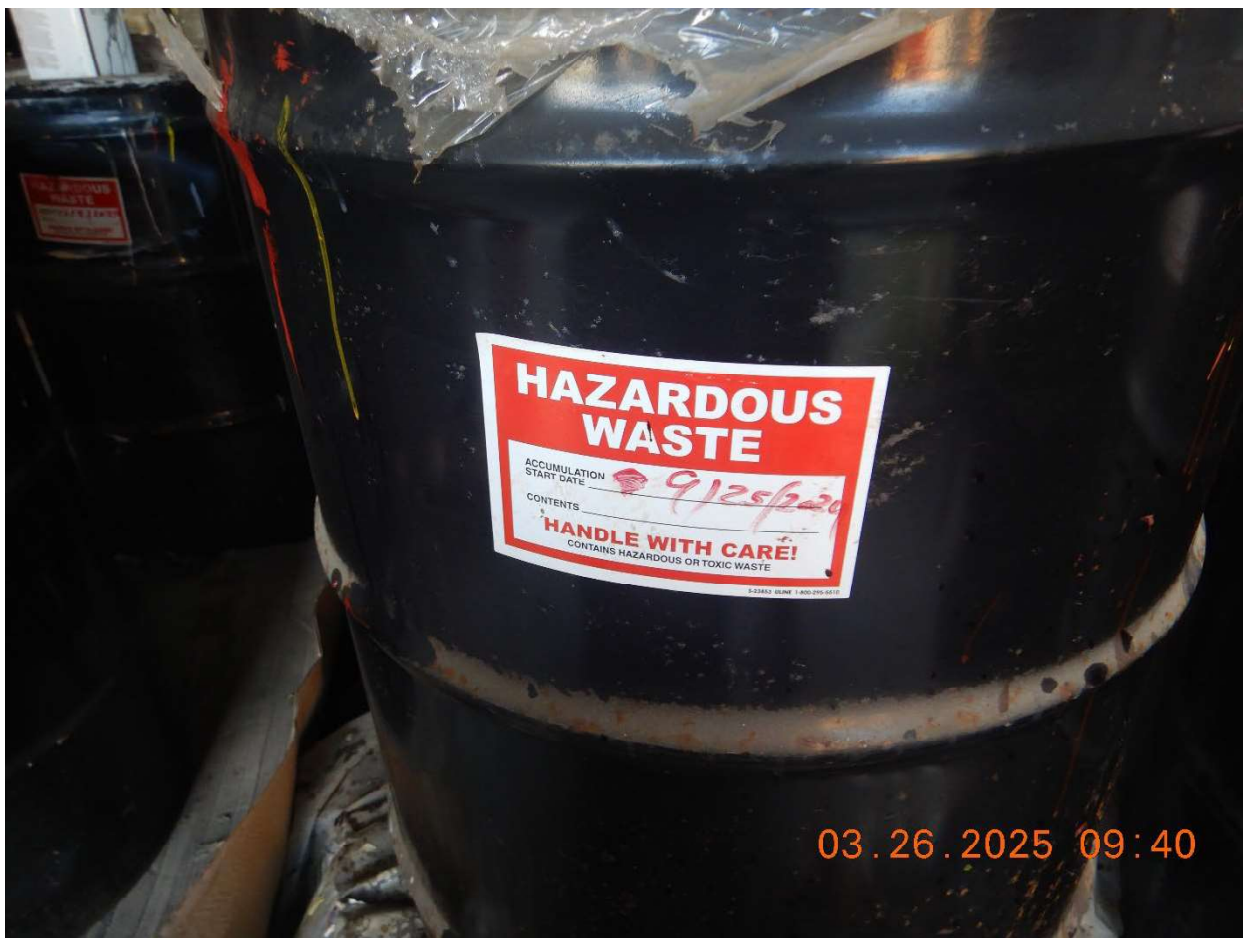
Photo No. 39

(see Appendix 1 – Photos 39, 41, 47, and 49) [**AOC #3** – MARS accumulated hazardous waste for more than 180 days - 40 CFR 262.16(b)]. The inspection team noted that the hazardous waste storage area drains to a sump in the middle of the right side of the building, and the sump drains directly outside of the building onto the ground (see Appendix 1 – Photos 50 and 51). Mr. Stephenson stated weekly inspections of the central accumulation area are not completed weekly [**AOC #4** – MARS did not complete weekly inspections of the hazardous waste central accumulation area - 40 CFR 262.16(b)(2)(iv)]. Overview pictures, including signage indicating the Hazardous waste storage area, and views inside the area, can be seen in Photos 52 to 54.
